# FISH CREEK BASIN SPRING BREAKUP

# 2011

## HYDROLOGIC ASSESSMENT

124033-MBJ-RPT-001

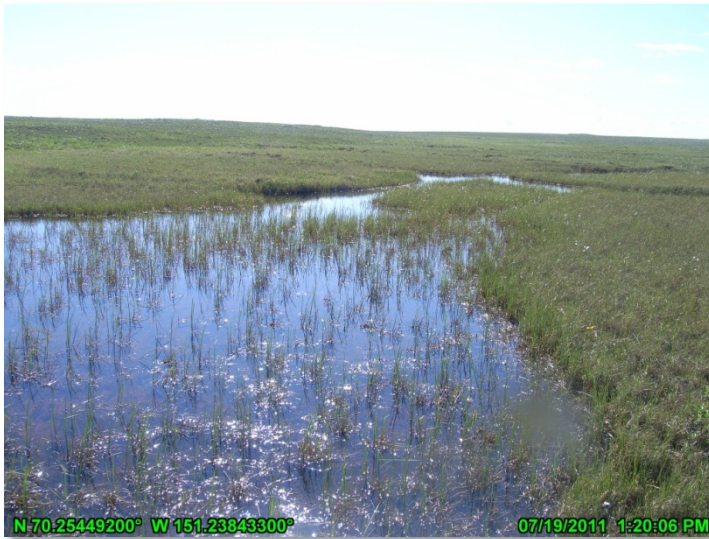
**Photo 2.1: Typical vegetation found in Clover B drainage, photo taken in vicinity of B1; July 19, 2011**

drainage may occur. Tussocks and native grasses cover both overbanks, with dwarf willows and native grass in the channel (Photo 2.1). The confluence with the Ublutuoch River lies approximately 0.2 miles downstream from the Clover B1 gage location, at Ublutuoch RM 11.1.

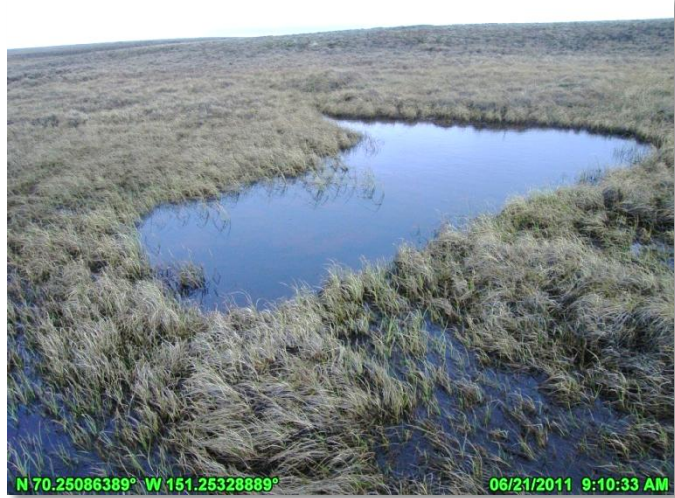
**Photo 2.2: Pond in the tundra in the vicinity of Clover C1 after flow has ceased; June 21, 2011**

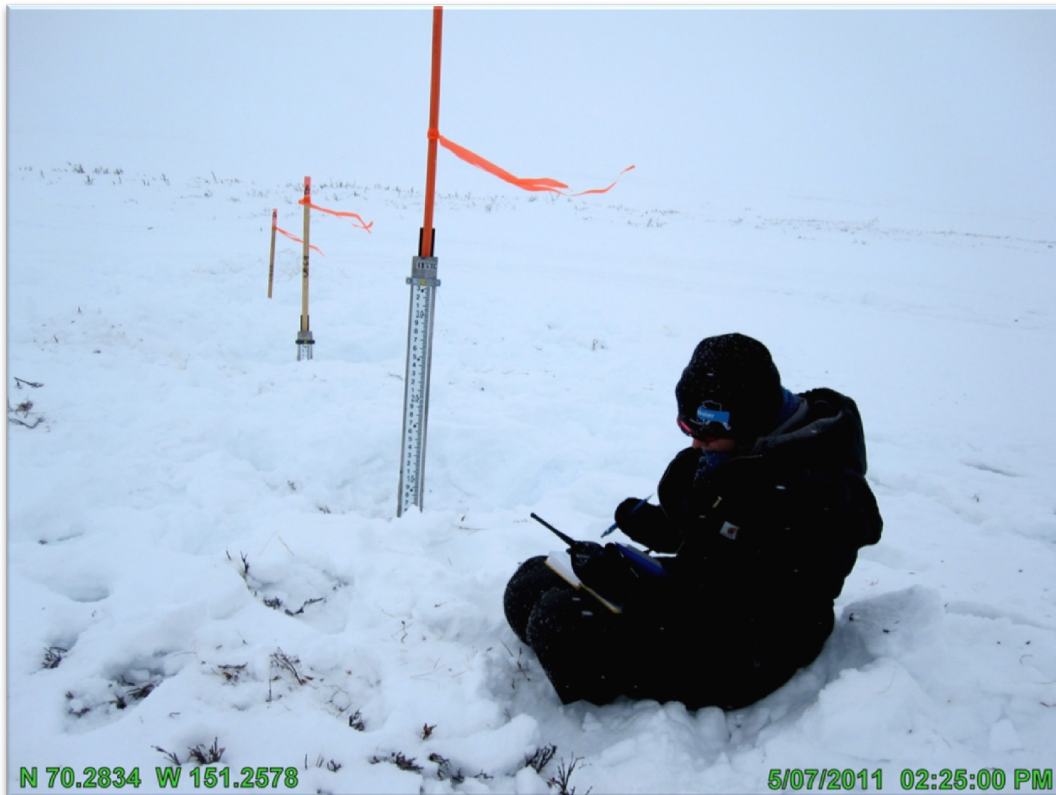
Photo 2.3: Gages at UB6.9, Gage A is closest to the channel (background), looking east;  
May 7, 2011

The Ublutuoch River monitoring sites were comprised of sets of three to four gages installed on the west bank of the river at RM 6.7, 6.8, and 6.9, as shown in Figure 2.1 and presented in Photo 2.3. The RM location designations, UB6.7, UB6.8, and UB6.9, refer to the distance in river miles from the confluence of the Ublutuoch River and Fish Creek. The gage locations were selected to monitor and document local breakup conditions at the proposed bridge location and upstream and downstream conditions of the proposed crossing. The proposed Ublutuoch bridge location at UB6.8 remains the same as it was in 2005, 2006, and 2010. At the proposed bridge site, the Ublutuoch River has a drainage area of approximately 228 square miles. The Ublutuoch River drainage basin is included in Figure 1.2.

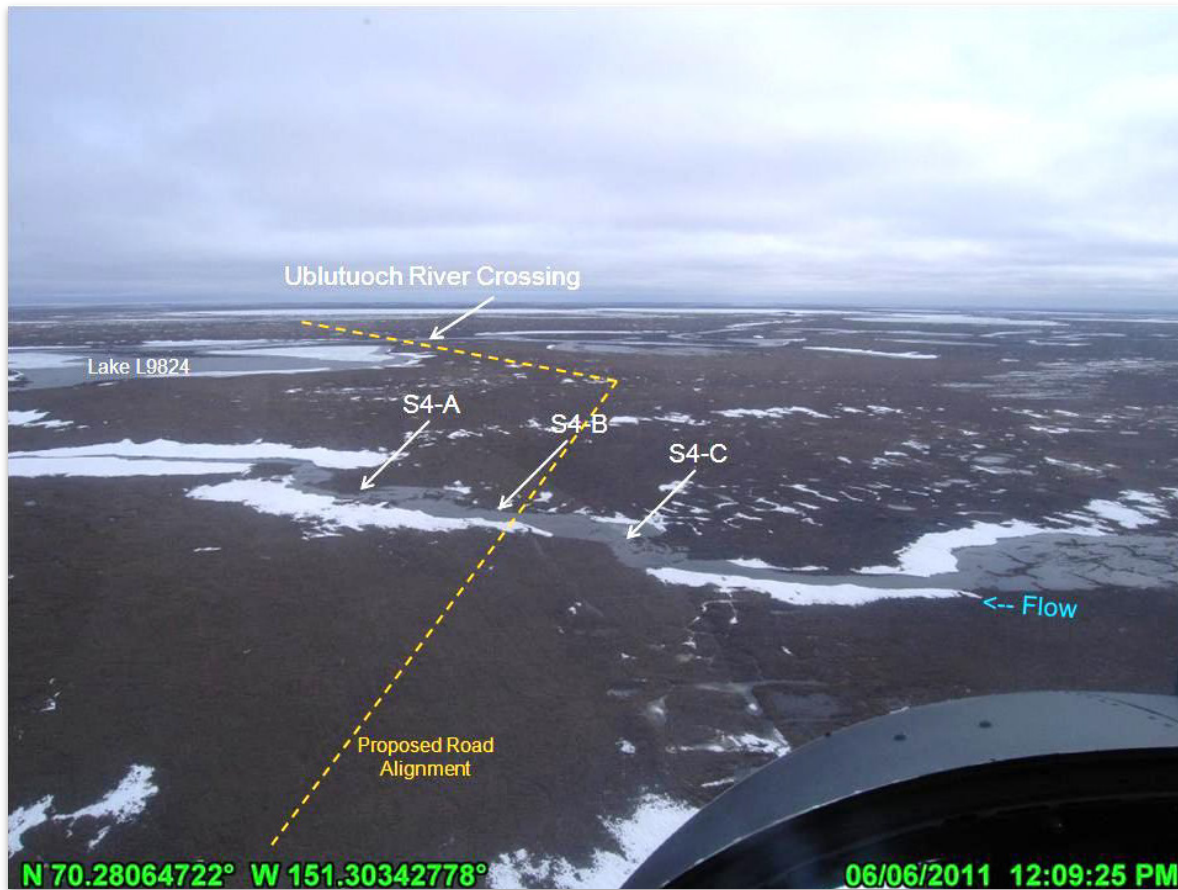
Photo 2.5: Flow in S4 during breakup monitoring, looking southeast; June 6, 2011

Channelized flow was present at S4 during spring breakup monitoring in 2005, 2006, 2009, and 2011 (Photo 2.5). This location was not monitored in 2010. Culverts are proposed as drainage structures for this GMT1 road crossing location. Three gages were placed at this site, one at the proposed road crossing centerline (S4-B), one approximately 330 feet upstream (S4-C), and one approximately 300 downstream of the crossing (S4-A). The purpose of the configuration of the gages at S4 was to facilitate the calculation of indirect discharge. See Figure 1.3 for the S4 monitoring locations in reference to the FCB, and Figure 2.4 for details.

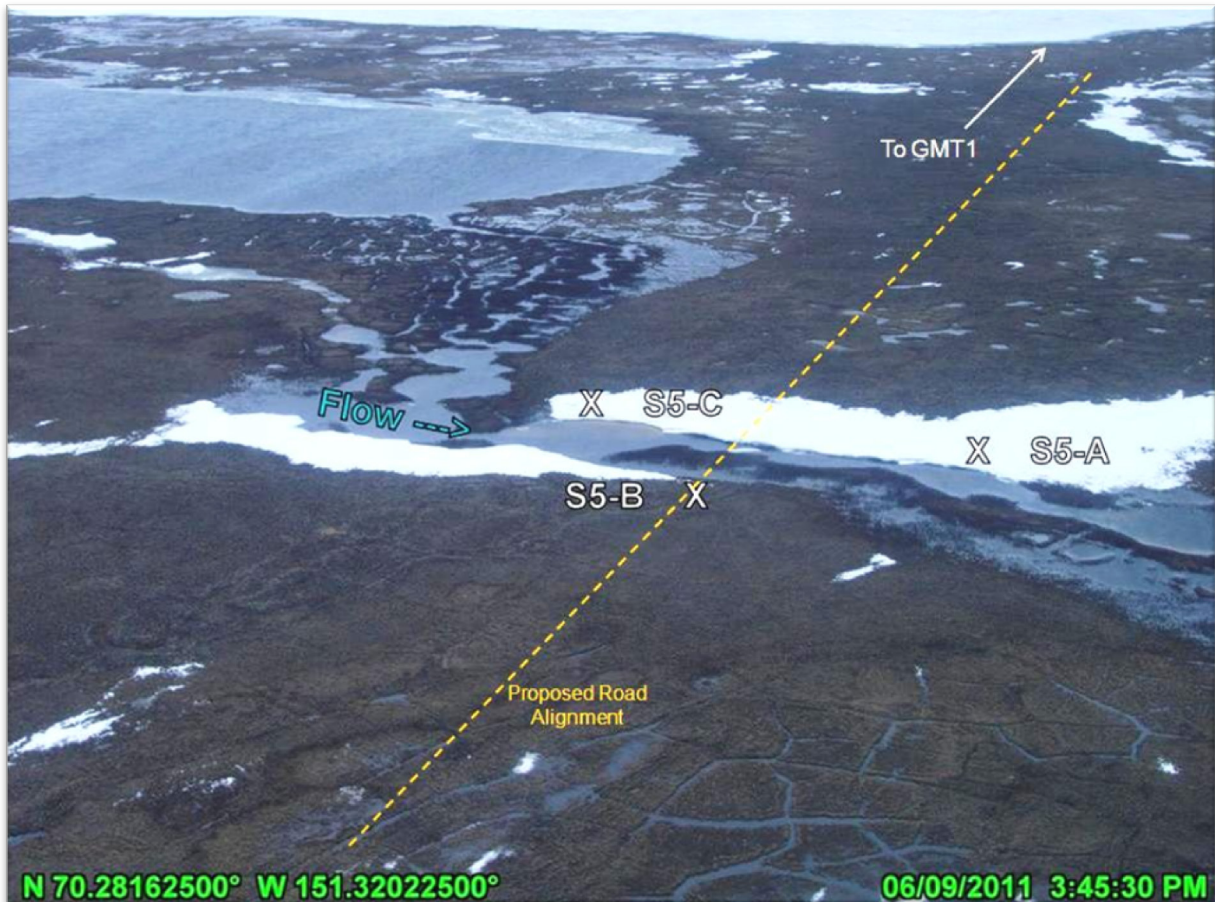
Photo 2.6: GMT 1 road crossing at S5, looking west; June 9, 2011

Channelized flow was present at this location during spring breakup monitoring in 2005, 2006, 2009, 2010, and 2011. A bridge is proposed as the drainage structure for this road crossing location. Three gages were placed at this site, one at the proposed bridge crossing centerline (S5-B), one gage approximately 200 feet upstream (S5-C), and one approximately 250 feet downstream of the crossing (S5-A). The configuration of the gages at S5 facilitates the calculation of indirect discharge. See Figure 1.3 for the S5 monitoring location in reference to the FCB, and Figure 2.5 for details.

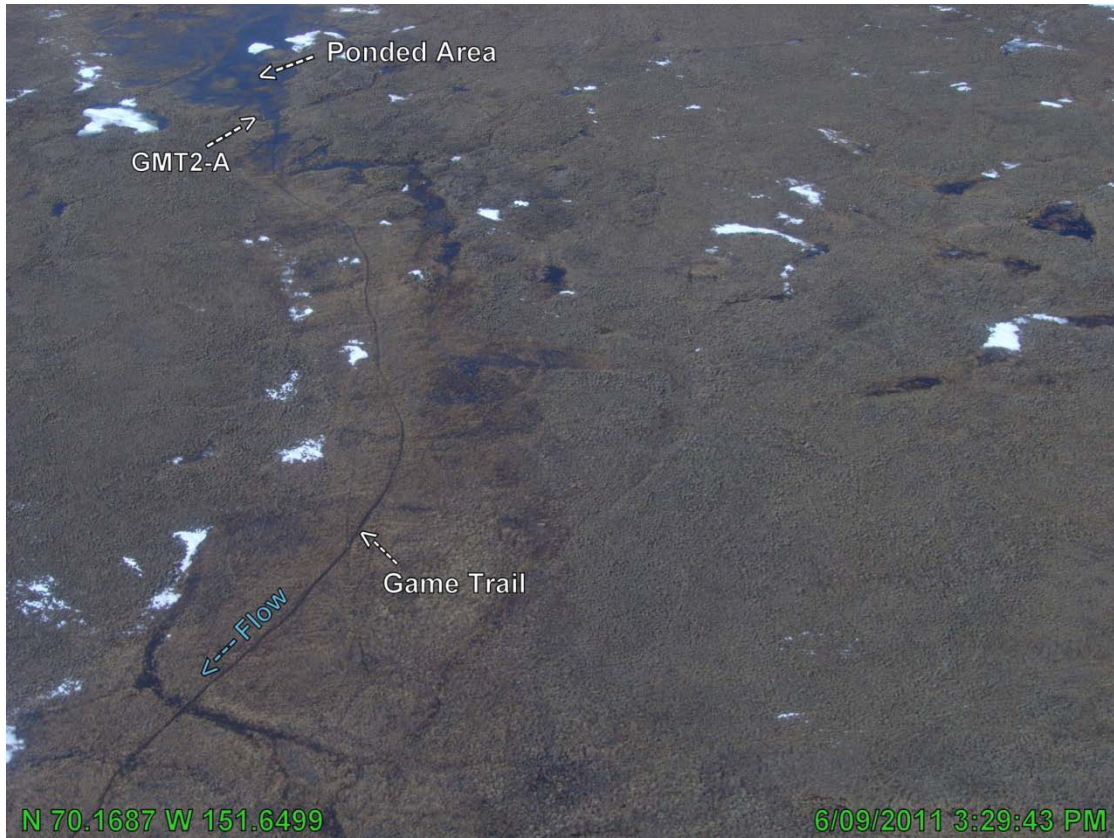
Photo 2.7: GMT2 Gage - Game trail downstream of gage and ponded area upstream of gage, looking north; June 9, 2011

Monitoring at the GMT2 location continued in 2011. The drainage at this location was well defined during breakup when channelized flow was present; later in the season flow ceased. Upstream of the GMT2 gage, the channel appeared to be confined to a game trail. Downstream of the gage, the channel widens into a large ponded area. When monitoring ended on July 19, 0.2 feet of water remained in the marshy ponded area by the gage. Tussocks and native grasses cover both overbanks and the channel. Figure 2.6 shows the location of the GMT2 gage.

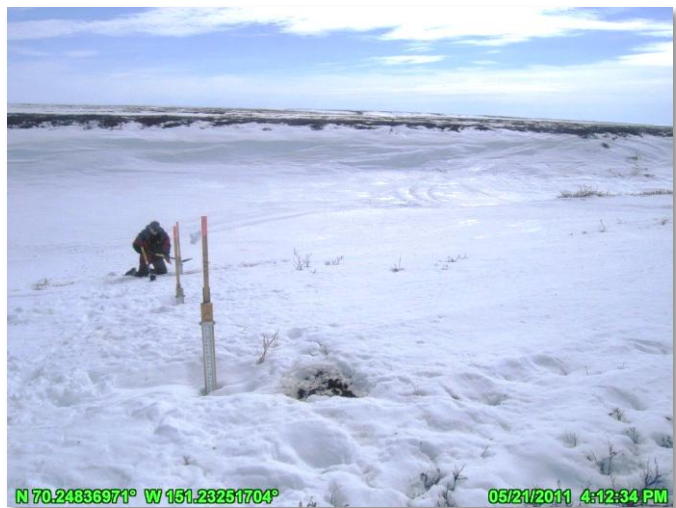
**Photo 3.1: Staff gage setup at a site along the Ublutuoch River, looking south; May 21, 2011**

Temporary staff gages consisted of one to four gage assemblies per site. Each gage assembly contained a metal gage faceplate mounted on a two-by-four timber attached with U-bolts to a 6-foot long 1.5-inch angle iron post driven approximately 2 feet into the ground. The horizontal position of each gage was recorded using a handheld Garmin Rino 530HCx in North American Datum of 1983 (NAD83) with wide area augmentation system (WAAS) enabled allowing for 1 meter (3 feet) horizontal accuracy. Photo 3.1 shows a setup of four staff gage assemblies at site UB11.45 on the Ublutuoch River.

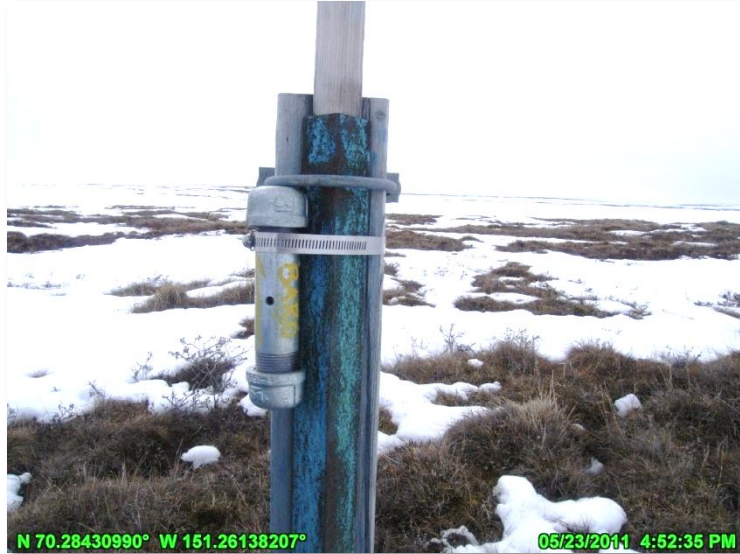
Photo 3.4: Barometric PT installed on UB6.8 Gage D, pre-breakup; May 23, 2011

Solinst® Levelogger Model 3001 PTs were installed at six gage locations: UB6.7, UB6.9, UB11.45, UB11.6, Clover B2, and Clover C2. The PT recorded pressure datum is the sum of the forces imparted by both the water column and atmospheric conditions. Variations in barometric pressure were taken into account using an independent barometric pressure logger: a Solinst® Barologger. A correction of local barometric pressure was obtained from the Barologger. The barometric pressure logger location was considered representative of the FCB. See Appendix A for PT and barometric pressure logger basis of elevation and horizontal positions.

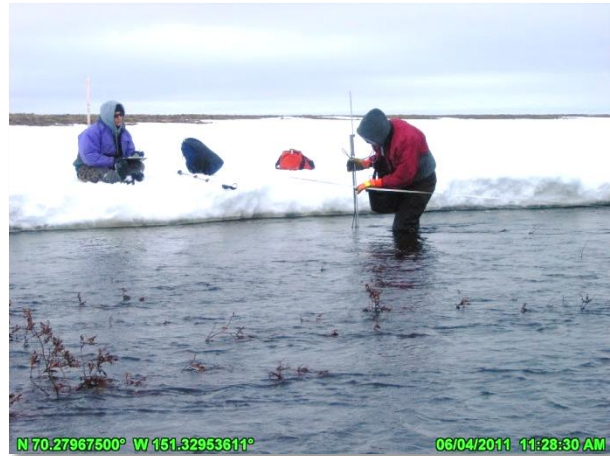
**Photo 3.5: Baker crew performing a direct discharge measurement at S5; June 4, 2011**

Discharge was measured directly and calculated indirectly based on field observations. Standard United States Geological Survey (USGS) midsection methods were used to measure discharge. When possible, velocity and discharge measurements were taken as close to the observed peak stage as possible to determine the peak direct discharge. Indirect discharges were calculated based on observed data.

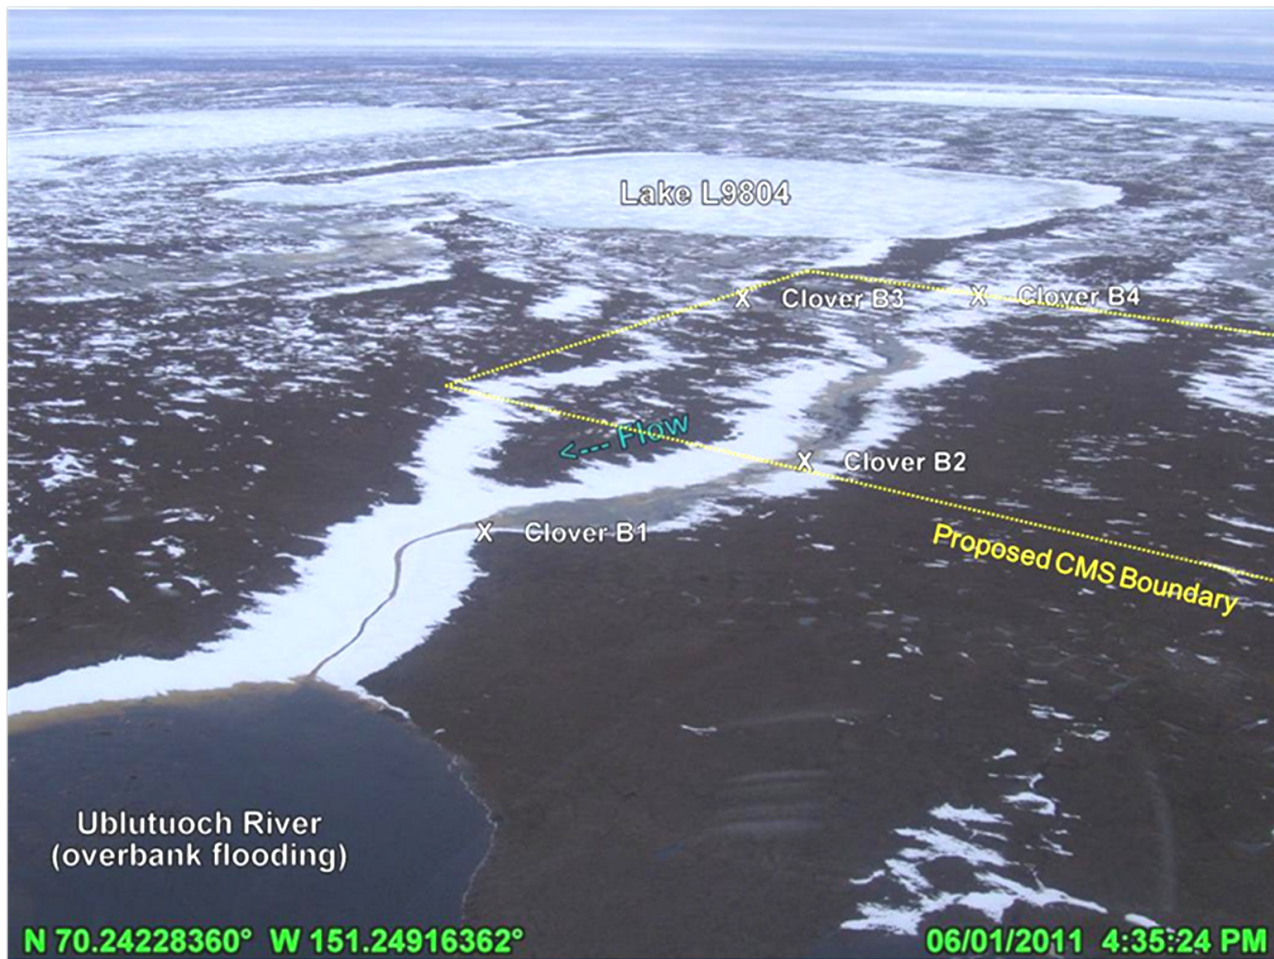
Photo 4.1: Clover B drainage at the beginning of spring breakup, looking upstream (southeast) from the Ublutuoch River; June 1, 2011

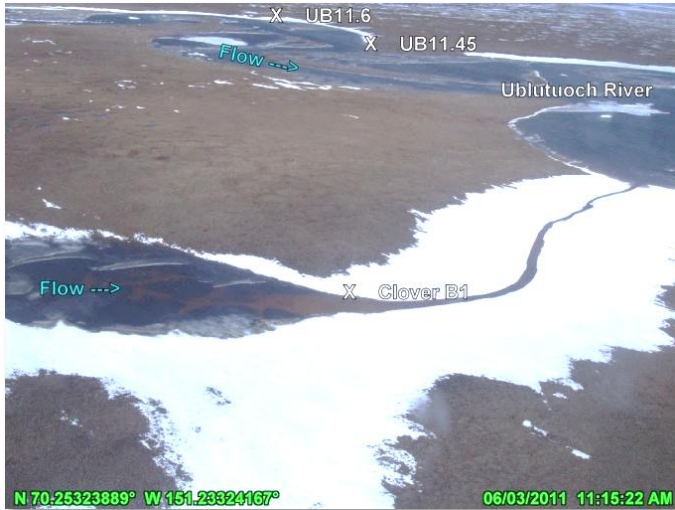
Photo 4.2: Clover B1 - Drainage flowing north into the Ublutuoch River during peak stage, looking northwest; June 3, 2011

Significant snow was present in this drainage at the beginning of breakup, with the majority of accumulation at the downstream location, Clover B1 (Photo 4.2). Ice was observed on the channel bed and remained until June 6. Flow downstream of B1 appeared to pass through a confined artificial channel bound by snow. This snow lined channel was open on June 9 (Photo 4.3), but had melted significantly by June 21 (Photo 4.4). By June 21, there was some snow remaining on the right bank, but the stage had dropped and it did not appear to affect flow.

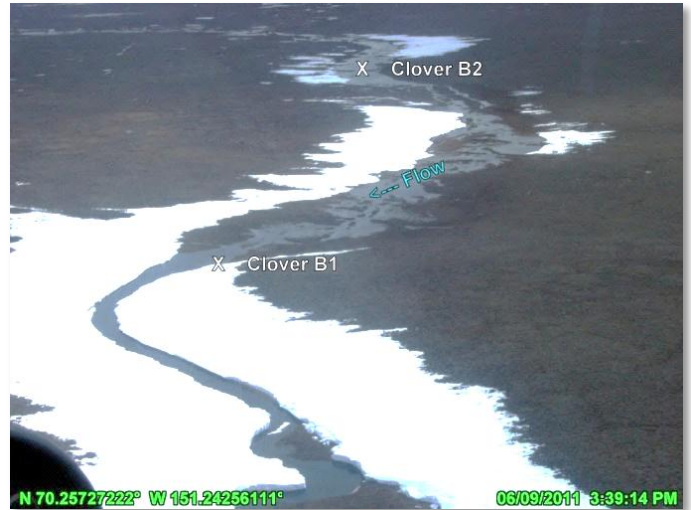
Photo 4.3: Clover B1 - As breakup flood flow recedes, looking upstream (south) toward Clover B2; June 9, 2011

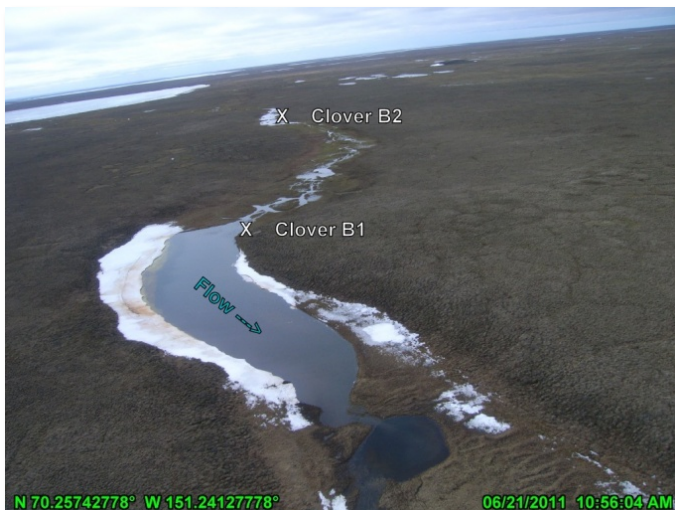
Photo 4.4: Clover B1 - After breakup; beaded pools with flow present, looking upstream (south) toward Clover B2; June 21, 2011

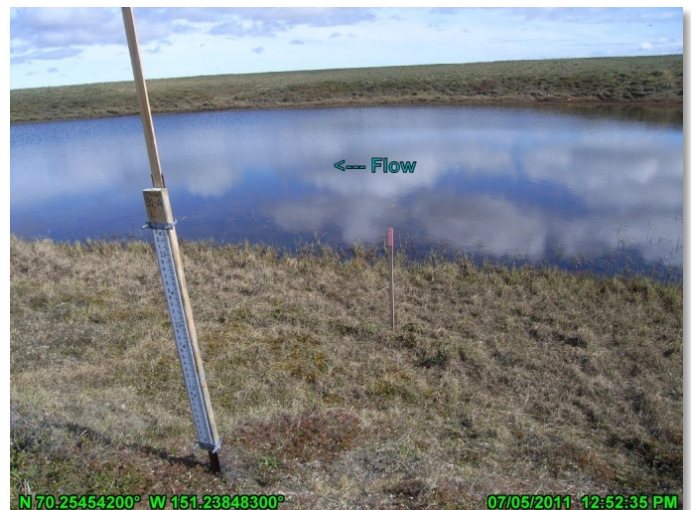
Photo 4.5: Clover B1 - After breakup; pool with flow, No Snow Present, looking east; July 5, 2011

By July 5, all snow in the vicinity of Clover B drainage had melted (Photo 4.5 and Photo 4.6). During final monitoring on July 19, the channel consisted of beaded pools, and low flow through grassy areas between the pools was still present (Photo 4.7).

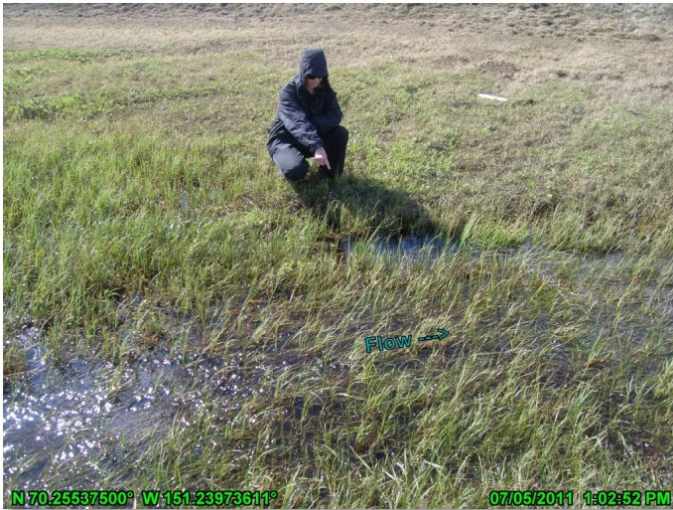
Photo 4.6: Clover B1 - Low flow between pools still present draining towards the Ublutuoch River; July 5, 2011

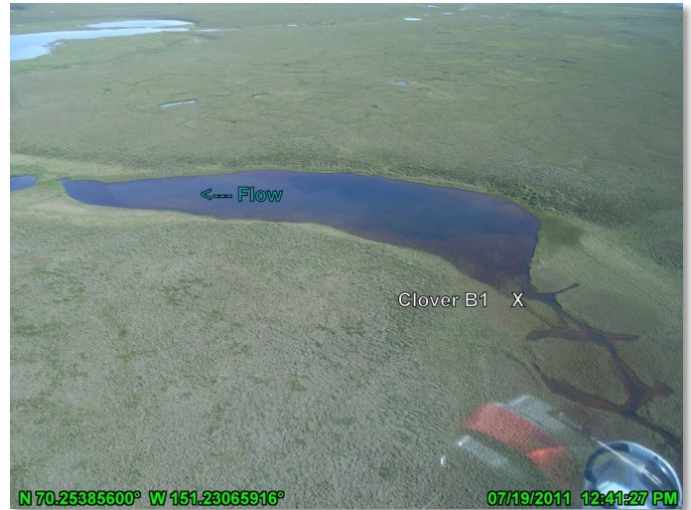
Photo 4.7: Clover B1 - Pool with low flow at the end of monitoring, looking northwest; July 19, 2011

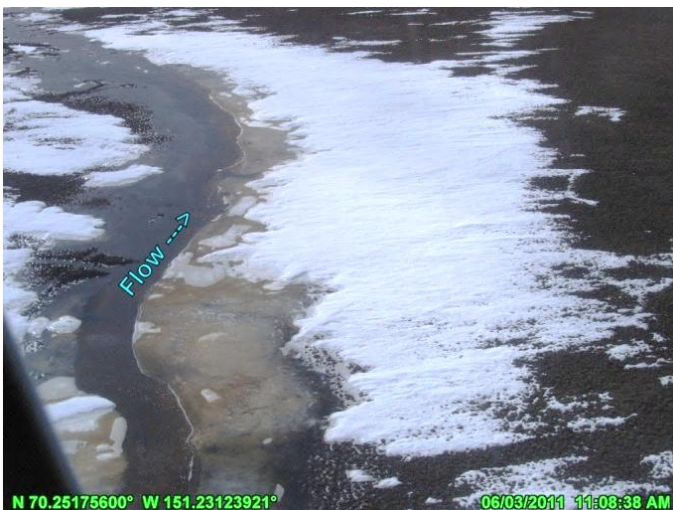
Photo 4.8: Clover B2 vicinity - After peak stage, looking downstream (north) toward Clover B1; June 3, 2011

At Clover B2, near the north edge of the CMS boundary, the channel was less confined by snow during breakup, but flow was still affected by shallow snowpack accumulation (Photo 4.8). Slush floes and bottom ice were observed in the channel until June 4, after which stage decreased and the channel opened. Photo 4.9 and Photo 4.10 show Clover B2 as breakup flood water receded. By June 21, no snow was present on either bank at Clover B2 (Photo 4.11).

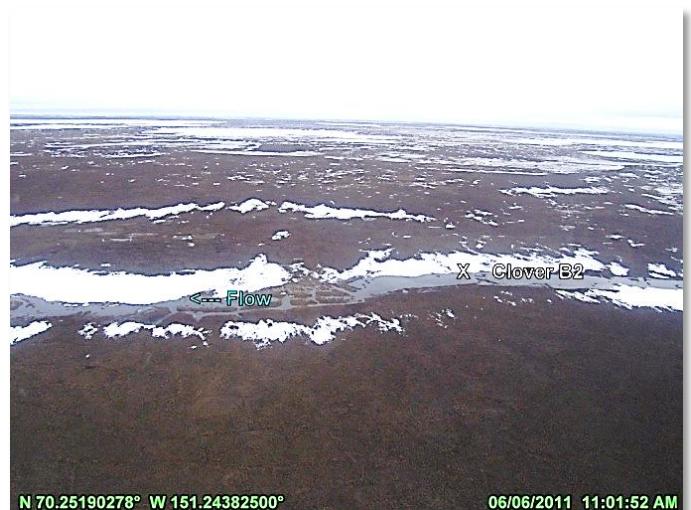
Photo 4.9: Clover B2 - As breakup flood flow receded, looking east; June 6, 2011

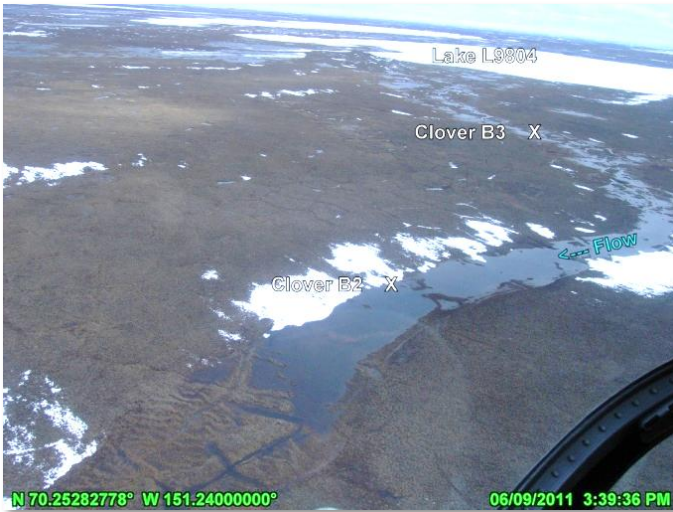
Photo 4.10: Clover B2 - As breakup flood flow recedes, looking upstream (southeast) toward Clover B3; June 9, 2011

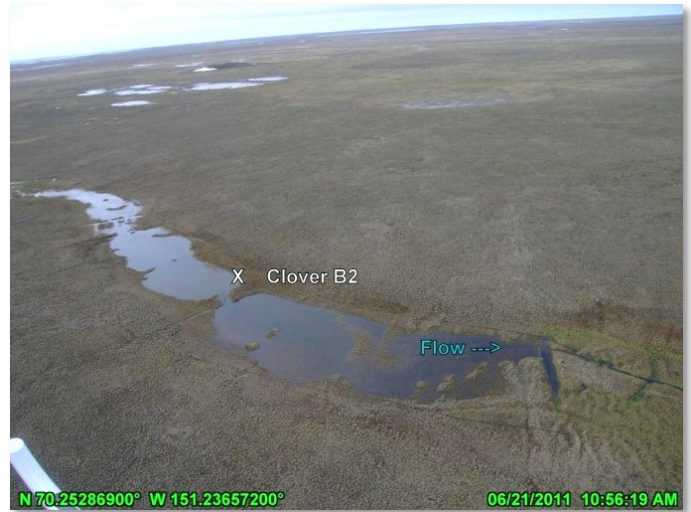
Photo 4.11: Clover B2 - After breakup; beaded pools with flow present, looking upstream (southwest); June 21, 2011

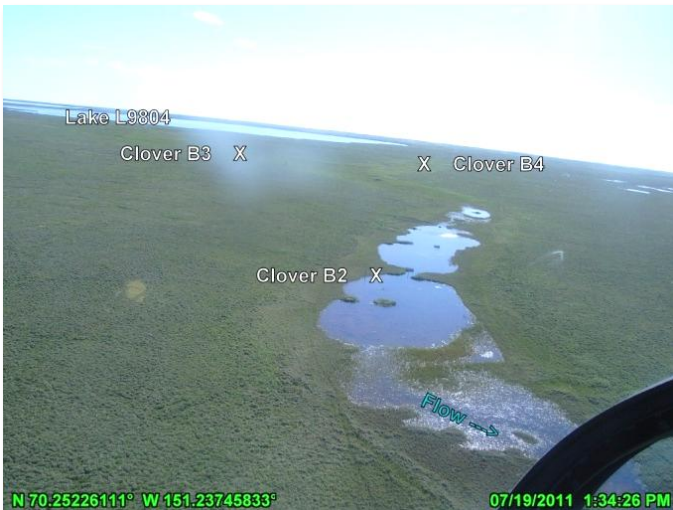
Photo 4.12: Clover B2 - After breakup; beaded pools with flow present, looking upstream (southeast) toward Clover B3; July 19, 2011

By July 5, no snow was present in the area (Photo 4.12). During final monitoring on July 19, Clover B2 consisted of beaded pools with low flow present (Photo 4.13).

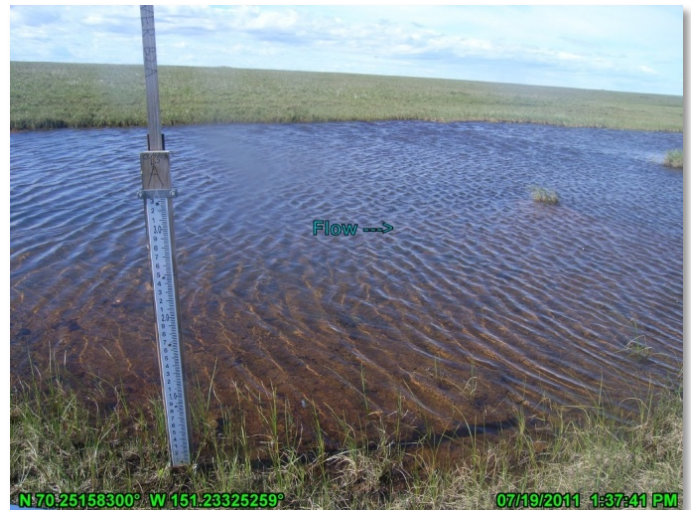
Photo 4.13: Clover B2 - Pool with low flow at the end of monitoring, looking west; July 19, 2011

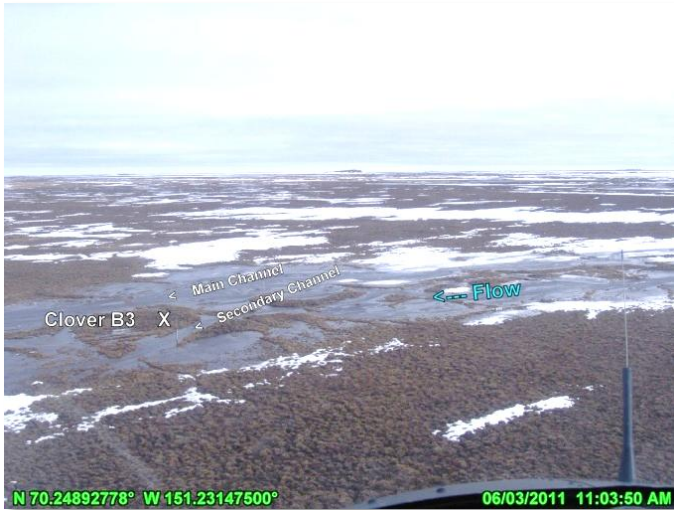
Photo 4.14: Clover B3 - After peak stage, looking east; June 3, 2011

Clover B3 during spring breakup was poorly defined because of the low topographic relief (Photo 4.14). At the beginning of monitoring on June 1, flow was divided into two distinct channels. By June 4 as stage decreased, flow had divided into multiple polygon cracks. No snow was present in the channel by June 4, and the majority of snow in the area had melted by June 6 (Photo 4.15). Photo 4.16 and Photo 4.17 show Clover B3 as breakup flow receded.

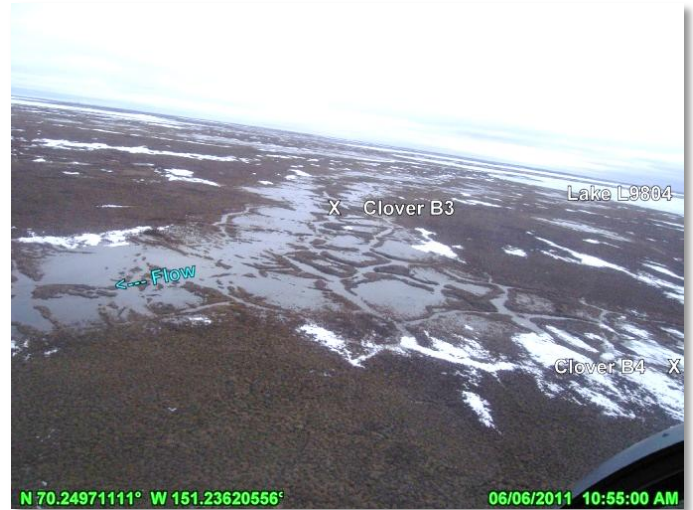
Photo 4.15: Clover B3 - Flow in polygon cracks as stage drops, looking upstream (southeast) with Clover B4 site to the south; June 6, 2011

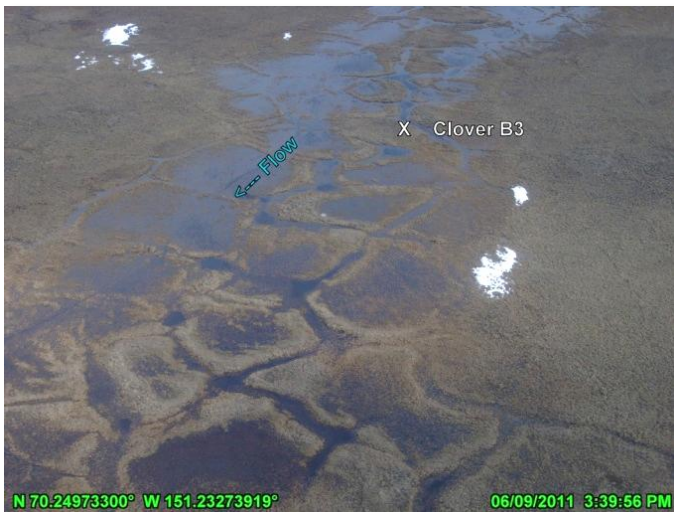
Photo 4.16: Clover B3 - Polygon crack as breakup flood flow recedes, looking upstream (east); June 9, 2011

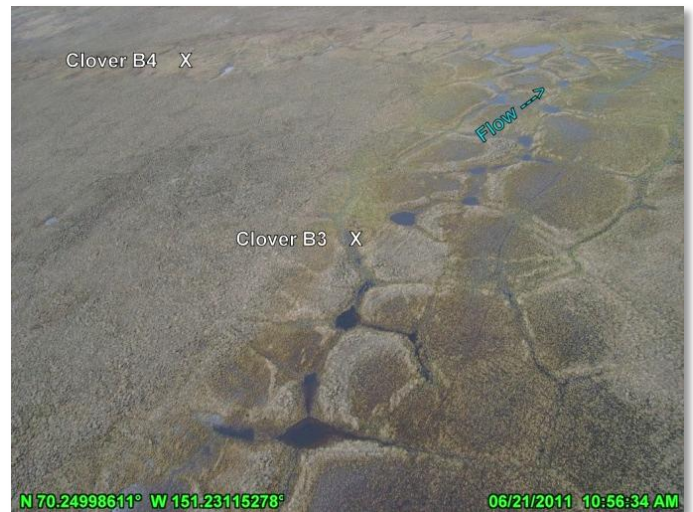
Photo 4.17: Clover B3 - After breakup; polygon crack with small pools, flow present, looking downstream (west); June 21, 2011

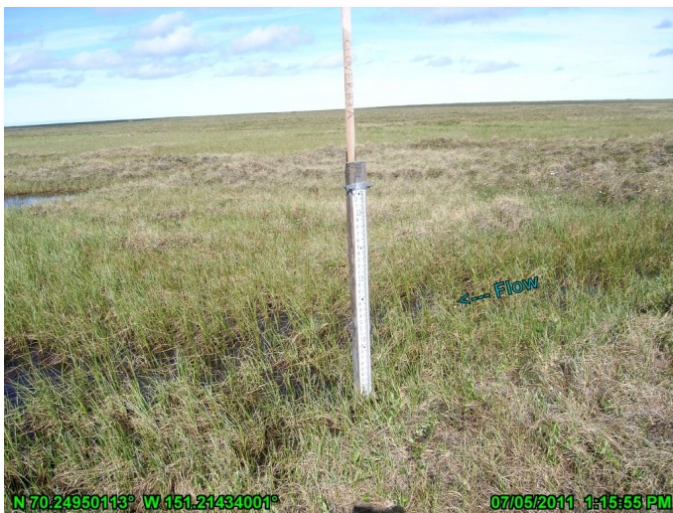
Photo 4.18: Clover B3 - After breakup; polygon crack with low flow, looking east; July 5, 2011

On July 5, low flow was observed through a single polygon crack (Photo 4.18). During the final monitoring visit on July 19, the channel consisted of small ponds, marshy areas, and polygons. No visible flow was seen (Photo 4.19).

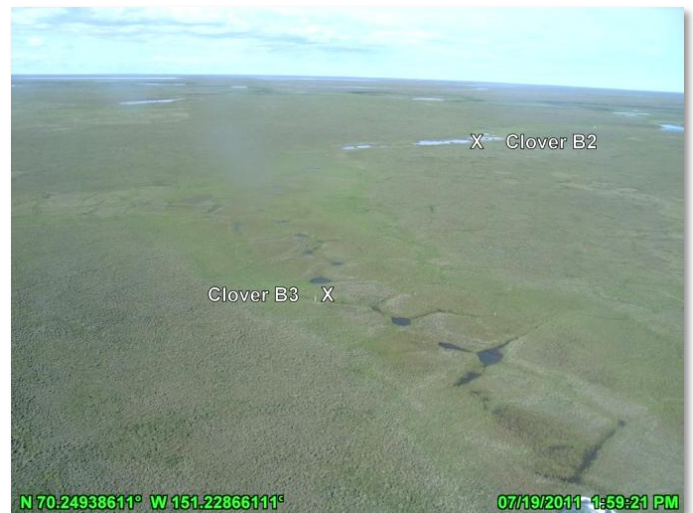
Photo 4.19: Clover B3 - Small ponds and marshy areas, no visible flow, looking downstream (north); July 19, 2011

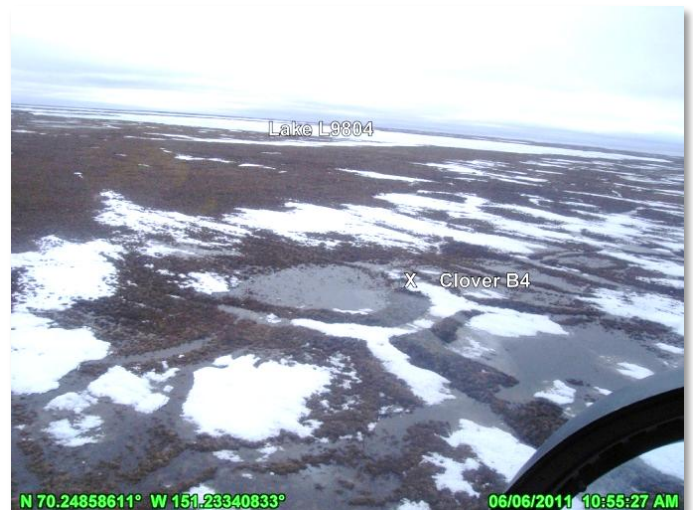
Photo 4.21: Clover B4 - Local melt, no channelized flow, looking upstream (southeast); June 6, 2011

During the spring breakup monitoring period, no distinguishable channelized flood flow was observed at Clover B4 (Photo 4.20, Photo 4.21 and Photo 4.22). Collected WSE data at B4 was the result of local melt and overland sheet flow.

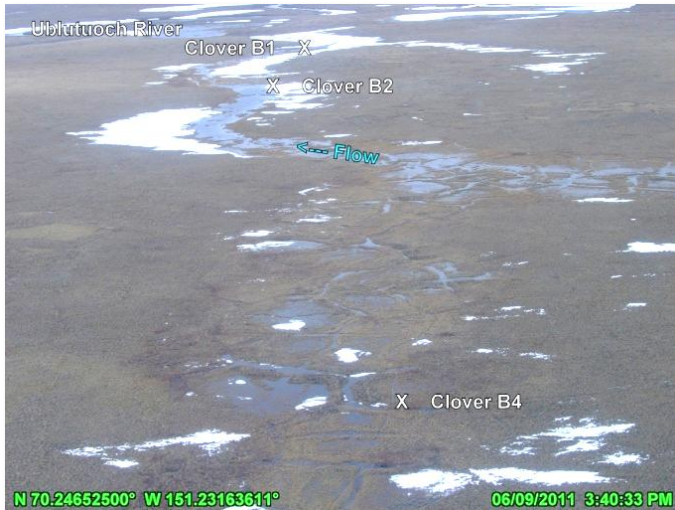
Photo 4.22: Clover B4 - Local melt, no channelized flow, looking downstream (north); June 9, 2011

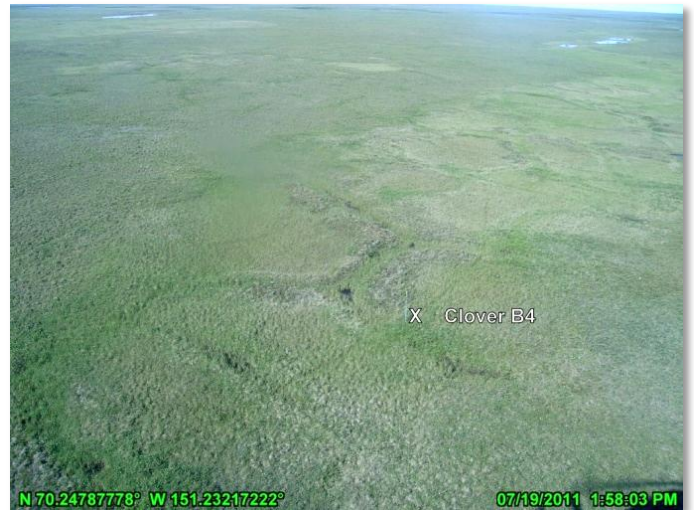
Photo 4.23: Clover B4 - Small ponds and marshy areas, no flow, looking upstream (south); July 19, 2011

The majority of snow had melted by June 21. Small ponds of water were present at this location throughout the monitoring period including the final visit on July 19 (Photo 4.23).

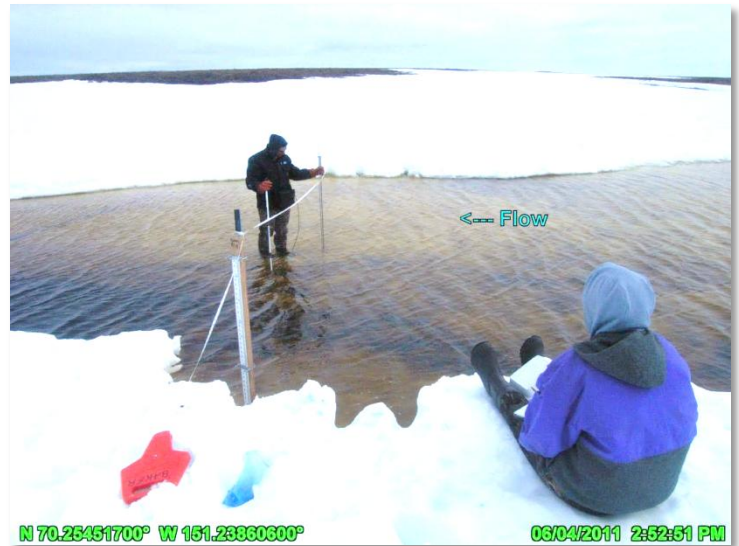
Photo 4.24: Channel conditions during discharge measurement at Clover B1, looking east; June 4, 2011

Direct discharge measurements at all Clover B locations were rated poor based on channel conditions. The channel cross sections at all sites were irregular and transformative because of ice and snow. During initial period of breakup flow, the channel at Clover B1 was confined by snow, and as breakup progressed, the channel broadened. Photo 4.24 shows channel conditions during the discharge measurement at Clover B1, and Photo 4.25 shows conditions of the main channel during the discharge measurement at Clover B3.

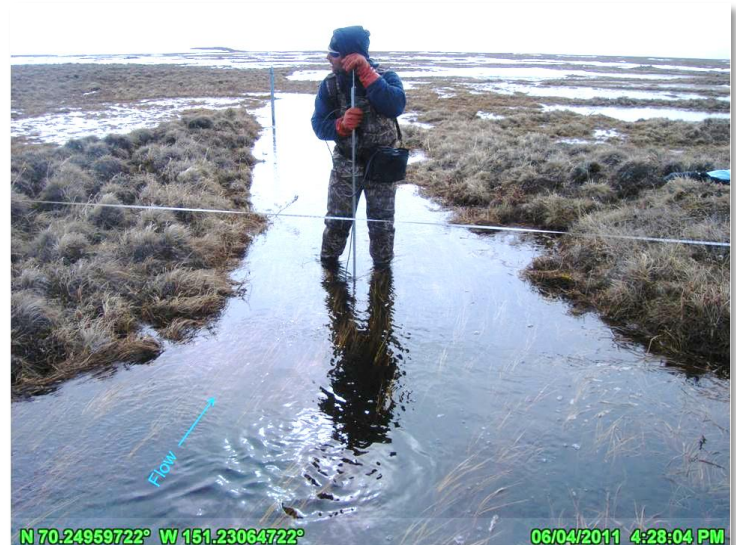
Photo 4.25: Main channel conditions during discharge measurement at Clover B3, looking downstream (northwest); June 4, 2011

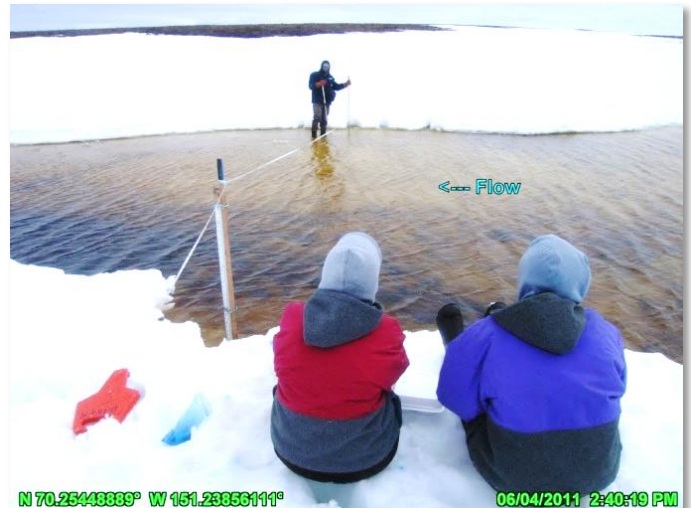
Photo 4.27: Channel conditions during the 2011 Clover B1 discharge measurement, from left bank; June 4, 2011

Table 4.4 shows a summary and comparison of the 2010 and 2011 discharge data for the Clover B1 site. The channel conditions for Clover B1 in 2010 and 2011, with respect to presence of snow and ice were similar. Channel conditions at Clover B1 during the discharge measurements in 2010 and 2011 are shown in Photo 4.26 and Photo 4.27, respectively.

The direct discharge measured in 2011 was estimated to be approximately 27 hours after peak stage which was about 15 hours later than in 2010. Velocities in 2011 were measured to be 1.29 feet per second (fps) slower than those in 2010. Additionally, there is a 2.52 feet difference between the 2010 and 2011 WSE recorded during the direct discharge measurement. Also between 2010 and 2011, there was a 2.74 feet difference in the recorded peak WSE which resulted in a smaller channel cross-sectional area that was used to calculate the peak indirect discharge for Clover B1.

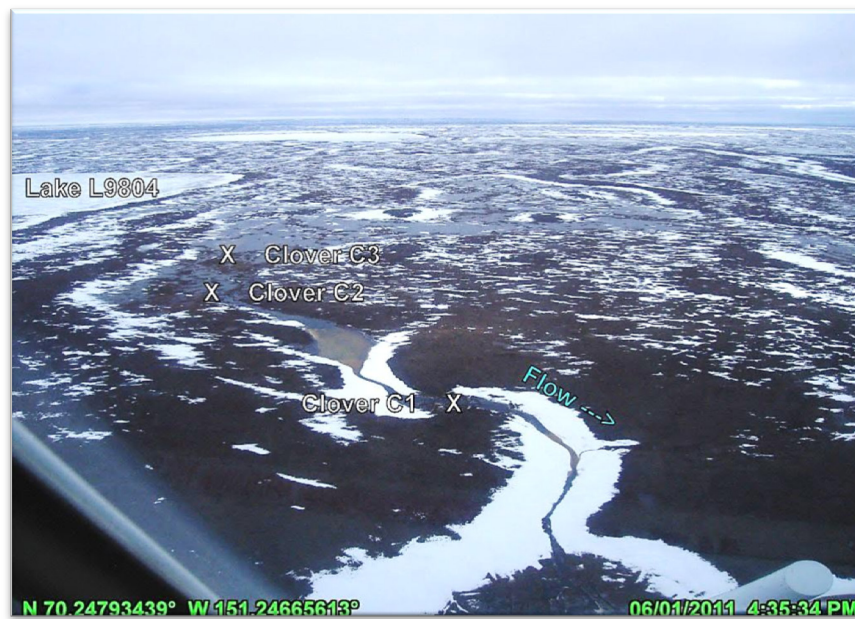
Photo 4.28: The Clover C drainage at the beginning of spring breakup, looking upstream (southeast) from the Ublutuoch River, June 1, 2011

Daily gage WSE data collection at all Clover C sites began June 1. After breakup, monitoring continued at Clover C every two weeks through July. Flow was still present in this channel on July 19, after which observations were discontinued. The PT installed at Clover C2 recorded data from May 20 through July 20. This data was recovered and is presented in Table 4.5. Photo 4.28 shows the Clover C drainage on June 1. At the bottom of the photo, Clover C is seen draining into the Ublutuoch River.

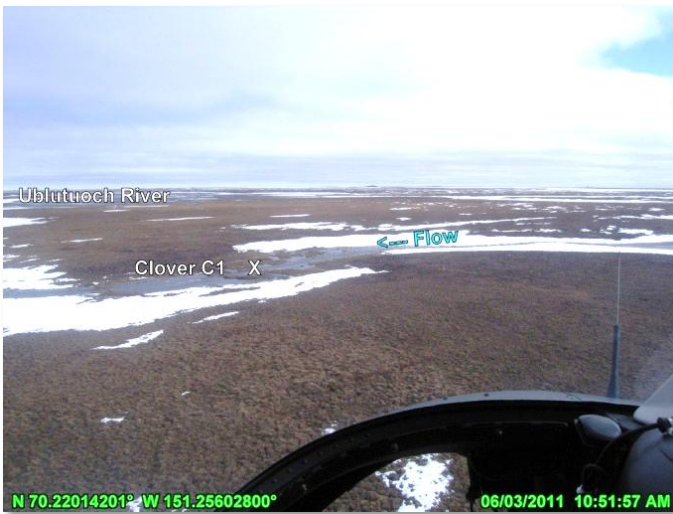
Significant snow was present in the Clover C drainage at the beginning of breakup, with the majority of accumulation at the downstream location of C1. Breakup flow passed through a moderately defined channel that was confined and cut through snow upstream and downstream of the gage location (Photo 4.29). Ice remained on the bottom of the channel at Clover C1 until June 3. By June 6, stage had dropped. The channel was open, but some snow was observed on the overbanks upstream and downstream (Photo 4.30 and Photo 4.31) on June 9. By June 21 (Photo 4.32), the snow had melted.

Photo 4.29: Clover C1 - After peak stage, looking northeast; June 3, 2011

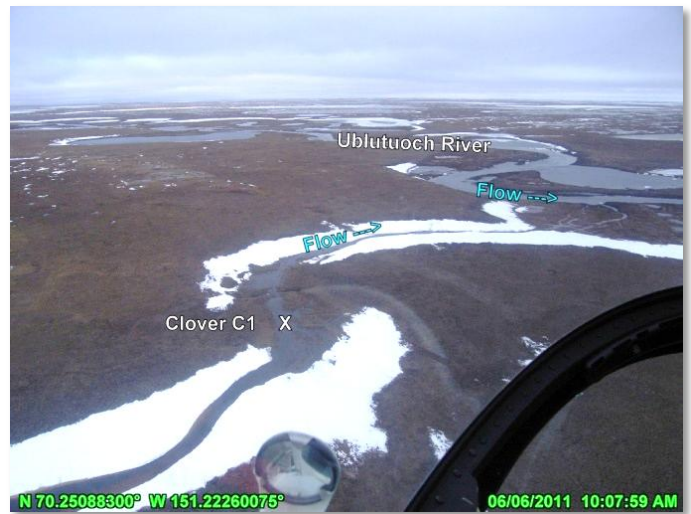
Photo 4.30: Clover C1 - Drainage flowing north into the Ublutuoch River as breakup flows recede, looking northwest; June 6, 2011

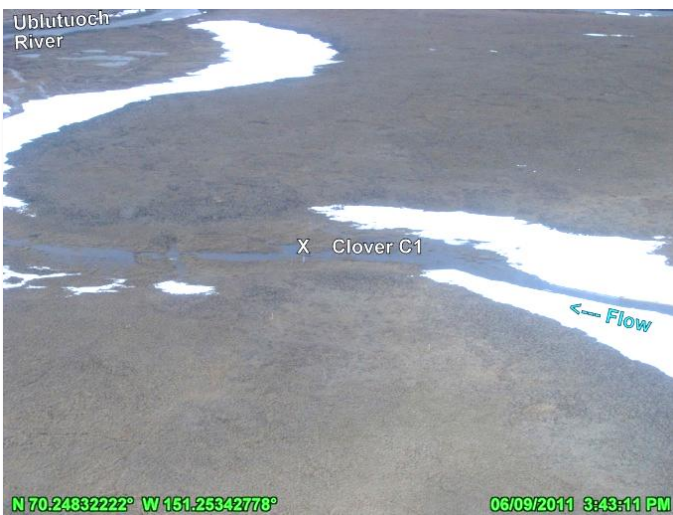
Photo 4.31: Clover C1 - As breakup flood flow recedes, looking northeast; June 9, 2011

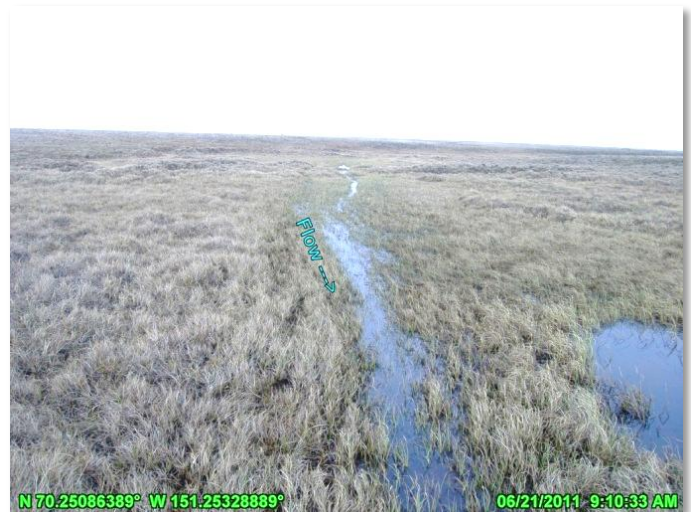
Photo 4.32: Clover C1 - After breakup; snow melted in area, looking upstream (southeast) toward Clover C2; June 21, 2011

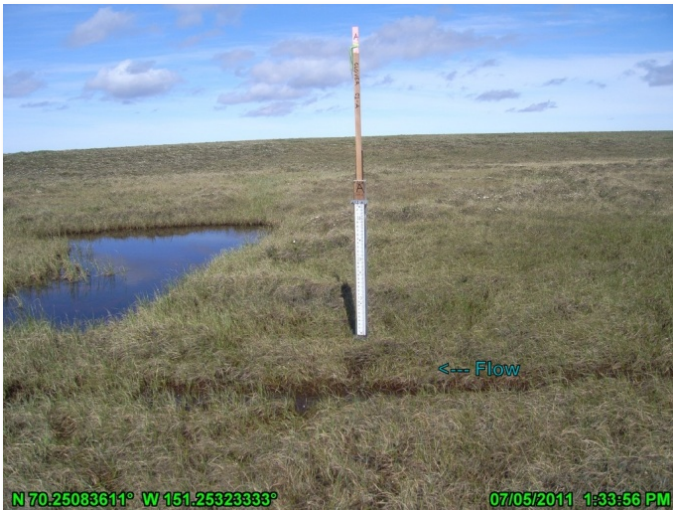
On July 5, a small channel through grass was observed with low flow present (Photo 4.33). During the final monitoring visit on July 19, the area was marshy with some small ponds and no visible flow was seen (Photo 4.34).

Photo 4.33: Clover C1 - After breakup; small grassy channel with low flow, looking east; July 5, 2011

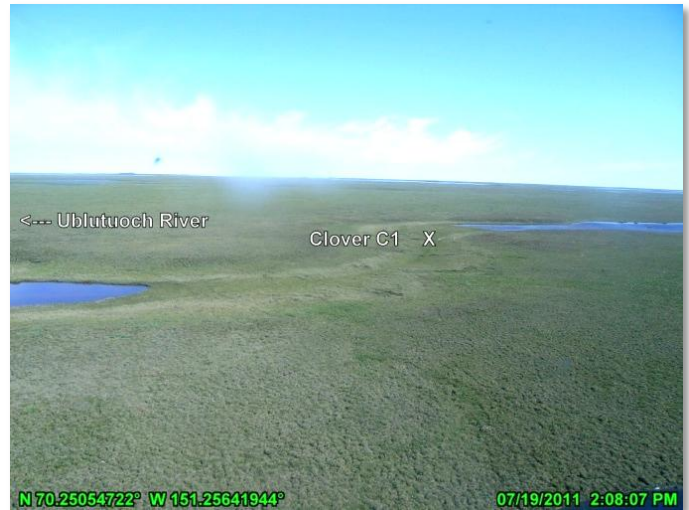
Photo 4.34: Clover C1 - Small ponds and marshy areas, no visible flow, looking east; July 19, 2011

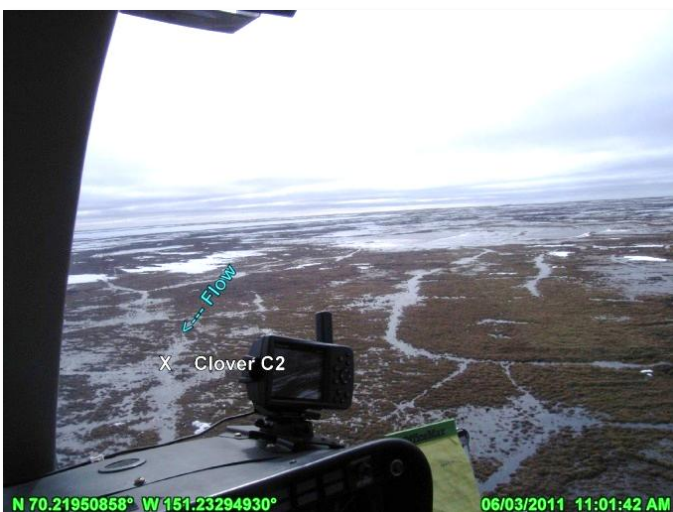
At the north edge of the CMS boundary, the channel at Clover C2 was poorly defined because of low topographic relief. Flow was divided into a few polygon cracks as stage decreased. No snow was present in the channel by June 3 (Photo 4.35), and the majority of snow in the area had melted by June 6 (Photo 4.36). The channel was losing definition by June 9 (Photo 4.37) and by June 21, no flow was observed, and the area was marshy (Photo 4.38).

Photo 4.35: Clover C2 - Flow in polygon cracks as stage drops, looking upstream (south); June 3, 2011

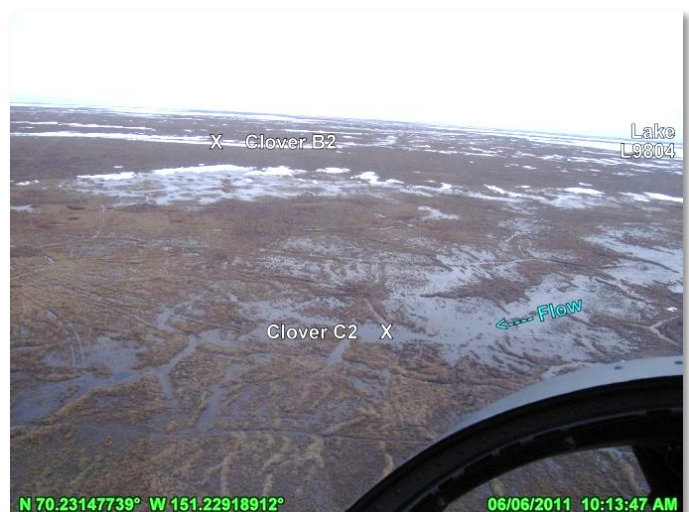
Photo 4.36: Clover C2 - The majority of snow in the area melted; looking east, June 6, 2011
