# FISH CREEK BASIN SPRING BREAKUP

# 2011

## HYDROLOGIC ASSESSMENT

124033-MBJ-RPT-001

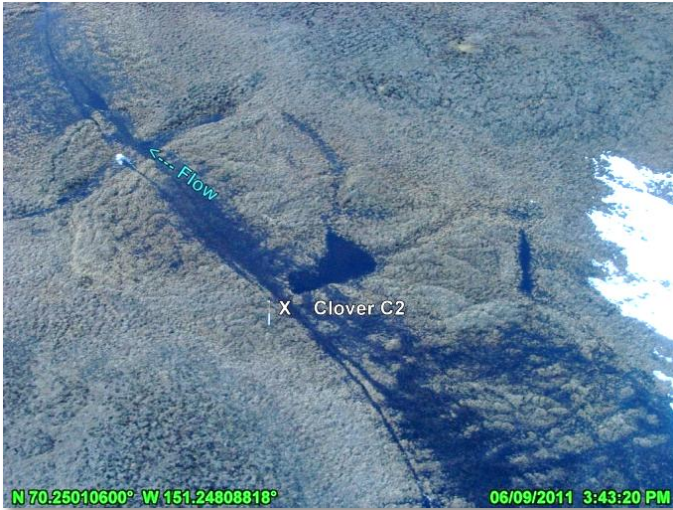
At the north edge of the CMS boundary, the channel at Clover C2 was poorly defined because of low topographic relief. Flow was divided into a few polygon cracks as stage decreased. No snow was present in the channel by June 3 (Photo 4.35), and the majority of snow in the area had melted by June 6 (Photo 4.36). The channel was losing definition by June 9 (Photo 4.37) and by June 21, no flow was observed, and the area was marshy (Photo 4.38).

Photo 4.37: Clover C2 - Channel losing definition as stage drops further, looking north;, June 9, 2011

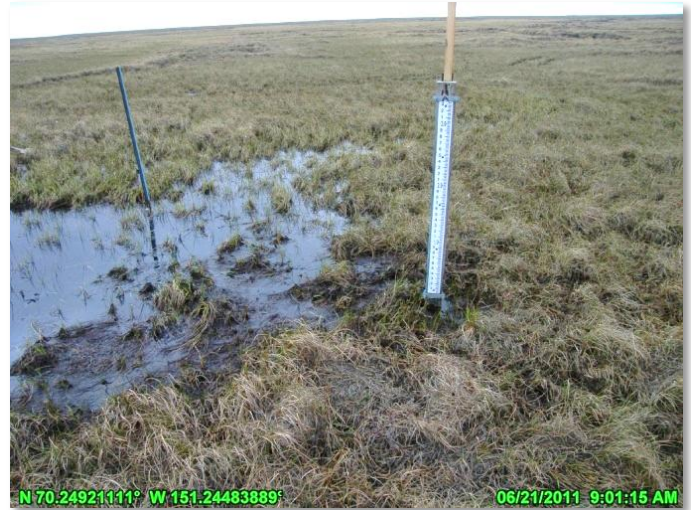
Photo 4.38: Clover C2 - No flow through marshy area, no defined channel, looking east; June 21, 2011

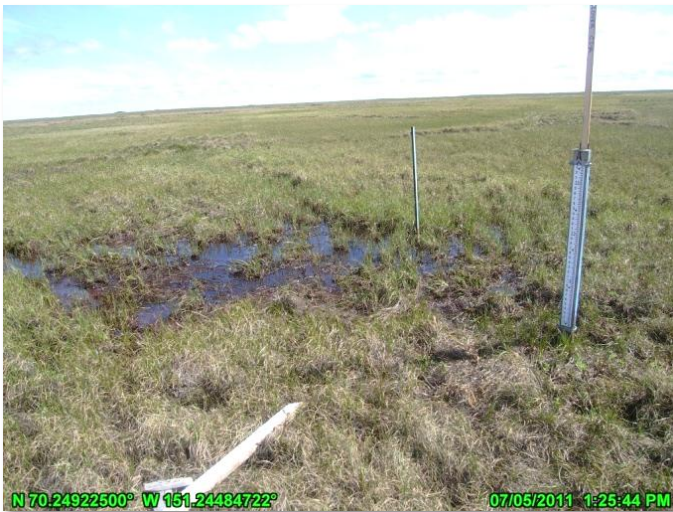
Photo 4.39: Clover C2 - No flow through marshy area, looking east; July 5, 2011

No change in site conditions at C2 was observed on July 5 (Photo 4.39) and during final monitoring on July 19; the area was still marshy though slightly less wet (Photo 4.40).

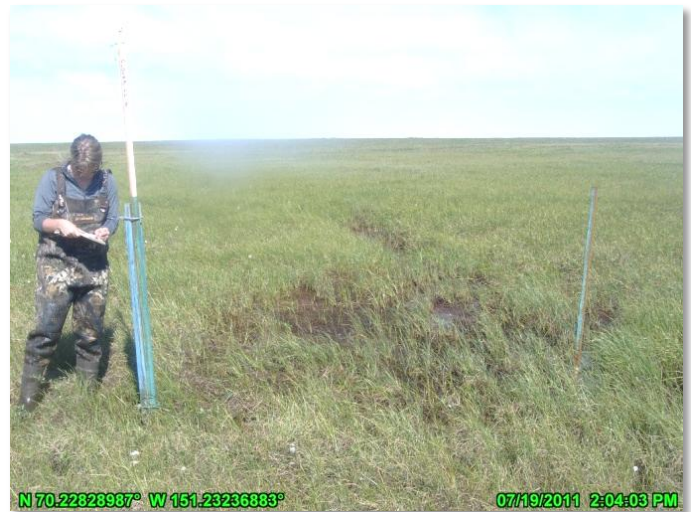
Photo 4.40: Clover C2 - No flow through marshy area, looking southeast; July 19, 2011

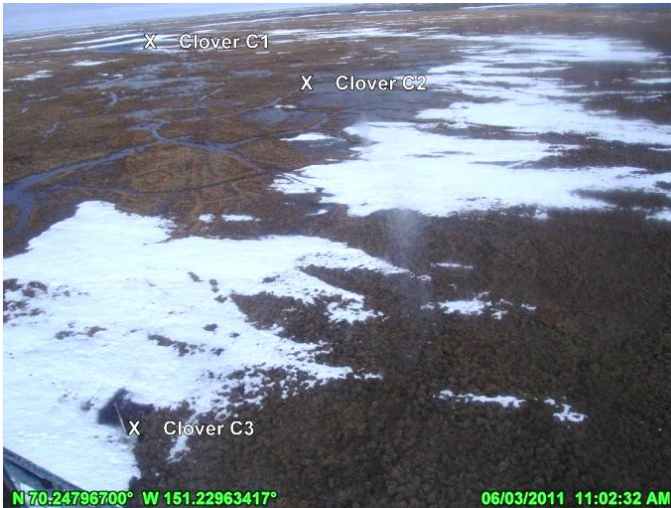
No channelized flood flow was observed at Clover C3 during the spring breakup monitoring period (Photo 4.41 and Photo 4.42). WSE data collected during breakup was the result of local melt and overland sheet flow. Ponded water was present at this location through June 9, and the area was drier by June 21 (Photo 4.43). No water was observed at Clover C3 during the monitoring visit on July 19 (Photo 4.44).

Photo 4.41: Clover C3 - Snow beginning to melt during breakup, no channelized flow, looking downstream (northwest) toward Clover B2; June 3, 2011

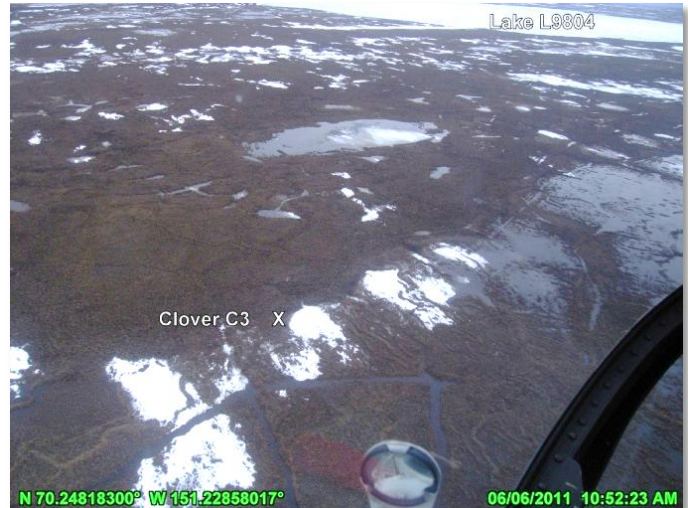
Photo 4.42: Clover C3 - Local melt, no channelized flow, looking east; June 6, 2011

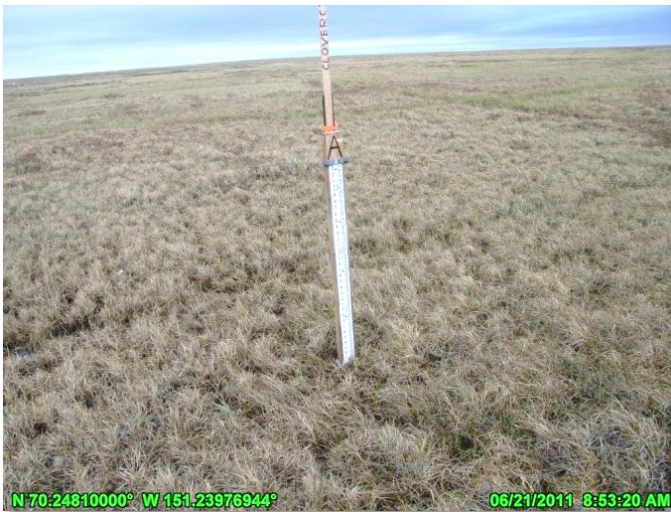
Photo 4.43: Clover C3 - Area dry, looking east; June 21, 2011

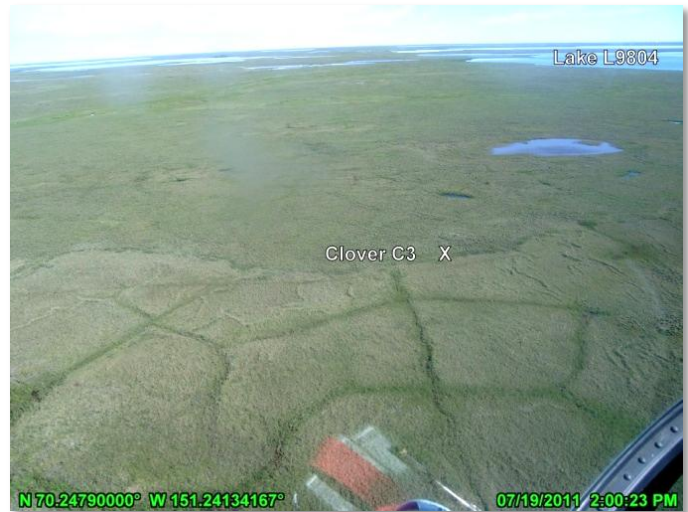
Photo 4.44: Clover C3 - Area dry, looking east; July 19, 2011

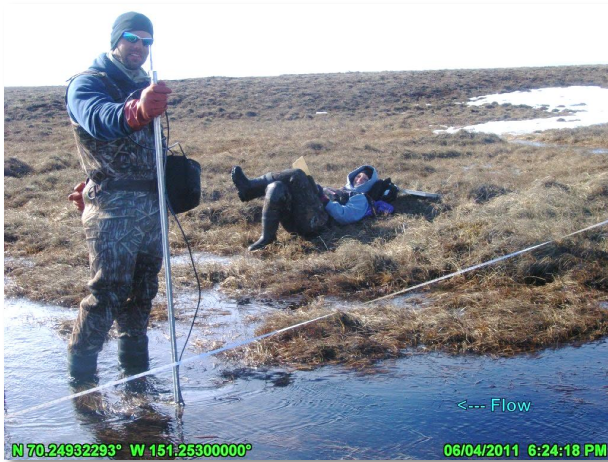
Photo 4.45: Discharge measurement at Clover C1; June 4, 2011

Direct discharge measurements at all Clover C locations were rated poor based on channel conditions; cross sections at all sites were irregular and transformative due to ice and snow upstream and downstream of Clover C1. Photo 4.45 shows the discharge measurement being performed at Clover C1.

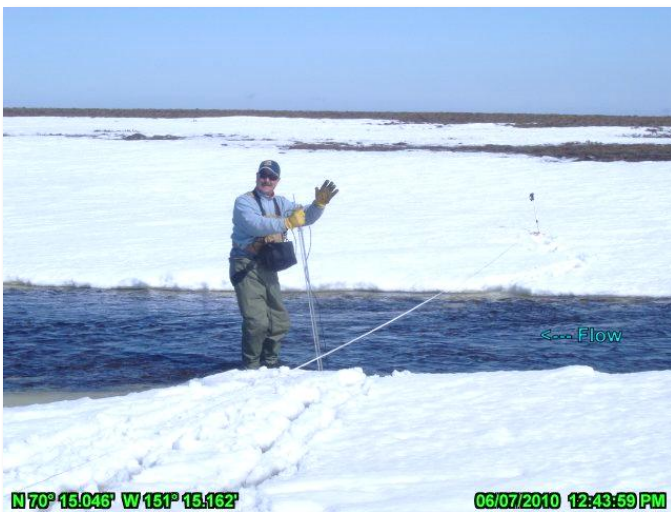
Table 4.8 shows a summary and comparison of the 2010 and 2011 discharge data for the Clover C1 site. The channel conditions for Clover C1 in 2010 and 2011, with respect to presence of snow and ice were distinctly different. Channel conditions at Clover C1 during the discharge measurements in 2010 and 2011 are shown in Photo 4.46 and Photo 4.47, respectively.

Photo 4.46: Channel conditions during the 2010 Clover C1 discharge measurement; June 7, 2010

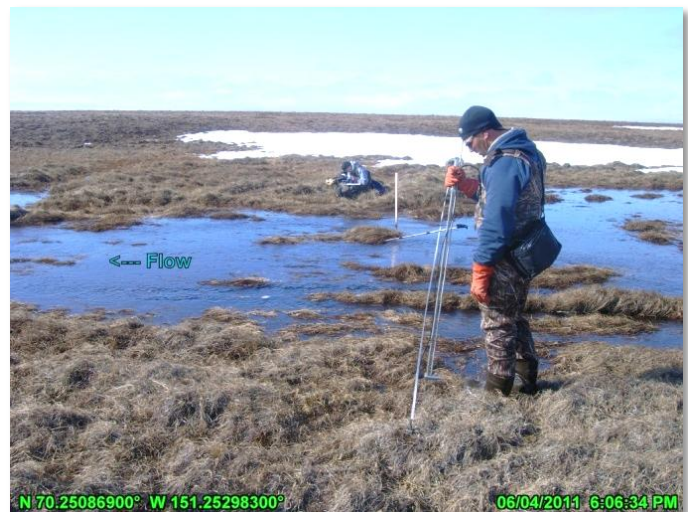
Photo 4.47: Channel conditions during the 2011 Clover C1 discharge measurement; June 4, 2011

The direct discharge measured in 2011 was estimated to be approximately 66 hours after peak stage. Velocities in 2011 were measured to be 1.51 fps slower than those in 2010. There was a 0.26 foot difference between the 2010 and 2011 WSE recorded during the direct discharge measurement and no significant difference in peak WSE. Differences in calculated peak cross-sectional area between 2010 and 2011 were about 1 square foot.

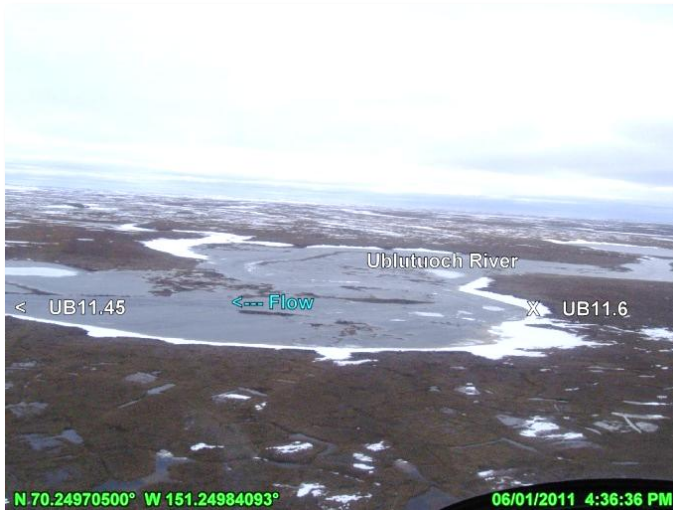
Photo 4.48: Breakup flow through the UB11.45-UB11.6 reach of the Ublutuoch River, looking upstream (southwest); June 1, 2011

By June 1, significant flow containing ice rafts, snow and slush were present in this reach of the Ublutuoch River (Photo 4.48). Flow was overbank and the gages at UB11.45 were overtopped. An additional gage was installed at this location higher up the bank. Significant snow surrounded the gages at UB11.6 (Photo 4.49) throughout the breakup season. Snow quickly melted at UB11.45, which is on a point bar in the river. Conditions were similar through June 3, with fewer floes and slush in the channel. Temperatures cooled at this time, and breakup melting progressed less rapidly throughout the FCB. By June 6, WSE had dropped considerably. Flow velocities were high, generally confined within the stream banks and carried occasional small floes (Photo 4.50). Snow was still present when daily monitoring ceased on June 9 (Photo 4.51). No significant ice jams were observed in the vicinity of the UB11.45-UB11.6 reach during spring breakup 2011.

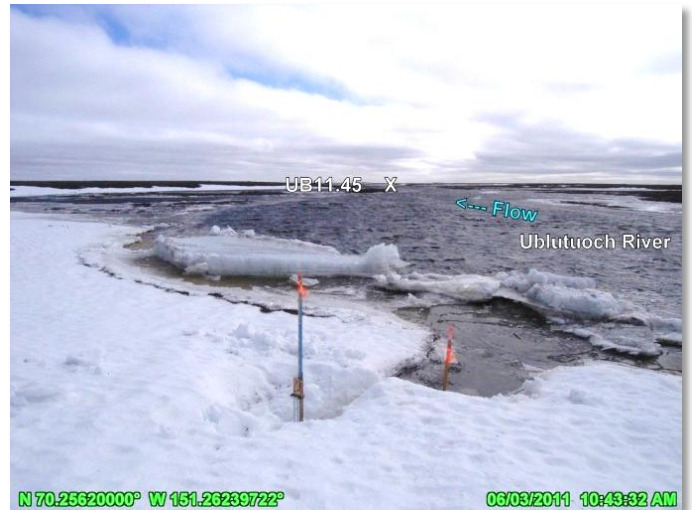
Photo 4.49: - Gages at UB11.6 surrounded by snow, UB11.45 downstream in the background, looking east; June 3, 2011

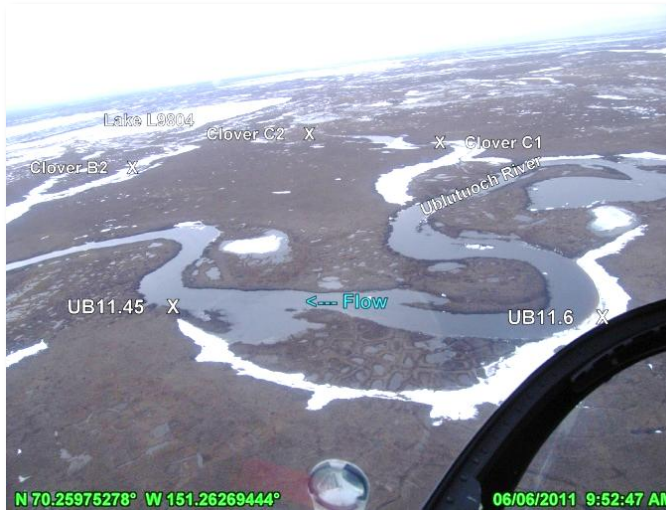
**Photo 4.50: Flow confined to channel banks as stage drops at UB11.45-UB11.6, looking south; June 6, 2011**

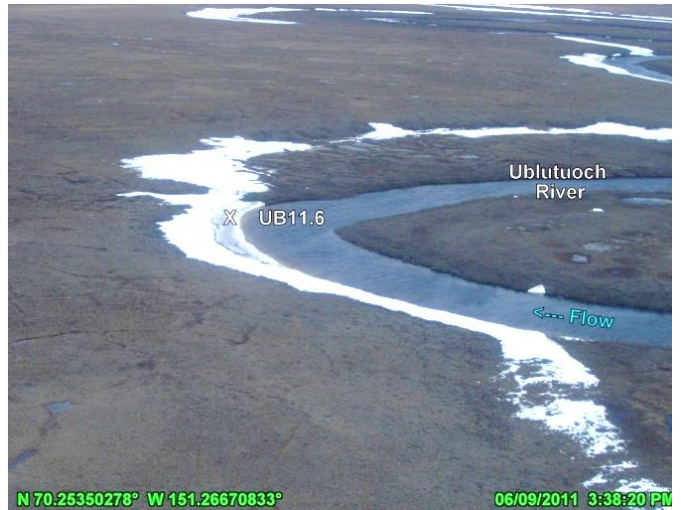
**Photo 4.51: Snow still present as breakup flow recedes at UB11.6, looking downstream (east); June 9, 2011**

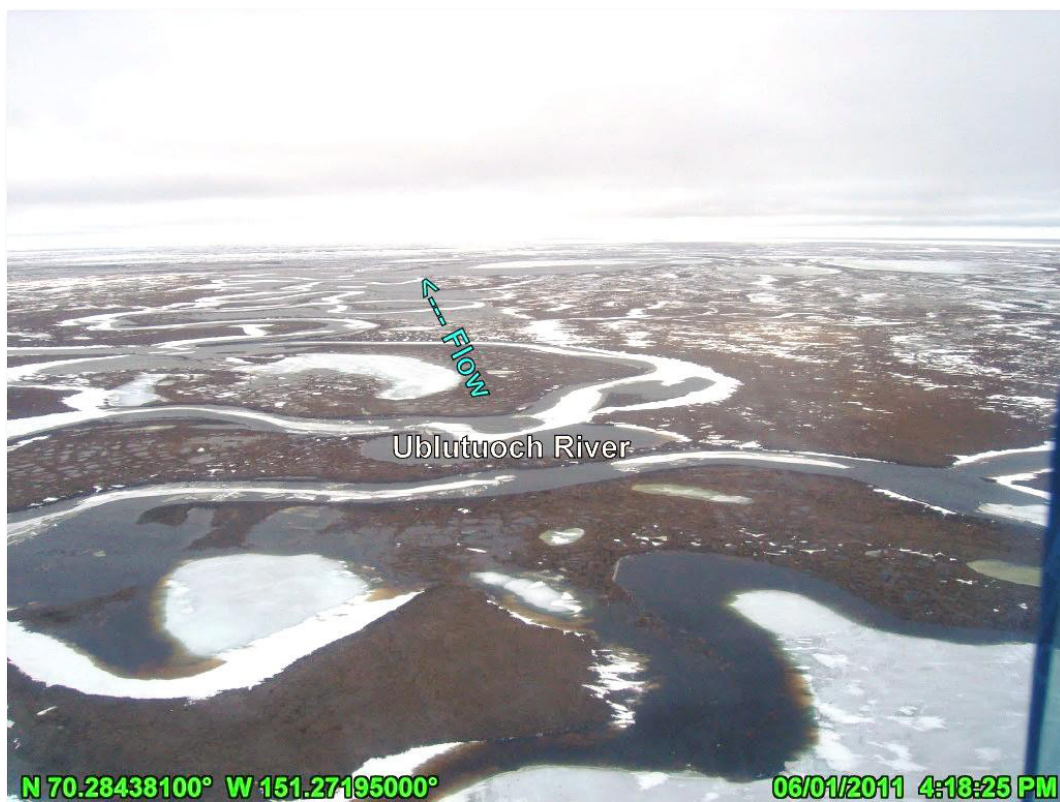
Photo 4.52: Breakup flow and channel ice in the Ublutuoch River, looking downstream (north) from UB6.8; June 1, 2011

By June 1, significant flow was present in this reach of the Ublutuoch River, inundating the overbank areas. There was some snow along the right bank and discrete sections of ribbon ice throughout the channel (Photo 4.52). No ice jams had formed in the vicinity. There was some channel ice approximately 0.3 RM upstream of UB6.9 on June 2. Also on June 2, the stage was high on the overbanks (Photo 4.53 and Photo 4.54), and occasional ice floes were beginning to jam on intact channel ice downstream of UB6.7, near Lake L9824.

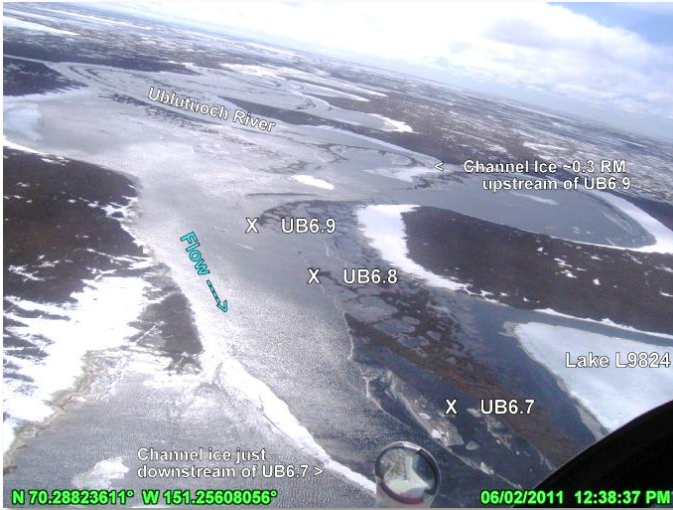
Photo 4.53: Peak stage in the Ublutuoch River at the proposed bridge crossing (UB6.8), downstream of UB6.7 looking upstream (south); June 2, 2011

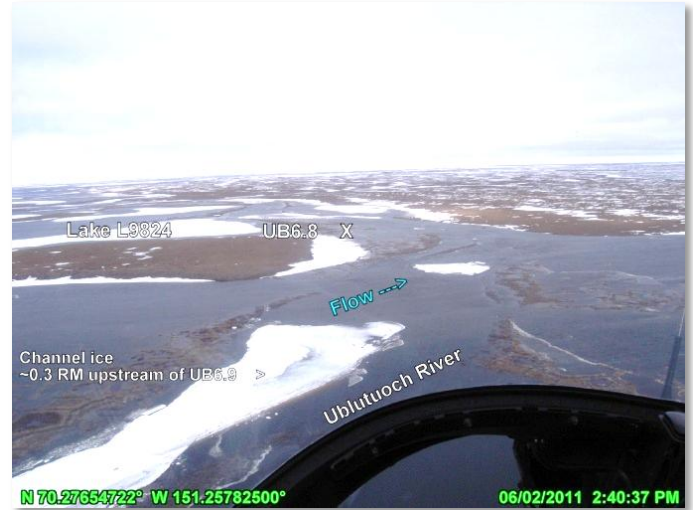
Photo 4.54: Peak stage in the Ublutuoch River at the proposed bridge crossing (UB6.8), upstream of UB6.9 looking downstream (northeast); June 2, 2011

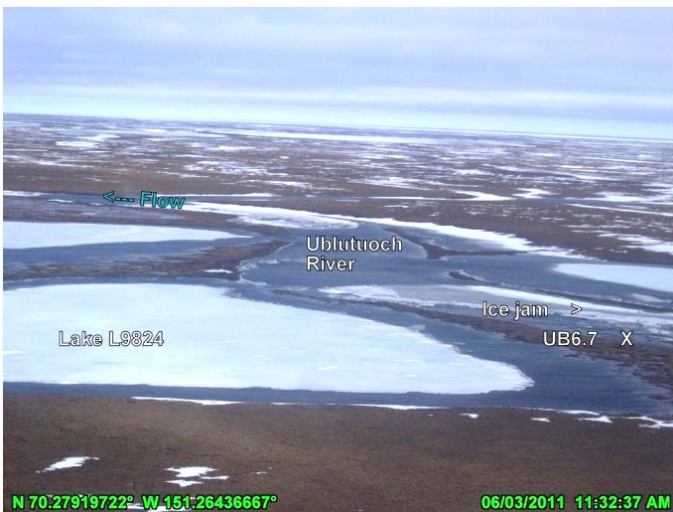
Photo 4.55: Ice jam forming downstream of UB6.7, looking downstream (northeast); June 3, 2011

Temperatures cooled on June 3, and breakup melting progressed less rapidly throughout the FCB. The ice jam downstream of UB6.7 was still in place on June 3 (Photo 4.55), and more floes had jammed on the channel ice upstream of UB6.9 (Photo 4.56).

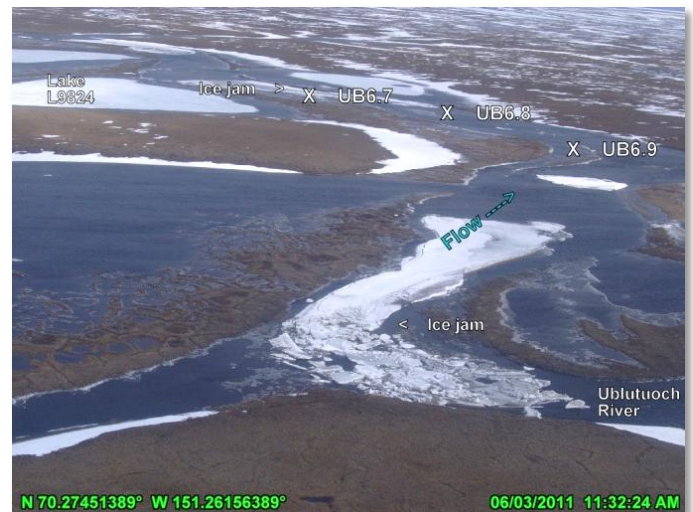
Photo 4.56: Ice jam upstream of UB6.9, looking downstream (northeast); June 3, 2011

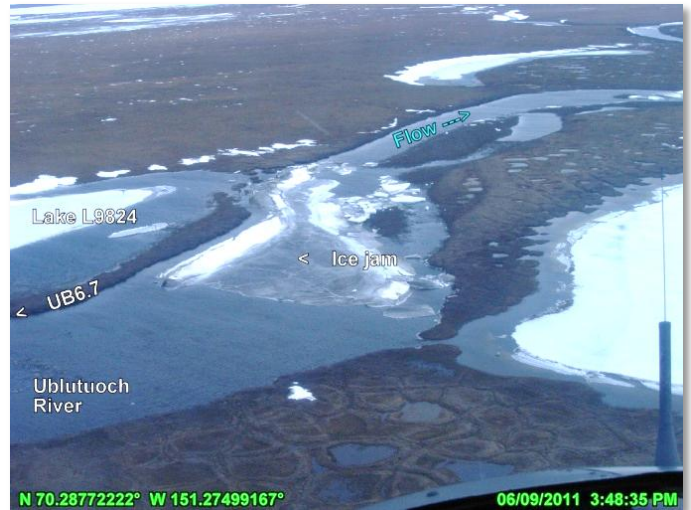
By June 6, stage had dropped considerably, and flow was generally confined within the stream banks (Photo 4.57). The channel was ice and snow free except where there were jams. The ice jams downstream of UB6.7 and upstream of UB6.9 were still present on June 6 and were melting in place by June 9 (Photo 4.58).

Photo 4.58: Ice jam downstream of UB6.7 melting in place, looking downstream (northwest); June 9, 2011

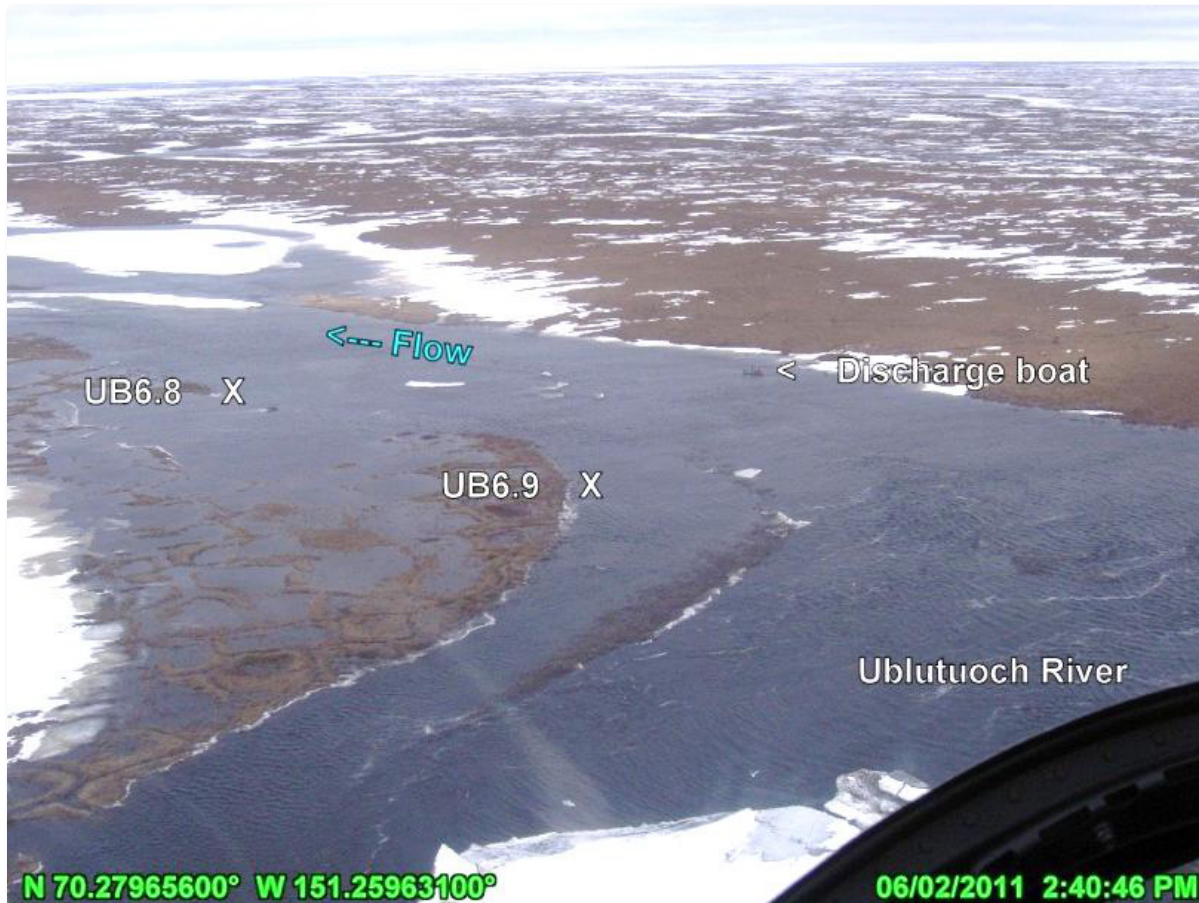
Photo 4.59: Channel conditions during the discharge measurement at the proposed Ublutuoch bridge location (UB6.8), upstream of UB6.9 looking downstream (northeast); June 2, 2011

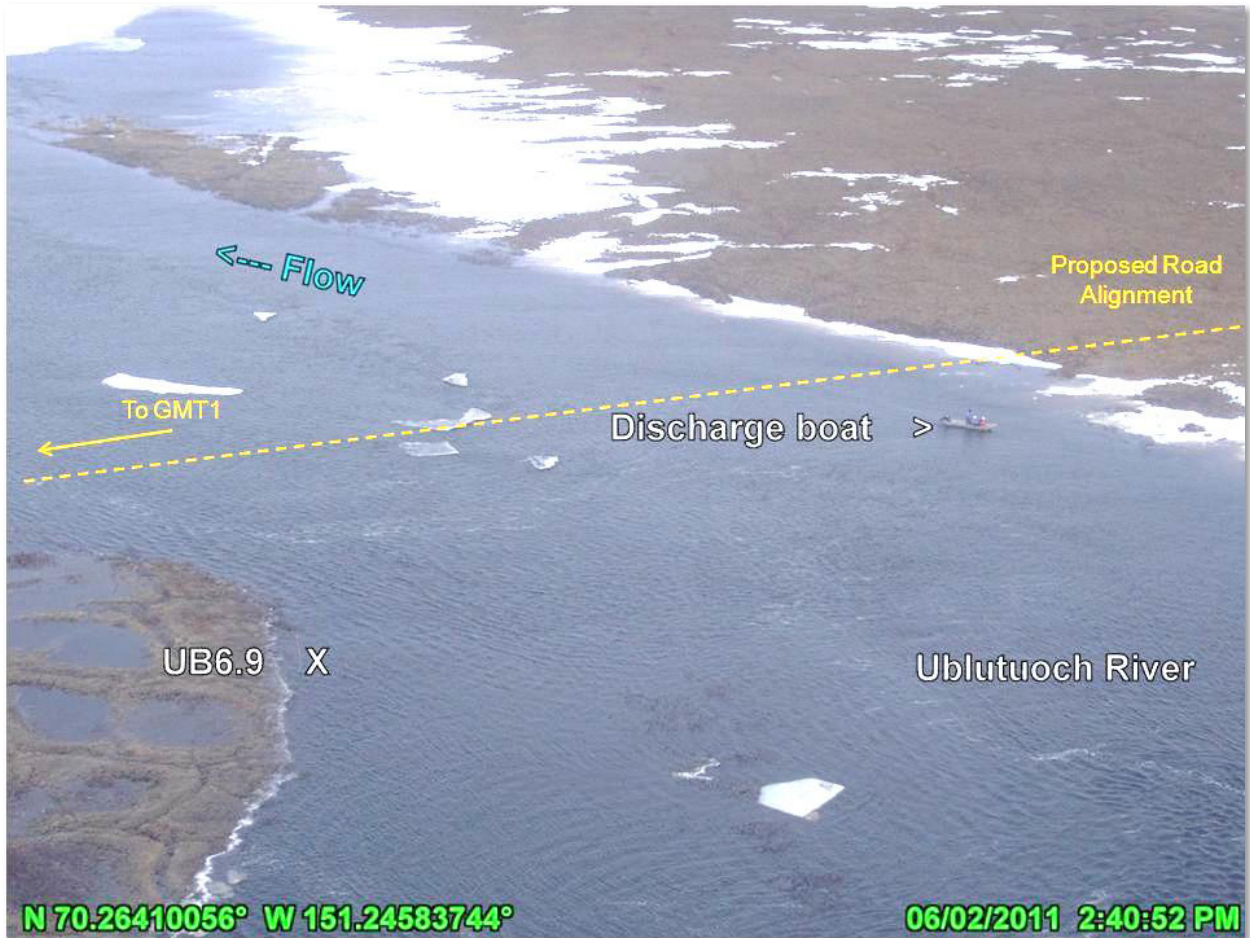
Standard USGS midsection techniques (Rantz 1982) were used to measure direct discharge at the proposed GMT1 road Ublutuoch River bridge crossing location (UB6.8). A Price AA velocity meter was used to measure velocities at UB6.8. Measurements were taken using a sounding reel connected to a boat-mounted boom with a 30-pound Columbus-type lead sounding weight. A tag line was used to define the cross section and to delineate measurement subsections within the channel. The Price AA meter was rated by the USGS at the Office of Surface Water (OSW) Hydraulic Laboratory in 2011 prior to breakup. A spin test of the meter was successfully completed prior to the discharge measurement at the Ublutuoch River. To ensure accurate performance of meters, procedures outlined in OSW Technical Memorandum No. 99.06 (1999) were followed. Photo 4.60 shows this method being used at UB 6.8, the proposed bridge crossing site at the Ublutuoch River.

A direct discharge measurement in the Ublutuoch River was conducted at UB6.8 on June 2 beginning at 1:55 PM, approximately at the time of peak flow. Discharge was measured to be 2,200 cubic feet per second (cfs). The measurement was rated fair to poor based on channel conditions. The channel is not uniform; the left bank side is much shallower than the right bank side. Occasional ice floes were present in the channel during the discharge measurement, and jams were beginning to form on channel ice approximately 1,700 feet upstream and 1,000 feet downstream of the tagline, near the UB6.7 gages. The upstream jam was causing flow to divert into the low-lying areas and oxbow lakes on both left and right overbanks, and the downstream jam was causing more flow to divert into Lake L9824 to the west and the unnamed lake to the east. Photo 4.59 and Photo 4.60 show channel conditions at UB6.8 during the direct discharge measurement.

Photo 4.60: Baker crew performing discharge measurement at the proposed Ublutuoch bridge location (UB6.8), looking downstream (northeast); June 2, 2011

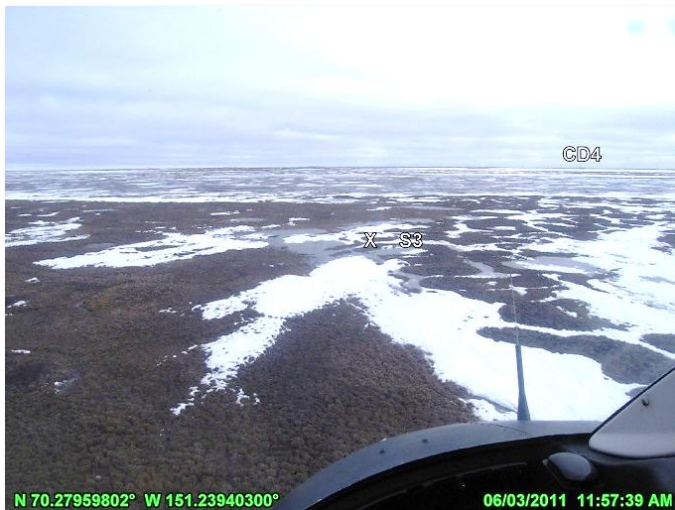
Spring breakup at this location was characterized by quick melting until June 3 when temperatures decreased and breakup progressed less rapidly (Photo 4.61). There was no channelized hydraulic connection observed between the ponded area west of Lake L9308 and the Ublutuoch River, and measurable flow was not present in the vicinity of the gage location during spring breakup monitoring (Photo 4.62). WSE and peak stage data are considered the result of local melt and overland sheet flow.

Photo 4.61: Breakup conditions at S3, looking east; June 3, 2011

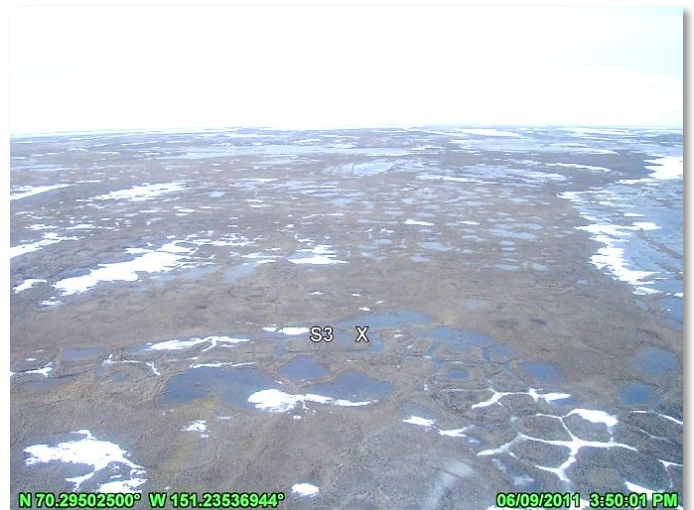
Photo 4.62: S3 - Local melt and no channelized flow, looking north; June 9, 2011

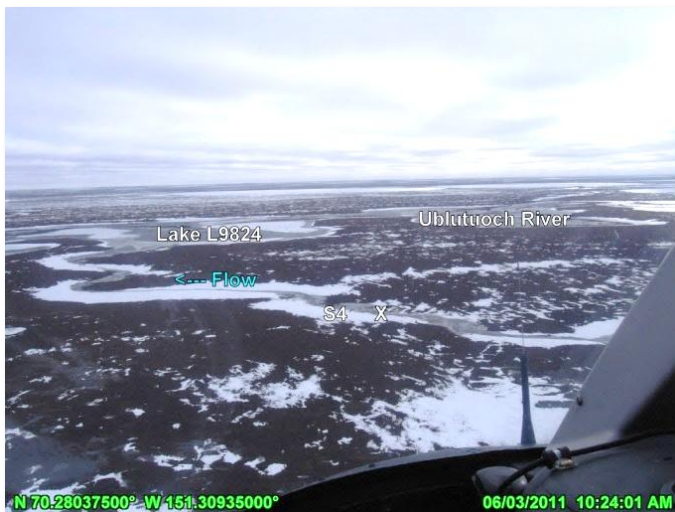
By June 1, significant flow was present in this drainage and conditions were overbank, though ice and snow were present in the channel limiting flow into overbank areas, particularly along the left bank. Topography of the right bank is steeper than the left bank. The channel is shallower upstream of the gages, and flow was less confined by snow in the overbank areas. The channel was narrower downstream and more confined by topography and snow. During monitoring, stage was high enough to channelize the beaded pools into a smoother reach. Temperatures cooled on June 3, and breakup melting progressed less rapidly throughout the FCB. Conditions at this time were similar to June 1 (Photo 4.63 and Photo 4.64), and ice was still present in some portions of the channel bottom. By June 4, there was no longer bottom ice and stage had dropped though still over bank. The channel had divided into braids that were mostly free of ice and snow, though some snow remained on the left bank of the crossing location, S4-B (Photo 4.65). Beaded pools were more evident by June 9, as stage receded and snow melted along the stream banks (Photo 4.66).

Photo 4.63: S4 - Stream draining northeast into Lake L9824; June 3, 2011

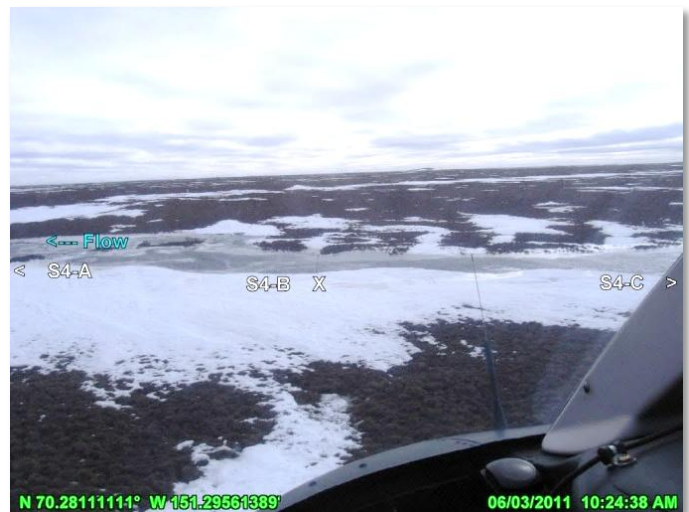
Photo 4.64: Breakup conditions at S4 reach after peak stage; June 3, 2011

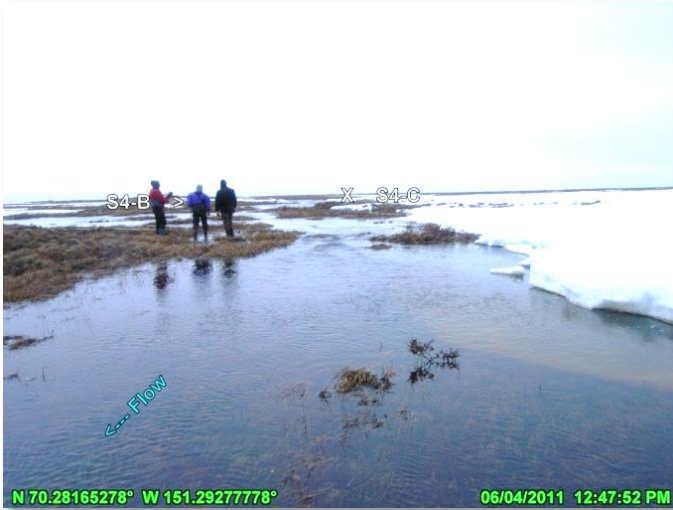
Photo 4.65: Channel conditions at S4 as stage drops, upstream of S4-A looking upstream (southwest); June 4, 2011

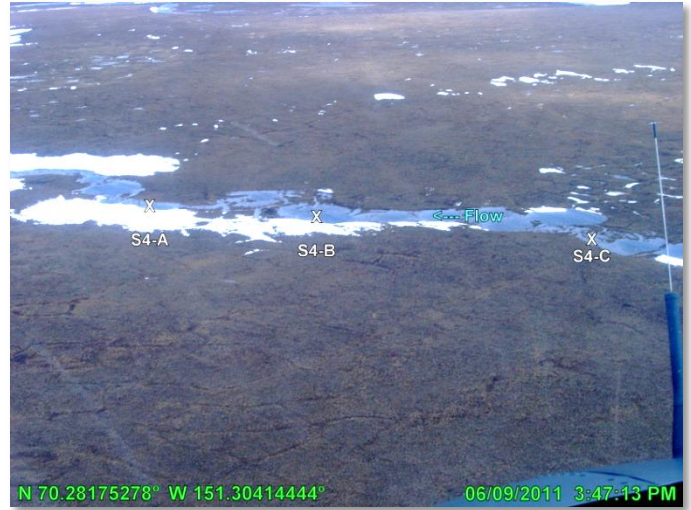
Photo 4.66: Beaded pools become more evident as breakup flows recede in S4 stream, looking east; June 9, 2011

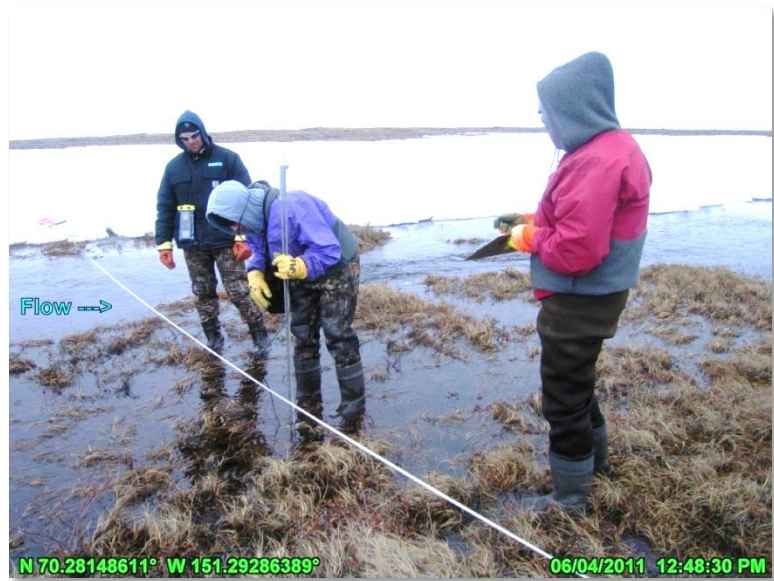
A direct discharge measurement was performed at S4 (centerline S4-B) on June 4, beginning at 12:45 PM, approximately 60 hours after peak. Discharge was measured to be 4.4 cfs. The measurement was rated poor based on channel conditions. The channel was braided and contained willows and grass. Areas of pooled water were upstream and downstream of the measurement location and some water was flowing under snow along the left bank. Photo 4.67 shows S4 channel conditions during the discharge measurement.

**Photo 4.67: Channel conditions during the discharge measurement at the proposed S4 crossing location, looking west; June 4, 2011**

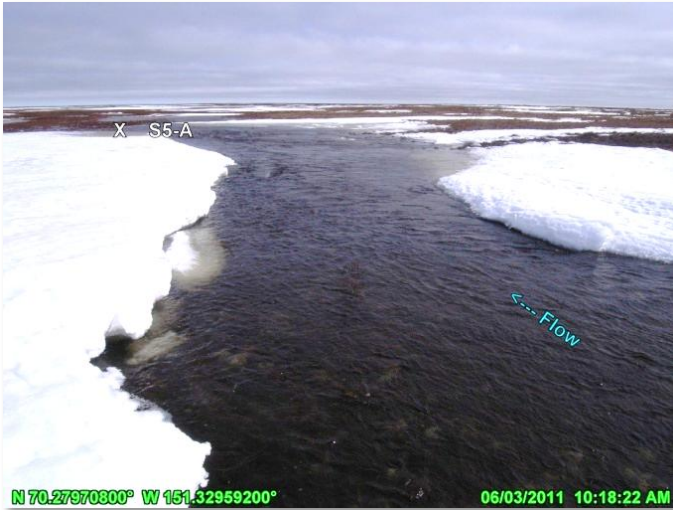
Photo 4.68: Channel conditions at proposed S5 crossing location (S5-B) after peak stage, looking downstream (north) toward S5-A; June 3, 2011

Temperatures cooled on June 3, and breakup melting progressed less rapidly throughout the FCB. Conditions at this time were similar to June 1, with slush floes and ice still present in portions of the channel bottom (Photo 4.68 and Photo 4.69). By June 4, stage had dropped though still over bank. Some portions of the channel bottom were icy. On June 4, snow was observed on both banks which confined flow (Photo 4.70), although some flow was present underneath the snow.

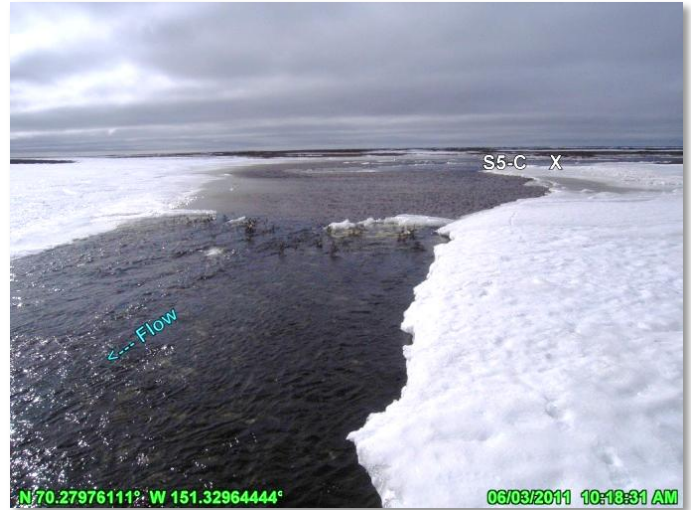
Photo 4.69: Channel conditions at proposed S5 crossing location (S5-B) after peak stage, looking upstream (southwest) toward S5-C; June 3, 2011

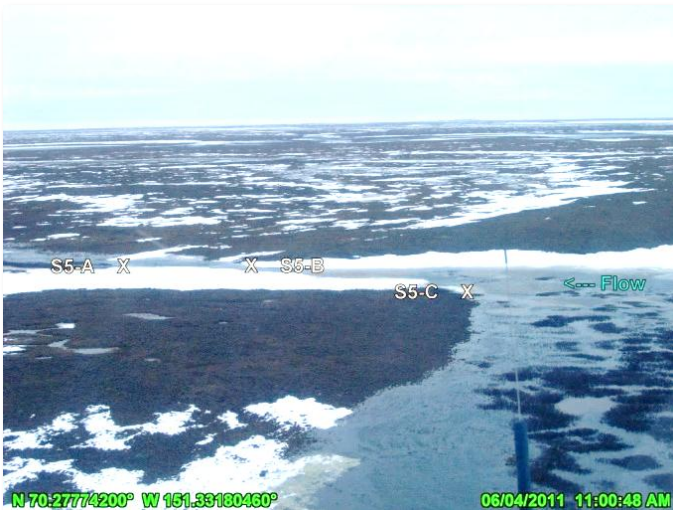
Photo 4.70: Breakup conditions at S5 reach, snow on overbanks looking east; June 4, 2011

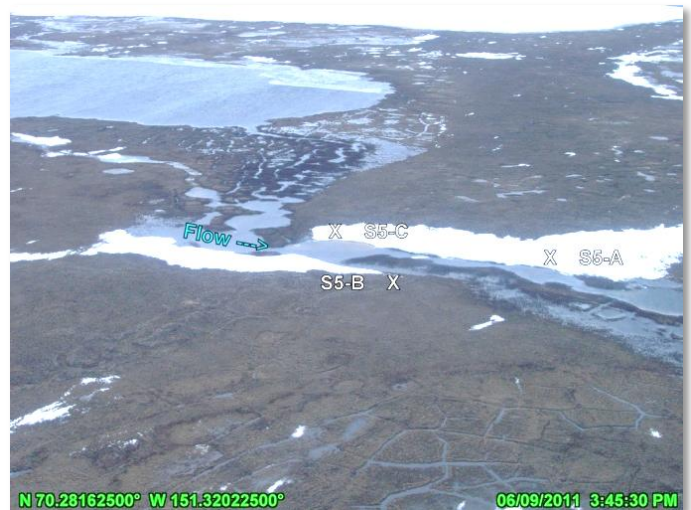
Photo 4.71: Beaded pools become more evident as breakup flows recede in S5 stream, looking west; June 9, 2011

Beaded pools in the channel were more evident by June 6. By June 9, stage and the amount of snow continued to decline along the banks of S5 (Photo 4.71).

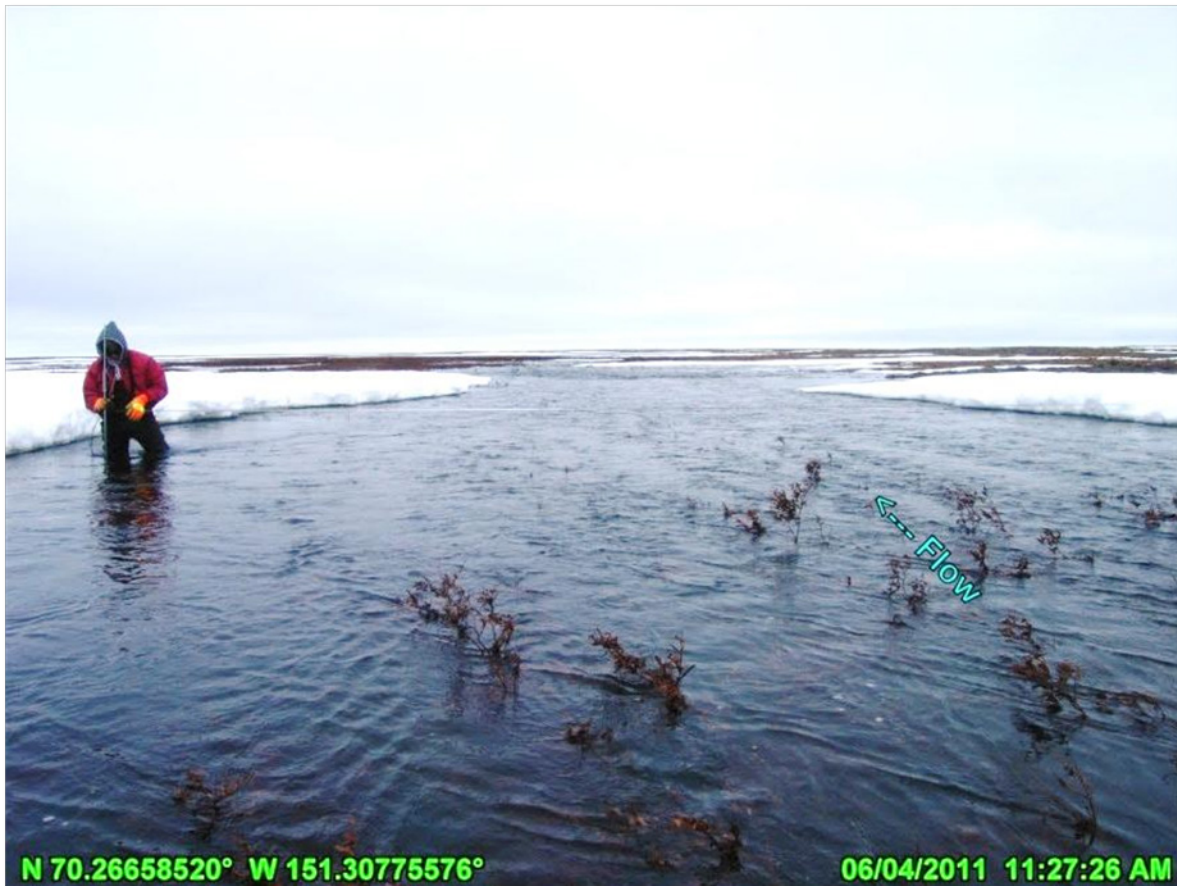
Photo 4.72: Channel conditions during the discharge measurement at the proposed S5 bridge location, looking downstream (northeast); June 4, 2011

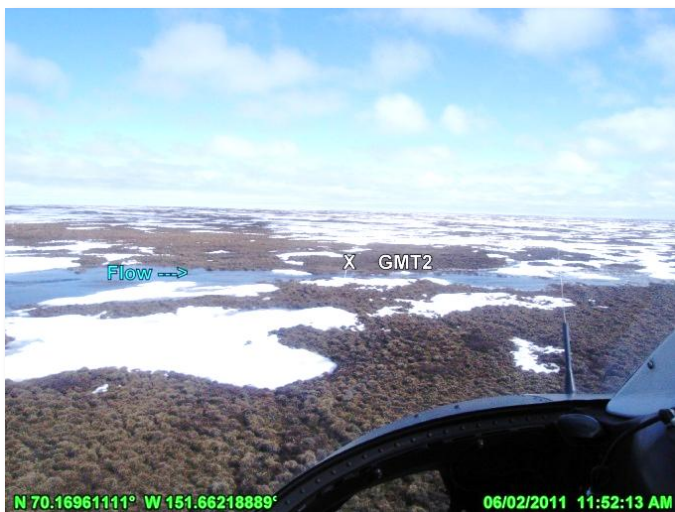
Photo 4.73: GMT2 channel conditions, after peak stage, looking east; June 2, 2011

By June 2, flow was present in this drainage and conditions were over bank (Photo 4.73). At the crossing location, the channel is well defined with higher flow velocity bound upstream and downstream by beads or pools of lower flow velocity. Some snow was present along the banks and throughout the area. Temperatures cooled on June 3, and breakup melting progressed less rapidly throughout the FCB. Conditions on June 3 were similar to June 1, and the channel was generally ice and snow free (Photo 4.74).

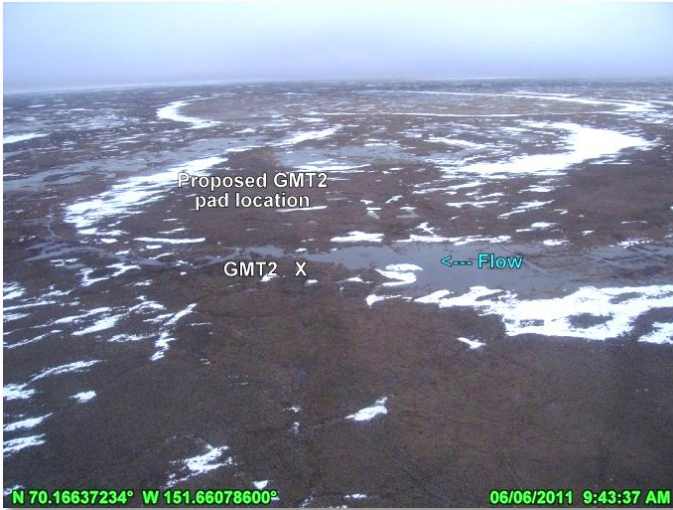
Photo 4.75: Pooled area upstream and polygon crack downstream of GMT2, no defined channel, looking west; June 6, 2011

By June 4, stage had dropped. Snow was observed in the general vicinity and in the upstream bead or pool. The channel had lost definition by June 6 and was essentially flowing within a polygon crack (Photo 4.75). Flow had ceased by June 9 and the size of the upstream ponded area had decreased along with the amount of snow in the area (Photo 4.76). Channelized flow was not observed from within beaded stream north of GMT2 into Lake M9925 during monitoring.

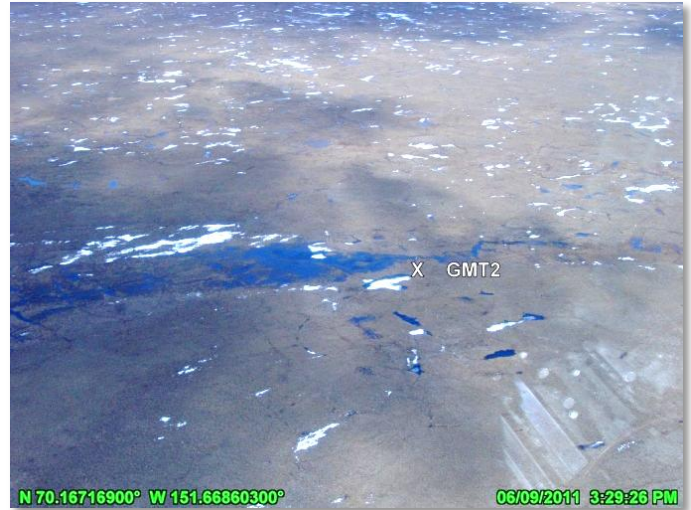
Photo 4.76: GMT2 becoming even less defined as breakup flood flow ceases, looking east; June 9, 2011
