2012 Alpine Pipeline River Crossing Monitoring

128228-MBJ-RPT-001
FINAL

Michael Baker Jr., Inc.
December 4, 2012

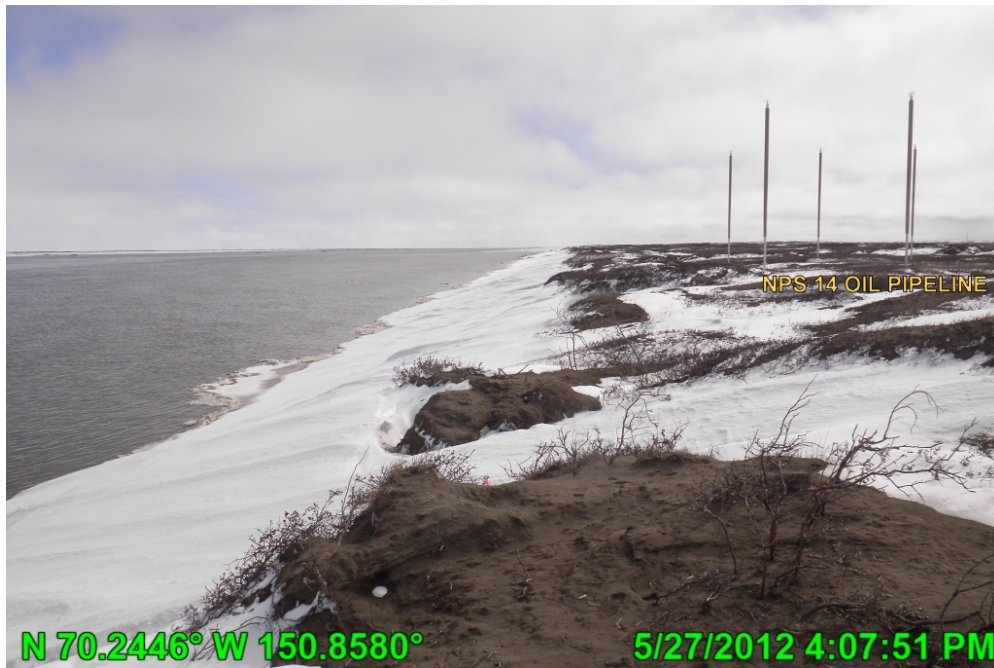
Photo A.1 HDD West bank during spring breakup, looking south, May 27, 2012

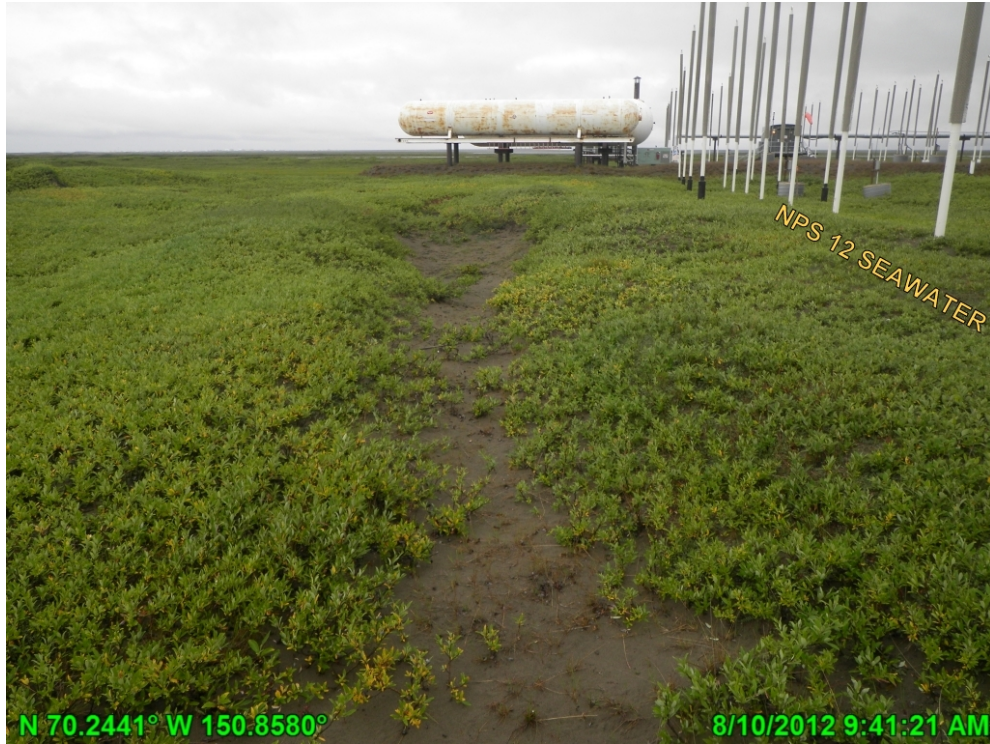
Photo A.7 HDD West depression off NPS 12 Seawater pipeline centerline, August 10, 2012

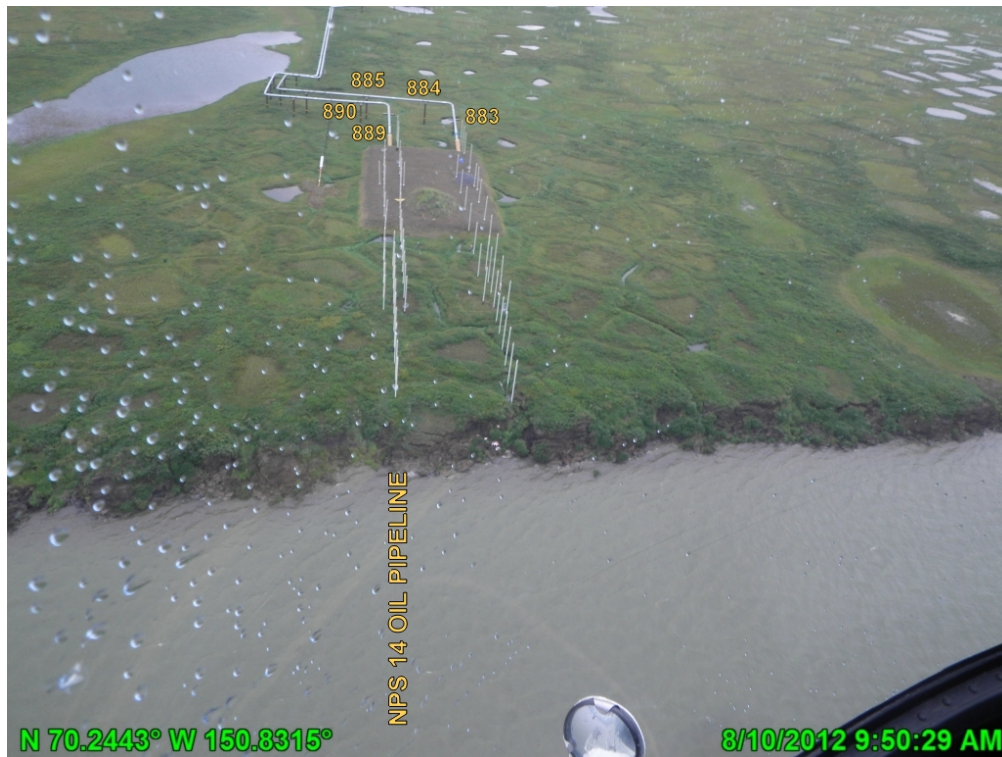
Photo A.10 HDD East bank, looking east, August 10, 2012

As observed in 2010, some erosion and sloughing has occurred along the east bank, with exposed sandbags and Styrofoam evident. While the date of placement is not known, it is understood by Baker that the sandbags and Styrofoam were installed in the bank to combat further erosion. Site conditions encountered during the 2012 field visit were similar to those observed during the 2011 field visit.

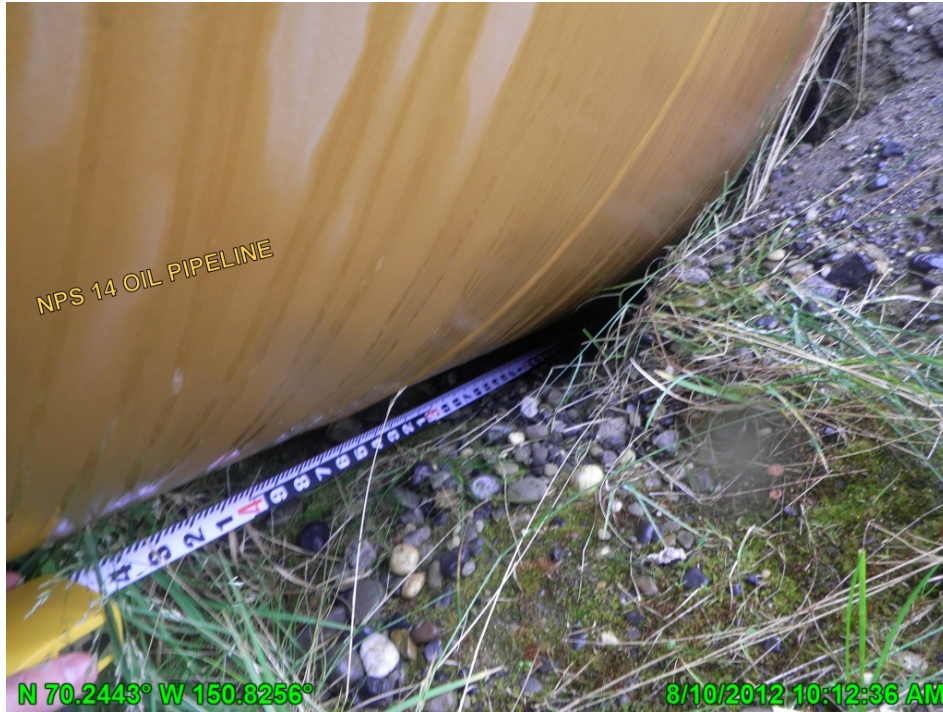
Photo A.11 Sloughing of the HDD East gravel pad, August 10, 2012

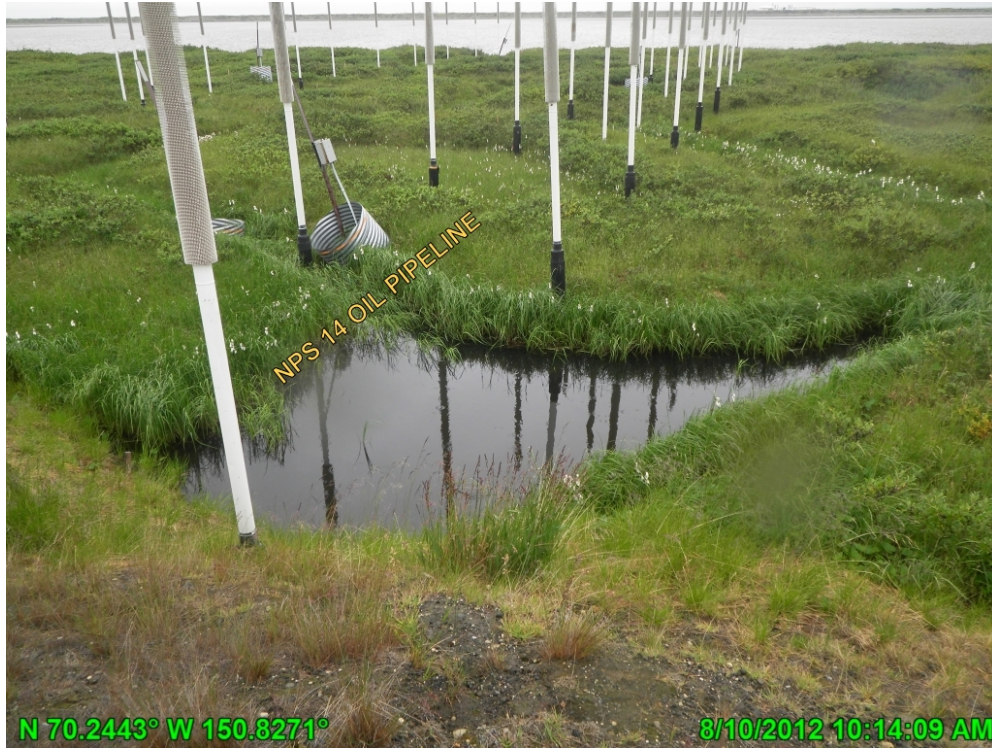
The cumulative subsidence measured at any of the cross sections was less than 3.3 feet. Maximum cumulative subsidence at cross section E was 3.2 feet. Cross section B saw the maximum incremental change since 2011 with a drop of 1.2 feet. A polygon trough does pass over the seawater casing axis; however, features of the trough do not meet or exceed the allowable physical conditions listed in the Monitoring Criteria

Photo A.13 Polygonal trough over NPS 14 Oil pipeline, August 10, 2012

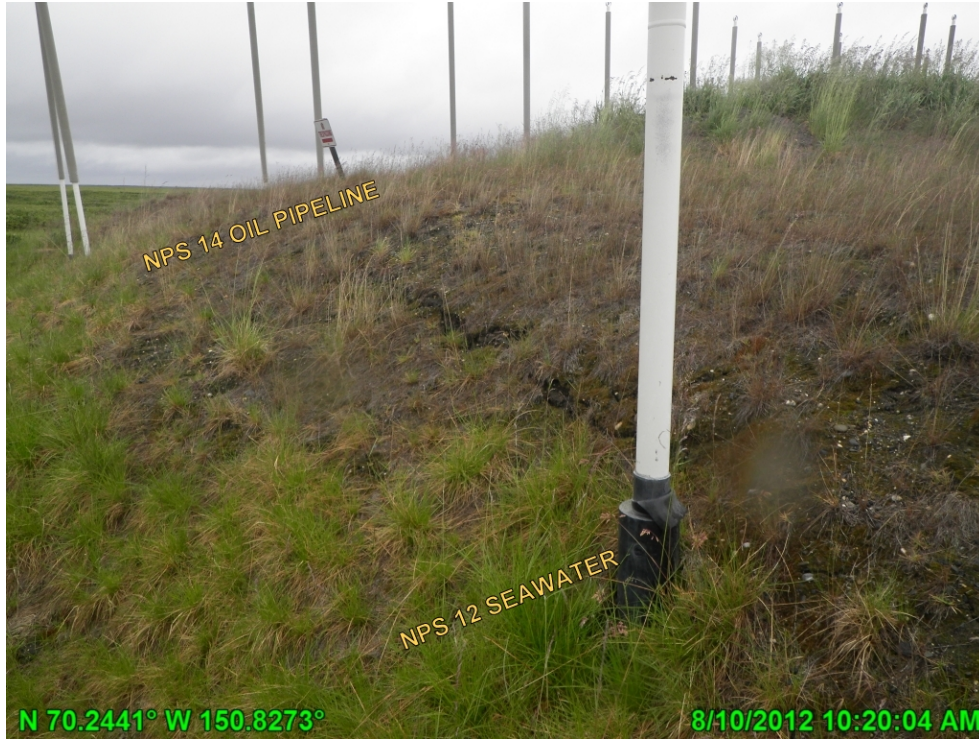
Photo A.15 Sloughing of the HDD East gravel pad west slope, August 10, 2012

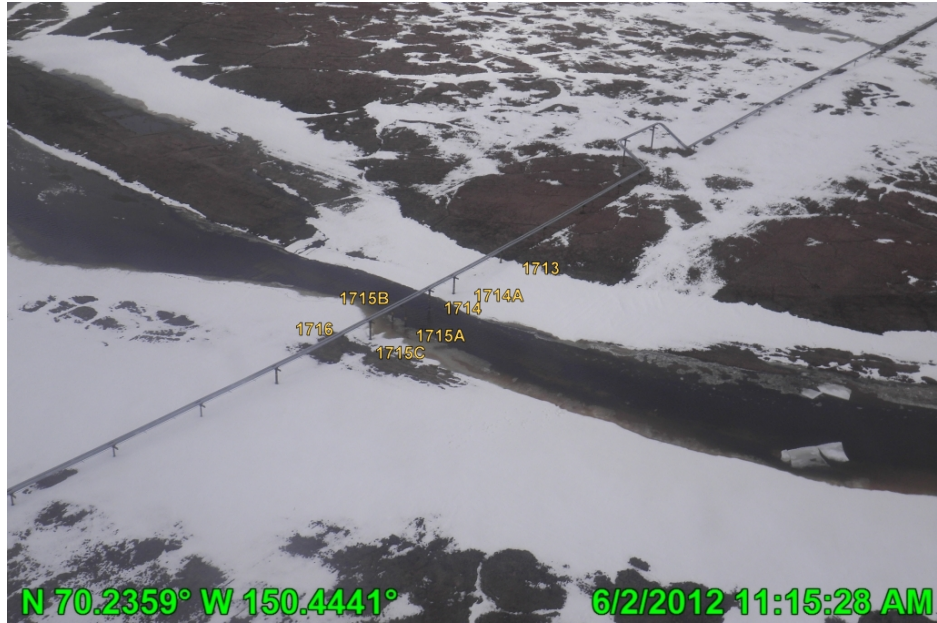
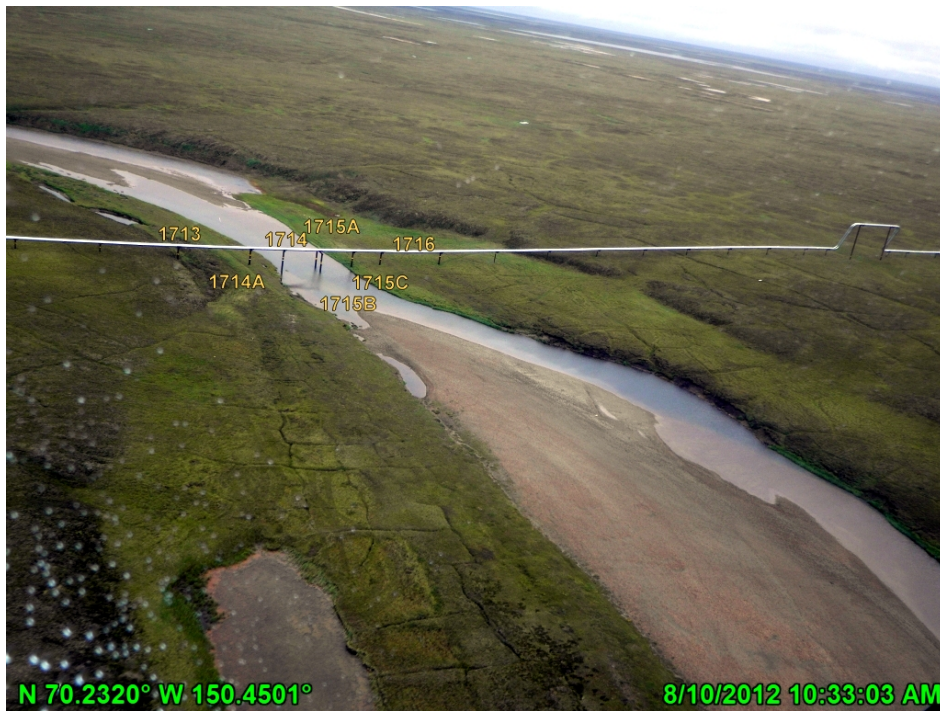
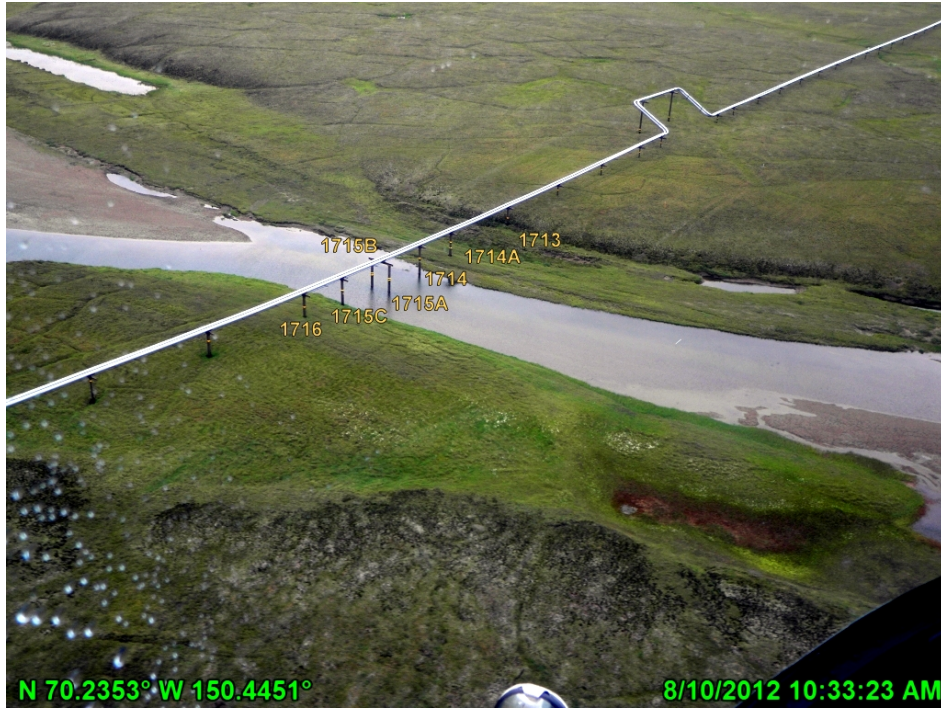
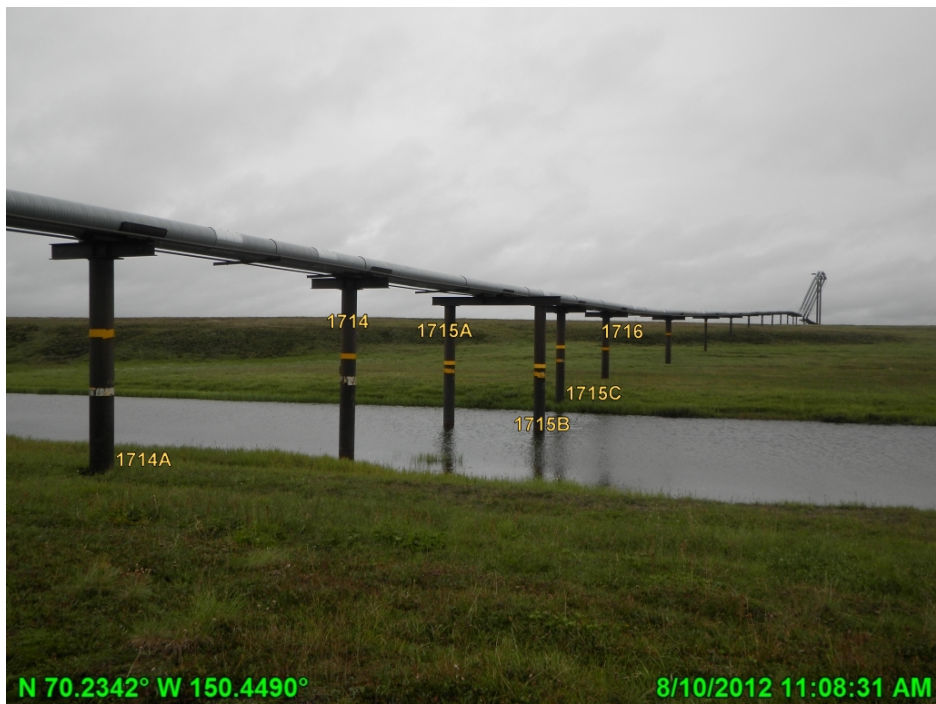
The Kachemach River crossing was evaluated by visual observation, ground and aerial photography (Photo A.17 through Photo A.20; Appendix A), and field surveys. At the time of the field visit, flow was observed across the entire gravel channel. The channel is approximately 75 feet wide with a maximum depth of approximately 4 feet. Spring breakup observations in 2012 suggest flow was confined to the active gravel bed channel and did not reach the overbank regions adjacent to the river crossing.

Appendix D includes a drawing of the bank migration survey in addition to tabular data; Photo A.17 through Photo A.20; Appendix A shows site conditions.
