# 2013 Fish Creek Basin Spring Breakup Monitoring and Hydrologic Assessment

Michael Baker Jr., Inc.  
3900 C Street  
Suite 900  
Anchorage, Alaska 99503  
135006-MBJ-RPT-001  
December 2013

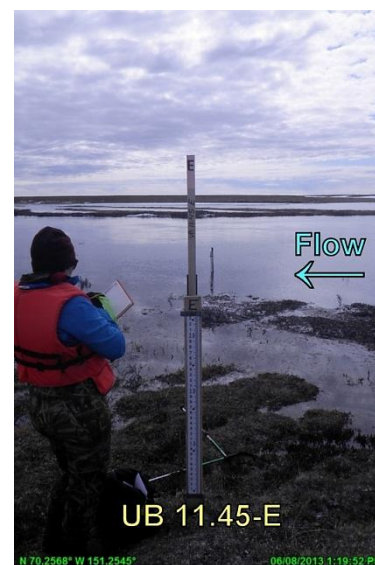
**Photo 2.1: WSE reading at UB11.45, looking northeast; June 8, 2013**

Stage or WSE data was obtained from hydrologic gage readings and pressure transducer (PT) data. All monitoring sites had staff gages installed. Site visits were performed as conditions allowed. WSE data was taken at the following sites during spring breakup: Clover B1, Clover B2, Clover B3, Clover C1, Clover C2, UB6.7, UB6.8, UB6.9, UB11.45, UB11.6, and S4, S5, and S6. Photo 2.1 shows WSE data collection at UB11.45.

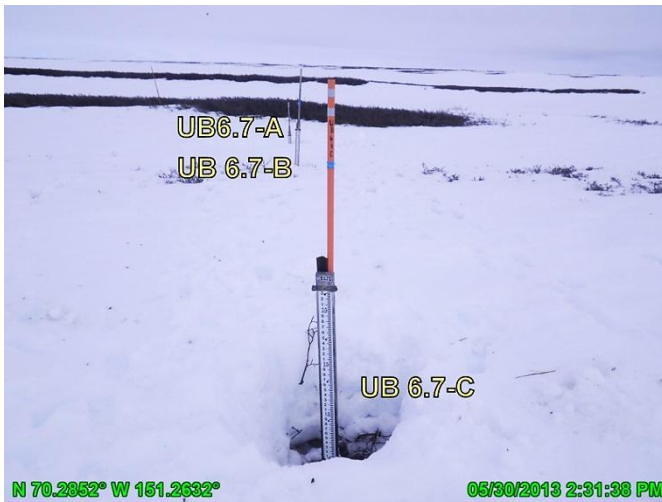
**Photo 2.2: Gages at UB6.7, looking northeast; May 30, 2013** each site, gages are identified with alphabetical designations A, B, C, D, or E, with gage A being closest to the water's edge. Gages were installed with an overlap in coverage of vertical elevation. The overlapping vertical coverage provides for redundancy with WSE readings and acts as a backup if a gage is lost due to an ice floe or the stream becomes unsafe to wade. Photo 2.2 shows the array of gages at UB6.7 with gage A closest to the water's edge.

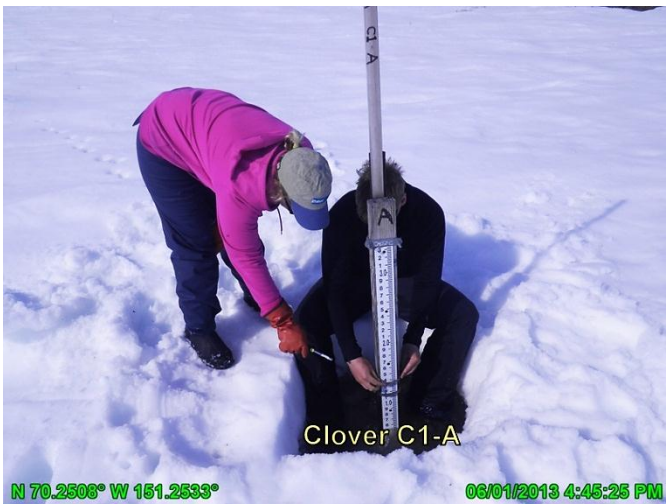
Photo 2.3: Installing a PT at Clover C1, looking northeast;  
June 1, 2013

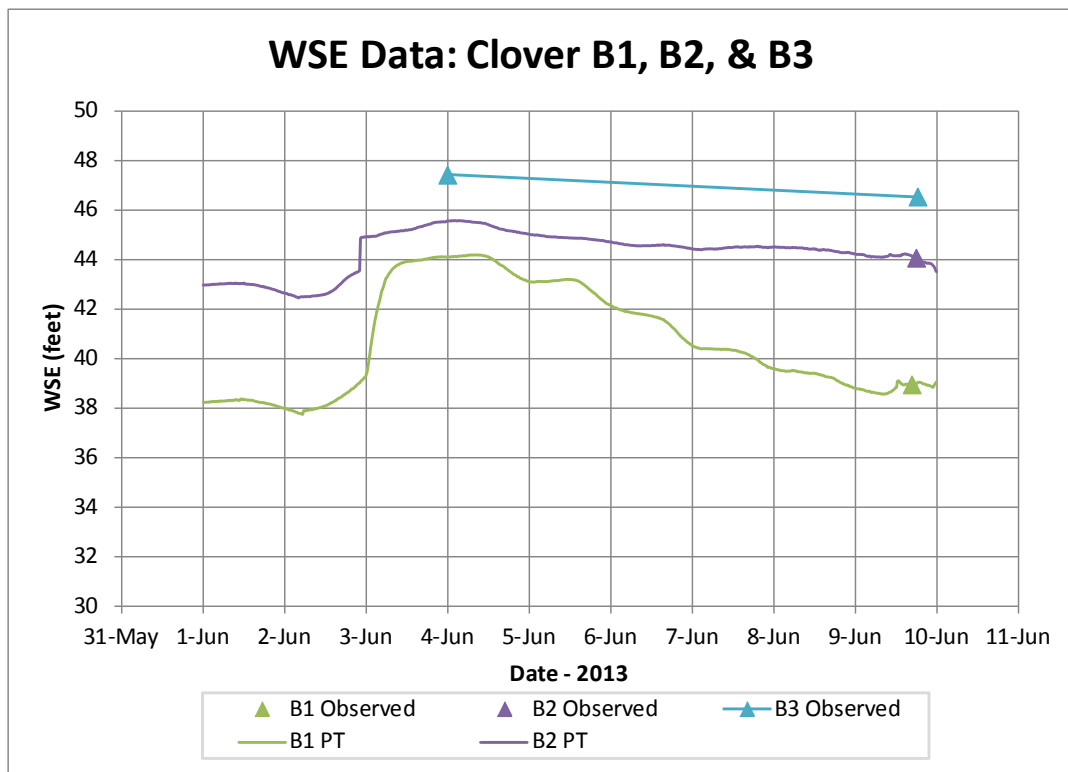
1. Elevations based on MEG at 46.984 feet, BAKER CP 3 at 48.000 feet, and CLARK at 47.293 feet, established by Baker in 2010 using a handheld Garmin Rino 520HCx GPS
2. Elevations not referenced to BPMSL

**Graph 3.1: 2013 Stage Data for B1, B2, & B3 (Clover B Gages)**

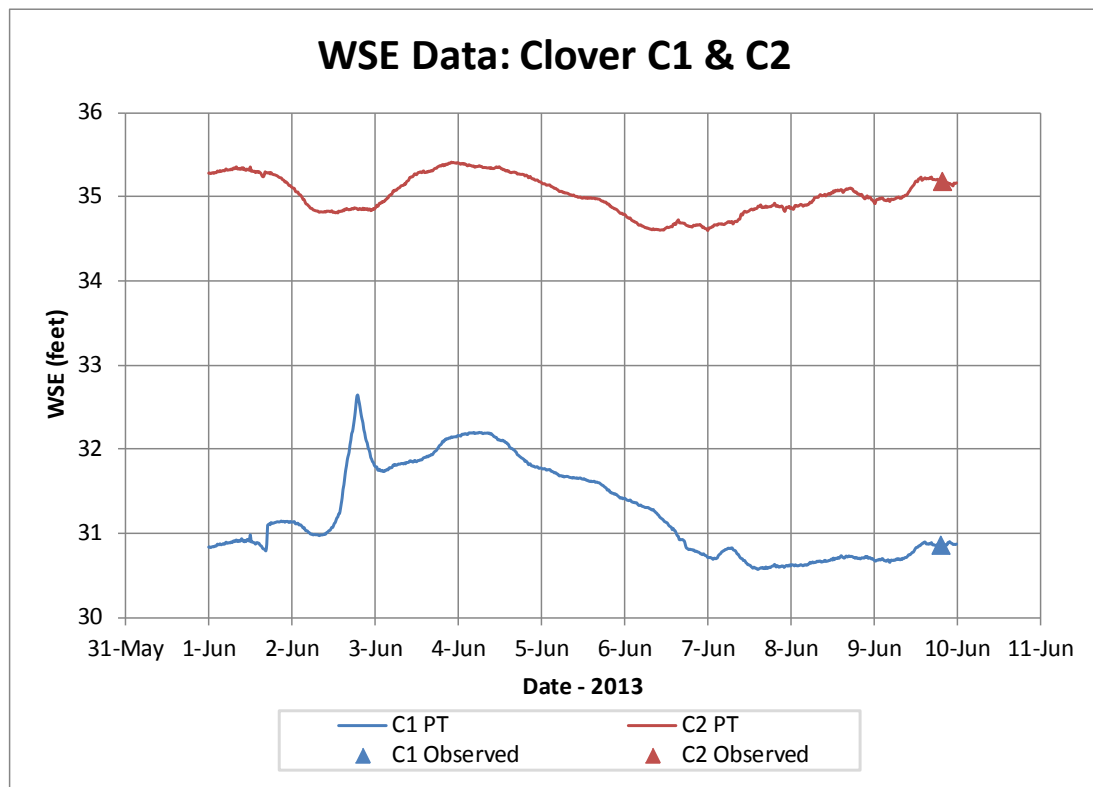
1. Elevations based on EICKELMAN at 36.542 feet, BAKER CP 2 at 35.000 feet, and SHOCKER at 36.216 feet, established by Baker in 2010 using a handheld Garmin Rino 520HCx GPS
2. Elevations not referenced to BPMSL

**Graph 3.2: 2013 Stage Data for C1 and C2 (Clover C Gages)**

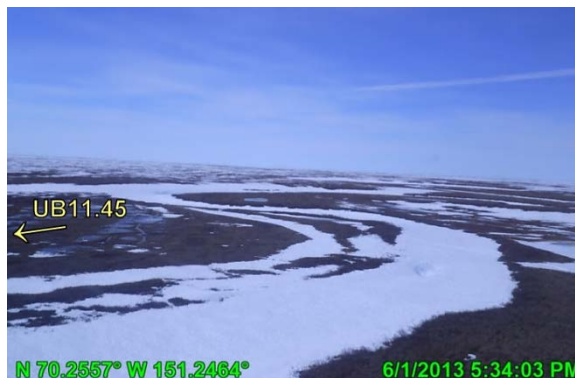
On June 1, local melt was present within polygon depressions on the surrounding tundra. The Ublutuocho River was still full of drifted snow, and no flow was observed in the main channel (Photo 3.5).

**Photo 3.5: Drifted snow in the main channel of the Ublutuocho River near UB11.45 and UB11.6, looking northeast; June 1, 2013**

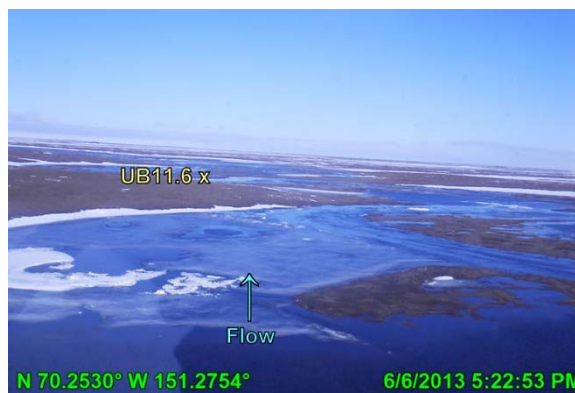
On June 6, flooding conditions were observed at the UB11.45 and UB11.6 gage locations. The surrounding tundra was mostly snow-free. Open water and overbank flooding was observed on the Ublutuocho River main channel (Photo 3.6). Stranded ice floes were present on the banks of UB11.45 indicating water levels had peaked (Photo 3.7). No ice jams were observed in the vicinity of the UB11.45-UB11.6 reach during spring breakup 2013.

**Photo 3.6: Breakup conditions near UB11.6 showing overbank flooding, looking northeast; June 6, 2013**

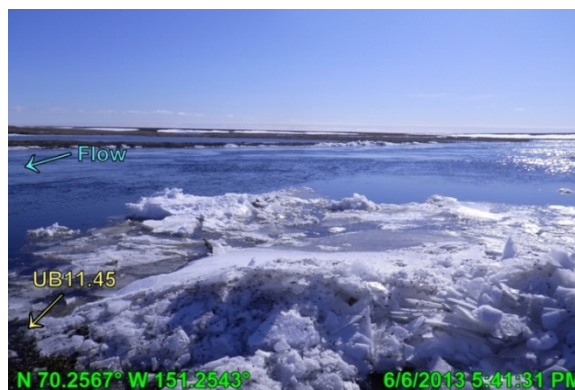
**Photo 3.7: Stranded ice floes at UB11.45, looking south; June 6, 2013**

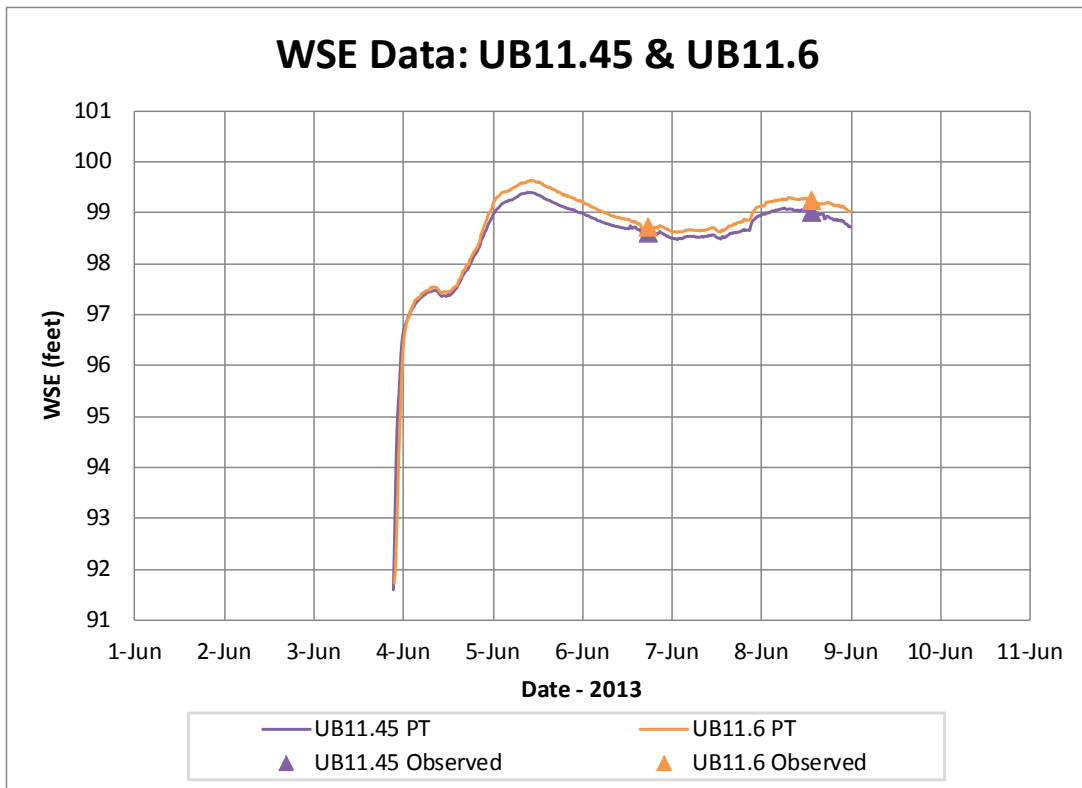
1. Elevations based on GUTZWILLER at 100.000 feet, established by Baker in 2011
2. Elevations not referenced to BPMSL

**Graph 3.3: 2013 Stage Data for UB11.45 and UB11.6**

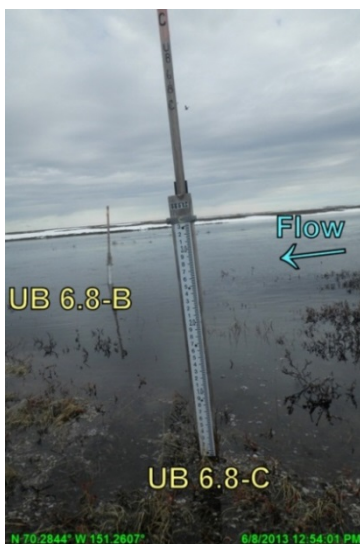
On June 8, ice-free overbank flooding was observed at UB6.8 and UB6.9 (Photo 3.10 and Photo 3.11). On June 10, overbank flooding and ice floes were present in the channel of the Ublutuoch River upstream of UB6.9 as stage decreased (Photo 3.12). No ice jams were observed at UB 6.7, UB6.8, or UB6.9 locations during breakup monitoring activities.

Photo 3.10: UB6.8 reach showing ice free channel and overbank flooding, looking northeast; June 8, 2013

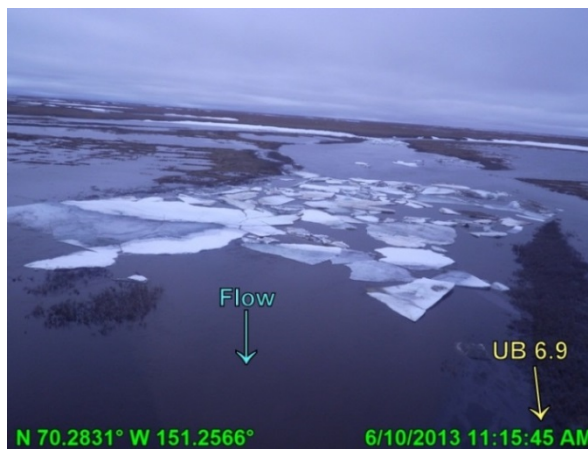
Photo 3.12: Overbank flooding and ice floes upstream of UB6.9, looking south; June 10, 2013

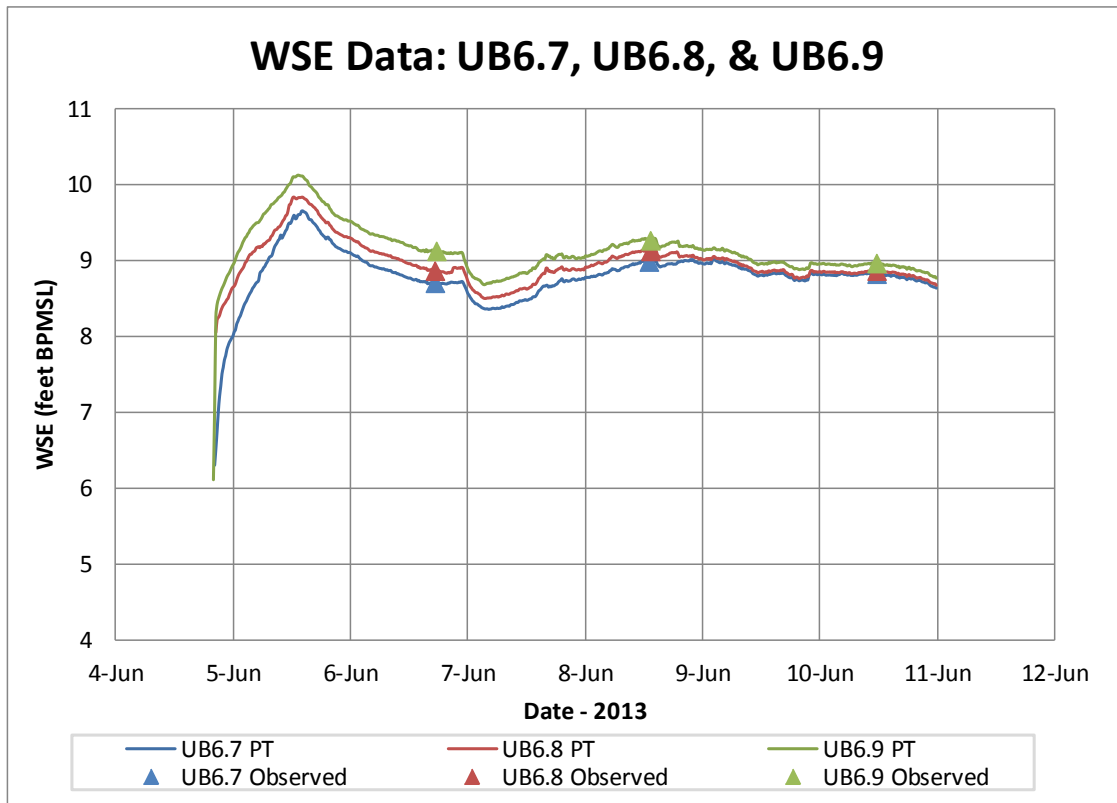
1. Elevations based on CP09-11-09B at 9.638 feet BPMSL, surveyed by LCMF in 2009

Graph 3.4: 2013 Stage Data for UB6.7, UB6.8, and UB6.9

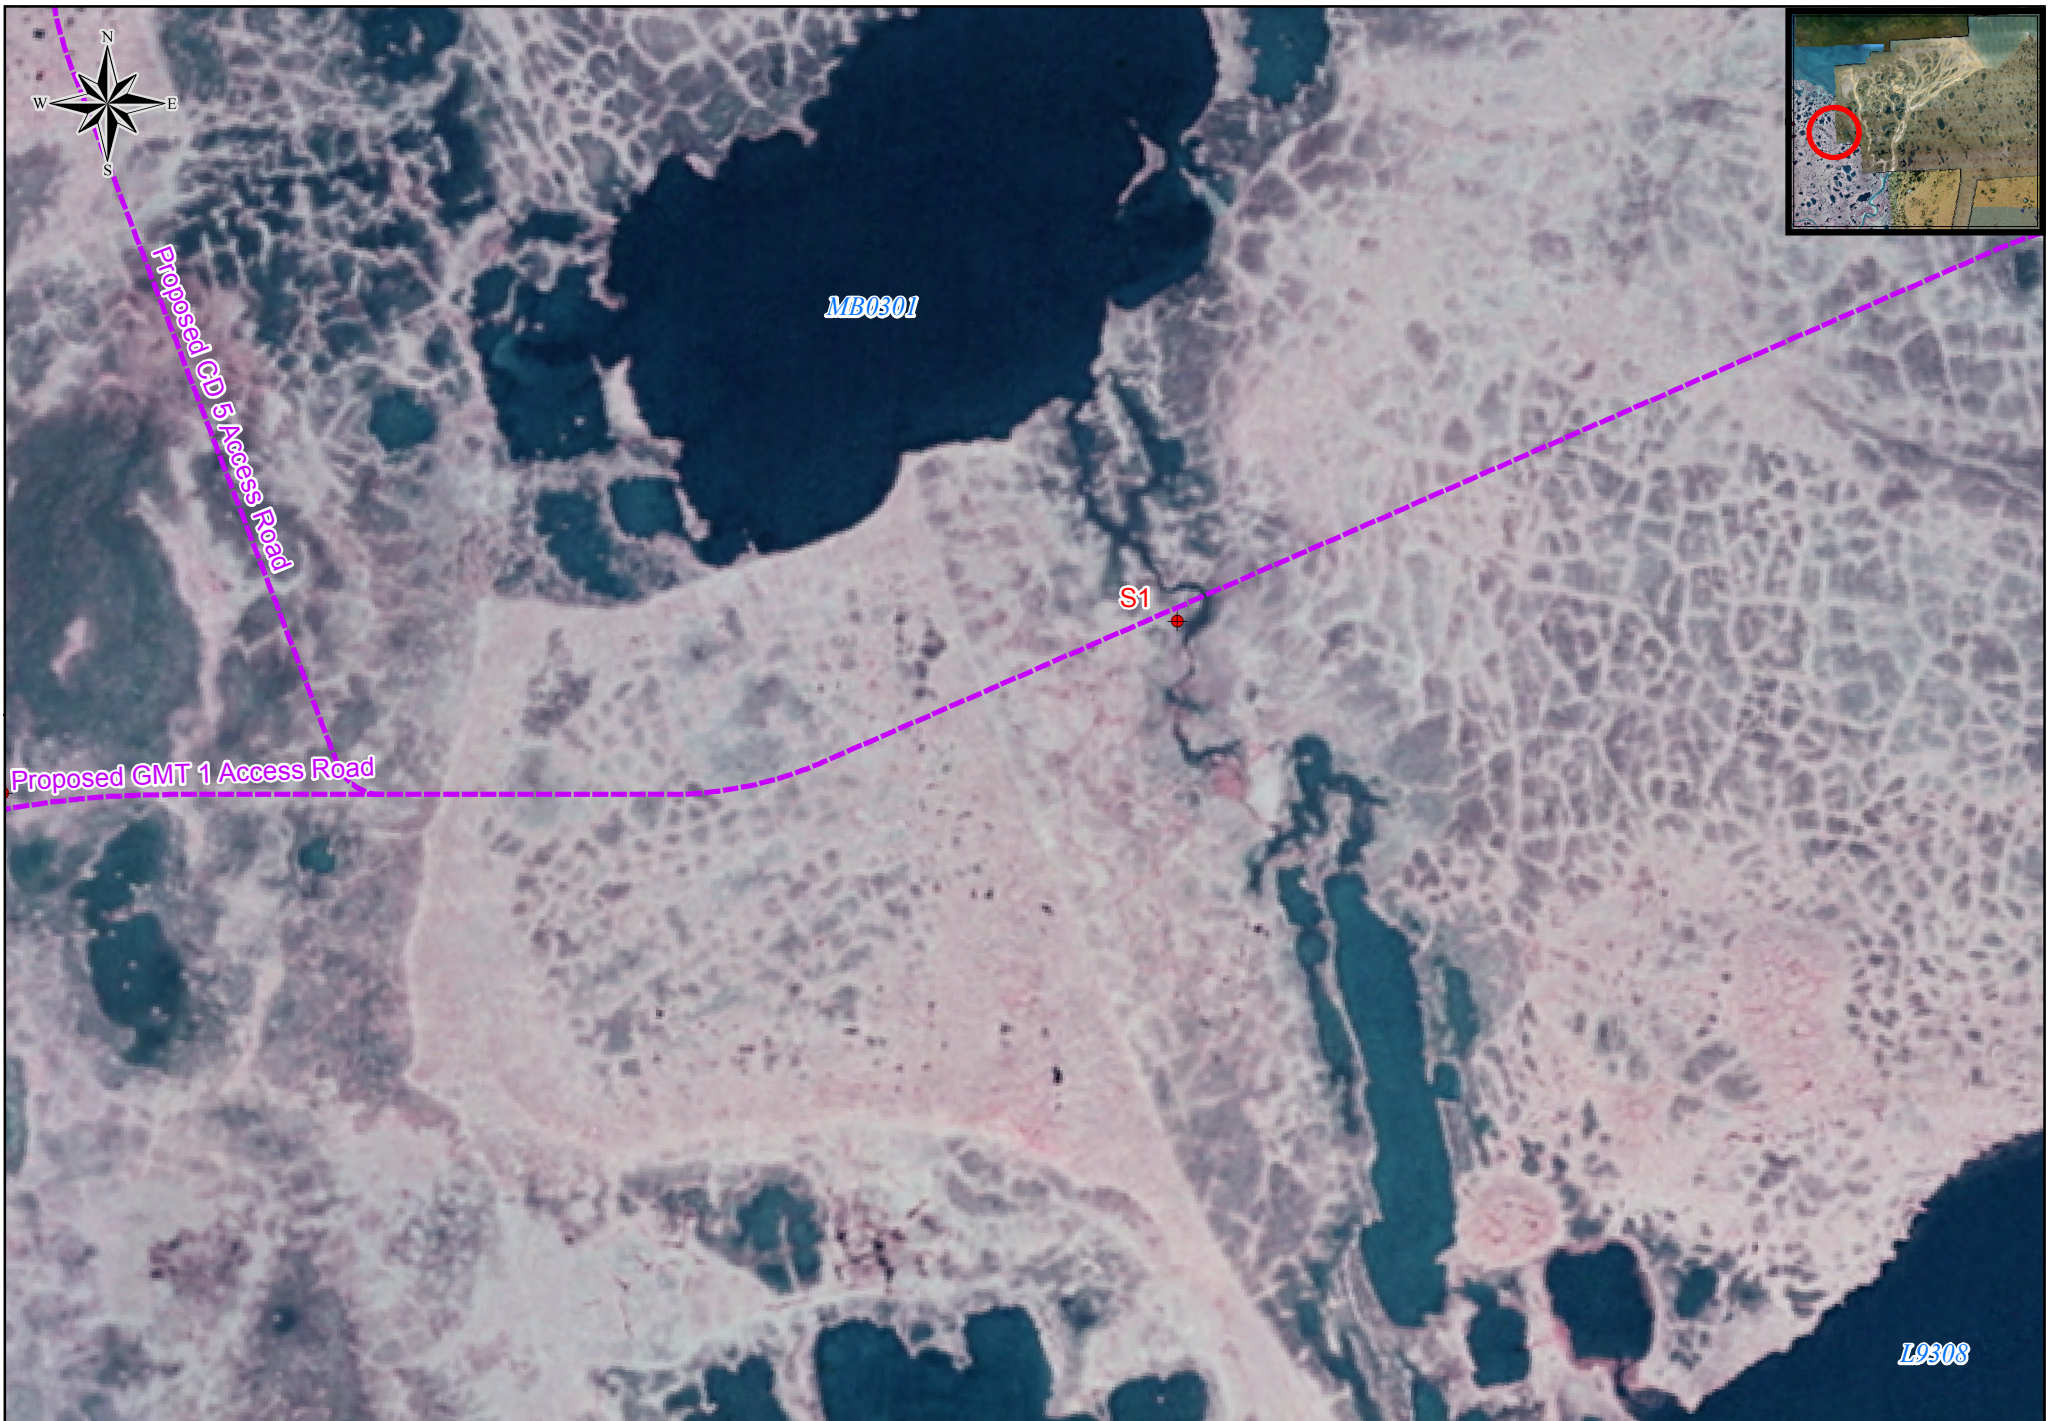
2013 FCB Breakup S1 Plan
FIGURE: 3.4
(SHEET 1 of 1)

In 2013, seven small streams, S1, S2, S3, S4, S5, S6, and S7 were monitored during spring breakup. Monitoring locations were chosen based on the location of proposed drainage structures provided by PND and observations made during 2009 and 2010 breakup monitoring. The small stream crossing gage locations monitored in 2013 are shown in Figure 3.4 through Figure 3.10 in numerical order. Profiles are shown for small stream crossings S4 and S5.

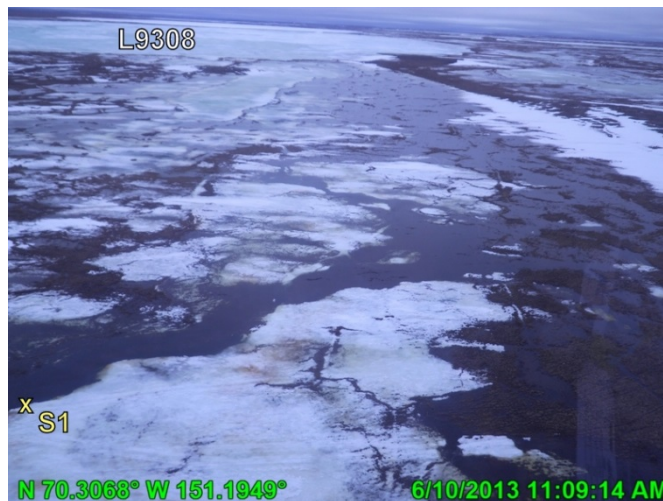
On June 10, visual observations were conducted by helicopter overflight at the S1 gage location. Extensive ponded water and decayed snow cover was observed in the swale between Lake MB0301 Lake L9308 (Photo 3.13). Lake ice was still present in Lake MB0301. No visible flow was observed at S1 during breakup monitoring activities.

**Photo 3.13: S1 gage location showing decayed snow cover and local melt, looking south; June 10, 2013**

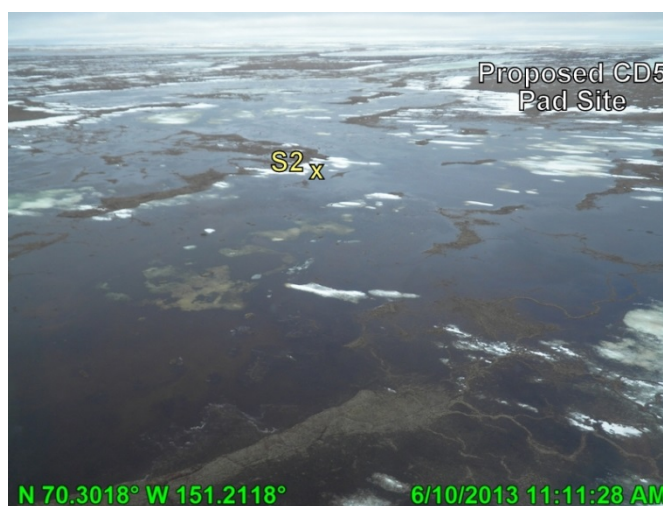
On June 10, visual observations were conducted by helicopter overflight at the S2 gage location. Extensive ponded water was present in all low lying areas and over patches of highly decayed snow cover (Photo 3.14). No visible flow was observed at S2 during breakup monitoring activities.

**Photo 3.14: S2 gage location showing extensive local melt and decayed snow cover, looking north; June 10, 2013**

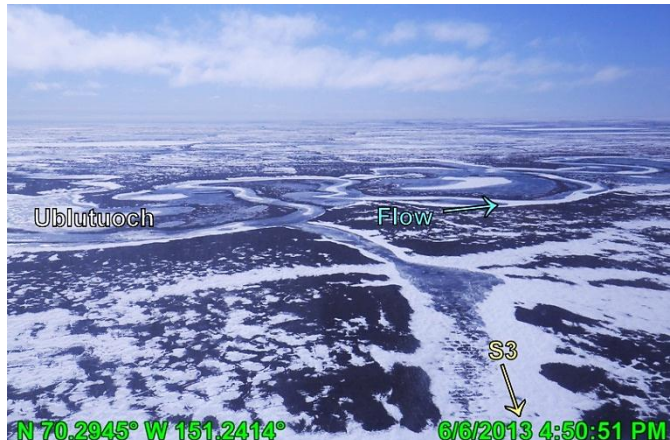
On June 6, visual observations were conducted by helicopter overflight at the S3 gage location. Drifted snow was present in low lying areas with local melt accumulating in polygon depressions within the S3 drainage. Backwater from the Ublutuoch River was observed flooding into the lower reach of the S3 drainage (Photo 3.15).

Photo 3.15: The lower reach of S3 drainage showing drifted snow, local melt in polygons, and connection to the Ublutuoch River, looking west; June 6, 2013

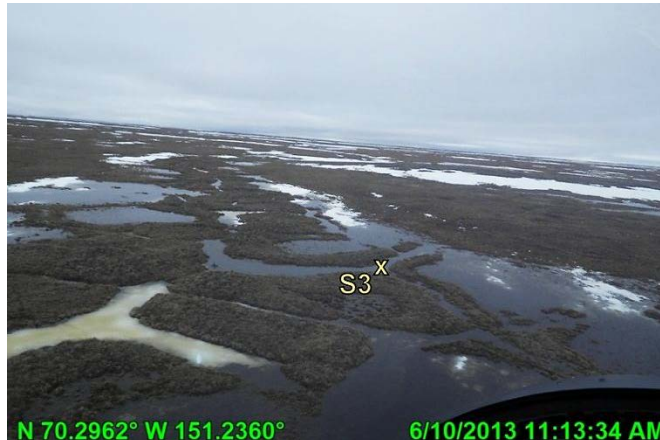
On June 10, visual observations were conducted by helicopter overflight. Most of the drifted snow had melted, and ponded water remained in low lying areas of the drainage (Photo 3.16). No visible flow was observed at S3 during breakup monitoring activities.

Photo 3.16: S3 gage location showing local melt in low lying areas, looking south; June 10, 2013

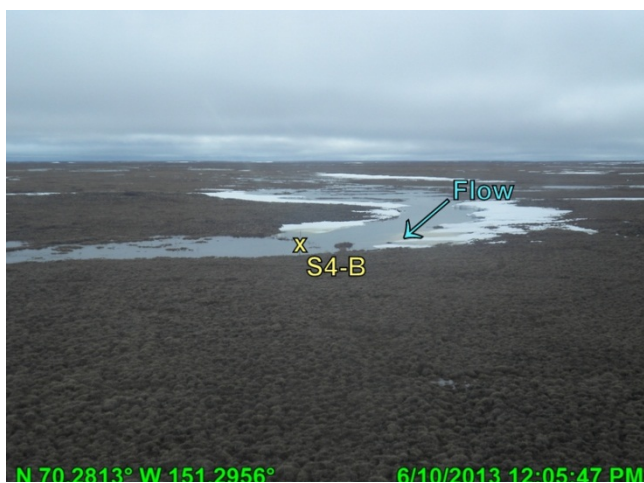
Photo 3.17: S4-B gage location showing broad channel flowing through snow pack on banks, looking south; June 10, 2013

On June 10, open water was observed in the drainage though intermittent patches of saturated snow still remained along the banks. Bottom-fast ice was present in pooled areas along the stream (Photo 3.17).

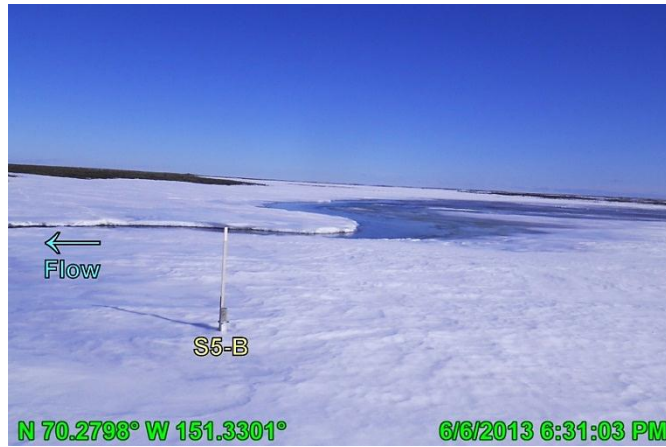
On June 6, PTs were installed at the S5-A and S5-C gages, and initial WSEs were recorded at all S5 gages. On June 6, flow was observed over and through extensive accumulations of drifted snow within the drainage. Hydraulic conditions were characterized as flow over saturated snow upstream of S5-B gage transitioning to an incised channel in the snow pack downstream of the S5-B gage and proposed S5 crossing location (Photo 3.18). Saturated snow along the drainage was present at the S5-A gage location downstream of the proposed S5 crossing (Photo 3.19 and Photo 3.20).

Photo 3.18: Flow over and through saturated snow at proposed S5 crossing location (S5-B), looking west; June 6, 2013

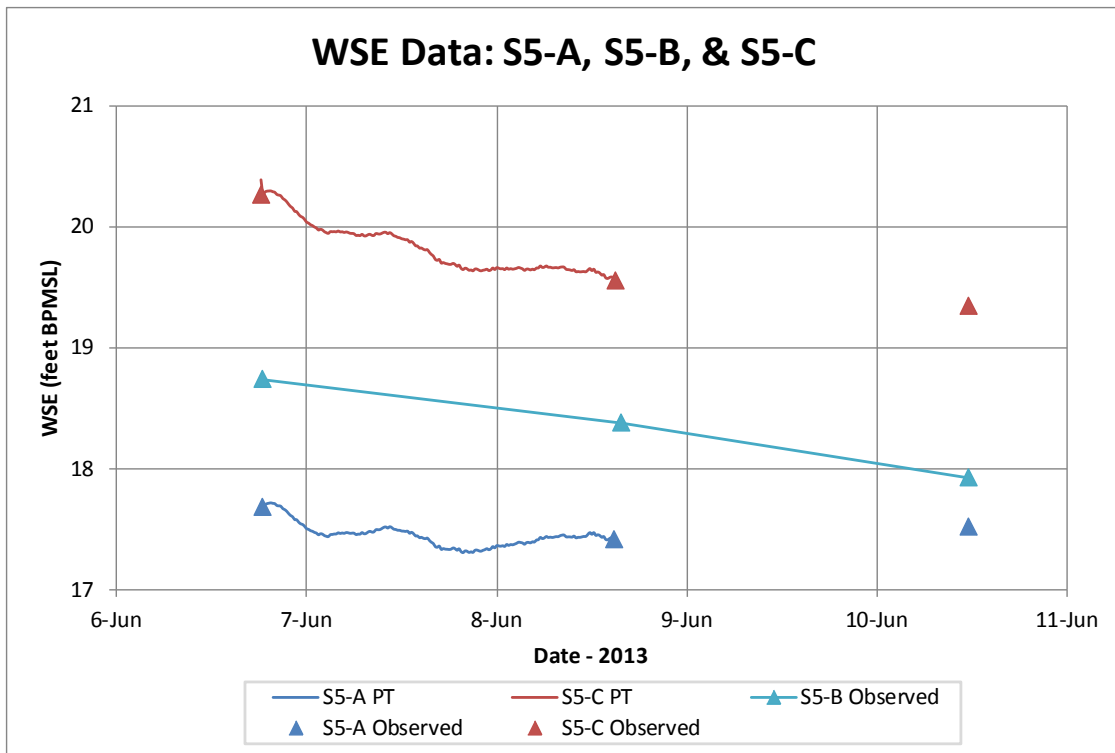
Stage at S5 continued to decline from the initial reading throughout the monitoring period, and it is possible peak WSE occurred before the first gage readings and pressure transducer installation. Initial WSE readings on June 6 were 17.72 feet, 18.74 and 20.39 feet at S5-A, S5-B and S5-C, respectively (Table 3.8 and Graph 3.6).

**Graph 3.6: 2013 Stage Data for Small Stream Crossing S5**

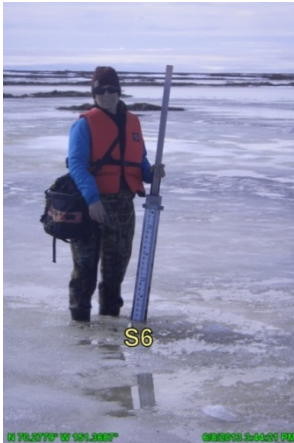
Photo 3.21: S6 gage location with local melt and saturated snow, looking west; June 8, 2013

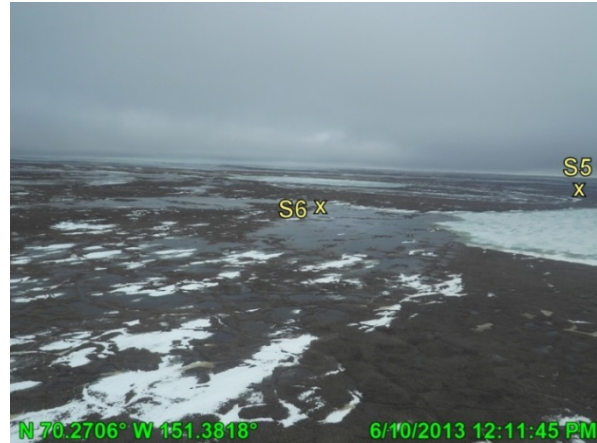
On June 10, the S6 drainage was characterized by ponded water, with little snow remaining (Photo 3.22). On the morning of June 10, the WSE on gage S6 was 23.72 feet. No visible flow was observed at S6 during breakup monitoring activities.

Photo 3.22: S6 drainage showing no flow, local melt, and little snow, looking northeast; June 10, 2013

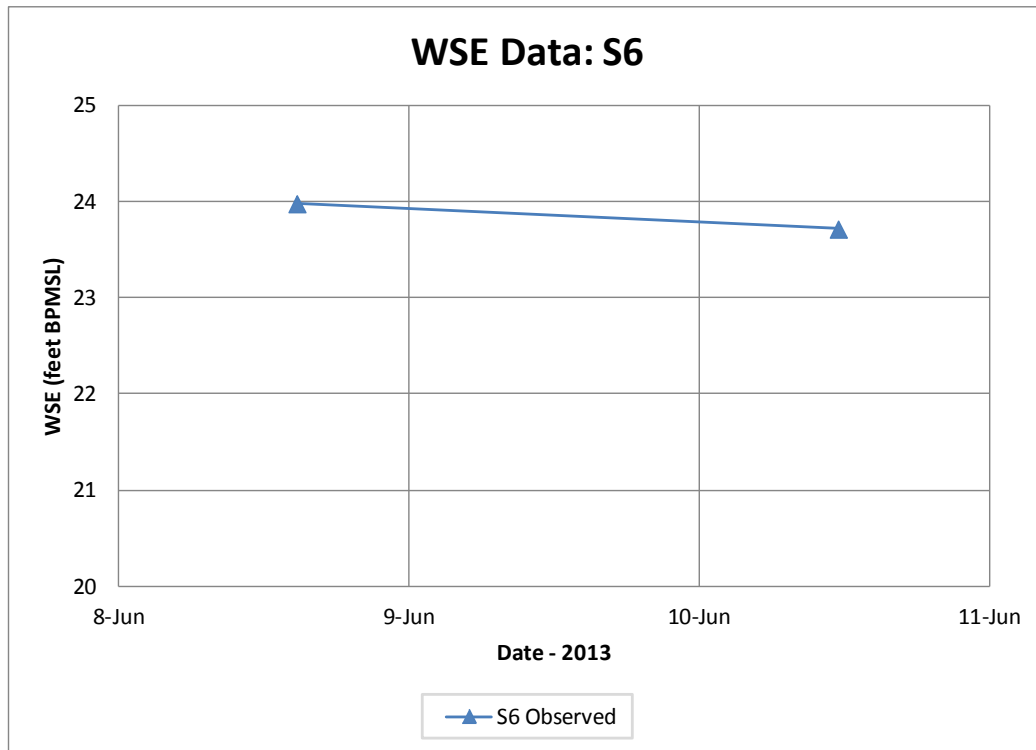
1. Elevations based on BRAD at 25.78 feet BPMSL, surveyed by LCMF in 2005

Graph 3.7: 2013 Stage Data for Small Stream Crossing S6

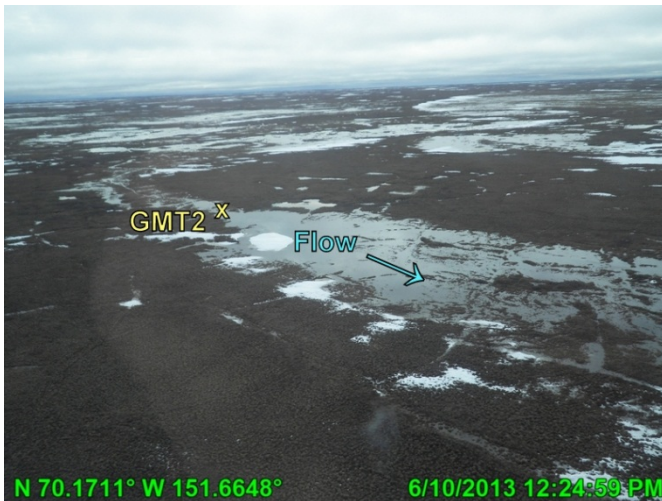
Photo 3.24: GMT2 area showing a small channel connecting low lying areas, looking northeast; June 10, 2013

On June 10, visual observations were conducted by helicopter overflight at the GMT2 gage location. Most of the snow cover in the GMT2 drainage area had melted. The drainage was characterized by flow in a small channel connecting several low lying areas (Photo 3.24).

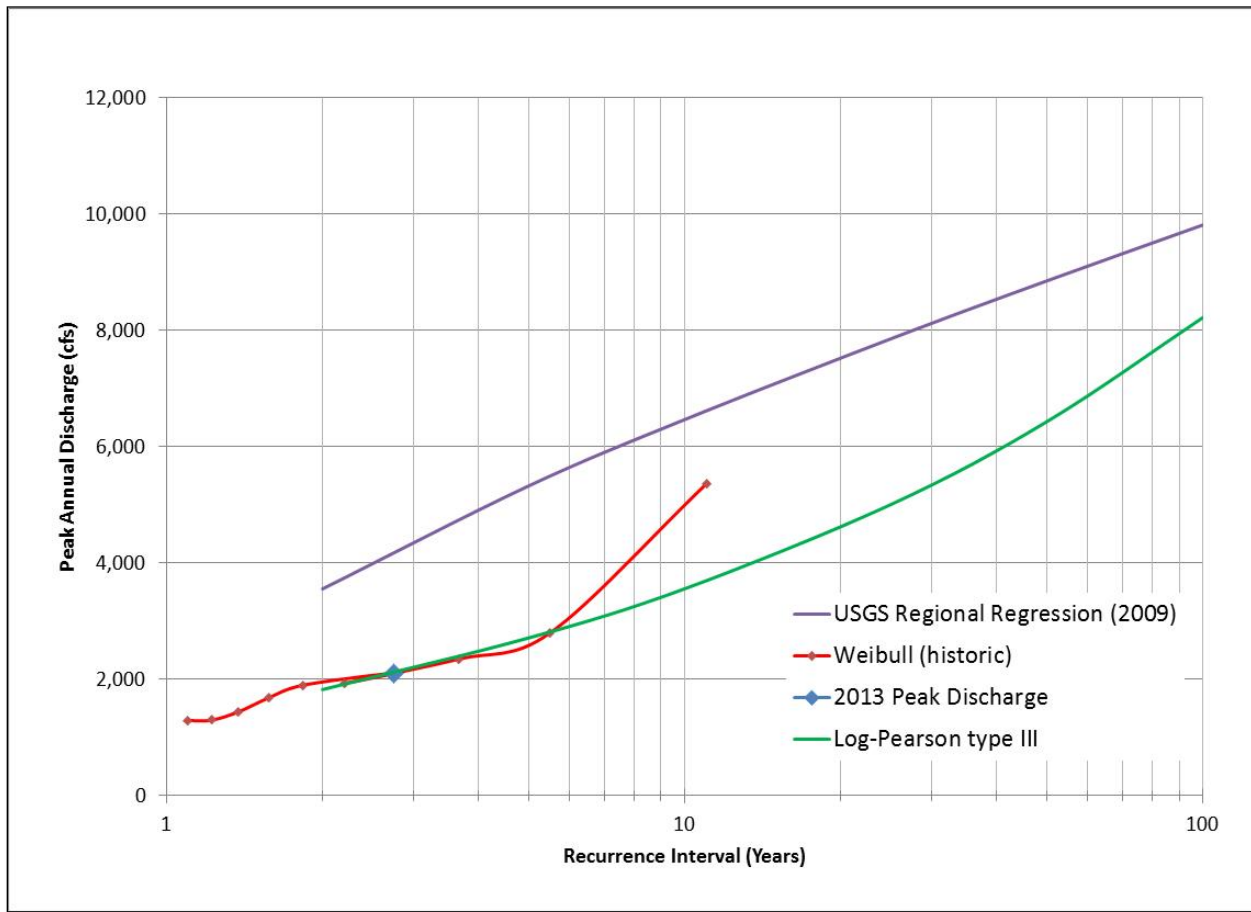
In 2009, an initial flood frequency analysis was performed for UB6.8. Results of this analysis are the basis for current design values and are presented in Table 4.2. This analysis uses the U.S Geological Survey (USGS) Region 7 regression equations, which use stream drainage areas and are based on empirical regional data. Results from this analysis tend to be conservative when compared to site-specific data. In 2013, Weibull analysis and the U.S. Water Resource Council recommended Log Pearson Type III distribution. These recommendations were performed using 10-years of historical peak discharge data and are compared to the Region 7 regression equation results and the 2013 peak discharge in Graph 4.1. The historical record comparison shows the regression equations over-predict the discharge quantities for a given recurrence interval, particularly for the lower recurrence flood years, when ice and snow would have more of an impact. The 2013 peak discharge in the Ublutuoch River at UB6.8 was 2,110 cfs, corresponding to a recurrence interval of 2.8- and 3.0-years based on the Weibull and Log Pearson Type III analysis, respectively. The 2013 peak discharge corresponds to less than a 2-year recurrence interval, based on the regression equations.

**Graph 4.1: Ublutuoch River UB6.7, UB6.8, and UB6.9 Flood Frequency Estimates**
