Alpine Pipeline River Crossing Monitoring

2014

**ConocoPhillips**
Alaska

September 2014
141674-MBJ-RPT-001

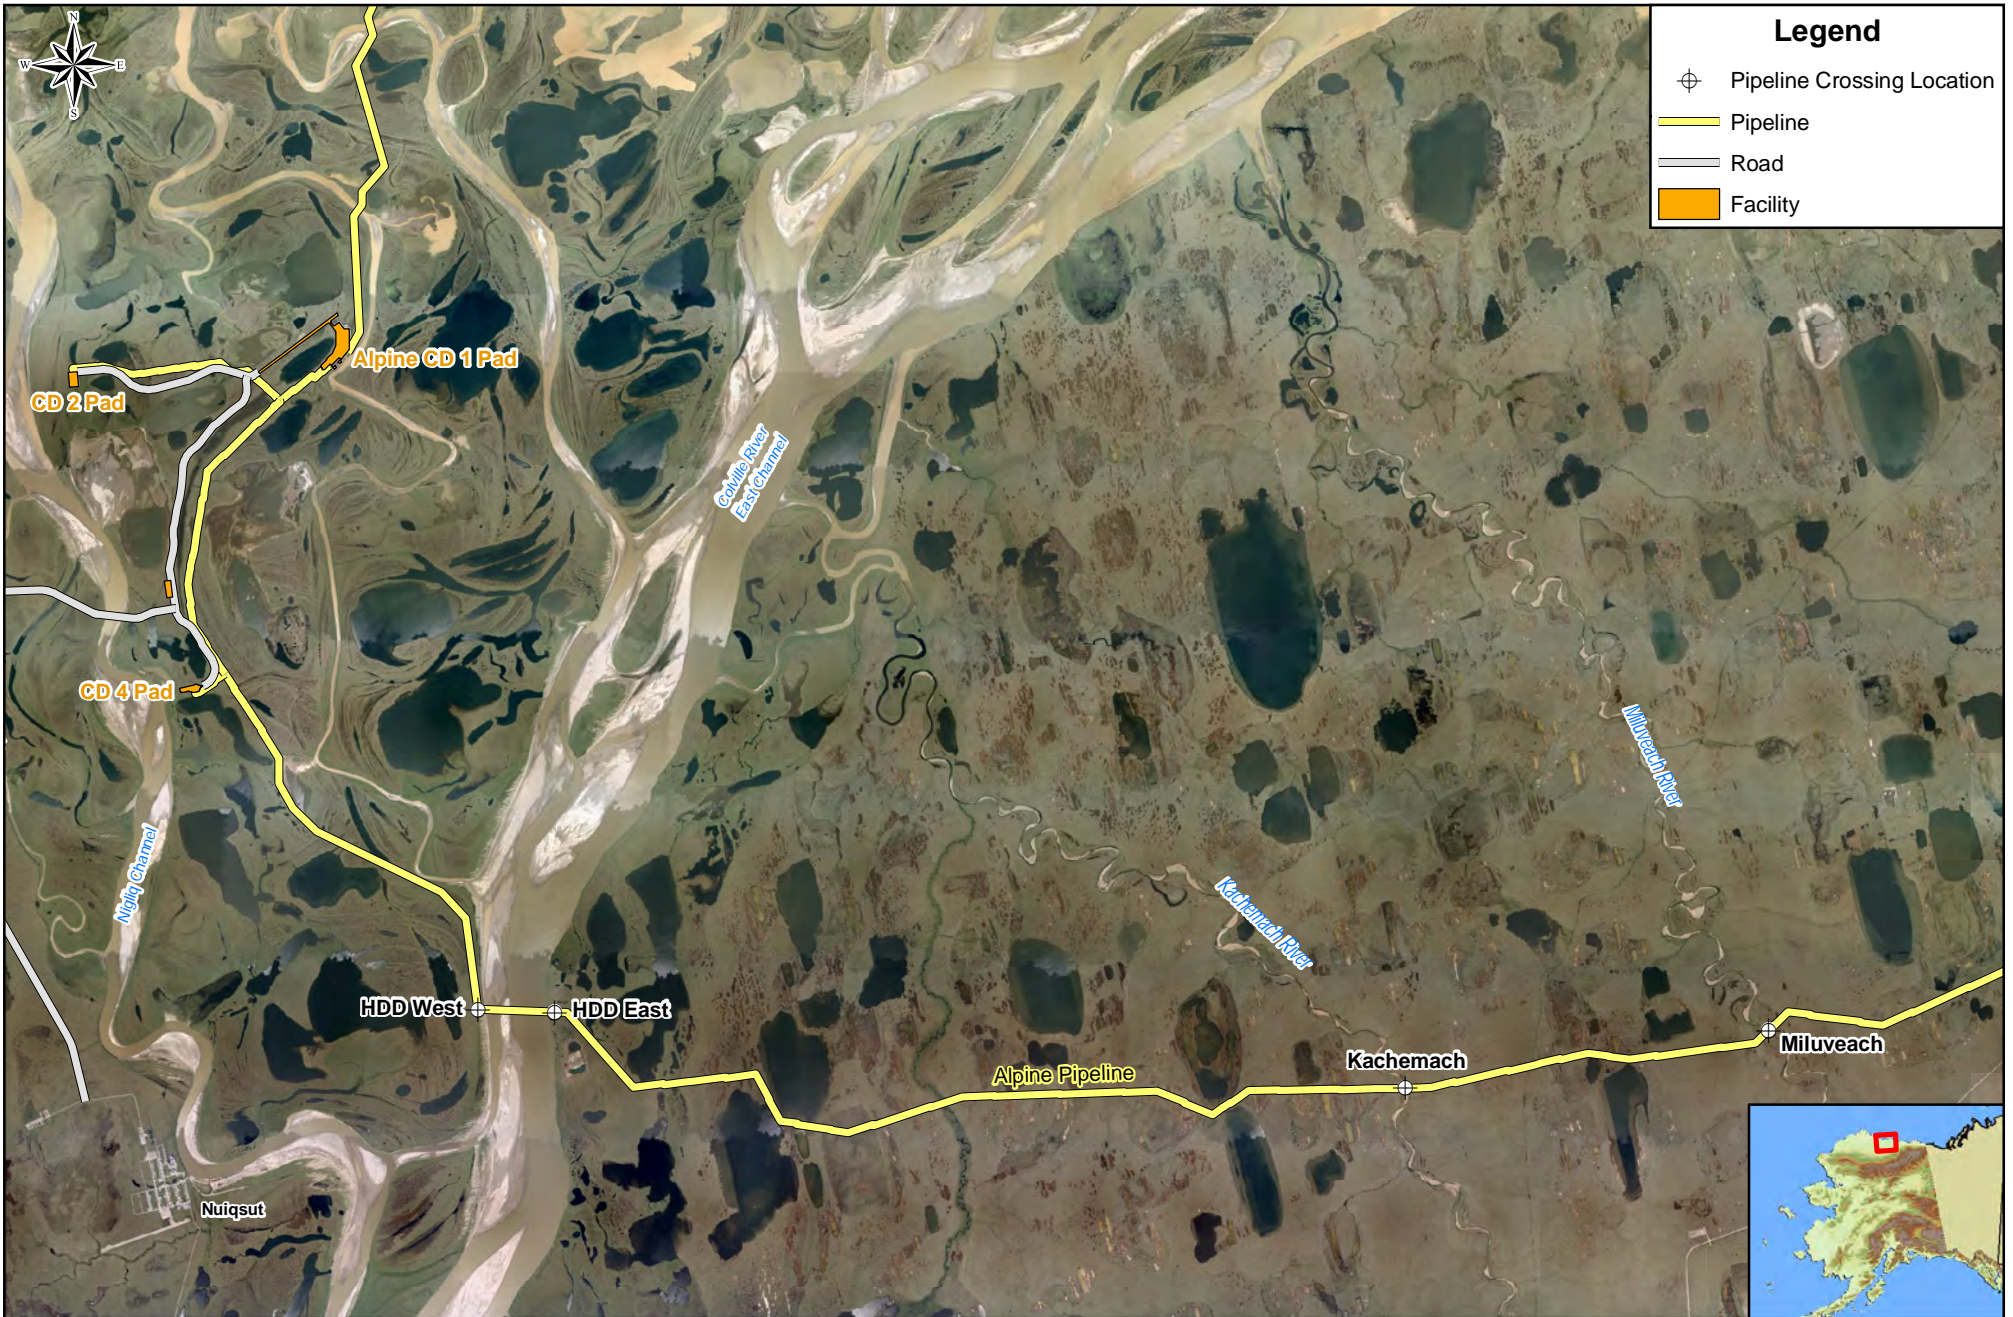
Baker conducted the 2014 Alpine Pipeline river crossing monitoring. The 2014 monitoring activities included visual observations and pipeline tilt measurements at the three crossings, and LCMF bank erosion and pile cap elevation surveys at the HDD crossing of the Colville River East Channel. The 2014 Alpine Pipeline River Crossing monitoring sites are included in Figure 1.

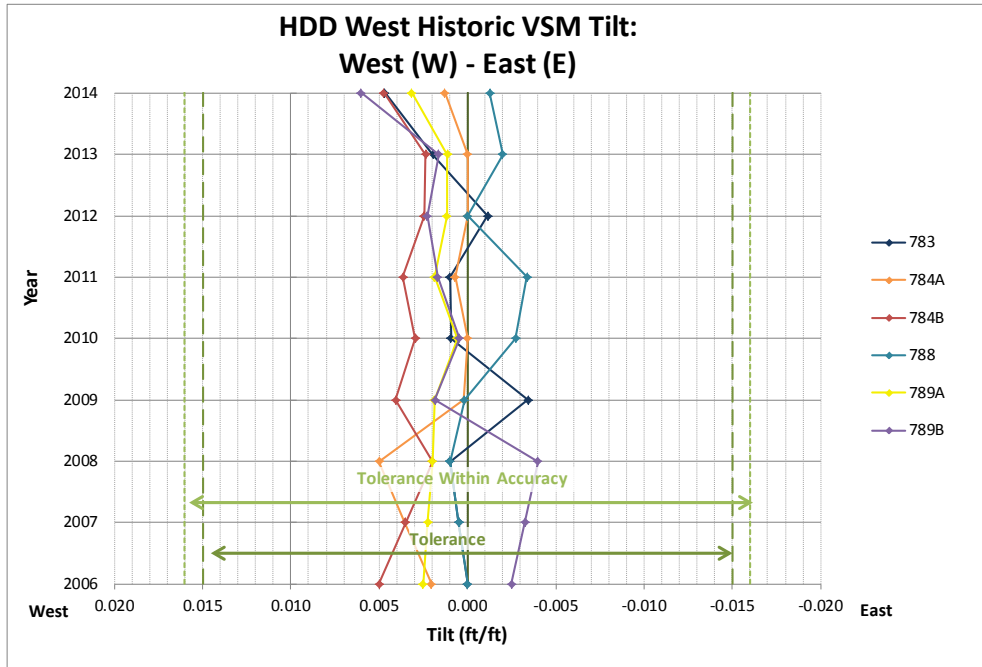
Graph 2 HDD West VSM Historical Change in Tilt, East/West

- Notes:**
1. Positive tilt indicates west (W), negative tilt indicates east (E)
 2. Project tilt tolerance for VSM is +/- 0.015 ft/ft.
 3. Survey accuracy of this project is +/-0.001 ft/ft.
 4. Historical tilt directions were corrected based on review of all past measurements; the magnitude remains unchanged.

All VSM at HDD West were found to be within project tilt tolerances.

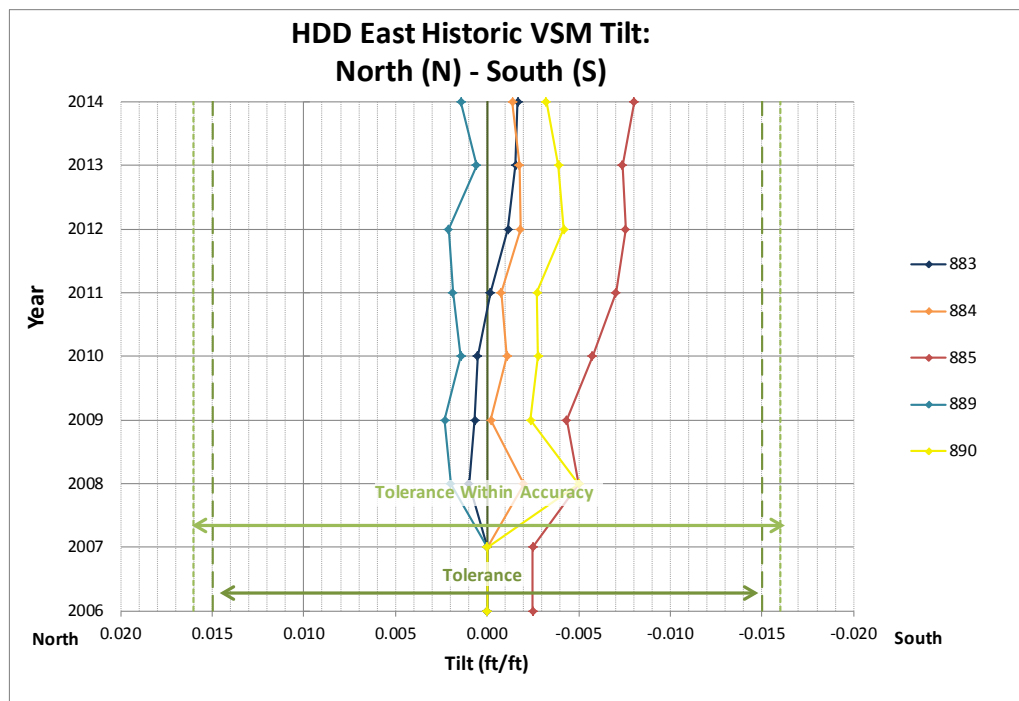
Graph 3 HDD East VSM Historical Change in Tilt, North/South

- Notes:
1. Positive tilt indicates north (N), negative tilt indicates south (S)
 2. Project tilt tolerance for VSM is +/- 0.015 ft/ft.
 3. Survey accuracy of this project is +/-0.001 ft/ft.
 4. Historical tilt directions were corrected based on review of all past measurements; the magnitude remains unchanged.

Graph 3 and Graph 4 present the historical VSM change in tilt by orientation between 2006 and 2014 (Baker 2006, 2007, 2008, 2009, 2010, 2011, 2012 and 2013).

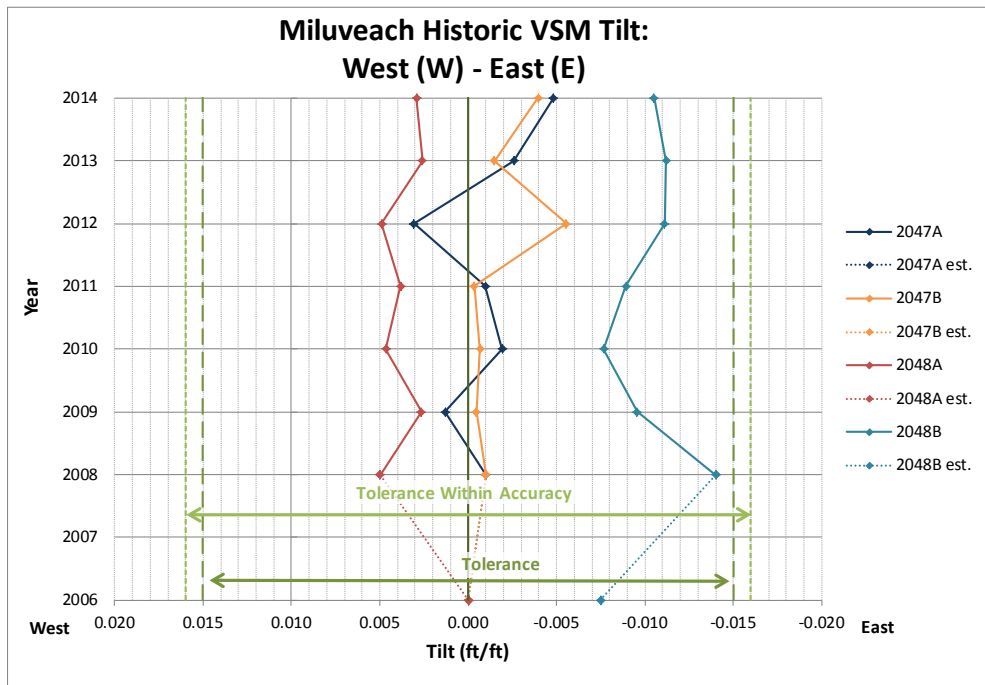
Graph 8 Miluveach River VSM Historical Change in Tilt, East/West

- Notes:
1. Positive tilt indicates west (W), negative tilt indicates east (E)
 2. Tilt measurements were not taken at this location in 2007; tilt is estimated between 2006 and 2008.
 3. Project tilt tolerance for VSM is +/- 0.015 ft/ft.
 4. Survey accuracy of this project is +/- 0.001 ft/ft.
 5. Historical tilt directions were corrected based on review of all past measurements; the magnitude remains unchanged.

Based on visual inspection, the VSMs do not affect the Miluveach River channel at the crossing location. All VSMs at the Miluveach River remain within project tolerances. No excessive bank erosion or scour was observed at the Miluveach River crossing.

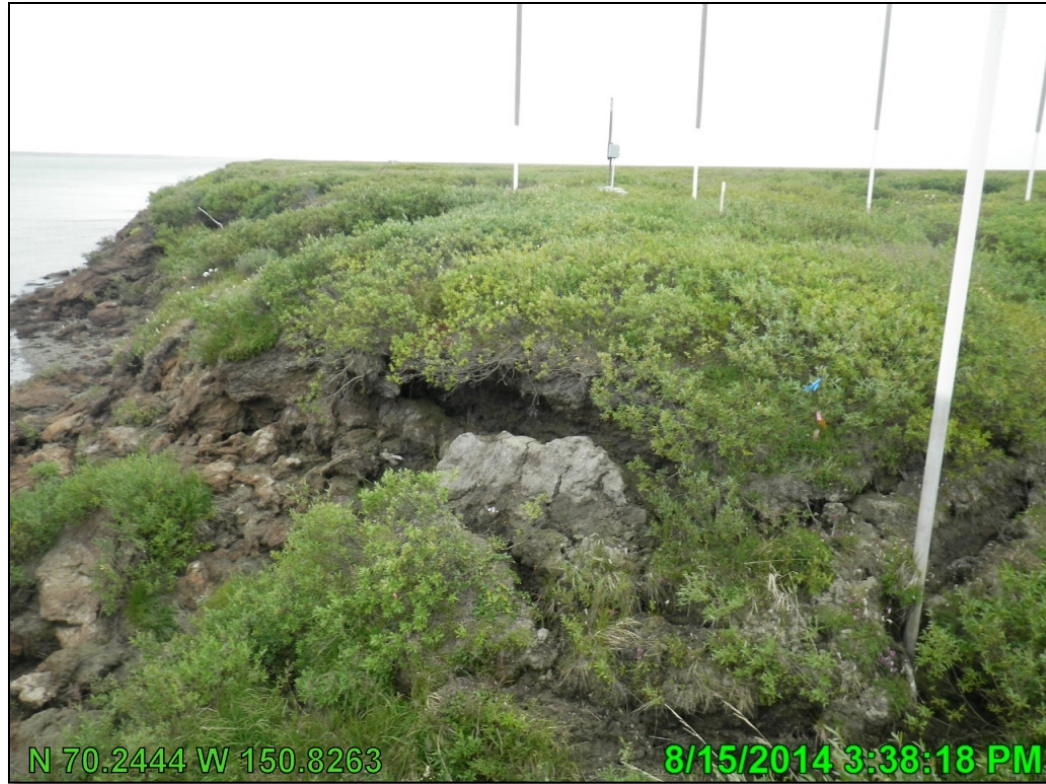
Photo A.18 HDD East bank, looking north; August 15, 2014

Additional erosion and sloughing continues along the east bank north of the NPS 14 oil pipeline and at the polygon trough near the NPS 12 seawater pipeline. Exposed sandbags and Styrofoam were evident at the toe of the polygon trough, similar to site conditions encountered during the 2013 field visit. While the date of placement is not known, it is understood by Baker that the sandbags and Styrofoam were installed in the bank to combat further erosion.

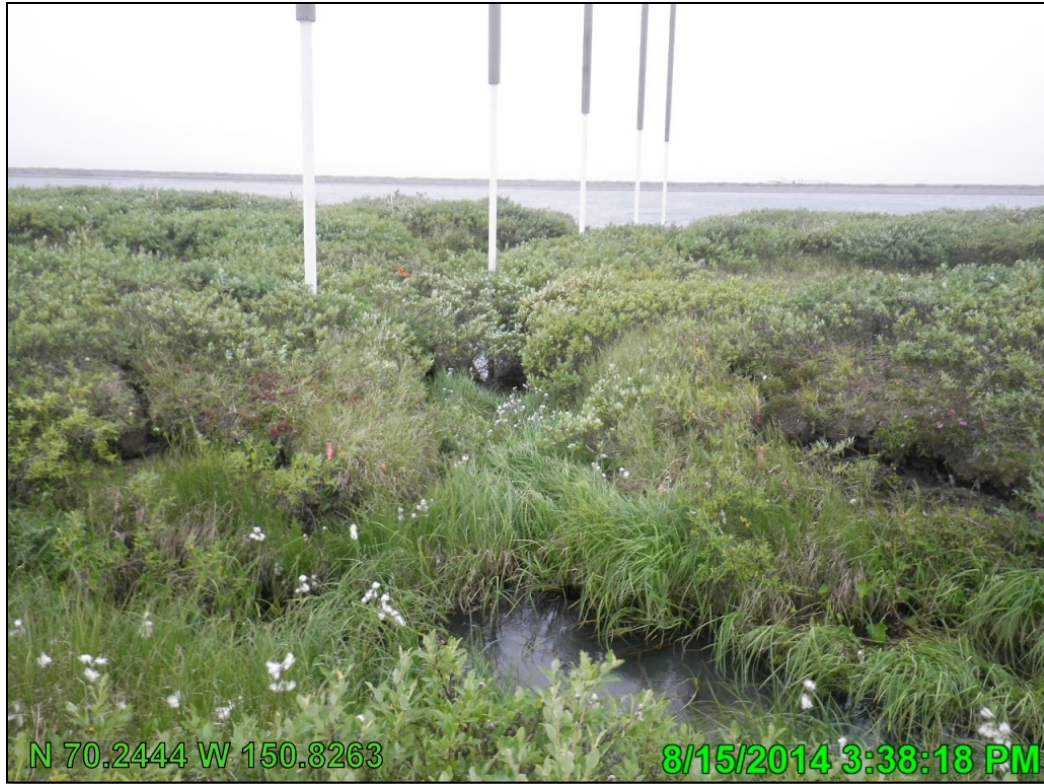
Photo A.20 HDD East polygon trough, looking southwest; August 15, 2014

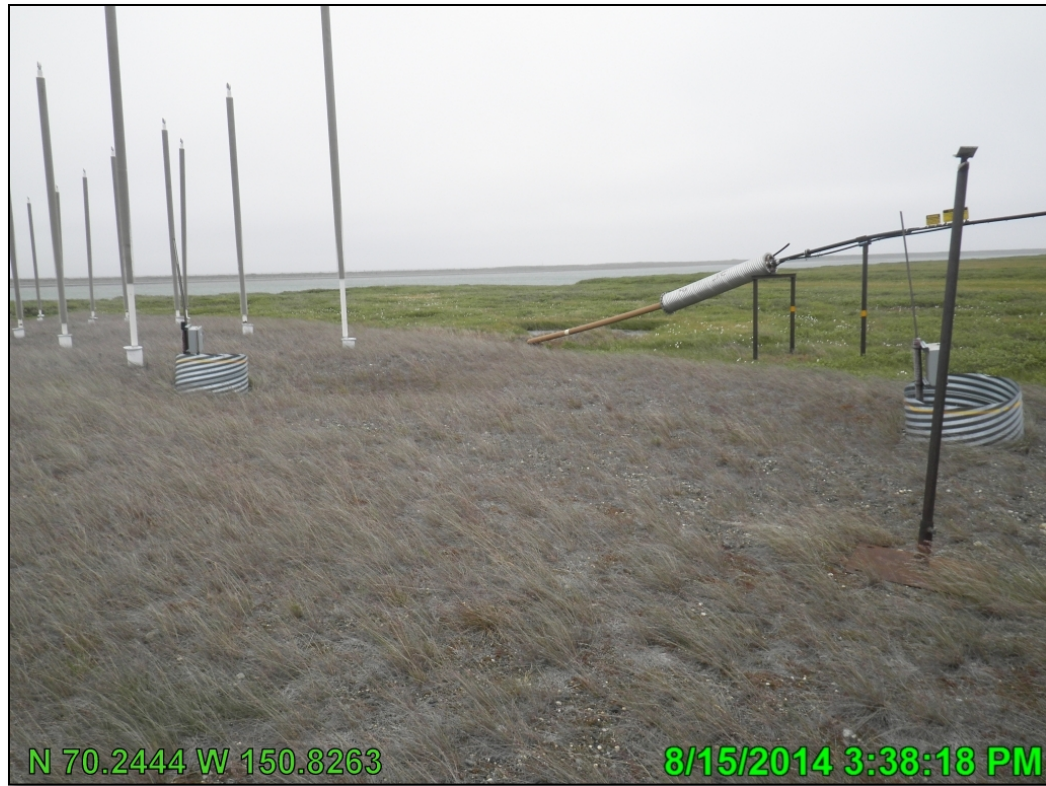
Photo A.22 HDD East depression over the NPS Oil Pipeline, looking northwest; August 15, 2014

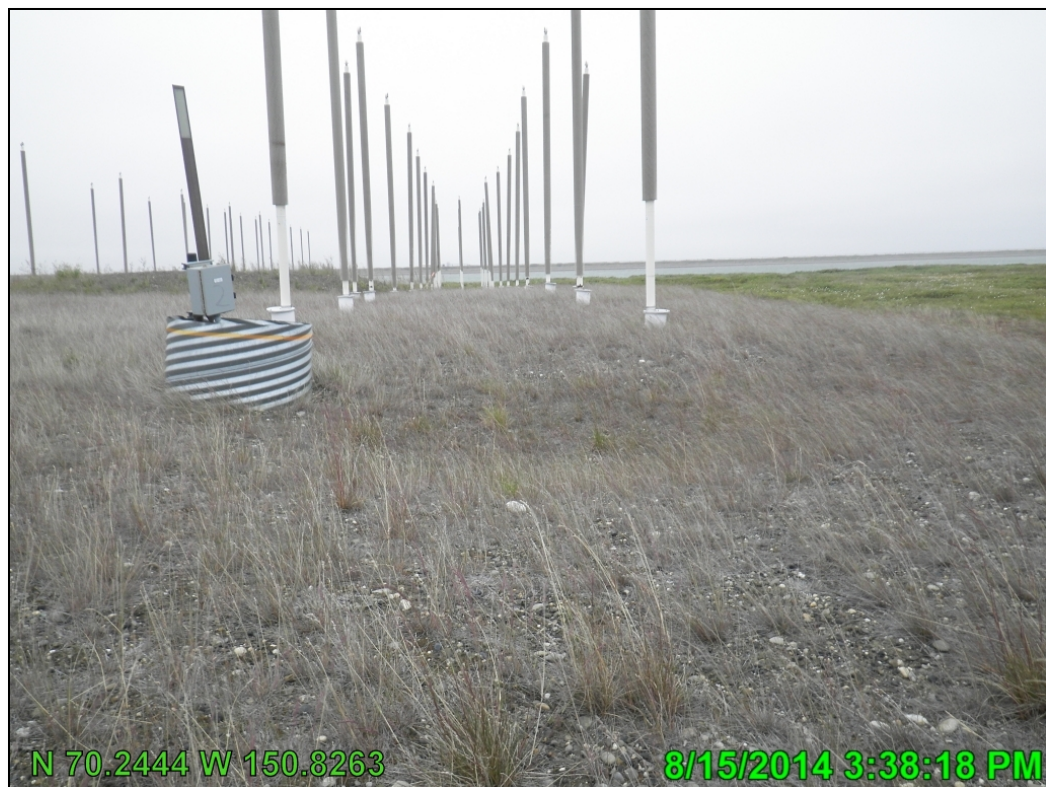
Photo A.23 HDD East depression over the NPS Oil Pipeline, looking west; August 15, 2014

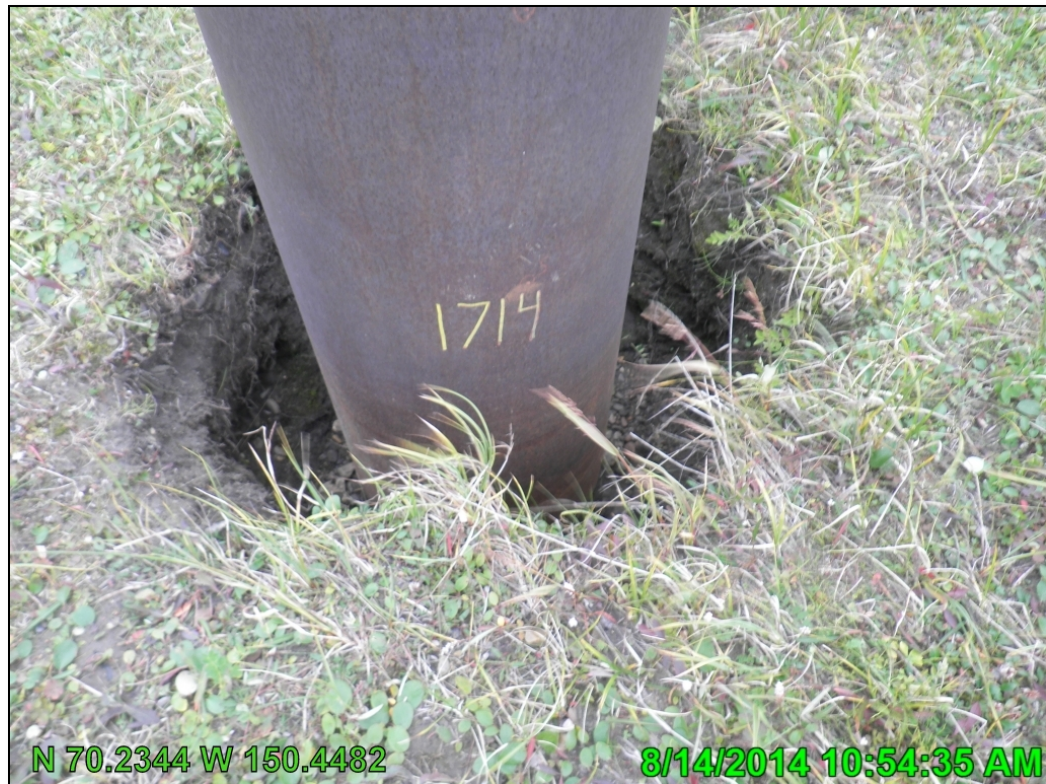
Photo A.37 Kachemach River VSM 1714; August 14, 2014

Visual observations and measurements were collected to evaluate scour for the VSMs located within the active Kachemach River channel. VSM 1715A and 1715B have permanent steel casings installed as a countermeasure to control local scour. The observed depth of scour on the inside of the casing was less than on the outside at both VSMs. No excessive scour was observed at the base of any VSM located within the channel or nearby floodplain. The design scour limit for the main channel of the Kachemach River is 6.9 feet BP mean sea level (BPMSL) (Baker 2003c). No quantitative scour survey was conducted during this monitoring cycle. The last topographic scour survey was conducted by LCMF in 2004 (Baker 2004). Table 9 contains observed scour conditions during the 2014 field visit. Ground depressions observed at the base of VSM 1714, 1715C and 1716 are likely the result of consolidated backfill material and are not attributed to hydraulic events.

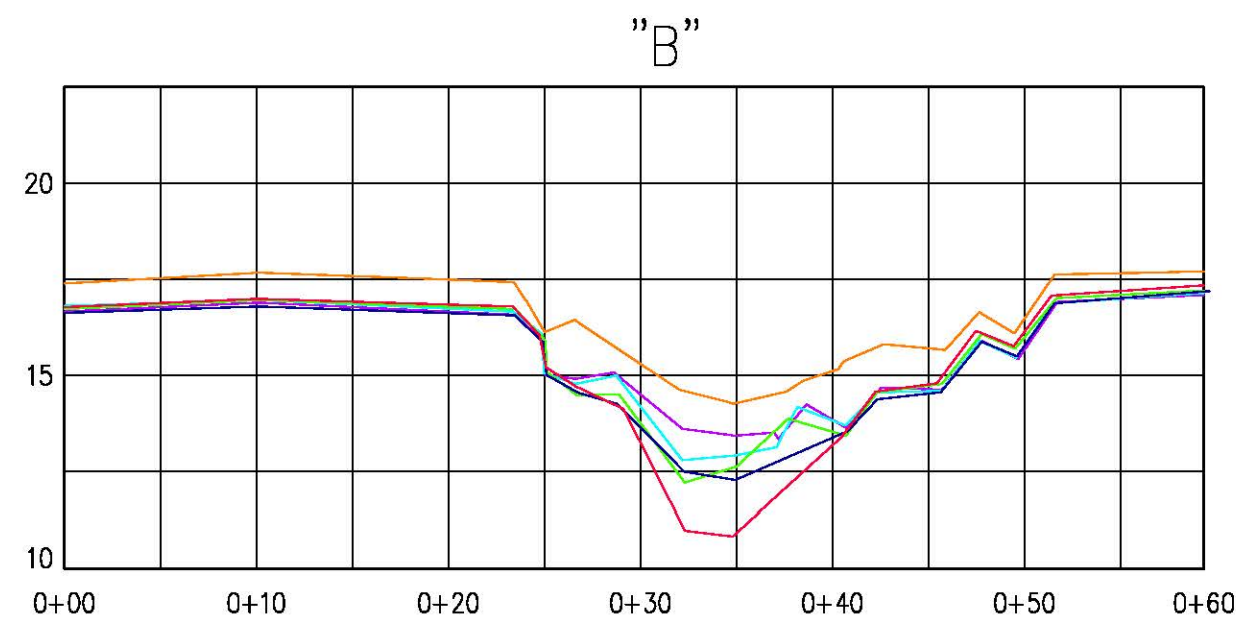
CROSS SECTIONS, POLYGON TROUGH

The cumulative subsidence measured at all of the cross sections along the polygon trough was less than 3.7 feet. Maximum cumulative subsidence at cross section B was 3.6 feet. Cross section A saw the maximum incremental change since 2013 with an increase of 1.8 feet. A polygon trough does pass over the seawater casing axis; however, features of the trough do not meet or exceed the allowable physical conditions listed in the 2014 Monitoring Criteria. All VSM at HDD East were found to be within project tilt tolerances. Pile caps were not monitored at this location.
