2014

Fish Creek Basin Spring Breakup Monitoring and Hydrological Assessment

Michael Baker Jr., Inc.
3900 C Street, Suite 900
Anchorage, Alaska 99503
907-273-1600
December 2014

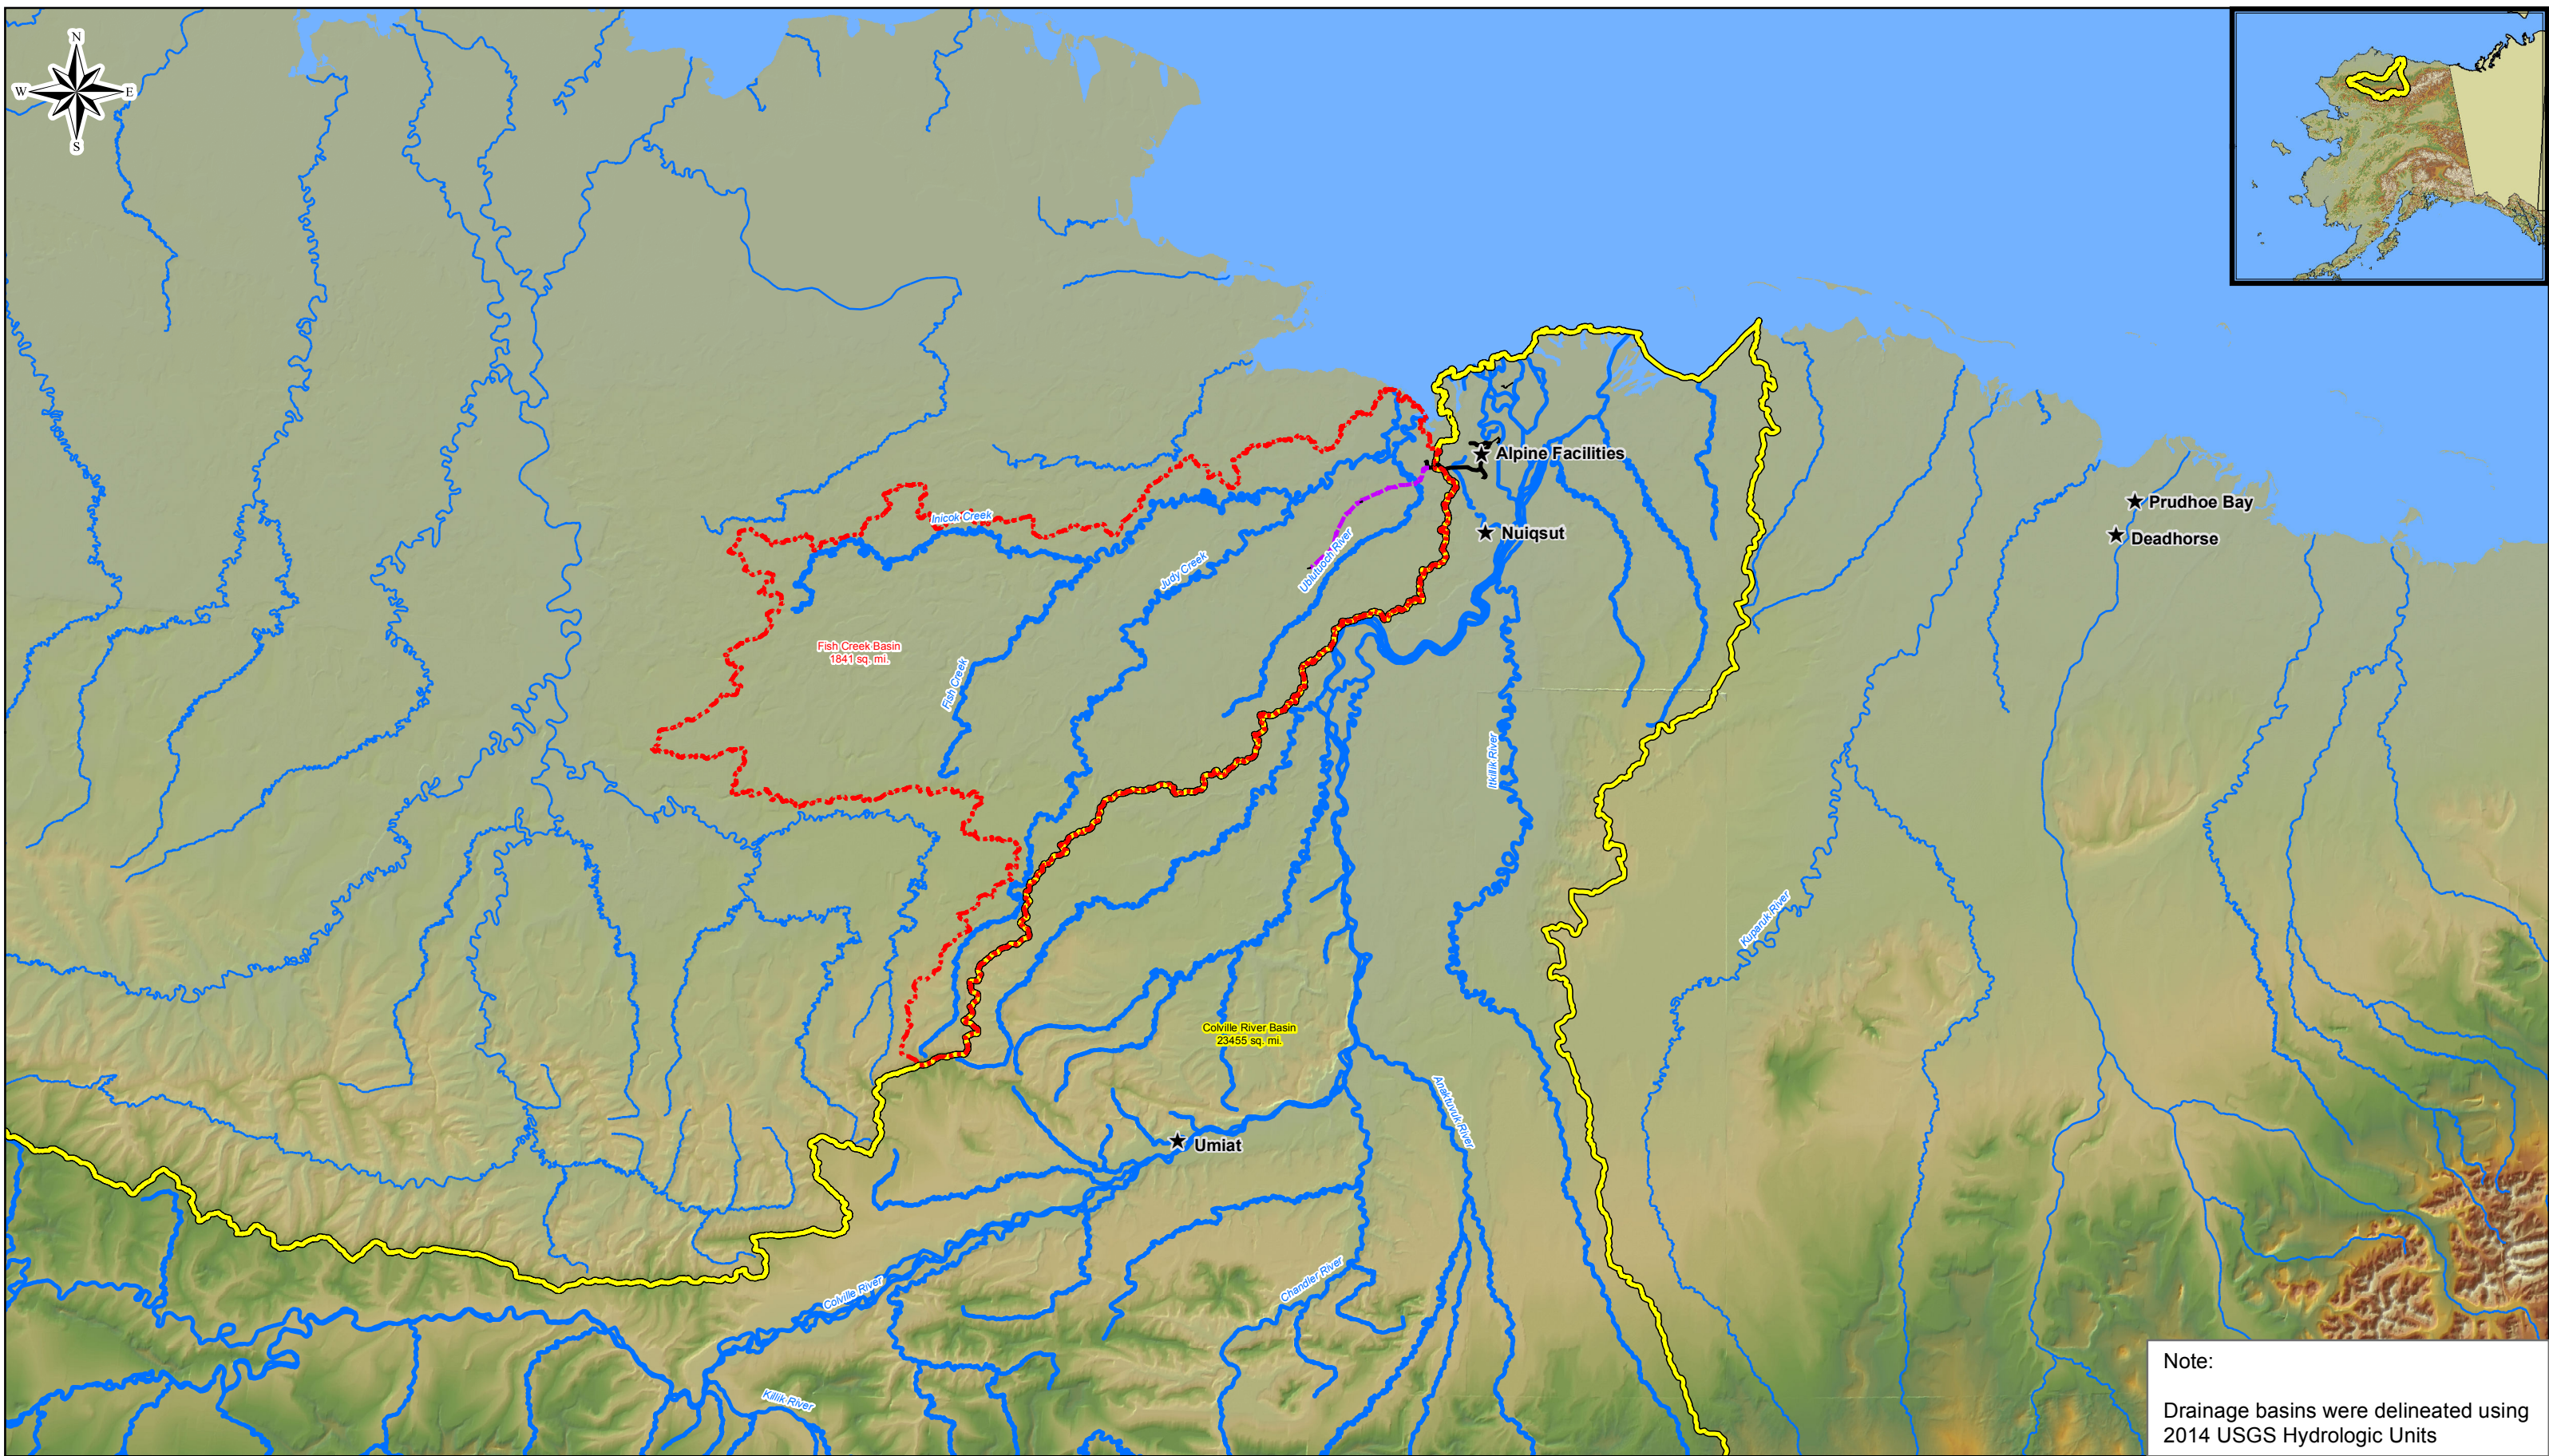
FIGURE: 1.1
 (SHEET 1 of 1)

Gaging sites are listed in Table 1.1. Figure 1.1 shows the FCB drainage basin. Figure 1.2 shows the 2014 monitoring locations in relation to the proposed infrastructure and material source. Gage location coordinates and their vertical control references are provided in Appendix A, A.1 and A.2.

Fish Creek & Colville River
 Drainage Basins

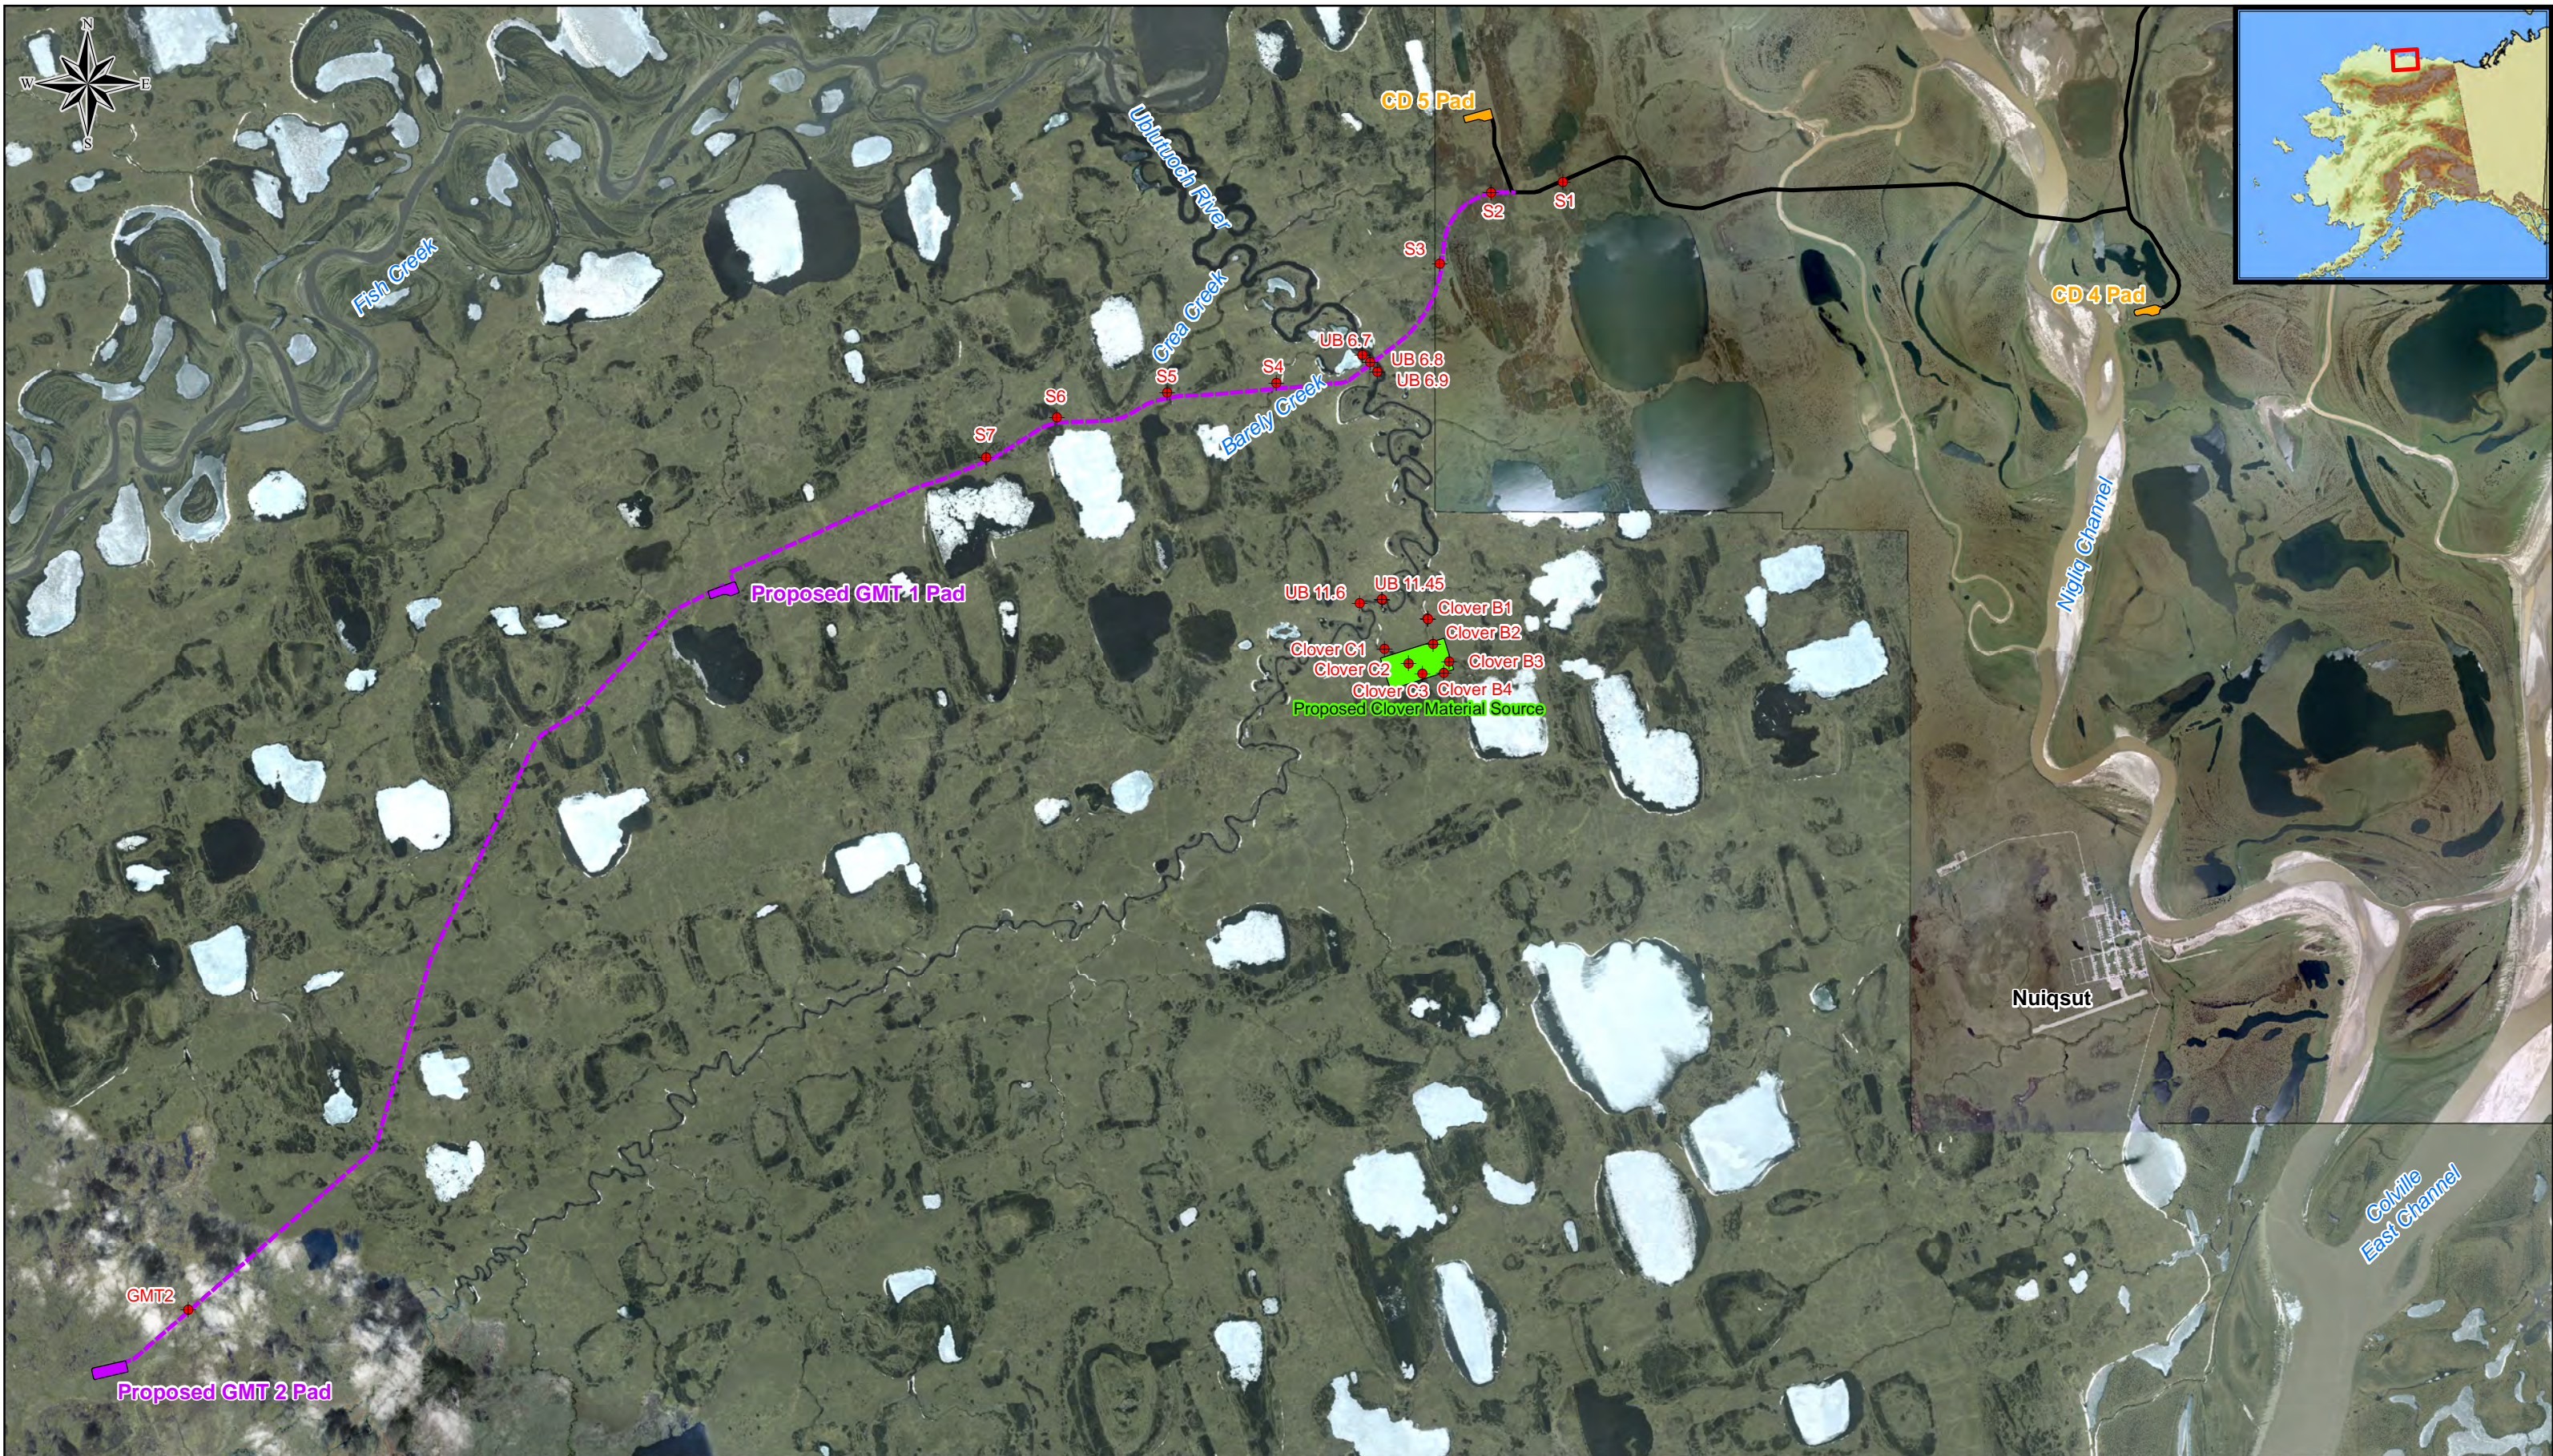
2014 FCB Breakup
Monitoring Locations
FIGURE: 1.2
(SHEET 1 of 1)

Staff gages are designed to measure floodwater elevations relative to a known or assumed datum. Their locations are shown on Figure 1.2. Bed degradation, erosion, and ice impacts can require re-installation, rehabilitation, and re-survey of the gages and is performed as needed in the fall and the early spring before breakup. At each site, chalk is applied to the angle iron gage supports down to the water surface (Photo 2.2). Subsequent high water marks (HWM) are recorded when floodwaters wash away the chalk. On gage without PTs, the peak WSE can be captured as a HWM because field staff are not always present to read the gage during the peak event.

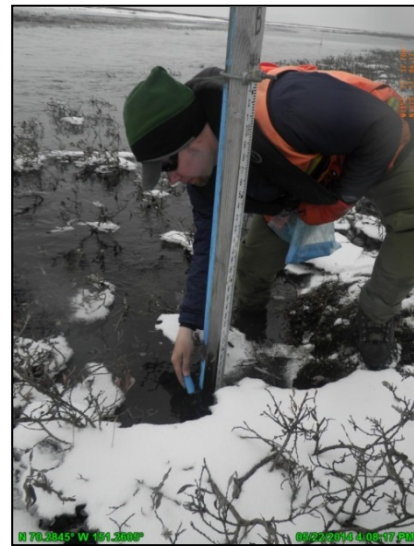
Photo 2.2: Chalking gage to collect HWM; May 22, 2014

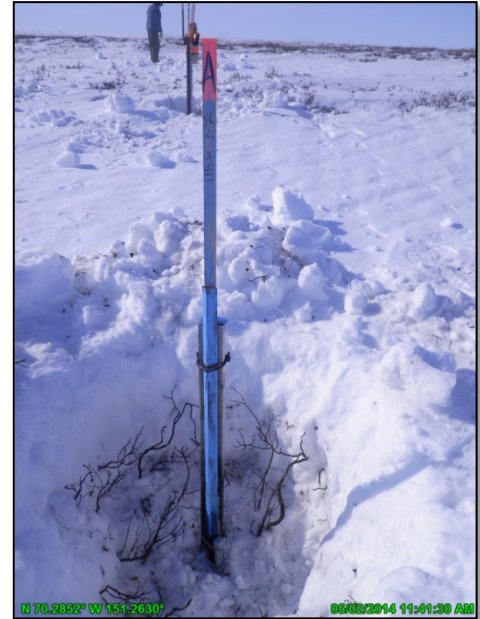
Photo 2.3: PT installed during rehabilitation of gage UB6.7-A; May 2, 2014

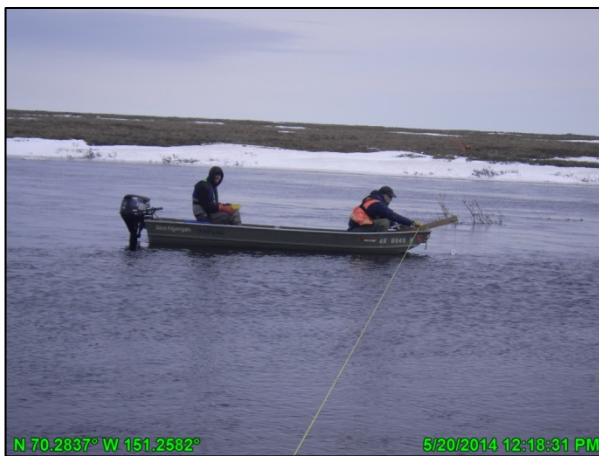
Photo 2.4: Discharge measurement at UB6.9; May 20, 2014

A Price-type AA velocity meter was used to measure velocities near gage UB6.9 on the Ublutuoch River. Measurements were taken using a sounding reel connected to a boat-mounted boom with a 30-pound Columbus-type lead sounding weight (Photo 2.4). A tag line was used to define the cross section and to

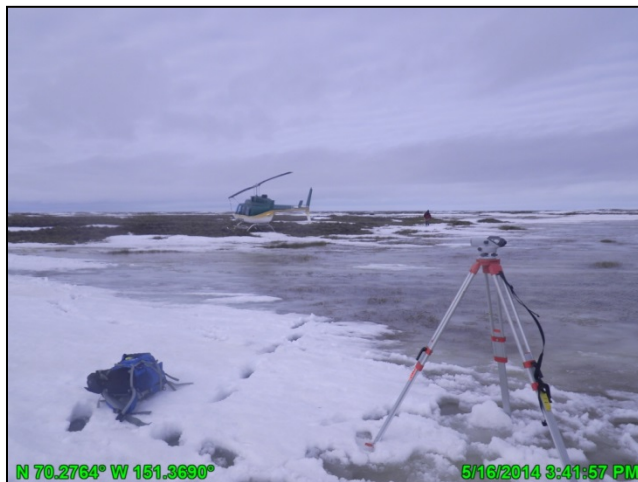
Photo 3.1: Small stream gage S6, local melt; May 16, 2014

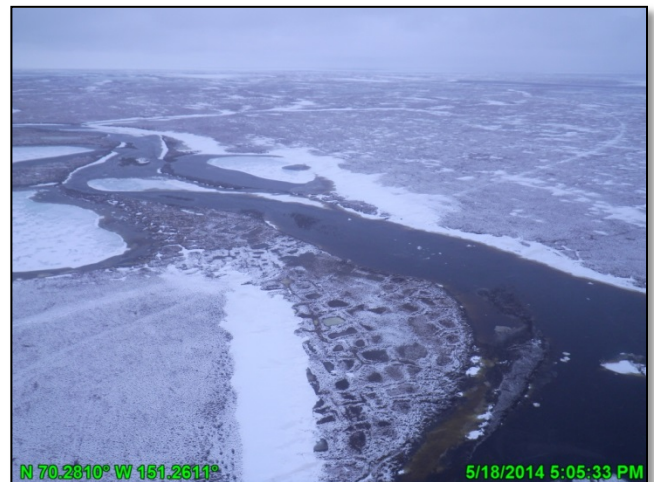
Photo 3.2: Ublutuoch River at gage UB6.8 looking downstream; May 18, 2014

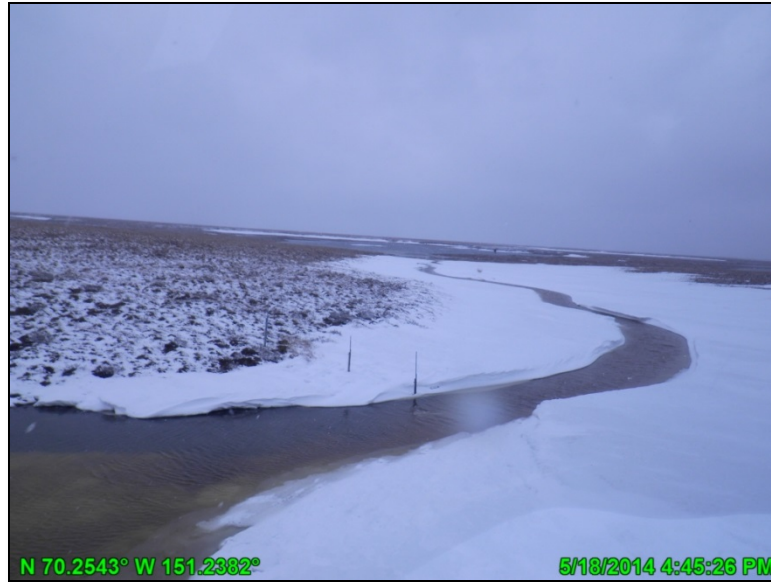
Photo 3.3: Clover drainage at gage B1 conveying flow; May 18, 2014

Following peak stage at gages Clover B1 and B2 on May 16, WSE declined steadily. On May 18, the Clover B drainage was conveying flow (Photo 3.3). No additional rise in stage was observed. At the Clover C drainage, local melt and ponded water was observed.

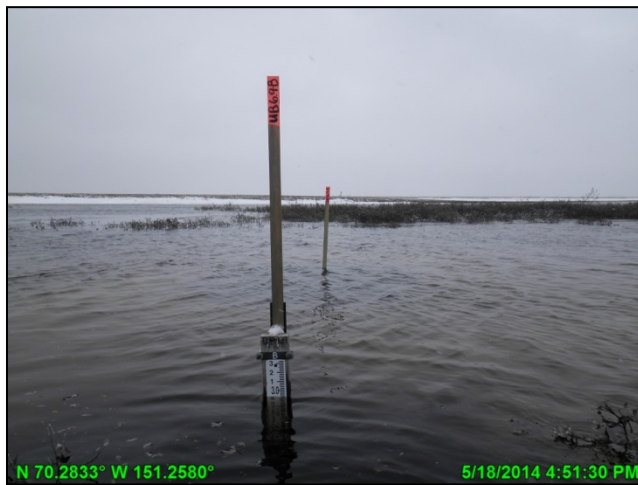
Photo 3.5: Ublutuoch River at UB6.9 near peak stage; May 18, 2014

Gage readings began on May 18, and the Ublutuoch was flowing at near bankfull stage (Photo 3.5). Peak stage occurred on May 19. At the peak stage, adjacent oxbow lakes and paleochannels were connected to the Ublutuoch River (Photo 3.6). Stage decreased steadily until May 29. Stage began to increase on May 31, and a second smaller crest occurred on June 6. When gage observations ended on June 9, stage was falling, and surrounding tundra polygon depressions were filled with local melt and snow. Table 3.1 shows the observations at the time of gage readings, and Graph 3.1 shows the WSE data for the Ublutuoch River at the proposed GMT Road crossing.

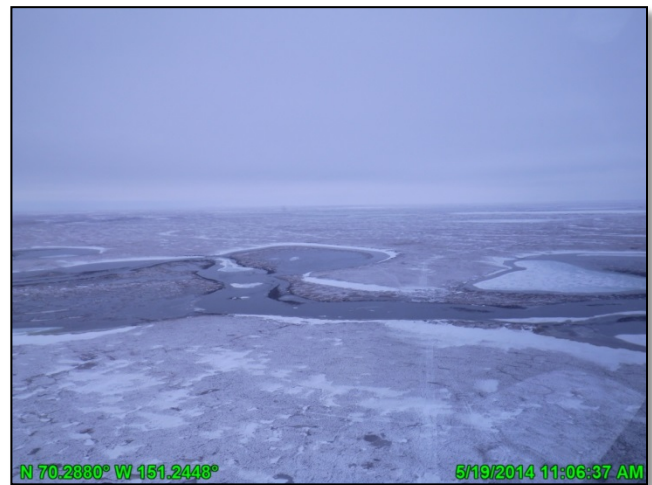
Photo 3.6: Ublutuoch River near UB6.8 at peak stage; May 19, 2014

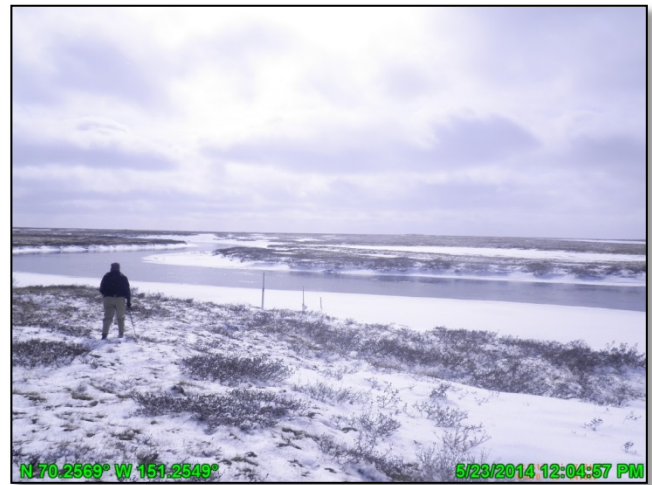
Photo 3.8: Ublutuoch River at gage UB11.45, stage receded from peak; May 23, 2014

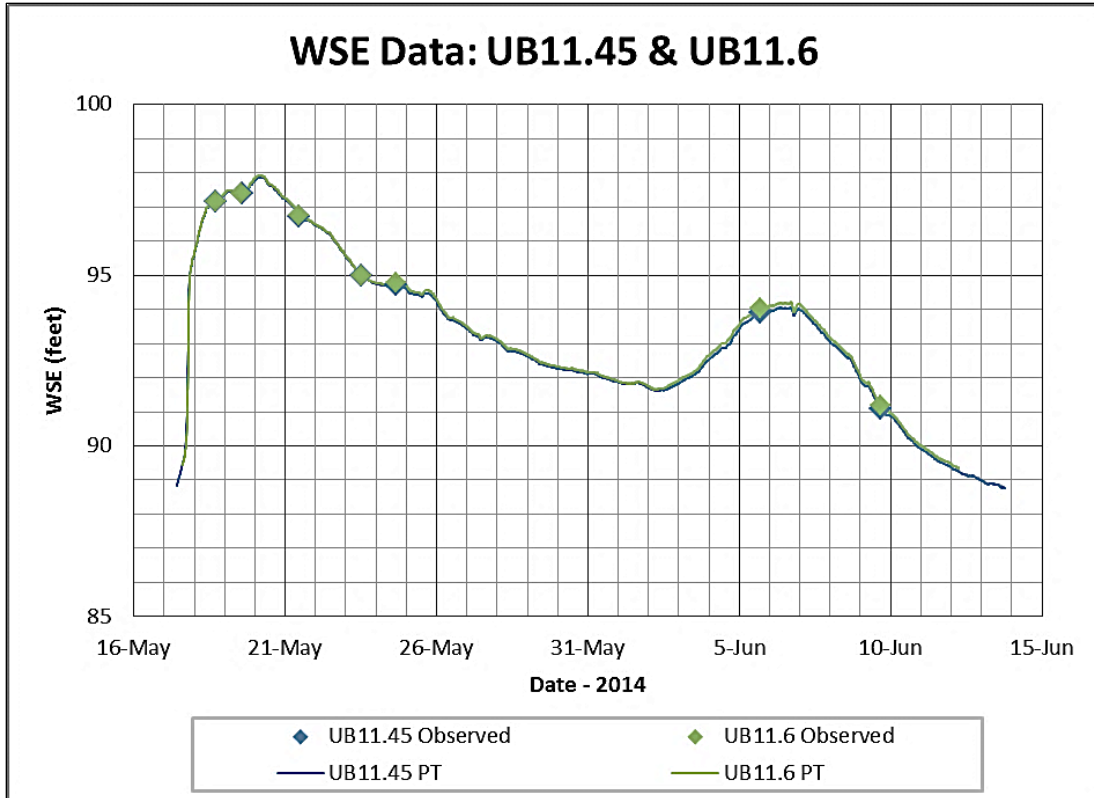
Graph 3.2: Ublutuoch River Gages UB11.45 and UB11.6 Stage Data

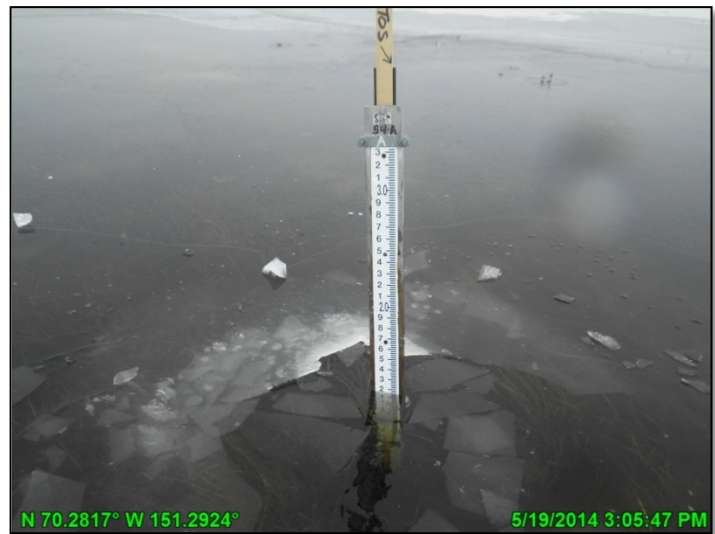
Photo 3.9: Barely Creek gage S4 prior to peak stage; May 19, 2014

At Barely Creek, minimal flooding was observed on May 19, and a thin layer of ice covered the water surface (Photo 3.9). Peak stage occurred on May 20 at gages S4-A, S4-B and S4-C. A second crest in stage occurred on May 31 at gage S4-A and on June 5 at gages S4-B and S4-C. Stage was falling on June 9 when observations ended. Table 3.3 summarizes observations at the time of gage readings, and Graph 3.3 shows the WSE data for at gage S4.

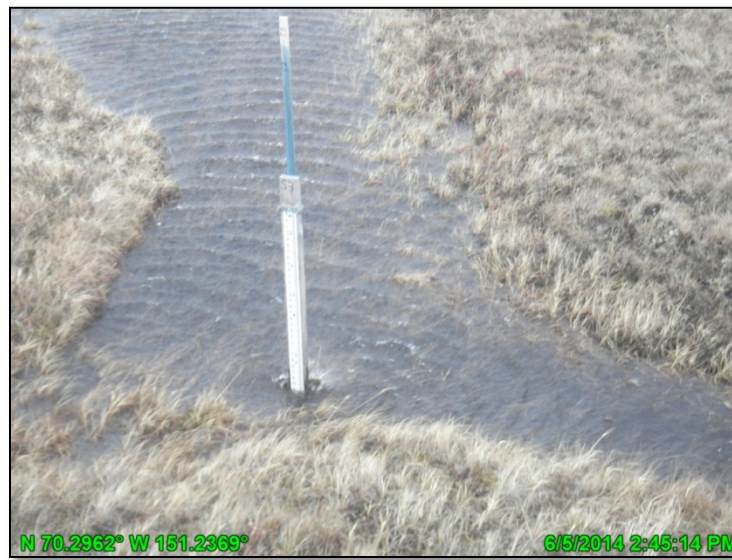
Photo 3.11: S3 gage on June 5, 2014 during peak stage; June 5, 2014

The three small drainages monitored by gages S3, S6, and S7 received minimal water; flooding was not observed at these sites. Photo 3.11 through Photo 3.13 show the gages at the time of observed peak WSE. Pounded, local melt was present. Table 3.5 summarizes the observations at time of gage readings, and Graph 3.5 shows the WSEs remained relatively constant throughout the breakup period.

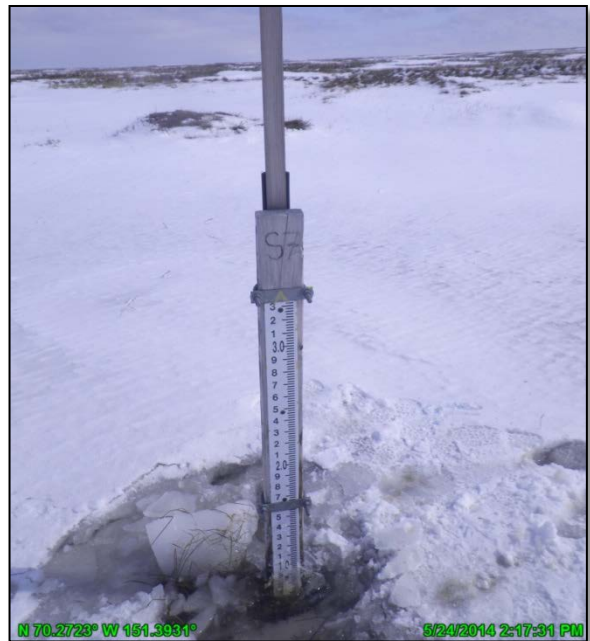
Photo 3.13: S7 gage during peak stage; May 24, 2014

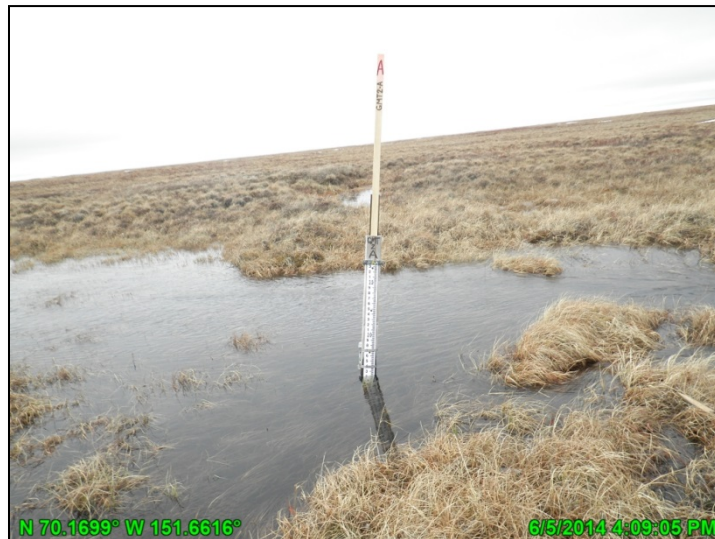
Photo 3.14: GMT2 gage during peak observed stage; June 5, 2014

The small drainage monitored by gage GMT2 received local melt. Peak WSE was observed on June 5. Water was ponded throughout the breakup monitoring period. Photo 3.14 shows the GMT2 gage at peak observed stage, and Table 3.6 shows the WSE data and observations at the time of gage readings.

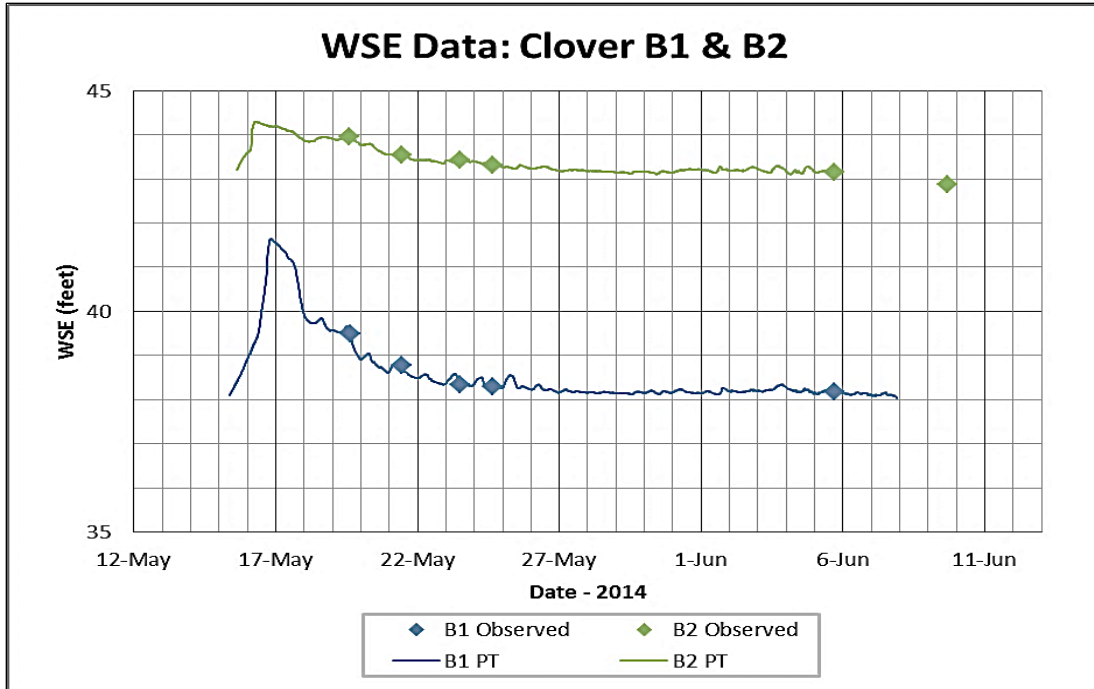
Graph 3.6: Clover B Gages 2014 Stage Data

The PTs began recording water on May 15, and WSE peaked on May 16. Flooding was not observed. Following the peak, stage decreased steadily, and gages were either dry or had minimal ponded water when observations ended on June 9. Table 3.7 shows the observations at the time of gage readings, and Graph 3.6 shows the WSE data for the Clover B gages.

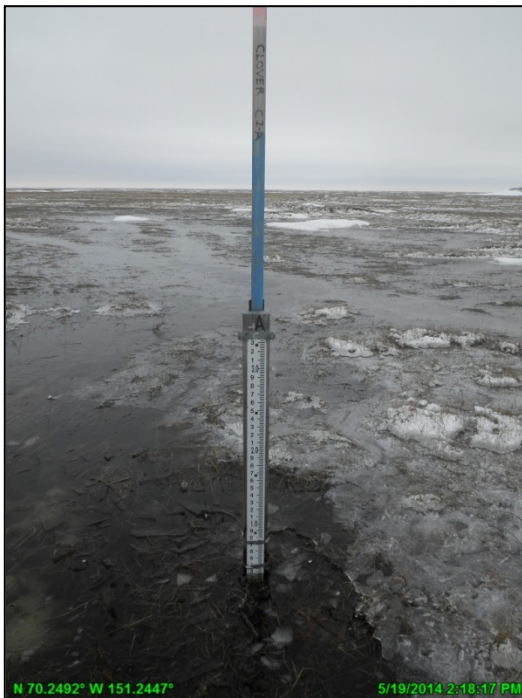
Photo 3.15: Clover gage C2 at peak stage; May 19, 2014

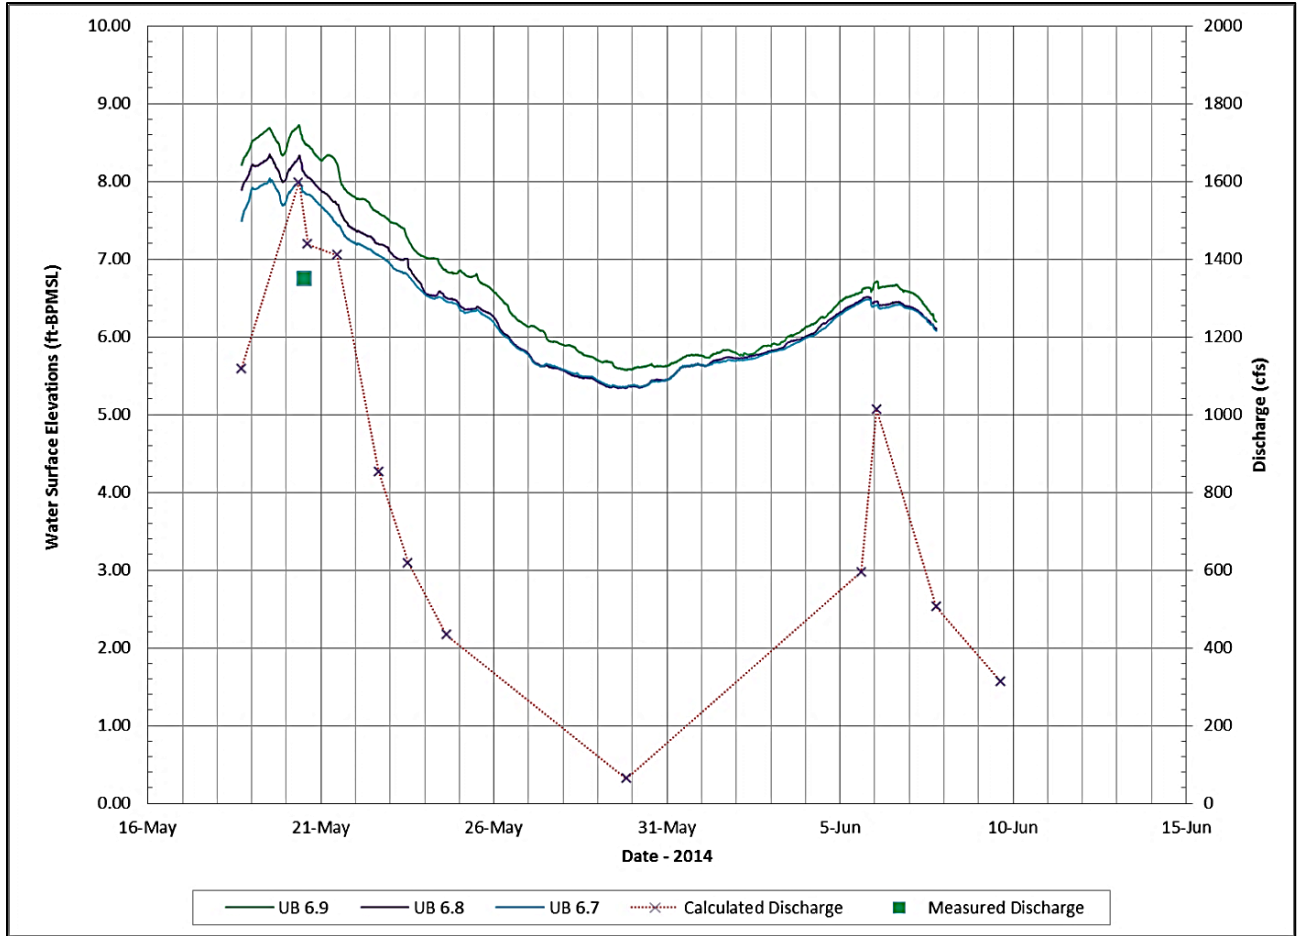
Estimated peak discharge for the Ublutuocho River is 1,600 cfs and occurred on May 20 with a corresponding WSE of 8.31 feet BPMSL at UB6.8. A summary of the calculated discharge results and corresponding WSE elevations is presented in Graph 4.1. The 2014 cross sectional geometry collected during direct discharge is located in Appendix B, B.1.

Graph 4.1: Ublutuoch River Discharge and Corresponding WSE

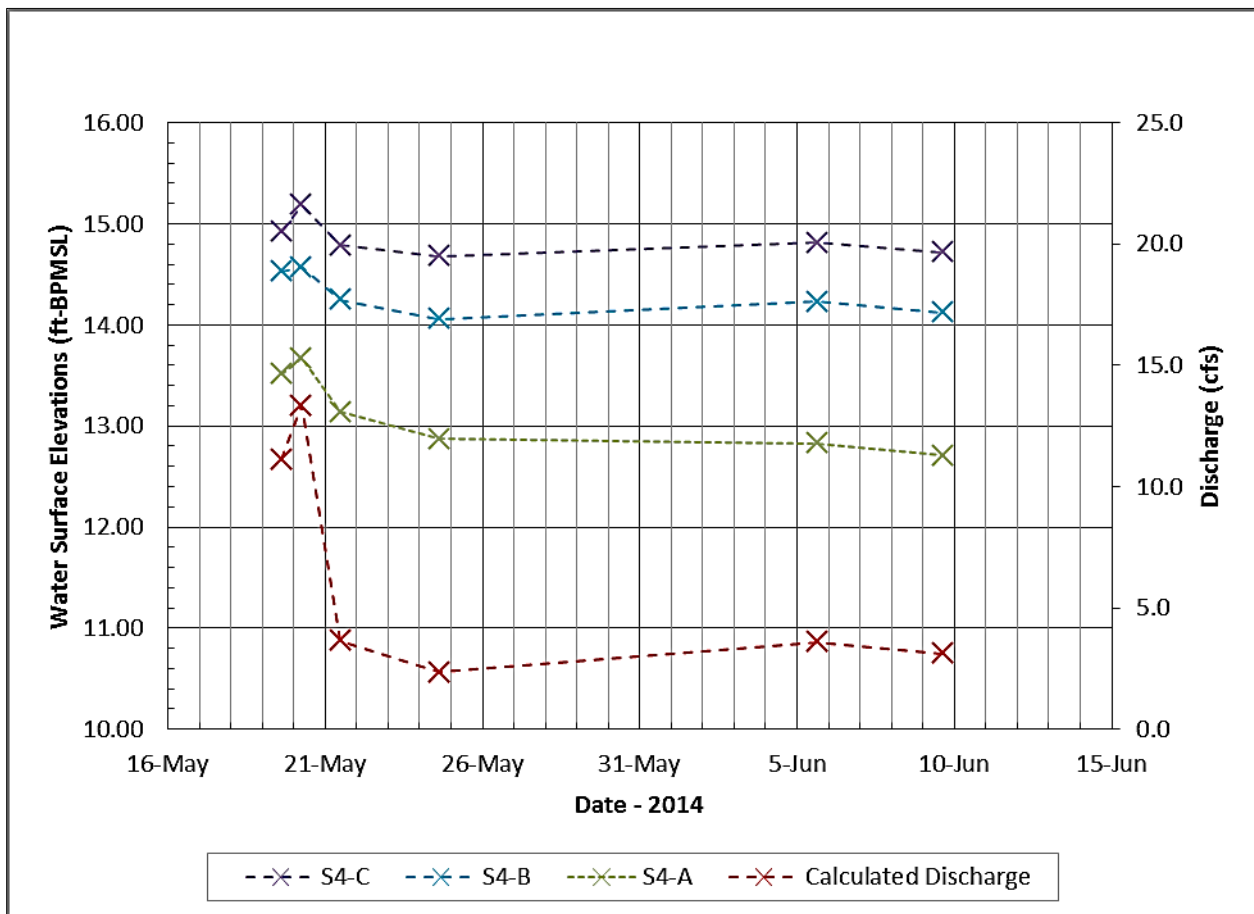
Estimated peak discharge for Barely Creek at gage S4 is 13 cfs and occurred on May 20 with a corresponding WSE of 14.57 feet BPSML at S4-B. Discharge was estimated with normal depth computations using the energy grade-line slope as approximated by the water surface slope between S4-A and S4-C, the corresponding WSE at S4-B, and the 2010 cross-sectional data. The results are considered a high estimate because the calculations assume a snow- and ice-free channel. Saturated snow was present at the time, increasing stage above snow-free conditions.

Graph 4.2: Barely Creek Calculated Discharge and Corresponding WSE

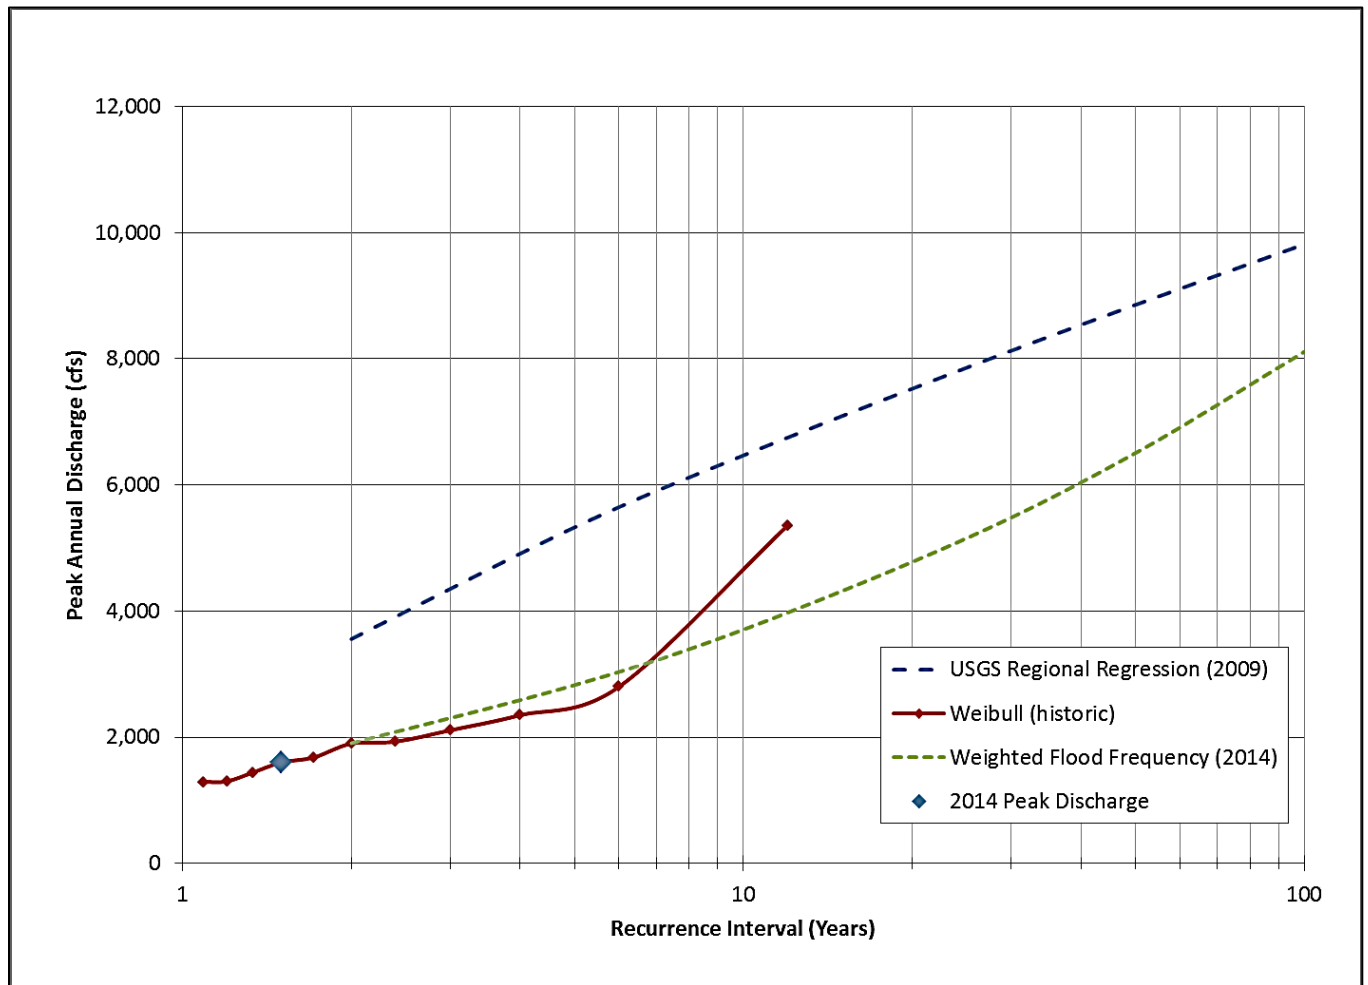
Graph 6.1: Ublutuoch River Peak Discharge and Discharge Frequency Estimates

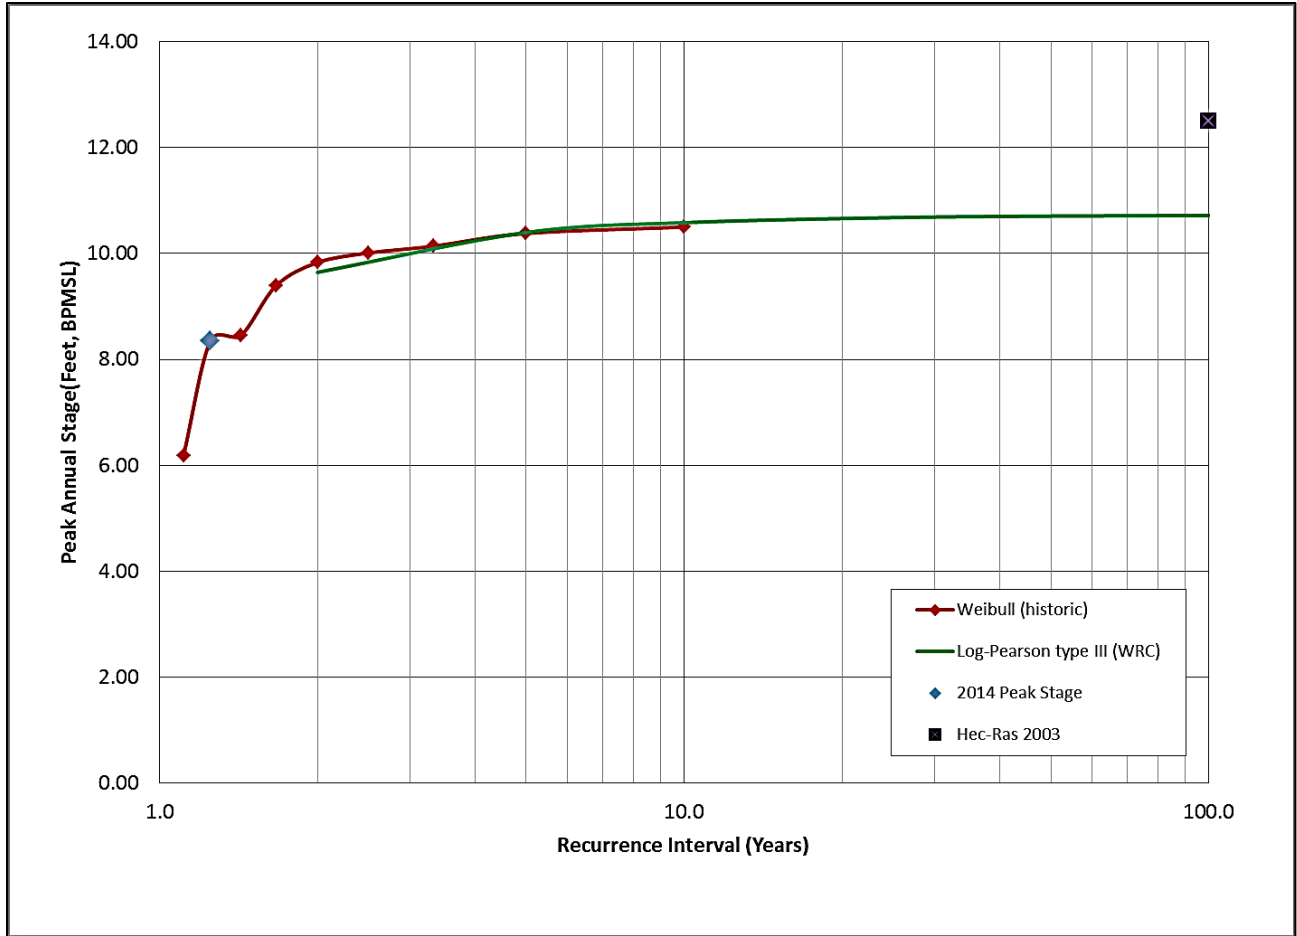
Stage frequency for the Ublutuoch River at gage UB6.8 is estimated with three methods. A Log-Pearson type III stage frequency analysis was performed for the Ublutuoch River using 8-years of data from gage UB6.8. This analysis assumes open channel conditions; however, the Ublutuoch River is typically impacted by snow and ice. Stage data for rivers impacted by snow and ice is generally not extrapolated beyond the observed record (USACE 2002 and FEMA 2003). Annually, recurrence intervals are assigned to each of the current and historical peak stage values using the Weibull plotting equation (USACE 1982). In addition to the statistical analysis, a HEC-RAS model was developed in 2003, using the 2003 flood frequency analysis, to estimate the 100-year flood stage (Baker 2003).

Graph 6.2: Ublutuoch River Peak Stage and Stage Frequency Estimates
