2014

Fish Creek Basin Spring Breakup Monitoring and Hydrological Assessment

Michael Baker Jr., Inc.
3900 C Street, Suite 900
Anchorage, Alaska 99503
907-273-1600
December 2014

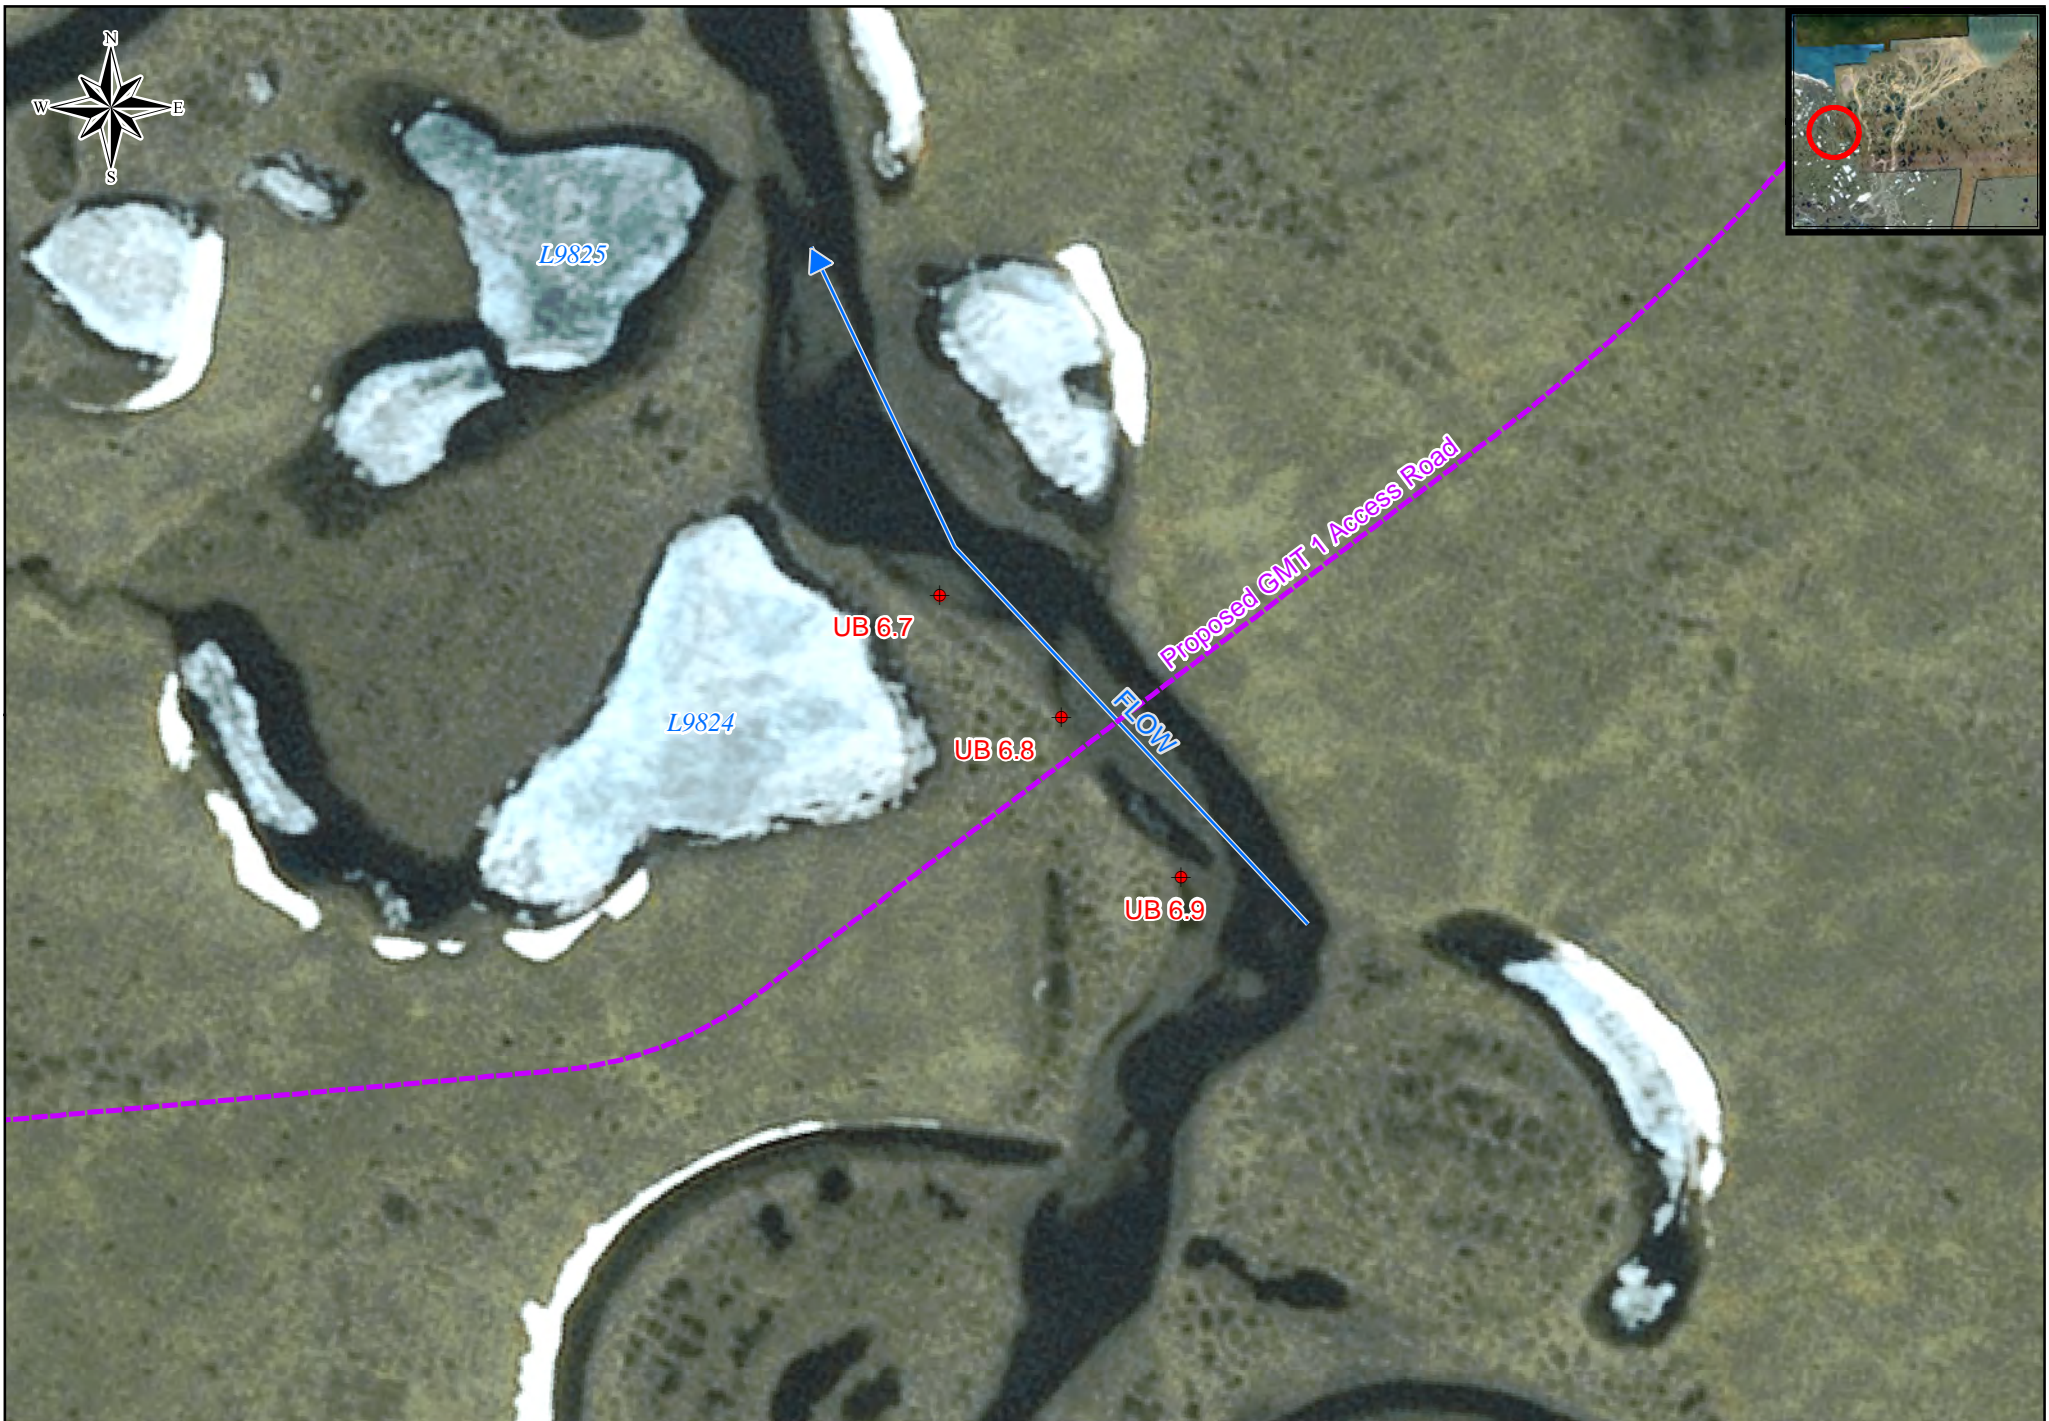
B.1 *Ublutuoch River Gage UB6.9 Plan and Profile*

1. BASIS OF ELEVATION, CP09-11-09B.
2. CHANNEL PROFILE MEASUREMENTS COMPLETED MAY 2014 BY GCY, MNU AND KMB

① FISH CREEK BASIN – UBLUTUOCH RIVER UPSTREAM CROSS SECTION

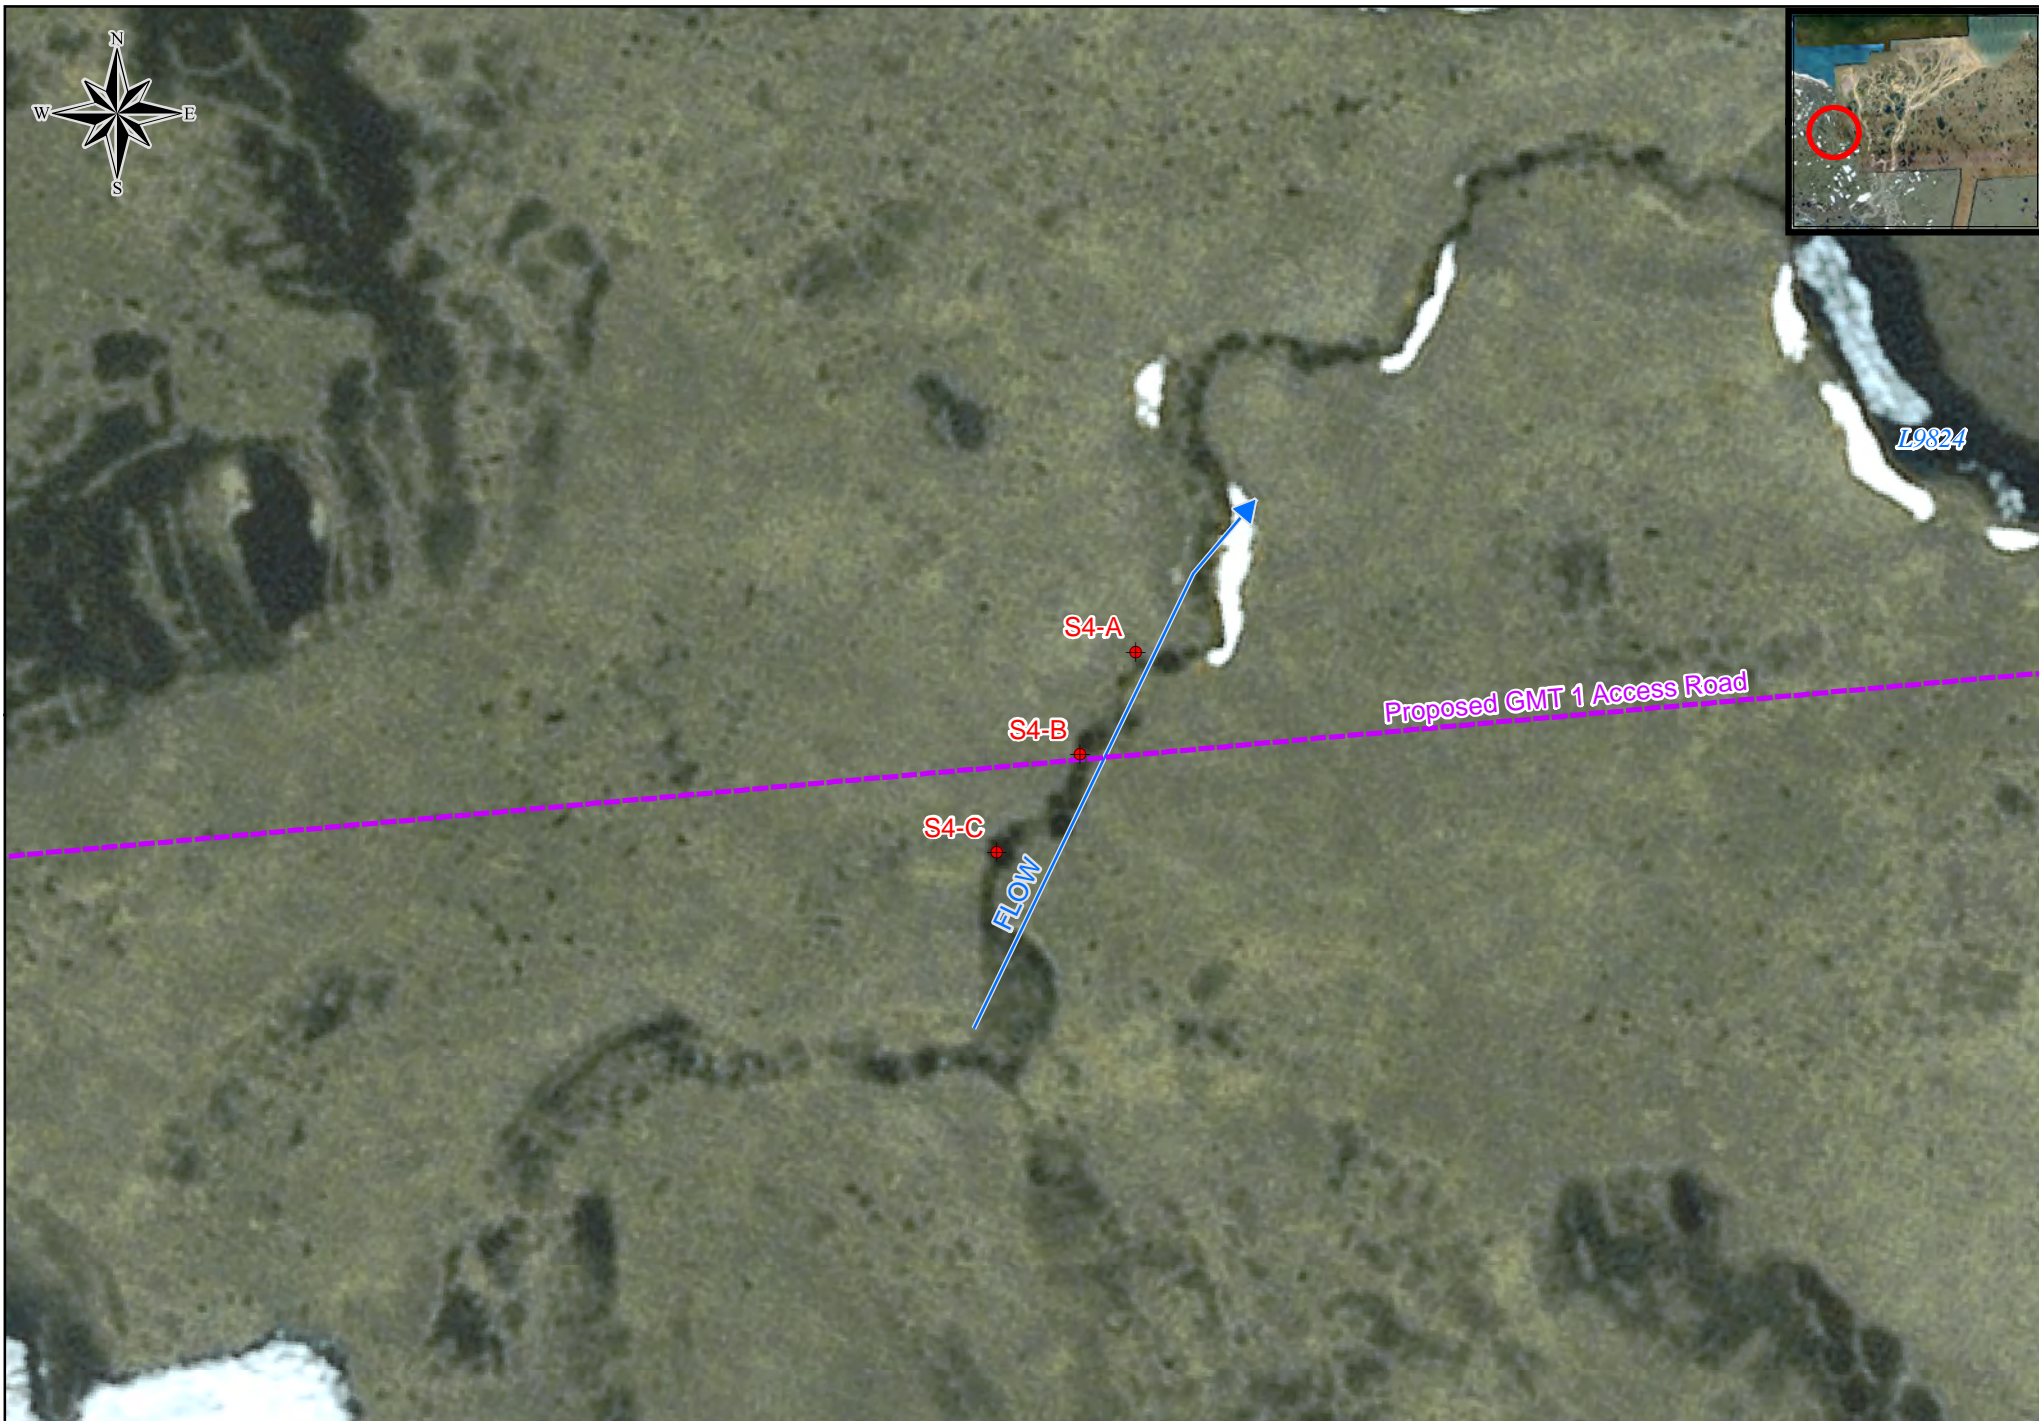
B.2 *Barely Creek Gage S4 Plan and Profile*

1. BASIS OF ELEVATION, CP09-11-09B.
2. CHANNEL PROFILE MEASUREMENTS COMPLETED JUNE 2010 BY JPM, HLR, AND EJK

① FISH CREEK BASIN – BARELY CREEK CENTERLINE CROSS SECTION

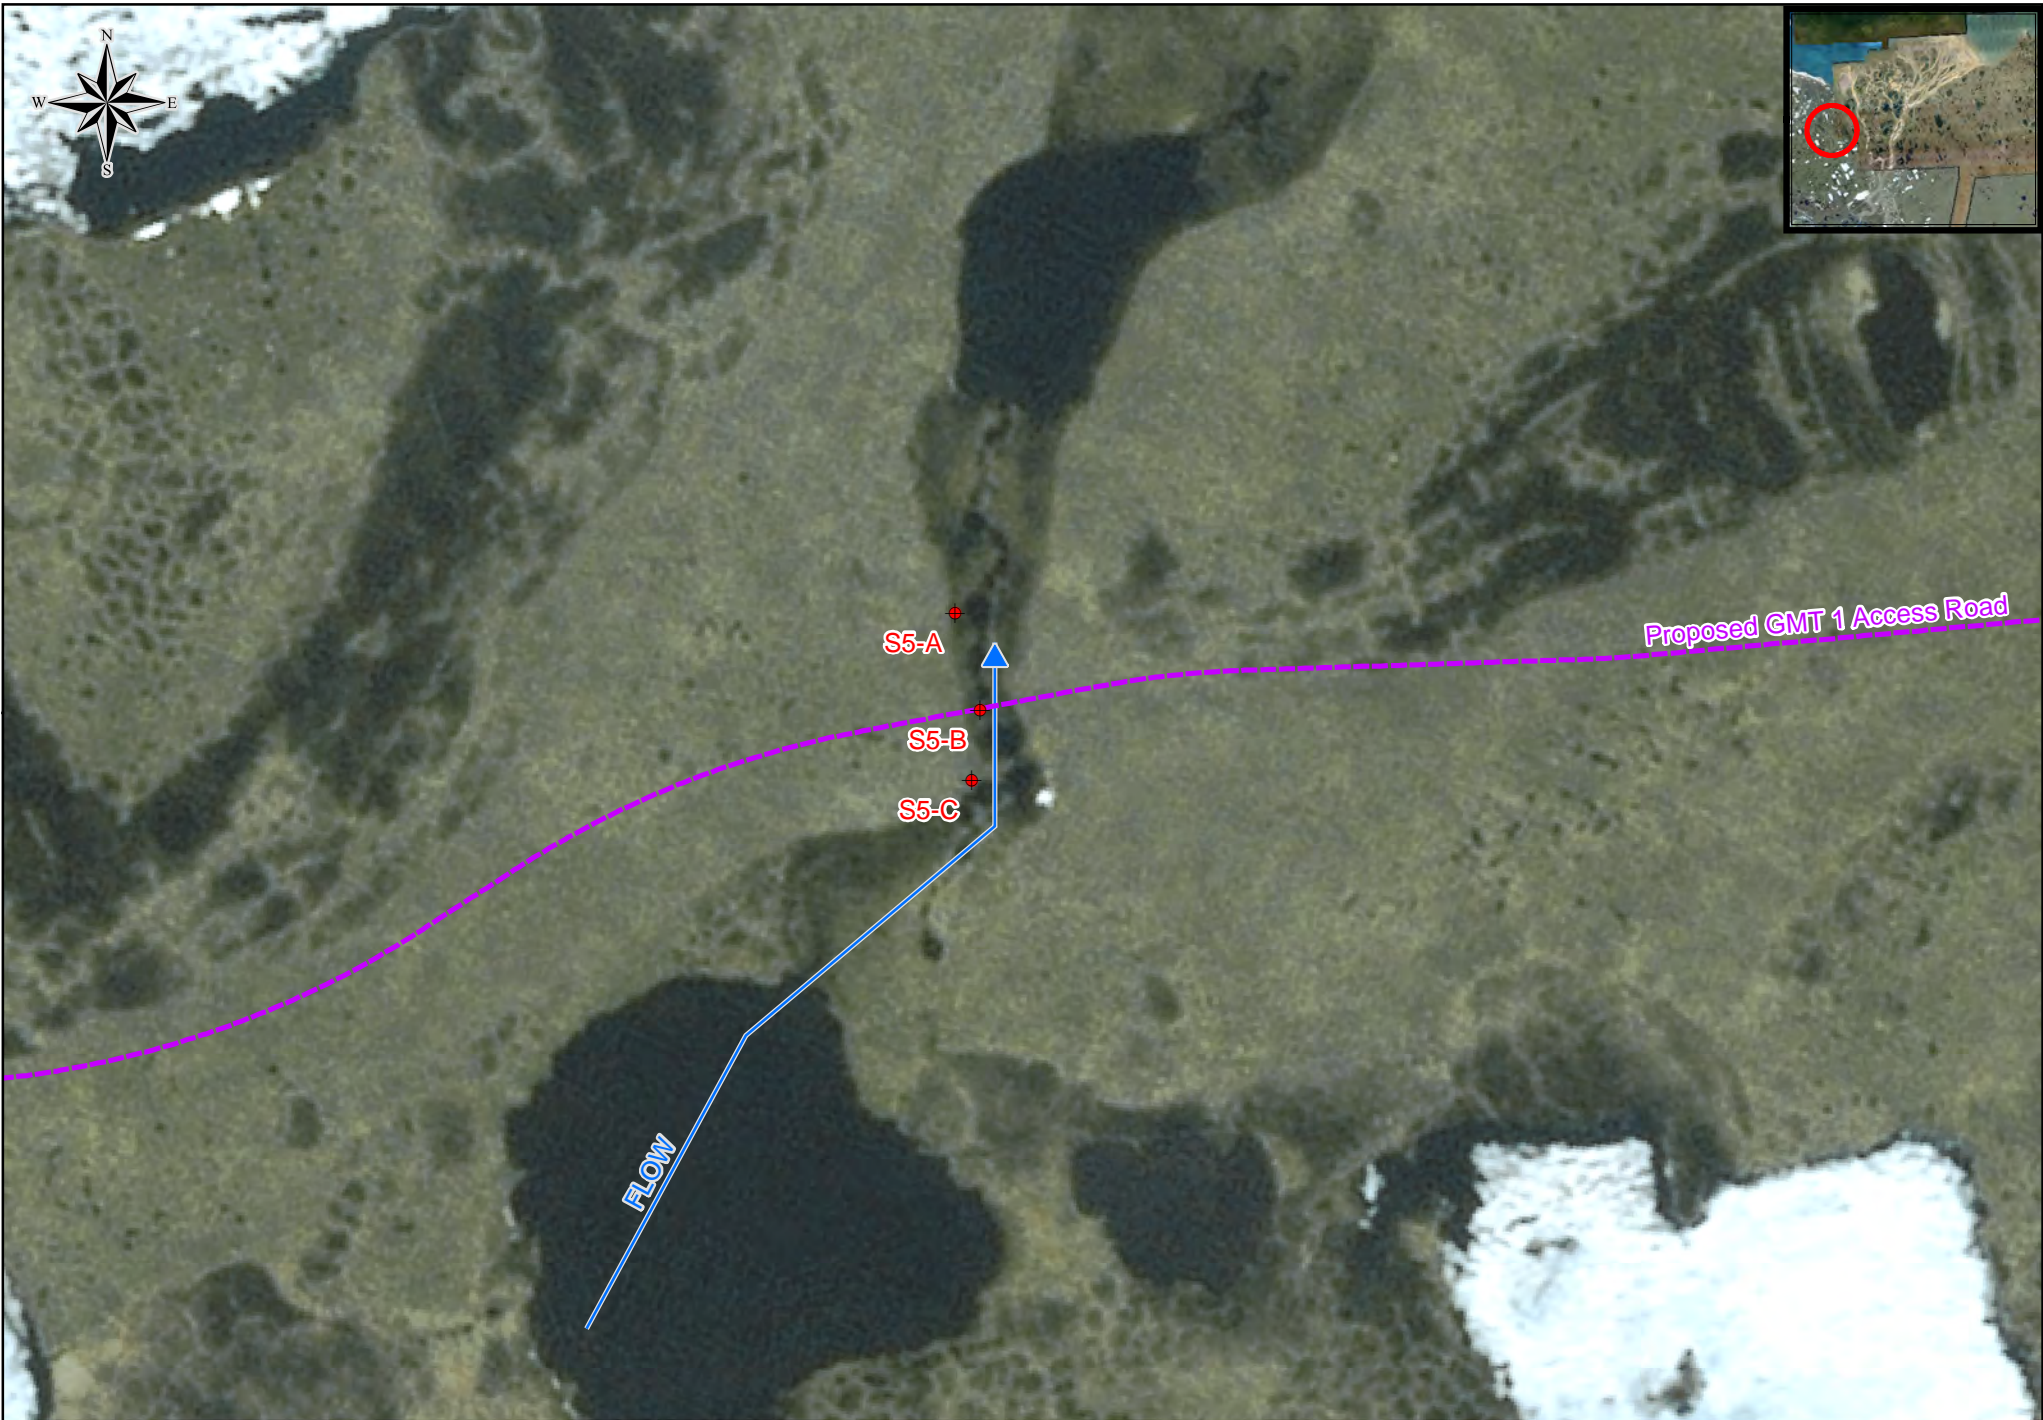
Crea Creek Gage S5 Plan and Profile

1. BASIS OF ELEVATION, CP09-11-09B.
2. CHANNEL PROFILE MEASUREMENTS COMPLETED JUNE 2010 BY JPM, HLR, AND EJK

① FISH CREEK BASIN – CREA CREEK CENTERLINE CROSS SECTION
