2016/2017

Alpine Ice Road Support Water Quality Sampling Summary Report

ConocoPhillips
Alaska

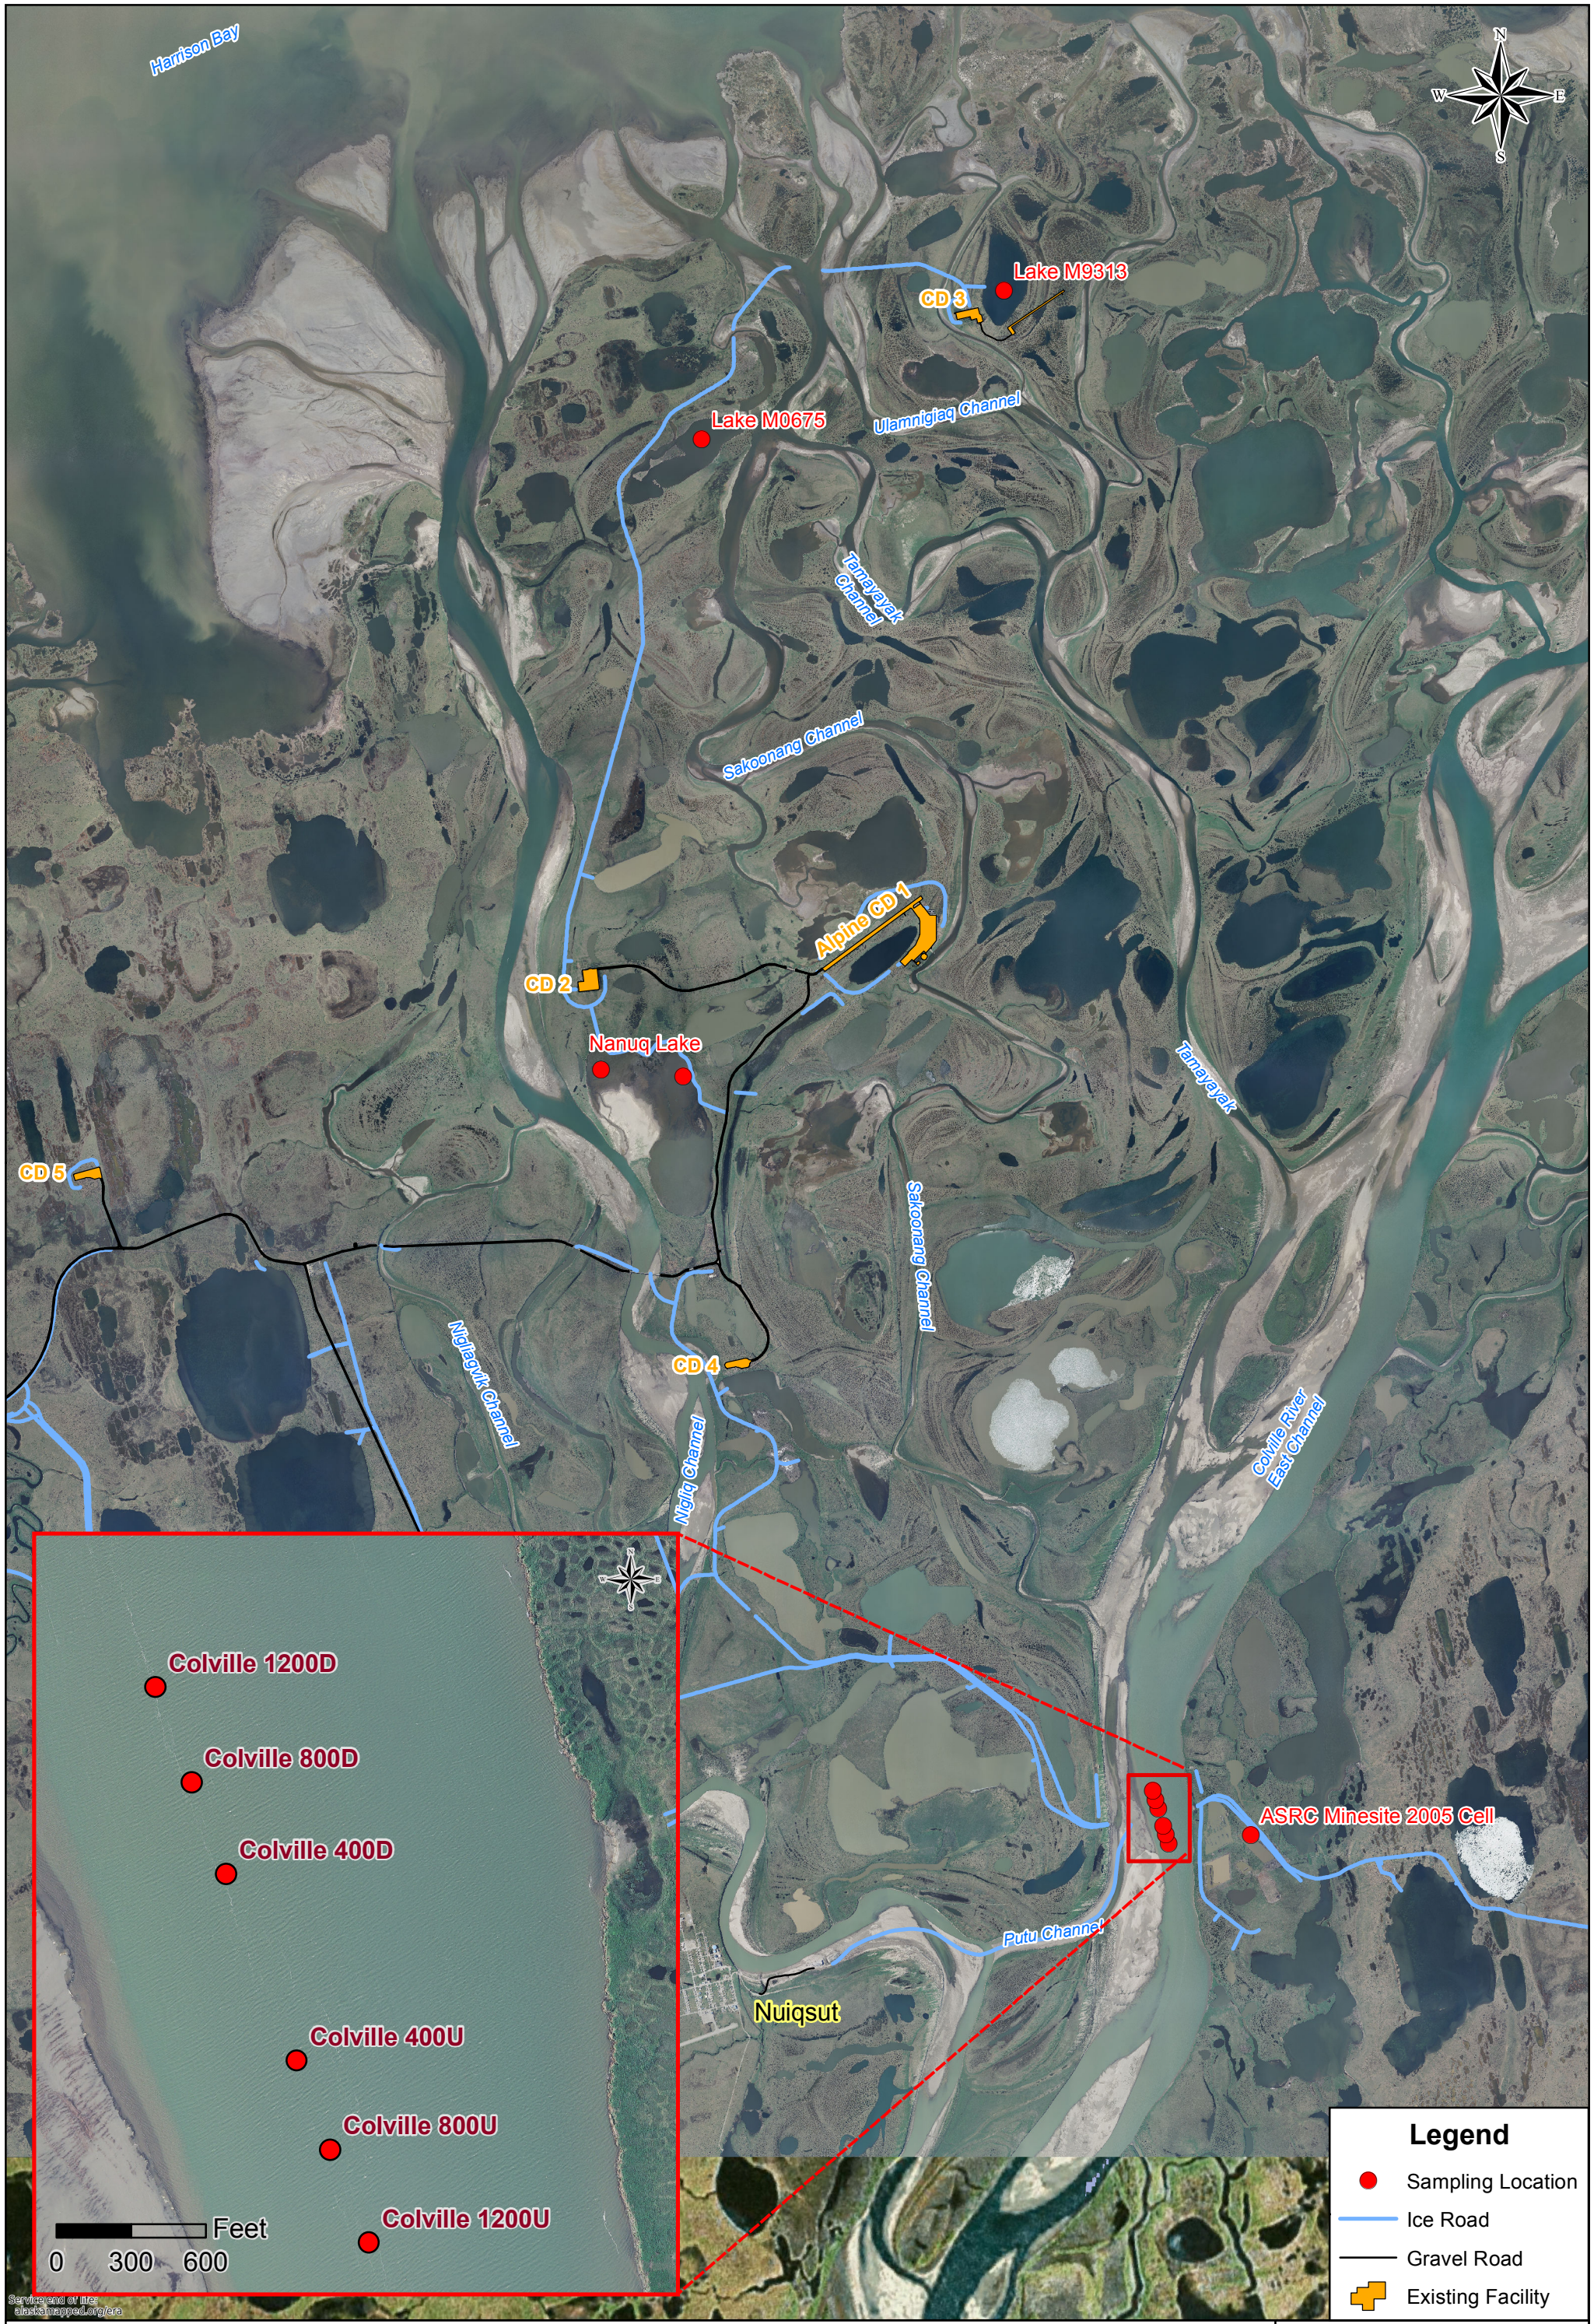
Drawn: BTG File: Figure 1

The 2016/2017 Alpine ice road support water quality sampling locations included six locations upstream and downstream from the centerline of the Colville River ice bridge, two locations near the north side of the ASRC Minesite 2005 Cell, one location near the center of Lake M0675, one location near the center of Lake M9313, and two locations near the Northwest (NW) and Northeast (NE) corners of Nanuq Lake (referred to as Relic Site NW and Relic Site NE). The water quality sampling parameters included the following: in-situ measurements for snow depth, freeboard, ice thickness, and water depth; in-situ recordings for temperature, conductivity, dissolved oxygen (DO), salinity, and velocity; ex-situ recordings for temperature, conductivity, salinity, pH, and settleable solids; and calculations for specific conductance (SC), DO, and total dissolved solids (TDS).

Six locations at points 400, 800, and 1,200 feet upstream and downstream from the centerline of the Colville River ice bridge were marked with snow poles during the first sampling event. These locations are in the approximate thalweg of the Colville River where maximum depth has historically been observed. Sampling events at the Colville River ice bridge took place at these locations weekly. The snow poles were removed at the end of the season. All other sampling locations were established during previous ice road construction seasons and located via NAD83 coordinates provided by CPAI as sampling was required. No markers were installed at any sites other than at the Colville River.

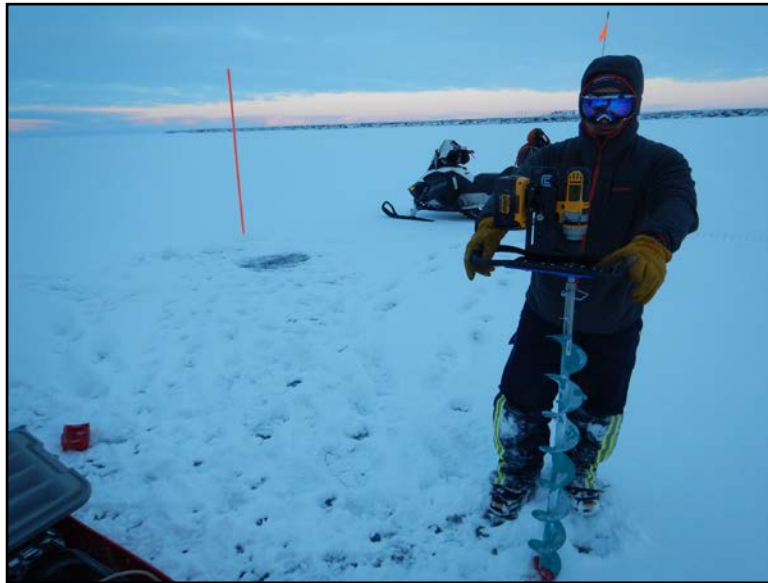
Photo 1: 6-Inch Diameter Auger with Drill

Water quality was investigated by drilling sample holes through the ice using either a 2-inch or 6-inch diameter auger attached to a 36 volt battery operated drill (Photo 1). In-situ and ex-situ recordings were collected using a YSI Pro1030 or YSI ProPlus water quality meter, two Hanna HI98128 handheld pH meters, a YSI ProODO meter, and a HACH FH950 electromagnetic velocity meter. The YSI Pro1030 was

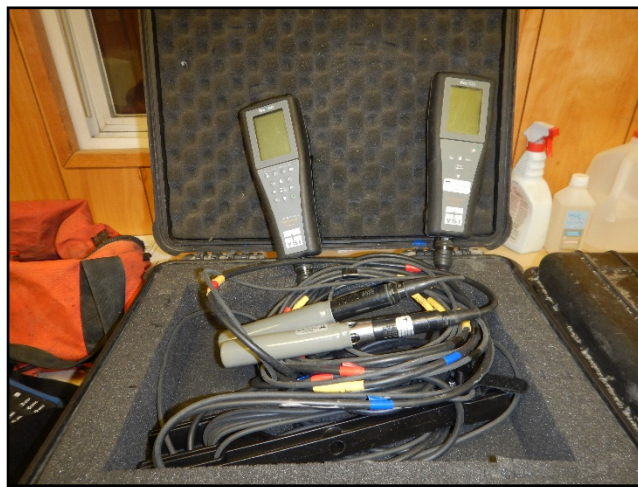
Photo 2: Data Cable Delineation

Snow depth and freeboard were measured with a survey pocket rod, ice thickness was measured with an ice pole marked in one-foot increments, and water depth was measured using the YSI Pro1030 or YSI ProPlus meter data cables marked in one-foot increments (Photo 2). Freeboard was measured from the top of ice to the water surface and water depth was measured from the water surface to the bottom of the river or lake.

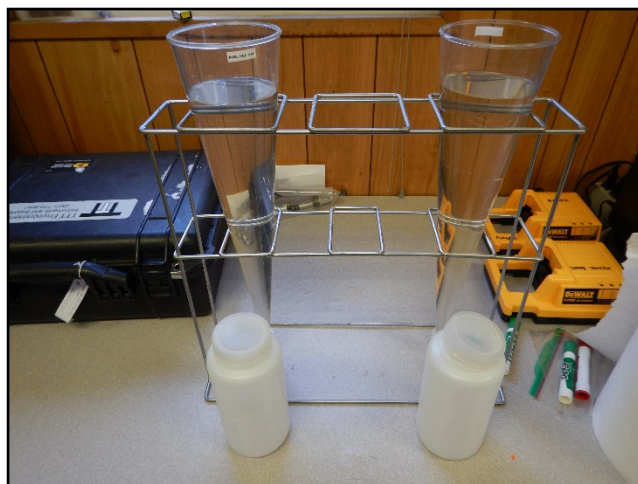
Photo 3: Volumetric Test for Settleable Solids

hose. At the time of sample collection, any visual observation of oily sheen was documented. Temperature and pH were recorded within 15 minutes of sample collection and the average value of each recording was reported. Upon returning to CD1, a volumetric test for settleable solids, following the methods outlined in the Nebraska Water Environment Association lab manual, *The Standard Methods for the Examination of Water and Wastewater: 2540 F: Settleable Solids* (Rice, Baird, Eaton, & Clesceri 2012), was performed on both water samples (Photo 3).

Measured pH ranged between 6.7 and 7.5 throughout the monitoring season. No oily sheen was observed and no settleable solids were measured during any of the sampling events.
