2018

ALPINE SATELLITE DEVELOPMENT PLAN (ASDP) WATER QUALITY MONITORING

ASDP WATER QUALITY MONITORING

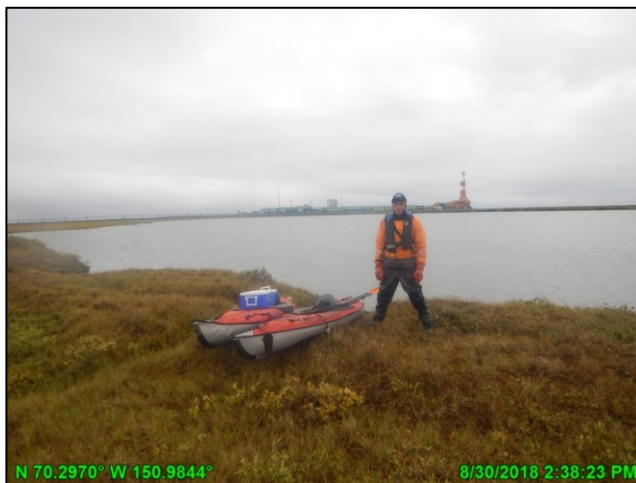
Photo 1: Equipment used to collect water quality data and samples; August 30, 2018

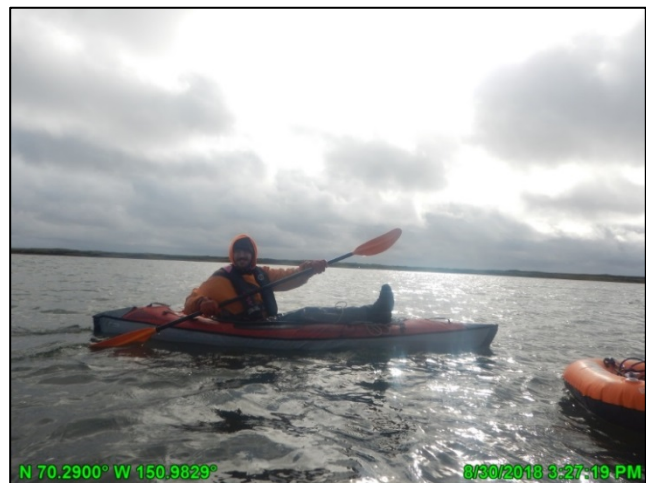
Photo 2: Preparing for sampling at Lake L9324; August 30, 2018

In-situ water quality data measurements and laboratory sample collections were performed at all three lakes by a two-person team on August 30, 2018. The team used inflatable kayaks with an attached support raft for transporting the sampling equipment (Photo 1 and Photo 2). In-situ water quality instruments were provided by TTT Environmental. Laboratory analyses and sample collection bottles were provided by Arctic Fox Environmental, Inc. (Arctic Fox). Prior to sampling, aerial reconnaissance was conducted to identify possible inflow and outflow sources, and to determine if lakes were hydraulically connected to other nearby surface water sources. It was also confirmed that each lake was well-mixed and lacked definable stratums prior to analytic sample collection. Field sampling methods were based on U.S. Geological Survey (USGS 2006), Ward and Harr (1990), and U.S. Army Corps of Engineers (USACE 1987) methods.

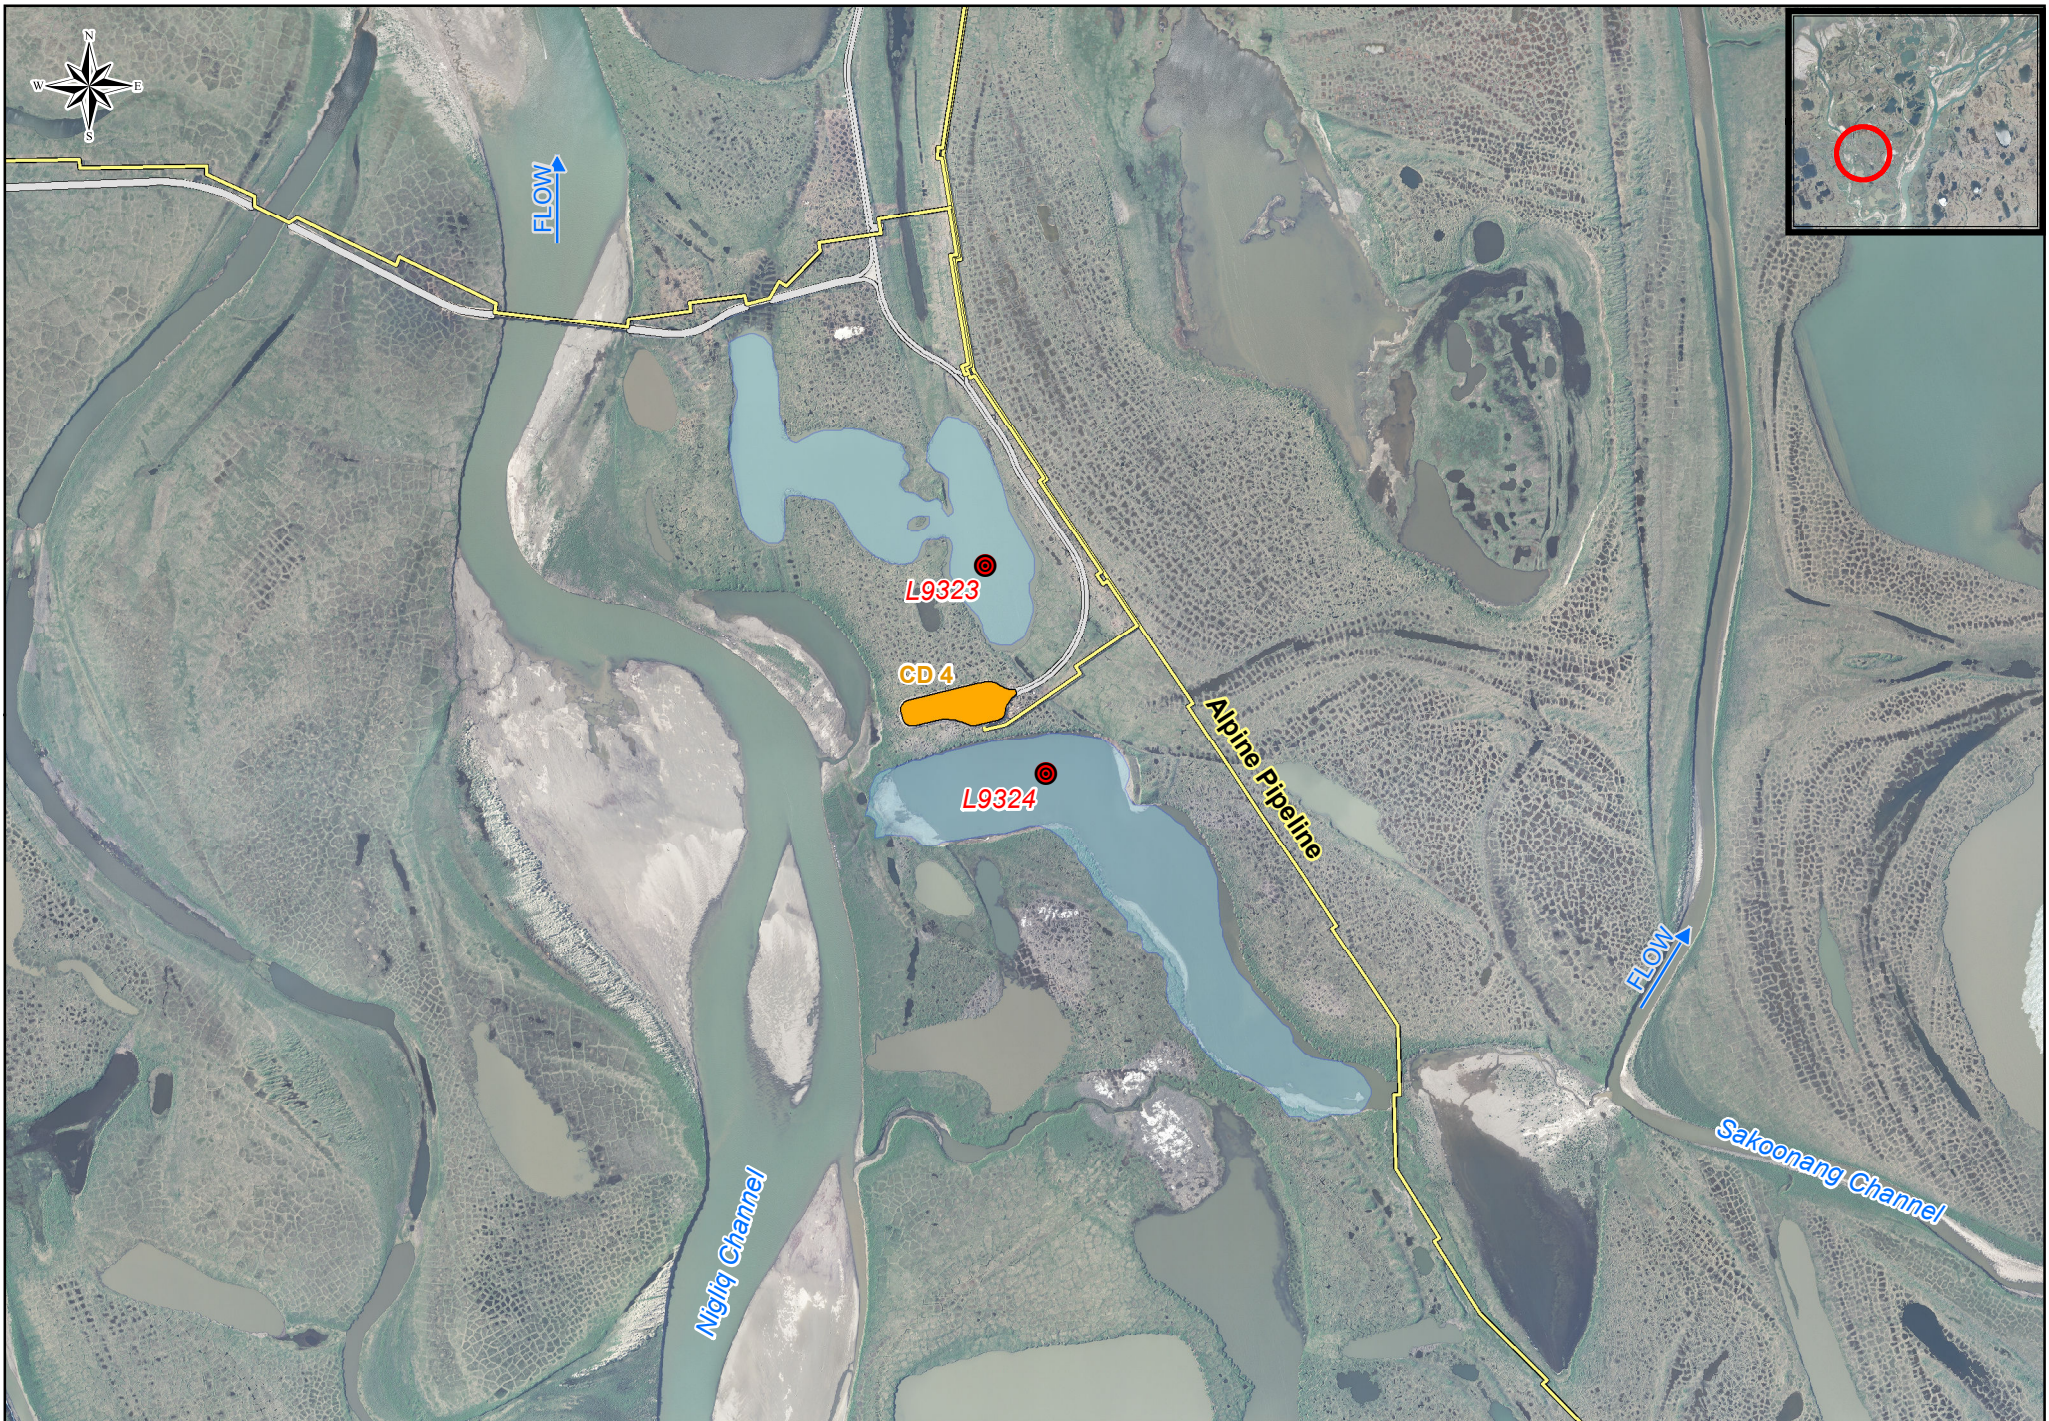
Lakes L9323 & L9324 ASDP Water Quality Sampling Locations
FIGURE: 2 (SHEET 1 of 1)

Sampling locations were identified in the field using a handheld global positioning system Garmin Oregon 650t referenced to the World Geodetic System of 1984 coordinate system. The sampling locations for lakes L9323 and L9324 are shown in Figure 2. Figure 3 shows the sampling location for Lake M9313.

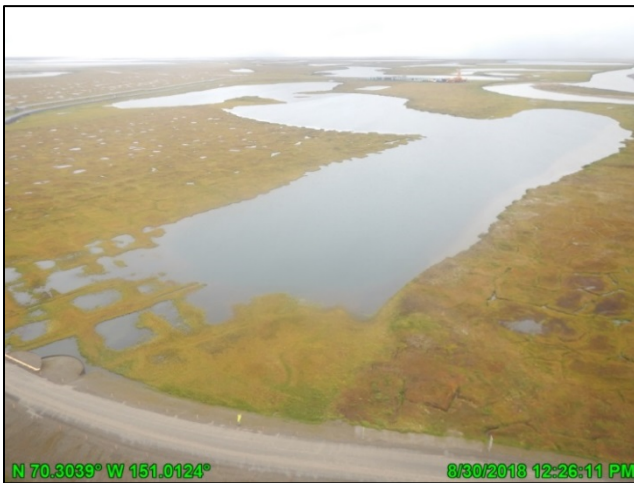
Photo 3: Lake L9323, looking south toward Nigliq Channel and CD4 pad; August 30, 2018

Located east of the Nigliq Channel, Lake L9323 is moderately sized with grassy banks and some taller vegetation on the periphery. Lake L9323 was hydraulically isolated at the time of sampling. No odor or film was observed while sampling the lake.

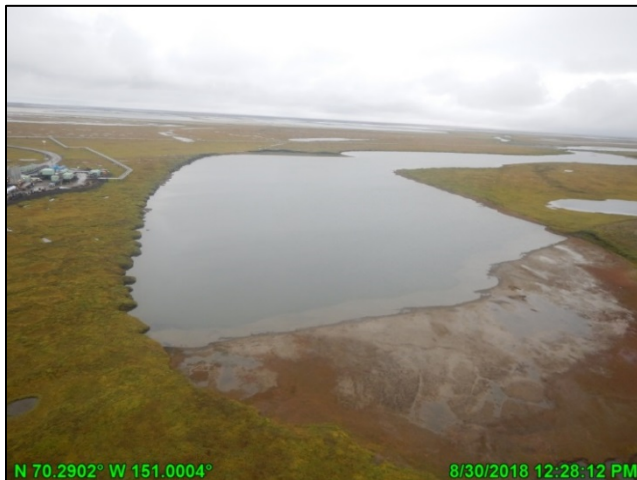
Photo 7: Lake L9324, looking east near CD4; August 30, 2018

Located east of the Nigliq Channel, Lake L9324 is moderately sized with grassy banks and willows. Some bluffs surround the lake. At the time of sampling, Lake L9324 was hydraulically connected to the South Paleo Lake and Sakoonang Channel. No odor or film was observed while sampling the lake.

Average turbidity for lakes L9323, L9324, and M9313 was 0.6 NTU, 3.3 NTU, and 0.8 NTU, respectively. The higher NTU value for Lake L9324 has been observed in previous years of sampling and is likely the result of the hydraulic connection to the South Paleo Lake and Sakoonang Channel during sampling.

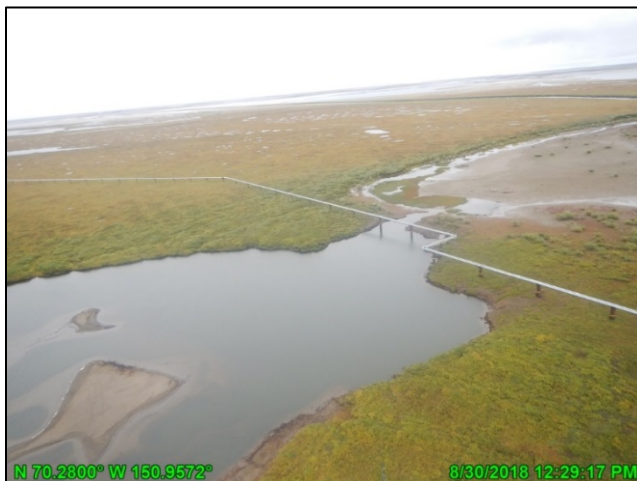
Photo 9: Hydraulic connection between Lake L9324 and South Paleo Lake, looking northeast; August 30, 2018

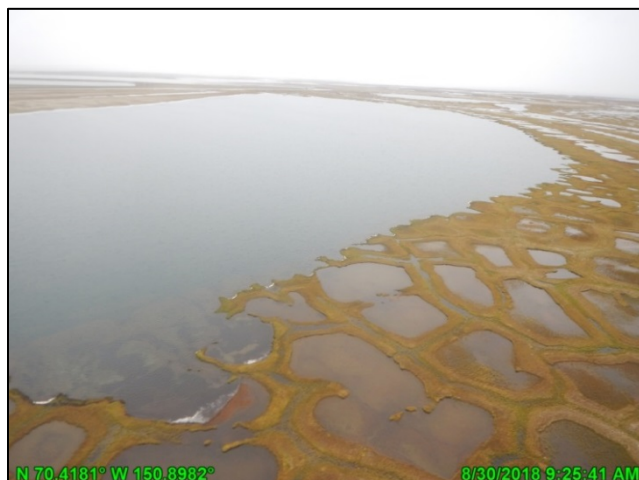
Photo 11: Lake M9313, looking north; August 30, 2018

Located east of the Ulamnigiq Channel, Lake M9313 is large with low grassy banks. At the time of sampling, Lake M9313 was not hydraulically connected to any major water bodies. No odor or film was observed while sampling the lake.
