# 2018

## ALPINE PIPELINE HYDROLOGY MONITORING

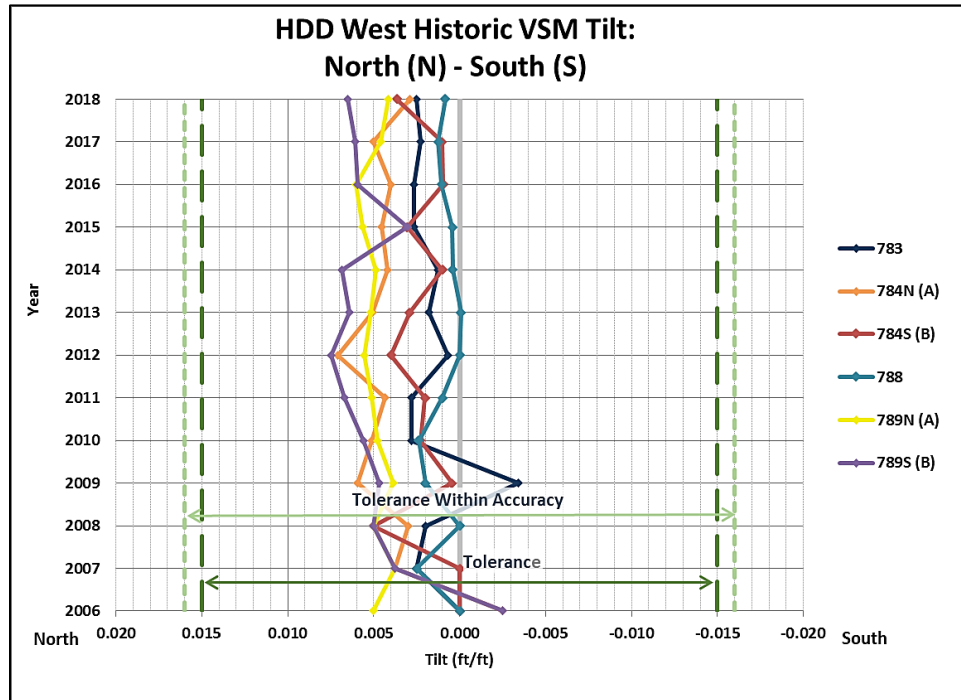
**Graph 3.1: HDD West VSM Historical Change in Tilt, North/South**

- Notes:**
1. Positive tilt indicates north (N), negative tilt indicates south (S).
  2. Project tilt tolerance for VSM is +/- 0.015 ft/ft.
  3. Survey accuracy of this project is +/-0.001 ft/ft.

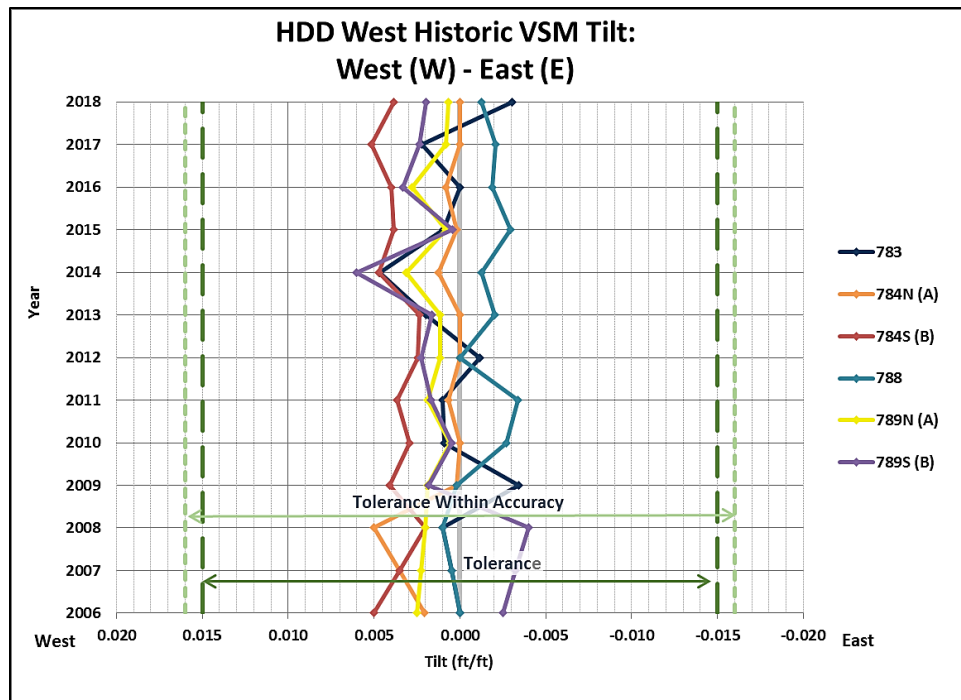
**Graph 3.2: HDD West VSM Historical Change in Tilt, East/West**

- Notes:**
1. Positive tilt indicates west (W), negative tilt indicates east (E).
  2. Project tilt tolerance for VSM is +/- 0.015 ft/ft.
  3. Survey accuracy of this project is +/-0.001 ft/ft.

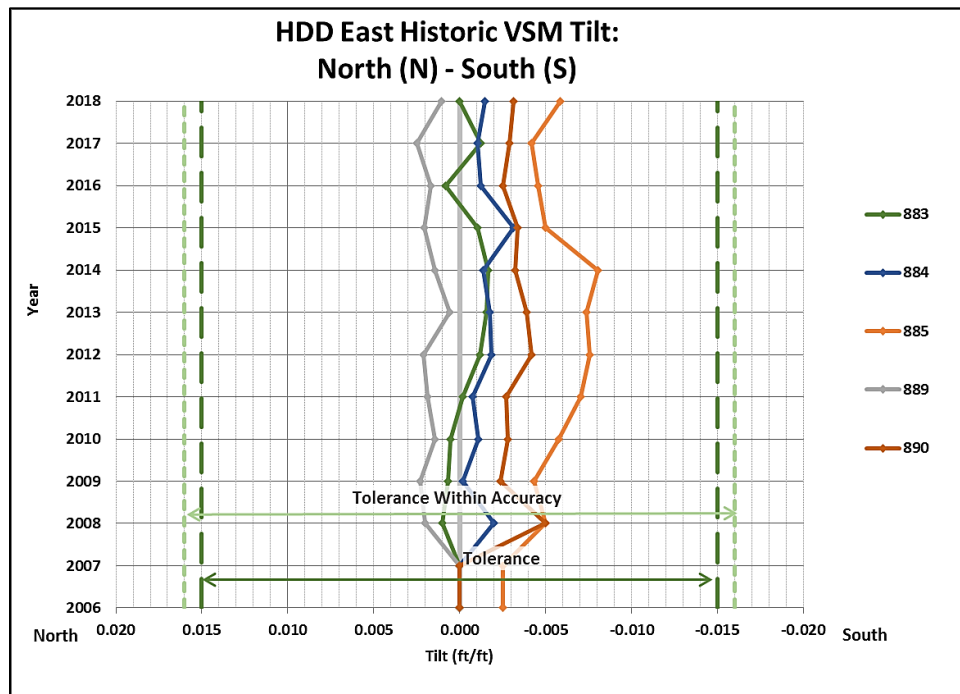
**Graph 3.3: HDD East VSM Historical Change in Tilt, North/South**

- Notes:**
1. Positive tilt indicates north (N), negative tilt indicates south (S).
  2. Project tilt tolerance for VSM is +/- 0.015 ft/ft.
  3. Survey accuracy of this project is +/-0.001 ft/ft.

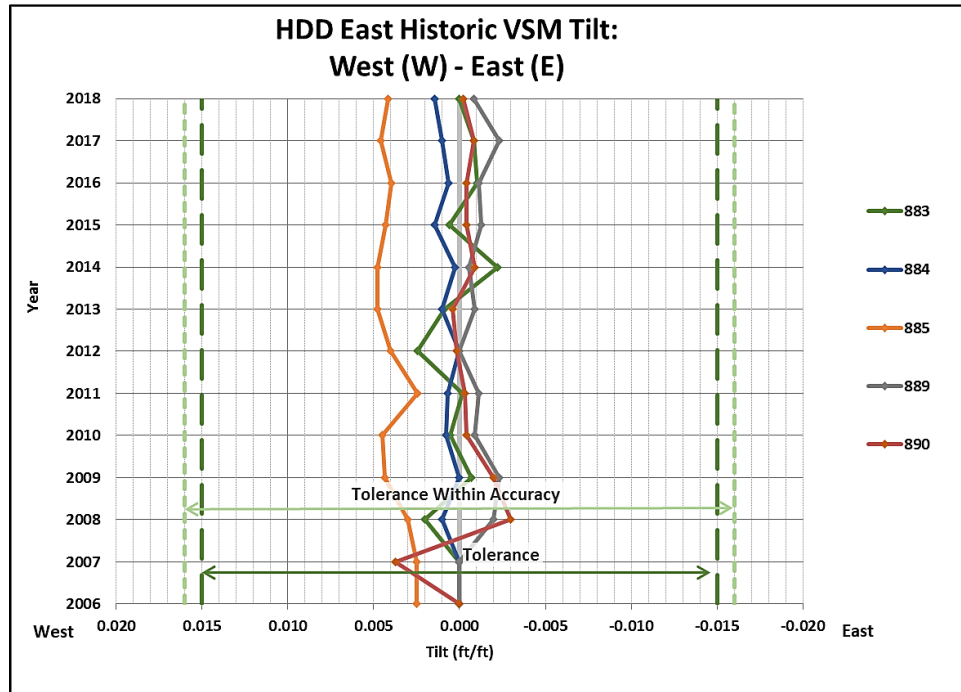
**Graph 3.4: HDD East VSM Historical Change in Tilt, East/West**

- Notes:**
1. Positive tilt indicates west (W), negative tilt indicates east (E).
  2. Project tilt tolerance for VSM is +/- 0.015 ft/ft.
  3. Survey accuracy of this project is +/-0.001 ft/ft.

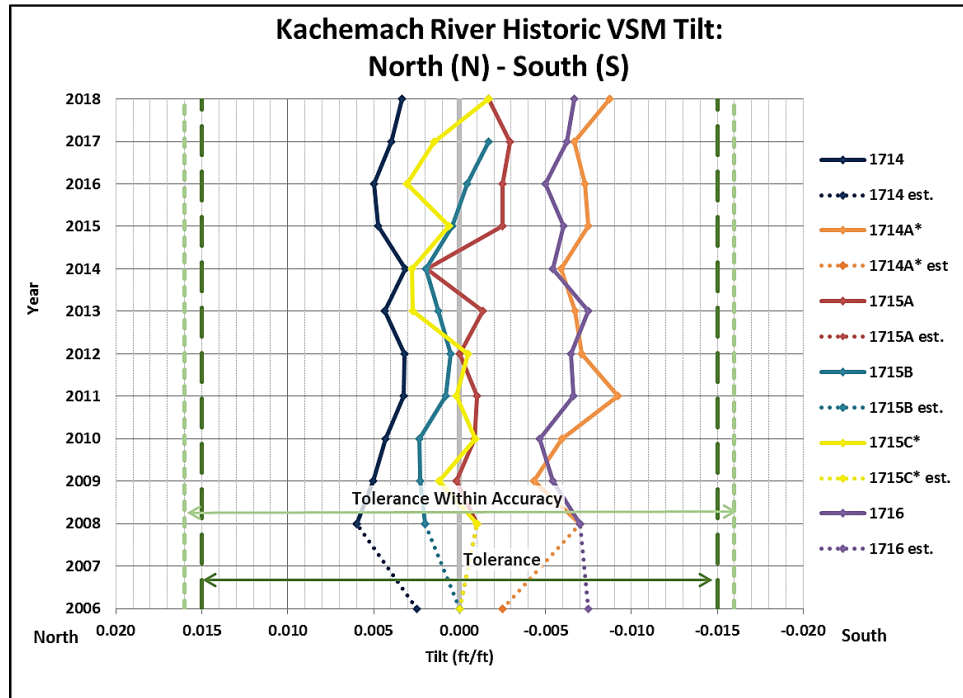
**Graph 3.5: Kachemach River VSM Historical Change in Tilt, North/South**

- Notes:**
1. Positive tilt indicates north (N), negative tilt indicates south (S).
  2. Project tilt tolerance for VSM is +/- 0.015 ft/ft.
  3. Survey accuracy of this project is +/-0.001 ft/ft.

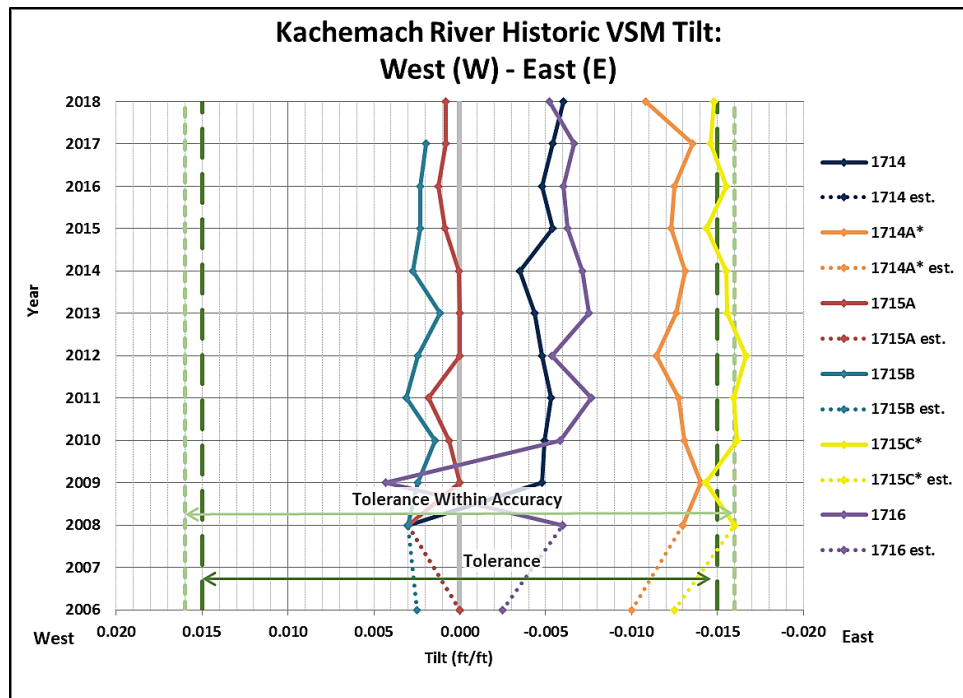
**Graph 3.6: Kachemach River VSM Historical Change in Tilt, East/West**

- Notes:**
1. Positive tilt indicates west (W), negative tilt indicates east (E).
  2. Project tilt tolerance for VSM is +/- 0.015 ft/ft.
  3. Survey accuracy of this project is +/-0.001 ft/ft.

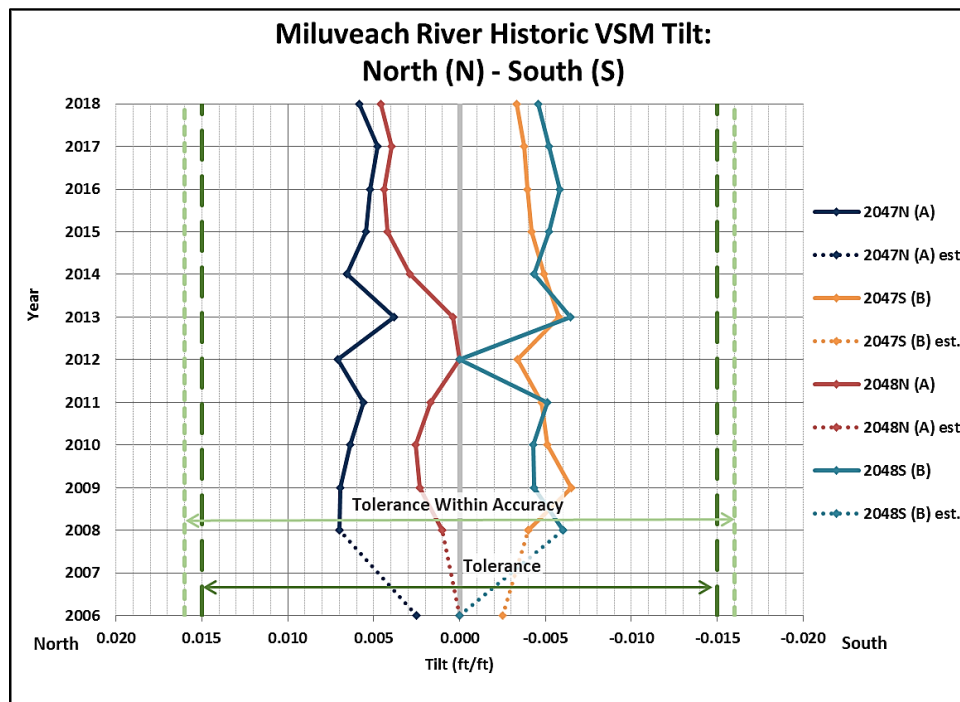
**Graph 3.7: Miluveach River VSM Historical Change in Tilt, North/South**

- Notes:**
1. Positive tilt indicates north (N), negative tilt indicates south (S).
  2. Project tilt tolerance for VSM is +/- 0.015 ft/ft.
  3. Survey accuracy of this project is +/-0.001 ft/ft.
  4. Tilt measurements were not taken at this location in 2007; tilt is estimated between 2006 and 2008.

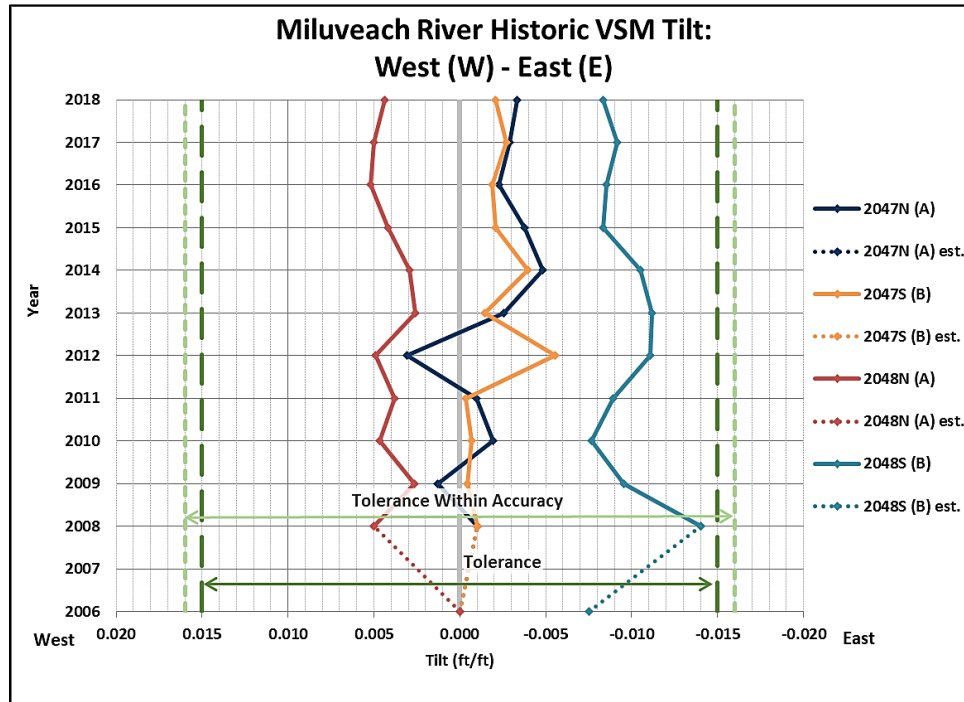
**Graph 3.8: Miluveach River VSM Historical Change in Tilt, East/West**

- Notes:**
1. Positive tilt indicates west (W), negative tilt indicates east (E).
  2. Project tilt tolerance for VSM is +/- 0.015 ft/ft.
  3. Survey accuracy of this project is +/-0.001 ft/ft.
  4. Tilt measurements were not taken at this location in 2007; tilt is estimated between 2006 and 2008.

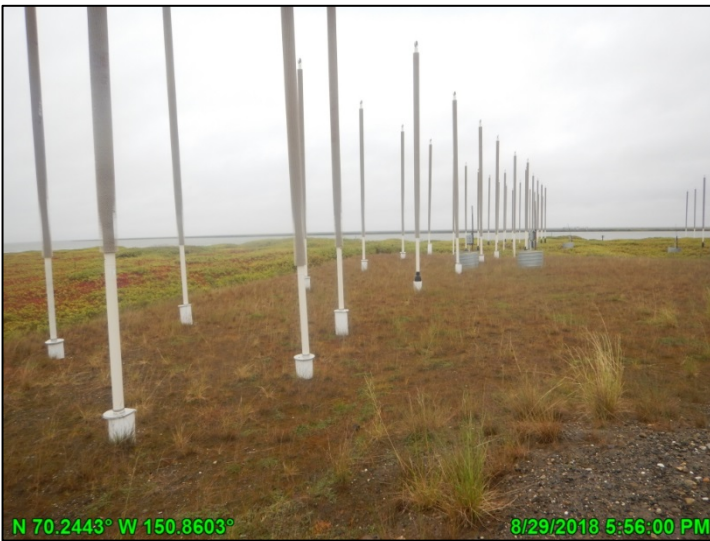
**Photo A.7: HDD West gravel pad and north side thermosyphons, looking east; August 29, 2018**

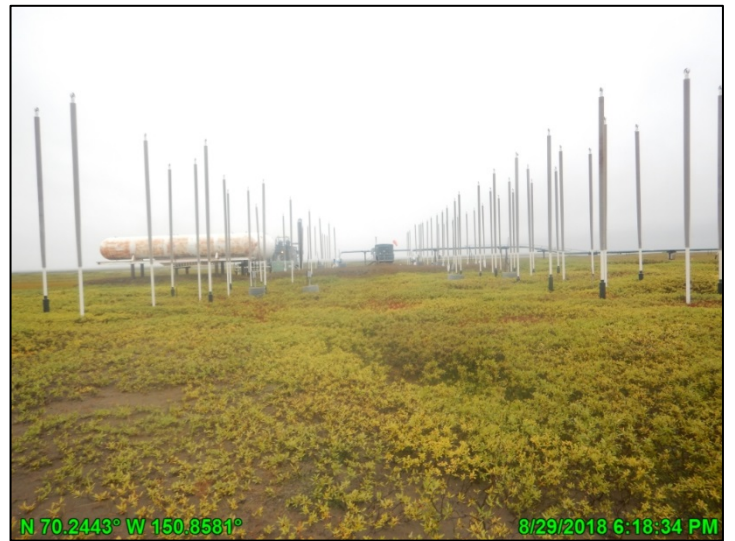
**Photo A.8: HDD West gravel pad and north side thermosyphons, looking west; August 29, 2018**

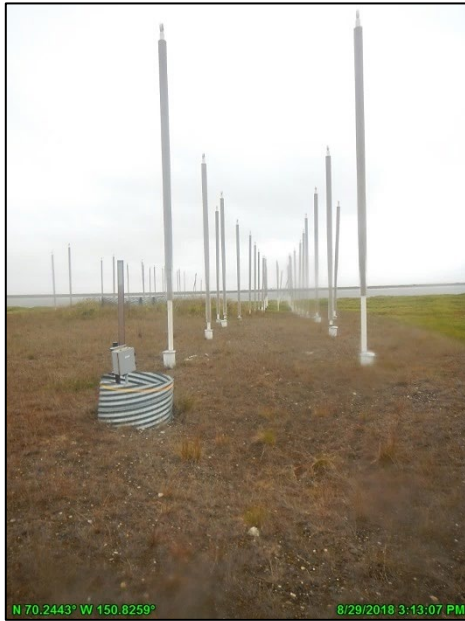
Several thermosyphons sustained damage from ice impacts during spring breakup in 2015. The damaged thermosyphons are not impacting the integrity of the pipeline and are not contributing to further bank erosion.

**Photo A.17: HDD East gravel pad and north side thermosyphons, looking west; August 29, 2018**

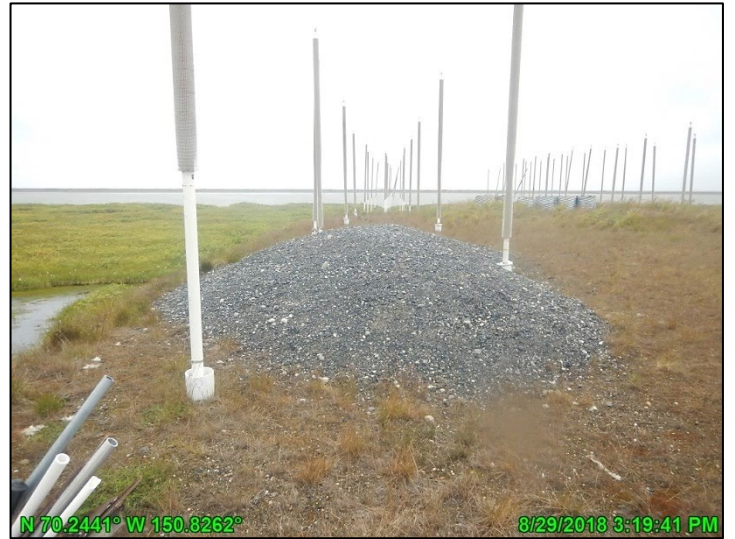
**Photo A.18: HDD East gravel pad and south side thermosyphons, looking west; August 29, 2018**

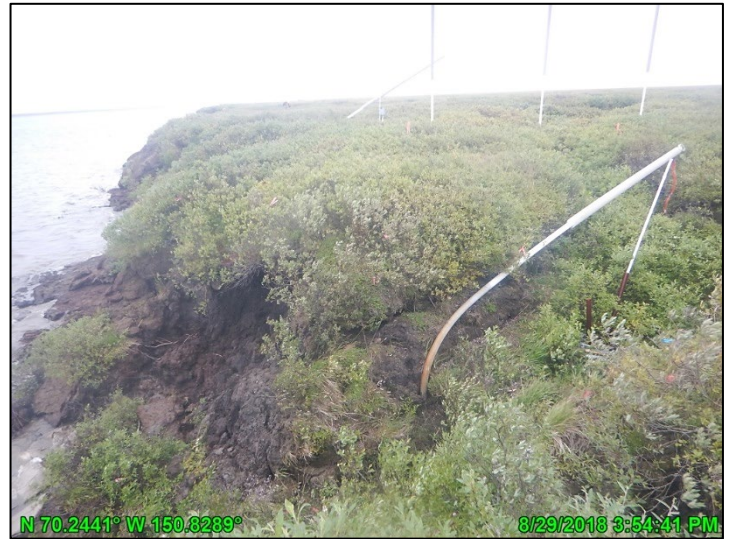
Active erosion and sloughing continue along the east bank north of the NPS 14 oil pipeline. In 2001, sandbags and Styrofoam were installed in the bank to reduce melting ice lenses and combat further erosion. Exposed sandbags and Styrofoam were evident at the toe of the polygon trough, similar to site conditions encountered during the 2017 field visit.

**Photo A.20: HDD East bank, looking north (downstream); August 29, 2018**

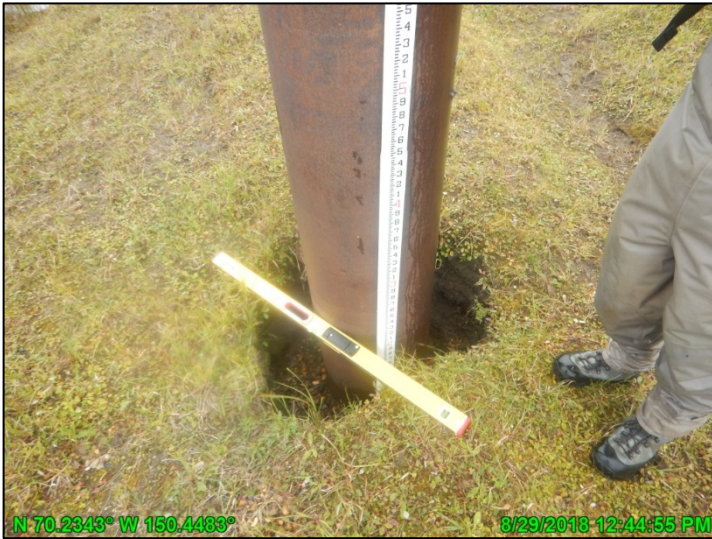
No excessive scour was observed at the base of any VSM located within the main channel or floodplain. Ground depressions observed at the base of VSM 1714, 1715C, and 1716 are likely the result of consolidated backfill material and are not attributed to hydraulic events. A summary of VSM scour results in the floodplain of the Kachemach River is presented in Table 3.9.

**Photo A.29: Kachemach River VSM ground depression measurement; August 29, 2018**

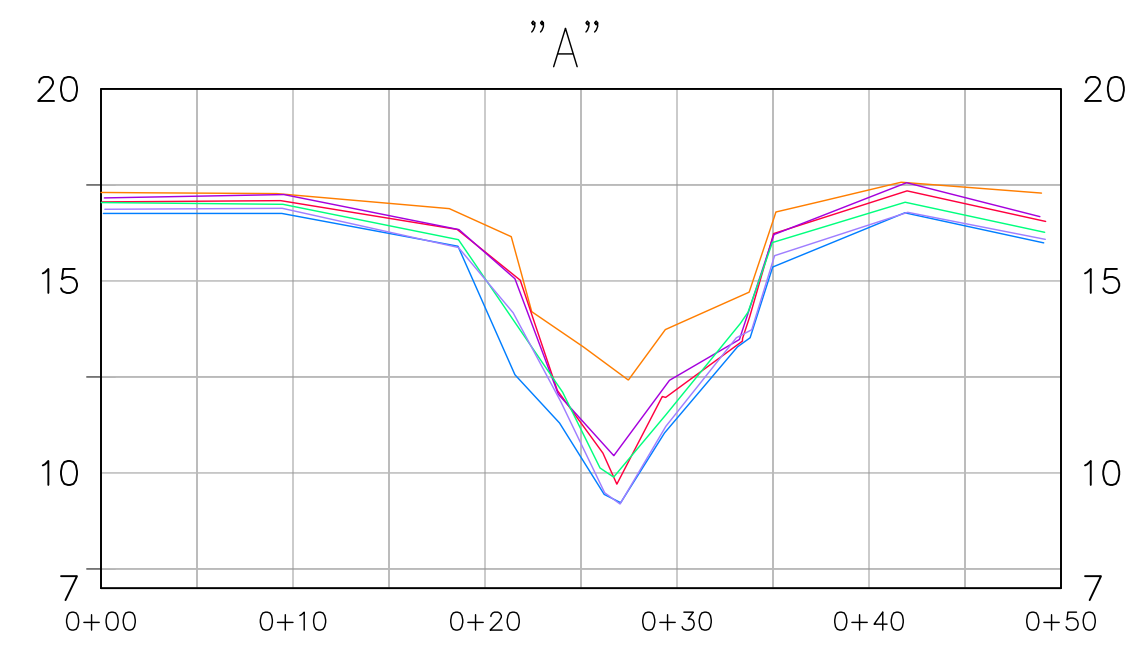
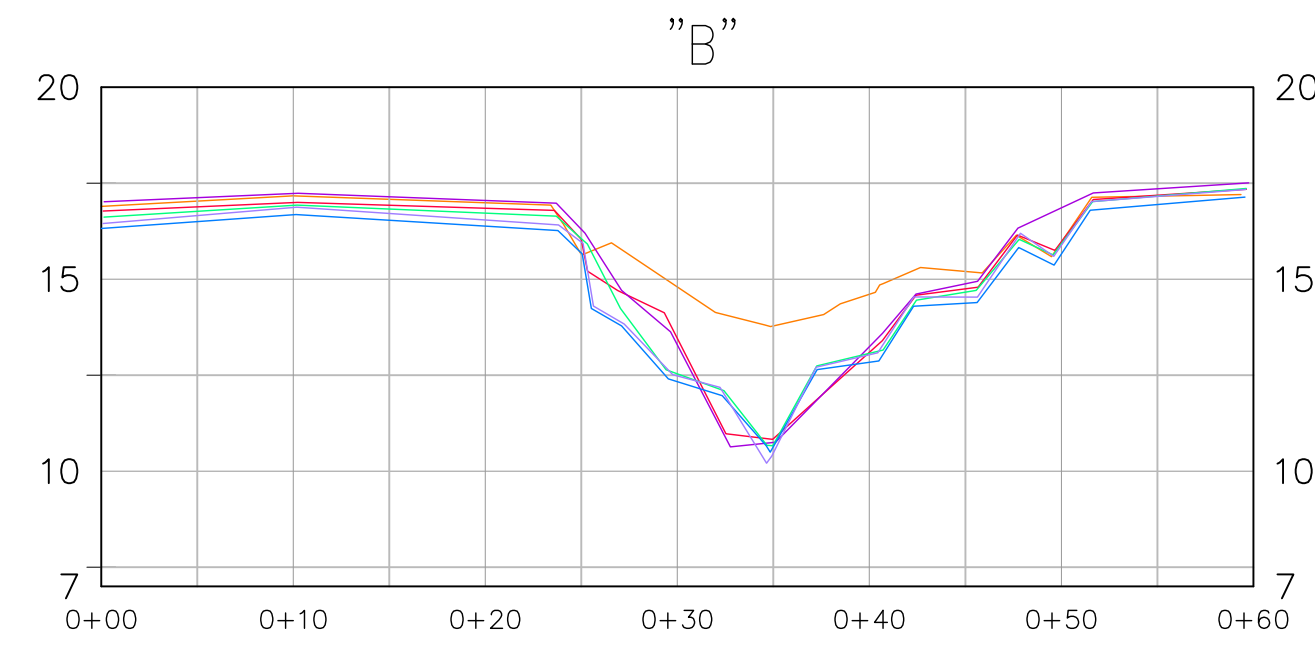
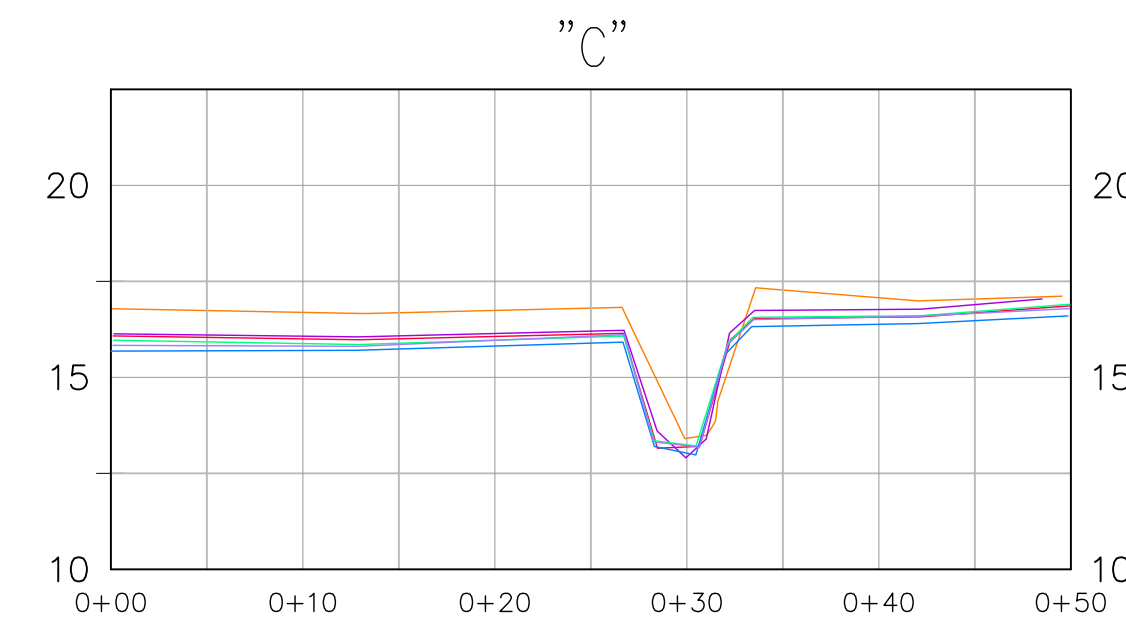
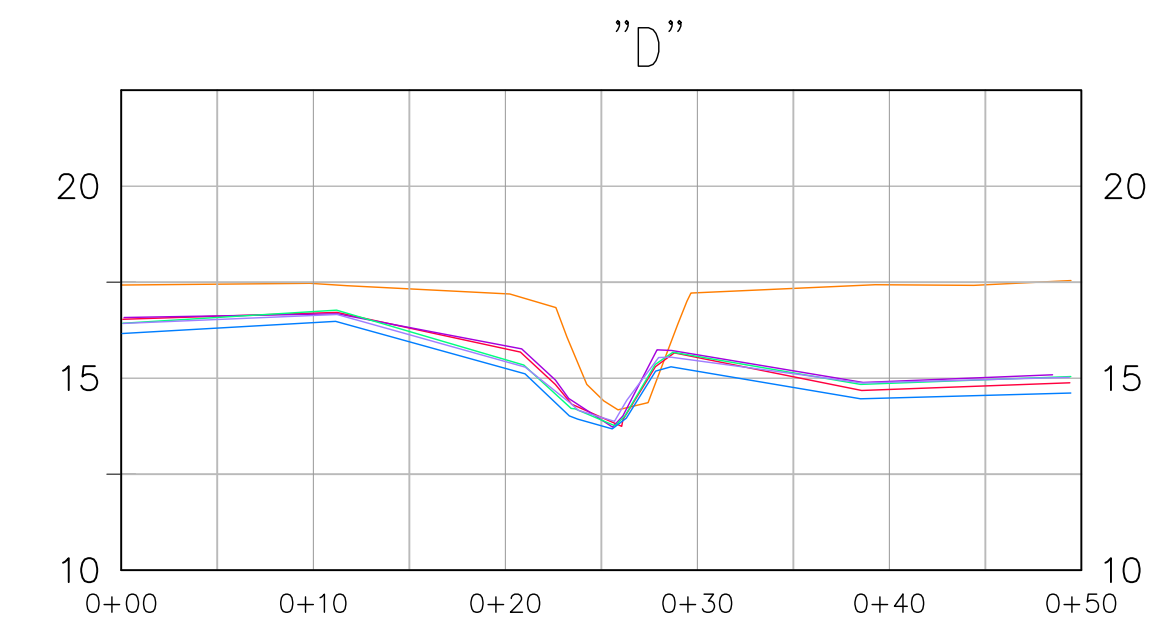
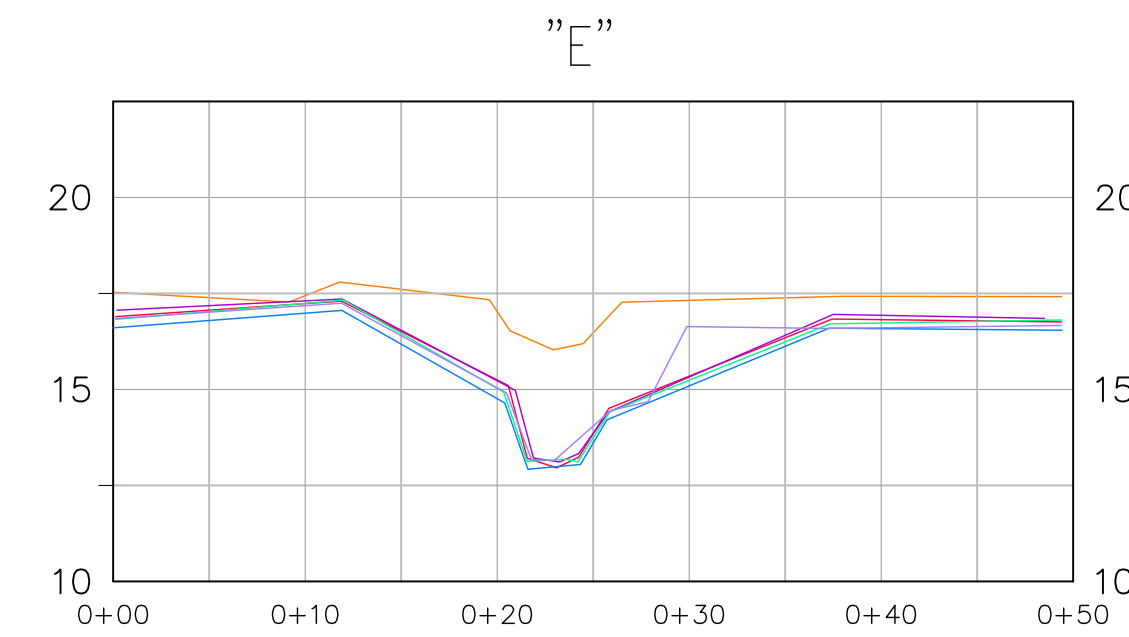
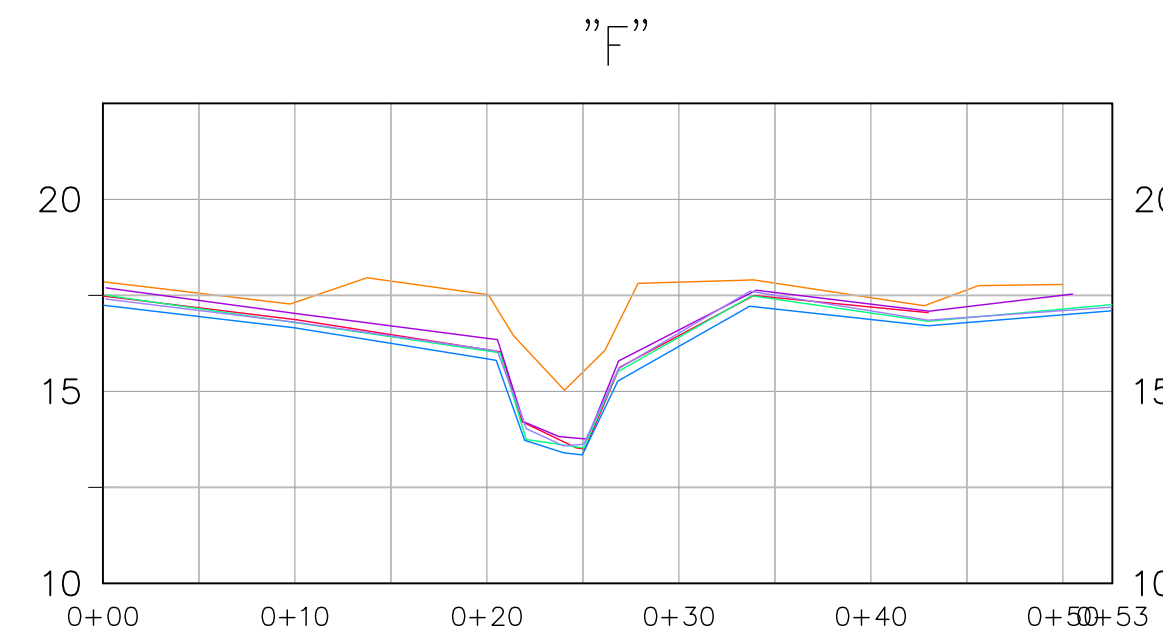
CROSS SECTIONS, POLYGON TROUGH

Maximum incremental subsidence between 2017 and 2018 was 0.8 feet observed at STA 0+27 at cross section D. Maximum cumulative subsidence between 2001 and 2018 was 4.1 feet observed at STA 0+27 at cross section A. Cross section B experienced a maximum cumulative subsidence between 2001 and 2018 of 4.0 feet at STA 0+35.

HORIZONTAL SCALE = 1"=10' VERTICAL SCALE = 1"=5'

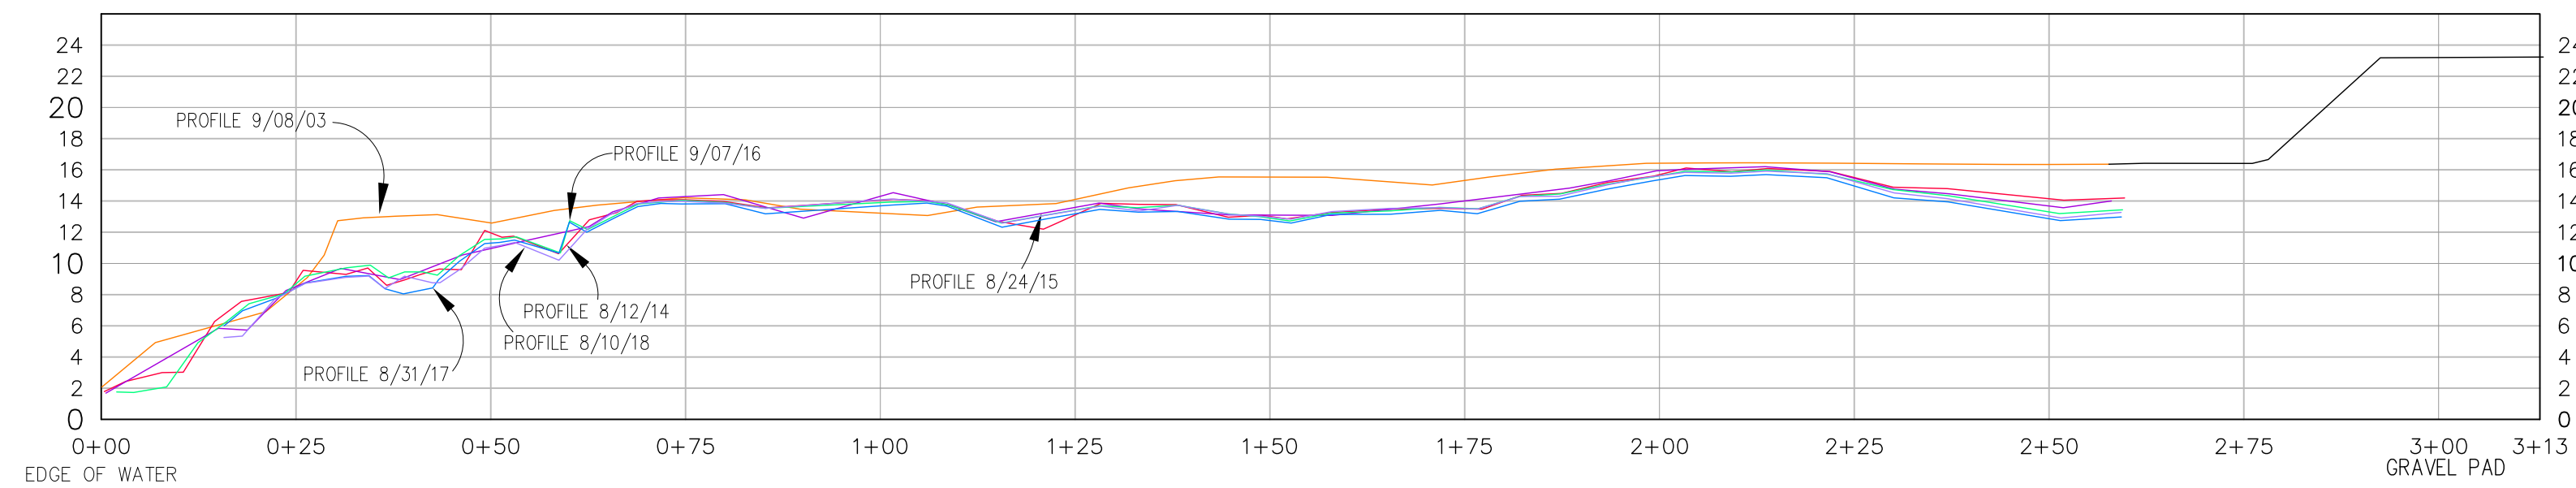
CENTERLINE PROFILE, POLYGON TROUGH

HORIZONTAL SCALE = 1"=20' VERTICAL SCALE = 1"=10'
