COLVILLE RIVER DELTA  
SPRING BREAKUP MONITORING &  
HYDROLOGICAL ASSESSMENT

# 2018 FIELD REPORT

Michael Baker International (Michael Baker) provided hydrology monitoring services to ConocoPhillips Alaska, Inc. (CPAI) for the Alpine Development Project in the Colville River Delta (CRD). Alpine facilities include the Colville Delta CD1 processing facility and the CD2, CD3, CD4, and CD5 pads, access roads, and pipelines.

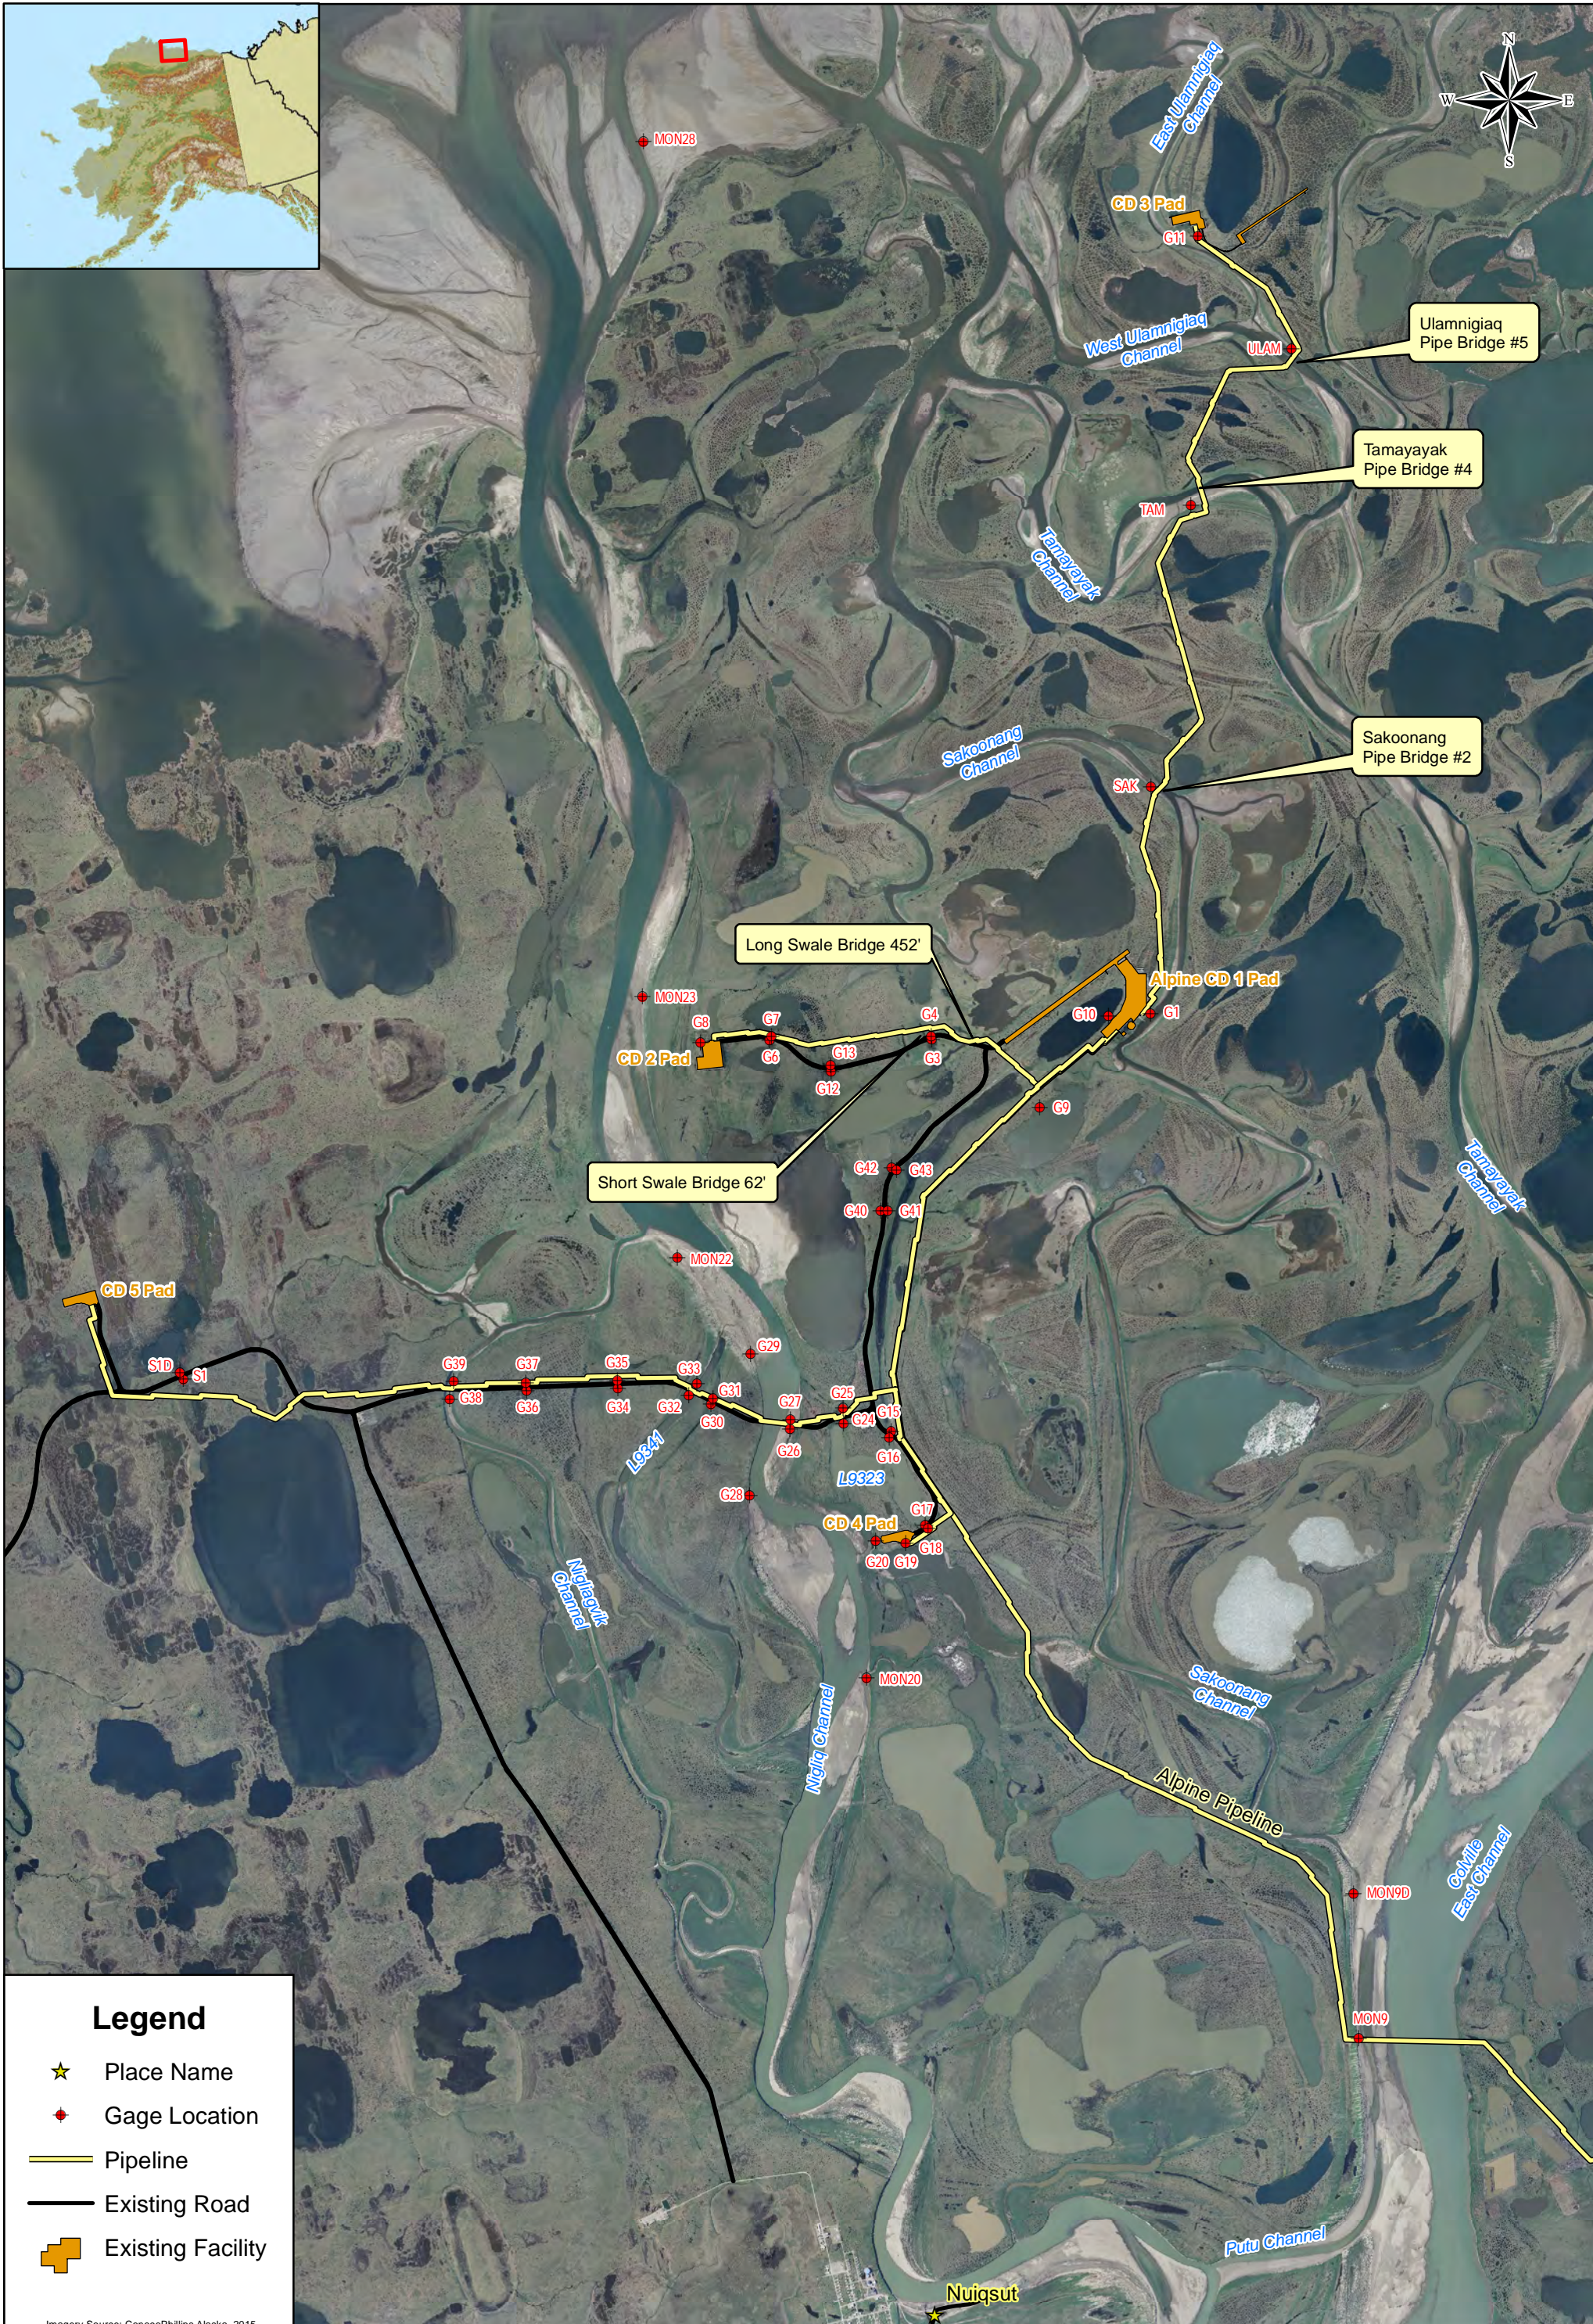
| FIGURE 2 |

| 2018 SPRING BREAKUP<br>ALPINE AREA FACILITIES |
| Monitoring Locations |

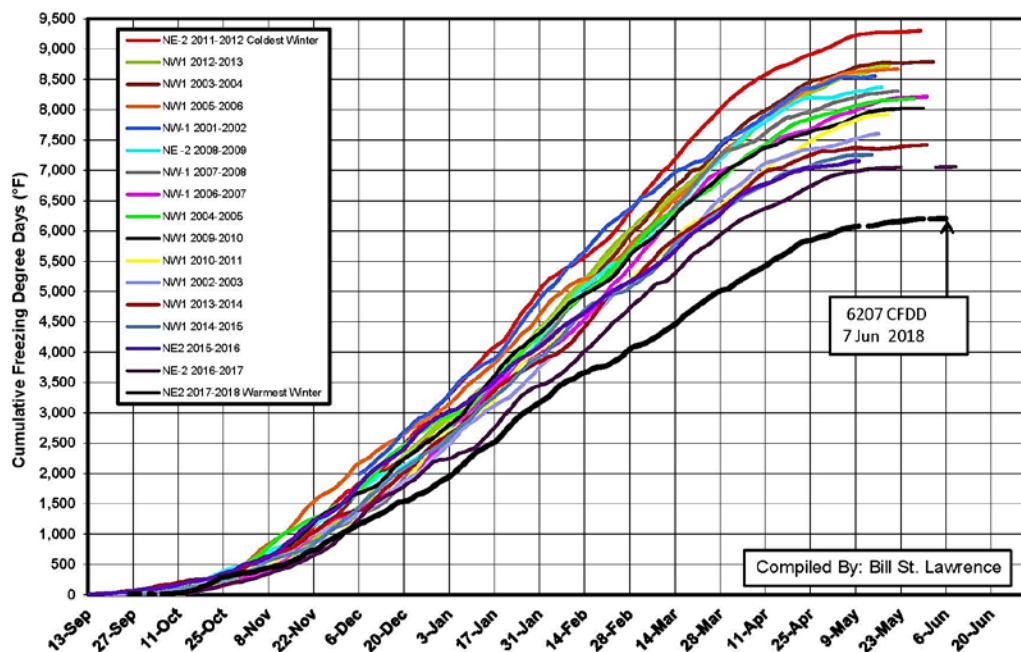
According to cumulative freezing degree-days (CFDD) measured at the National Petroleum Reserve Alaska (NPR-A) tundra monitoring station, the 2017-2018 (September – May) winter was the warmest on record for the past 17 years (Graph 3.1, ICE 2018).

**Graph 3.1: NPR-A N. Tundra Monitoring Station CFDD, Winters 2002-2018 (ICE 2018)**

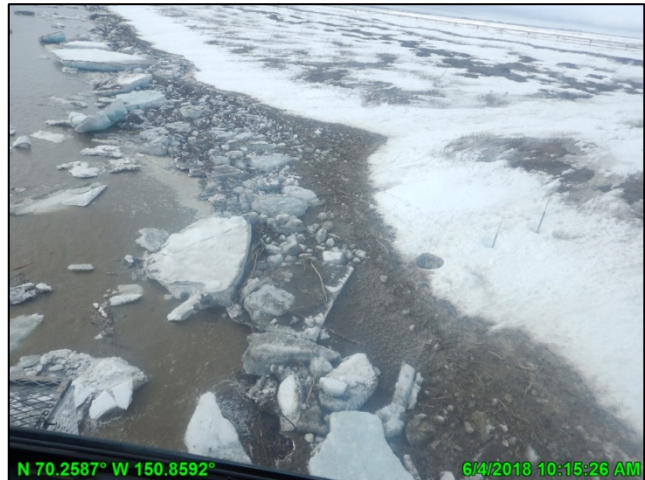
On June 3, the East Channel ice jam reformed further downstream near the Kachemach River confluence. Stage continued to drop in the Colville River, East Channel, Nigliq Channel, and around Alpine facilities (Photo 6). The Long Swale Bridge continued to convey flow and a small flow path had been cut through the snow underneath the Short Swale Bridge. As of June 5, stage in the Nigliq Channel and East Channel was continuing to drop. Remaining channel ice broke up into floes which progressed with minimal jamming to the outer extents of the CRD.

Photo 6: Grounded ice at MON9D indicating stage had dropped, looking south; June 4, 2018

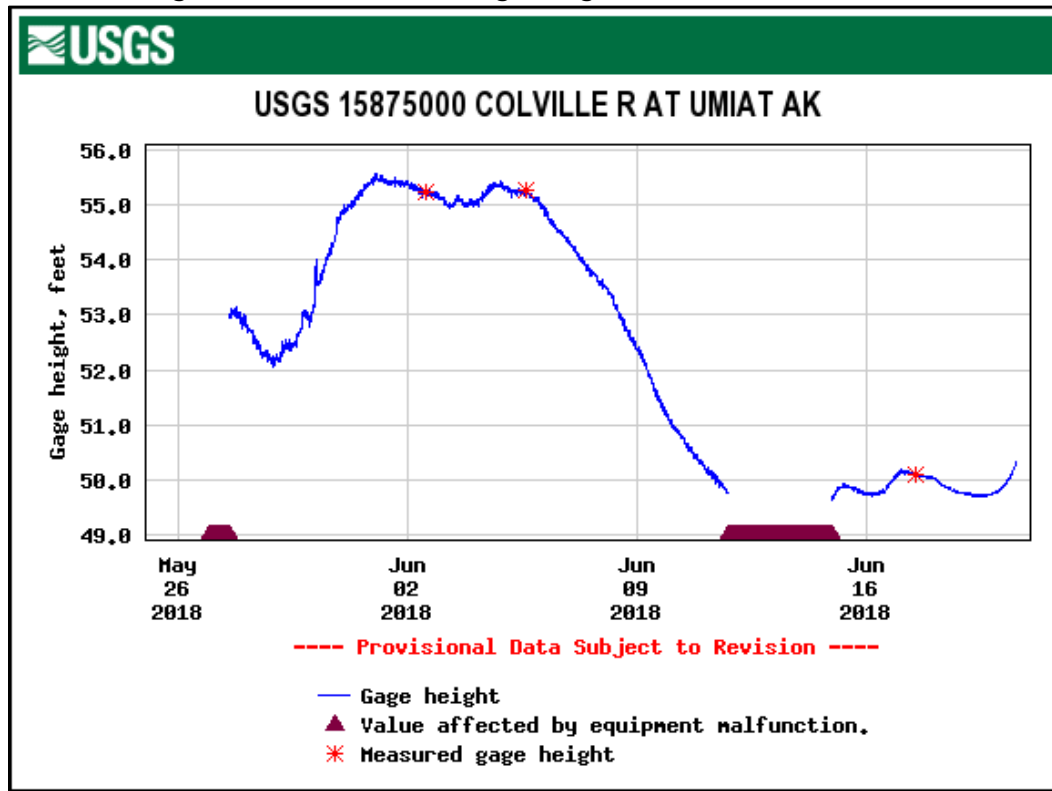
The 2018 spring breakup flood occurred over a three-week period and was characterized as a protracted, low magnitude event. The USGS gage on the Colville River at Umiat was inoperable until May 27 and experienced equipment malfunctions between June 11 and June 14. Peak stage at Umiat occurred at 12:15 a.m. on June 1 with a gage height of 55.51 feet (Figure 3). National Weather Service (NWS) flood stage at this location is 59 feet. Preliminary PT data and HWMs indicate peak stage in the Colville River at MON1 was 17.0 ft BPMSL and occurred around 4:15 a.m. on June 2. This value falls between the 50% and 20% chance exceedances of occurring in a given year (i.e. between the 2- and 5-year recurrence interval stages), when compared to the historical record (Michael Baker 2017).

Figure 3: Colville River Gage Height at Umiat (USGS 2018)
