2019 Alpine Satellite Development Plan (ASDP) Water Quality Monitoring

ConocoPhillips
Alaska

The 2019 Alpine Satellite Development Plan (ASDP) Water Quality Monitoring Report presents the results of lake monitoring conducted in August 2019 for ConocoPhillips Alaska, Inc. (CPAI). This report includes monitoring results of lakes L9323, L9324, and M9313 as well as new in-situ monitoring at lakes B8530 and L9327. Lakes L9323, L9324, and M9313 have been monitored annually since 2007. An overview of the study lakes relative to Alpine facilities is presented in Figure 1.

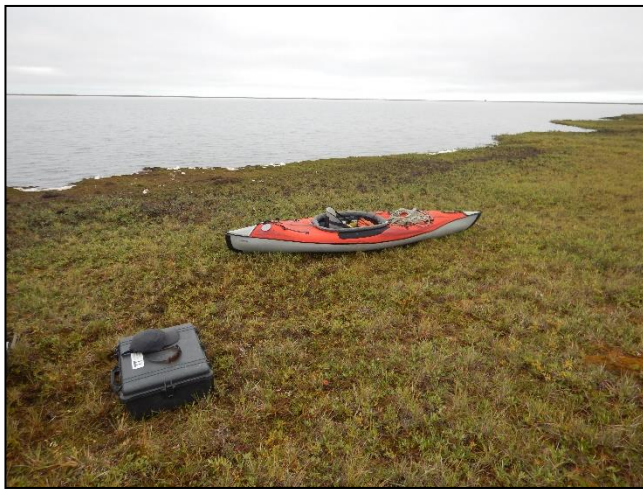
Photo 1: Equipment used to collect water quality data and samples; August 15, 2019

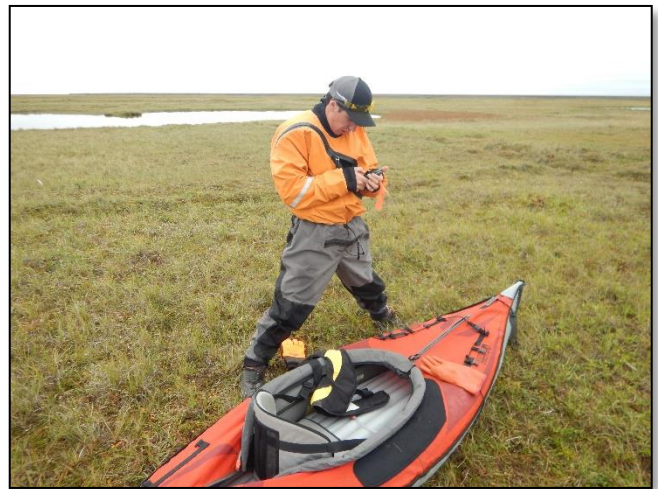
Photo 2: Preparing for sampling at Lake L9324; August 15, 2019

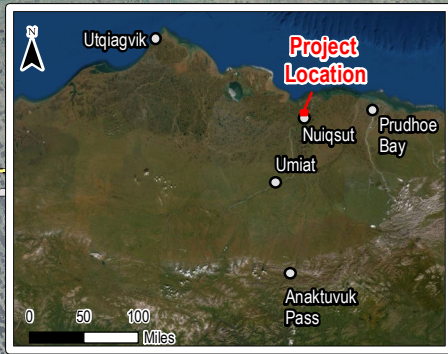
FIGURE 2

Sampling locations were identified in the field using a handheld global positioning system Garmin Oregon 650t referenced to the World Geodetic System of 1984 coordinate system. The sampling locations for lakes L9323 and L9324 are shown in Figure 2, Lake M9313 is shown in Figure 3, and lakes L9327 and B8530 are shown in Figure 4.

2019 ASDP
Monitoring Locations
Lake L9323 & L9324

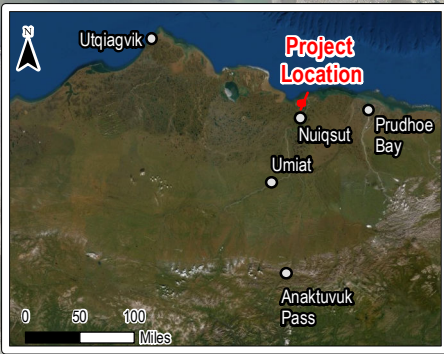
FIGURE 3

2019 ASDP
 Monitoring Locations
 Lake M9313

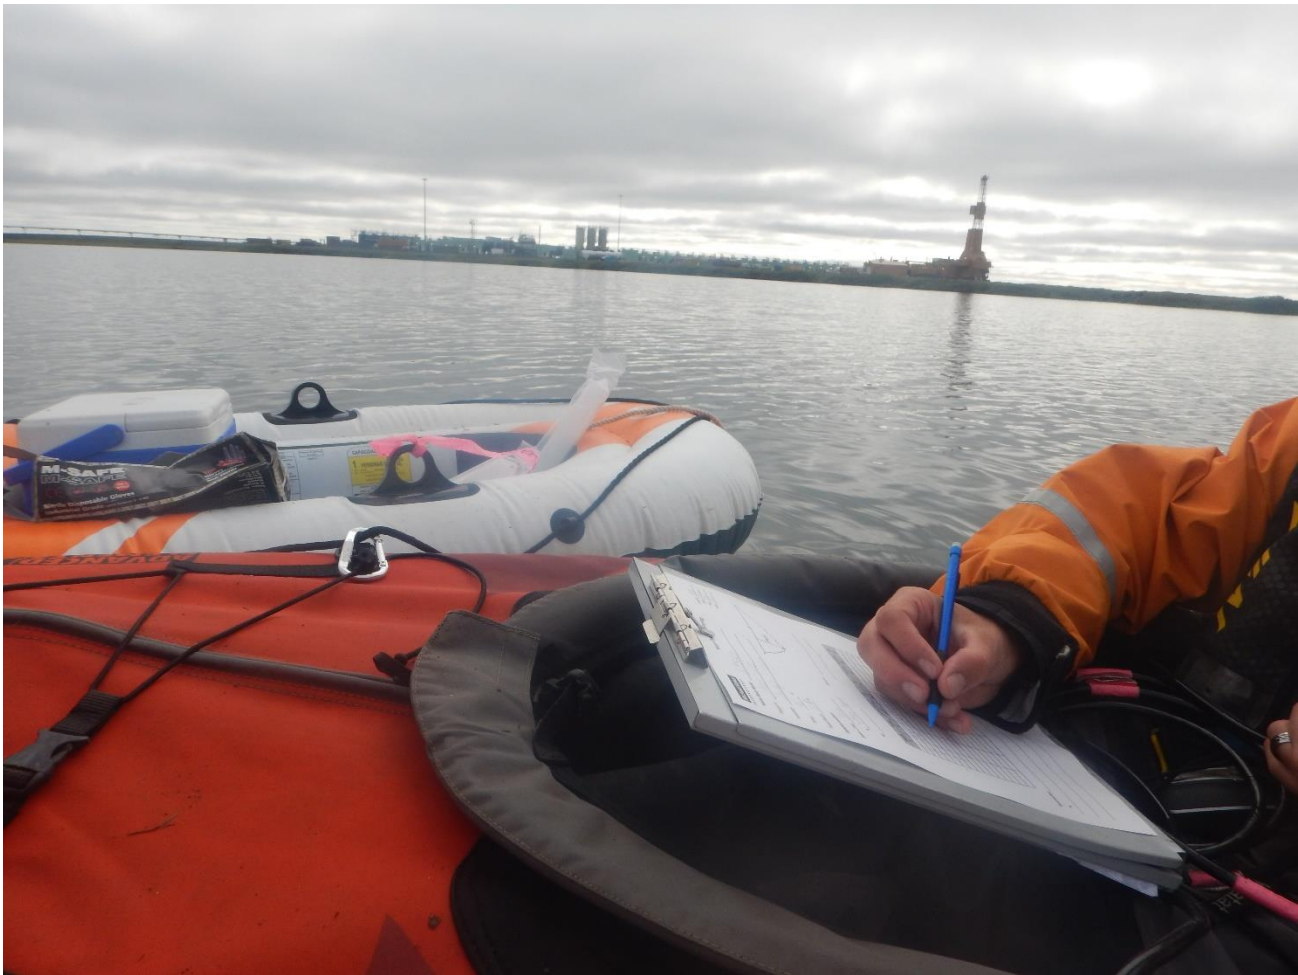
Lake L9323 is located east of the Nigliq Channel. The CD5 road is adjacent to the north and the CD4 road is adjacent to the east. This lake can become hydraulically connected to the Nigliq and/or Sakoonang Channels during flooding. A bridge in the CD5 road allows for the passage of overbank flow out of the lake. At the time of sampling it was not, based on aerial visual inspection, hydraulically connected to any streams or distinct water bodies. No odor or film was observed while sampling the lake (Photo 3).

Photo 3: Sampling at Lake L9323; August 15, 2019

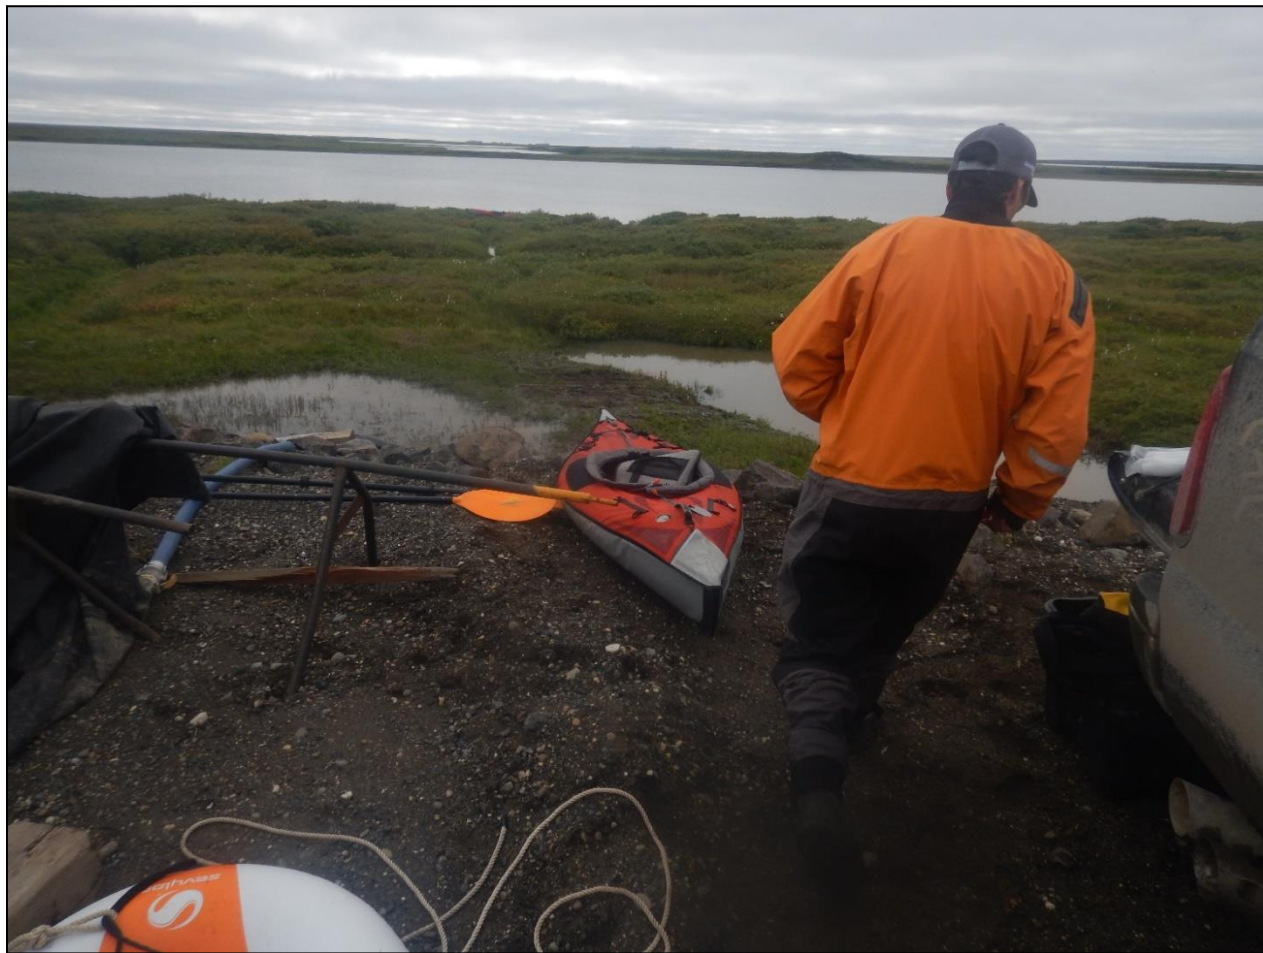
Lake L9324 is located east of the Nigliq Channel. The CD4 pad is adjacent to the north. This lake can become hydraulically connected to the Nigliq and Sagoonang channels during flooding. At the time of sampling, Lake L9324 was hydraulically connected to the Sagoonang Channel to the east via a paleolake. The Alpine Sales pipeline crosses the connection between lakes. No odor or film was observed while sampling the lake (Photo 4).

Photo 4: Prepping to sample at Lake L9324; August 15, 2019

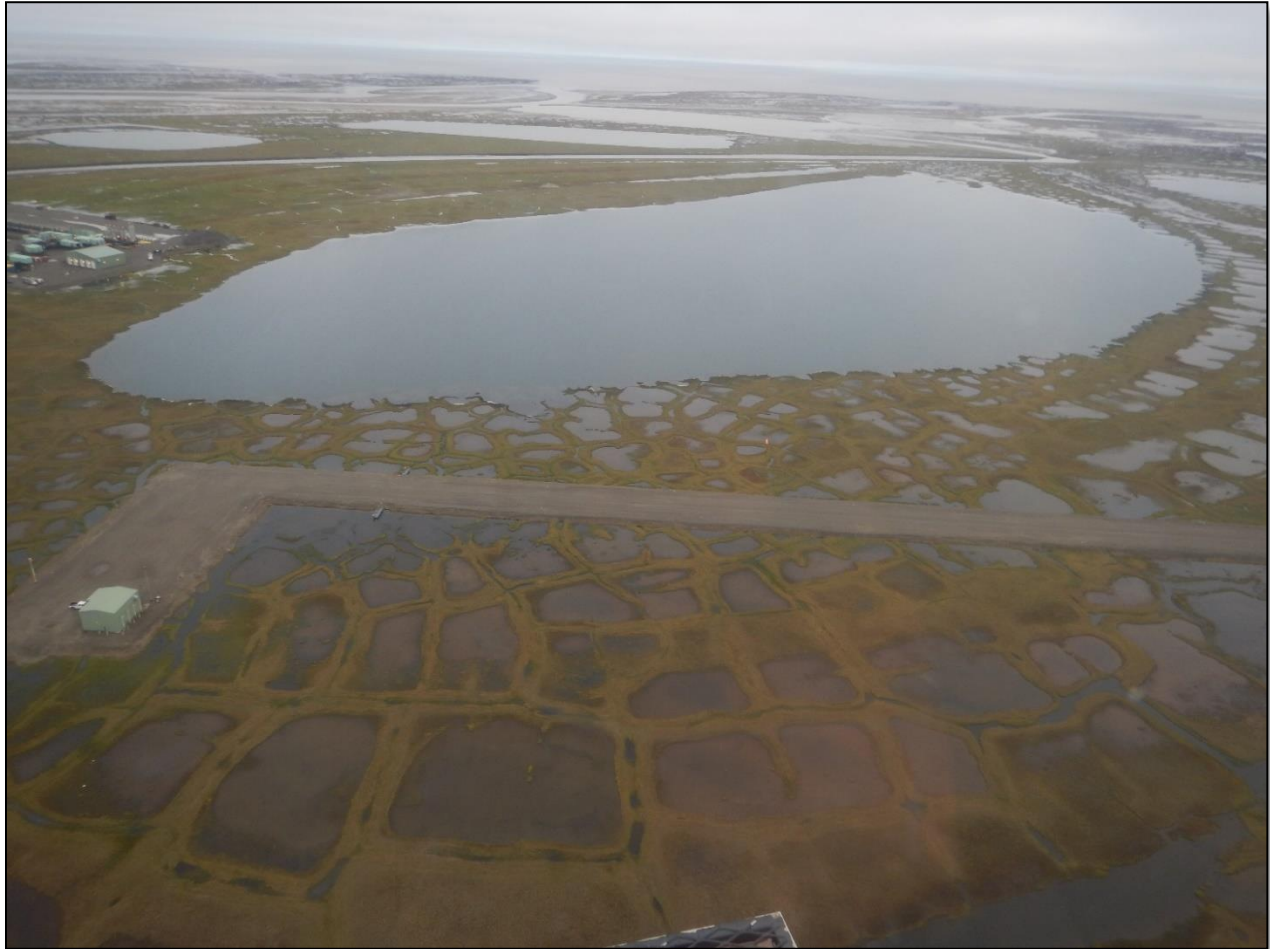
Lake M9313 is located adjacent north of the CCD3 pad and runway, east of the Ulamnigiaq Channel. This lake can become hydraulically connected to the Ulamnigiaq Channel during flooding. At the time of sampling it was not, based on aerial visual inspection, hydraulically connected to any streams or distinct water bodies (Photo 5). No odor or film was observed while sampling the lake.

Photo 5: Lake M9313, looking northwest; August 15, 2019

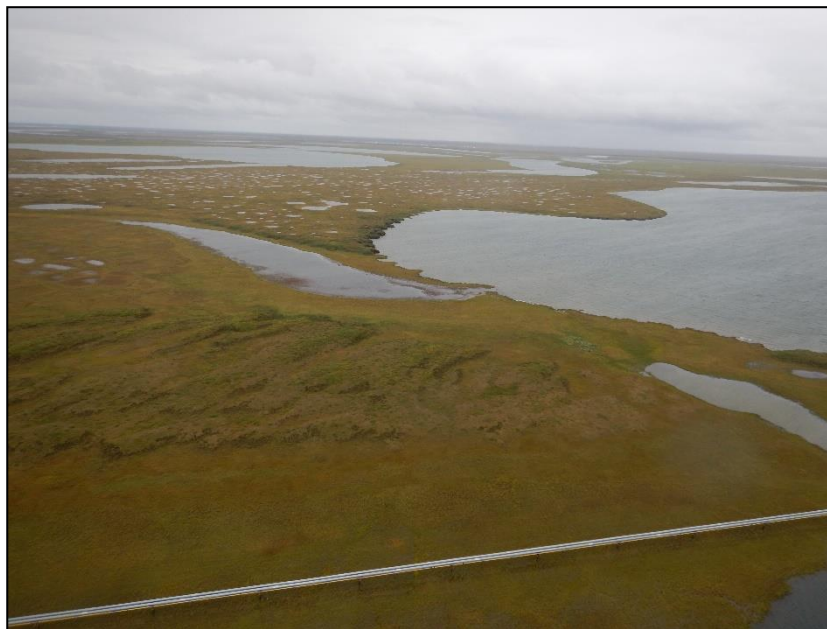
Lake L9327 is located between the Nigliq and Colville East Channels adjacent south to the Alpine Sales pipeline. It can become hydraulically connected to adjacent lakes during flooding. At the time of sampling it was not, based on aerial visual inspection, hydraulically connected to any major streams or distinct water bodies (Photo 6 and Photo 7). No odor or film was observed while sampling the lake.

Photo 6: Lake L9327, looking south past the Alpine Sales pipeline; August 14, 2019

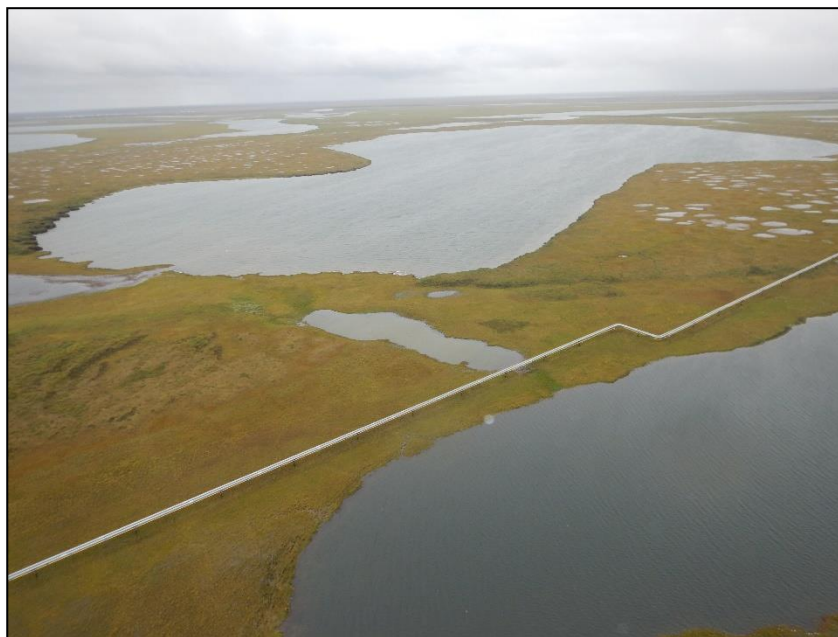
Photo 7: Lake L9327, looking southwest past the Alpine Sales pipeline; August 14, 2019

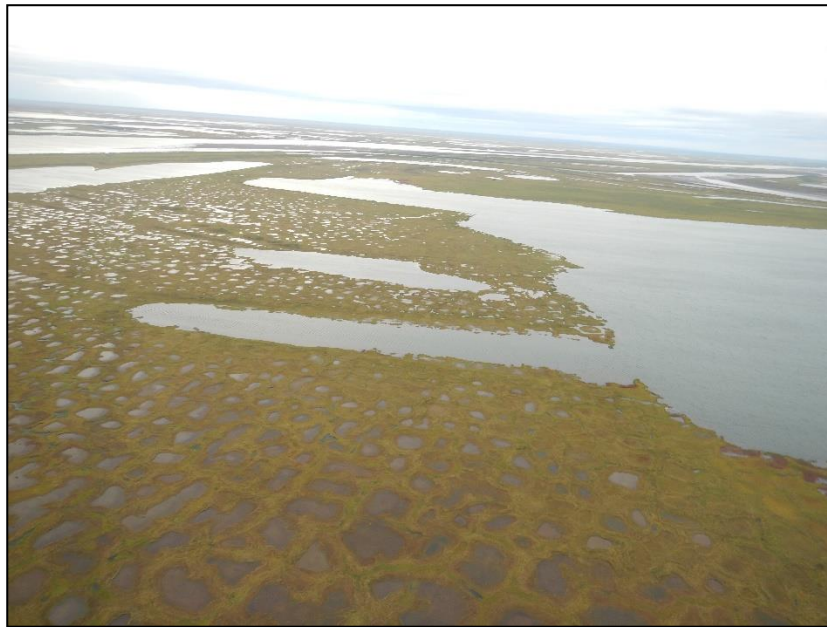
Lake B8530 is located between the Nigliq and Colville East Channels overland to the west of the Colville HDD crossing. It can become hydraulically connected to adjacent lakes during flooding. At the time of sampling it was not, based on aerial visual inspection, hydraulically connected to any major streams or distinct water bodies (Photo 8 and Photo 9). No odor or film was observed while sampling the lake.

Photo 8: Lake B8530, looking southeast toward the Colville East Channel; August 14, 2019
