# REPORT

## Alpine Satellite Development Project Water Quality Monitoring

**PREPARED BY:**  
MICHAEL BAKER INTERNATIONAL  
3900 C STREET SUITE 900  
ANCHORAGE, AK 99503

ConocoPhillips  
Alaska

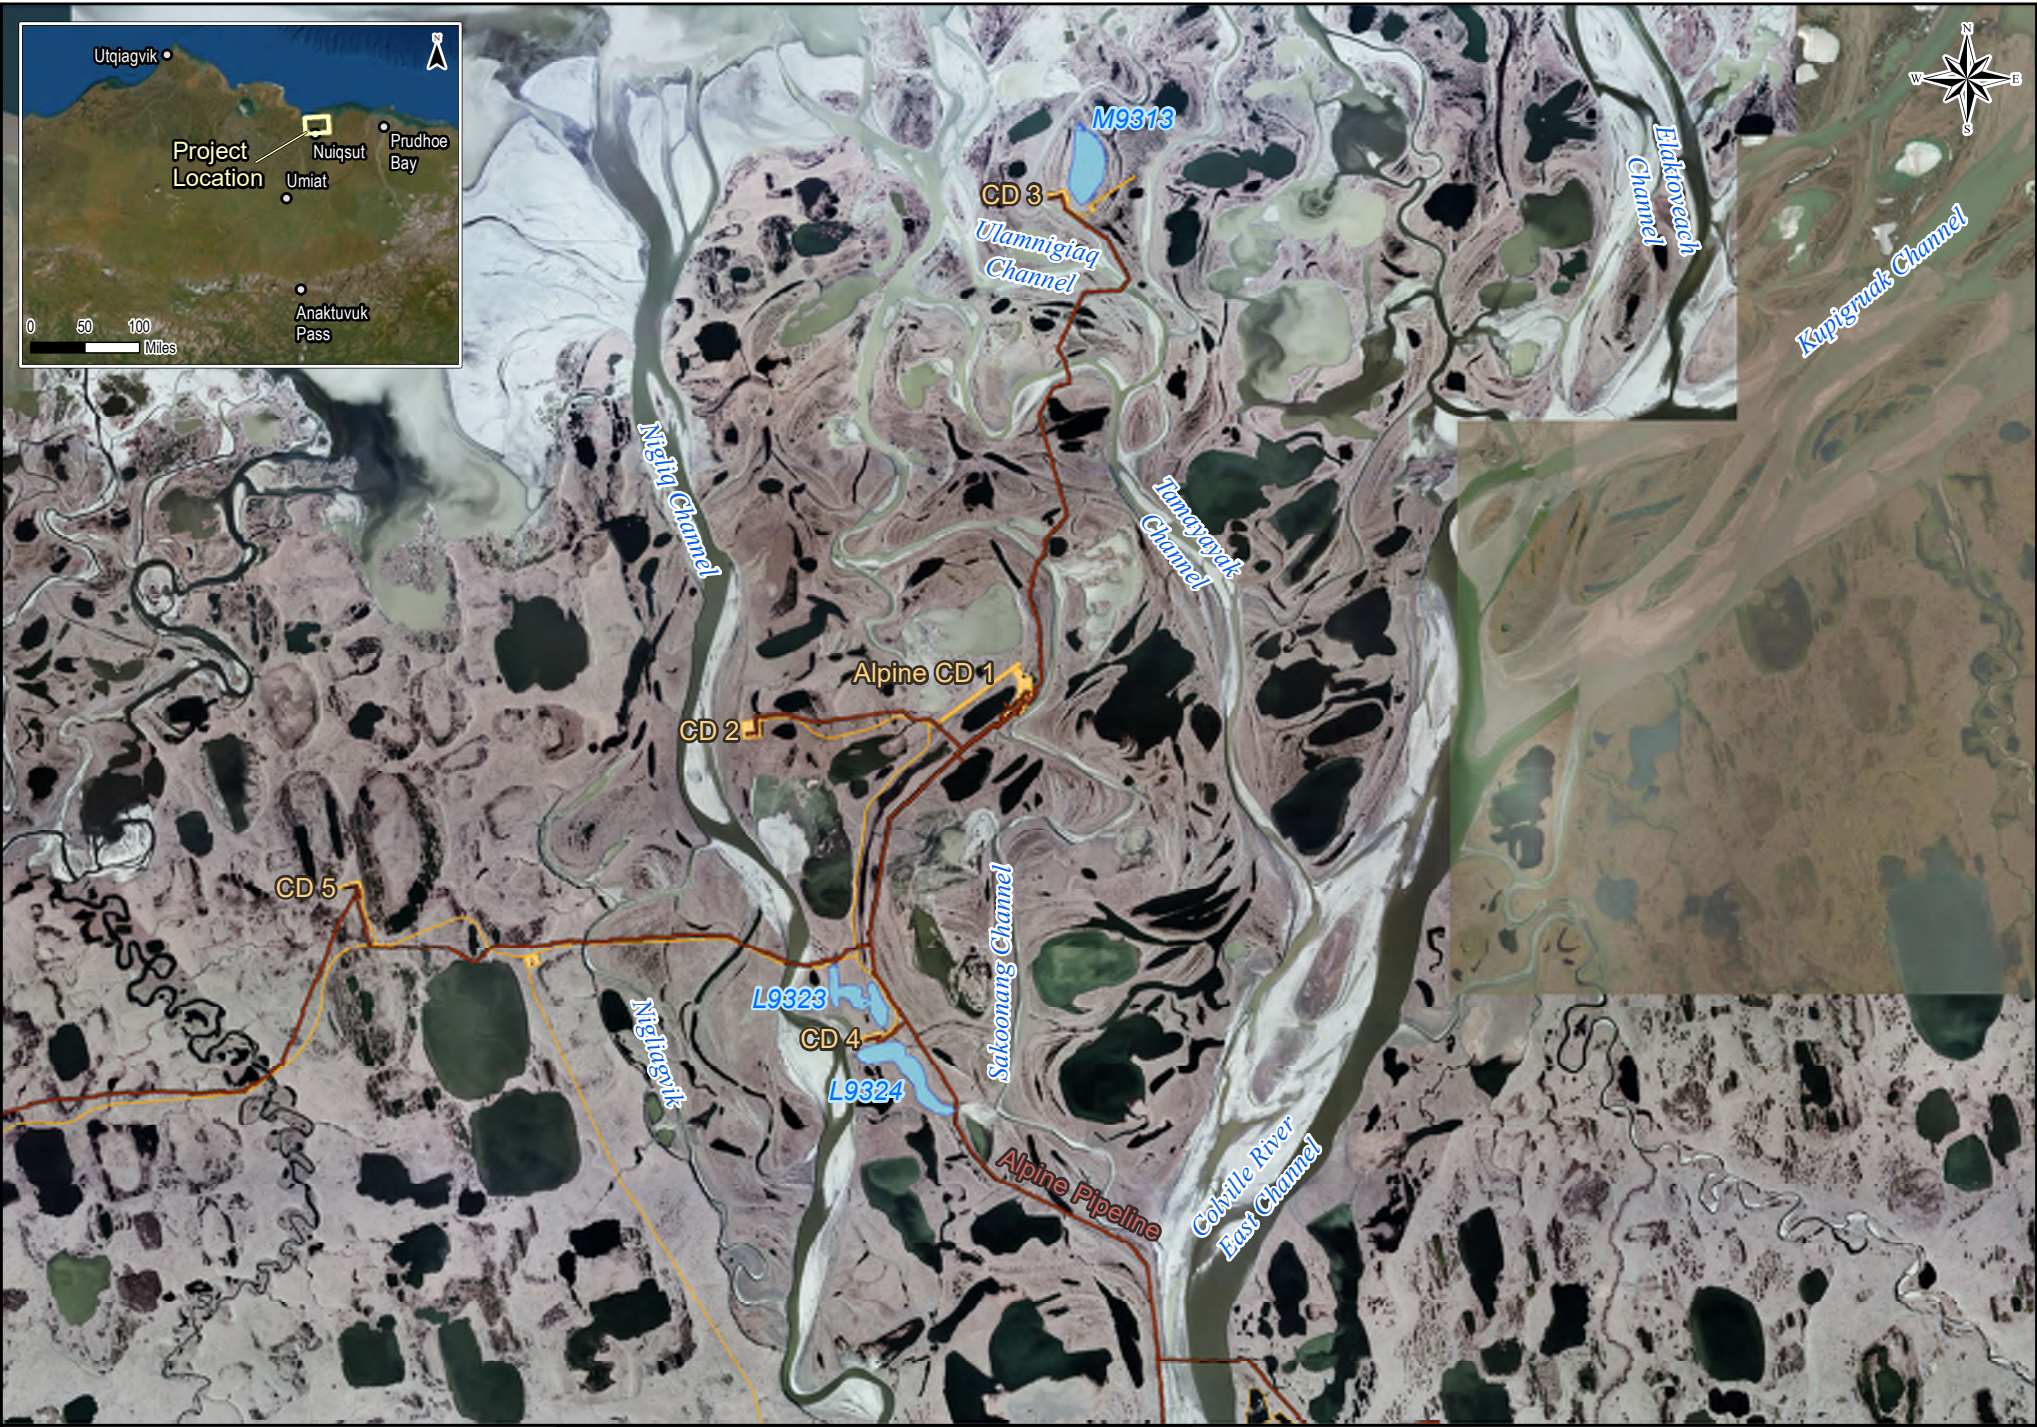
FIGURE 1

2020 ASDP  
 Monitoring Locations  
 Overview Map

The 2020 Alpine Satellite Development Plan (ASDP) Water Quality Monitoring Report presents the results of lake monitoring conducted in September 2020 for ConocoPhillips Alaska, Inc. (COPA). This report includes monitoring results of lakes L9323, L9324, and M9313 which have been monitored annually since 2007. An overview of the study lakes relative to Alpine facilities is presented in Figure 1.

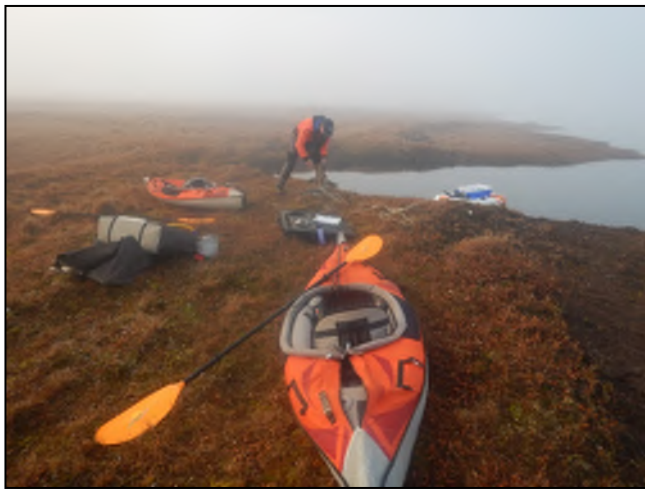
Photo 1: Equipment used to collect water quality data and samples; September 17, 2020

Field investigations were conducted by a two-person team at lakes L9323, L9324, and M9313. Soloy Helicopters, LLC provided helicopter access to Lake M9313. A pickup truck was used to access lakes L9323 and L9324. The team used inflatable kayaks with a tethered support raft for transporting the sampling equipment to the sample locations (Photo 1 and Photo 2).

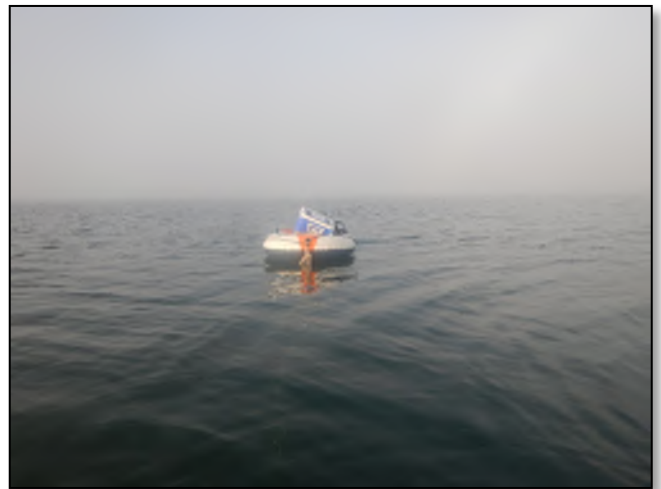
Photo 2: Support raft towing sampling equipment; September 17, 2020

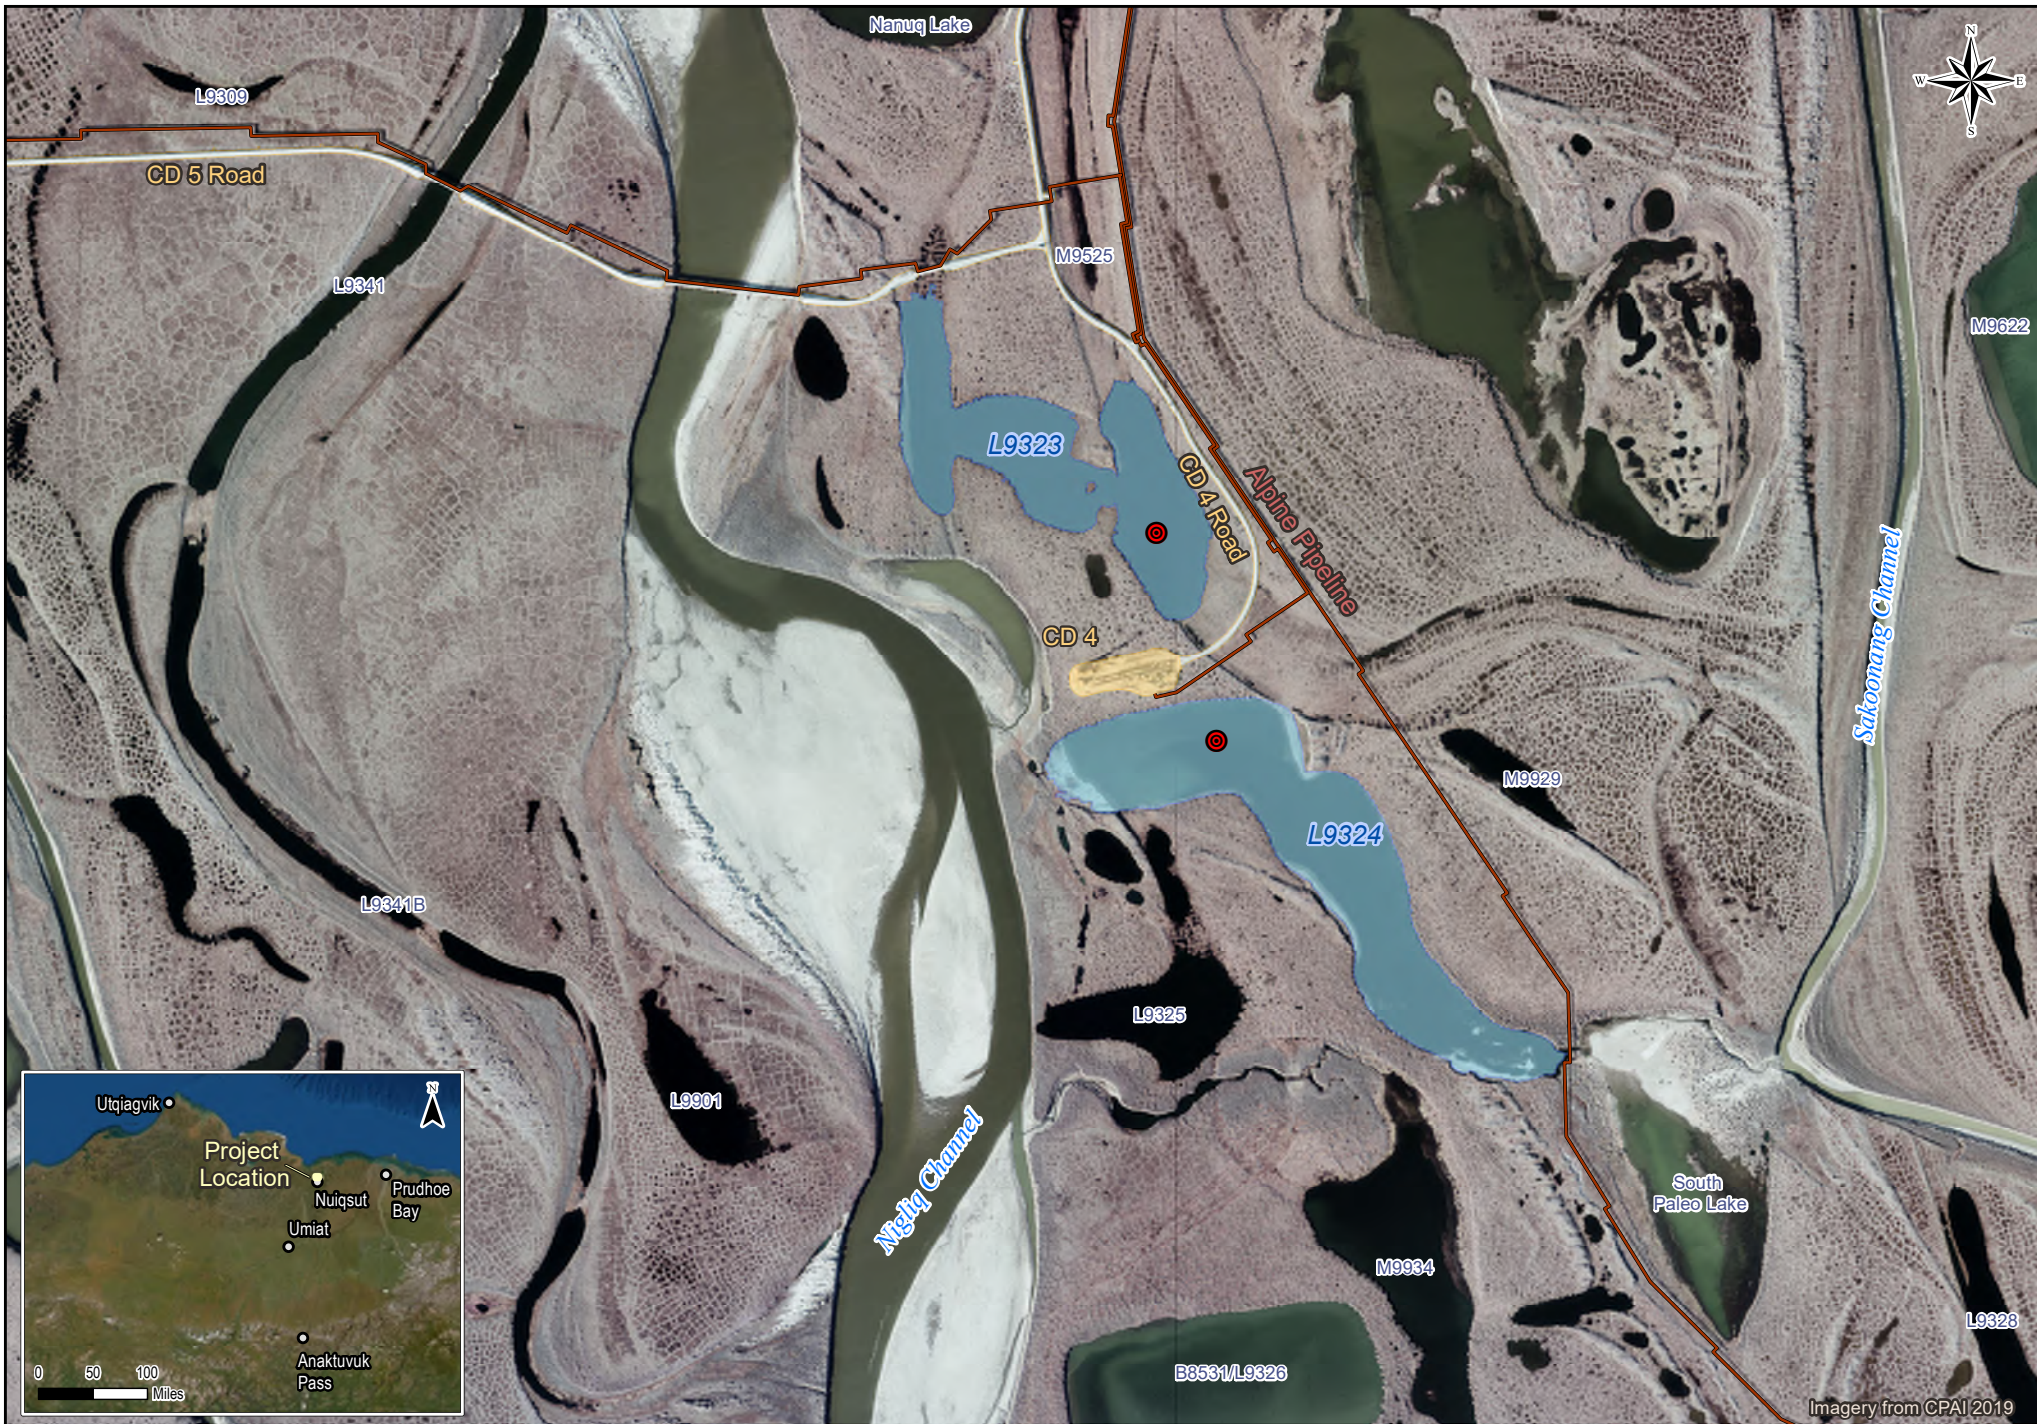
FIGURE 2

2020 ASDP  
Monitoring Locations  
Lake L9323 & L9324

Sampling locations were identified in the field using a handheld global positioning system Garmin Oregon 650t referenced to the World Geodetic System of 1984 coordinate system. The sampling locations for lakes L9323 and L9324 are shown in Figure 2, and Lake M9313 is shown in Figure 3.

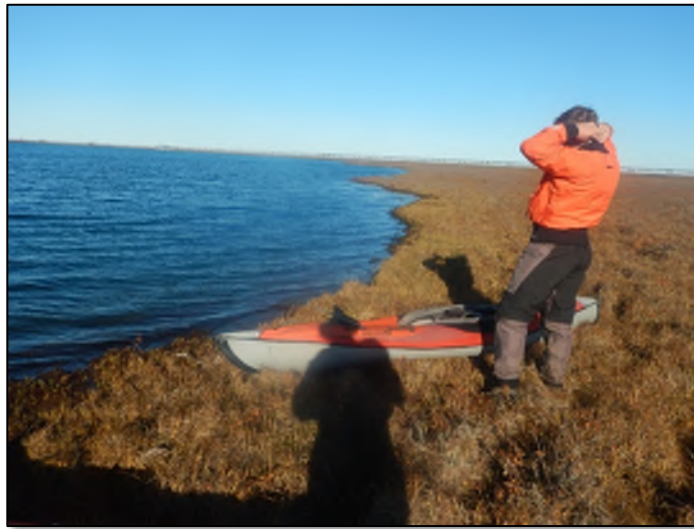
Lake L9323 is located east of the Nigliq Channel. The lake has the CD5 road to the north and the CD4 road to the east. This lake can become hydraulically connected to the Nigliq and/or Sakoonang Channels during flooding, as was the case during the 2020 spring breakup flood (Photo 4). A bridge in the CD5 road allows for the passage of overbank flow out of the lake. At the time of sampling, the lake was not hydraulically connected to adjacent rivers based on aerial visual inspection. No odor or film was observed while sampling the lake (Photo 3).

Photo 3: Preparing for sampling at lake L9323; September 17, 2020

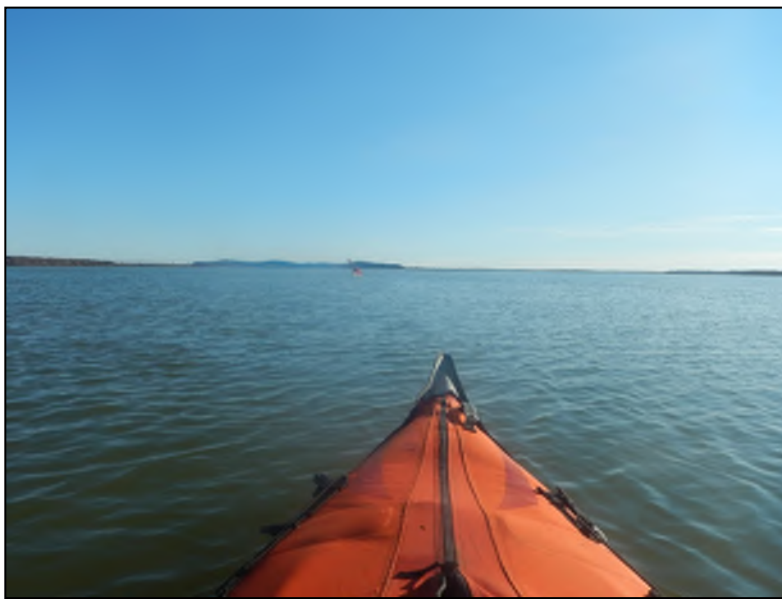
Lake L9324 is located east of the Nigilq Channel. The CD4 pad is to the north of the lake. This lake can become hydraulically connected to the Nigilq and Sakoonang channels during flooding, as was the case during the 2020 spring breakup flood (Photo 6). At the time of sampling, Lake L9324 was hydraulically connected to the Sakoonang Channel to the east via a paleolake. The Alpine Sales pipeline crosses the connection between Lake L9324 and the south paleo lake. No odor or film was observed while sampling the lake (Photo 5).

Photo 5: Kayaking to sample location at Lake L9324; September 17, 2020

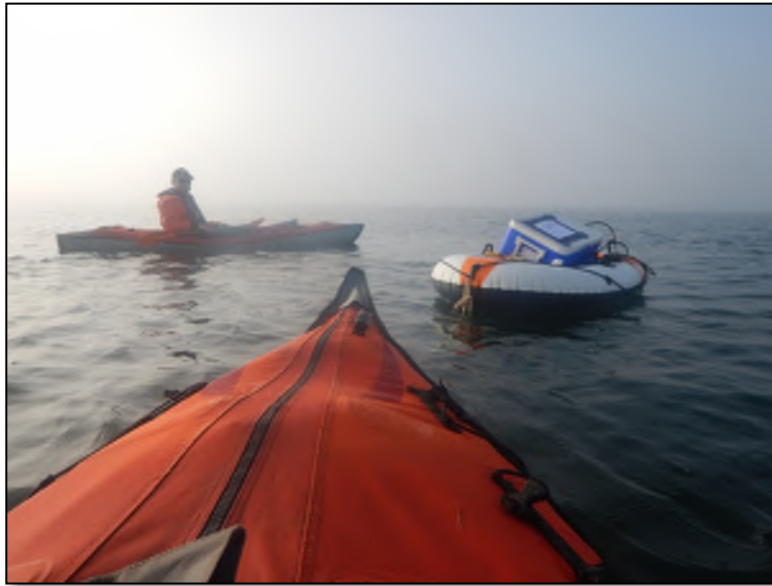
Lake M9313 is located north of the CD3 pad and runway and east of the Ulamnigiq Channel. This lake can become hydraulically connected to the Ulamnigiq Channel during flooding. During the 2020 spring breakup flood, there was no visible evidence that Lake M9313 was hydraulically connected to the Ulamnigiq Channel (Photo 8). At the time of sampling it was not, based on aerial visual inspection, hydraulically connected to any streams or distinct water bodies. No odor or film was observed while sampling the lake (Photo 7).

Photo 7: Crew just after collecting in-situ measurements and samples for laboratory analysis on Lake M9313; September 17, 2020

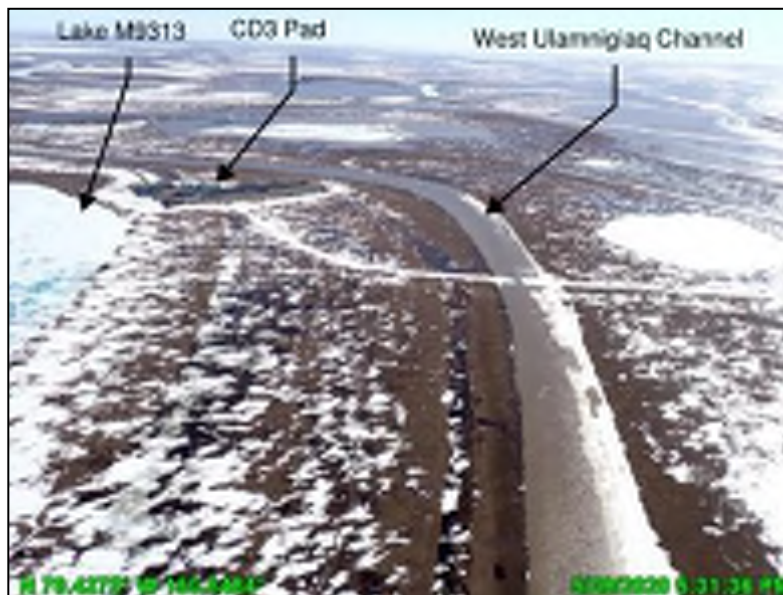
Photo 8: Flow confined within the banks of the West Ulamnigiq Channel next to Lake M9313; looking South; May 29, 2020
