ALPINE PIPELINE RIVER CROSSINGS

MONITORING REPORT

September 2011
123744-MBJ-RPT-001

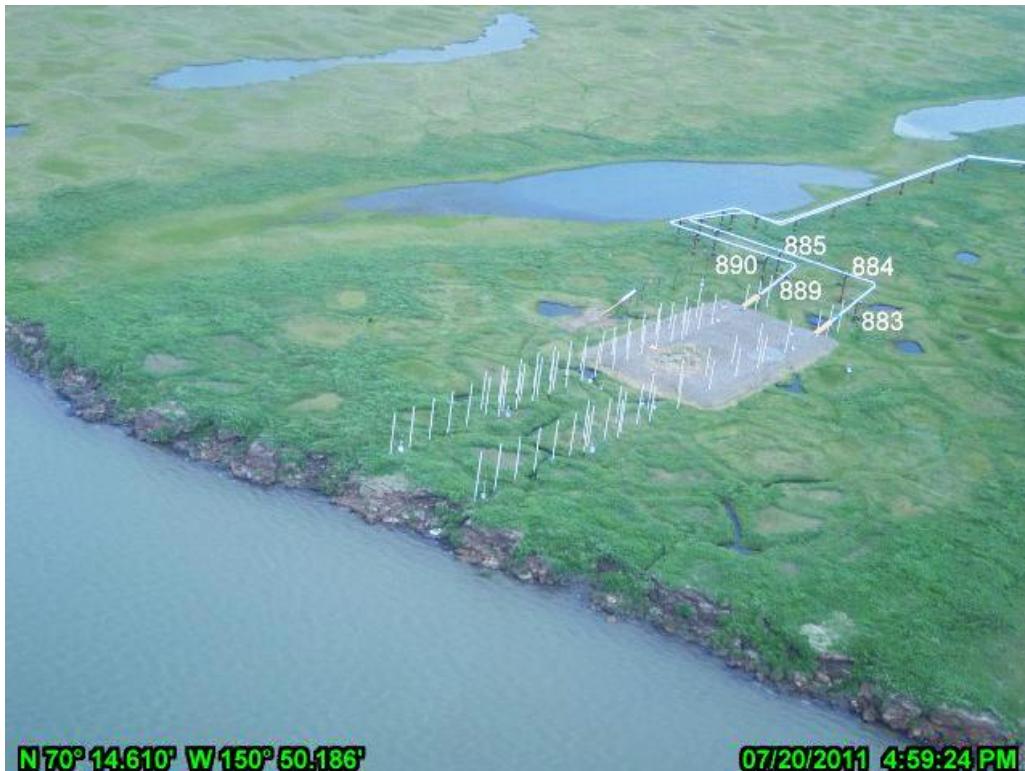
PHOTO A.13 HDD EAST, JULY 20, 2011: AERIAL VIEW OF TROUGH FROM WATER,
LOOKING NORTHEAST

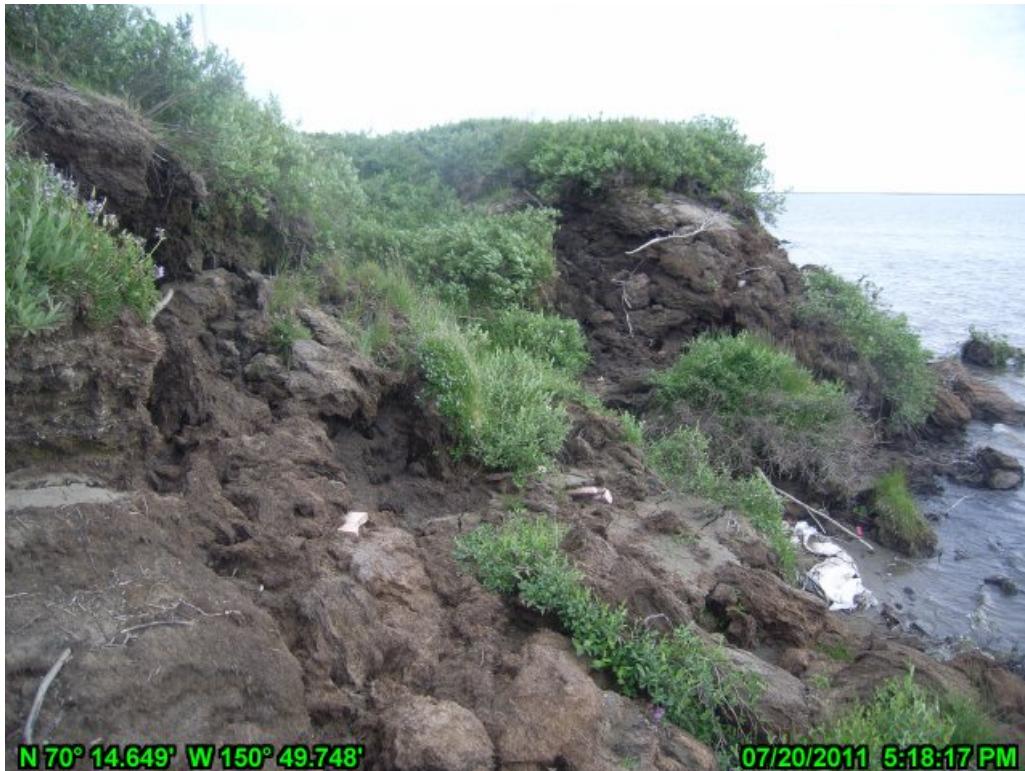
As observed in 2010, some erosion and sloughing has occurred along the east bank, with exposed sandbags and Styrofoam evident. While the date of placement is not known, it is understood by Baker that the sandbags and Styrofoam were installed in the bank to combat further erosion. Site conditions encountered during the 2011 field visit were similar to those observed during the 2010 field visit. (Photo A.14 through Photo A.15 in Appendix A).

PHOTO A.14 HDD EAST, JULY 20, 2011: TROUGH FROM TOE OF BANK, LOOKING
SOUTHEAST

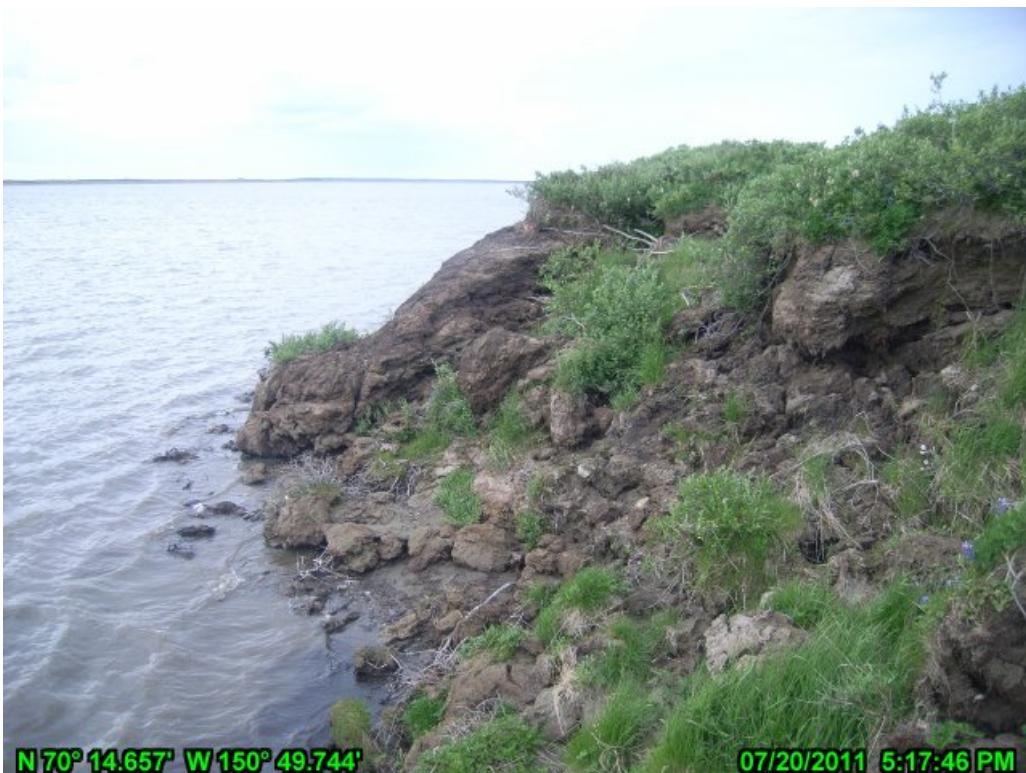
PHOTO A.15 HDD EAST, JULY 20, 2011: EAST BANK, LOOKING NORTH

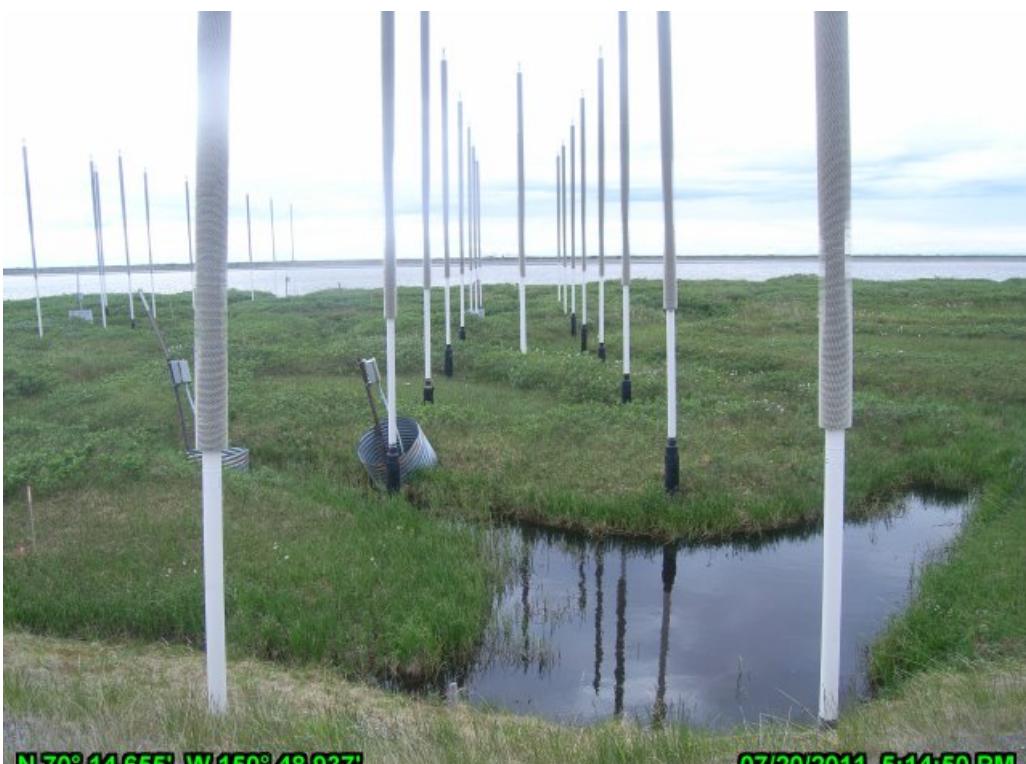
PHOTO A.16 HDD EAST, JULY 20, 2011: LOOKING WEST THROUGH THERMOSIPHONS WITH TROUGH IN FOREGROUND
