**GEOMORPHOLOGY AND HYDROLOGY OF THE
COLVILLE RIVER DELTA, ALASKA, 1993**

Second Annual Report

PART I. SPRING BREAKUP OBSERVATIONS AT CROSS SECTION 6

PART II. FLOOD DISTRIBUTION

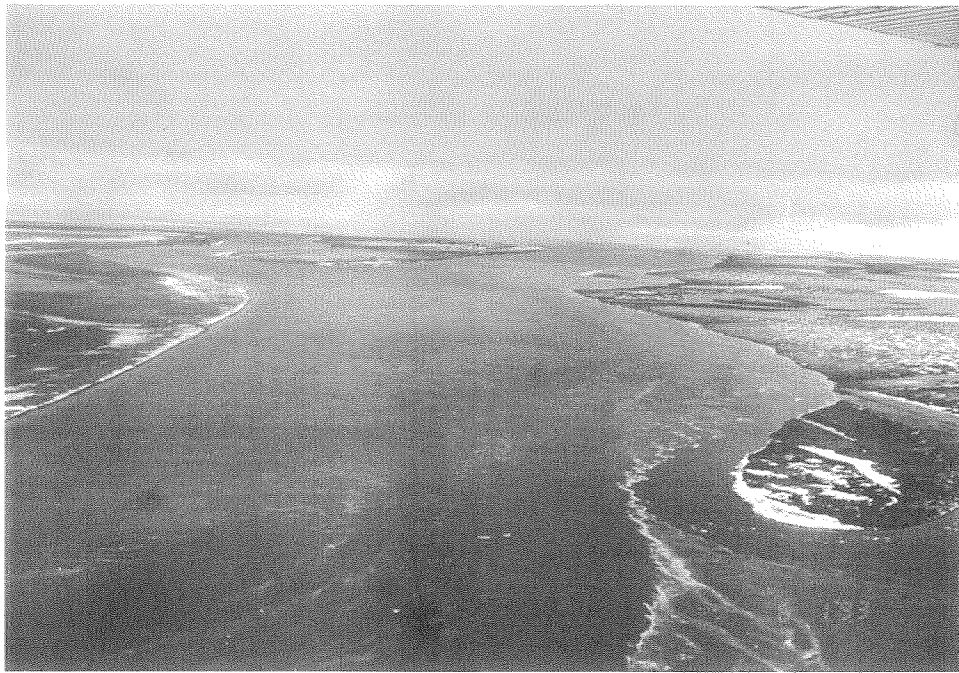
(a) Looking north at Cross Section 6. The river is nearly free of ice floes.

By the morning of 1 June, the ice floes were limited to the low-water channel near the east bank, where the current is the fastest. In mid-afternoon on 1 June, an aerial observation was made of the ice floes between Cross Sections 6 and 1. An aerial view looking north (downstream) at Cross Section 6 shows that the channel is nearly free of ice by this time (Figure 5a).

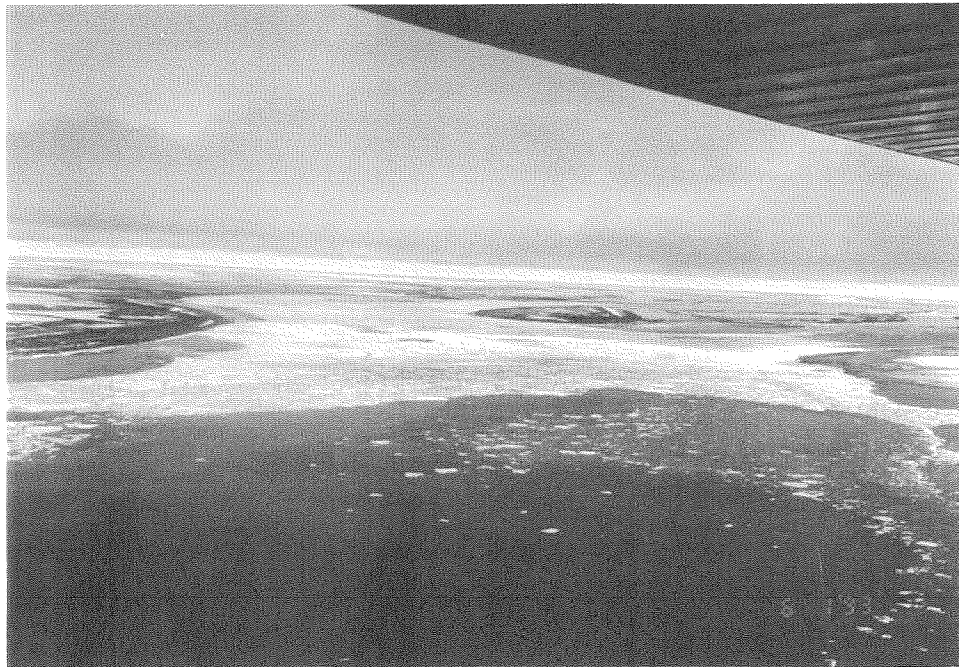
(b) Looking north toward Cross Section 1. The river is choked with ice.

At the time of the aerial observation on 1 June, the river was choked with ice in the vicinity of Cross Section 1 (Figure 5b), and water was flowing into distributaries on either side of the main channel. There did not appear to be a large drop in the water-surface elevation from the upstream side to the downstream side of the ice-choked reach. Thus, we assumed that backwater from this ice-choked reach

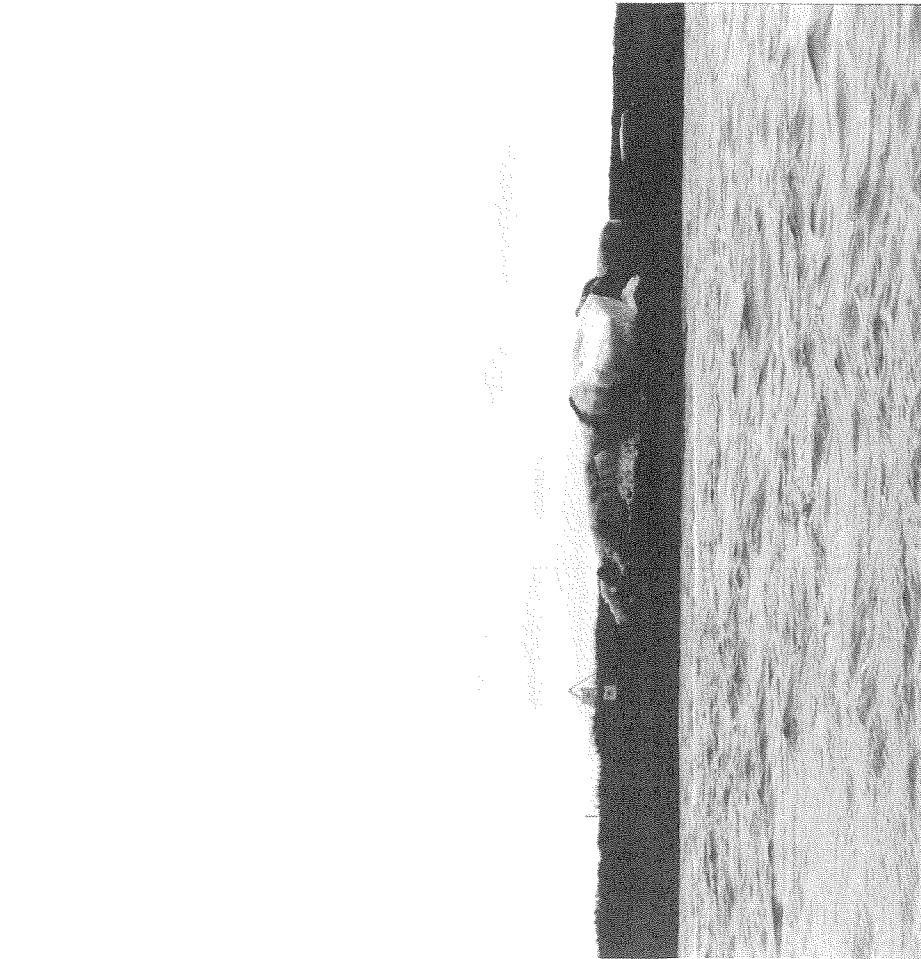
(a) A large rafted ice floe near Cross Section 6

On 4 June, the size of ice floes that had rafted on the east bank between Cross Section 6 and the Itkillik River were measured. Only floes greater than 2 ft thick and 5 ft across were recorded. The floes ranged in size from 7.5 to 13.5 ft wide, 12 to 26 ft long, and 2.5 to 5.5 ft thick. The floes were stacked 2 and 3 layers high in places. An example of one of the larger rafted floes is shown in Figure 6a.

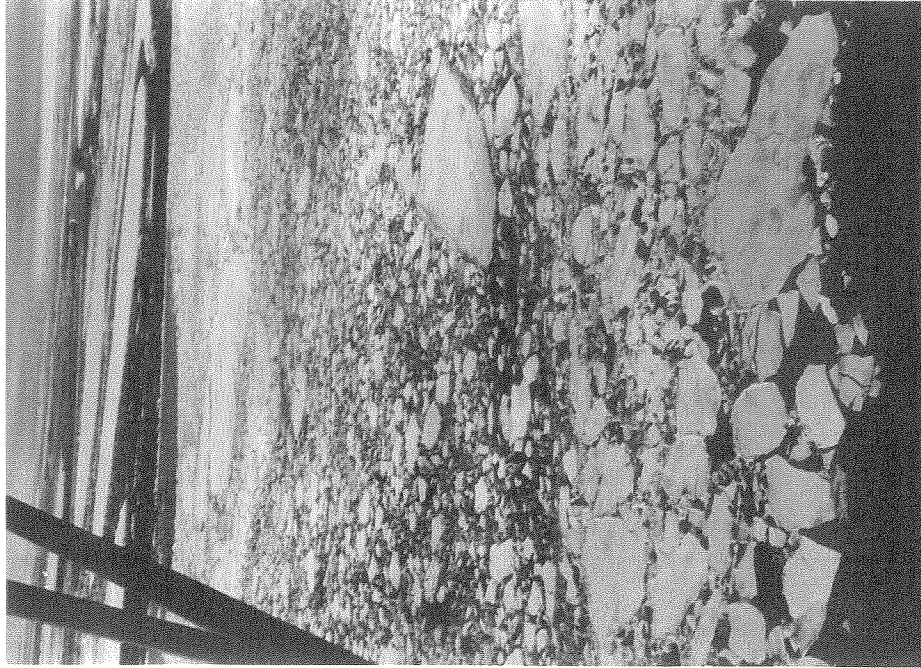
(b) Large ice floes near Cross Section 1

It is likely that the largest floes were not rafted, or that the larger floes may have broken when they were rafted. Larger floes were observed during breakup at Cross Section 6 and from the air at Cross Section 1 (Figure 6b). The largest floes at Cross Section 1 were estimated to be 80 to 118 ft wide, and 129 to 150 ft long.

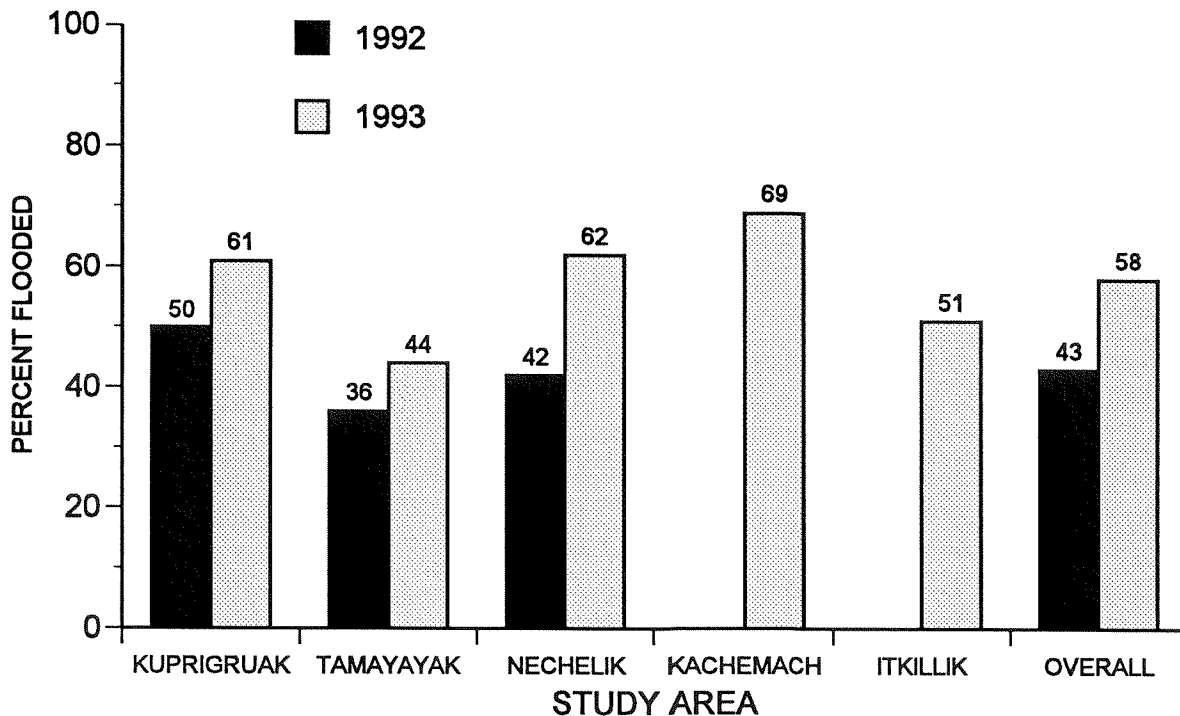
Figure 11. Percentage of total area covered by flood water in five study areas in the Colville River Delta, 1992-1993.

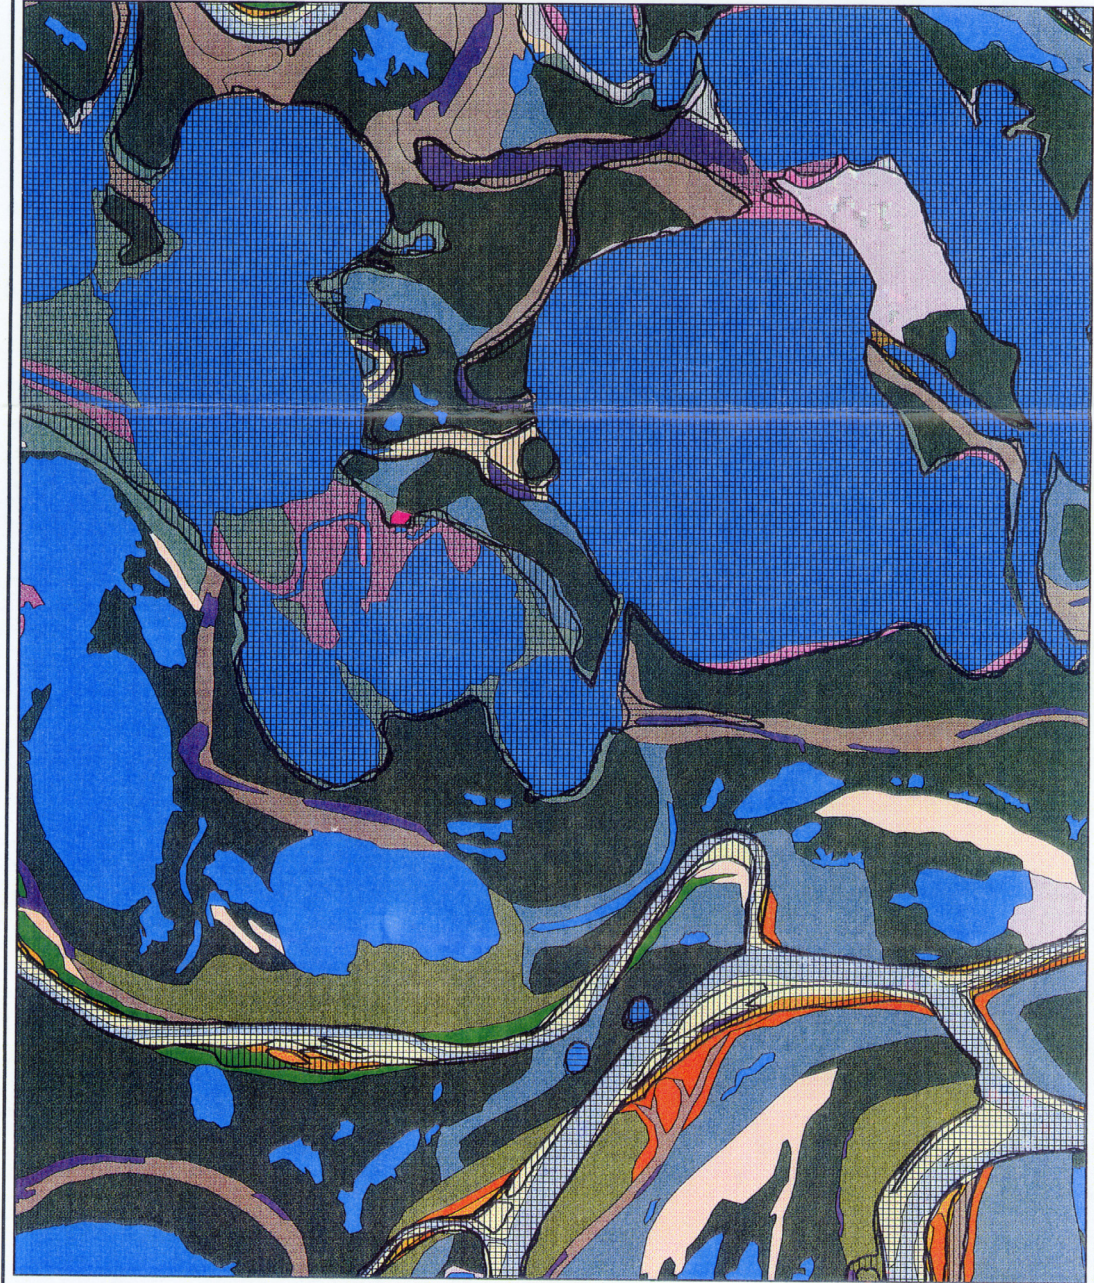
Date: 21 Sept 1993 AGIS File: KUPIFL93.MAP

INTEGRATED TERRAIN UNITS

- Sand Dune/Vegetated
- Riverbed/Sandbar
- Riverbed/Nonpatterned/Partially Vegetated
- Riverbed/Nonpatterned/Riparian Low, Tall Shrub
- High-water Channel/Nonpatterned/Partially Vegetated
- High-water Channel/Nonpatterned/Wet Meadow
- High-water Channel/Nonpatterned/Salt-killed Meadow
- Cover Alluvium/Nonpatterned/Wet Meadow
- Cover Alluvium/Disjunct Polygons/Wet Meadow
- Cover Alluvium/L.C.P., Low Density/Wet Meadow
- Cover Alluvium/L.C.P., Low Density/Salt-killed Meadow
- Cover Alluvium/L.C.P., High Density/Wet Meadow
- Thaw Lake Deposit/Nonpatterned/Barren
- Thaw Lake Deposit/Nonpatterned/Partially Vegetated
- Thaw Lake Deposit/Nonpatterned/Wet Meadow
- Thaw Lake Deposit/Nonpatterned/Salt Marsh
- Thaw Lake Deposit/Pingo/Upland Dwarf Shrub
- River or Stream Channel
- Channel Lake
- Thaw Lake, Pond

FLOODED AREAS

- 1 JUNE 1993
- 8 JUNE 1992

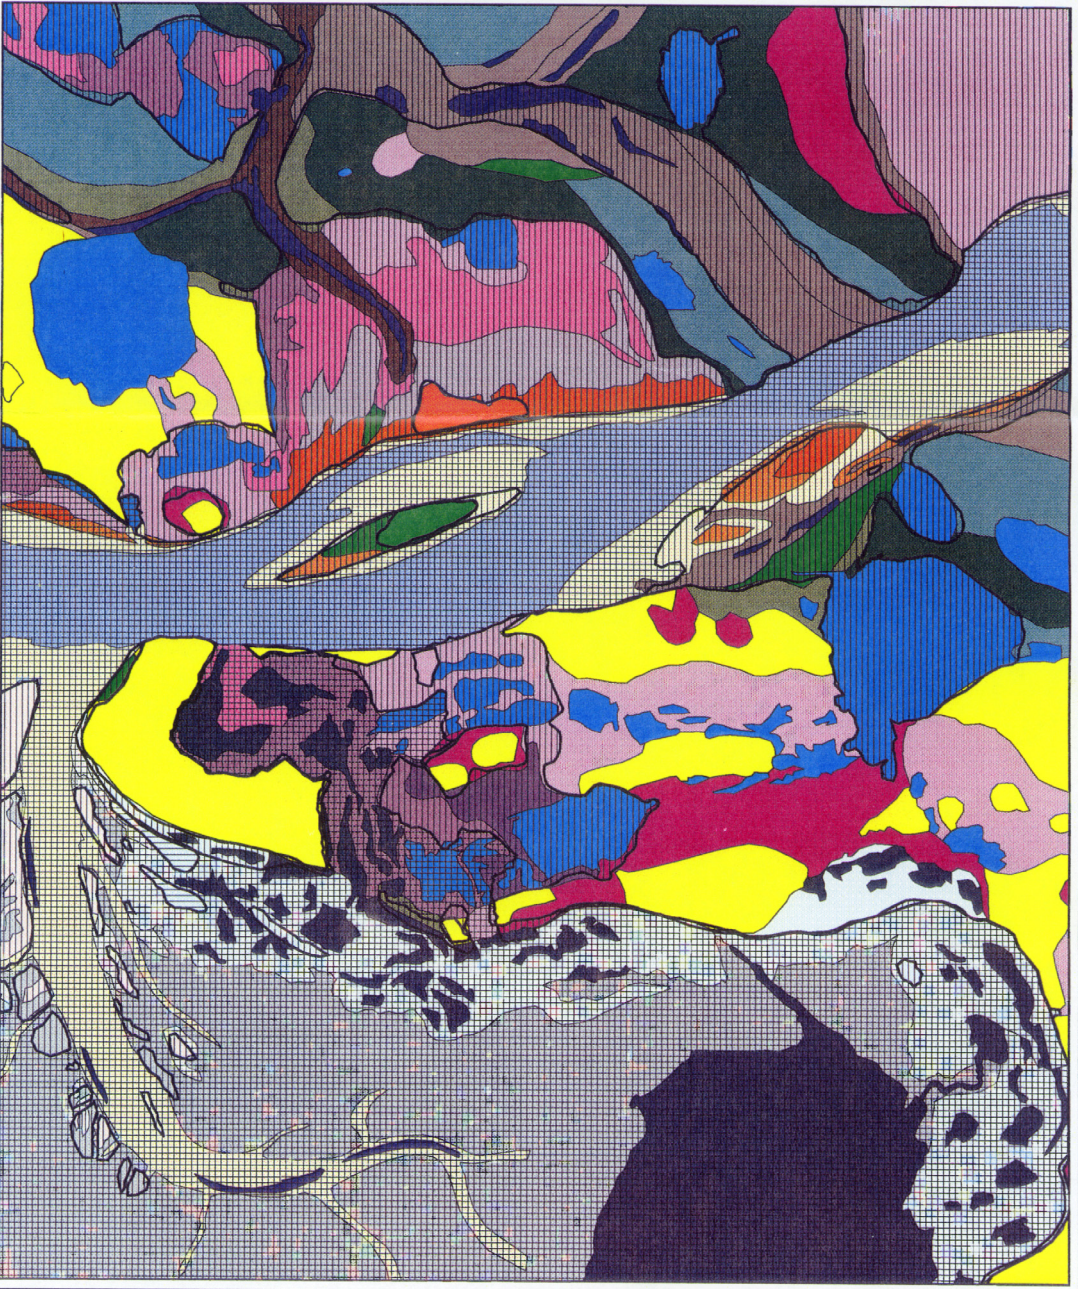
Date: 22 Sept 1993 AGIS File: TAMFLD93.MAP

INTEGRATED TERRAIN UNITS

- Loess/All Other Subunits Grouped
- Riverbed/Sandbar
- Riverbed/Nonpatterned/Partially Vegetated
- Riverbed/Nonpatterned/Riparian Low, Tall Shrub
- High-water Channel/Nonpatterned/Wet Meadow
- High-water Channel/Nonpatterned/Salt Marsh
- Cover Alluvium/Nonpatterned/Wet Meadow
- Cover Alluvium/Disjunct Polygons/Wet Meadow
- Cover Alluvium/L.C.P., Low Density/Wet Meadow
- Cover Alluvium/L.C.P., High Density/Wet Meadow
- Thaw Lake Deposit/Nonpatterned/Barren
- Thaw Lake Deposit/Nonpatterned/Partially Vegetated
- Thaw Lake Deposit/Nonpatterned/Wet Meadow
- Thaw Lake Deposit/Nonpatterned/Salt Marsh
- Thaw Lake Deposit/Disjunct Polygons/Salt-killed Meadow
- Thaw Lake Deposit/L.C.P., Low Density/Wet Meadow
- Tidal Flat/Barren
- Tidal Flat/Partially Vegetated
- Tidal Flat/Salt Marsh
- River or Stream Channel
- Channel Lake
- Thaw Lake, Pond
- Nearshore Water, Brackish Pond Grouped

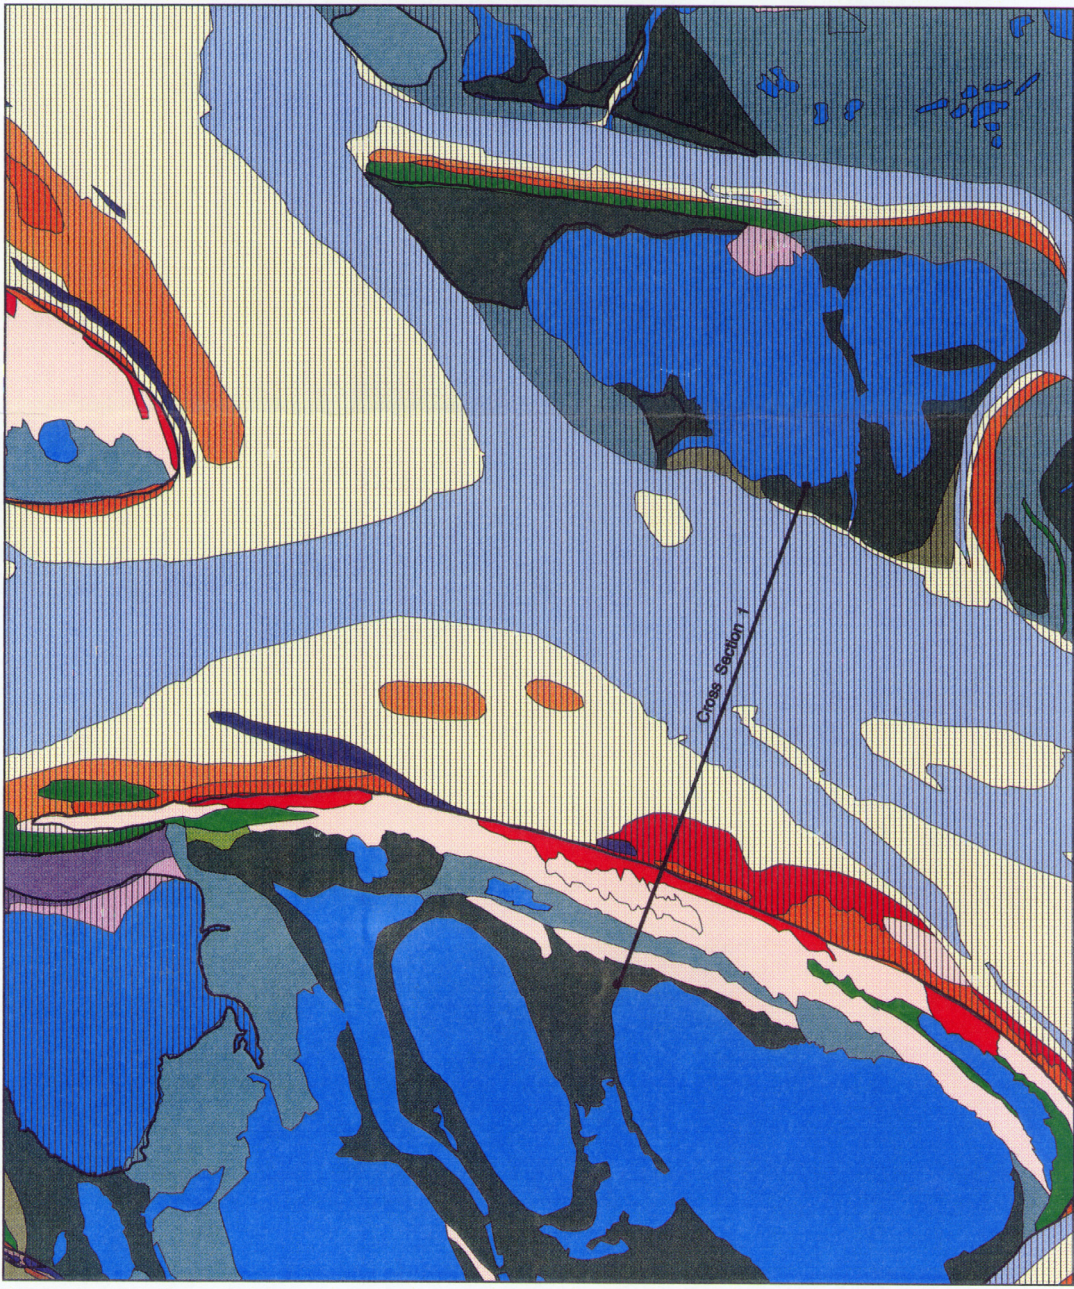
ARCO Alaska, Inc.
COLVILLE GEOMORPHOLOGY AND HYDROLOGY
Fig. 16: Flood Distribution in Kachemach Study Area, Colville River Delta, 1993
Alaska Biological Research, Inc.
Date: 22 Sept 1993 AGIS File: KACHFL93.MAP

- Sand Dune/Partially Vegetated
- Sand Dune/Vegetated
- Riverbed/Sandbar
- Riverbed/Nonpatterned/Partially Vegetated
- Riverbed/Nonpatterned/Riparian Low, Tall Shrub
- High-water Channel/Nonpatterned/Wet Meadow
- High-water Channel/Nonpatterned/Riparian Low, Tall Shrub
- Cover Alluvium/Nonpatterned/Wet Meadow
- Cover Alluvium/Disjunct Polygons/Wet Meadow
- Cover Alluvium/L.C.P., Low Density/Wet Meadow
- Cover Alluvium/L.C.P., High Density/Wet Meadow
- Cover Alluvium/L.C.P., High Density/Riparian Low, Tall Shrub
- Thaw Lake Deposit/Nonpatterned/Wet Meadow
- Thaw Lake Deposit/Nonpatterned/Low, Tall Shrub
- River or Stream Channel
- Channel Lake
- Thaw Lake, Pond

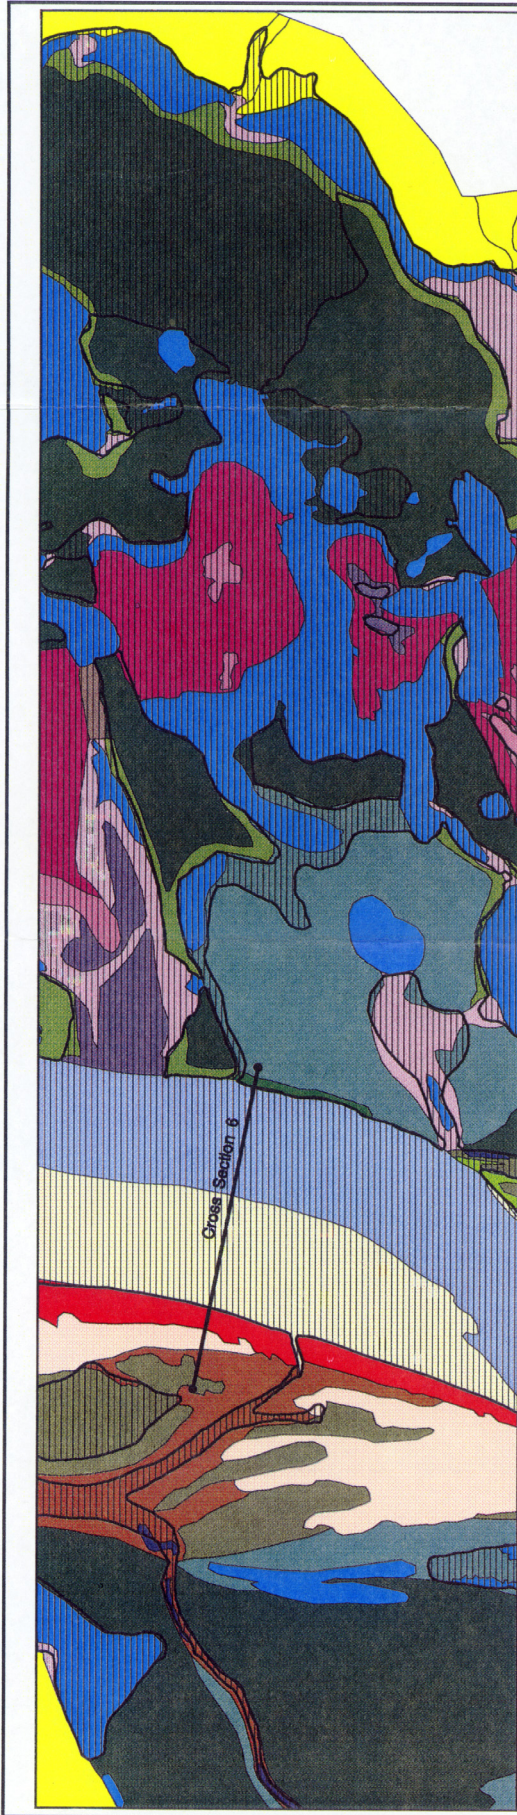
Map based on 1:18000 CIR photography, 8 July 1982
 Map Projection: UTM-5, NAD27

FLOODED AREAS
