Colville River Delta 2016 Spring Breakup Field Report

Prepared for ConocoPhillips Alaska, Inc.

June 30, 2016

Michael Baker International
3900 C Street, Anchorage, AK 99503

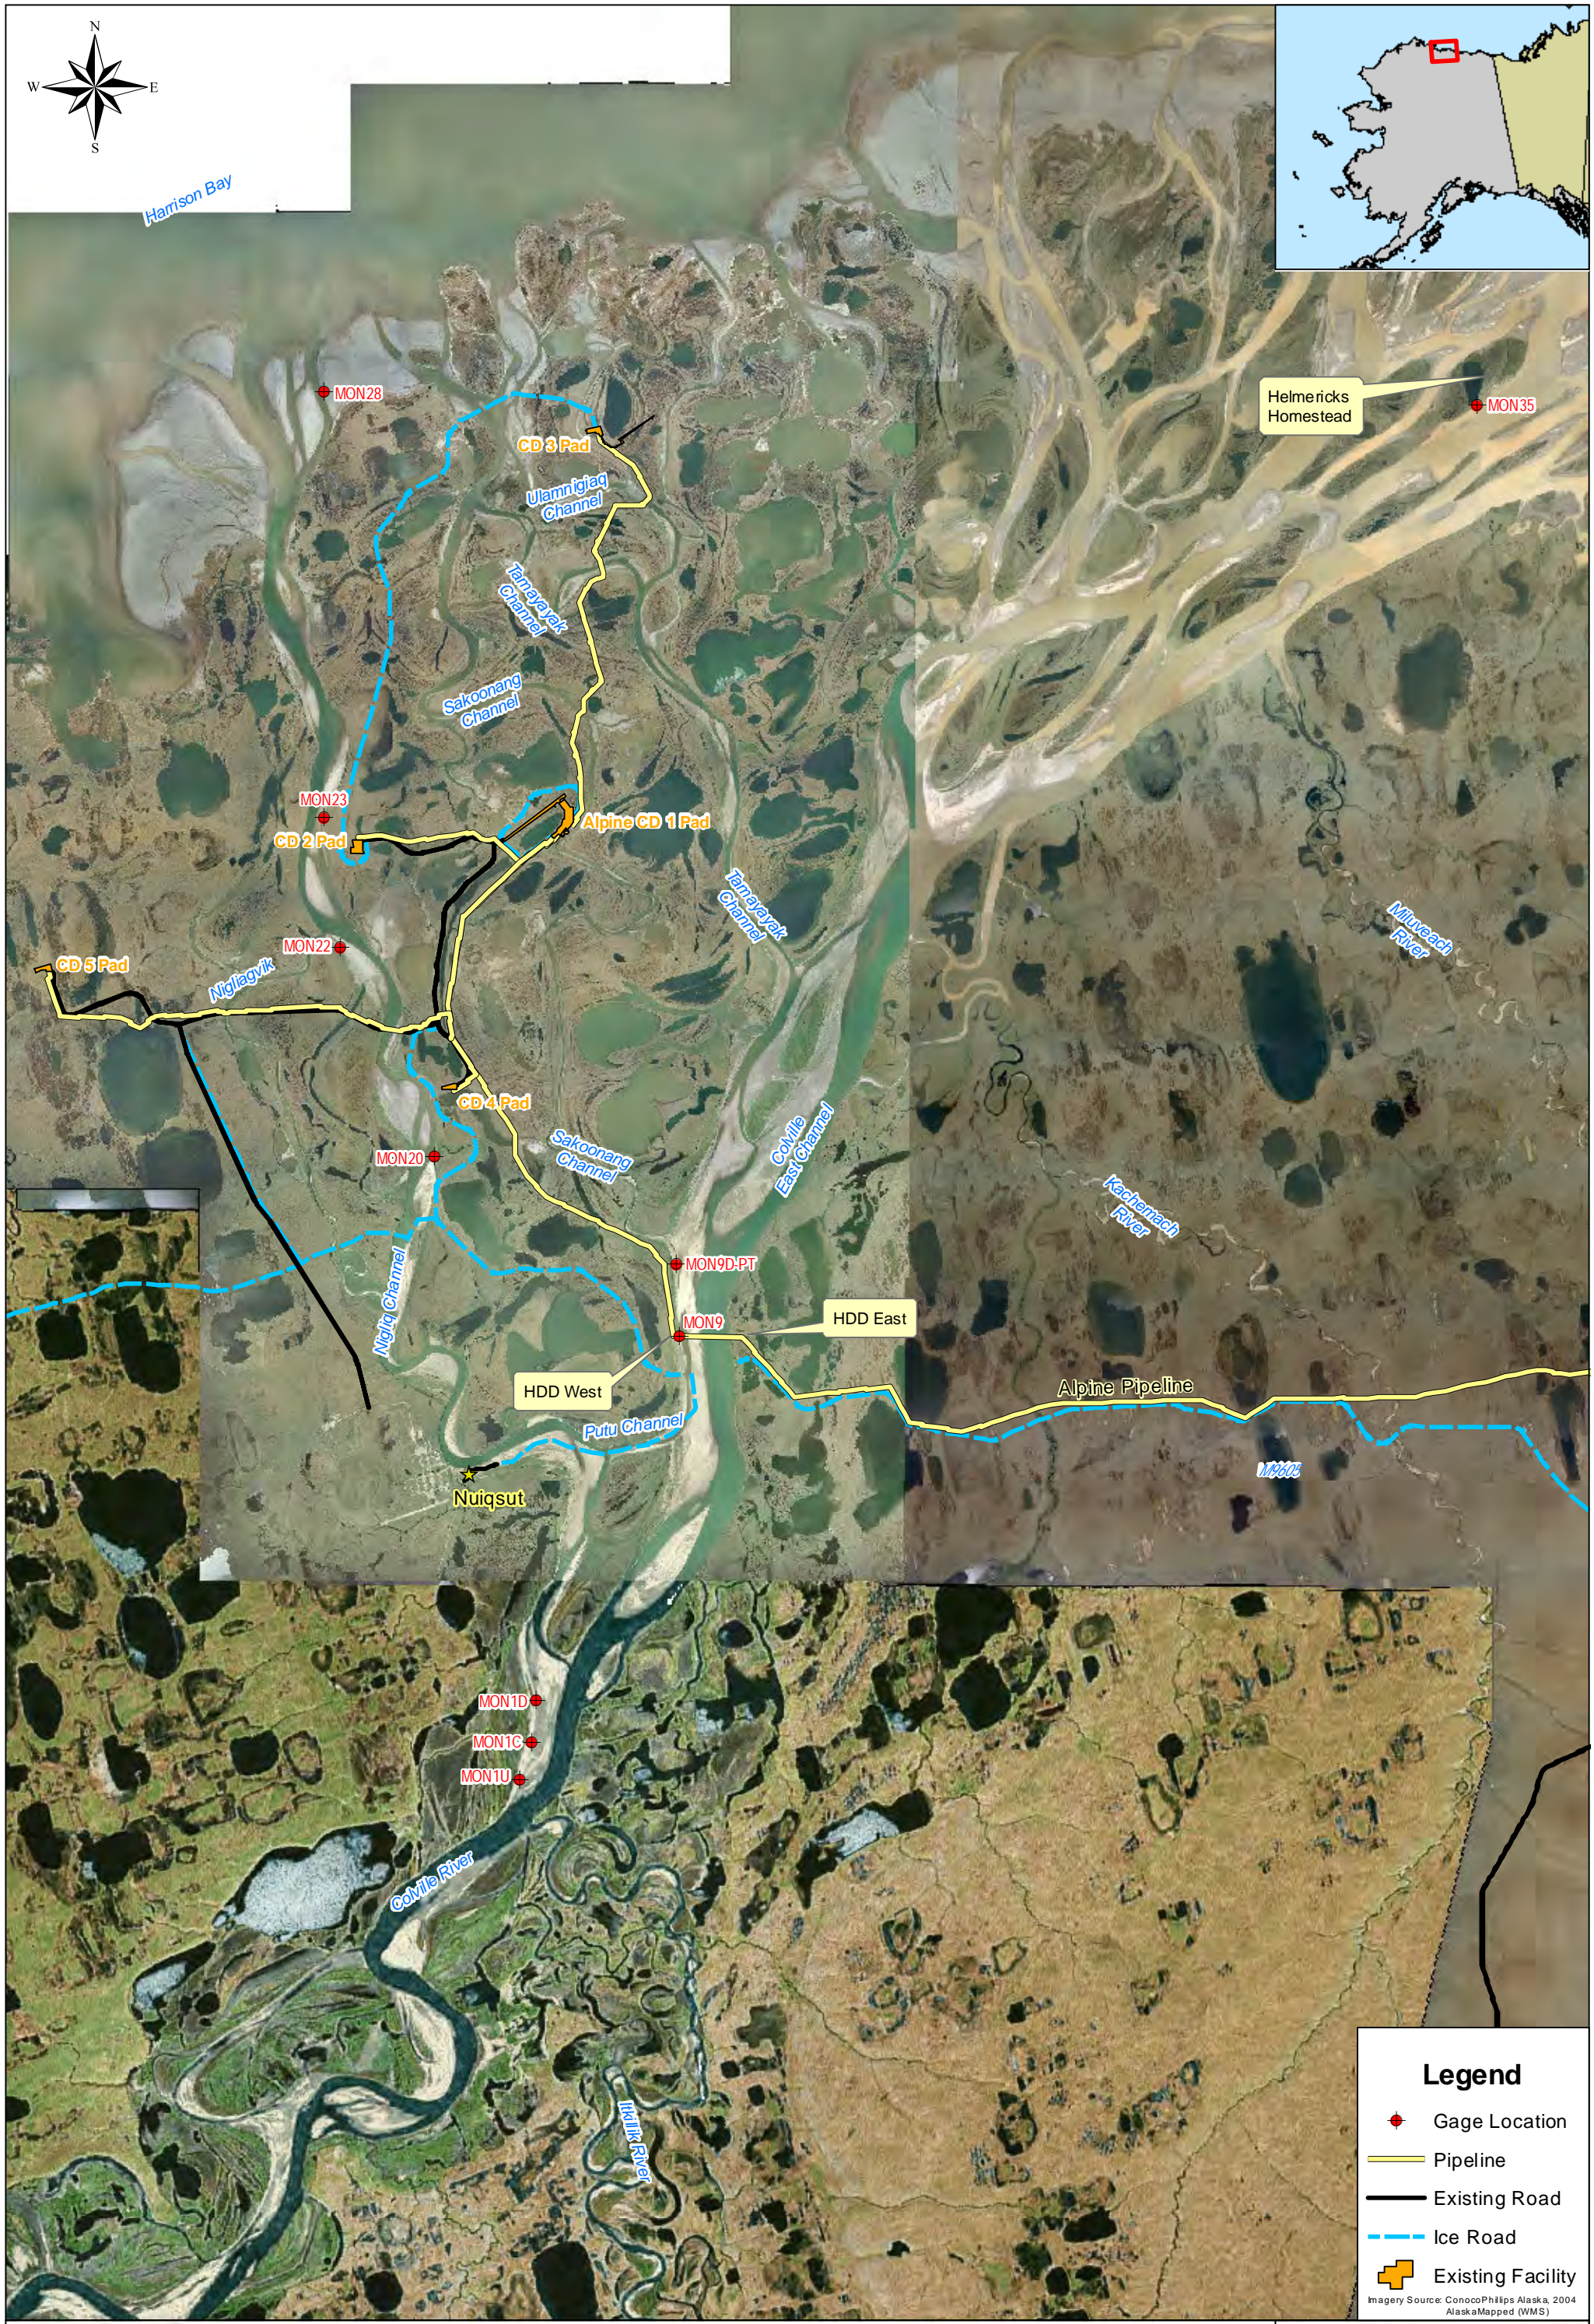
FIGURE: 1

2016 SPRING BREAKUP
COLVILLE RIVER DELTA

Monitoring Locations

The objective of the CRD Spring Breakup Monitoring and Hydrologic Assessment Program is to estimate the magnitude of the 2016 breakup flooding by documenting the distribution of floodwater and measuring water surface elevations (WSE) and flow volume rate (discharge) at preselected locations. Monitoring locations cover the entire delta (Figure 1.1) with a focus around oilfield infrastructure, particularly cross-drainage structures (Figure 1.2).

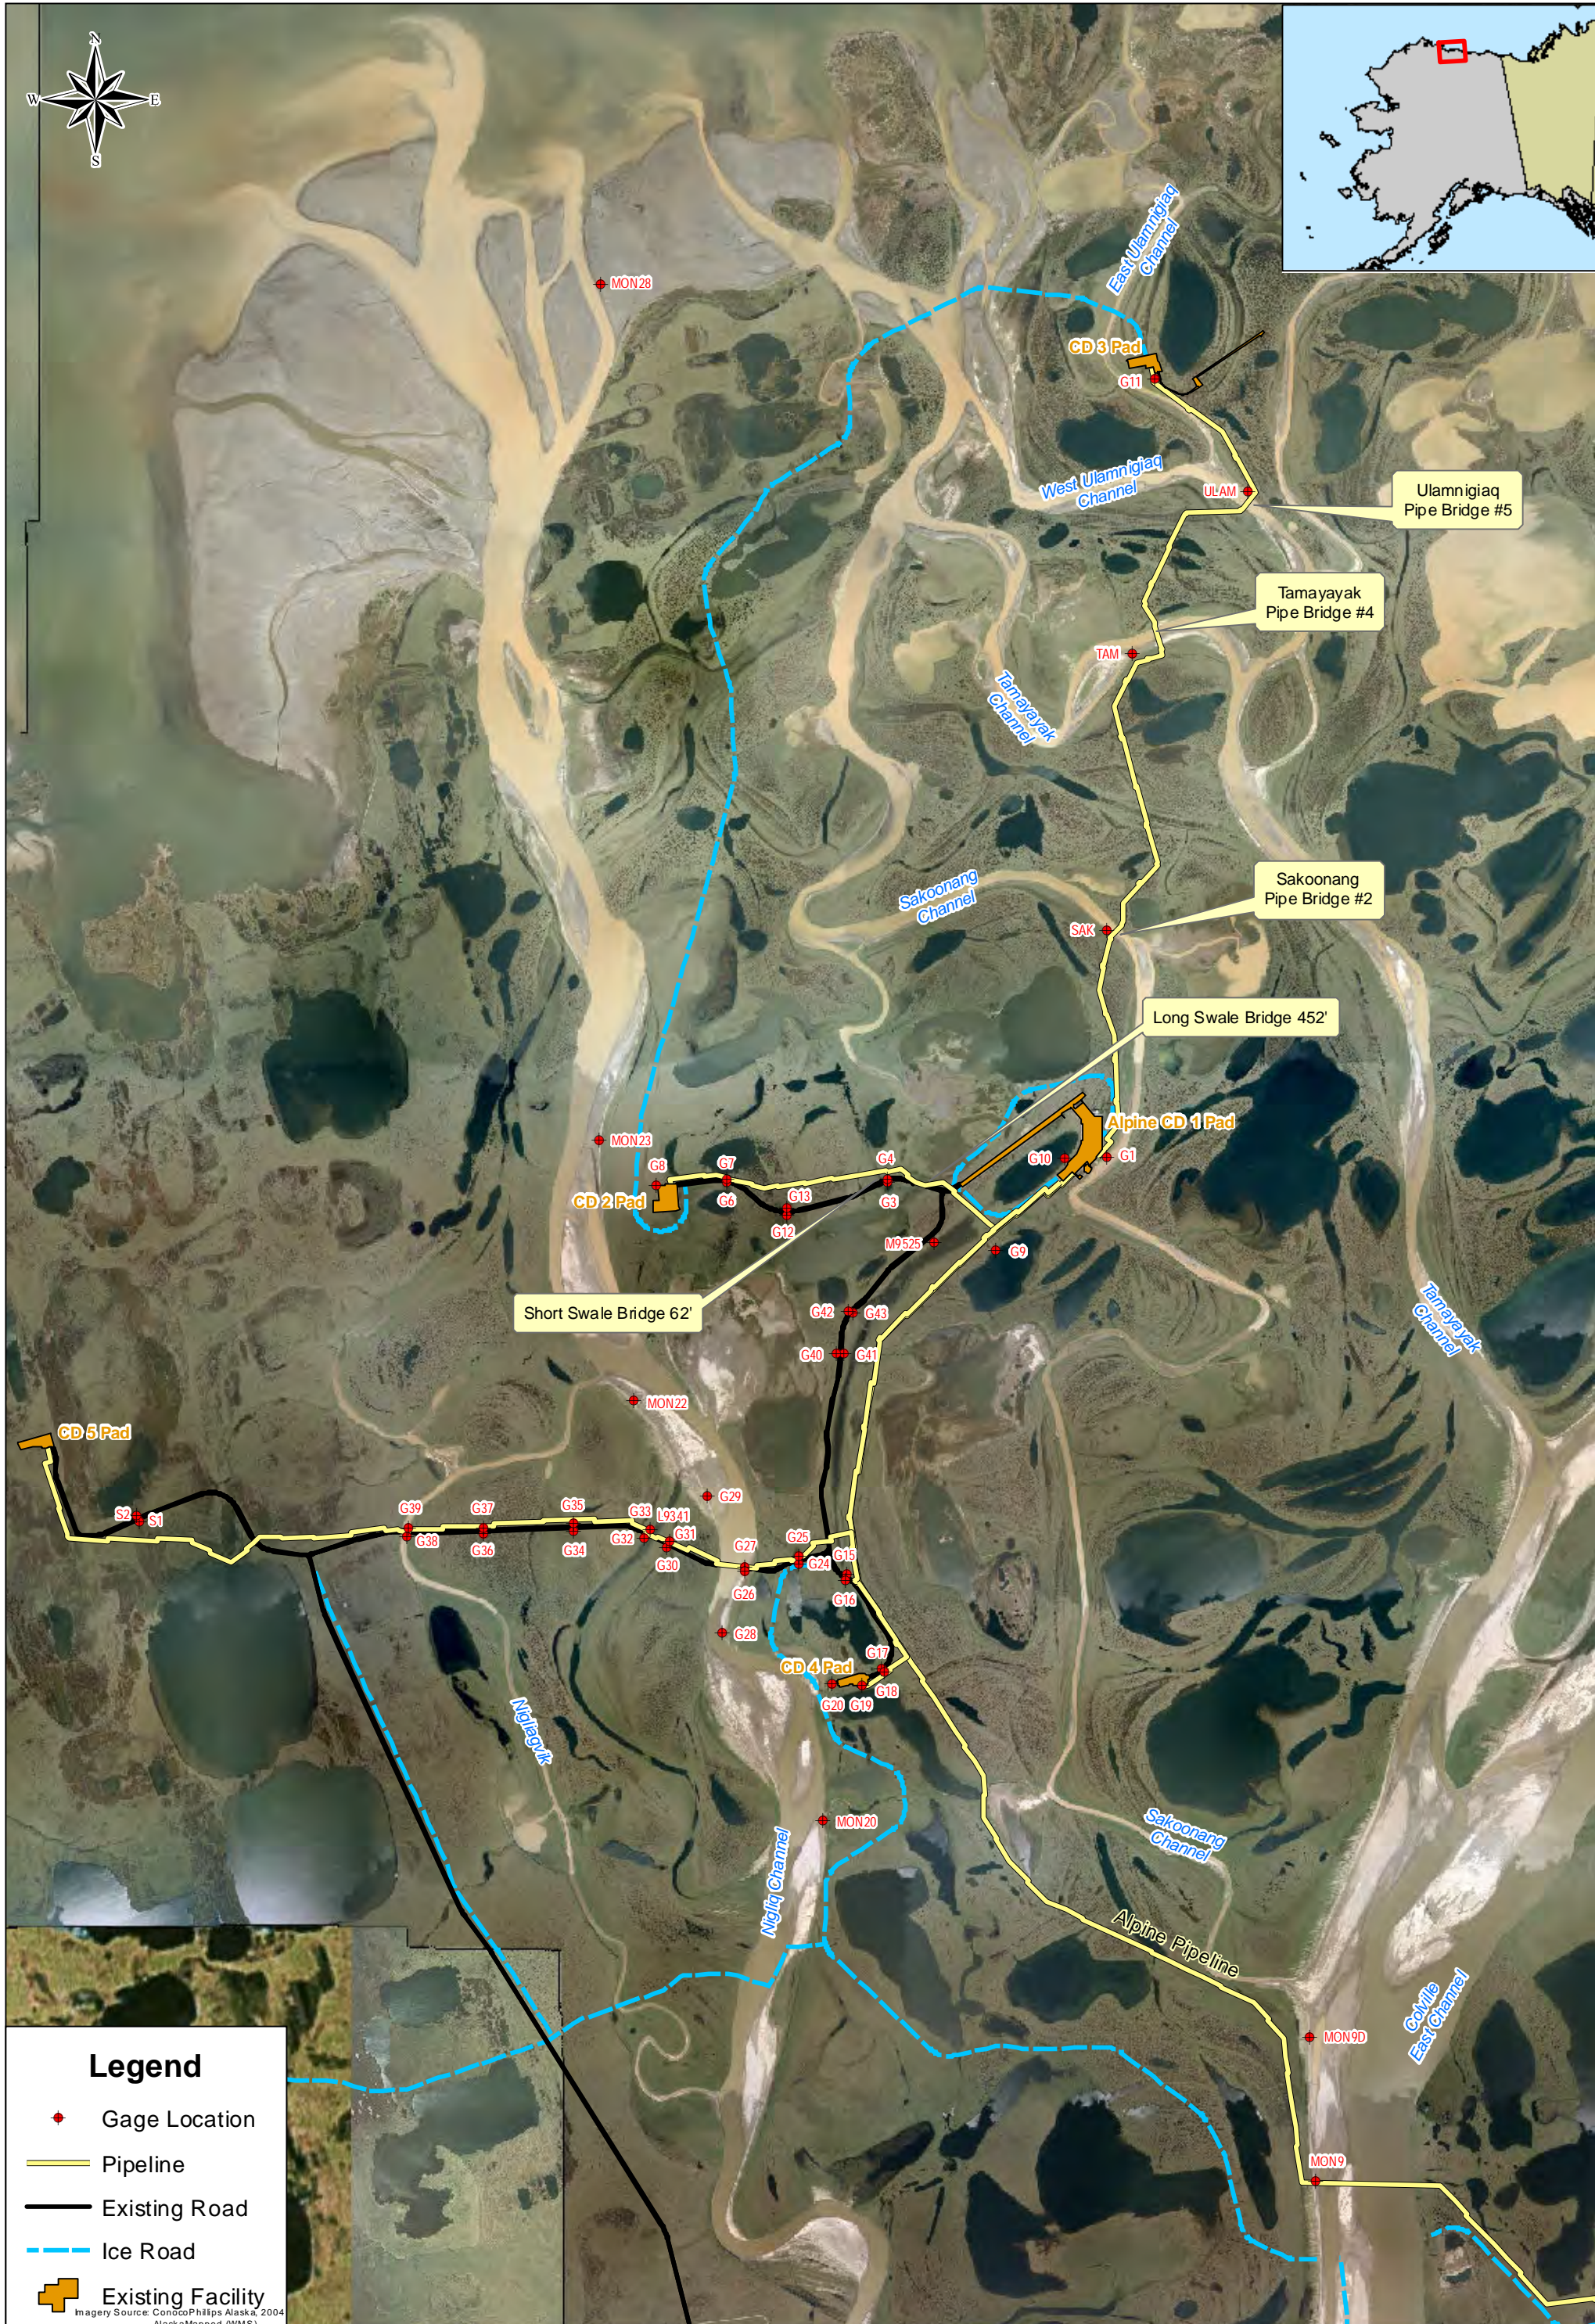
FIGURE: 2

2016 SPRING BREAKUP
 ALPINE AREA FACILITIES

Monitoring Locations

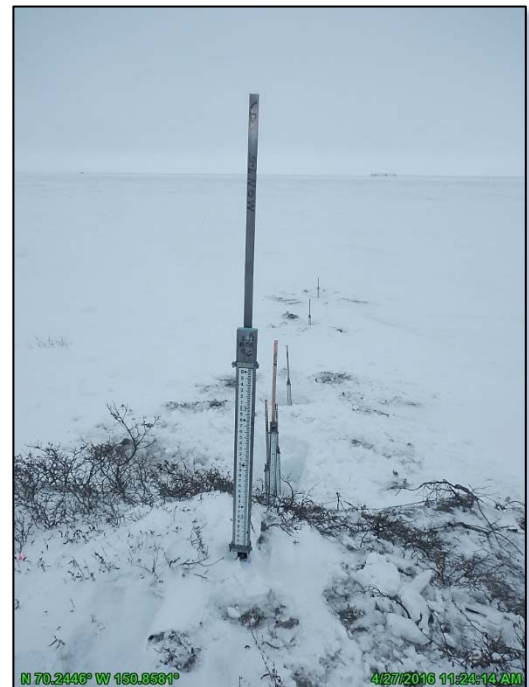
Photo 2.1: Gage set MON9 showing staff gage elevation overlap from the “A” gage nearest the channel to the “G” gage at the top of the bank; April 27, 2016

Staff gages were used to measure changes in WSE. The gage elevations were surveyed to control points referenced to British Petroleum Mean Sea Level (BPMSL). Most monitoring locations had gage sets consisting of multiple gages. The number of gage assemblies per site depends on the slope of the channel bank and overbank. In locations where terrain elevation varied by more than three feet, multiple gages were installed linearly from the edge of the low water channel up to the overbank (Photo 2.1). When gages were destroyed by ice, temporary gages were installed or an elevation survey was completed to the water surface.

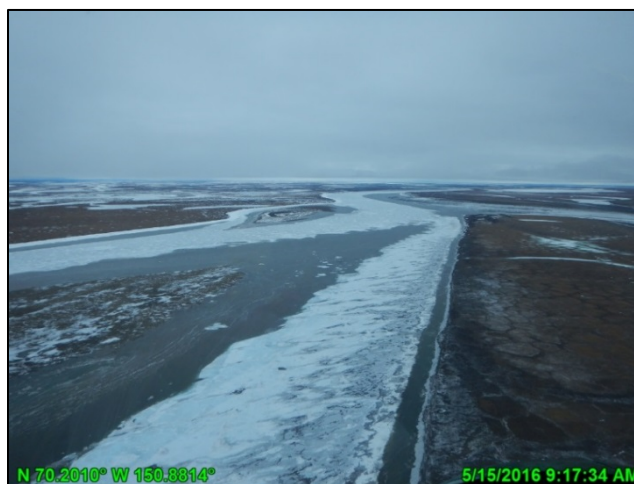
Photo 3.1: Arrival of the leading edge in the East Channel north of the Nigliq Channel bifurcation, looking south; May 15, 2016

On the morning of May 15, the leading edge passed MON₁ and reached the Tamayayak Channel bifurcation in the East Channel (Photo 3.1). A 7.4 mile long ice jam was observed near Ocean Point with minimal backwater upstream of the ice jam.

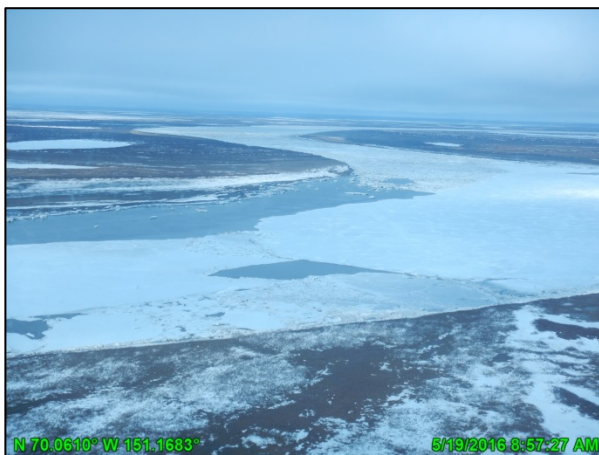
Photo 3.2: Downstream extent of ice jam near Ocean Point, looking southwest; May 19, 2016

On May 19, the downstream extent of the ice jam near Ocean Point remained in place while the upstream extent had moved downstream approximately 1.4 miles (Photo 3.2). Stranded ice floes along the banks indicated water levels had dropped behind the ice jam, coinciding with dropping water levels throughout the delta and in most distributary channels.

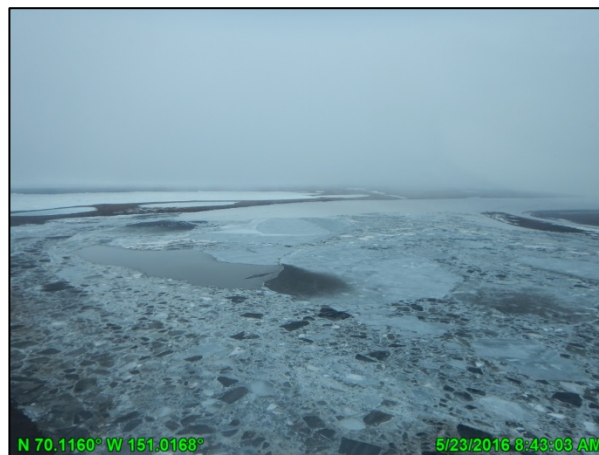
Photo 3.3: Downstream extent of ice jam near Ocean Point, looking southwest; May 23, 2016

On the morning of May 23, the ice jam located upstream of MON₁ was still in place (Photo 3.3), but released shortly thereafter. Peak stage was observed at MON₁ in the afternoon on May 23 as the ice jam and resulting backwater moved downstream. The East Channel was free of intact channel ice up to the Sakoonang Channel bifurcation. Ice jams formed at the Tamayayak Channel bifurcation (Photo 3.4) and in the Nigliq Channel upstream of Nuiqsut. The ice jam in the Nigliq Channel was diverting flow into the East Channel through the Putu Channel. The stage was relatively low and within the banks of the main channels. Overflow from the Sakoonang Channel filled low-lying paleo lakes and channels east and south of the CD₄ Road. Nigliq Channel overflow was again conveyed through Nanuq Lake into Lake M9524 and through the CD₂ Swale Bridges.

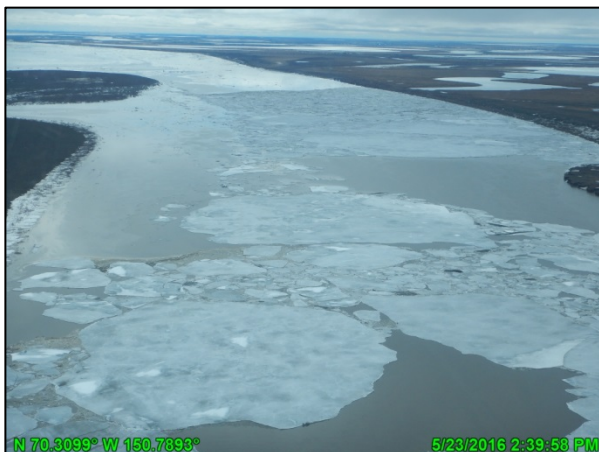
Photo 3.4: Ice jam forming in the East Channel at the Tamayayak bifurcation, looking south; May 23, 2016

On May 24, the upstream extent of intact channel ice in the East Channel was located between the Kachemach and Miluveach river confluences. The ice jam at the Tamayayak Channel bifurcation had moved downstream and reformed upstream of the intact channel ice. The ice jam in the Nigliq Channel had advanced downstream of Nuiqsut and no significant overbank flooding was observed. Further downstream in the Nigliq Channel, the channel ice was still intact (Photo 3.5) but starting to deteriorate.

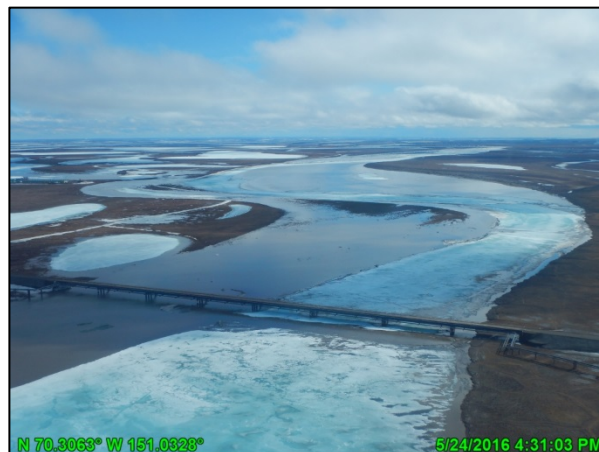
Photo 3.5: Intact channel ice starting to deteriorate near the Nigliq Bridge, looking south; May 24, 2016

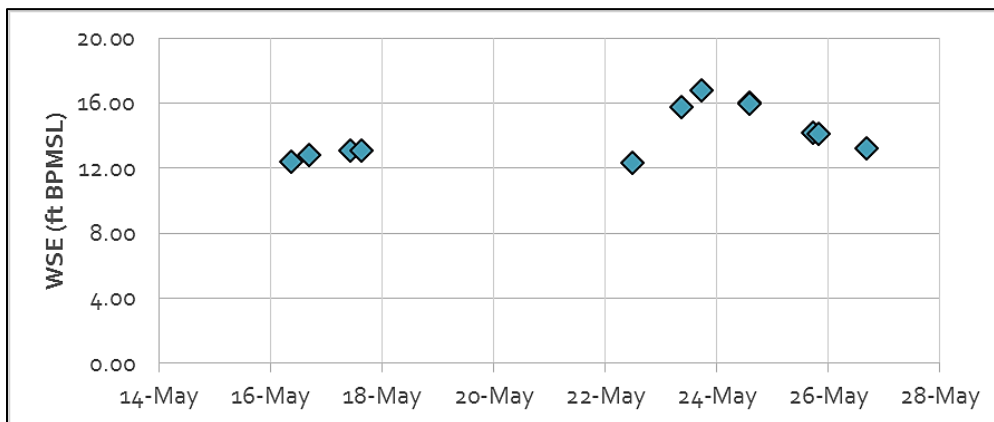
Figure 3.2: Preliminary WSEs at MON1 based on staff gage readings

Stage in the Colville River, at the head of the delta (MON1), peaked in the afternoon on May 23 as a result of an upstream ice jam release. Preliminary staff gage observations and HWMs, indicate peak stage at MON1 was 17.2 feet BPMSL (Figure 3.2). Based on historical data, the preliminary peak stage at MON1 was approximately a 2-yr event.
