2006 Colville River Delta and Fish Creek Basin Spring Breakup and Hydrological Assessment

Submitted to **ConocoPhillips**

Submitted by **Baker**

108604-MBJ-RPT-001

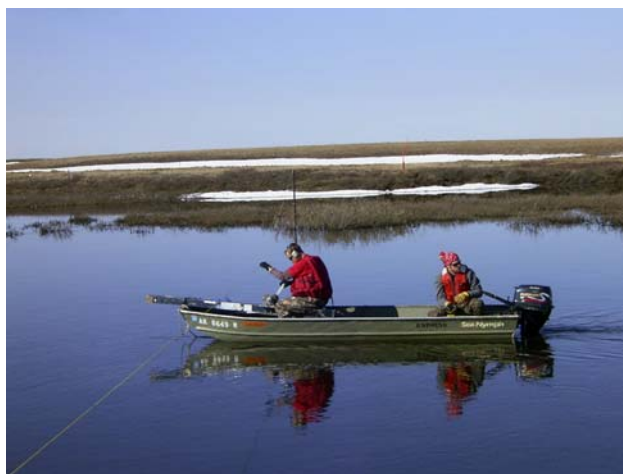
Photo 2-1 Ublutuoch River Boat Discharge Measurement, June 9, 2006.

Direct discharge measurements at the ASDP Sites, Ublutuoch River RM 6.8, and at the Alpine swale bridges were completed using standard USGS midsection techniques (Rantz 1982). A tag line was used to define the cross section and delineate the measurement subsections within the channel. Select discharge measurements in the Alpine culverts were directly measured using a USGS wading rod and either a Price AA or Price Pygmy velocity meter. At the Alpine swale bridges and Ublutuoch River RM 6.8, a Price AA current meter and sounding reel mounted on a boat-type boom was used to measure velocity, and a 30-pound Columbus-type lead sounding weight was used to stabilize the meter and measure depth. Photo 2-1 presents a typical discharge measurement by boat at the Ublutuoch River.

Measurements were completed at the Alpine swale bridges from the bridge deck; at the Ublutuoch River, the measurement was completed from a boat. At the ASDP Sites, a USGS wading rod was used with a variety of velocity meters which included a Price AA, Price Pygmy, and Marsh McBirney Flow Mate 2000 velocity meters. Photo 2-2 shows a typical discharge measurement by wading at Site 10.

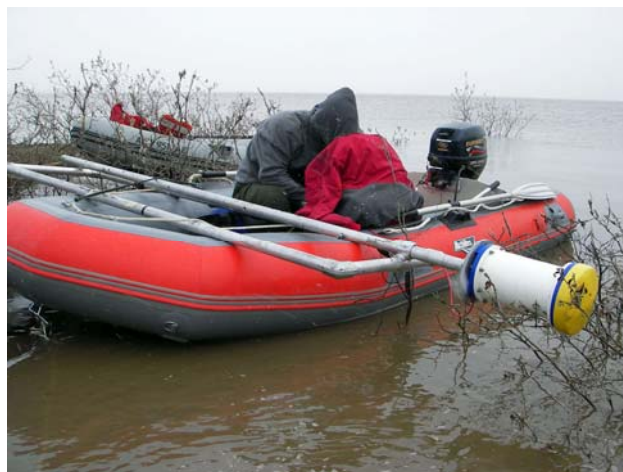
Photo 2-3 Preparing for ADCP Measurement at Monument 1D Site, May 26, 2006.

The Sentinel ADCP was mounted to a 13-foot Achilles SGX-132 inflatable raft powered by a 10 hp outboard motor using a framework fabricated of aluminum tube spanning the boat's fore gunwales. The aluminum framework provided a rigid and secure placement of the ADCP unit while allowing necessary adjustments as river conditions required as identified in Photo 2-3.

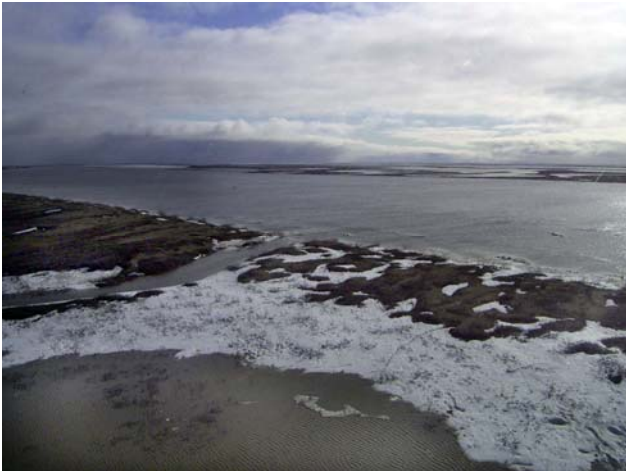
Photo 3-1 Monument 1 Reach, May 29, 2006.

gage sets at Monument 1 Downstream, Monument 1, and Monument 1 Upstream; each installed on the west bank of the Colville River Main Channel. Photo 3-1 shows Monument 1 reach on May 29, 2006, representing the only reach of the Colville River where the flow from all primary contributors is confined in a single channel. Monument 28 and the Helmricks Homestead monitoring locations are within the braided floodplain of the CRD and represent

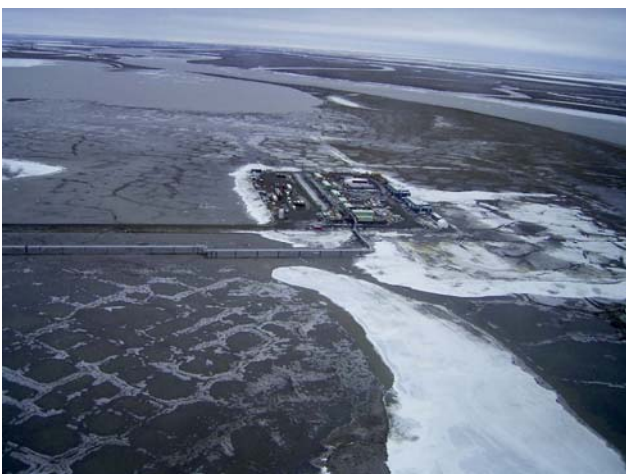
Photo 3-2 Nigliq Channel from CD2 looking South, June 4, 2006.

selected to represent conditions along the Nigliq Channel from downstream of CD2 to upstream of CD4. Photo 3-2 shows a view of this segment of the Nigliq Channel looking from the CD2 pad towards the south. Monument 20 is located on the east bank, Monument 22 is located on the west bank, and Monument 23 is located on the east bank of the Nigliq Channel; they have been monitored intermittently since 1998.

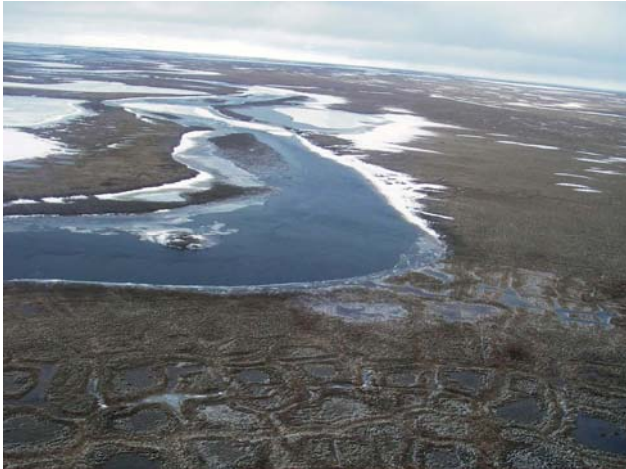
Photo 3-3 Ublutuoch River UB 6.8, June 4, 2006.

confluence. The monitoring site at the proposed Ublutuoch River Bridge site included gage sets at RM 6.7, 6.8, and 6.9 on the northeast bank of the Ublutuoch River, see Photo 3-3. These gage locations were selected to document the conditions of breakup at the location of the proposed Ublutuoch River Bridge.

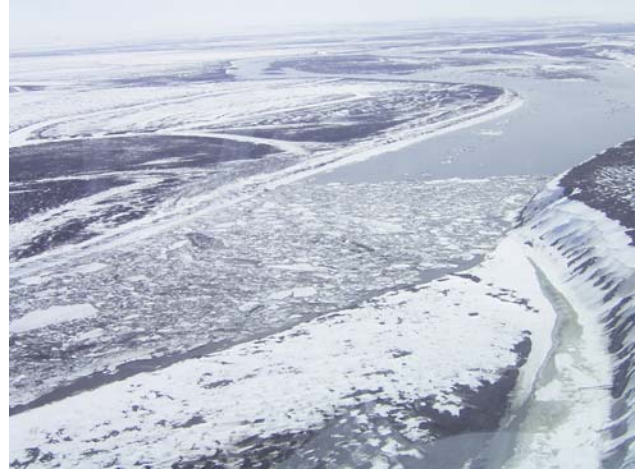
Photo 4-1 Ice Jam near Ocean Point, May 24, 2006

Meltwater was initially reported at Umiat on May 23. A reconnaissance flight on May 24 identified rising waters at Ocean Point directly upstream of an ice jam in the Colville River (Photo 4-1). Local melt and low flow conditions continued on the East and Nigliq channels through May 25. On May 26, ice remained intact across the East Channel, while shallow flow entered the Nigliq Channel.

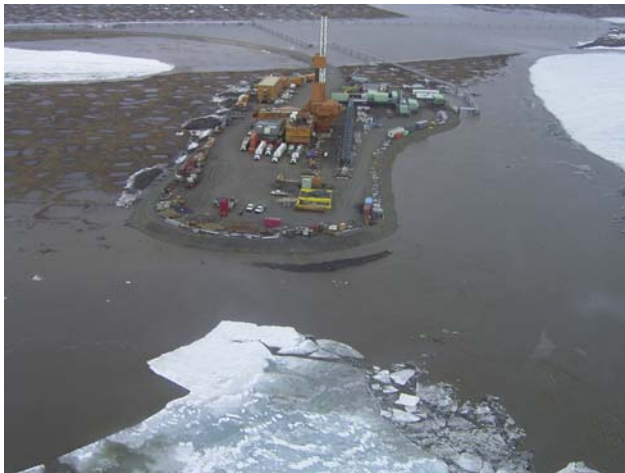
Photo 4-4 CD4 with Floodwater, May 30, 2006.

Stage and observation records for the gages near CD4 are presented in Table 4-28 and Table 4-29; Photo 4-4 and Photo 4-5 show the breakup conditions at CD4.

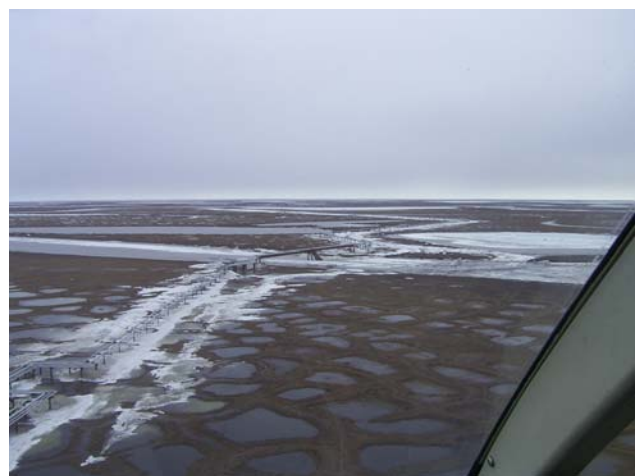
Photo 4-6 Sakoonang Channel Pipeline Bridge, June 2, 2006.

The pipeline bridge crossings of the Sakoonang (Photo 4-6), Tamayagiaq (Photo 4-7) and Ulamnigiaq (Photo 4-8) Channels near CD3 were observed from May 27 to June 3. On May 28, floodwaters and ice jams observed in the East and Nigliq Channels caused a steady rise in stage at each of the crossings. By May 30, the stage had increased four feet at the Sakoonang, two feet at the Tamayagiaq, and 2½ feet at the Ulamnigiaq pipeline crossing sites. The peak stage occurred the early morning of May 31, when the Sakoonang Channel crossing reached

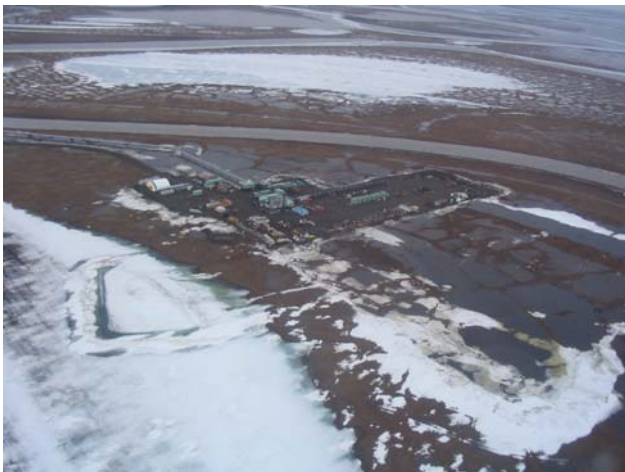
Photo 4-9 CD3 Pad, June 1, 2006.

Gage 12, on the east side of CD3, first recorded water on May 27. Gage 11, on the west side of CD3, recorded first water on May 28. Floodwaters rose about one foot through May 30 and Gage 11 reached a peak stage of 5.55 feet in the early morning of May 31. Gage 12 reached a peak stage of 5.35 feet on the morning of June 1. By June 2, Gage 11 was dry and Gage 12 recorded a stage of 4.31 feet. Photo 4-9 shows the CD3 pad on June 1. Table 4-31 presents the stage and observation records for Gages 11 and 12 near CD3.

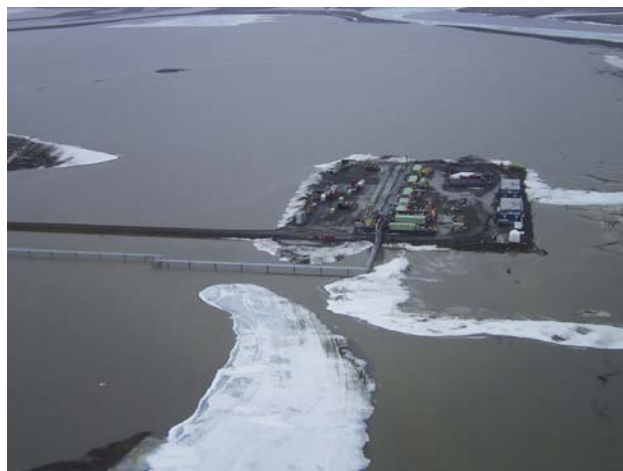
Photo 4-10 CD2 Pad, May 31, 2006.

stage of 9.72 feet at Gage 3, 8.85 feet at Gage 4, 9.95 feet at Gage 6, 9.17 feet at Gage 7 and 9.34 feet at Gage 8. Stage began to drop as floodwaters receded and the East Channel ice jam released the morning of May 31. By June 1, the Nigliq Channel ice jam released and the stage dropped by 1½ feet. The final readings for the CD2 gages occurred on June 3. Table 4-32 and Table 4-33 present the stage and observation records for Gages 3 through 8, near CD2. Photo 4-10 shows the CD2 pad on May 31.

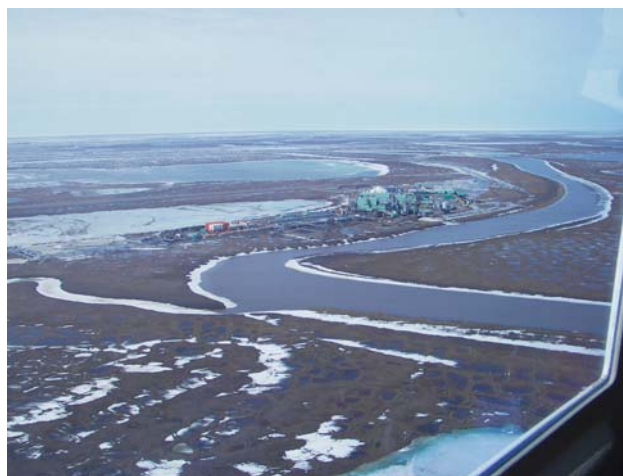
Photo 4-11 CD1 Pad, May 28, 2006.

Gage 1 on the east side of the CD1 pad on the Sakoonang Channel was monitored from May 28 to June 9. Gage 9 at Lake L9312 and Gage 10 at Lake L9313 were monitored from May 28 throughout the summer of 2006. Gage 1 recorded a three-foot increase in stage by the morning of May 30, while stage at Gages 9 and 10 increased by two feet. Gage 1 reached a peak stage in the early morning of May 31 of 9.29 feet and Gages 9 and 10 reached peak stages of 9.55 feet and 9.95 feet, respectively. As floodwaters receded and the ice jams released in the East and Nigliq Channels, stage began dropping. By June 1, the ice jam in the Nigliq Channel had cleared, and the stage at Gages 1, 9, and 10 decreased by approximately 1½ feet. Gage 9 and Gage 10 also showed recharge of the lakes L9312 and L9313 by local melt and by floodwater from the Colville River. Table 4-34 and Table 4-35 present the stage and observation records for Gages 1, 9, and 10 near CD1. Photo 4-11 presents the conditions at the CD1 pad on May 28.

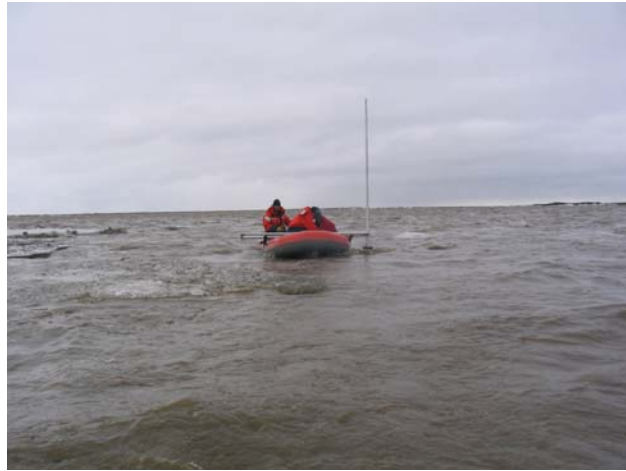
Photo 4-12 Direct Discharge (ADCP) Measurement on Colville River, May 29, 2006.

Between May 29 and June 1, four direct discharge measurements were completed on the Colville River in the vicinity of the Monument 1 reach using ADCP techniques (Photo 4-12). Processed discharge data is presented in Appendix B. A minimum of four transects and one loop test were completed each of the four days. Standard deviation of daily measured discharges ranged from 1 to 3 % of the mean total discharge. Loop tests confirmed the presence of a moving bed on all four sampling days and provided adjustment values for measured discharge.

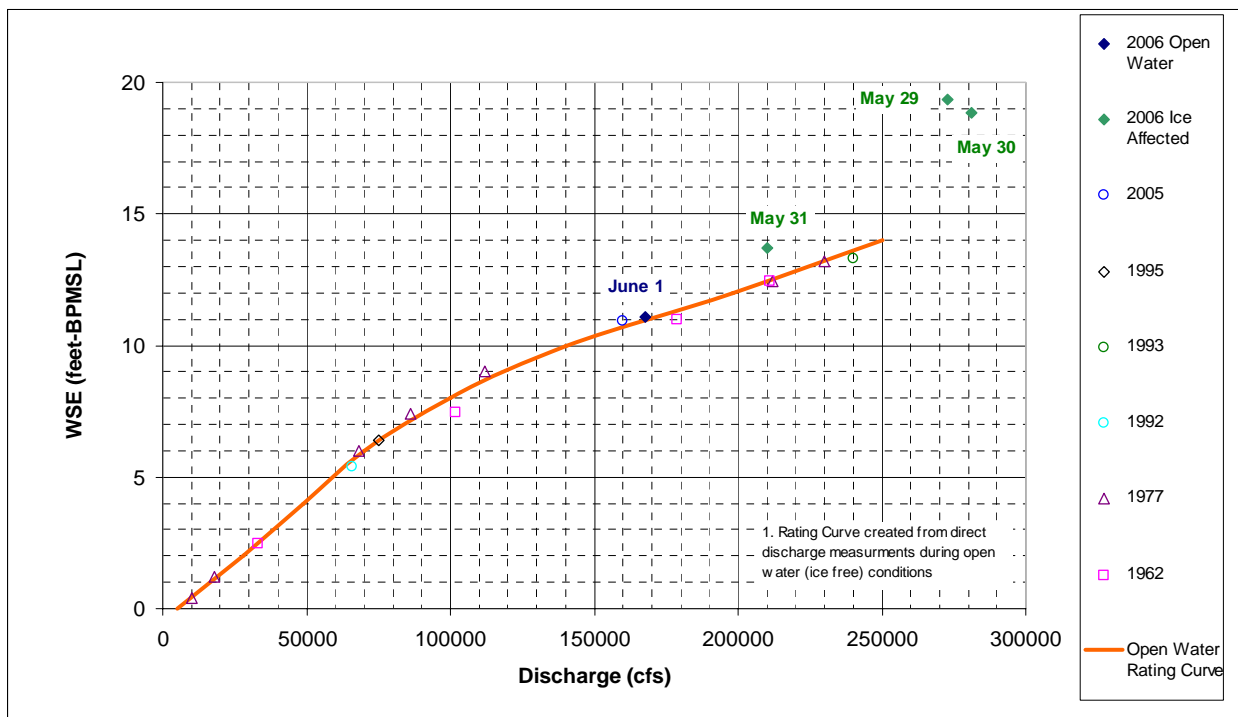
Graph 4-1 Monument 1 Rating Curve with Observed Direct Discharge Values

The 2006 spring breakup is the first year that direct discharge measurements are available before and after peak stage occurred at Monument 1. During the May 29 and May 30 discharge measurements, extensive ice jamming in the Nigliq and East Channels resulted in near record stage at Monument 1. Peak discharge occurred on May 30 shortly after water surface elevations began to drop, coinciding with the downstream migration of the East and Nigliq Channel ice jams. By May 31, stage had dropped significantly at Monument 1 by approximately five feet in 24 hours. As the East Channel ice jam cleared and water surface slope at Monument 1 increased, the ice jam was still present in the Nigliq Channel. These relationships to some extent influenced the direct discharge measurements and stage at Monument 1. When this stage and discharge relationship is compared with the Monument 1 rating curve (Graph 4-1) these discharge values plot above the rating curve, as is expected given the ice conditions on these days.

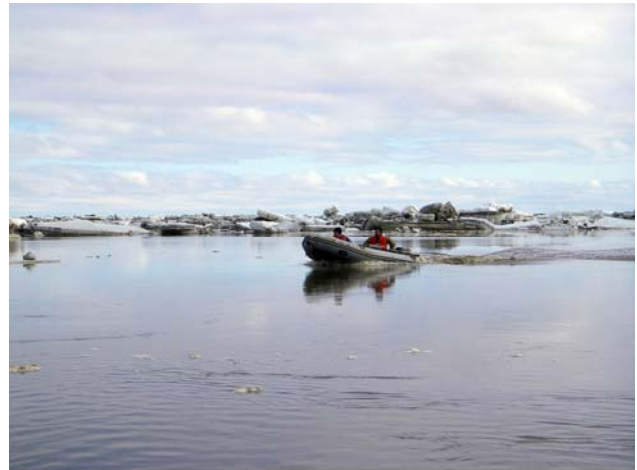
Photo 4-13 Nigliq Channel South of Monument 23, June 1, 2006.

ADCP techniques were used to measure discharge of the Nigliq Channel at Monument 23 on June 1, approximately four hours after completing direct discharge measurements at Monument 1. Processed discharge data is presented in Appendix B. Four transects and one loop test were conducted over a twenty minute period. The loop test confirmed a moving bed and provided adjustment values with a resulting mean corrected discharge of 43,000 cfs. Standard deviation of the four measured discharges was approximately 4% of mean total discharge. Table 4-3 summarizes the 2006 discharge measurement data on the Nigliq Channel at Monument 23 and Figure 4-2 Sheet 1 presents a plan of the location of the discharge measurement at Monument 23.

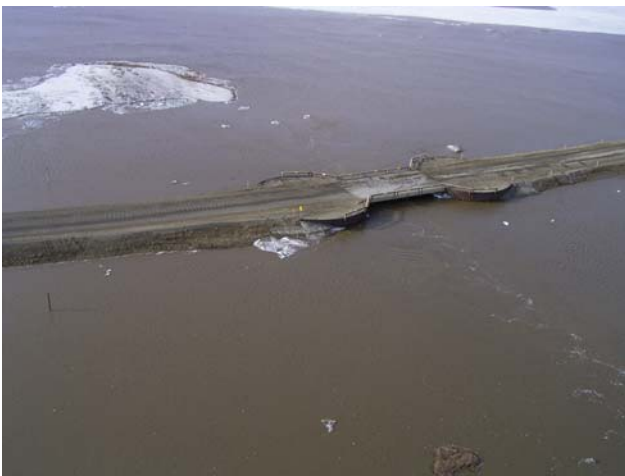
Photo 4-14 62-foot Swale Bridge, May 29, 2006.

To monitor the performance of drainage structures and to comply with stipulated monitoring requirements outlined in USACE Permit No. POA-2004-253, velocity and discharge at the swale bridges were measured and estimated for a variety of conditions.

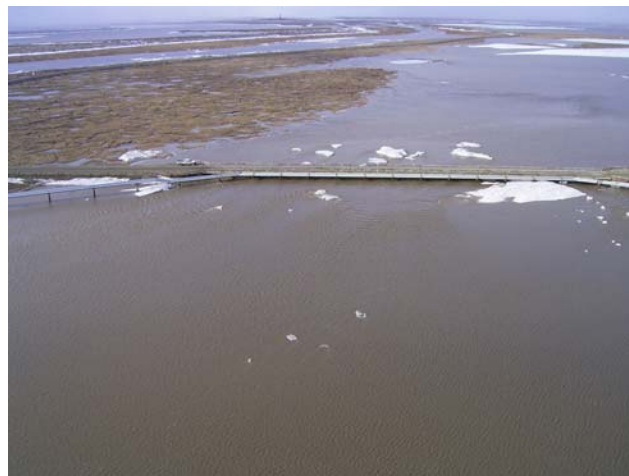
Photo 4-15 452-foot Swale Bridge, May 29, 2006.

On May 31, discharges at the 62-foot (Photo 4-14) and 452-foot (Photo 4-15) swale bridges were measured at 980 and 3320 cfs, respectively. Table 4-4 presents a summary of the 2006 discharge measurement data at the Alpine swale bridges. The complete discharge notes are presented in Appendix C. The mean adjusted velocity of the 62-foot bridge was 1.59 fps and the maximum adjusted velocity was 2.24 fps. The mean adjusted velocity of the 452-foot bridge was 1.89 fps and the maximum adjusted velocity was 2.55 fps. The maximum non-adjusted at-point velocity recorded was 2.79 fps at the 62-foot bridge and 2.77 fps at the 452-foot bridge. Each mean and maximum adjusted velocity accounts for the angle of flow coefficient while the non-adjusted at-point velocity represents the actual velocity of the water as measured.

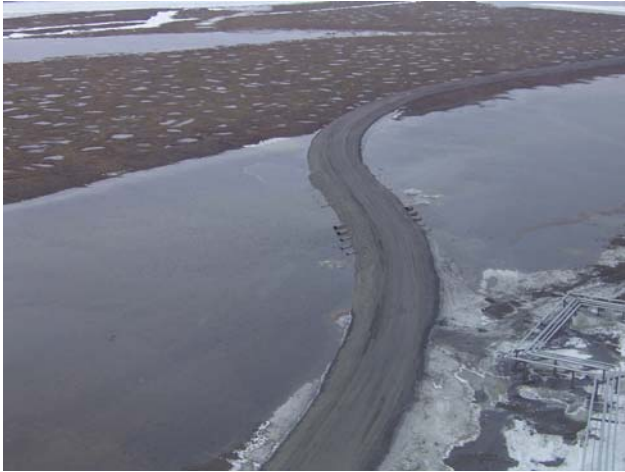
Photo 4-16 Northern CD4 Culvert Battery, May 30, 2006.

The differential between headwater and tailwater elevations for the CD4 culverts is represented by the water surface elevation differential between Gages 15 and 16 at the northern culvert battery and between Gages 17 and 18 at the southern culvert battery. At the northern CD4 culverts, the maximum water surface elevation differential between the gage sets occurred during peak stage on May 30 at 10:30 PM and was recorded to be a differential of 2.5 feet between Gages 15 and 16 (Photo 4-16). At the southern CD4 culverts, the maximum water surface elevation differential between the gage sets did not occur during peak stage, but occurred approximately five hours prior to the observed peak stage. The maximum recorded water surface elevation differential at the southern CD4 culverts was 2.7 feet and was observed on May 30 at 5:15 PM between Gages 17 and 18 (Photo 4-17).

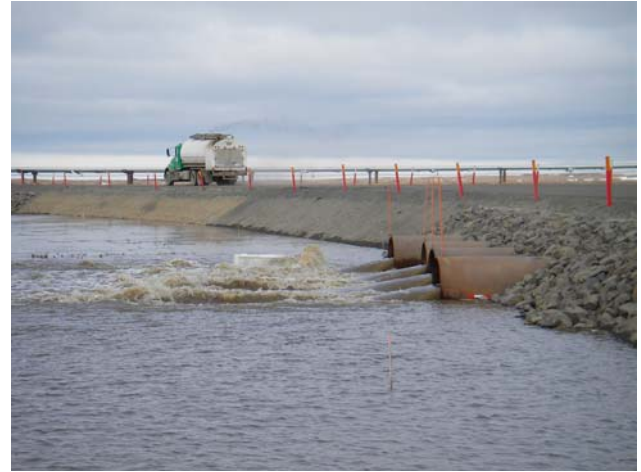
Photo 4-17 Southern CD4 Culvert Battery, May 30, 2006.

The water surface elevation differential along the CD4 road at the northern culverts was greater than 0.5 feet for less than four days between May 29 and June 2; the water surface elevation differential along the CD4 road at the southern culverts was greater than 0.5 feet for less than a 24-hour duration between May 30 and May 31. Flow is estimated to have stopped on June 3 for the CD4 culverts. A comparison of stage and discharge during breakup for the CD4 culverts is presented in Graph 4-3.

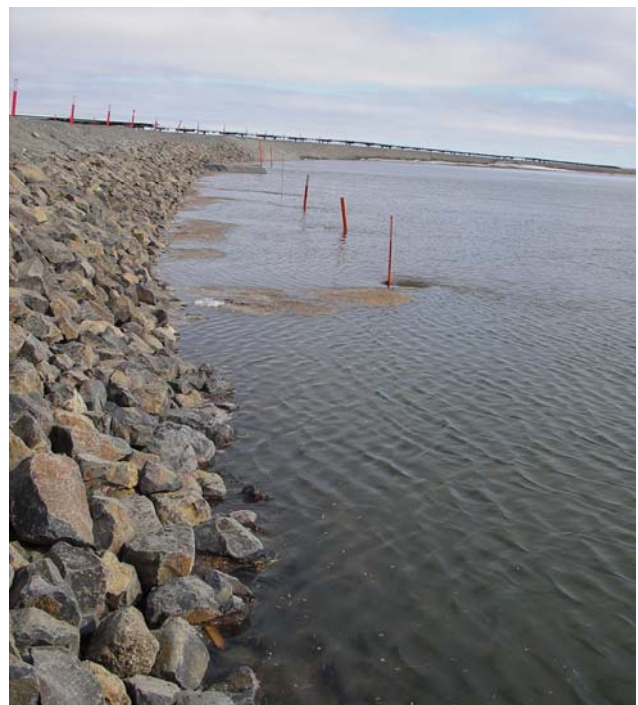
Photo 4-18 Peak Headwater at Northern CD4 Culvert Battery, May 30, 2006.

Alpine’s gravel pads and access roads were inspected for erosion following spring breakup on June 14 and July 21. At no location along the gravel structures was a significant amount of erosion observed. The edges of the CD1 and CD3 pads were not inundated with flood water; however, the gravel bases along the pads and roads of CD2 and CD4 were partially submerged (Photo 4-18). As a result, a relatively small volume of fine-grained sediment was washed from the CD2 and CD4 road embankments in certain areas; however, no slumping or side slope deterioration was observed. Photo 4-19 and Photo 4-20 presents the minor erosion observed on the north side of the CD4 road in the northern paleochannel region which represents the only location along the CD2 and CD4 road where

minor erosion was observed. High water marks along the gravel facilities were identified along the CD2 and CD4 road; however no sign of erosion was identified at any other location. The conditions of the majority of the CD2 and CD4 road after breakup are best represented by Photo 4-21, and Photo 4-22. The CD2 and CD4 pads were structurally unaffected by floodwaters.

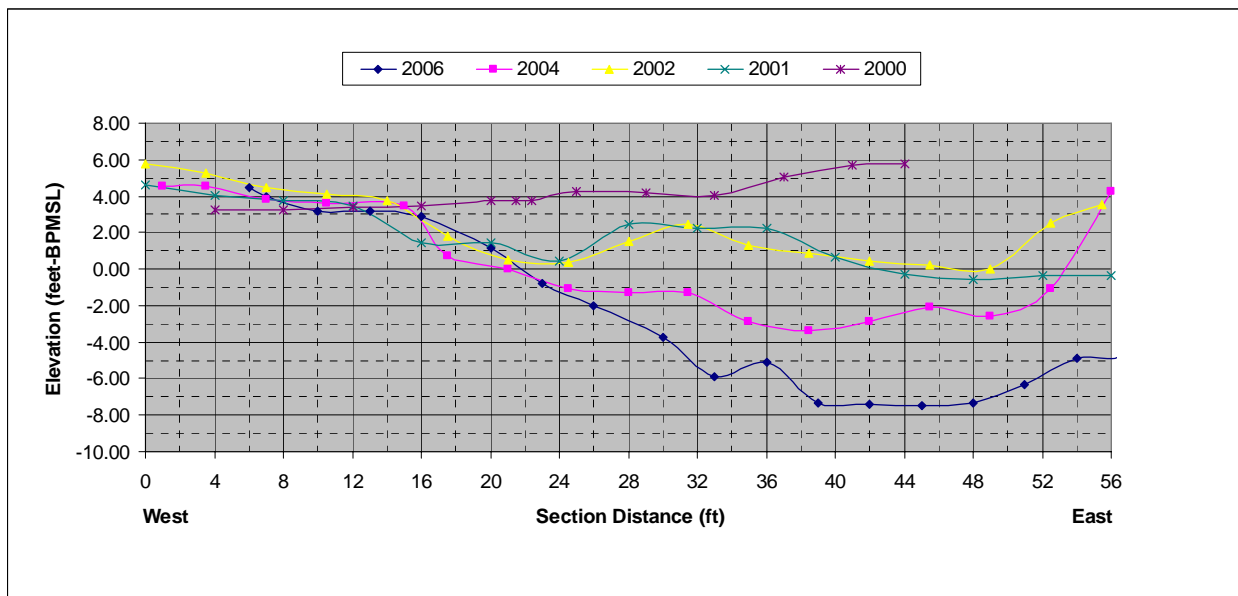
Graph 4-7 Annual Bridge Bed Level – 62-Foot Alpine Swale Bridge 2000-2006

The sub-aqueous thermoerosion condition is the thermal and hydraulic process of erosion of fine-grained ice-bonded sediments. The energy of moving water each spring has caused thermal disruption of the ice rich permafrost and the transport of the sediment from the region between the bridge abutments. The erosion condition is limited to the hydraulic process and takes place when the energy of moving water each spring transports thawed sediment from the region. The effects of the scour, which includes erosion and melting processes, are greatest during spring flooding. A review of historical thermoerosion indicates that thermoerosion occurs during breakup if peak stage is greater than approximately 8.6 feet.

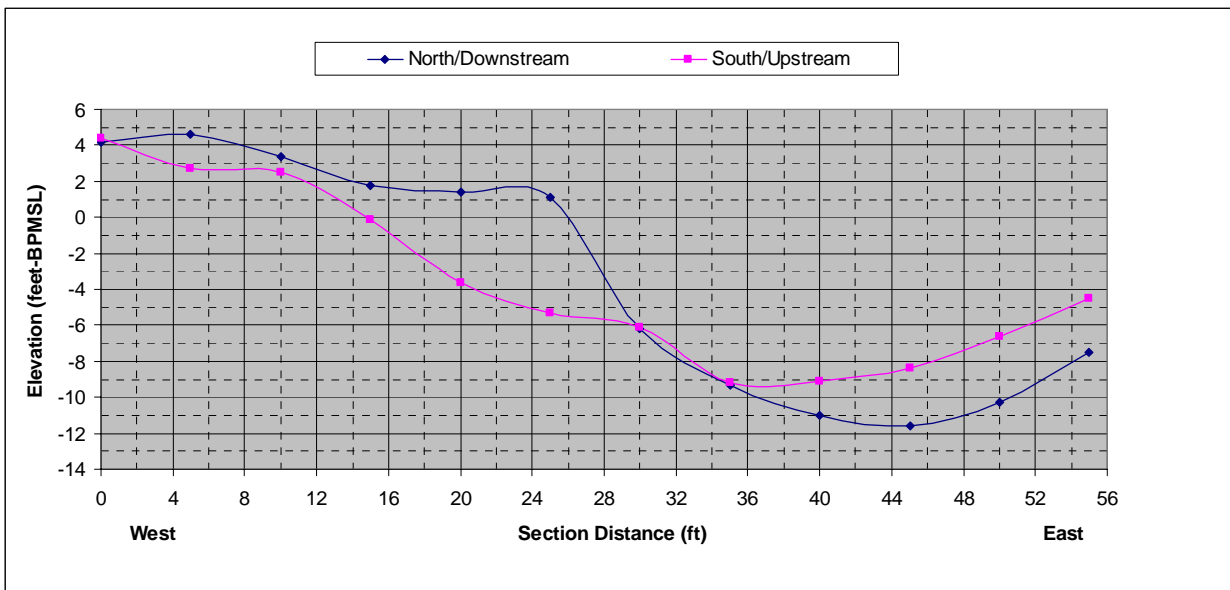
Graph 4-8 Post Breakup Channel Survey – 62-Foot Alpine Swale Bridge 2006

On July 21 2006, the channel was surveyed on the upstream and downstream edges of the bridge to validate the 2006 soundings measured during breakup and to determine the extent of scour downstream of the bridge. The post breakup 2006 channel survey indicated that the mean upstream channel depth was -0.3 feet deeper than the downstream channel and the maximum scour depth of -11.6 feet was recorded on the downstream side of the bridge. Graph 4-8 presents the 2006 upstream and downstream channel survey conducted on July 21.

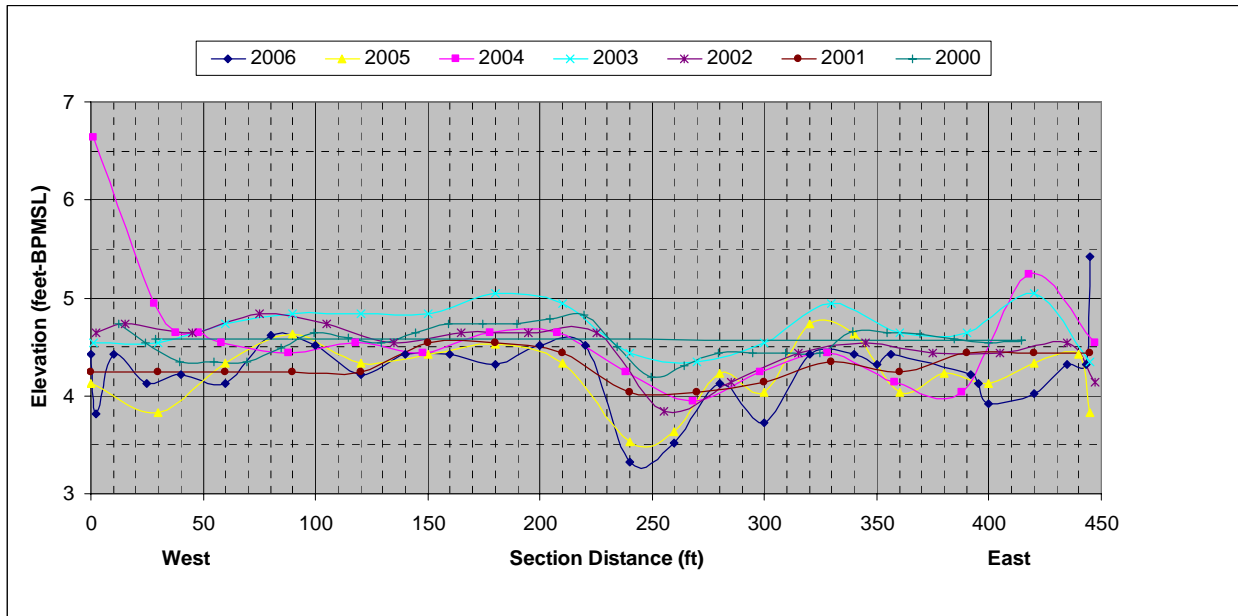
Graph 4-9 Annual Bridge Scour – 452-Foot Alpine Swale Bridge 2000-2006

There is no indication of significant channel scour along the measured cross section at the 452-foot swale bridge. Minor channel scour has occurred between 2005 and 2006 near the bridge midpoint in the area of the 250-foot measuring section to a maximum depth of 3.5 feet in 2005 and 3.3 feet in 2006. The mean channel elevation from 2000 to 2006 was 4.5 feet, indicating that the maximum depth of net scour was approximately one foot. Graph 4-9 presents the historical discharge soundings at the 452-foot swale bridge.

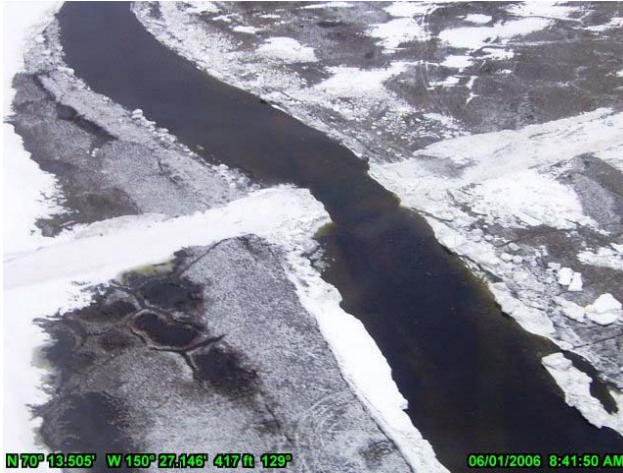
Photo 4-25 Kachemach River Ice Bridge during Breakup with Ice Road in Place, June 1, 2006.

No significant erosion or scour was observed during breakup at or near the Colville River East Channel or at the Kachemach River ice bridge crossings. Photo 4-25 and Photo 4-26 represent conditions at the Kachemach River ice bridge crossing during and ten days after breakup, respectively. Photo 4-27 represents conditions of the Kachemach River at the ice bridge crossing in late July after breakup. Photo 4-28 and Photo 4-29 represent the Colville River East Channel ice bridge during and post breakup.

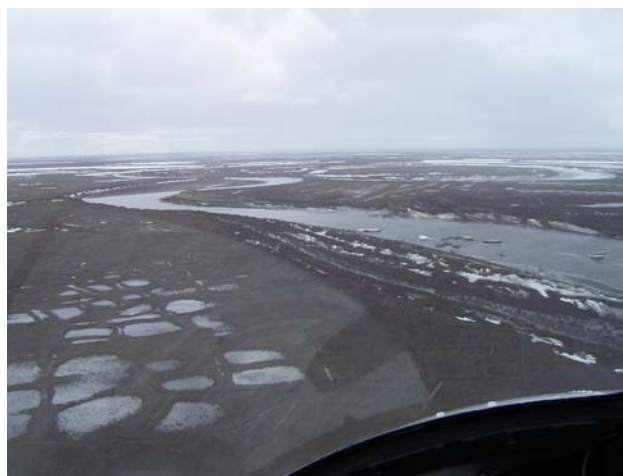
Photo 5-1 Judy Creek, June 3, 2006.

Judy Creek was the first channel to become active in the FCB with floodwaters reaching pressure sensors at J13.8 on May 27. The first flowing water in the FCB was observed in Judy Creek on May 28, approximately one mile above the confluence with Fish Creek. As floodwater in Judy Creek advanced downstream, flow in Fish Creek also became active with floodwaters reaching pressure sensors at Fish Creek F25.1 on May 30. Ice and snow were observed in both Fish and Judy Creeks at the beginning of breakup and remained in Fish and Judy Creeks through June 6. Photo 5-1 shows conditions of Judy Creek on June 3. By June 7, both channels were flowing relatively ice-free.

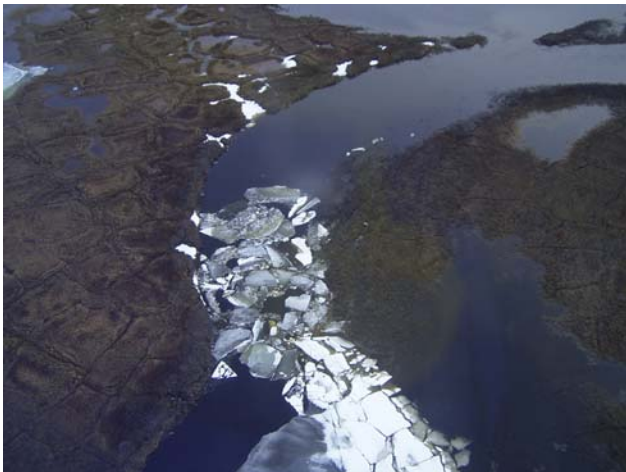
Photo 5-2 Floating ice in the Ublutuoch River, June 7, 2006.

Localized melt and standing water along the Ublutuoch River was noted several days prior to the occurrence of floodwater and on May 30, a reconnaissance flight over the Ublutuoch River revealed the leading edge of saturated snow at UB 6.8. Snow was observed in the channel impacting flow through June 1 and the first measurable water was recorded at UB 6.8 on June 2. Floodwater continued to rise in

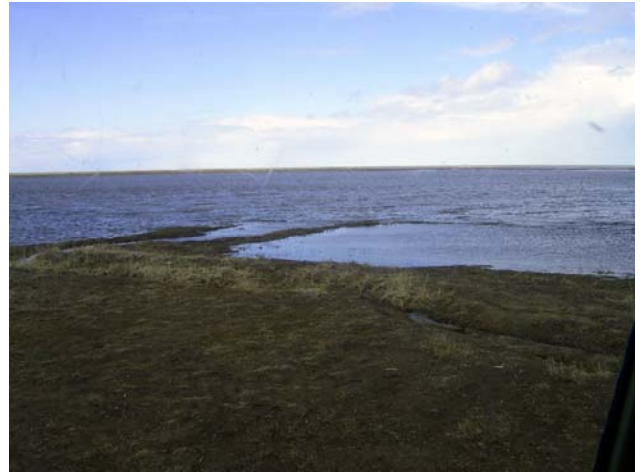
Photo 5-4 Fish Creek F0.7, June 11, 2006.

Water surface elevation measurements at Judy Creek J13.8 began on May 27 and continued until June 13; the Judy Creek data are presented in Table 5-7. The high water elevation at J13.8 of 35.56 feet was estimated to have occurred on May 30 and stage generally declined throughout the remaining breakup event. Because all Fish Creek monitoring locations were downstream of the Fish and Judy confluence, the water surface elevation records of Fish Creek were each initially impacted by flow from Judy Creek. Water surface elevations at Fish Creek F0.7, F10.3, and F25.1 continued from May 30 through June 17; data are presented in Table 5-8. The high water elevation of 17.91 feet at F25.1 was estimated to have occurred in the afternoon of May 30 and was the result of flow from Judy Creek. After May 30, stage steadily declined until June 5 when stage increased for several days due to flow originating from the Fish Creek headwaters, see Photo 5-3. Stage at F25.1 during this secondary peak did not exceed the elevation of the primary peak and after June 13 stage steady declined. At F0.7 and F10.3, seasonal high water

surface elevations were observed early in the breakup season resulting from Judy Creek flow. Photo 5-4 shows the conditions of Fish Creek at F0.7 on June 11.

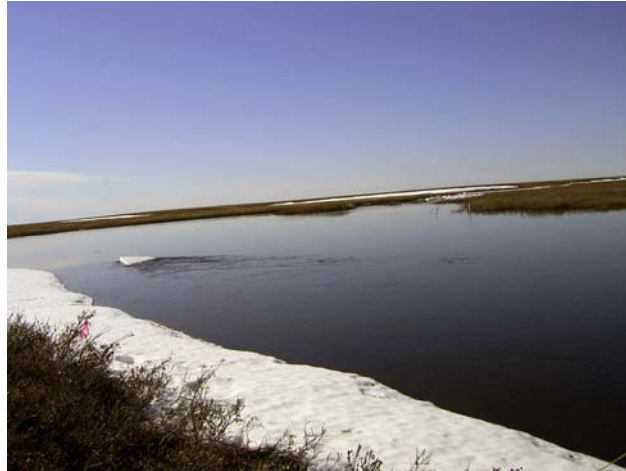
Photo 5-5 Ublutuoch River UB 6.8, June 9, 2006.

throughout breakup with the last observations recorded on June 11. Observations of stage at UB 1.9 were relatively limited in 2006; however, stage at UB 1.9 was consistent with observations at UB 6.8. Table 5-9 presents the observations, water surface elevations, and discharge measurements recorded for UB 1.9, UB 6.7, UB 6.8, and UB 6.9.

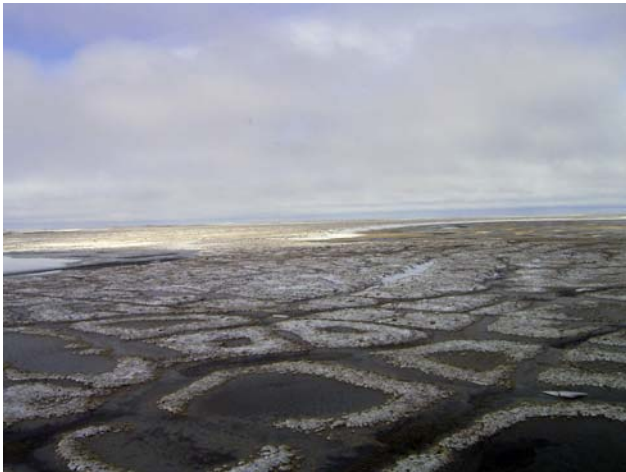
Photo 5-6 Site 1, June 3, 2006.

The Site 1 centerline peak water surface elevation was estimated to have occurred during the morning of June 4 at an elevation of 10.08 feet. Throughout breakup, stage fluctuated by approximately 0.21 feet at the centerline gage. Flow was not present on June 2 and peak discharge was recorded on June 3 at 2.7 cfs as shown in Photo 5-6. Flow dropped to less than 1 cfs by June 4 and by June 7 no flow was observed. Table 5-10 presents the observations, water surface elevations, and discharge measurements recorded for Site 1.

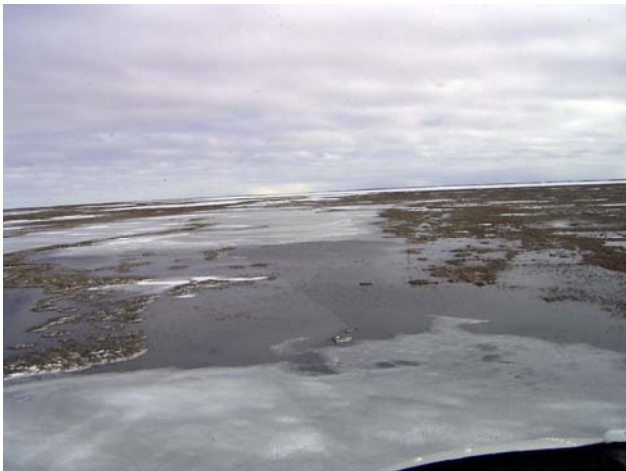
Photo 5-7 Site 2, June 4, 2006.

The Site 2 centerline peak water surface elevation occurred on June 3 at an elevation of 19.53 feet. Photo 5-7 shows the conditions of Site 2 the day after peak stage on June 4. Throughout breakup, stage fluctuated by approximately 0.12 feet at the centerline gage. Flow was not present at any time during breakup. Table 5-11 presents the observations and water surface elevations recorded for Site 2.

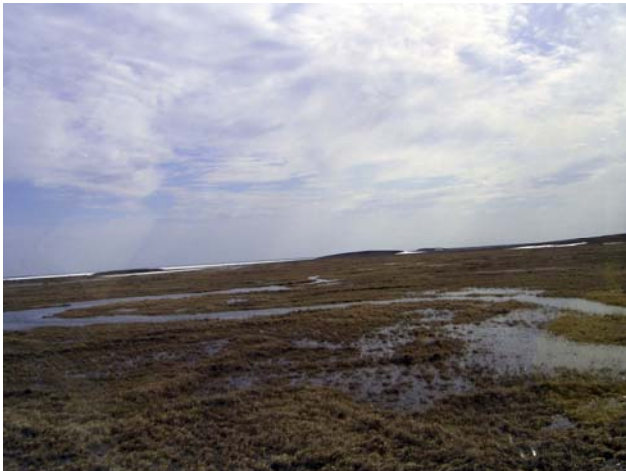
Photo 5-8 Site 3, June 10, 2006.

of Site 3 are shown in Photo 5-8 on June 10. Flow dropped to less than 4 cfs by June 16. Table 5-12 presents the observations, water surface elevations, and discharge measurements recorded for Site 3.

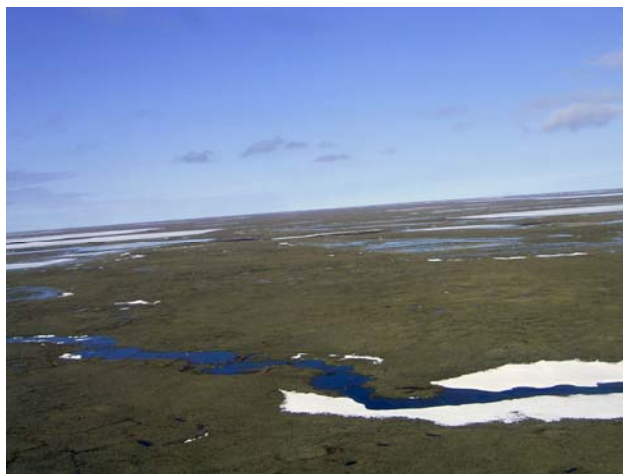
Photo 5-9 Site 5, June 8, 2006.

The Site 5 centerline peak water surface elevation occurred on June 2 at an elevation of 14.50 feet. Throughout breakup, stage fluctuated by approximately 0.67 feet at the centerline gage. Flow was 1.7 cfs on June 5 and peak discharge was recorded on June 7 at 8.2 cfs. Photo 5-9 shows the conditions of Site 5 the day after peak discharge on June 8. Flow dropped to 4 cfs by June 9. Table 5-13 presents the observations, water surface elevations, and discharge measurements recorded for Site 5.

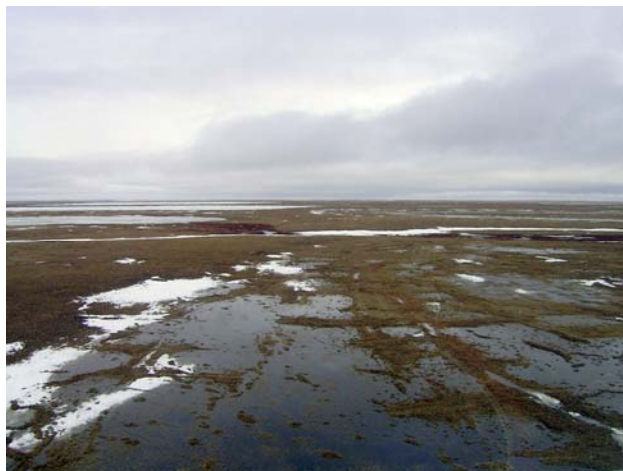
Photo 5-10 Site 6, June 7, 2006.

The Site 6 centerline peak water surface elevation occurred on June 9 at an elevation of 17.51 feet. Throughout breakup, stage fluctuated by approximately 0.88 feet at the centerline gage. Flow was 14.1 cfs on June 6 and peak discharge was recorded on June 9 at 71 cfs. The conditions of Site 6 are shown in Photo 5-10 on June 7. Flow dropped to 44 cfs by June 12. Table 5-14 presents the observations, water surface elevations, and discharge measurements recorded for Site 6.

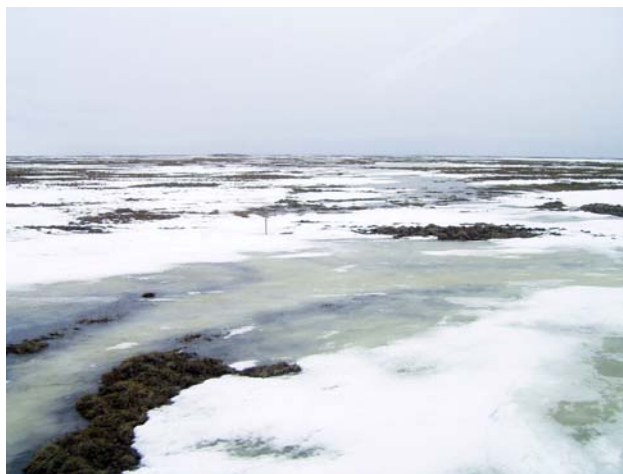
Photo 5-11 Site 7, June 2, 2006.

The conditions of Site 7 are shown in Photo 5-11 on June 2. The Site 7 centerline peak water surface elevation occurred on June 4 at an elevation of 23.33 feet. Throughout breakup, stage fluctuated by approximately 0.51 feet at the centerline gage. Flow was 0.2 cfs on June 6 and peak discharge was recorded on June 7 at 4.4 cfs. Flow dropped to 3.2 cfs by June 8. Table 5-15 presents the observations, water surface elevations, and discharge measurements recorded for Site 7.

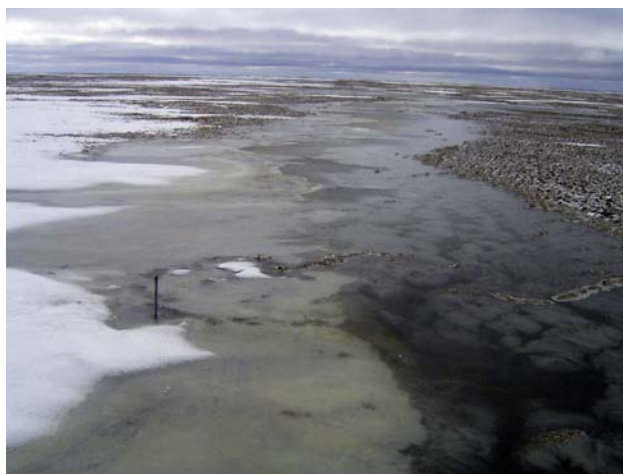
Photo 5-15 Site 11, June 3, 2006.

The Site 11 centerline peak water surface elevation occurred on June 2 at an elevation of 20.95 feet. Photo 5-15 shows the conditions of Site 11 the day after peak stage on June 3. Throughout breakup, stage fluctuated by approximately 0.75 feet at the centerline gage. Flow was less than 1 cfs on June 4 and peak discharge was recorded on June 6 at 2.7 cfs. Flow dropped to 2.4 cfs by June 7. Table 5-19 presents the observations, water surface elevations, and discharge measurements recorded for Site 11.

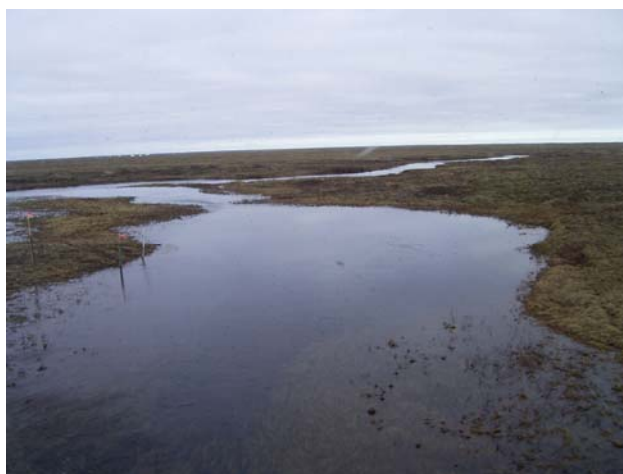
Photo 5-16 Site 12, June 12, 2006.

The Site 12 centerline peak water surface elevation occurred on June 2 at an elevation of 17.00 feet. Throughout breakup, stage fluctuated by approximately 0.57 feet at the centerline gage. Flow was 24.7 cfs on June 5 and peak discharge was recorded on June 7 at 46.4 cfs. The conditions of Site 12 are shown in Photo 5-16 on June 12. Flow dropped to 18.5 cfs by June 16. Table 5-20 presents the observations, water surface elevations, and discharge measurements recorded for Site 12.

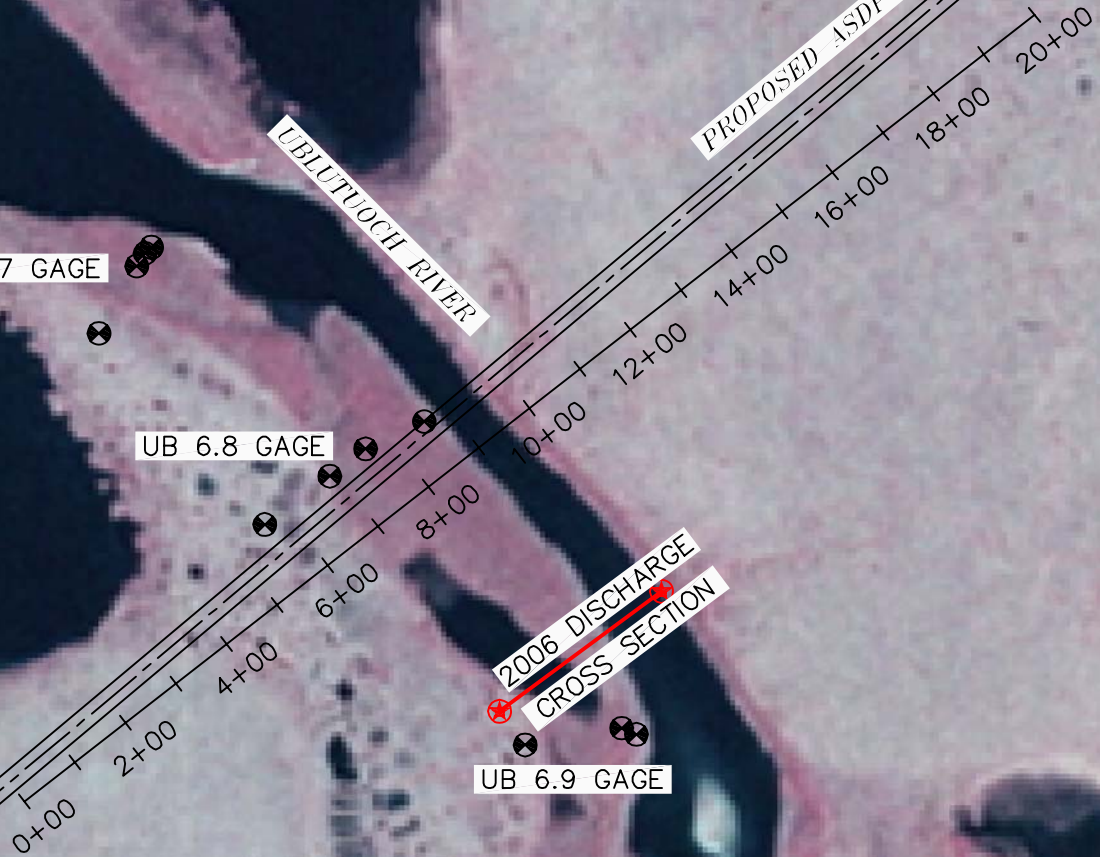
2006 SPRING BREAK-UP
UBLUTUOCH 6.8
PLAN
FIGURE 5-1
(SHEET 1 OF 2)

2006 DISCHARGE
CROSS SECTION
