ALPINE PIPELINE RIVER CROSSINGS 2010 MONITORING REPORT

Michael Baker, Jr., Inc.

September 2010

120259-MBJ-RPT-001

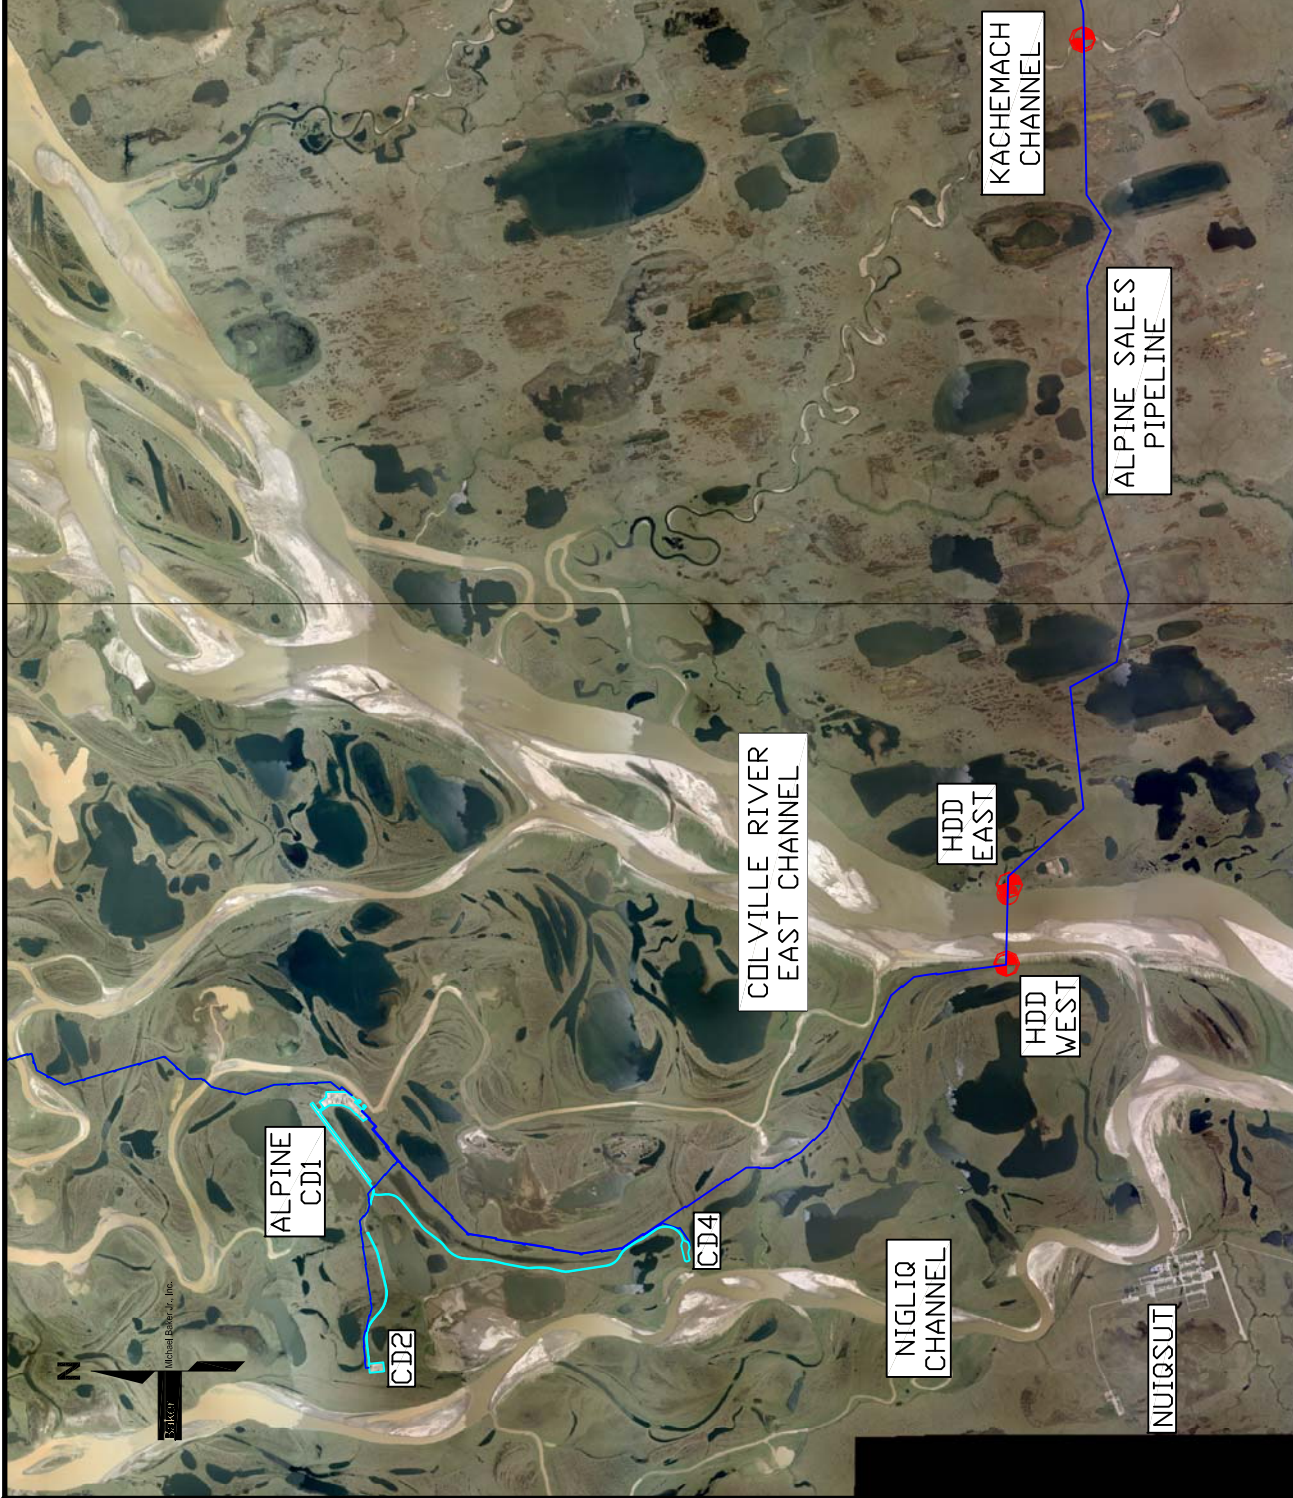
FIGURE 1

The 2010 monitoring event included visual observations at all three crossings, as well as LCMF bank erosion surveys at the HDD crossing. Figure 1 illustrates the location of the crossings.

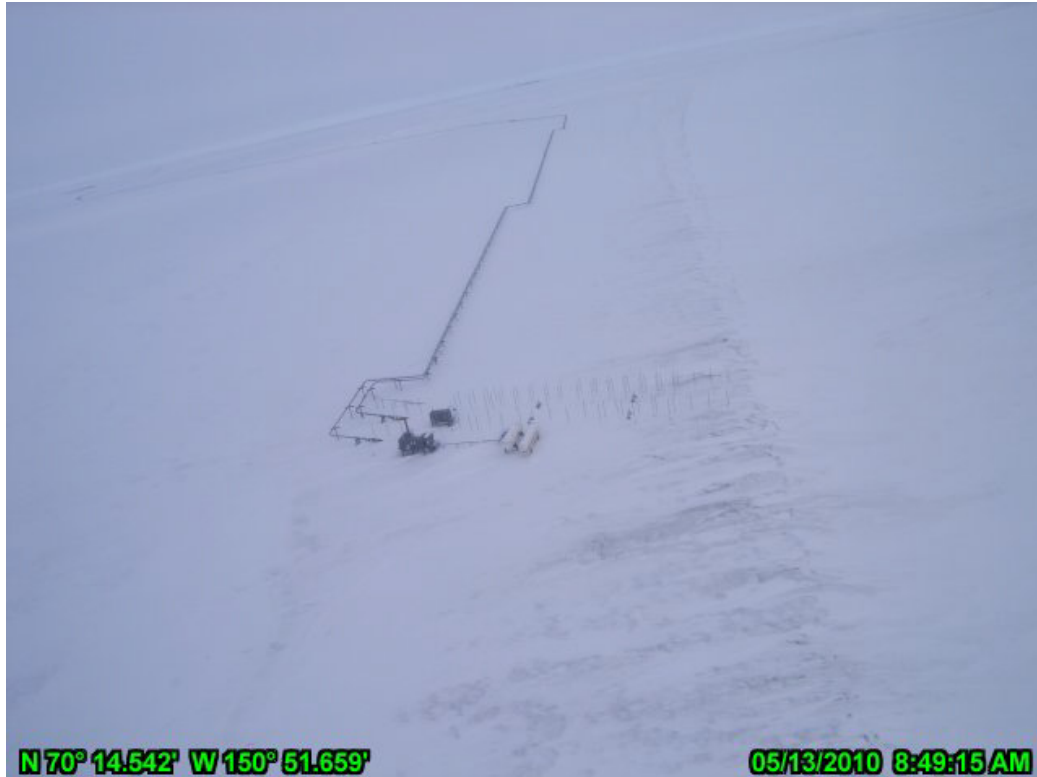
PHOTO A.1 HDD WEST, MAY 13, 2010: PRE-BREAKUP LOOKING NORTH

While floodwaters reached the west bank, the 2010 Colville River breakup floodwaters did not overtop the west bank of the channel. Some erosion was evident along the west bank. Two distinct debris lines, composed of mainly sticks and small timber, were observed on the bank of the HDD West pipeline crossing. One debris line was located at the toe of the HDD west bank and was most likely deposited following peak stage on the Colville River. A second, lower, debris line was noted approximately 25 feet east of the bottom toe of the bank, between the toe of the bank and the present edge of water. This lower elevation debris line is most likely due to a secondary smaller peak event in the East Channel.

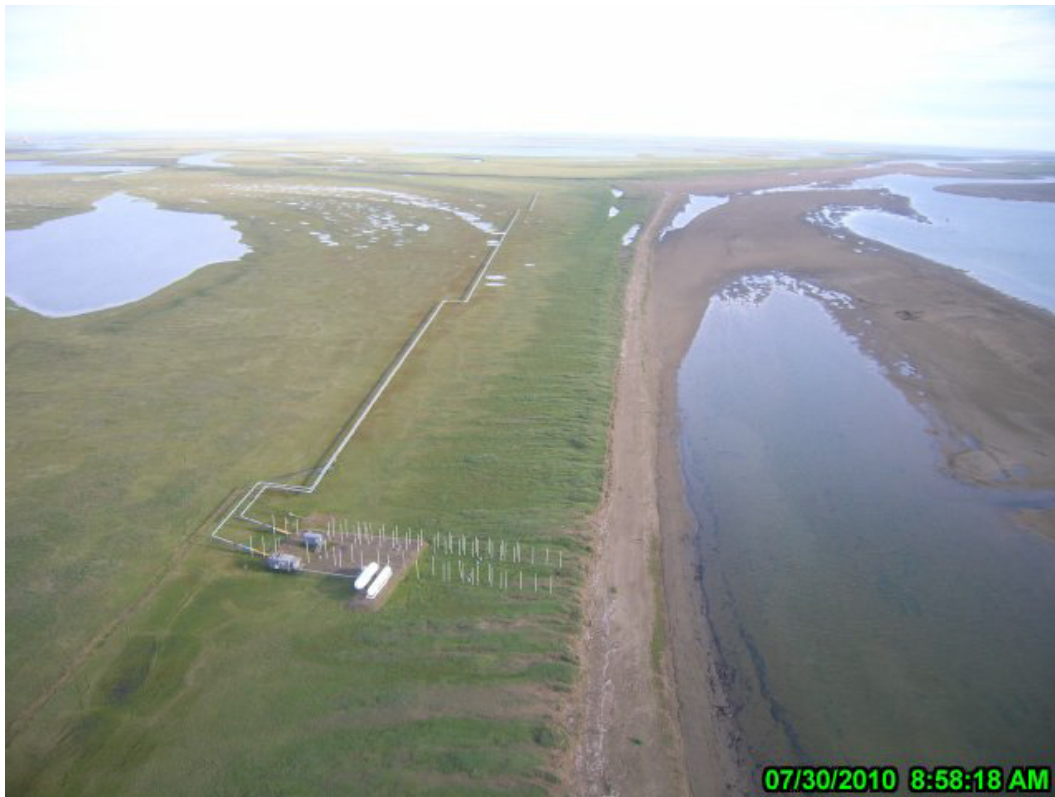
PHOTO A.3 HDD WEST, JULY 30, 2010: WEST BANK, LOOKING NORTH

Based on visual observations, bank erosion does not appear to be significant, although some erosion was evident upon visual inspection. Flow direction is largely unchanged. The pipelines appeared to be in good condition with no apparent leaks.

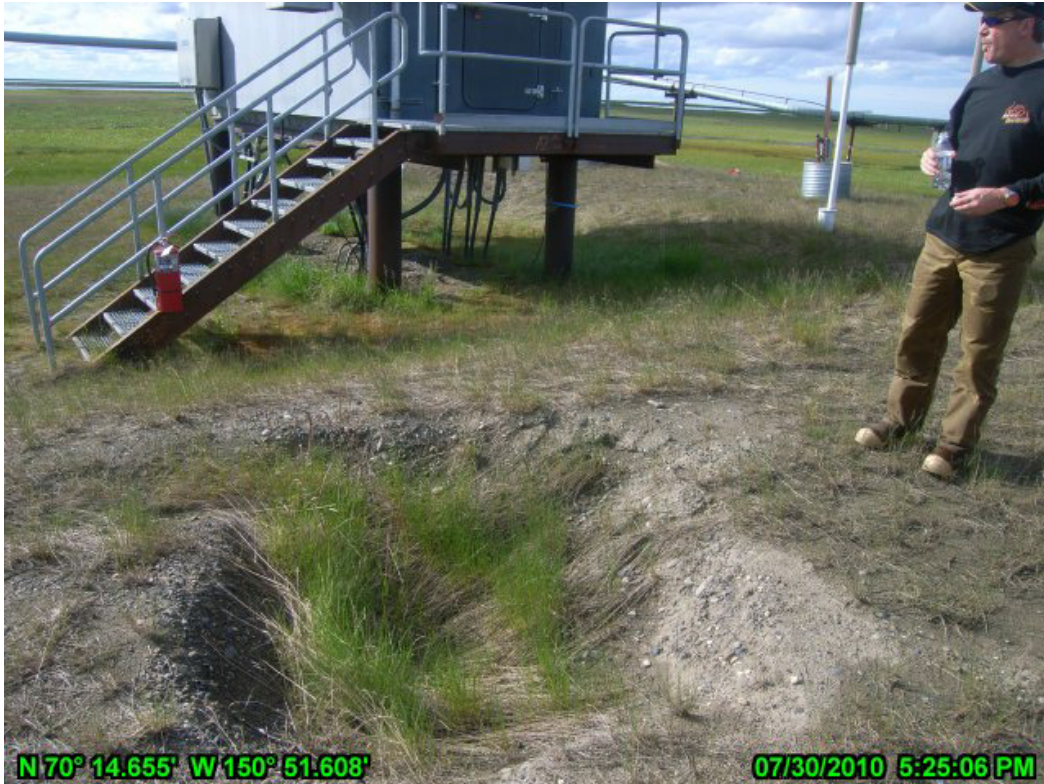
PHOTO A.5 HDD WEST, JULY 30, 2010: PIT IN GRAVEL PAD EAST OF CP MODULE BUILDINGS

In 2009, Baker identified three “pits” in the gravel pads near the buildings at HDD West (Baker 2009). These pits were still present during the 2010 survey and did not change significantly from the 2009 visual survey. Photo A.5 in Appendix A shows an example of one of the three pits in the gravel pad. All three pits are located west of the large propane tanks, and generally east of the two CP Module buildings, and do not appear to affect the integrity of the pad.

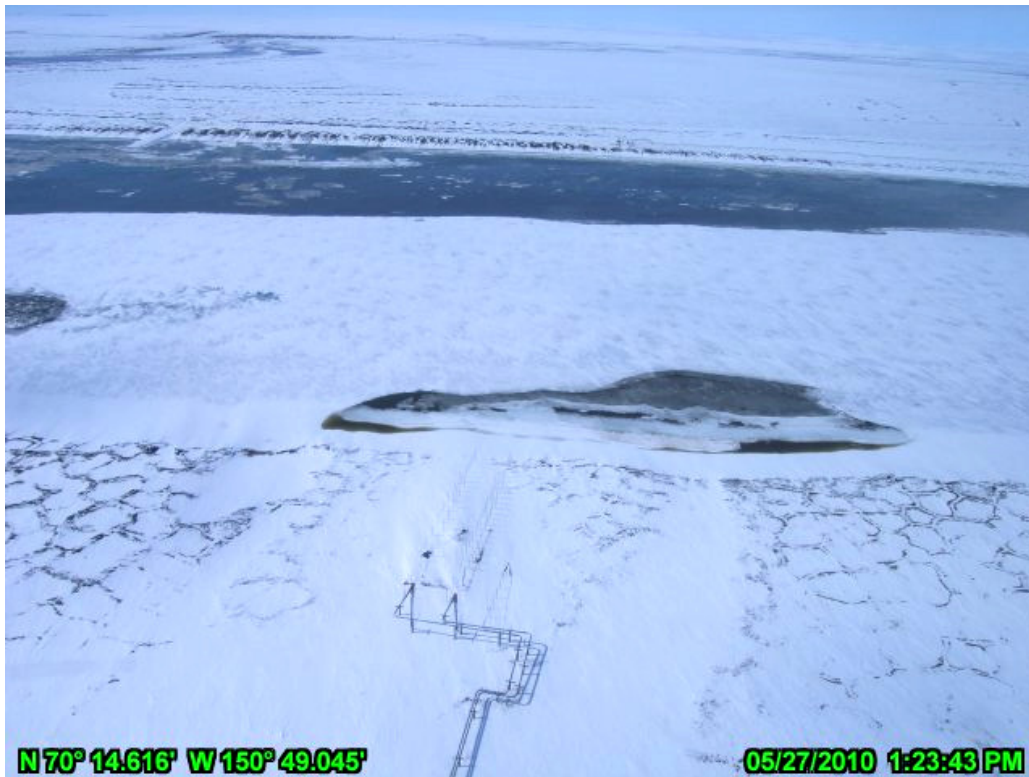
PHOTO A.6 HDD EAST, MAY 27, 2010: FIVE DAYS BEFORE PEAK STAGE, LOOKING WEST

The east bank of the Colville River HDD crossing was evaluated by visual observation, review of ground and aerial photography (Photo A.6 through Photo A.13 in Appendix A), as well as both field and topographic surveys. The 2010 Colville River breakup floodwaters did not overtop the east bank of the channel.

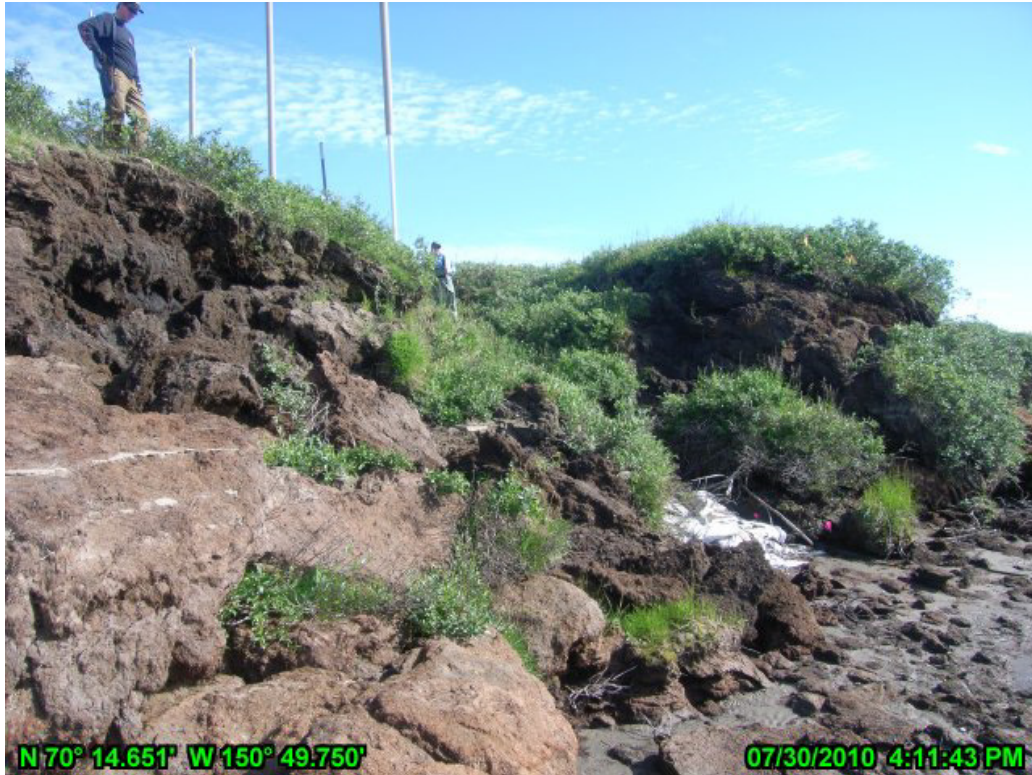
PHOTO A.11 HDD EAST, JULY 30, 2010: TROUGH FROM TOE OF BANK, LOOKING SOUTHEAST

As noted in 2009, some erosion and sloughing has occurred along the east bank, with exposed sandbags and Styrofoam evident. While the date of that placement is not known, it is our understanding that the sandbags and Styrofoam were placed in the bank to combat further erosion. As noted during the field visit, some large pieces of tundra have collapsed down the embankment into the channel. (Photo A.11 through Photo A.12 in Appendix A).

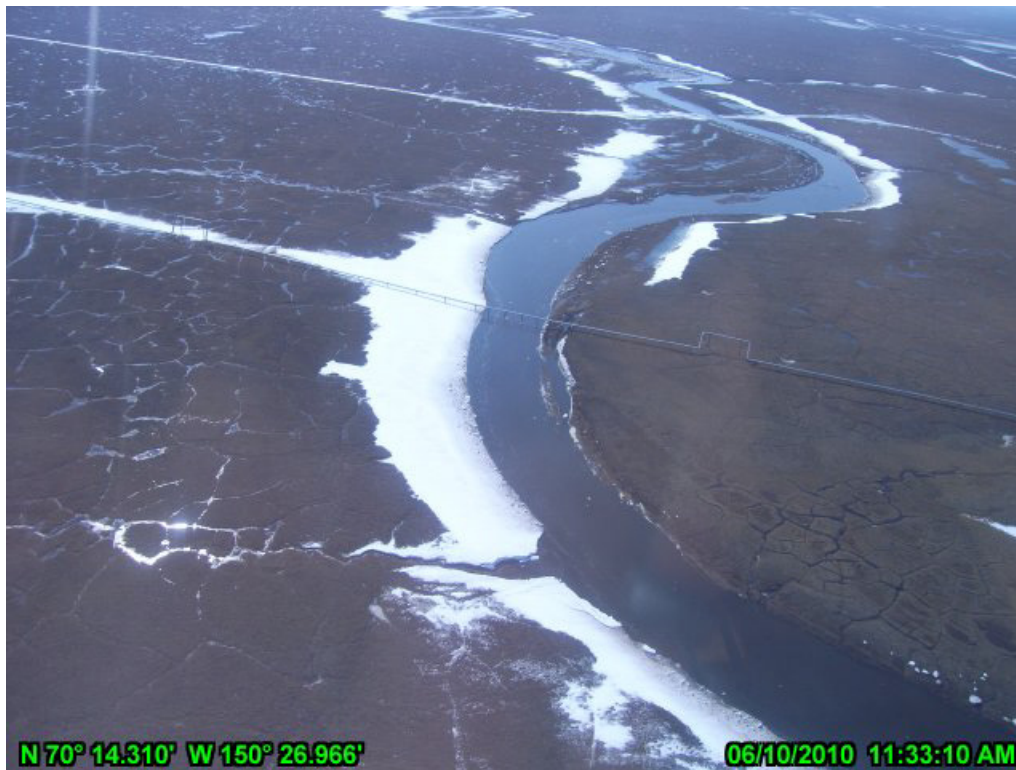
PHOTO A.14 KACHEMACH RIVER CROSSING, JUNE 10, 2010: LOOKING SOUTHEAST

The Kachemach River crossing was evaluated by visual observation, review of ground and aerial photography (Photo A.14 through Photo A.20; Appendix A), and field surveys. At the time of the field visit, flow was observed within and across the gravel channel bottom at a depth of generally less than four feet.

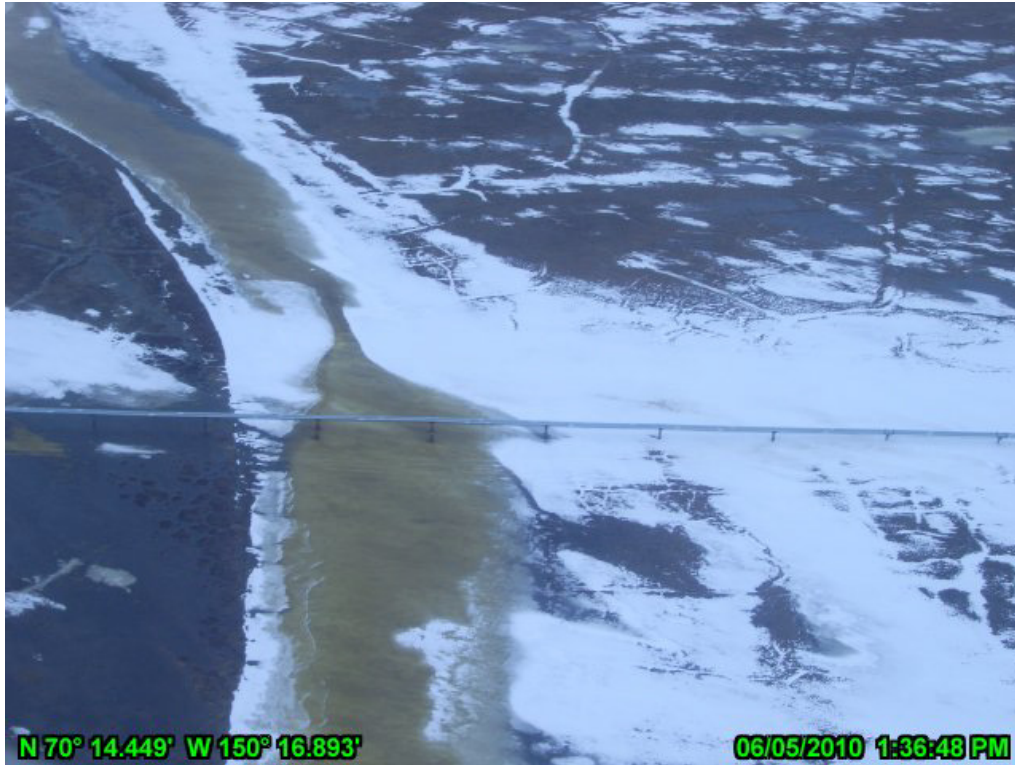
PHOTO A.21 MILUVEACH RIVER CROSSING, JUNE 5, 2010: PRE-BREAKUP, LOOKING NORTH

The Miluveach River crossing was evaluated by visual observation, review of ground and aerial photography (Photo A.21 through Photo A.28; Appendix A), and field surveys. At the time of the field visit, flow was observed to be confined to the east side of the channel, approximately 11.0 feet in width, and 0.55 feet deep. Based on visual observation, flow from the 2010 breakup was confined to the main channel and did not appear to have reached the overbank regions adjacent to the river crossing.
