2014

CD5 LAKES RECHARGE STUDIES

141010-MBJ-RPT-001 | 8/26/2014

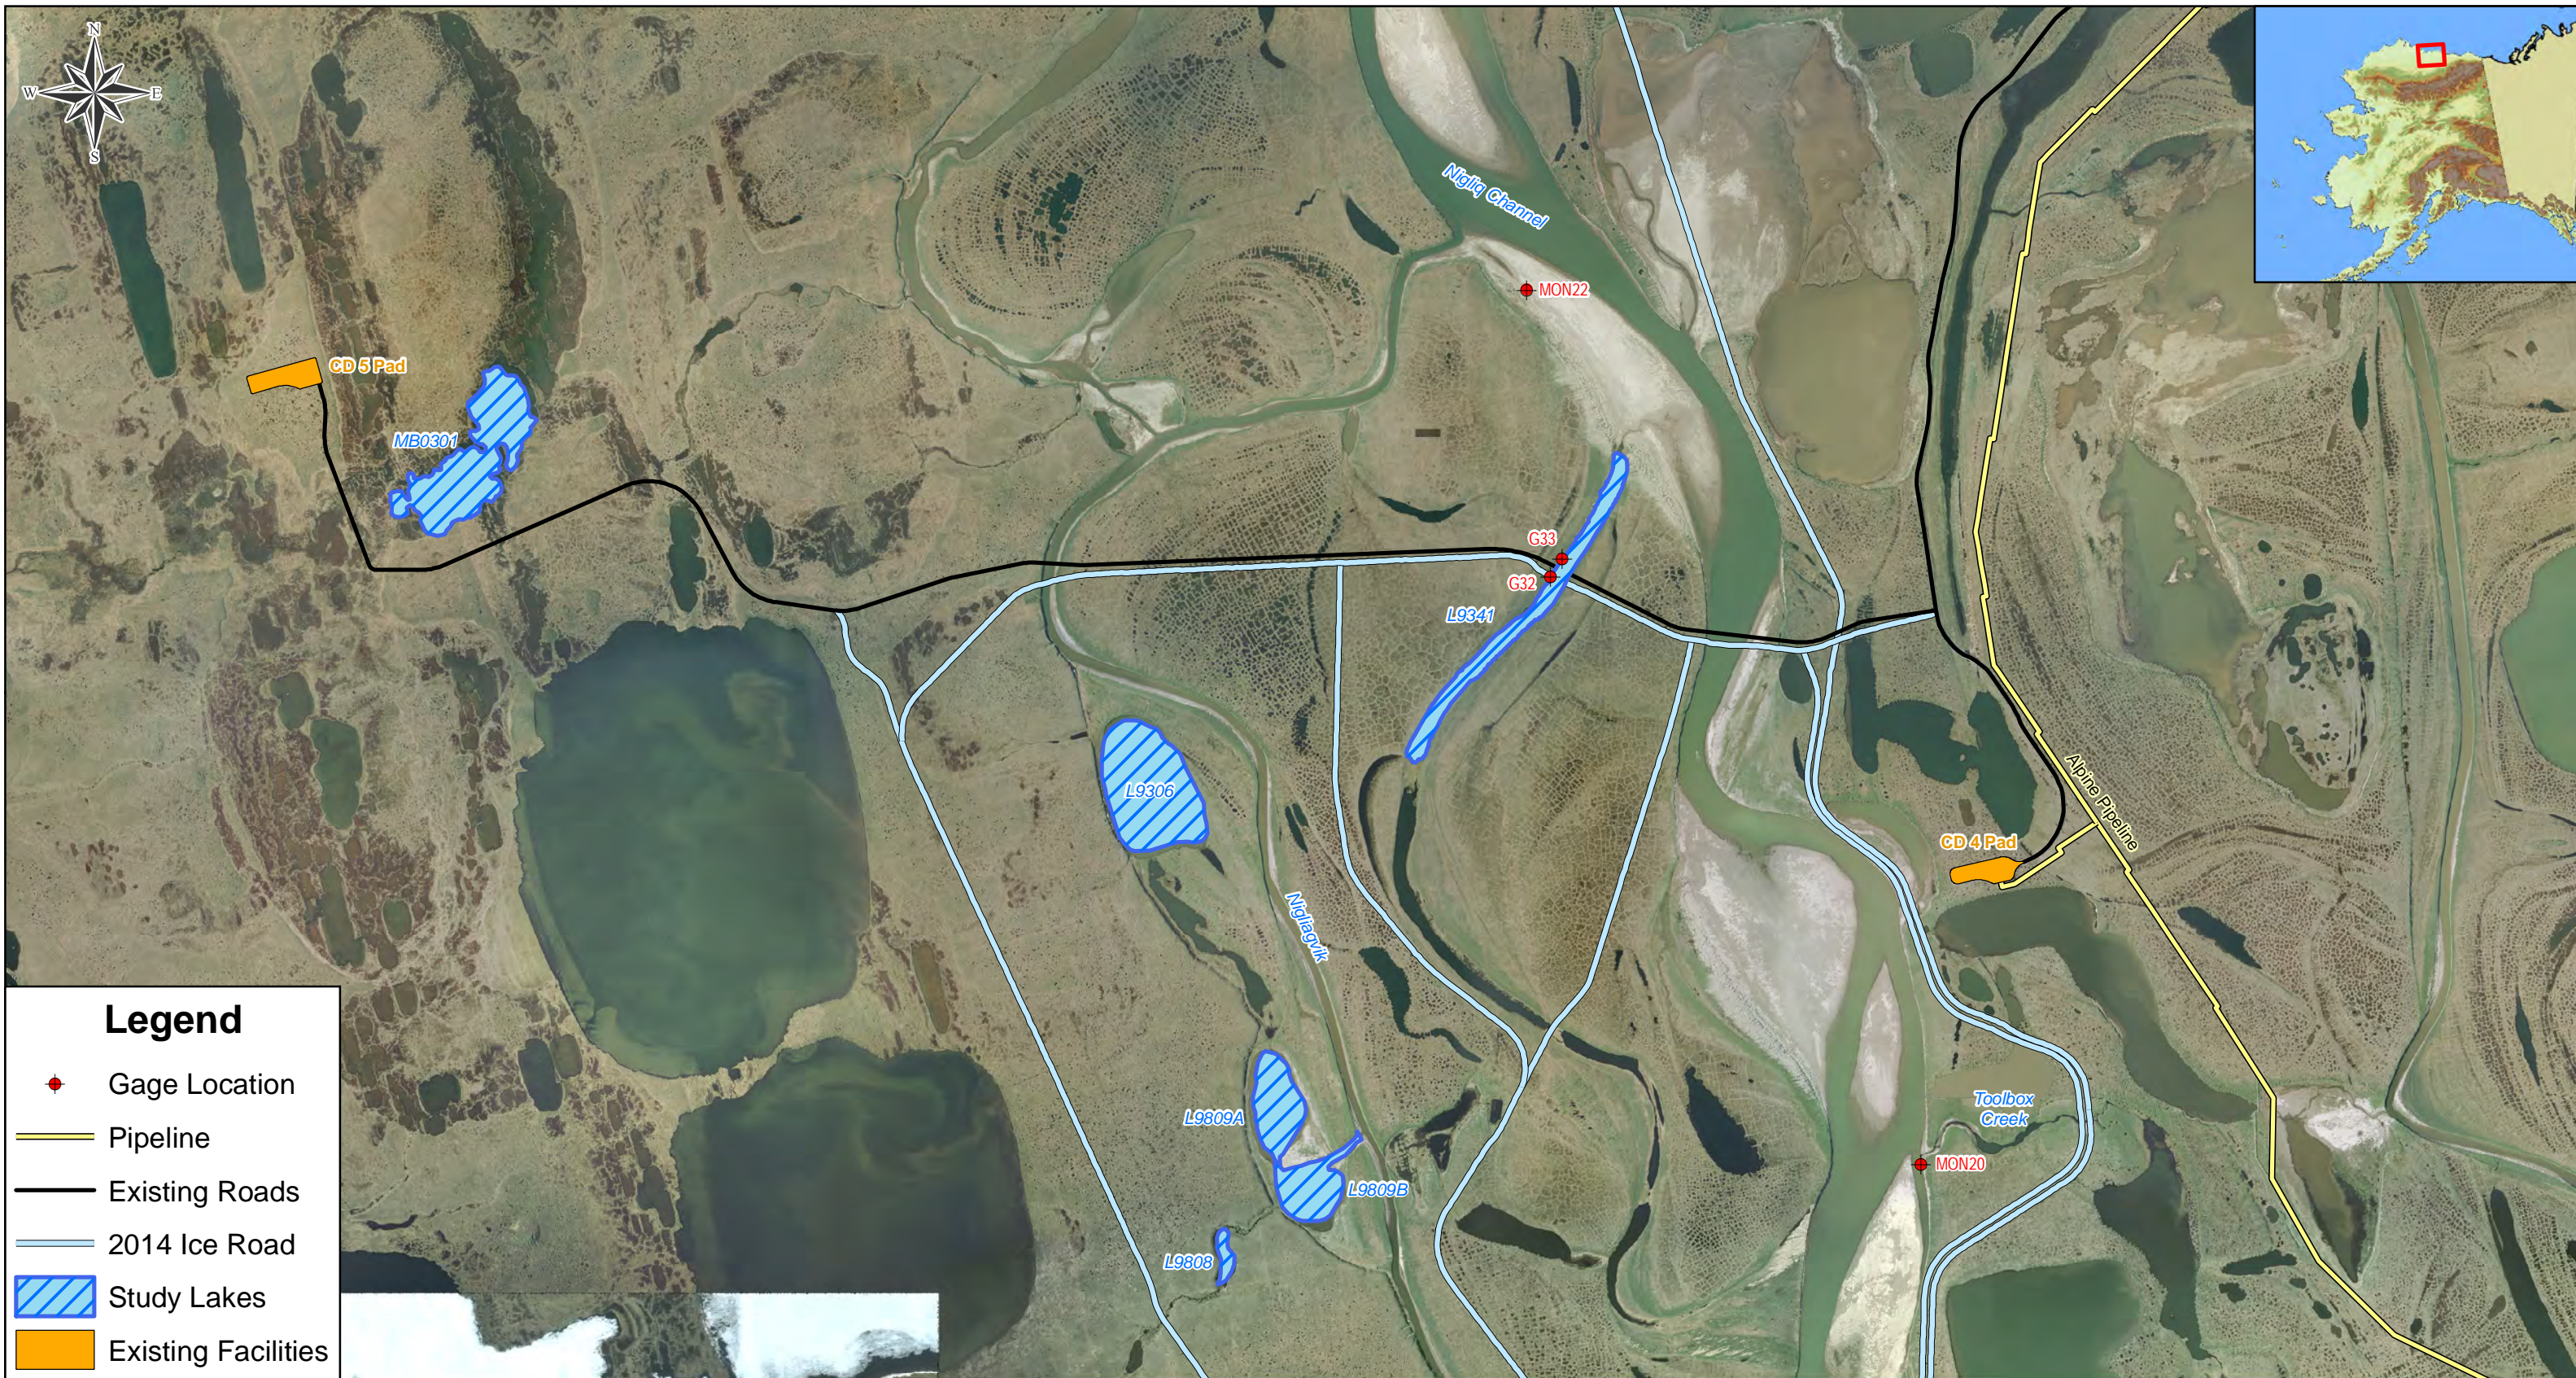
2014 CD5 AREA LAKES RECHARGE STUDY
FIGURE: 1.1
(SHEET 1 of 1)

The objectives of the 2014 CD5 Lakes Recharge Studies include collection and analysis of spring breakup recharge data at six water withdrawal lakes. Lake studies included observations and photos at all lakes and gage water surface elevation (WSE) measurements at Lake L9341. The 2014 CD5 Lakes are listed in Table 1.1 and the locations are shown on Figure 1.1.

- ◆ Gage Location
- Pipeline
- Existing Roads
- 2014 Ice Road
- Study Lakes
- Existing Facilities

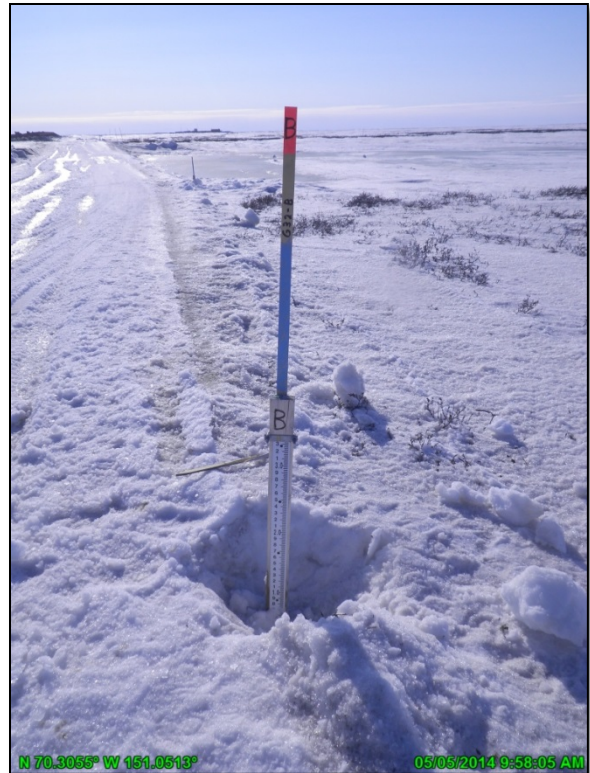
Photo 3.1: Staff gage, G32-B on Lake L9341, pre-breakup; May 5, 2014

A staff gage assembly consists of a metal gage faceplate mounted on a two-by-four timber. The timber is attached with U-bolts to a 1.5-inch wide angle iron driven approximately 2 feet into the ground. All gages installed are indirect-read staff gages; meaning, the values read on the gage faceplate do not directly correspond to a known elevation. Photo 3.1 shows a gage setup at Lake L9341. A tabulated list of gage and temporary benchmark (TBM) locations is included in Appendix A.

Standard differential leveling techniques were used to establish the staff gage elevation with a local TBM. Elevations of the staff gages at Lake L9341 were based on a preexisting TBM tied to British Petroleum Mean Sea Level (BPMSL) elevation.

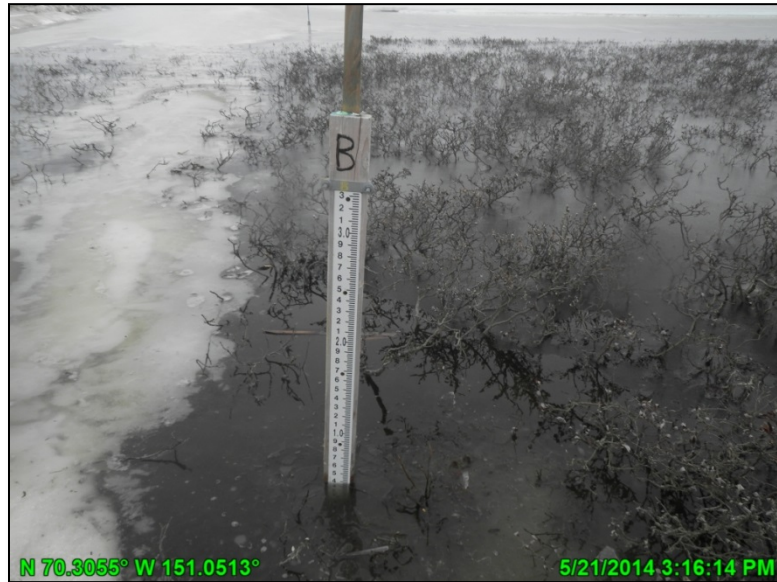
Photo 4.1: Gage G32 during breakup; May 21, 2014

Existing gages G32 and G33 were used to monitor recharge of Lake L9341 (Photo 4.1 and Photo 4.2). The WSE data and hydrograph for Lake L9341 are presented in Table 4.1.

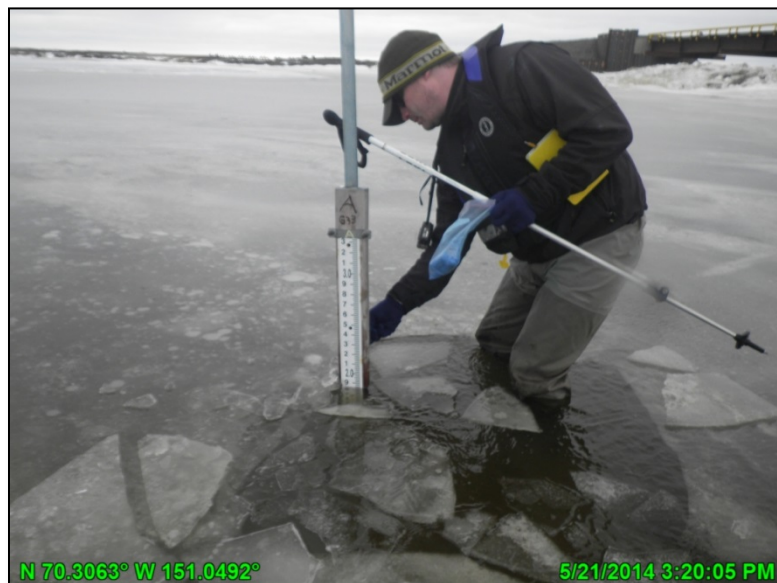
Photo 4.2: Gage G33 during breakup; May 21, 2014

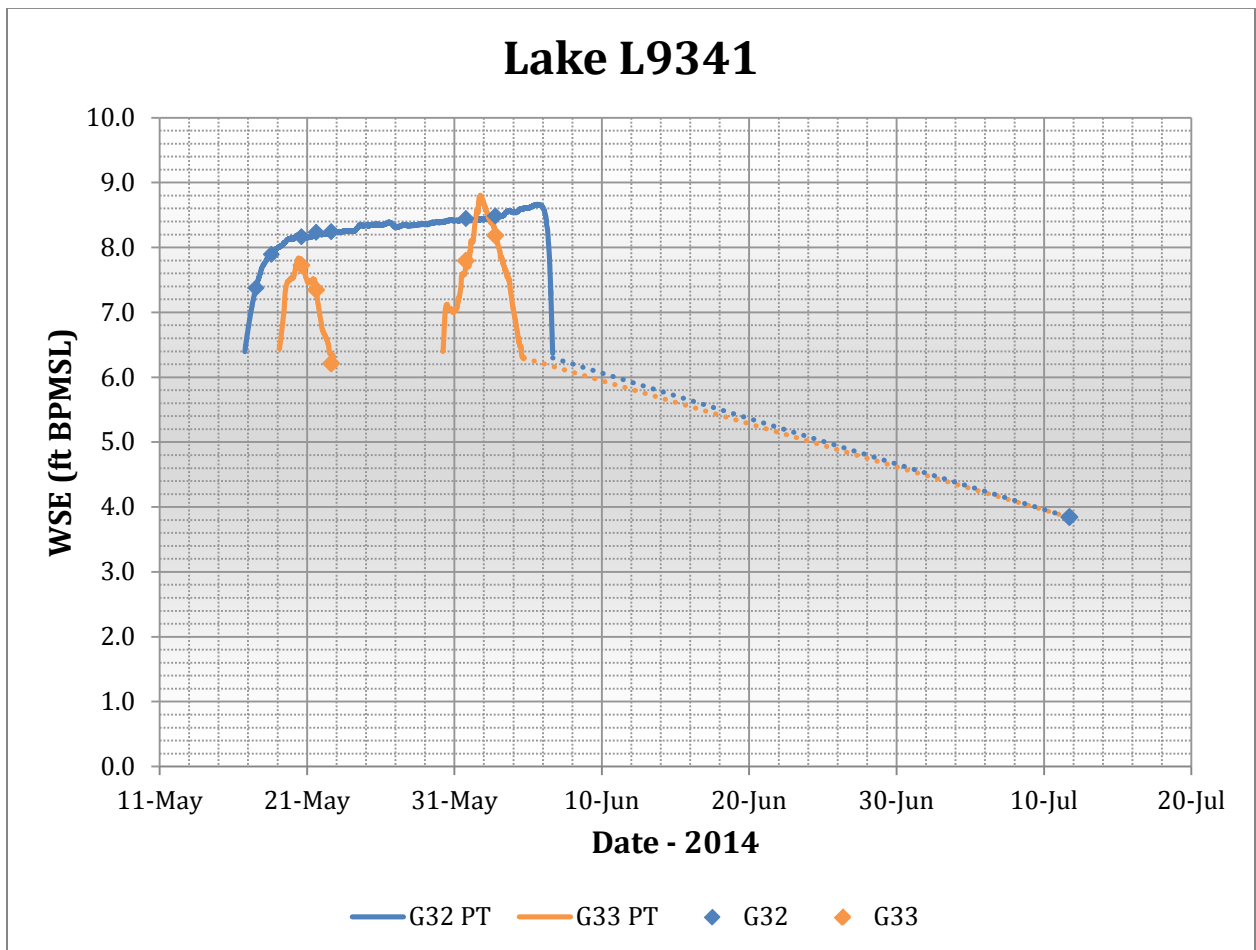
Table 4.1: WSE Data for Lake L9341

Date and Time	WSE (feet BPMSL)		Observations
	G32	G33	
5/17/14 12:49 PM	7.37	-	Pressure transducer and gages are dry at G33
5/18/14 2:19 PM	7.89	-	Water begins to pond south of ice bridge crossing near G32
5/20/14 2:52 PM	8.16	7.72	Backwater effects observed from the Nigliq Channel
5/21/14 3:15 PM	8.23	7.34	
5/22/14 3:38 PM	8.24	6.21	Pressure transducer dry at G33
5/31/14 7:08 PM	8.44	7.79	
6/1/14 6:00 PM	-	8.80	Peak stage – based on pressure transducer data
6/2/14 7:04 PM	8.48	8.18	
6/5/14 3:30 PM	8.67	-	Peak stage – based on pressure transducer data
7/11/14 5:30 PM	3.84	3.84	Not hydraulically connected to the Nigliq Channel

1. Elevations are assumed based on Monument MON27 at 13.91 feet elevation BPMSL, surveyed by LCMF in 2014
2. Dashed line indicates a greater time interval between observations and that the change in WSE is not likely direct

A hydrograph showing changes in WSE over time was used to determine estimated lake recharge at Lake L9341. Recession of floodwaters is evident in a negative slope after peak stage, indicating the lake has recharged over bankfull conditions and is discharging excess water by means of overbank flow.

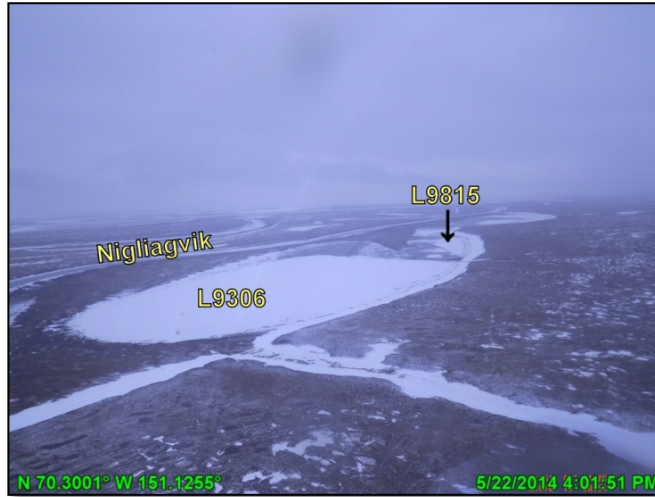
Photo B.1: Lake L9306 pre-breakup, looking southeast; May 22, 2014

During open water season, lakes L9809A and L9809B were hydraulically connected to the Nigliagvik; Lake L9306 was likely connected to Lake L9815 to the south. Other observed hydraulic connections with lakes L9341, L9808, and MB0301 are likely seasonal and limited to an increase in stage conditions during spring breakup. These lakes should be considered hydraulically isolated during the remainder of the year.

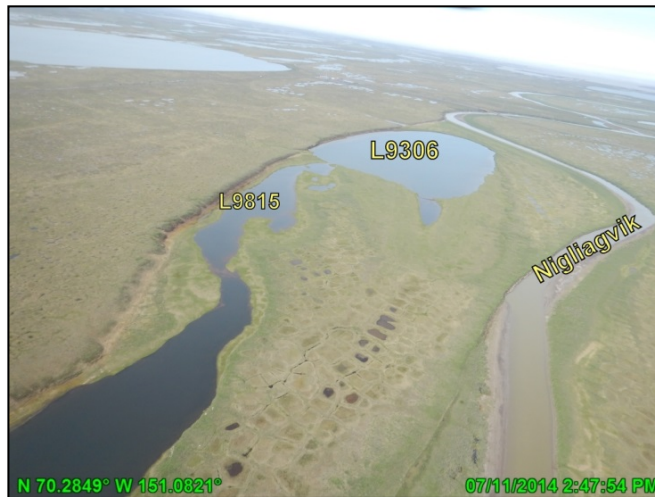
Photo B.2: Lake L9306 post breakup, looking northwest; July 11, 2014

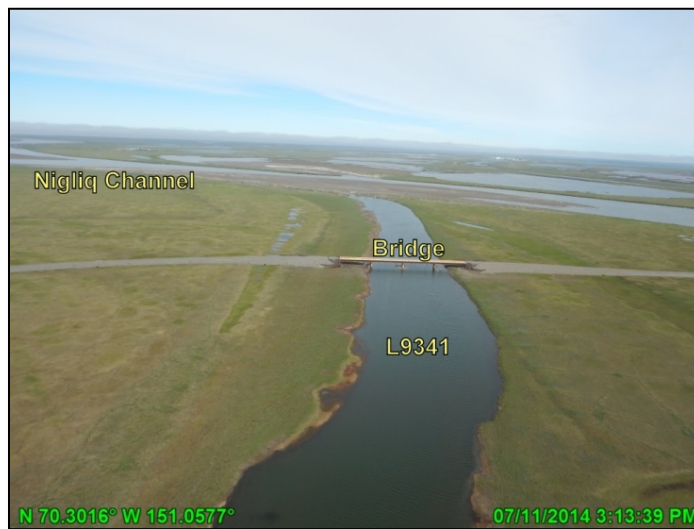
Photo B.4: Lake L9341 post-breakup, looking northeast; July 11, 2014

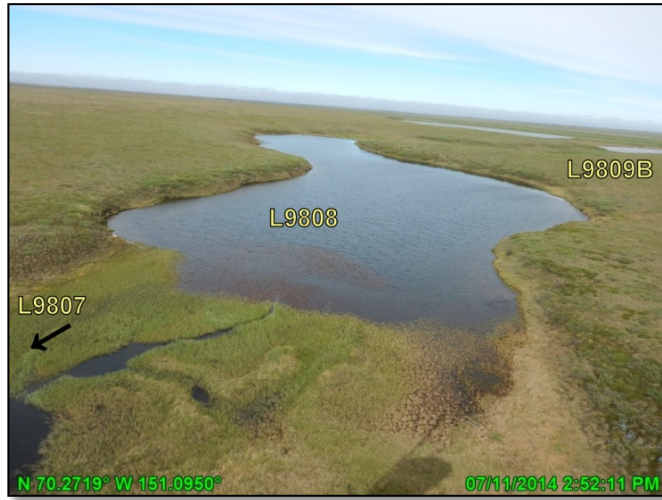
Photo B.5: Lake L9808 post-breakup, looking northeast; July 11, 2014

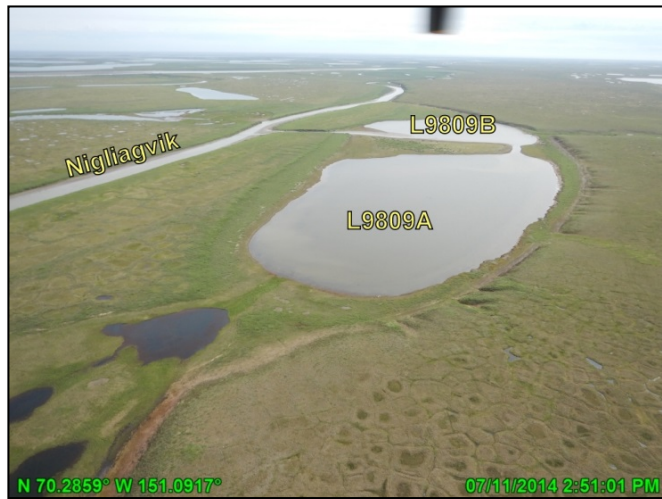
Photo B.6: Lake L9809A post-breakup, looking south; July 11, 2014

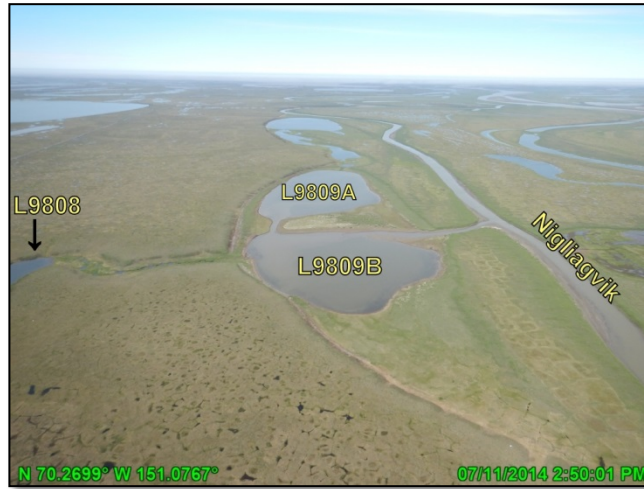
Photo B.7: Lake L9809B post-breakup, looking north; July 11, 2014

Lake L9809B recharged primarily from local flow from the Nigliagvik. Lakes L9306, L9808, L9809A, and MB0301 recharged from channelized flow from neighboring lakes.

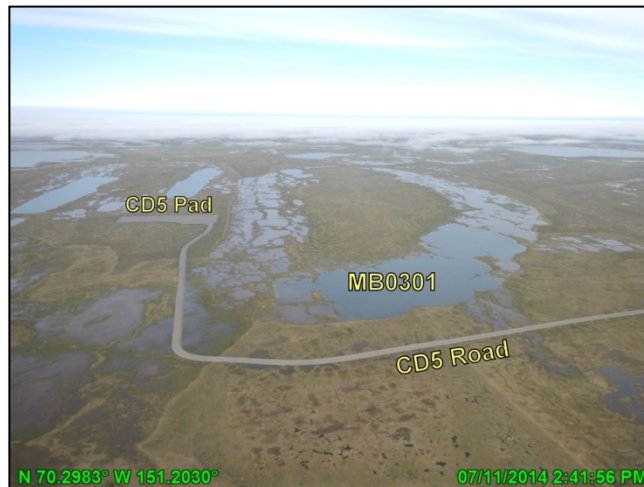
Photo B.9: Lake MB0301 post-breakup, looking north; July 11, 2014
