2014

EXPLORATION LAKES RECHARGE STUDIES

141011-MBJ-RPT-001 | 8/26/2014

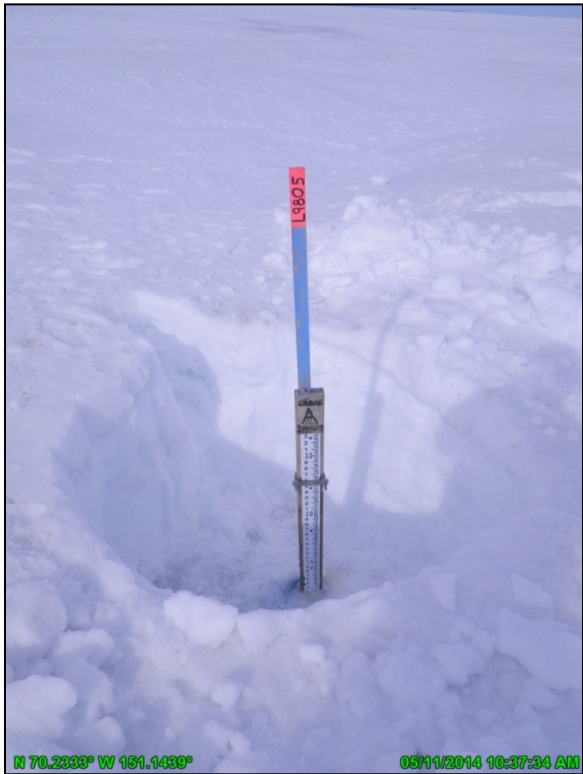
**Photo 3.1: Staff gage at Lake L9805, pre-breakup;
May 11, 2014**

A staff gage assembly consists of a metal gage faceplate mounted on a two-by-four timber. The timber is attached with U-bolts to a 1.5-inch wide angle iron driven approximately 2 feet into the ground. All gages installed are indirect-read staff gages; meaning, the values read on the gage faceplate do not directly correspond to a known elevation. Photo 3.1 shows the gage setup at Lake L9805. A tabulated list of gage and the temporary benchmark (TBM) location is included in Appendix A.

Changes in WSE were measured at Lake L9805. This gage was rehabilitated for 2014 and WSE monitoring was conducted during the pre-breakup, breakup, and post-breakup periods.

Baker installed a gage on Lake L9805 in May 2013; however, because of limited resources, Lake L9805 was not visited consistently throughout the monitoring program. The WSE data for Lake L9805 is presented in Table 4.1.

Date and Time	WSE ¹ (feet)	Observations
5/11/14 10:00 AM	92.85	
7/11/14 11:45 AM	93.04	No hydraulic connections

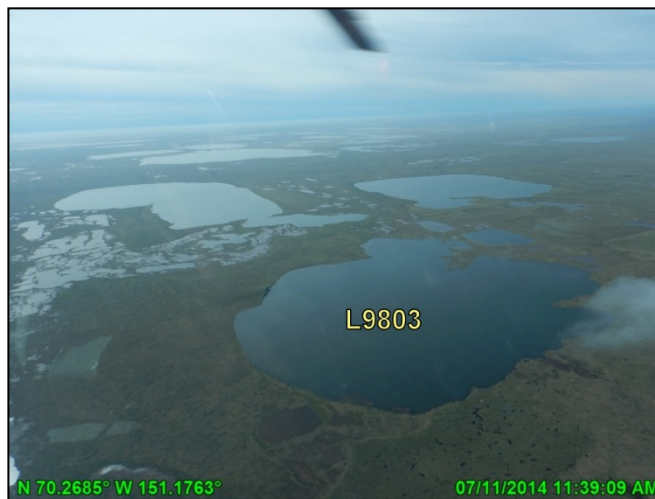
B.1 Lake L9803

Photo B.1: Lake L9803 pre-breakup, looking south; May 23, 2014

Photo B.2: Lake L9803 post-breakup, looking south; July 11, 2014

Recharge of lakes L9803, L9804, L9817, L9826, L9911/R0061, M1301, and M9914 was determined by visual observation and aerial photographs. These seven lakes were observed to fully recharge over bankfull during the 2014 monitoring season. Bankfull recharge was determined through visual observations of outflow.

Study Lake	Recharge to Bankfull	Primary Recharge Mechanism	Additional Hydraulic Connection ¹		Estimated Bankfull WSE ² (feet BPMSL)
			Flow In	Flow Out	
L9803	√	Local melt	No channelized flow	Flow into wetland (northwest)	--
L9804	√	Local melt	No channelized flow	Sheet flow into the Clover Material Source area (northwest)	--
L9805	Not Confirmed	Local melt	No channelized flow	No channelized flow	93.0
L9817	√	Local melt	No channelized flow	Flow into wetlands (west)	--
L9826	√	Ublutuoch River overbank flow	Ublutuoch River overbank flow and channelized flow from lakes L9803 and L9804	Sheet flow into Ublutuoch River (north)	--
L9911/R0061	√	Local melt	Local melt	Channelized flow into wetland (north)	--
M0024	Not Confirmed	Local melt	Channelized flow from wetlands (southeast)	No channelized flow	--
M1301	√	Local melt	No channelized flow	Flow into wetlands (south)	--
M9914	√	Local melt	Channelized flow from wetlands (south)	Flow into wetlands (north)	--

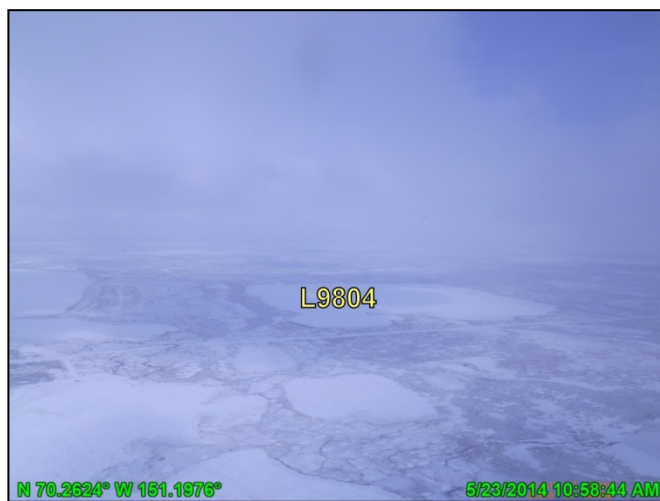
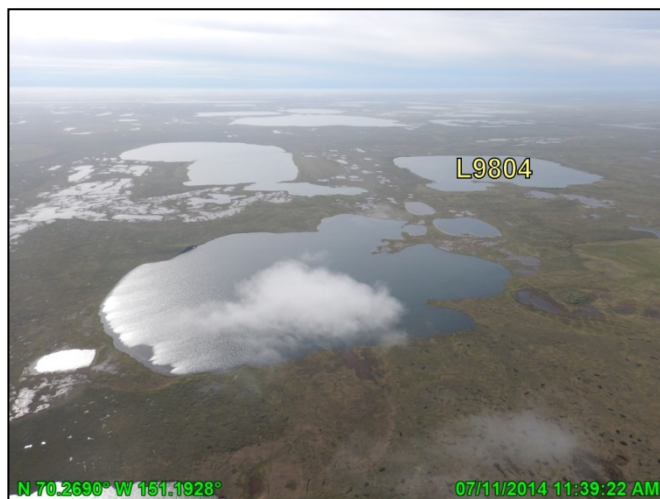
Photo B.3: Lake L9804 pre-breakup, looking southwest; May 23, 2014

Photo B.4: Lake L9804 post-breakup, looking southwest; July 11, 2014

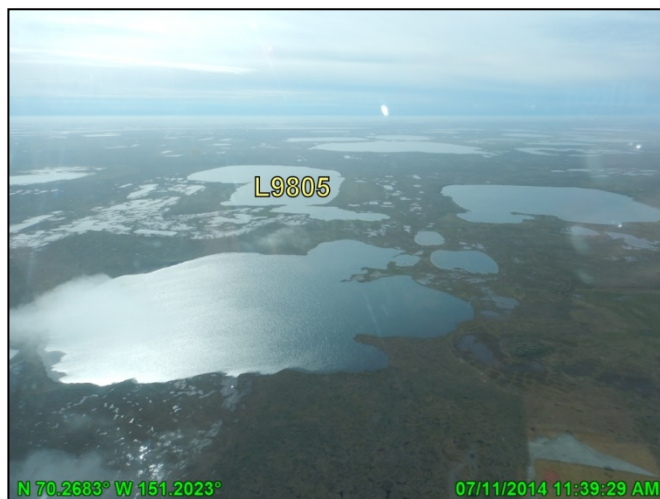
Photo B.5: Lake L9805 pre-breakup, looking southeast; May 23, 2014

Photo B.6: Lake L9805 post-breakup, looking south; July 11, 2014

Lakes L9805, M0024, M9915, M9922, M9923, and R0062 primary recharge mechanism was from local melt. These lakes were not observed draining into nearby water bodies or tundra. Based on available observations, bankfull recharge could not be confirmed. Regular visits to each lake were not possible and outflow drainage may have occurred between observations.

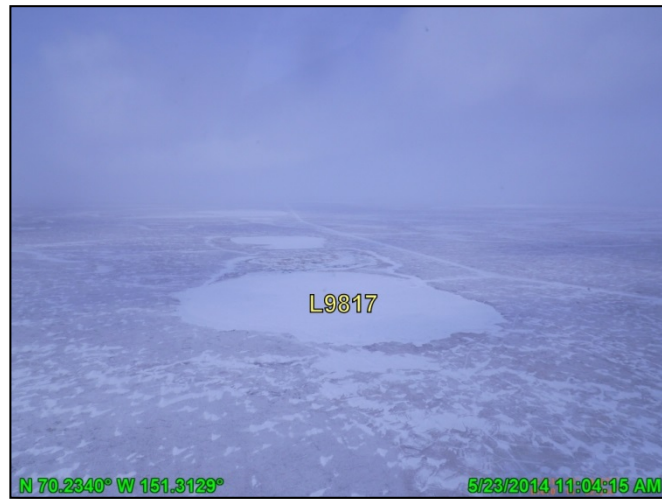
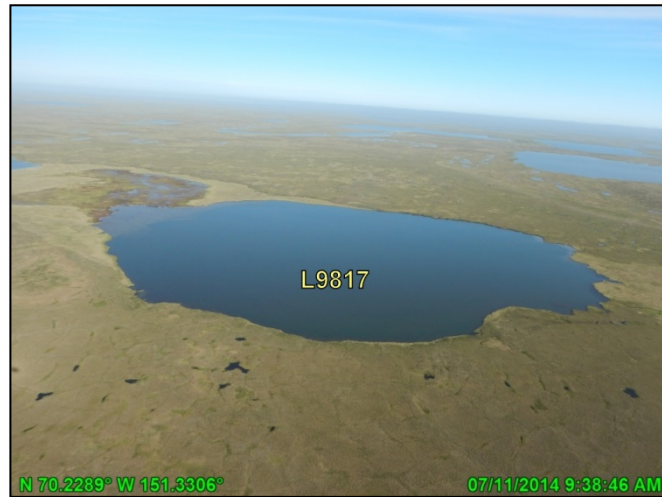
Photo B.7: Lake L9817 pre-breakup, looking west; May 23, 2014

Photo B.8: Lake L9817 post-breakup, looking northwest; July 11, 2014

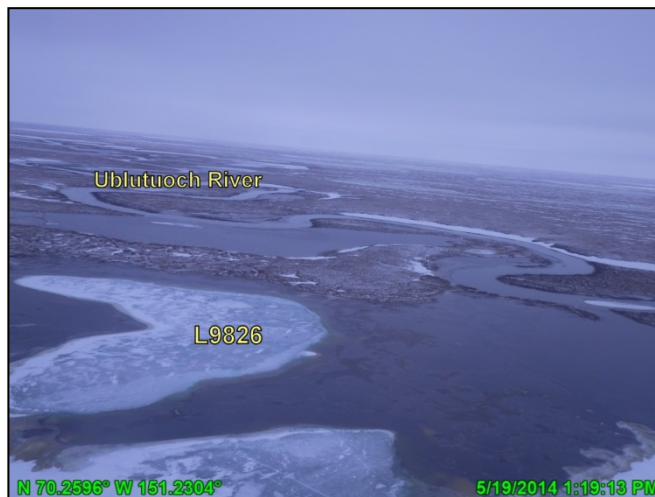
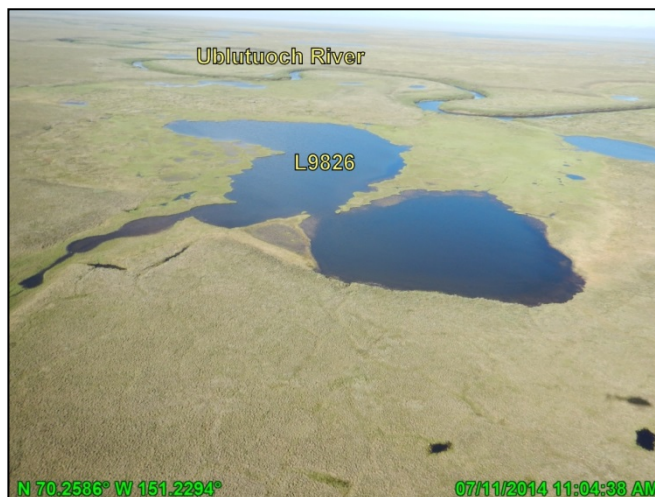
Photo B.9: Lake L9826 pre-breakup, looking west; May 19, 2014

Photo B.10: Lake L9826 post-breakup, looking west; July 11, 2014

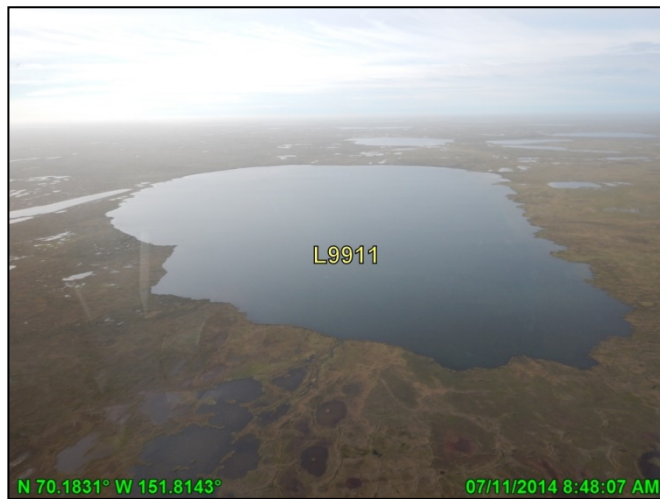
Photo B.11: Lake L9911 pre-breakup, looking northwest; May 23, 2014

Photo B.12: Lake L9911 post-breakup, looking south; July 11, 2014

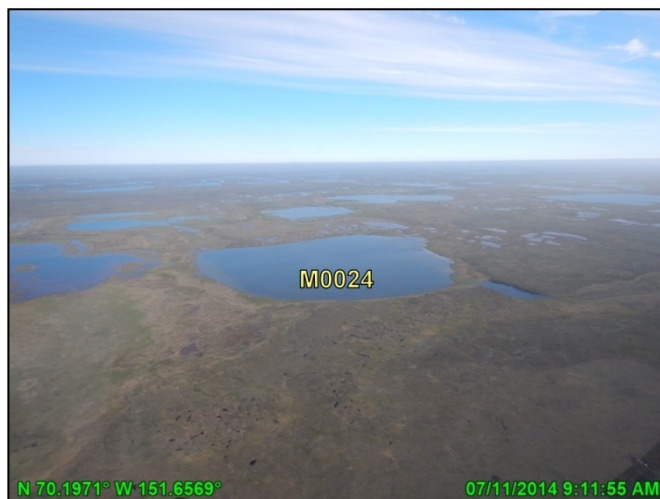
Photo B.13: Lake M0024 pre-breakup, looking south; May 23, 2014

Photo B.14: Lake M0024 post-breakup, looking northeast; July 11, 2014

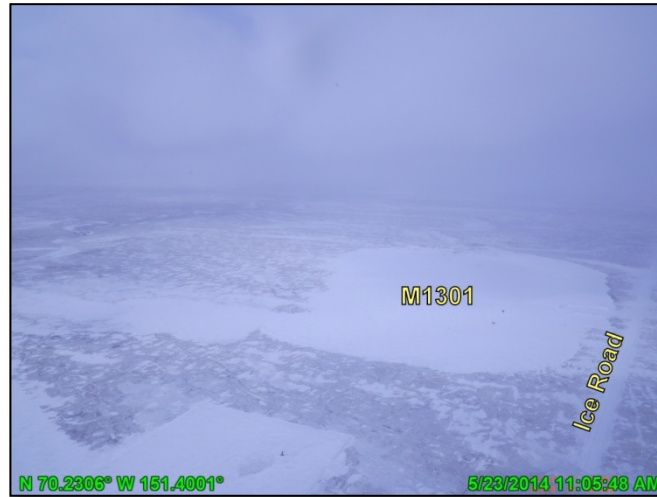
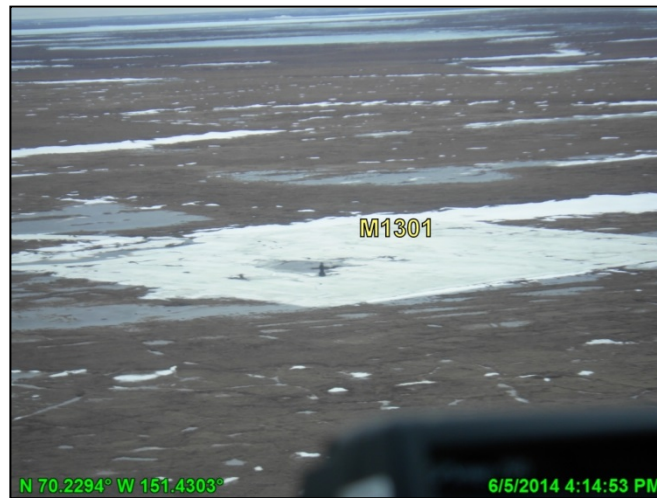
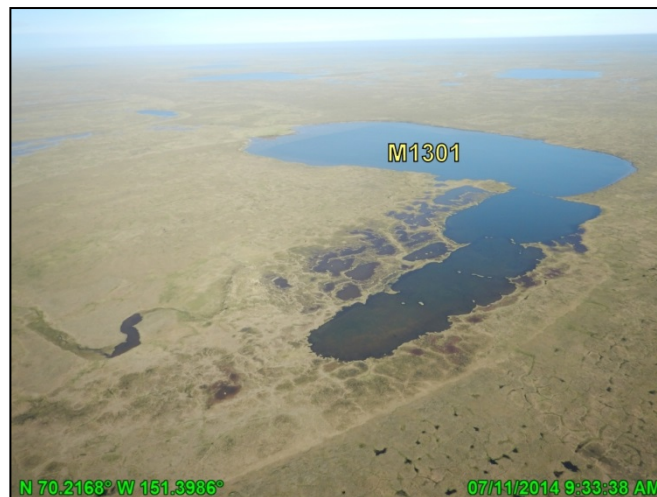
Photo B.15: Lake M1301 pre-breakup, looking southwest; May 23, 2014

Photo B.16: Lake M1301 during breakup, looking south; June 5, 2014

Photo B.17: Lake M1301 post-breakup, looking northwest; July 11, 2014

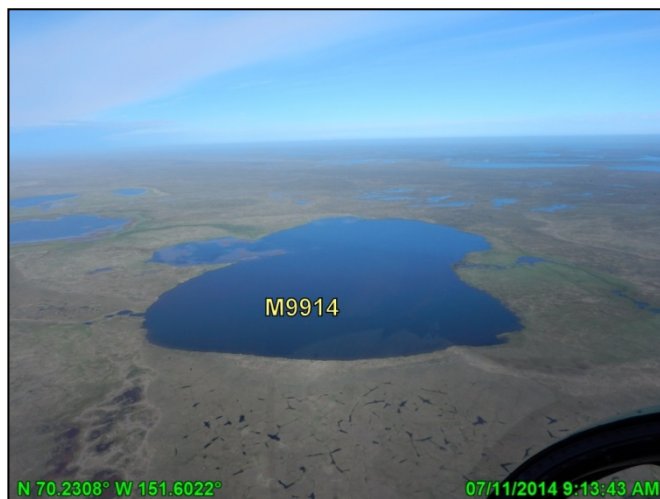
Photo B.18: Lake M9914 pre-breakup, looking northwest; May 23, 2014

Photo B.19: Lake M9914 post-breakup, looking northwest; July 11, 2014

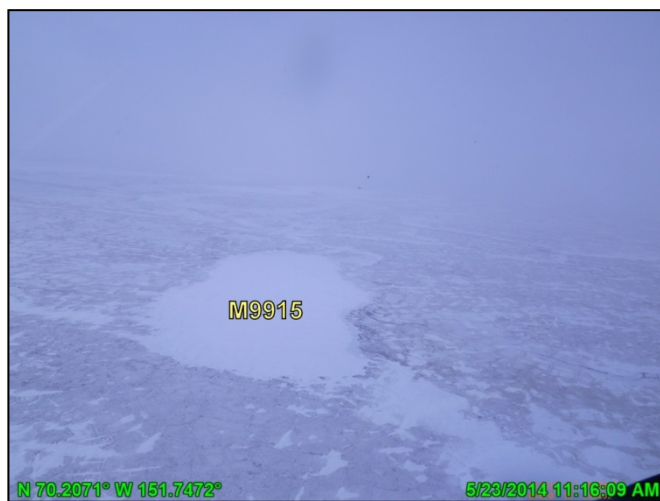
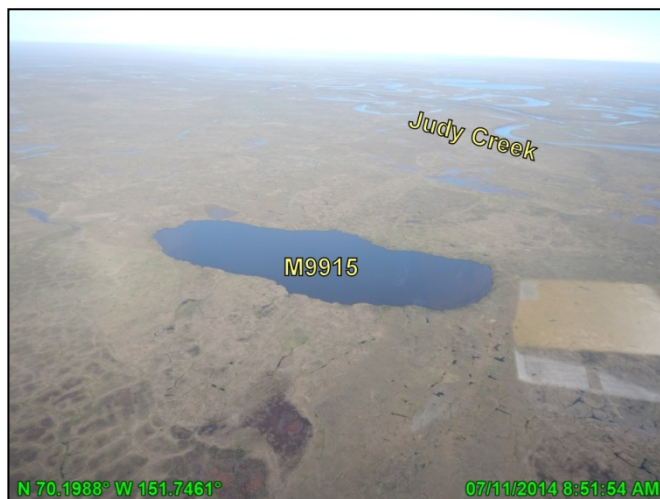
Photo B.20: Lake M9915 pre-breakup, looking southwest; May 23, 2014

Photo B.21: Lake M9915 post-breakup, looking northwest; July 11, 2014

M9915	Not Confirmed	Local melt	No channelized flow	No channelized flow	--
M9922	Not Confirmed	Local melt	No channelized flow	No channelized flow	--
M9923	Not Confirmed	Local melt	No channelized flow	No channelized flow	--
R0062	Not Confirmed	Local melt	No channelized flow	No channelized flow	--
<p>Notes:</p> <p>1. Observations between May 1 and July 12, 2014. Unless specified, hydraulic connections are likely seasonal only.</p> <p>2. WSE estimated based on gage readings for all years available</p> <p>-- Visual observations only, WSE not available</p>

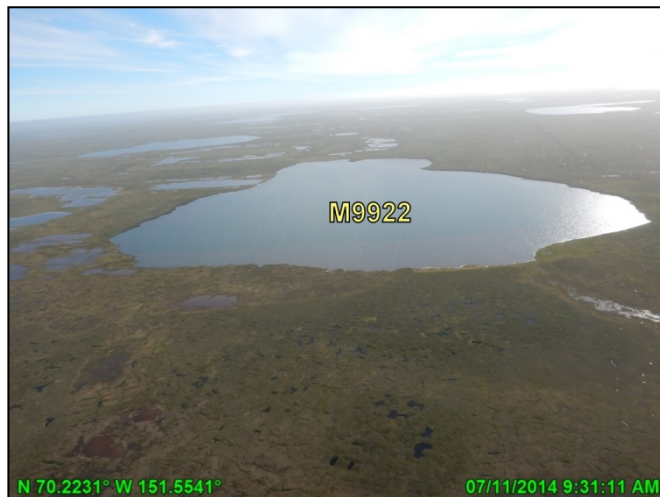
Photo B.22: Lake M9922 pre-breakup, looking west; May 23, 2014

Photo B.23: Lake M9922 post-breakup, looking west; July 11, 2014

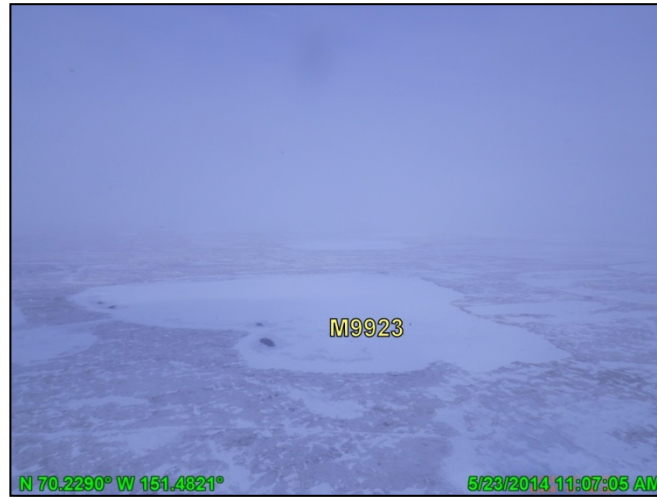
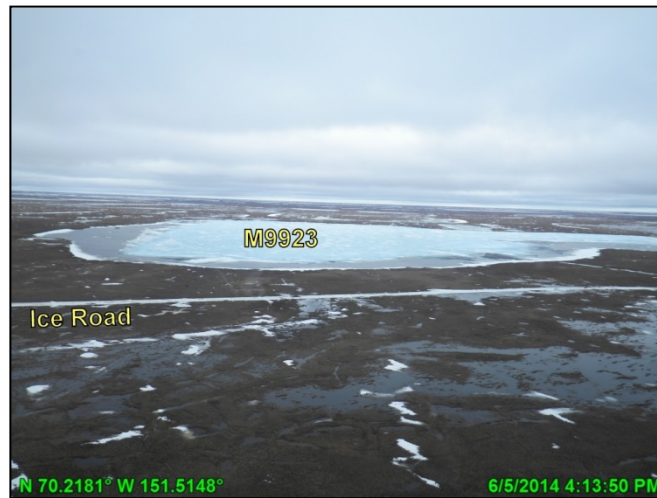
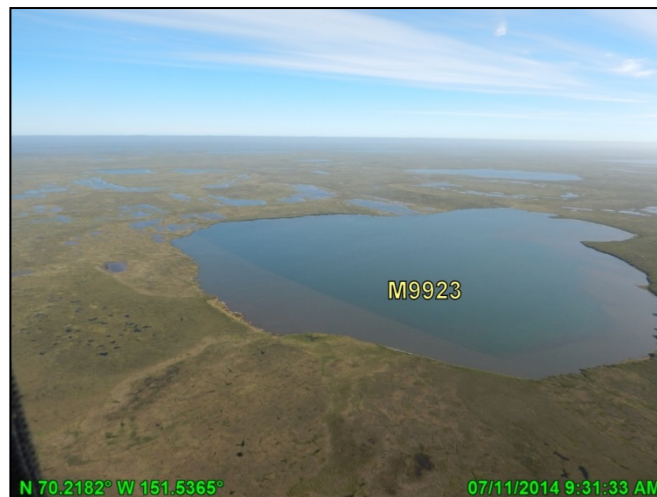
Photo B.24: Lake M9923 pre-breakup, looking west; May 23, 2014

Photo B.25: Lake M9923 during breakup, looking north; June 5, 2014

Photo B.26: Lake M9923 post-breakup, looking north; July 11, 2014

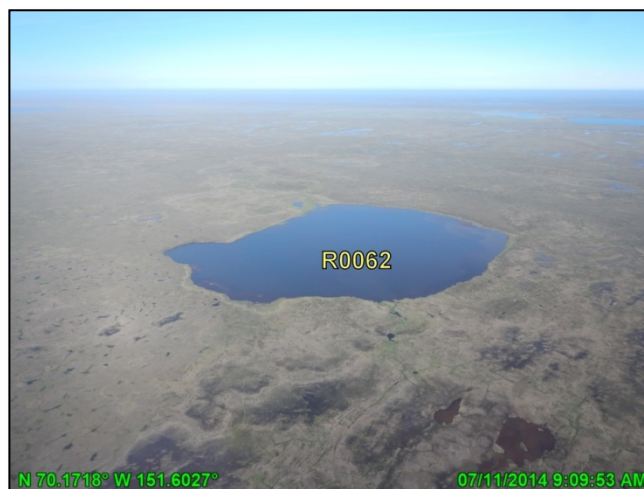
Photo B.27: Lake R0062 pre-breakup, looking northeast; May 23, 2014

Photo B.28: Lake R0062 post-breakup, looking northwest; July 11, 2014
