Alpine Satellites Development Plan

2004 Spring Breakup and Hydrologic Assessment

March 2005
103478-MBJ-RPT-001

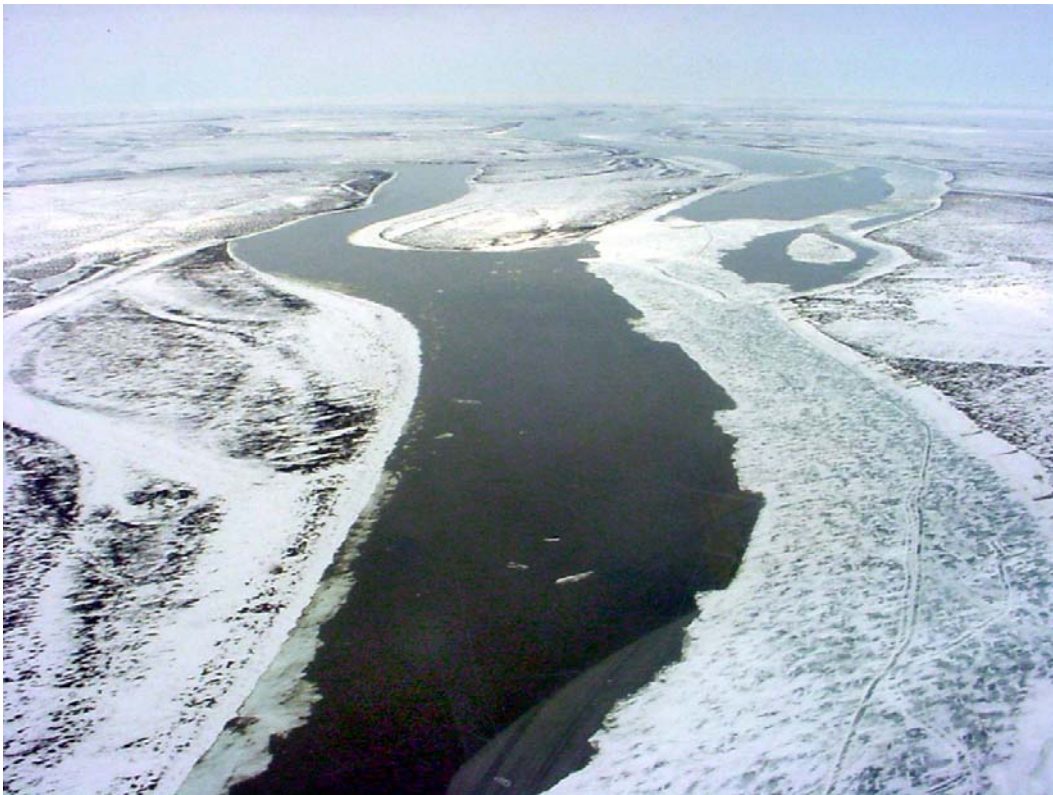
Photo 3-2 Floating ice bridged at the entrance to the East Channel. May 21, 2004.

Based on the two-dimensional surface water model, at Monument 01 near the head of the Colville Delta, the spring 2004 peak discharge had an average expected recurrence interval of about 5 years. However, based on observed water surface elevations at Monument 01, the recurrence interval would have been predicted to be a 14-year event. This difference in the stage discharge relationship is due to the presence of an ice sheet that partially covered the active channel at Monument 01 and the backwater effects of the ice bridge observed at the confluence of the East Channel and Nigliq Channel.

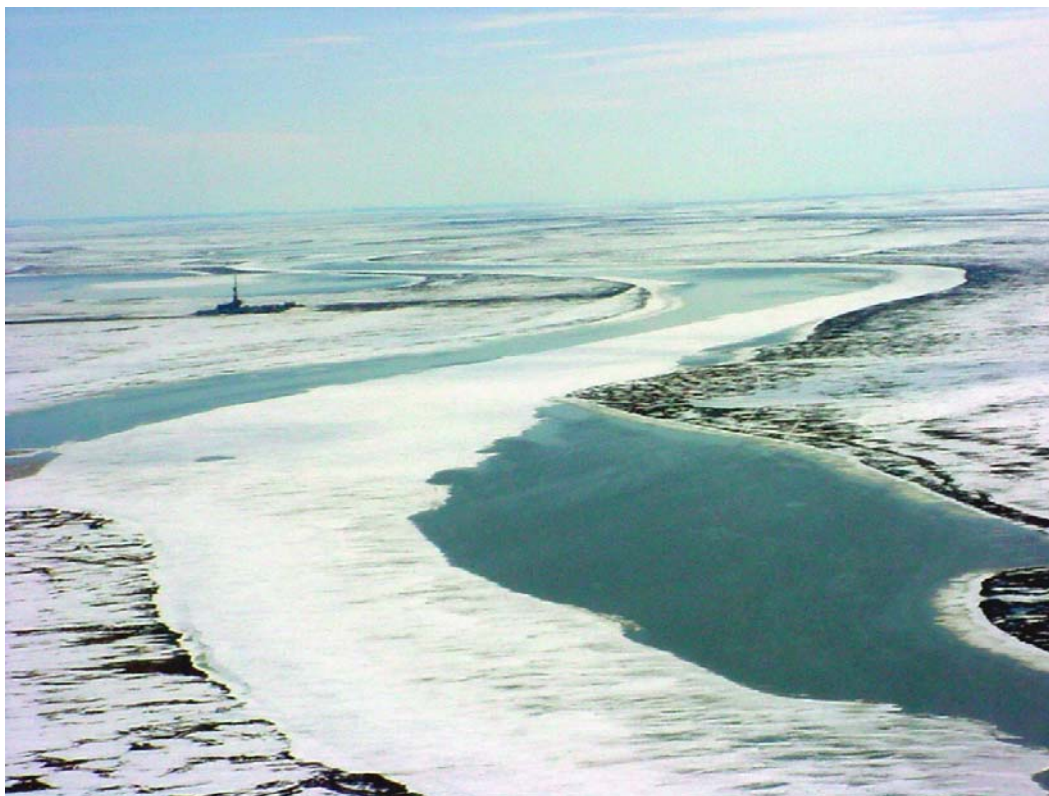
Photo 3-3 Looking south along the Nigliq Channel in the vicinity of the proposed bridge location near Monument 23. May 21, 2004.

Photo 3-3 and 3-4 show breakup conditions on May 23 and May 26 near the proposed Nigliq bridge site.

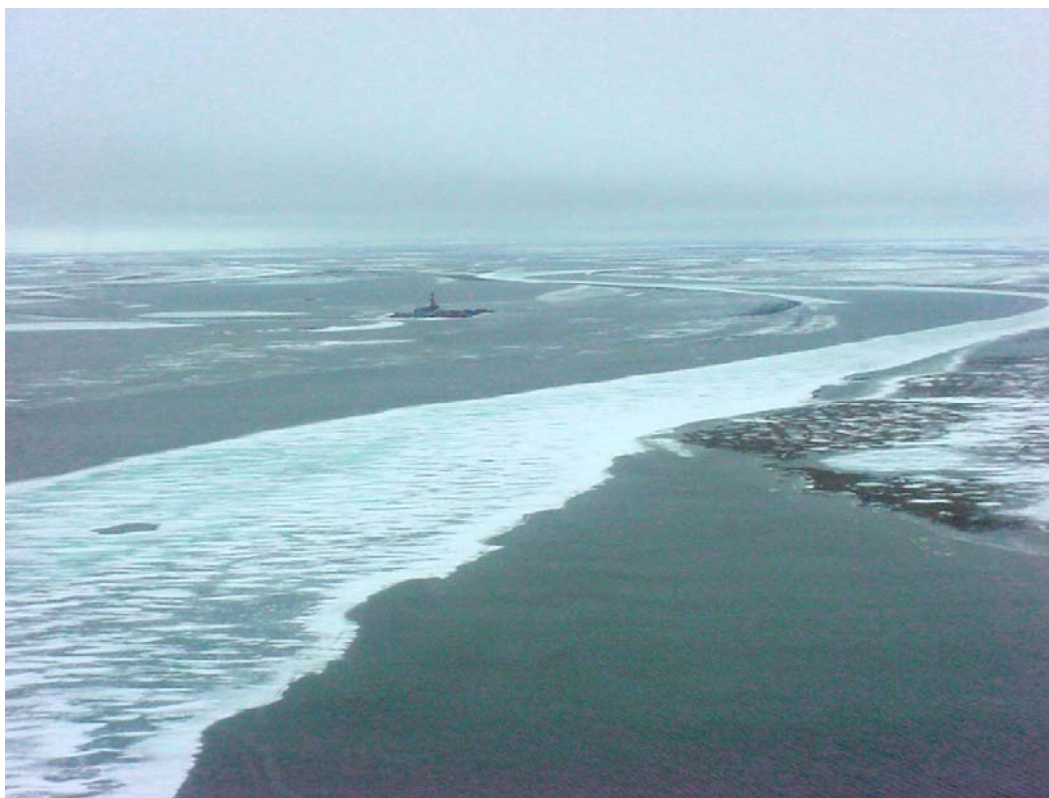
Photo 3-4 Looking south along the Nigliq Channel near Monument 23 approximately five days after the arrival of floodwaters. May 26, 2004.

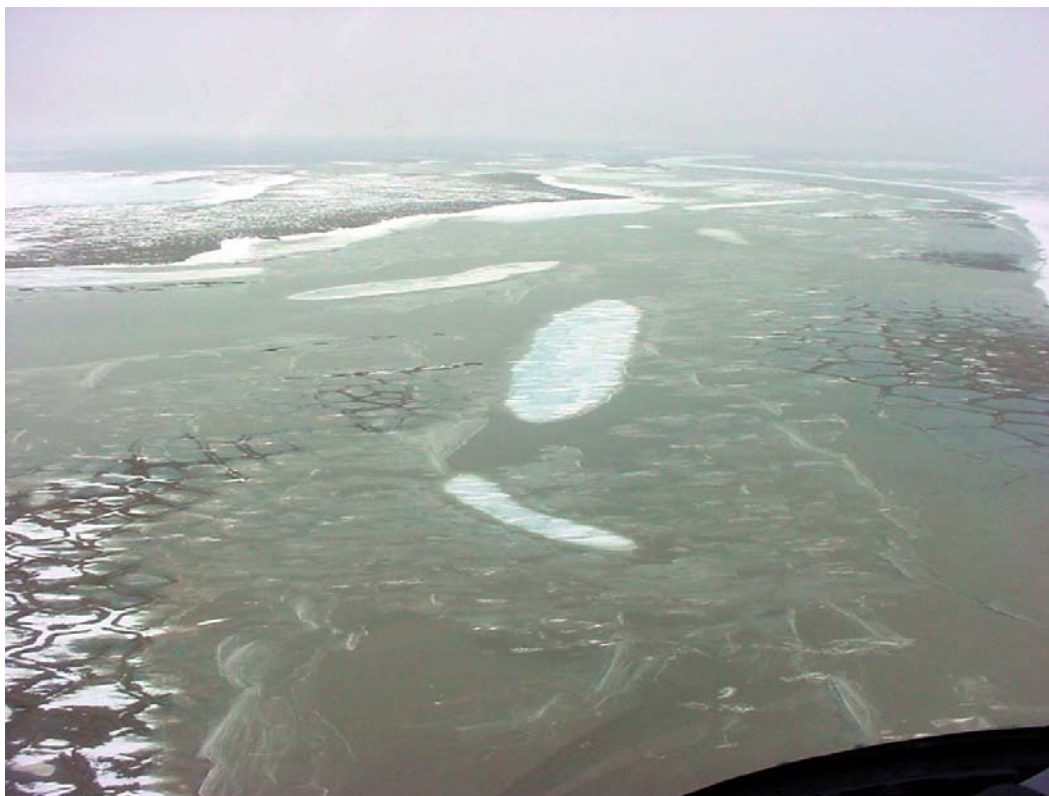
Photo 3-5 Looking north across the East and West Paleochannels area. The Nigliq Channel is on the extreme right. May 28, 2004.

The peak stage at the Paleochannels East and West monitoring sites occurred on the evening of May 27 at elevations of 9.81 and 9.76 feet, respectively. Water surface elevation and observation records for temporary staff gages at the Paleochannels are presented in Tables 3-6 and 3-7. Photos 3-5 and 3-6 show flooding conditions in the vicinity of the East and West Paleochannels approximately 12 hours after the occurrence of the peak water surface elevation in that area.

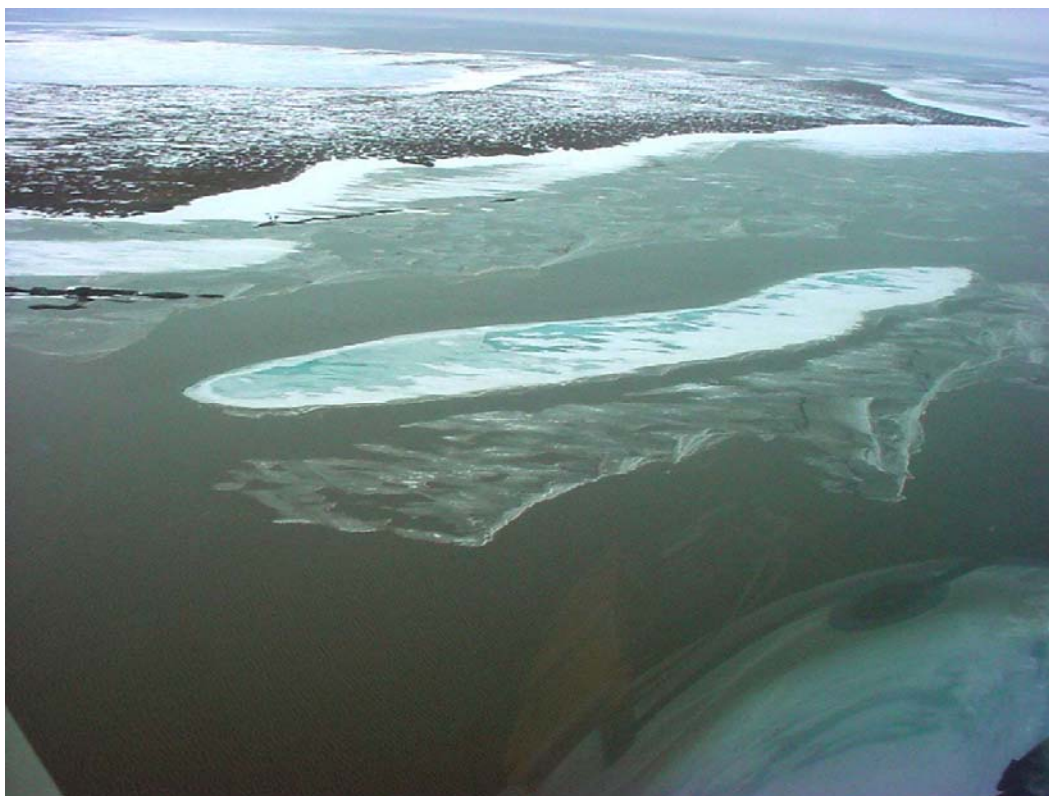
Photo 3-6 Detail of the East and West Paleochannel monitoring sites. May 28, 2004.

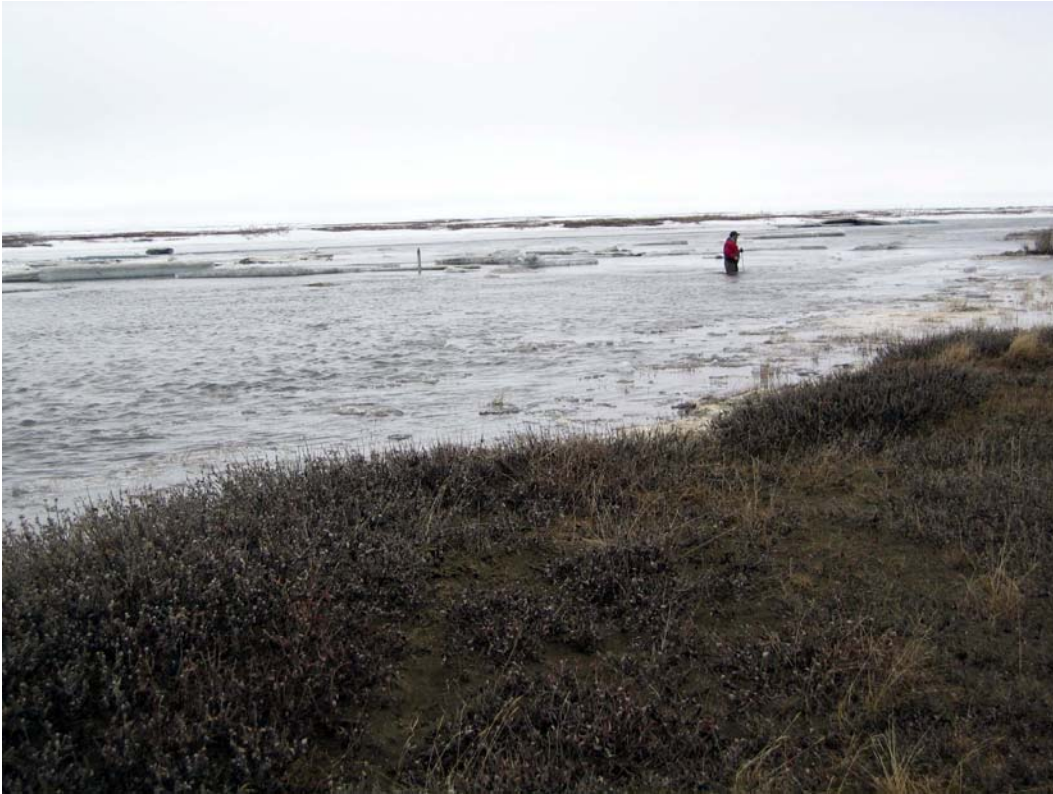
Photo 4-1 Water surface elevation measurements on Fish Creek began on May 29 when flows originating in the Judy Creek tributary were noted on the gages at monitoring locations downstream of the Fish/Judy confluence. Flow in Fish Creek proper was not observed until June 2. May 29, 2004.

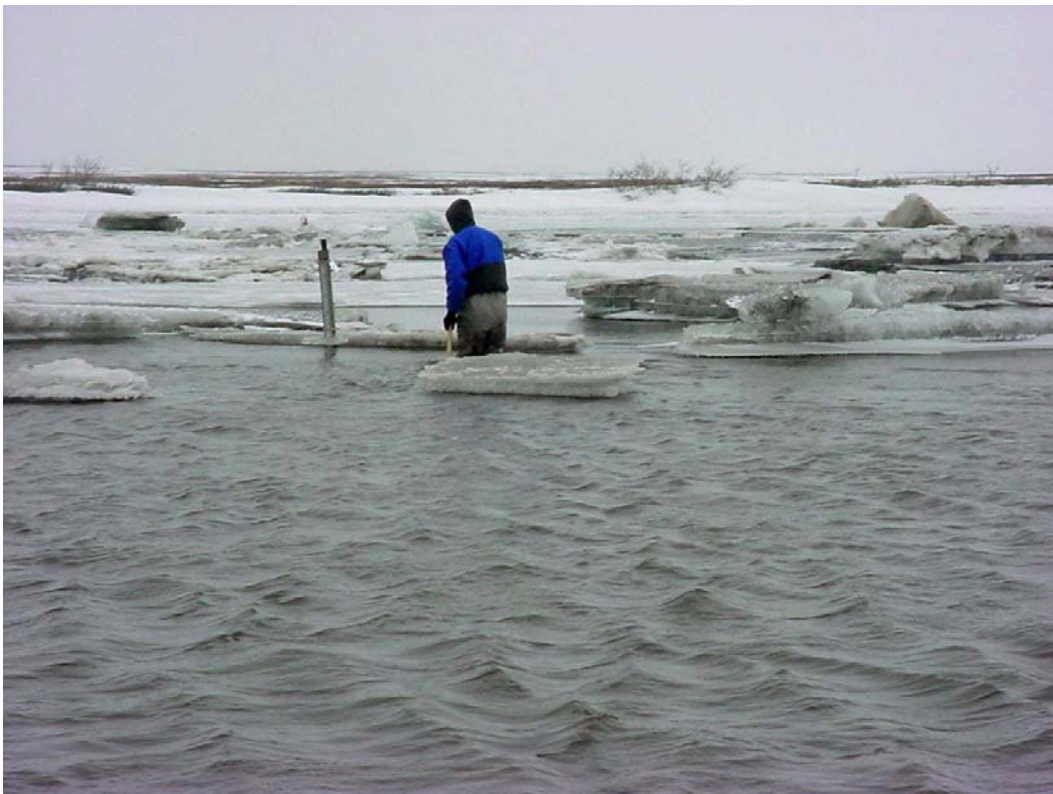
Photo 4-2 Breakup flooding on Fish Creek was characterized by heavy floating ice and frequent ice jamming that affected localized water surface elevations at some monitoring stations. May 30, 2004.

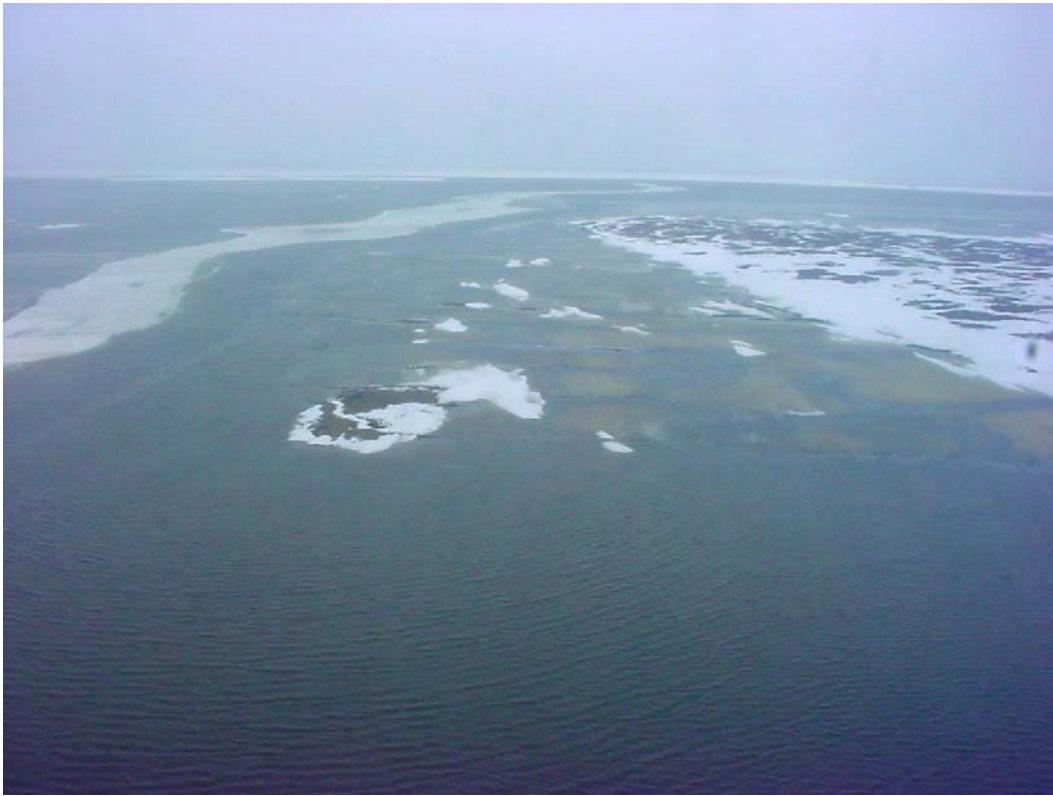
Photo 4-3 The relatively early occurrence of the peak stage at Fish 0.7 was likely a result of backwater effect from peaking floodwaters at the mouth of the Colville River combined with high wind. Note wind-driven southerly swell. May 30, 2004.

The peak water surface elevation at monitoring station Fish Creek river mile 0.7 was recorded on the morning of May 30. At this time however, water at the Fish Creek river mile 0.7 site was documented to be from the Colville River. Water from the Nigliq Channel was flowing across the sea ice and entering the mouth of Fish Creek causing water to backup into the river, and observed flow from Fish Creek was not documented at Fish Creek river mile 0.7 until June 2.

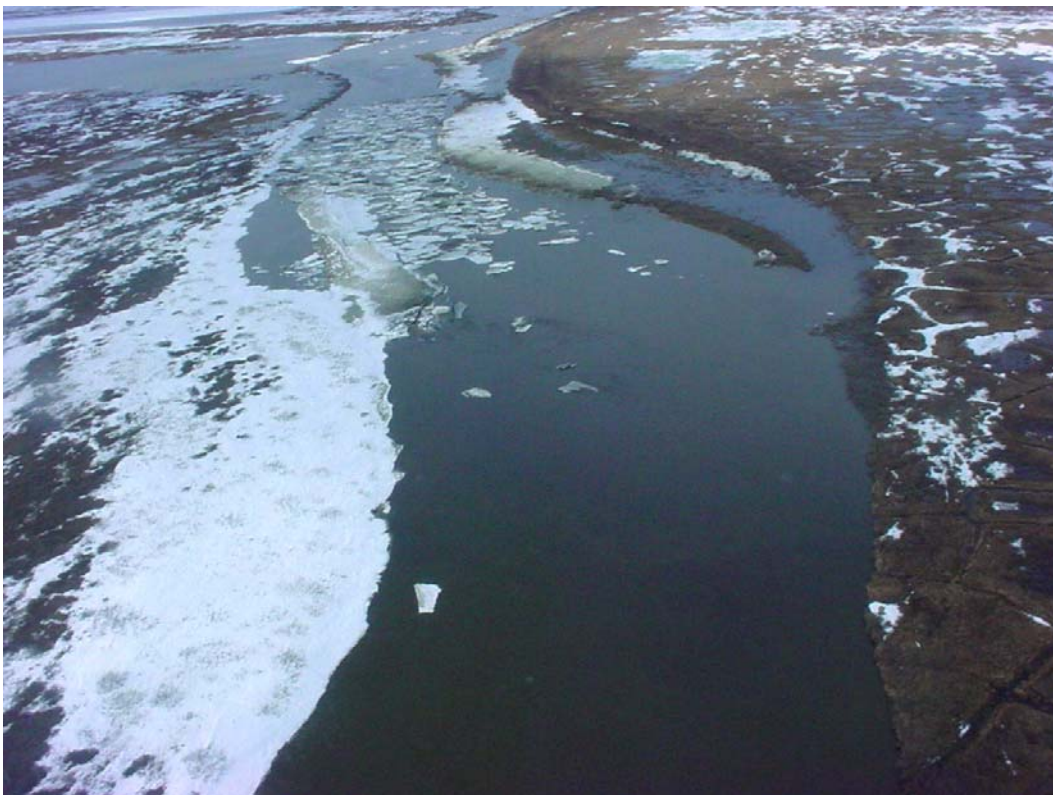
Photo 4-4 Small ice jam at Fish 10.3 that affected localized water surface elevations at Fish 10.9 monitoring site. The Fish 10.3 gages were located downstream of the jam and water surface elevations there were not affected. June 3, 2004.

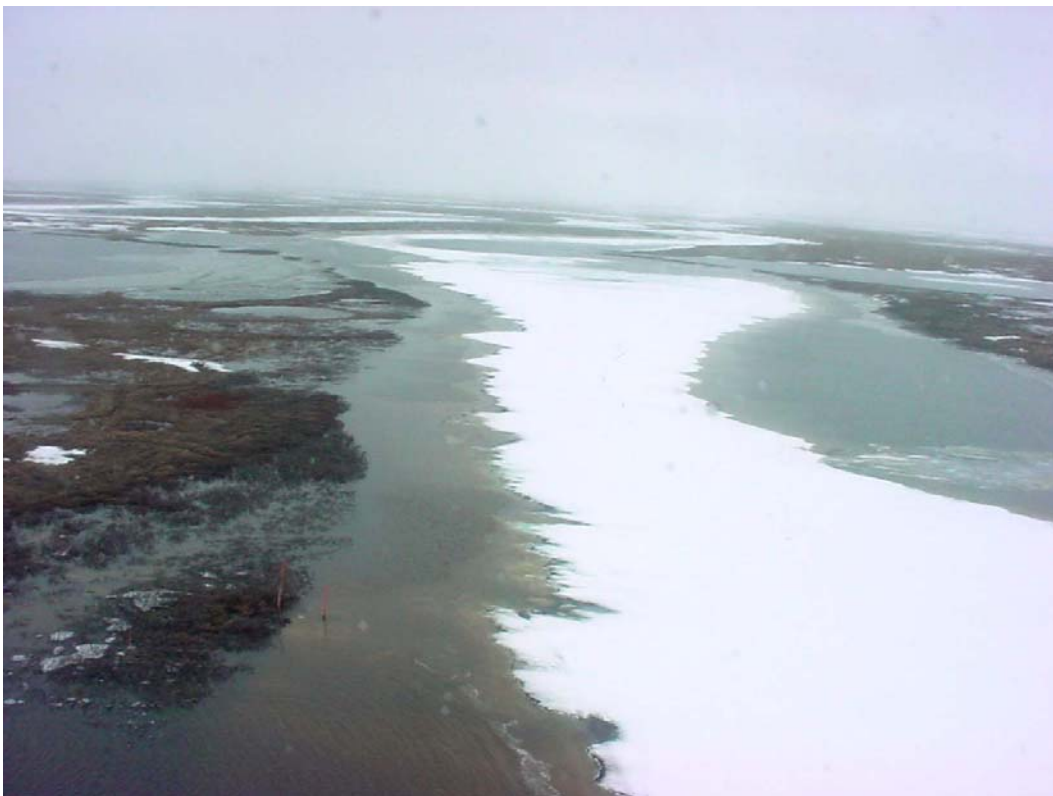
Photo 4-6 The water in the lower Ublutuoch River during the early stages of breakup was not flow from the Ublutuoch River itself, but rather backwater from flows over intact channel ice on Fish and Judy Creeks. Note that flooding from backwater extends to a point approximately one-quarter of a mile upstream of the gages (visible at lower left) at the Ublutuoch mile 1.9 monitoring site. May 30, 2004.

Flooding on the Ublutuocho River in 2004 was similar to observations made in 2003. Backwater effects from Fish Creek resulted in water on the furthest downstream gages located at river mile 1.9 six days prior to the arrival of floodwaters at the proposed bridge crossing located at mile 6.8. Peak water surface elevations on the Ublutuocho River at river mile 6.8 and 1.9 occurred over intact channel ice and snow on June 6 and June 7, respectively. Direct discharge measurements were conducted on the Ublutuocho River at the proposed bridge site on June 5 and June 6.

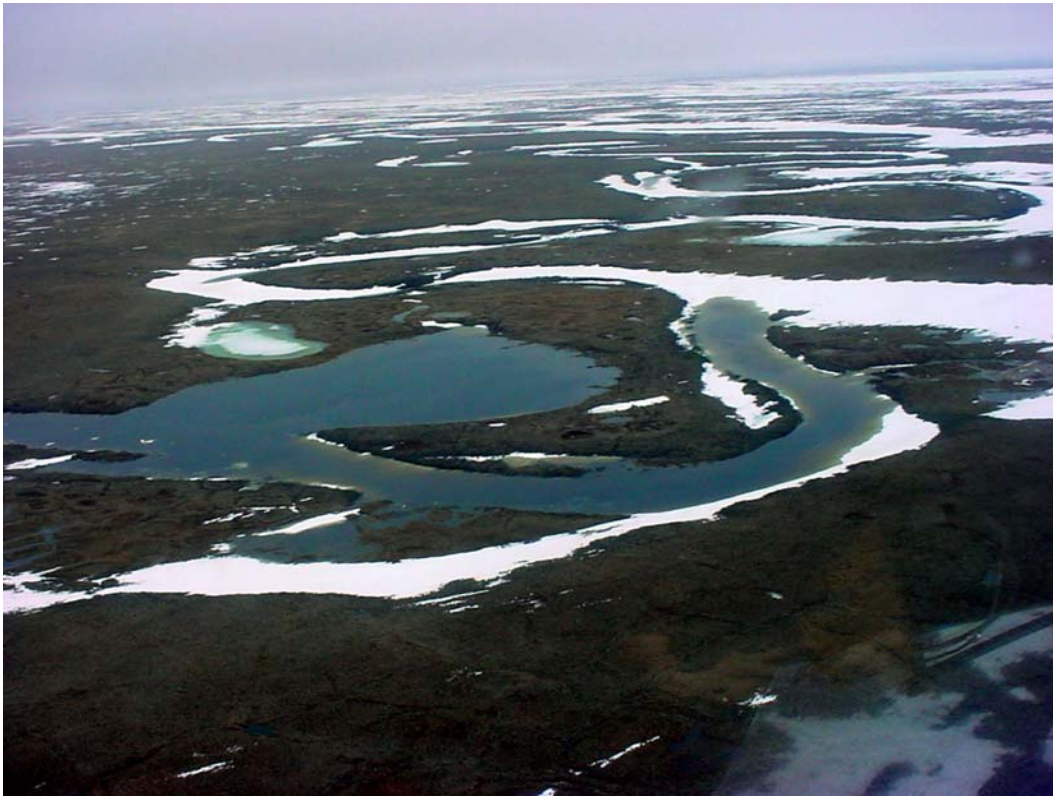
Photo 4-7 Leading edge of breakup floodwaters on the Ublutuoch River approximately 3.5 air miles upstream of the proposed bridge location at mile 6.8. June 3, 2004.

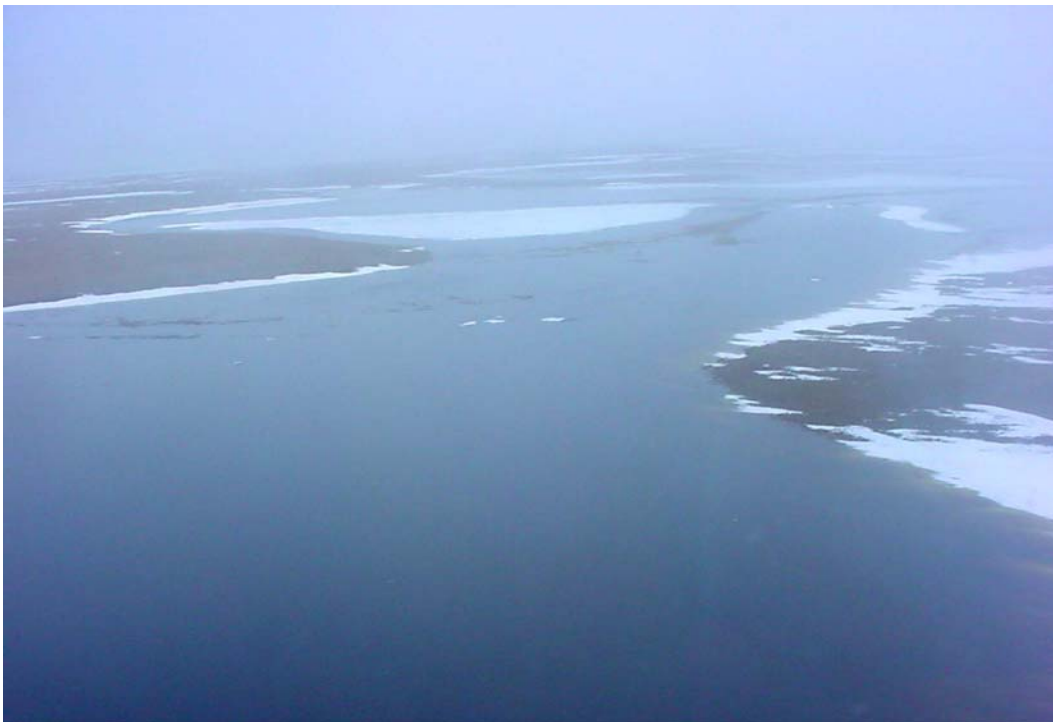
Photo 4-8 Less than 24 hours later, the leading edge had moved through the mile 6.8 bridge site (shown) and commingled with Fish Creek backwater in the lower portions of the Ublutuoch River. Flow at this point was over intact channel ice and snow at all monitoring sites. June 4, 2004.

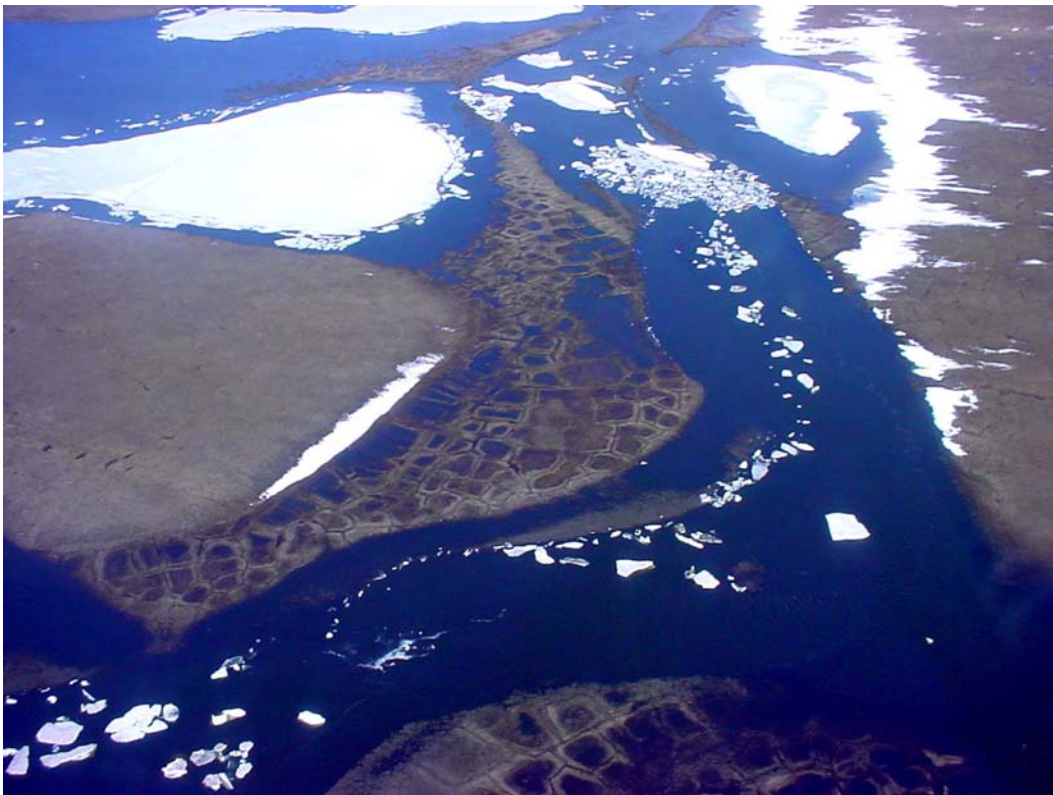
Photo 4-10 Water levels at the Ublutuoch bridge site (shown) dropped relatively quickly after the peak stage though small ice jams continued to cause localized, temporary water surface elevation increases that were reflected as secondary peaks on the hydrograph. June 9, 2004.

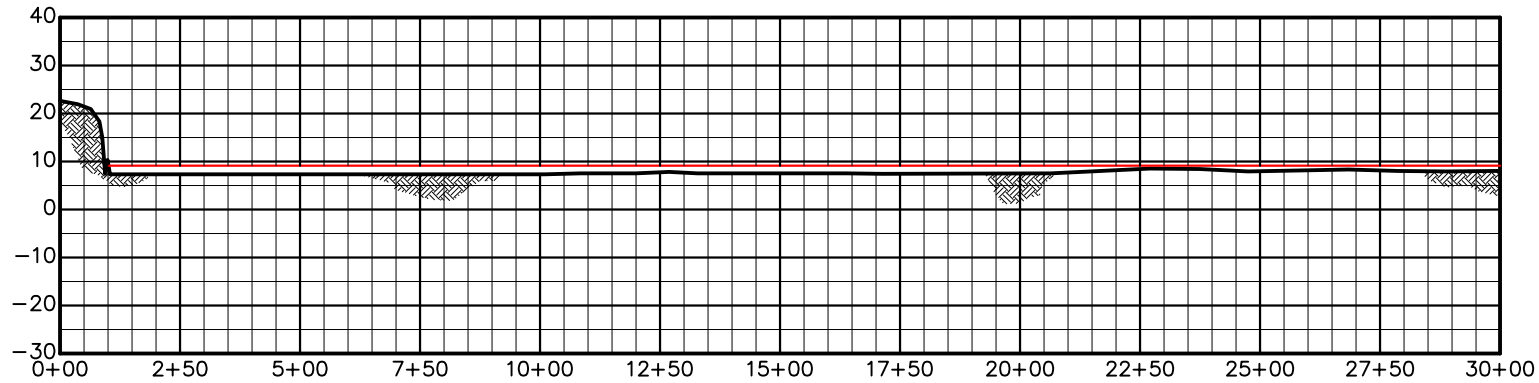
NIGLIQ CHANNEL (AT BRIDGE)
STA 0+00 TO 30+00

NIGLIQ CHANNEL (AT BRIDGE)
STA 30+00 TO 67+50
