# **2008** Colville River Delta Spring Breakup & Hydrologic Assessment

**Michael Baker Jr., Inc.**  
December 2008  
114132-MBJ-RPT-001

## Executive Summary

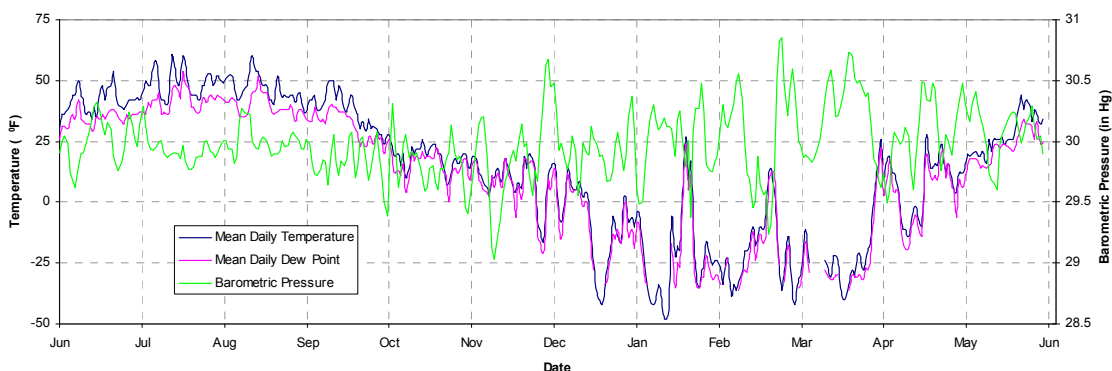
**Graph 1-1 Mean Daily Temperature, Dew Point, and Barometric Pressure  
(June 2007 – May 2008)**

are presented in Graph 1-1. Mean daily wind speeds, maximum daily wind gusts, and humidity are presented for the year in Graph 1-2.

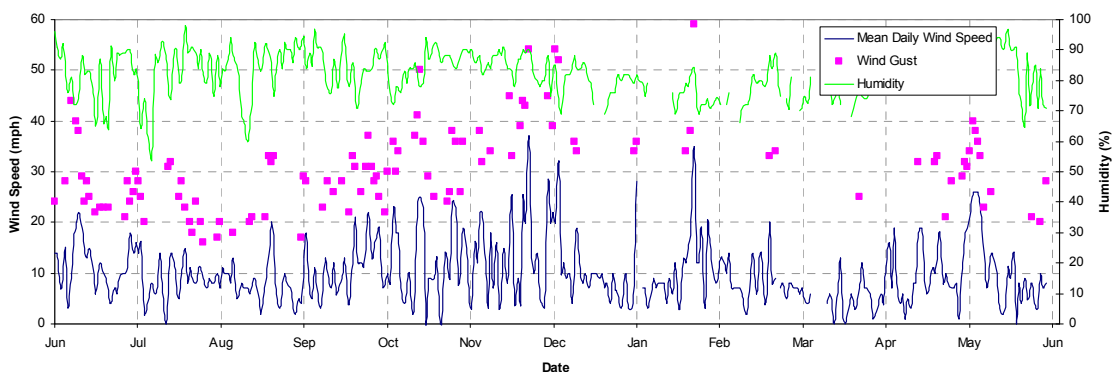
**Graph 1-2 Mean Daily Wind Speed and Maximum Daily Wind Gust  
(June 2007 – May 2008)**

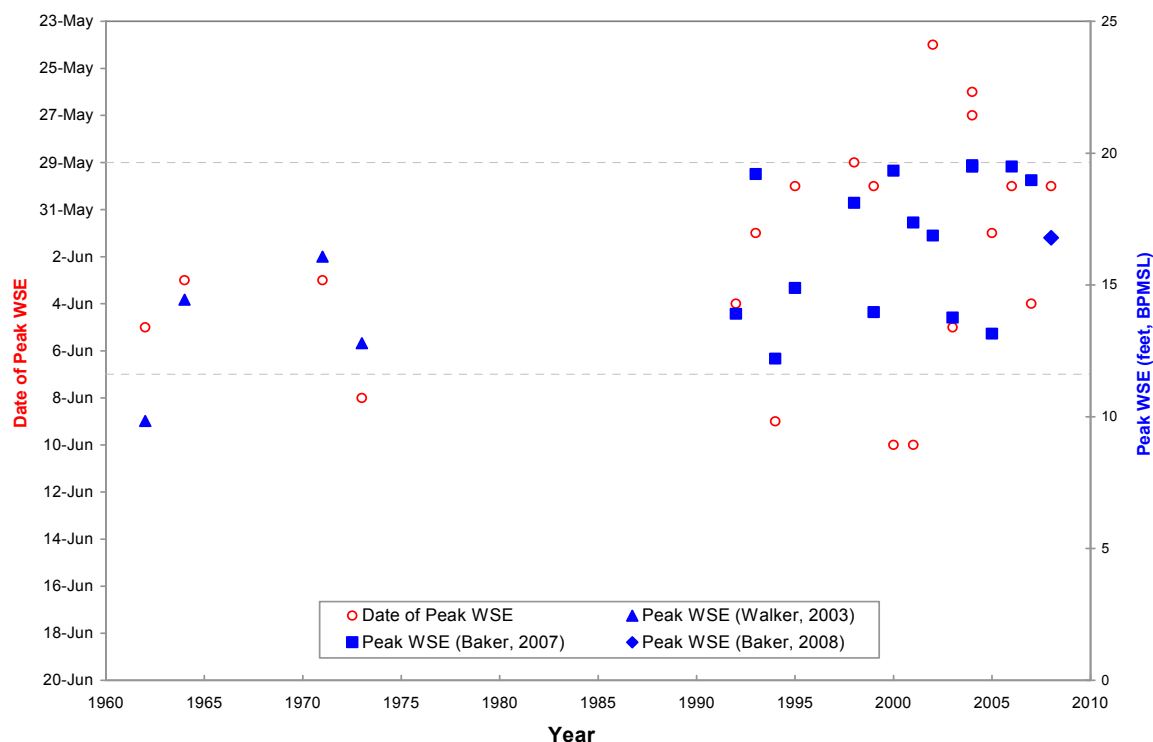
**Graph 1-3 Monument 1 Annual Peak Water Surface Elevations and Dates**

Peak water surface elevations in the CRD have typically occurred within a 10-day period, from May 29 to June 7, as shown in Graph 1-3. The 2008 peak WSE occurred at Monument 1 on May 30, within the historic 10-day period for peak WSE. The peak WSE was measured at 17.29 feet (BPMSL). This value is lower than maximum peak water surface elevation of 19.83 observed over the historic record. The peak discharge was estimated to have occurred on May 28, prior to peak stage.

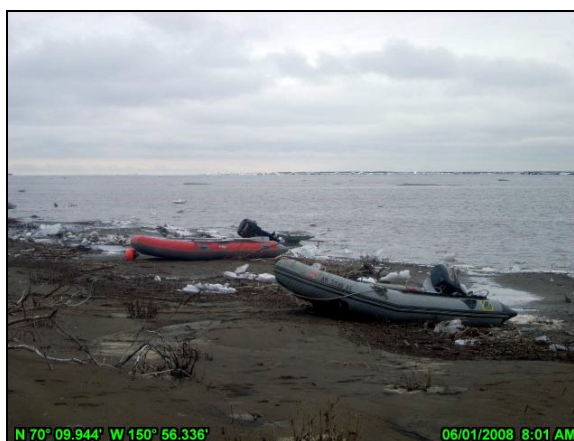
Photo 3-1 ADCP Direct Discharge  
Measurement Boats at Monument 1,  
June 1, 2008

The Sentinel ADCP was mounted to an Achilles SGX-132 inflatable raft powered by a 25 hp outboard motor using a fabricated aluminum tube framework spanning the boat's fore gunwales (Photo 3-1). The aluminum framework provided a rigid and secure placement of the ADCP unit while allowing necessary adjustments as river conditions required.

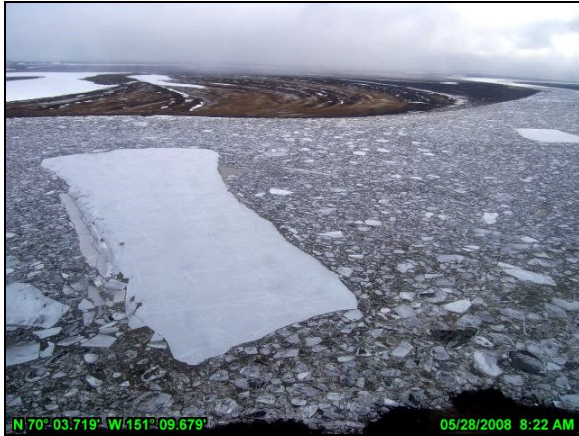
Photo 4-5 Ice Jam 12 Miles Upstream  
Monument 1, May 28, 2008

An ice jam was observed approximately 12 miles upstream of Monument 1 in the morning on May 28 (Photo 4-5). This ice jam likely slowed the steady rise in water surface elevation in the Delta. On May 29, the ice jam had released and another jam formed approximately 3 miles upstream of Monument 1; the reach at Monument 1 was clear of channel ice (Photo 4-6 and Photo 4-7). By midday on May 30 (Photo 4-8), the ice jam released and ice flowed through the reach at Monument 1. Ice jammed again near the Nigliq and East Channels bifurcation, causing significant backwater at Monument 1. The water surface elevation began rising at the rate of about 1.5 feet per hour. Peak stage at Monument 1 occurred in the early evening on May 30 at an elevation of 17.29 feet.

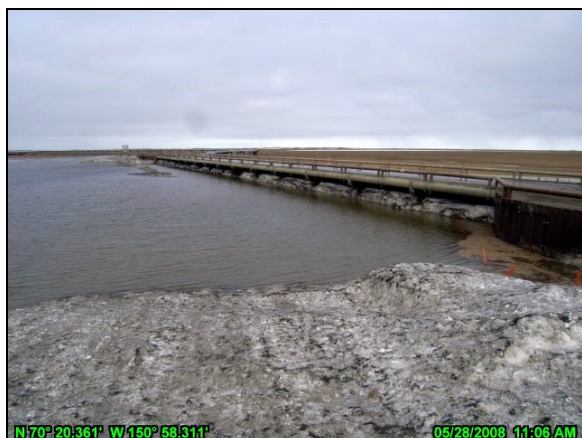
Photo 4-15 Snow Packed 452-foot Swale Bridge (upstream/south), May 28, 2008

As floodwaters reached the CD2 access road swale bridges on the morning of May 28, flow under the bridges was impeded by a significant amount of packed snow (Photo 4-15). This packed snow caused a damming effect on the south side of the bridges before releasing later in the afternoon on May 28 (Photo 4-16).

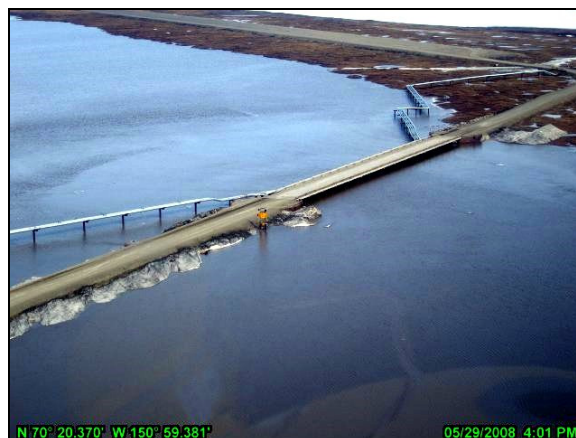
Photo 4-16 452-foot Swale Bridge (upstream/south), May 29, 2008

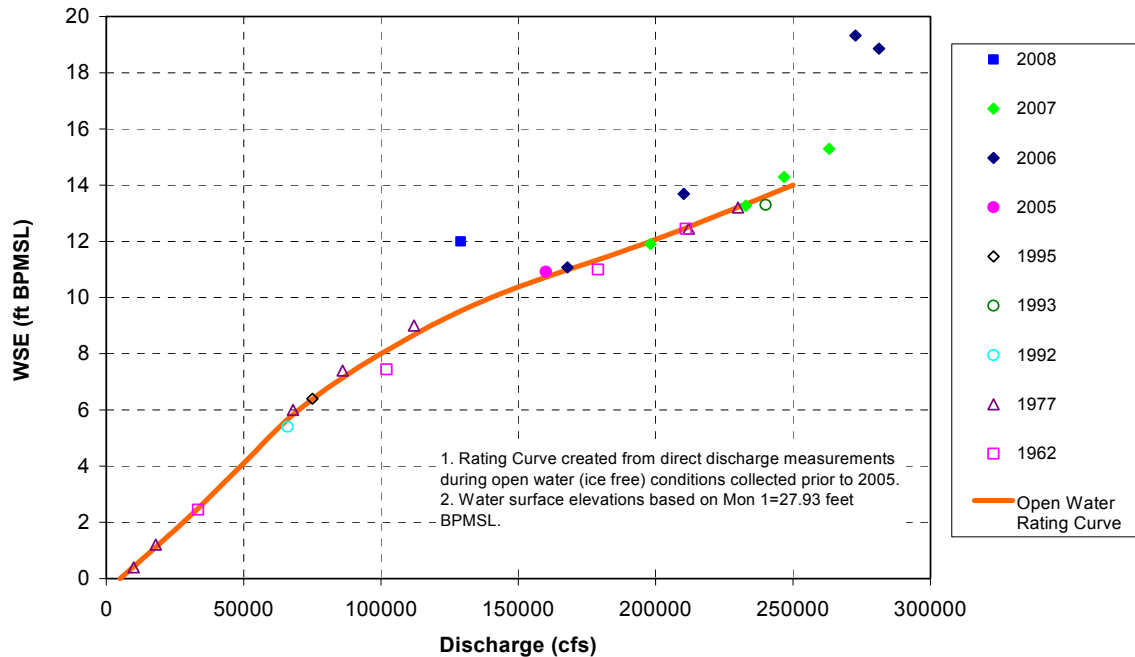
**Graph 4-1 Monument 1 Stage-Discharge Rating Curve with Direct Discharge**

The direct discharge is plotted against the Monument 1 stage-discharge rating curve in Graph 4-1. The direct discharge plots off of the rating curve. The shift is likely due to backwater from downstream ice jamming and/or sediment deposition in the channel resulting from low flow velocities. Backwater can raise water surface elevations without the normal associated increase in discharge while sediment deposition can change the bedform geometry, changing the relationship between stage and discharge. Figure 4-1 shows the location of the discharge measurement.

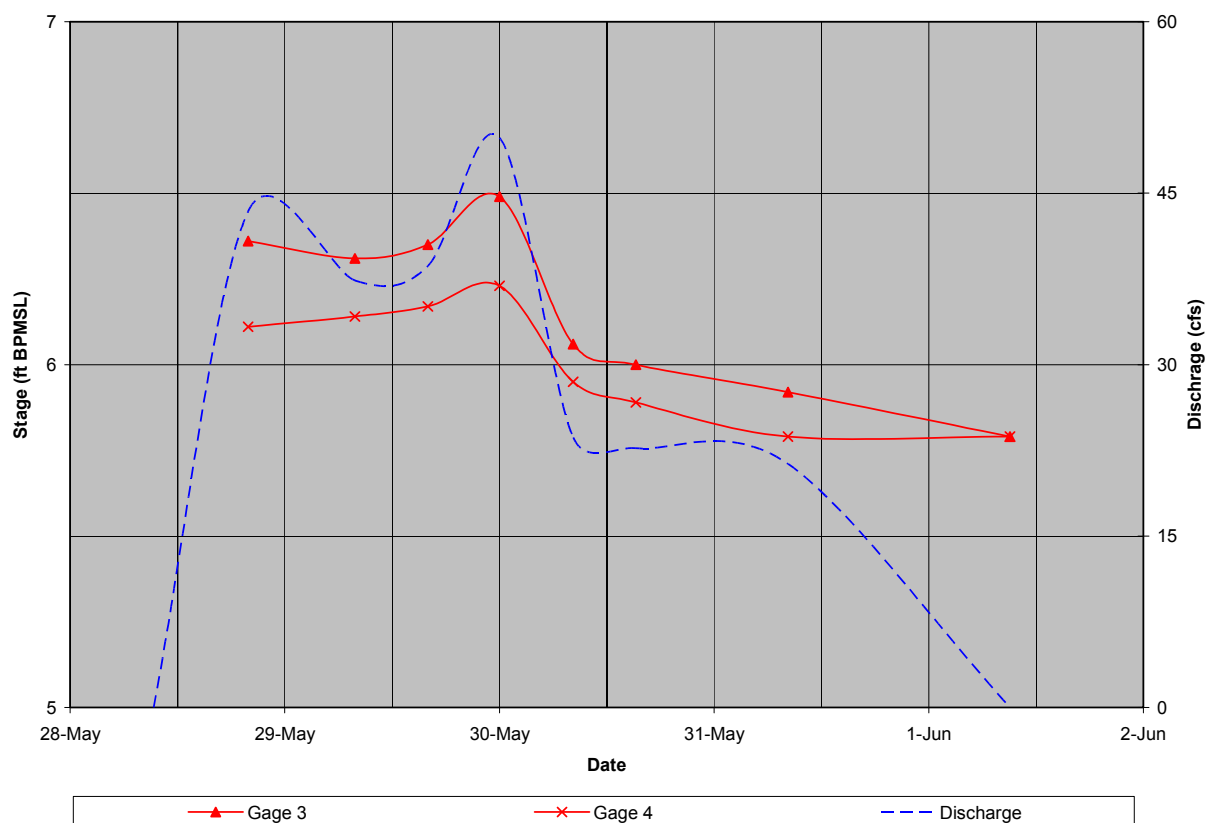
**Graph 4-2 CD2 Road Culverts Estimated Discharge vs. Stage**

In 2008, the differential between headwater and tailwater elevations for the CD2 culverts that passed water is based on the water surface elevation observed at Gages 3 and 4, given their proximity to the culverts. The maximum differential between Gages 3 and 4 occurred during peak stage on May 30 with a differential of 0.26 feet. Flow through the CD2 culverts is estimated to have stopped on June 1 when headwater and tailwater elevations were observed to be near equal. A comparison of stage and discharge during breakup for CD2 culverts is presented in Graph 4-2.

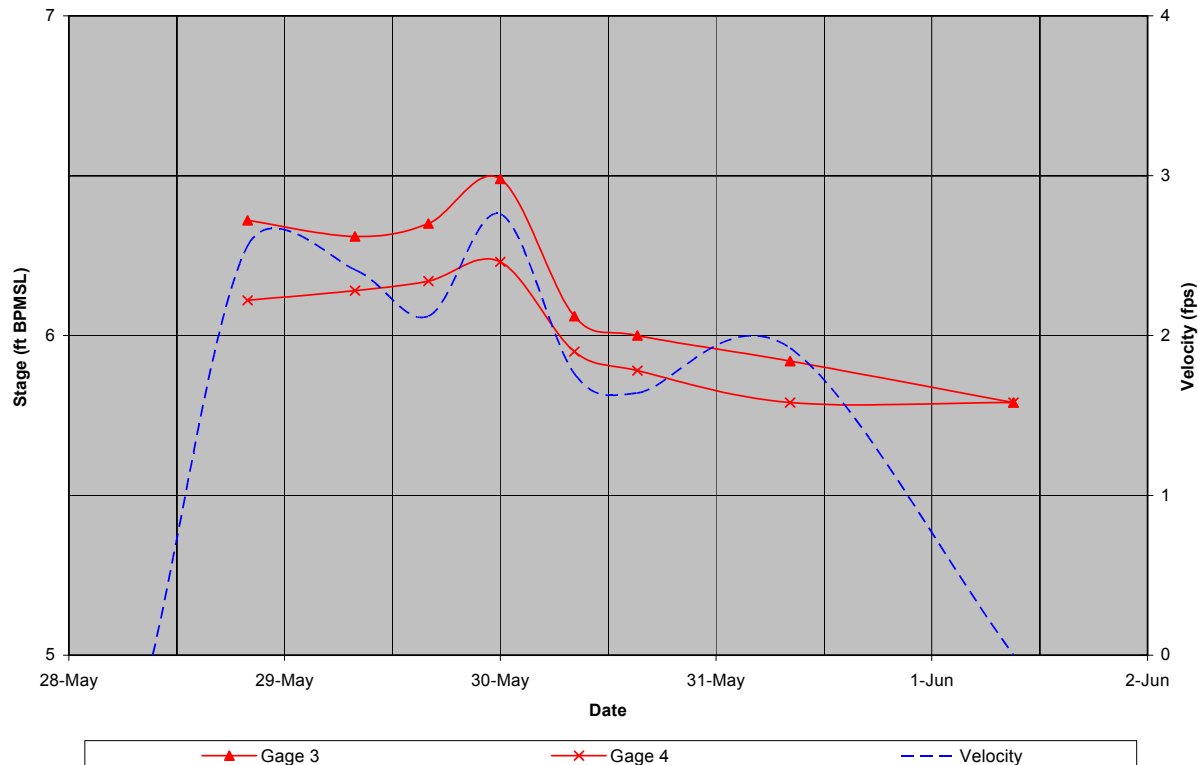
**Graph 4-3 CD2 Road Culverts Estimated Velocity vs. Stage**

The velocity estimates for the CD2 culverts is related to water surface differentials between the headwater and the tailwater elevations. The velocity for each culvert was greatest during the largest differential between headwater and tailwater. A comparison of stage and velocity for the CD2 culverts is presented in Graph 4-3.

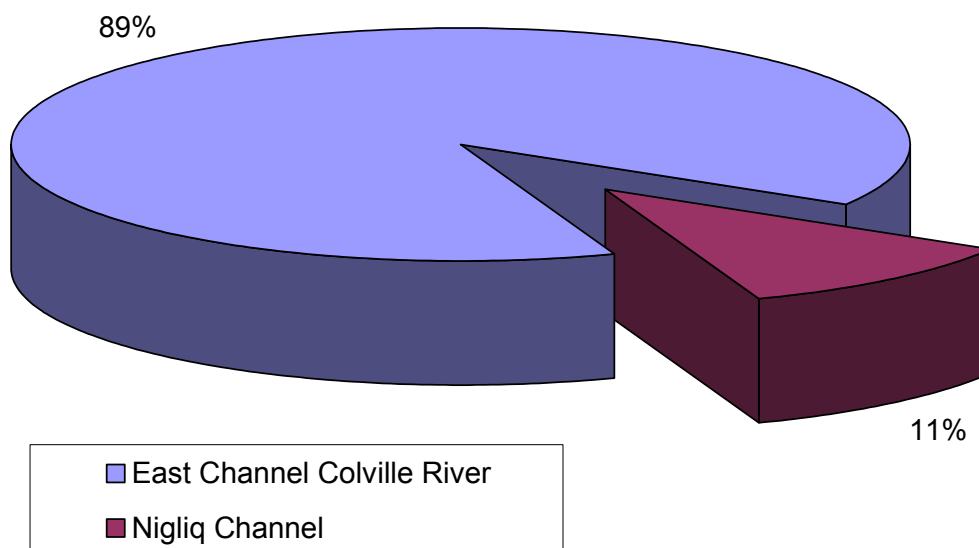
**Graph 4-4 2008 CRD Estimated Peak Discharge Distribution**

During the 2008 spring breakup peak discharge, approximately 89% of the flow in the CRD passed through the East Channel with the remaining 11% passing down the Nigliq Channel, including the Alpine facilities drainage structures. Graph 4-4 presents the 2008 estimated peak flow distribution in the CRD.

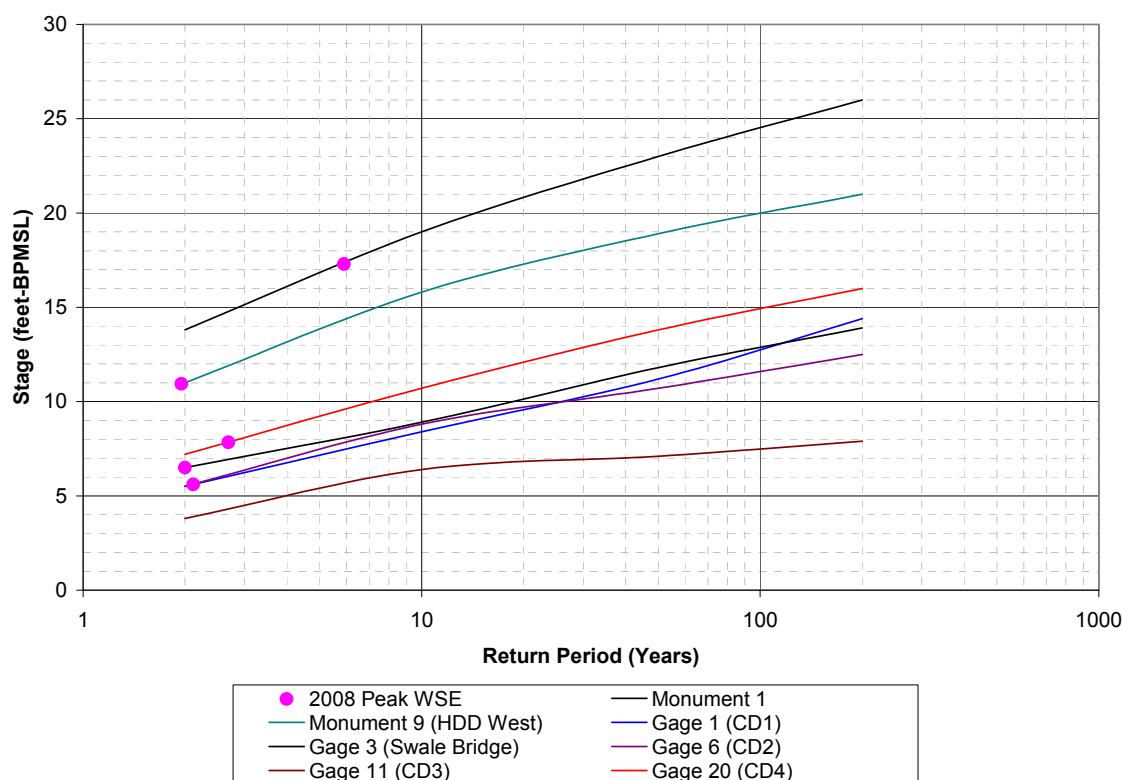
**Graph 4-5 Colville River Delta 2D Model Predicted Water Surface Elevation & Return Interval**

The 2D surface water model was developed to predict open water conditions during low frequency, high magnitude flood events having 50- and 200-year recurrence intervals. To estimate the relationship between discharge and stage during lower magnitude flood events, 2- and 10-year flood events have been modeled. The model assumes open water, steady-state conditions, and does not account for snow, channel ice, or ice jams. Graph 4-5 presents predicted water surface elevations at selected locations for 2-, 10-, 50-, and 200-year floods and the respective 2008 peak stage (big pink dots).

Typically, observed water surface elevations will be greater than those predicted by the 2D model during small magnitude flood events due to the presence of ice and snow in the channels. With an extended period of record, a stage frequency analysis can be performed to better estimate low flood stage within the delta impacted by recurrent ice jamming. This was done in 2006 and is described in the next section.

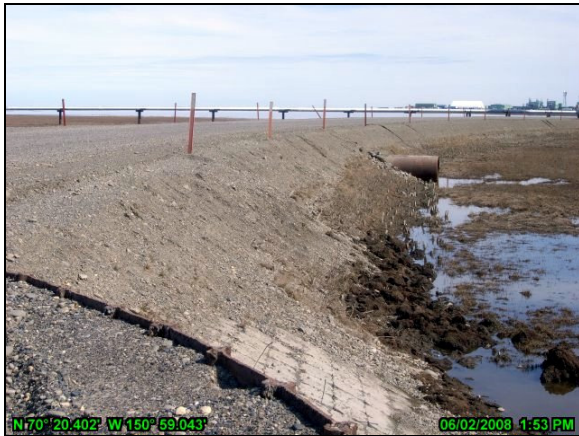
Photo 4-17 CD2 Access Road near 62-foot Swale Bridge, June 2, 2008

In April 2007, riprap was placed under the 62-foot swale bridge to prevent further thermoerosion and hydraulic-scour at the east sheet pile abutment. Annual survey profiles of the channel bed at the bridge crossing conducted by LCMF are presented in Baker 2007a. In 2007, the channel was surveyed by Baker pre- and post-breakup to identify potential settlement of the placed material. Survey data collected on the upstream (south) side of the swale bridge are presented in Graph 4-6. Survey profiles collected by Baker indicate that minor settlement of the riprap material occurred between May 30, 2007, July 19, 2007, and June 2, 2008.

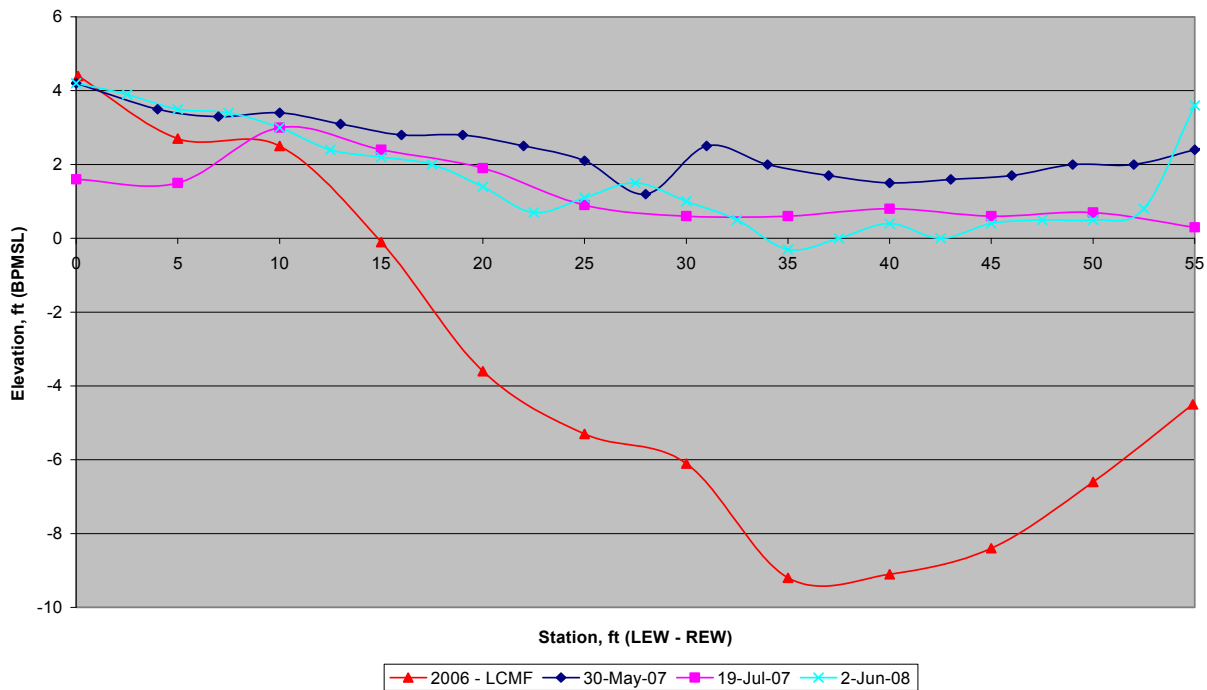
Graph 4-6 2008 62-foot Swale Bridge Channel Survey (Upstream/South)

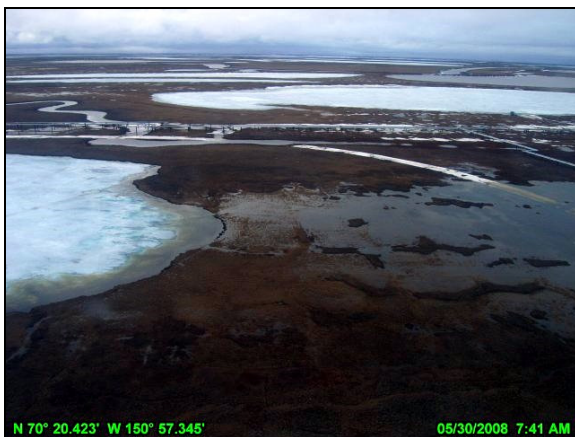
Photo 4-19 Lake L9313 receiving overland floodwater and L9312 isolated from overland floodwater, May 30, 2008

Photo 4-19 and Photo 4-20 show Lake L9313 being recharged by floodwater near peak stage. In the background of Photo 4-19 Lake L9312 is isolated from floodwater.

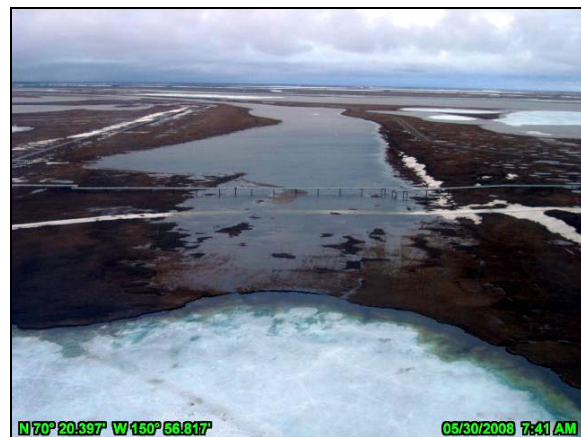
Photo 4-20 Lake L9313 receiving overland floodwaters from the Sakoonang Channel, May 30, 2008

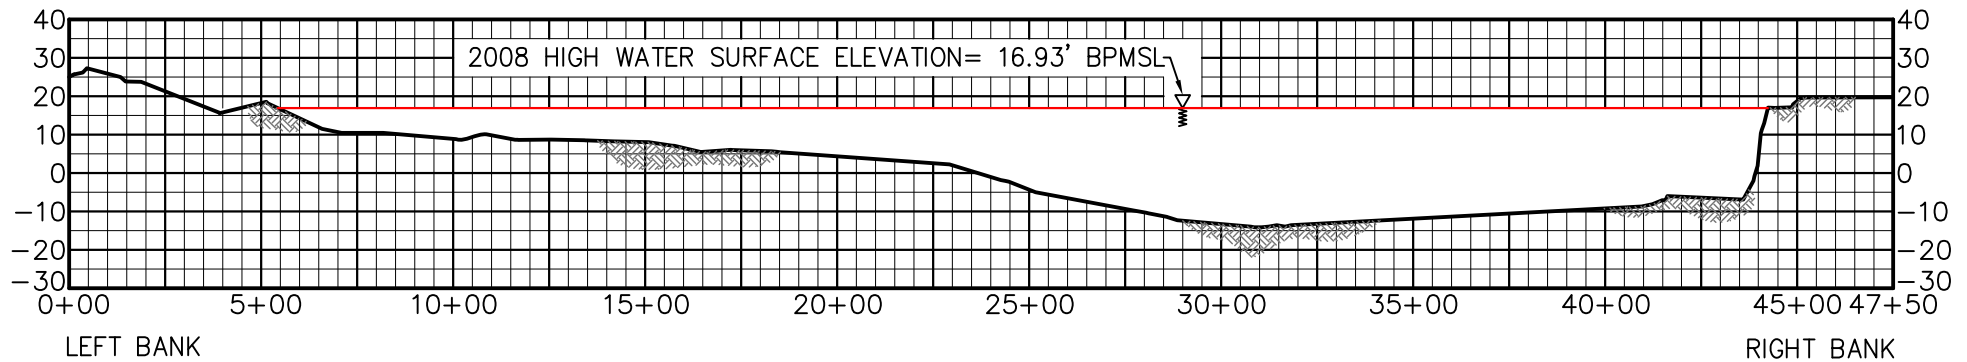
1D COLVILLE RIVER CROSS SECTION AT MONUMENT 1 DOWNSTREAM  
SCALE: HORZ. 1"= 500' / VERT. 1" = 50'

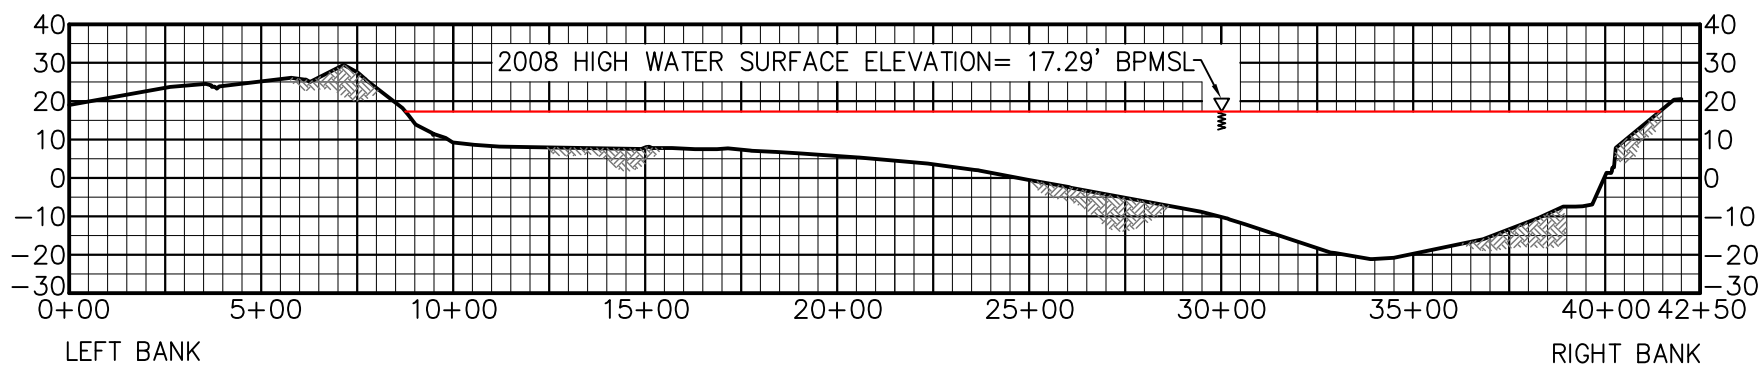
1 COLVILLE RIVER CROSS SECTION AT MONUMENT 1  
SCALE: HORZ. 1" = 500' / VERT. 1" = 50'

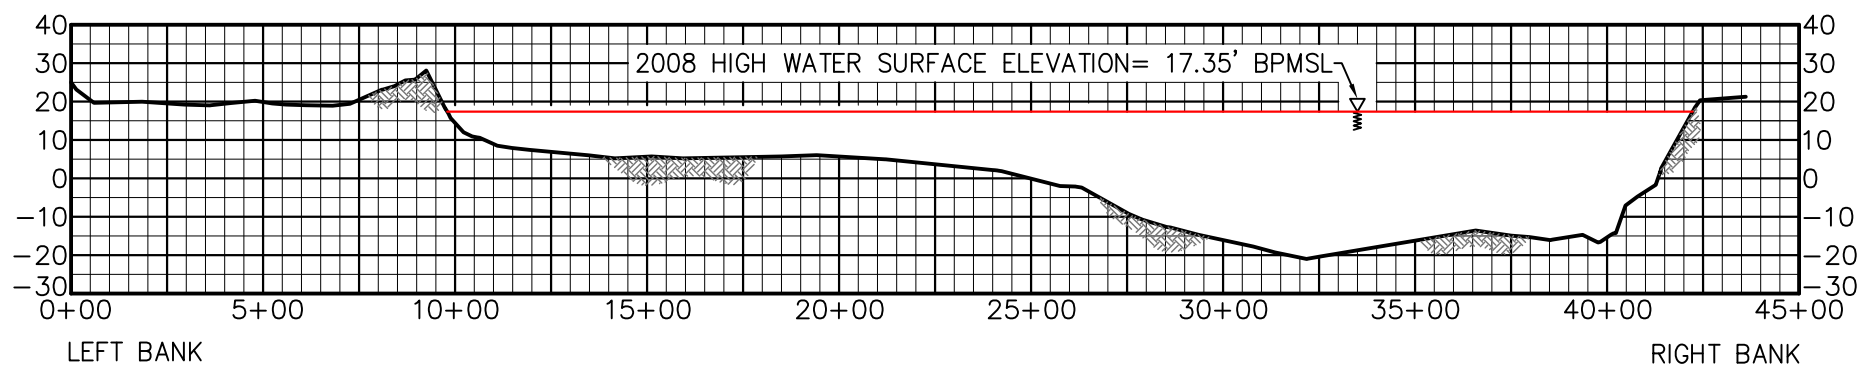
1U COLVILLE RIVER CROSS SECTION AT MONUMENT 1 UPSTREAM  
SCALE: HORZ. 1"= 500' / VERT. 1" = 50'

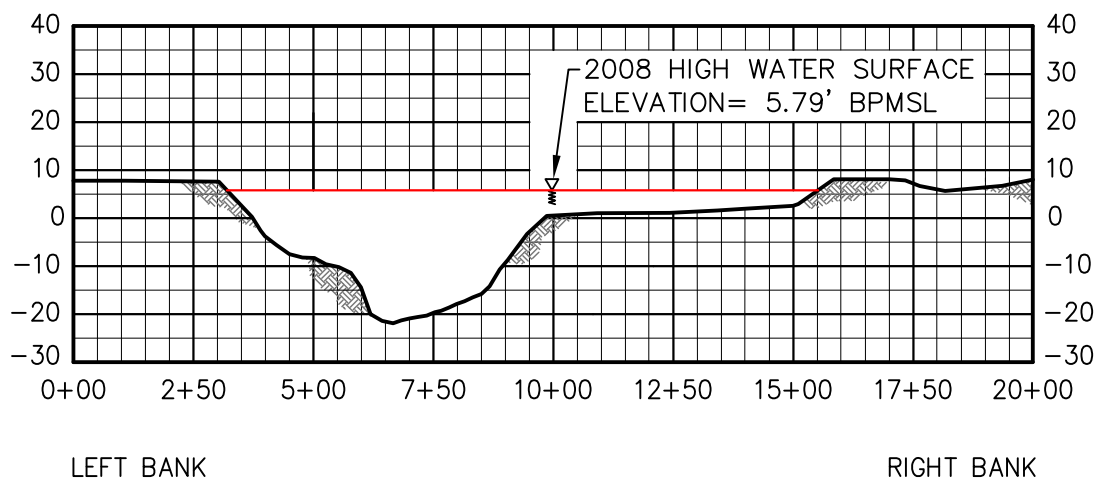
1 MONUMENT 23 CROSS SECTION  
SCALE: HORZ. 1"= 400' / VERT. 1" = 40'

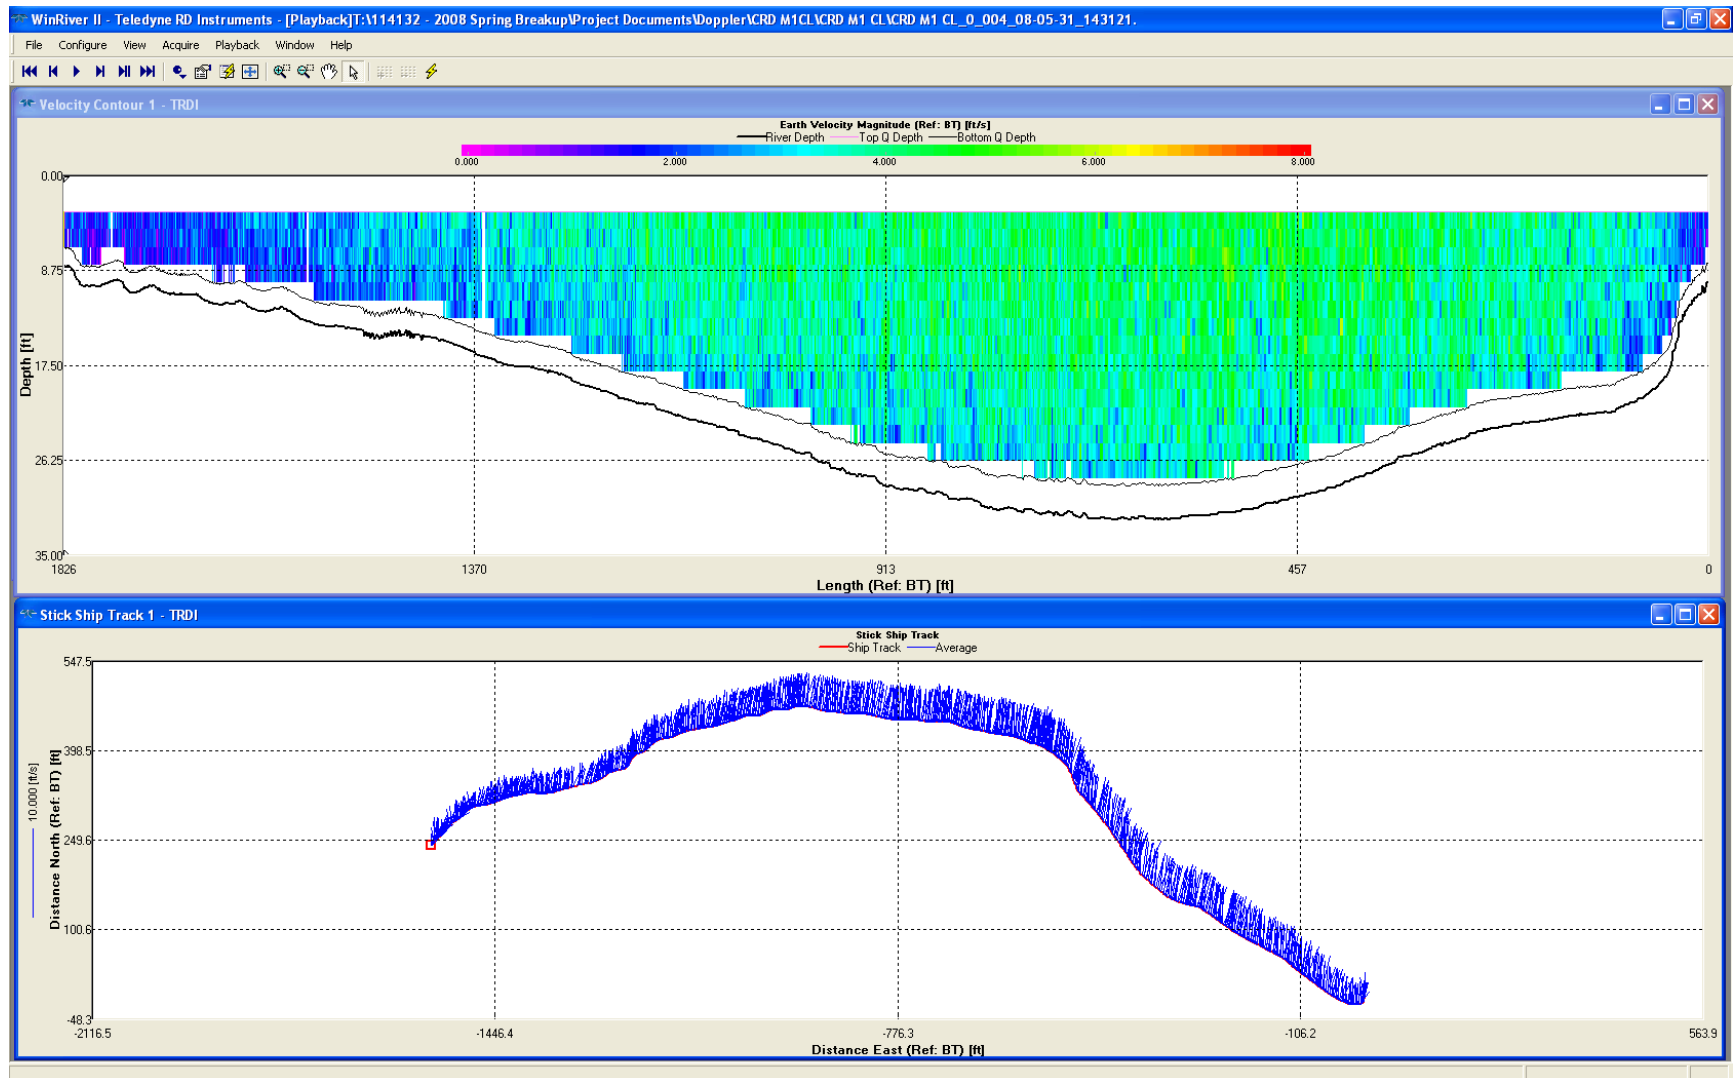
## Monument 1 Colville River ADCP Direct Discharge Transect 2, WinRiver II Velocity and Ship Plots May 31, 2008

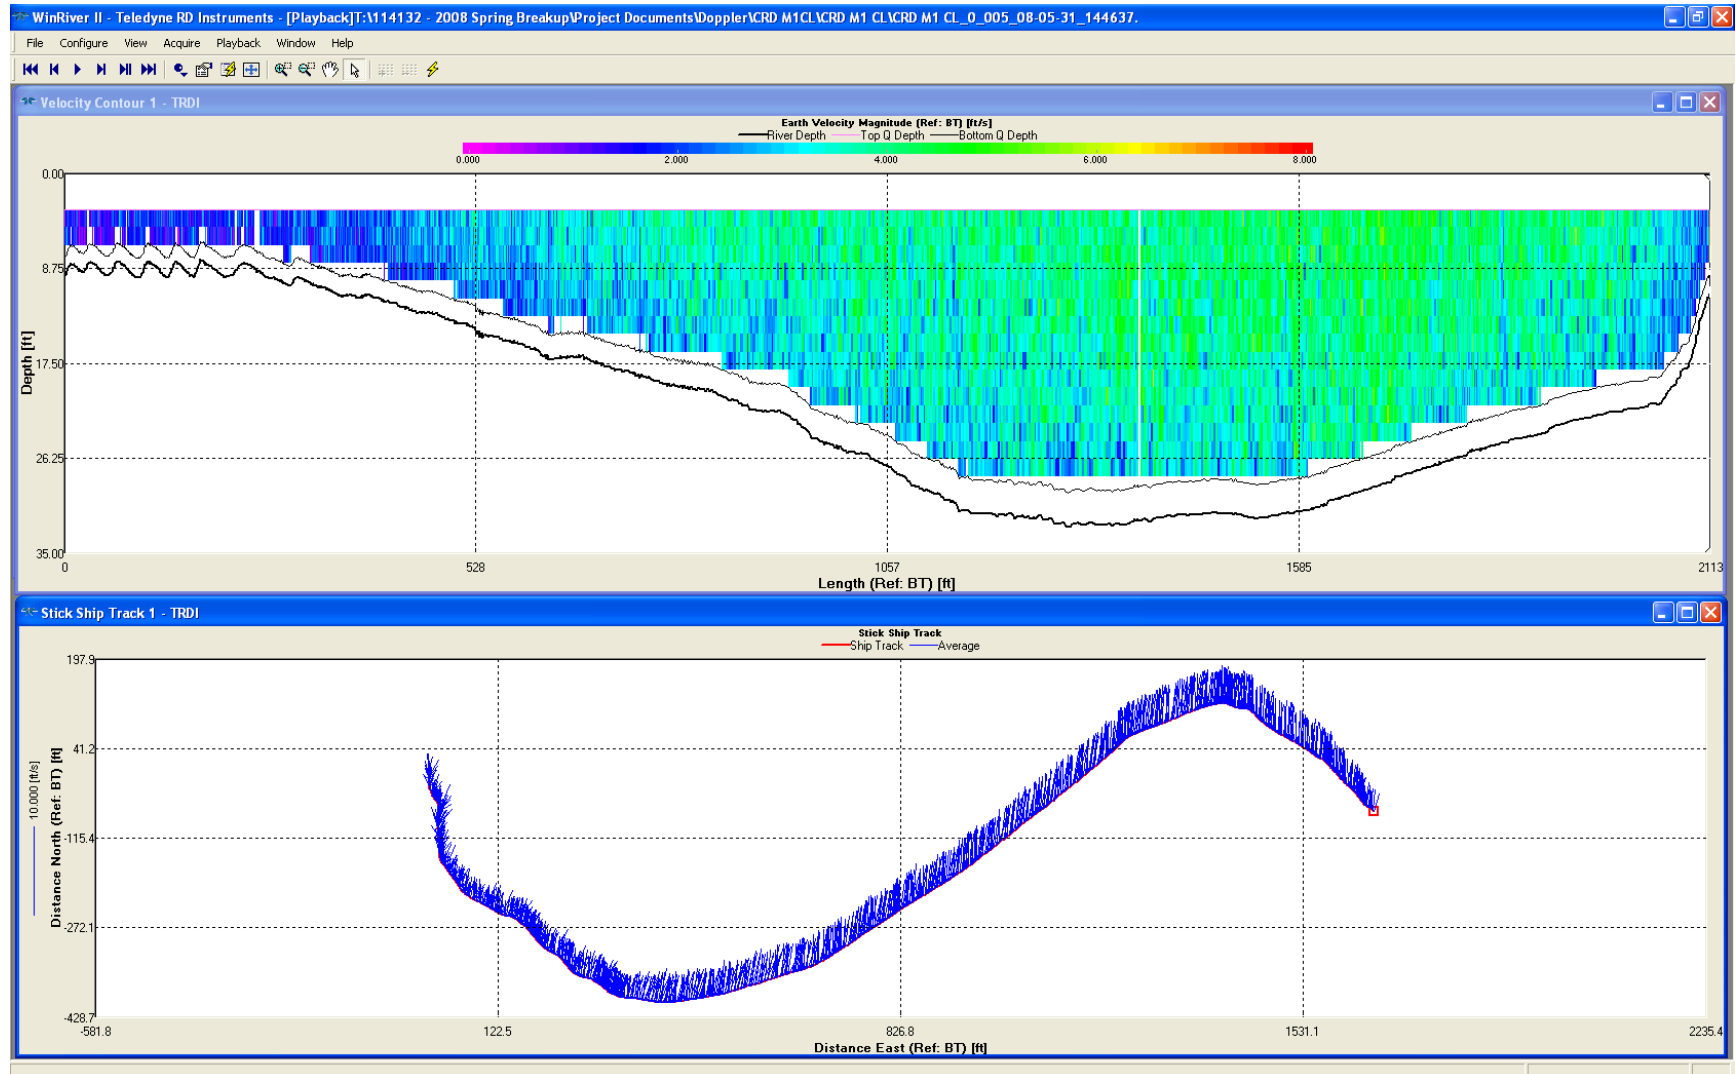
# Monument 1 Colville River ADCP Direct Discharge Transect 3, WinRiver II Velocity and Ship Plots May 31, 2008

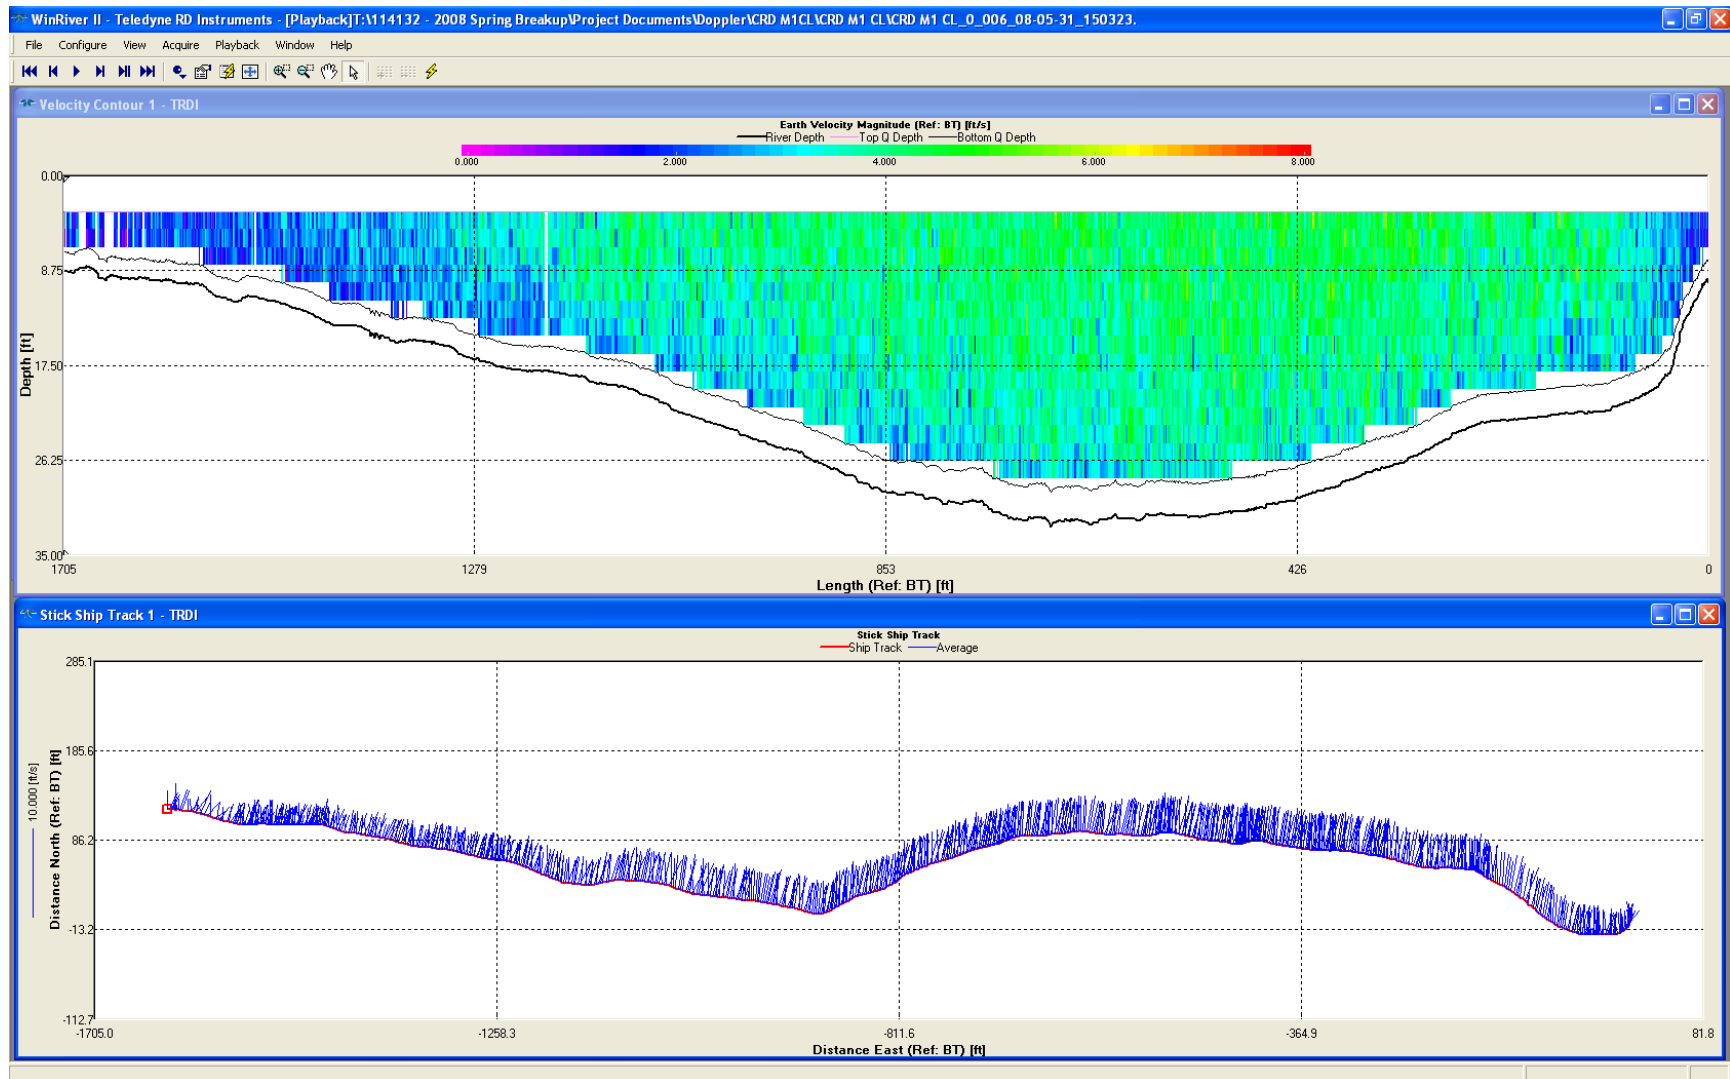
## Monument 1 Colville River ADCP Direct Discharge Transect 4, WinRiver II Velocity and Ship Plots May 31, 2008
