# 2013 Alpine Pipeline River Crossing Monitoring 135894-MBJ-RPT-001

**Baker** Michael Baker Jr., Inc. September 25, 2013

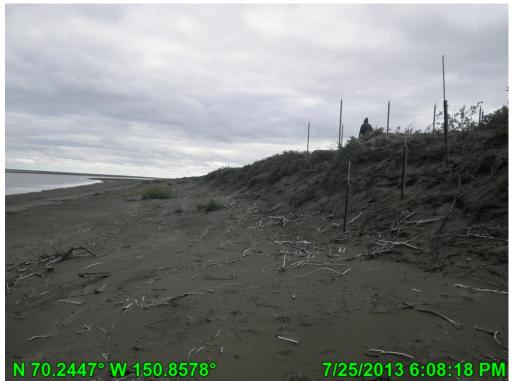
The 2013 Colville River spring breakup floodwaters reached, but did not overtop the west bank of the channel. Some erosion was evident along the west bank. One distinct debris line composed of sticks and small pieces of drift wood was observed at the toe of the bluff (Photo A.9).

Photo A.9 HDD West bank, looking south; July 25, 2013

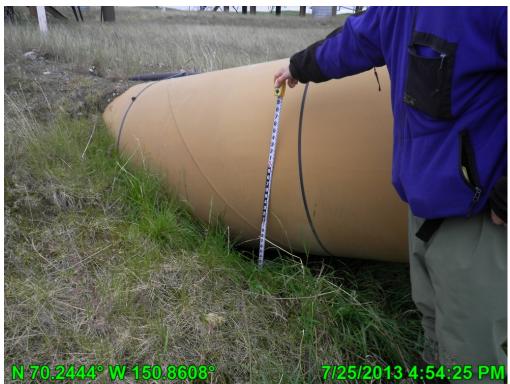
Photo A.12 HDD West sloughing of gravel pad; July 25, 2013

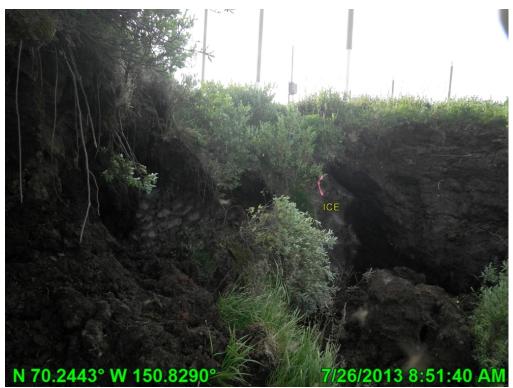
Photo A.20 HDD East bank exposed ice, looking southeast; July 26, 2013

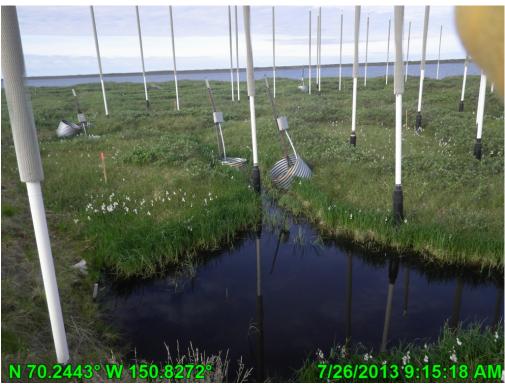
The cumulative subsidence measured at any of the cross sections along the polygon trough was less than 3.6 feet. Maximum cumulative subsidence at cross section E was 3.5 feet. Cross section A saw the maximum incremental change since 2012 with a drop of 1.4 feet. A polygon trough does pass over the seawater casing axis; however, features of the trough do not meet or exceed the allowable physical conditions listed in the 2013 Monitoring Criteria.

Photo A.22 HDD East polygon trough, looking southeast; July 26, 2013

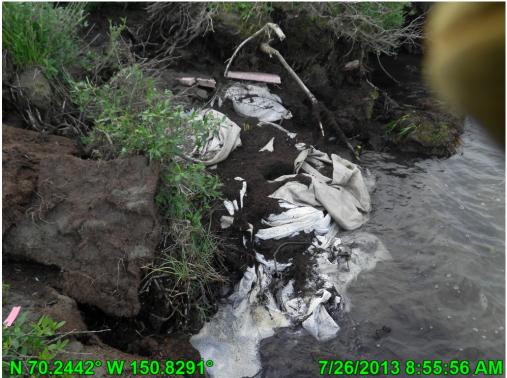
Additional erosion and sloughing has occurred along the east bank north of the NPS 14 oil pipeline and at the polygon trough near the NPS 12 seawater pipeline. Exposed sandbags and Styrofoam were evident at the toe of the polygon trough, similar to site conditions encountered during the 2012 field visit (Photo A.23). While the date of placement is not known, it is understood by Baker that the sandbags and Styrofoam were installed in the bank to combat further erosion.

Photo A.23 HDD East exposed sandbags on bank; July 26, 2013

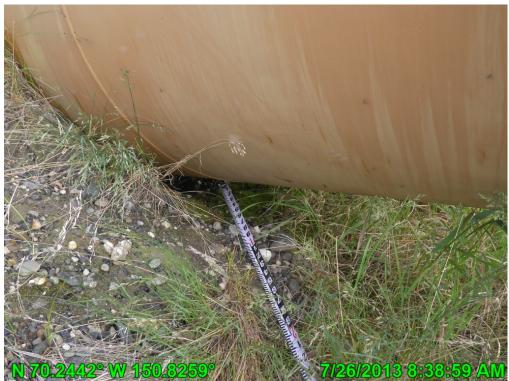
Photo A.24 HDD East sloughing of gravel pad; July 26, 2013
