2019 HABITAT MONITORING AND ASSESSMENT CD5 DEVELOPMENT PROJECT

Prepared for
ConocoPhillips Alaska, Inc.
Anchorage, Alaska

Prepared by
ABR, Inc.—Environmental Research & Services
Fairbanks and Anchorage, Alaska

February 2020

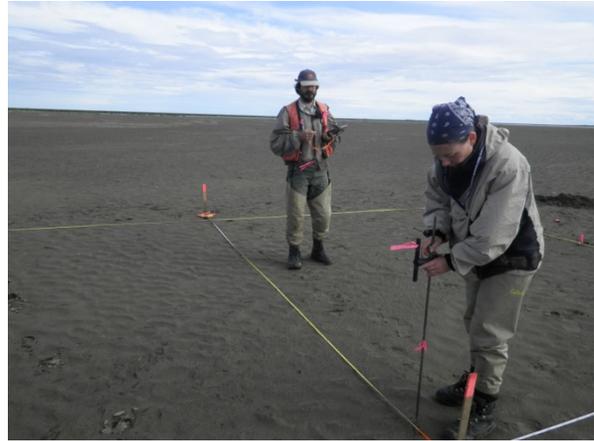
Vegetation Plot Line layout.

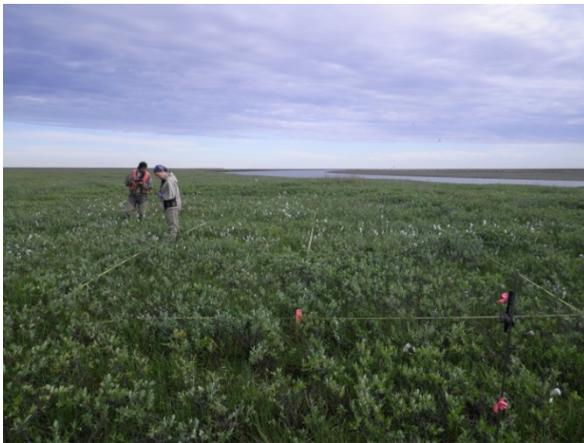
Vegetation Plot "box plot" layout.

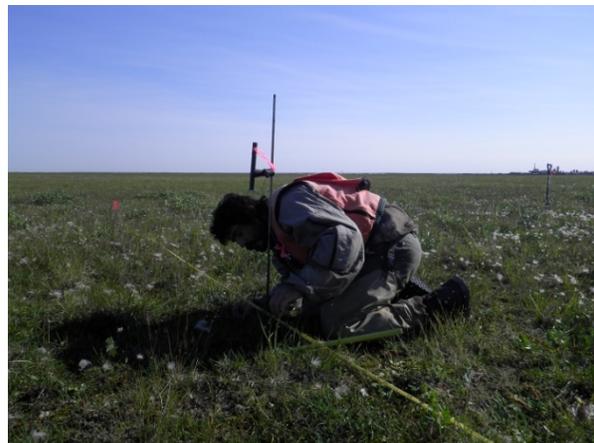
Botanist using a laser pointer mounted on a frost probe conduct point counts along a vegetation sampling line.

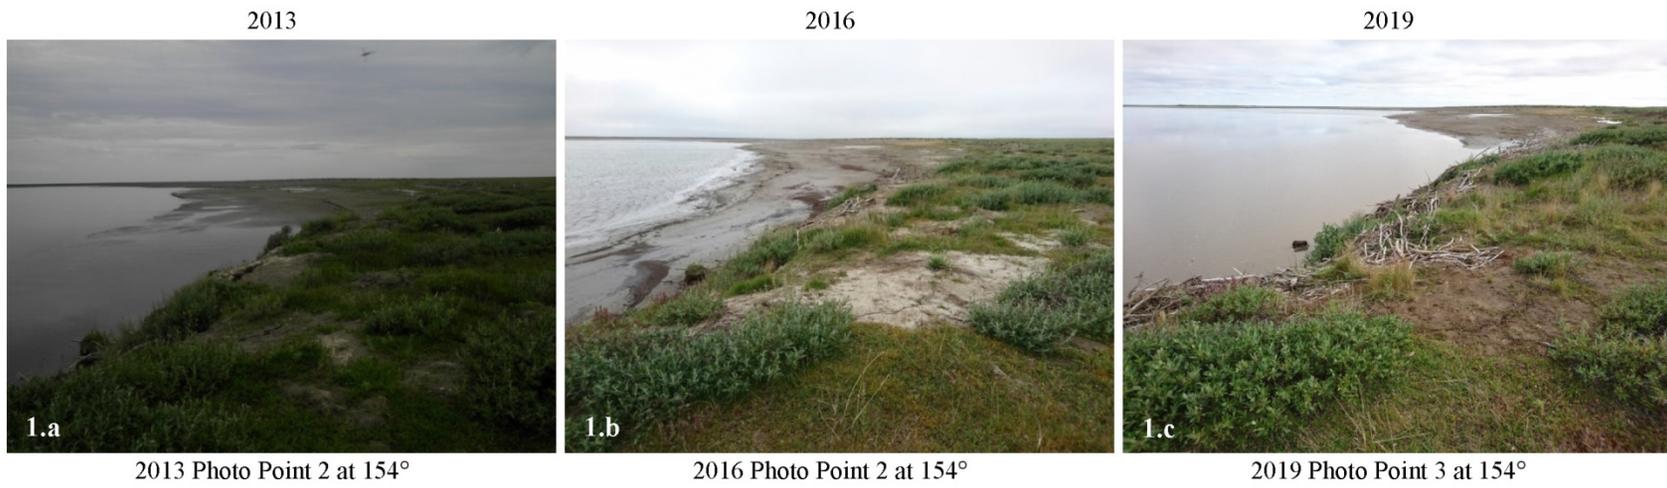
Figure 3.7 Photographs from the Geomorphology Monitoring Photo Point 2, CD5 Habitat Monitoring Study Area, northern Alaska, 2013–2019. Photographs include Photo Point 2 at 154° degrees in 1.a) 2013, 1.b) 2016, and 1.c) 2019.

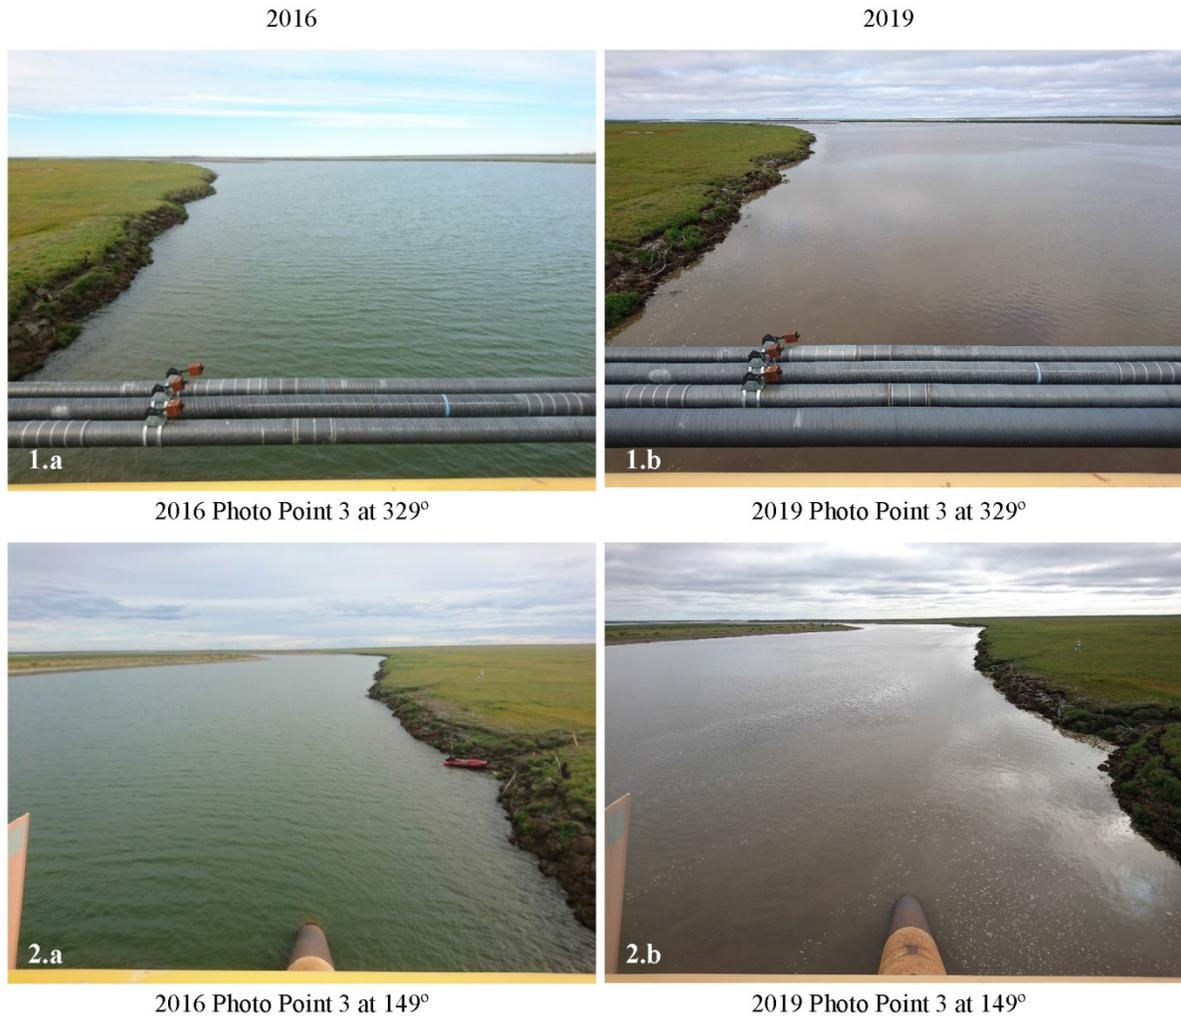
Figure 3.8 Photographs from the Geomorphology Monitoring Photo Point 3, CD5 Habitat Monitoring Study Area, northern Alaska, 2016–2019. Photographs include Photo Point 3 at 329° degrees in 1.a) 2016, and 1.b) 2019; and Photo Point 3 at 149° degrees in 2.a) 2016, and 2.b) 2019. This point was added in 2016 to monitor for landscape change from the Nigliq Channel. There is no 2013 photo because the bridge that this photo was taken from had not yet been constructed.

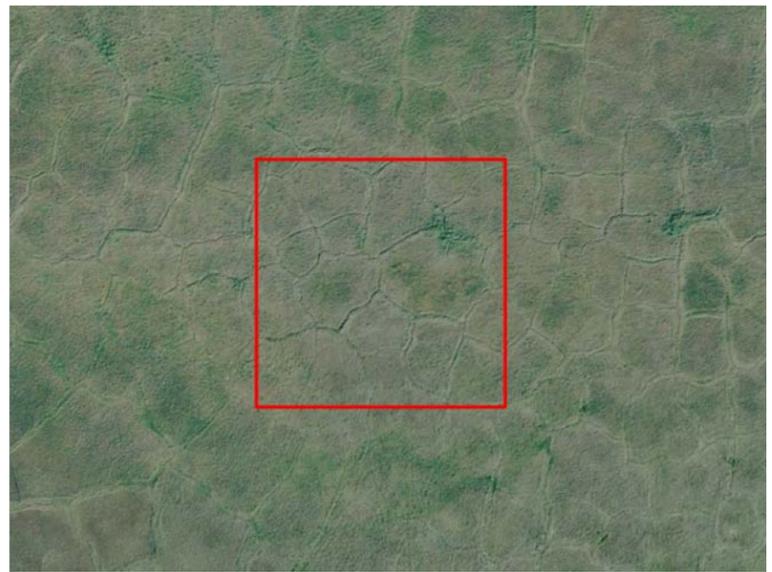
High-centered, Low-relief Polygons (Phl)

Nineteen surface forms occur in the updated mapping (Figure 3.26, Table 3.16). As in both the 2012 and 2015 maps, the dominant surface forms were Disjunct Polygon Rims; Low-centered, Low-relief, Low-density Polygons; and Non-patterned, each of which cover approximately 20% of the CD5 Study Area. Surface forms related to low-centered polygons are very common; these features are associated with ice-rich permafrost and collectively cover nearly one-third of the CD5 Study Area. Water accounts for 13.6% of the total area, and Lakes with Islands 7.5%. All other surface forms are relatively rare, with an areal cover <2% each. Examples of common ice-wedge polygon surface forms are provided in Figure 3.27.

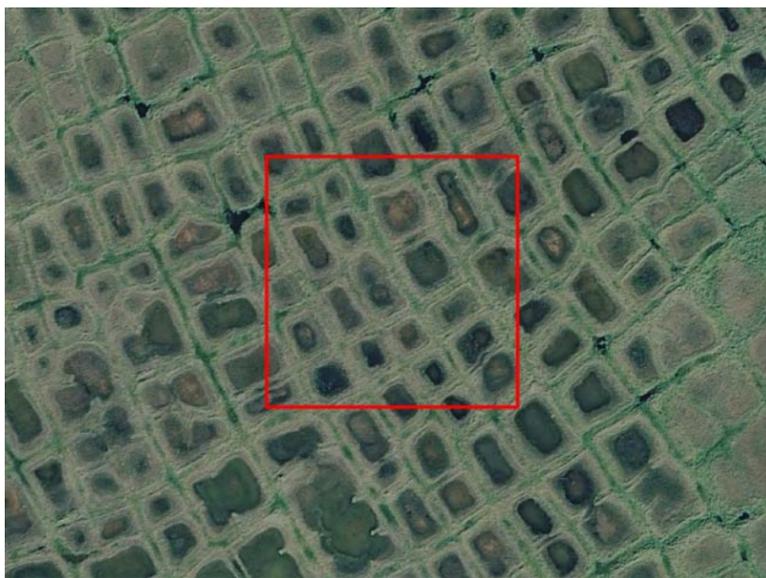
Low-centered, High-relief, High-density Polygons (Plhh)

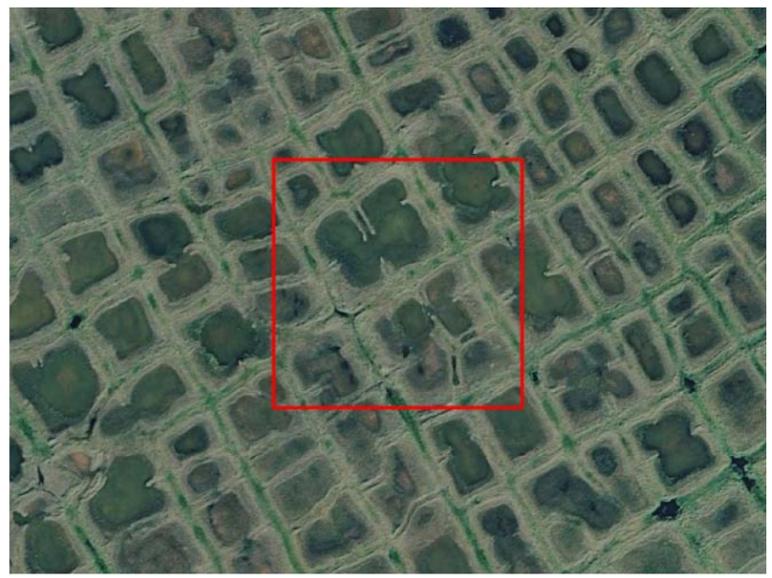
Low-centered, High-relief, Low-density Polygons (Plhl)

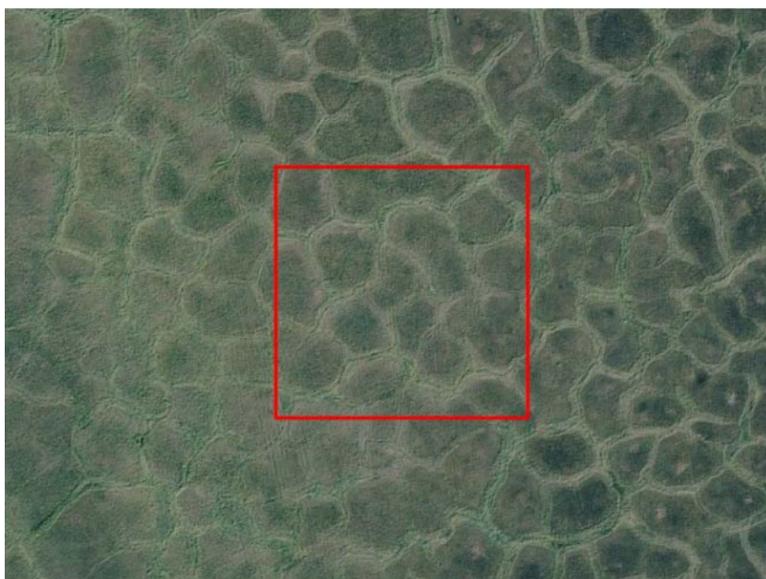
Low-centered, Low-relief, High-density Polygons (Pllh)

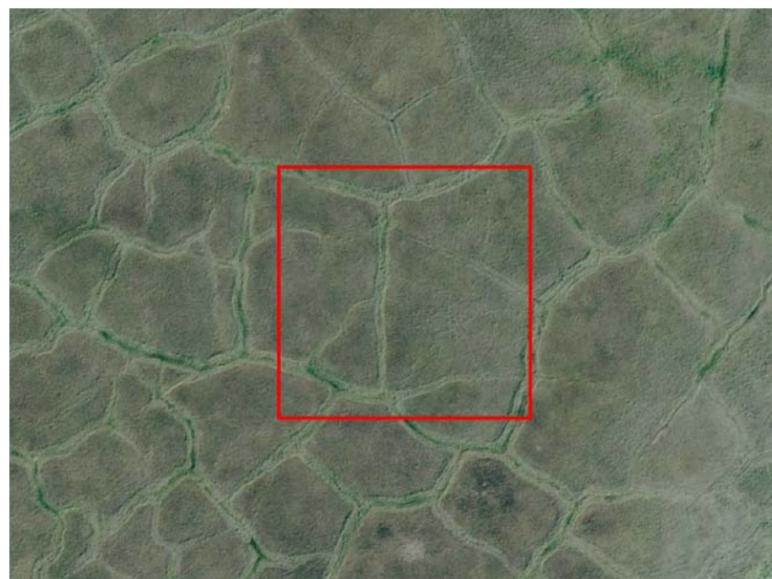
Low-centered, Low-relief, Low-density Polygons (Plll)

Figure 3.27. Examples of common ice-wedge polygon surface forms in the CD5 Habitat Monitoring Study Area, northern Alaska, 2013–2019.

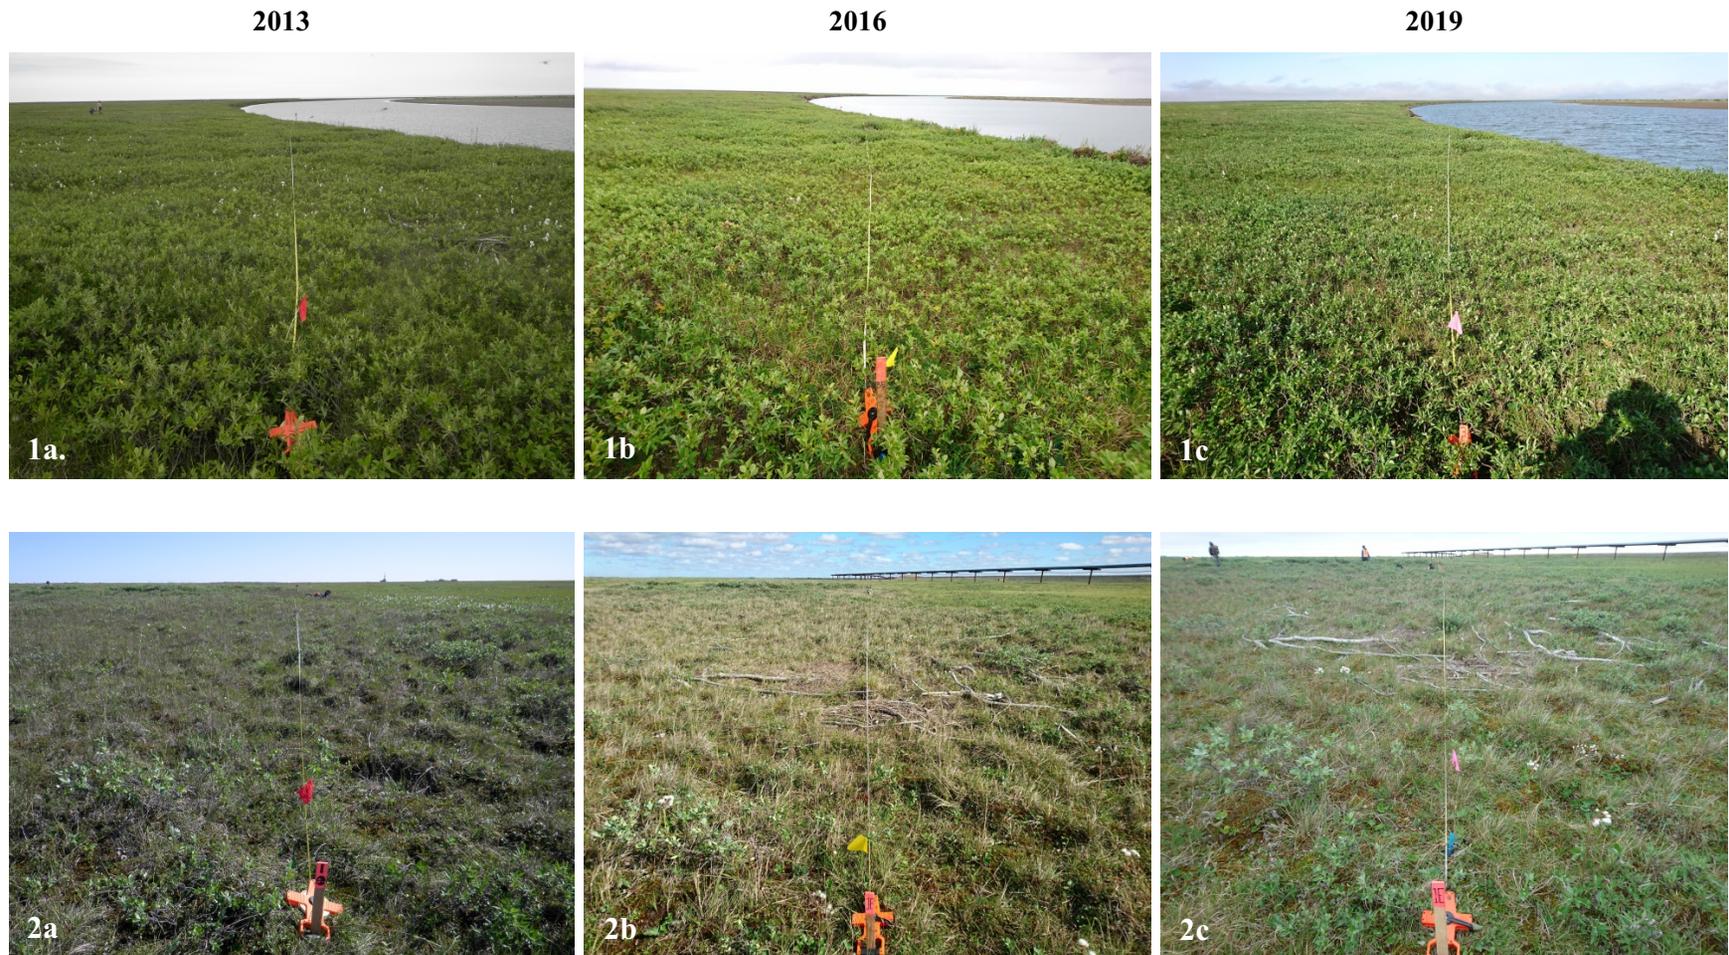
Figure 3.39 Upper Panels (1a,1b, and 1c), examples of drift lines observed in 2013 but not in 2016 and 2019. Lower Panels (2a, 2b, and 2c), drift lines observed in 2016 and 2019 but not in 2013.

Figure 3.39	Upper Panels, examples of drift lines observed in 2013 but not in 2016 and 2019.	130

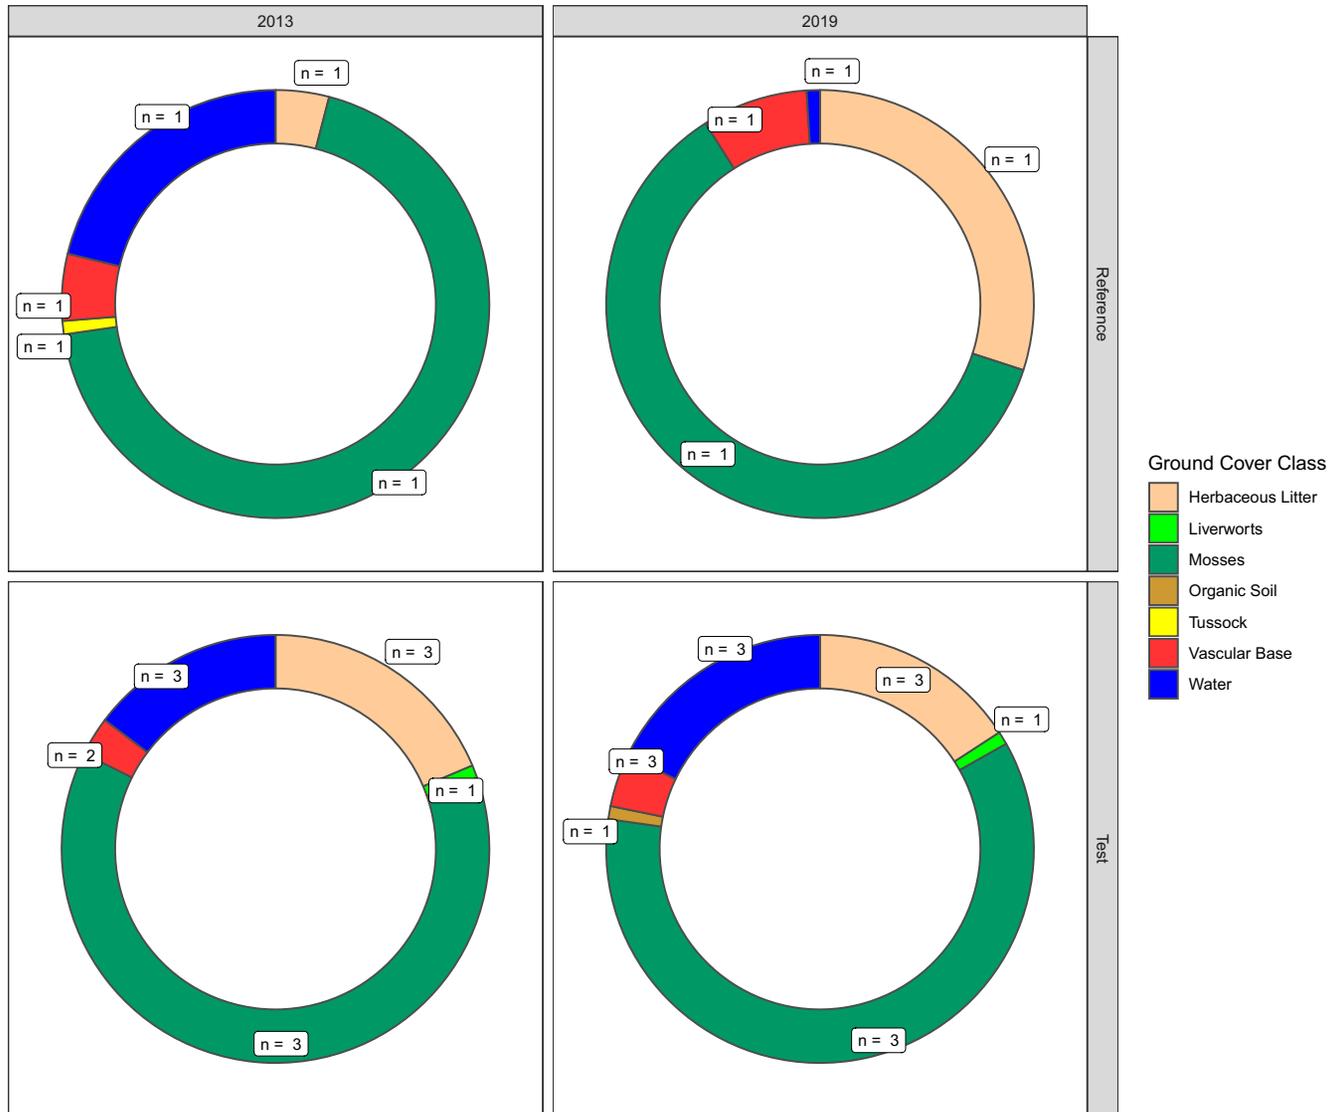
Appendix D7. Ring charts displaying the proportion of average total ground cover for the plot ecotype Lowland Organic-rich Circumneutral Wet Sedge-Willow Meadow by sample year, study area, and ground cover class, CD5 Habitat Monitoring Study Area, northern Alaska, 2013 and 2019.

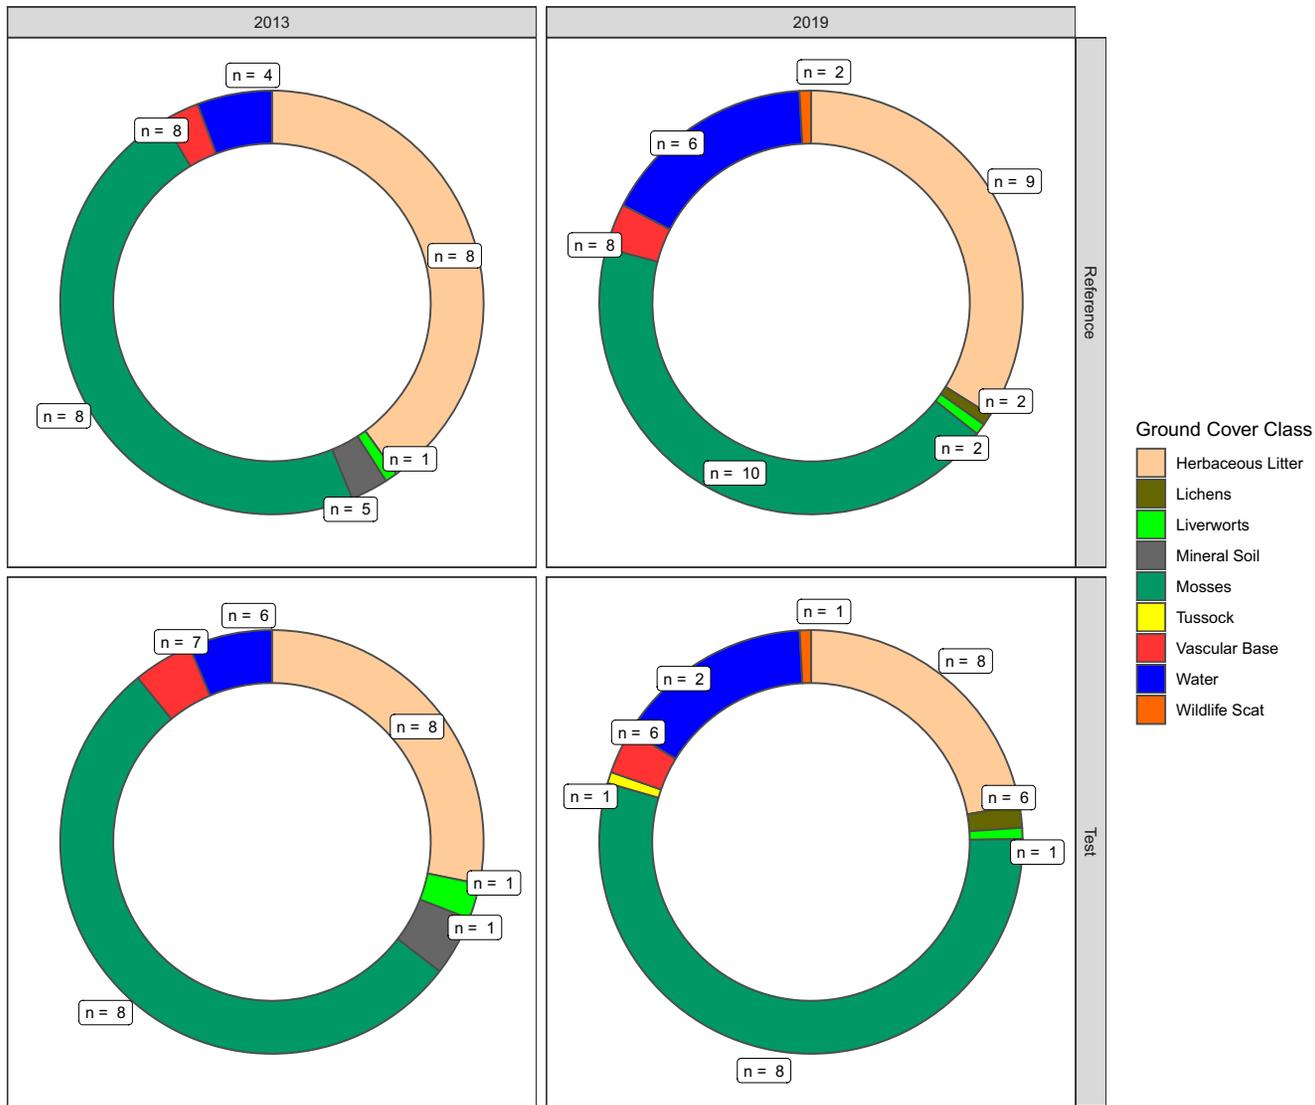
Appendix D11. Ring charts displaying the proportion of average total ground cover for the plot ecotype Riverine Loamy-Organic Circumneutral Moist Low Willow-Sedge Meadow by sample year, study area, and ground cover class, CD5 Habitat Monitoring Study Area, northern Alaska, 2013 and 2019.

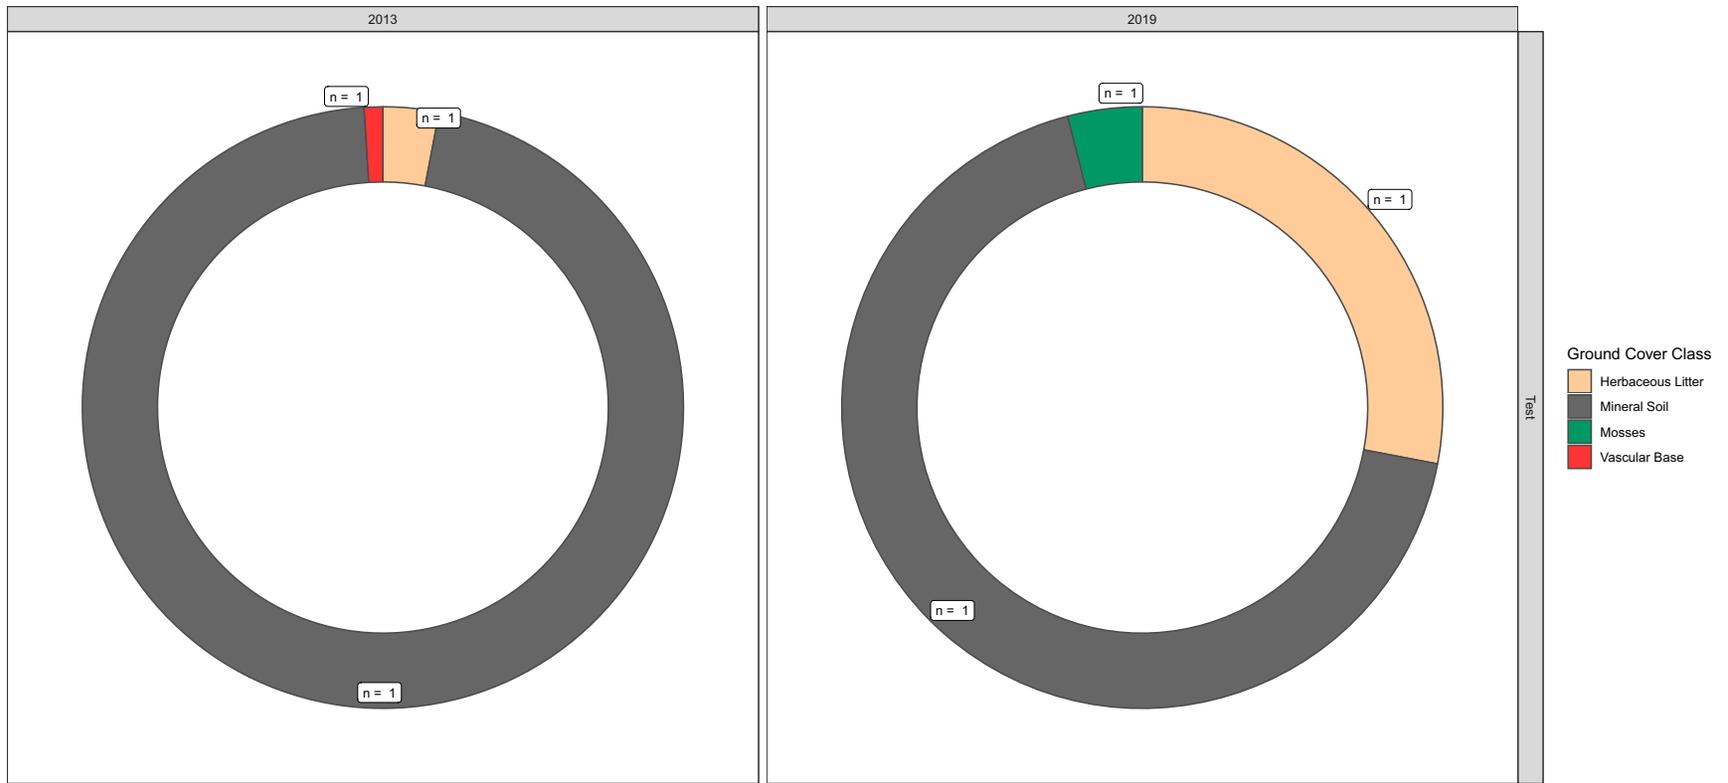
Appendix D16. Ring charts displaying the proportion of average total ground cover for the plot ecotype Upland Sandy Alkaline Dry Barrens by sample year, study area, and ground cover class, CD5 Habitat Monitoring Study Area, northern Alaska, 2013 and 2019.
