# CD-North Development Project

## 2001 Spring Breakup and Hydrologic Assessment

**October 2001**  
25008-MBJ-RPT-002

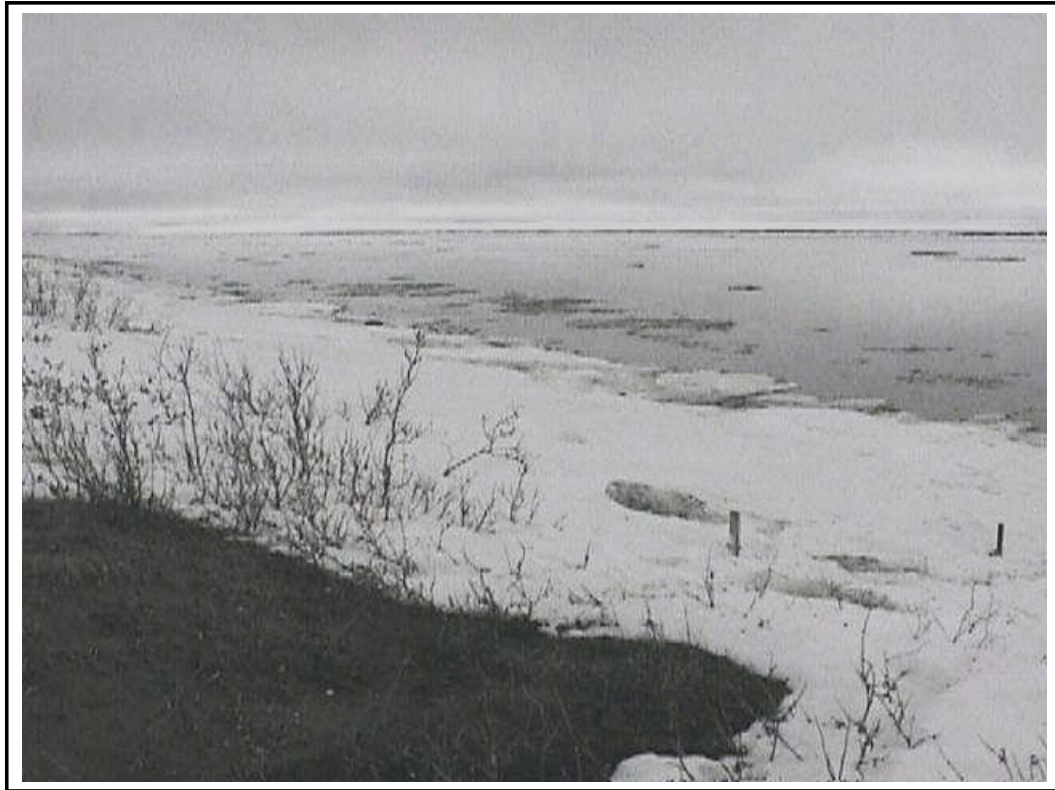
**Photo 2-3. Temporary Benchmark 01U, 6 June 2001. Looking east across the Colville River.**

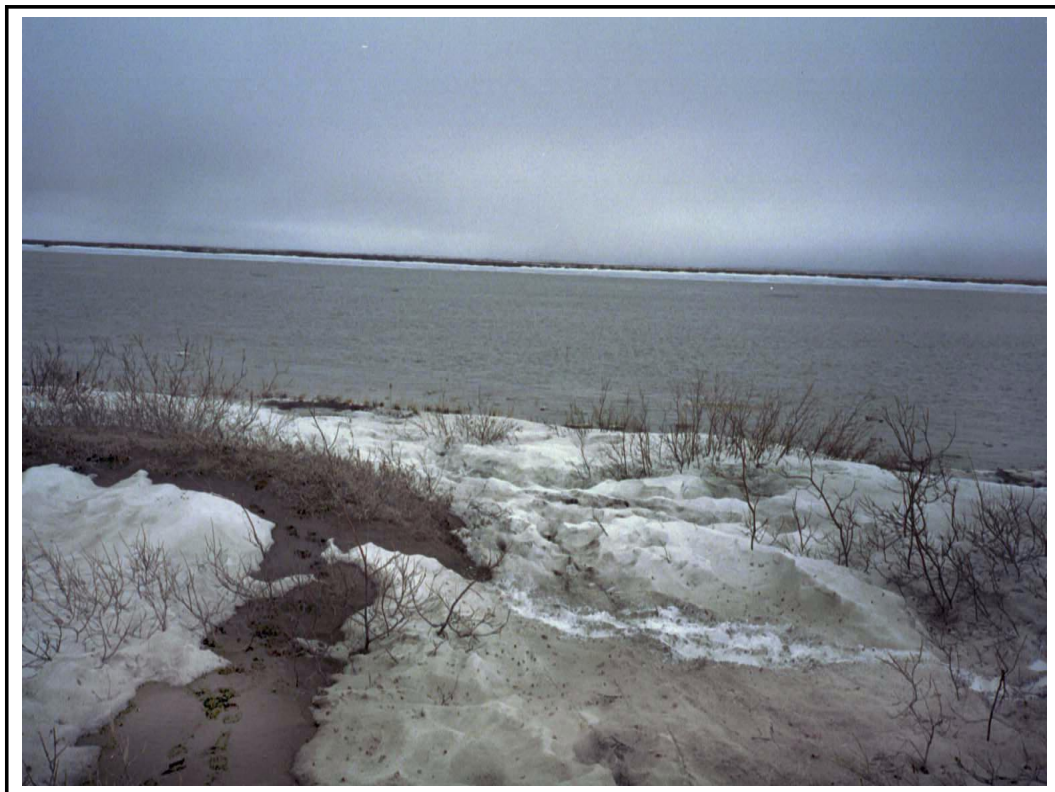
**Photo 2-4. Monument 01, 6 June 2001. Looking east across the Colville River.**

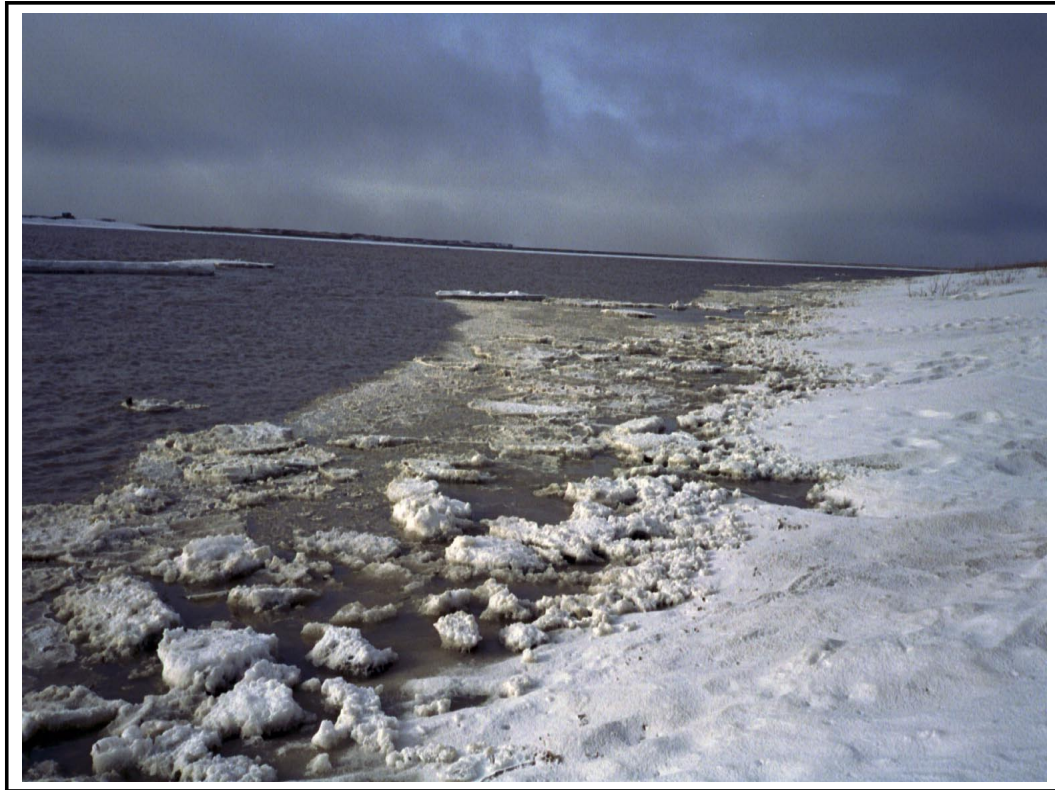
Photo 2-5. Temporary Benchmark 01U, 7 June 2001. Looking south (upstream).

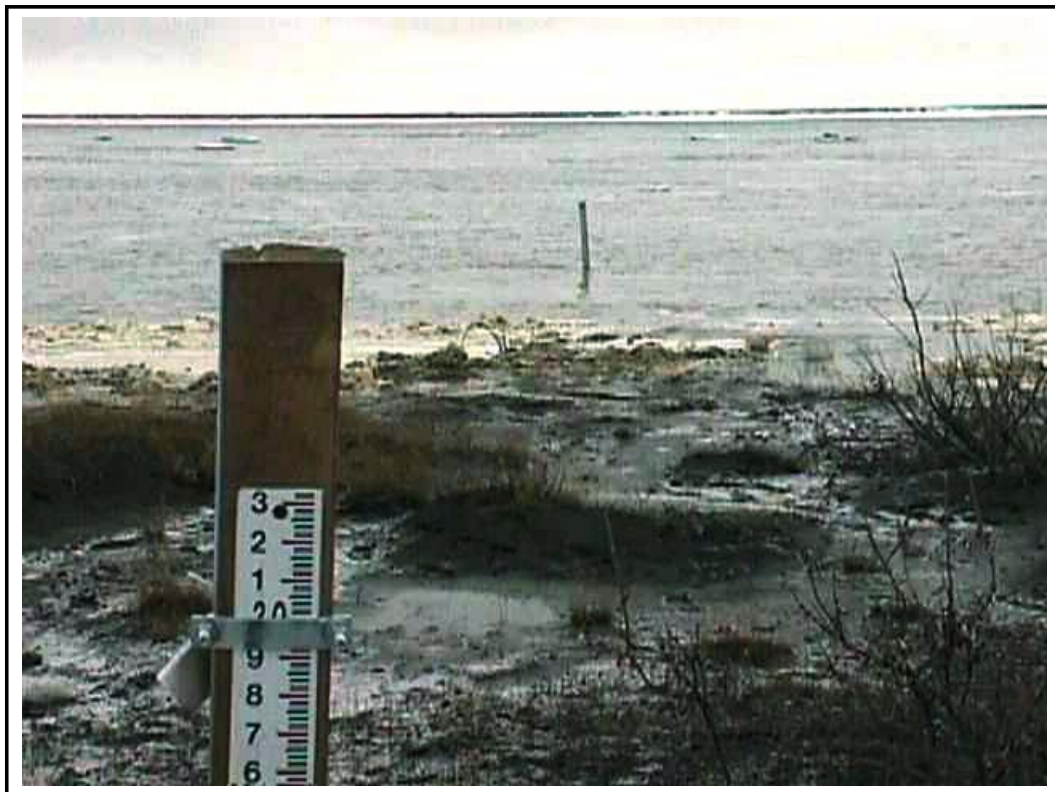
Photo 2-6. Temporary Benchmark 01D, 9 June 2001. Looking east across the Colville River.

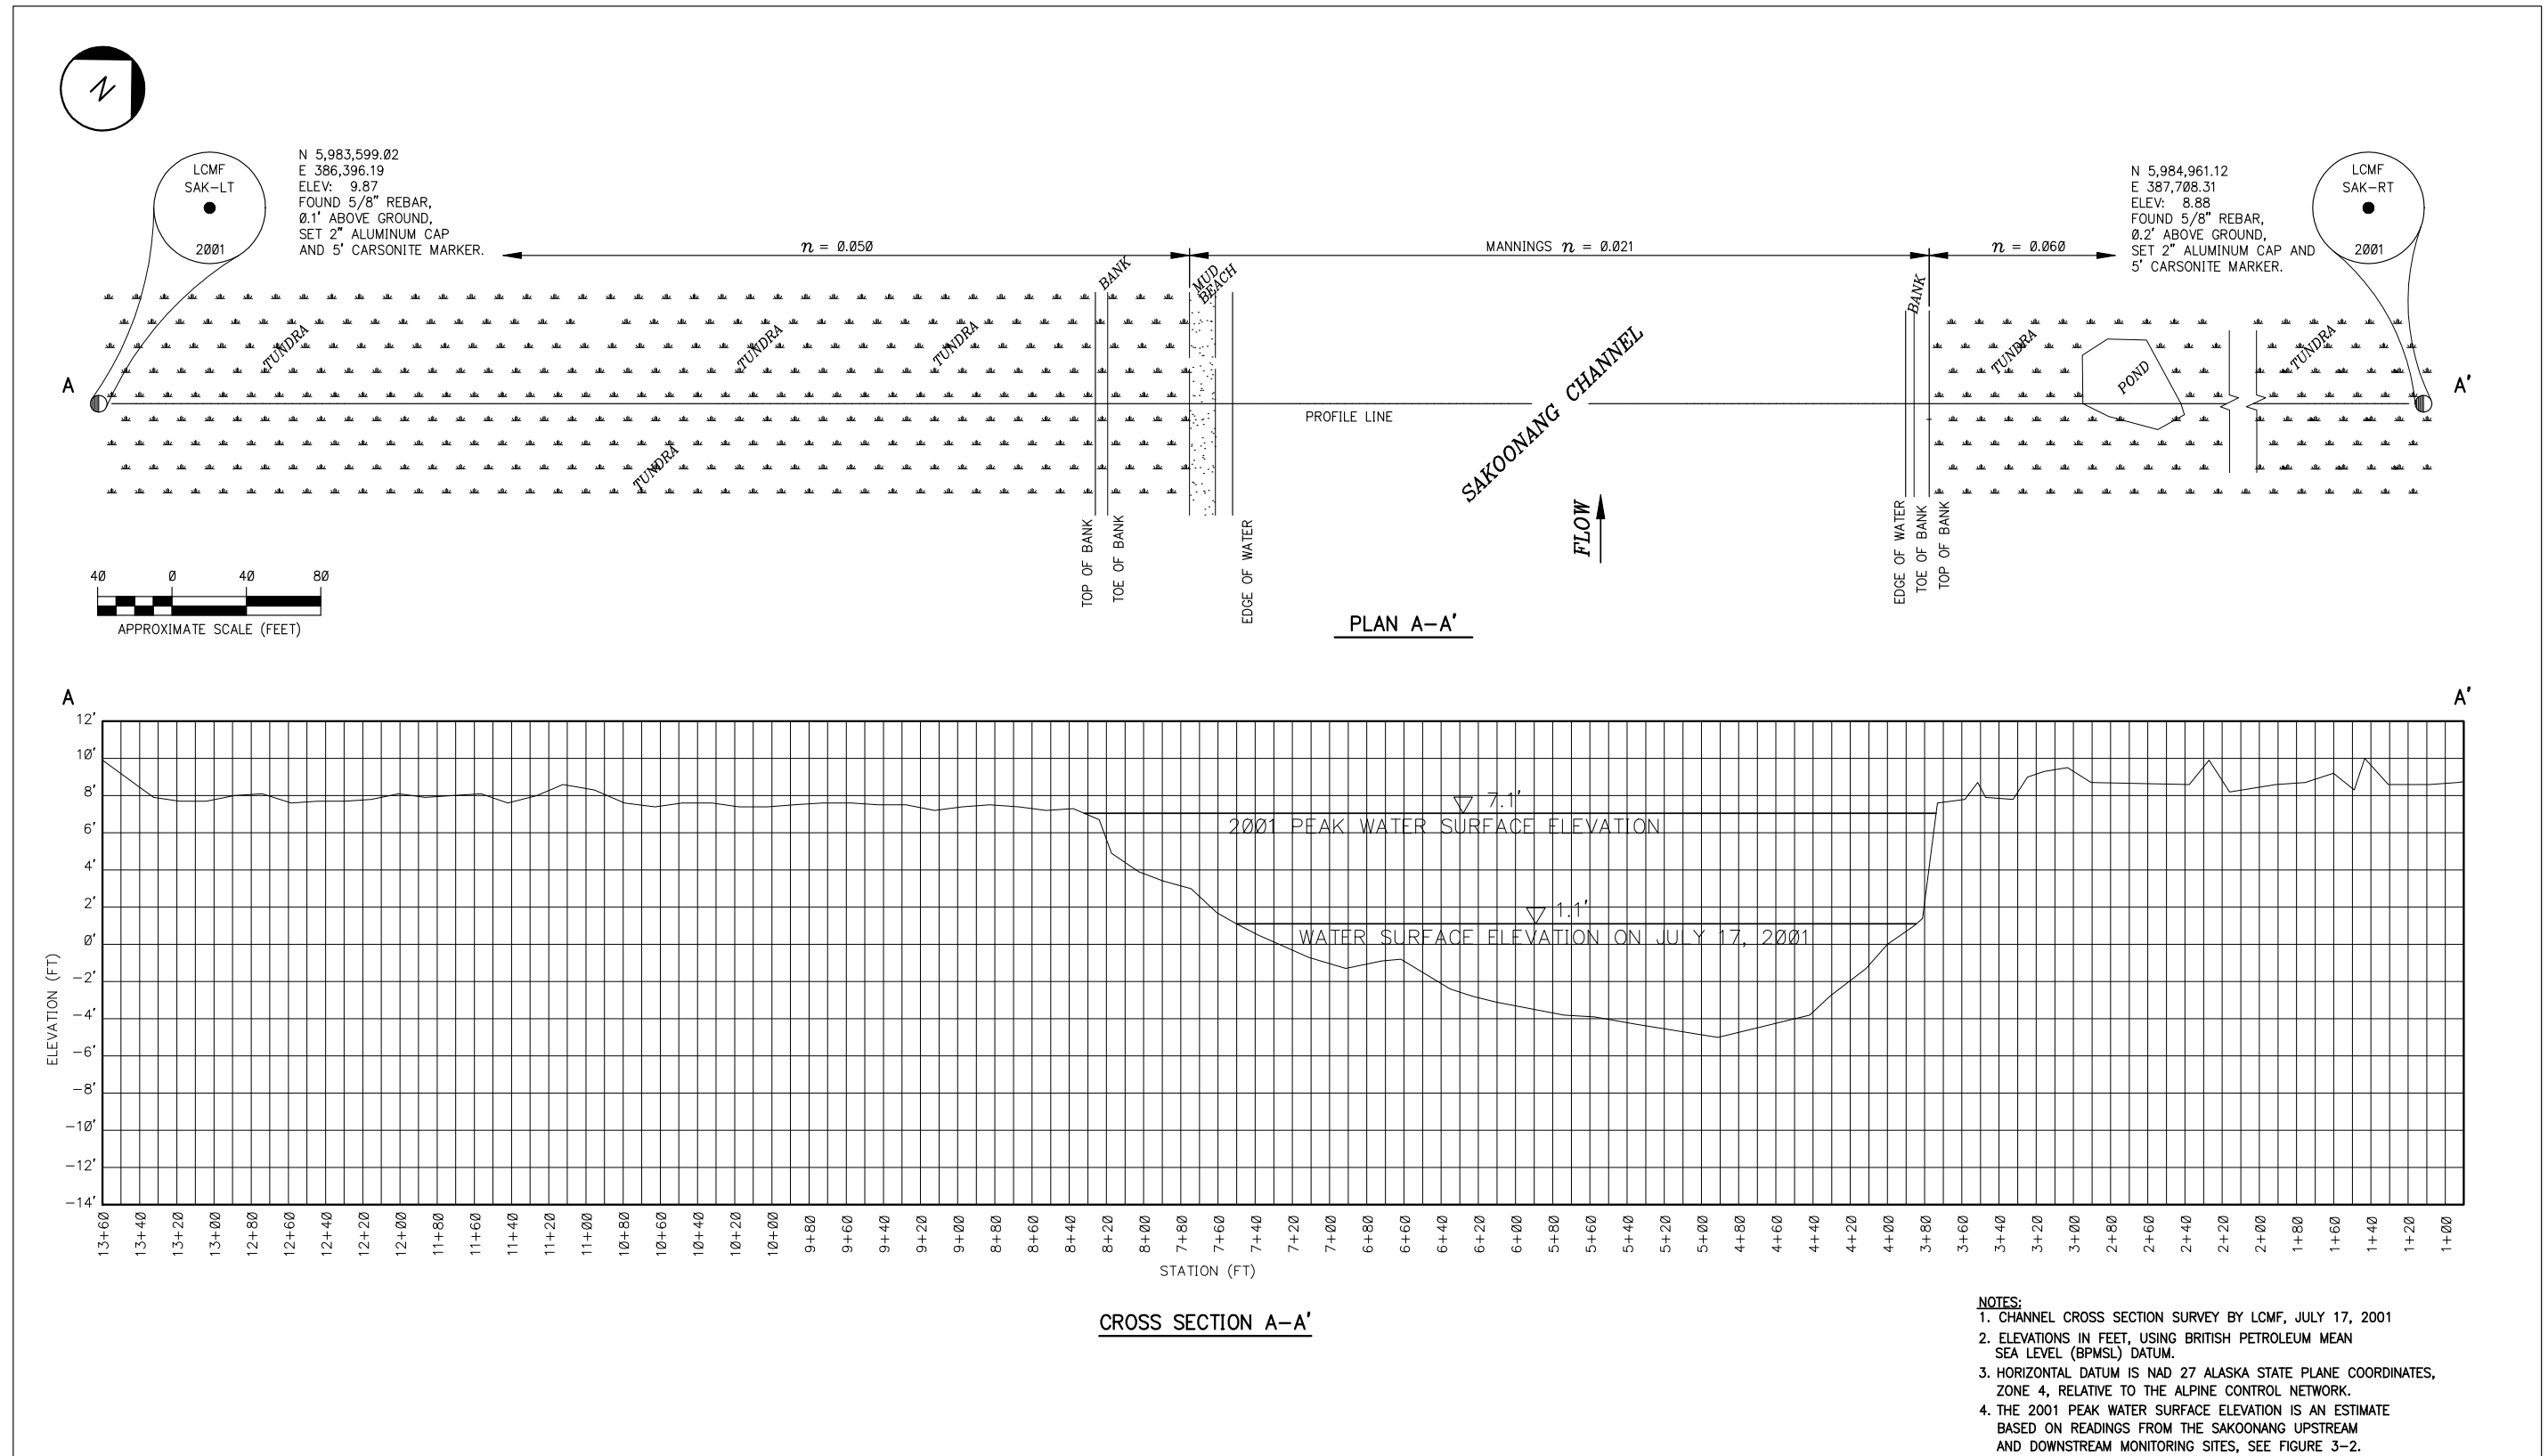
Figure 3-3. Sagoonang Channel

The Sakoonang Channel is asymmetrical and generally trapezoidal in shape in the vicinity of the proposed pipeline crossing. During 2001 spring breakup, flow was confined entirely to the active channel. At the time of the peak water surface elevation, the top width of flow was 460 feet, average depth was 6.6 feet, and the maximum depth was 12.1 feet. The Sakoonang Channel at the proposed pipeline crossing is shown in cross section in Figure-3-3.

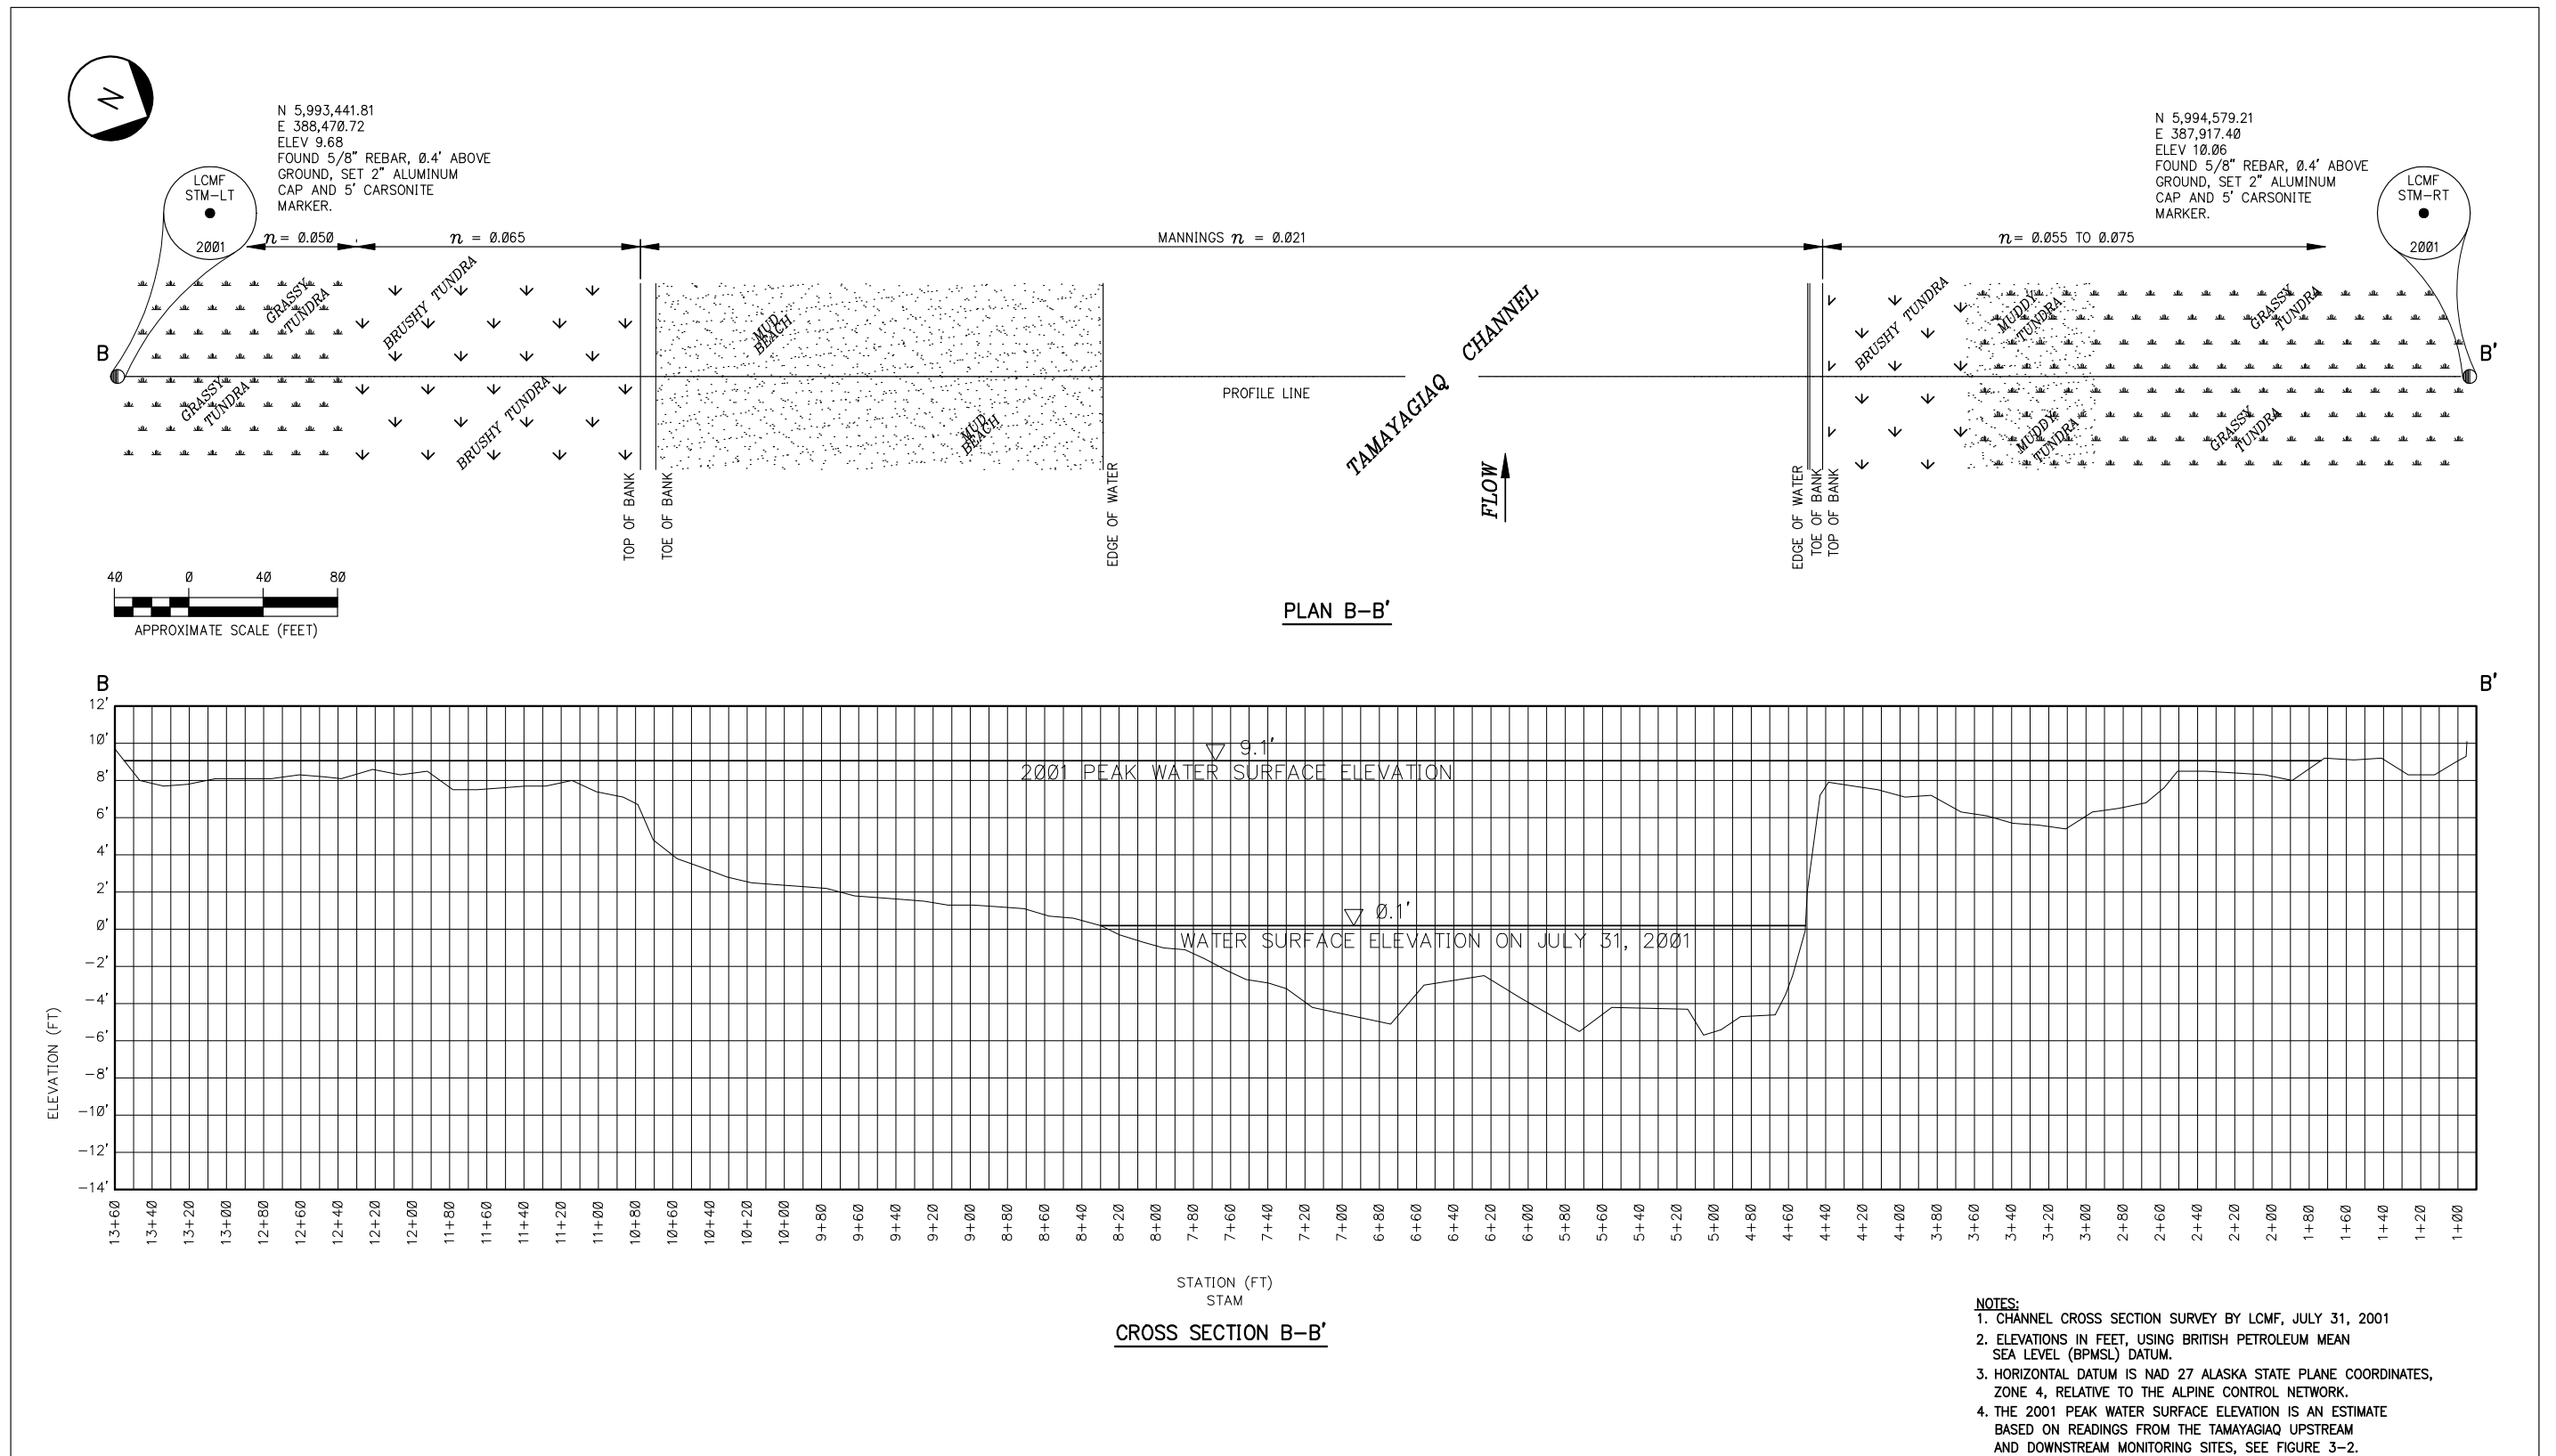
Figure 3-4. Tamayagiaq Channel

The Tamayagiaq Channel is asymmetrical and generally trapezoidal in shape in the vicinity of the proposed pipeline crossing. At the time of the peak water surface elevation, the top width of water was approximately 1,180 feet, and water was flowing on both the right and left overbanks. The average depth was 5.8 feet, and the maximum depth was 14.8 feet at the time of the peak water surface elevation. The Tamayagiaq Channel at the proposed pipeline crossing is shown in cross section in Figure-3-4.

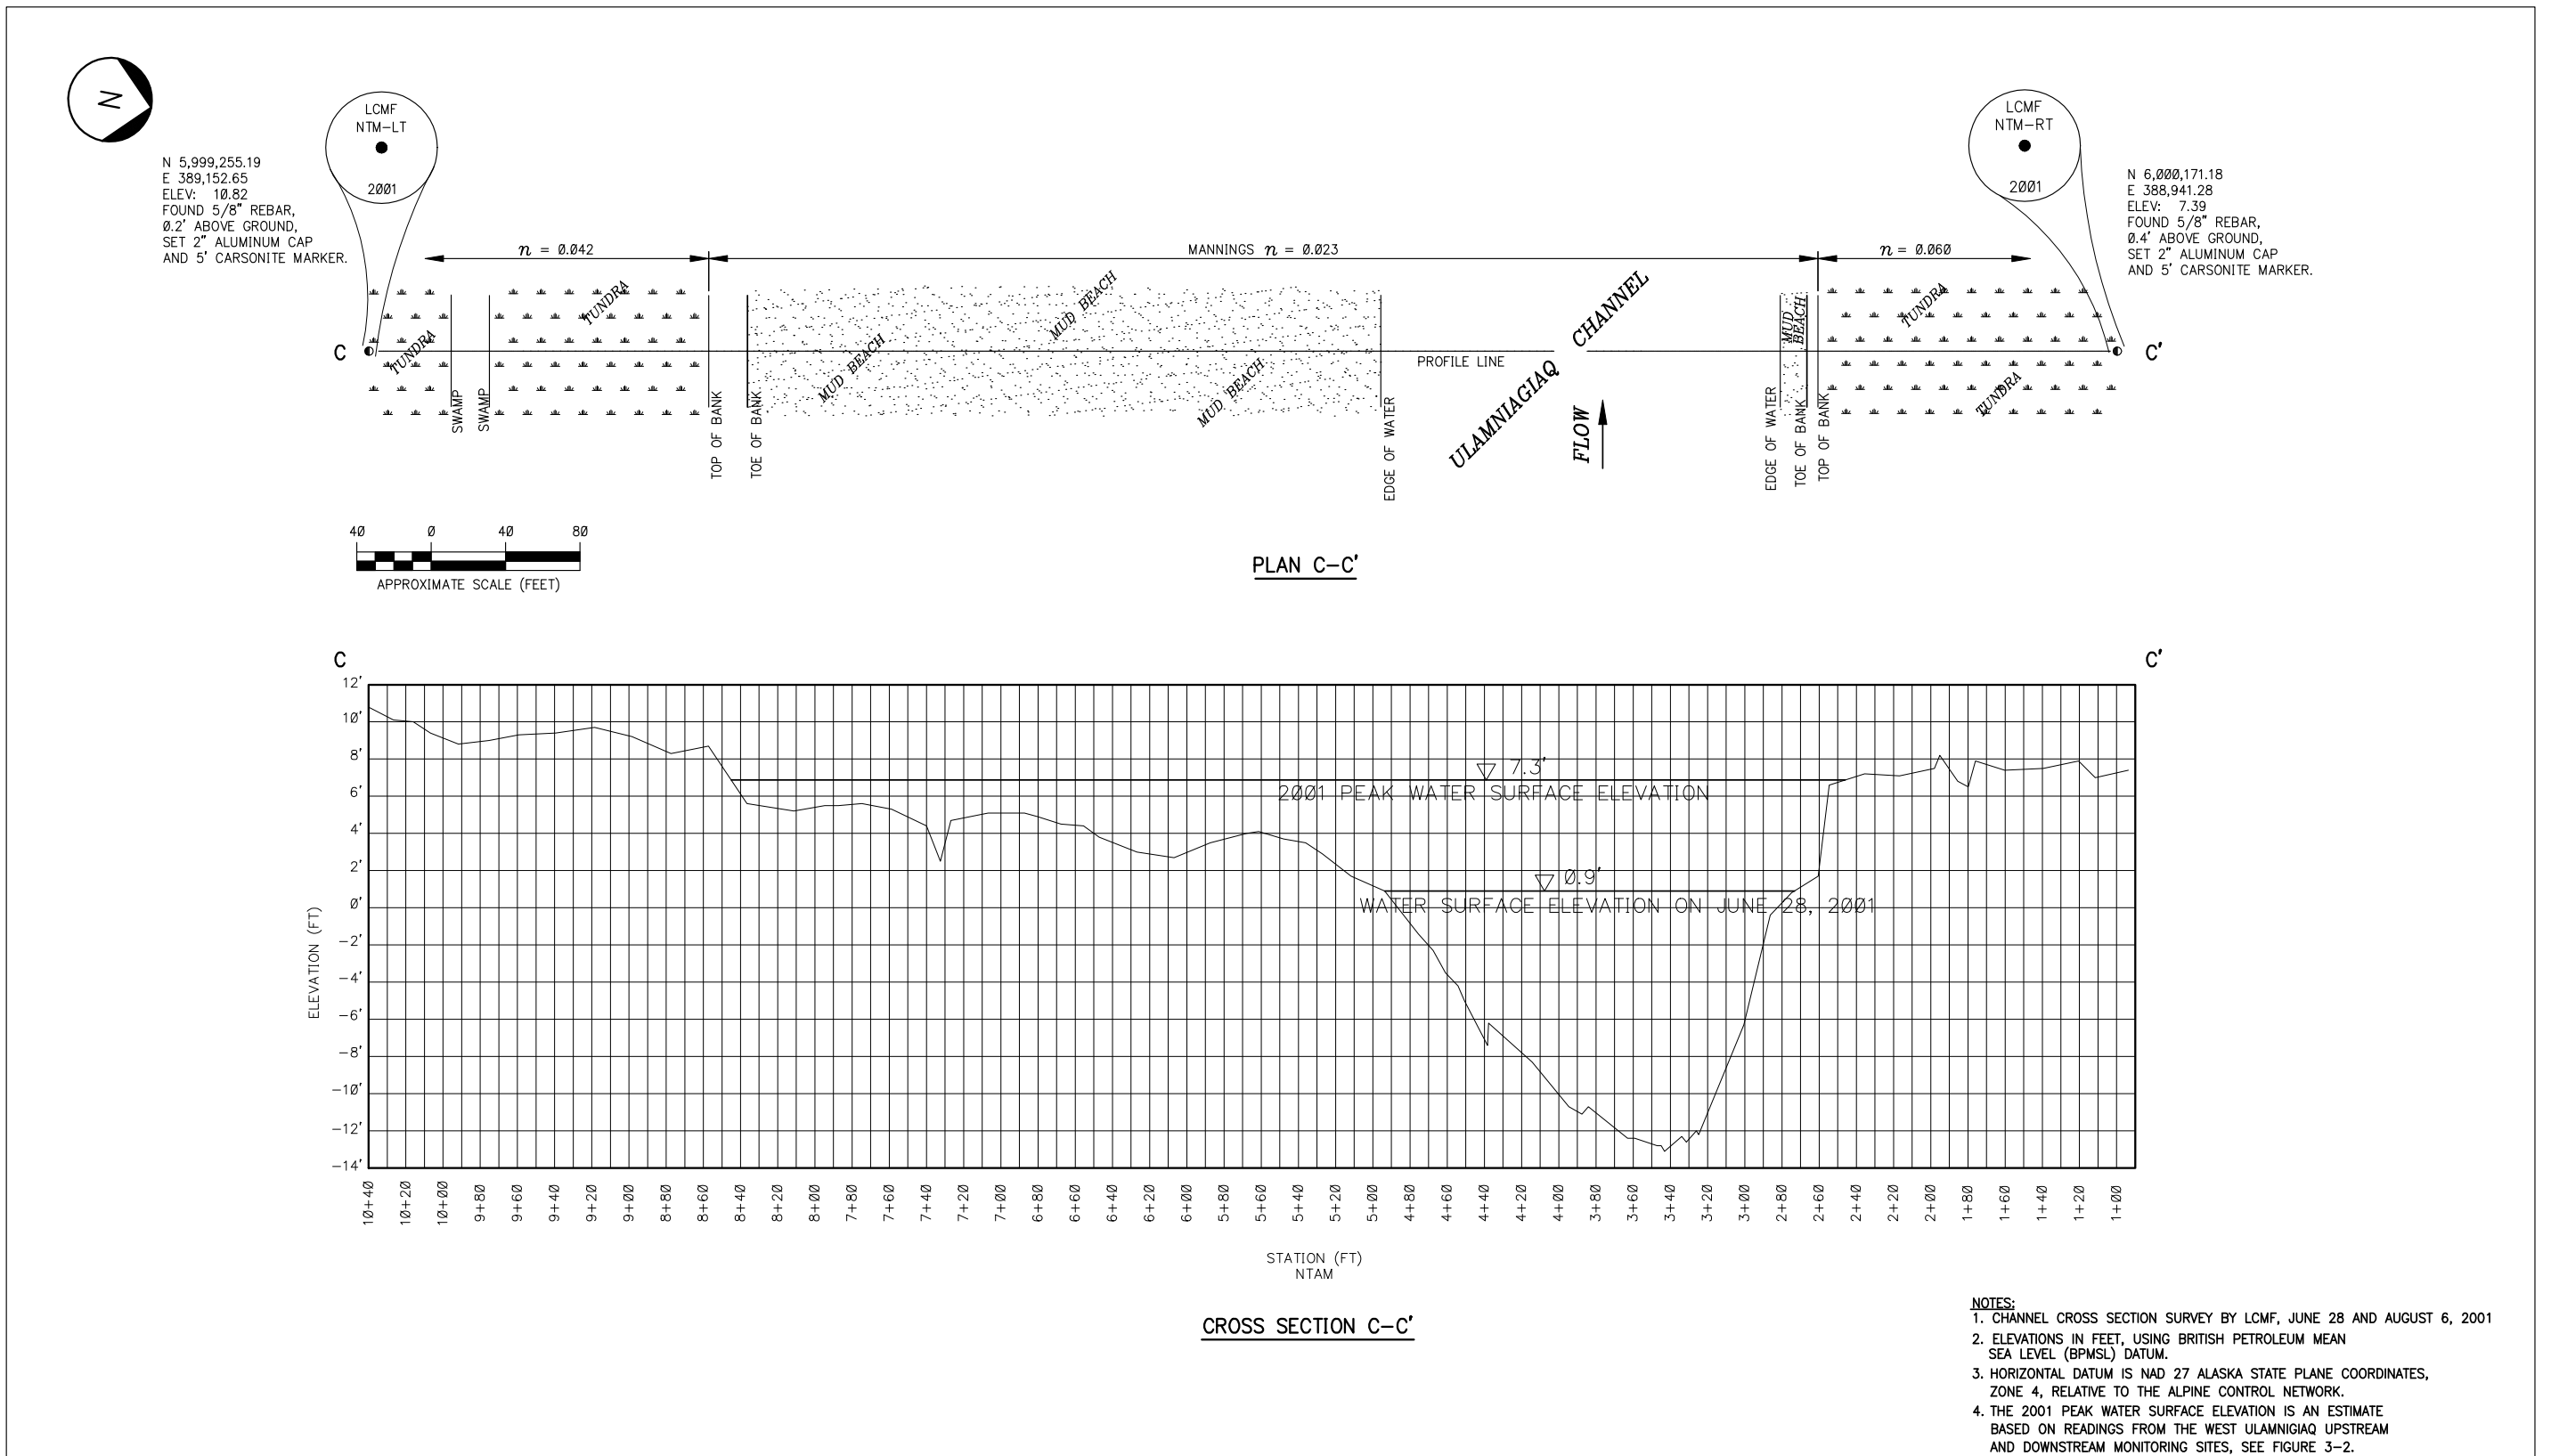
Figure 3-5. Ulamniaq Channel

The Ulamnigiaq Channel is asymmetrical and generally trapezoidal in shape in the vicinity of the pipeline crossing. At the time of the peak water surface elevation, the top width of water was approximately 600 feet, average depth was 8.4 feet, and the maximum depth was 20.4 feet. The Ulamnigiaq Channel at the proposed pipeline crossing is shown in cross section in Figure-3-5.

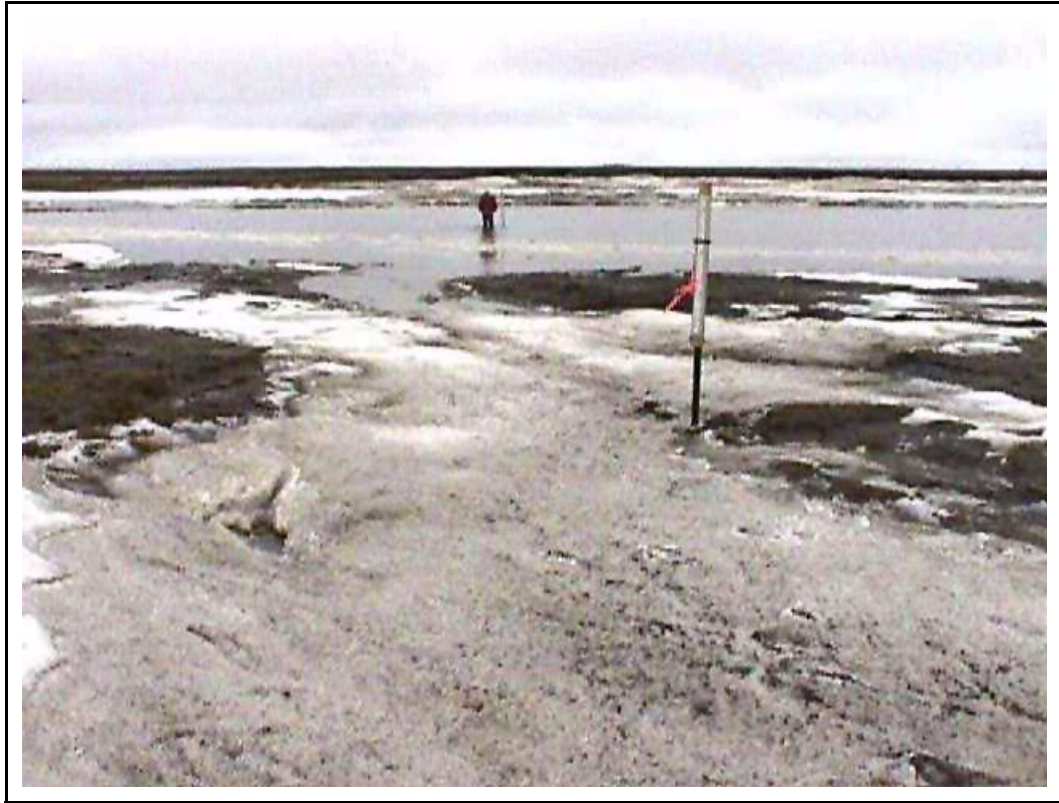
In the Tamayagiaq Channel, flowing water was first observed on 7 June. Water surface elevations peaked at 9.13 feet and 8.60 feet at the upstream and downstream monitoring sites, respectively. In the vicinity of the proposed pipeline crossing the peak water surface elevation was estimated to be 9.1 feet. Peak water surface elevations occurred on the morning on 11 June and no intact channel ice or snow was visible; however, ice floes up to 30 feet across and 4 feet thick were observed. Based on normal depth calculations, it was estimated that at the time the peak water surface elevation occurred, peak discharge on the Tamayagiaq Channel at the proposed pipeline crossing was approximately 21,500 cfs with an average velocity of 3.2 ft/sec. Water surface elevation and observations for the Tamayagiaq Channel are summarized in Table 3-3. Photos 3-3, 3-4, and 3-5 show the Tamayagiaq Channel on 6 and 11 June, respectively.

**Photo 3-3. Tamayagiaq Channel, 6 June 2001. Looking north across the channel from the downstream gages.**

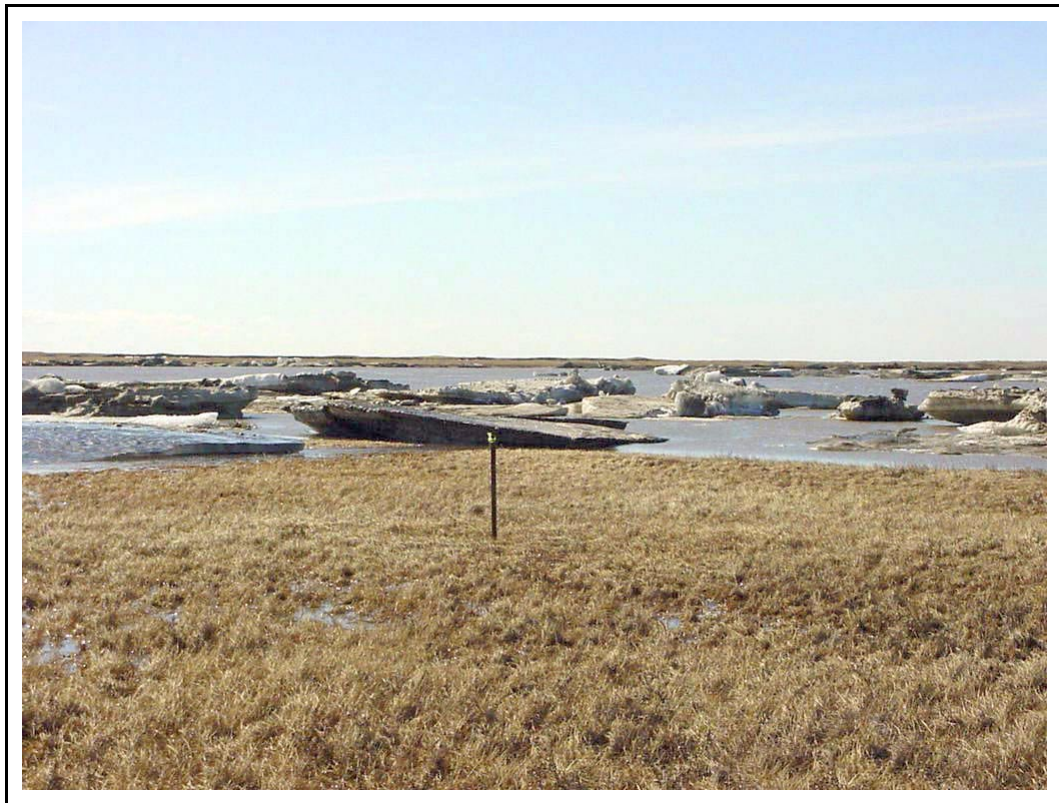
**Photo 3-4. Tamayagiaq Channel, 11 June 2001. Looking west across the channel from the downstream gages.**

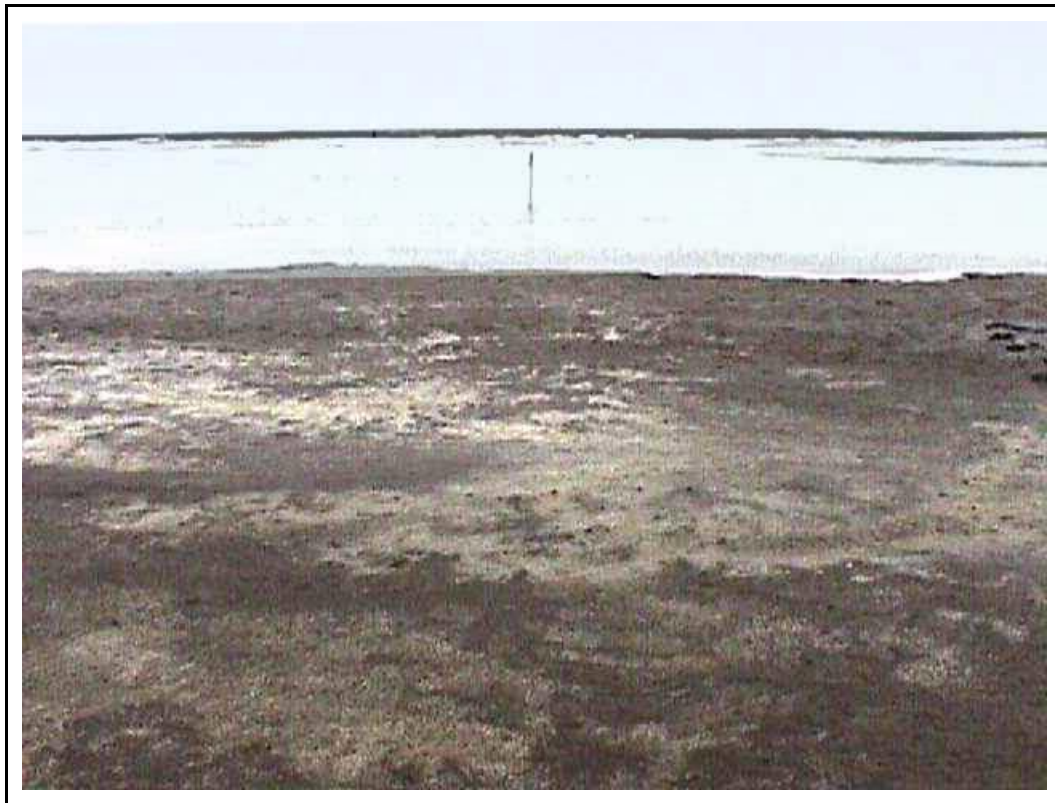
Based on normal depth calculations it was estimated that at the time the peak water surface elevation occurred, peak discharge on the Ulamnigiaq Channel at the proposed pipeline crossing was approximately 14,200 cfs with an average velocity of 3.2 ft/sec. Water surface elevation and observations for the Ulamnigiaq Channel are summarized in Table 3-4. Photos 3-6 and 3-7 show conditions at the Ulamnigiaq Channel on 6 and 11 June, respectively.

**Photo 3-6. Ulamnigiaq Channel, 6 June 2001. Looking northeast across channel from the downstream gages.**

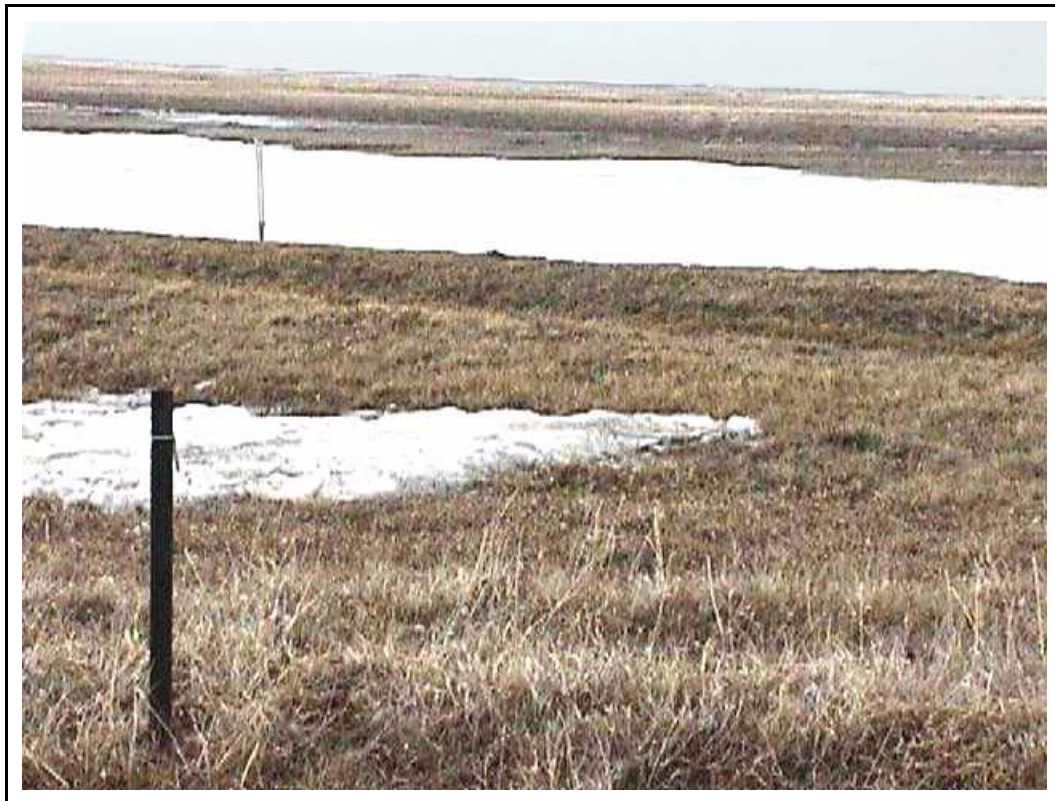
Based on normal depth calculations, it was estimated that at the time the peak water surface elevation occurred, peak discharge on the West Ulamnigiq Channel at the proposed pipeline crossing was approximately 12,200 cfs with an average velocity of 2.82 ft/sec. Water surface elevations and observations for the West Ulamnigiq Channel are summarized in Table 3-5. Photos 3-8 and 3-9 shows snow conditions in the West Ulamnigiq Channel on 7 and 9 June, respectively.

**Photo 3-8. West Ulamnigiaq Channel, 7 June 2001. Looking west across the channel from the upstream cross section.**

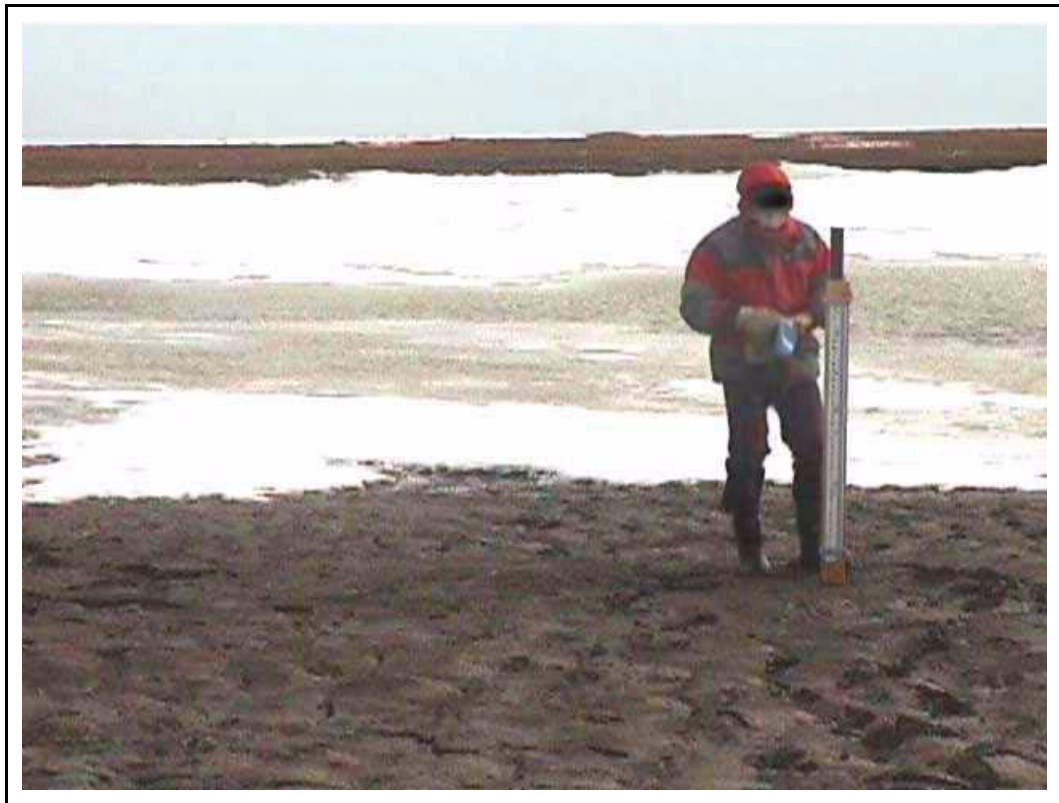
the water surface elevation in the West Ulamnigiq Channel (adjacent and to the west of the proposed pad location) peaked at 7.57 feet. In the East Ulamnigiq Channel (adjacent and to the east of the proposed pad location) the water surface elevation peaked at 7.43 feet. Channel and snow conditions in the East Ulamnigiq Channel were similar to the conditions observed in the West Ulamnigiq Channel. Photos 3-10 and 3-11 show conditions in the East Ulamnigiq Channel on 7 and 9 June, respectively.

**Photo 3-10. East Ulamnigialq Channel, 7 June 2001. Looking east across the channel from the gages.**
