CD-South Development Project

**2002 Spring Breakup and Hydrologic
Assessment**

November 2002

25436-MBJ-DOC-002

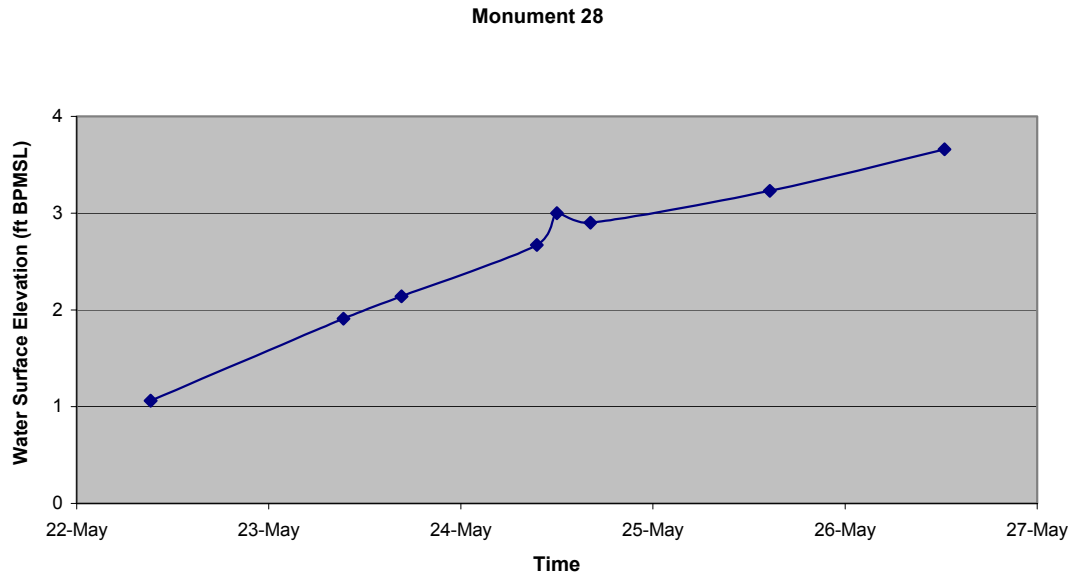
Date	Time	Water Surface Elevation (feet BPMSL)	Observations
5/23/2002	9:20	1.91	No intact channel ice present in distributary where gages are located. Main Nigliq Channel has low water channel ice intact.
5/23/2002	16:35	2.14	
5/24/2002	9:30	2.67	
High Water Mark		3.00	High water mark occurred on May 24 between 09:30 and 16:10.
5/24/2002	16:10	2.90	No visible ice floating in channel.
5/25/2002	14:36	3.23	
5/26/2002	12:25	3.66	Staff gages destroyed. Nigliq channel ice still intact adjacent to gage location.

1. Elevations are based on an elevation of 3.66 feet BPMSL for Monument 28, established by Lounsbury & Associates in 1998.
2. GPS coordinates for Monument 28 are N70° 25' 33.2" W151° 03' 49.6" (NAD 27), surveyed by Lounsbury and Associates.
3. Staff gages destroyed on May 26. No high water mark available. Reading on May 26 from Monument 28.

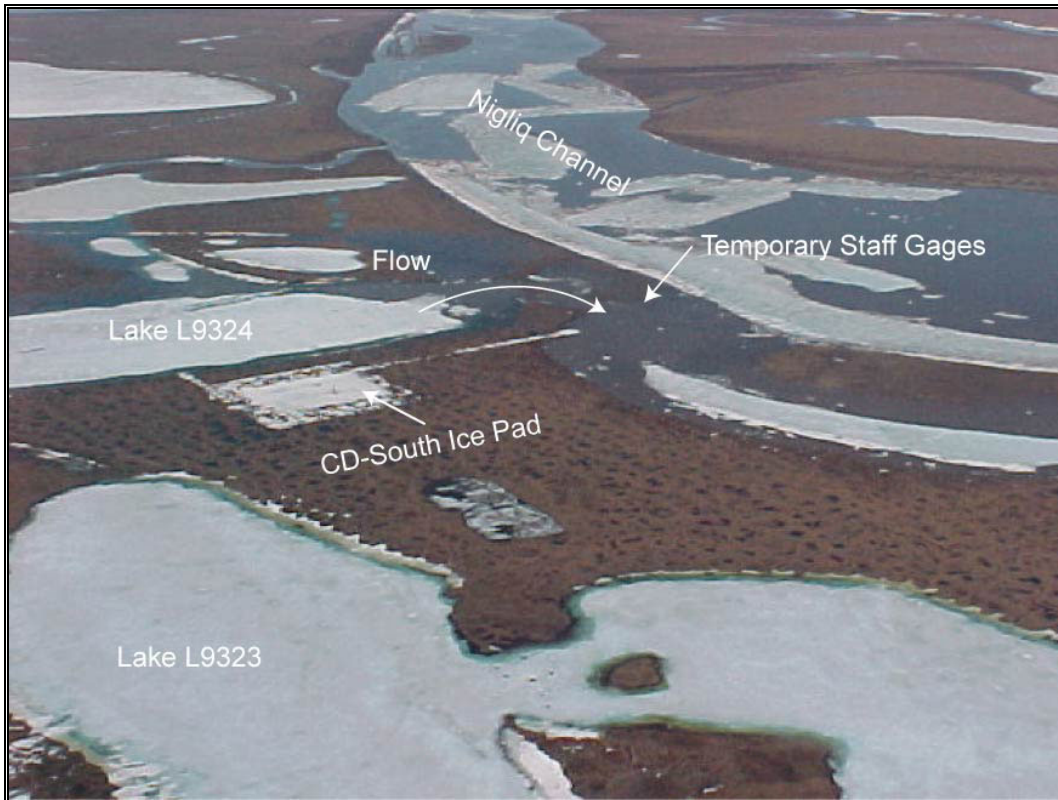
Photo 3-6 Temporary benchmark 20N. Looking southwest at the Nigliq Channel and the proposed CD-South pad location.

The second breach is located to the east of the southern-most portion of Lake L9324 (Figure 1, Location B) at the 90° channel bend. Flow was observed through this breach into the adjacent shallow muddy lake, through Lake L9324, and into the Niqliq Channel (Photos 3-6, 3-7, 3-8, 3-9, 3-14, 3-15, and 3-16). Recharge contributions to the floodplains east of the proposed alignment from this second breach were negligible compared to the contributions observed from the breach located east of Lake M9525.

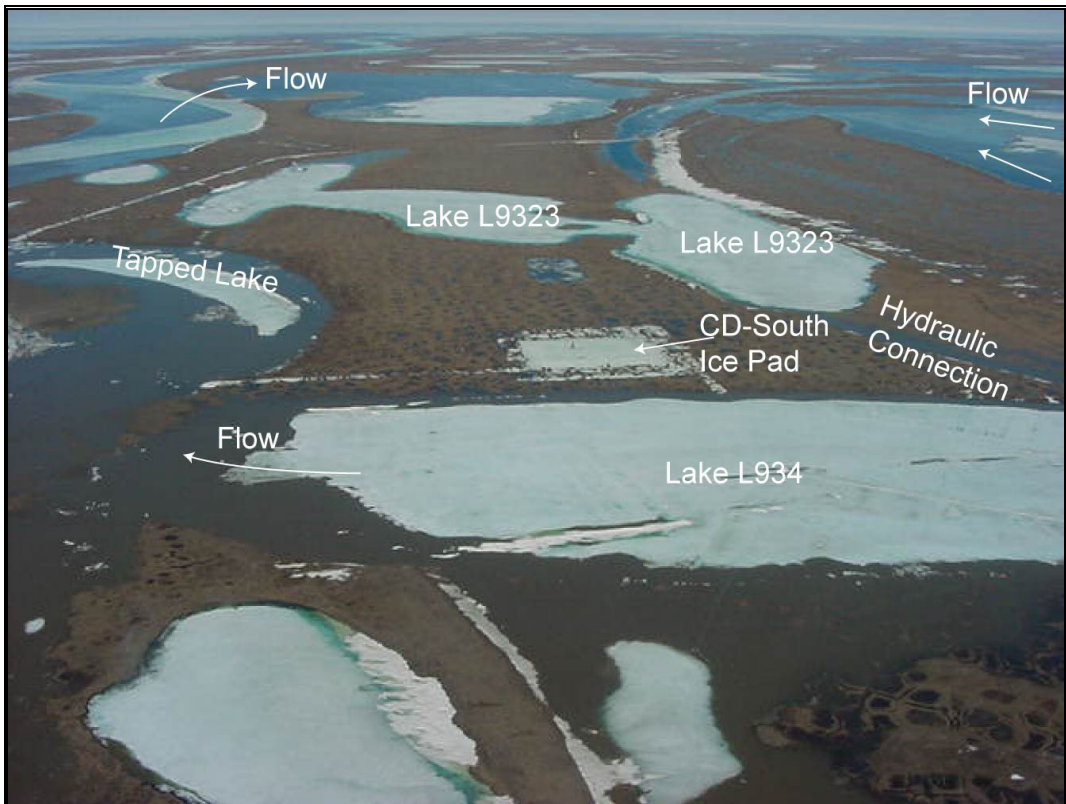
Photo 3-8 Looking north towards the proposed CD-South pad location.

The area east of the proposed road alignment was recharged by two breaches in the Sakoonang Channel. The first breach is located to the east of Lake M9525 where the Sakoonang Channel begins a “U” shaped bend (Figure 3-2, Location A). This breach was the primary mechanism for recharge to the east of the proposed alignment (Photos 3-8, 3-10, & 3-15).

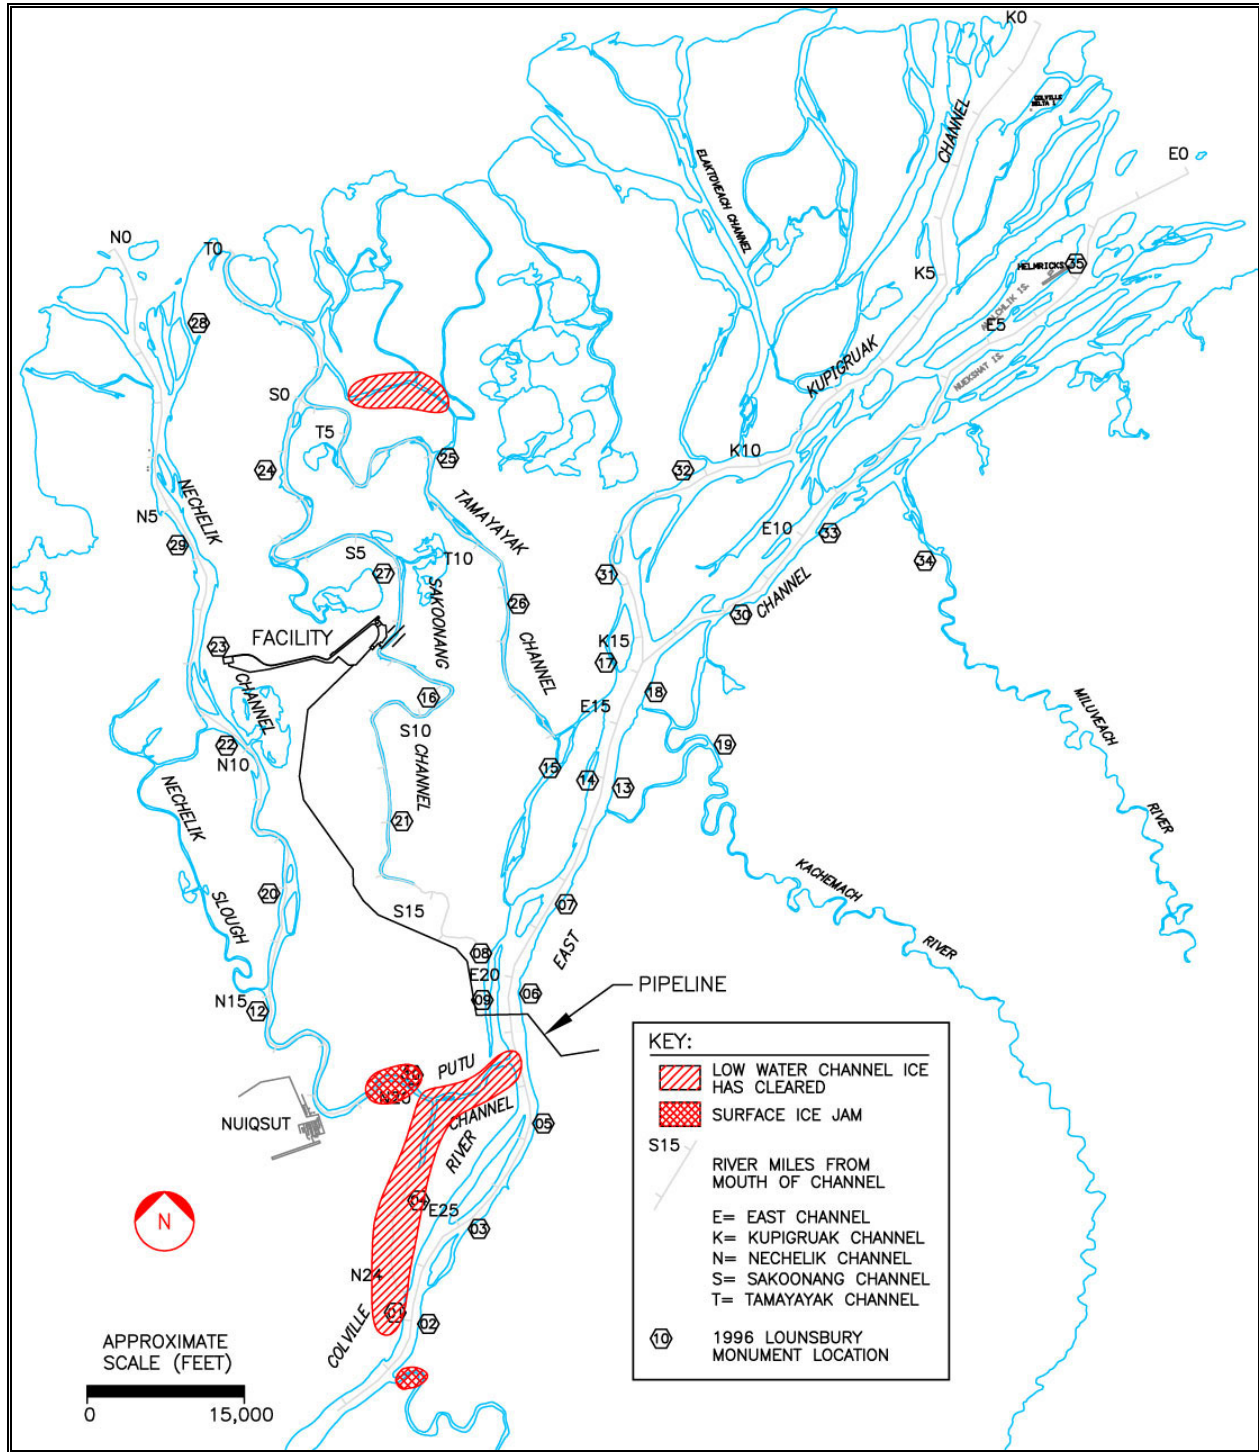
Figure B-1 Low Water Channel Ice Survey, May 23, 2002.

On the morning of 23 May, the first day of flowing water, the channel ice in the upper East and upper Nigliq channels was floating and beginning to break apart. Low water intact channel ice in all main channels was floating and becoming saturated by rising floodwaters. The Sagoonang Channel near Alpine was between 50 and 80 percent ice-free. Channel ice in the smaller channels in the lower portions of the delta was deteriorating rapidly as floodwaters rose and inundated these channels.
