Alpine Pipeline HDD Crossing

2007 Monitoring Report

ConocoPhillips

111620-MBJ-RPT-001

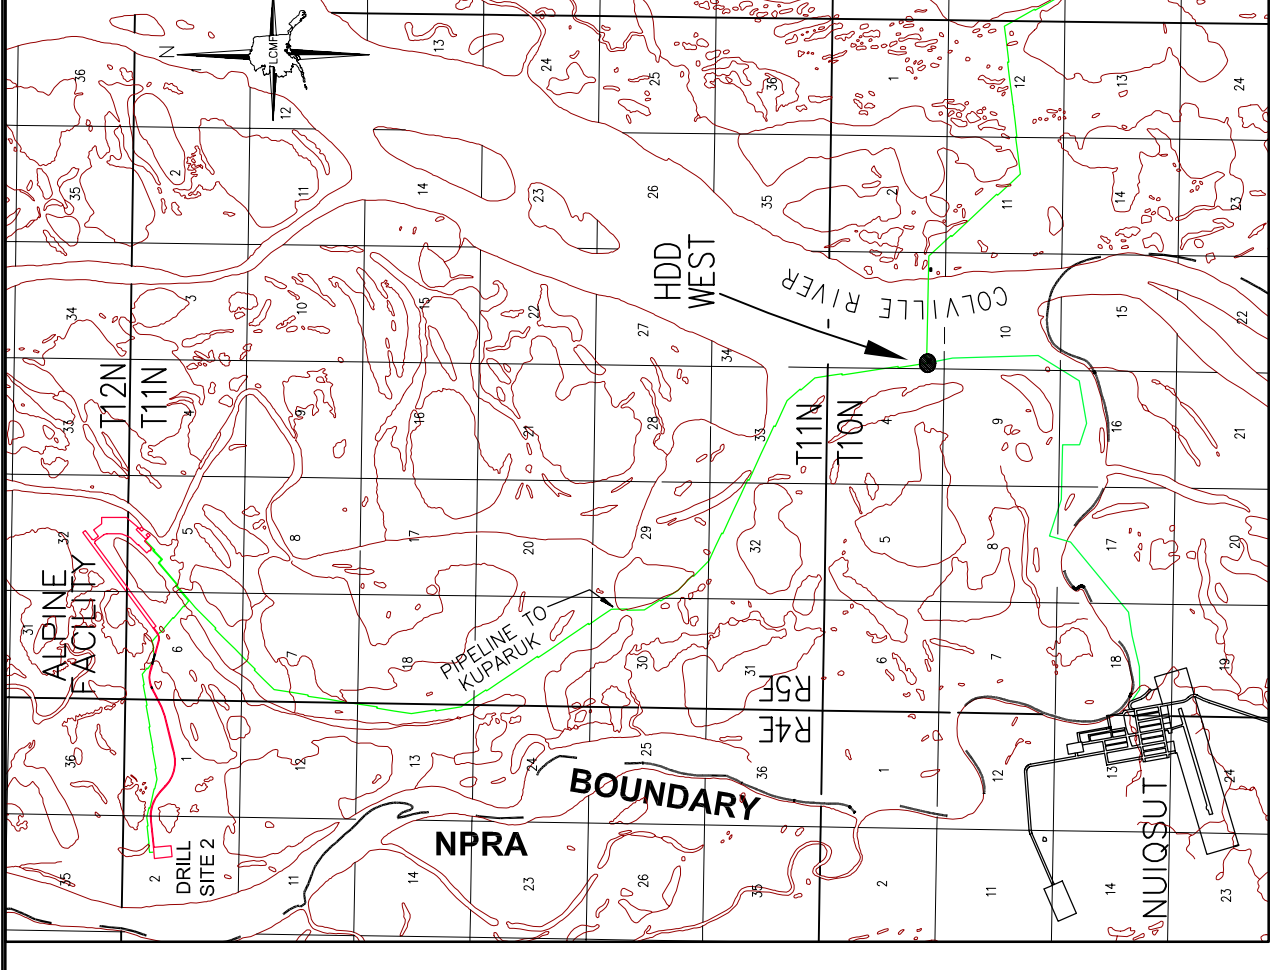
Appendix B HDD West Survey Data

The greatest bank erosion observed between the 2006 and 2007 monitoring events was 1.0 feet, occurring approximately 150 feet downstream of the pipeline centerline.

A maximum erosion of 18.7 feet, between April 2002 and August 2007, has been measured along the top of bank at a single location 120 feet north of the NPS 14 oil pipeline centerline. This yields a maximum average rate of 3.5 feet/year over the monitoring period. The average rate of erosion along the 440-foot top of bank was measured to be 0.6 feet/year. A summary of the LCMF surveying results for the HDD West Bank crossing is presented in **Appendix B**. The measured average annual rate of bank erosion is less than the observed long-term historic average rate of 0.8 feet/year, and less than the estimated maximum erosion rate used for design of 2.3 feet/year (Baker 1997).

Approximately 9.0 feet of bank erosion at the NPS 14 oil pipeline centerline has occurred since 1997 (0.9 feet/year) based on a comparison of 2007 survey data and the 1997 scour control point (**Appendix B**). The observed bank erosion at the NPS14 oil centerline equals approximately 9% of the design setback as of 2007. The west bank erosion has not yet reached the 50% design setback; however, if either bank “migrates 50% of the design setback, erosion rates or possible mitigation measures will be evaluated” (Baker 1999).

While the erosion of the banks near the HDD crossing of the Colville River does not appear to have been affected by the construction or operation of the pipeline, continued monitoring at these locations is recommended.

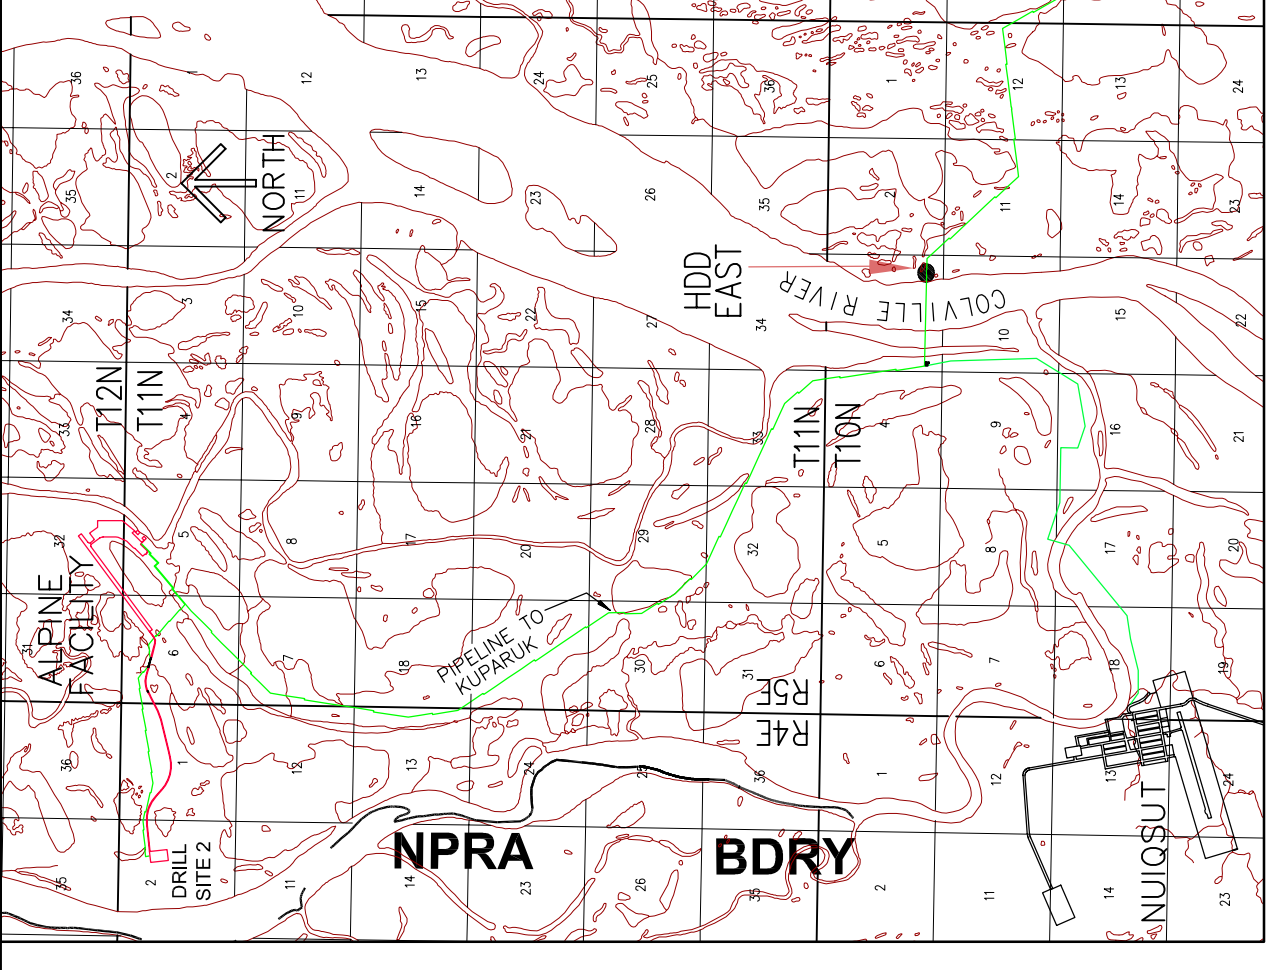
Appendix C HDD East Survey Data

The greatest bank erosion observed between the 2006 and 2007 monitoring events was 4.2 feet over the seawater pipeline, occurring approximately 110 feet downstream of the oil pipeline centerline.

A maximum erosion of 31.0 feet, between October 2001 and August 2007, has been measured along the top of bank at a single location 110 feet south of the NPS 14 oil pipeline centerline. This yields a maximum average rate of 6.2 feet/year over the monitoring period. The average rate of erosion along the 335-foot top of bank was measured to be 2.1 feet/year. A summary of the LCMF surveying results for the HDD East Bank crossing is presented in **Appendix C**. The measured average annual rate of east bank erosion is greater than the observed long-term historical average rate of 1.5 feet/year, but less than the estimated maximum erosion rate used for design of 2.5 feet/year (Baker 1997).

Approximately 8.8 feet of bank erosion at the NPS 14 oil pipeline centerline has occurred since 1997 (0.9 feet/year) based on a comparison of 2007 survey data and the 1997 scour control point (**Appendix C**). As of 2007, the observed bank erosion equals approximately 8% of the design setback which is less than was estimated in 1997. The east bank erosion has not yet reached the 50% design setback; however, if the bank “migrates 50% of the design setback, erosion rates or possible mitigation measures will be evaluated” (Baker 1999).
