COLVILLE RIVER DELTA SPRING BREAKUP 2009 HYDROLOGIC ASSESSMENT

ConocoPhillips Alaska, Inc.

December 2009
117011-MBJ-RPT-001

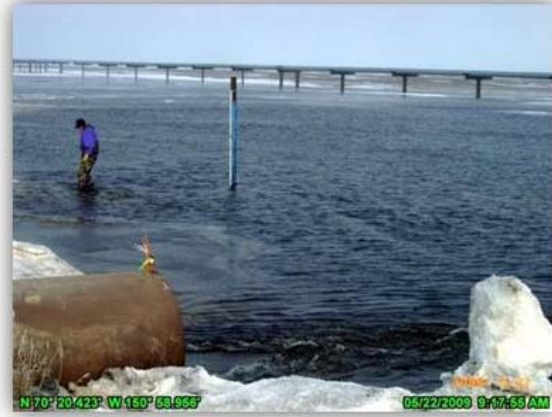
Taken along the CD2 road, Photo 2.3 shows G4, culvert CD2-22 and the CD2 pipeline. Figures showing the facility gage locations in relation to drainage structures are provided in Section 4.0 of this report.

PHOTO 2.3: G4 AND CULVERT CD2-22. MAY 22, 2009

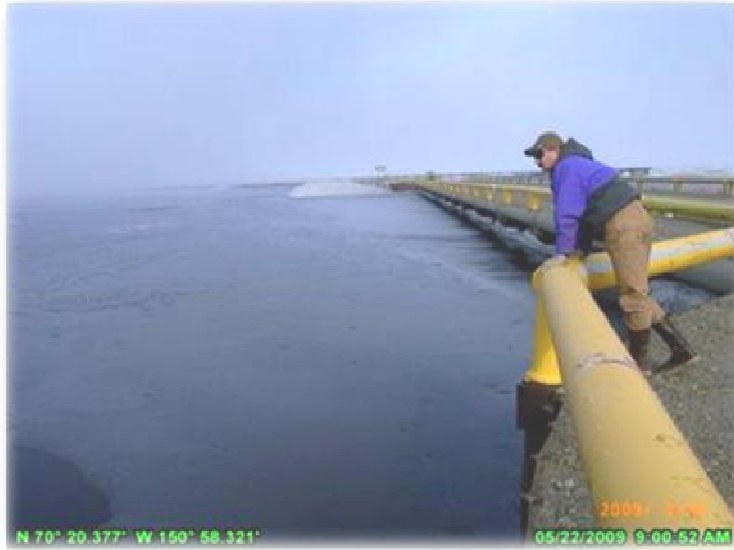
PHOTO 2.5: SOUTH SIDE 452-FT (LONG) SWALE BRIDGE; SNOW DAM PRESENT BLOCKING FLOW. MAY 22, 2009.

Discharge measurements were performed at the long bridge and at selected nearby culverts in addition to gaging WSE along the roads. Discharge measurements were not performed at all of the drainage structures because flow conditions were too low for meaningful measurements. Photo 2.5 and Photo 2.6 show the 452-ft swale bridge when an ice and snow dam temporarily blocked flow from south to north.

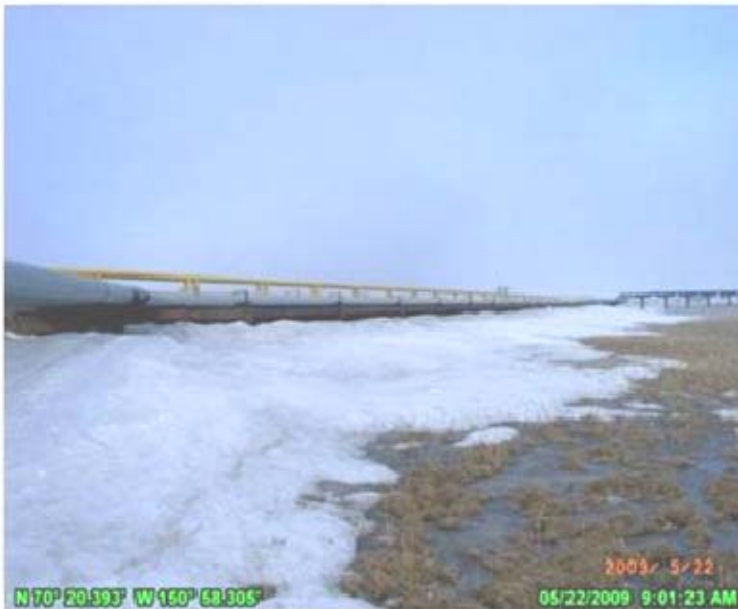
PHOTO 2.6: NORTH SIDE OF 452-FT SWALE BRIDGE; SNOW DAM. MAY 22, 2009.

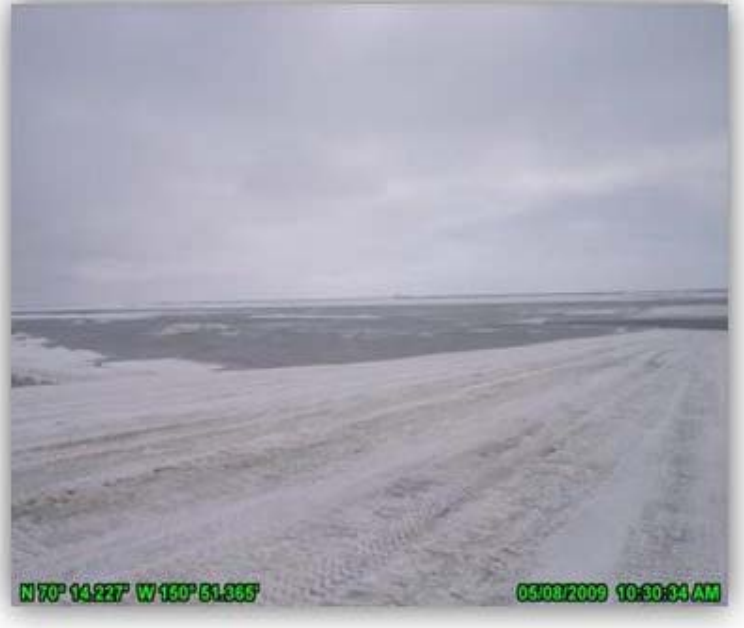
PHOTO 2.7: EAST CHANNEL ICE BRIDGE. MAY 8, 2009.

observation of each area. Photo 2.7 shows the eastern stretch of the Colville River East Channel ice bridge during the early stage of breakup.

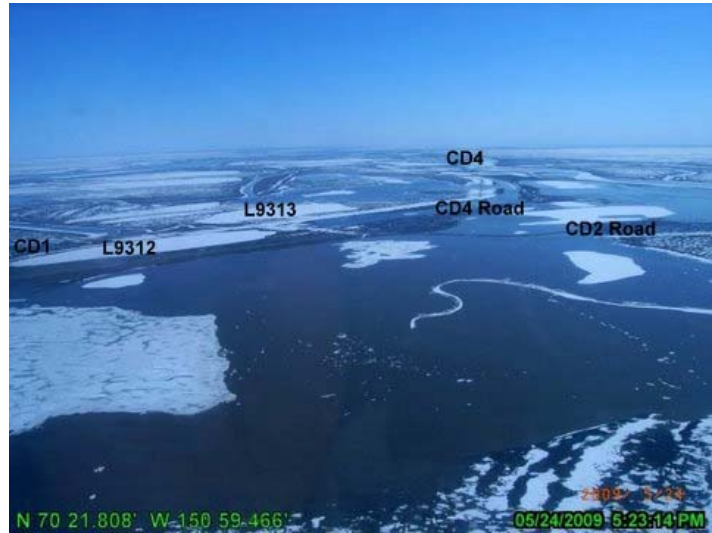
PHOTO 4.15: CD2 AND CD4 ACCESS ROADS. MAY 24, 2009.

Photo 4.15 is an aerial view looking south towards the CD2 access road, both swale bridges, and the CD4 road, taken on May 24. Photo 4.16 is an aerial view taken on May 25 looking north along a portion of the CD4 road and pipeline; the CD2 road and Alpine are in the background.

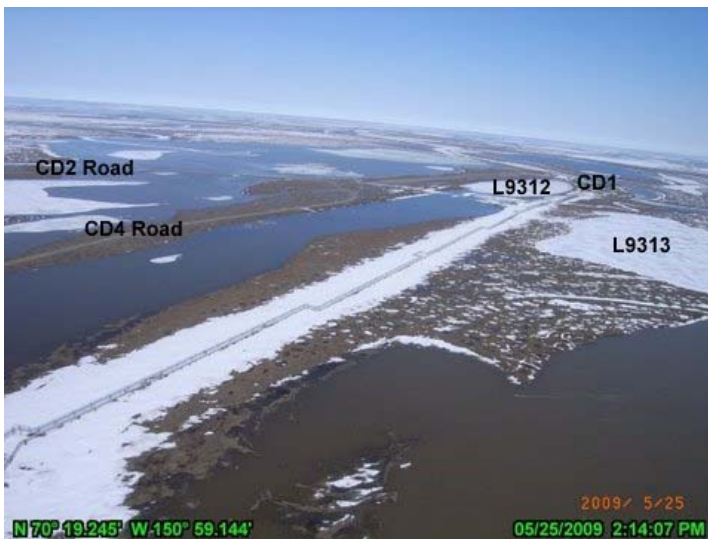
PHOTO 4.16: CD2 AND CD4 ACCESS ROADS. MAY 25, 2009.

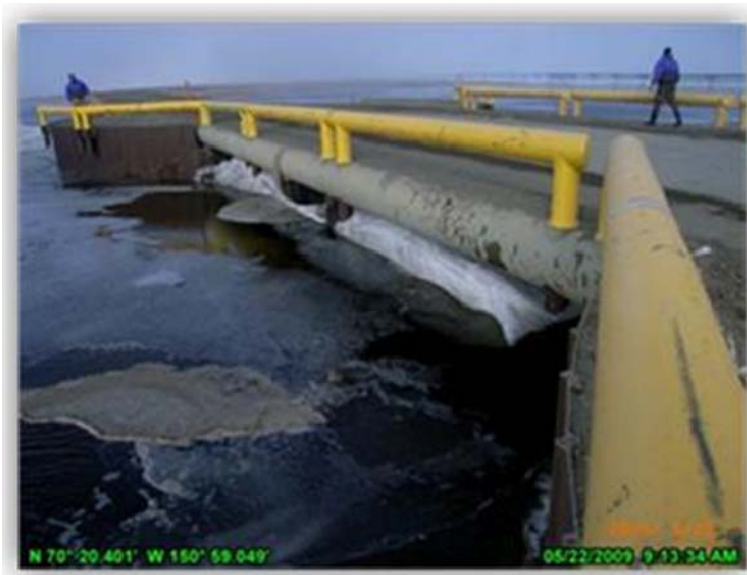
By May 22 significant flow was observed in the Sakoonang Channel at Gage G1, passing south to north under the CD2 access road 62-ft swale bridge and through nearby culverts. Flow was not observed under the 452-ft swale bridge the morning of May 22 due to a large ice and snow dam, as can be seen in Photo 2.5 and Photo 2.6. The dam held until the evening of May 22 (Photo 4.22). Photo 4.23 and Photo 4.24 show flow on the south and north sides of the CD2 access road in the vicinity of the smaller bridge on May 22. Direct discharge measurements were taken on May 26 at the 452-ft swale bridge and at selected culverts.

PHOTO 4.23: FLOW UNDER 62-FT SWALE BRIDGE, SOUTH SIDE. MAY 22, 2009.

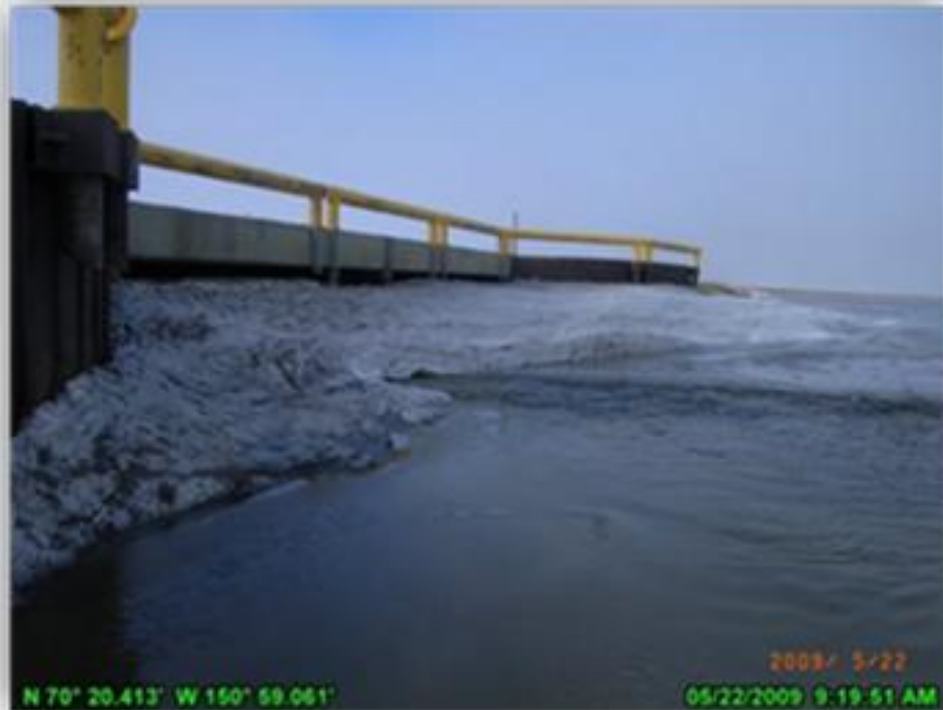
PHOTO 4.24: FLOW UNDER 62-FT SWALE BRIDGE, NORTH SIDE. MAY 22, 2009.

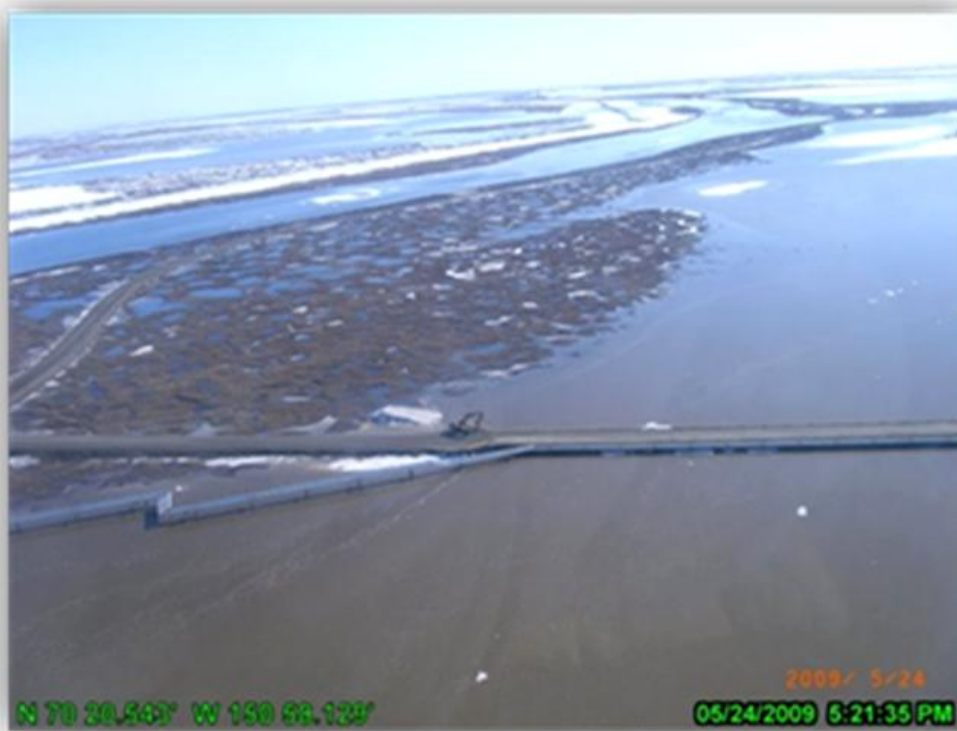
Discharge data for the 452-ft swale bridge is provided in Table 5.4; discharge data for selected culverts is shown in Table 5.5 through Table 5.8. Photo 4.25 shows a portion of CD2 and CD4 access roads, as well as a section of the 452-ft swale bridge just before peak stage at the facilities.

PHOTO 4.25: AERIAL VIEW, 452-FT SWALE BRIDGE. MAY 24, 2009.

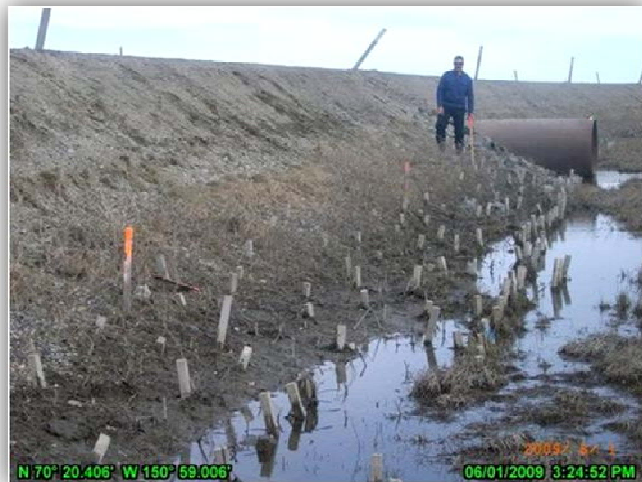
Floodwater was observed along the CD2 road in the vicinity of the swale bridges. Visual inspection of the CD2 road near the swale bridges revealed high water marks where breakup flows reached the lower portions of the gravel road prism. Photo 4.26, Photo 4.27, and Photo 4.28 show representative photos taken on June 1 along the CD2 access road. Photo 4.29, Photo 4.30, and Photo 4.31 show representative photos taken on June 2 along the CD4 access road.

High water marks along the CD2 Access Road were identified by debris stranded on the gravel side slopes or by noting where silts and fine-grained sands were washed from the road prism. Orange-topped lath in the photos were placed to better show the location and elevation of high water. All lath placed to indicate erosion limits was removed after photos were taken. No indications of significant erosion due to breakup floodwater were observed anywhere on the Alpine gravel facilities.

PHOTO 4.27: CD2 ROAD SOUTHEAST OF THE 62-FT SWALE BRIDGE. JUNE 1, 2009.

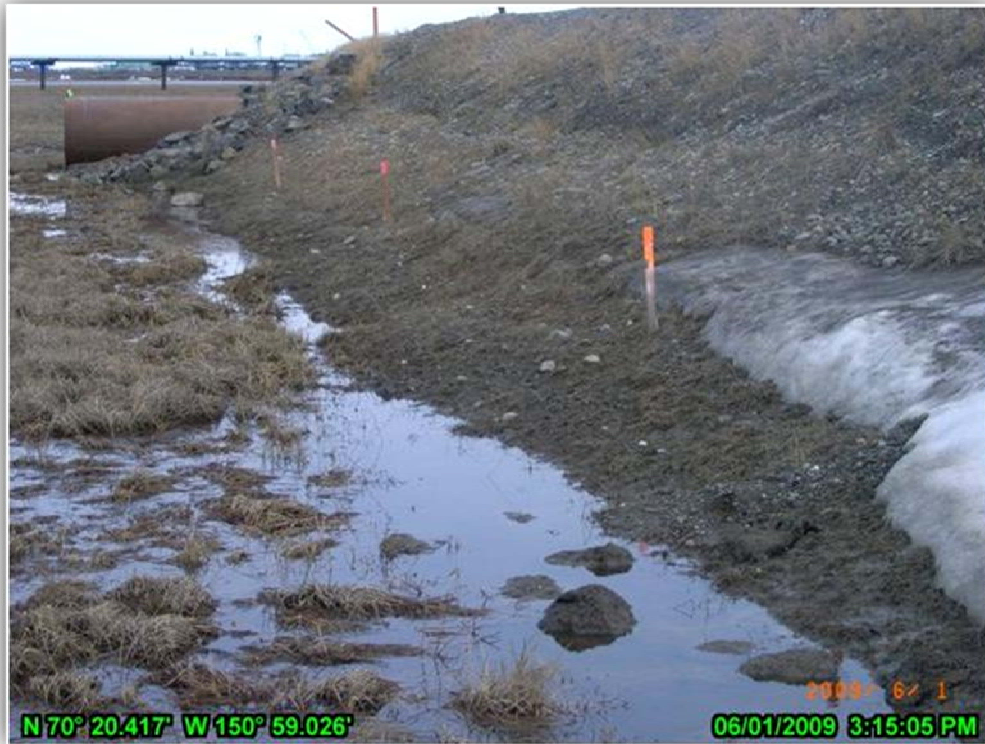
PHOTO 4.28: CD2 ROAD NEAR THE 62-FT SWALE BRIDGE. JUNE 1, 2009.

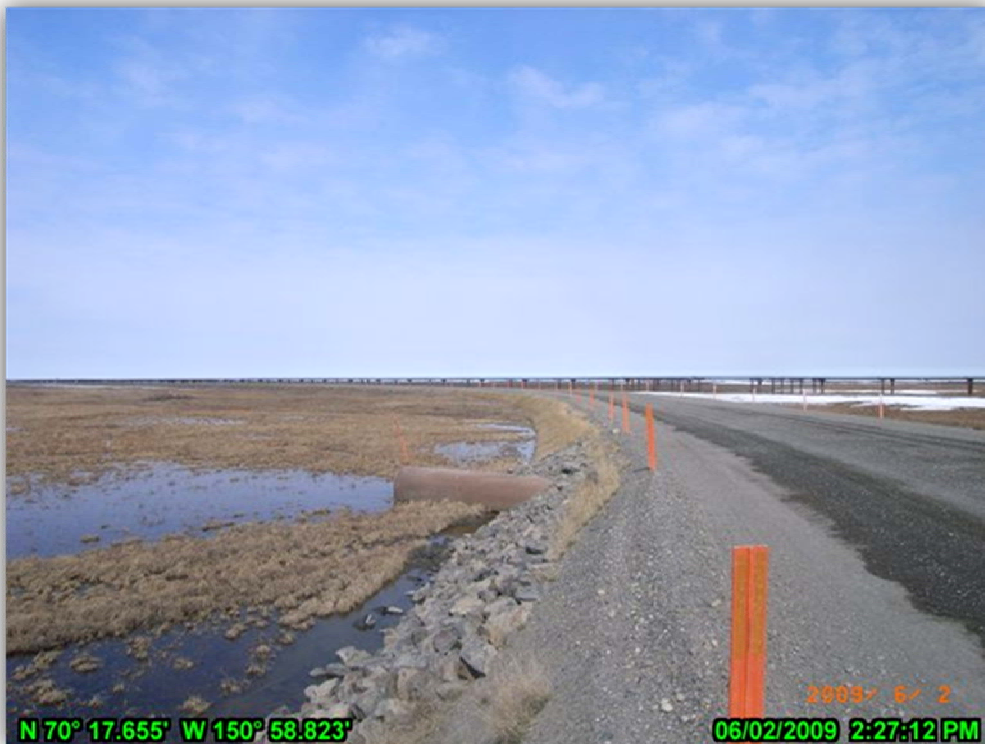
PHOTO 4.29: CD4 ACCESS ROAD NEAR CULVERT CD4-24. JUNE 2, 2009.

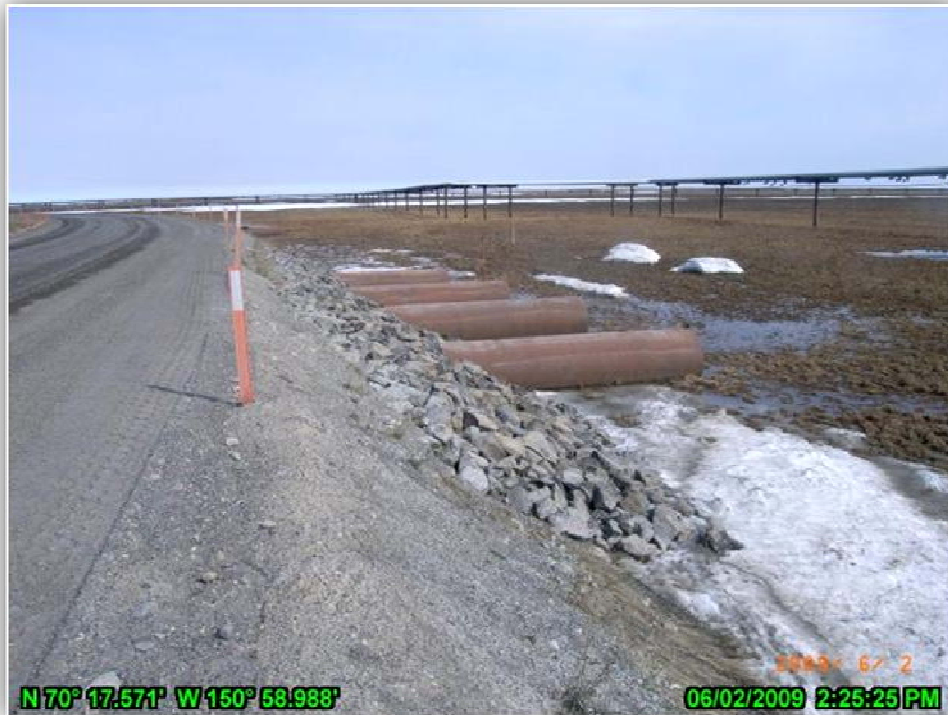
PHOTO 4.30: CD4 ACCESS ROAD CULVERT BATTERY CD4-29 THROUGH -32. JUNE 2, 2009.

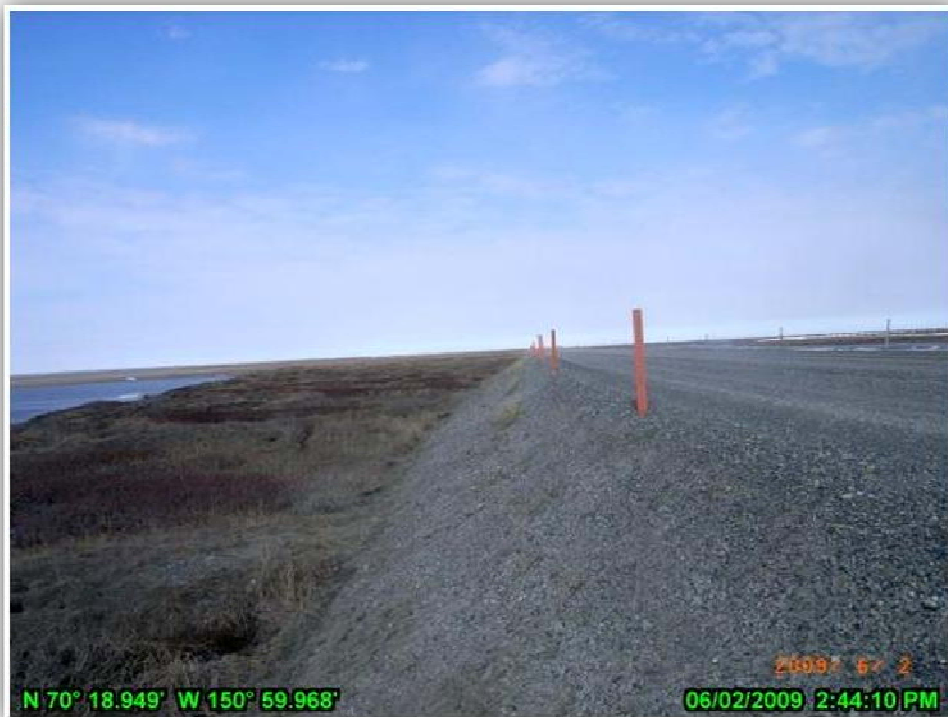
PHOTO 4.31: CD4 ACCESS ROAD. JUNE 2, 2009.

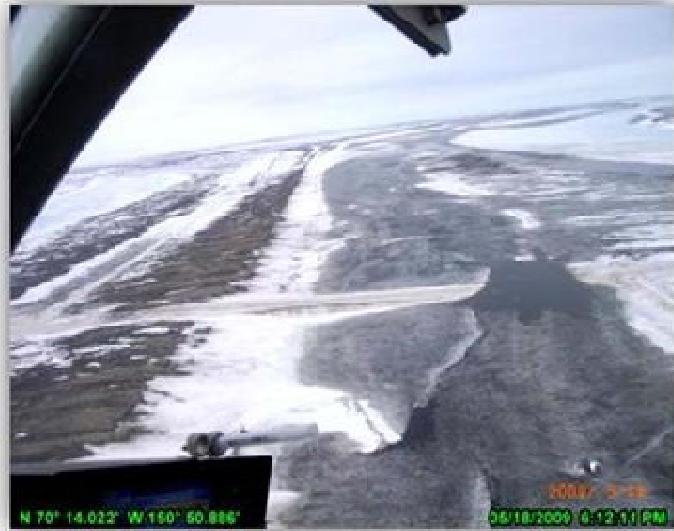
The first visual evidence of melt at the Colville East Channel ice bridge was recorded on May 8, after early warm temperatures initiated pre-breakup conditions throughout the CRD. Open water was first seen at that location on May 18. By May 28, the majority of the channel was open, with only the ice road transitions on either side of the channel remaining.

PHOTO 4.32: COLVILLE EAST CHANNEL ICE BRIDGE, LOOKING SOUTH. MAY 18, 2009.

Photo 4.32 and Photo 4.33 show conditions at the Colville East Channel ice bridge crossing on May 18. Photo 4.34 shows the remnants of the western ramp on May 28.

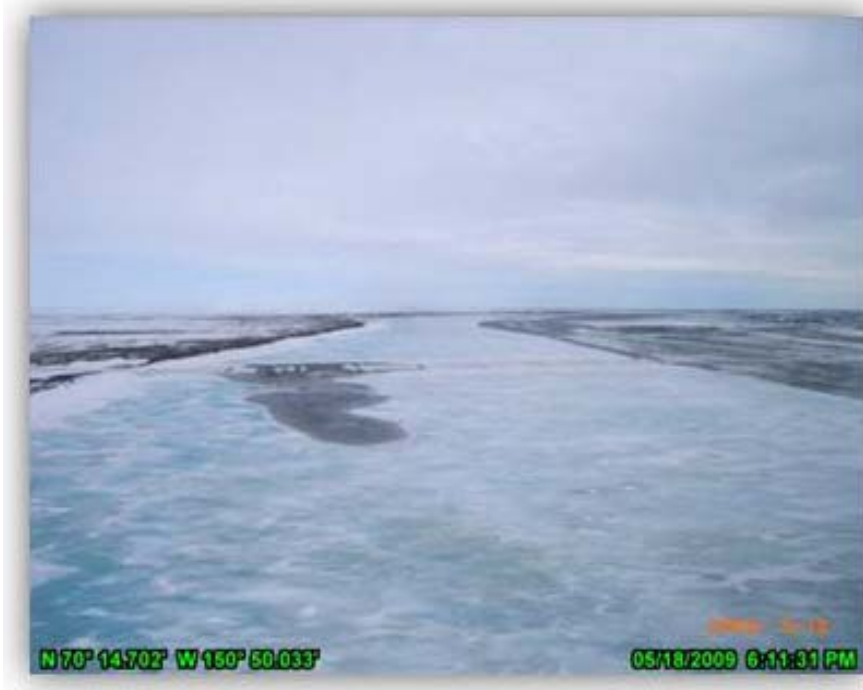
PHOTO 4.33: COLVILLE EAST CHANNEL ICE BRIDGE, LOOKING NORTH. MAY 18, 2009.

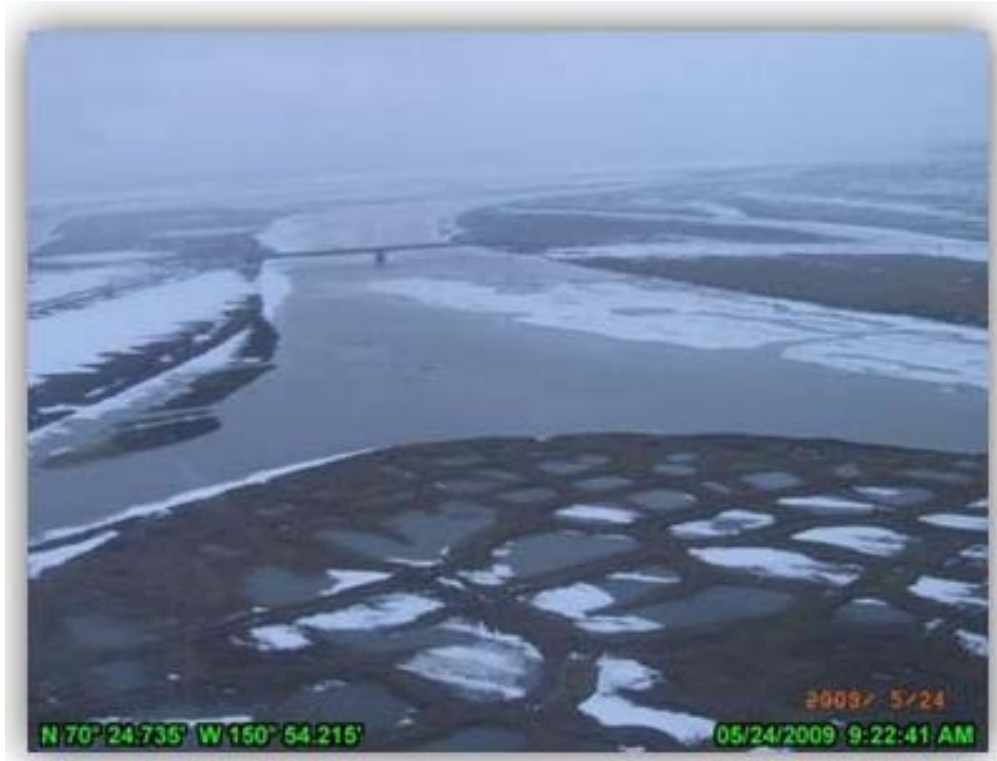
Stage at all gages, the SAK and TAM gages in particular, was most likely affected by ice jamming both in channel and from the Colville. Photo 4.36 shows ice from the released Colville ice jam diverting into the Sakoonang Channel. Photo 4.37 is an aerial view of the Ulamnigiaq pipe bridge during peak stage. Photo 4.38 shows gage TAM-B on May 28, 2009. Photo 4.39 shows an aerial view of the Tamayagiaq on June 2.

PHOTO 4.37: ULAMNIGIAQ PIPE BRIDGE. MAY 24, 2009.

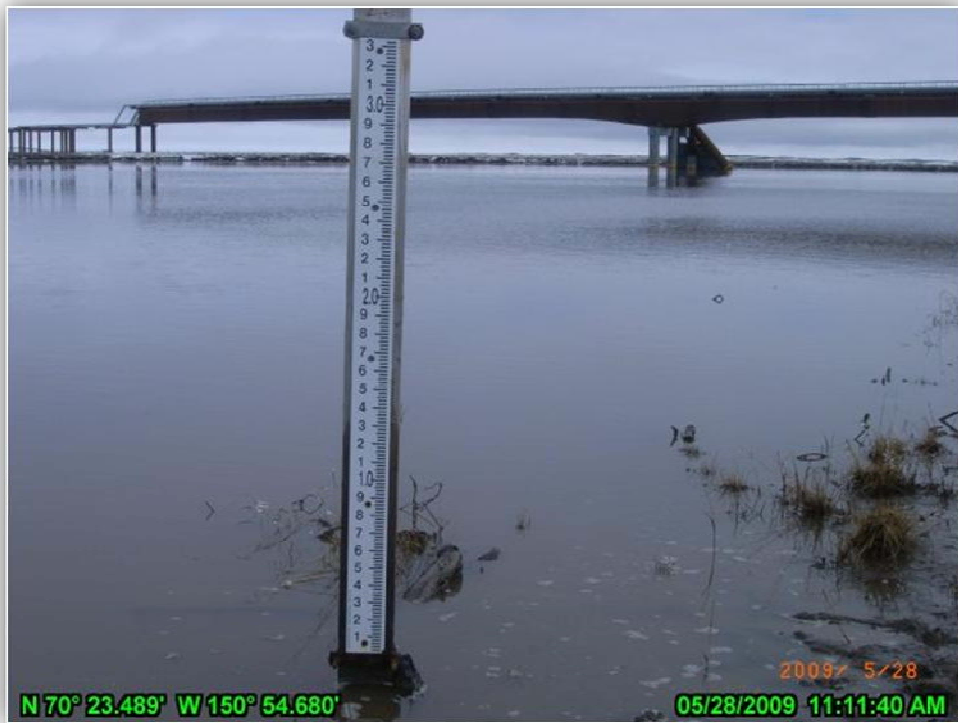
PHOTO 4.38: TAMAYAGIAQ PIPE BRIDGE AND GAGE TAM-B. MAY 28, 2009.

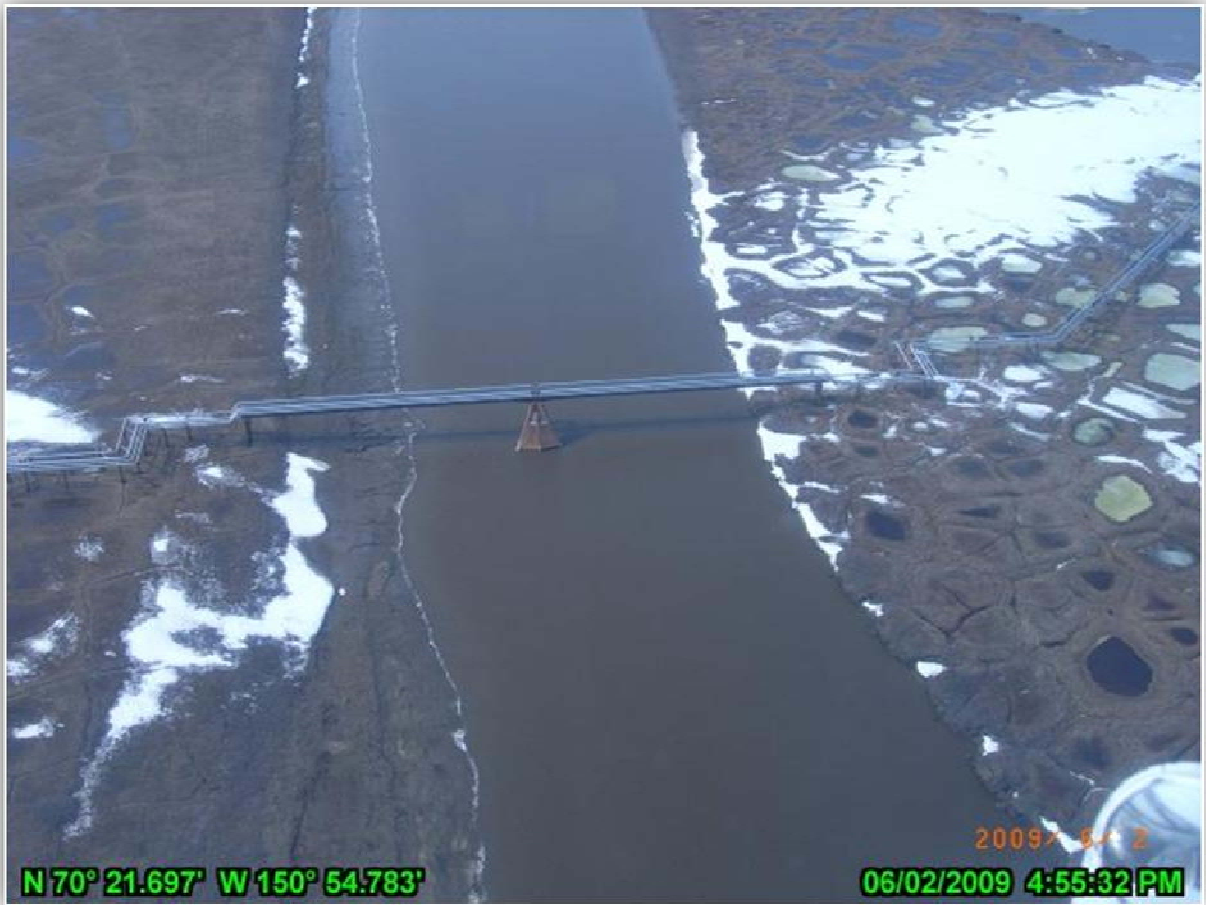
PHOTO 4.39: TAMAYAGIAQ PIPE BRIDGE. JUNE 2, 2009.

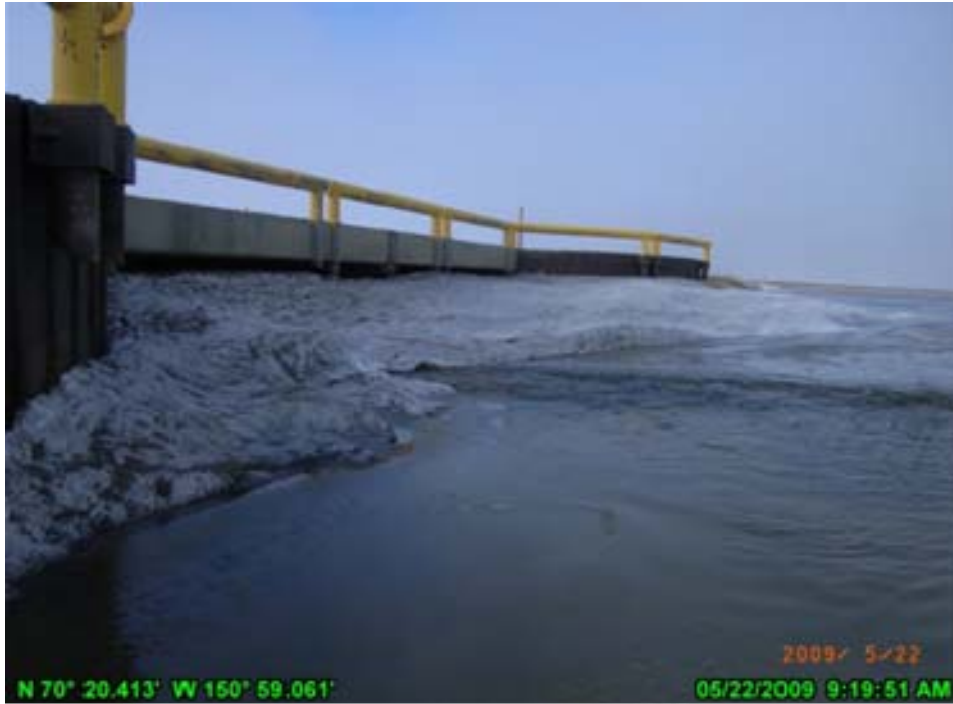
PHOTO 5.2: SNOW/ICE DAM ON UPSTREAM SIDE OF 62-FT SWALE BRIDGE. MAY 22, 2009.

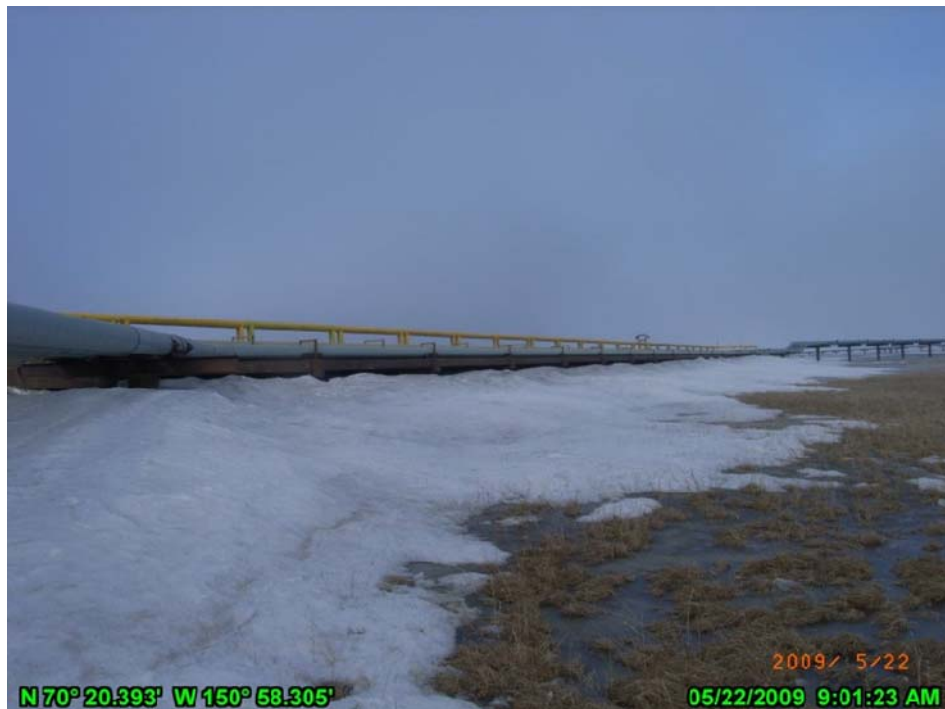
PHOTO 5.3: SNOW/ICE DAM ON UPSTREAM SIDE OF 452-FT SWALE BRIDGE. MAY 22, 2009.
