**COLVILLE RIVER DELTA
SPRING BREAKUP
2010 HYDROLOGIC
ASSESSMENT**

Colville River Delta Spring Breakup

2010 Hydrologic Assessment

119863-MBJ-RPT-001
November 2010

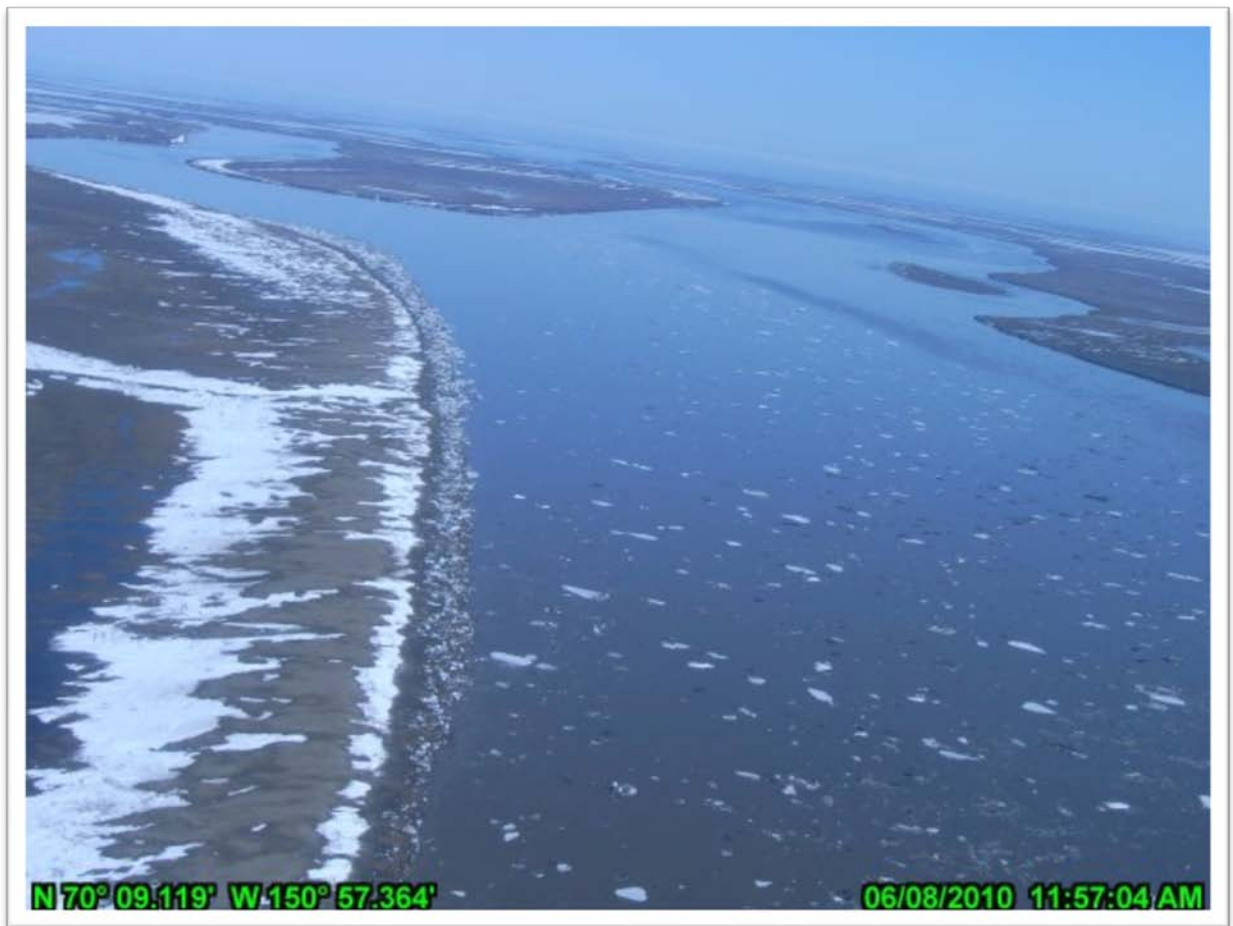
Photo 2.1: Colville River at MON1, looking north (Nigliq Channel on the left and East Channel on the right); June 8, 2010.

The Colville River Delta is bounded upstream by MON1 at the head of the delta. Photo 2.1 shows the Colville River reach at MON1, located at RM E27.1. The Colville River divides into the Nigliq and East Channels approximately one mile downstream from MON1. The larger East Channel flows east of the Alpine facilities. The smaller Nigliq Channel flows past the village of Nuiqsut, to the west of the Alpine facilities. The mouth of the delta lies downstream at the end of a braided floodplain where the many channels empty into Harrison Bay.

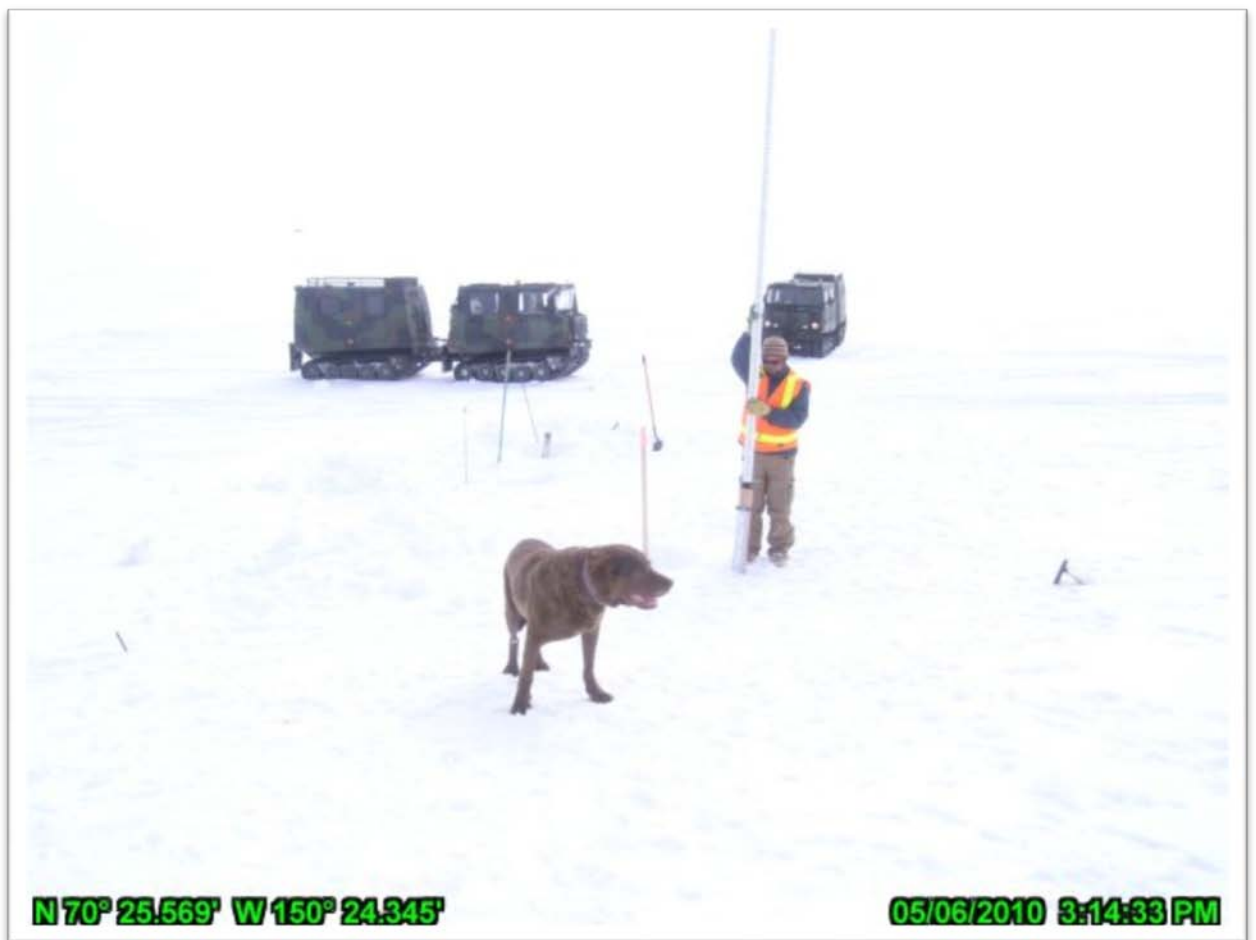
Photo 2.2: MON35 surveying gages on Colville East Channel at Helmericks Homestead; May 6, 2010.

Near Harrison Bay, the East Channel monitoring site is located at Helmericks Homestead in the vicinity of MON35 at RM E3.0. MON35 has been monitored intermittently since 1999.

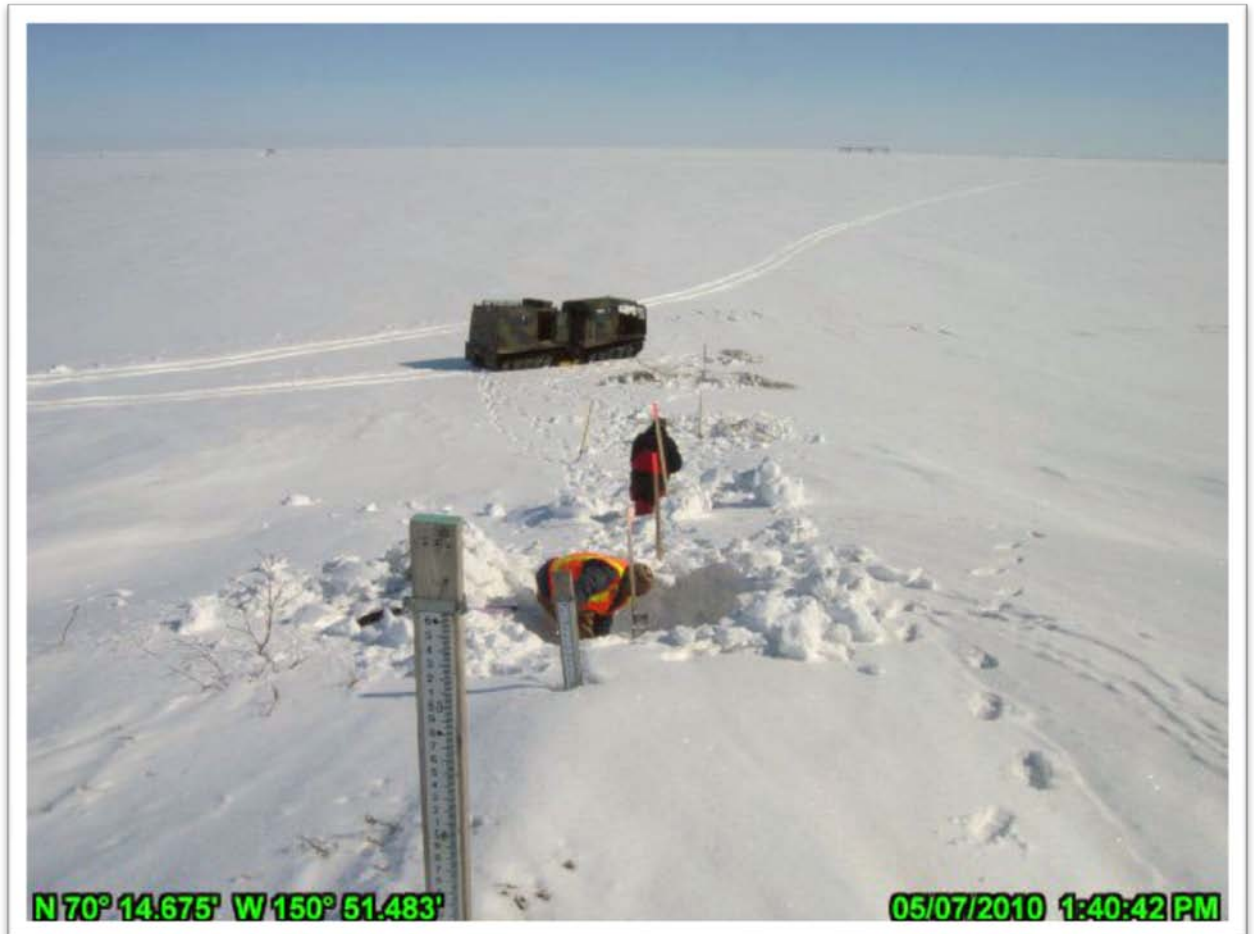
Photo 2.3: MON9, west bank of Colville River, looking east; May 7, 2010.

Between the MON1 and MON35 monitoring locations, a gaging station at Monument 9 (MON9 at RM E16.8) was selected to monitor the HDD crossing of the Alpine Sales Pipeline. This location is downstream of the Putu Channel and upstream of the Sakoonang Channel distributaries. MON9 has been monitored annually since 2005.

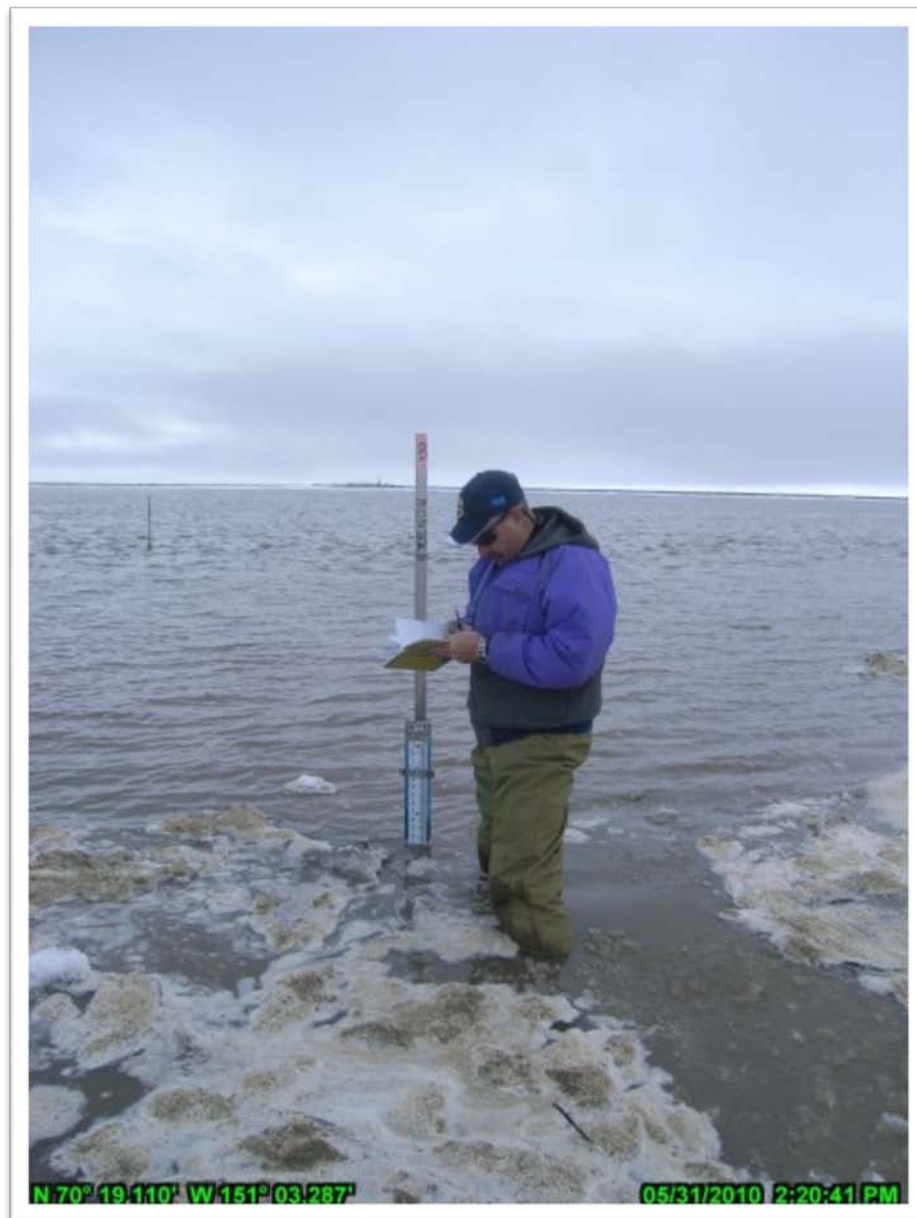
Photo 2.4: MON22 gage reading, looking northeast (CD2 in background); May 31, 2010.

Monument 22 (MON22), the next site downstream (north) along the Nigliq Channel, is located approximately midway between CD2 and CD4 at RM N8.8. Gages are located on the west bank. Photo 2.4 shows the proximity of the MON22 gage location to the CD2 pad.

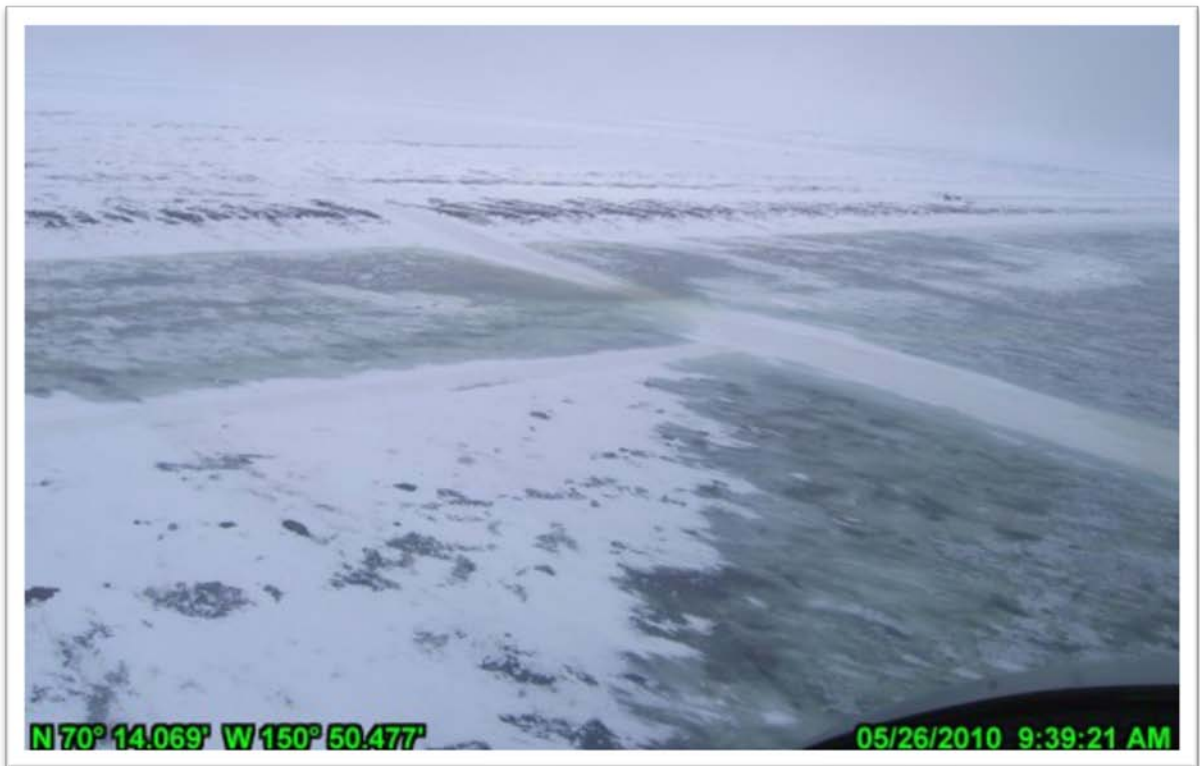
Photo 2.6: Colville River ice bridge prior to breakup; May 26, 2010.

During the winter of 2009-2010, an ice road was constructed connecting the 2L Pad at Kuparuk and the Alpine facilities. The ice road crossed several drainages and channels, the most significant being the Kachemach River and the East Channel of the Colville River (less than ½ mile upstream from the HDD crossing). A spur road was constructed south from the west bank of the Colville River at the ice bridge crossing, extending along the Nigliq Channel to the village of Nuiqsut. The ice bridge crossings of the Kachemach and the Colville rivers were the primary monitoring focus before, during, and after breakup. Monitoring included visual observation and photography of each crossing area. Photo 2.6 shows the Colville River ice bridge near HDD during the early stages of breakup.

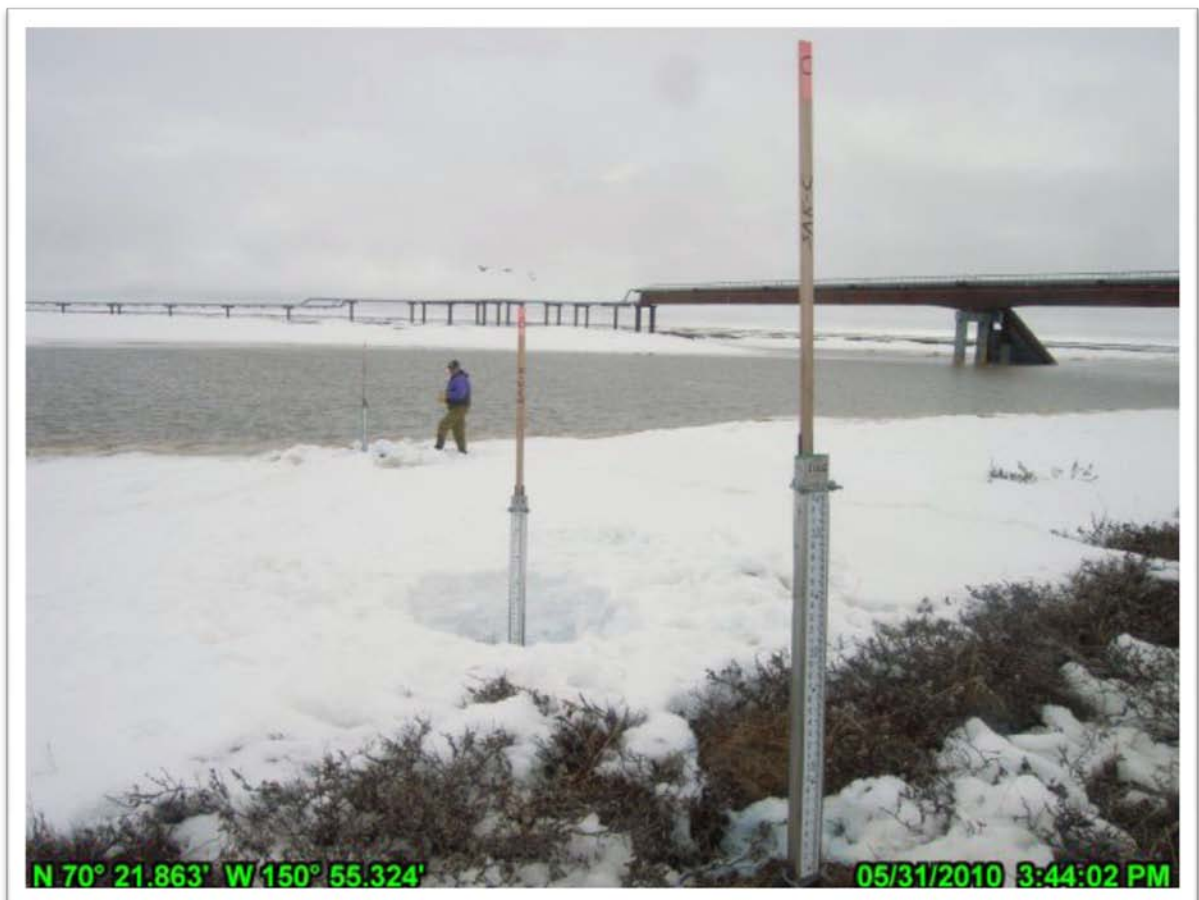
Photo 2.7: Monitoring gages at Sakoonang Channel crossing looking east; May 31, 2010.

The CD3 pipeline crosses three significant channels between CD1 and CD3. These locations include Crossing #2 on the southwest bank of the Sakoonang (SAK), Crossing #4 on the south bank of the Tamayayak (TAM), and Crossing #5 on the northeast bank of the Ulamnigaiq (ULAM). Gaging stations were installed at each of the three crossings to monitor breakup conditions at these locations, all of which have been monitored intermittently since 2000. Repair and survey of all CD3 pipeline crossing gages was completed on May 9.

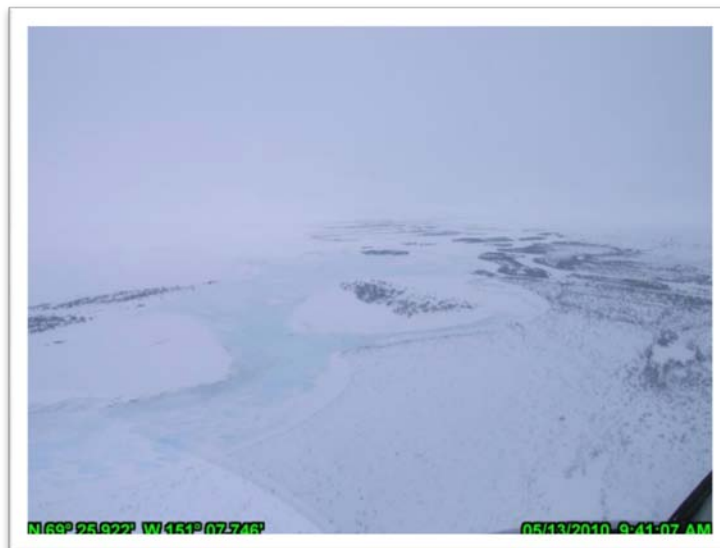
Photo 4.1: Anaktuvuk River, 9.5 miles upstream from the Colville River confluence; May 13, 2010.

The confluence of the Anaktuvuk River into the Colville River lies approximately 65 river miles upstream of the head of the CRD (MON1). No signs of melt were observed during a reconnaissance flight on May 13, 2010, in either the Anaktuvuk River upstream from the confluence (Photo 4.1) or the Colville River downstream from the confluence (Photo 4.2).

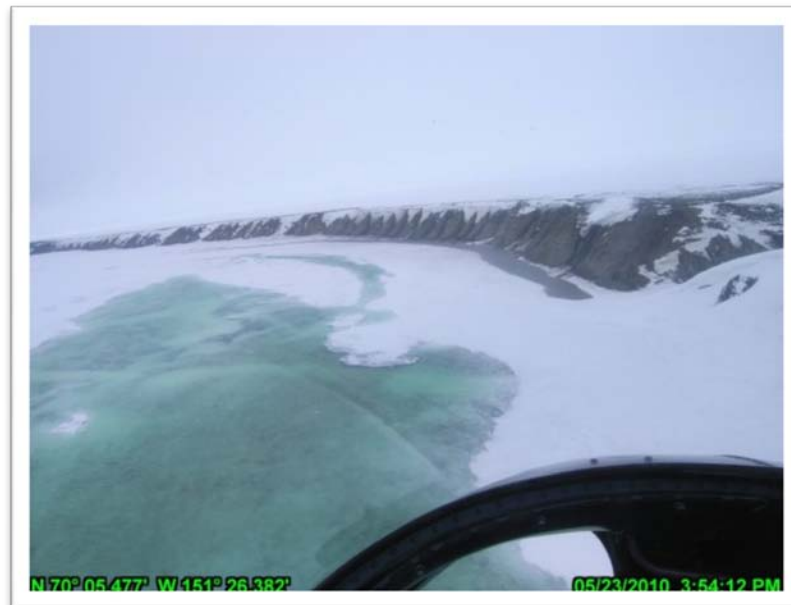
Photo 4.3: Leading edge in the Colville River upstream from Ocean Point; May 23, 2010.

On May 19, 2010, the Bristow helicopter pilot and NS Helicopter Coordinator reported some areas of open flow in the Colville River approximately 3 miles downstream from the Anaktuvuk confluence. This represented the initial observation of breakup events in 2010 and can be considered the leading edge. By May 23, 2010, the leading edge on the Colville River was approximately 2.7 miles upstream of Ocean Point, and approximately 22.4 miles upstream of MON1C. (Photo 4.3).

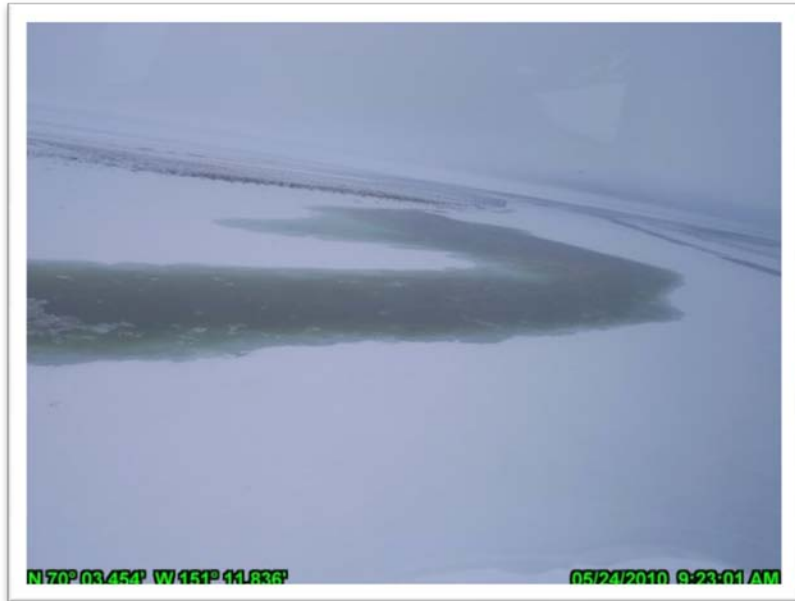
Photo 4.4: Leading edge in the Colville River 13.6 miles upstream from MON1; May 24, 2010.

Over the next 18.5 hours, the leading edge on the Colville River had progressed 8.7 miles further downstream, at a rate of nearly 0.5 miles per hour. On the morning of May 24, 2010, the leading edge was approximately 13.6 miles upstream from MON1 (Photo 4.4).

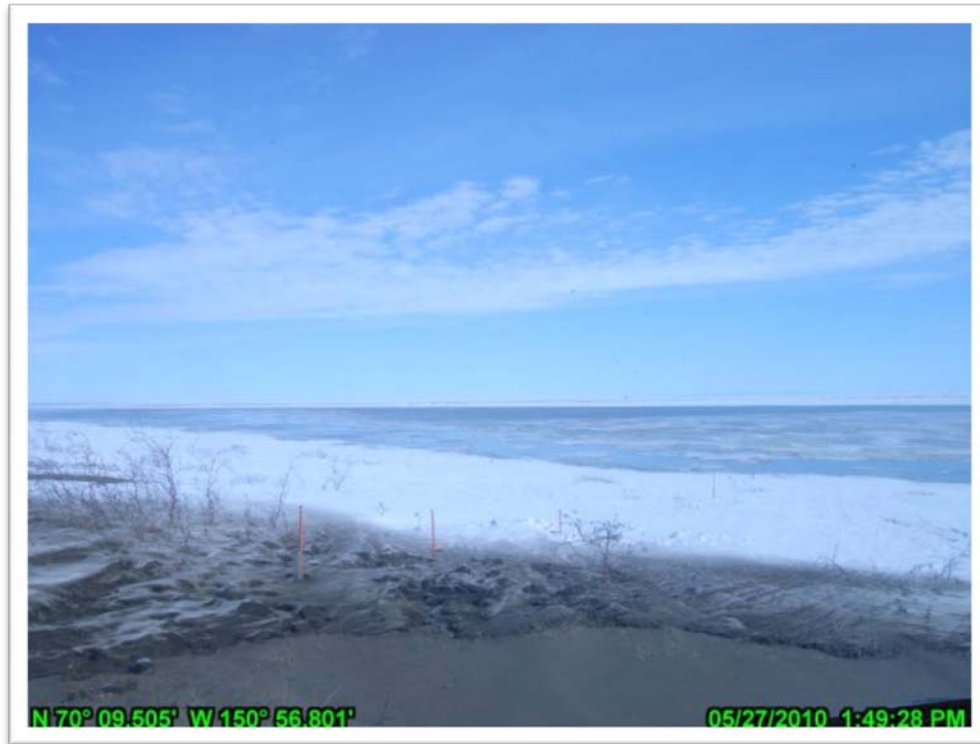
Photo 4.7: MON1U gages, Colville River; May 27, 2010.

Daily monitoring of the East Channel gages began on May 26. By May 27, the first measureable floodwater in the CRD was present on MON1U-A (Photo 4.7). The gages at MON1C and MON1D were still dry on the afternoon of May 28. Due to fog and freezing rain, it was not possible to collect gage WSE data in the East Channel on May 29. Measureable stage reached MON1C gages by May 30, and MON1D gages by May 31. The leading edge reached MON9 by the afternoon of May 26 and MON35 at Helmericks by the morning of May 27.

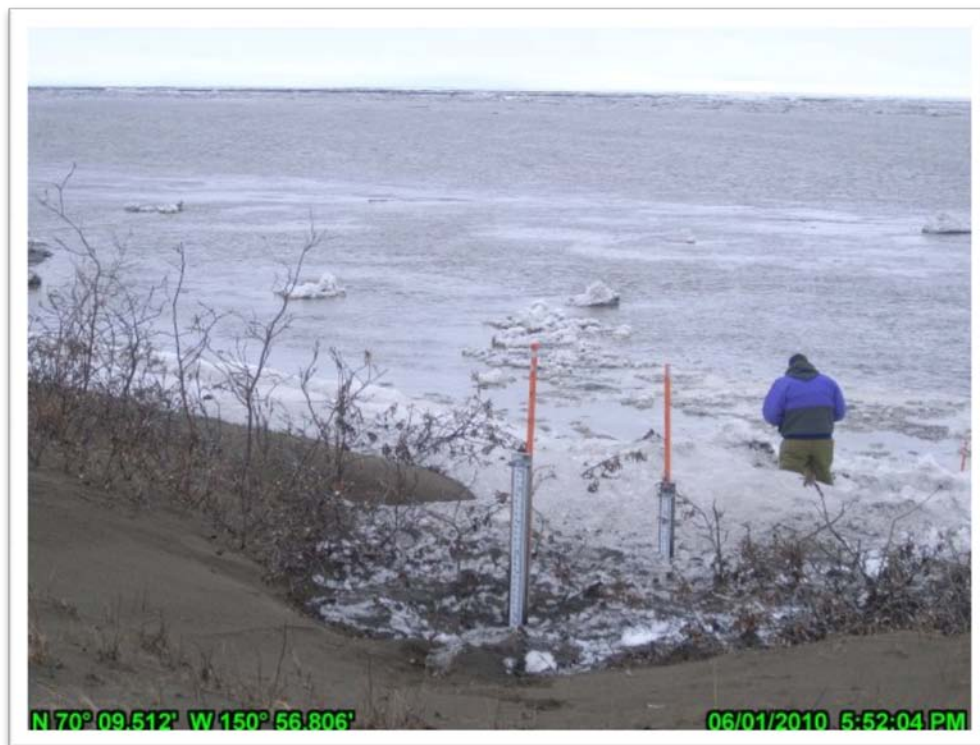
Photo 4.9: Reading gages at MON1U, near peak stage; June 1, 2010.

Beginning on May 31 and over the next 28 hours, water levels at MON1C rose an additional 4.6 feet, reaching a peak stage of 19.59 ft BPMSL on the evening of June 1 (Photo 4.9). On June 2 and 3, abundant stranded ice was observed at MON1, as shown in Photo 4.10 and Photo 4.11. By June 5, stage had dropped to 10.56 ft BPMSL at MON1C. On June 8, some in-channel ice floes persisted in the vicinity of MON1; the channel was largely open after June 8. WSE for MON1C is provided in Table 4.1. Table 4.2 shows WSE for MON1U and MON1D.

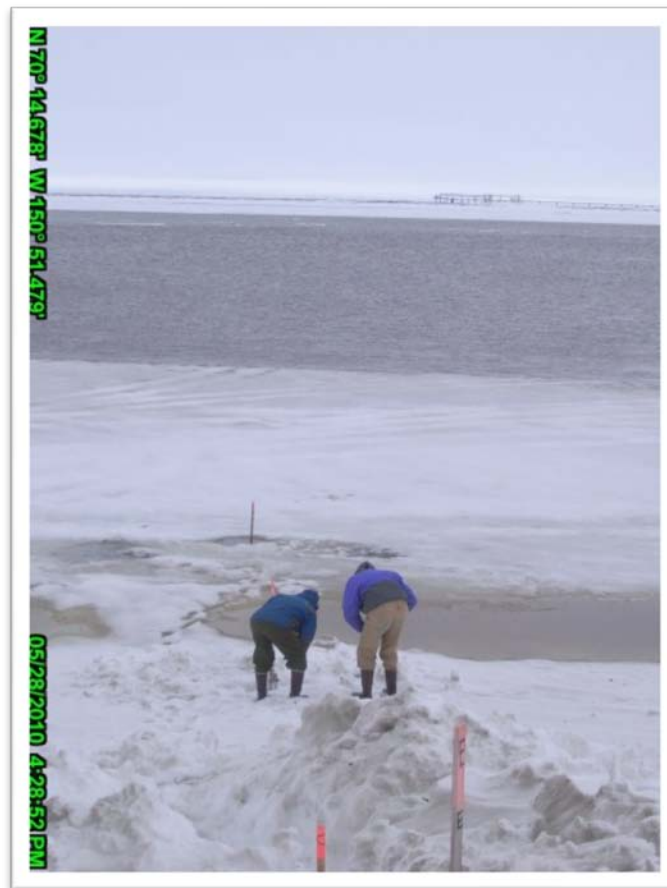
Photo 4.12: Gage reading at MON9; May 28, 2010.

The leading edge arrived at MON9 on May 26 and brought measureable flood flow; earlier gage readings at this location represent standing water due to local melt only. Stage rose gradually from an initial May 26 gage reading of 5.42 ft BPMSL to 11.78 ft BPMSL on May 31. As shown in Photo 4.12, on May 28 channel ice was still substantial, covering approximately 50% of the channel. Ribbon ice was present in the MON9 vicinity on May 31 and evidence of an ice jam was seen on June 1, as shown in Photo 4.13, Photo 4.14, and Photo 4.15. Between May 31 and June 1, overnight water levels rose another 5.1 feet to reach a peak stage of 16.88 ft BPMSL on the evening of June 1. On June 2, another ice jam had formed approximately $\frac{3}{4}$ mile upstream from MON9. This jam moved downstream of MON9 by June 3. On June 8, grounded ice was abundant on the banks and some floes still remained in channel. The channel in this vicinity was open after June 9. WSE for MON9 is provided in Table 4.3.

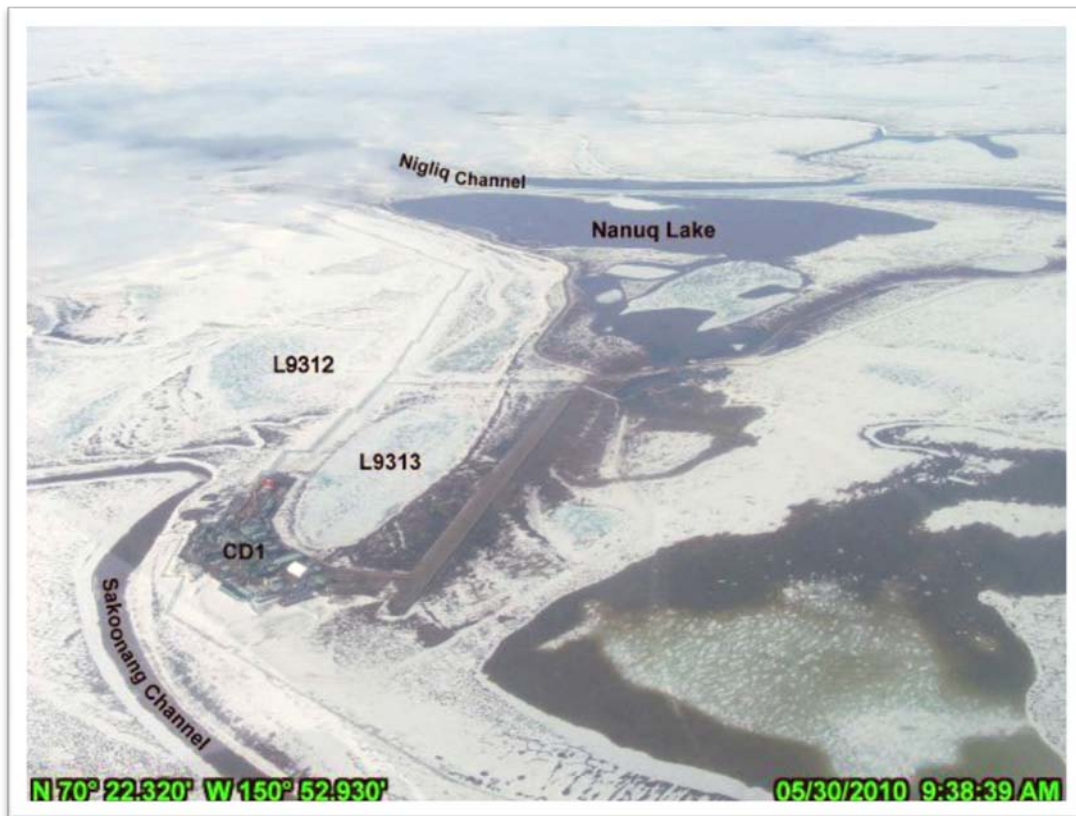
Floodwaters entered the Nigliq Channel on May 26, but due to initial low velocities, did not reach Nuiqsut until May 27. Floodwaters began filling Tapped Lake and Nanuq Lake on May 27. Nigliq Channel gage readings began on May 28, when flood stage was first measureable. Due to fog and freezing rain, gage WSE data collection was not possible on May 29. During a 20-minute reconnaissance flight on May 29, it was noted floodwaters had overtopped the banks of the Nigliq Channel and were flowing across Nanuq Lake, as shown the following day in Photo 4.16.

Photo 4.16: Nigliq Channel floodwaters reach Nanuq Lake; CD1 shown in foreground; May 30, 2010.

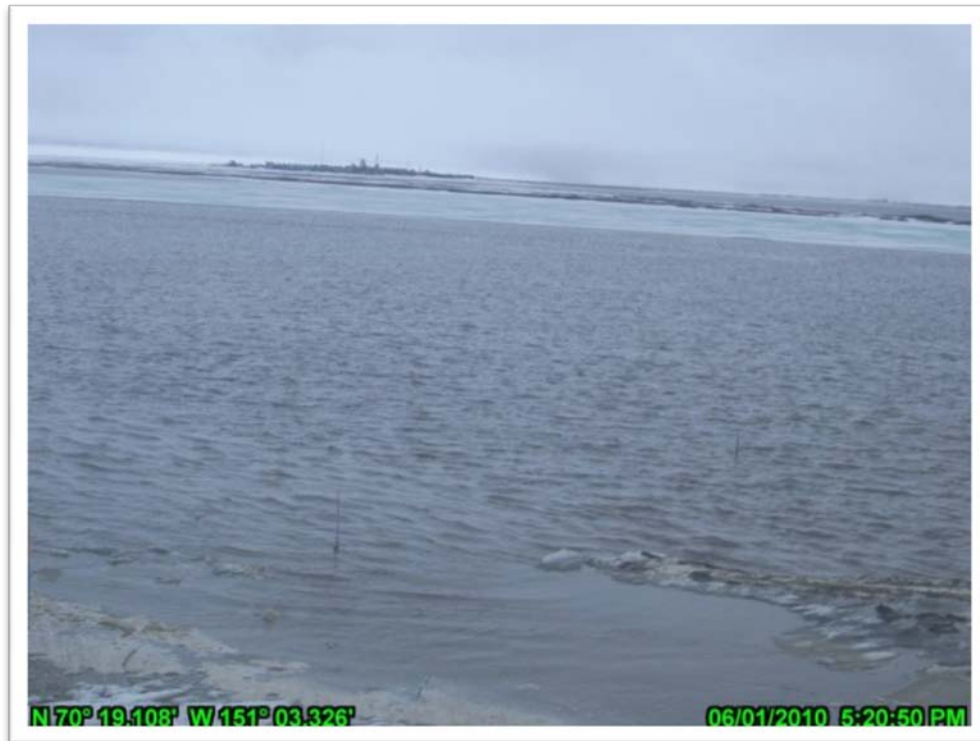
Just upstream from CD2 at MON22, floodwater was measureable on the gages by May 30, with an initial reading of 5.83 ft BPMSL. Significant ribbon ice persisted in this vicinity from May 30 through June 1, as gage WSE levels quickly rose to 8.34 ft BPMSL on June 1 (see Photo 4.18), a change of 2.51 feet. The stage rise was less than at MON20 due to flood flow lost towards facilities, particularly via Nanuq Lake. Water levels at

Photo 4.18: Floodwaters at MON22 one day prior to peak with CD2 in background; June 1, 2010.

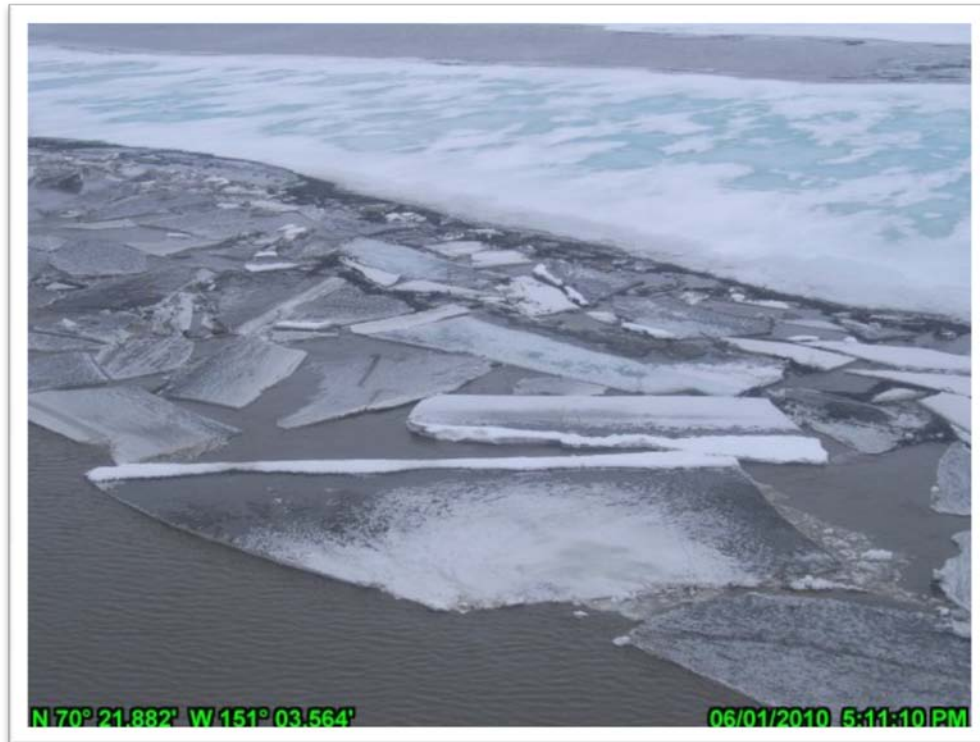
Photo 4.19: Ribbon ice and floes in the Nigliq Channel 1.4 miles downstream from MON23; June 1, 2010.

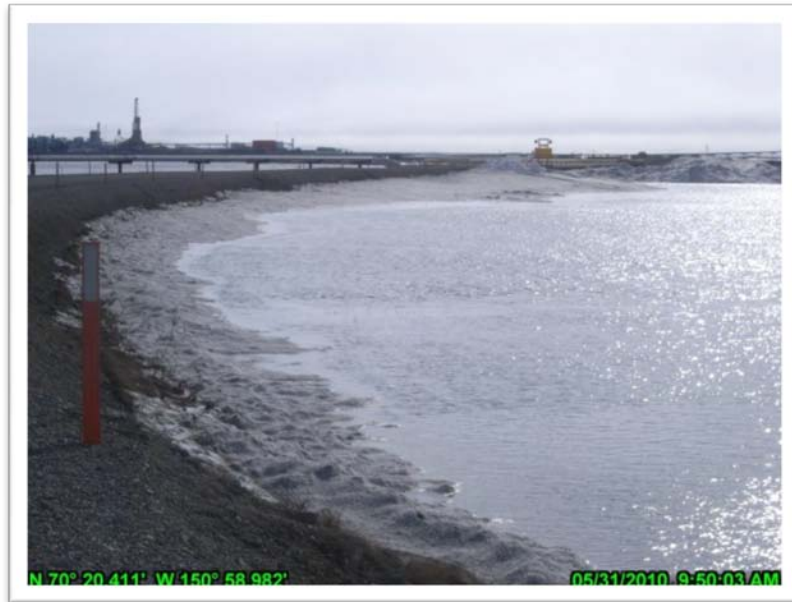
Both swale bridges, which pass the majority of the flow across the CD2 road, were clear of snow dams by June 1, prior to peak. Photo 4.20 shows floodwaters along the CD2 road on May 31. Photo 4.21 shows G4 near the swale bridges, one day prior to peak stage, on June 1. Floodwaters receded gradually after peak until June 4, then receded more quickly.

Photo 4.20: Floodwaters at CD2 road near swale bridges; May 31, 2010.

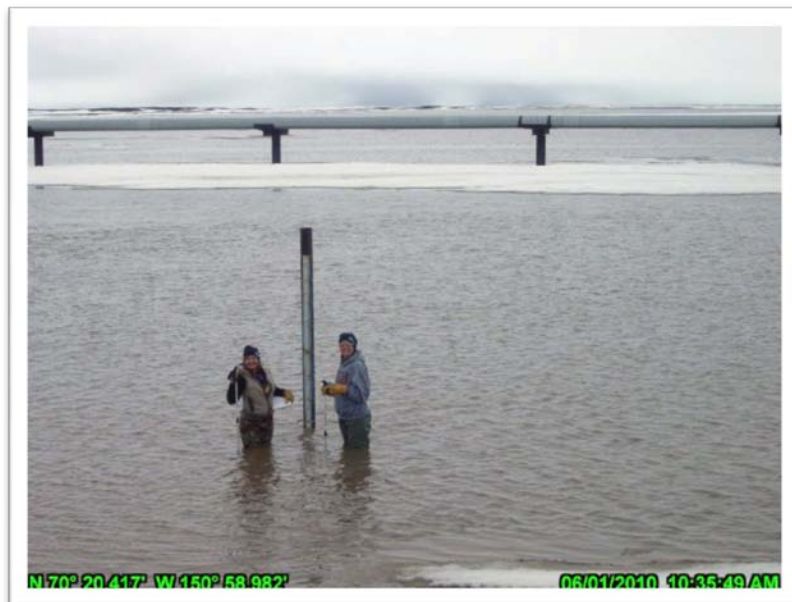
Photo 4.21: G4 along CD2 road one day prior to peak stage; June 1, 2010.

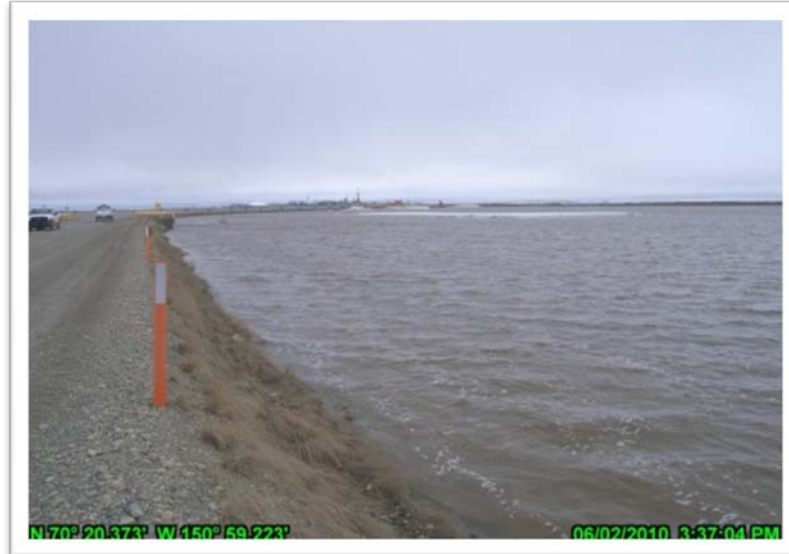
Floodwater reached measurable levels on G6, G7, G12, and G13 by June 1. Similar to G3/G4, these additional gages along the CD2 road showed a steady rise of flood water, each peaking on June 2, as shown in Photo 4.22 and Photo 4.23. Abundant snow quantities around these gages likely affected stage measurements during peak, and certainly affected flow

Photo 4.22: Floodwaters along CD2 road near peak stage; June 2, 2010.

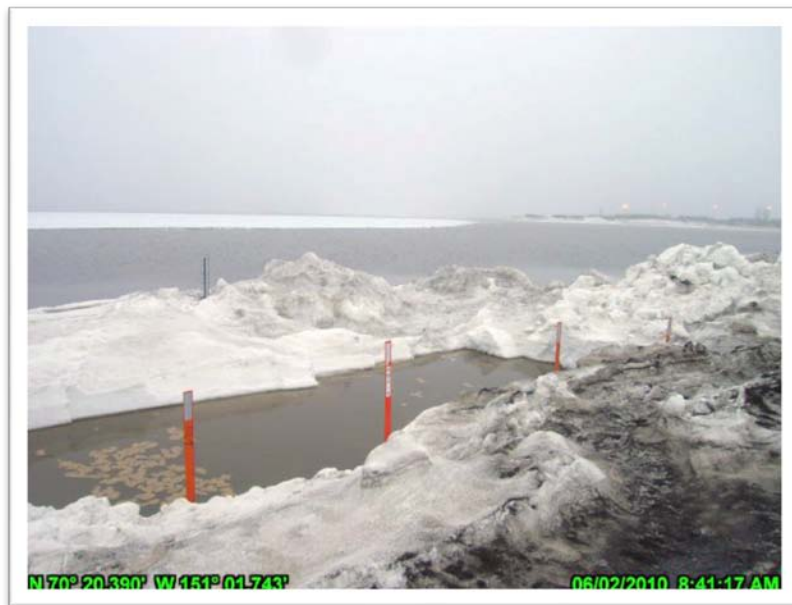
Photo 4.23: G6 near peak stage; June 2, 2010.

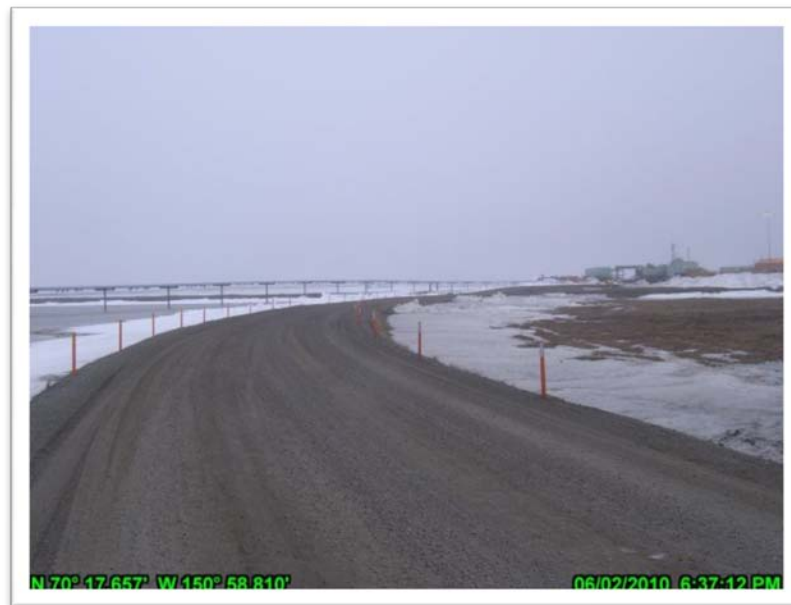
Relatively little flood flow passed under the CD4 access road in 2010, due in part to topography and to the abundant quantities of snow that remained in place along the road throughout breakup. WSE rose quickly at G18 after initial measurements on June 1 to a peak of 11.72 ft BPMSL on June 2. This flow did not come from the Nigliq Channel, but was instead primarily backwater from the Sakoonang Channel filling the paleochannel adjacent to the CD4 road. Photo 4.24 shows water along the southwest side of the CD4 road east of G17/G18 on June 2. Flow did not pass under the road from G18 to G17 and G17 remained dry in 2010.

Photo 4.24: Water along CD4 road; June 2, 2010.

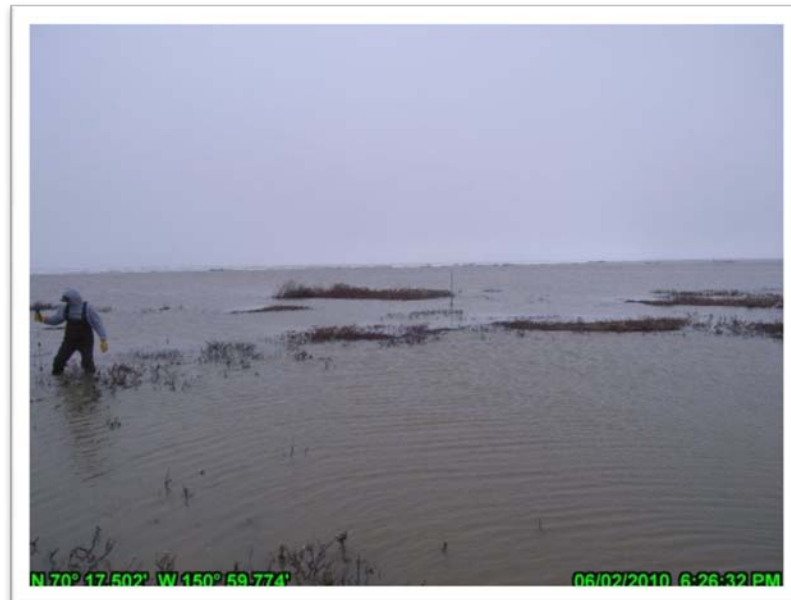
were no longer measurable. These data coincide with the formation and release processes of a major ice jam in the Nigliq Channel between June 1 and June 6. There was no grounded ice in the vicinity of G20 following breakup. The G20 area near peak stage is shown in Photo 4.25.

Photo 4.25: G20 near CD4 just prior to peak stage; June 2, 2010.

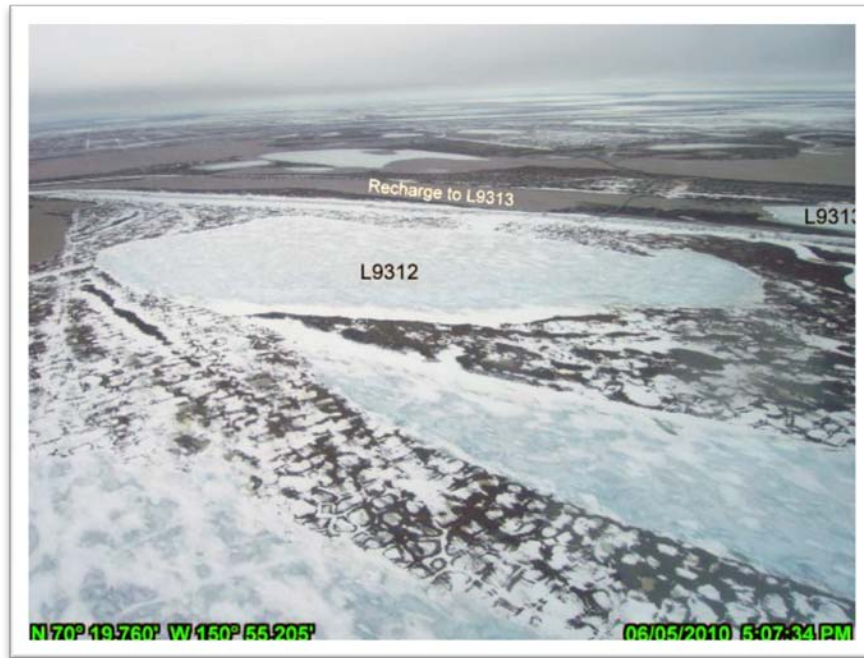
Lake L9312, located southwest of the CD1 pad, is surrounded by higher tundra than is Lake L9313. L9313 often receives floodwater recharge while L9312 does not, as shown in Photo 4.26 and Photo 4.27.

Photo 4.26: Lake L9312; June 5, 2010.

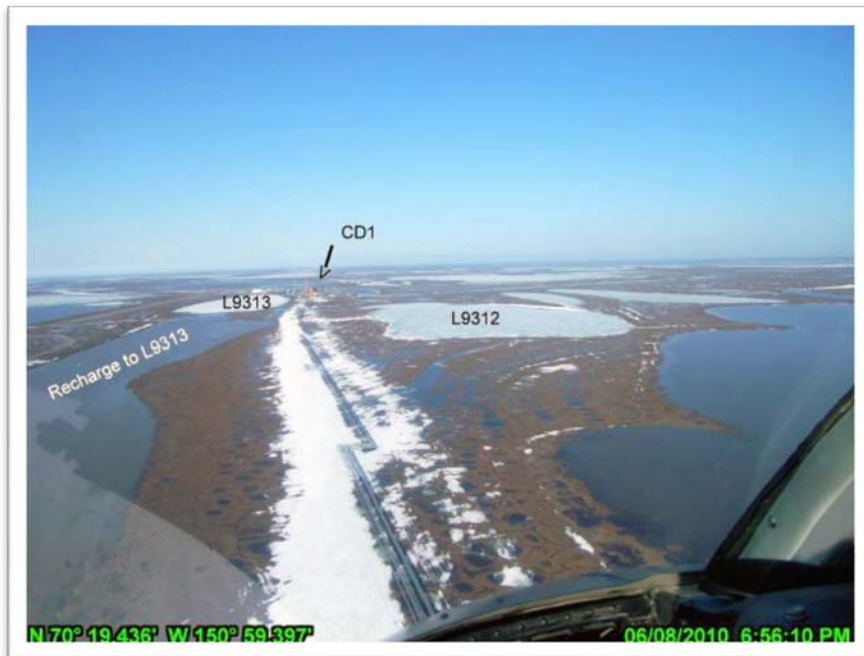
Photo 4.27: Local melt recharge, Lake L9312; June 8, 2010.

Floodwater levels during the 2010 spring breakup did not reach L9312. Recharge was a result of local melt only. Bankfull conditions were not achieved at L9312. Based on the historical record, bankfull elevation is approximately 7.8 ft BPMSL (Baker 2005).

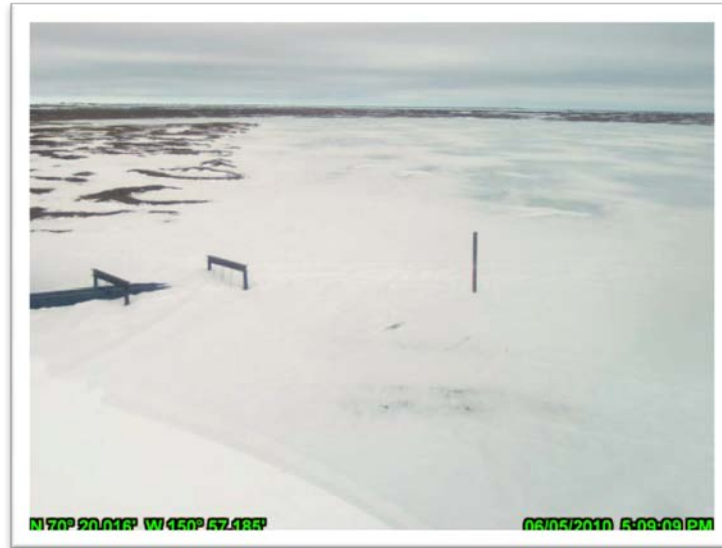
Water surface elevation was surveyed pre-breakup on May 11, 2010. At that time, the elevation of Lake L9312 was 7.11 ft BPMSL. Ice remained on the lake throughout the breakup season and into June as seen in Photo 4.28.

Photo 4.28: G9 and frozen Lake L9312; June 5, 2010.

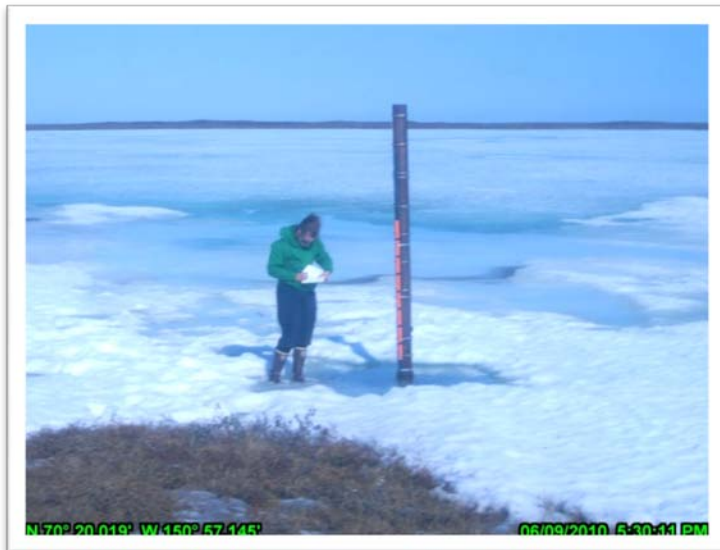
Photo 4.29: Gage reading G9, one day after peak, Lake L9312; June 9, 2010.

Peak WSE at L9312 (G9) was 7.63 ft BPMSL measured on June 8. WSE dropped off slightly following the peak elevation. Photo 4.29 shows G9 and L9312 one day after the peak WSE reading. Final WSE recorded for L9312 was 7.58 ft BPMSL on June 14. Water surface elevations for L9312 as measured at G9 are presented in Table 4.15.

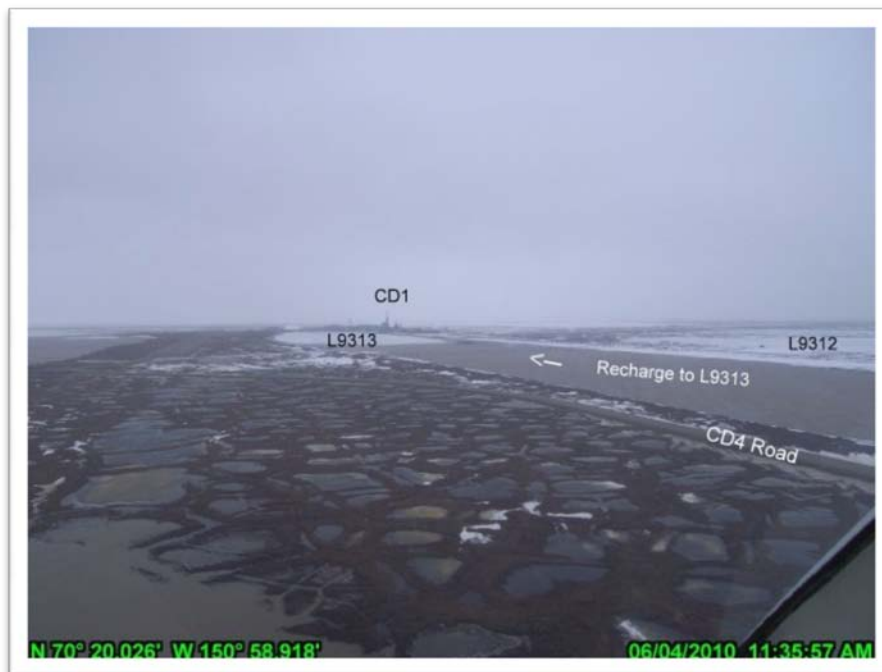
Lake L9313 is situated adjacent to the southwest side of the CD1 pad. Water surface elevation was surveyed pre-breakup on May 11, 2010. At that time, the elevation of L9313 was 5.83 ft BPMSL. Beginning on June 2, floodwaters reached L9313 from the Sakoonang-filled paleochannel along the east side of the CD4 road. L9313 also received floodwater recharge from the Nigliq Channel via Nanuq Lake and Lake M9524 (see Photo 4.30 and Photo 4.31).

Photo 4.30: Floodwater recharge Lake L9313; June 4, 2010.

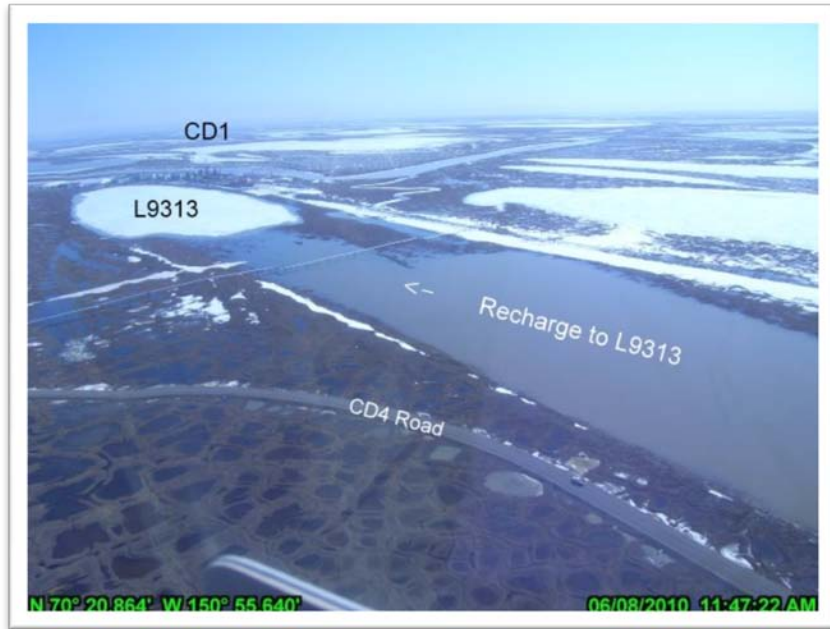
Photo 4.31: Floodwater recharge Lake L9313; June 8, 2010.

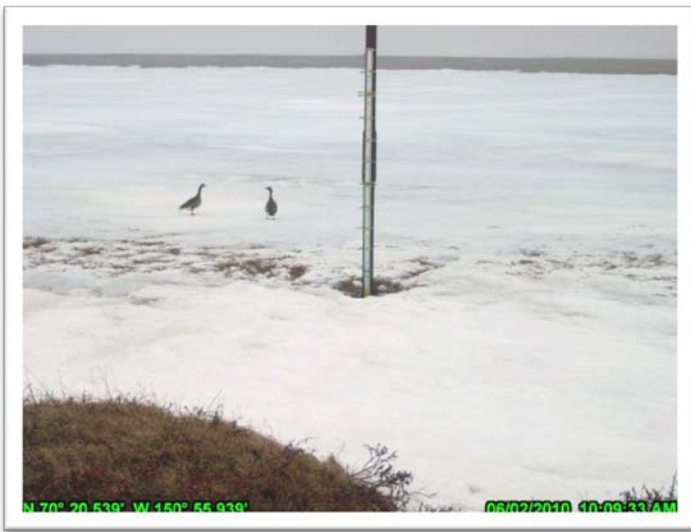
Photo 4.32: Lake L9313 as floodwaters began to recharge; June 2, 2010.

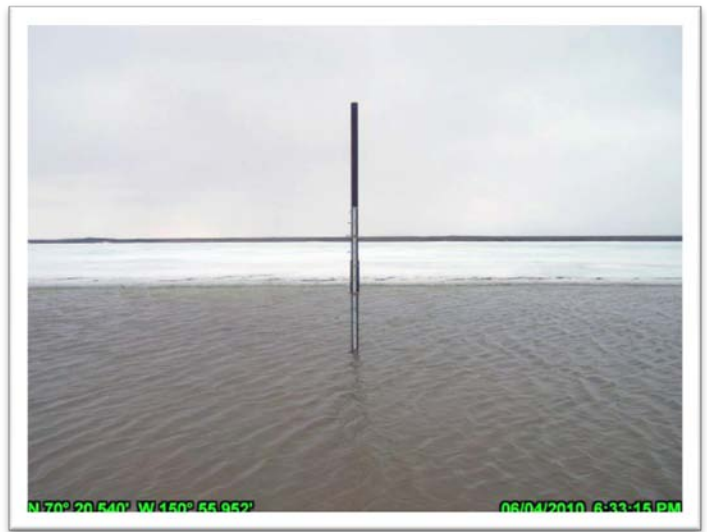
Daily monitoring of G10 (Lake L9313) began on June 3 with a gage reading of 7.52 ft BPMSL, which was the peak WSE for L9313. This coincided with the time of peak stage around the CD1 facility. WSE on L9313 dropped off following June 3, and the last WSE reading of 6.65 ft BPMSL was taken on the evening of June 4 (see Photo 4.33).

Photo 4.33: G10, Lake L9313; June 4, 2010.
