**COLVILLE RIVER DELTA
SPRING BREAKUP
2010 HYDROLOGIC
ASSESSMENT**

Colville River Delta Spring Breakup

2010 Hydrologic Assessment

119863-MBJ-RPT-001
November 2010

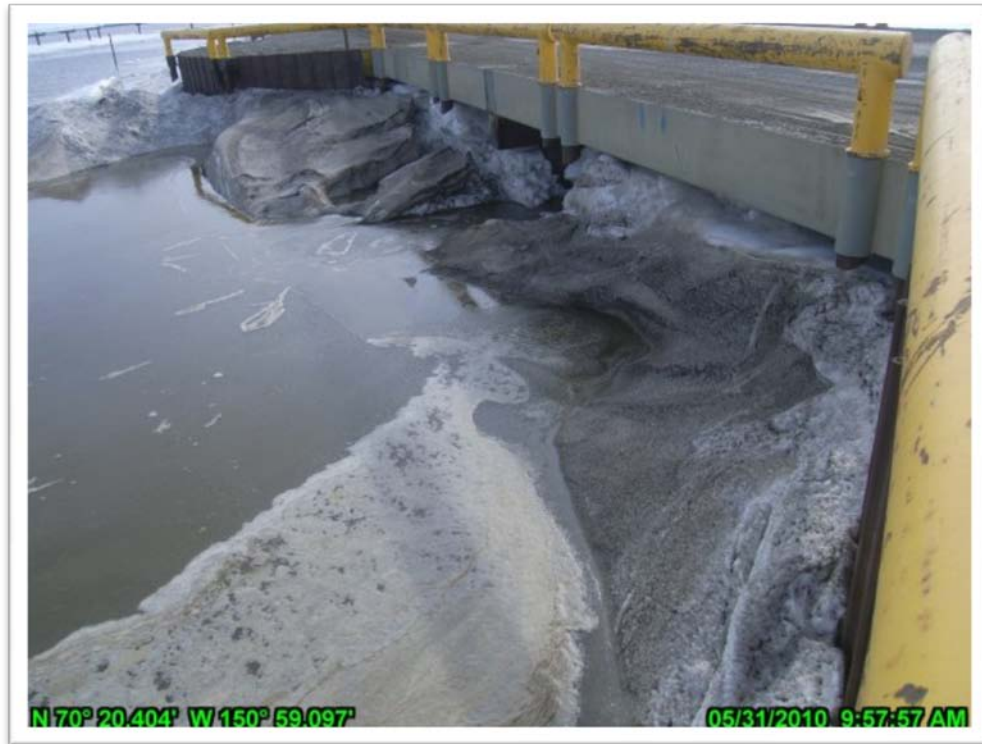
By May 29, floodwaters began to reach the CD2 road area, and several culverts began to pass water from south to north. On May 30, the long swale bridge began to pass some discharge, though it was partly blocked with snow (see Photo 4.34). Also on May 30, the short swale bridge was completely blocked with ice and snow, preventing passage of flow, as shown in Photo 4.35. On May 30, gage readings began at G3 and G4, the easternmost gages along the CD2 road. By May 31, the short swale bridge remained 95% blocked by snow and ice. Ice rafts were noted on the upstream side of the CD2 road, but were not noticeably moving.

Photo 4.35: 62-ft swale bridge blocked by snow; May 31, 2010.

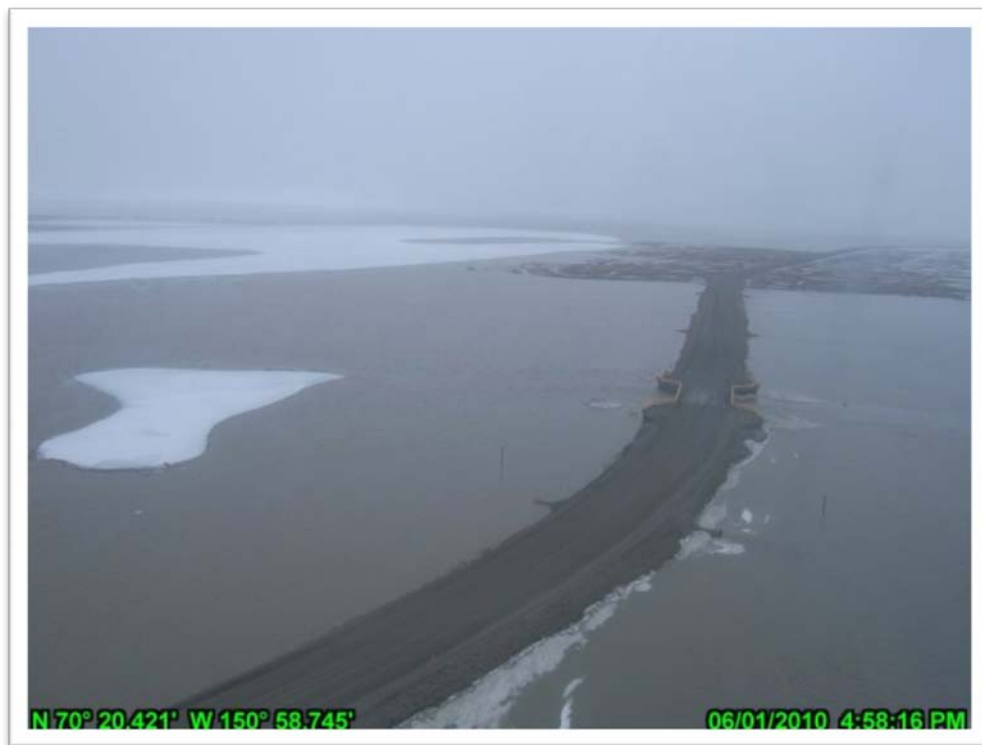
Photo 4.36: Aerial view of 62-ft swale bridge; June 1, 2010.

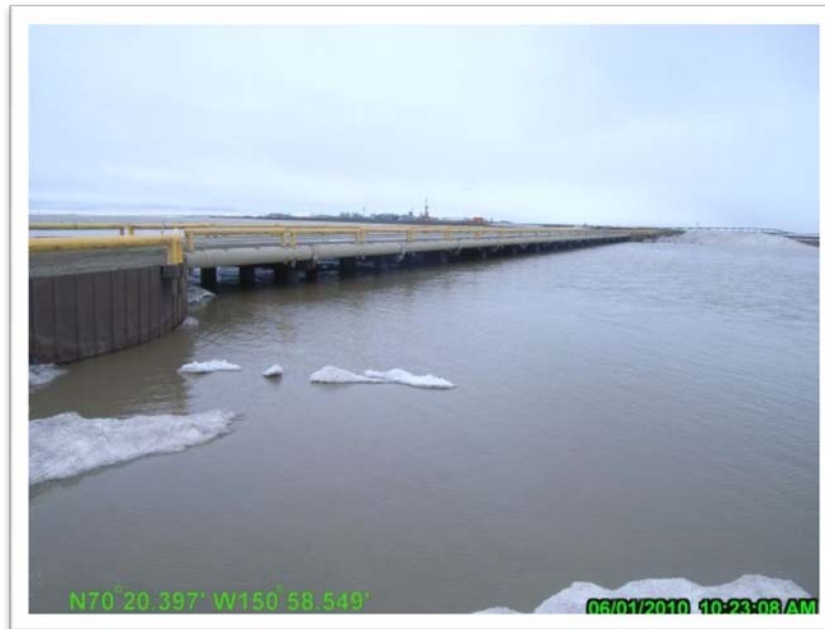
Direct discharge measurements were taken on June 1 and June 3 at the long and short swale bridges, respectively. Photo 4.37 shows discharge beneath the 452-ft swale bridge at the time of the direct discharge measurement.

Photo 4.37: 452-ft swale bridge one day prior to peak stage; June 1, 2010.

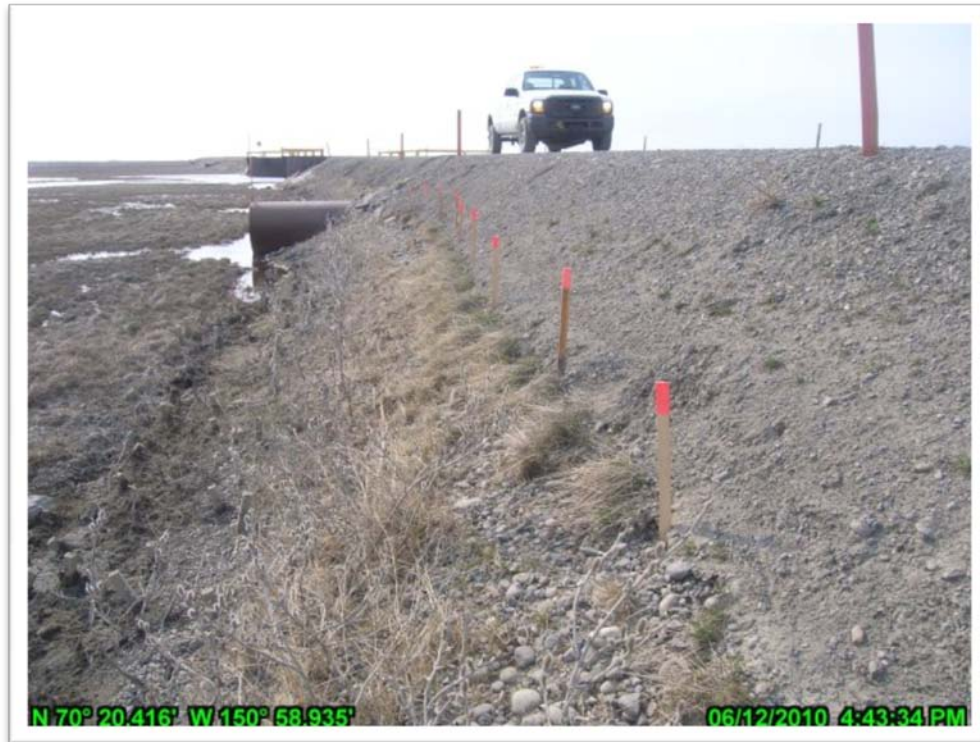
High water marks were observed along the CD2 road as a result of floodwater erosion. Photo 4.38, Photo 4.39, Photo 4.40, and Photo 4.41 are representative photos of the observed erosion along the CD2 gravel road prism following peak stage of breakup floodwater. Generally, the erosion of the CD2 access road was limited to the upstream (south) side of the road prism in the vicinity of the swale bridges.

Photo 4.39: Orange lath used to indicate maximum elevation of erosion line along CD2 road; June 12, 2010.

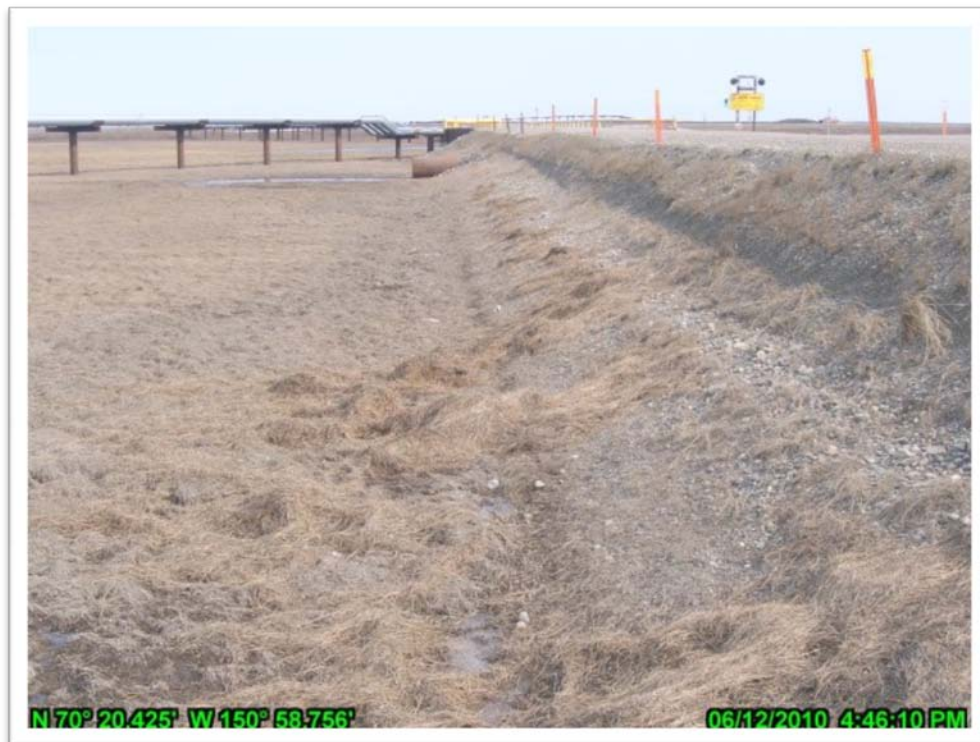
Photo 4.40: Erosion of the north side of the CD2 road prism in the vicinity of culvert CD2-24; June 12, 2010.

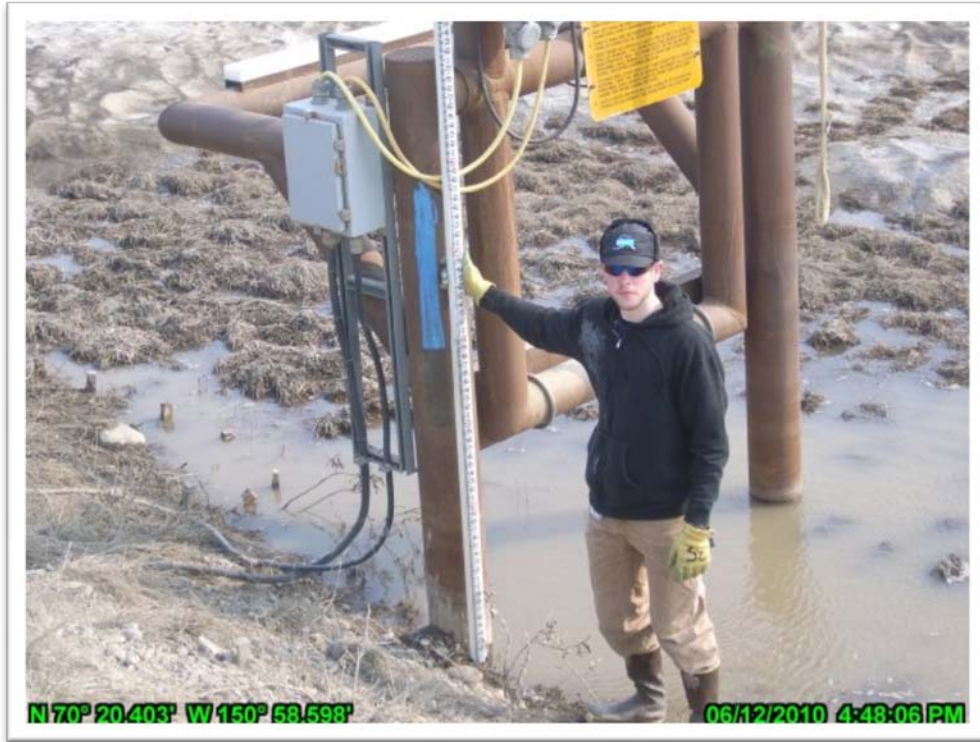
Photo 4.41: High water mark (bottom of blue chalk line) on runway signal light CD2 road at base of road prism; June 12, 2010.

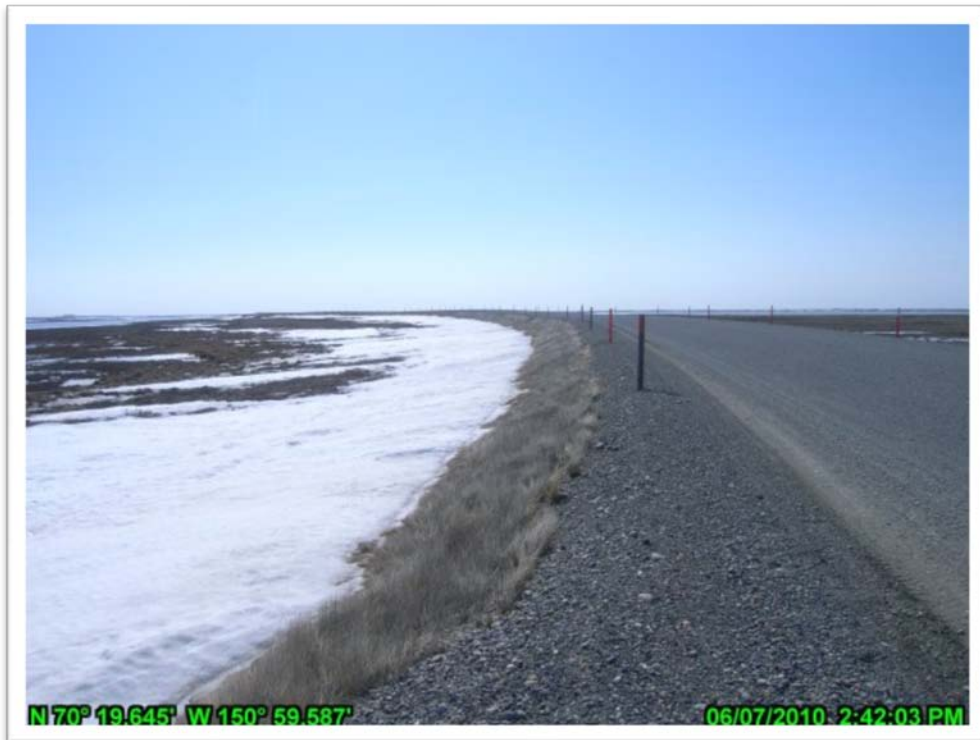
Floodwater reached the base of the CD4 gravel road prism in some areas; however, the amount of floodwater was not significant enough to result in any noteworthy erosion. Photo 4.42, Photo 4.43, and Photo 4.44 are

Photo 4.42: West side of CD4 road prism looking south, midway to CD4; June 7, 2010.

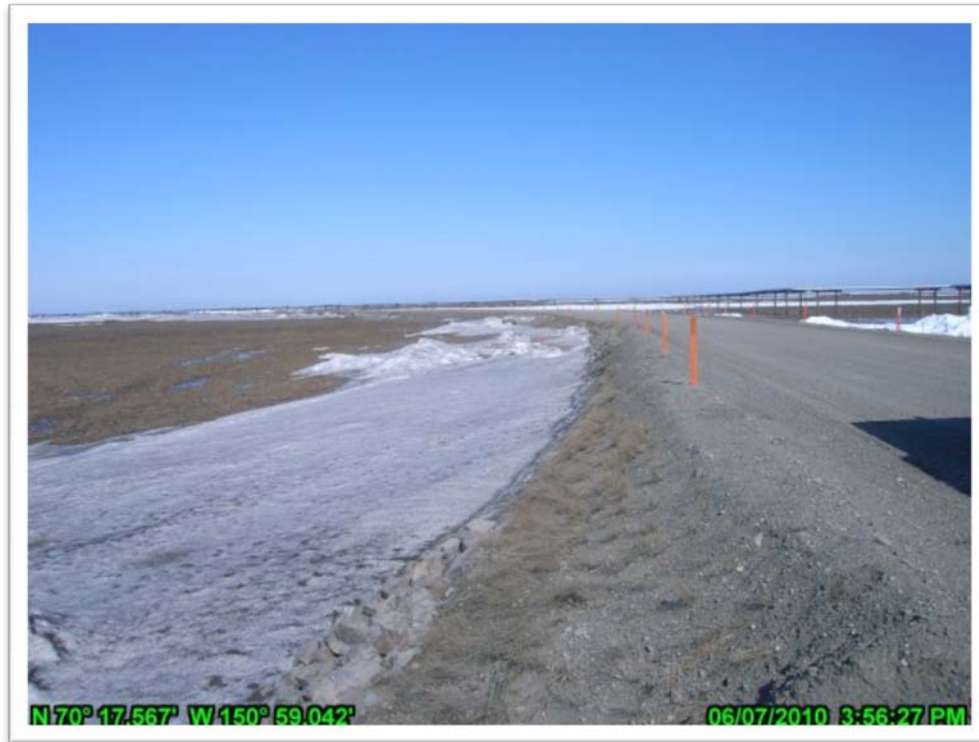
Photo 4.43: CD4 road prism looking east, vicinity of CD4; June 7, 2010.

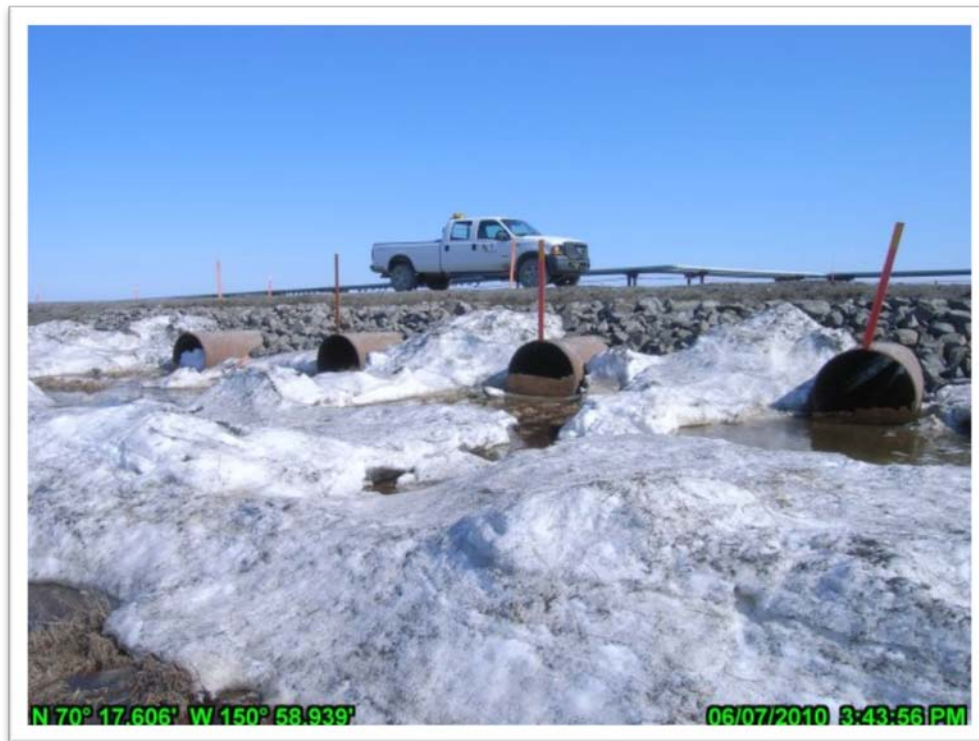
Photo 4.44: Snow in place post breakup, vicinity of culverts CD4-25 through CD4-28, looking southeast; June 7, 2010.

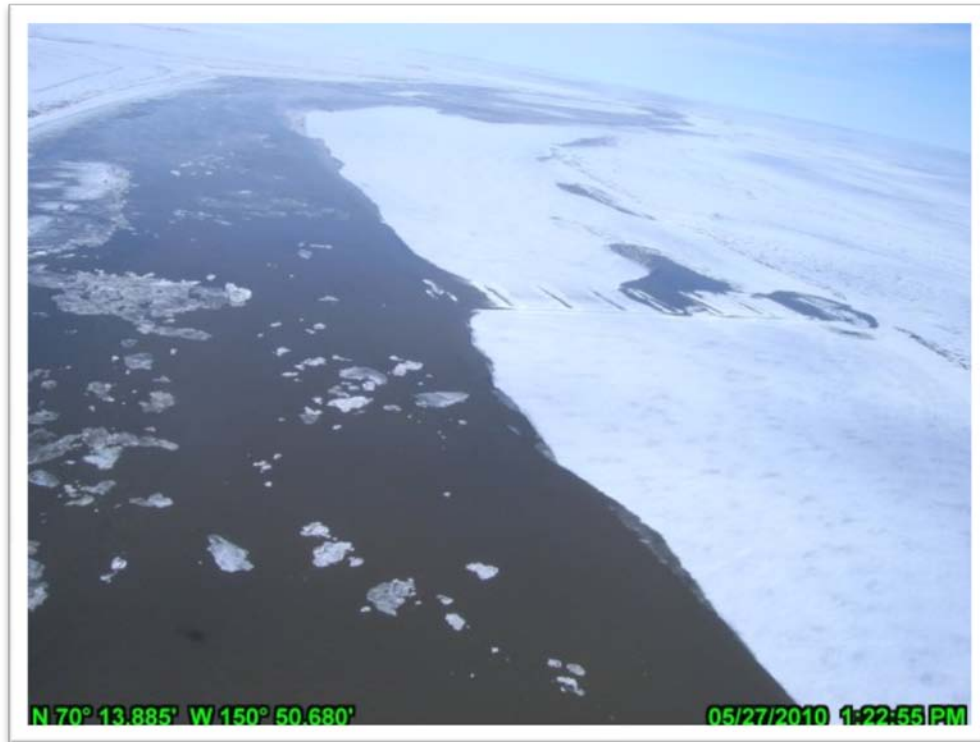
The first visual evidence of melt at the East Channel ice bridge was recorded on May 25 when water was observed in the slots cut into the ice bridge (Photo 4.45). By May 27, floodwater was beginning to flow through the area and ice floes were observed (Photo 4.46). By June 5, the East Channel ice bridge was no longer visible and was not affecting flow, with the exception of the western ramp (Photo 4.47).

Photo 4.46: Flowing water and ice floes, looking north, East Channel Colville River; May 27, 2010.

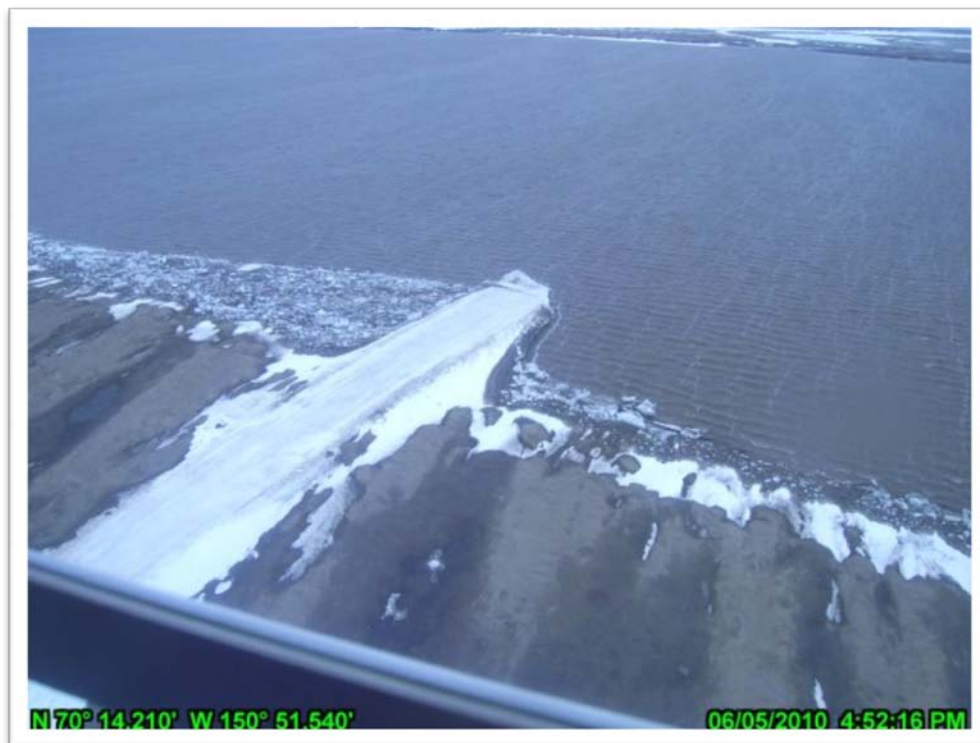
Photo 4.47: Colville River East Channel ice bridge essentially melted with the exception of the western ramp, looking east; June 5, 2010.

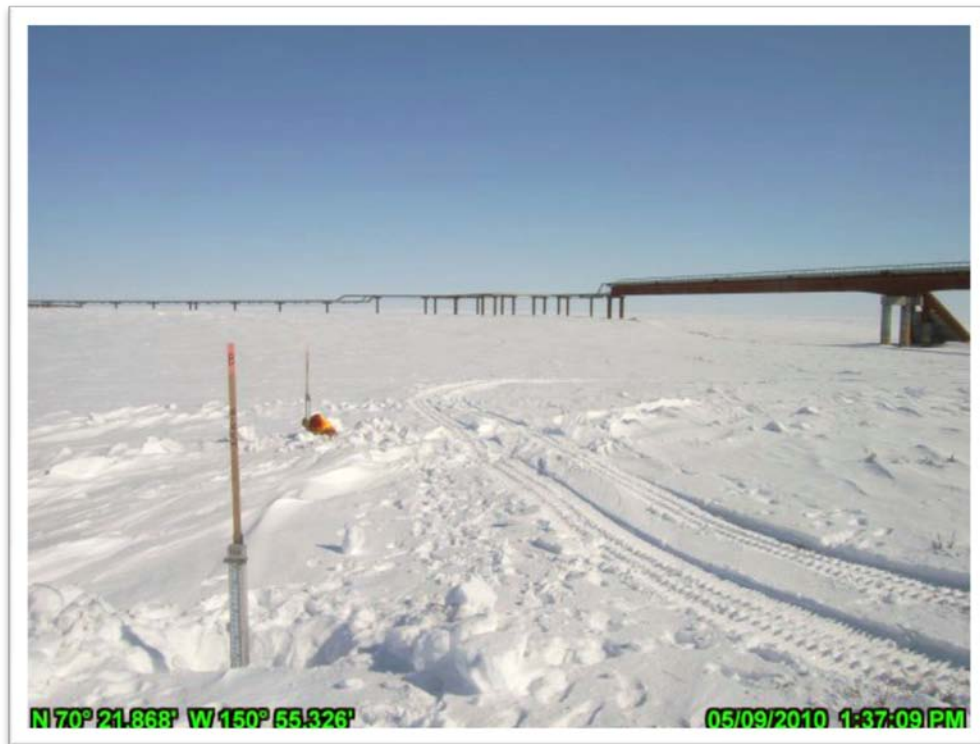
Photo 4.51: Installation of gages pre-breakup, Sagoonang Channel pipeline crossing; May 9, 2010.

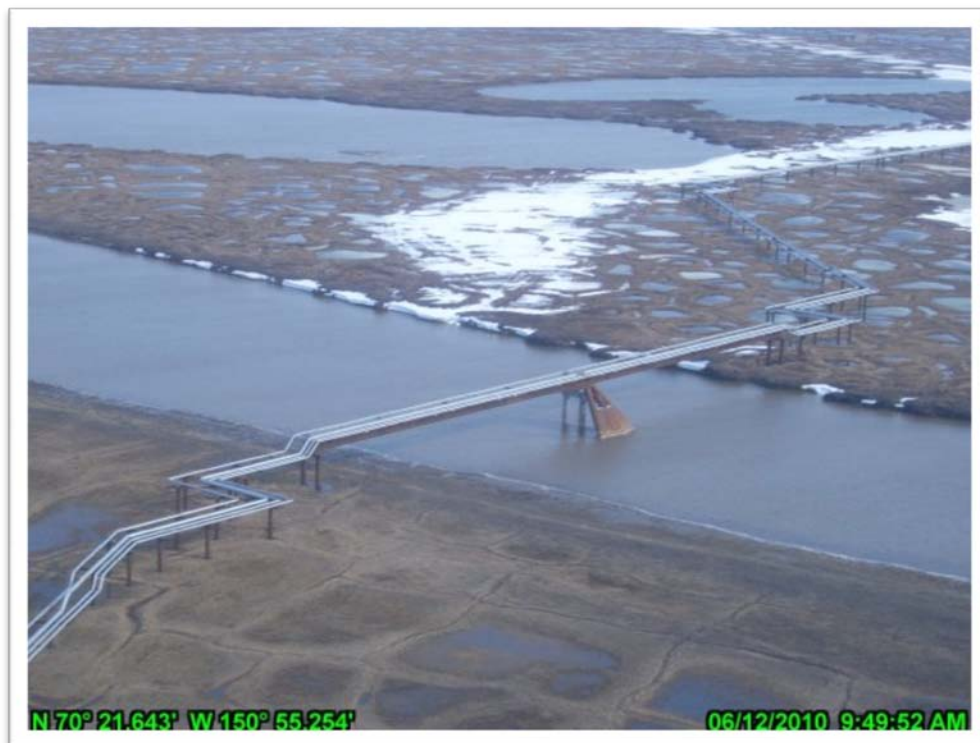
Elevated stage at all locations was most likely due to ice jamming within the local channels as well as effects due to ice jamming within the East Channel. Photo 4.52 shows the Sakoonang pipeline crossing post breakup. Photo 4.53 and Photo 4.54 show initial floodwater passing through the Tamayayak and Ulamnigiq pipeline bridge crossings respectively.

Photo 4.52: Sagoonang Channel pipeline crossing post breakup, looking south; June 12, 2010.

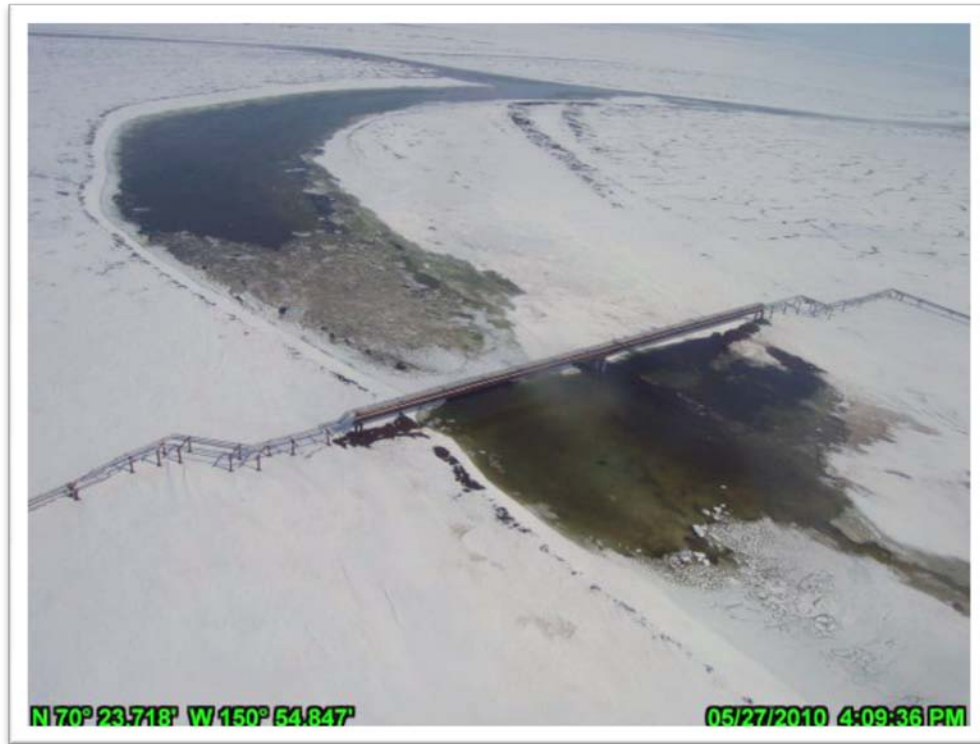
Photo 4.53: Initial floodwater passing under Tamayayak Channel pipeline bridge, looking northeast; May 27, 2010.

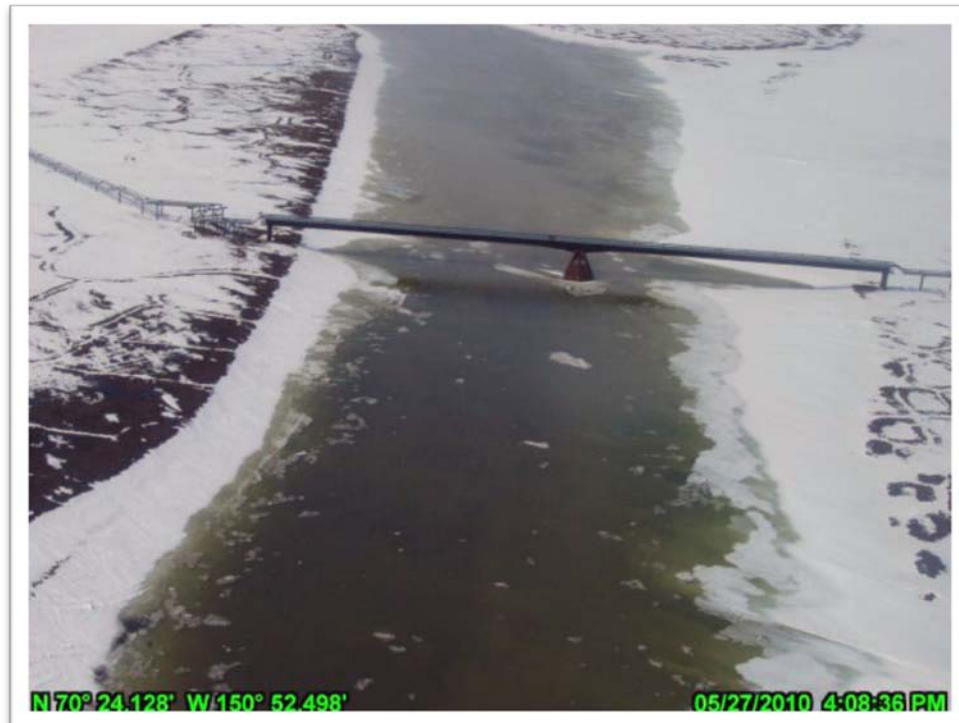
Photo 4.54: Initial floodwater passing under Ulamnigraq Channel pipeline bridge crossing, looking northwest; May 27, 2010.

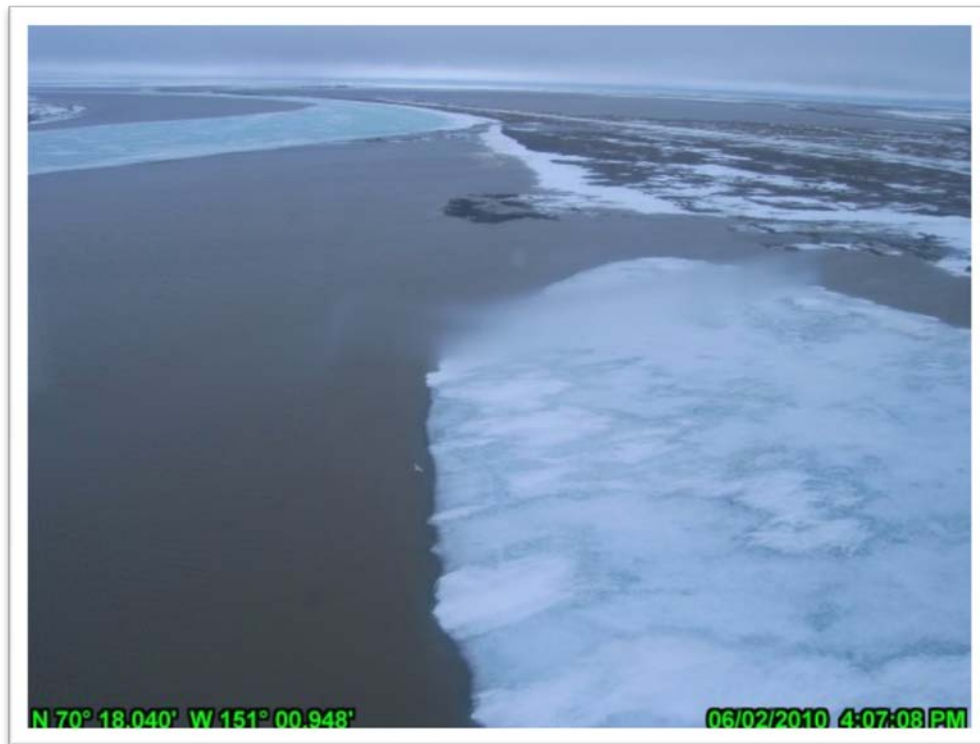
Daily gage readings commenced on May 27 at G21, with an initial reading of 4.48 ft BPMSL, and local melt only observed. Channel ice and abundant ribbon ice were present near the G21 location until ice began to breakup on June 3. Peak stage at the proposed Nigliq crossing occurred on June 2 with a WSE of 9.65 ft BPMSL. Photo 4.56 shows the Nigliq Channel just north of the proposed CD5 crossing near peak stage on June 2.

Photo 4.56: View north along Nigliq Channel from proposed CD5 road crossing at G21; June 2, 2010.

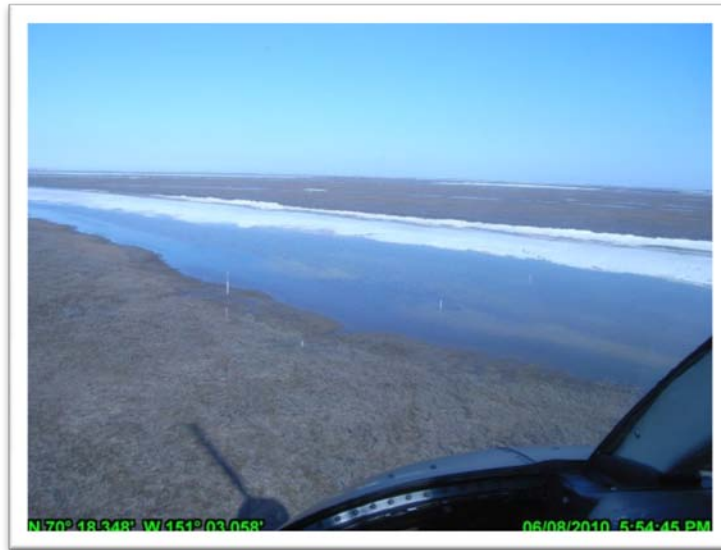
The proposed CD5 road crossing of Lake L9341 is monitored at G22. As of May 30, no water was identified on the G22 gage. Aerial observation on June 4 noted possible recharge of Lake L9341 from the southwest, with possible contribution from the Nigliagvik. As shown in Photo 4.57, by June 8, competent ice remained along the east bank. At the same time, L9341 was recharging through a small channel to the north of the lake. On June 8, WSE on the gage was 5.63 ft BPMSL. Stage rose 0.22 feet over the next two days to a WSE of 5.85 ft BPMSL recorded on June 10. By June 12, the WSE dropped to 5.34 ft BPMSL and monitoring was discontinued. WSE data and observations are provided in Table 4.18.

Photo 4.57: Lake L9341 at proposed CD5 road crossing (G22); June 8, 2010.

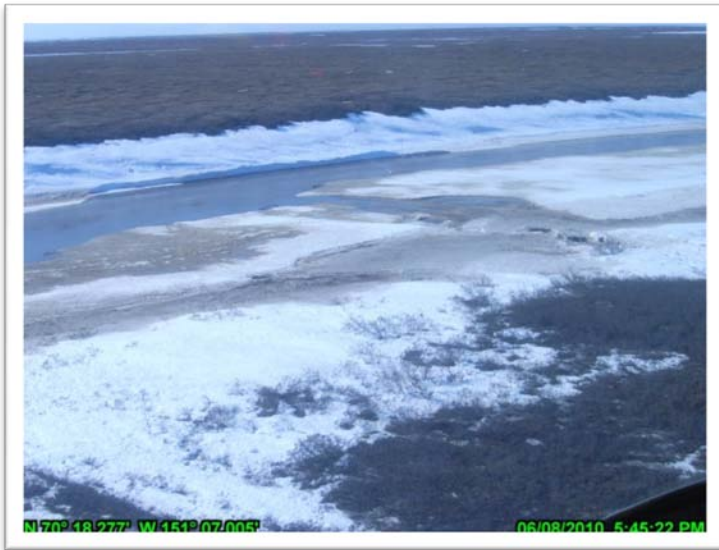
G23 along the Nigliagvik is utilized to monitor WSE at the proposed CD5 crossing. On May 30, local melt resulted in a WSE of 5.25 ft BPMSL. Flow from the Nigliq Channel was observed entering the Nigliagvik from both the upstream and downstream confluences, approaching the crossing location from both directions. Peak WSE occurred late on June 2 or early on June 3 at 8.69 ft BPMSL. By June 4, the flow direction was still not clear, and an abundant amount of snow remained in the channel. By June 8, the observed WSE was 4.85 ft BPMSL and monitoring was discontinued. Recorded WSE and observations for G23 are provided in Table 4.19.

Photo 4.58: Nigliagvik at proposed CD5 road crossing (G23); June 8, 2010.

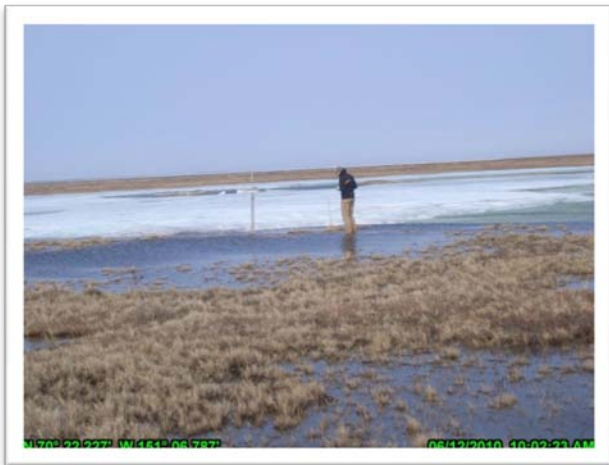
The observation of a HWM on June 12 (Photo 4.59) indicated that the peak stage for FWR1 occurred sometime between the afternoon of June 10 and the morning of June 12. It was estimated that peak stage at FWR1 occurred midday on June 11 with an elevation of 5.40 ft BPMSL.

Photo 4.59: FWR1 gage reading one day after peak (observation of HWM), looking north; June 12, 2010.

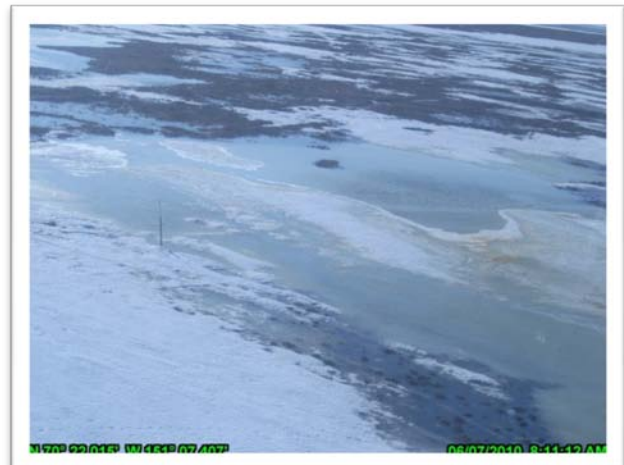
On June 7, the first hydrologic observation was made at FWR2, which turned out to be the peak stage with an elevation of 4.30 ft BPMSL. This peak stage observation was confirmed by the following day's observation (June 8) with an observed HWM of 4.30 ft BPMSL. Photo 4.60 is an aerial photo of the FWR2 gage site on the day of recorded peak stage.

Photo 4.60: FWR2 Aerial photo peak stage (gage on left side of photo), looking southeast; June 7, 2010.

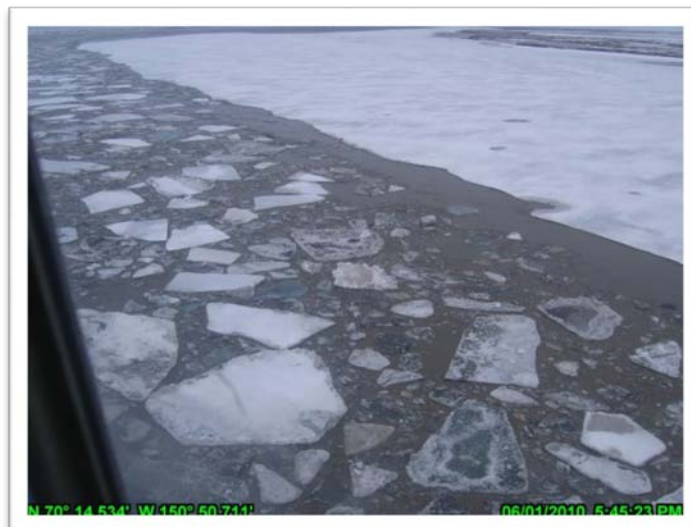
Photo 5.2: Ice jam and channel ice in the vicinity of MON9 (HDD); June 1, 2010.

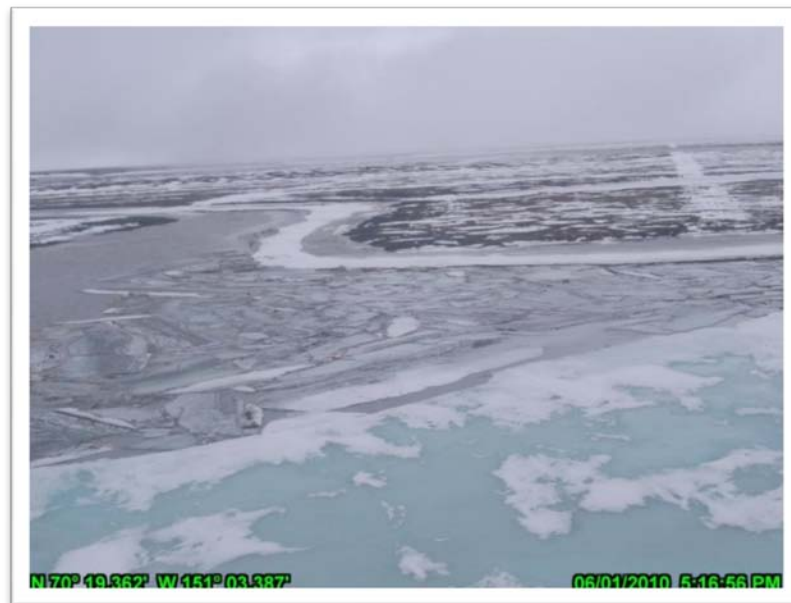
Flow in the Nigliq Channel during 2010 breakup was influenced by ice, as shown in Photo 5.3.

Photo 5.3: Ribbon ice and ice jamming just downstream of MON22; June 1, 2010.

While peak stage at MON23 occurred on June 2, significant ribbon ice was observed in-channel from May 30 until June 3. A large ice jam entered the Nigliq Channel from the East Channel on June 1, eventually clearing past MON23 around June 6, resulting in a series of jam and release events as the obstruction moved downstream.

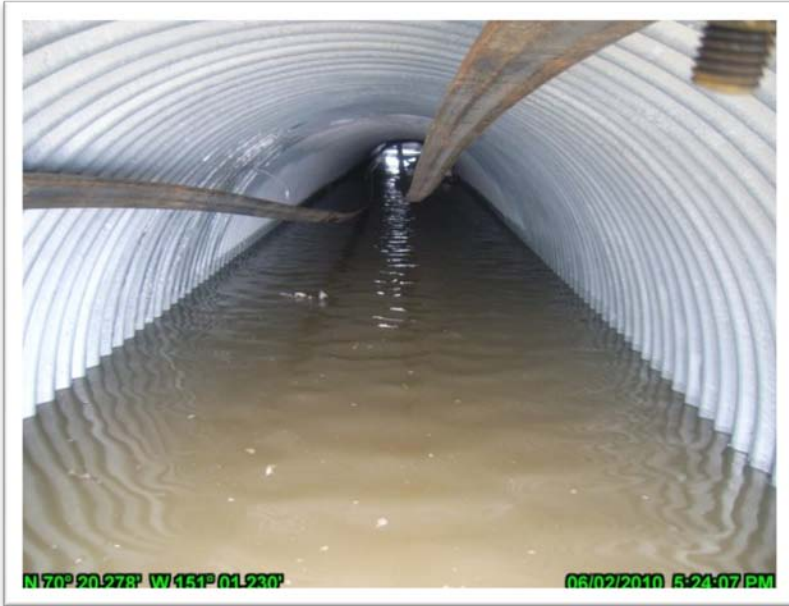
In September of 2008, changes were made to six of the existing CMP culverts (CD2-9 through CD2-14). These culverts were experiencing deformation due to road prism loading. They were retrofitted by

inserting a smooth circular sleeve, anchored at each end. Forty-eight inch diameter smooth sleeves were inserted into five existing 60-inch diameter CMPs; one 60-inch diameter smooth sleeve was inserted into the 72-inch diameter CMP. With regard to flow conveyance, the smooth sleeves reduce some friction losses in the culvert, but this is countered by smaller diameter available for flow compared to the larger original CMPs. Furthermore, the smooth sleeves do not extend the length of the CMP, but are centered in the CMP. Photo 5.4 shows the tie anchors for the smooth sleeves in culvert CD2-10.

Photo 5.4: Interior CD2 road culvert CD2-10 showing smooth sleeve tie anchors inside CMP culvert; June 2, 2010.

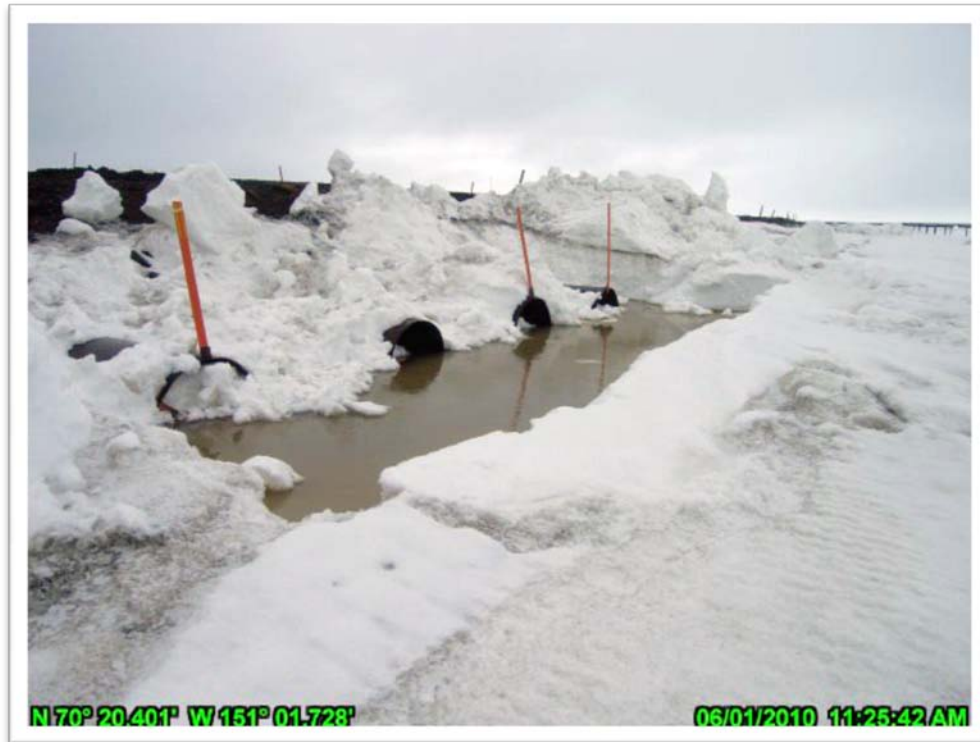
Floodwater was observed flowing through 17 CD2 road culverts (CD2-1, CD2-4 through CD2-7, CD2-10, CD2-13 through CD2-16, and CD2-18 through CD2-24) and backwater was observed in one CD4 culvert (CD4-24A). This backwater resulted in little flow through the CD4 culverts. Snow blockage and wood debris were present in the vicinity of several of the Alpine road culverts during breakup as shown in Photo 5.5 and Photo 5.6; this affected the hydraulic performance and discharge of the CD2 culverts in particular. Flow impediments, including snow and debris blockage, as well as the presence of damaged culvert inverts (Photo 5.7), were considered when comparing calculated discharge values with observed values.

Photo 5.6: Snow blockage, downstream side CD2 road culverts CD2-4 through CD2-7; June 1, 2010.

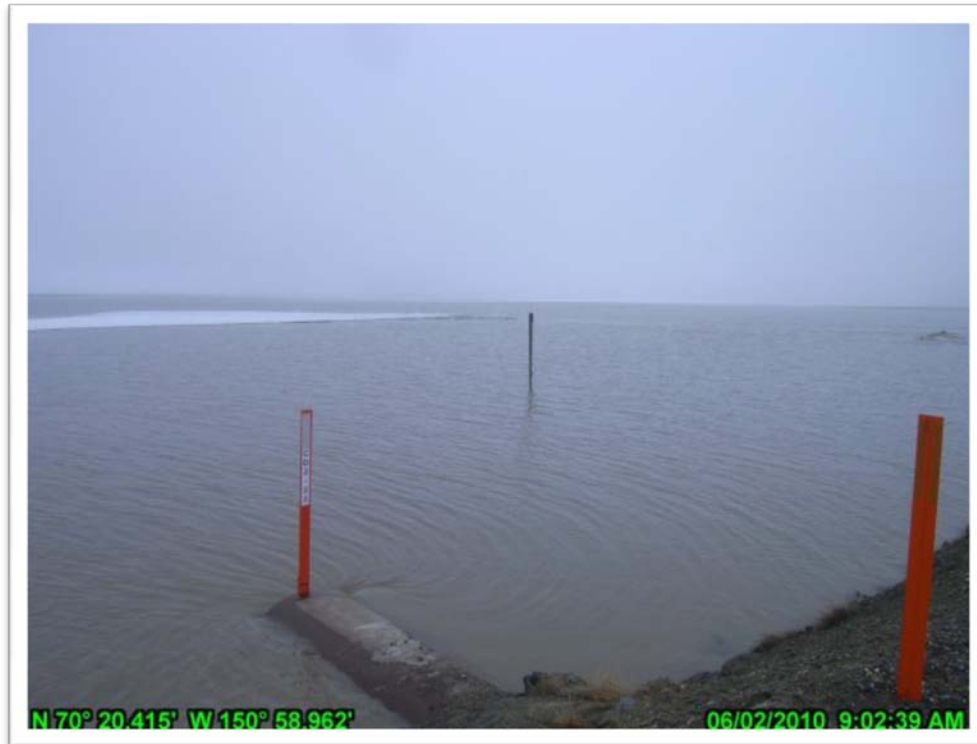
June 2 water depths and velocities measured at the CD2 road culverts are provided in Table 5.5. This represents conditions at culverts close to the time of peak stage as observed at the CD2 road gages (Photo 5.8 and Photo 5.9). The measured velocities ranged from less than 0.1 feet per second (fps) to 4.5 fps. Based on direct depth and velocity measurements, the total discharge flowing through CD2 culverts was 319 cfs, ranging from 0.1 cfs to 49.2 cfs.

Photo 5.8: Near peak stage at culvert CD2-22; June 2, 2010.

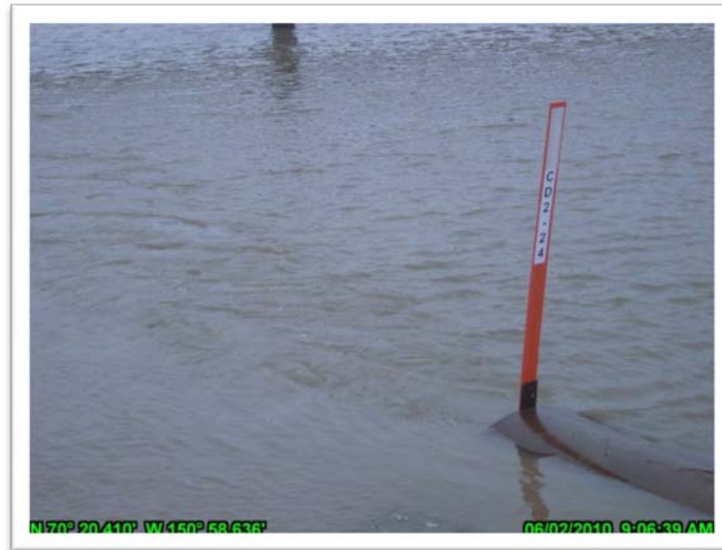
Photo 5.9: Near peak stage at culvert CD2-24; June 2, 2010.
