Colville River Delta

ConocoPhillips
Alaska

Colville River Delta Spring Breakup 2011 Hydrologic Assessment

January 2012

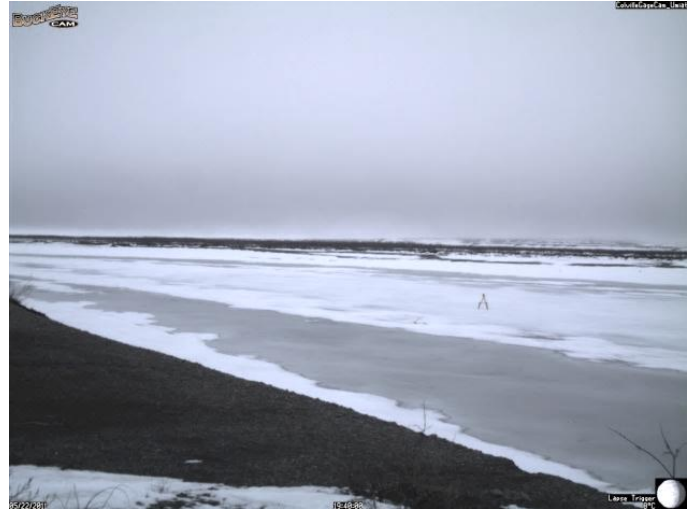
PHOTO 4.2: LEADING EDGE IN COLVILLE RIVER PASSING UMIAT, FROM UMIAT LIVE CAMERA PROVIDED BY USGS; MAY 22, 2011 AT 7:40PM

On May 22, 2011, at around noon, Baker personnel took a reconnaissance flight upstream of MON1. A leading edge was observed in the Anaktuvuk River at approximately 4.5 RM upstream of the Anaktuvuk-Colville River confluence. Later on May 22, the Umiat live camera recorded a leading edge in the Colville River passing through Umiat sometime between 7:30 p.m. and 7:40 p.m. (Photo 4.1 and Photo 4.2). Umiat is approximately 93 RM upstream of MON1.

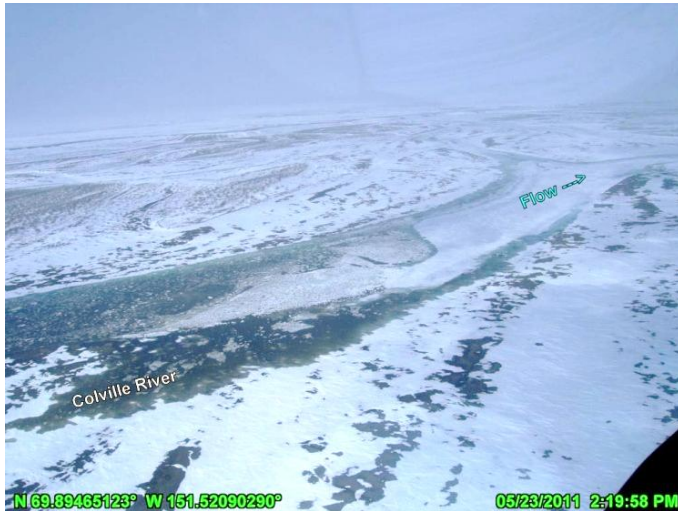
On May 23 at around 2:00 p.m., the leading edge was observed in the Colville River about 35 RM upstream of MON1 (Photo 4.3). The breakup water appeared to be highly turbid and many ice floes were seen. After 7:00 p.m. on May 22, the speed of the leading edge in the Colville River was estimated at approximately three miles per hour (mph).

PHOTO 4.3: LEADING EDGE IN COLVILLE RIVER ~35 RM UPSTREAM OF MON1, LOOKING DOWNSTREAM (NORTH); MAY 23, 2011

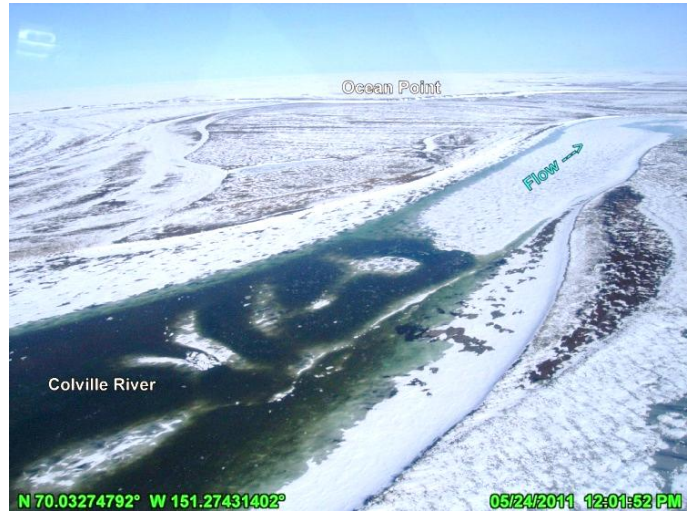
On May 24 at 2:00 p.m. the Colville River leading edge had moved through Ocean Point and was located at about 15 RM upstream of MON1 (Photo 4.4). Photo 4.4 was taken approximately 2 hours prior to the leading edge passing Ocean Point. During the course of the previous 24 hours, the average speed of the leading edge had slowed to approximately one mph.

PHOTO 4.4: LEADING EDGE IN COLVILLE RIVER APPROACHING OCEAN POINT, LOOKING DOWNSTREAM (NORTH); MAY 24, 2011

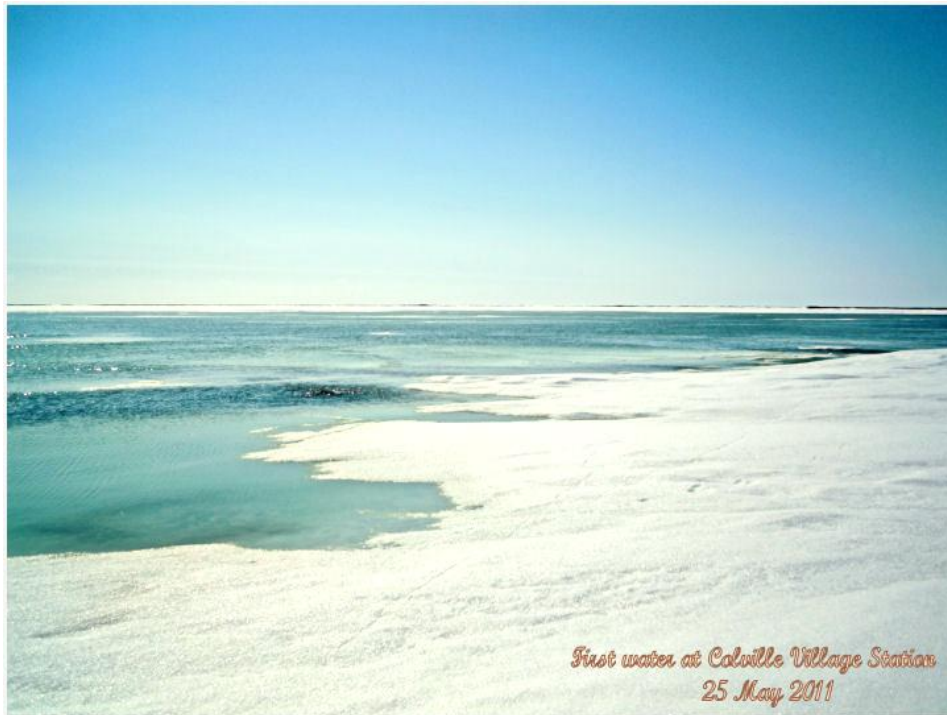
PHOTO 4.5: LEADING EDGE IN EAST CHANNEL ARRIVES AT MON35 (HELMERICKS HOMESTEAD) LOOKING UPSTREAM (PHOTO PROVIDED BY JIM HELMERICKS); MAY 25, 2011

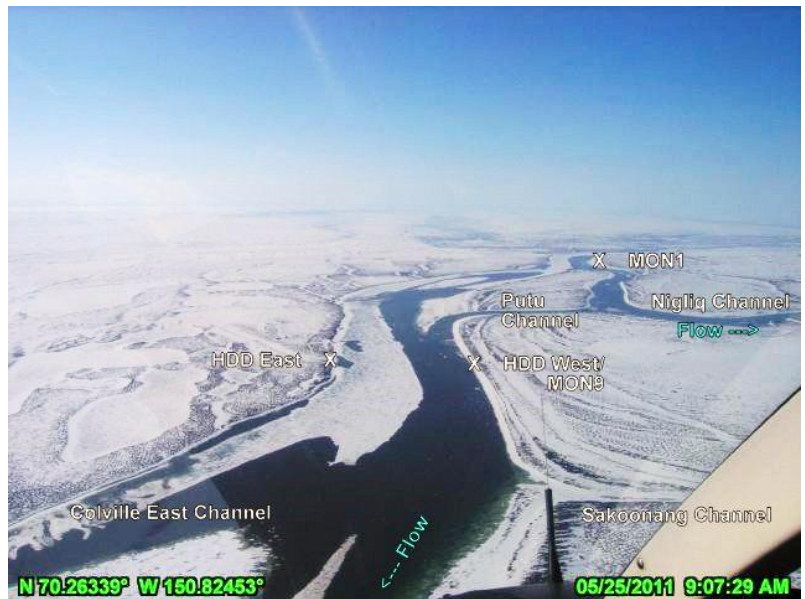
The leading edge reached MON1 on the morning of May 25. From here, floodwaters continued downstream into either the East Channel or the Nigliq Channel. The leading edge on May 25 is shown in Photo 4.6 and Photo 4.7. By the evening of May 25, the leading edge had arrived at the farthest gage downstream in the East Channel (MON35).

PHOTO 4.6: LEADING EDGE IN COLVILLE RIVER DELTA LOOKING UPSTREAM (SOUTH); MAY 25, 2011

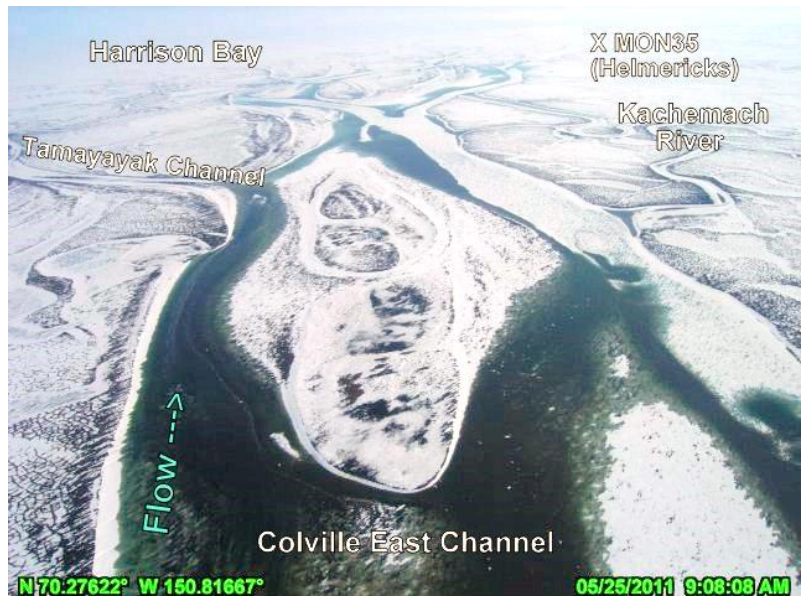
PHOTO 4.7: LEADING EDGE IN THE EAST CHANNEL, LOOKING DOWNSTREAM (NORTH); MAY 25, 2011

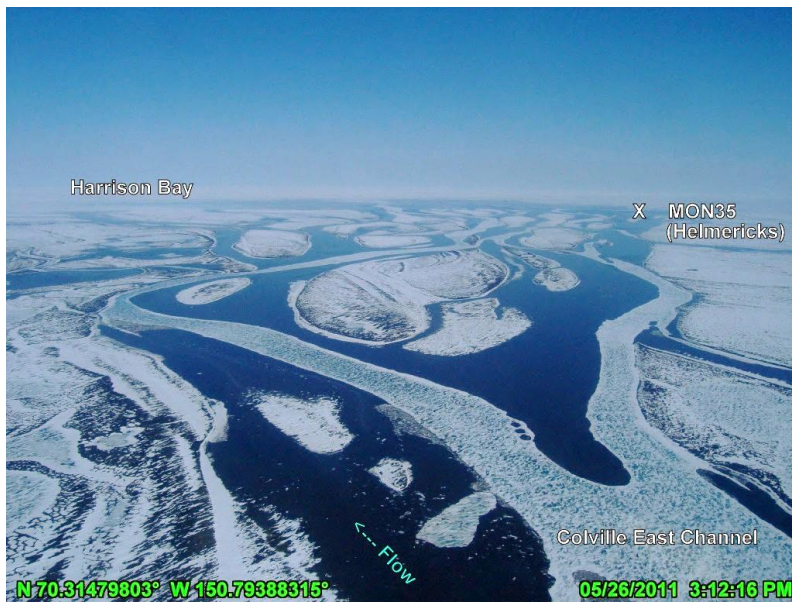
From May 25 through May 27, the stage continued to increase at a relatively constant rate for each of the East Channel monitoring sites; approximately 0.1 feet per hour at the MON1 and MON9 gages, and about 0.02 feet per hour at MON35. Ribbon ice was present in the channel. Occasional floes were seen but no ice jamming was observed between MON1 and MON35 (Photo 4.8 and Photo 4.9).

PHOTO 4.8: INTACT RIBBON ICE IN THE EAST CHANNEL LOOKING DOWNSTREAM (NORTH); MAY 26, 2011

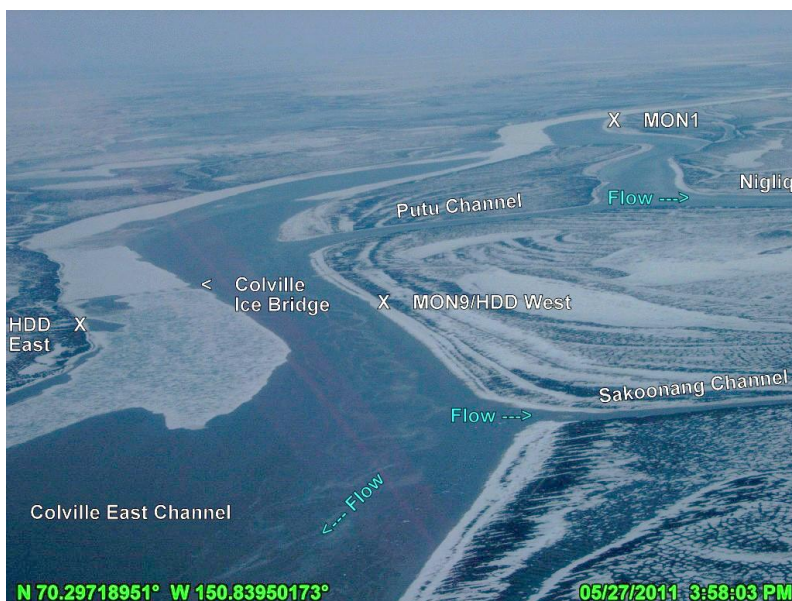
PHOTO 4.9: INTACT RIBBON ICE IN THE EAST CHANNEL LOOKING UPSTREAM (SOUTH); MAY 27, 2011

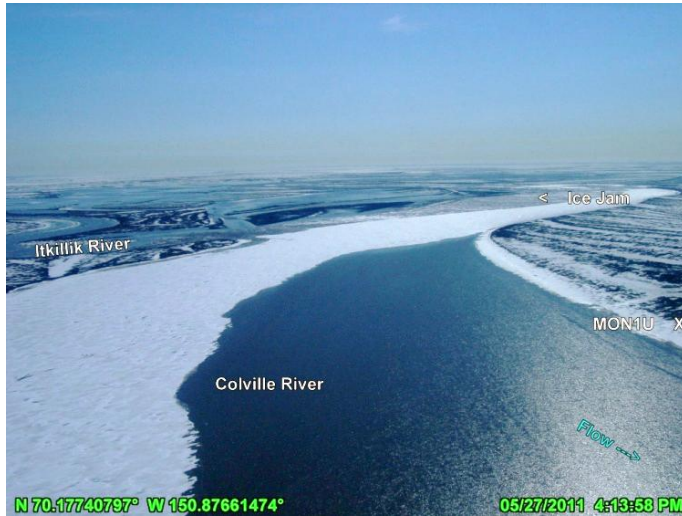
At midday on May 27, a major ice jam was observed upstream of MON1. This jam was probably responsible for the spike in WSE earlier in the day. The downstream edge of the jam was forming on ribbon ice that spanned the channel from the left (west) bank to the right (east) bank at the confluence of the Itkillik River (Photo 4.10). The upstream edge of the jam was approximately nine RM from MON1, and significant flow had backed upstream of the CRD (Photo 4.11). Downstream channels were flowing at less than bankfull stage.

PHOTO 4.10: MAJOR ICE JAM CAUGHT ON CROSS-CHANNEL ICE AT MOUTH OF ITKILLIK RIVER UPSTREAM OF MON1, LOOKING UPSTREAM (SOUTH); MAY 27, 2011

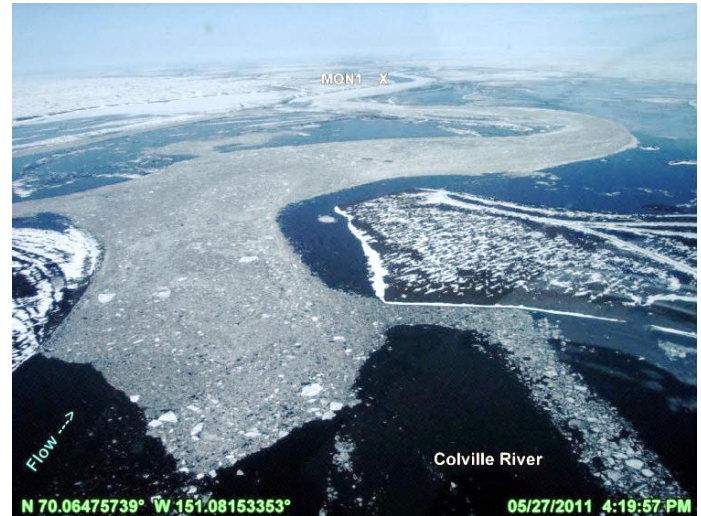
PHOTO 4.11: MAJOR ICE JAM UPSTREAM OF MON1, UPSTREAM EDGE, LOOKING DOWNSTREAM (NORTH); MAY 27, 2011

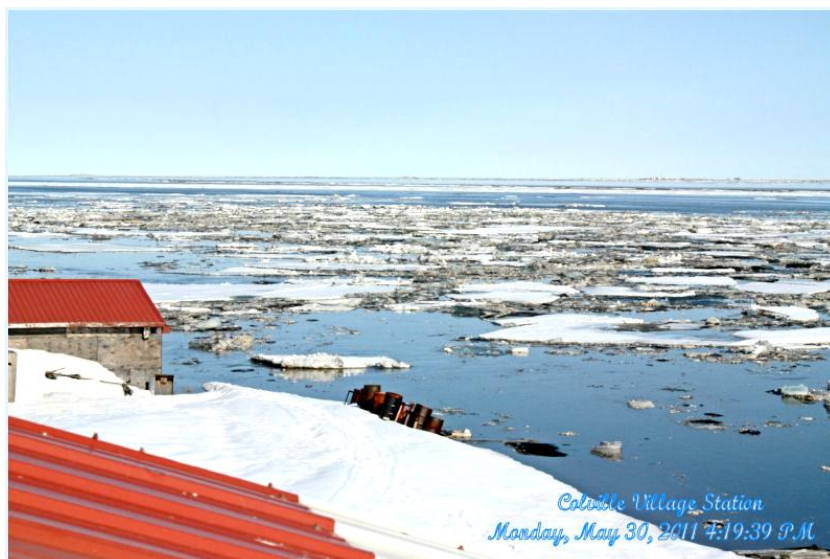
on May 29, the MON9 PT recorded the passing of the surge of water with a peak WSE of 12.02 feet BPMSL. The majority of the floes jammed again downstream of the entrance to the Tamayayak on May 29 (Photo 4.13) and, later, floes associated with the release of this jam were observed at MON35 at around mid-day on May 30 (Photo 4.14).

PHOTO 4.14: FLOES IN THE VICINITY OF MON35 (HELMERICKS), REMAINDER OF EAST CHANNEL ICE JAM, LOOKING DOWNSTREAM (PHOTO PROVIDED BY JIM HELMERICKS); MAY 30, 2011

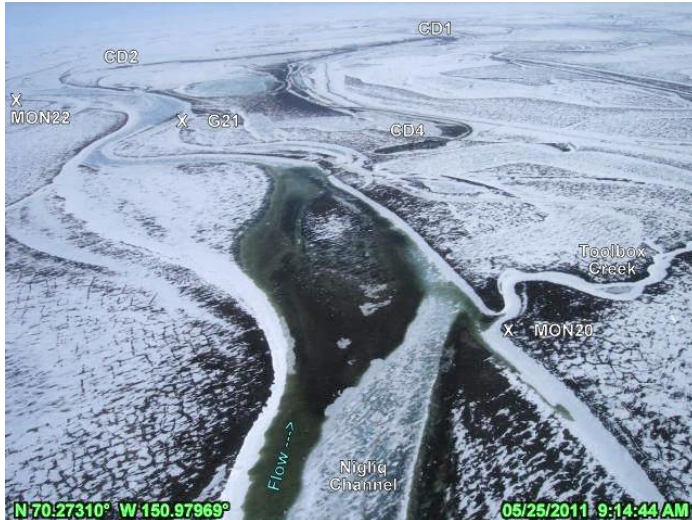
Early in the morning on May 25, the leading edge had entered the Nigliq (Photo 4.15). By approximately 5:15 p.m., the leading edge had reached MON28, the farthest downstream gage in the Nigliq Channel (Photo 4.16).

PHOTO 4.15: A.M.—LEADING EDGE IN NIGLIQ CHANNEL IN THE VICINITY OF CD4, LOOKING DOWNSTREAM (NORTH); MAY 25, 2011

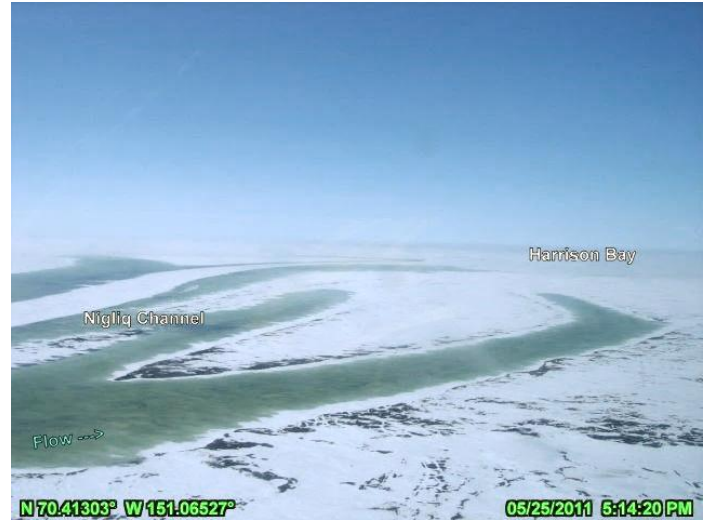
PHOTO 4.16: P.M.—LEADING EDGE IN NIGLIQ CHANNEL IN THE VICINITY OF MON28, LOOKING DOWNSTREAM (NORTH); MAY 25, 2011

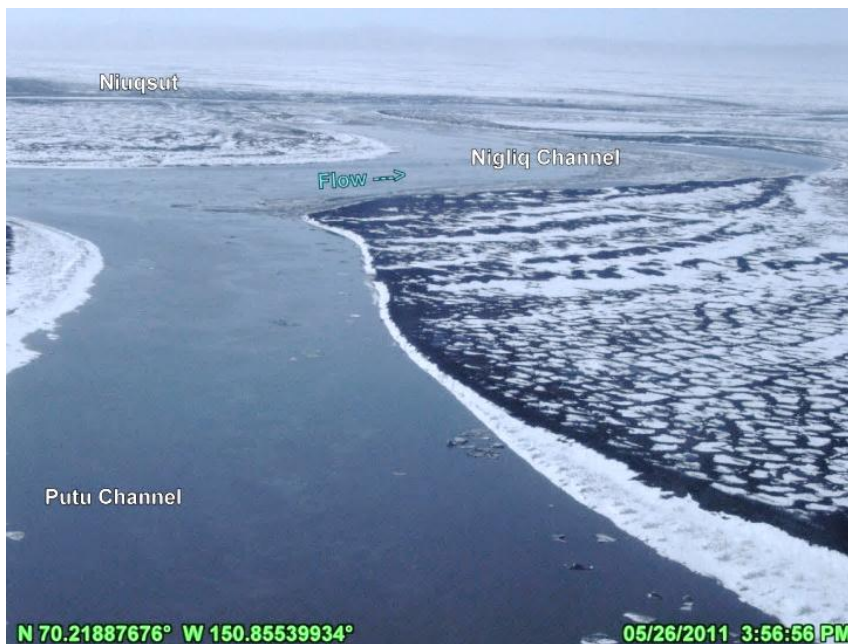
PHOTO 4.17: NIGLIQ CHANNEL NEAR NUIQSUT, LOOKING DOWNSTREAM (WEST); MAY 26, 2011

On May 26, stage continued to rise in the Nigliq Channel and most of the channel ice remained intact. Ribbon ice was intact throughout the majority of the channel from upstream of MON20 to MON28. There were no ice jams near facilities, and the Colville-Nigliq bifurcation was mostly clear of ice (Photo 4.17), although there were some rafted floes. Channel ice was observed breaking up in the vicinity of Nuiqsut, likely the result of the ice jam activity upstream of MON1.

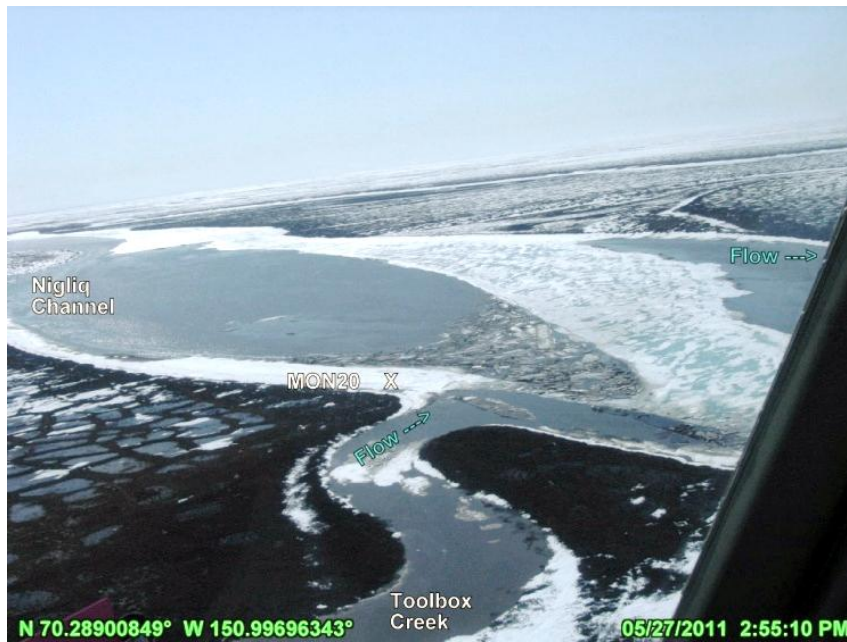
floes were observed, and some had begun to catch behind channel ice that spanned from the left (west) to the right (east) bank of the Nigliq at MON20, as seen in Photo 4.18. By 1:00 p.m., WSE were high enough to reach the lowest gages at each Nigliq Channel monitoring location (Table 4.5 through Table 4.8). By the

PHOTO 4.18: FLOES BEGINNING TO JAM ON INTACT CHANNEL ICE NEAR MON20, LOOKING UPSTREAM (SOUTHWEST); MAY 27, 2011

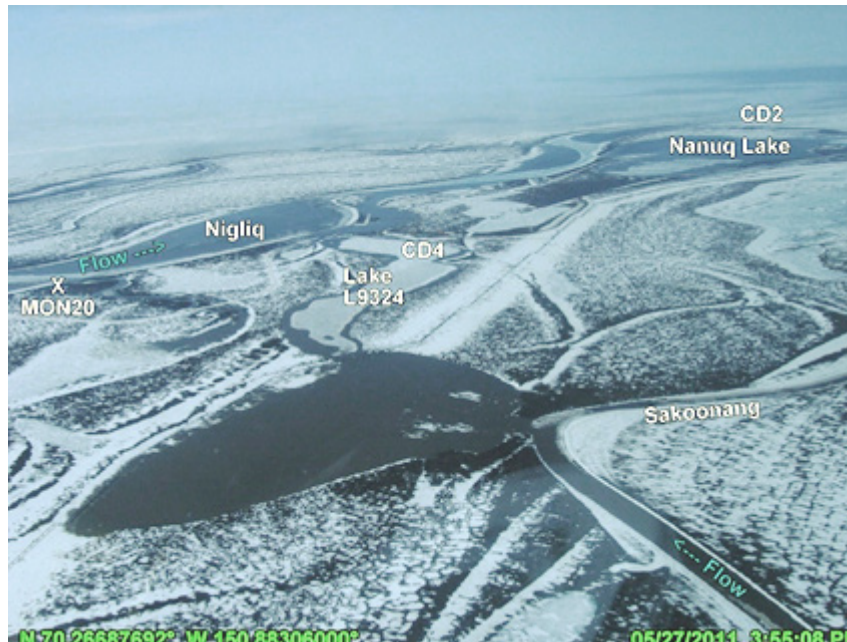
afternoon of the May 27, flow from the Sakoonang was observed entering the Nigliq Channel via Lake L9324, and Nanuq Lake was recharging (Photo 4.19).

PHOTO 4.19: FLOW ENTERING NIGLIQ FROM SAKOONANG VIA LAKE L9324; NIGLIQ RECHARGING NANUQ LAKE, LOOKING DOWNSTREAM (NORTH); MAY 27, 2011

Flow entering the Sakoongang from the East Channel had diverted into an unnamed swale southeast of CD4 and was passing under the pipeline into the Nigliq Channel via Lake L9324 (Photo 4.19). The swale bridges, which pass the majority of the flow through the CD2 road prism, were passing floodwaters downstream (north) from Lake M9524, which was being recharged from the Nigliq Channel via Nanuq Lake.

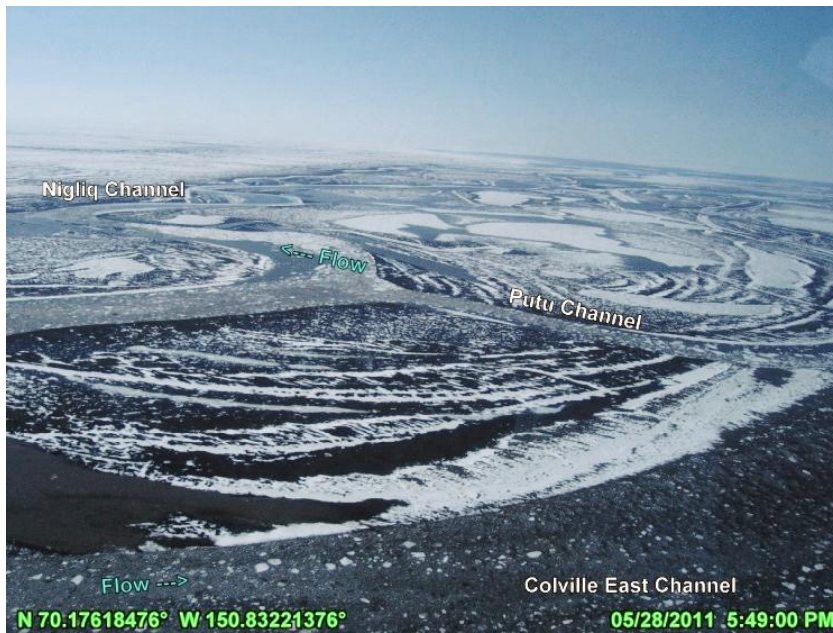
A major ice jam located at the head of the delta (MON1), approximately two RM upstream of the East Channel-Nigliq bifurcation, released on the afternoon of May 28. Some floes diverted into the Nigliq Channel (Photo 4.20), jamming on intact ribbon ice near Nuiqsut. The small surge of flow that passed by Nuiqsut slowly advanced down the Nigliq Channel and was recorded later in the evening by the G21PT. A spike in the G21 hydrograph can be seen at approximately 6:00 p.m. (Table 4.18). This spike in WSE is not evident in the hydrographs of other gage sites along the Nigliq Channel because, in 2011, PTs were only installed at the Nigliq monitoring locations that were associated with the proposed CD5 bridge crossing. Hydrographs for MON20, MON22, and MON23 are based on visual observations and, normally, visual observations are not conducted away from facilities between 6:00 p.m. and 6:00 a.m. In absence of a PT, spikes in WSE from ice jam releases may elude hydrographs that are based exclusively on visual observations. High-water marks can provide the WSE of hydrograph spikes, but the timing of such spikes must be estimated and these data alone are not always reliable.

PHOTO 4.20: ICE FLOES RESULTING FROM AN ICE JAM RELEASE UPSTREAM OF MON1 ENTERING THE NIGLIQ CHANNEL, LOOKING DOWNSTREAM; MAY 28, 2011

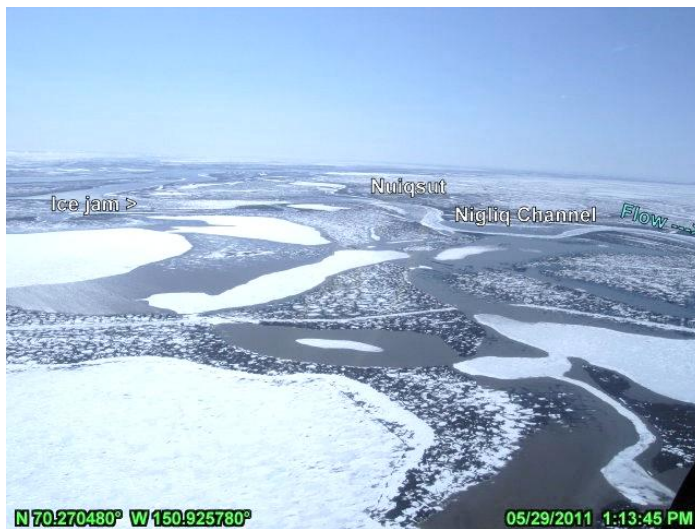
On May 29, WSE in the Nigliq Channel remained relatively unchanged. The floes diverted down the Nigliq Channel when the ice jam upstream of MON1 released on May 28 had not progressed downstream and were jamming on channel ice near Nuiqsut. As a result, water was diverting overland into Lake B8530 (Photo 4.21). Another effect of the ice jam was to reduce flood flow entering the Nigliq Channel, the majority instead passing through the East Channel. Ribbon ice, generally intact partially because of the relatively lower breakup flow, was still present downstream of Nuiqsut from MON20 to MON28 (Photo 4.22). Occasional floes in the channel were caught on cross-channel ice.

PHOTO 4.21: FLOES RELEASED FROM JAM UPSTREAM OF MON1 IN NIGLIQ NEAR NUIQSUT, LOOKING UPSTREAM (SOUTH); MAY 29, 2011

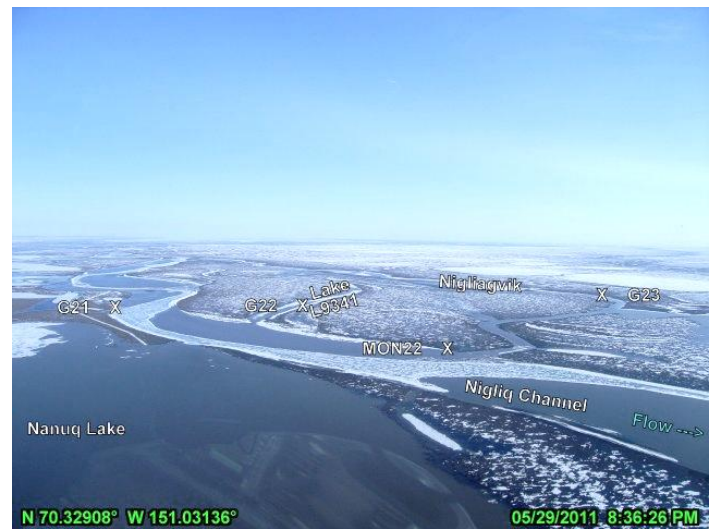
PHOTO 4.22: INTACT RIBBON ICE IN NIGLIQ CHANNEL FROM MON20 DOWNSTREAM, LOOKING UPSTREAM (SOUTHWEST); MAY 29, 2011

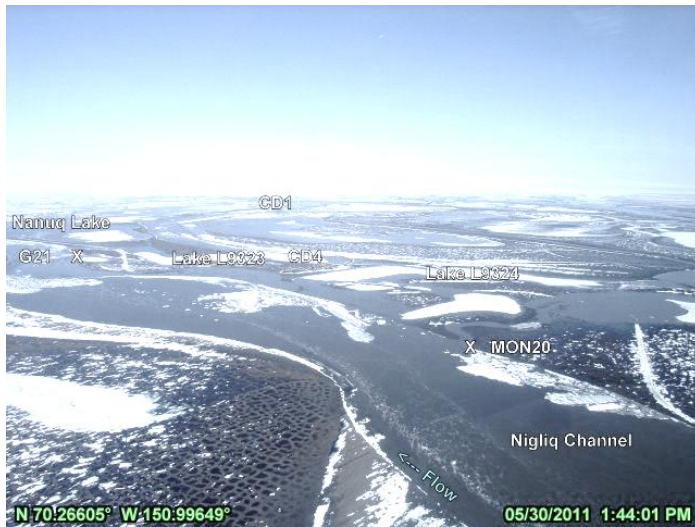
PHOTO 4.23: RIBBON ICE IN NIGLIQ CLEARED, OCCASIONAL FLOES REMAINING NEAR CD4, LOOKING DOWNSTREAM (NORTHEAST); MAY 30, 2011

Channel ice had mostly cleared in the vicinity of MON20, CD4, and Nuiqsut by midday on May 30, though some floes remained (Photo 4.23). Ribbon ice was still intact in the channel from MON22 downstream to MON28 and floes were jamming on channel ice in the vicinity of MON22 (Photo 4.24). Release of ice at this location was estimated to have occurred around 4:00 p.m., resulting in a peak WSE at MON22 of 8.97 feet BPMSL based on a HWM on the gage (Table 4.6). As the surge of water continued to progress downstream, a peak WSE of 8.15 feet BPMSL at MON23 was estimated to have happened four hours later, at around 8:00

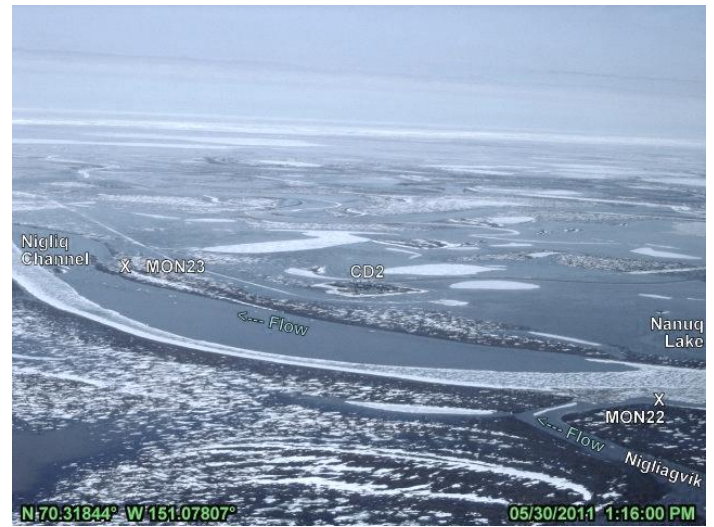
PHOTO 4.24: RIBBON ICE NEAR MON23 AND CD2, FLOES JAMMED ON CROSS-CHANNEL ICE AT MON22, LOOKING DOWNSTREAM (NORTHEAST); MAY 30, 2011

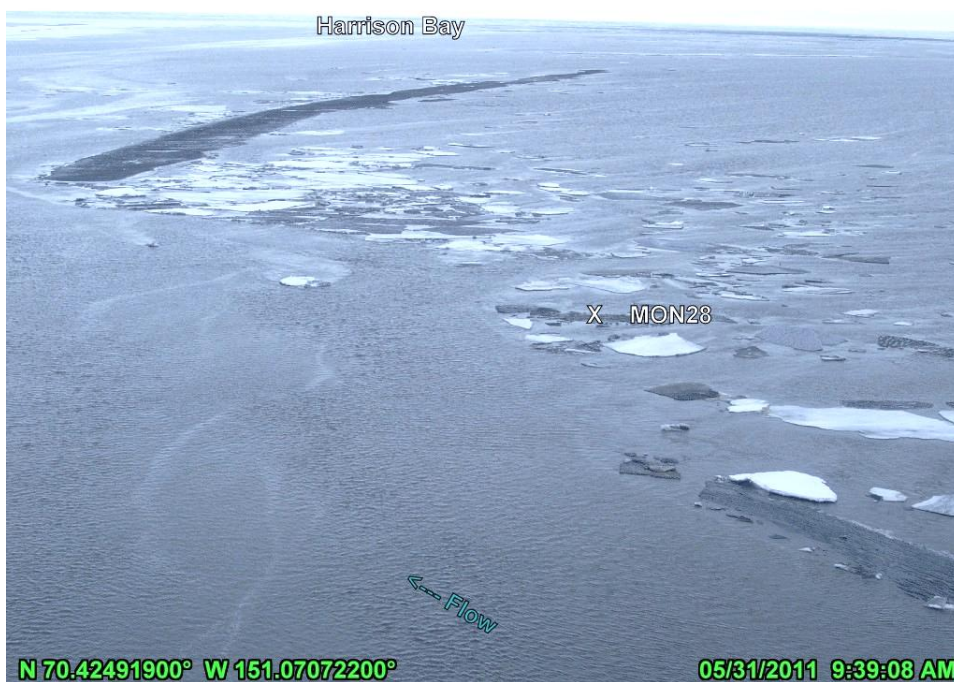
After May 30, WSE in the Nigliq Channel steadily decreased as ice in the channel progressively moved to MON28 (Photo 4.25). By the end of the day on May 31, monitoring of the Nigliq ended.

PHOTO 4.25: FLOES IN THE NIGLIQ CHANNEL AT MON28; MAY 31, 2011

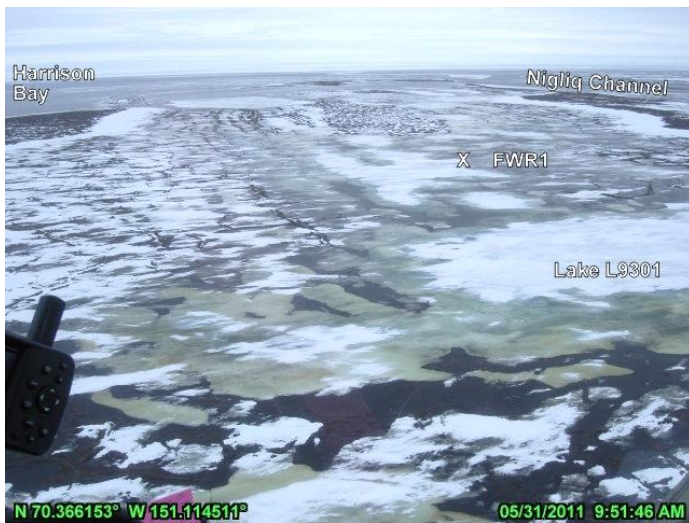
Spring breakup at both FWR1 and FWR2 was characterized by quick, and then slower, snow-melt into pools of standing water. There was no channelized hydraulic connection observed between Lake L9301 and the ponded areas to the northwest (FWR1) or southwest (FWR2) and there were no measureable velocities in the vicinity of either gage location during spring breakup monitoring. Photo 4.26 and Photo 4.27 show FWR1 during peak stage and Photo 4.28 and Photo 4.29 show FWR2 during peak stage.

PHOTO 4.26: FWR1 MONITORING LOCATION DURING PEAK STAGE, LOOKING NORTH; MAY 31, 2011

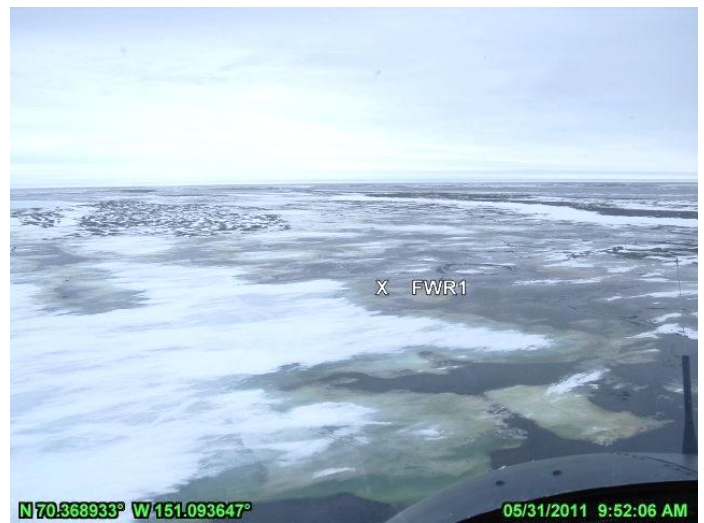
PHOTO 4.27: FWR1 DURING PEAK STAGE, NO EVIDENCE OF CHANNELIZED FLOW OBSERVED, LOOKING NORTH; MAY 31, 2011

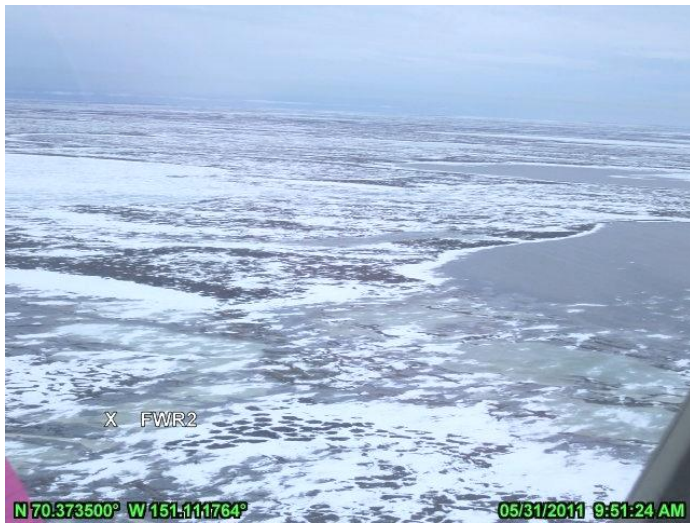
PHOTO 4.28: FWR2 MONITORING LOCATION DURING PEAK STAGE, LOOKING SOUTHWEST; MAY 31, 2011

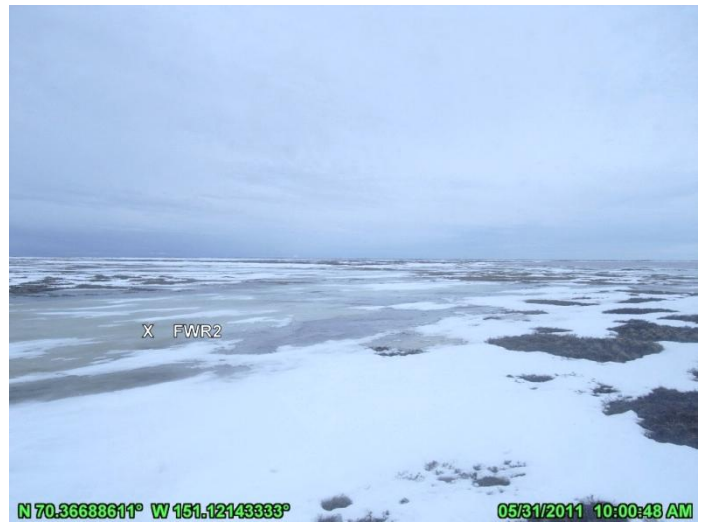
PHOTO 4.29: FWR2 DURING PEAK STAGE, NO EVIDENCE OF CHANNELIZED FLOW OBSERVED, LOOKING SOUTHWEST; MAY 31, 2011.

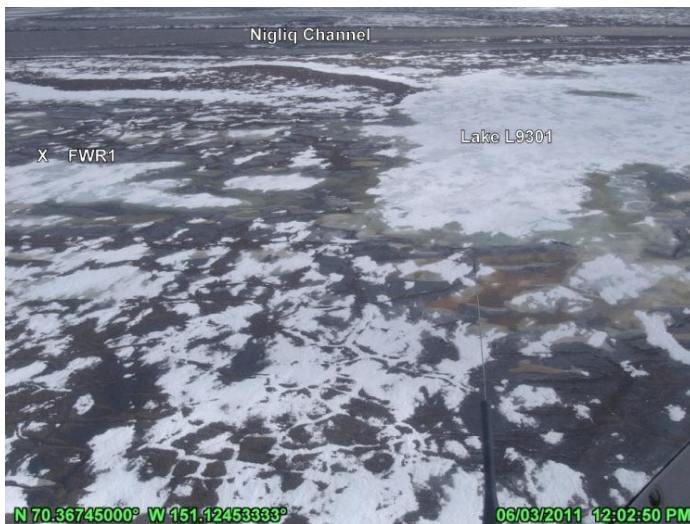
WSE and peak stage data are considered to be the result of local melt and overland sheet flow and, therefore, hydrographs for these monitoring locations were not included in this report. Photo 4.30 and Photo 4.31 show FWR1 and FWR2, respectively, during the final field observation for these locations.

PHOTO 4.30: FWR1 AREA AS MONITORING IS DISCONTINUED, LOOKING EAST; JUNE 3, 2011

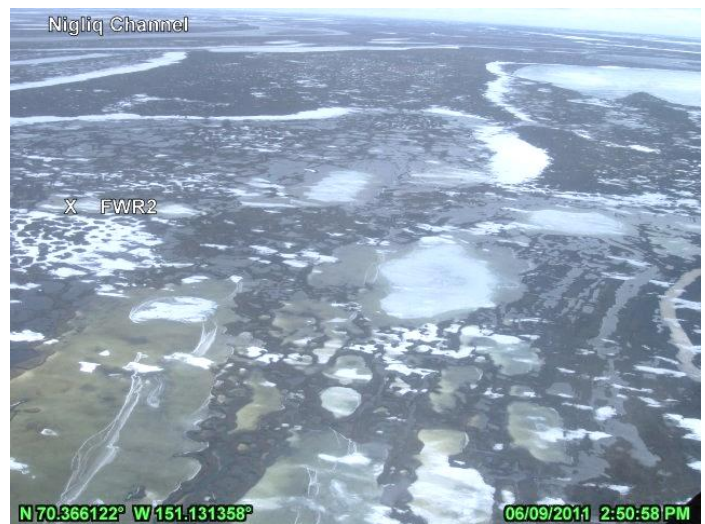
PHOTO 4.31: FWR2 AREA AS MONITORING IS DISCONTINUED, LOOKING SOUTH; JUNE 9, 2011

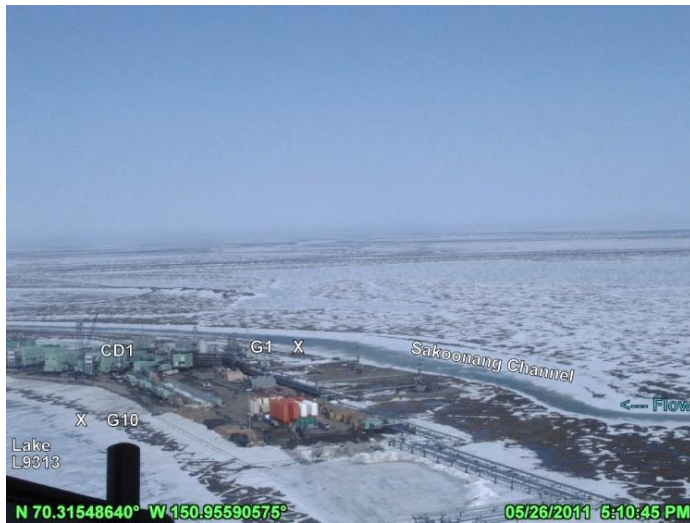
PHOTO 4.32: LOCAL MELT IN SAKOONGANG NEAR CD1, LOOKING UPSTREAM (NORTHEAST); MAY 26, 2011

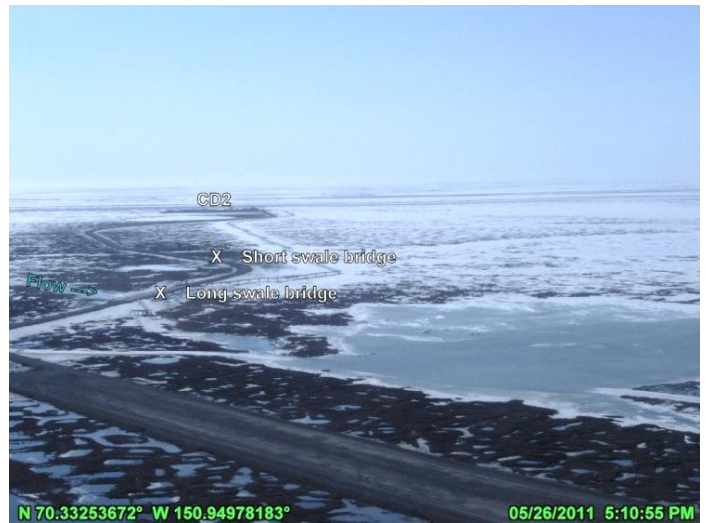
PHOTO 4.33: LOCAL MELT NEAR CD2 ROAD ACCESS STRUCTURES, LOOKING WEST; MAY 26, 2011

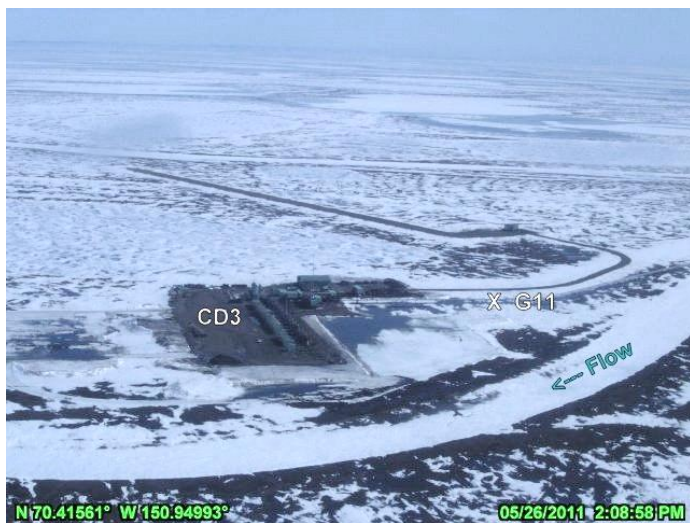
PHOTO 4.34: LOCAL MELT NEAR CD3 FACILITIES, LOOKING EAST; MAY 26, 2011

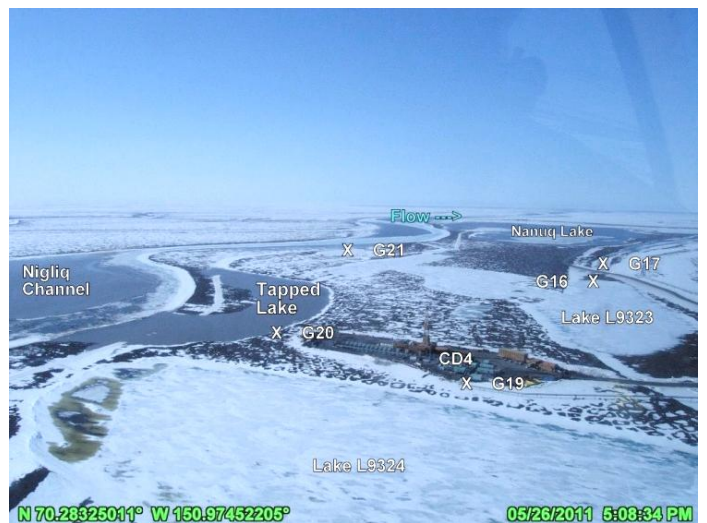
PHOTO 4.35: TAPPED LAKE AND NANUQ LAKE RECHARGING FROM NIGLIQ, LOOKING NORTHEAST; MAY 26, 2011

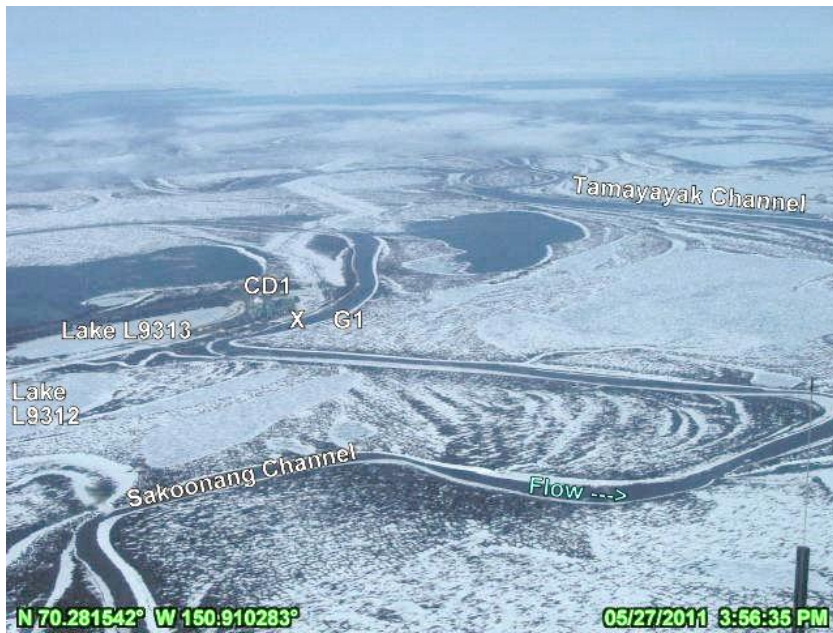
PHOTO 4.36: FLOW IN SAKOONGANG CHANNEL NEAR CD1, LOOKING DOWNSTREAM (NORTH); MAY 27, 2011

On May 27, flow in the Sakoongang reached Alpine facilities (Photo 4.36) and water was flowing through the swale bridges (G3 and G4) (Photo 4.37). The flow in the Sakoongang at G1 was still backwater from the Tamayayak, and this phenomenon can be seen in the hydrograph in Table 4.9.

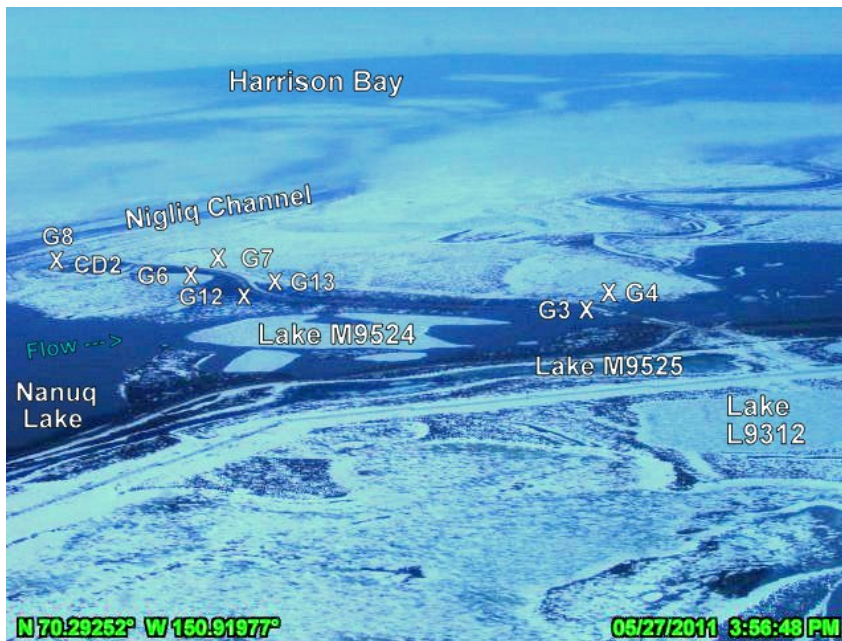
PHOTO 4.37: FLOW THROUGH CD2 ROAD SWALE BRIDGES FROM LAKE M9524 VIA NANUQ LAKE, LOOKING DOWNSTREAM (NORTH); MAY 27, 2011

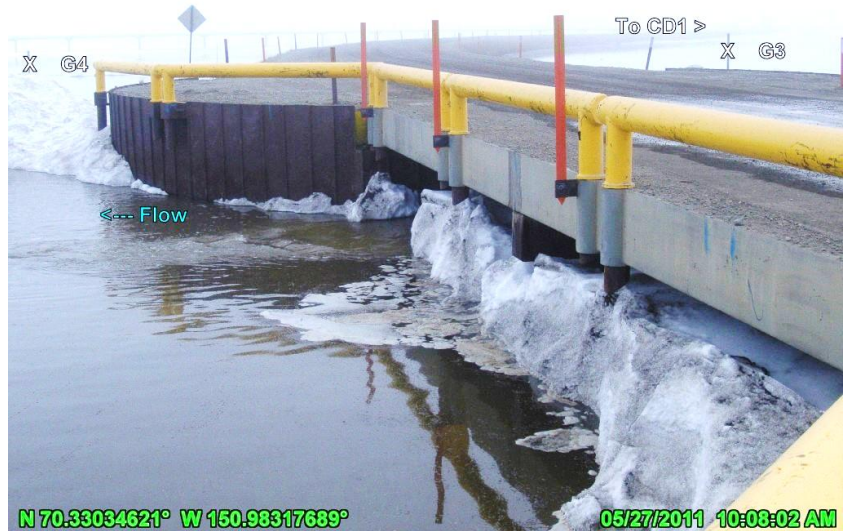
On May 27, water depth at the short swale bridge was about 2.5 feet and there was snow blocking the majority of flow underneath on the downstream side of the bridge (Photo 4.38). The long swale bridge also had some blockage on the downstream side of the bridge (Photo 4.39). Flood stage had risen sufficiently to pass flow through some culverts near the swale bridges. The hydrograph for G3 and G4 is included in Table 4.10.

PHOTO 4.38: INITIAL FLOW THROUGH THE 62-FOOT SWALE BRIDGE, SNOW BLOCKAGE ON DOWNSTREAM (NORTH) SIDE, LOOKING EAST; MAY 27, 2011

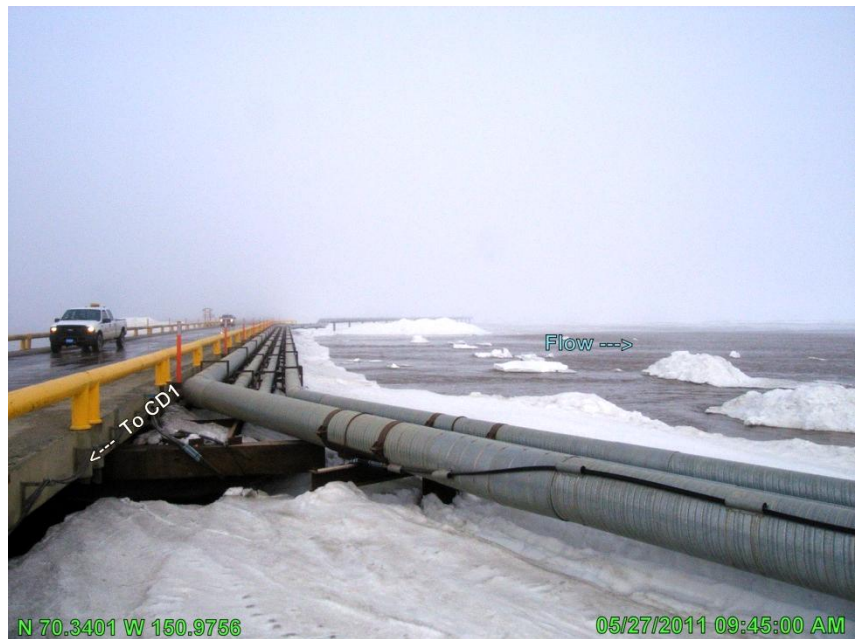
PHOTO 4.39: FLOW THROUGH THE 452-FOOT SWALE BRIDGE, SOME SNOW BLOCKAGE ON DOWNSTREAM (NORTH) SIDE, LOOKING WEST; MAY 27, 2011

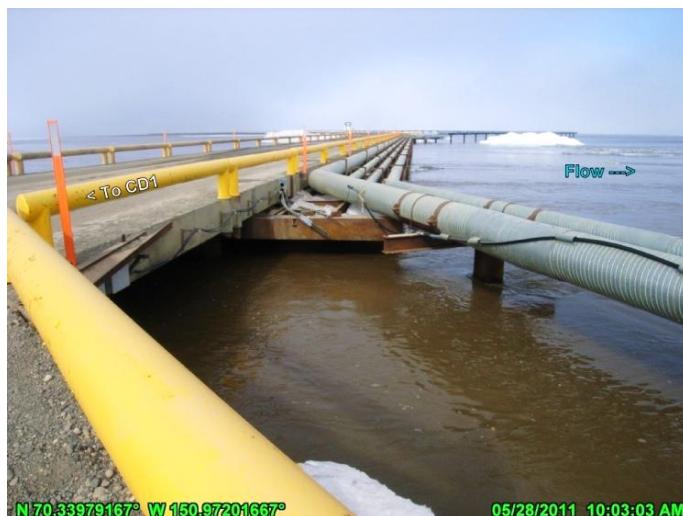
PHOTO 4.41: FLOW PASSING UNIMPEDED BY SNOW THROUGH THE 452-FOOT SWALE BRIDGE, DOWNSTREAM (NORTH) LOOKING EAST; MAY 28, 2011

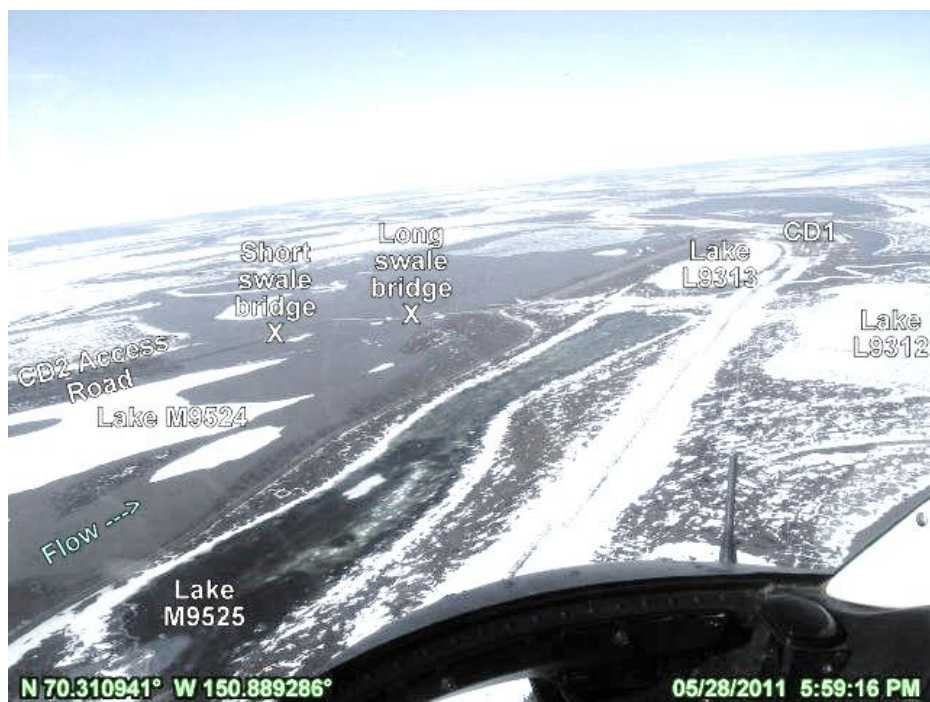
The Sakoonang was flowing downstream past G1 in the morning of May 28 and the majority of the small ice jams had cleared, though some snow was observed in the shallower portions of the channel. Floes entered the Sakoonang later in the evening as the result of an ice jam release upstream of MON1. Both swale bridges were generally clear of snow by the morning of May 28 (Photo 4.40 and Photo 4.41); flow had reached and was passing through all culverts near the remaining CD2 road gages (G6-G7 and G12-G13). Hydrographs for G6-G7 and G12-G13 are included in Table 4.11 and Table 4.13, respectively. Photo 4.42 shows flow through facilities on May 28.

PHOTO 4.42: FLOW THROUGH CD2 ROAD DRAINAGE STRUCTURES, AND FLOW IN THE SAKOONANG DOWNSTREAM PAST CD1, LOOKING DOWNSTREAM (NORTH); MAY 28, 2011

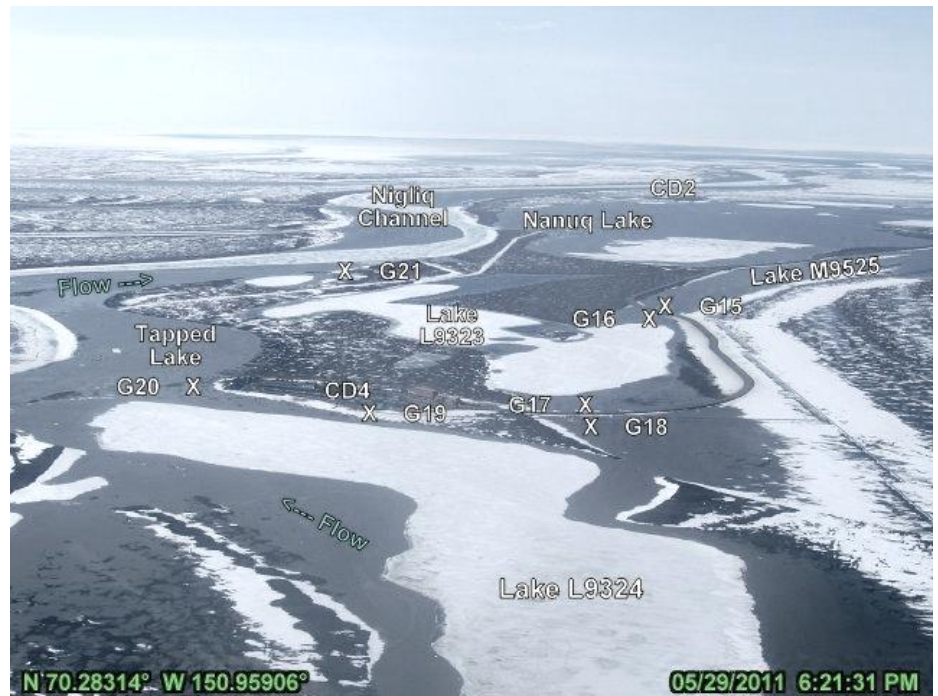
By May 29, floodwaters had progressed closer to facilities, and Lakes M9525, L9323, and L9324 became hydraulically connected (Photo 4.43). Lake M9525 was receiving floodwaters from Sagoonang overflow under the pipeline from the east and was hydraulically connected to Lake L9313 to the northeast (Photo 4.44). Lake L9324 was also receiving floodwaters from Sagoonang overflow under the pipeline from the southeast and was hydraulically connected to the Nigliq Channel to the northwest (Photo 4.45). By this time, flood flow was passing through the CD4 road culverts near G15-G16 between Lakes M9525 to the north and L9323 to the south and G17-G18 between Lakes L9323 to the north and L9324 to the south by May 29. The hydrograph for G15-G16 and G17-G18 is provided in Table 4.14.

PHOTO 4.43: HYDRAULIC CONNECTION BETWEEN LAKES M9525, L9323, AND L9324, LOOKING NORTH; MAY 29, 2011

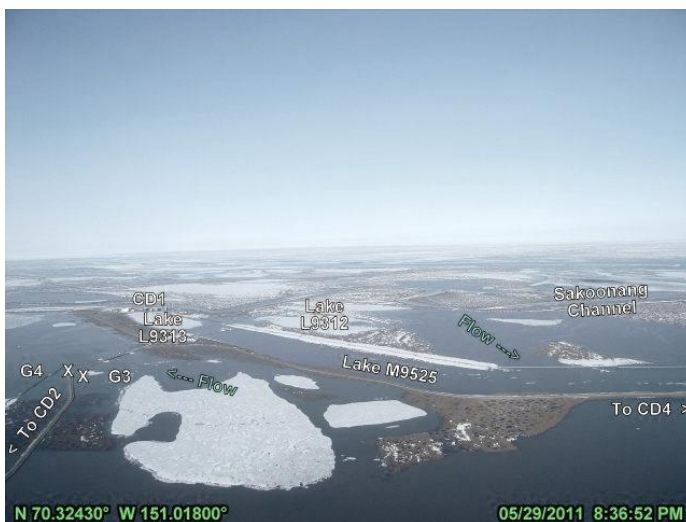
PHOTO 4.44: HYDRAULIC CONNECTION BETWEEN THE SAGOONANG, LAKE M9525, AND LAKE L9313, LOOKING EAST; MAY 29, 2011

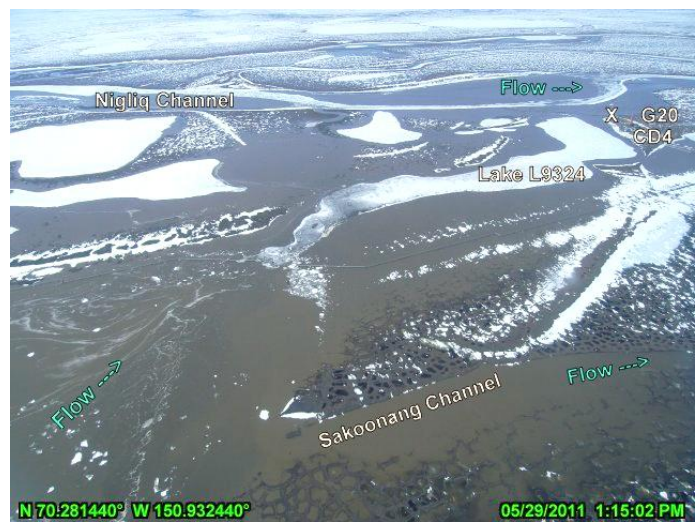
PHOTO 4.45: HYDRAULIC CONNECTION BETWEEN THE SAGOONANG, LAKE L9324, AND THE NIGLIQ, LOOKING WEST; MAY 29, 2011

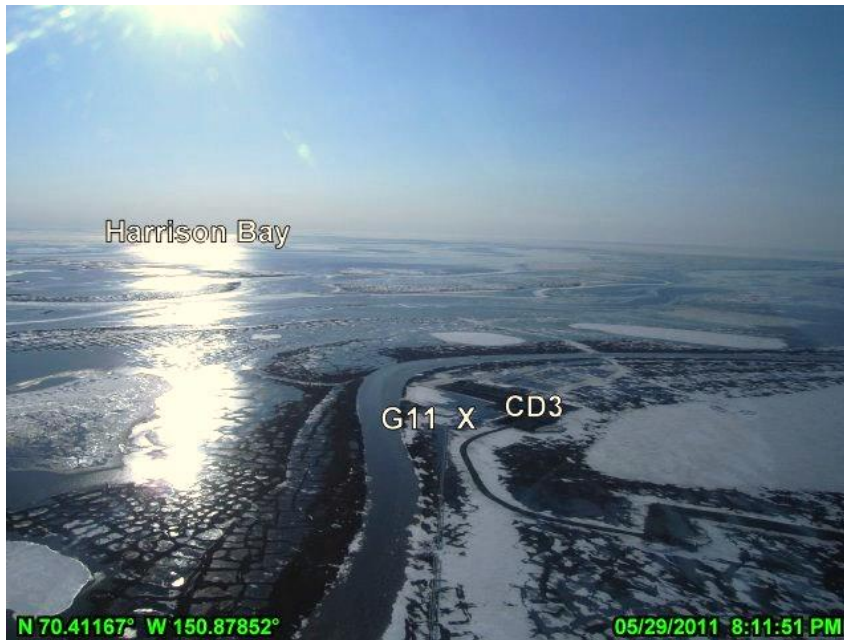
PHOTO 4.46: FLOW THROUGH CHANNEL WEST OF CD3, LOOKING DOWNSTREAM (NORTH); MAY 29, 2011

Flow had entered the channel west of CD3 from the Ulamnigiq by May 29, though stage was not high enough to reach G11 (Photo 4.46). The hydrograph for G11 is presented in Table 4.12.
