Colville River Delta

ConocoPhillips
Alaska

Colville River Delta Spring Breakup 2011 Hydrologic Assessment

January 2012

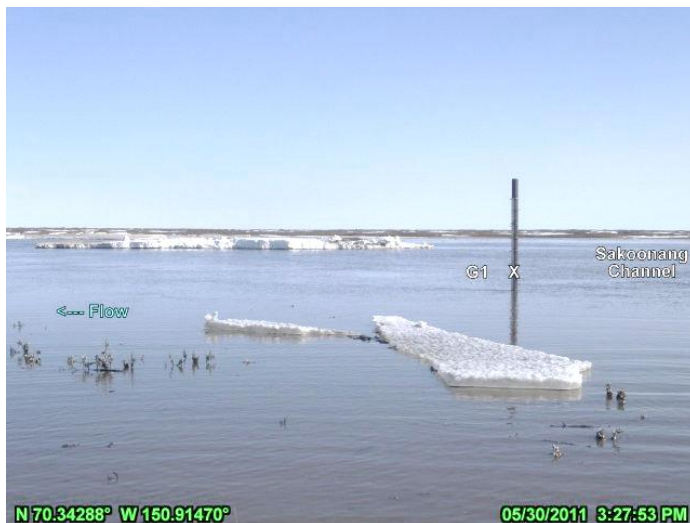
Based on a HWM and observation of nearby facilities, peak stage at CD1 (G1) was 9.33 feet BPMSL and is estimated to have occurred on the morning of May 30. Occasional ice

floes were in the vicinity of G1 at this time (Photo 4.47); the Sakoongang was clear by June 1. Photo 4.48 shows CD1 facilities and nearby pipelines and roads on May 30.

PHOTO 4.47: G1 IN THE SAKOONGANG OFF CD1 AFTER PEAK STAGE, LOOKING EAST; MAY 30, 2011

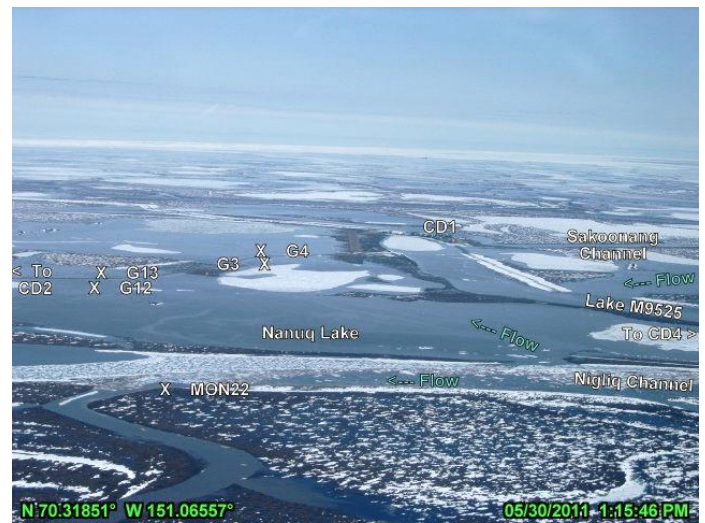
PHOTO 4.48: CD1, CD2, AND CD4 ROADS AFTER PEAK STAGE, LOOKING EAST; MAY 30, 2011.

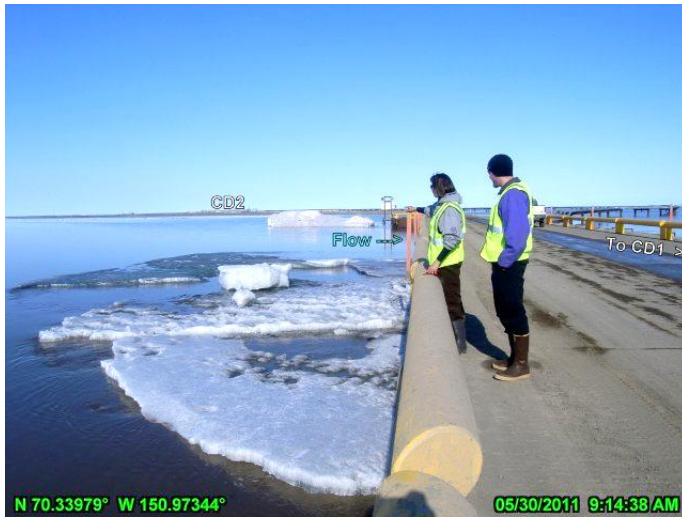
PHOTO 4.49: UPSTREAM (SOUTH) SIDE OF LONG SWALE BRIDGE AFTER PEAK STAGE, LOOKING WEST; MAY 30, 2011

Based on a HWM, WSE at G3 and G4 near the swale bridges peaked sometime at night on May 30. Peak stage at G3 and G4 was 8.89 and 8.59 feet BPMSL, respectively. Photo 4.49 and Photo 4.50 show the long and short swale bridge correspondingly, on May 30, just after peak stage. Ponded water was present under the short swale bridge on May 31 and was observed passing under the long swale bridge until observations were ended on June 1. The remaining gages near G12-G13 and G6-G7 showed a similar rise of floodwater, all peaking at around midnight on May 30. Photo 4.51 shows G13 just after peak stage. Photo 4.52 and Photo 4.53 show the culverts near G6 and G7, respectively, on May 30. Stage at these CD2 road

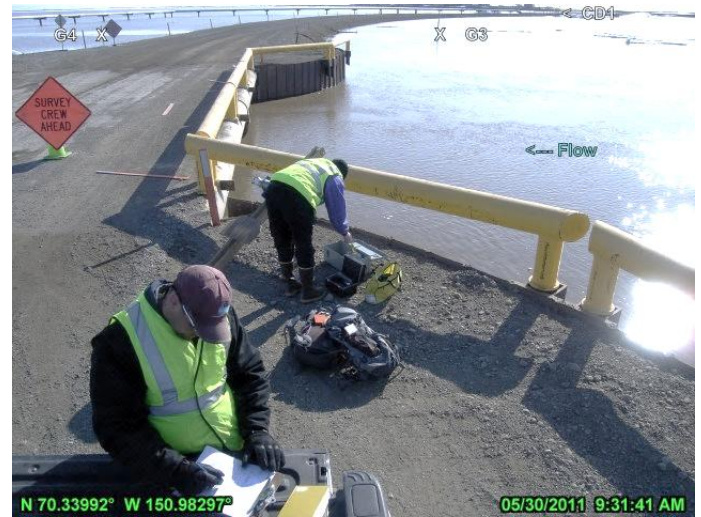
PHOTO 4.50: UPSTREAM (SOUTH) SIDE OF SHORT SWALE BRIDGE AFTER PEAK STAGE, LOOKING EAST; MAY 30, 2011

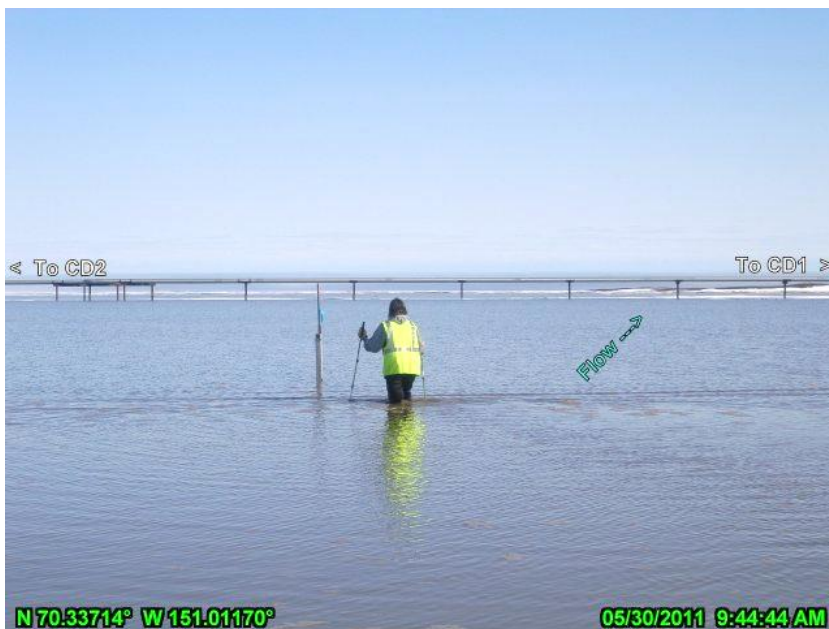
PHOTO 4.51: G13 ON THE DOWNSTREAM (NORTH) SIDE OF CD2 ROAD AFTER PEAK STAGE, LOOKING DOWNSTREAM; MAY 30, 2011

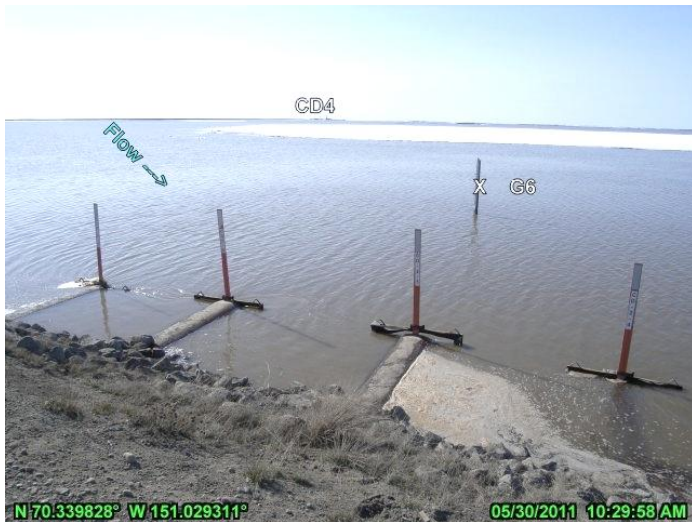
PHOTO 4.52: CD2 ROAD CULVERTS NEAR G6 PASSING FLOW AFTER PEAK STAGE, LOOKING UPSTREAM (SOUTH); MAY 30, 2011

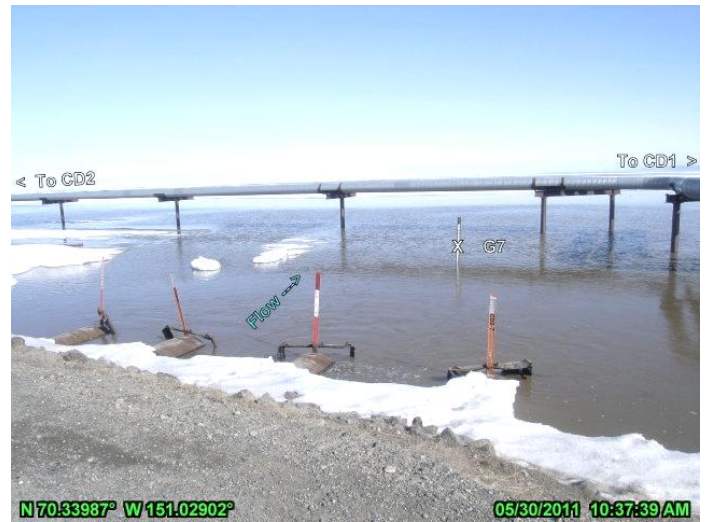
PHOTO 4.53: CD2 ROAD CULVERTS NEAR G7 PASSING FLOW AFTER PEAK STAGE, LOOKING DOWNSTREAM (NORTH); MAY 30, 2011

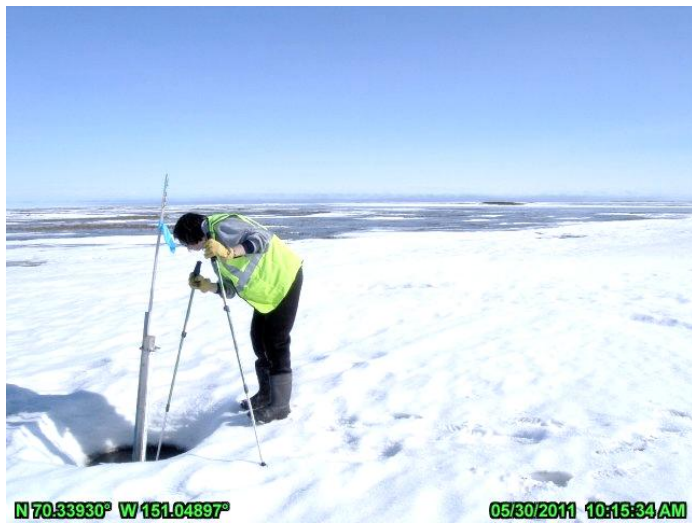
Floodwaters did not reach G8 on the west side of CD2 pad in 2011 (Photo 4.54), as a result no hydrograph was generated. During peak stage, floodwater did pass in the vicinity of the east, west, and south sides of the CD2 pad via the road drainage structures, Nigliq Channel, and Nanuq Lake (Photo 4.55).

PHOTO 4.54: NO EVIDENCE OF BREAKUP FLOOD FLOW IN THE VICINITY OF G8 ON THE WEST SIDE OF CD2 PAD, LOOKING NORTH; MAY 30, 2011

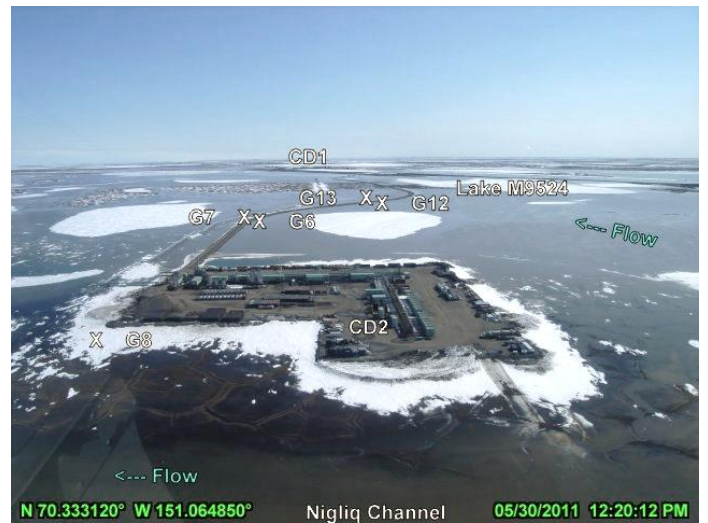
PHOTO 4.55: CD2 PAD AFTER PEAK STAGE, LOOKING EAST; MAY 30, 2011

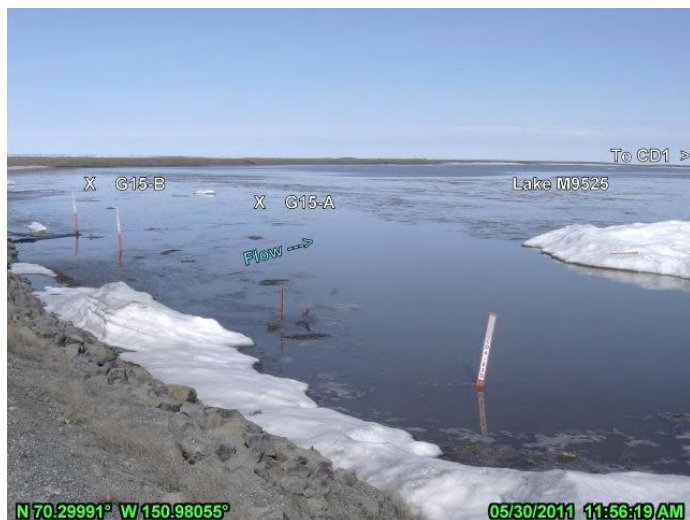
Relatively little spring breakup flow passed through the CD4 road culverts in 2011, due in part to topography and the impacts of ice on the flow characteristics of water through the CRD. Based on HWMs, stage at G15 and G16 probably peaked at around midnight on May 30, at 10.71 and 10.82 feet BPMSL, respectively. WSE at G17 also peaked around this time, at 12.12 feet BPMSL, and G18 peaked in the late afternoon on May 29, at 12.84 feet BPMSL. Photo 4.57 and Photo 4.58 show the culverts in the vicinity of G15 and G16, respectively, just after peak stage. Photo 4.59 and Photo 4.60 show the culverts in the vicinity of G17 and G18, respectively, just after peak stage.

PHOTO 4.57: CD4 ROAD CULVERTS IN THE VICINITY OF G15 (LAKE M9525) AFTER PEAK STAGE, LOOKING NORTHEAST; MAY 30, 2011

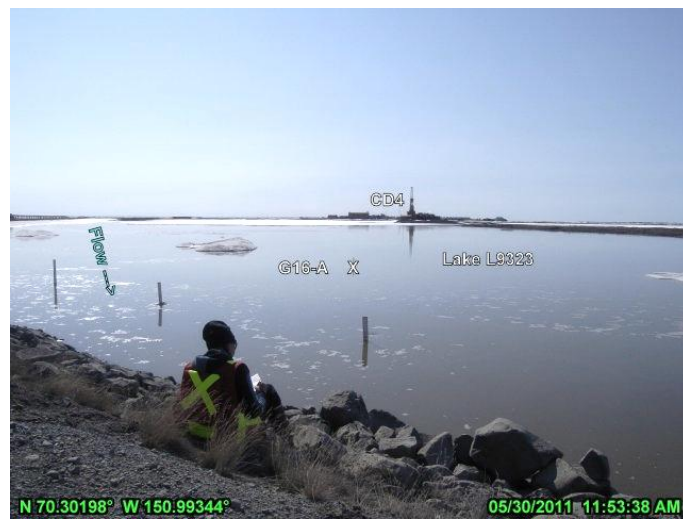
PHOTO 4.58: CD4 ROAD CULVERTS IN THE VICINITY OF G16 (LAKE L9323) AFTER PEAK STAGE, LOOKING SOUTHWEST; MAY 30, 2011

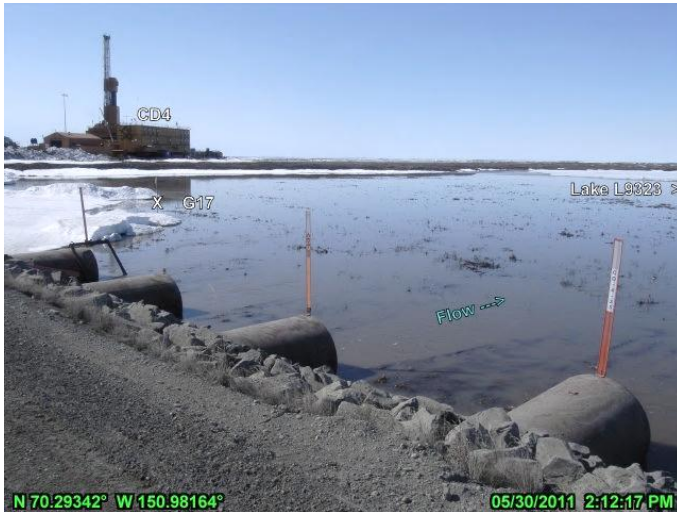
PHOTO 4.59: CD4 ROAD CULVERTS IN THE VICINITY OF G17 (LAKE L9323) AFTER PEAK STAGE, LOOKING EAST; MAY 30, 2011

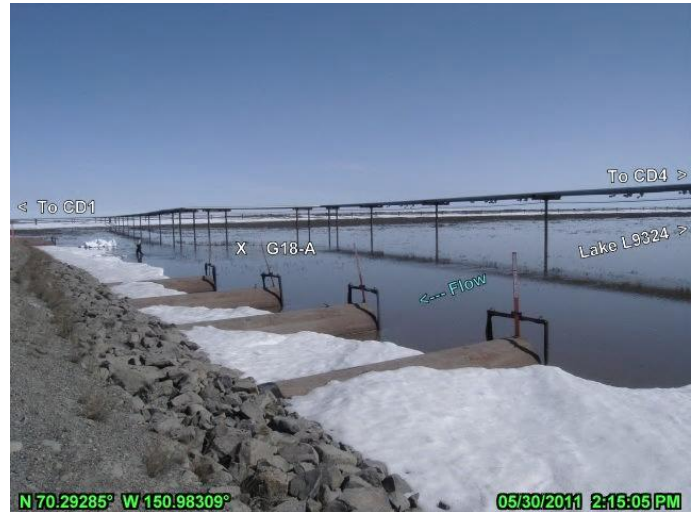
PHOTO 4.60: CD4 ROAD CULVERTS IN THE VICINITY OF G18 (LAKE L9324) AFTER PEAK STAGE, LOOKING WEST; MAY 30, 2011

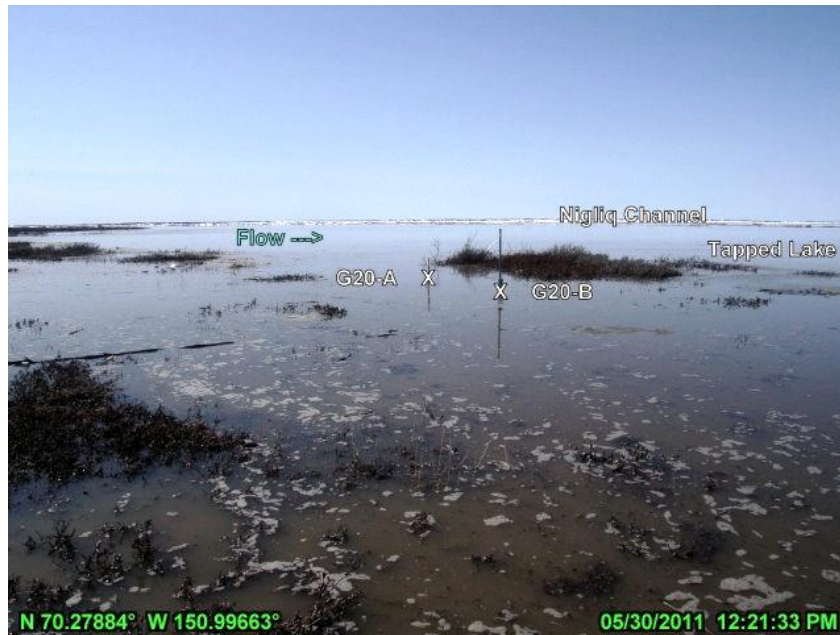
PHOTO 4.61: G20 ON THE WEST SIDE OF CD4 PAD ADJACENT TO TAPPED LAKE AFTER PEAK STAGE; MAY 30, 2011

Based on a HWM, peak stage at G20 on the west side of CD2 pad was estimated to have occurred in the morning of May 30, with a maximum WSE of 10.64 feet BPMSL. Shortly after peak WSE, stage fell sharply until June 1, when monitoring ceased for this location. No grounded ice was observed in the vicinity of G20 following breakup (Photo 4.61).

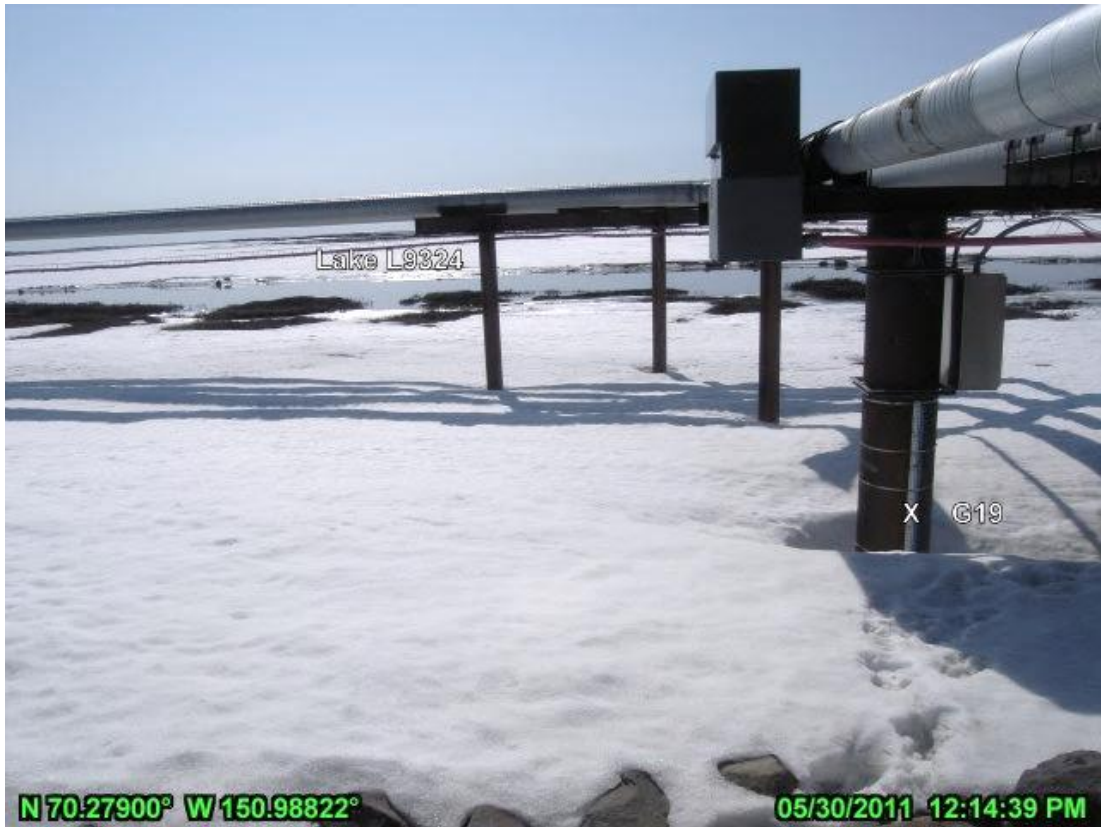
The 2011 spring breakup floodwaters did not increase enough to reach G19 on the south side of the CD4 pad (Photo 4.62) and, as a result, a hydrograph was not generated. Flood flow did pass on the west, east, and south sides of the pad through Lake L9324 into the Nigliq Channel via Tapped Lake and into Lake L9323 (Photo 4.63).

PHOTO 4.62: NO EVIDENCE OF BREAKUP FLOOD FLOW IN THE VICINITY OF G19 ON THE SOUTH SIDE OF CD4 PAD, LOOKING SOUTH; MAY 30, 2011

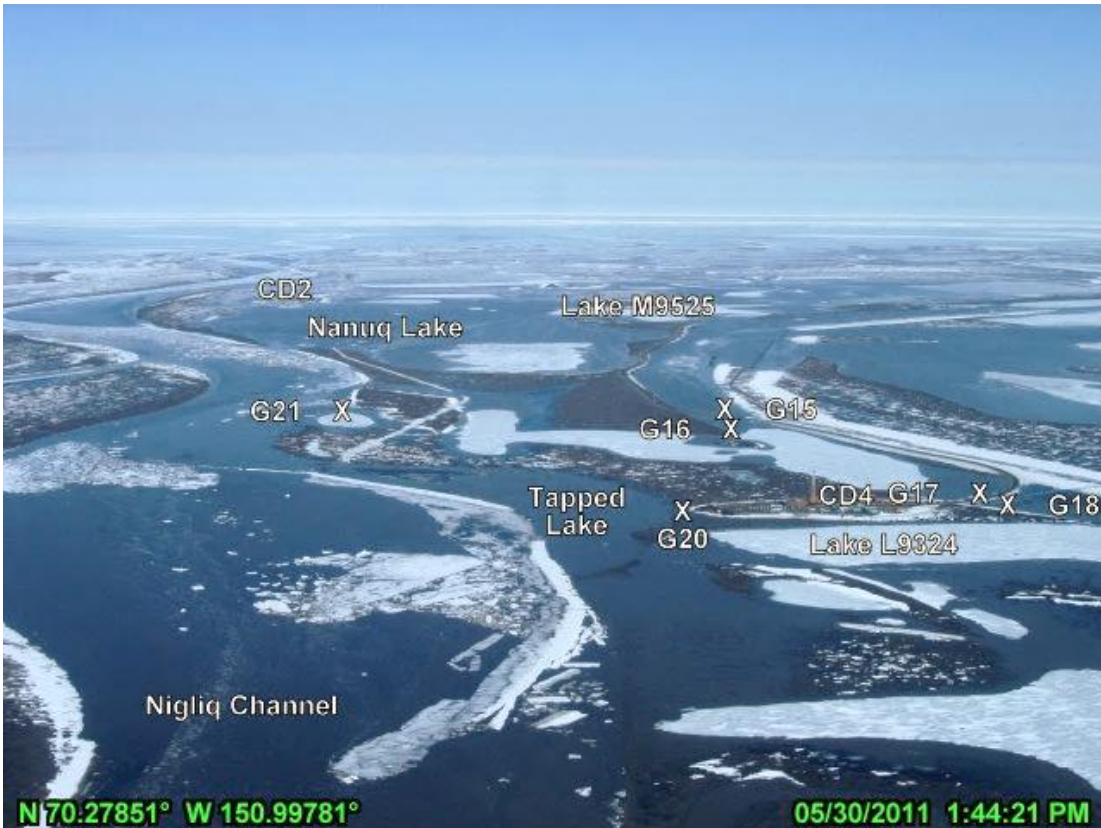
PHOTO 4.63: JUST AFTER PEAK STAGE AT CD4 PAD, LOOKING NORTH; MAY 30, 2011

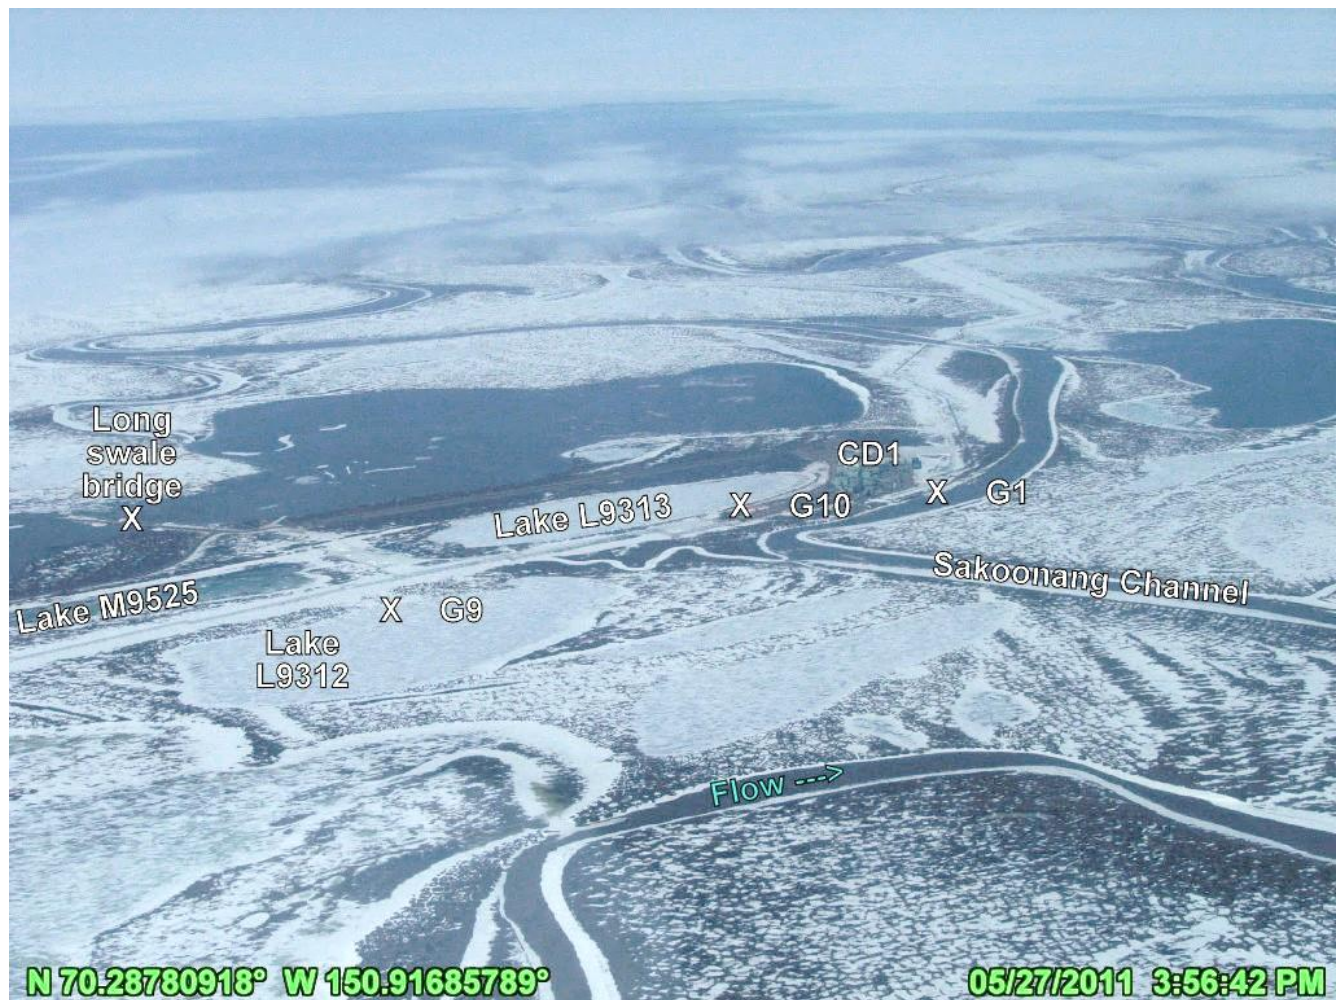
PHOTO 4.64: LAKE L9312 (G9) AND LAKE L9313 (G10) PRIOR TO BREAKUP, LOOKING NORTH; MAY 27, 2011

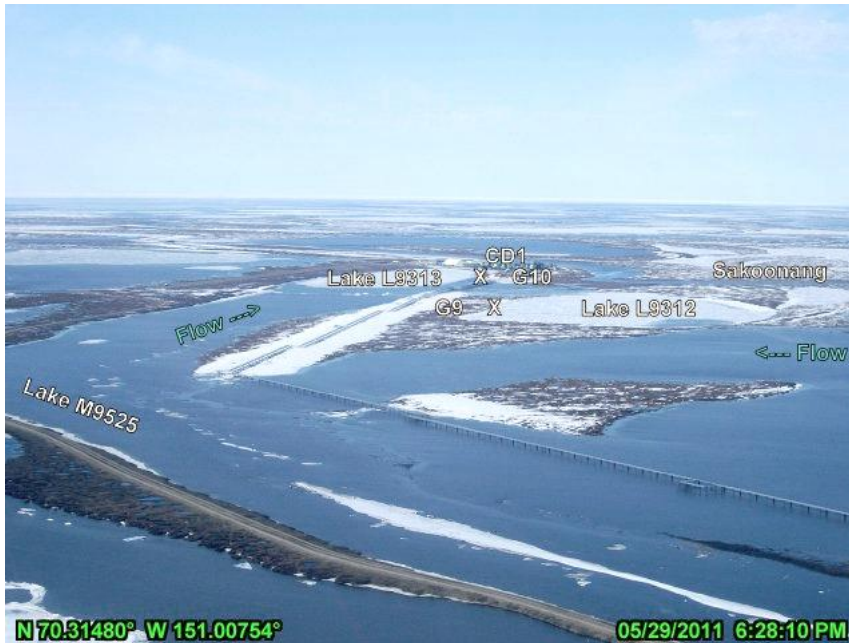
PHOTO 4.65: LAKE L9312 RECEIVING INITIAL RECHARGE FROM THE SAKOONANG AND LAKE L9313, LOOKING EAST; MAY 29, 2011

On the evening of May 29, Lake L9312 began receiving floodwaters from the Sakoonang to the west and from Lake L9313 to the east (Photo 4.65). Lake L9312 fully recharged to bankfull between May 30 and May 31, as stage rose overnight and then quickly decreased. Peak WSE at Lake L9312 (G9) was 10.72 feet BPMSL based on a HWM collected by field crews on May 31. Ice remained on the lake throughout the breakup season and into June. A hydrograph for L9312 (G9) is presented in Table 4.16.

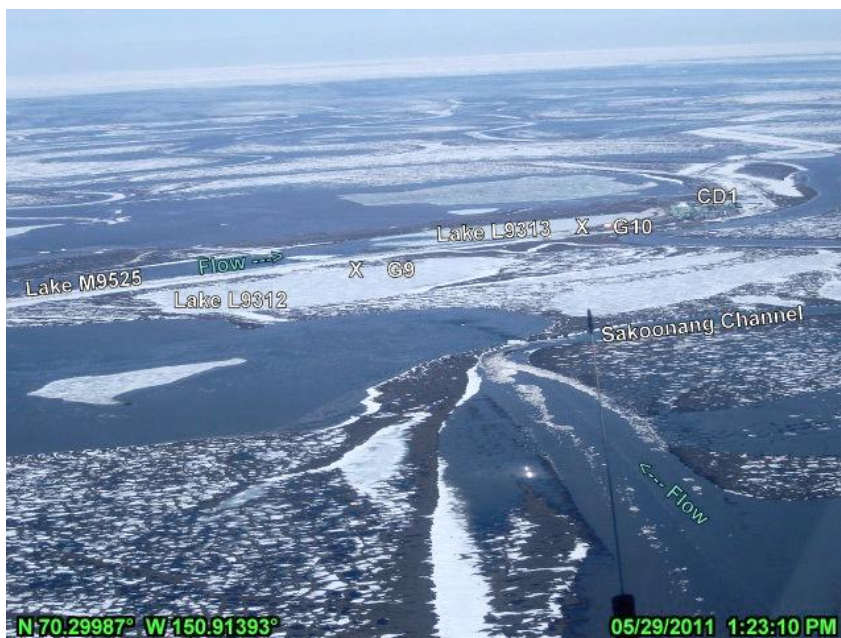
PHOTO 4.66: LAKE L9313 RECEIVING INITIAL RECHARGE FROM THE SAKOONANG VIA LAKE M9525, LOOKING NORTH; MAY 29, 2011

Lake L9313 is situated adjacent to the southwest side of the CD1 pad. On the morning of May 29, Lake L9313 began receiving overland flow from the Sakoonang via Lake M9525 to the west (Photo 4.66). Lake L9313 fully recharged to bankfull between May 29 and May 30, as stage rose overnight and then quickly decreased. Peak WSE at Lake L9313 (G10) was 10.67 feet BPMSL based on a HWM collected by field crews on May 30. Given the historical record, bankfull elevation is approximately 6.5 feet BPMSL (Baker 2006, 2007). Ice also remained on this lake throughout the breakup season and into June. A hydrograph for Lake L9313 (G10) is provided in Table 4.16.

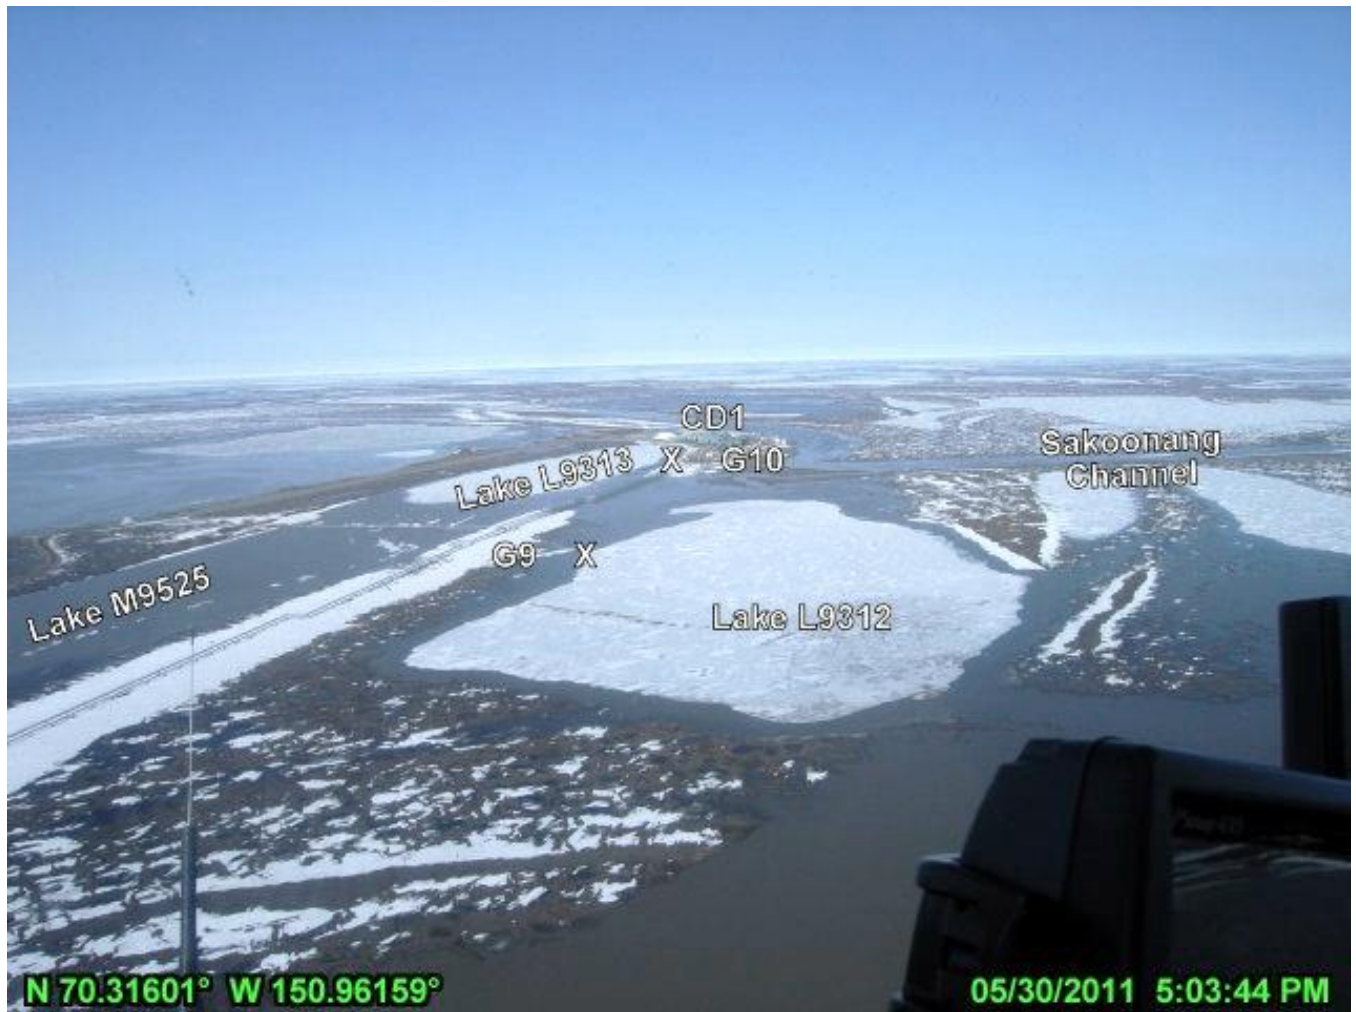
Photo 4.67 shows Lakes L9312 and L9313 over bankfull conditions.

PHOTO 4.67: LAKE L9312 (G9) AND LAKE L9313 (G10) RECHARGED OVER BANKFULL, LOOKING EAST; MAY 30, 2011

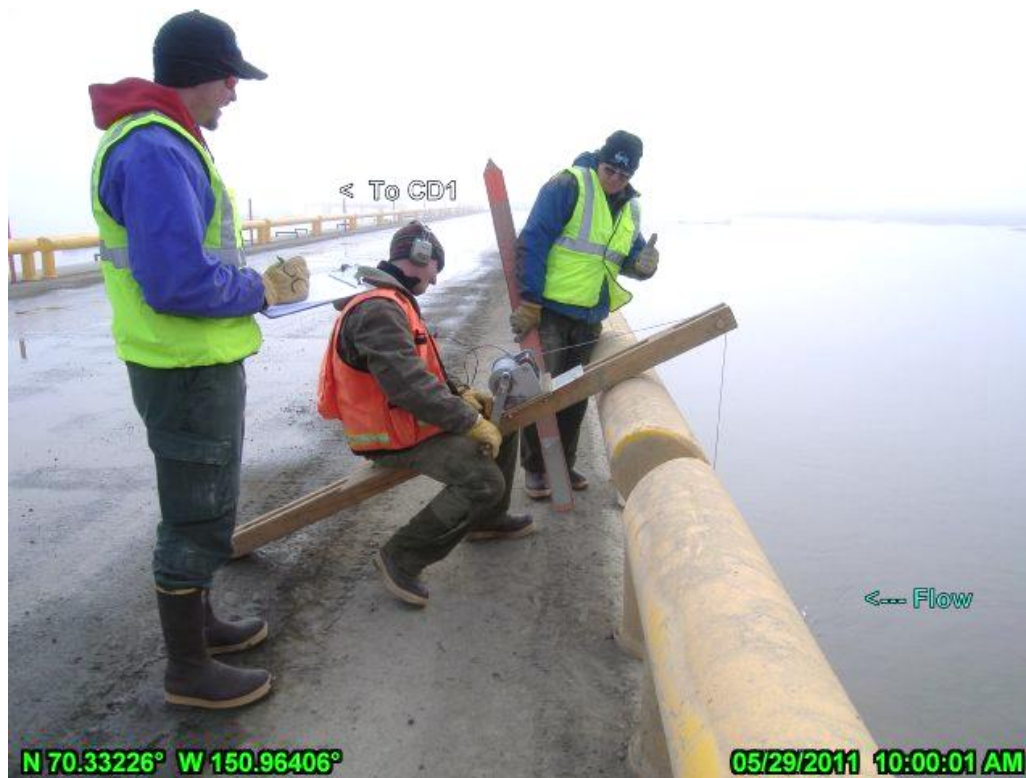
PHOTO 4.68: DISCHARGE MEASUREMENT FROM THE 452-FOOT SWALE BRIDGE, LOOKING EAST; MAY 29, 2011

Direct discharge measurements were taken at the long swale bridge on May 29 and June 1 and at the short swale bridge on May 28 and May 30. Photo 4.68 shows the field crew taking a discharge measurement at the 452-foot swale bridge on May 28, closest to peak stage. Discharge measurement data for both the 452-foot swale bridge and the 62-foot swale bridge is provided in Appendix C.

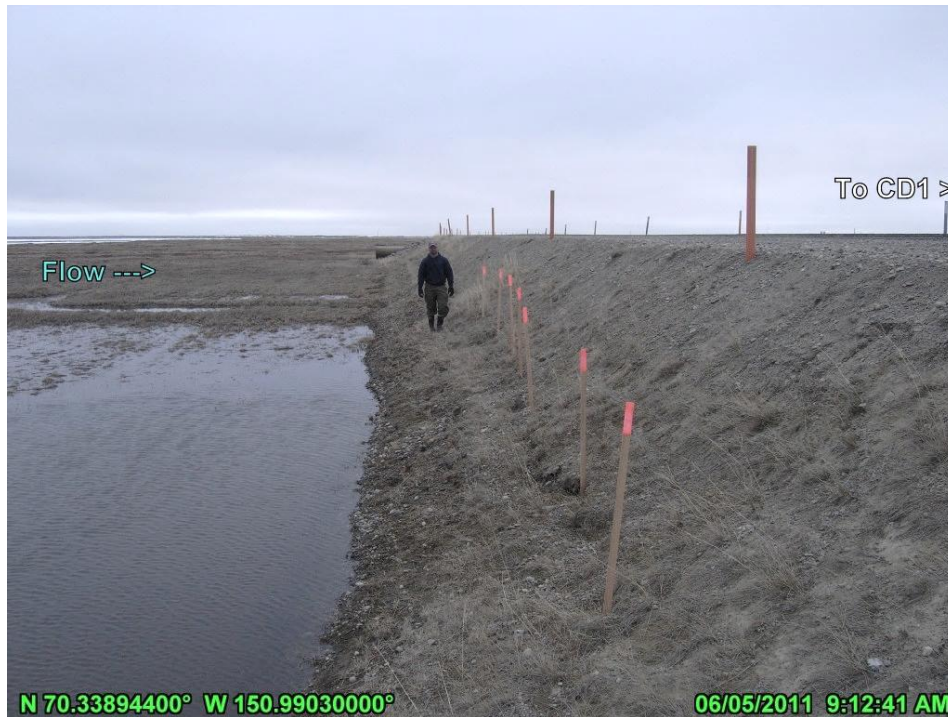
High-water marks in the road prism were observed along the CD2 road as a result of floodwater erosion. Photo 4.70, Photo 4.71, and Photo 4.72 are representative photos of the observed erosion along the CD2 gravel road prism following peak stage of breakup floodwater. Generally, the erosion of the CD2 access road was limited to the upstream (south) side of the road prism in the vicinity of the swale bridges.

PHOTO 4.71: EROSION SURVEY CD2 ROAD PRISM POST-BREAKUP, LOOKING WEST; JUNE 5, 2011

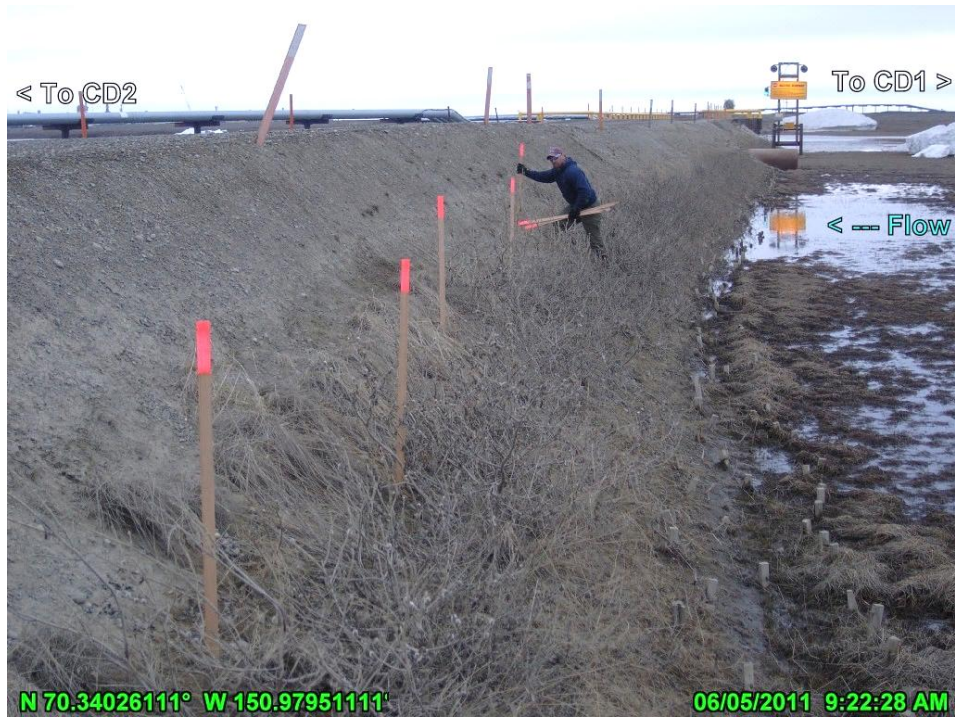
PHOTO 4.72: EROSION SURVEY CD2 ROAD POST-BREAKUP, BETWEEN SWALE BRIDGES, LOOKING EAST; JUNE 5, 2011

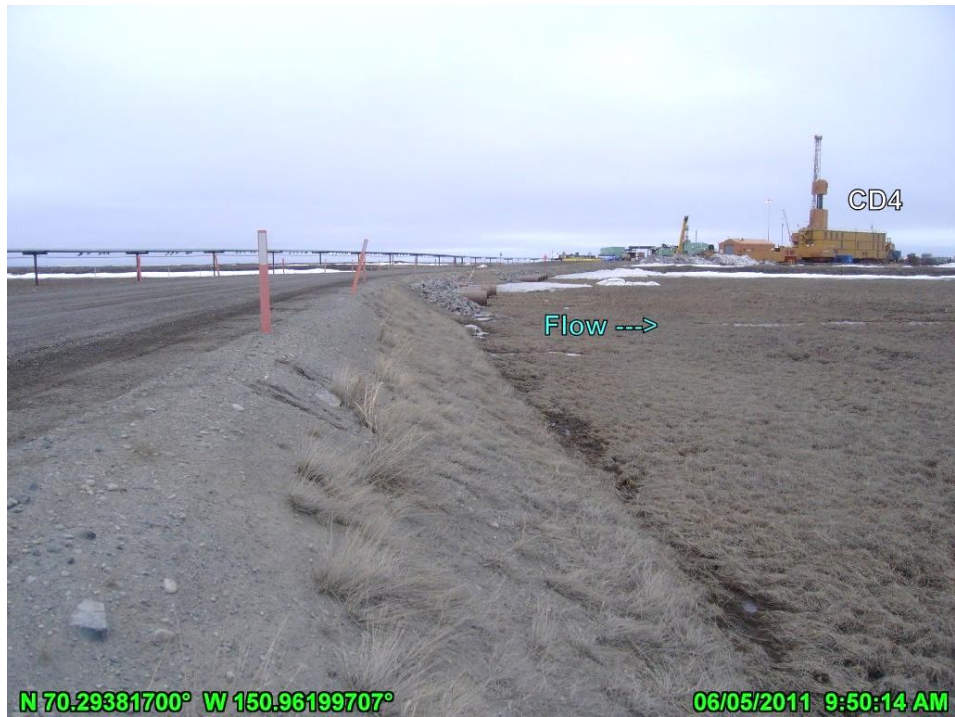
noteworthy erosion. Photo 4.73, Photo 4.74, and Photo 4.75 are representative photos of the conditions observed along the CD4 gravel road prism post peak stage.

PHOTO 4.73: EROSION SURVEY CD4 ROAD PRISM POST-BREAKUP, LOOKING SOUTH; JUNE 5, 2011

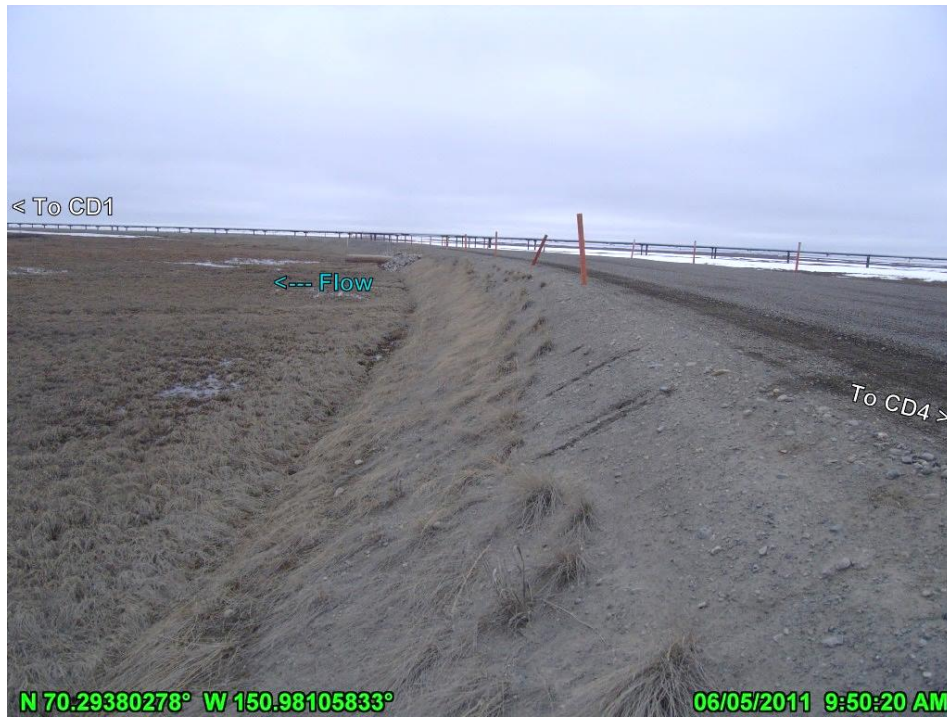
PHOTO 4.74: EROSION SURVEY CD4 ROAD PRISM POST-BREAKUP VICINITY OF CD4 PAD, LOOKING NORTH, JUNE 5, 2011

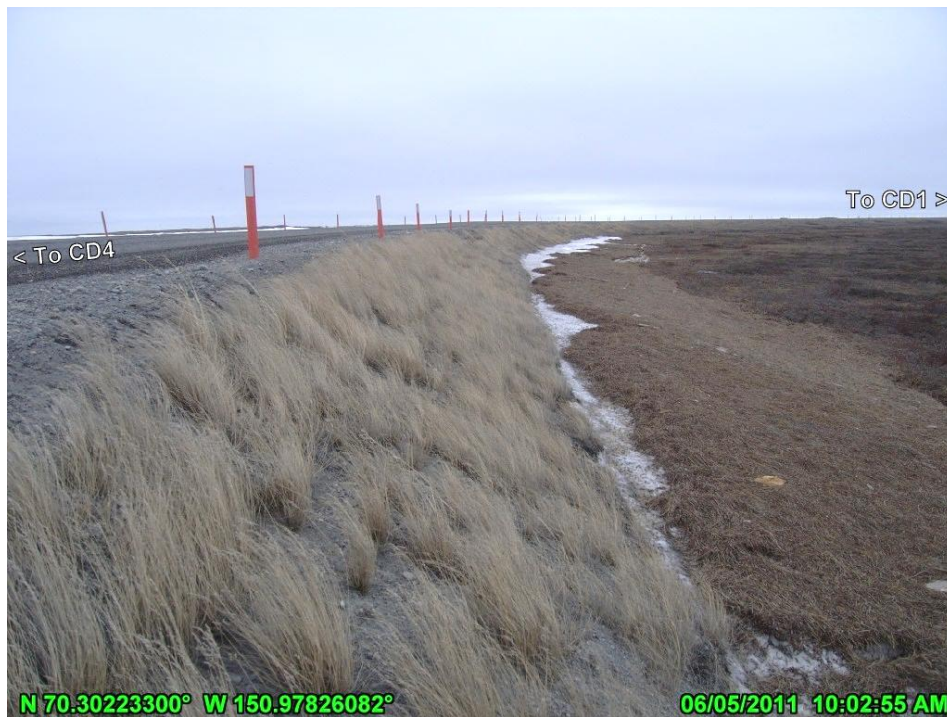
PHOTO 4.75: EROSION SURVEY CD4 ROAD, ORGANIC DEBRIS LEFT FROM RECEDED WATER AT TOE OF ROAD PRISM, LOOKING NORTH; JUNE 5, 2011

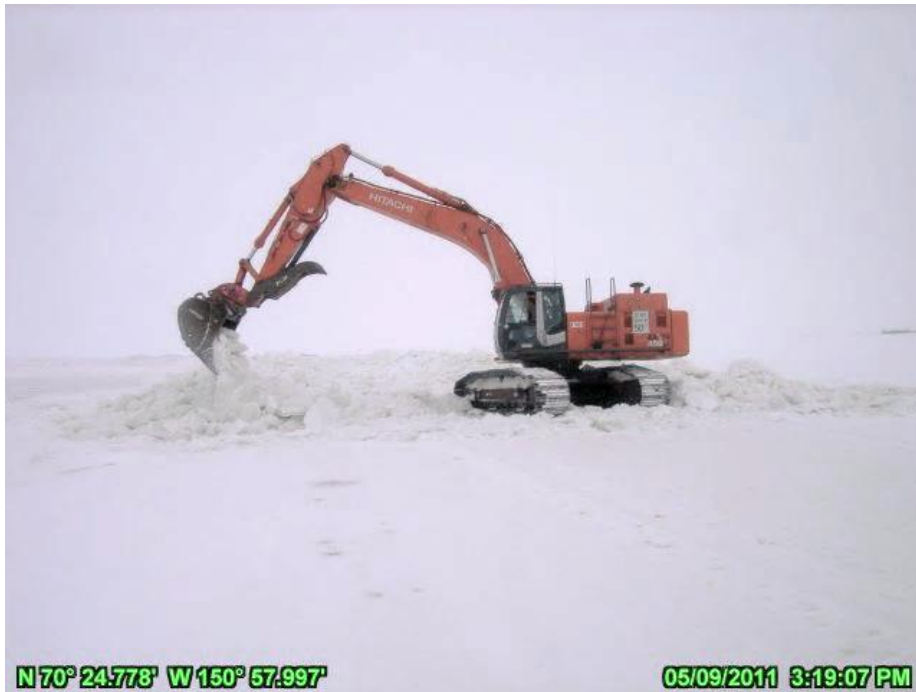
PHOTO 4.76: ICE ROAD CROSSINGS ARE DUG OUT PRIOR TO BREAKUP TO FACILITATE THE PASSAGE OF FLOOD FLOW; TAMAYAYAK ICE ROAD CROSSING; MAY 9, 2011

Ice road crossings were dug out prior to breakup, as shown in Photo 4.76. Ice bridge melt progressed smoothly throughout the breakup period at the East Channel and Kachemach River crossings; no significant erosion or scour was observed as a result of the ice bridges.

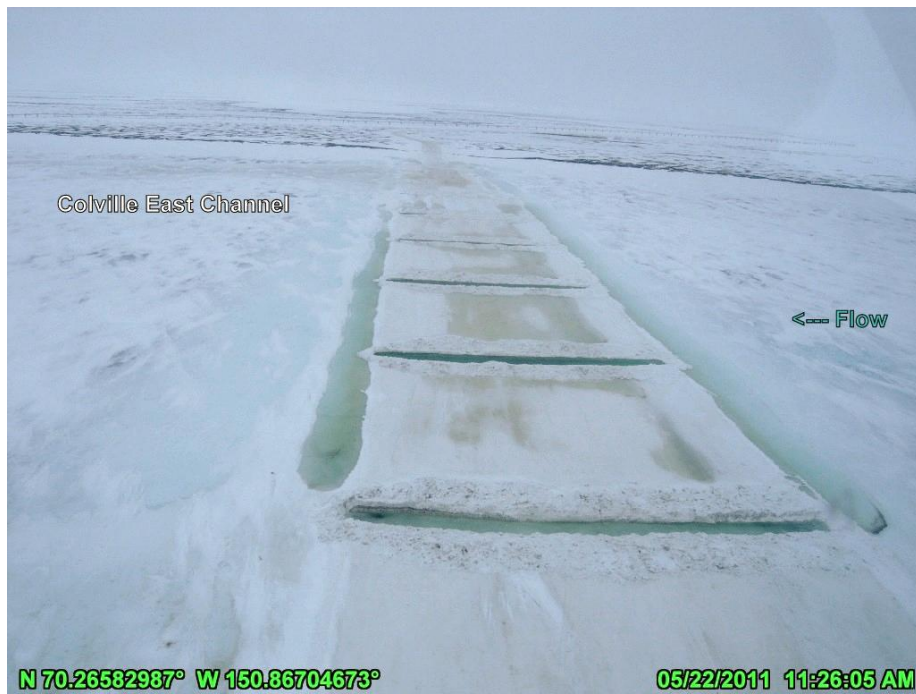
PHOTO 4.77: SLOTS CUT IN THE COLVILLE RIVER ICE BRIDGE PRE-BREAKUP, LOOKING EAST; MAY 22, 2011

The East Channel ice bridge is located approximately one-half mile upstream (south) of MON9. The first visual evidence of melt at the ice bridge was recorded on May 22, when water was observed within the slots cut into the ice bridge (Photo 4.77). By May 25, the leading edge had passed through the ice bridge and floodwater was beginning to flow through the area. During this time, the ice bridge did not appear to be adversely impacting flow (Photo 4.78). Photo 4.79 shows the Colville River ice bridge as floes from an ice jam release upstream of MON1 move through, clearing the channel of ribbon ice, and Photo 4.80 and Photo 4.81 show the remaining west and east sides on June 9, when monitoring was discontinued.

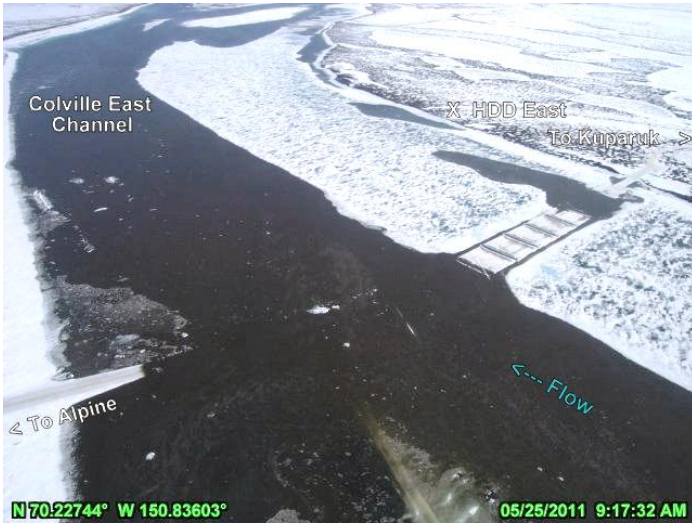
PHOTO 4.78: COLVILLE RIVER ICE BRIDGE, LOOKING UPSTREAM (SOUTHWEST); MAY 25, 2011

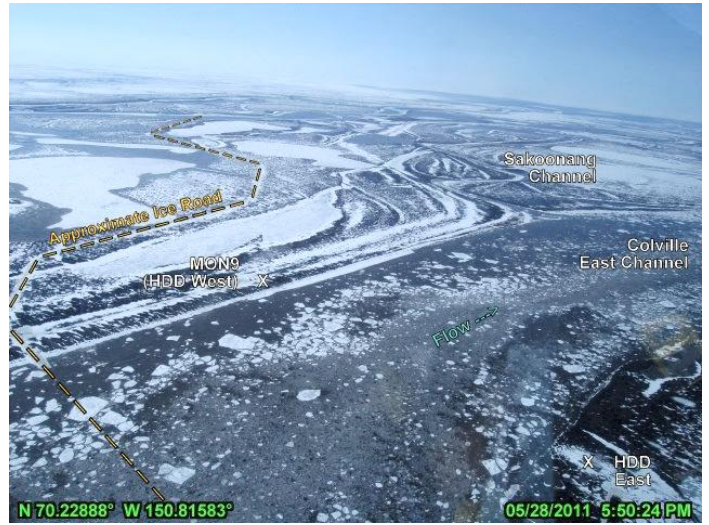
PHOTO 4.79: COLVILLE RIVER ICE BRIDGE AS MAJOR ICE JAM RELEASE CLEARS CHANNEL ICE, LOOKING DOWNSTREAM (NORTHWEST); MAY 28, 2011

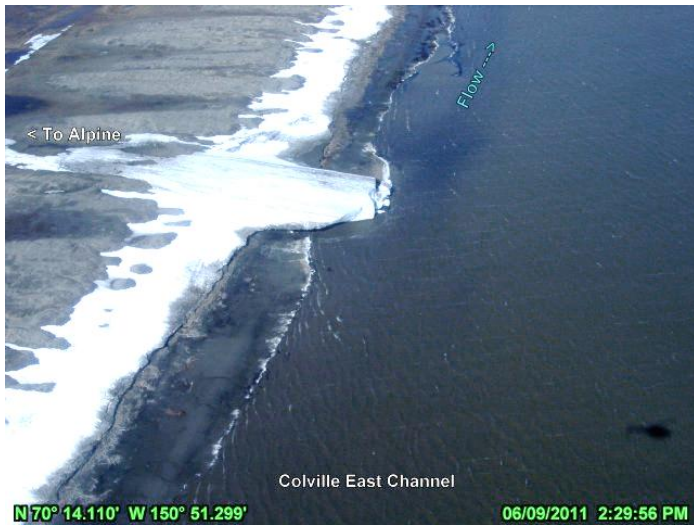
PHOTO 4.80: COLVILLE RIVER ICE BRIDGE WEST SIDE POST-BREAKUP, LOOKING DOWNSTREAM (NORTH); JUNE 9, 2011

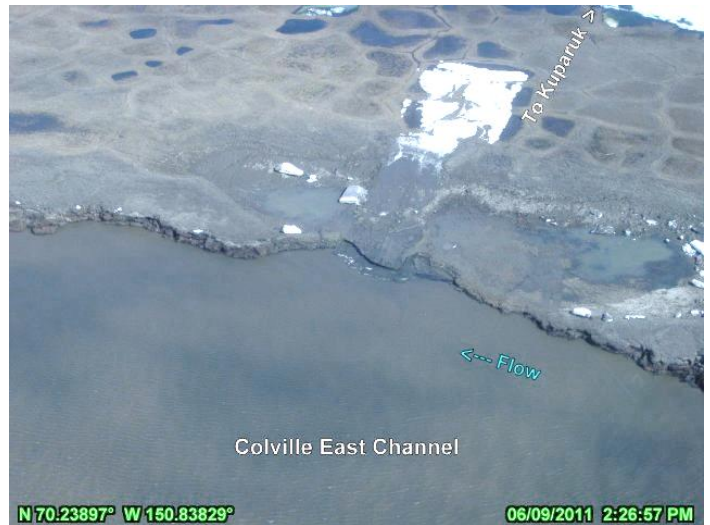
PHOTO 4.81: COLVILLE RIVER ICE BRIDGE EAST SIDE POST-BREAKUP, LOOKING EAST; JUNE 9, 2011

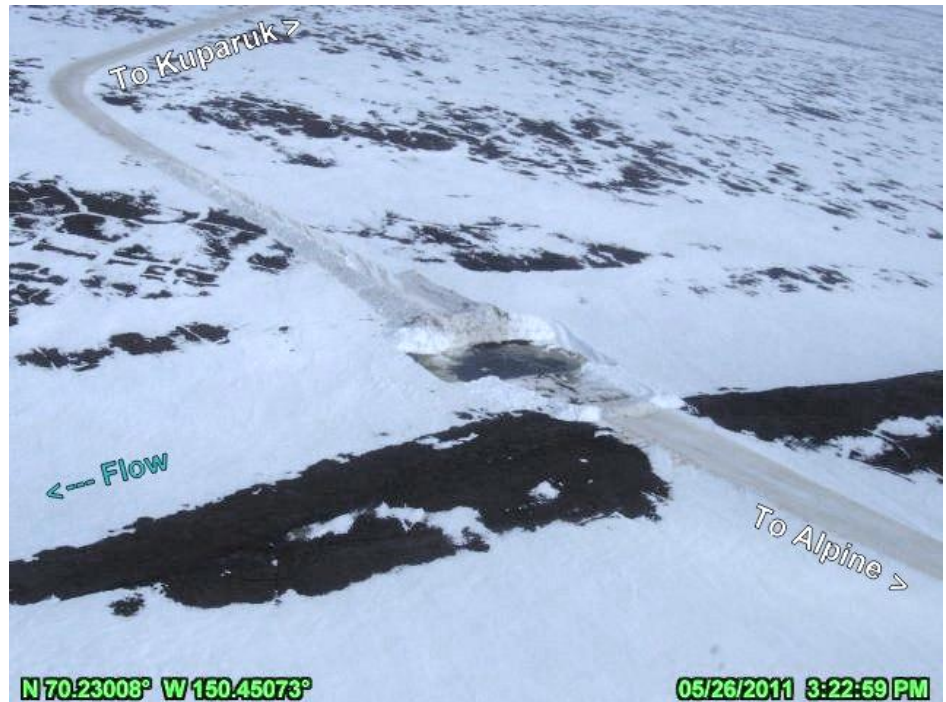
Initial aerial reconnaissance of the Kachemach River ice bridge crossing location was performed on May 26. The Kachemach River ice bridge was effectively wholly intact, with a slot cut into it near the center of the crossing (Photo 4.82). No evidence of flowing water was observed. On June 9, a second reconnaissance flight over the Kachemach River ice bridge was conducted and the channel seemed to be largely clear of ice. No indications of channel migration or bank erosion were observed. Ice rafts were perched on the banks and the ice bridge approaches were mainly intact (Photo 4.83).

PHOTO 4.82: KACHEMACH RIVER ICE BRIDGE SLOTTED PRE-BREAKUP, LOOKING SOUTHEAST; MAY 26, 2011

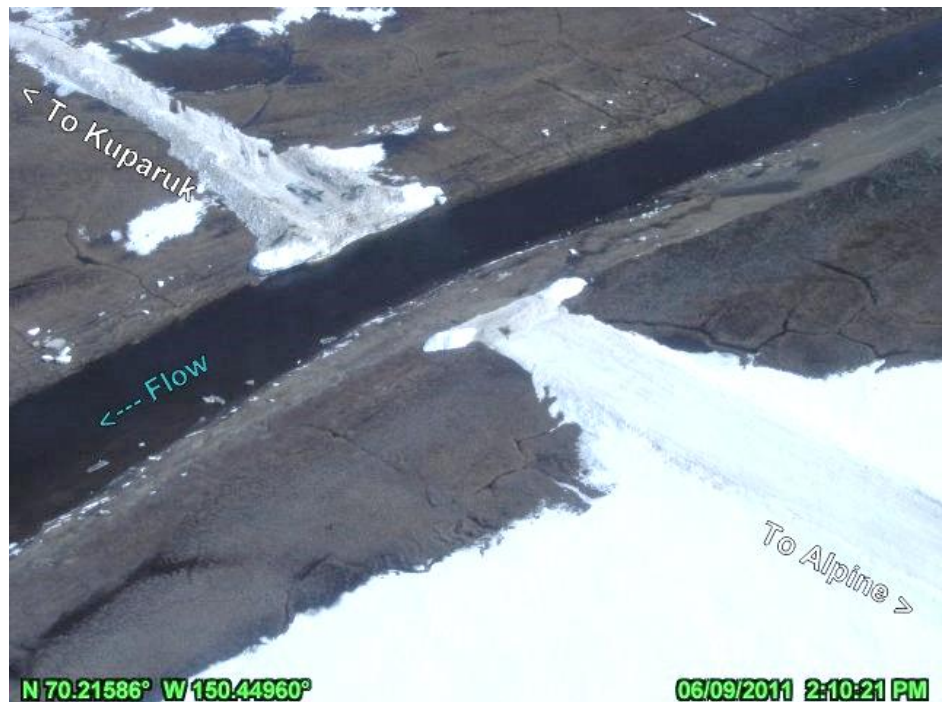
PHOTO 4.83: KACHEMACH RIVER ICE BRIDGE AS BREAKUP FLOWS RECEDE, LOOKING SOUTHEAST; JUNE 9, 2011

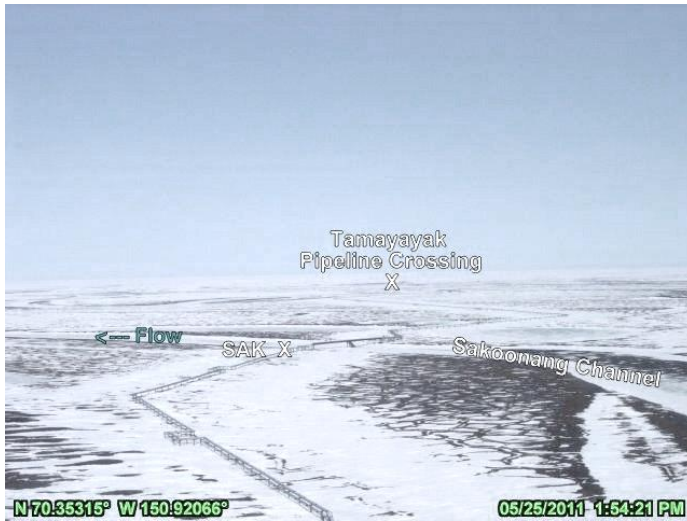
Daily monitoring of the pipeline crossings began May 25. Photo 4.84 shows the Sakoongang pipeline crossing with local melt in the vicinity. Photo 4.85 shows water beginning to enter the Tamayayak from the East Channel.

PHOTO 4.84: SAKOONGANG PIPELINE CROSSING PRIOR TO BREAKUP, LOOKING DOWNSTREAM (NORTH); MAY 25, 2011

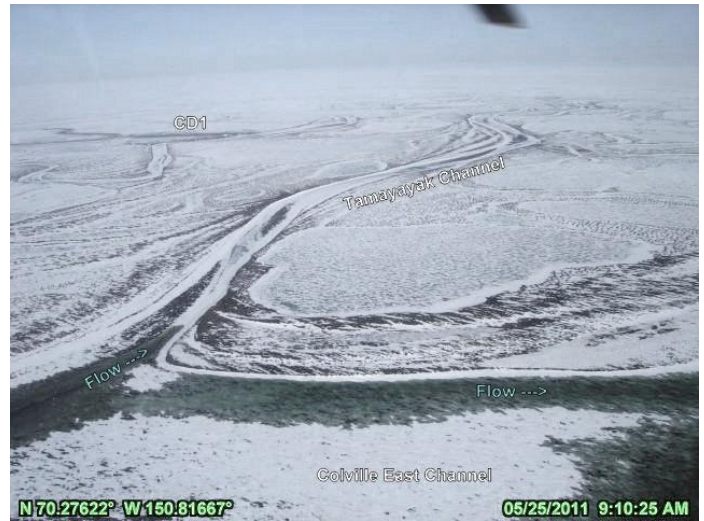
PHOTO 4.85: LEADING EDGE IN THE EAST CHANNEL ENTERING THE TAMAYAYAK, LOOKING DOWNSTREAM (WEST); MAY 25, 2011
