Colville River Delta

ConocoPhillips
Alaska

Colville River Delta Spring Breakup 2011 Hydrologic Assessment

January 2012

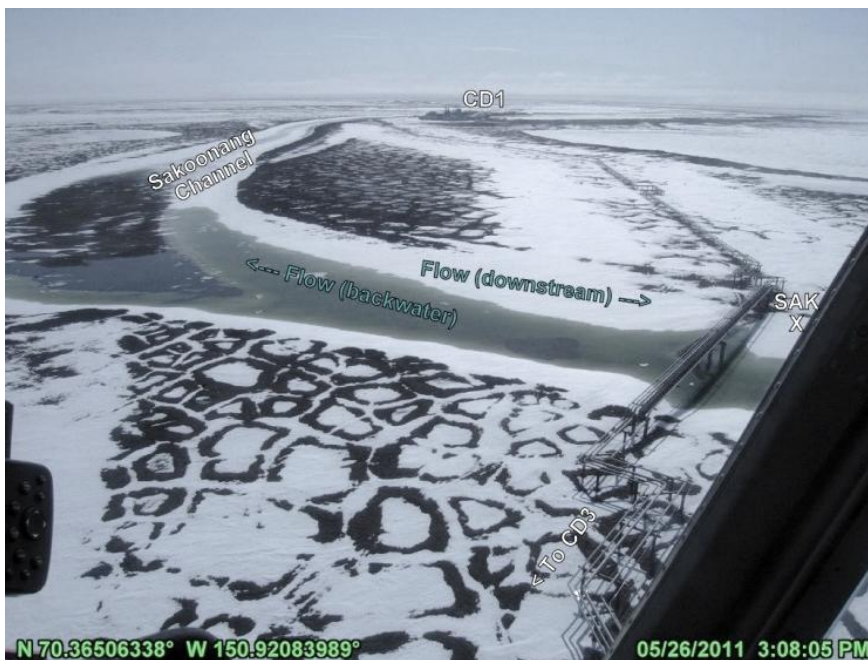
PHOTO 4.86: FLOW FROM THE TAMAYAYAK BACKING UPSTREAM IN THE SAKOONGANG PAST THE PIPELINE CROSSING, LOOKING UPSTREAM (SOUTH); MAY 26, 2011

WSE was initially measureable on all pipeline crossing gages by May 26. At that time, water flowing downstream in the Sakoongang had not yet reached the pipeline crossing and water from the Tamayayak was backing up the Sakoongang (Photo 4.86). Because of this, flow in these channels had a relatively low velocity. Photo 4.87 and Photo 4.88 show breakup progression at the Tamayayak and Ulamnigraq pipeline crossings on May 26.

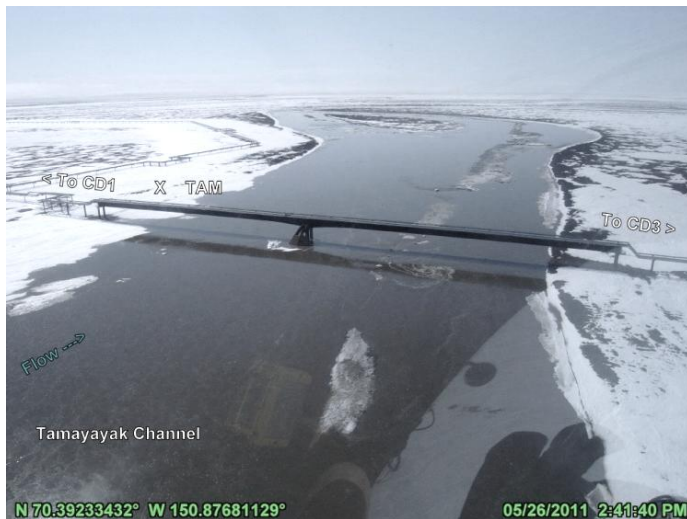
PHOTO 4.87: TAMAYAYAK PIPELINE CROSSING AS BREAKUP FLOWS PROGRESS, LOOKING DOWNSTREAM (WEST); MAY 26, 2011

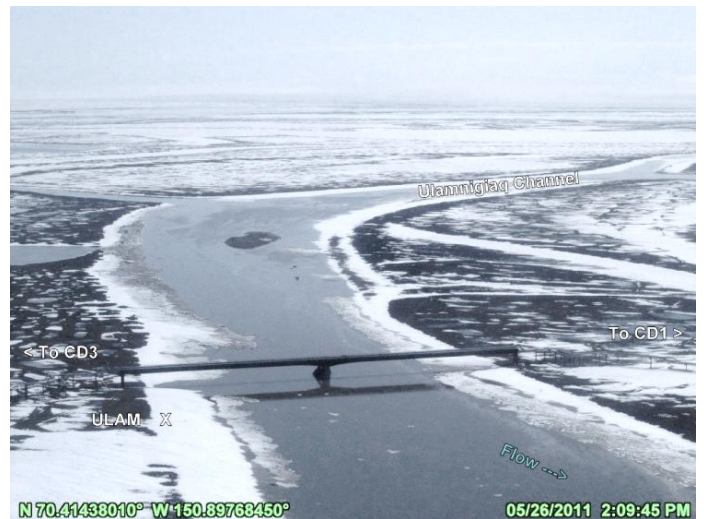
PHOTO 4.88: ULAMNIGIAQ PIPELINE CROSSING AS BREAKUP FLOWS PROGRESS, LOOKING UPSTREAM (SOUTHEAST); MAY 26, 2011

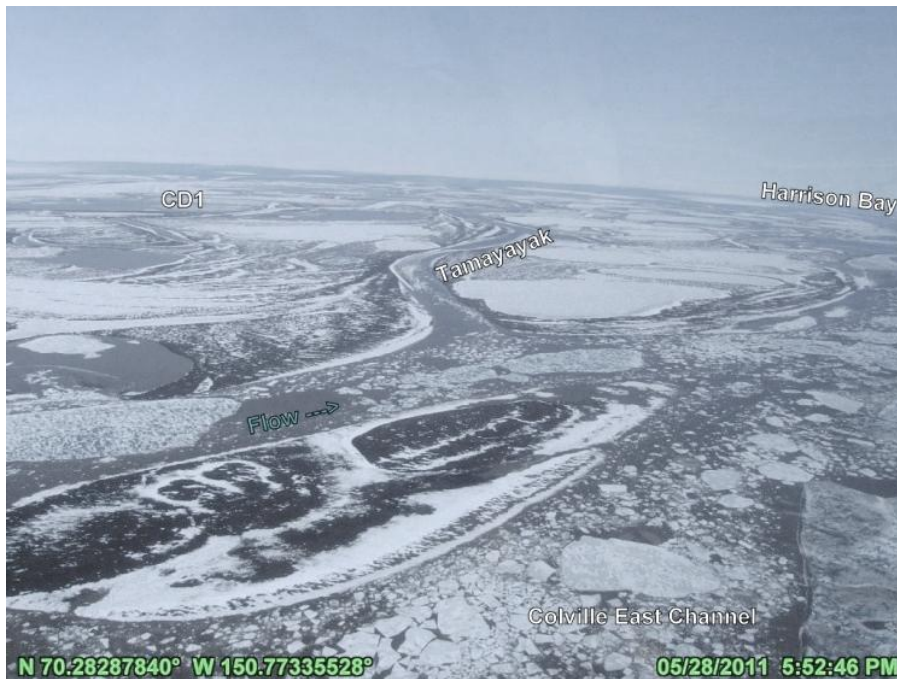
PHOTO 4.89: FLOES FROM ICE JAM RELEASE UPSTREAM OF MON1 DIVERT INTO THE TAMAYAYAK, LOOKING DOWNSTREAM (NORTHWEST); MAY 28, 2011

By May 28, flow had normalized in the Sagoonang and no further backwater effects were observed for the remainder of the breakup season. Ribbon ice was still present in portions of all pipeline crossing channels and snow was present along the banks. Later in the day, ice floes began entering the Sagoonang and Tamayayak (Photo 4.89) from the East Channel as the result of an ice jam release upstream of MON1. Overnight, the ice floes from the jam re-formed in the East Channel just downstream of the Tamayayak bifurcation.

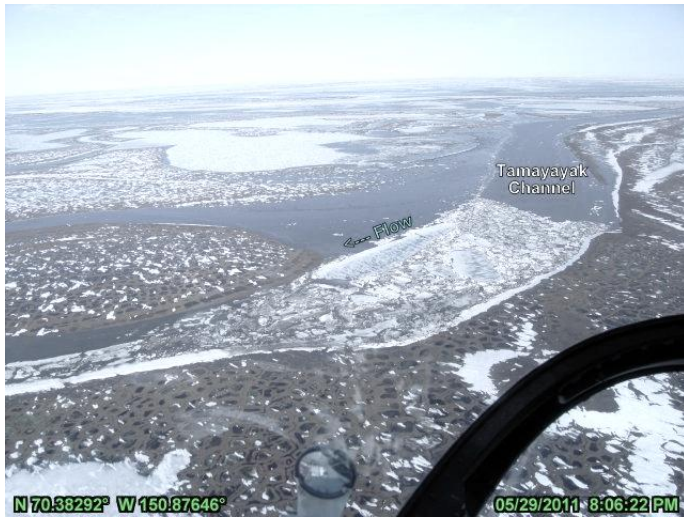
On May 29, an ice jam had formed in the Tamayayak upstream of the Ulamnigiaq bifurcation (Photo 4.90 and Photo 4.91). Rafted ice was seen near the Sagoonang pipeline crossing (Photo 4.92). Photo 4.93 shows the progression of breakup at the Ulamnigiaq pipeline crossing on May 29.

PHOTO 4.90: ICE JAM UPSTREAM OF THE TAMAYAYAK-ULAMNIGIAQ BIFURCATION, LOOKING UPSTREAM (SOUTHEAST); MAY 29, 2011

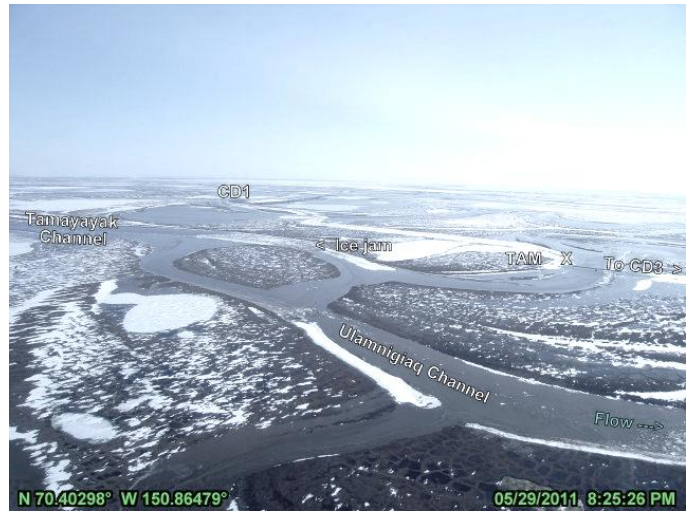
PHOTO 4.91: ICE JAM IN TAMAYAYAK UPSTREAM OF THE PIPELINE CROSSING AND ULAMNIGIAQ BIFURCATION, LOOKING SOUTHWEST; MAY 29, 2011

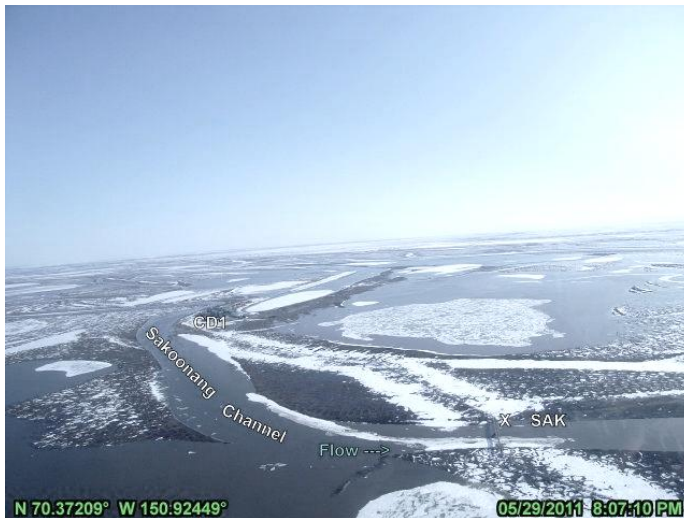
PHOTO 4.92: SAKOONGANG PIPELINE CROSSING JUST PRIOR TO PEAK STAGE, LOOKING UPSTREAM (SOUTHEAST); MAY 29, 2011

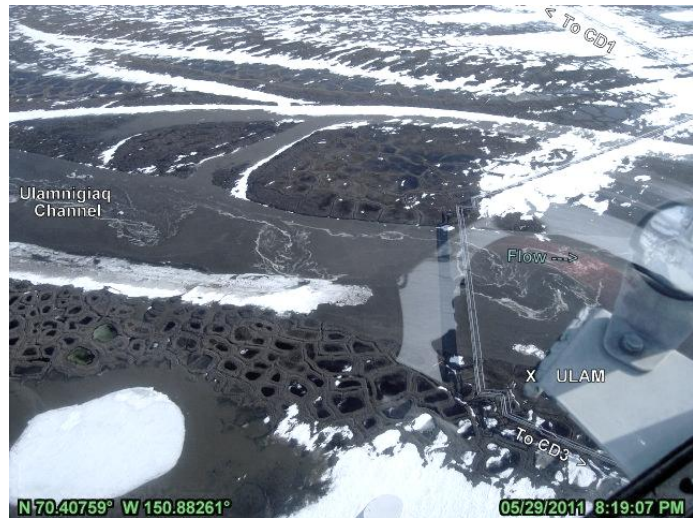
PHOTO 4.93: ULAMNIGIAQ PIPELINE CROSSING JUST PRIOR TO PEAK STAGE, LOOKING SOUTH; MAY 29, 2011

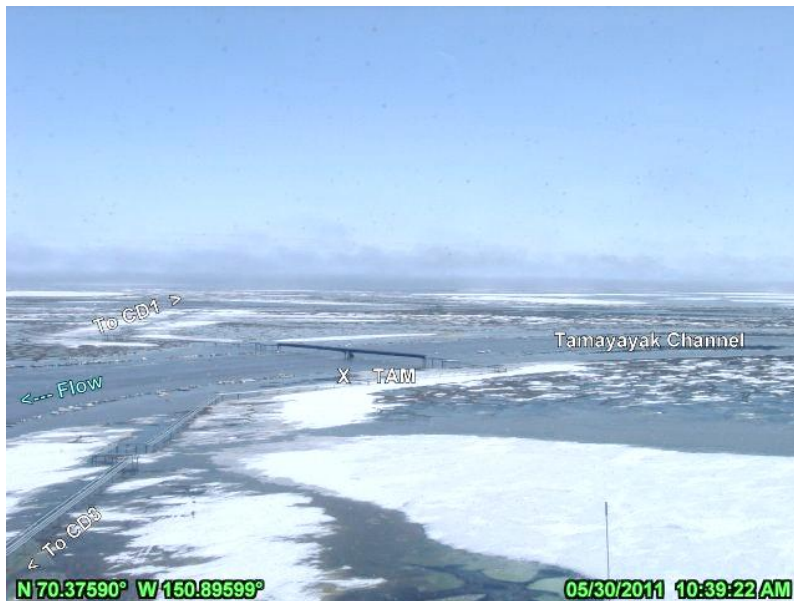
PHOTO 4.94: TAMAYAYAK PIPELINE CROSSING JUST AFTER PEAK STAGE, LOOKING WEST; MAY 30, 2011

This jam released overnight, sending a surge of water downstream, which caused a spike in the WSE at both the Tamayayak and Ulamnigiq monitoring locations. Stranded ice was observed on the banks of the Tamayayak (Photo 4.94 and Photo 4.95) and Ulamnigiq pipeline crossings on May 30.

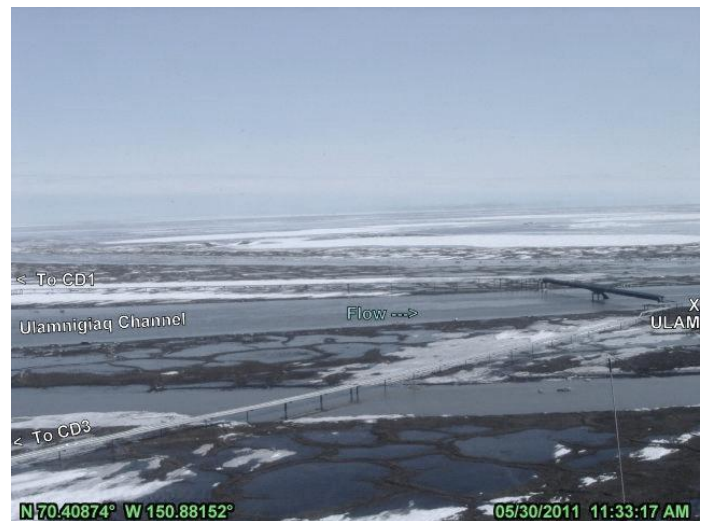
PHOTO 4.96: ULAMNIGIQ PIPELINE CROSSING JUST AFTER PEAK STAGE, LOOKING SOUTH; MAY 30, 2011

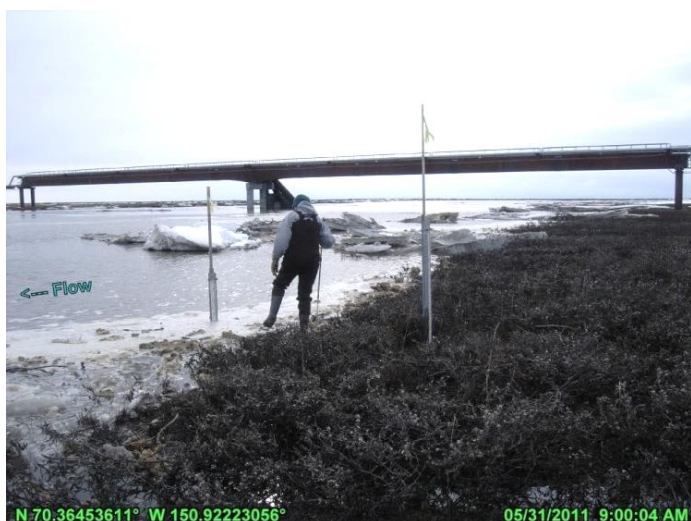
PHOTO 4.97: SAKOONGANG PIPELINE CROSSING AS BREAKUP FLOWS RECEDE, LOOKING NORTHEAST; MAY 31, 2011

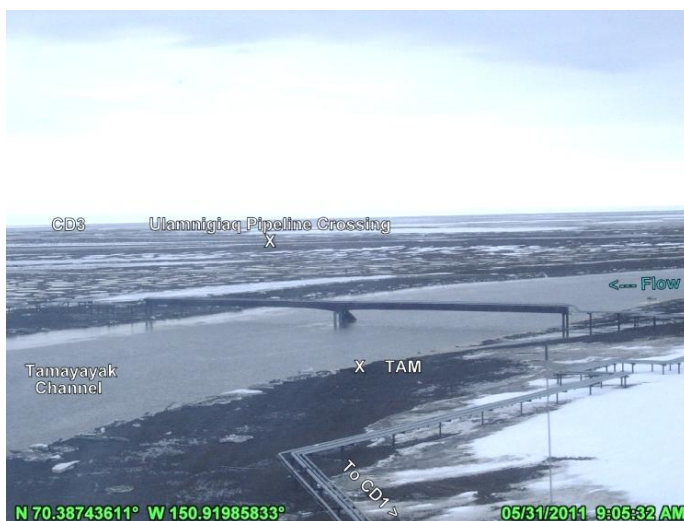
PHOTO 4.98: TAMAYYAK PIPELINE CROSSING AS BREAKUP FLOWS RECEDE, LOOKING NORTHEAST; MAY 31, 2011

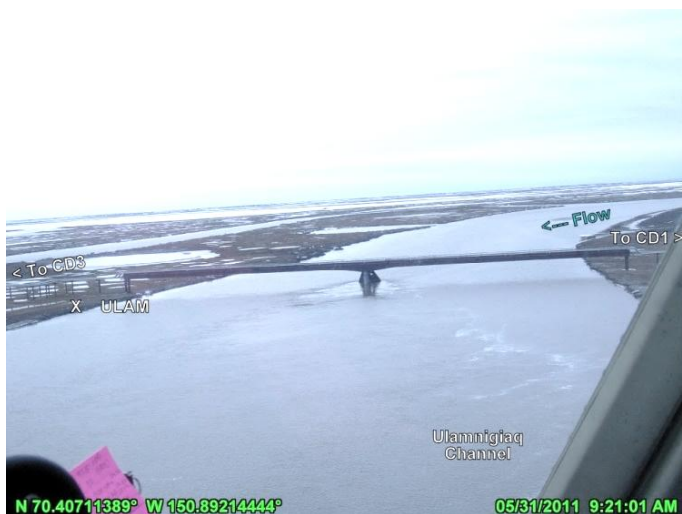
PHOTO 4.99: ULAMNIGLAQ PIPELINE CROSSING AS BREAKUP FLOWS RECEDE, LOOKING WEST; MAY 31, 2011

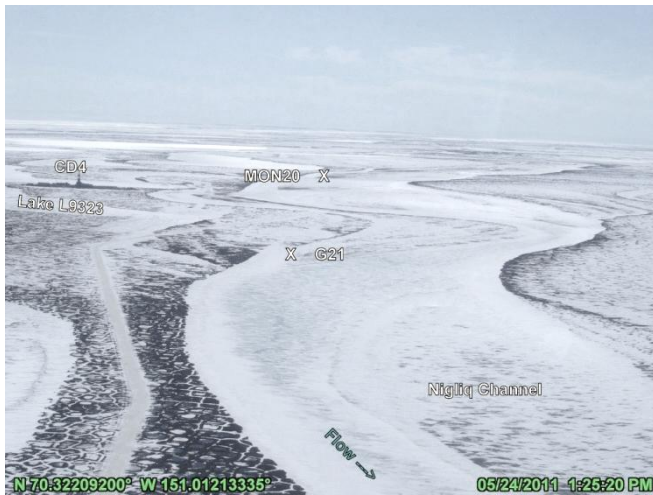
PHOTO 4.100: PROPOSED CD5 BRIDGE CROSSING AT THE NIGLIQ CHANNEL (G21) PRIOR TO BREAKUP, LOOKING UPSTREAM (SOUTH); MAY 24, 2011

Monitoring of the three proposed CD5 road bridge crossing locations was conducted at G21 (Nigliq, Photo 4.100), G22 (Lake L9341, Photo 4.101), and G23 (Nigliagvik, Photo 4.102). In addition to visual observations and documentation of gage readings, a pressure transducer was deployed at G21 and G21 upstream (G21U).

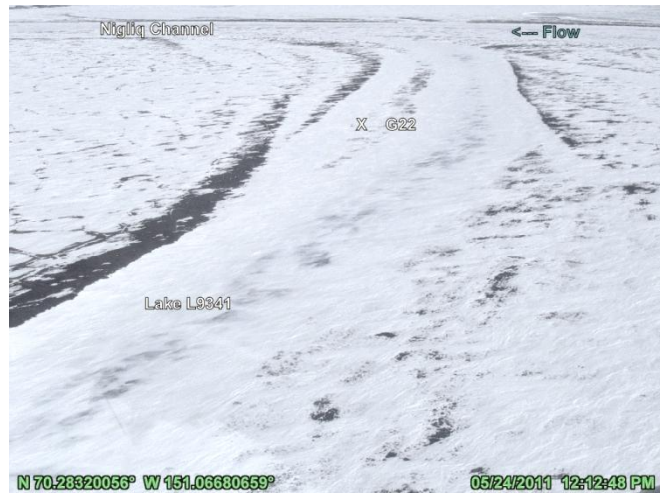
PHOTO 4.101: PROPOSED CD5 BRIDGE CROSSING AT LAKE L9341 (G22) PRIOR TO BREAKUP, LOOKING WEST; MAY 24, 2011

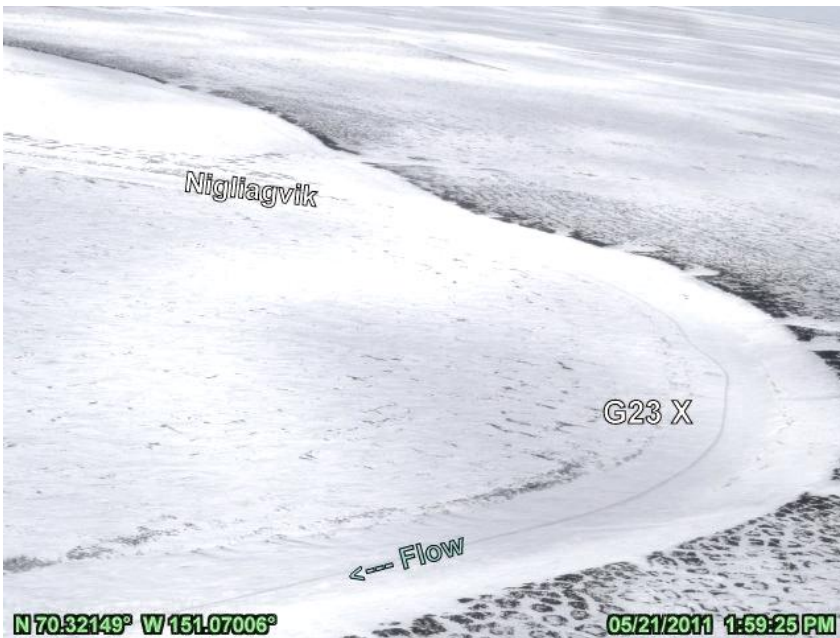
PHOTO 4.102: PROPOSED CD5 BRIDGE CROSSING AT THE NIGLIAGVIK (G23) PRIOR TO BREAKUP, LOOKING UPSTREAM (SOUTH); MAY 21, 2011

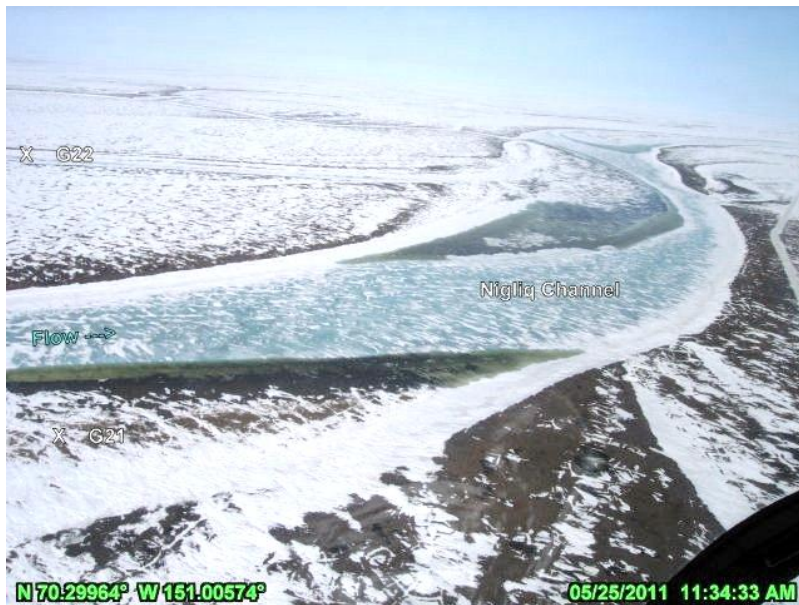
The G21 monitoring location is located between MON20 and MON22 on the Nigliq Channel at the proposed CD5 bridge crossing location. The G21 location and other nearby Nigliq Channel gages experienced similar breakup events, including discharge, stage, and ice effects. The leading edge in the Nigliq Channel reached G21 on May 25 (Photo 4.103). At that time, flow had entered the Nigliagvik.

PHOTO 4.103: LEADING EDGE IN THE NIGLIQ CHANNEL, PAST G21, LOOKING DOWNSTREAM (NORTH); MAY 25, 2011

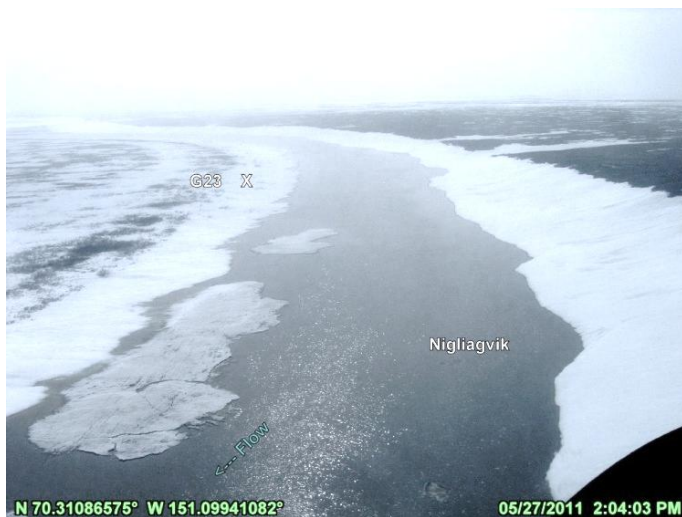
Water reached G23 along the Nigliagvik on May 27, when low-velocity flow was observed moving through the channel (Photo 4.104). Significant snow was present along both banks but no ice floes were seen. At that time, there was abundant ribbon ice near the G21 location, and it remained in the area until the last monitoring observation on June 3. Occasional ice floes in the area were wedged between ribbon ice and the banks near G21. Stage was not high enough for water to enter Lake L9341 (G22) at either end, near the Nigliq (northeast) or near the Nigliagvik (southwest), though there was some local melt and significant snow at the monitoring location (Photo 4.105).

PHOTO 4.104: INITIAL FLOW OBSERVED IN THE NIGLIAGVIK NEAR G23, LOOKING UPSTREAM (SOUTH); MAY 27, 2011

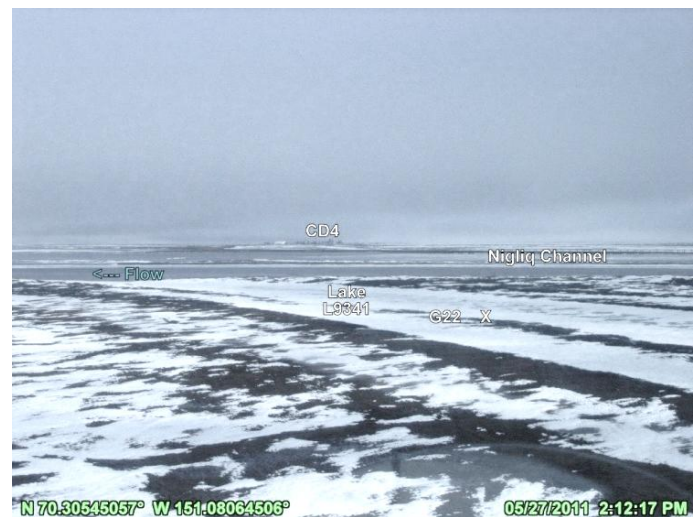
PHOTO 4.105: LOCAL MELT IN LAKE L9341 AT G22, LOOKING WEST; MAY 27, 2011

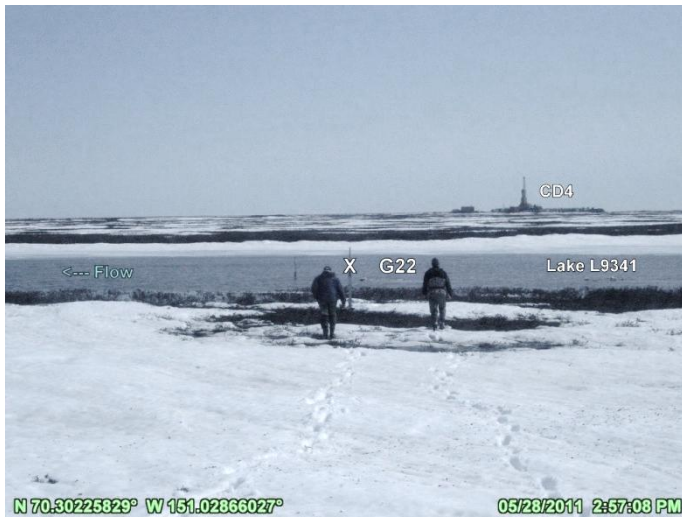
By May 28, Lake L9341 was recharging from the northeast via the Nigliq (Photo 4.106). A major ice jam upstream of MON1, released in the early evening of May 28, sent a surge of water and ice floes downstream into the East Channel and the Nigliq (Photo 4.107). This release is represented as a small rise in WSE on the hydrograph for G21, included in Table 4.18. Ice floes from this release became lodged on channel ice near Nuiqsut, which affected the amount of flood flow that was able to progress down the Nigliq Channel.

PHOTO 4.106: LAKE L9341 BEGINS TO RECHARGE FROM THE NIGLIQ, LOOKING SOUTHEAST; MAY 28, 2011

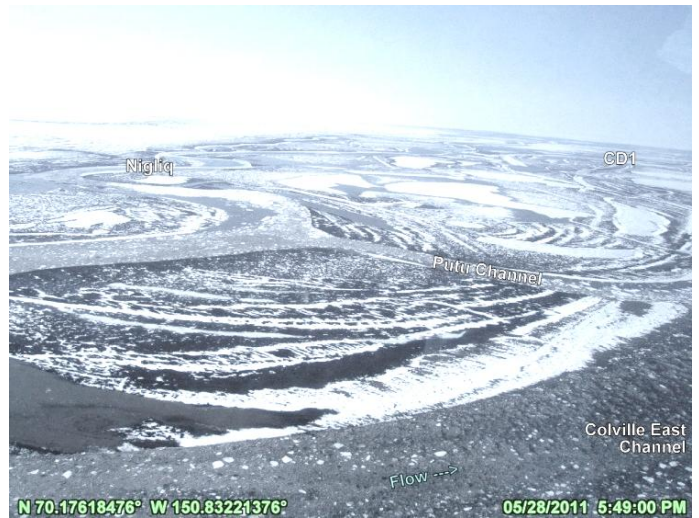
PHOTO 4.107: FLOES MOVING DOWNSTREAM INTO THE NIGLIQ CHANNEL AS THE RESULT OF AN ICE JAM RELEASE UPSTREAM OF MON1; MAY 28, 2011

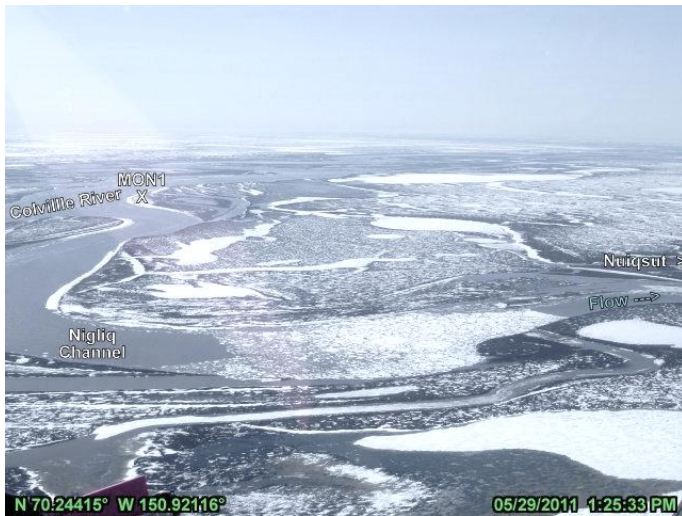
PHOTO 4.108: ICE JAM IN NIGLIQ NEAR NUIQSUT, LOOKING SOUTH; MAY 29, 2011

The ice jam near Nuiqsut was still in place on May 29 (Photo 4.108). Ribbon ice was intact in majority of the Nigliq Channel (Photo 4.109) and there were very few ice floes. By that time, Lake L9341 was connected with the Nigliagvik at the southeast end, where flow was entering and moving downstream into the Nigliq Channel.

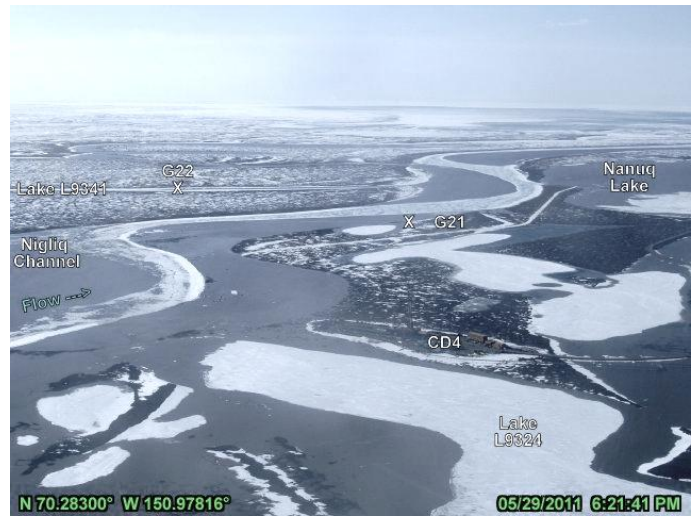
PHOTO 4.109: RIBBON ICE IN NIGLIQ, LOOKING DOWNSTREAM (NORTHWEST); MAY 29, 2011

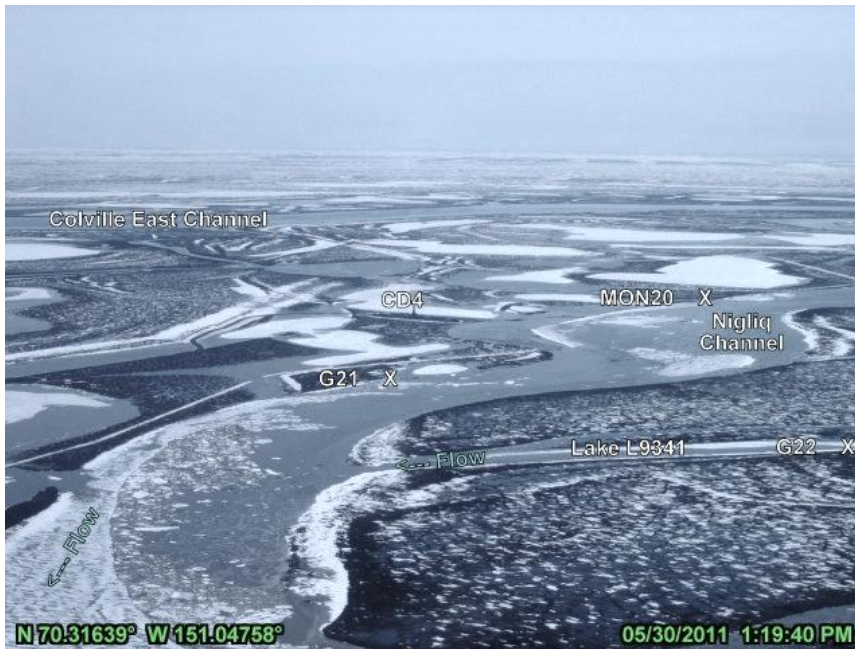
PHOTO 4.110: PEAK STAGE AT G21 IN THE NIGLIQ AND G22 AT LAKE L9341, LOOKING UPSTREAM (SOUTHWEST); MAY 30, 2011

Peak stage at all proposed CD5 road crossing locations occurred on May 30, in the afternoon at G21 (9.89 feet BPMSL) and in the evening at G22 (9.50 feet BPMSL) and G23 (8.78 feet BPMSL). Peak stage at all locations was likely the result of the ice jam in the Nigliq Channel near Nuiqsut releasing earlier in the day. The quick rise in stage as the surge of water moved downstream is apparent in the hydrograph for G21 (Table 4.18). Ribbon ice in the Nigliq Channel began to break up and move downstream on May 30 (Photo 4.110). Photo 4.111 shows G23 in the Nigliagvik a few hours before peak stage.

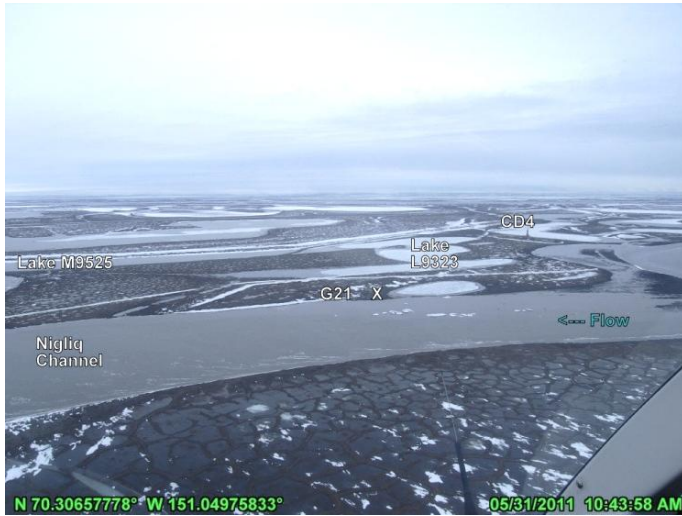
After May 30, stage receded quickly in the Nigliq, Lake L9341, and the Nigliagvik (Photo 4.112, Photo 4.113, and Photo 4.114, respectively). Daily monitoring ended at all proposed CD5 road crossing locations on May 31. At that time, the Nigliq Channel in the vicinity of G21 was fairly clear of ice and snow, although occasional floes were observed. Ice remained on Lake L9341, which was still connected to the Nigliq Channel to the northwest. There was significant ice and snow in the Nigliagvik in the vicinity of G23, the majority along the steeper and higher left (west) bank.

PHOTO 4.112: G21 IN THE NIGLIQ AS BREAKUP FLOWS RECEDE, LOOKING NORTHWEST; MAY 31, 2011

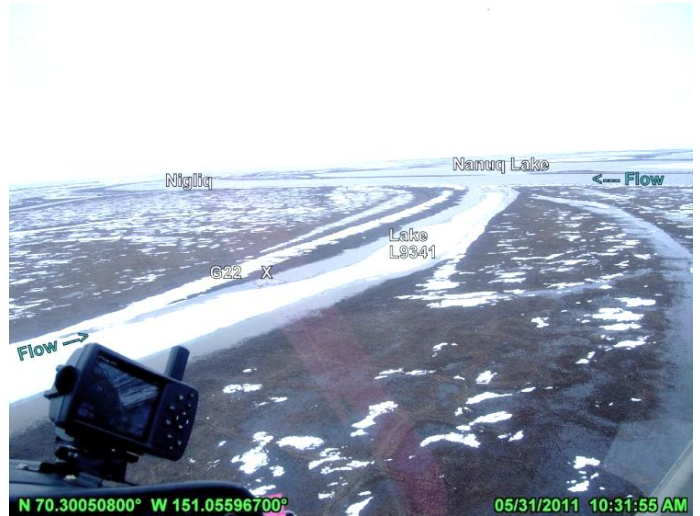
PHOTO 4.113: G22 AT LAKE L9341 AS BREAKUP FLOWS RECEDE, LOOKING EAST; MAY 31, 2011

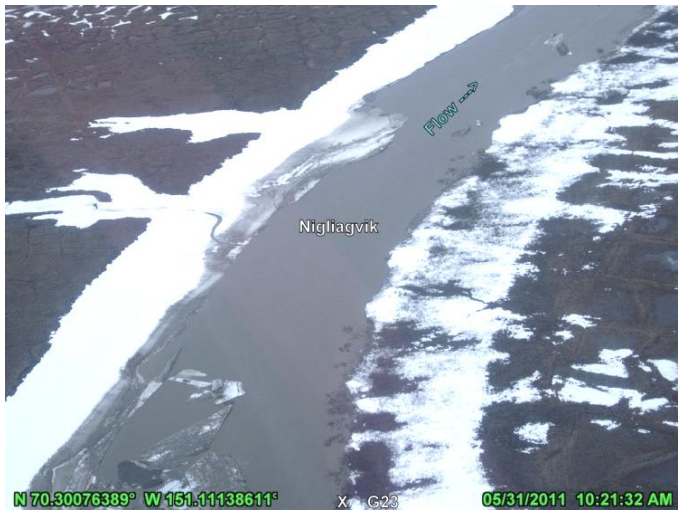
PHOTO 4.114: G23 IN THE NIGLIAGVIK AS BREAKUP FLOWS RECEDE, LOOKING DOWNSTREAM (NORTH); MAY 31, 2011

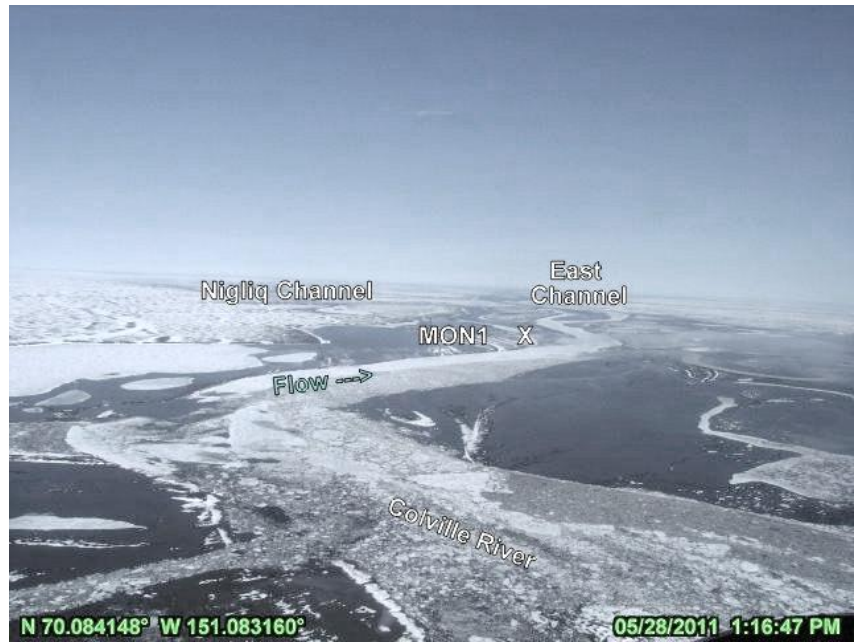
simultaneously. At the time of peak stage at MON1C (19.56 feet BPMSL at approximately 5:30 p.m. on May 28), discharge conditions were heavily influenced by the release of ice jams just upstream of MON1U (Photo 5.1 and Photo 5.2). On May 29 at approximately 4:00 p.m., the ice jam had moved to the Nigliq Channel near Nuiqsut and down the East Channel in the vicinity of MON9 near the horizontal directional drilled (HDD) crossing. This resulted in a second peak in the WSE for MON1. Ice jamming can cause significant backwater effects that are not accounted for when using UC and NUC calculation methods.

PHOTO 5.1: RIBBON ICE AND ICE JAM JUST DOWNSTREAM OF MON1, LOOKING DOWNSTREAM (NORTH); MAY 28, 2011

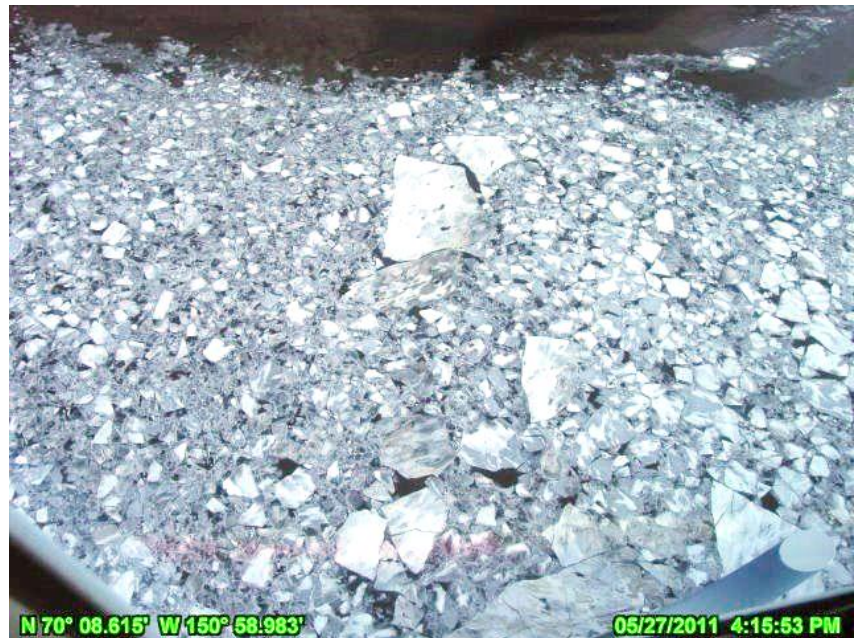
PHOTO 5.2: AERIAL PHOTO OF ICE JAM UPSTREAM OF MON1; MAY 27, 2011

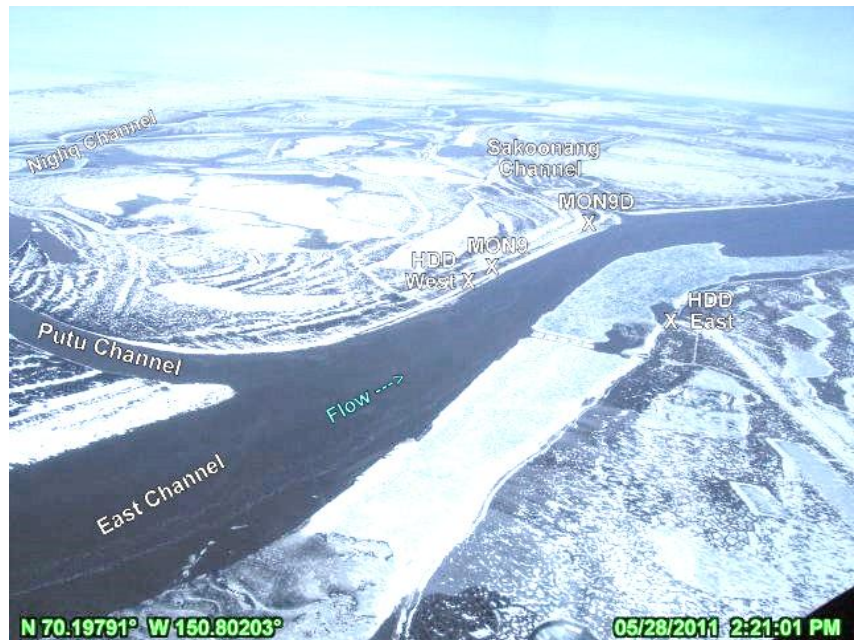
Flow in the East Channel during 2011 breakup was influenced by ice, as shown in (Photo 5.3). Photo 5.4 shows the East Channel near MON9 becoming more ice free by May 31, 2011.

PHOTO 5.3: RIBBON ICE NEAR MON9, LOOKING DOWNSTREAM (NORTHWEST); MAY 28, 2011

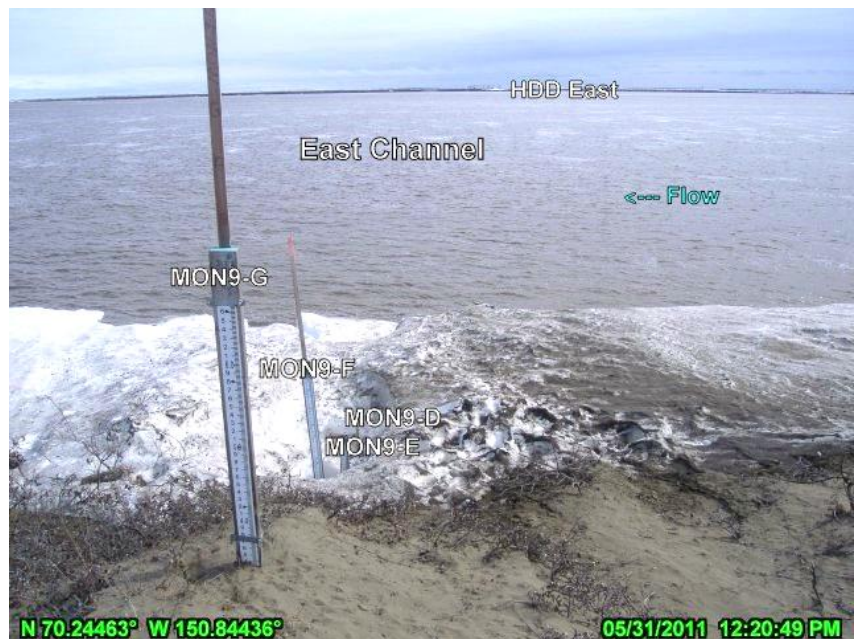
PHOTO 5.4: MON9 LOOKING EAST; MAY 31, 2011

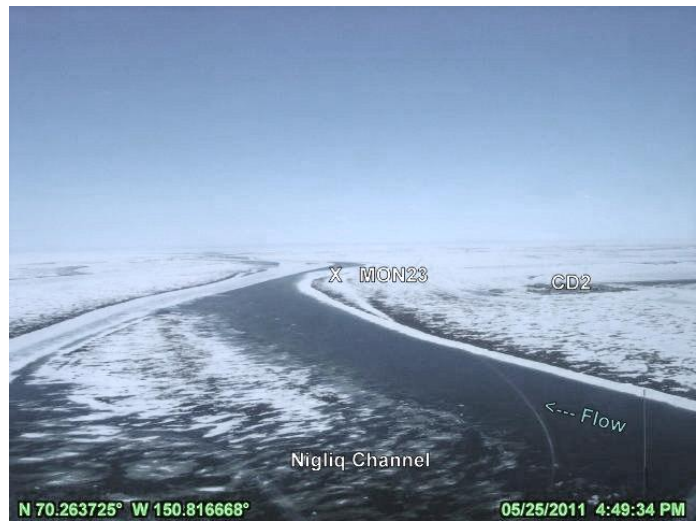
As stated, indirect discharge calculations are performed assuming an ice-free channel and are to be considered a conservative estimate. Flow in the Nigliq Channel during the 2011 breakup was influenced by ice, as shown in Photo 5.5 and Photo 5.6.

PHOTO 5.5: RIBBON ICE NEAR MON23, LOOKING DOWNSTREAM (NORTH); MAY 25, 2011

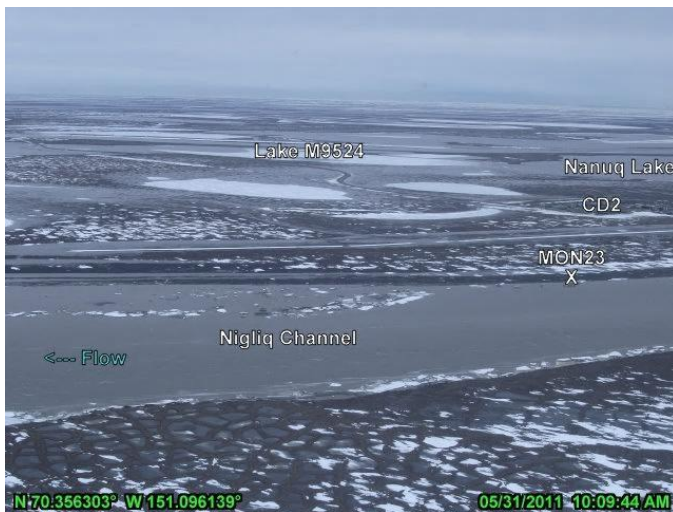
PHOTO 5.7: OCCASIONAL ICE FLOES IN NIGLIQ, LOOKING WEST; MAY 31, 2011

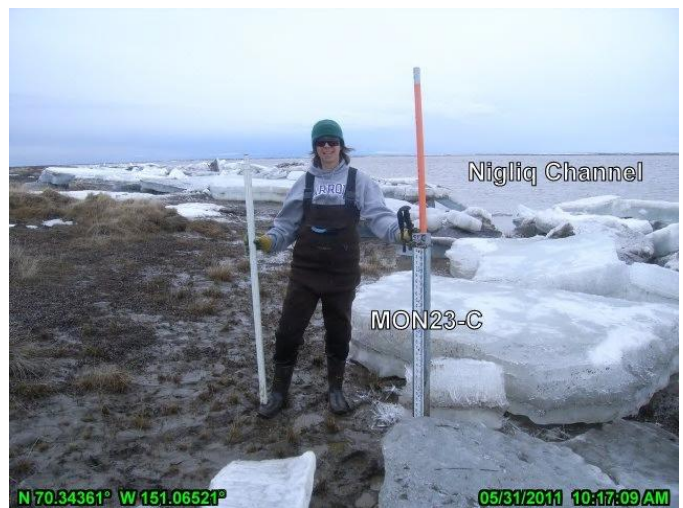
PHOTO 5.6: GROUNDED ICE AT MON23; MAY 31, 2011

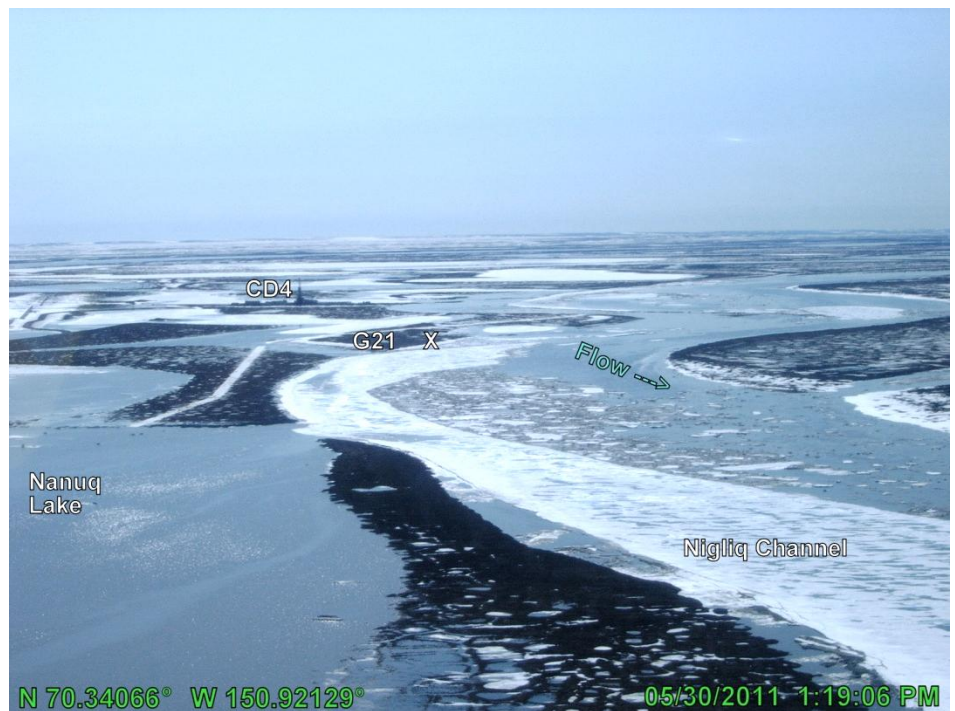
As discussed in Section 5.1, flow in the Nigliq Channel was affected by ice during the 2011 breakup (Photo 5.8). A comparison of the estimated indirect discharge values over time at MON23, located 3.4 RM downstream of G21, suggests that ice events were significant in the Nigliq Channel but did not equally affect both locations. The different magnitudes of ice effects at the two locations is due to ice jam proximity, loss of channelized flow downstream of G21 to overbank areas, and location of the majority of ice jam events occurring upstream of the proposed bridge crossing location.

PHOTO 5.8: ICE JAM IN NIGLIQ NEAR G21 AND G22, LOOKING UPSTREAM; MAY 30, 2011

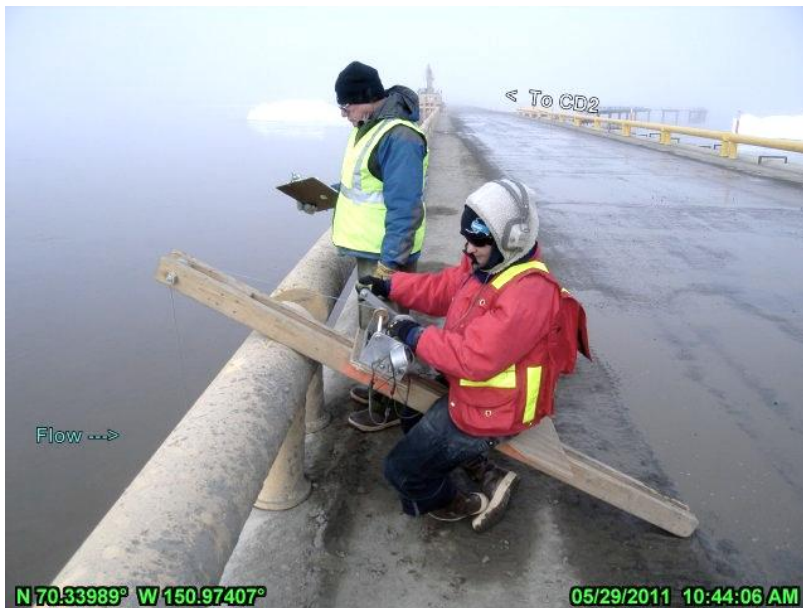
PHOTO 5.9: DISCHARGE MEASUREMENT AT THE 452-FOOT SWALE BRIDGE; MAY 29, 2011

There was some snow piled at the left (west) abutment on the upstream (south) side and occasional grounded ice floes in the area, neither of which were considered to significantly affect the measurement, which was rated as “good to fair,” based on channel conditions (Photo 5.9 and Photo 5.10).

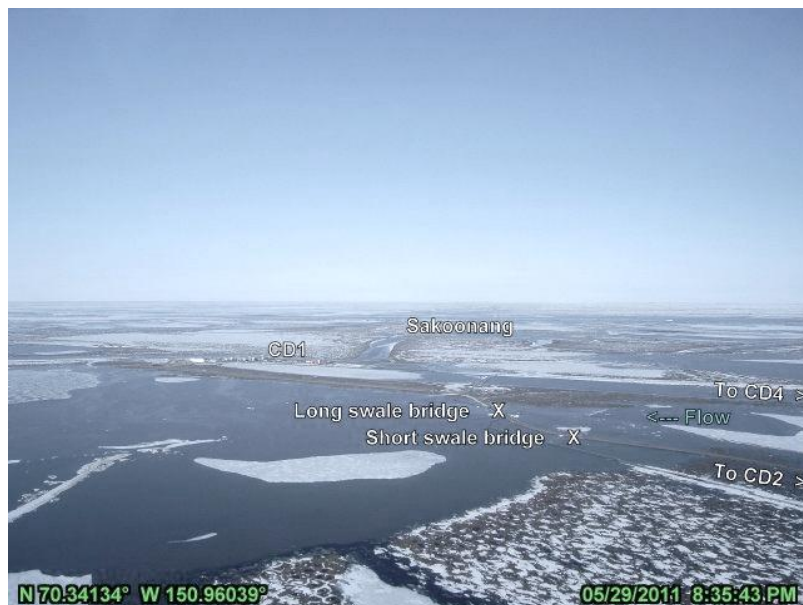
PHOTO 5.10: CONDITIONS AROUND FACILITIES NEAR THE 452-FOOT SWALE BRIDGE, LOOKING SOUTHWEST; MAY 29, 2011

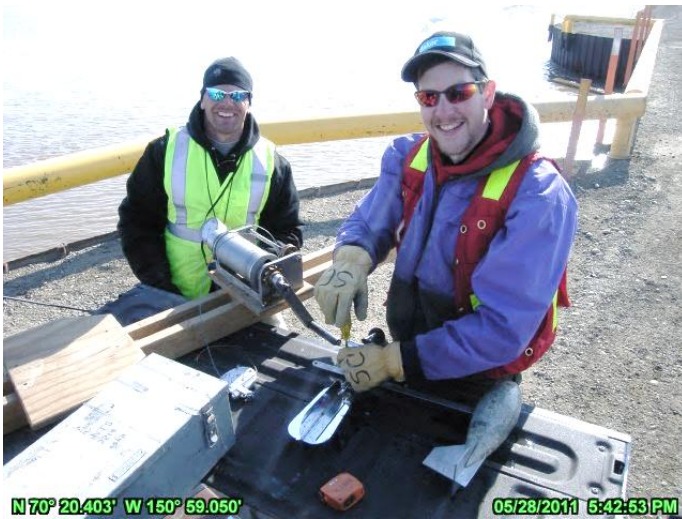
Two direct discharge measurements were conducted at the 62-foot swale bridge. Photo 5.11 shows preparation for the discharge measurement at the short swale bridge. The resulting discharge and velocity values from the measurement performed on May 28, 2011, 840 cfs, with 2.51 fps average velocity, were higher than those of the second measurement taken on May 30, 767 cfs, with 2.01 fps average velocity, as flood flows were receding. The bridge was approximately 90 percent clear of ice and snow on May 29; some snow remained at the left (west) downstream (north) abutment. Occasional ice floes passing through the area did not significantly affect the measurement. The measurement was rated as “fair,” based on channel conditions (Photo 5.12 and Photo 5.13).

PHOTO 5.11: PREPARING FOR THE DISCHARGE MEASUREMENT AT THE 62-FOOT SWALE BRIDGE; MAY 28, 2011

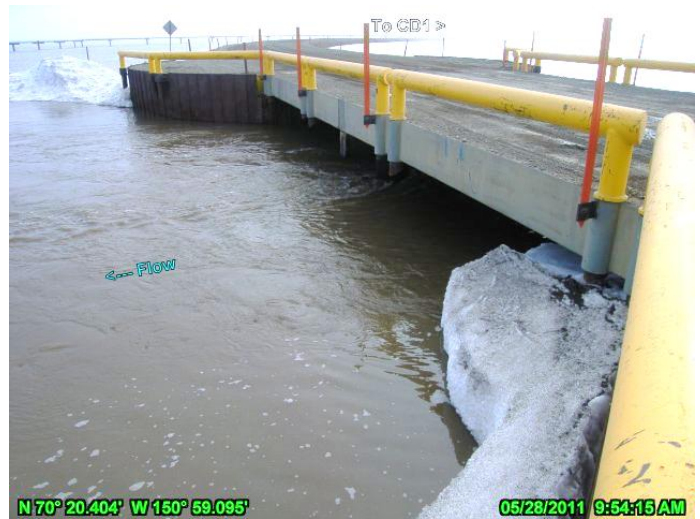
PHOTO 5.12: SNOW AT THE NORTHWEST ABUTMENT OF THE 62-FOOT SWALE BRIDGE; MAY 28, 2011

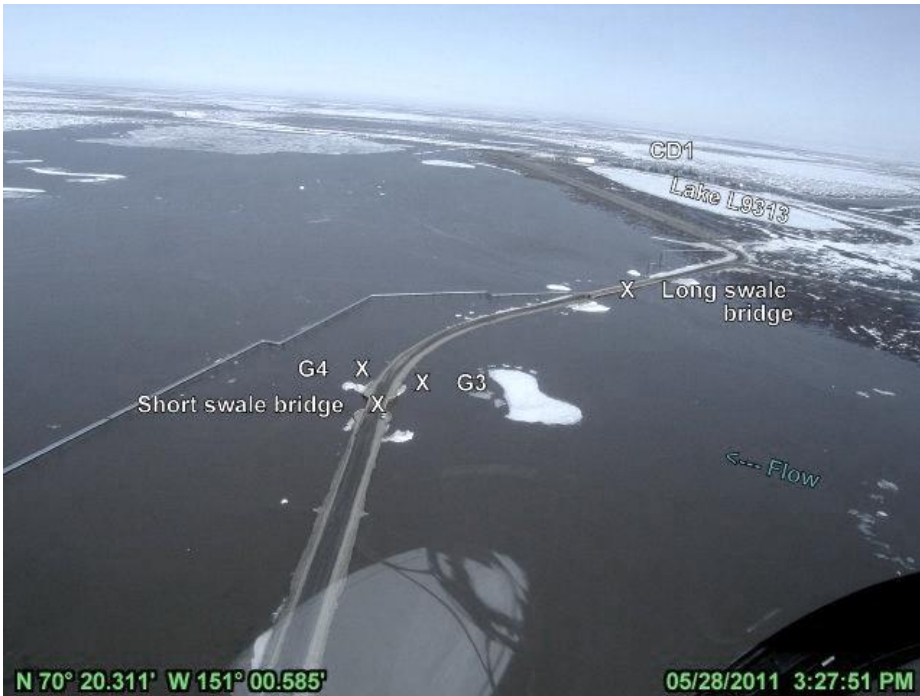
PHOTO 5.13: CONDITIONS AT FACILITIES NEAR THE SHORT SWALE BRIDGE, LOOKING WEST; MAY 28, 2011

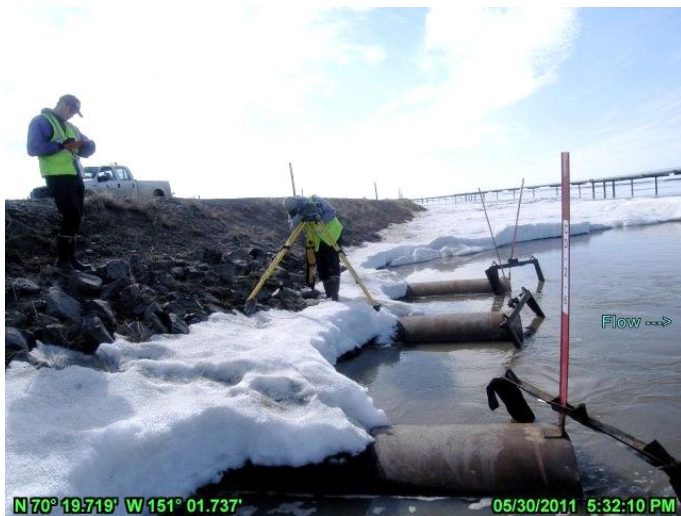
Calculated peak discharge and velocity for the culverts was estimated to have occurred between May 29 and May 30. Photo 5.14 to Photo 5.17 show culverts near G4, G6, G16, and G17 following peak stage.

PHOTO 5.14: CULVERTS NEAR G3-G4, TAILWATER JUST AFTER PEAK STAGE; MAY 30, 2011

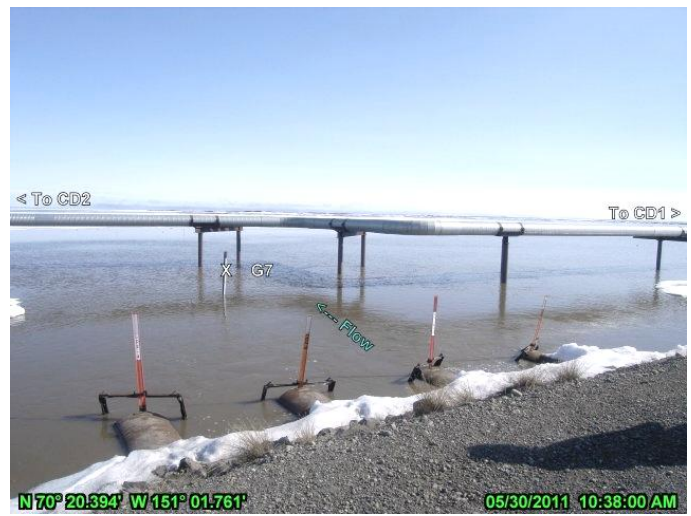
PHOTO 5.15: CULVERTS NEAR G6-G7, TAILWATER JUST AFTER PEAK STAGE; MAY 30, 2011

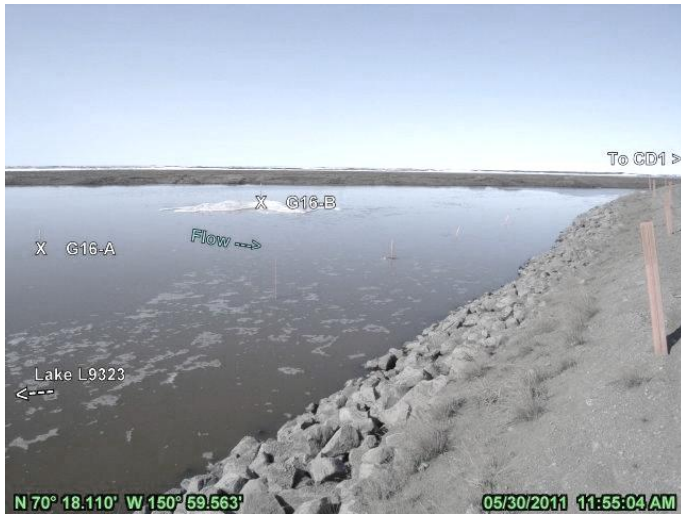
PHOTO 5.16: CULVERTS NEAR G15-G16, HEADWATER JUST AFTER PEAK STAGE; MAY 30, 2011

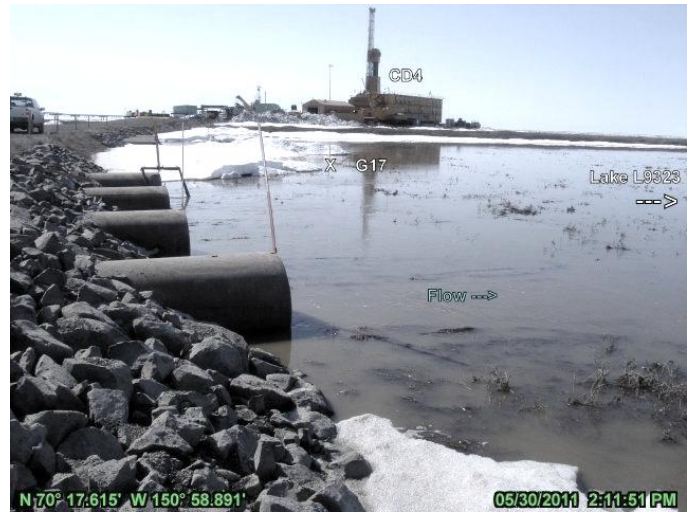
PHOTO 5.17: CULVERTS NEAR G17-G18, TAILWATER JUST AFTER PEAK STAGE; MAY 30, 2011
