2013 COLVILLE RIVER DELTA SPRING BREAKUP MONITORING & HYDROLOGIC ASSESSMENT

Michael Baker, Jr., Inc.
1400 West Benson Blvd.,
Suite 200
Anchorage, Alaska 99503

135141-MBJ-RPT-001 | November 2013

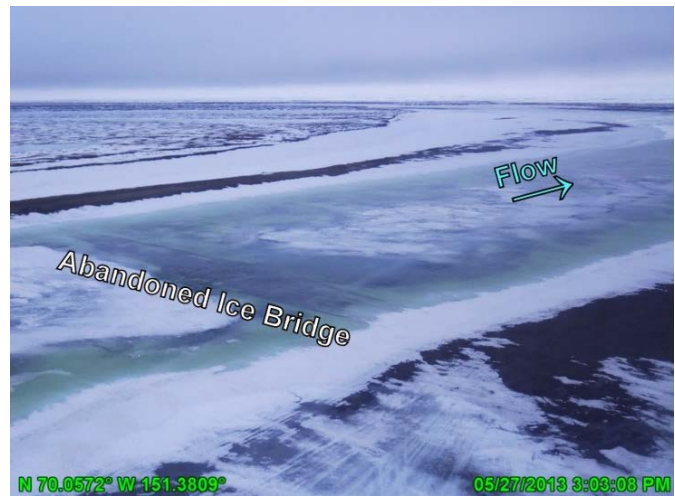
On May 27, field personnel performed a reconnaissance flight on the Colville River upstream of MON1. The leading edge of the melt water in the Colville River was identified approximately 1 mile downstream of Ocean Point. Ocean Point is 35 RM upstream of MON1. Flow was predominantly below the ice, with intermittent pockets of visible open water flow (Photo 3.2).

Photo 3.2: Melt water emerging from below the ice cover and flowing over remnants of an ice bridge near Ocean Point; May 27, 2013

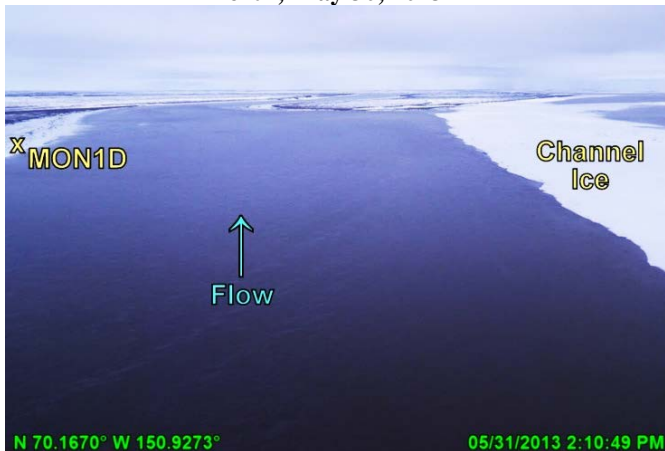
Photo 3.5: Intact channel ice along the east bank of the Colville River at MON1, looking north; May 31, 2013

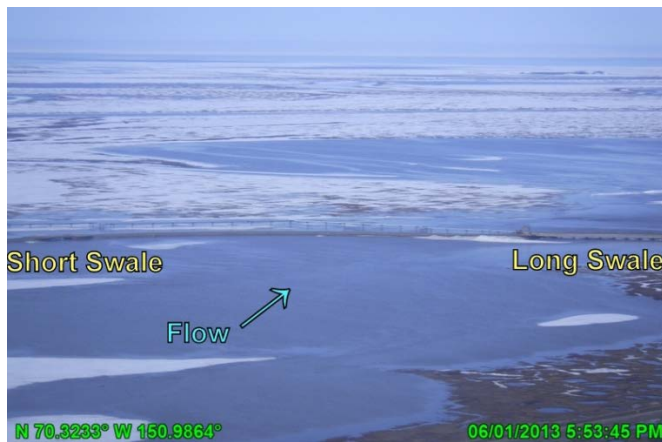
On June 1, flood water had reached facilities. Nanuq Lake and Lake M9524 had recharged over bankfull, and consequently both swale bridges and adjacent culverts along the CD2 road were observed conveying flow (Photo 3.7). Floodwater was also observed in the vicinity of the CD4 road and pad as Lake L9324 continued recharging from the Sakoonang and Nigliq channels (Photo 3.8). An ice jam was developing in the Colville River at the series of bends 7 RM upstream of MON1 (Photo 3.9). Ice floes obstructed by intact channel ice were observed accumulating in the channel bends. Backwater was contained within the active channel banks. The Colville River was free of intact channel ice upstream of the ice jam.

Photo 3.7: Floodwater passing through the CD2 swale bridges and adjacent culverts, looking southwest; June 1, 2013

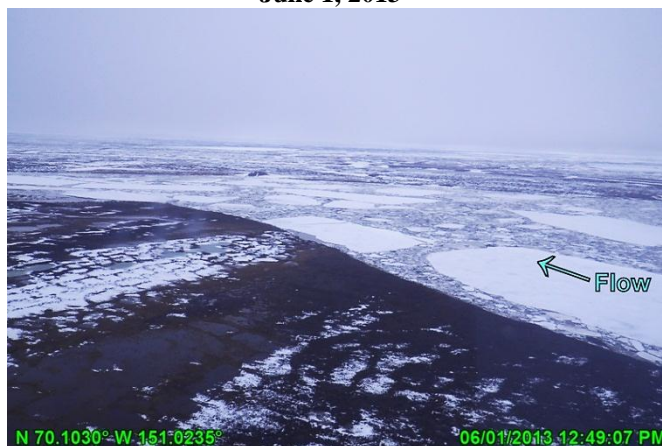
Photo 3.9: Ice jam upstream of MON1, looking southwest; June 1, 2013

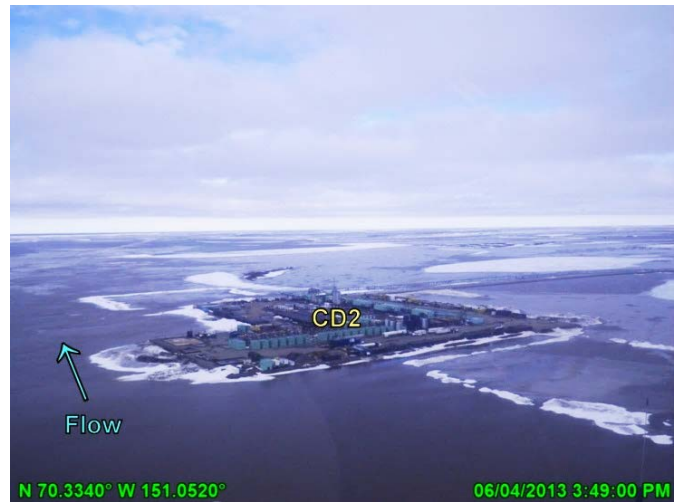
By the afternoon of June 4, floodwater had peaked near the CD2 facilities (Photo 3.12) and by June 5, had peaked near the CD4 and CD1 facilities. Stage crested at the Umiat gage on the morning of June 5 and was rapidly falling by June 6. The ice jam in the Nigliq Channel continued to slowly advance downstream as resilient intact channel ice persisted late into the flood event; however, backwater flooding diminished as water

Photo 3.12: CD2 facility during peak; June 4, 2013

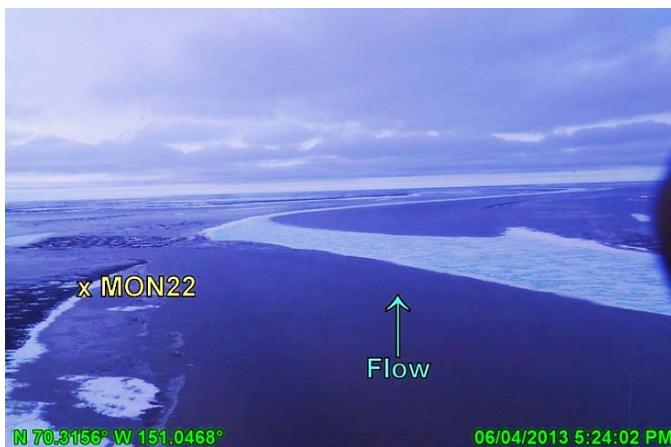
On June 4, an ice jam, located approximately 1 RM upstream of CD4, was observed in the Nigliq Channel. Floodwater was diverted around the upstream ice jam and extensive overbank flooding was observed around MON22 (Photo 3.15). No HWM was apparent on the MON22 gages. The observed peak WSE of 10.56 feet BPMSL was recorded on June 4 around 2:45 PM and is likely lower than the actual peak WSE (Table 3.4 and Graph 3.6). By June 6, stage had receded and grounded ice floes were observed on the bar near MON22 (Photo 3.16). Channel ice remained intact.

Photo 3.15: Extensive overbank flooding at MON22, looking north; June 4, 2013

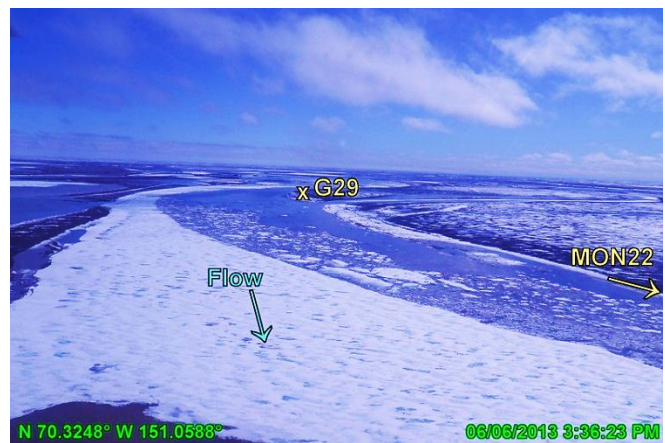
Photo 3.16: Intact channel ice in the Nigliq Channel with grounded ice floes on the bar near MON22; June 6, 2013

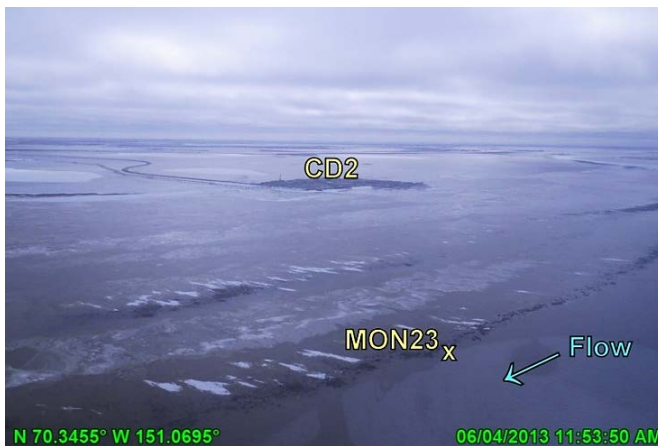
The leading edge in the Nigliq Channel passed MON23 on May 30. Stage was first measureable on the MON23 gages on June 1. On June 4, an ice jam, located approximately 1 RM upstream of CD4, was observed in the Nigliq Channel. Floodwater was diverted around the upstream ice jam and extensive overbank flooding was observed between MON23 and CD2 pad (Photo 3.17).

Photo 3.17: Extensive overbank flooding between MON23 and CD2 pad, looking southeast; June 4, 2013

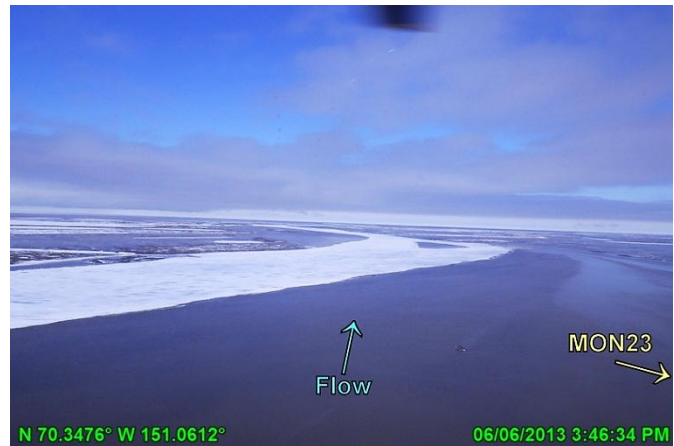
Photo 3.18: Intact channel ice in the Nigliq Channel at MON23, looking north; June 6, 2013

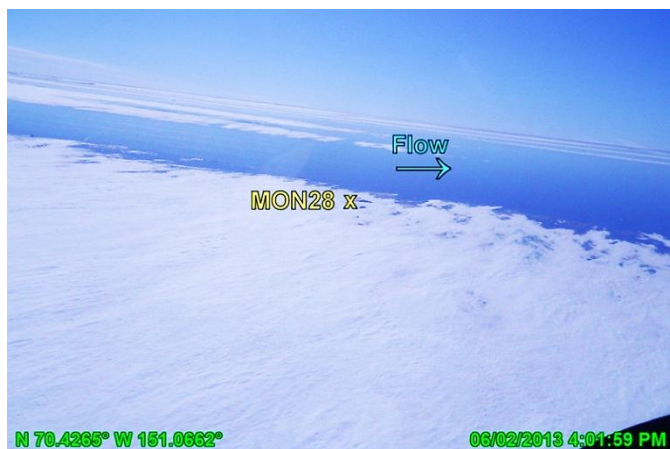
The leading edge passed MON28 sometime between May 30 and May 31. Stage was first measurable on the MON28 gage on the morning of May 31. On June 2, extensive overflow onto sea ice was observed north of MON28 (Photo 3.19).

Photo 3.19: Extensive overflow onto bottom fast sea ice near MON28, looking northwest; June 2, 2013

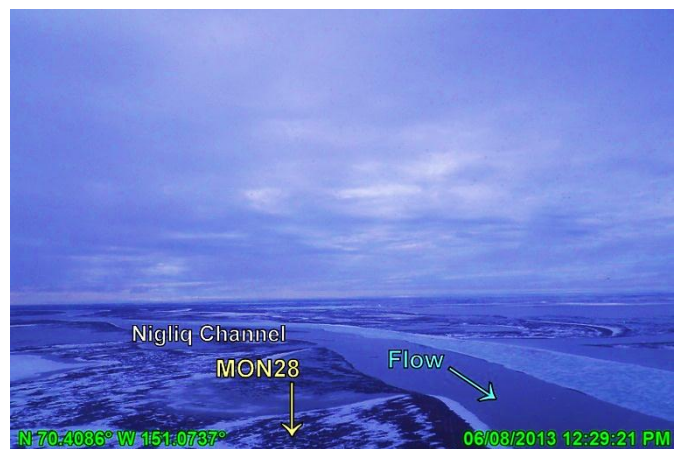
Photo 3.20: Intact channel ice in the Nigliq Channel south of MON28, looking south; June 8, 2013

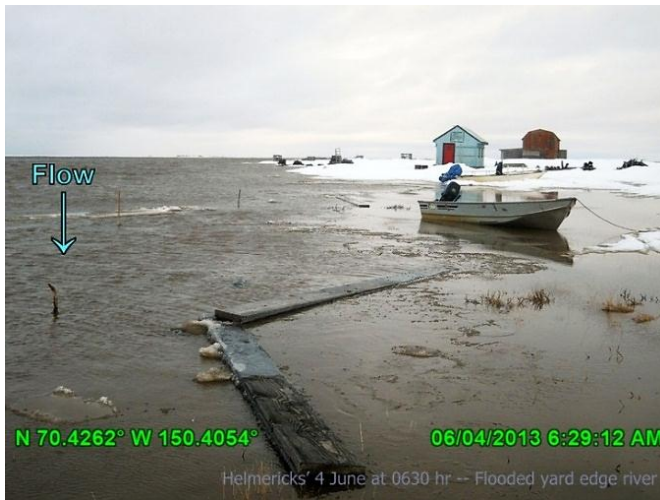
Water levels reached MON 35 gage D in the early morning of May 31. On June 1 and 2, the channel ice remained intact. By June 3, low sections of Anachlik Island and the runway were under water (Photo 3.21 and Photo 3.22). Flood water entered the Helmericks family’s drinking water lake on June 4 (Photo 3.23). On the morning of June 5, a peak WSE of 6.03 feet BPMSL was recorded around 8:30 AM (Table 3.7 and Graph 3.9).

Photo 3.21: Helmericks' flooded yard near the river edge; looking south; June 4, 2013

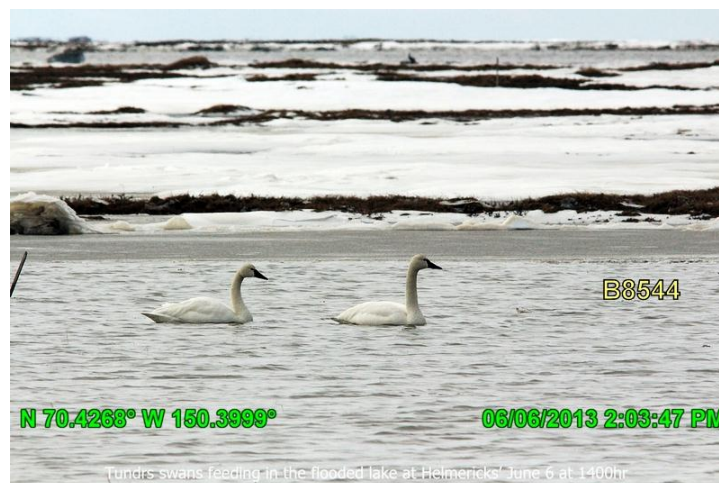
Photo 3.23: Tundra swans feeding at flooded Lake B8544, Helmericks family’s drinking water source; June 6, 2013

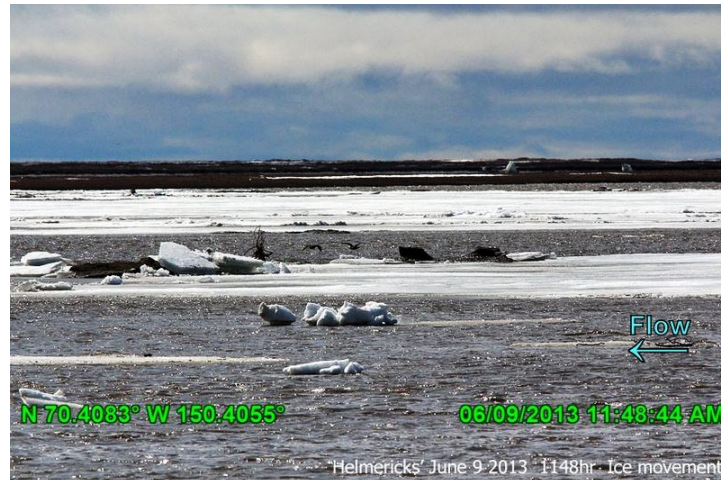
According to Jim Helmericks, the water level reached the second highest stage in the past 20 years and the breakup flood stage had not surpassed 6 feet since 2000 (6.03 in 2013). After June 5, water levels began to drop. On June 9, the channel ice began to break up and large floes mixed with sticks and crushed ice began to flow through the channel (Photo 3.24). An ice jam holding in the lower reaches of the Colville East Channel near Helmericks Homestead released on the evening of June 11.

Photo 3.24: Ice movement in the channel; June 9, 2013

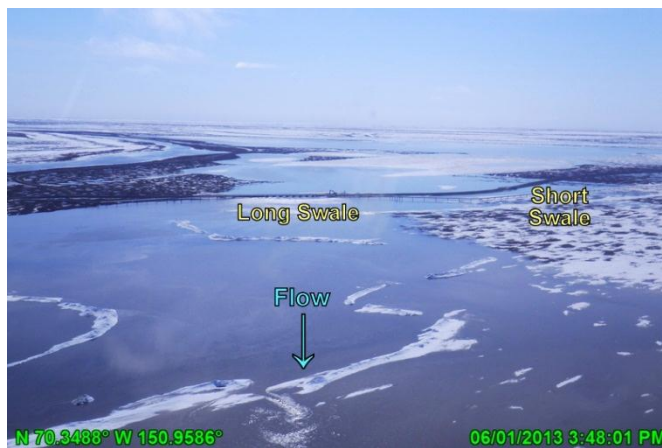
Photo 3.25: Initial flow through the swale bridges, looking south; June 1, 2013

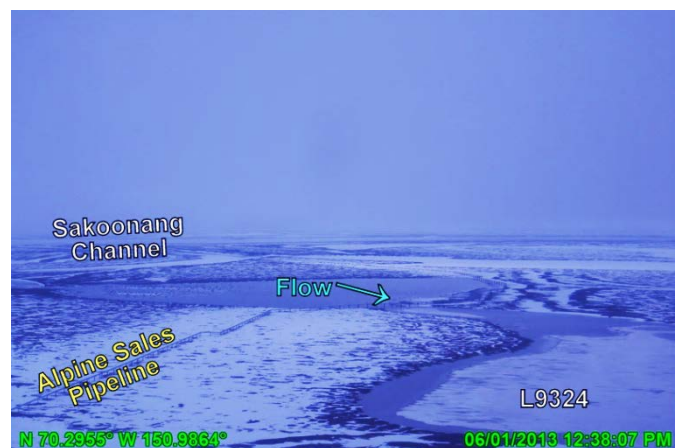
Photo 3.26: Sakoonang Channel flowing into Lake L9324, looking south; June 1, 2013

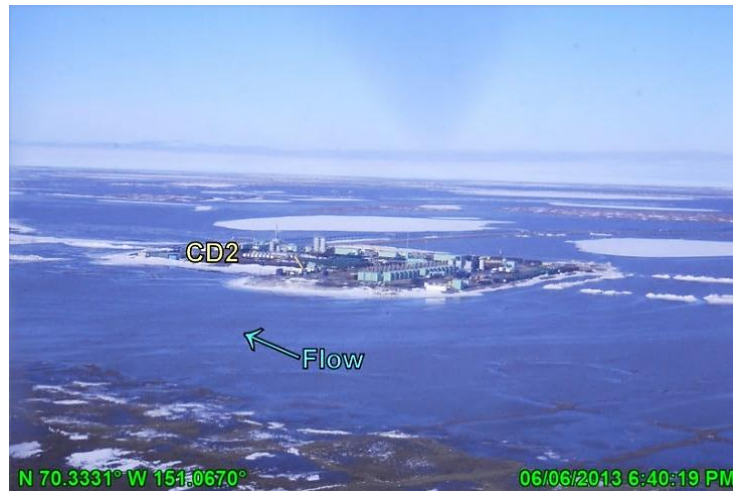
Photo 3.30: Nigliq Channel floodwaters remained high around the CD2 pad, looking northeast; June 6, 2013

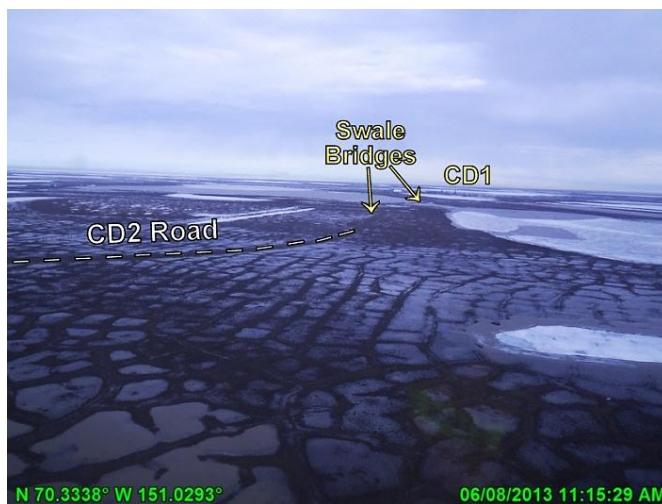
Photo 3.31: Recession of floodwater along the CD2 road, looking east; June 8, 2013

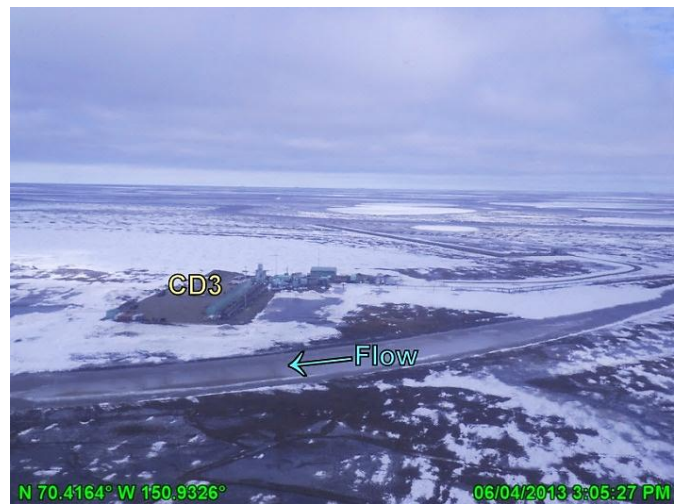
The CD3 pad and airstrip remained above flood level for the duration of the 2013 breakup flood event (Photo 3.32). Only local melt was observed at gage G11.

Photo 3.32: CD3 pad and airstrip near peak flood conditions, looking east; June 4, 2013

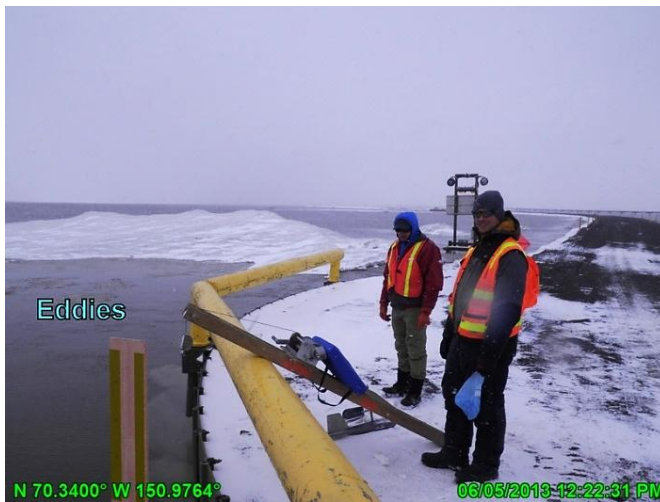
Discharge measurements at the 452-foot (long) and the 62-foot (short) swale bridges were performed near peak stage. Peak WSE at the CD2 road gages G3 and G4 occurred in the afternoon on June 4. Discharge measurements were performed in the afternoon on June 5 (Photo 3.33). Stage was falling during the discharge measurements. The direct discharge notes are available in Appendix D.

Photo 3.33: Beginning direct discharge measurements at the long swale bridge with snow berm upstream of left bank, looking southwest; June 5 2013

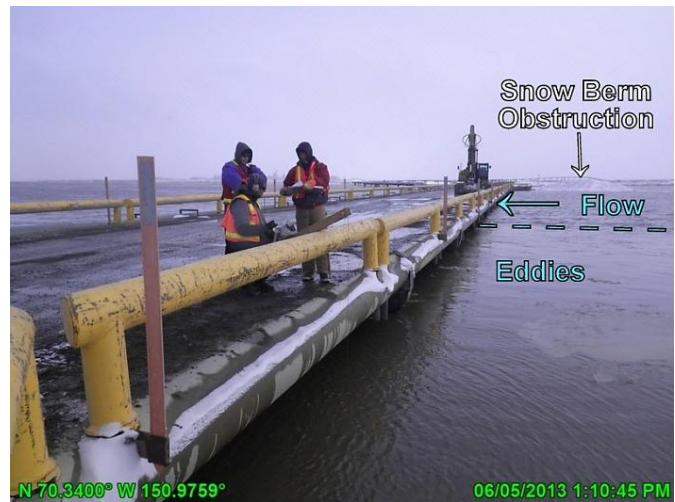
The resulting discharge and velocity values observed on June 5 at the long swale bridge were 7,286 cfs with an average velocity of 2.5 fps. The measurement was rated good based because no snow or ice obstructions were observed in the bridge profile between the abutments. Snow berms were present upstream of the long swale bridge which produced eddies causing a minor flow reversal along the left (west) abutment (Photo 3.34). Grounded ice was found downstream of the bridge and had no impact on the passage of flood water.

Photo 3.34: Conditions through the long swale bridge during direct discharge measurements, looking east; June 5, 2013

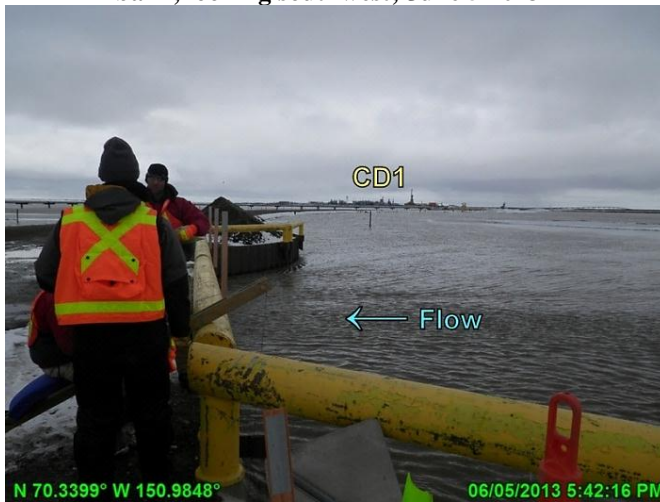
The observed discharge and velocity at the short swale bridge was 1,608 cfs and 3.6 fps. Minimal snow blockage along the left (west abutment) extending approximately 20 feet into the flow was observed at the time of measurement (Photo 3.35). The snow blockage did not appear to impede flow through the bridge opening; therefore, the measurement was rated good. Grounded ice was found downstream of the bridge and did not impact the passage of flood water (Photo 3.36).

Photo 3.35: Conditions upstream of the short swale bridge while preparing for the direct discharge measurements, looking east; June 5, 2013

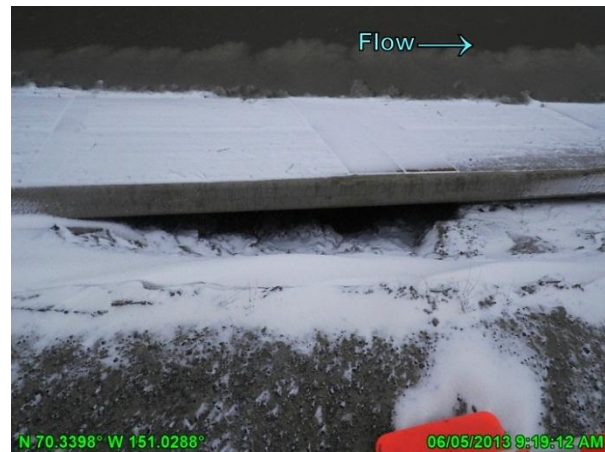
Snow was cleared from the CD2 and CD4 culvert batteries prior to the arrival of floodwater. Excavated snow from the upstream side of culvert battery CD2-4 through CD2-7 was placed directly in front of the culverts. During breakup, flow was diverted around the snow piles and accelerated as it flowed parallel to the road embankment before entering the culvert inlets. The focused flow along the road embankment caused local erosion to the road embankment east of the culvert battery. This was quickly identified and mitigated through erosion prevention measures. Photo 3.37 through Photo 3.41 shows the initial erosion and protection of the road at the CD2 culverts. By June 8, floodwater had receded from the gravel structures.

Photo 3.38: Erosion prevention implemented (rig mat) near peak WSE at CD2 culvert battery, June 5, 2013

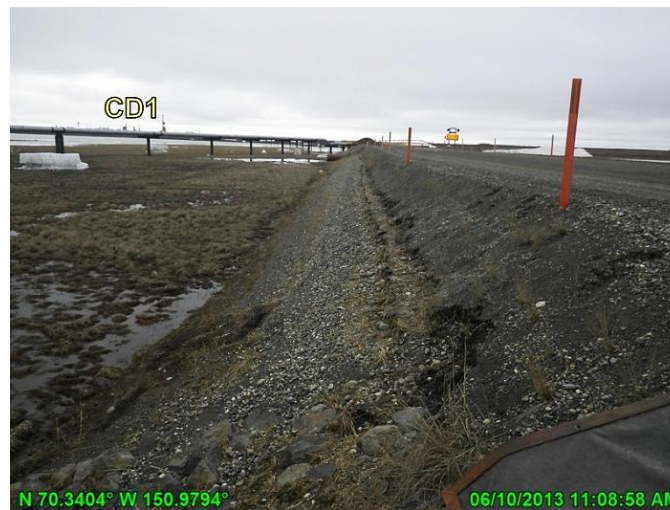
Following peak stage, visual inspections of the CD2 and CD4 gravel road prisms were conducted. Photographic documentation of the condition of the gravel facilities was recorded on June 10. High-water marks due to erosion were identified by debris stranded on the road prism side slopes or where silts and fine-grained sands had been winnowed or washed away. Photo 3.39 shows an example of winnowing on the downstream side of the CD2 road near culvert CD2-23. Minimal erosion was observed along the CD4 road, and was localized near the culvert batteries. Photo 3.40 shows representative conditions near the north and south CD4 batteries. As floodwater receded, tension cracks, seen in Photo 3.41, formed at the top of the slope between the swale bridges.

Photo 3.39: Winnowing of fine grained material on the south side of the CD2 road; June 10, 2013

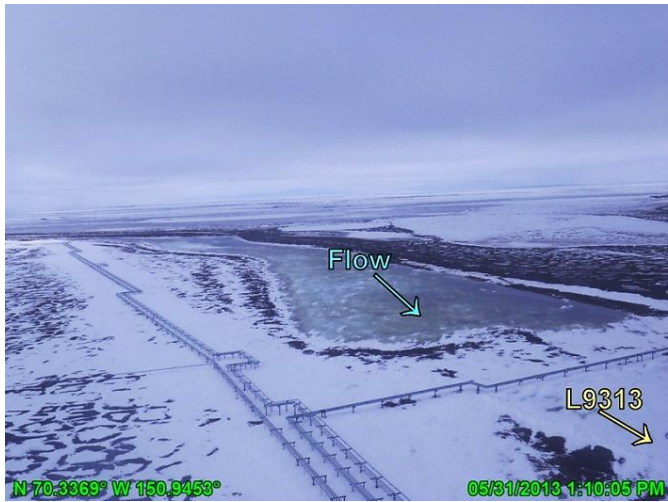
Photo 3.42: Initial recharge from Lake M9525 approaching Lake L9313, looking southwest; May 31, 2013

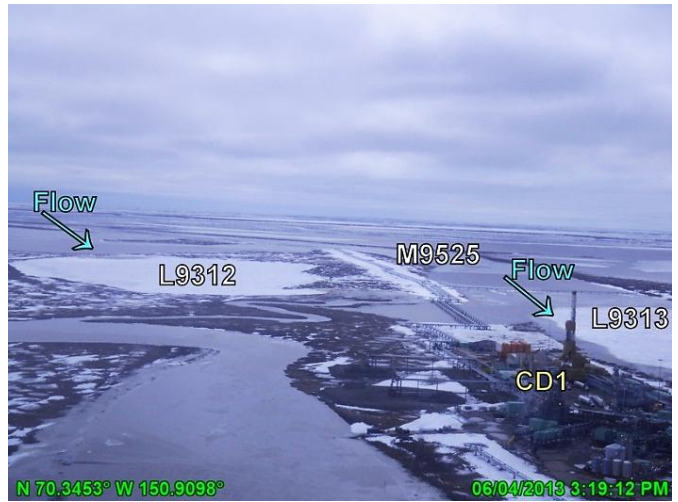
Photo 3.43: Lakes L9312 and L9313 receiving recharge from the Sagoonang Channel and Lake M9525 respectively, looking west; June 4, 2013

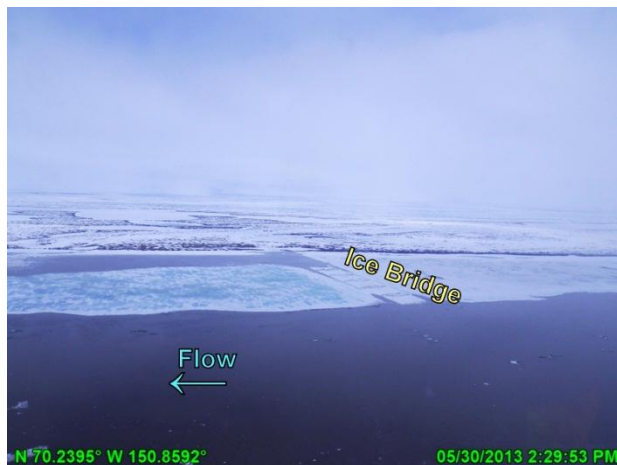
The leading edge passed the Colville ice bridge sometime between May 29 and May 30 (Photo 3.44). By the time peak WSE occurred, the ramp on the west side of the Colville ice bridge was all that remained intact (Photo 3.45).

Photo 3.44: The leading edge passed the Colville ice bridge, looking east; May 30, 2013

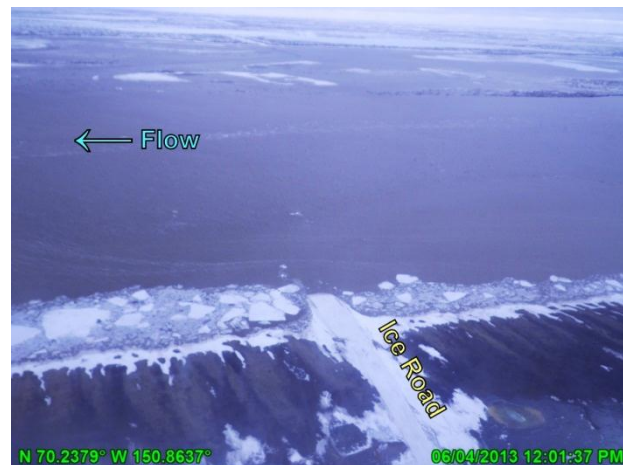
Photo 3.45: Colville ice bridge near peak WSE, looking east; June 4, 2013

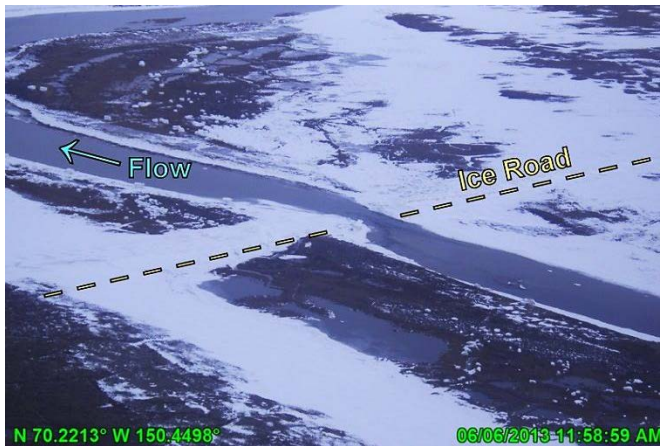
Breakup progression at the Kachemach River ice bridge was slower than at the Colville ice bridge. On June 2, local melt was present at the Kachemach River ice bridge. Photo 3.46 shows the Kachemach River ice bridge during breakup passing flow on June 6.

Photo 3.46: Low velocity flow passing Kachemach River ice bridge, looking north; June 6, 2013

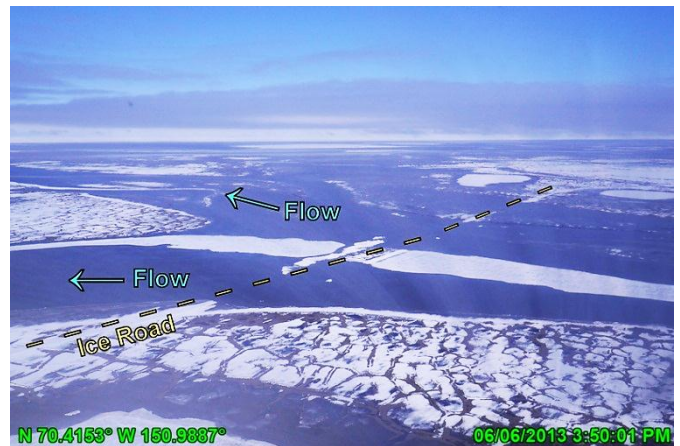
Flooding and melt during breakup at all other ice road crossings in the CRD progressed unimpeded; Photo 3.47 and Photo 3.48 show bridges passing flow on the Tamayayak Channel and at Toolbox Creek. The exploration ice road crossing on the Nigliq Channel and the Nigliagvik are shown in Photo 3.49 and Photo 3.50.

Photo 3.47: Tamayayak Channel ice bridge crossing, looking east; June 6, 2013

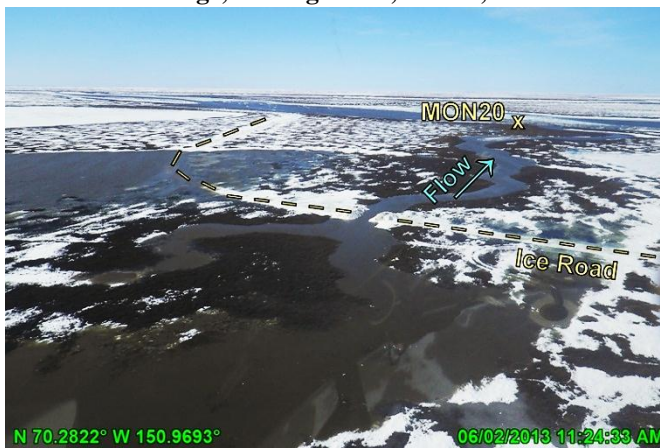
Photo 3.48: Low velocity flow passing Toolbox Creek ice bridge crossing, looking west; June 2, 2013

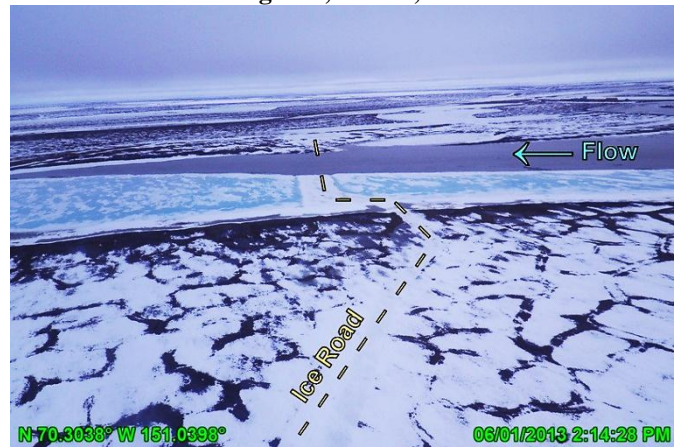
Photo 3.49: Nigliq Channel exploration ice bridge crossing passing flow, looking east; June 1, 2013

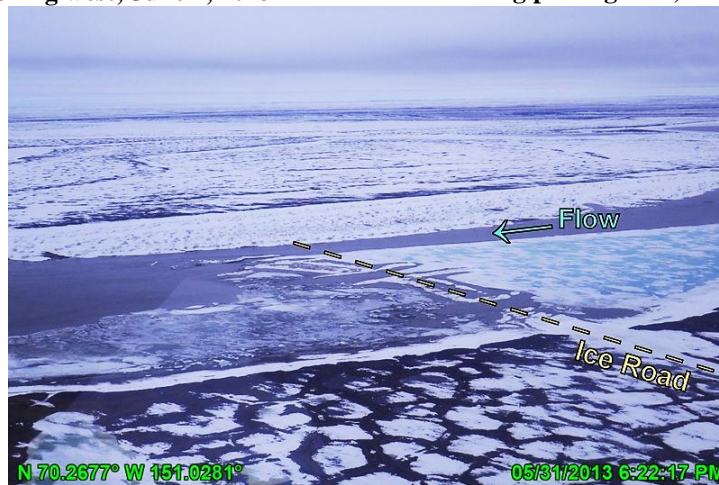
Photo 3.50: Nigliagvik exploration ice bridge crossing, looking southeast; May 31, 2013

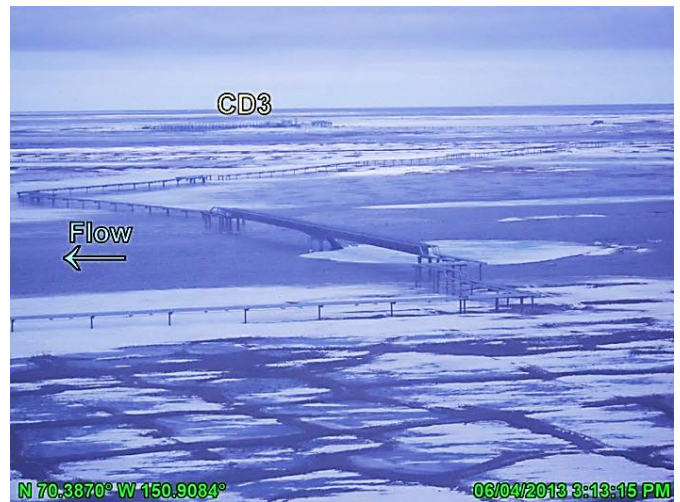
On June 4, an ice jam in the Colville East Channel at the Tamayayak Channel bifurcation was diverting floodwater down the Tamayayak and Sakoonang channels. According to PT data, peak stage at the TAM and ULAM occurred at 8:00 AM on June 4 with recorded WSEs of 9.49 feet BPMSL and 8.71 feet BPMSL, respectively (Table 3.31 and Graph 3.35). Extensive overbank flooding was observed at all three pipeline crossings (Photo 3.51 through Photo 3.53).

Photo 3.52: Overbank flooding at the Tamayayak Channel pipeline crossing, looking north; June 4, 2013

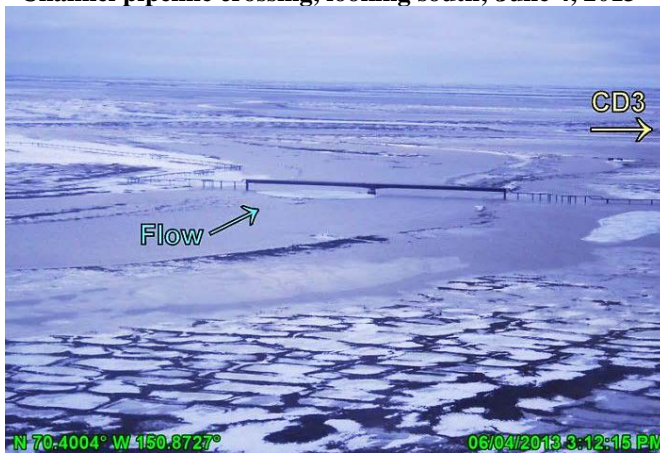
Photo 3.53: Overbank flooding at the Ulamnigiaq Channel pipeline crossing, Looking northwest; June 4, 2013

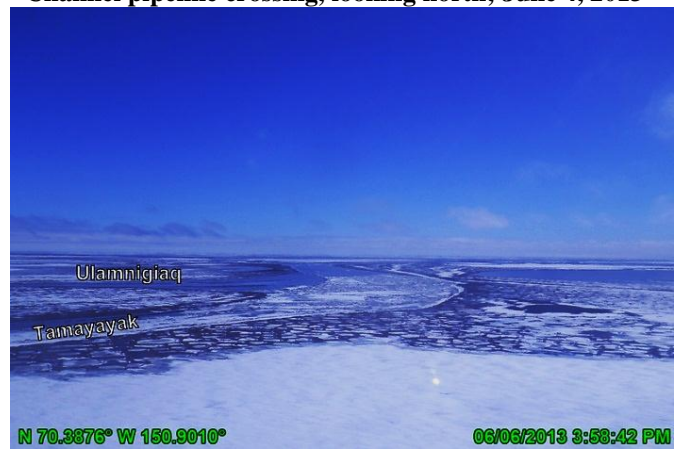
Floodwater directed through the CD2 swale bridges joined in the Sakoonang Channel downstream of the SAK pipeline crossing, contributing to the rising WSE on June 4. On June 6, an ice jam was observed on the Tamayayak Channel at the Ulamnigiq Channel bifurcation causing a slight drop in WSE at the TAM and ULAM crossings (Photo 3.54).

Photo 3.54: Ice jam on the Tamayayak Channel at the Ulamnigiaq Channel bifurcation, looking southeast; June 6, 2013

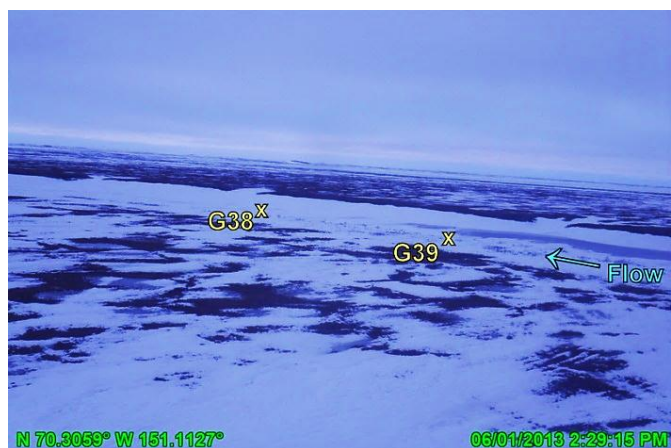
On June 1, stage was first measurable on the proposed Lake L9341 and Nigliagvik crossings. Leading edge traveling upstream and downstream in the Nigliagvik was converging at the proposed crossing (Photo 3.55). Nigliq Channel backwater was entering Lake L9341 from the north (Photo 3.56).

Photo 3.55: Leading edge traveling upstream at the proposed Nigliagvik crossing, looking southwest; June 1, 2013

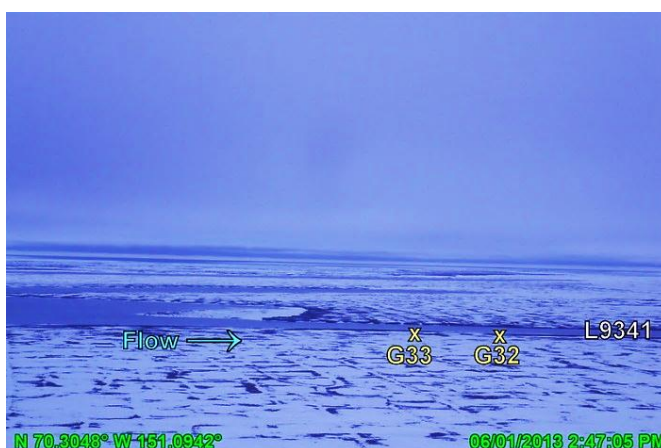
Photo 3.56: Nigliq Channel backwater entering Lake L9341 from the north, looking east; June 1, 2013

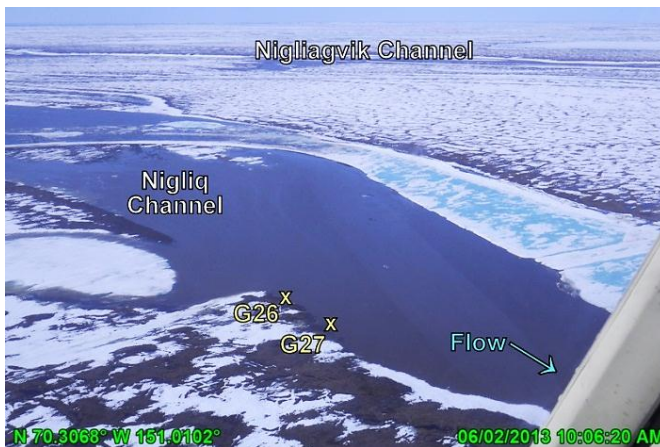
On June 2, water levels continued to increase in the Nigliq Channel. Channel ice remained intact at the proposed Nigliq Channel crossing and stage was approaching bankfull conditions (Photo 3.57). The small lake to the southeast of the proposed Nigliq Channel crossing was connected to the Nigliq Channel. Stage increased at the proposed Lake L9341 and Nigliagvik crossings; however, flow was stagnant at both locations.

Photo 3.57: Bankfull conditions and intact channel ice at the proposed Nigliq Channel crossing, looking southwest; June 2, 2013

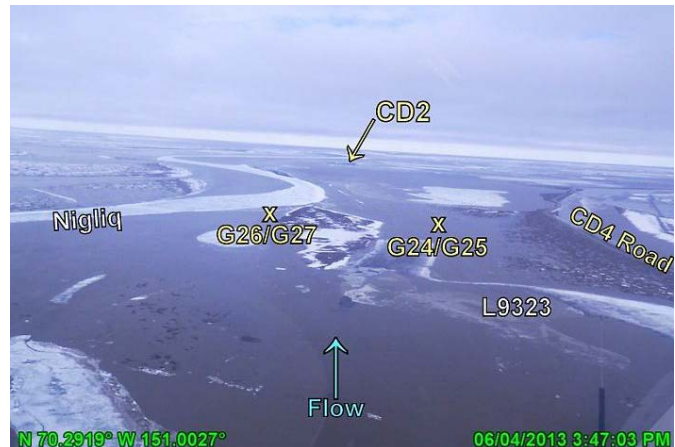
the upstream ice jam extensive overbank flooding was observed along the proposed CD5 road alignment and at all proposed crossings. Nigliq Channel floodwater inundated Lake L9323 and stage was measurable on gages G30/G31, situated on higher ground between the proposed Nigliq Channel and Lake L9341 crossings (Photo 3.58). Channel ice remained intact on the Nigliq Channel although some transverse cracks were forming (Photo 3.59).

Photo 3.58: Overbank flooding at the proposed Lake L9323 and Nigliq Channel crossing, looking north; June 4, 2013

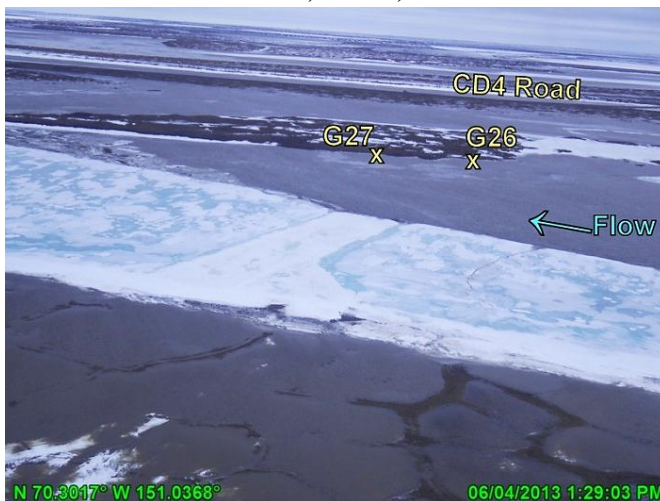
Photo 3.59: Intact channel ice with transverse cracks forming at the Nigliq Channel crossing, looking east; June 4, 2013

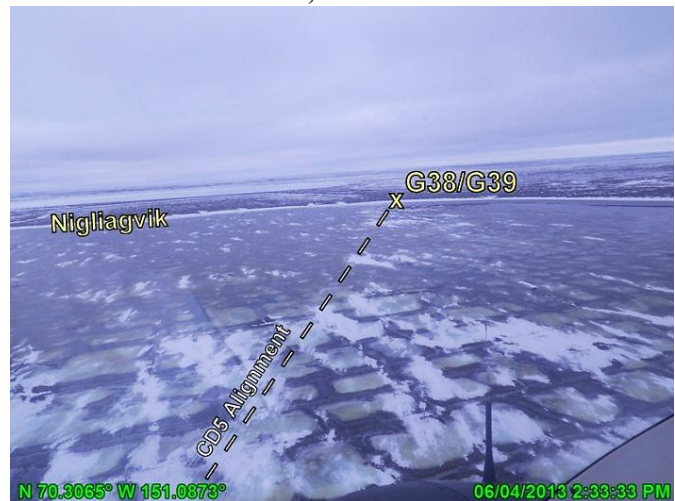
On June 4, extensive flooding was observed on the high ground between the proposed Lake L9341 and Nigliagvik crossings (Photo 3.60). Gages G34/G35 and G36/G37 situated along the proposed CD5 road between the proposed Lake L9341 and Nigliagvik crossings had measurable stage. WSE gradients were observed at the proposed Lake L9341 and Nigliagvik crossings indicating south to north flow.

Photo 3.60: Extensive flooding along the proposed CD5 road alignment between the proposed Lake L9341 and Nigliagvik crossings, looking west; June 4, 2013

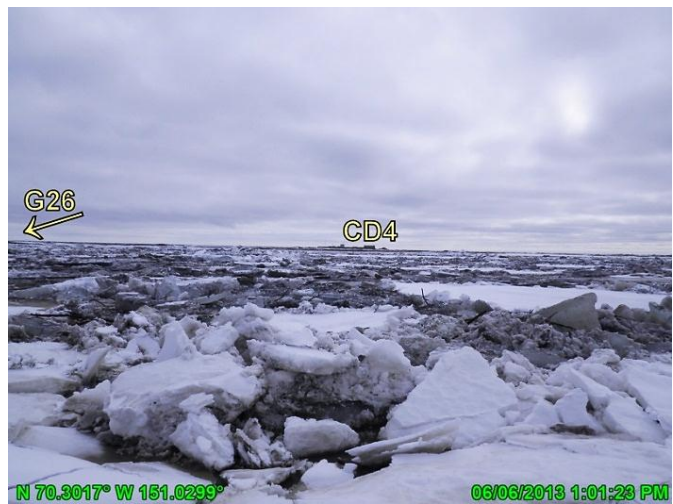
By June 6, the Nigliq Channel ice jam had advanced to the proposed Nigliq Channel crossing (Photo 3.61). Although stage had decreased at all proposed CD5 crossings, a large amount of backwater was retained by the ice jam causing overbank flooding at the proposed Nigliq Channel and Lake L9323 crossings. On the afternoon of June 6, the field crew observed the sudden release of the ice jam at the proposed Nigliq Channel crossing. Water levels were observed increasing as a surge of backwater and ice floes passed through the proposed crossing (Photo 3.62). A small ice jam was observed at the proposed Nigliagvik crossing on June 6, but did not appear to retain backwater.

Photo 3.62: Ice jam release at the proposed Nigliq Channel crossing, looking east; June 6, 2013

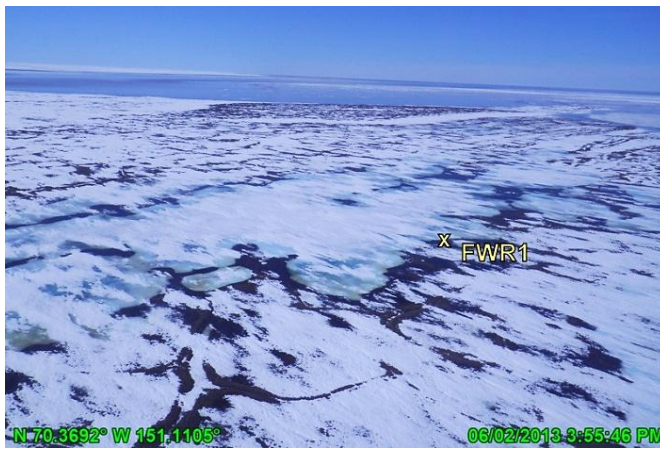
On June 2, much of the area around FWR1 and FWR2 was still frozen with snow cover and ponded water on top of bottom-fast ice in lakes and low centered polygons (Photo 3.63). Nigliq Channel overflow onto the sea ice in Harrison Bay was observed encroaching on the FWR1 and FWR1 area from the northwest.

Photo 3.63: Snow cover and ponded water near FWR1; overflow in Harrison Bay, looking northwest; June 2, 2013

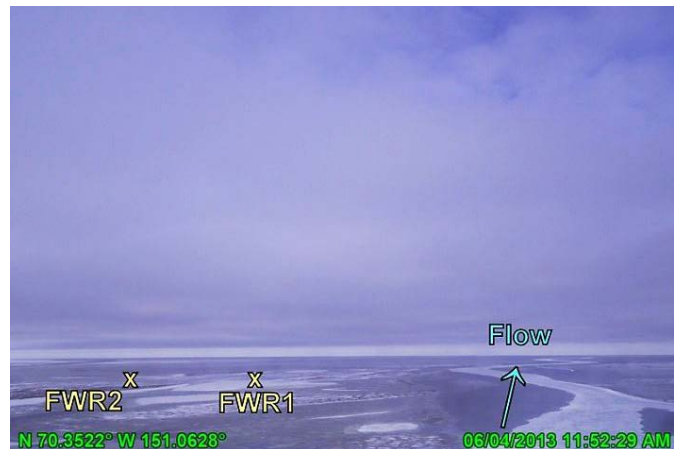
By June 4, widespread inundation was observed in the FWR1 and FWR2 area. Flooding was observed from the Nigliq Channel to the south and from Harrison Bay overflow to the northwest (Photo 3.64).

Photo 3.64: Widespread inundation near FWR1 and FWR2, looking northwest; June 4, 2013

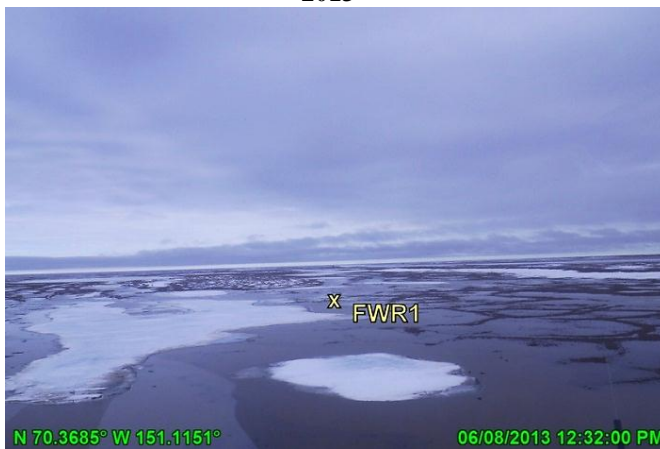
On June 8, WSE readings were collected from the air as the helicopter hovered above the gages. Extensive ponded water around FWR1 and FWR2 prevented the helicopter from landing (Photo 3.65). On June 30, a

Photo 3.65: Ponded water between FWR1 and FWR2, looking west; June 8, 2013

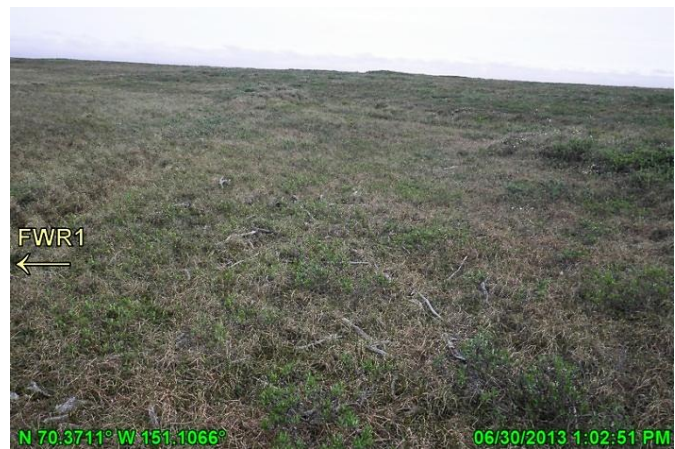
driftwood line near FWR1 was surveyed to help evaluate the peak stage (Photo 3.66). Table 3.39 and Graph 3.43 present observations and WSE recorded for FWR1 and FWR2. The 2D surface-water model was used to help qualify the accuracy of the driftwood line. Model comparison with the peak stage at MON23, located 2 RM upstream of FWR1 and FWR2, was used to justify this approach. The 2D surface-water model assumes open water, steady-state conditions, and does not account for the snow, channel ice, or ice jams. Snow and ice have less of an effect on flood stage in the outer delta near MON23, FWR1, and FWR2. Peak stage at MON23 on June 4 was 9.27 feet BPMSL which is 0.92 feet below the 50-yr modeled elevation. The measured driftwood line near FRW1 was 6.20 feet BPMSL which is 0.88 feet below the 50-yr modeled flood elevation. The consistent difference between the 50-yr modeled WSE, the 2013 peak WSE at MON23, and the driftwood line suggests the driftwood line is a reasonable approximation of peak WSE near FWR1 and FWR2.

Photo 3.66: Surveyed driftwood line near FWR1, looking north; June 30, 2013

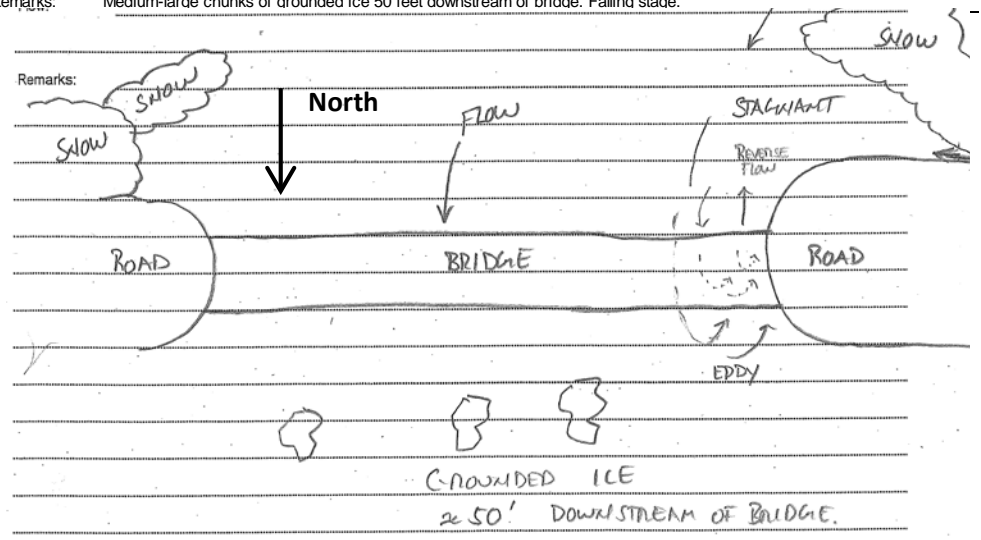
Short Swale Bridge

Flow: South to north. A back eddy was present behind a large snow pile, upstream and on the west side of the bridge, causing flow reversal along the west abutment.

Remarks: Medium-large chunks of rounded ice 50 feet downstream of bridge. Falling stage.

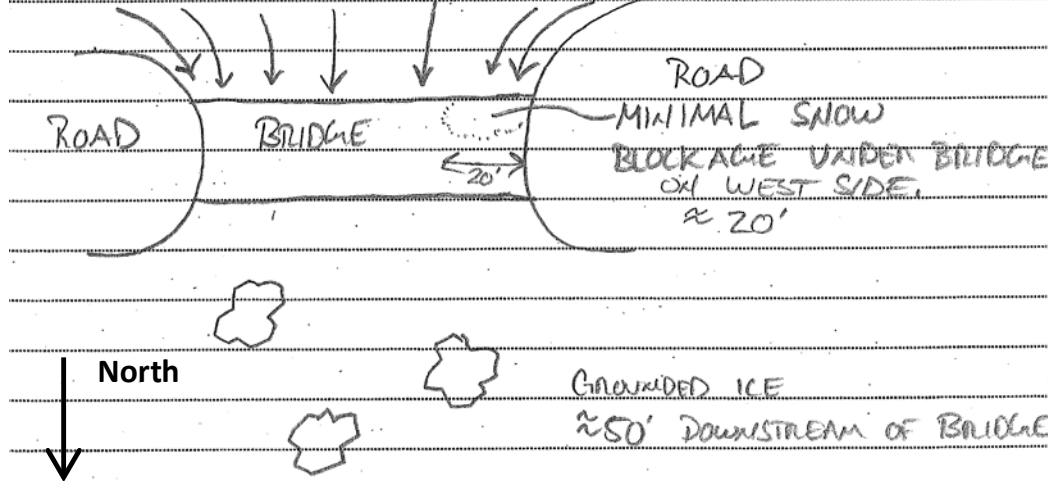
Flow: Smooth with small ripples

Remarks: Mostly snow free, medium-large chunks of rounded ice 50 feet downstream of bridge.
