2017

COLVILLE RIVER DELTA SPRING BREAKUP MONITORING & HYDROLOGICAL ASSESSMENT

Michael Baker

This report presents the observations and results from the 2017 Colville River Delta Spring Breakup Monitoring and Hydrological Assessment conducted by Michael Baker International for ConocoPhillips Alaska. In the Colville River Delta, the breakup and downstream movement of river ice typically occurs during a three-week period in May and June. The spring breakup event historically produces flooding, and rapid rise and fall of stage can occur as the result of ice jam formation and release. Annual study and reporting of spring breakup is required by U.S. Army Corps of Engineers Permits 2-960874 Special Condition #6, POA-2004-253 Special Condition #17, and POA-2005-1576 Special Conditions #1 and #17 and Alaska Department of Fish and Game Permits FH04-III-0238, FG97-III-0260, FG99-III-0051, and FG97-III-0190. The analyses provide data to support design, permitting, and operation of oilfield development.

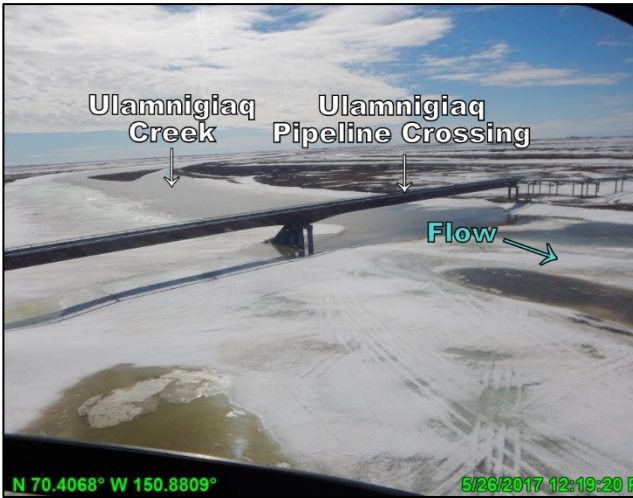
Photo 3.4: Floodwater at the Ulamniglaq Pipeline Crossing, looking southeast (upstream); May 26, 2017

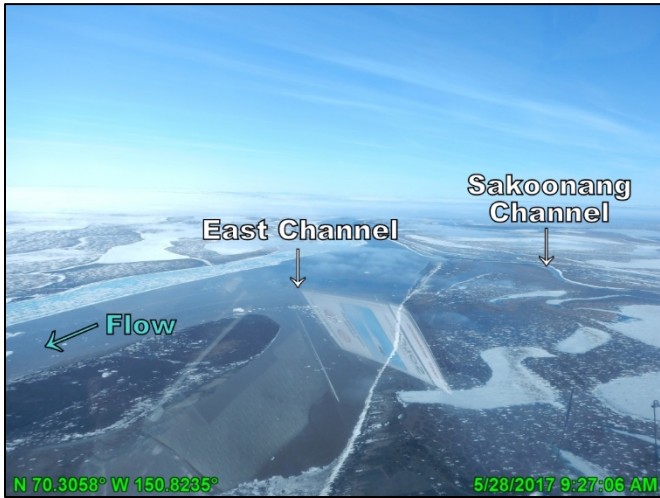
Photo 3.7: Degrading channel ice in the East Channel, looking south (upstream); May 28, 2017

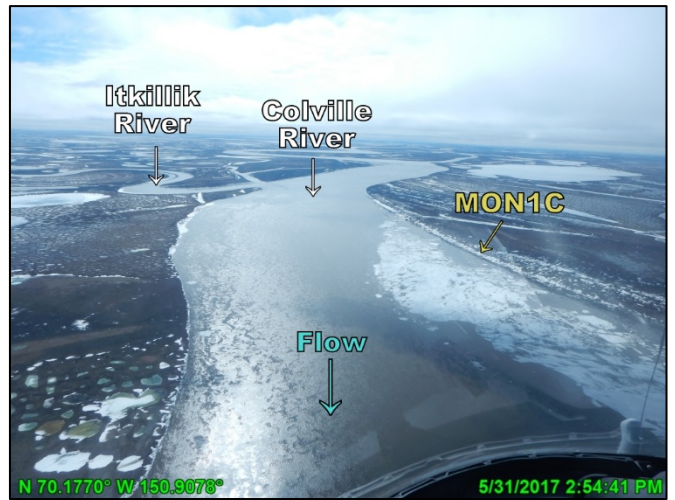
Peak stage and peak discharge at MON1 were the results of backwater from the ice jam within the MON1 reach (Photo 4.1 and Photo 4.2). The ice jam formed between MON1C and MON1D resulting in backwater at MONC and MON1U, just prior to release. Additionally, ice floes were moving through the reach when the ice jam released, impacting stage. The estimated peak discharge was assigned a fair quality rating (Table 2.1) because of these influences.

Photo 4.2: Conditions the day after peak stage and peak discharge at MON1, looking south (upstream); May 31, 2017

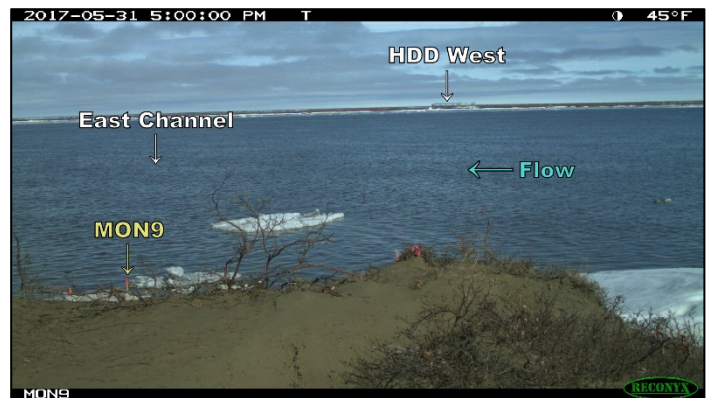
Peak stage at MON9 and MON9D were the result of backwater from the downstream ice jam at the Sagoonang Channel bifurcation. Prior to peak discharge, channel ice remained intact throughout the reach (Photo 4.3). At the time of peak discharge, the ice jam release at MON1 flushed the intact channel ice and ice floes were observed moving through the reach (Photo 4.4). After peak discharge, ice floes backed up behind the downstream intact channel ice at the Sagoonang Channel bifurcation (Photo 4.5). The estimated discharge was assigned a fair to poor quality rating (Table 2.1) due to these influences. Site specific discharge data and plan and profile drawings are provided in Appendix C.2.2.

Photo 4.4: Conditions during peak discharge at MON9, looking east; May 31, 2017

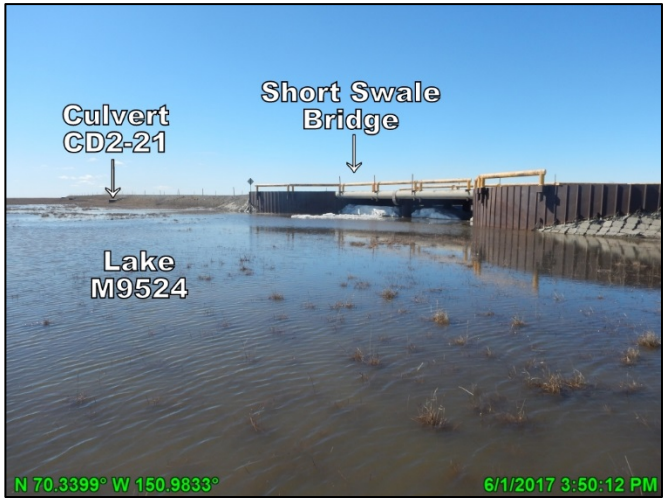
Floodwater along the CD2 road was only present in the vicinity of gages G3/G4. The Long Swale Bridge and three adjacent culverts conveyed flow from the Nigliq Channel into Lake M9524 via Nanuq Lake (Photo 4.9). Minimal floodwater reached the Short Swale Bridge and was not hydraulically connected at the downstream side, therefore, discharge was not measured or calculated (Photo 4.10).

Photo 4.10: Conditions at the CD2 road Short Swale Bridge the day after peak stage, looking northwest (downstream); June 1, 2017

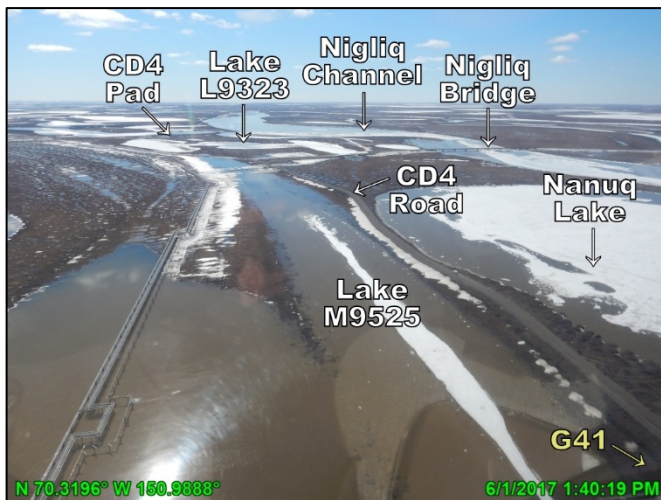
Gages G40/G41 and G42/G43 remained dry throughout monitoring (Photo 4.14). Culvert equalization was observed at gages G15/G16 (Photo 4.15). No discernable flow was observed and discharge was not measured or calculated.

Photo 4.14: North end of CD4 road one day after peak stage, looking south; June 1, 2017

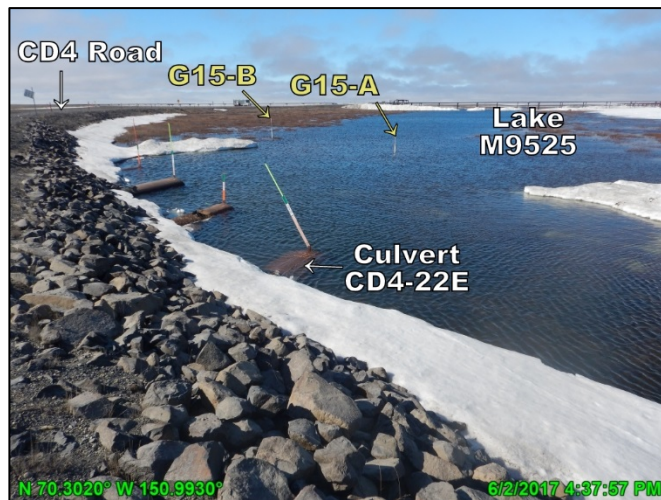
Photo 4.15: Equalization at CD4 road culverts at gage G15/G16 two days after peak stage, looking northeast; June 2, 2017

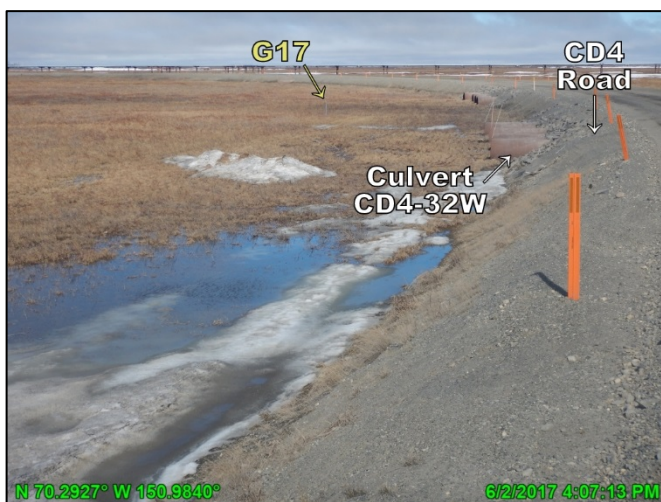
Gage G17 remained dry throughout monitoring (Photo 4.16). A slight rise in stage at gage G18 was due to ponded local melt. Flow was observed and measured at one culvert associated with gages G17/G18. Peak discharge was not calculated due to gage G17 remaining dry.

Photo 4.16: CD4 road at gage G17 and associated culverts the day of measured discharge, looking east; June 2, 2017

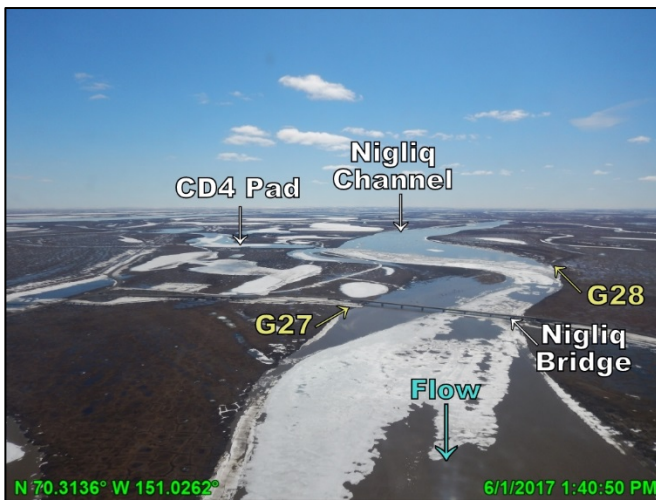
Peak stage at the Nigliq Bridge occurred as floodwater from the May 30 ice jam release at MON1 was conveyed downstream. In the process, the ice jam adjacent to Nuiqsut released and channel ice between Nuiqsut and MON20 broke up and jammed upstream of the Nigliq Bridge reach. Channel ice and floes were present throughout the Nigliq Bridge reach during peak stage and through the following day (Photo 4.19).

Photo 4.19: Nigliq Bridge the day of peak discharge and the day after peak stage, looking south (upstream); June 1, 2017

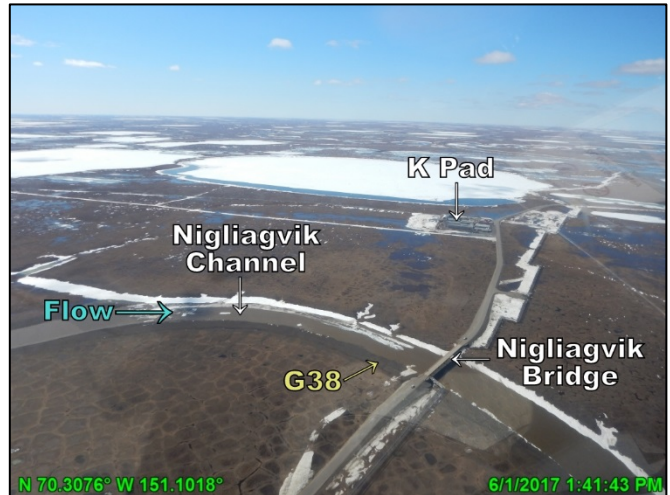
Discharge was measured from the upstream side of the Nigliagvik Bridge on June 1. At the time of the measurement, the Nigliagvik channel was clear of snow and ice (Photo 4.23). The average velocity was 1.28 fps and the highest depth-averaged velocity was 1.62 fps. The quality

Photo 4.23: Nigliagvik Bridge conditions the day of discharge measurement, looking east; June 1, 2017

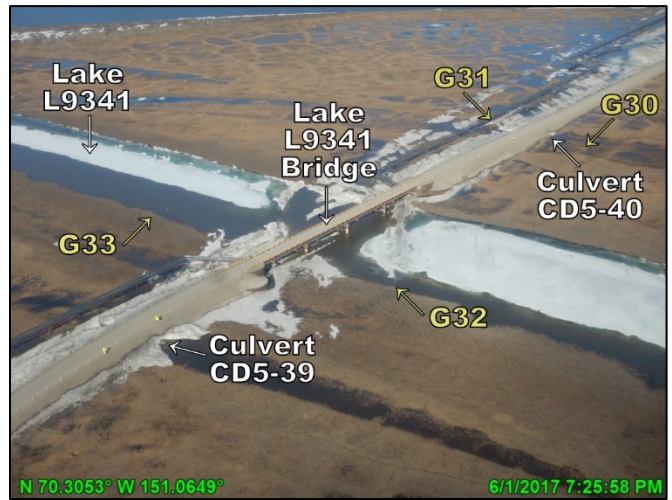
Gages G34/G35 (Photo 4.24) and gages G36/G37 were dry throughout monitoring. Peak stage at gages G30/G31 was recorded as a HWM. Low flow through the paleochannel at gages G30/G31, attributed to the equalization of local melt, (Photo 4.25) was measured at one associated culvert. Peak discharge through this culvert was not determined because the HWMs were of low confidence. Gages G30/G31 stage and discharge data is provided in Graph 4.17 and the direct discharge measurement is summarized in Table 4.5.

Photo 4.25: Low flow through a culvert associated with gages G30/31, looking west; June 1, 2017

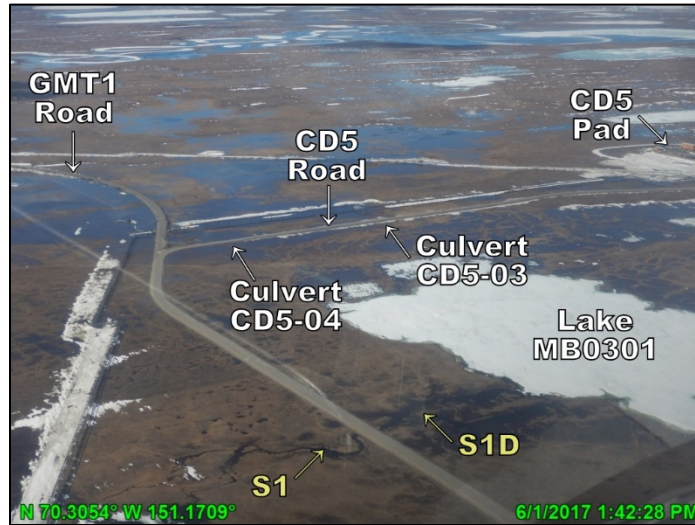
Discharge was measured at other culverts along the CD5 road to the west of the Nigliagvik Channel, provided below in Table 4.6. Stage remained below the PT elevation at gages S1/S1D throughout breakup. Peak stage at gage S1 was recorded as a HWM and channelized downstream (south to north) flow between lakes was measured at two associated culverts. Photo 4.26 shows hydraulic connections through culverts CD5-03 and CD5-04. Peak discharge through these culverts was not determined because gage S1D did not have a HWM. Gages S1/S1D stage and discharge data is provided in Graph 4.18 and the direct discharge measurements are summarized in Table 4.7.

Photo 4.26: Hydraulic connections through CD5 culverts CD5-03 and CD5-04 and culverts at S1/S1D gages, looking northwest; June 1, 2017

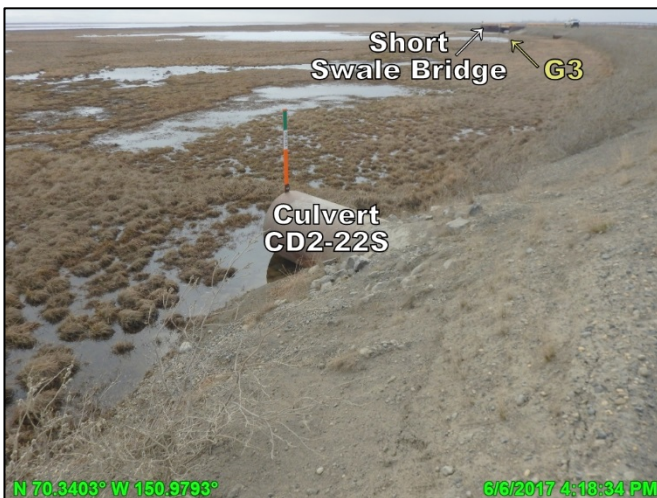
Alpine road and pads were inspected for erosion between June 5 and 7. Other than minor washlines, no discernable erosion was observed during aerial and ground reconnaissance of the CD2 (Photo 5.1), CD4 (Photo 5.2), and CD5 (Photo 5.3) roads. Floodwaters did not reach CD5 bridge abutments or the majority of the CD5 road within the CRD. A prominent washline from 2015 spring breakup was evident along portions of the CD2, CD4, and CD5 roads. There were no signs of sloughing or undermining at drainage structures. Additional photo documentation of erosion surveys and breakup conditions along the Alpine facilities roads and pads are shown in Appendix D.1.

Photo 5.3: South side of CD2 road, looking west; June 6, 2017

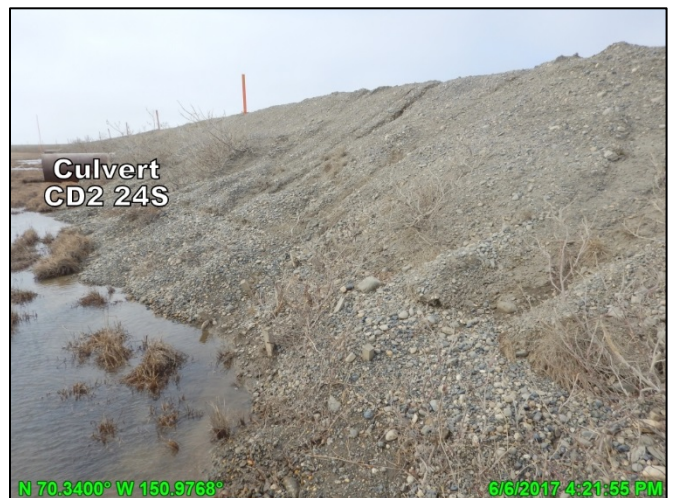
Photo 5.4: South side of CD2 road near the Long Swale Bridge looking west; June 6, 2017

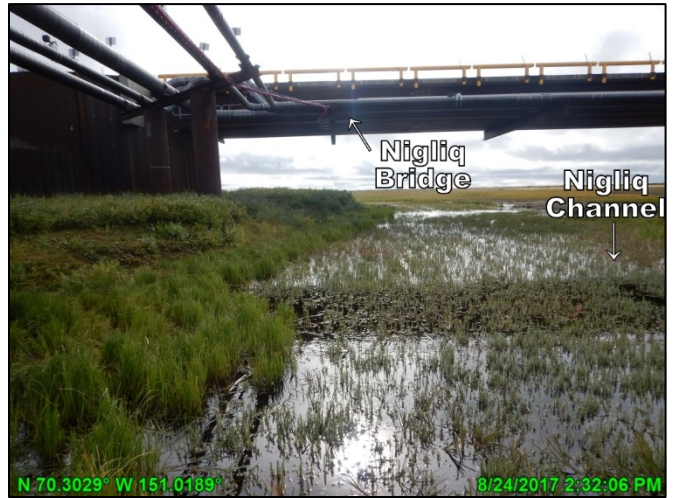
Maximum incremental and cumulative erosion at the Nigliq Bridge (station 12+00) and Nigliagvik Bridge (station 5+00) and maximum incremental, maximum cumulative, and average erosion along the entire top of bank is presented below in Table 6.3. Photos from the bank erosion survey are presented below in Photo 6.1, Photo 6.2, Photo 6.3, and Photo 6.4. Bank erosion survey drawings and tabulated data are presented in Appendix E.2 (UMIAQ 2017c).

Photo 6.2: East bank of the Nigliq Channel north of the Nigliq Bridge, looking south; August 24, 2017

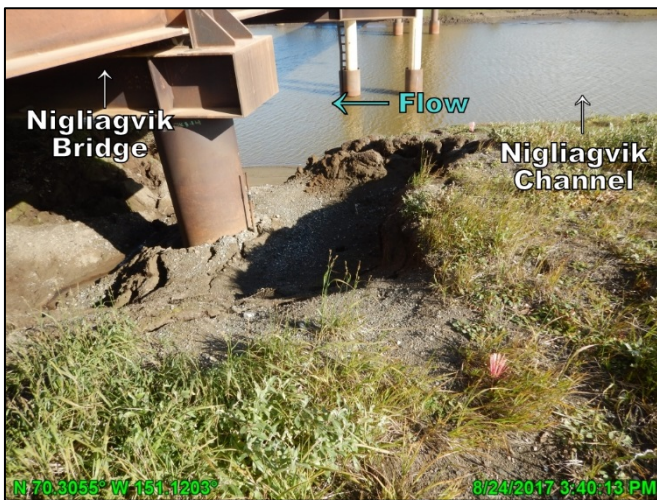
Photo 6.3: Bank subsidence at the west bank of the Nigliagvik Bridge, looking east; August 24, 2017

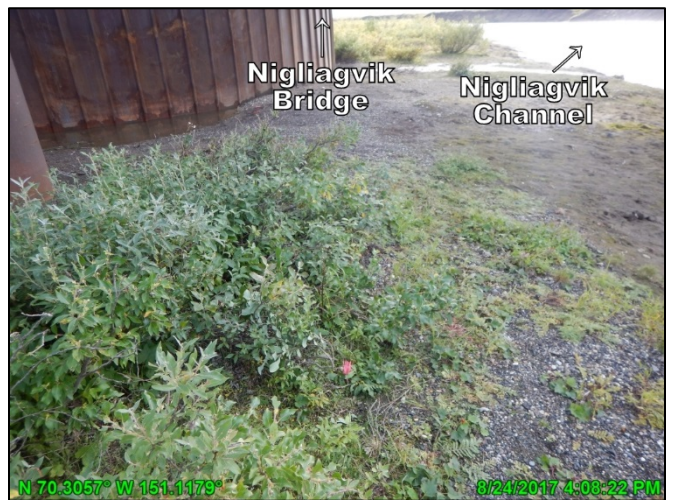
Photo 6.4: East bank of Nigliagvik Channel at the Nigliagvik Bridge abutment, looking south; August 24, 2017

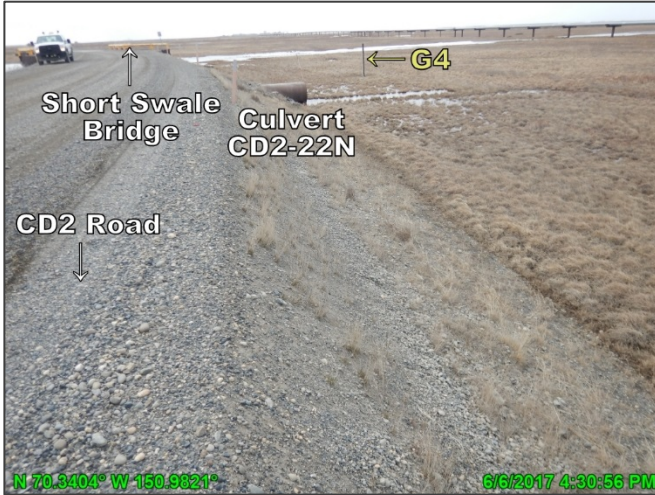
Photo D.1: North side of CD2 road east of Short Swale Bridge, looking west; June 6, 2017

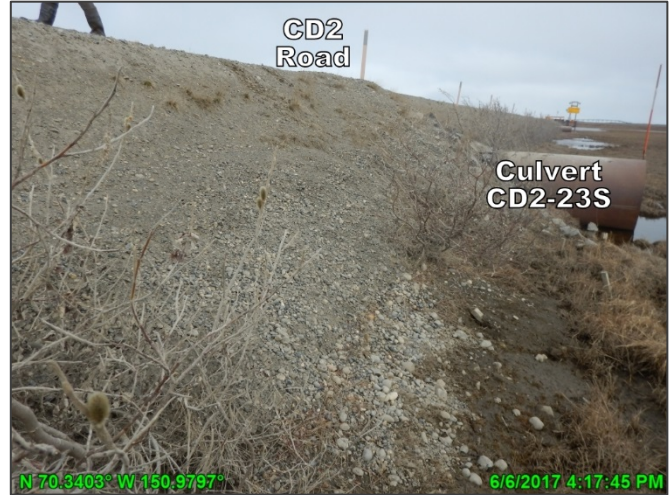
Photo D.2: South side of CD2 road east of Short Swale Bridge, looking east; June 6, 2017

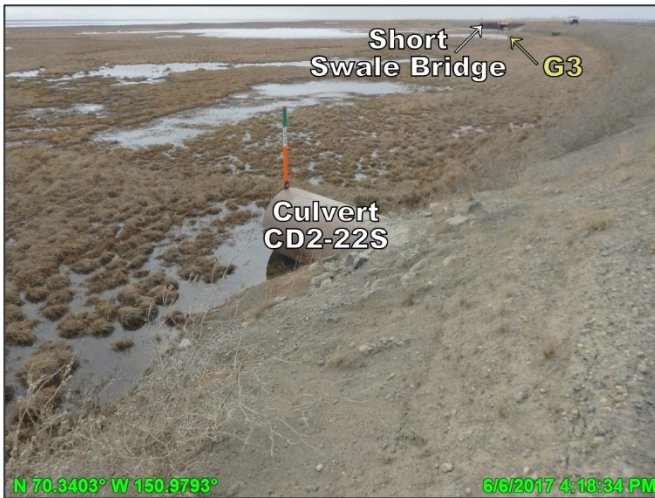
Photo D.3: South side of CD2 road, looking south; June 6, 2017

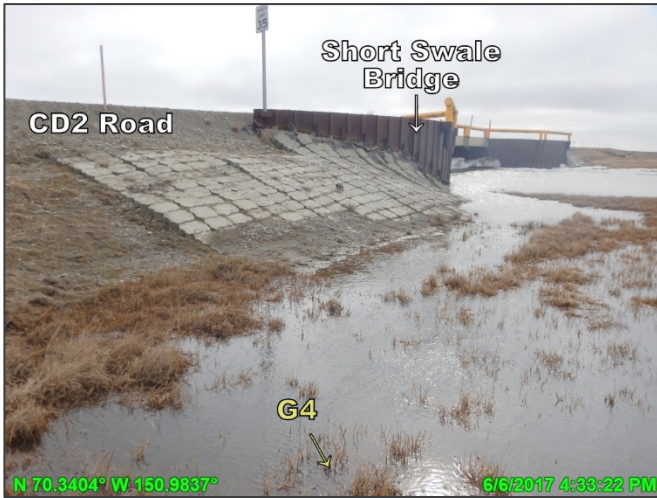
Photo D.5: North side of CD2 road east of the Short Swale Bridge, looking southwest; June 6, 2017

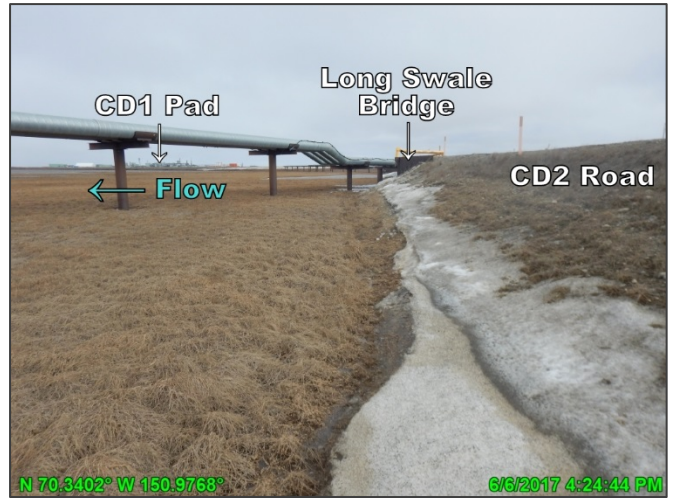
Photo D.6: North side of CD2 road west of the Long Swale Bridge, looking east; June 6, 2017

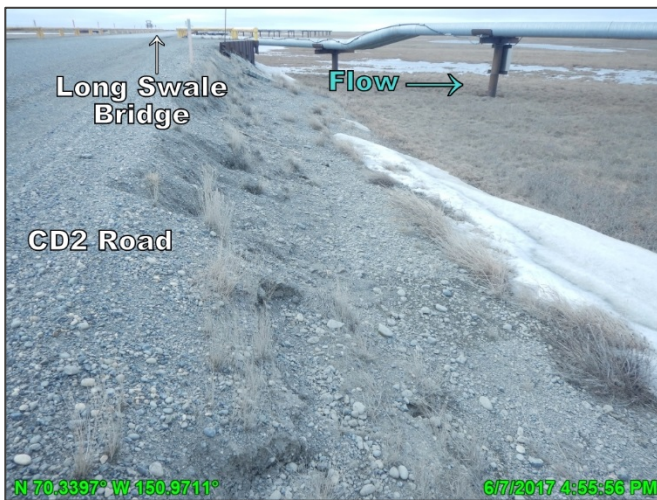
Photo D.7: North side of CD2 road east of Long Swale Bridge, looking west; June 7, 2017

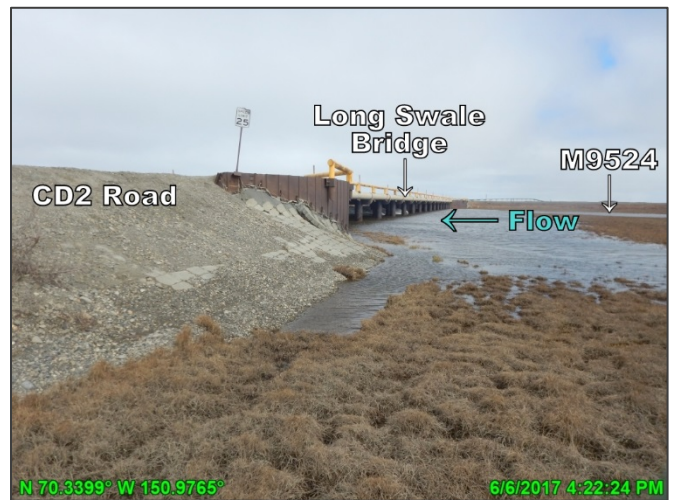
Photo D.8: South side of CD2 road west of the Long Swale Bridge, looking east; June 6, 2017

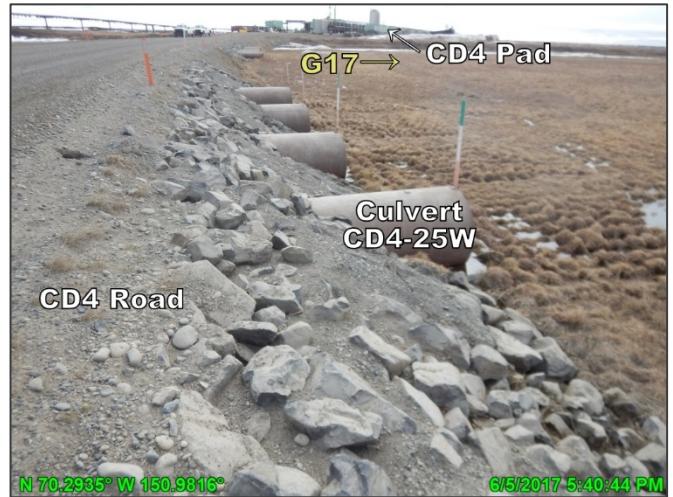
Photo D.10: North side of CD4 road east of CD4 pad, looking west; June 5, 2017
