2017

GMT1 Spring Breakup & Summer Monitoring & Hydrological Assessment

Michael Baker

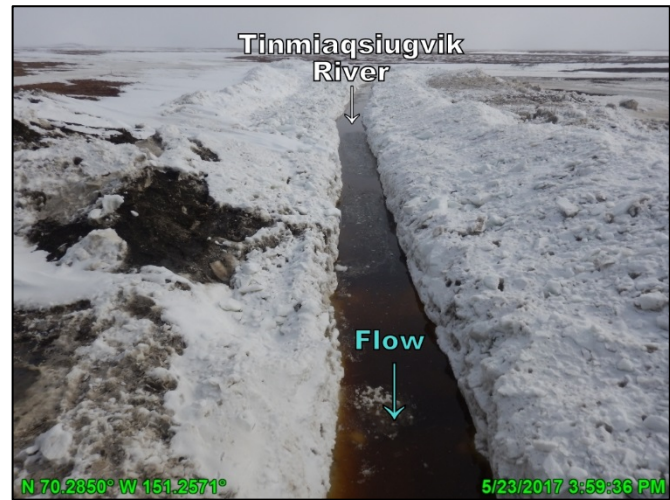
Photo 3.2: Pondered local melt in the slotted section of the Tinmiaqsiugvik River, looking southeast (upstream); May 23, 2017

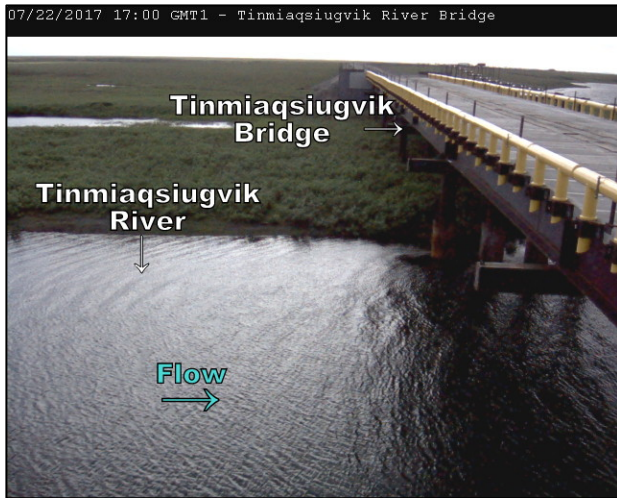
Photo 4.6: Peak summer discharge (upstream flow direction) at the Tinmiaqsiugvik Bridge, looking southwest; July 22, 2017

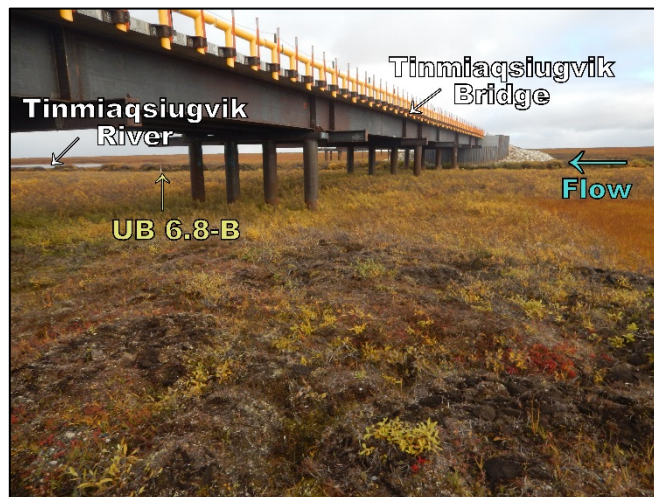
Summer discharge was measured from the same location as the spring breakup discharge measurement. The average velocity was 0.94 fps and the highest depth-averaged velocity within a particular section was 1.11 fps. The quality of the measurement was classified as good based on open channel and uniform flow conditions at the time of measurement (Photo 4.8).

Photo 4.8: Flow confined within the main channel at the Tinmiaqsiugvik Bridge the day of summer discharge measurement, looking northeast; September 9, 2017

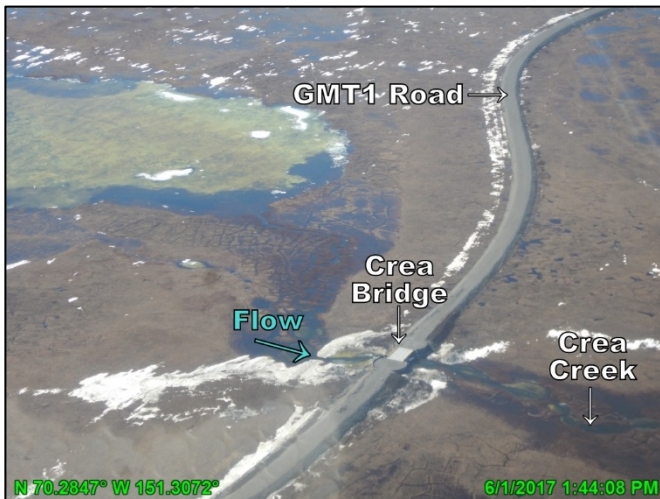
Photo 4.11: Ice and snow influence at the Crea Bridge the day of spring peak discharge, looking southwest; June 1, 2017

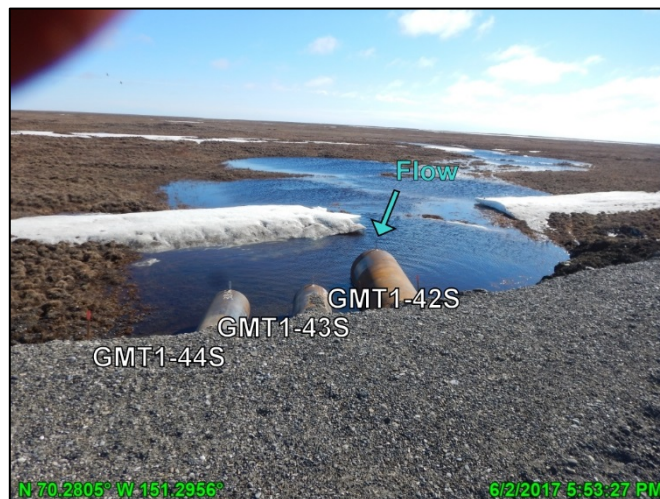
Photo 4.21: Barely Creek culvert battery the day of spring measured discharge, looking southwest (upstream); June 2, 2017

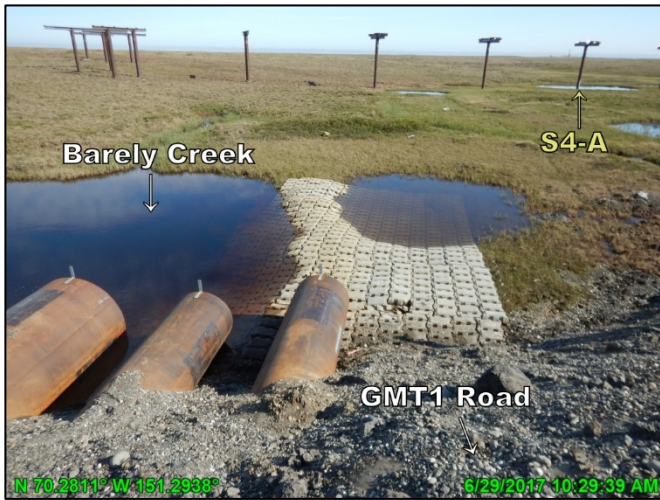
Summer stage, discharge, and velocity at the Barely Creek culvert battery were lower than during spring breakup. The upstream and downstream stage hydrographs and observations during site visits suggest that water was present but ponded early in the summer. Flow was passed by one (Photo 4.22) to three culverts (Photo 4.23) in the battery throughout the remainder of the summer.

Photo 4.22: Summer flow through one Barely Creek culvert, looking north; June 29, 2017

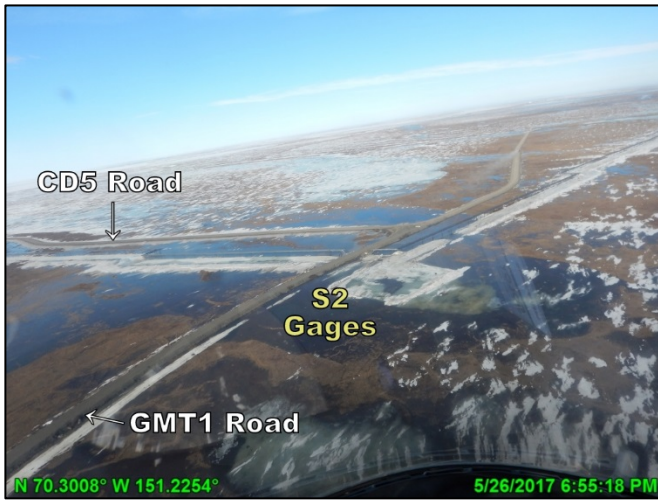
On May 26, the ice road and drifted snow on the south (upstream) side of the GMT1 access road had mostly melted and neither were influencing drainage patterns (Photo 4.24). The pipeline construction ice road located north (downstream) of the GMT1 pipeline and north (downstream) of the GMT1 access road north (downstream) of the GMT1 pipeline was still intact and meltwater was accumulating between that and the GMT1 access road. S2 PTs began recording concurrent rising stage on both sides of the access road, suggesting a hydraulic connection was established through the culverts.

Photo 4.24: S2 gages and culverts the day prior to spring peak stage and the day after spring peak discharge, looking northeast; May 26, 2017

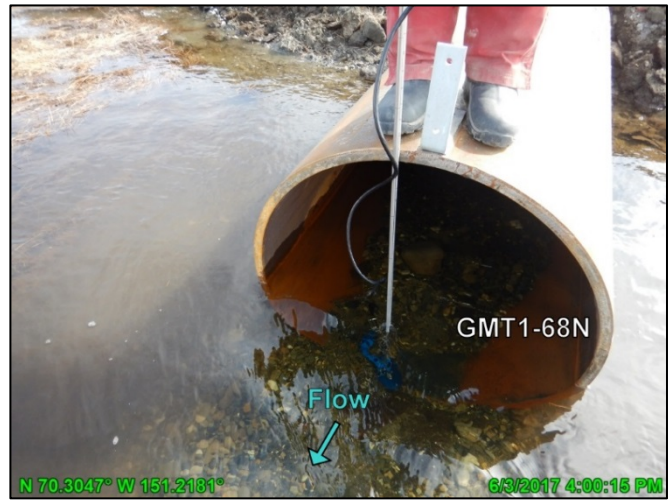
Spring velocity and discharge were measured at the outlets of culverts GMT1-65 through GMT1-69 (Photo 4.25). The average velocity through these culverts was 1.2 fps. The quality of the measurement was classified as good based on open channel conditions at the time of measurement.

Photo 4.25: Culvert GMT1-68 the day of spring discharge measurement, looking south; June 3, 2017

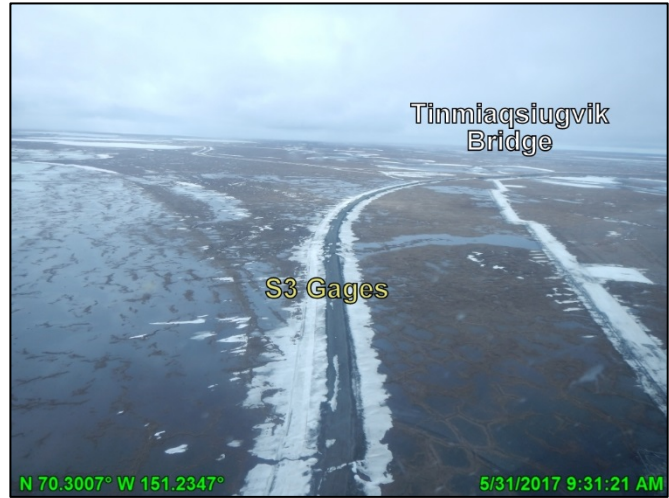
Photo 4.27: S3 gages the day prior to peak stage at gage S3-A, looking south; May 31, 2017

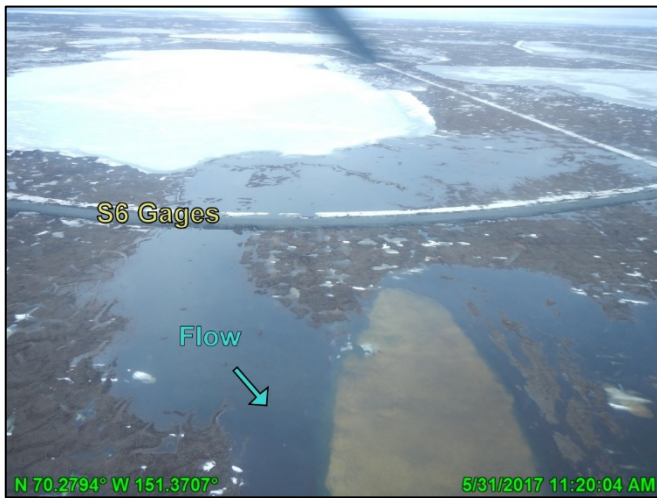
On the day of peak stage, streamflow in the drainage had melted a path through the remaining ice road and flow through the culverts was unobstructed (Photo 4.30, Photo 4.31, and Photo 4.32). Spring velocity and discharge were measured at the outlets of culverts GMT1-31 through GMT1-33 (Photo 4.33). The average velocity through these culverts was 1.1 fps. The quality of the measurement was classified as good based on open channel conditions at the time of the measurement.

Photo 4.32: S6 gages and culverts the day of spring peak stage and discharge, looking south (upstream); May 31, 2017

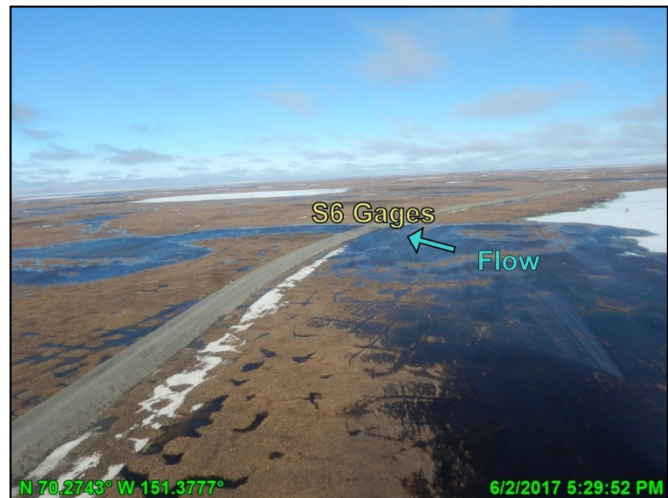
Photo 4.33: S6 gages and culverts the day of spring measured discharge, looking northeast; June 2, 2017

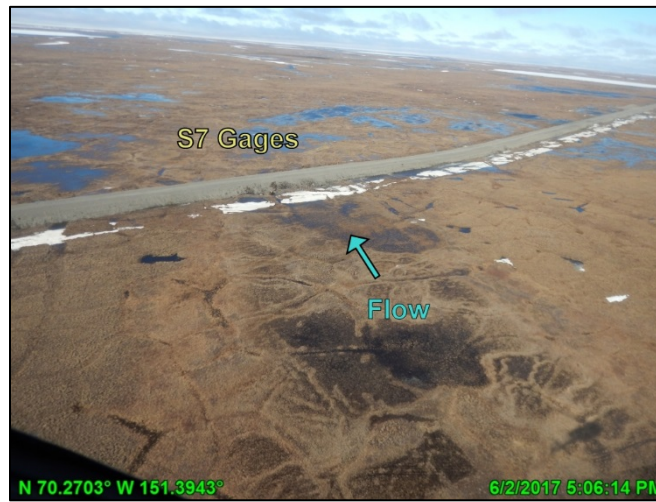
Spring velocity and discharge were measured at the outlets of culverts GMT1-25 (Photo 4.36). All other culverts remained dry. The velocity through this culvert was 0.3 fps. The quality of the measurement was classified as good based on open channel conditions at the time of the measurement.

Photo 4.36: S7 gages the day of spring measured discharge, looking north (downstream); June 2, 2017

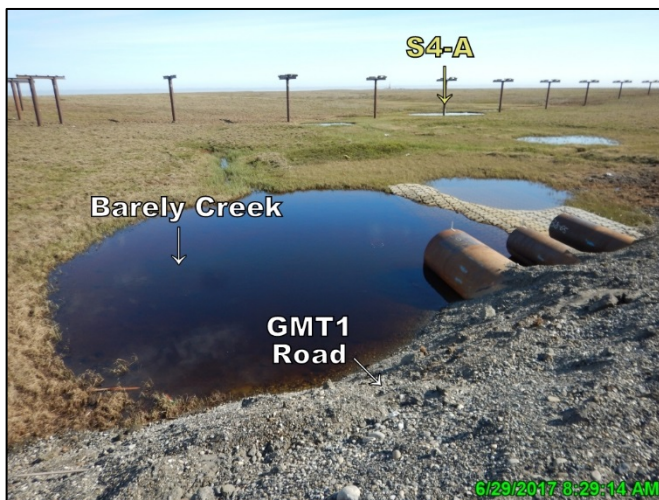
Photo 7.3: Barely Creek culvert battery outlet, looking northeast (downstream); June 29, 2017

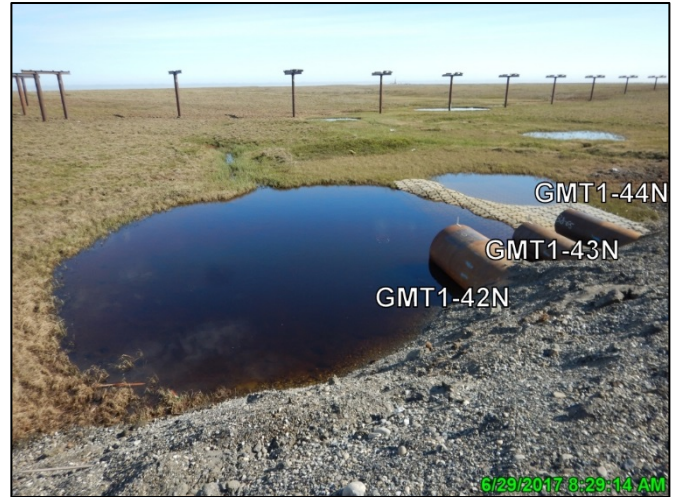
Photo D.2: Barely Creek culvert battery outlet, looking northeast (downstream); June 29, 2017

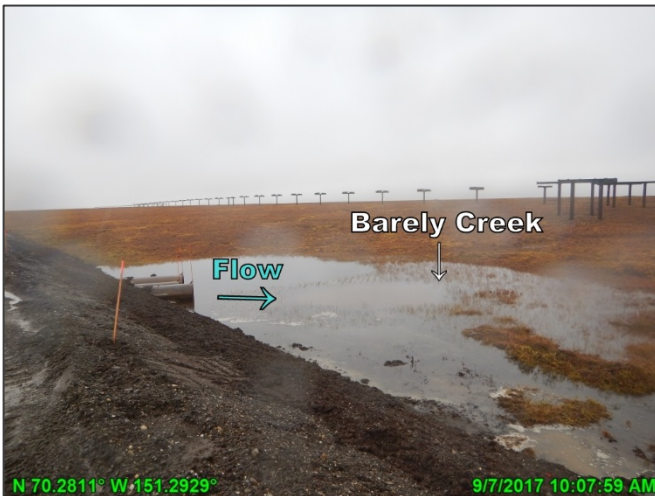
Photo D.3: Barely Creek culvert battery outlet, looking northwest; September 7, 2017

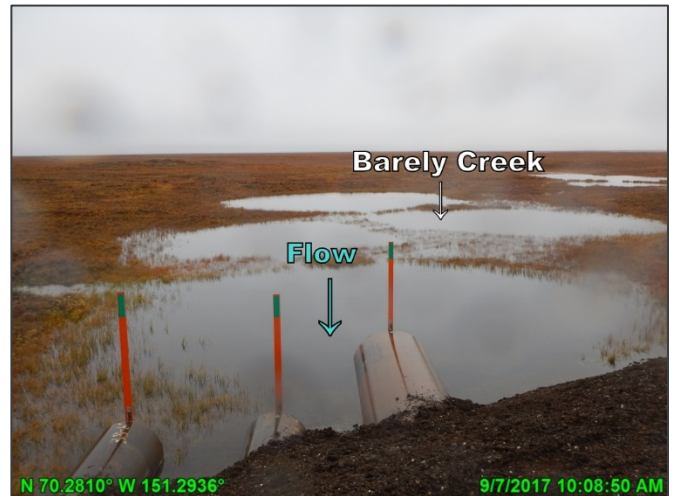
Photo D.4: Barely Creek culvert battery inlet, looking south (upstream); September 7, 2017

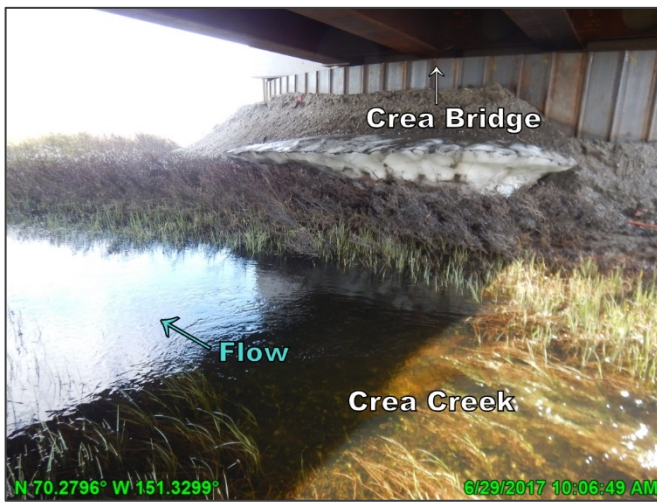
Photo D.7: Crea Bridge right (east) abutment, looking northeast (downstream); June 29, 2017

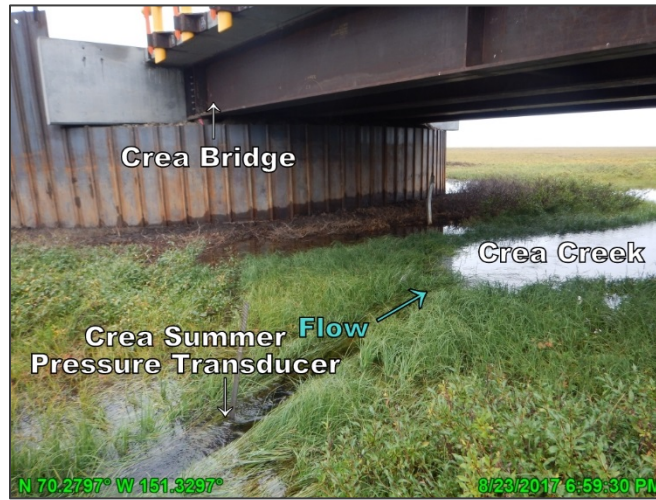
Photo D.9: Crea Bridge left (west) abutment, looking northwest (downstream); August 23, 2017

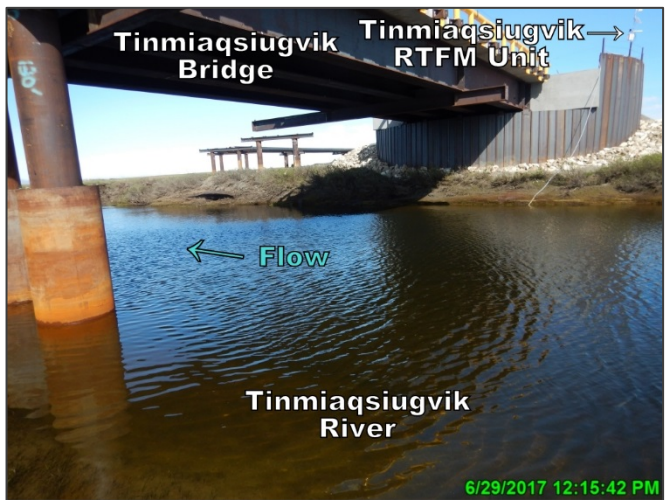
Photo D.13: Tinmiaqsiugvik Bridge right (east) abutment, looking northeast; June 29, 2017

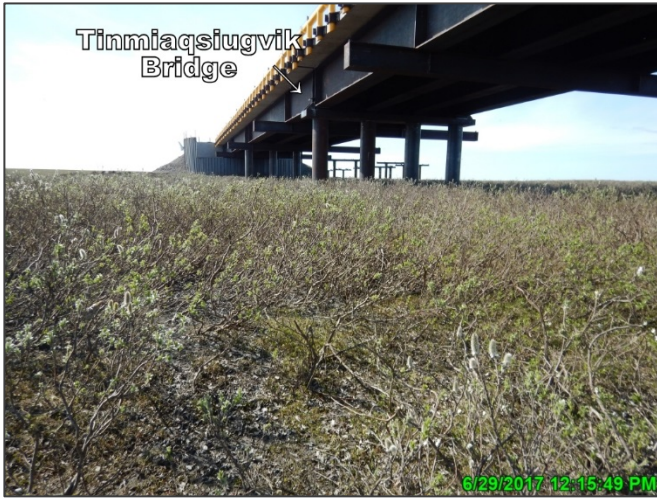
Photo D.14: Tinmiaqsiugvik Bridge left (west) abutment, looking northwest; June 29, 2017

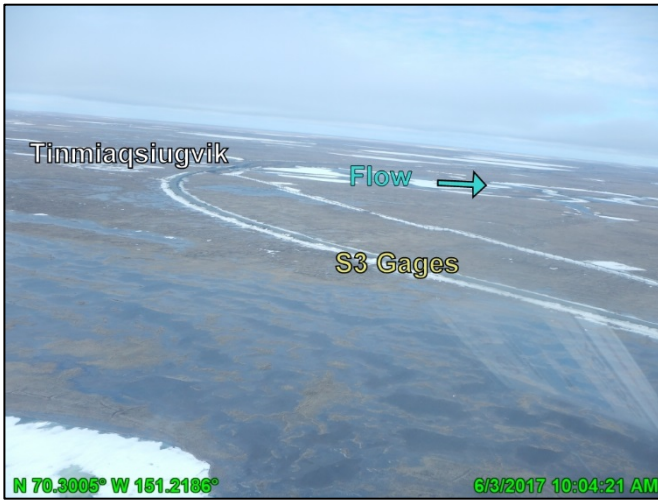
Photo D.17: S3 gages and culverts, looking west; June 3, 2017

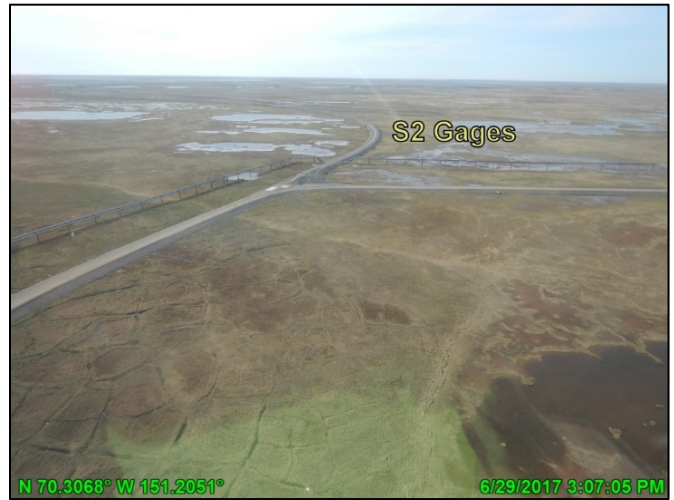
Photo D.18: S2 gages and culverts, looking west; June 29, 2017

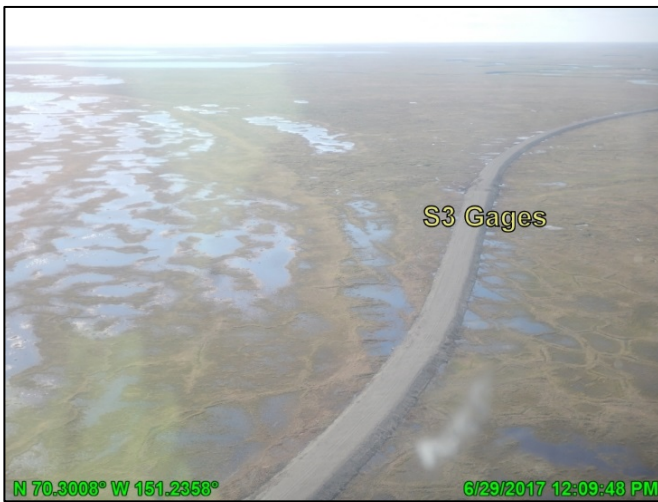
Photo D.19: S3 gages and culverts, looking west; June 29, 2017

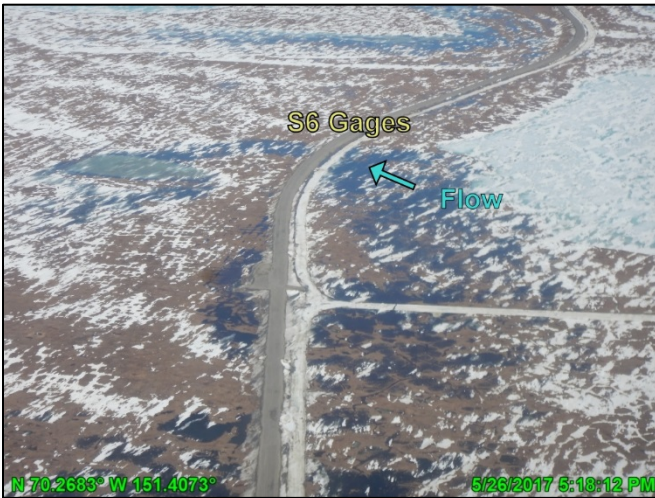
Photo D.21: S6 gages and culverts, looking east; May 26, 2017

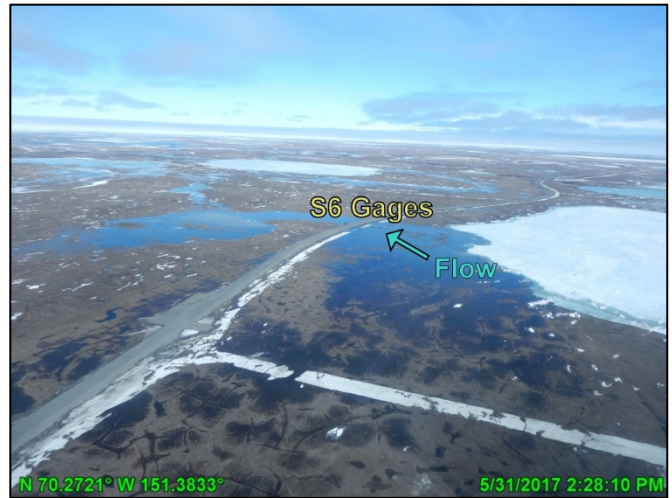
Photo D.22: S6 gages and culverts, looking northeast; May 31, 2017

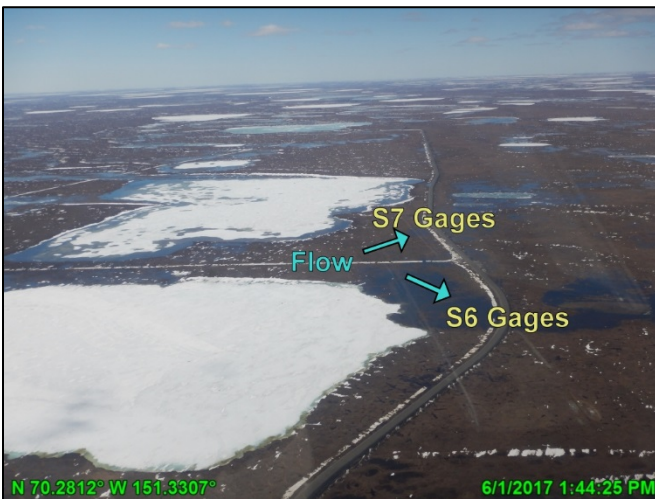
Photo D.23: S6 and S7 gages and culverts, looking west; June 1, 2017

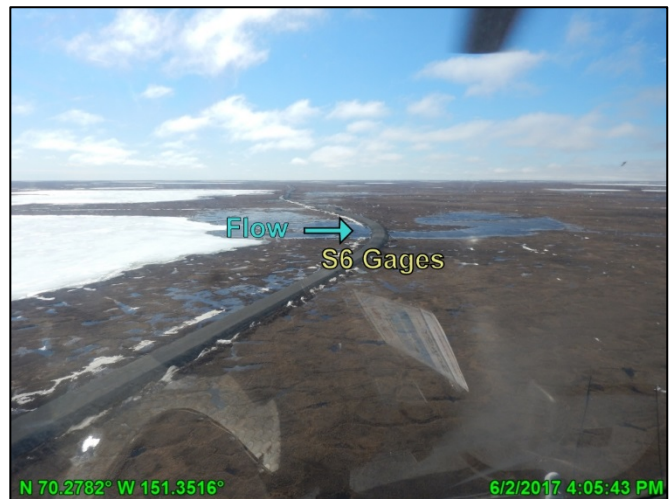
Photo D.24: S6 gages and culverts, looking west; June 2, 2017

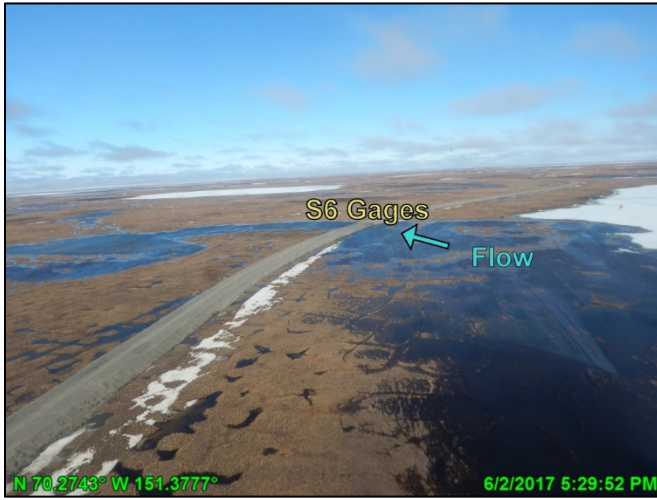
Photo D.25: S6 gages and culverts, looking east; June 2, 2017

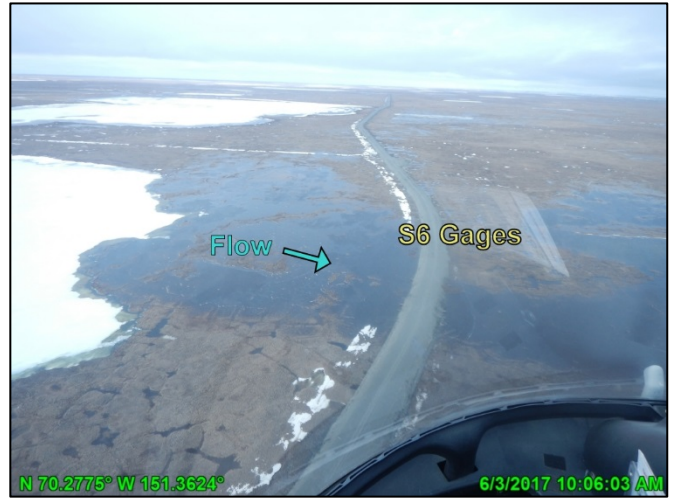
Photo D.26: S6 gages and culverts, looking west; June 3, 2017

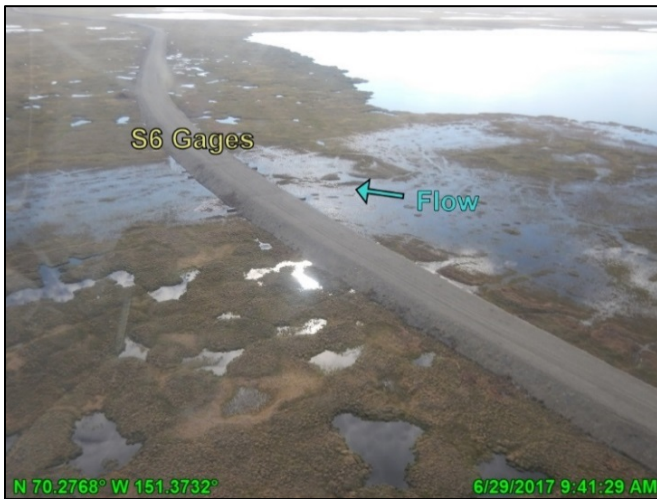
Photo D.27: S6 gages and culverts, looking east; June 29, 2017

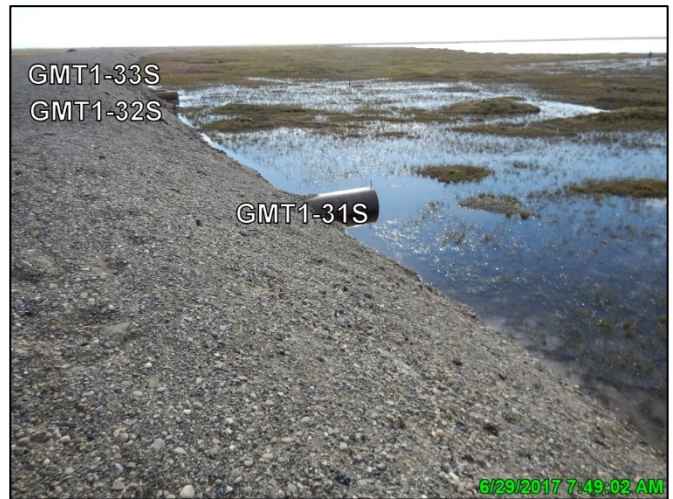
Photo D.28: S6 culverts GMT1-31 through 33, looking east; June 29, 2017

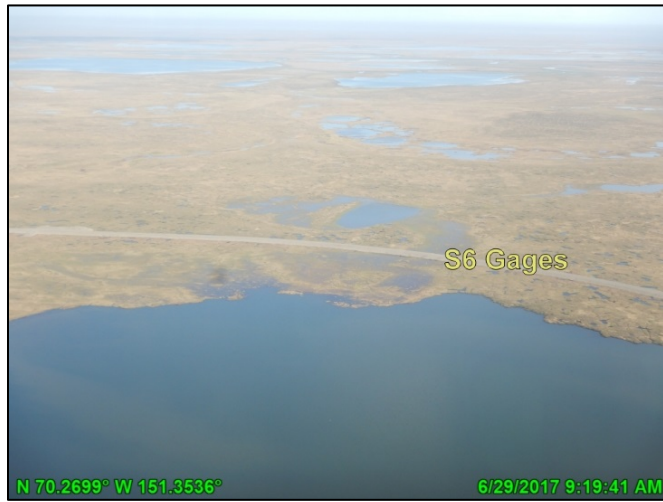
Photo D.29: S6 gages and culverts, looking northwest; June 29, 2017

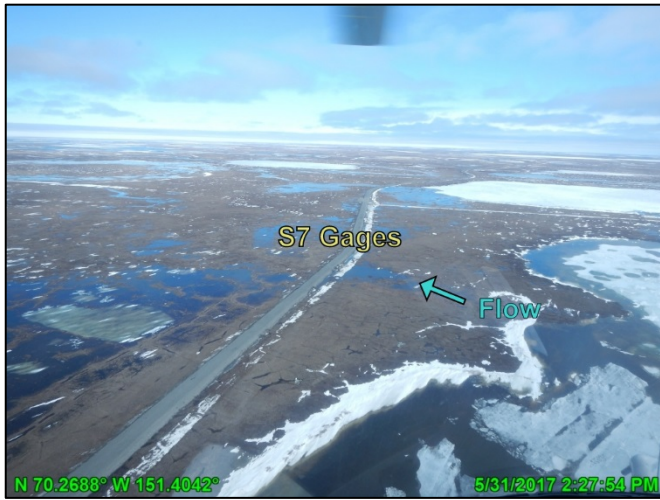
Photo D.30: S7 gages and culverts, looking east; May 31, 2017

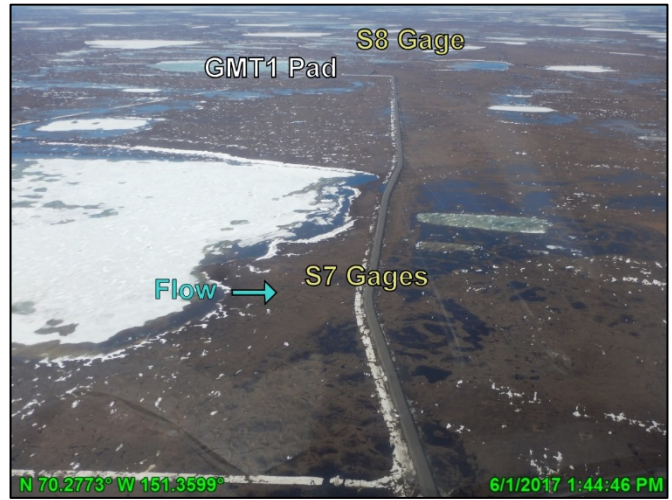
Photo D.31: S7 gages and culverts, looking west; June 1, 2017

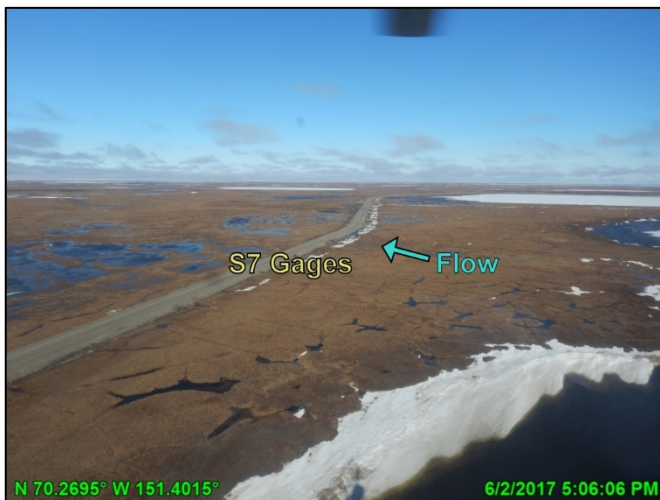
Photo D.32: S7 gage and culverts, looking east; June 2, 2017

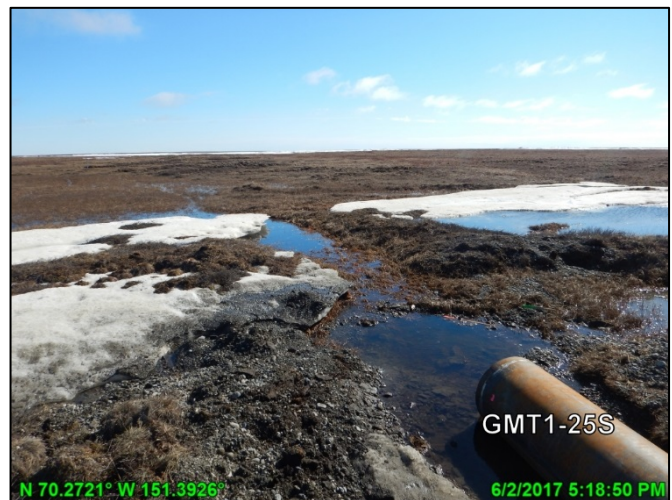
Photo D.33: S7 culvert GMT1-25, looking south; June 2, 2017

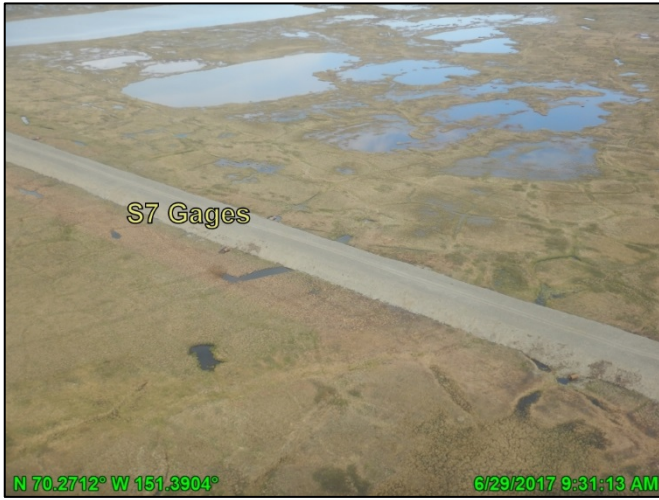
Photo D.34: S7 gages and culverts, looking northwest; June 29, 2017

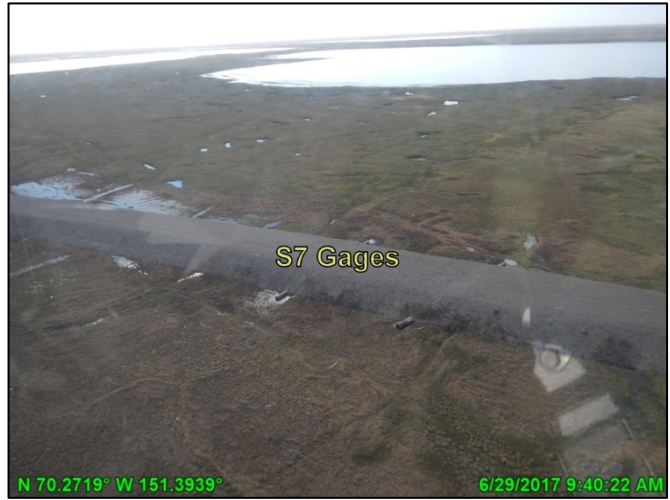
Photo D.35: S7 gages and culverts, looking southeast; June 29, 2017

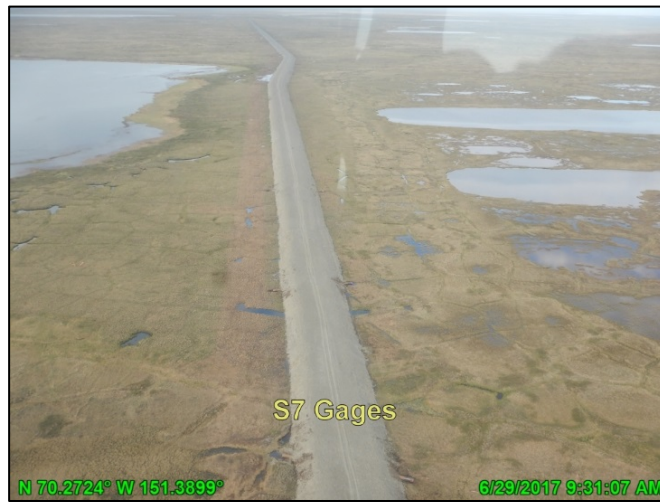
Photo D.36: S7 gages and culverts, looking west; June 29, 2017

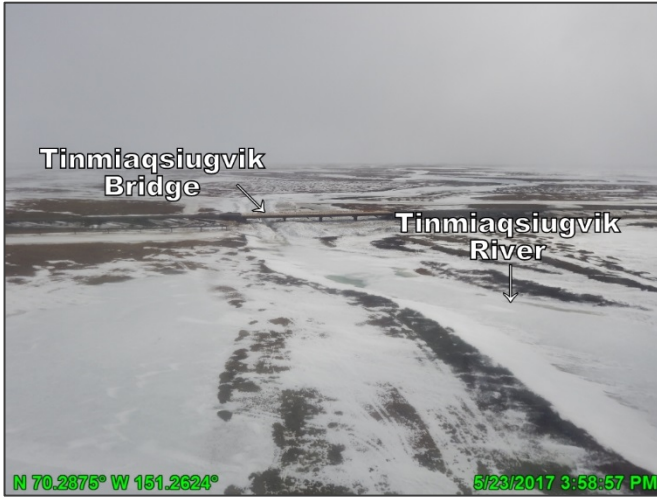
Photo D.40: Tinmiaqsiugvik River pre-breakup, looking southeast (upstream); May 23, 2017

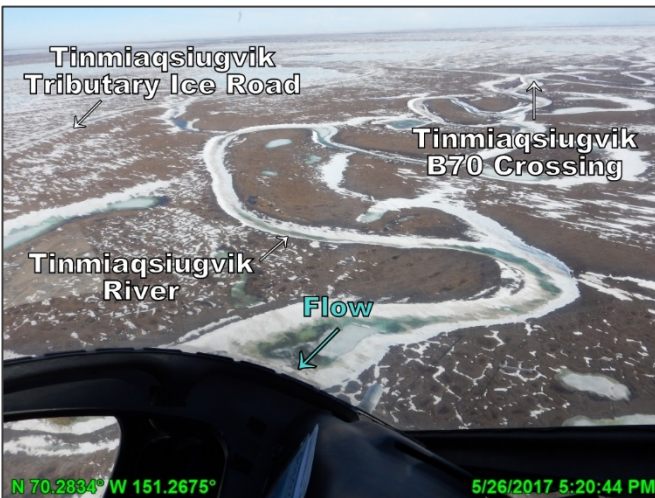
Photo D.45: Tinmiaqsiugvik Tributary and B70 during breakup, looking south; May 26, 2017
