2018

COLVILLE RIVER DELTA SPRING BREAKUP MONITORING & HYDROLOGICAL ASSESMENT

Michael Baker
INTERNATIONAL

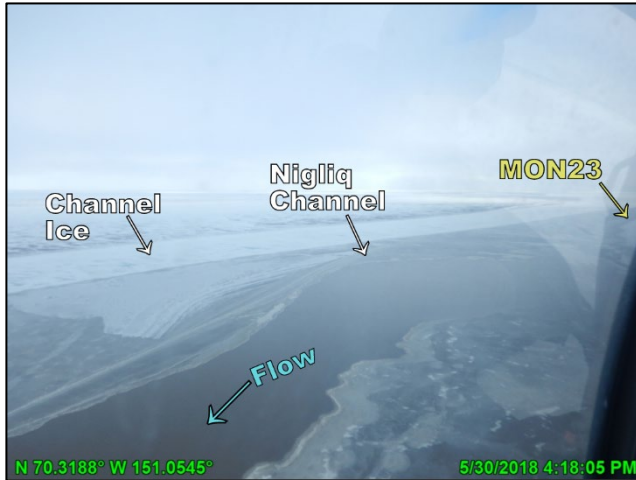
On May 19, leading edge in the Nigliq Channel was observed passing by Nuiqsut and hinge cracks were observed along intact channel ice indicating a rise in stage. By May 20, visible floodwater was observed at most monitoring locations in the Nigliq Channel. Stage remained low in the Nigliq Channel before slowly increasing around May 30 (Photo 4.10).

Photo 4.10: MON22 three days before peak stage looking southwest (upstream); May 30, 2018

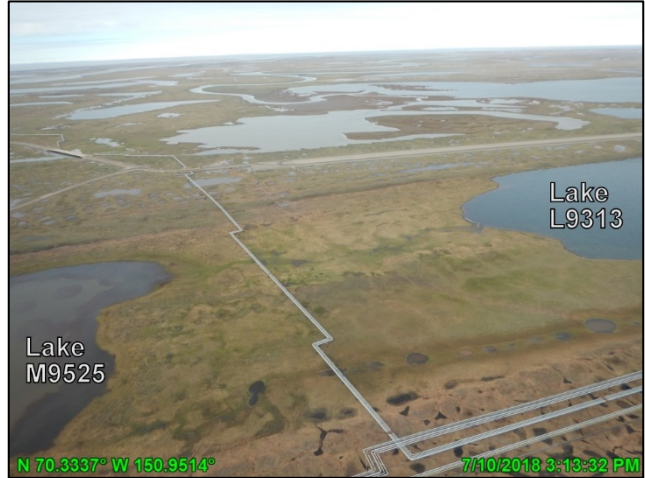
Photo 4.17: Hydraulic connection between Lake M9525 and Lake L9313 looking northwest; July 10, 2018

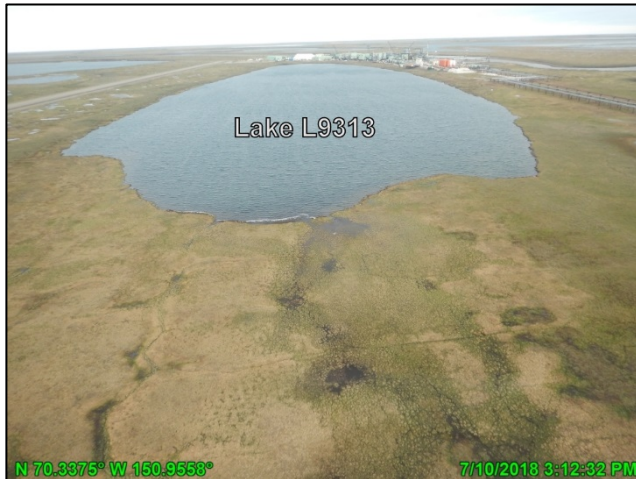
Photo 4.18: Outflow from Lake L9313 looking northeast; July 10, 2018

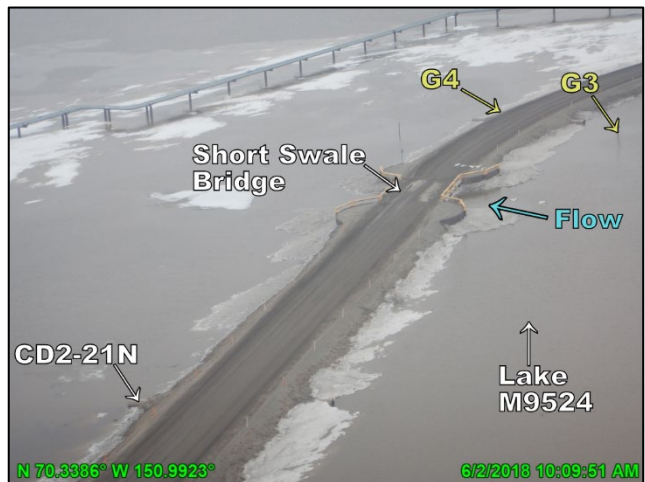
The measured average velocity through the Short Swale Bridge 0.22 fps and the highest velocity was 0.84 fps. At the time of the measurement, a flow path had developed through the snow drift under the bridge. This created a vortex on the upstream side of the bridge. The snow around the abutment contracted the flow under the bridge and back eddies occurred on the downstream side of the bridge as exiting flow expanded.

Photo 4.21: CD2 road Short Swale Bridge the day of peak stage, looking northeast (downstream); June 2, 2018

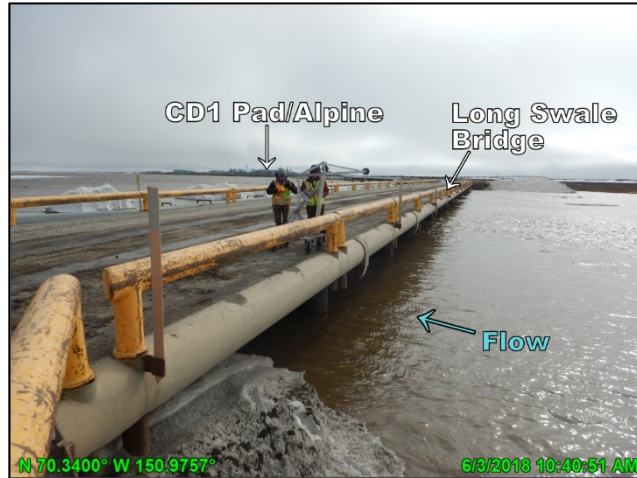
Photo 4.22: Long Swale Bridge the day of the discharge measurement, looking east; June 3, 2018

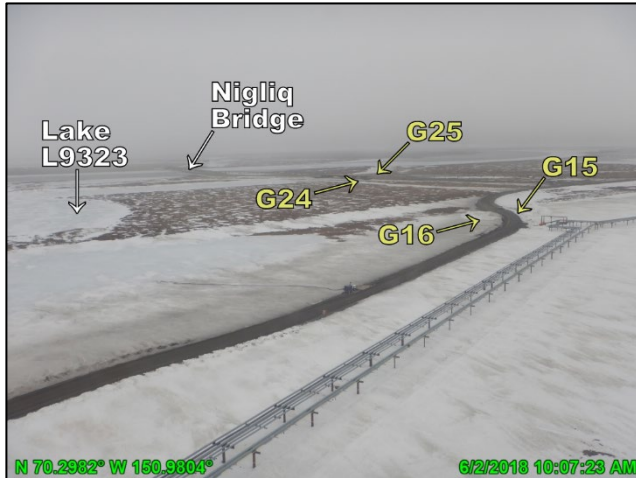
Gages G40/G41 and G42/G43 remained dry throughout monitoring. Local melt was observed at gages G15/G16 (Photo 4.26 and Photo 4.27). No discernable flow was observed at G15/G16 and discharge was not measured or calculated.

Photo 4.26: North end of CD4 road the day of peak stage at G16, looking north; June 2, 2018

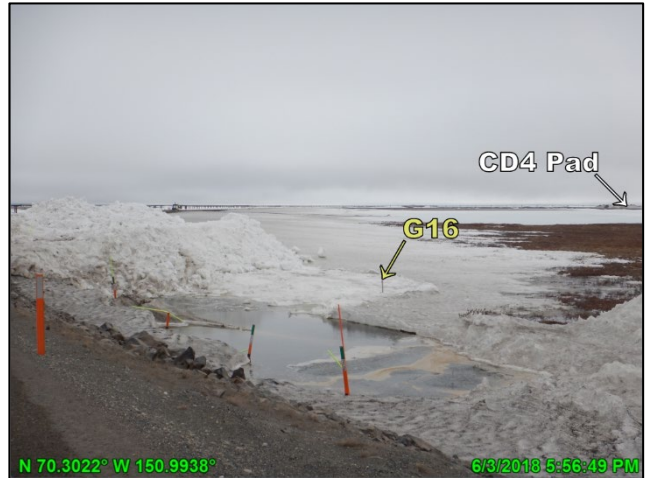
Photo 4.27: CD4 road culvert at gage G16 the day after peak stage, looking south; June 3, 2018

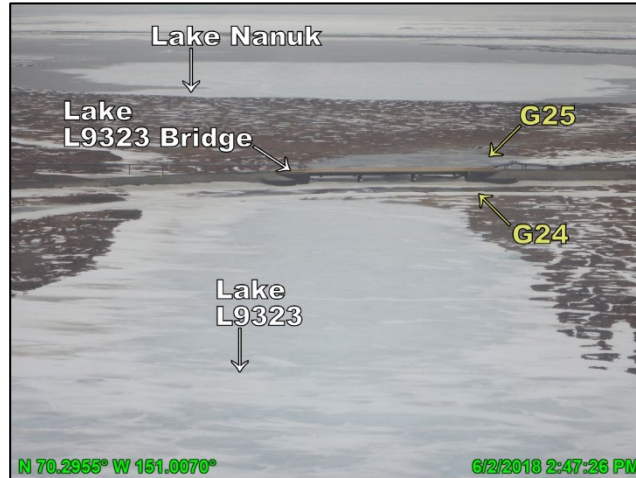
Photo 4.30: CD5 road at gage G24/G25 two days prior to peak stage at G25, looking north; June 2, 2018

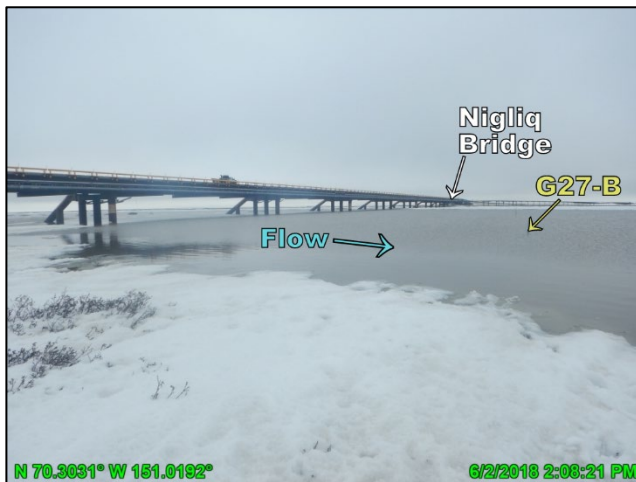
Photo 4.31: Nigliq Bridge, the day before peak stage, looking west; June 2, 2018

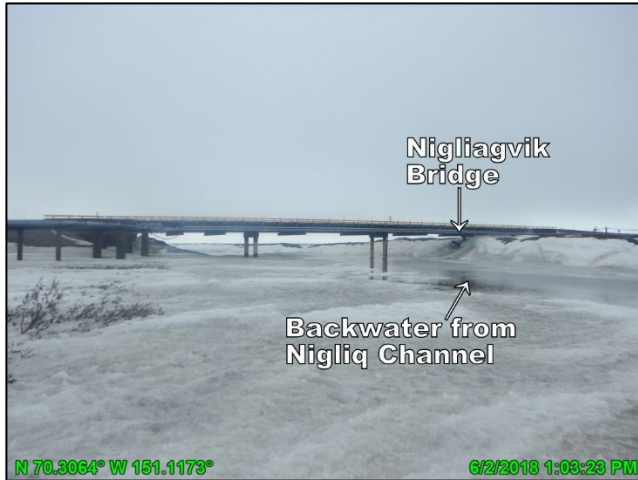
Photo 4.35: Nigliagvik Channel the day prior to peak stage, looking south (upstream); June 2, 2018

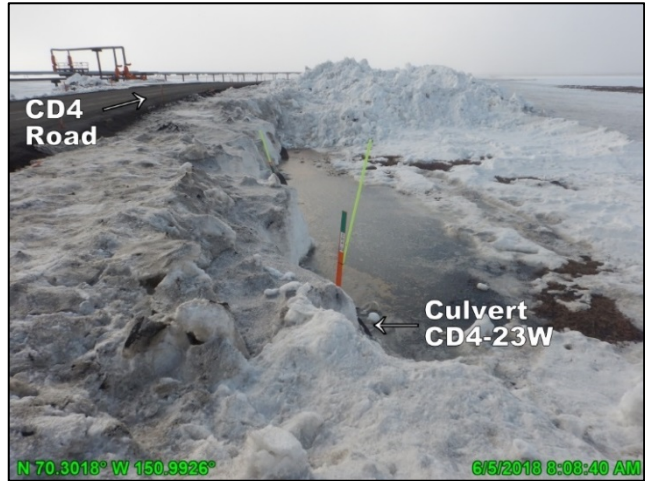
Alpine road and pads were inspected for erosion between June 4 and June 6 (Photo 5.1 through Photo 5.4). Other than minor washlines, no discernable erosion was observed during aerial and ground reconnaissance of the CD2, CD4, and CD5 roads. Floodwaters did not reach CD5 bridge abutments or the CD5 road within the CRD. A prominent washlines from 2015 spring breakup was evident along portions of the CD2, CD4, and CD5 roads. There were no signs of sloughing or undermining at drainage structures. Additional photo documentation of erosion surveys and breakup conditions along the Alpine facilities roads and pads are shown in Appendix D.

Photo 5.2: West side of CD4 road near CD5 intersection, looking southeast; June 5, 2018

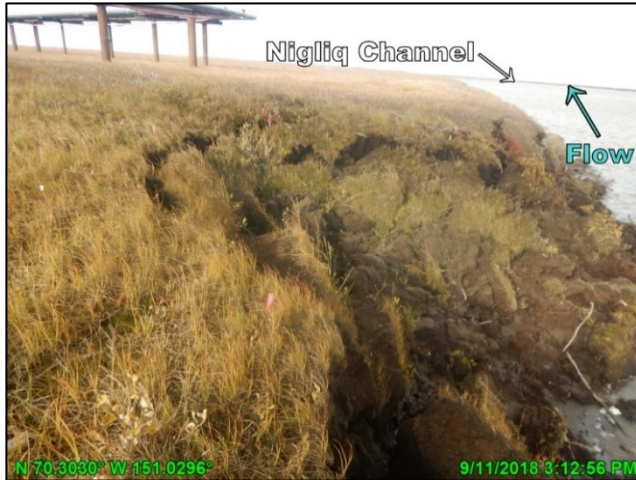
Photos from the bank erosion survey at the Nigliq Bridge and Nigliagvik Bridge are presented in Photo 6.1 through Photo 6.4. Maximum incremental and cumulative erosion at the Nigliq Bridge and Nigliagvik Bridge and maximum incremental, maximum cumulative, and average erosion along the top of bank, upstream and downstream of the bridges, is presented in Table 6.3. Bank erosion tabulated data presented in Appendix E (UMIAQ 2018b).

Photo 6.1: West bank of the Nigliq Channel under the Nigliq Bridge, looking north; September 11, 2018

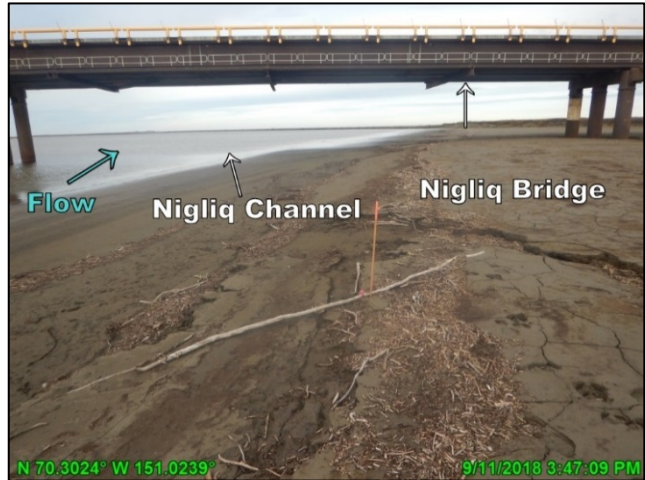
Photo 6.2: East bank of the Nigliq Channel near the Nigliq Bridge, looking north; September 11, 2018

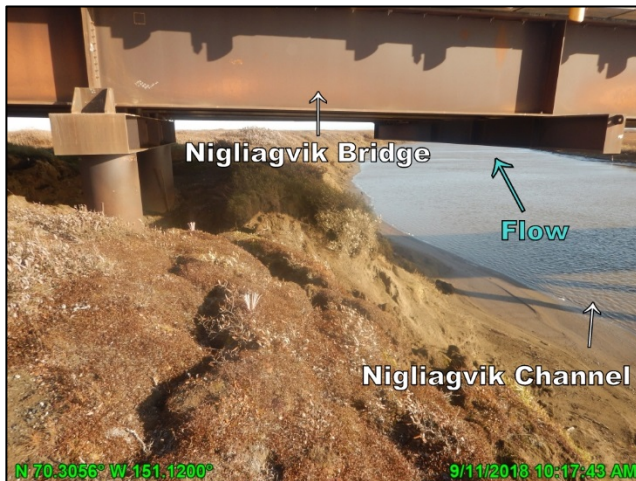
Photo 6.3: West bank of the Nigliagvik Channel at the Nigliagvik Bridge, looking north; September 11, 2018

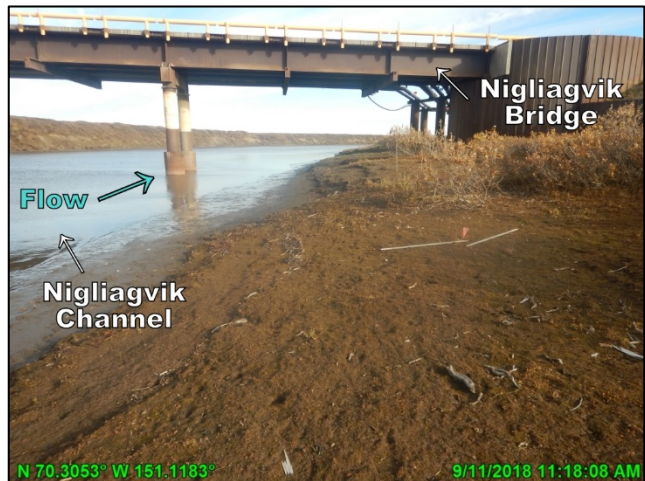
Photo 6.4: East bank of the Nigliagvik Channel at the Nigliagvik Bridge abutment, looking north; September 11, 2018

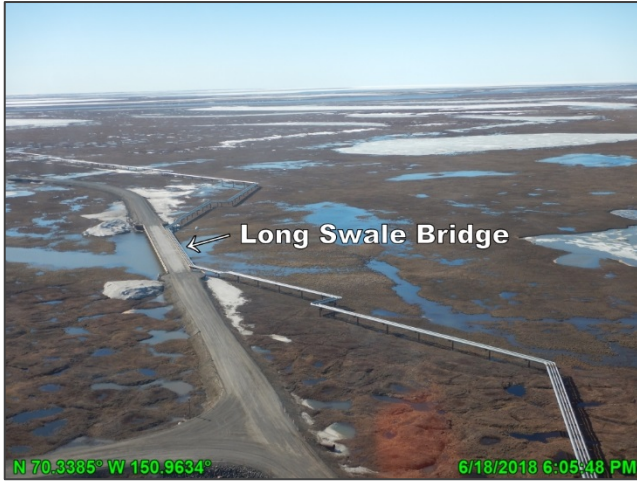
During peak conditions, floodwater in the delta was generally confined within channels, lakes, and swales and did not reach most infrastructure (roads/pads) in the delta. Measured pier scour was minimal. Post-breakup visual inspections of all roads and pads found no evidence of erosion or damage.

Photo D.1: CD2 road at the Long Swale Bridge post breakup, looking west; June 18, 2018

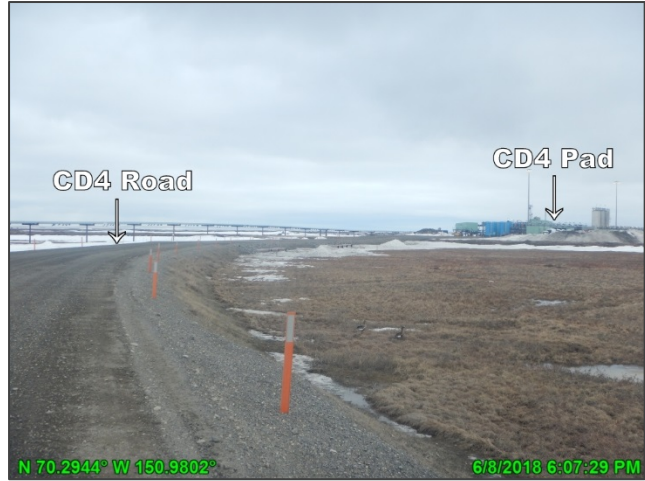
Photo D.2: CD4 road near the CD4 Pad, looking west; June 8, 2018

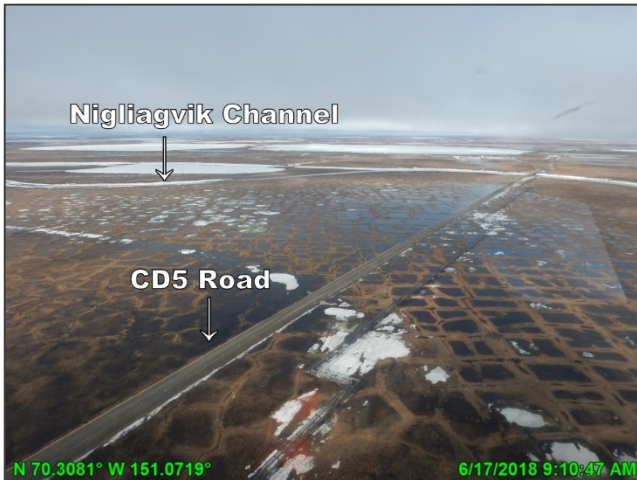
Photo D.3: CD5 road between Lake L9341 and the Nigliagvik Channel, looking southwest; June 17, 2018

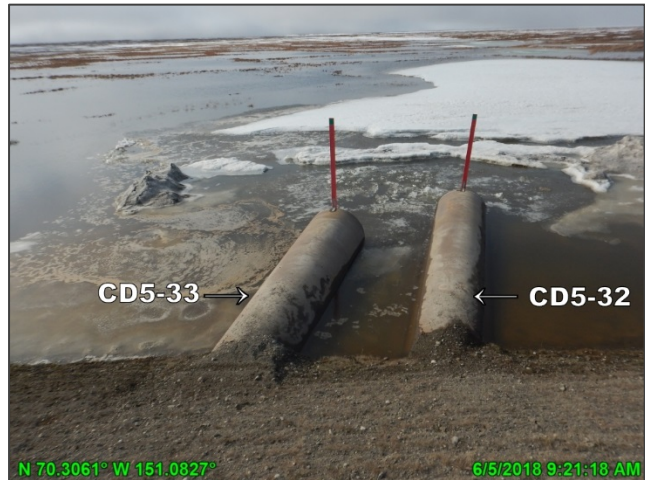
Photo D.4: Culverts along the CD5 road, looking south; June 5, 2018

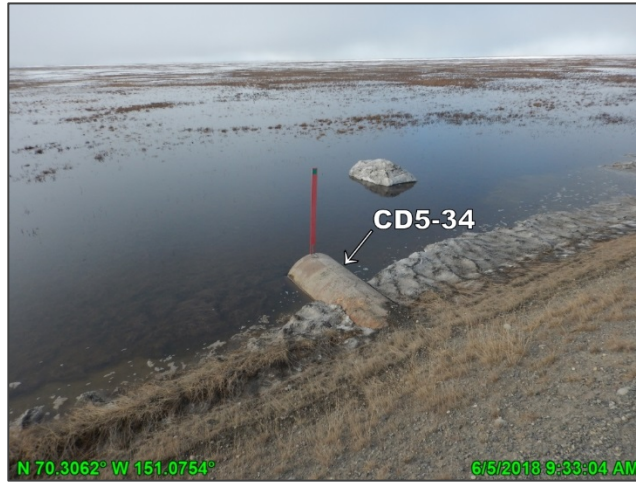
Photo D.5: Culverts along the CD5 road, looking south; June 5, 2018

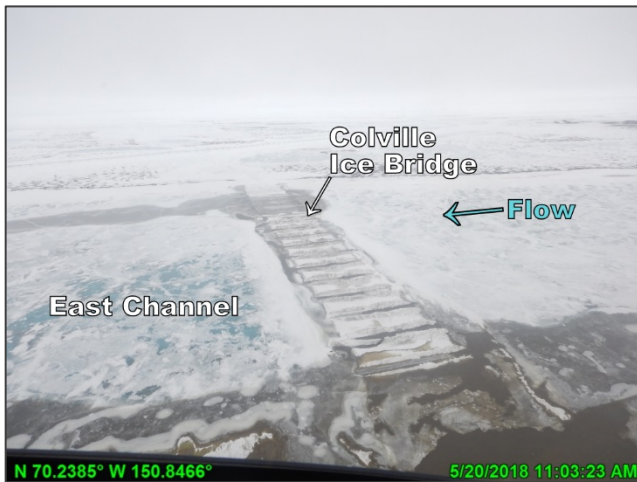
Photo D.6: Colville River East Channel at HDD pre-breakup, looking east; May 20, 2018

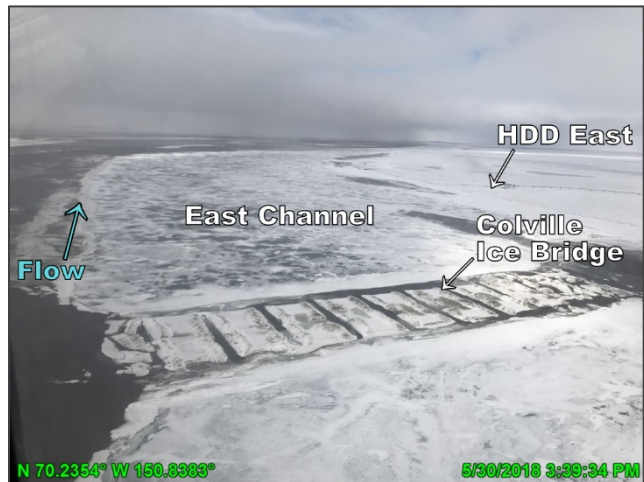
Photo D.7: Colville River East Channel at HDD during breakup, looking north; May 30, 2018

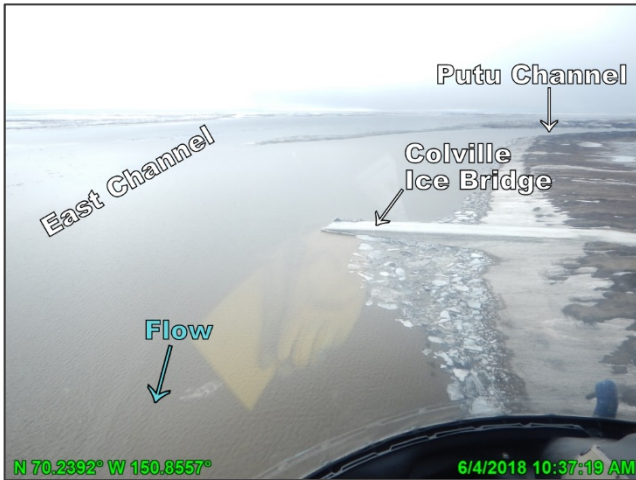
Photo D.8: Colville River East Channel at HDD post-breakup, looking south, June 4, 2018

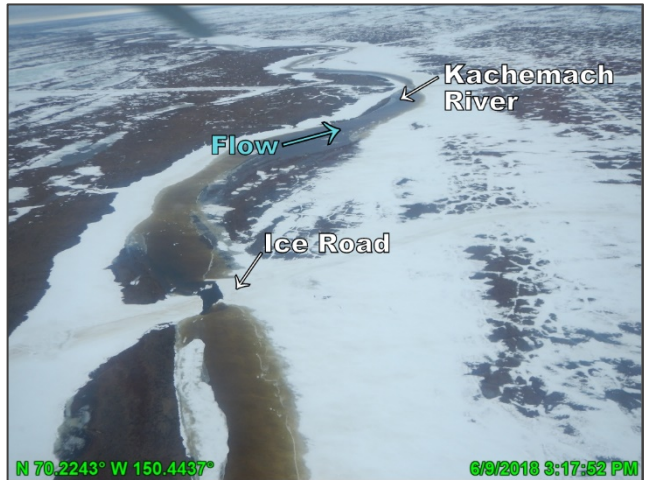
Photo D.9: Kachemach River during breakup, looking north; June 9, 2018

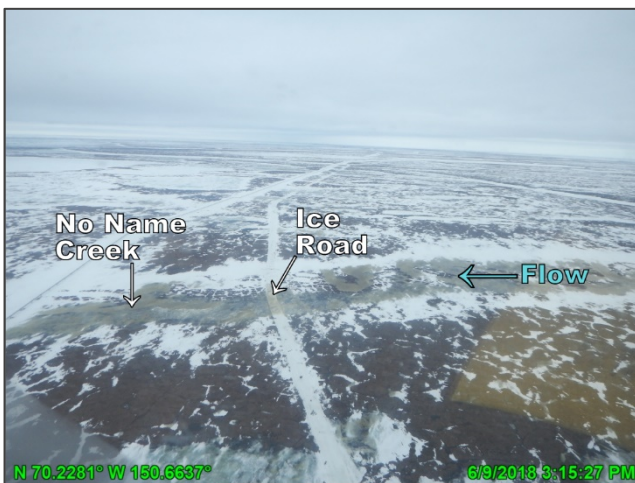
Photo D.18: No Name Creek pre-breakup, looking east; June 4, 2018

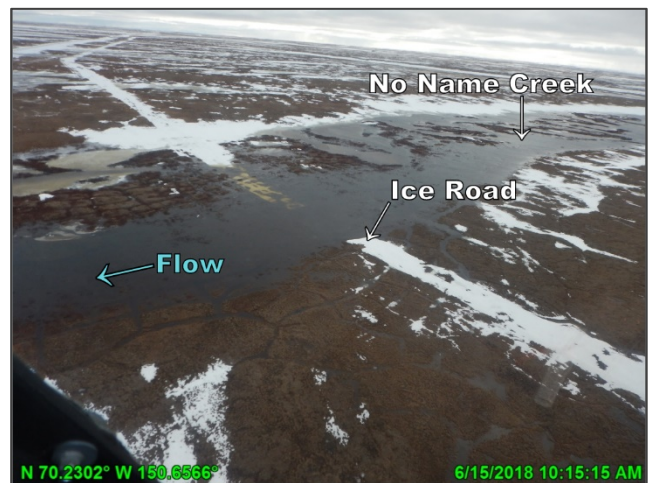
Photo D.19: No Name Creek post-breakup, looking northwest; June 15, 2018
