2018

GMT1 SPRING BREAKUP & SUMMER MONITORING & HYDROLOGICAL ASSESSMENT

Michael Baker

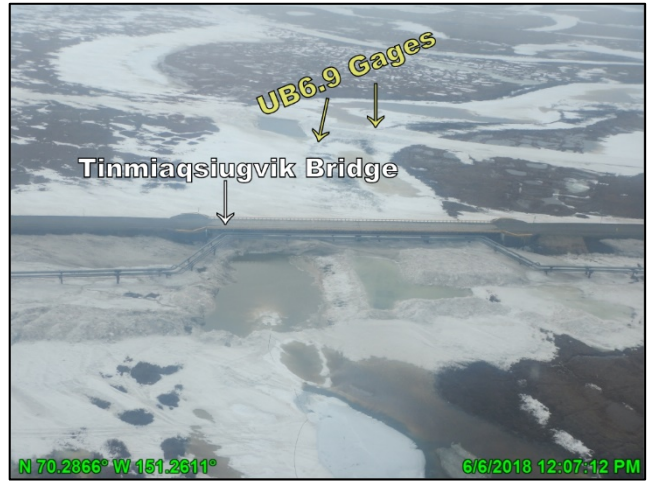
Photo 3.2: Tinmiaqsiugvik Bridge, looking south (upstream); June 6, 2018.

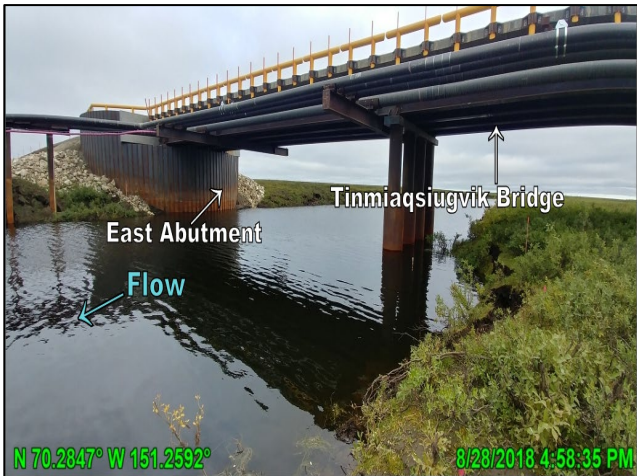
Continuous discharge and velocity was calculated based on ice- and snow-free conditions during the summer and remained well below peak discharge and peak velocity calculated during spring breakup (Photo 4.5 and Photo 4.6). Indirect summer calculations, including the estimated highest summer discharge and velocity, were assigned a good quality rating based on open-channel conditions.

Photo 4.5: Tinmiaqsiugvik Bridge, looking southeast; August 28, 2018

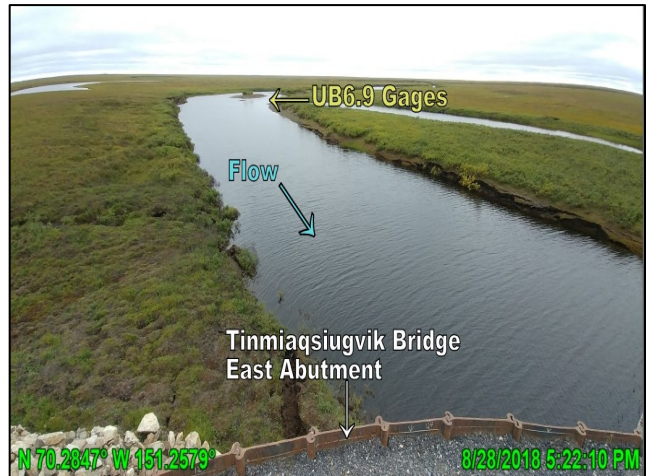
Photo 4.6: Tinmiaqsiugvik Bridge, looking south; August 28, 2018

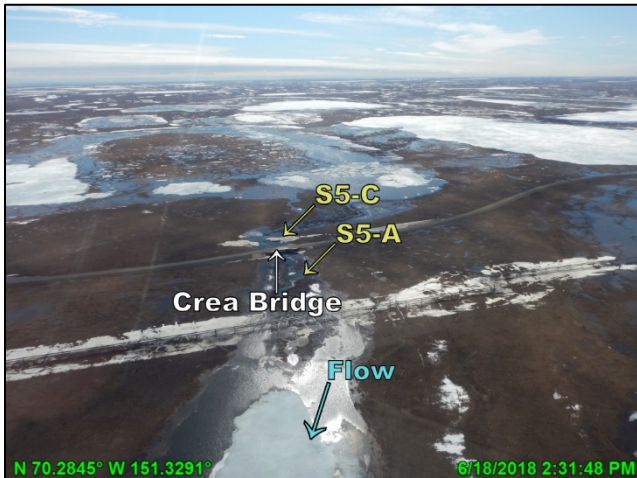
Photo 4.9: Crea Bridge, looking south; June 18, 2018

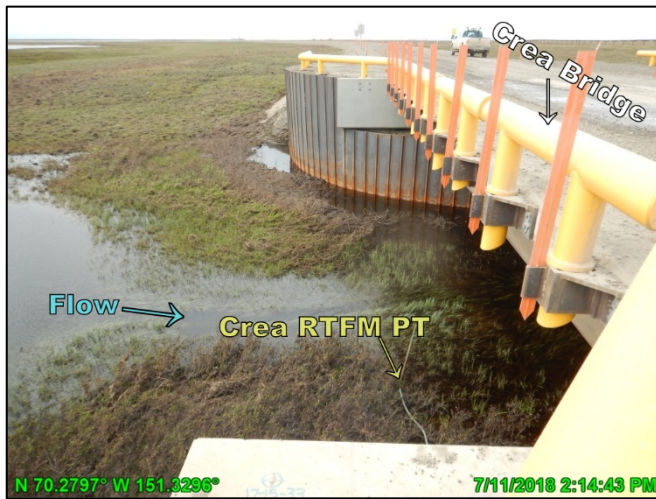
Crea Creek was ice and snow free and flow was conveyed within main channel banks when field crews returned to the site in early July. Summer stage, discharge, and velocities at the Crea Bridge were significantly lower than during spring breakup (Photo 4.11 and Photo 4.12).

**Photo 4.11: Crea Bridge, looking west;
July 11, 2018**

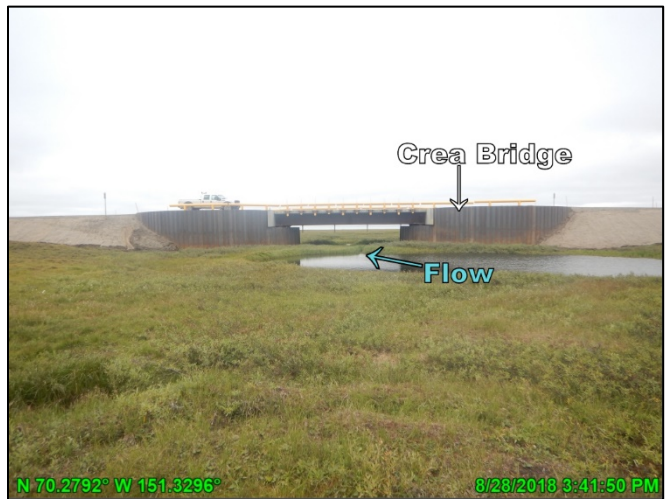
**Photo 4.12: Crea Bridge, looking north
(downstream); August 28, 2018**

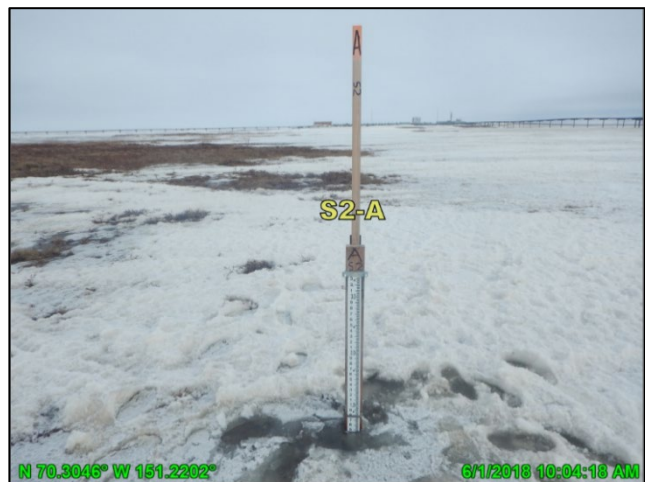
On June 1, ponded meltwater was observed at the upstream (S2-B) gage on the south side of the GMT1 access road (Photo 4.19). Snow initially blocked the culverts from conveying flow and minimal local melt was observed at the downstream (S2-A) gage on the north side of the road (Photo 4.20). Observations from the evening of June 3 show significant meltwater at both S2 gages. PT data suggests that the culvert impediment was cleared early on June 3, as similar and concurrent stage trends between gage sites indicate a hydraulic connection was established through the culverts.

Photo 4.20: S2-A, looking north; June 1, 2018

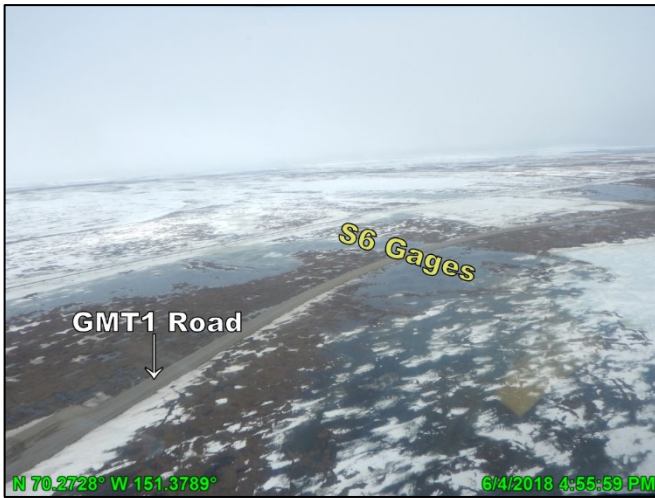
Photo 4.25: S6, looking south; June 4, 2018

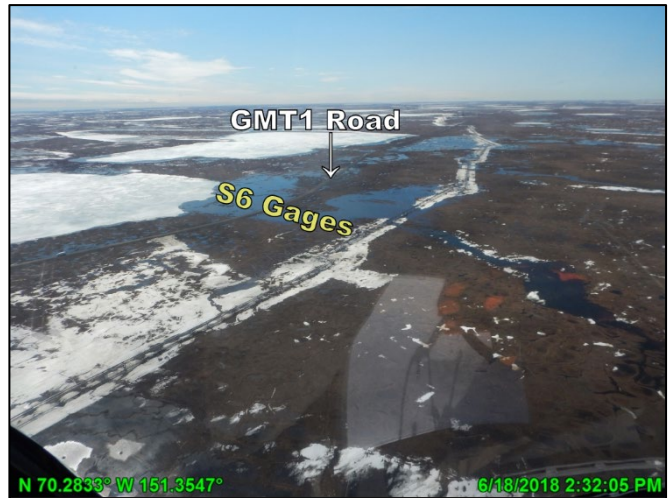
On May 14, local meltwater was accumulating on the upstream gage (S6-B). PT data shows an increase of stage at the upstream gage site around May 16. Peak stage was initially reported as June 8 in the GMT1 2018 Culvert Monitoring Report (Michael Baker 2018), however, after retrieving and analyzing PT data, peak stage occurred at the upstream gage on May 18 and was the result of isolated local melt. A hydraulic connection through the culverts was likely established around May 21, when the upstream stage data rapidly receded. Stage remained low until the start of June. Peak stage was recorded at S6-A on June 3. Aerial observations from June 4 show flooding over low-lying areas and equalized hydraulic conditions upstream and downstream of the road, suggesting the culverts were conveying low velocity flow (Photo 4.25). By June 18, minimal snow remained along the banks of the drainage and flow was generally well-confined to the defined channel (Photo 4.26).

Photo 4.26: S6, looking south; June 18, 2018

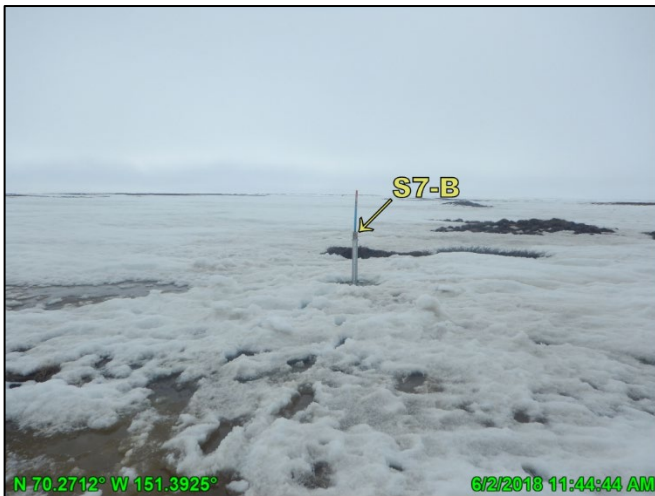
On May 26, local melt was observed at the downstream gage (S7-A) along with saturated snow between the gage and the road. Peak stage was recorded at the upstream gage (S7-B) on June 2 and was the result of local, disconnected meltwater (Photo 4.27). S7-B stage began steadily receding after June 2. Observations on June 8 show culverts GMT1-21 through GMT1-24 dry while culverts GMT1-25 through GMT1-29 had pooled, stagnant water on each side (Photo 4.28). The stagnant water was likely caused by iced-in culvert bladders. Hydraulic connection was likely established through culverts GMT1-25 and GMT1-26 around June 9, corresponding with a decrease in stage at the upstream gage and a rise in stage at the downstream gage. Peak stage at S7-A occurred on June 9 and was attributed to the hydraulic connection established through the GMT1-25 and GMT1-26 culverts (Photo 4.29). Discharge was not measured at any of the culverts related to the S7 drainage since no discernable flow was observed on June 8, the day culvert discharge measurements were taken. By June 17, minimal snow remained in the S7 drainage area. (Photo 4.30).

Photo 4.27: S7-B, looking south June 2, 2018

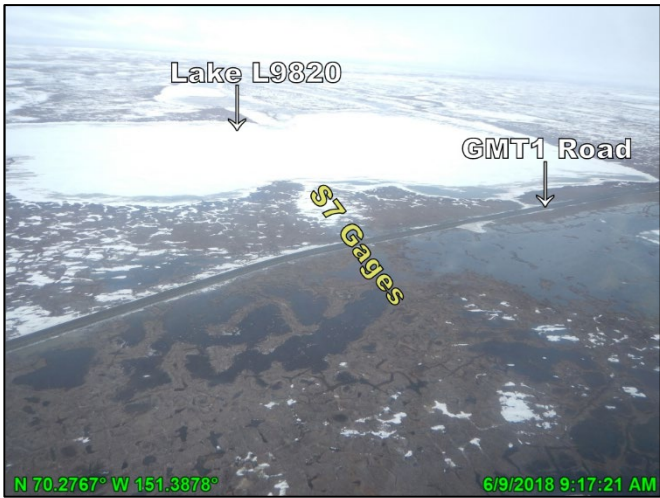
Photo 4.29: Peak stage conditions at S7, looking south; June 9, 2018

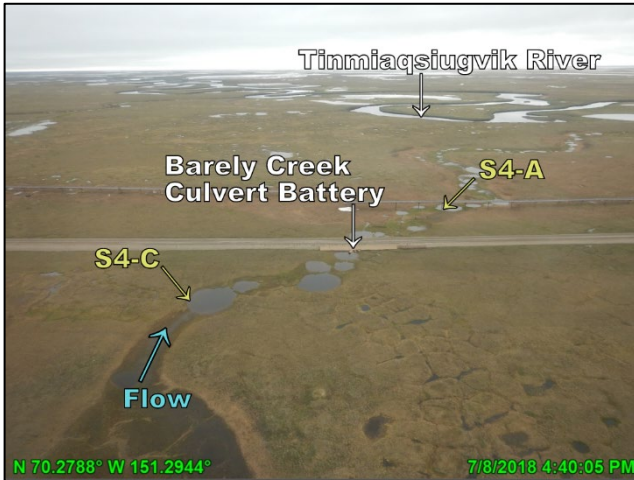
Photo D.1: Barely Creek culvert battery, looking north (downstream); July 8, 2018

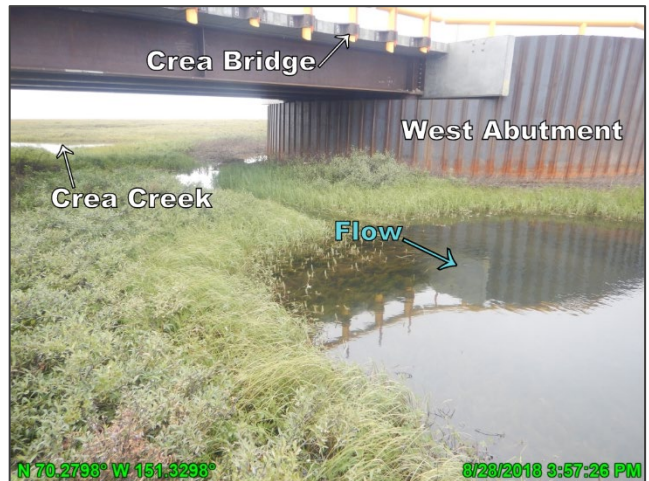
Photo D.8: Flow under Crea Bridge, looking south (upstream); August 28, 2018

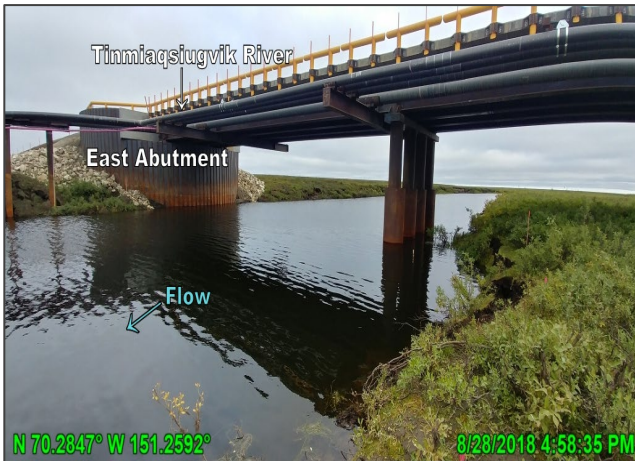
Photo D.12: Tinmiaqsiugvik Bridge, looking southeast (upstream); August 28, 2018

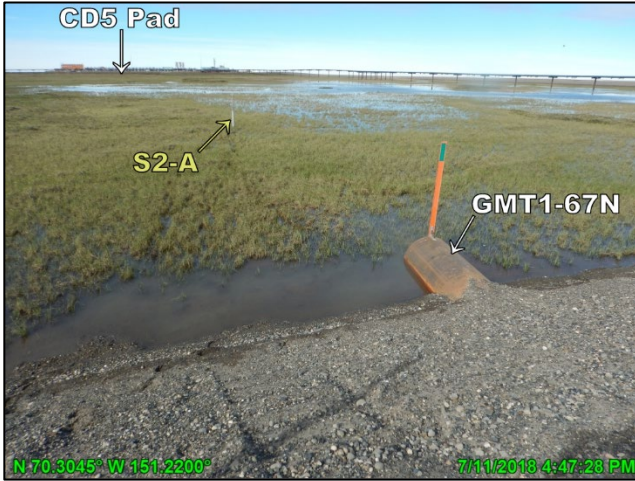
Photo D.17: S2 gages and culverts, looking north; July 11, 2018

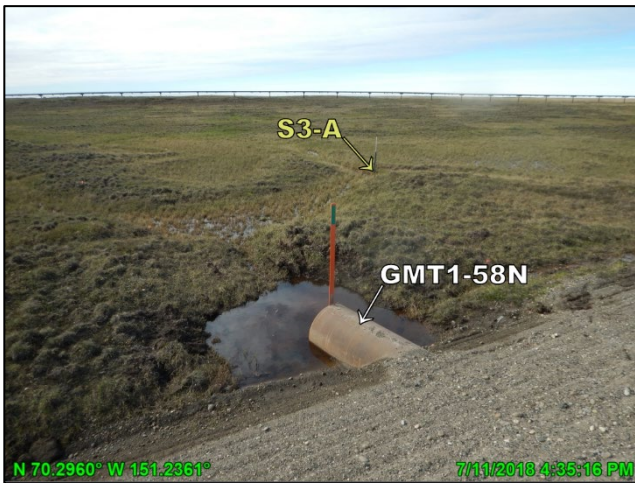
Photo D.19: S3 gages and culverts, looking north; July 11, 2018

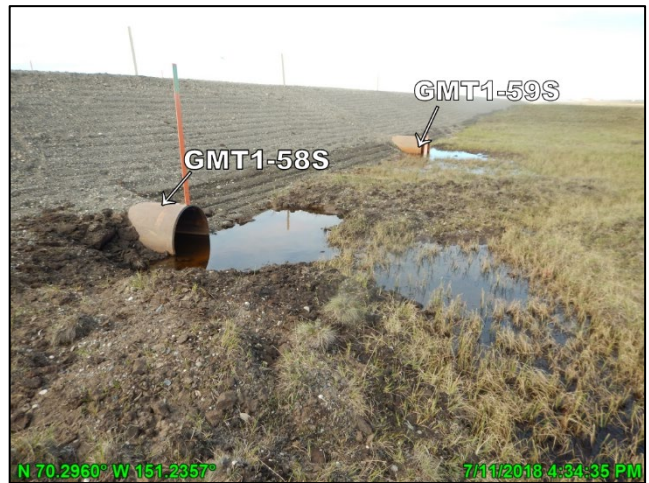
Photo D.20: S3 culverts GMT1-58 through 59, looking north; July 11, 2018
