2020 Colville River Delta Spring Breakup Monitoring & Hydrological Assessment - Final

ConocoPhillips
Alaska

EXECUTIVE SUMMARY

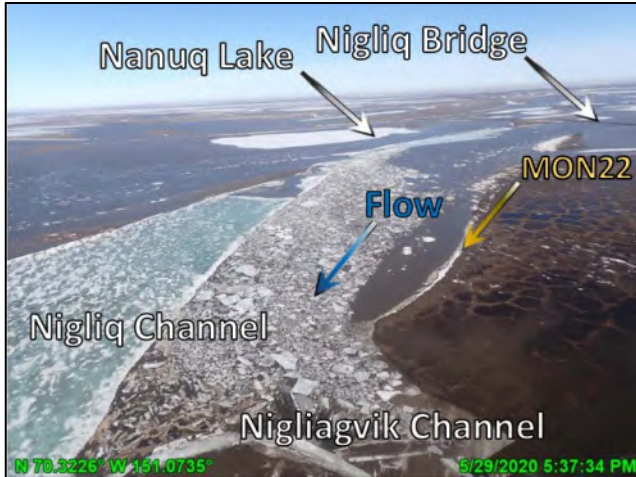
Photo 4-15 Ice jam near the Nigliagvik Channel confluence, looking southeast (upstream); May 29, 2020

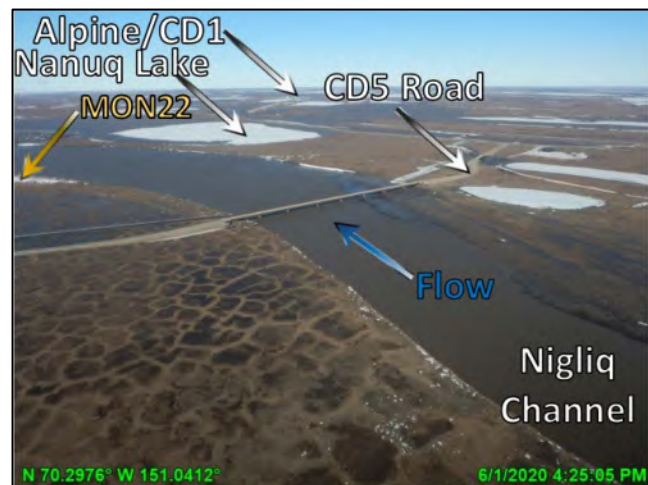
During peak stage, widespread overbank flooding was observed around the CD4 pad, along the CD5 road, and along the CD2 road and pad (Photo 4-16, Photo 4-17, and Photo 4-18). The ice jam near MON22 was observed to still be in place at approximately 5:30 PM on May 29. By May 31, aerial observations confirmed the ice jam near MON22 had cleared, and stage had receded below bankfull (Photo 4-19 and Photo 4-20). Widespread stranded ice was observed near CD2.

Photo 4-20: Receding stage in Nigliq Channel, looking north (downstream); June 1, 2020

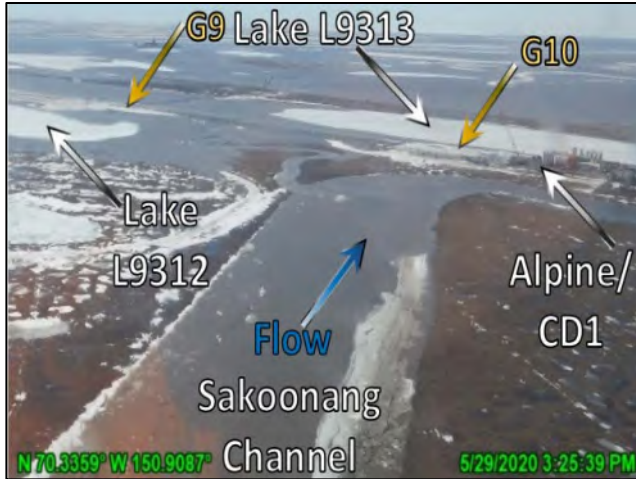
Photo 4-23: Overland recharge of both Lakes L9312 and L9313 near peak stage, looking east; May 29 2020

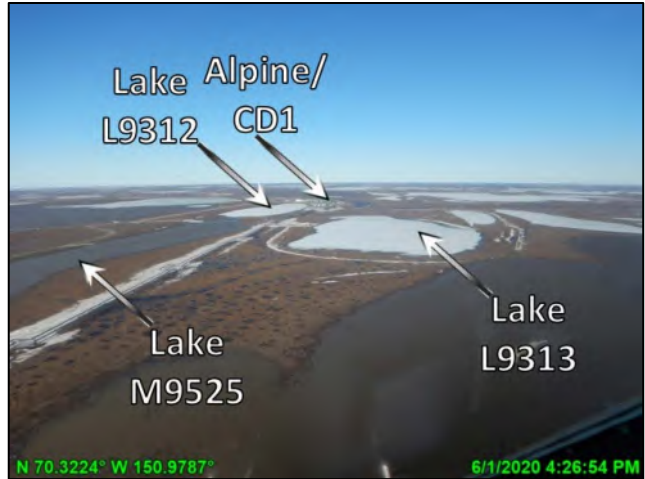
Photo 4-24: Lake L9312 after recharge from overland flow, looking east; June 1, 2020

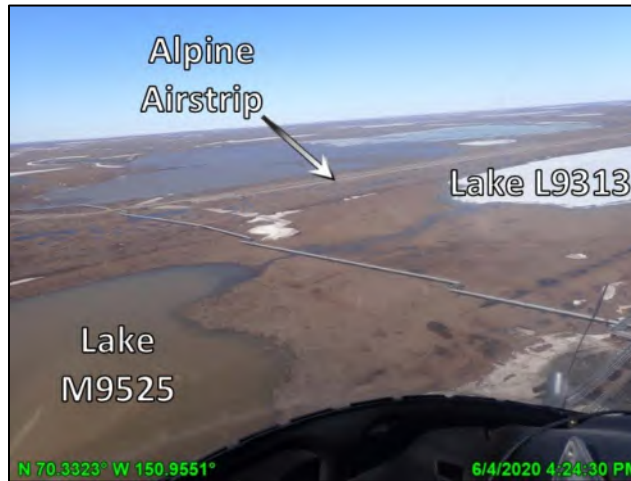
Photo 4-25: Lake L9313 hydraulically connected to Lake M9525 after peak stage; June 4, 2020

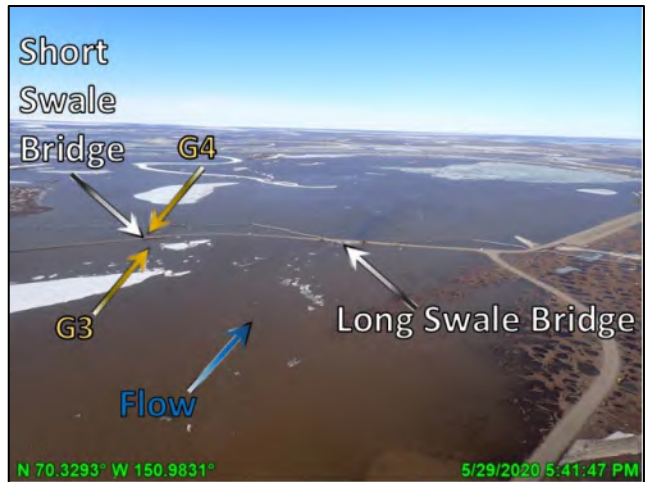
Photo 4-29: Floodwater passing through the swale bridges near peak stage; looking north (downstream) May 29, 2020

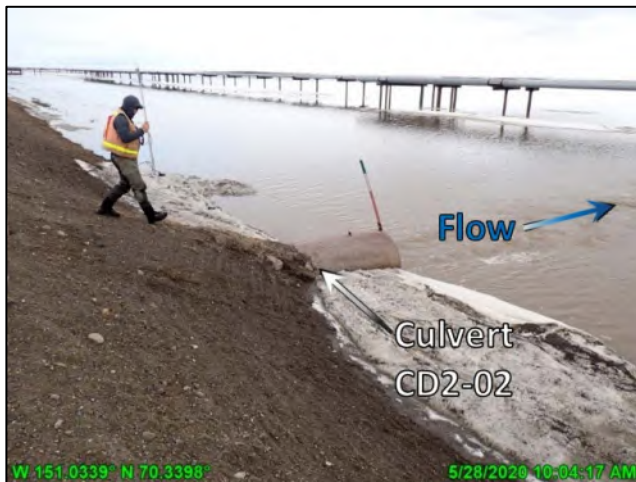
Photo 4-30: Crew measuring discharge through culvert CD2-02, looking northwest; May 28, 2020

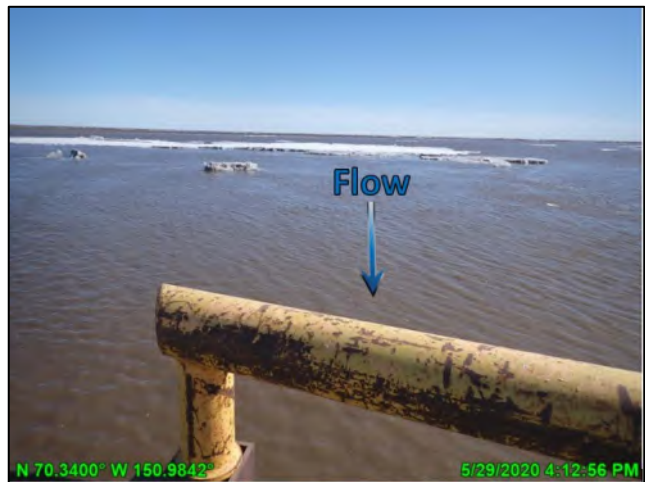
The average velocity measured through the short swale bridge on May 29 was 5.17 fps and the highest depth average velocity within a single section was 6.43 fps. Ice was present south of the bridge but did not obstruct flow through the discharge cross section (Photo 4-31). The overall quality rating of the discharge measurement was classified as fair based on conditions at the time of the measurement.

Photo 4-31: Ice present south of Short Swale Bridge during discharge measurement, looking south (upstream); May 29, 2020

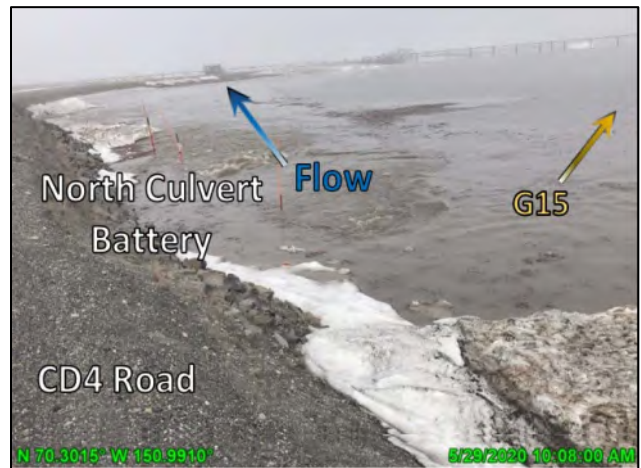
Initial localized melt was observed at road gages G15/G16 on May 28. The stage hydrographs indicate additional floodwater was accumulating by late day May 28 as water levels in Lake M9525 increased from the Sagoonang Channel (Photo 4-35). Stage at G15 and G16 rose approximately 4-feet from the evening of May 28 to the morning of May 29 and water levels equalized across the CD4 road through the north culvert battery. On the morning of May 29, the ice jam in the Nigliq Channel at Nuiqsut released and the surge of floodwater inundated Lake L9323 and surrounding floodplain, resulting in a rapid stage increase at G16. Stage peaked at G16 around mid-day on May 29 and coincided with peak stage at adjacent Nigliq Channel gages. G16 peak stage was approximately 2 feet higher than at G15, and the culverts were flowing at full capacity from south to north. Stage peaked at G15 on the evening of May 29 and stage at G16 dropped rapidly. Minimal stage differential between G15 and G16 was noted by May 30 indicating water levels had once again equalized. During peak conditions, the culvert battery was completely submerged, and turbulent flow was observed at the outlets (Photo 4-36). Discharge was not measured at this site due to safety concerns associated with culvert access during the high discharge and stage conditions.

Photo 4-36: Turbulent flow through north culvert battery at G15/G16 near peak stage, looking north (downstream); May 29, 2020

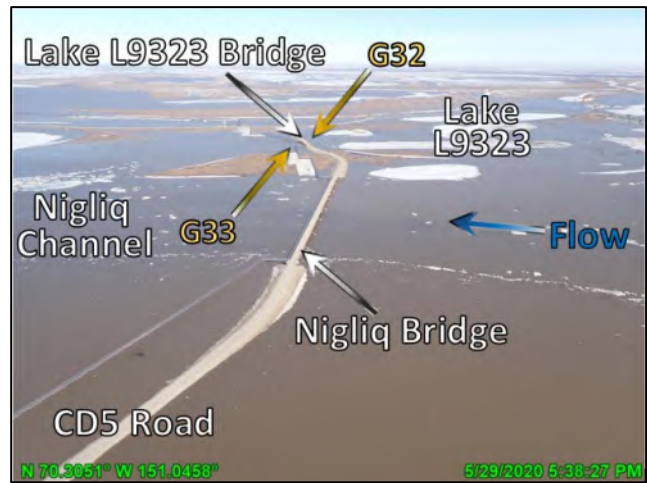
Isolated localized meltwater was observed near Lake L9323 Bridge on May 28 (Photo 4-41). PT data indicates floodwater reached the G24/G25 gages during early morning on May 29, shortly after the ice jam in the Nigliq Channel at Nuiqsut released. Peak stage occurred around noon on May 29. Aerial observations around peak stage showed widespread overbank flooding, with Lake L9323 hydraulically connected to the Nigliq Channel and the

Photo 4-42: Lake L9323 bridge near peak stage, looking east; May 29, 2020

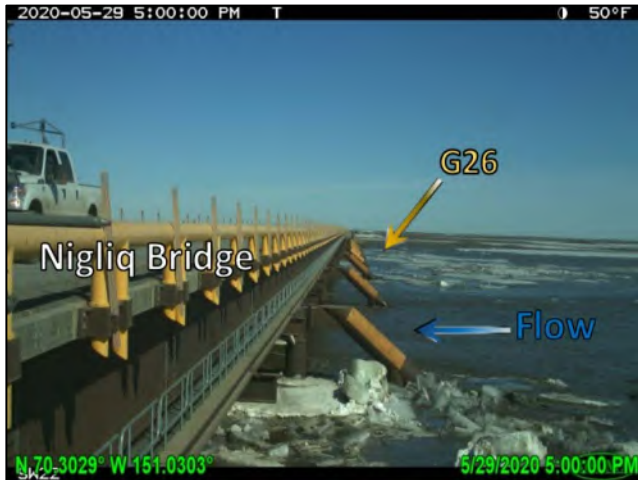
Photo 4-47: Peak stage at the Nigliq Bridge, looking east; May 29 2020

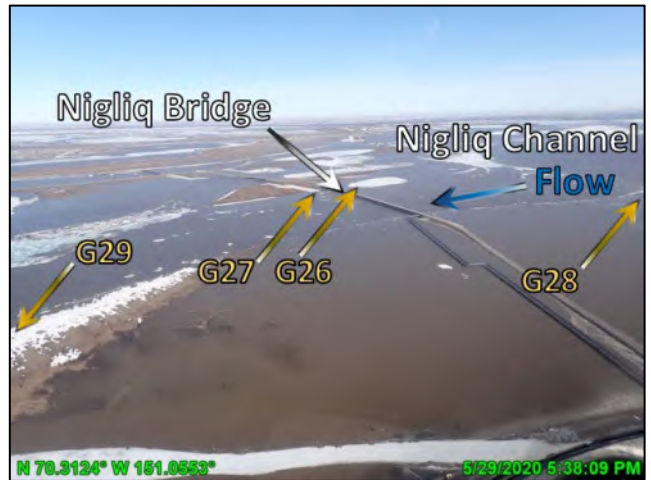
Photo 4-48: Overbank flooding at the Nigliq Bridge, looking southeast (upstream); May 29, 2020

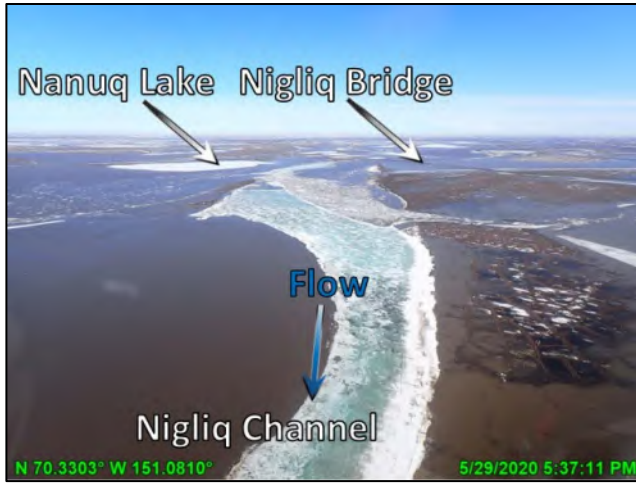
Photo 4-49: Widespread floodwater inundation downstream of Nigliq Bridge crossing, looking south (upstream); May 29, 2020

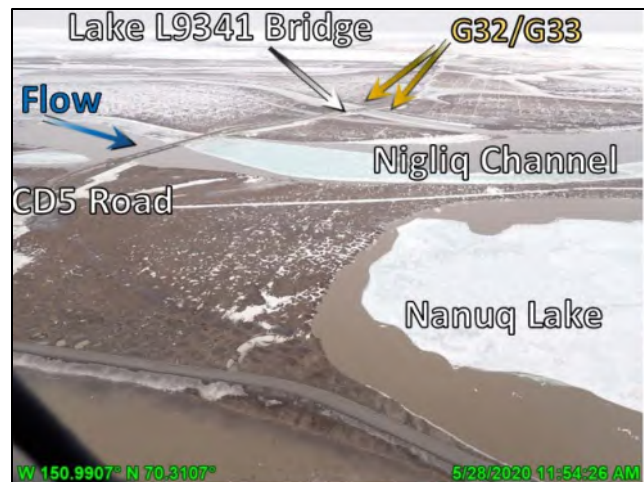
Photo 4-54: Lake L9341 hydraulically connected to Nigliq Channel on north end, looking southwest; May 28, 2020

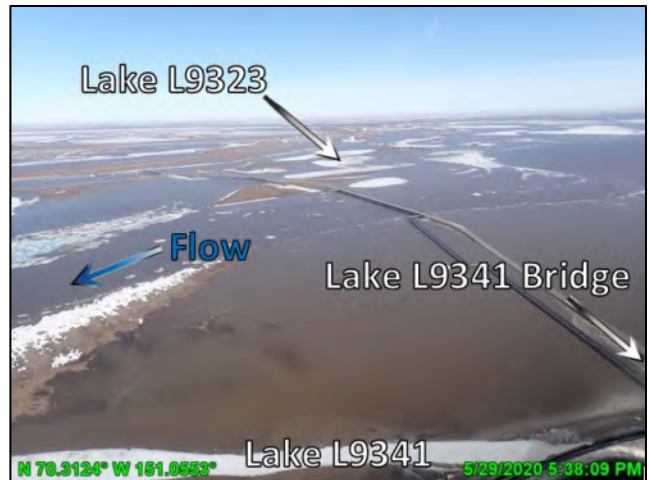
Photo 4-56: Overbank flooding near the Lake L9341 bridge crossing, looking southeast (upstream); May 29, 2020

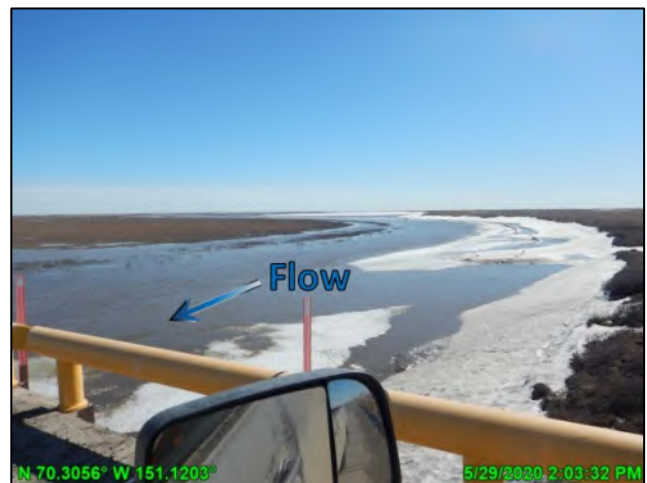
Photo 4-60: Nigliagvik Bridge near peak stage, looking southeast; May 29, 2020

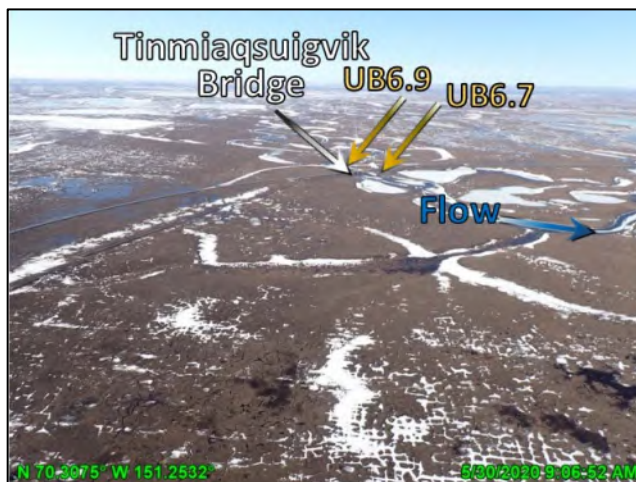
Photo 4-65: Tinmiaqsiugvik Bridge prior to peak stage, looking south (upstream); May 30, 2020

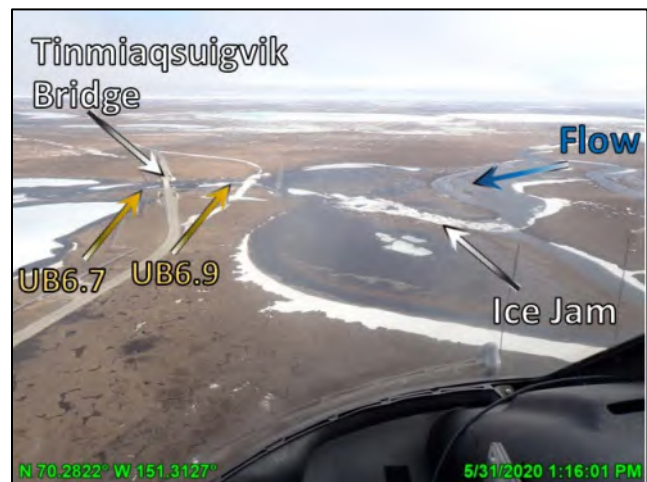
Photo 4-66: Ice jam upstream of the Tinmiaqsiugvik Bridge, looking southeast (upstream); May 31, 2020

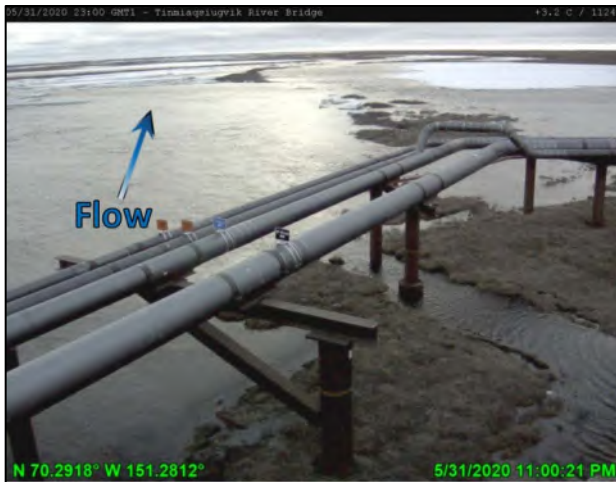
Photo 4-67: RTFM photo from directly downstream of Tinmiaqsuigvik Bridge at peak stage, looking north (downstream); May 31, 2020

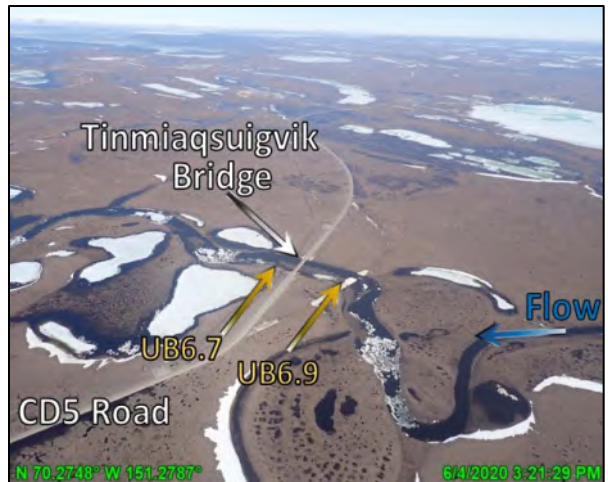
Meltwater was initially observed as discontinuous pools in the channel during an overflight on May 24. Snow cover was estimated at 85% along the GMT1/MT6 road. On May 28, meltwater was hydraulically connected through the bridge crossing. Stage began steadily rising on May 29 as recorded on both upstream and downstream gages. On May 30, aerial observations revealed stage below bankfull and channel ice intact near the crossing (Photo 4-65). A small ice jam was observed upstream of the bridge on May 31. This jam appeared to hold minimal backwater as overbank flow paths developed around the jam (Photo 4-66). Stage continued to rise until peak stage on May 31. Observations near peak stage revealed minor overbank flooding in low-lying areas near the gages (Photo 4-67). After peaking, stage gradually receded to summer flow levels. An overflight on June 4 showed the ice jam still in place as water levels receded (Photo 4-68).

Photo 4-68 Ice jam still in place upstream from the bridge crossing, looking northeast (downstream); June 4, 2020

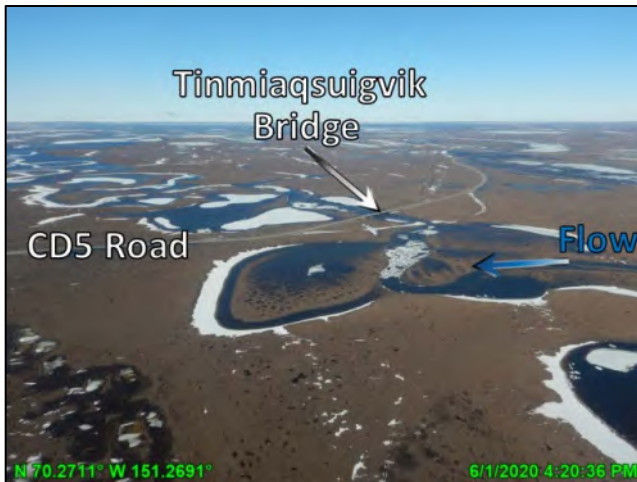
Discharge was measured on the morning of June 1 from the upstream side of the bridge. At the time of the measurement, the channel was mostly free of ice and snow with minor ice floes releasing from the jam upstream of the bridge (Photo 4-69 and Photo 4-70). Peak discharge occurred on June 1 about 2 hours after discharge was measured. The discharge quality rating was classified as fair due to minor ice effects at the time of the measurement.

Photo 4-69: Ice jam upstream of Tinmiaqsuigvik Bridge in place after peak stage, looking north (downstream); June 1, 2020

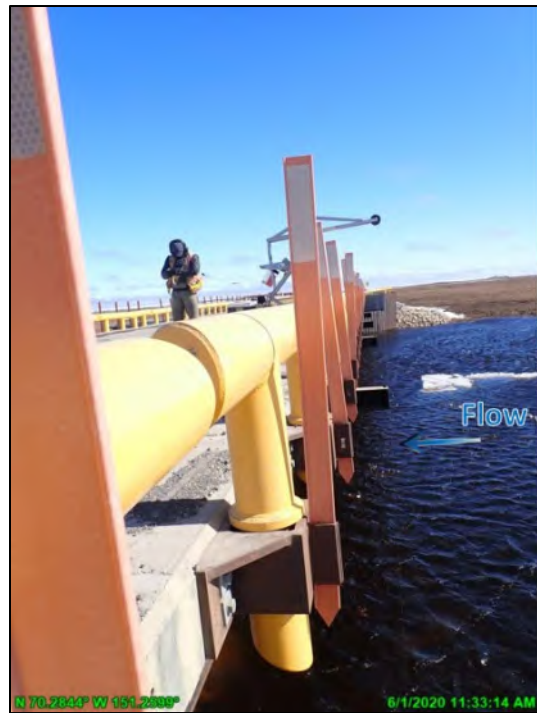
Photo 4-70: Tinmiaqsuigvik Bridge during discharge measurement looking east; June 1, 2020

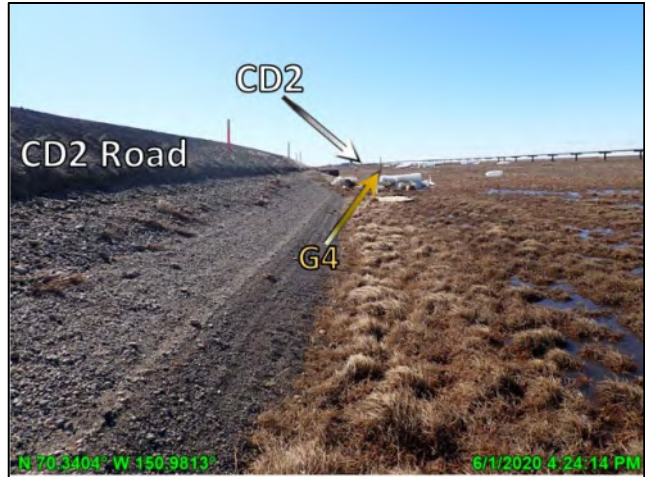
Alpine roads and pads were inspected for erosion on June 1. Washlines were noted on the north side of the CD2 road between the long and short swale bridge, however vegetation under the washlines suggest this was from a flood event prior to 2020, likely 2015. Photo 5-1 through Photo 5-4 shows the CD2 and CD4 road, after stage had receded. No discernable erosion directly attributable to 2020 breakup flooding was observed during aerial and ground reconnaissance of the CD2, CD4, and CD5 roads. Floodwaters did reach most CD5 bridge abutments, but no discernable erosion was observed along the abutments. Washlines from 2015 spring breakup, which was the largest historical flood event to impact Alpine facilities, remain evident along portions of the CD2, CD4, and CD5 roads. There were no signs of sloughing or undermining at drainage structures.

Photo 5-2: CD2 road post-breakup, looking northwest; June 1, 2020

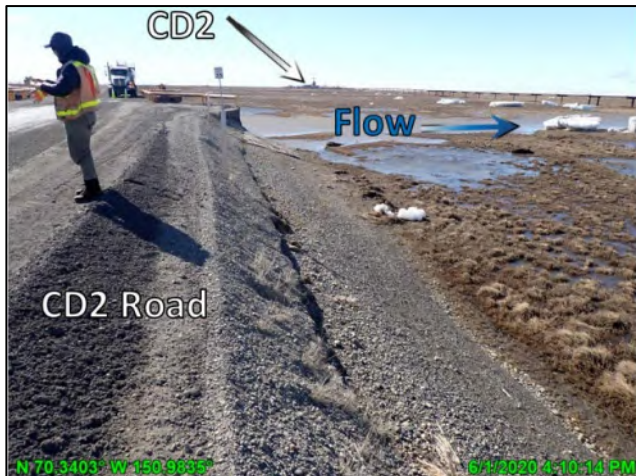
Photo 5-3: CD2 road near Short Swale Bridge post-breakup, looking west; June 1, 2020

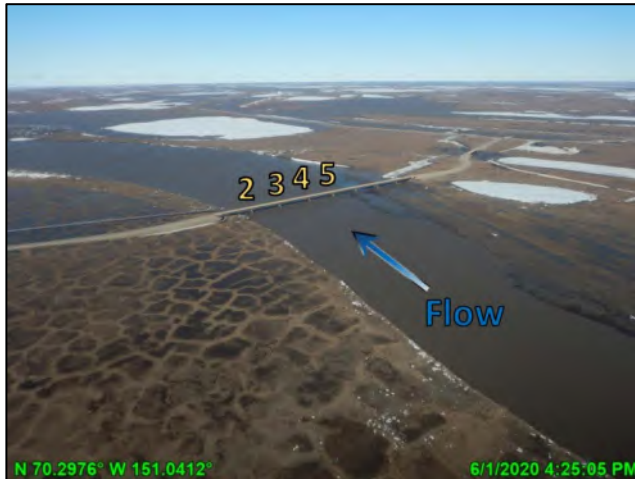
Photo 6-1: Pier numbers on the Nigliq Bridge, looking northeast; June 1, 2020

The minimum post-breakup scour elevation (-30.2 ft BPMSL at pier 4, pile D) is 1.3 ft below the 50-year design scour elevation and 2.8 ft above the 200-year scour elevation. A comparison of design and observed scour elevations are presented in Table 6.1. Real-time pier scour at piers 2 through 5 and corresponding WSEs during spring breakup monitoring are presented in Graph 6-1 through Graph 6-4. Real-time pier scour measurements at pier 2 and pier 3 recorded approximately 5 and 4 ft of scour below the 2019 post-breakup survey elevation, respectively. At piers 4 and 5, real-time scour measurements recorded approximately 1 ft of scour followed by infilling to the 2019 post breakup survey elevation.

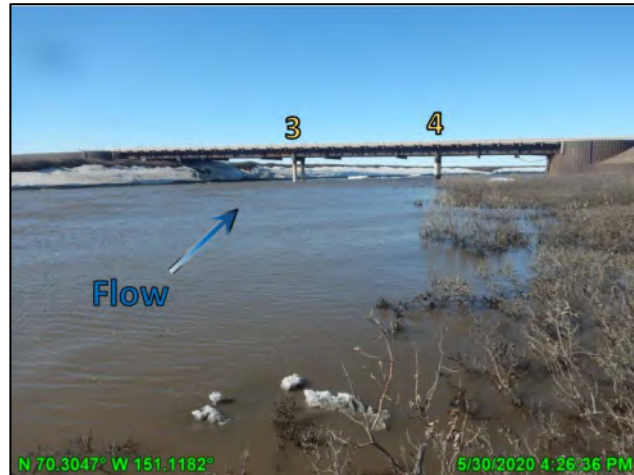
Photo 6-2: Pier numbers on the Nigliagvik Bridge, looking north; May 30, 2020

Real-time pier scour was measured during spring break up at the downstream pile at each scour-susceptible pier group. Post-breakup pier scour elevations that encompass all piles in each pier group were measured by UMIAQ in August 2020. Photo 6-1 and Photo 6-2 show pier numbers for the Nigliq and Nigliagvik bridges, respectfully. Post-breakup contour plots around the piers and within the main channel of the Nigliq Bridge and Nigliagvik Bridge are provided in Appendix E (UMIAQ 2020a).

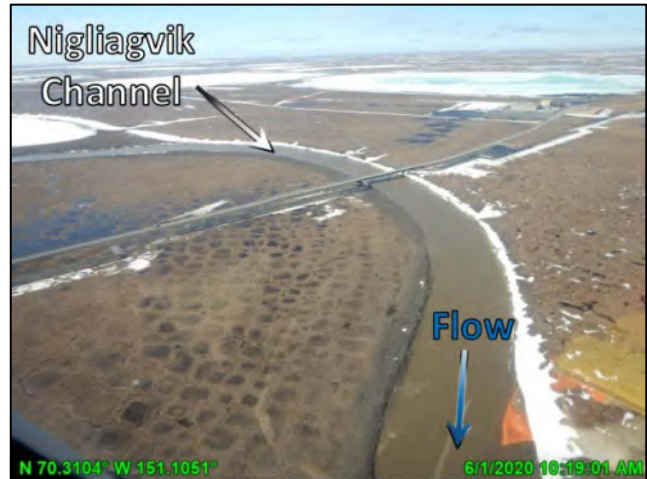
Photo 6-4: Nigliagvik channel post breakup showing no channel migration, looking southwest; June 1, 2020

Aerial photos taken post breakup showing no apparent channel migration of the Nigliq and Nigliagvik Channels are presented in Photo 6-3 and Photo 6-4, respectively. A bank erosion survey upstream and downstream of the Nigliq and Nigliagvik Bridges was performed on August 29 and August 24, respectively. Site conditions during the bank erosion survey at the Nigliq Bridge are presented in Photo 6-5 and Photo 6-6. Maximum incremental and cumulative erosion at the Nigliq Bridge and Nigliagvik Bridge and maximum incremental, maximum cumulative, and average erosion along the top of bank, upstream and downstream of the bridges, is presented in Table 6.3. Bank erosion tabulated data from the bank erosion survey is presented in Appendix E (UMIAO 2020).

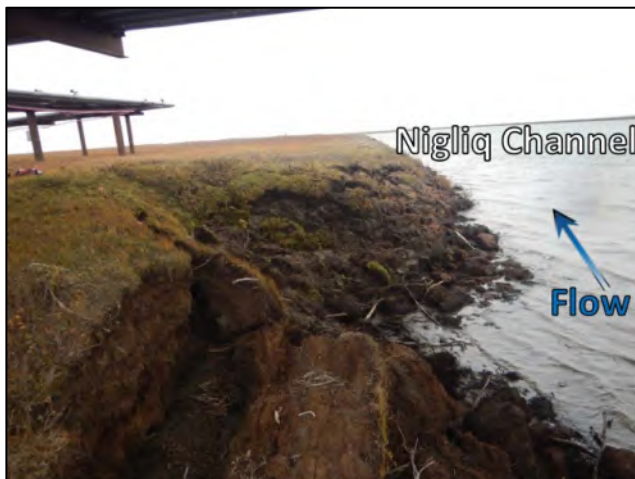
Photo 6-5: West bank of the Nigliq Channel near the Nigliq Bridge, looking north; September 7, 2020

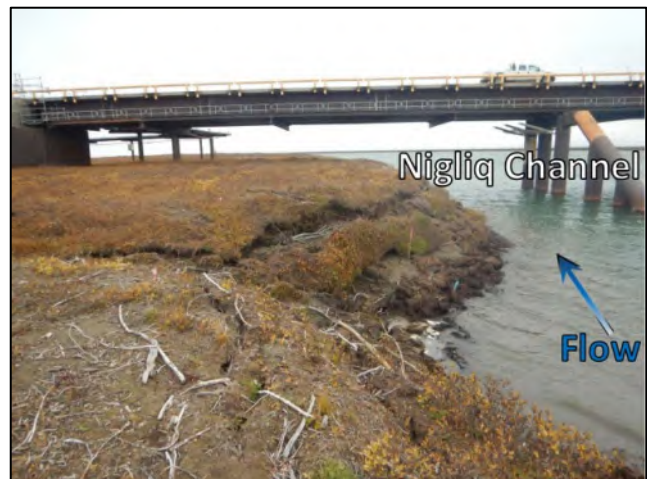
Photo 6-6: West bank of the Nigliq Channel south of the Nigliq Bridge, looking north; September 7, 2020

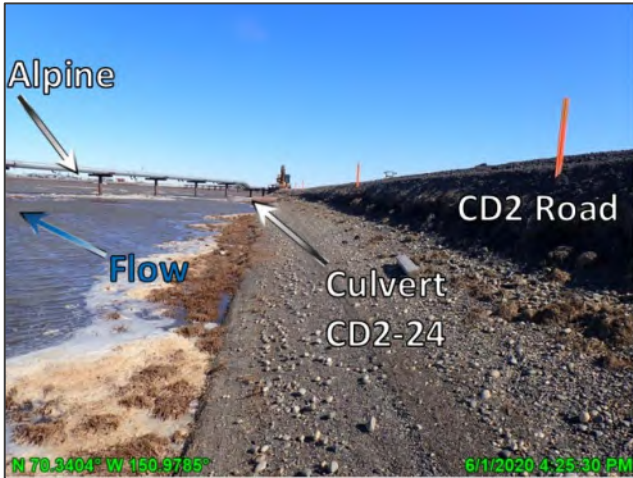
Photo D.1: CD2 road embankment near long swale bridge NE abutment, looking east; June 1, 2020

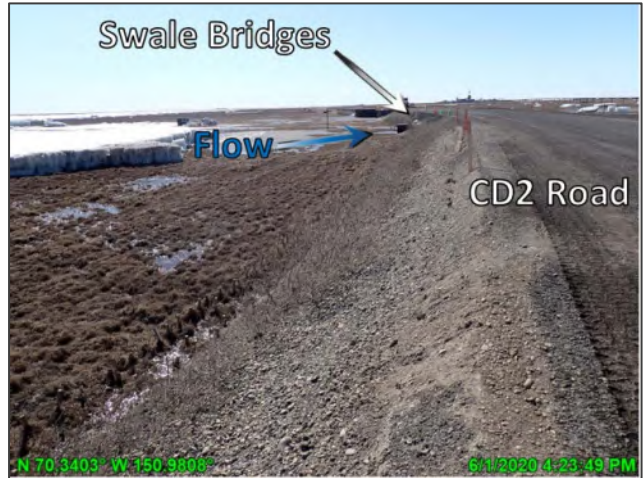
Photo D.2: CD2 road between long swale and short swale bridges, looking northeast; June 1, 2020

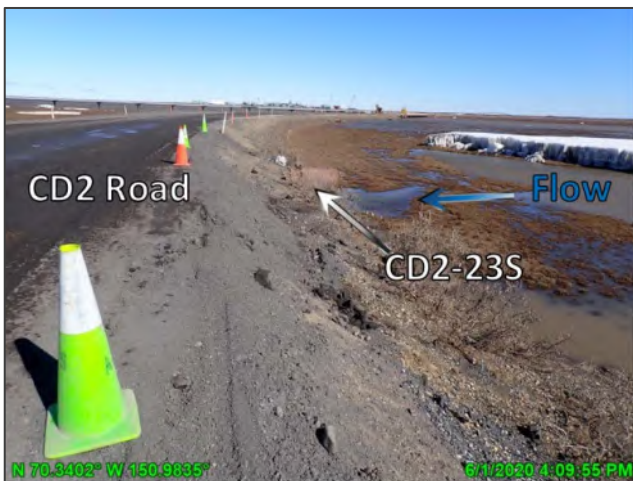
Photo D.3: CD2 road between long swale and short swale bridges, looking southeast; June 1, 2020

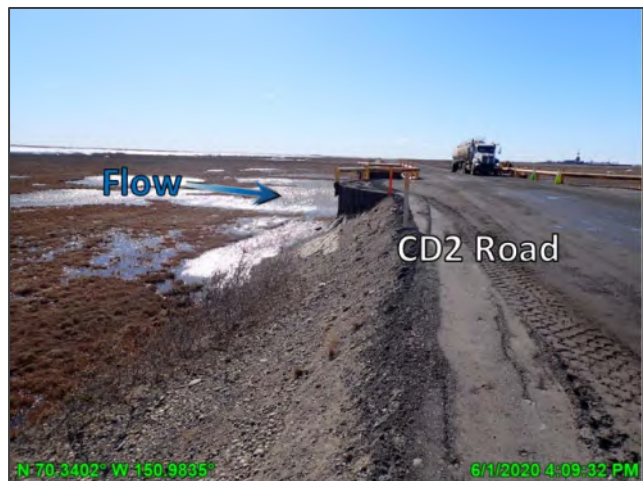
Photo D.4: CD2 road short swale bridge SW abutment, looking east; June 1, 2020

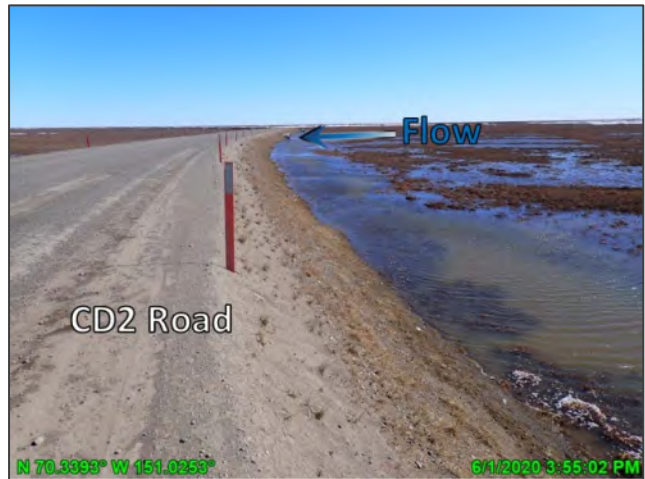
Photo D.8: Road in vicinity of culvert CD2-8S post-breakup, looking southwest; June 1, 2020

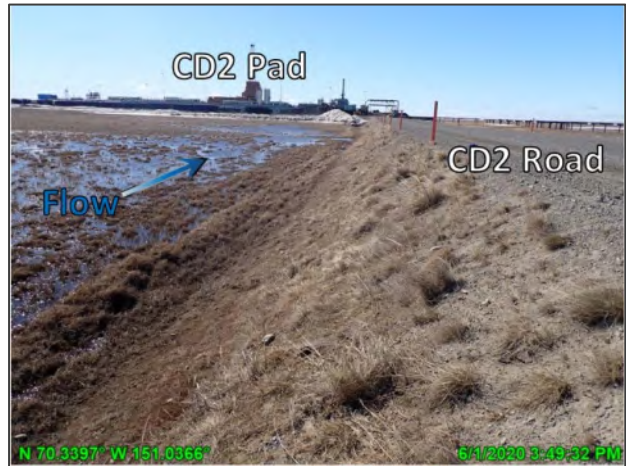
Photo D.12: Road in vicinity of culvert CD2-1S post-breakup, looking east; June 1, 2020

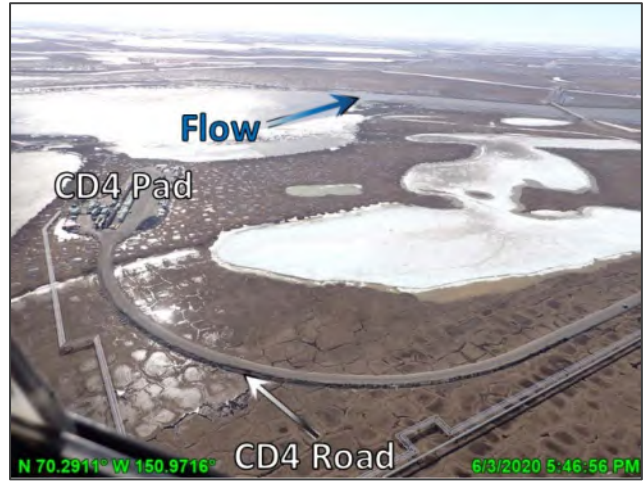
Photo D.14: CD4 road in vicinity of G18 culverts post-breakup, looking northeast; June 3, 2020

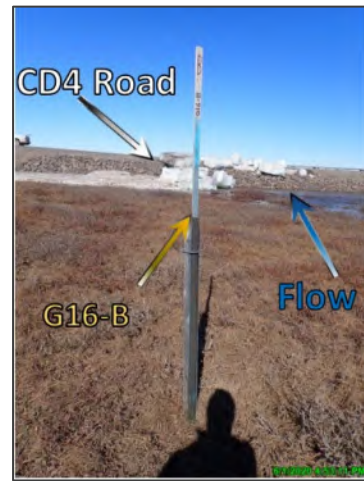
Photo D.16: CD4 road with stranded ice in vicinity of north CD4 culvert battery post-breakup, looking north; June 1, 2020

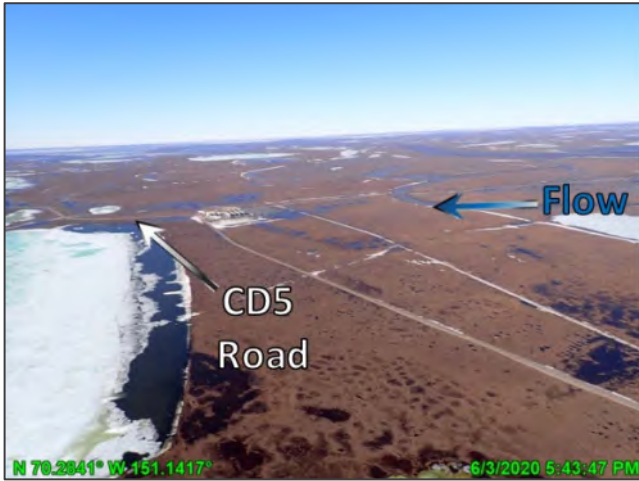
Photo D.17: CD5 road in the vicinity of K-Pad as breakup subsides, looking south; June 3, 2020

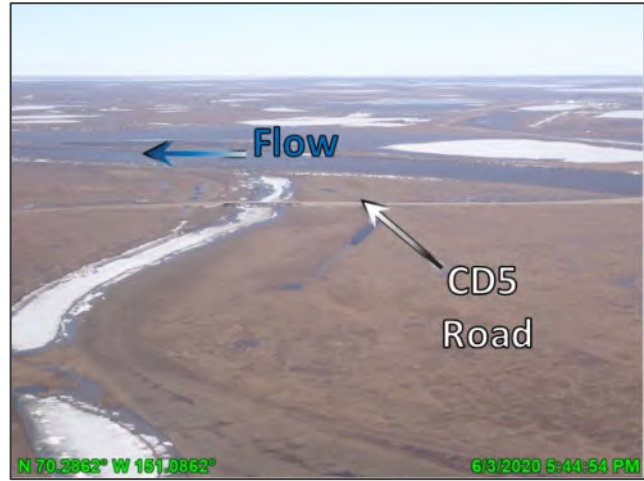
Photo D.18: CD5 road Lake L9341 Bridge as breakup subsides, looking North; June 3, 2020

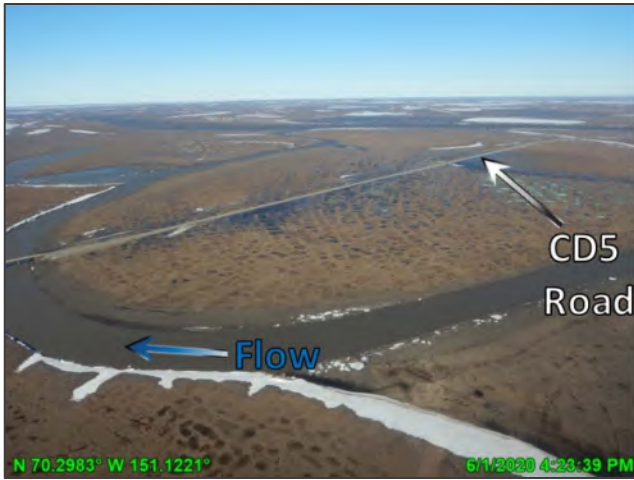
Photo D.21: CD5 road near Nigliagvik Bridge post-breakup, looking north; June 1, 2020

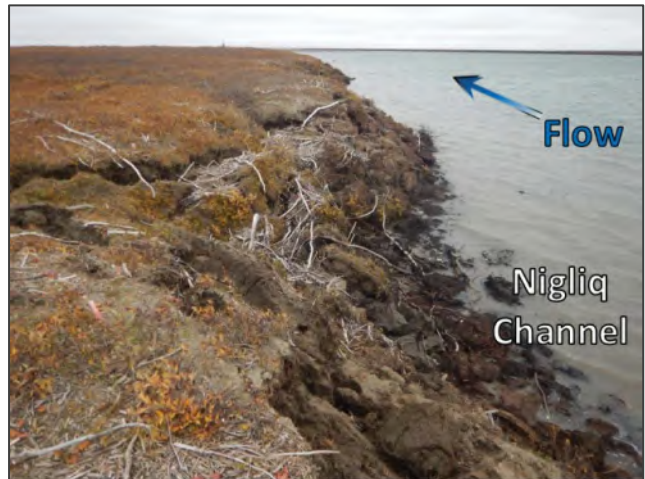
Photo D.24: East bank of Nigliq channel north of CD5 road during fall setup, looking north; September 7, 2020

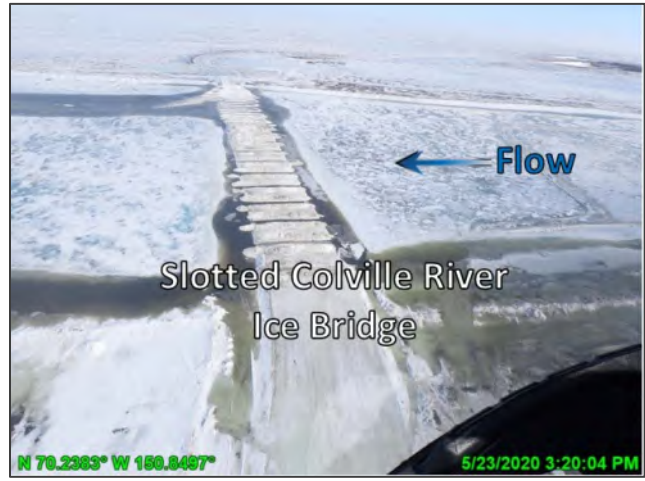
Photo D.26: Initial flow through the slotted Colville River Ice Bridge, looking east; May 23, 2020

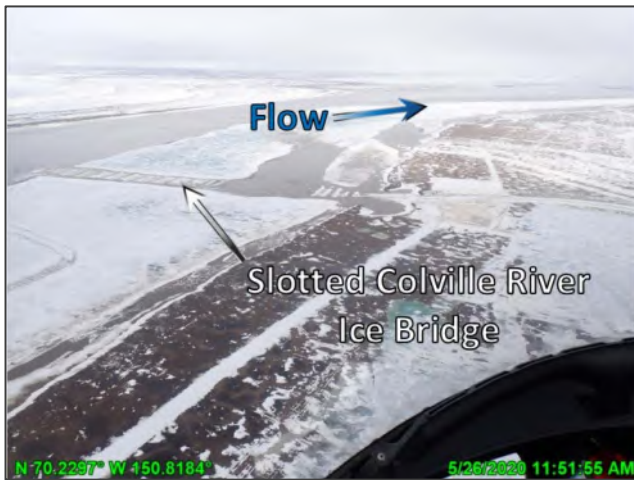
Photo D.27: Meltwater progression through the slotted Colville River Ice Bridge, looking north (downstream); May 26, 2020

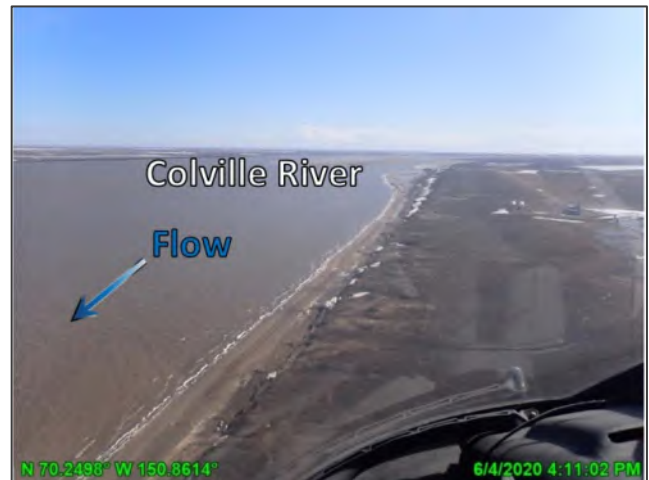
Photo D.28: Open channel at Colville River Ice Bridge, looking south (upstream); June 4, 2020

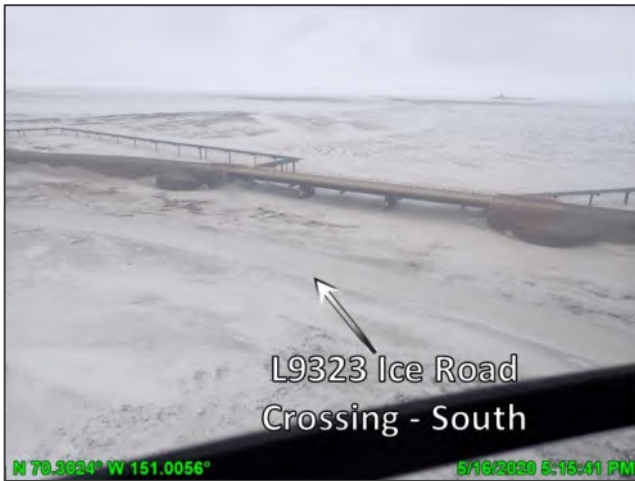
Photo D.31: Pre-breakup near the L9323 ice road crossing-south, looking northwest, May 16, 2020

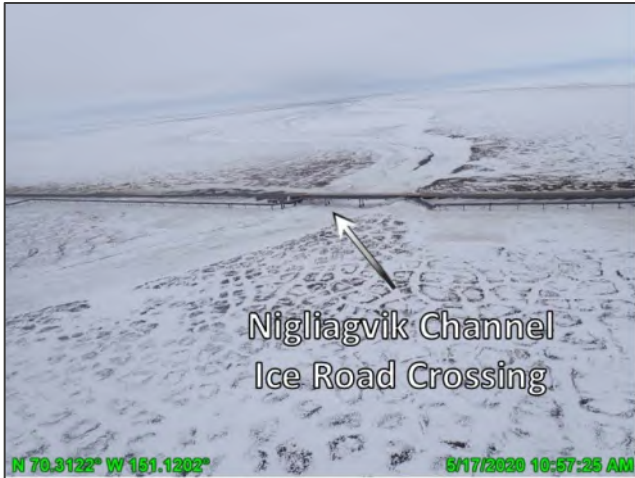
Photo D.34: Pre-breakup conditions at the Nigliagvik ice road crossing, looking south (upstream); May 17, 2020

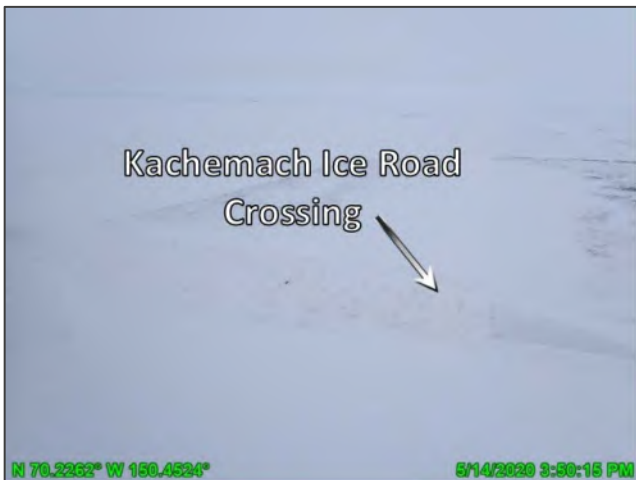
Photo D.40: Pre-breakup conditions at the slotted Kachemach ice road crossing, looking east; May 14, 2020

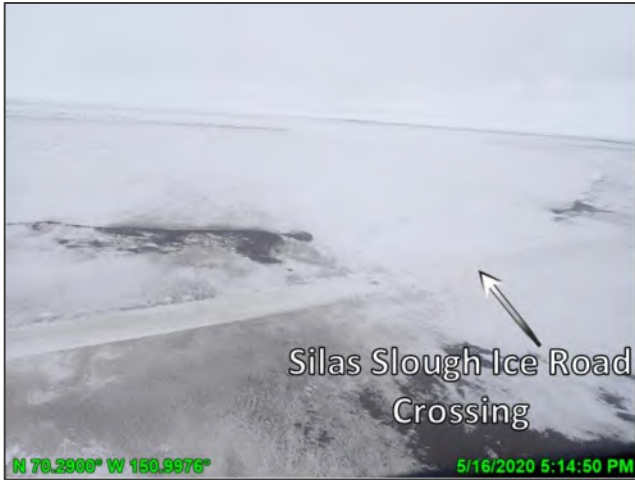
Photo D.42: Pre-breakup conditions at the slotted Silas Slough ice road crossing, looking west; May 16, 2020

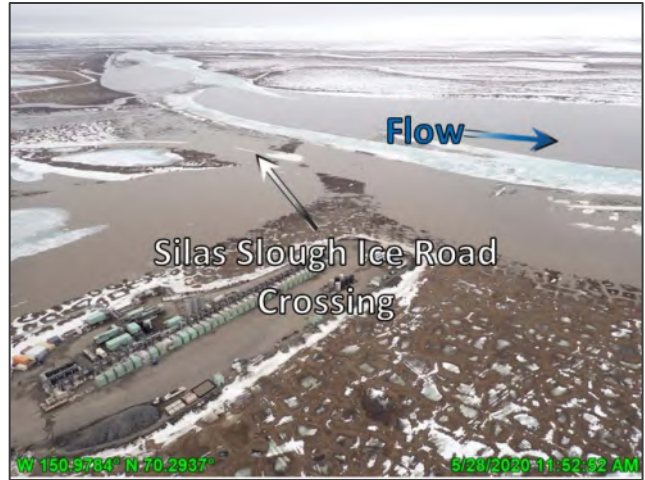
Photo D.43: Peak stage near the slotted Silas Slough ice road crossing, looking southwest; May 28, 2020

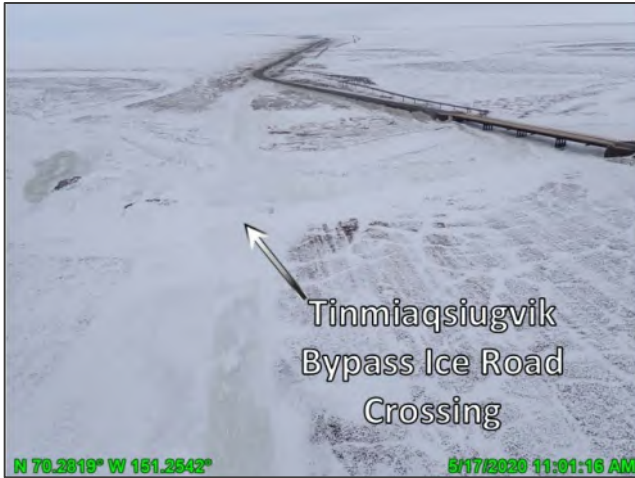
Photo D.55: Pre-breakup conditions at the slotted Tinmiaqsiugvik Bypass ice road crossing, looking northwest; May 17, 2020

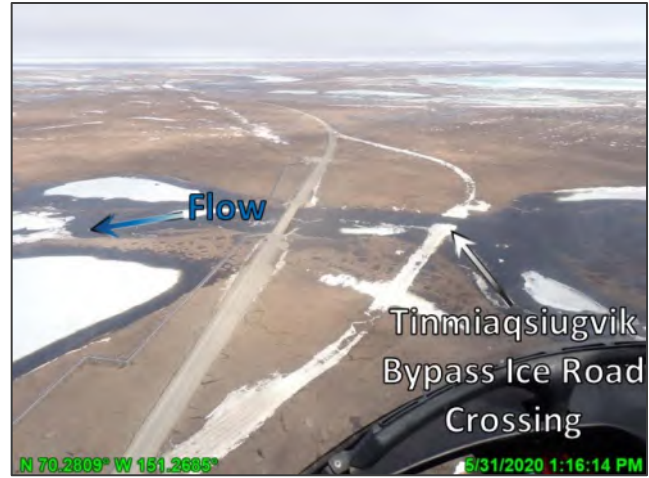
Photo D.56: Peak stage near the Tinmiaqsiugvik Bypass ice road crossing, looking east; May 31, 2020
