2020 Willow Spring Breakup and Summer Monitoring & Hydrological Assessment - Final

Michael Baker International
3900 C Street Suite 900
Anchorage, AK 99503

ConocoPhillips
Alaska

178179-MBI-HH-RPT-001

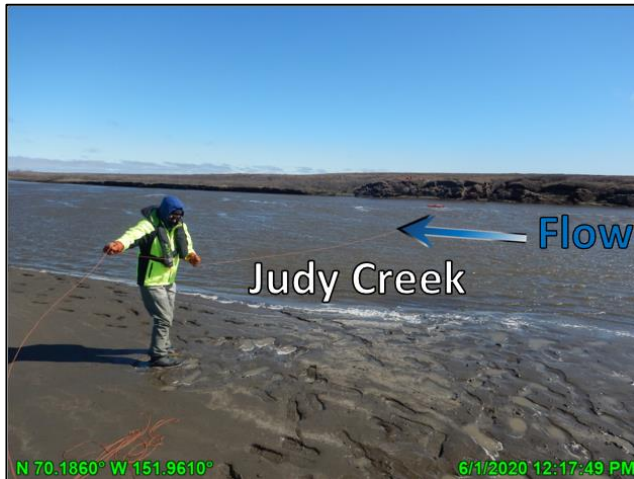
Discharge was measured using a tethered ADCP at J13.8 on June 1, approximately 2 days after peak stage. During the measurement, minimal ice floes were observed in the channel and no saturated snow was visible along the banks at the measurement cross section (Photo 4.16 and Photo 4.17). The measurement was influenced by a moving bed, the effects of which were analyzed and applied as a correction to the discharge output. The quality of the discharge measurement was classified as fair based on an equipment Bluetooth malfunction producing incomplete cross-sectional transect data.

Photo 4.16: Crews measuring discharge at J13.8, looking east (downstream); June 1, 2020

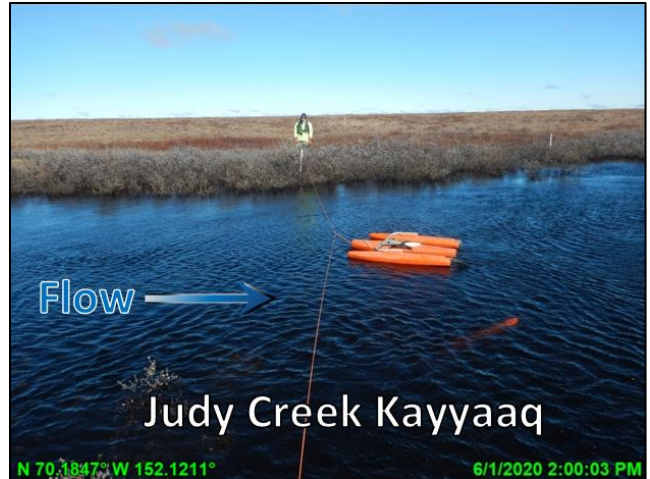
Discharge during spring breakup was measured using a tethered ADCP at the UC2C gage station on June 1, approximately 2 days after peak stage. During the measurement, the channel was clear of snow and ice and flow was confined to within the channel banks (Photo 4.26 and Photo 4.27). The overall quality of the discharge measurement was classified as fair. The moving bed measurement associated with UC2C was negligible and not included as a correction to the overall measurement.

Photo 4.27: Crews measuring discharge at UC2C, looking north; June 1, 2020

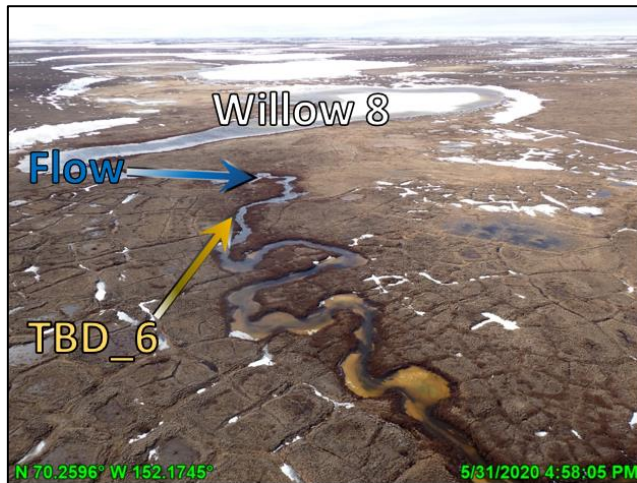
Photo 4.61: Visible snow and ice near TBD_6, looking west (upstream); May 31, 2020.

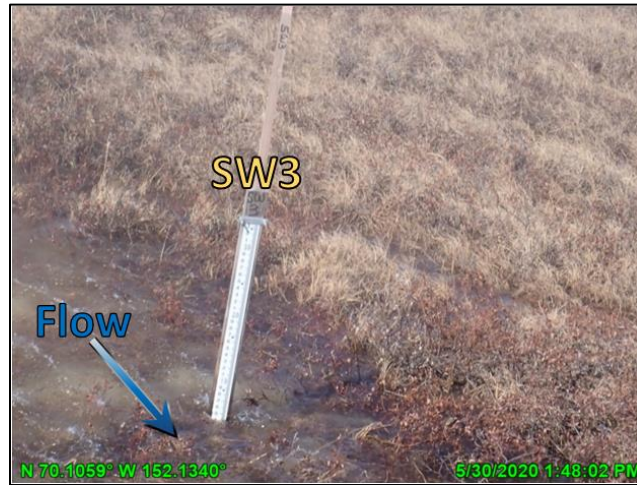
The CPAI proposed alignment crosses Swale 3 at the SW3 monitoring location. Limitations due to COVID-19 prevented the MBI field teams from reaching SW3 for set up and monitoring during the 2020 monitoring season. An aerial photograph of the SW3 gage taken on May 30, 2020 indicates that water did reach the gage at 0.42 ft on the gage (Photo 4.73).

Photo 4.73: Gage SW3 (no PT) pictured with water on the gage, looking south (upstream) ; May 30, 2020

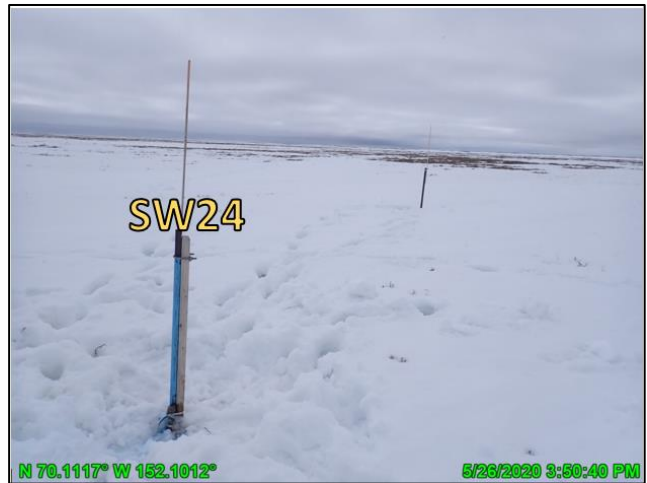
On May 26 aerial site observations revealed 75% snow cover in the SW24 drainage (Photo 4.84 and Photo 4.85). By the early morning of May 28, meltwater flowing out of the unnamed lake reached the PT and peaked later that day. Aerial observations on May 30 show that snow and ice were present in the drainage, particularly on the unnamed lake, but the channel was clear (Photo 4.86). Stage appeared near bankfull. This section of the swale was predominantly shallow and wide with a grass-lined bottom. An HWM captured on May 28 recorded peak stage as 85.23 ft.

Photo 4.85: SW24 gage with installed PT, looking east; May 26, 2020

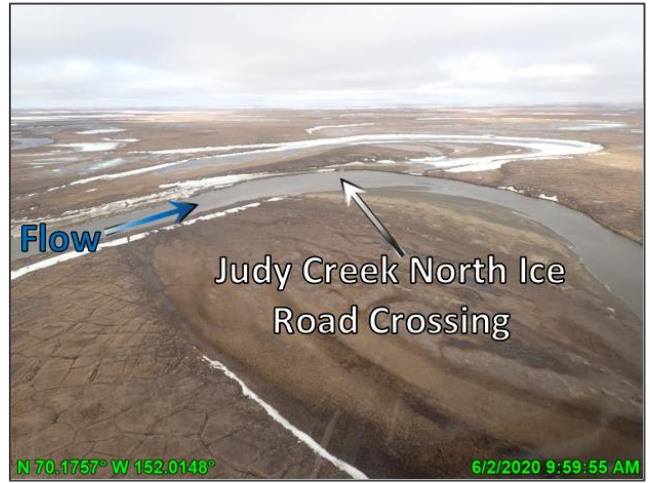
Photo D.2: Post-breakup conditions at the Judy Creek North ice road crossing, looking west; June 2, 2020

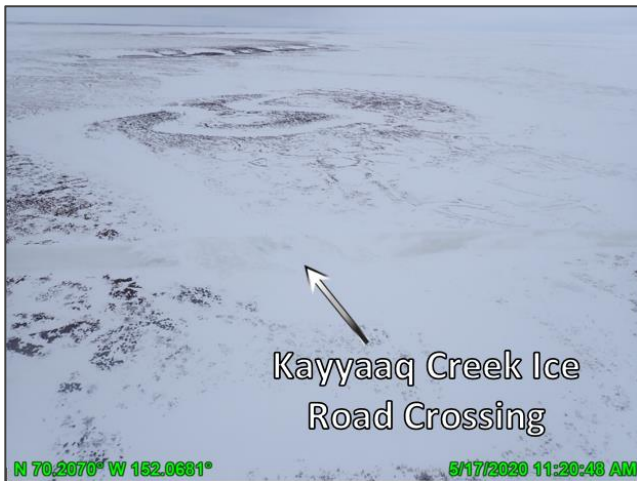
Photo D.7: Pre-breakup conditions at the slotted Kayyaaq Creek ice road crossing, looking southwest; May 17, 2020

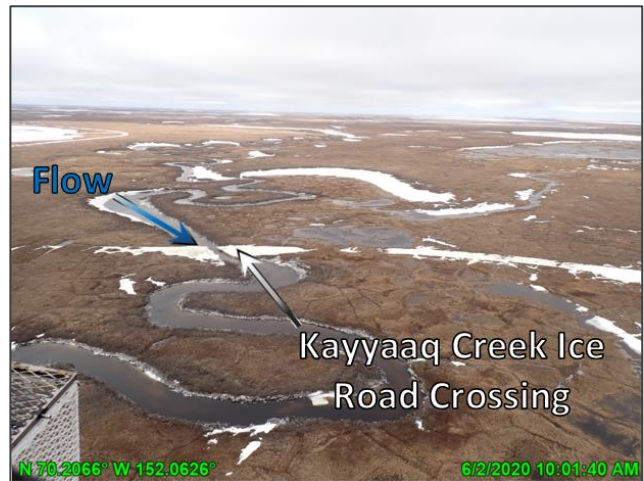
Photo D.8: Post-breakup conditions at the Kayyaaq Creek ice road crossing, looking south (upstream); June 2, 2020

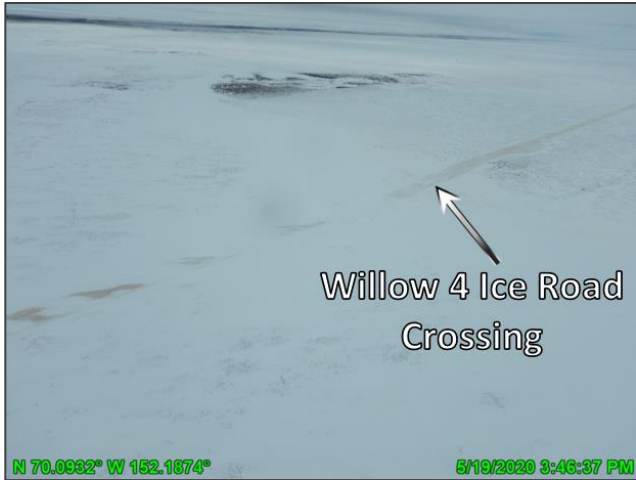
Photo D.9: Pre-breakup conditions at the slotted Willow 4 ice road crossing, looking north; May 29, 2020

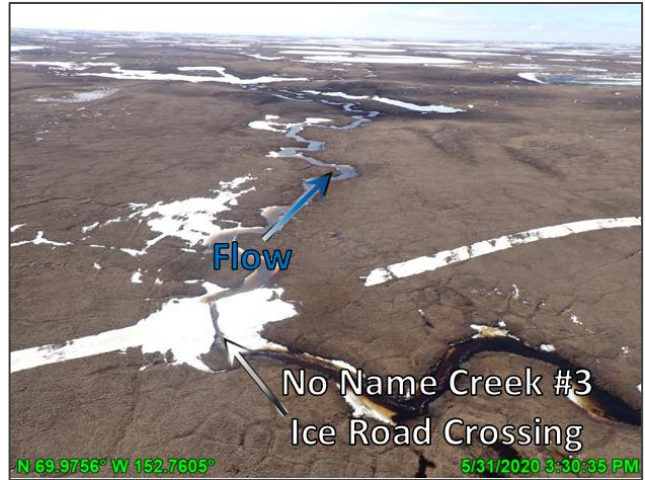
Photo D.17: Breakup conditions at the No Name Creek #3 ice road crossing, looking southwest (upstream); May 31, 2020

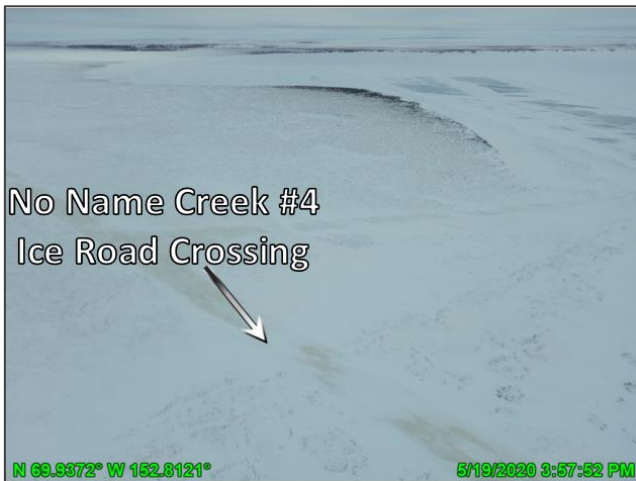
Photo D.18: Pre-breakup conditions at the slotted No Name Creek #4 ice road crossing, looking south; May 19, 2020

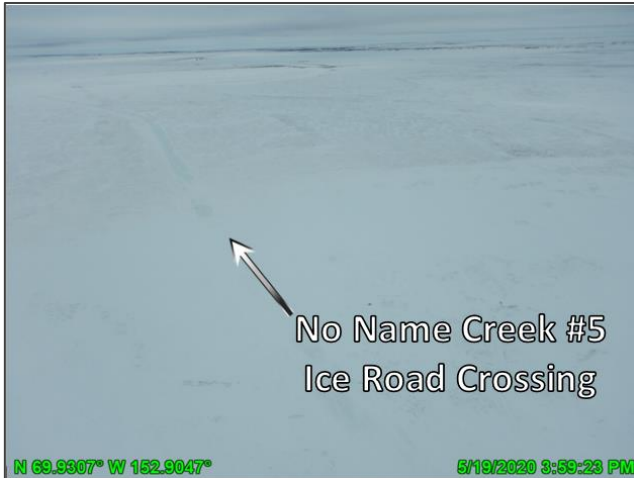
Photo D.20: Pre-breakup conditions at the slotted No Name Creek #5 ice road crossing, looking east; May 19, 2020

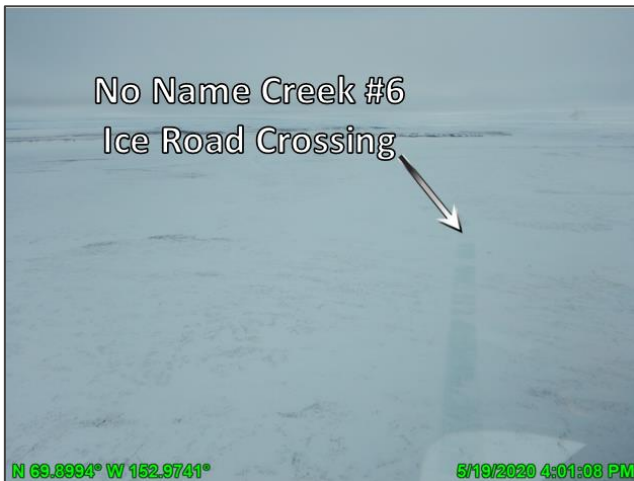
Photo D.22: Pre-breakup conditions at the slotted No Name Creek #6 ice road crossing, looking south; May 19, 2020

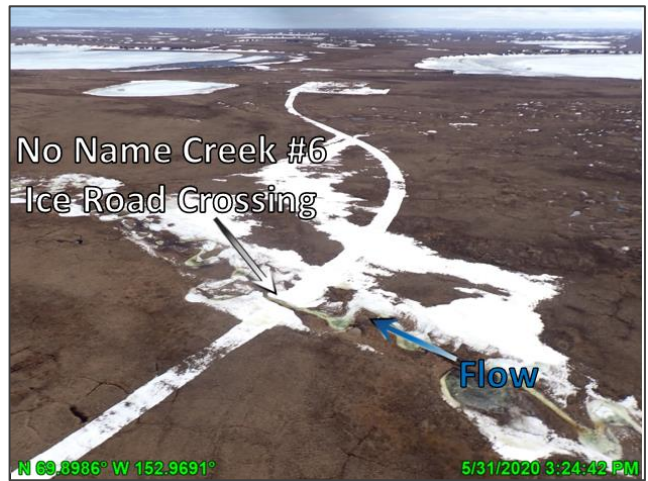
Photo D.23: Breakup conditions at the No Name Creek #6 ice road crossing, looking east; May 31, 2020

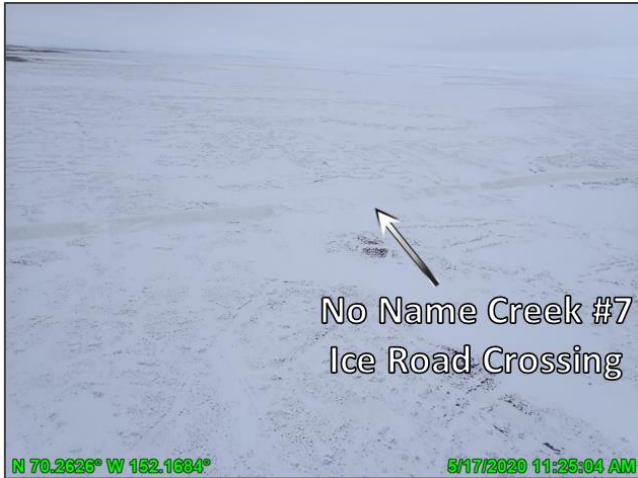
Photo D.24: Pre-breakup conditions at the slotted No Name Creek #7 ice road crossing, looking northwest; May 17, 2020
