# Colville River Delta

Spring Breakup Monitoring &  
Hydrological Assessment

# 2021

**Michael Baker**

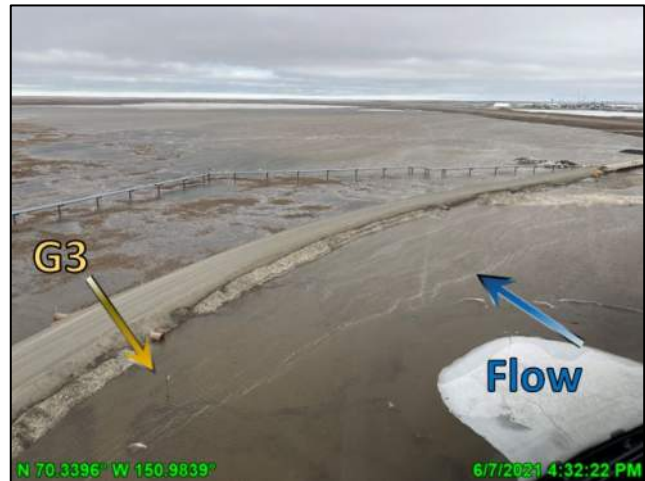
All bridges and culverts along the CD2 road performed as designed during this year's breakup event. Peak discharge through this area is estimated to have occurred on June 7, concurrent with measured discharge across the CD2 road measured at the long swale bridge.

Photo 4.30: Floodwater passing through culverts near peak stage; looking northeast (downstream) June 7, 2021

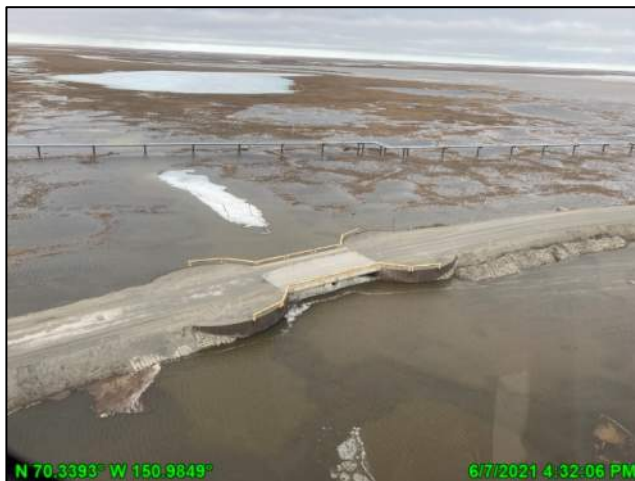
Photo 4.31: Drifted snow and ice underneath the short swale bridge, looking north; June 7, 2021

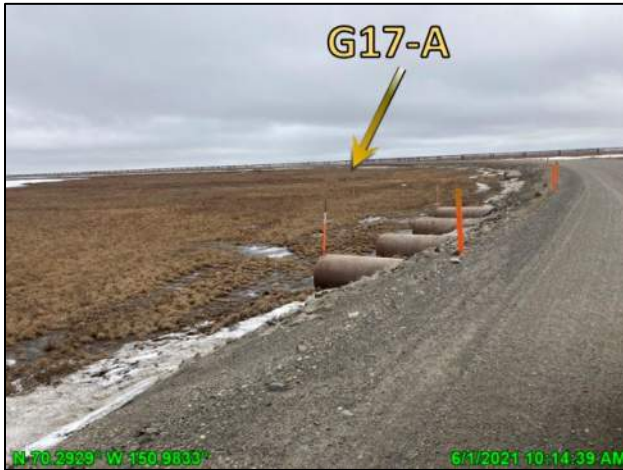
Photo 4.36: Local melt at CD4 road south culvert battery near G17/G18, looking northeast; June 1, 2021

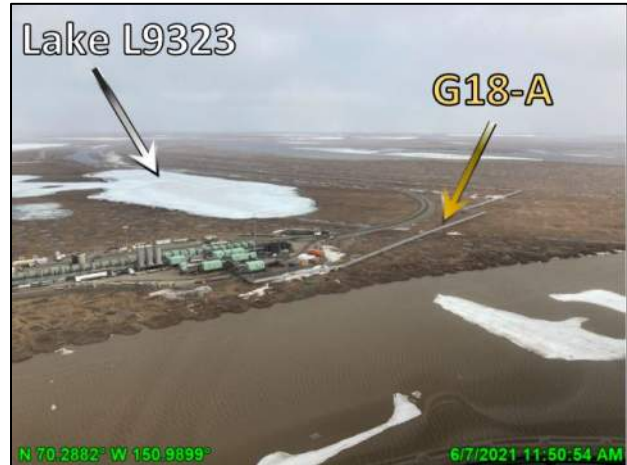
Photo 4.37: Conditions at CD4 pad near peak stage, looking north; June 7, 2021

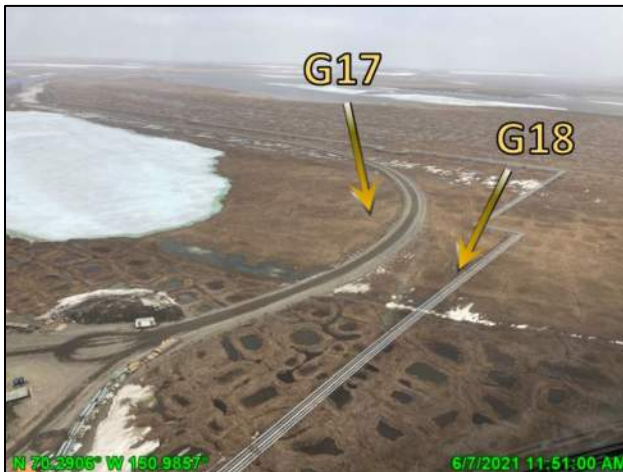
Photo 4.38: Conditions prior to peak on CD4 road near Gage G17/G18, looking northeast; June 7, 2021

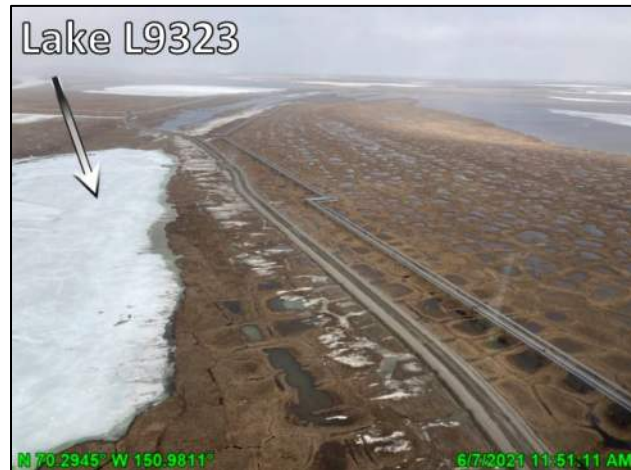
Photo 4.39: Conditions along the CD4 road prior to peak, looking north; June 1, 2021

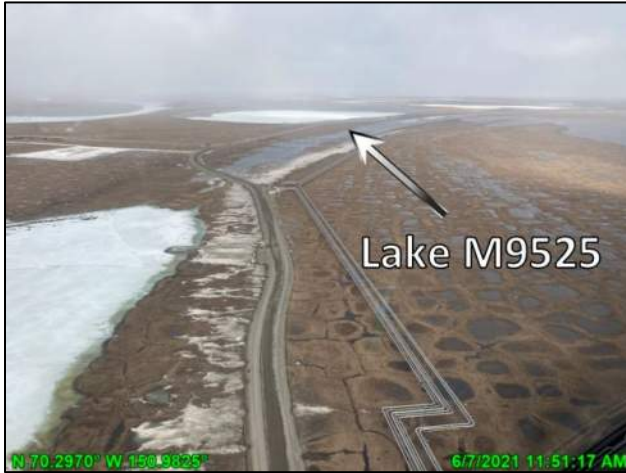
Photo 4.40: Conditions prior to peak at the CD4 road near G15/G16 culvert battery, looking north; June 7, 2021

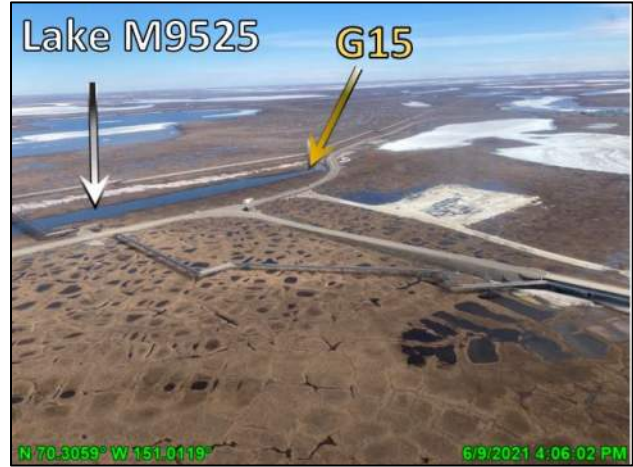
Photo 4.41: CD4 and CD5 intersection near G15/G16 culvert battery after peak stage, looking southeast; June 9, 2021

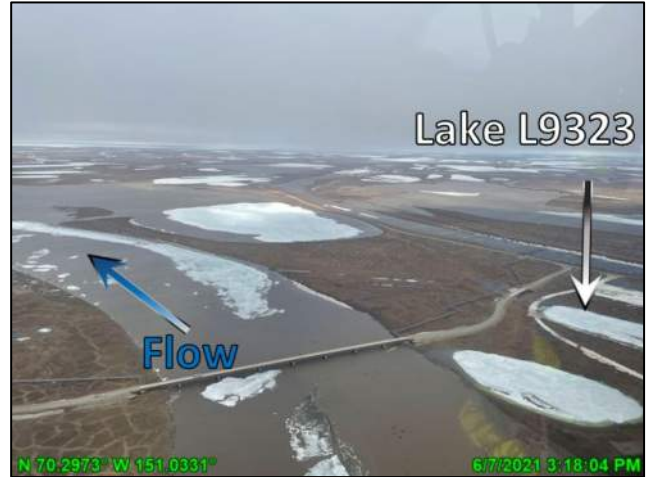
Photo 4.43: Nigliq Channel and Lake L9323 bridge near peak stage showing no overbank flooding, looking northeast; June 7, 2021

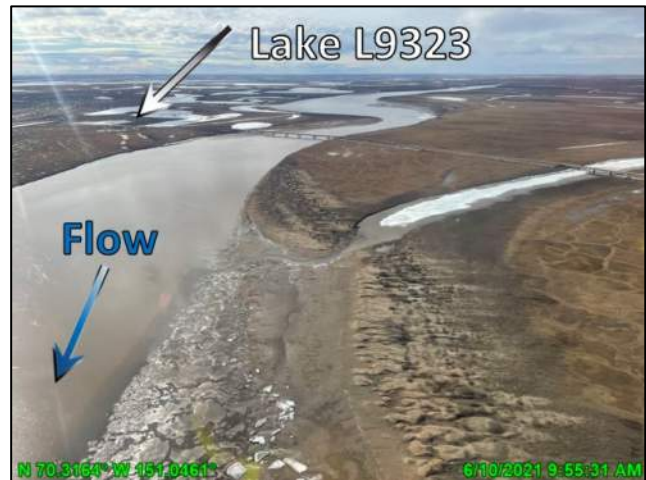
Photo 4.45: Lake L9323 bridge 3 days after peak stage showing no hydraulic connection, looking south; June 10, 2021

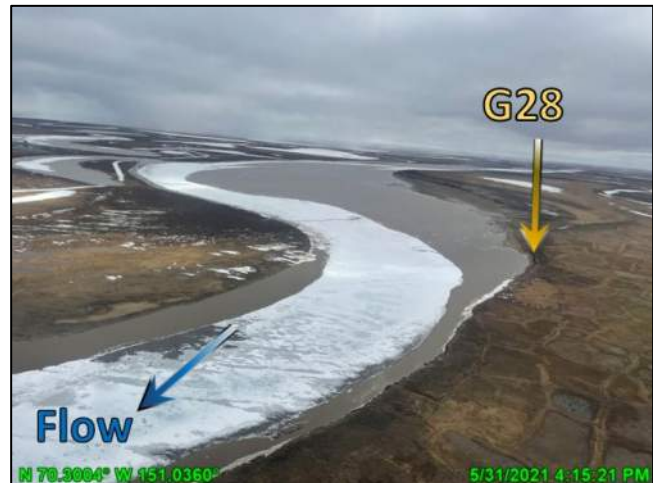
Photo 4.47: Channel ice persisting upstream of the bridge, looking southeast (upstream); May 31, 2021

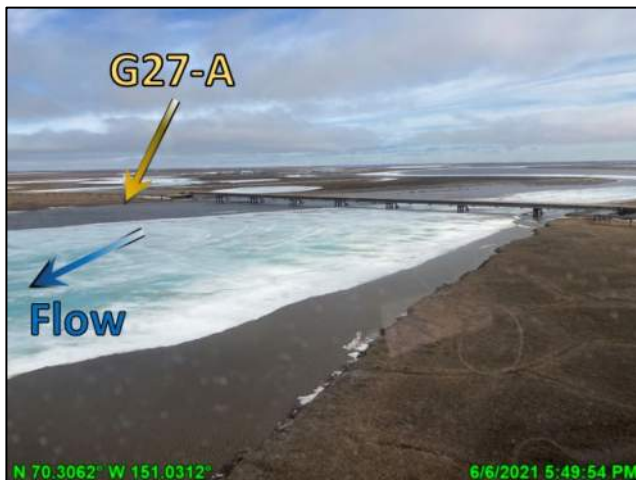
Photo 4.48: Rising stage with channel ice persisting at the Nigliq bridge, looking southeast (upstream); June 6, 2021

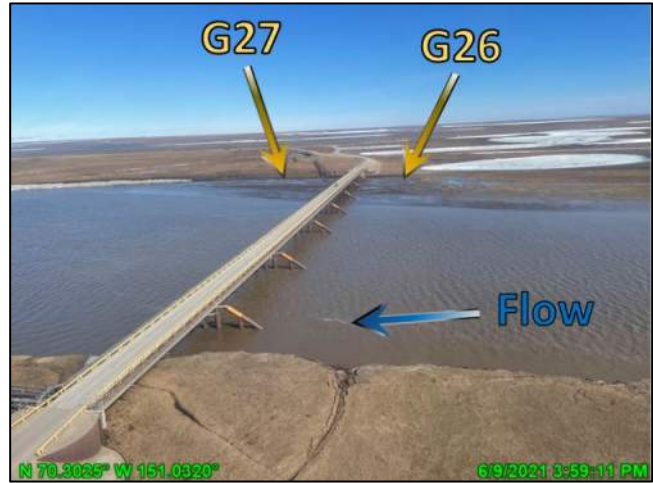
Photo 4.51: Open water conditions at the Nigliq bridge with receding stage, looking east; June 9, 2021

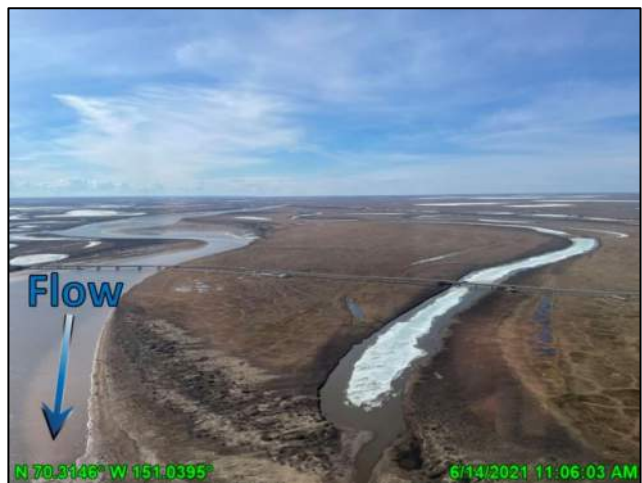
Photo 4.55: Channel ice persisting in Lake L9341 throughout the monitoring period, looking south; June 14, 2021

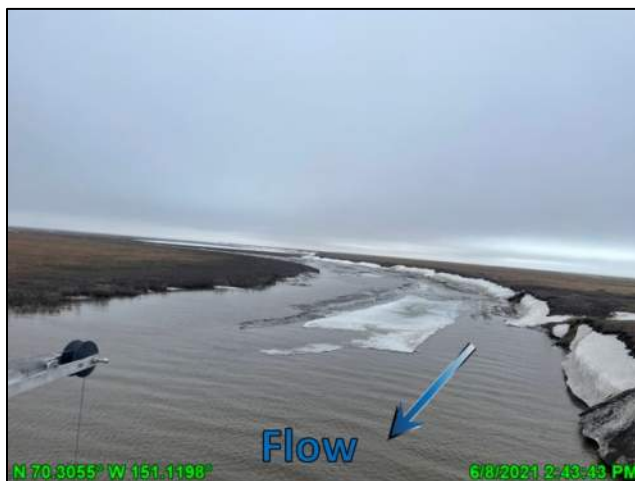
Photo 4.58: Conditions at the Nigliagvik Bridge during discharge measurement one day after peak stage, looking southwest (upstream); June 8, 2021

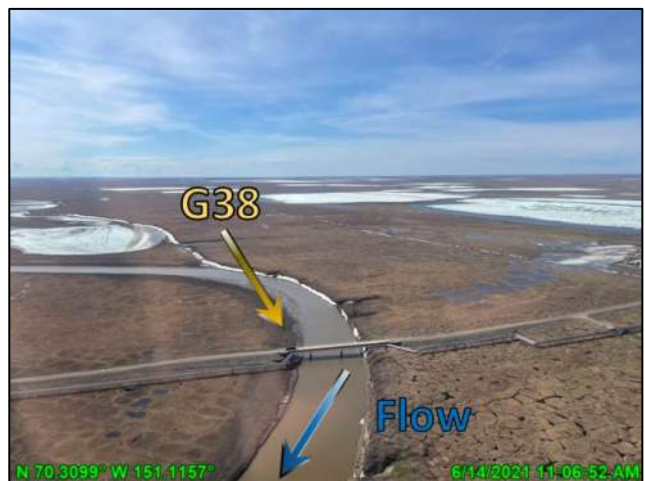
Photo 4.59: Stage below bankfull in the Nigliagvik Channel, looking south (upstream); June 14, 2021

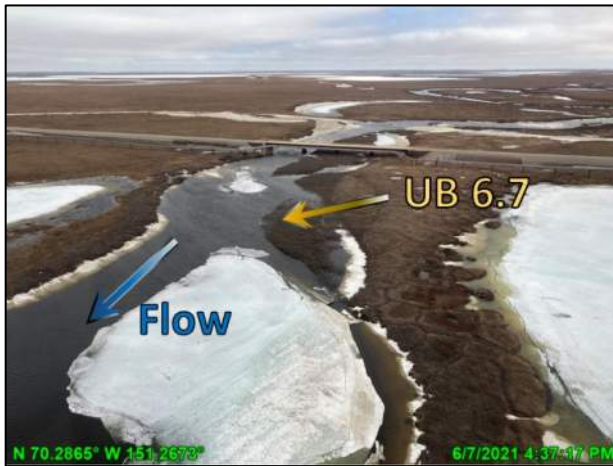
Photo 4.66: Tinmiaqsiugvik Bridge with persisting snow approximately 11 days after peak, looking south (upstream); June 7, 2021

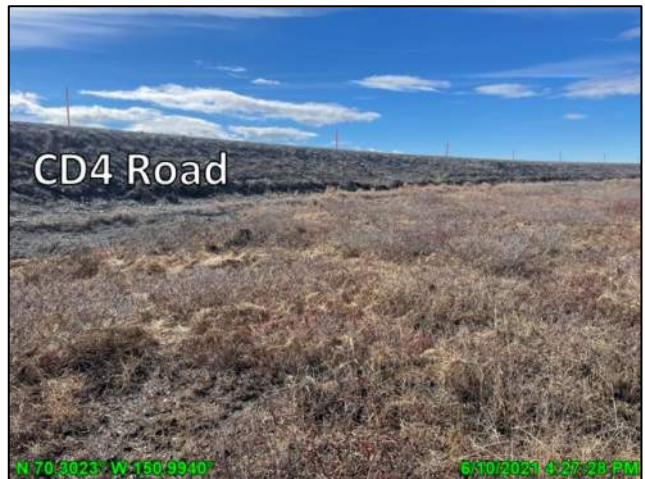
Alpine roads and pads were inspected for erosion on June 9 and June 10. Washlines were noted on the north side of the CD2 road between the long and short swale bridge; however, vegetation under the washlines suggest this was from flood events prior to 2021, likely from 2015. Photo 5.1 through Photo 5.4 shows the CD2 and CD4 road, after stage had receded. No discernable erosion directly attributable to 2021 breakup flooding was observed during aerial and ground reconnaissance of the CD2, CD4, and CD5 roads. Floodwaters did not reach any of the CD5 bridge abutments, and no discernable erosion was observed along the abutments. Washlines from 2015 spring breakup, which was the largest historical flood event to impact Alpine facilities, remain evident along portions of the CD2, CD4, and CD5 roads. There were no signs of sloughing or undermining at drainage structures.

Photo 5.4: CD4 road post breakup near Gage G16, looking northwest; June 10, 2021

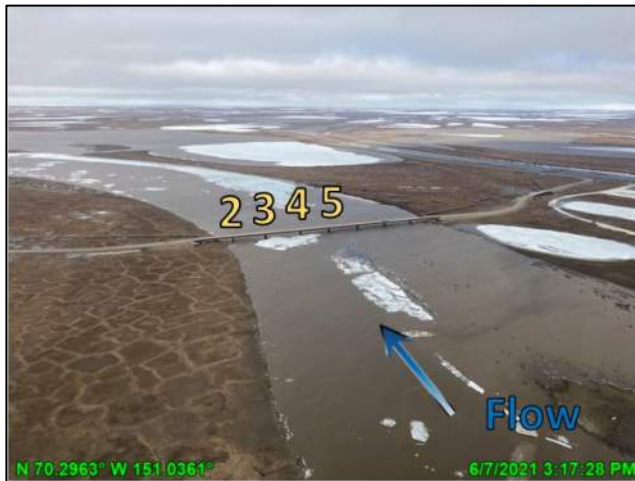
Photo 6.1: Pier numbers on the Nigliq Bridge, looking northeast (downstream); June 7, 2021

A comparison of design and observed scour elevations are presented in Table 6.1. The minimum post-breakup scour elevation (-33.5 ft BPMSL at pier 4, pile D) is 4.6 ft below the 50-year design scour elevation and 0.5 ft below the 200-year scour elevation. Real-time pier scour at piers 2 through 5 and corresponding WSEs during spring breakup monitoring are presented in Graph 6.1 through Graph 6.4. At piers 2, 3, 4, and 5, real-time scour measurements recorded approximately 0 ft of scour from the 2020 post breakup survey elevation.

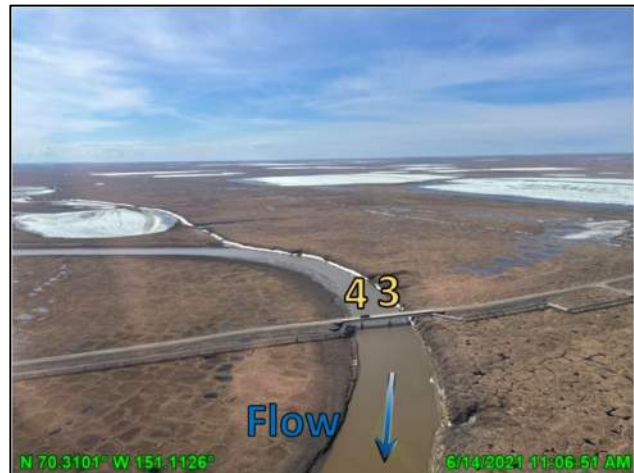
Photo 6.2: Pier numbers on the Nigliagvik Bridge, looking south (upstream); June 14, 2021

The minimum post-breakup scour elevation (-5.0 ft BPMSL at pier 4, pile B) is 9.2 ft above the 50-year design scour elevation and 16.8 ft above the 200-year scour elevation. A comparison of design and observed scour elevations are presented in Table 6.2. Real-time pier scour at pier 3 and corresponding WSEs during spring breakup monitoring is presented in Graph 6.5. Real-time pier scour measurements indicated approximately 0 ft of active scour during peak conditions compared to the 2020 post breakup survey.

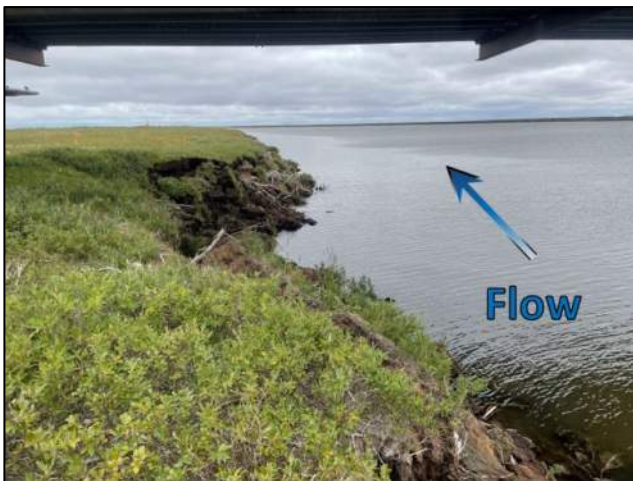
Photo 6.5: West bank of the Nigliq Channel near the Nigliq Bridge, looking north; August 12, 2021

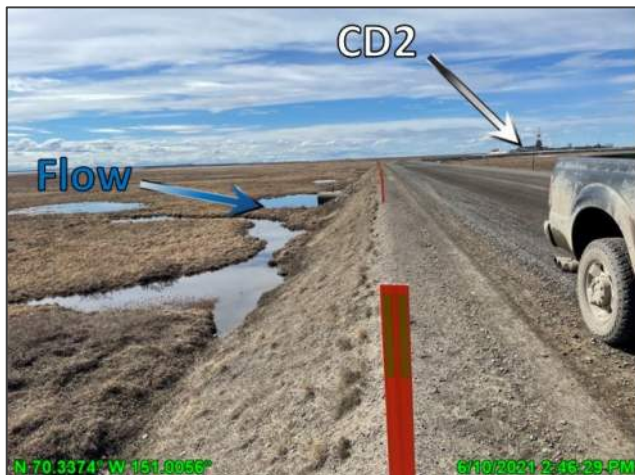
Photo D.3: CD2 road embankment in the vicinity of culvert CD2-16, looking northwest; June 10, 2021

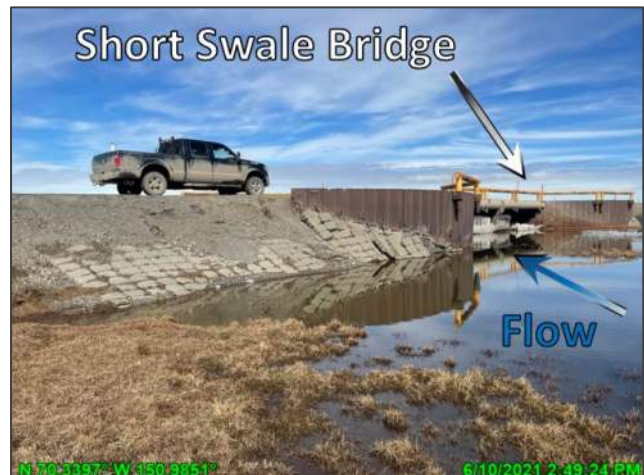
Photo D.4: CD2 road short swale bridge SW abutment, looking northeast; June 10, 2021

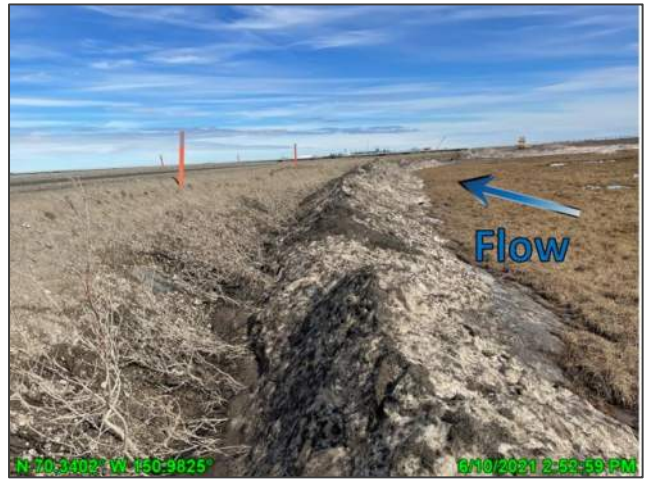
Photo D.6: CD2 road embankment in between the long swale and short swale bridge post-breakup, looking east; June 10, 2021

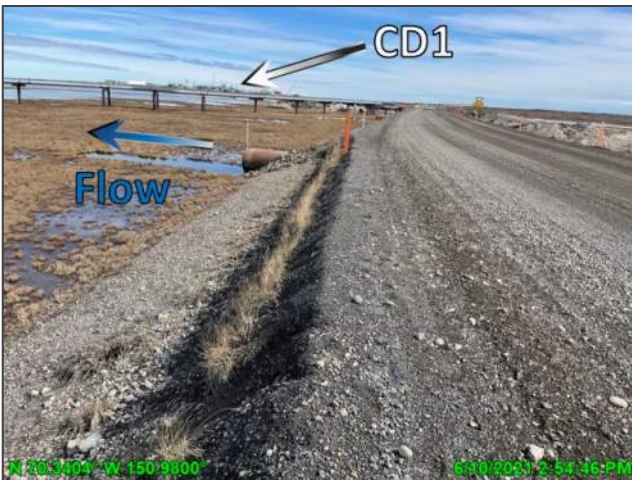
Photo D.7: Road in vicinity of culvert CD2-23 post-breakup, looking southeast; June 10, 2021

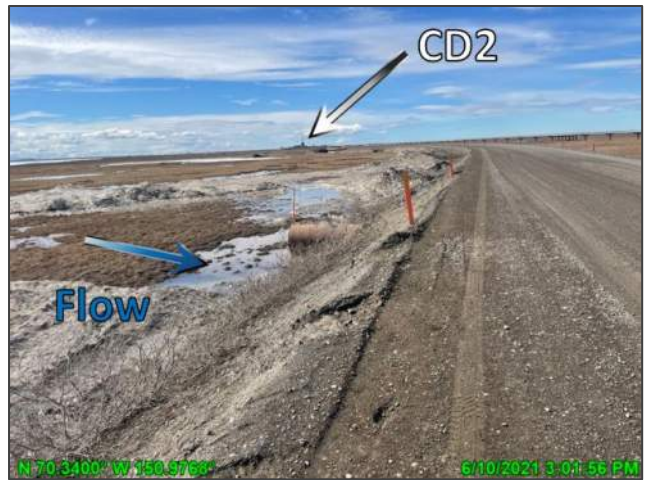
Photo D.8: Road in vicinity of culvert CD2-23 post-breakup, looking northwest, 2021

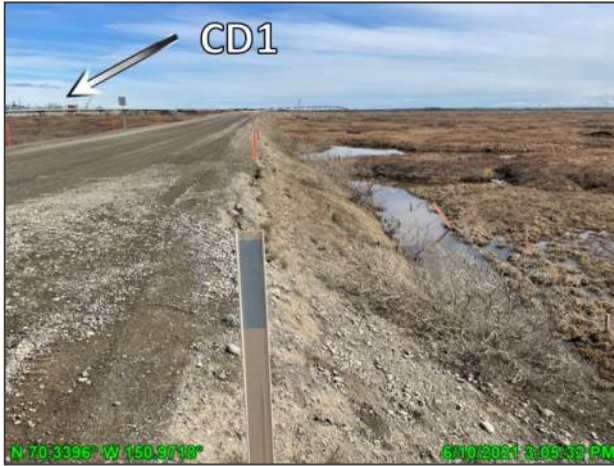
Photo D.9: CD2 road embankment in the vicinity of the long swale bridge, looking south east; June 10, 2021

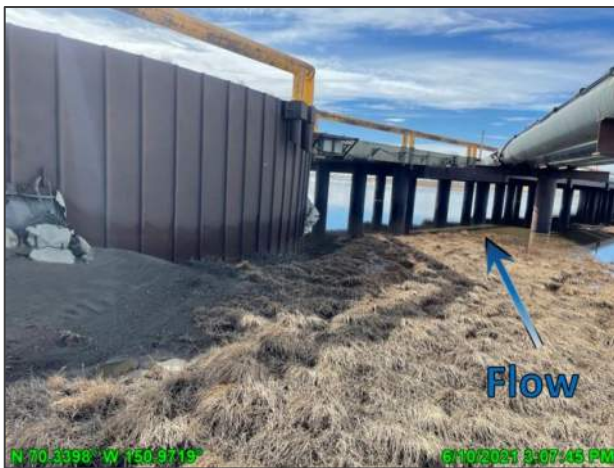
Photo D.11: CD2 long swale SW abutment, looking north; June 10, 2021

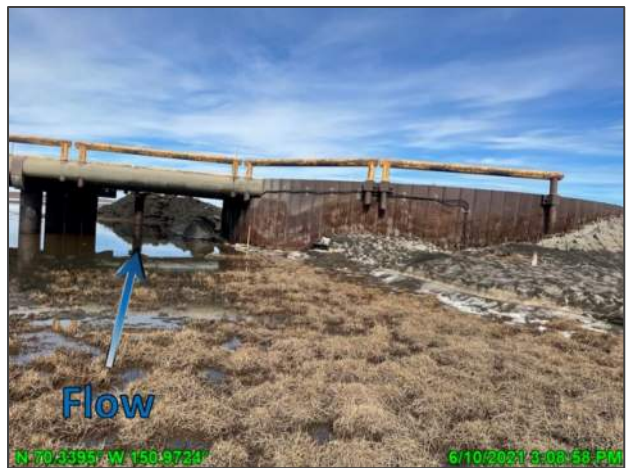
Photo D.12: CD2 long swale SE abutment, looking north; June 10, 2021

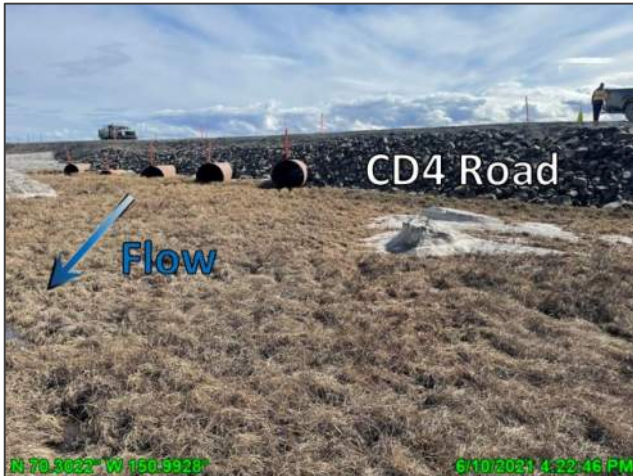
Photo D.13: CD4 road in vicinity of G15 culverts post-breakup, looking southwest; June 10, 2021

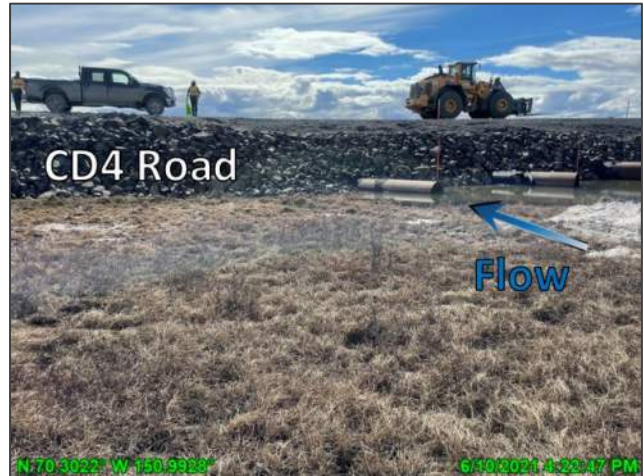
Photo D.14: CD4 road in vicinity of G15 culverts post-breakup, looking west; June 10, 2021

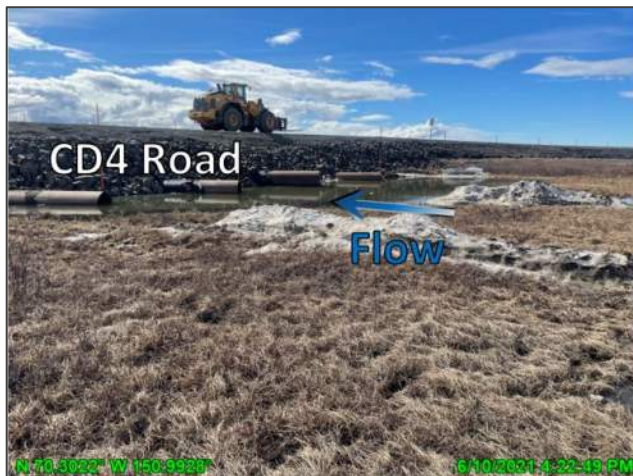
Photo D.15: CD4 road in vicinity of G15 culverts post-breakup, looking west; June 10, 2021

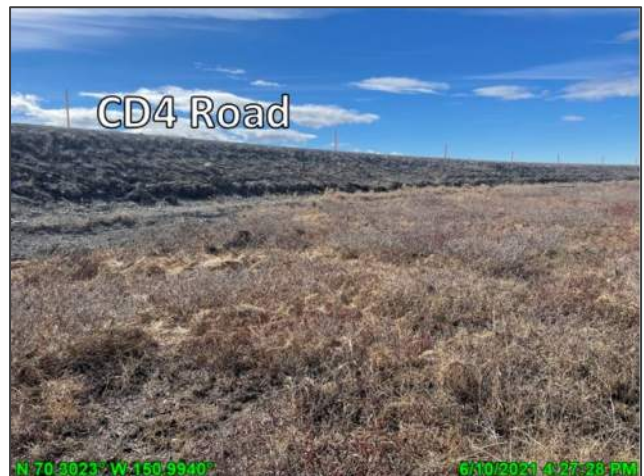
Photo D.16: CD4 road embankment in the vicinity of G15 post-breakup, looking north; June 10, 2021

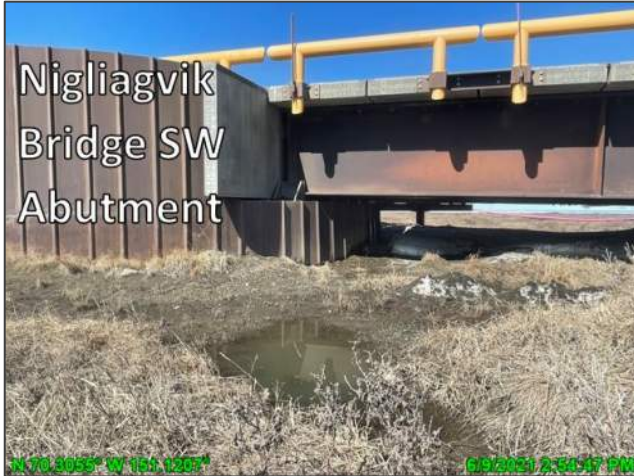
Photo D.17: Nigliagvik SW abutment post-breakup, looking north; June 9, 2021

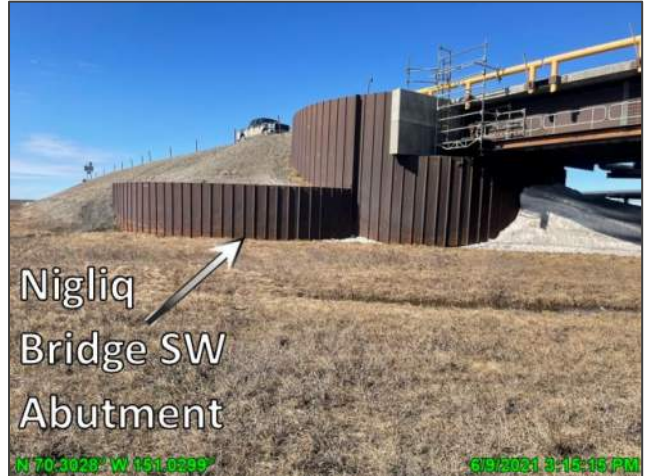
Photo D.18: Nigliq SW abutment post-breakup, looking north; June 9, 2021

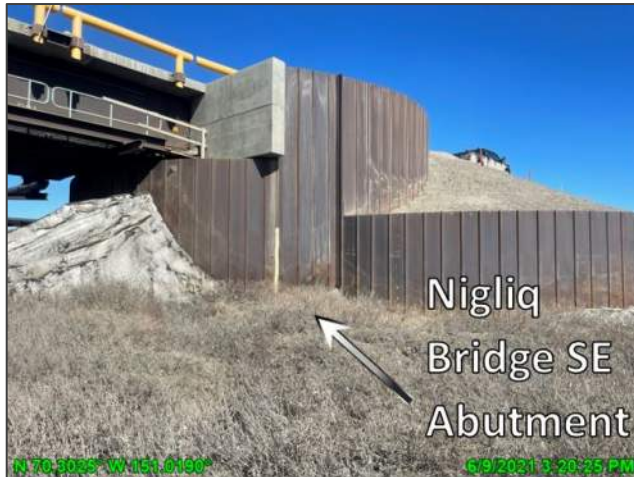
Photo D.19: Nigliq SE abutment post-breakup, looking northeast; June 9, 2021

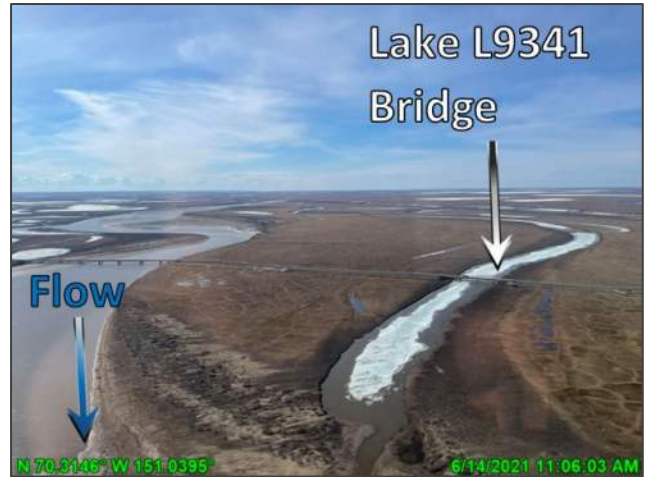
Photo D.20: CD5 road in between Lake L9341 and Nigliq Channel post-breakup, looking south; June 14, 2021

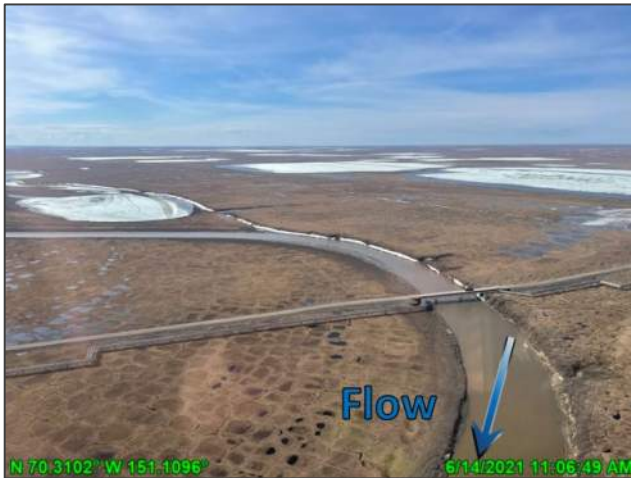
Photo D.21: CD5 road near Nigliagvik Bridge post-breakup, looking south; June 14, 2021

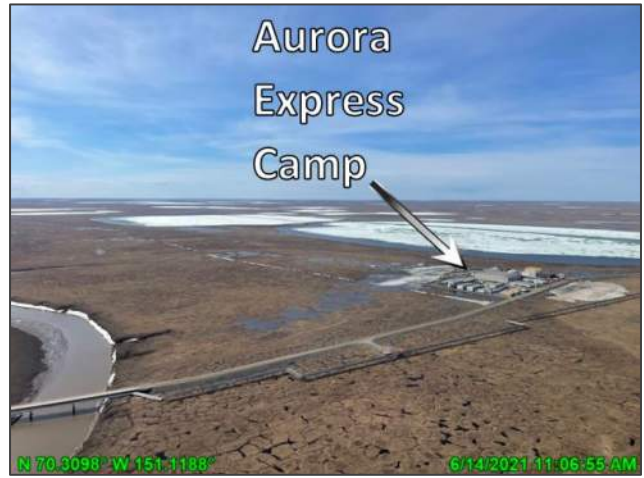
Photo D.22: CD5 road west of the Nigliagvik bridge, looking southwest; June 14, 2021

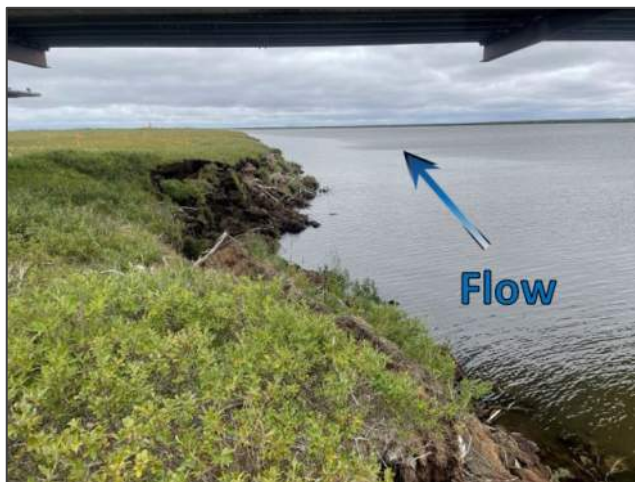
Photo D.23: West bank of Nigliq Channel south of CD5 road during bank erosion survey, looking north; August 12, 2021

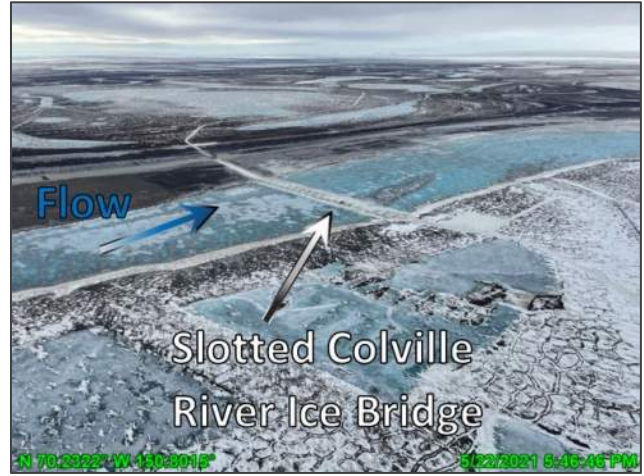
Photo D.26: Local melt near the slotted Colville River Ice Bridge, looking northwest; May 2, 2021

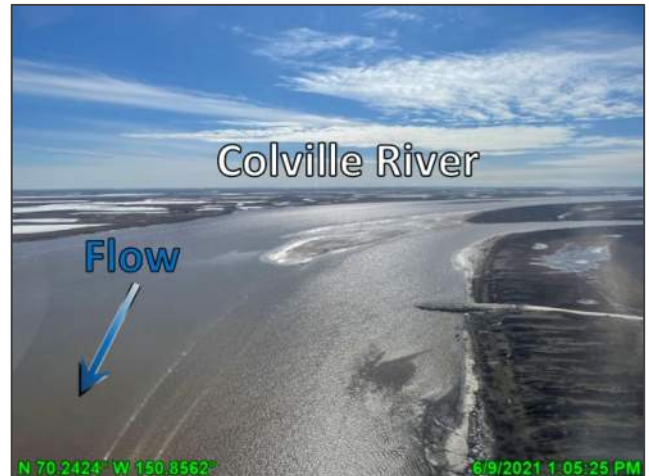
Photo D.27: Meltwater progression through the slotted Colville River Ice Bridge, looking south (upstream); June 6, 2021
