Culvert Monitoring Report
2021 Greater Moose's Tooth 2
(GMT2/MT7)
Spring Breakup

GMT2/MT7 SPRING BREAKUP

CULVERT MONITORING REPORT

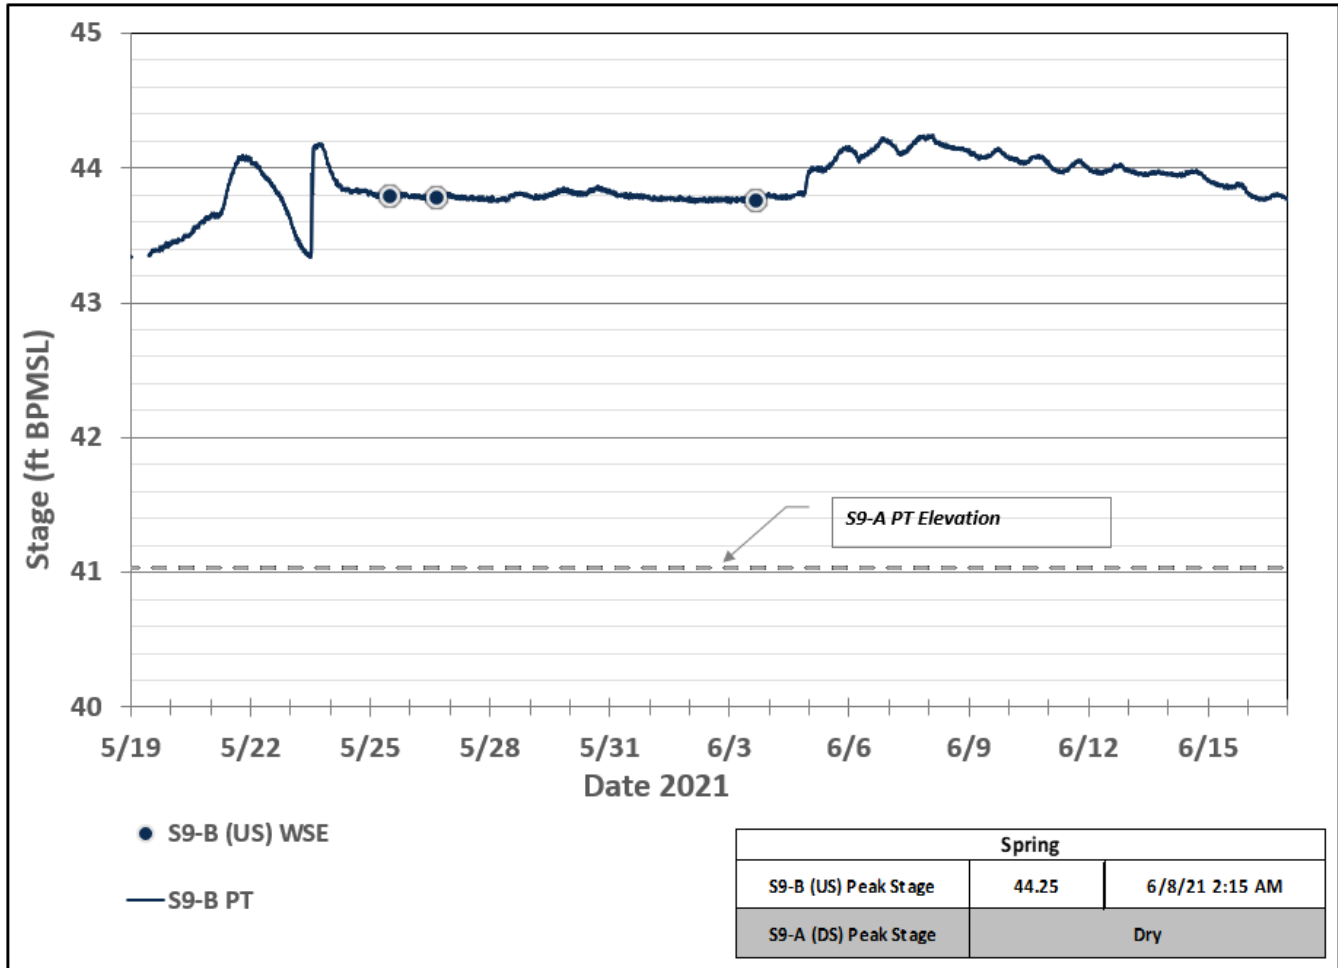
Graph 3.2: S9 Water Surface Elevations

The S9 gages are situated in a low-lying area near the outlet of Lake M9925 near culvert MT7-71. Flow, when present, is conveyed north through surrounding culverts via polygon cracks. During and after breakup, some ponding on the upstream side of the road is expected due to the road being located on the edge of a lower-lying depression within the drainage.

On May 21, isolated pockets of localized meltwater were observed in the drainage near the road embankments (Photo F.1). The ice road along the pipeline alignment, on the south side of the GMT2/MT7 road, remained intact. Meltwater remained impounded on the south side of the gravel road through early June. On June 5, meltwater from Lake M9925 had cut a path through the ice road and was flowing through culvert MT7-70, which is positioned on higher ground than culvert MT7-71 (Photo F.2). Meltwater remained impounded in the low-lying area behind culvert MT7-71 which was blocked by ice and snow.

The ice road between the GMT2/MT7 pipeline alignment and the GMT2/MT7 road had negligible impacts to drainage in the area. With the exception of temporary blockages from ice and drifted snow accumulation, all culverts were observed to be functioning as designed and natural drainage patterns in the area were maintained.

S9 spring breakup stage data is provided in Graph 3.2. Measured discharge data is presented in section 3.4. Photos are provided in Appendix F.1.

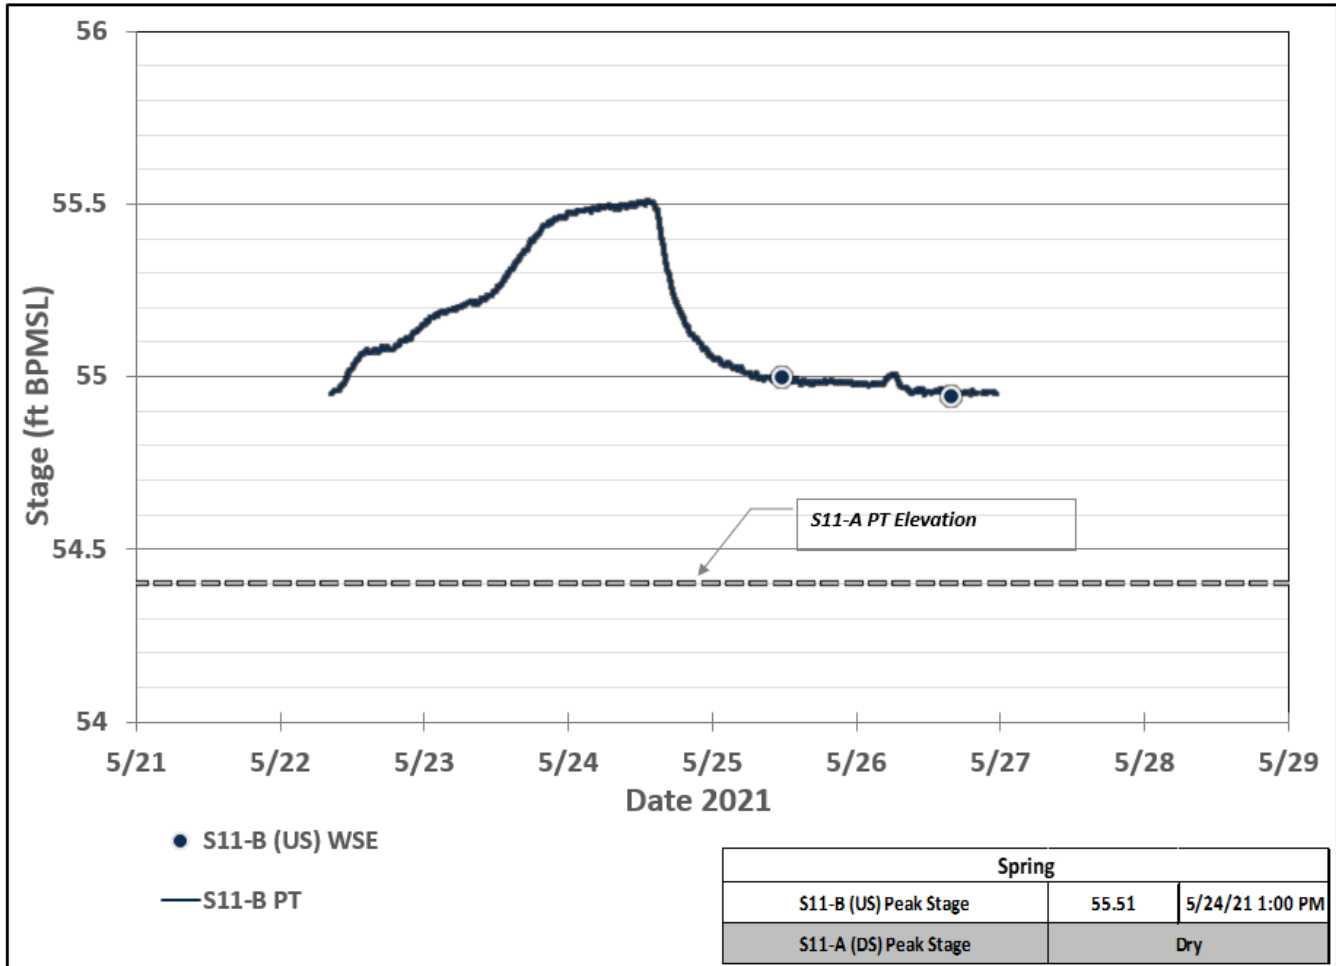
Graph 3.3: S11 Water Surface Elevations

The S11 gages are in a low-lying area between Lakes M9923 and M9922. Flow, when present, is conveyed north through surrounding culverts via polygon cracks. Culverts MT7-54 through MT7-58 are in this low-lying feature. The S11 gages are positioned to record stage where flow is generally concentrated, near culvert MT7-56.

On May 23, localized meltwater was observed near the GMT2/MT7 road but had not reached the road embankment (Photo F.9). The ice road along the pipeline alignment on the south side of the GMT2/MT7 road remained intact. Meltwater reached the GMT2/MT7 road embankment on May 24 and stage peaked on the upstream gage, S11-B (Photo F.10). Following peak, stage decreased steadily as meltwater flowed through culvert MT7-57. Culvert MT7-56 was blocked with ice and snow. Stage continued to decrease, and minimal meltwater was observed along the road embankments by June 5 (Photo F.11), although some meltwater appeared to be retained behind the ice road. Observations from June 26 showed the natural drainage patterns established (Photo F.12).

An ice road between the GMT2/MT7 pipeline alignment and the GMT2/MT7 road retained some meltwater but had negligible impacts to drainage in the area. In past years, culvert MT7-56 has been observed perched on the north side but drifted snow along the embankments prevented crews from evaluating it this year. With the exception of temporary blockages from ice and drifted snow accumulation, all culverts were observed to be functioning as designed and natural drainage patterns in the area were maintained.

S11 spring breakup stage data is provided in Graph 3.3. Measured discharge data is presented in section 3.4. Photos are provided in Appendix F.3.

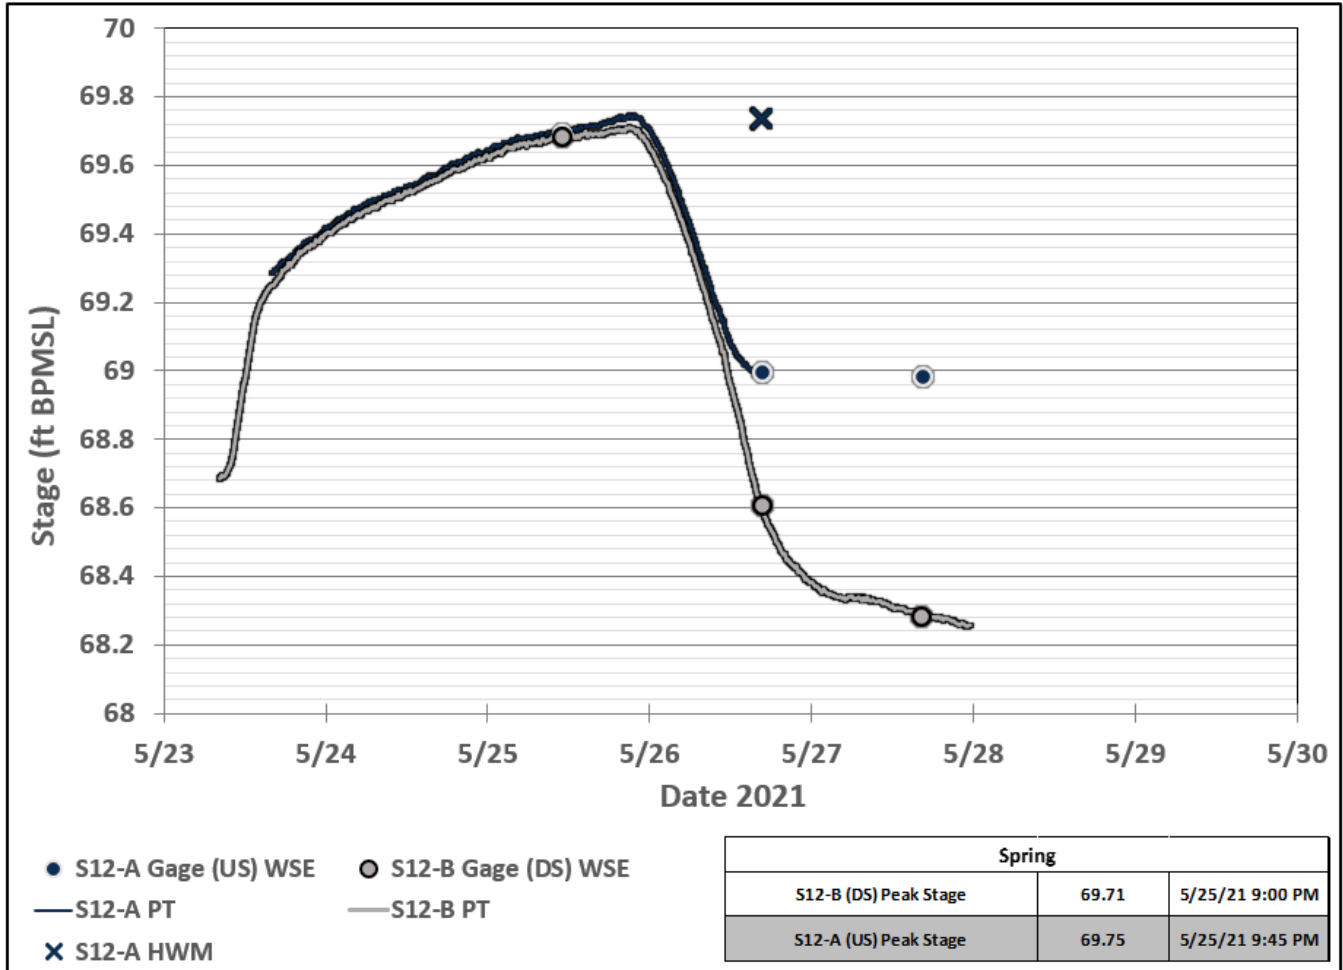
Graph 3.4: S12 Water Surface Elevations

The S12 gages are in a low-lying area between Lake Z06005 and MB0401. Flow, when present, is conveyed south through surrounding culverts via polygon cracks. Culverts MT7-29 through MT7-32 are within the low-lying feature. The S12 gages are positioned to capture flow primarily through culvert MT7-31.

On May 24, meltwater was observed on the east (downstream) side of the road near culverts MT7-30 and MT7-32. This meltwater was impounded by the ice road along the pipeline alignment, with backwater extending to the GMT2/MT7 road embankment (Photo F.13). After the 24th, PT data showed nearly equal water levels on each side of the GMT2/MT7 road, indicating proper conveyance of meltwater through the area culverts. Peak stage occurred on the evening of May 25. After peak, stage receded throughout the rest of the monitoring period.

Disconnected ponding and a channel through the ice road were observed on May 27 during an overflight (Photo F.14). On June 2, minimal meltwater was observed along the road embankments (Photo F.15). Observations from June 26 showed the natural drainage patterns established (Photo F.16).

An ice road between the GMT2/MT7 pipeline alignment and the GMT2/MT7 road temporarily impounded meltwater but had negligible impacts to natural drainage once a channel was established. All culverts were observed to be functioning as designed and natural drainage patterns in the area were maintained.

S12 spring breakup stage data is provided in Graph 3.4. Detailed measured discharge data is presented in section 3.4. Photos are provided in Appendix F.4.

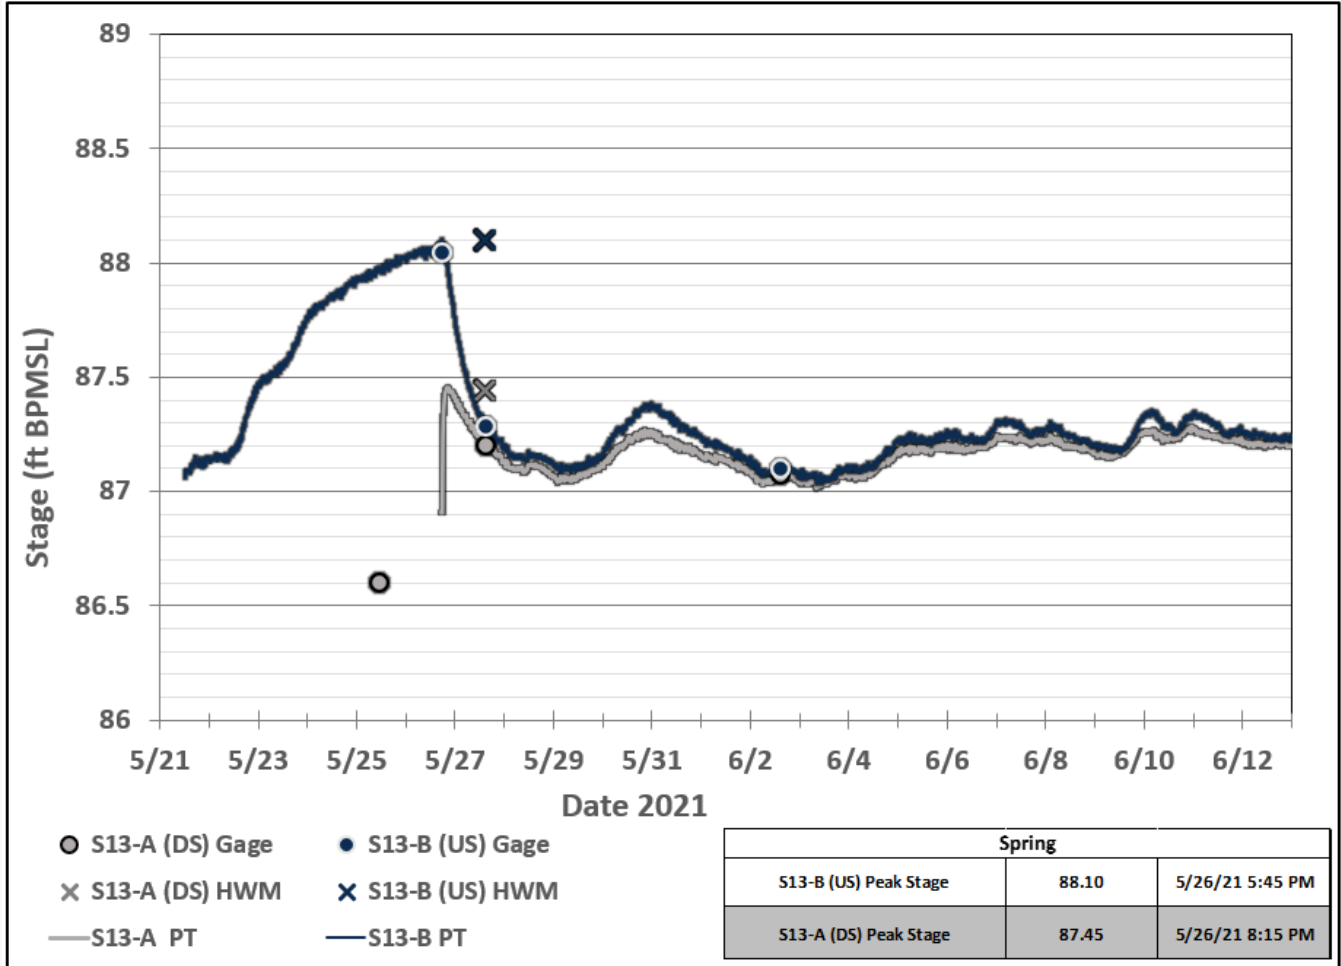
Graph 3.5: S13 Water Surface Elevations

An ice road between the GMT2/MT7 pipeline alignment the GMT2/MT7 road had negligible impacts on drainage in the area. Also, the newly constructed all-season ice pad along the GMT2/MT7 road east of the GMT2/MT7 pad did not appear to have any impacts on drainage. Culvert MT7-09 was observed slightly perched on the south side but was not impacting drainage, however there is potential for development of a scour hole in the future. With the exception of temporary blockages from ice and drifted snow accumulation, all culverts were observed to be functioning as designed and natural drainage patterns in the area were maintained.

S13 spring breakup stage data is provided in Graph 3.5. Detailed measured discharge data is presented in section 3.4. Photos are provided in Appendix F.5.
