# Colville River Delta 2014 Spring Breakup Field Report

**ConocoPhillips**

Michael Baker Jr., Inc.  
3900 C Street, Suite 900  
Anchorage, AK 99503

7/16/2014

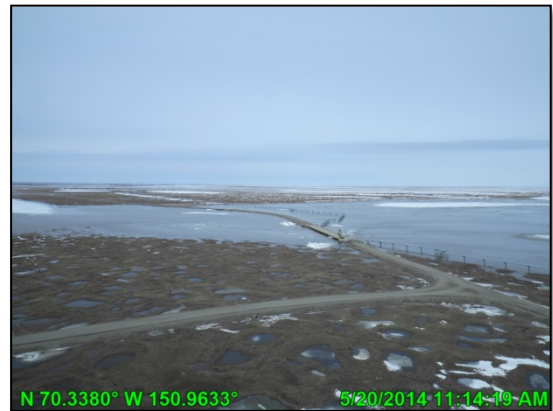
On May 20, the swale bridges and a few culverts along the CD2 road began conveying water (Photo 4). An ice jam was located north of Ocean Point with minimal overbank flooding behind the jam.

**Photo 4: Swale bridges conveying water; May 20, 2014**

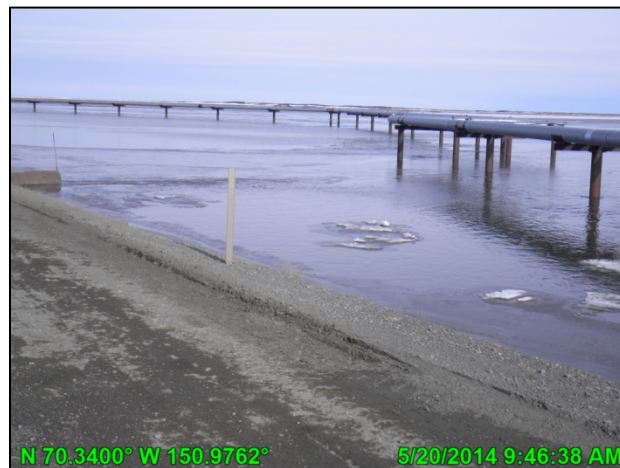
The first peak stage at MON1 (14.34 feet BPMSL) occurred on May 20 (Preliminary), and is earlier than the historical average. Nigliq Channel flood water continued to enter the Nanuq Lake basin, and the CD2 swale bridges and culverts continued conveying flow (Photo 5). On May 21, water levels continued to increase in the delta and around facilities. On May 22, a direct discharge measurement was collected at the long swale bridge on the CD2 Road. Ponded water was present at the short swale bridge, and no discharge measurement was collected. Discharge was also measured at culverts conveying flow along the CD2 and CD4 roads. Photo 6 and Photo 7 show the CD4 and CD5 roads on May 22 and a few CD4 road culverts on May 23. The ice jam north of MON1 remained intact. Competent channel ice continued to prevent the release of the jam and stranded ice along the banks and shoals upstream of the ice jam indicated backwater was receding. WSE at the Colville East, Sakoonang, and Nigliq Channels were also decreasing.

**Photo 5: CD2 road culvert conveying water; May 20, 2014**

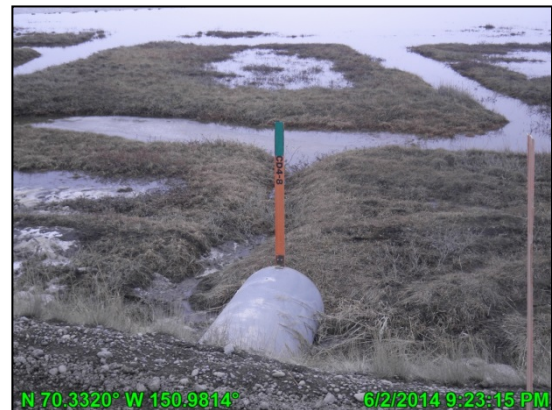
**Photo 9: CD4 Road culvert with no flow  
present; June 2, 2014**

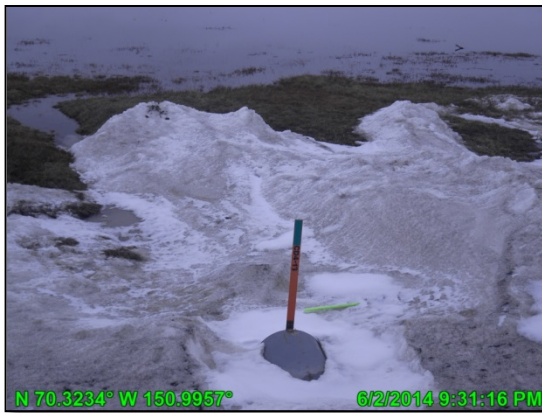
**Photo 10: Minimal flow through CD4 Road culvert; June 2, 2014**

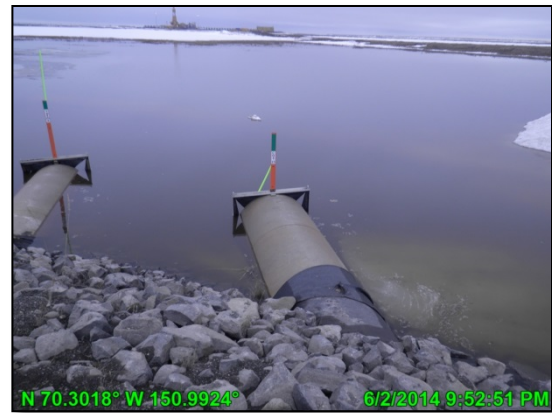
**Photo 11: Flow through CD4 Road culverts; June 2, 2014**

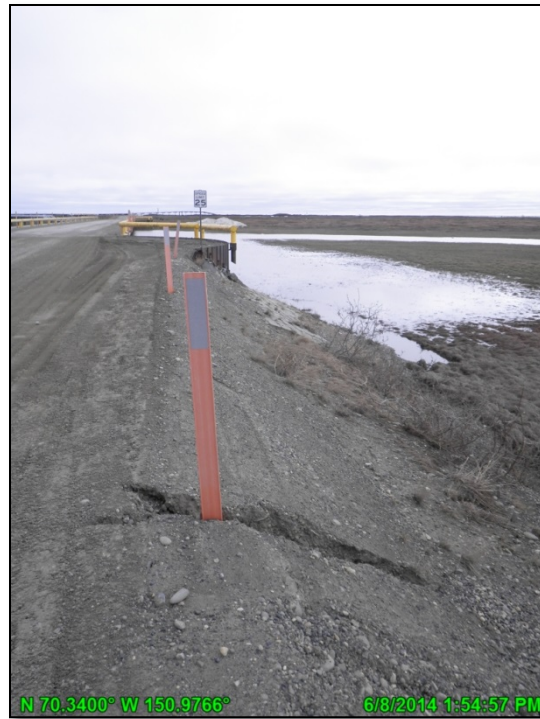
On June 8, Baker conducted a visual inspection to document erosion resulting from breakup flooding along the CD2 and CD4 roads. Other than a minor high water scarp (Photo 13) and runoff effects at delineators (Photo 14) no discernable erosion was observed on facility roads.

Photo 14: Minor erosion around road delineator; June 8, 2014

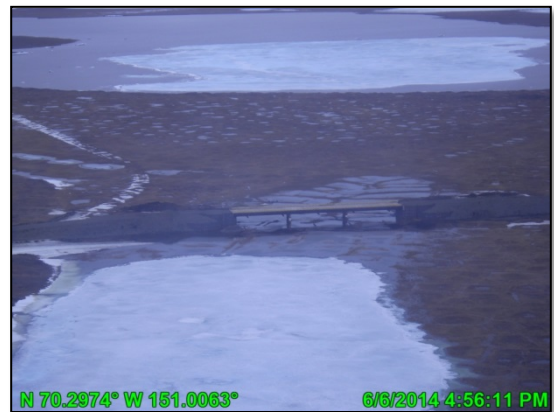
The two bridged lakes, L9341 and L9323, remained mostly frozen throughout breakup; they were ice covered on May 25 and partially open on June 5 and 6 (Photo 15 and Photo 16). Photo 17 shows the CD5 road between Lake L9341 and the Nigliagvik Channel.

Throughout the monitoring period, no flow was conveyed through the Lake L9323 bridge crossing. Lake L9341 connected to the Nigliq Channel, but flow under the bridge was not observed.

Photo 16: Lake L9323 Bridge and CD5 access road culvert; June 6, 2014

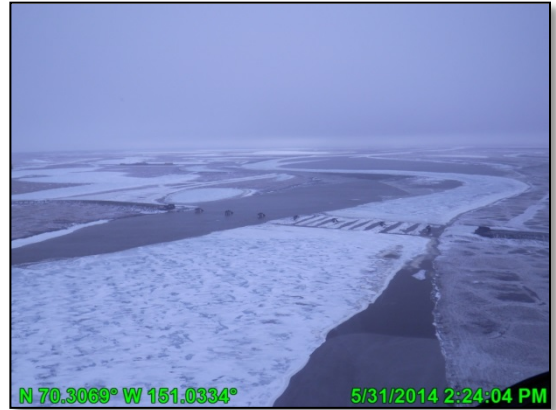
Intact channel ice was present at the Nigliq Channel crossing on May 22 and 31 (Photo 18 and Photo 19), and open water conditions were observed by June 3 (Photo 20 and Photo 21). No flow was observed through the CD5 road culverts; some areas had ponded water. No water was observed around the multi-season ice pad or other CD5 pads throughout the monitoring period (Photo 22). A direct discharge measurement was collected downstream of the Nigliq Channel crossing on June 5.

**Photo 19: Nigliq Channel crossing looking  
upstream; May 31, 2014**

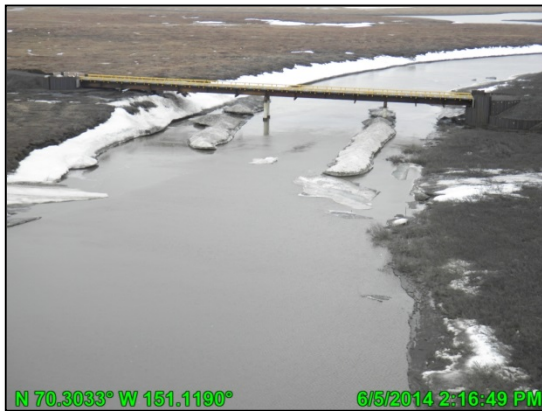
On June 5 at the Nigliagvik Bridge, there was bottom fast ice along the east bank, drifted snow along the west bank and plowed snow piles upstream of the bridge. By June 5, the channel was open and some drifted snow persisted along the west bank and near the piers (Photo 23). A direct discharge measurement was collected from the Nigliagvik Bridge crossing on May 24. Snow drifts and ice shelves were on both sides of the channel and potentially bottom fast ice. A second discharge measurement was collected from the Nigliagvik Bridge crossing on June 8. At that time, the channel was clear of ice with drifted snow on the west bank and no bottom fast ice (Photo 24).

**Photo 23: Nigliagvik Bridge looking downstream;  
June 5, 2014**

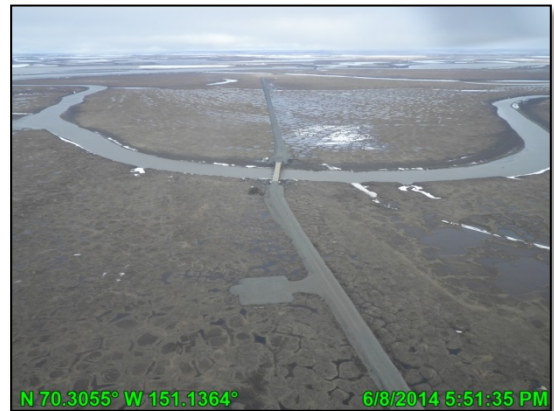
**Photo 24: Nigliagvik Bridge looking east; June 8,  
2014**

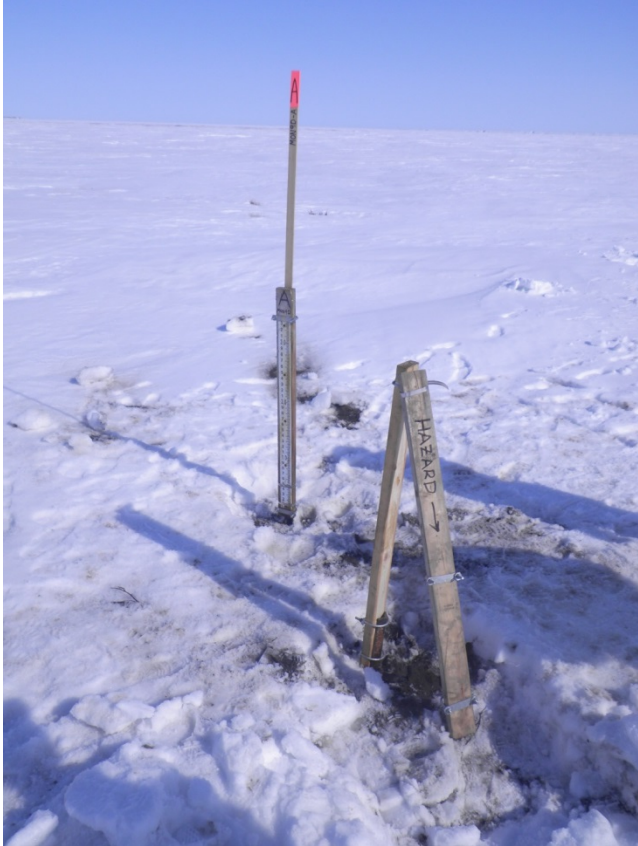
Photo 2: Hazardous exposed steel at MON9D marked; May 2, 2014

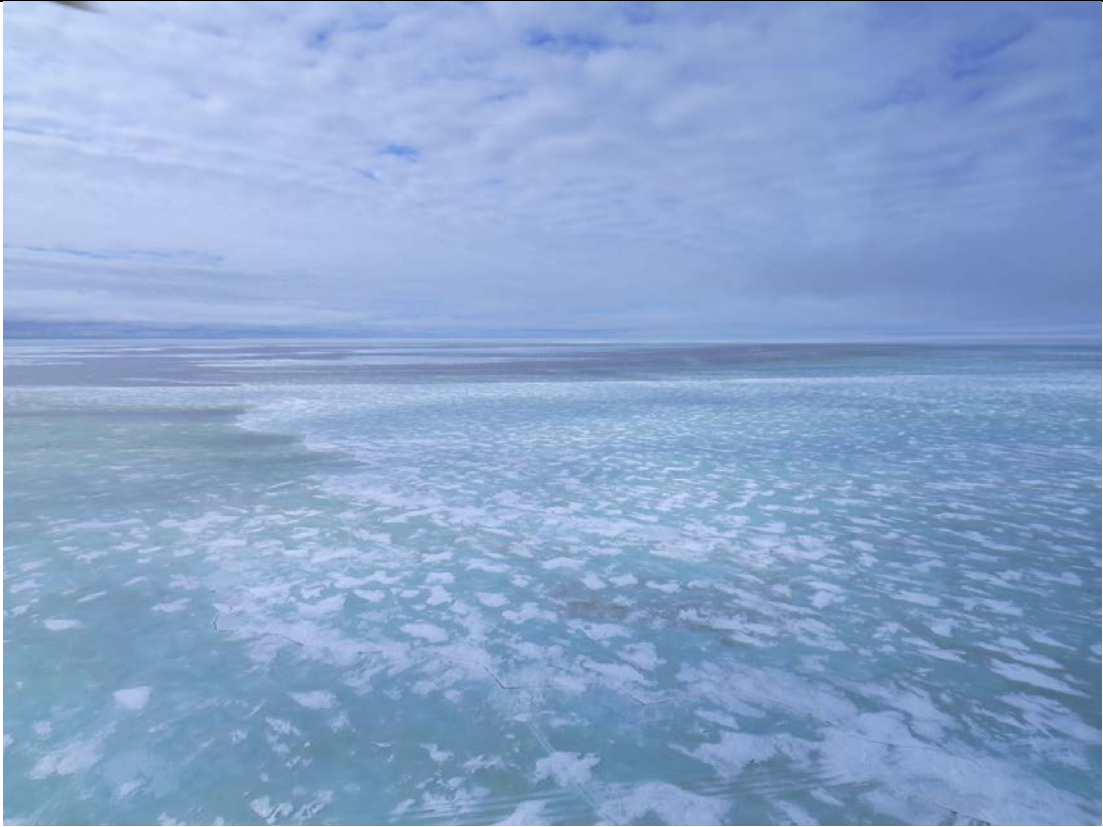
**Photo 5: Flood water meeting the coast; May 17, 2014**

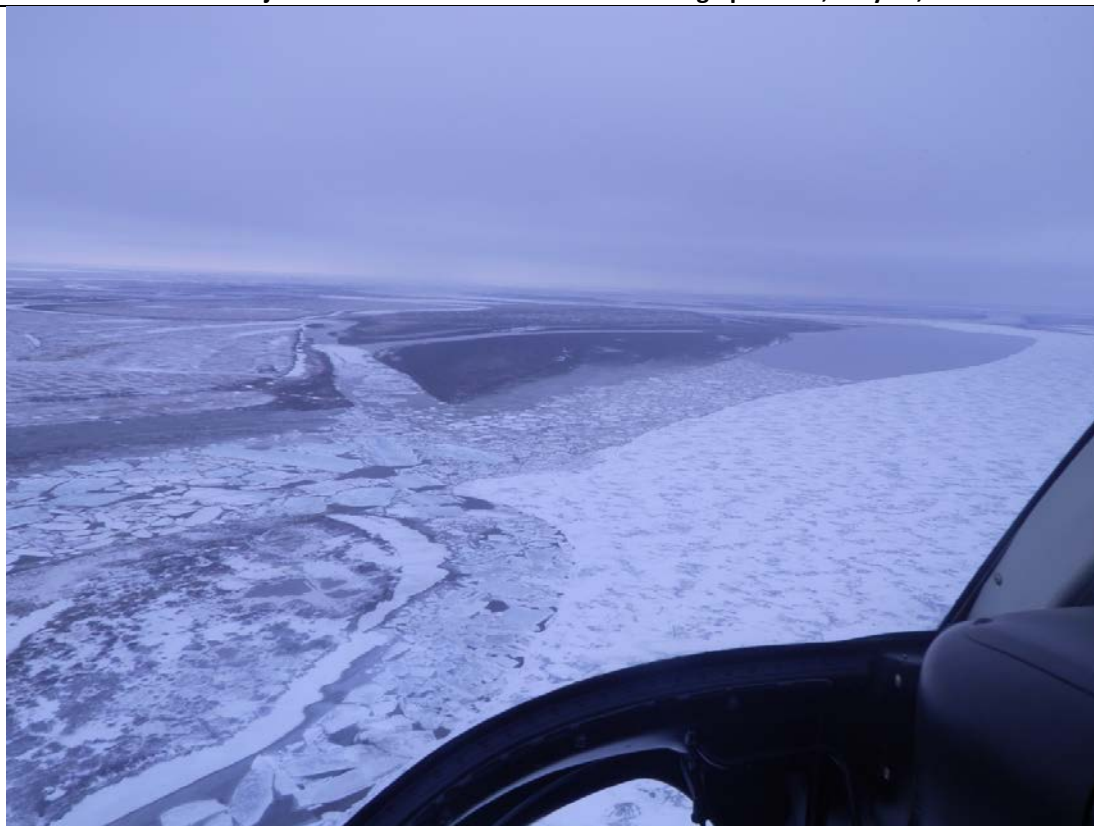
Photo 2: Ice jam downstream of Ocean Point looking downstream; May 19, 2014

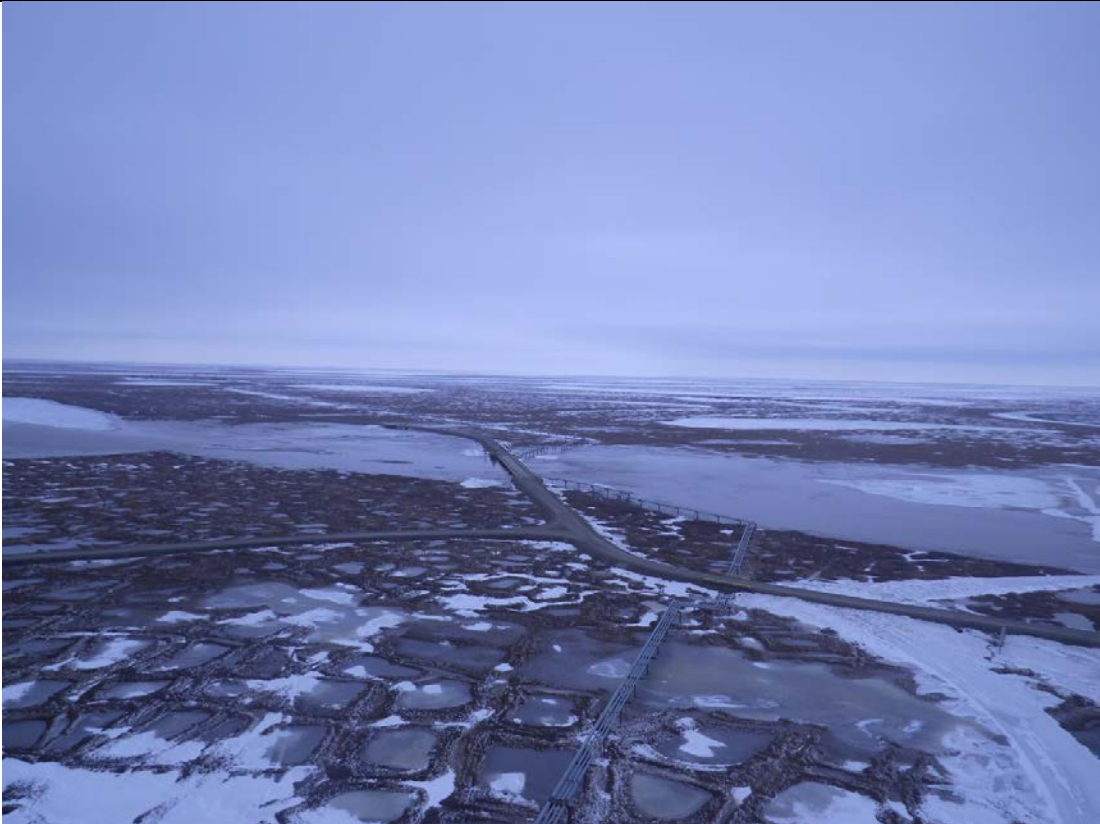
Photo 3: Long swale bridge on CD2 Road conveying water; May 19, 2014

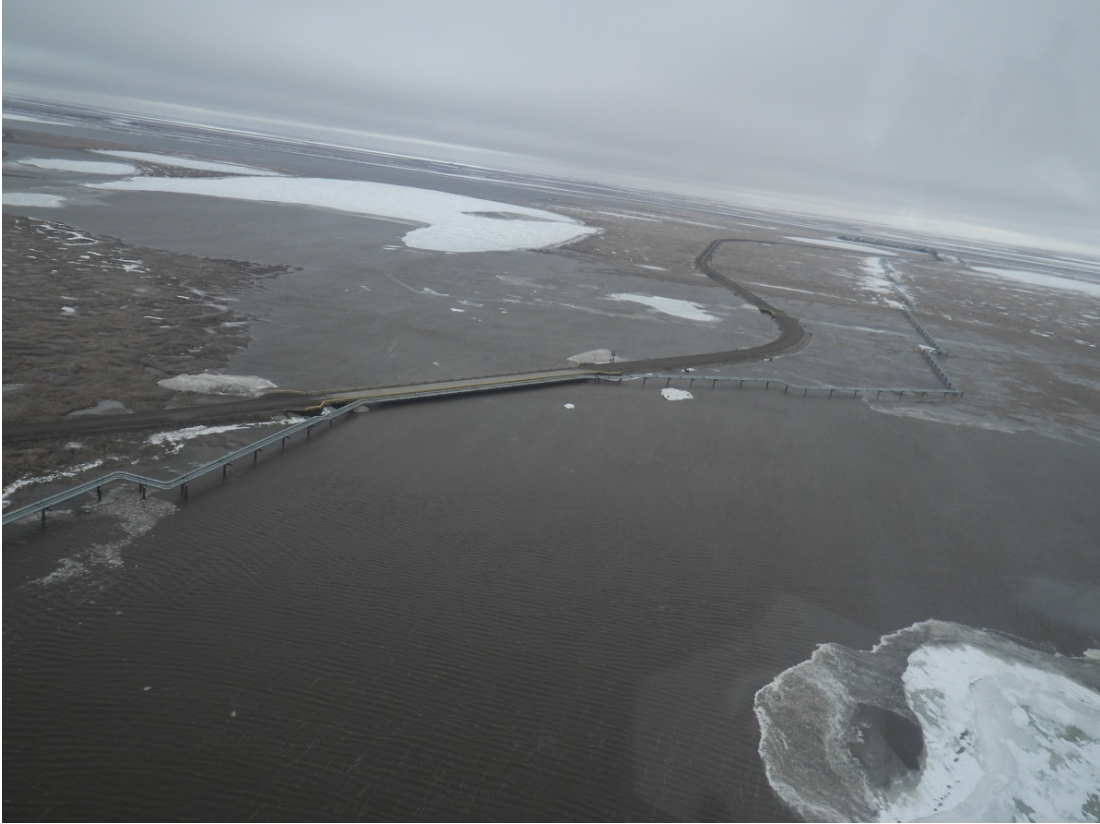
Photo 1: Flow through CD2 swale bridges; May 30, 2014

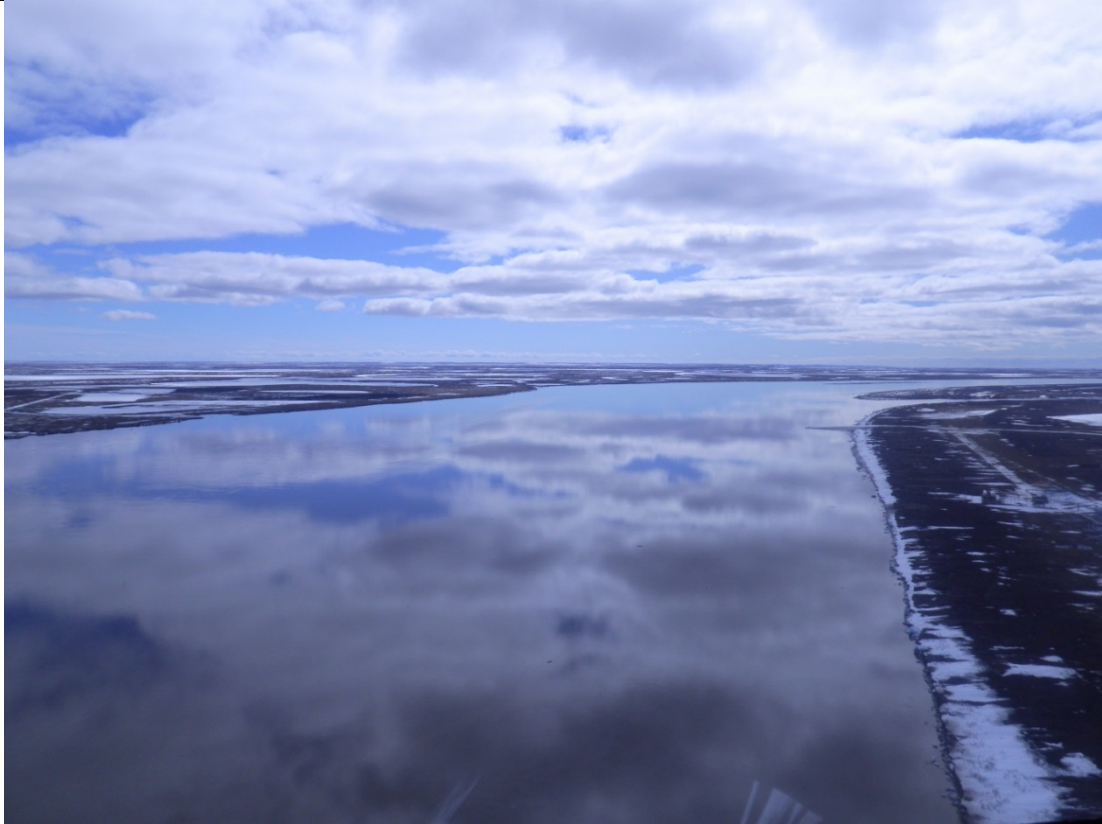
Photo 1: Remains of the Colville River ice bridge ramp near MON9; June3, 2014

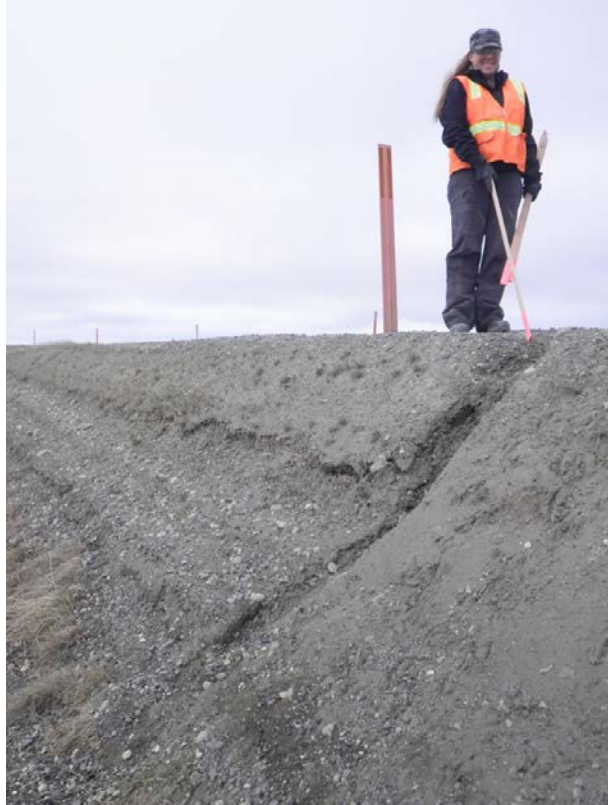
Photo 2: Minor runoff erosion effects on CD2 Road; June 8, 2014
