# 2014

# Colville River Delta Spring Breakup

## Monitoring and Hydrological Assessment

Michael Baker Jr., Inc.  
3900 C Street, Suite 900  
Anchorage, Alaska 99503  
907-273-1600  
November 2014

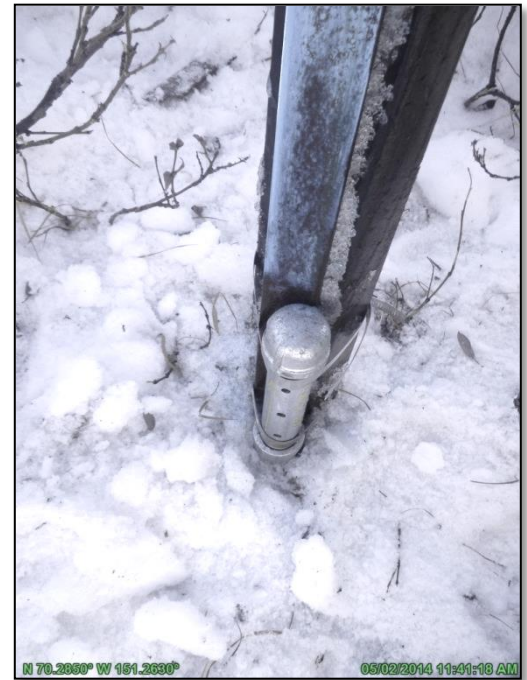
**Photo 2.3: Pressure transducer setup;  
May 2, 2014**

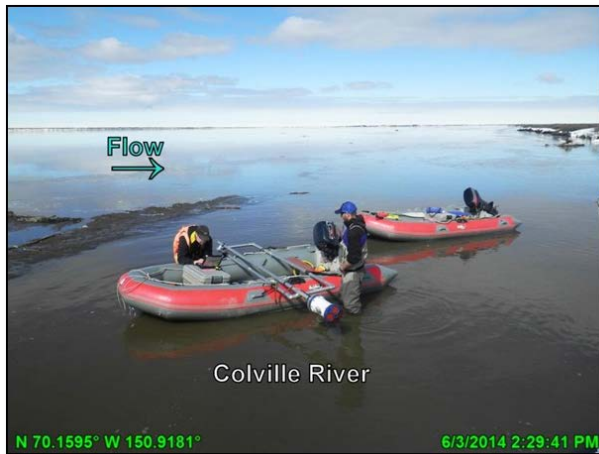
Photo 2.4: Readyng boats, gear, and ADCP for discharge measurement at MON1, looking north; June 3, 2014

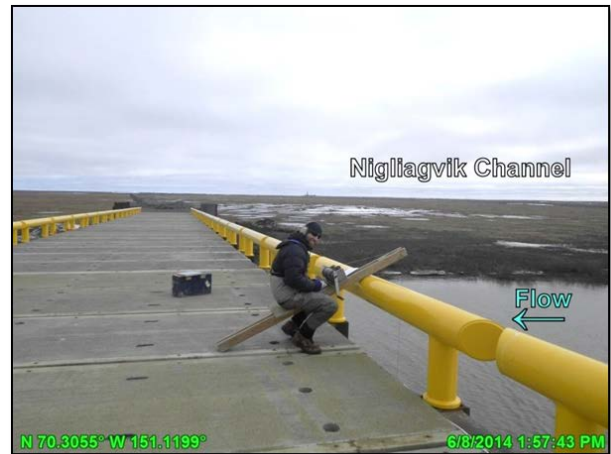
Photo 2.5: Nigliagvik Channel Bridge direct discharge measurement collection, looking east; June 8, 2014

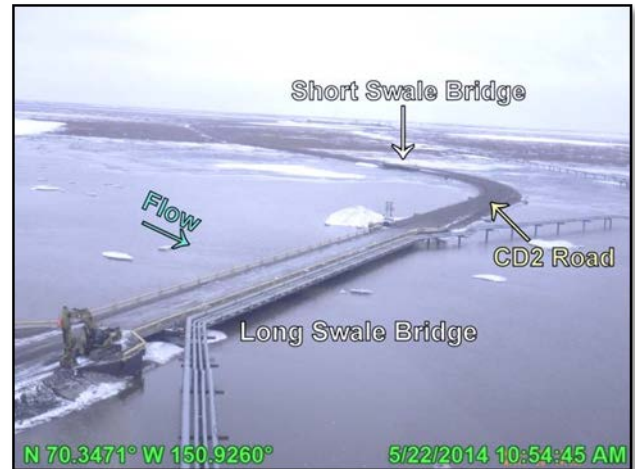
On May 20, the swale bridges and a few culverts along the CD2 road were conveying water (Photo 3.2). Floodwaters crested at MON1 (14.34 feet BPMSL).

**Photo 3.2: CD2 Road swale bridges conveying water, looking west; May 22, 2014**

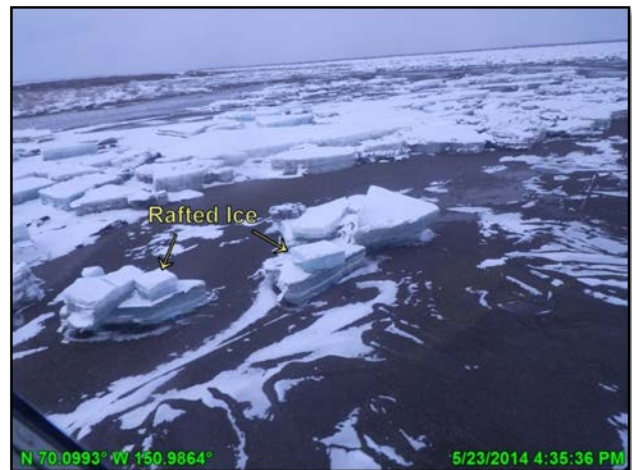
On May 22, a direct discharge measurement was collected at the Long Swale Bridge on the CD2 road. Local melt water was ponded by the Short Swale Bridge. Discharge was also measured at culverts conveying flow along the CD2 road. No flow was observed at the CD4 and CD5 road culverts. The ice jam north of Ocean Point remained intact. Grounded ice and shoals within and upstream of the ice jam were visible, and there was low water and no overbank flooding behind the ice jam indicating the backwater was receding (Photo 3.3 and Photo 3.4).

**Photo 3.4: Rafted ice within ice jam upstream of MON1 (looking west); May 23, 2013**

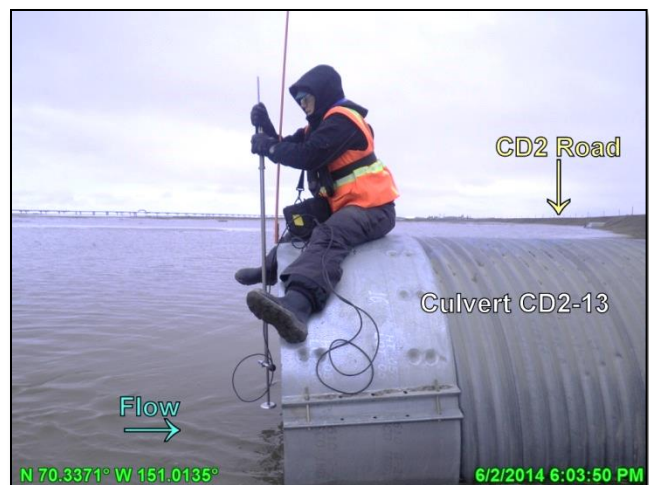
Direct discharge measurements were collected at the CD2 road culverts conveying floodwater and the Long Swale Bridge on May 22 within 24-hour of the first crest in floodwaters, and at both swale bridges on June 2 within 24-hours of peak stage (Photo 3.11). On May 22, ponded, local melt water was present at the Short Swale Bridge, so a direct discharge measurement was not collected. Erosion surveys along the CD2 road were conducted on May 25 and June 8.

**Photo 3.11: Collecting a discharge measurement at CD2 Road culvert during peak stage, looking northwest; June 2, 2014**

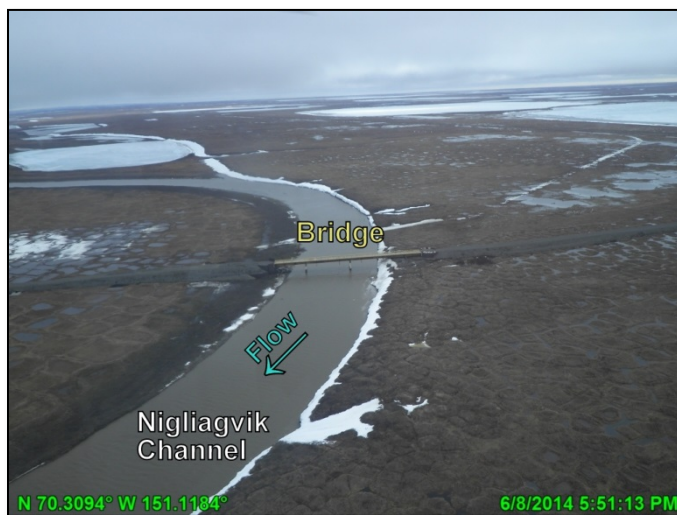
On May 16, the Nigliagvik Channel was connected to the Nigliq Channel at both ends. Floodwaters crested at gages G38 (upstream) and G39 (downstream) adjacent to the bridge on May 20. The channel near the bridge was mostly free of ice except for shorefast ice along the banks on May 24, when the first direct discharge measurement was collected. Floodwaters began to recede on May 21 and continued until May 31, when WSE increased. Peak stage was observed on June 1. An ice jam was located at the mouth of the Nigliagvik Channel near the Nigliq confluence between June 2 and 5. There was no discernable backwater, and floodwaters were conveying around and under the ice jam. On June 6, the ice jam was no longer in place. On June 8, the Nigliagvik Channel was mostly free of ice, with traces of shorefast ice on the west bank at the bridge location (Photo 3.17). A second direct discharge measurement was collected.

Photo 3.17: Nigliagvik Channel Bridge, looking south, June 8, 2014

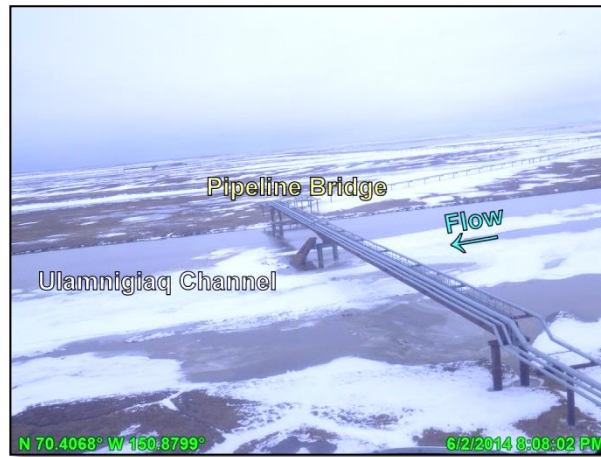
Peak stage occurred at the SAK, TAM and ULAM gages on June 2 (Photo 3.18, Photo 3.19, and Photo 3.20, respectively). Small ice jams were present in the Tamayayak and Sakoonang Channels on June 2. Intact channel ice remained at the TAM and SAK gage locations at the pipeline crossings. An ice jam was upstream of the pipeline crossing on the Tamayayak Channel, and the Sakoonang Channel ice was intact by the CD1 Pad. The Sakoonang Channel was connected to the North and South Paleo Lakes and Lake L9282/B8534. On June 3, some intact channel ice was near the pipeline crossing on the Sakoonang Channel, and ice flows were in the Tamayayak Channel. Minimal overbank flooding was noted on the Sakoonang Channel, and the ice jam upstream of the pipeline crossing broke up on June 4. On June 6, floodwaters from Lake L9282/B8534 were observed draining into the Sakoonang Channel.

Photo 3.20: Ulamnigiq Channel pipeline crossing at peak stage, looking north; June 2, 2014

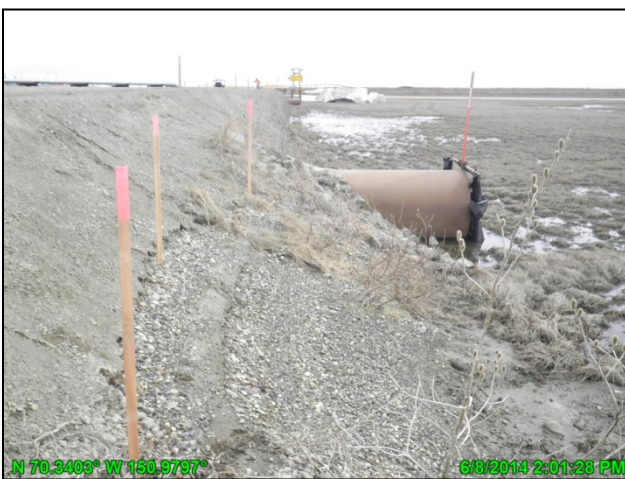
Other than minor high water scarp and runoff effects at delineators, no discernable erosion was observed during visual inspections of the CD2 and CD4 gravel road prisms. A prominent erosion line from the 2013 spring breakup was evident. Floodwaters did not reach the CD5 road prism or pad; therefore, an erosion survey was not conducted. Signs of erosion were not visible during aerial and ground reconnaissance. Photo 5.1 shows ponded water typical of breakup conditions along the CD5 road, and Photo 5.2 and Photo 5.3 show conditions during the road erosion survey along the CD2 and CD4 roads, respectively. Additional photo documentation of erosion surveys and breakup conditions along the CD5 road are shown in Appendix C.2.

Photo 5.2: CD2 Road Erosion Survey, looking north; June 8, 2014

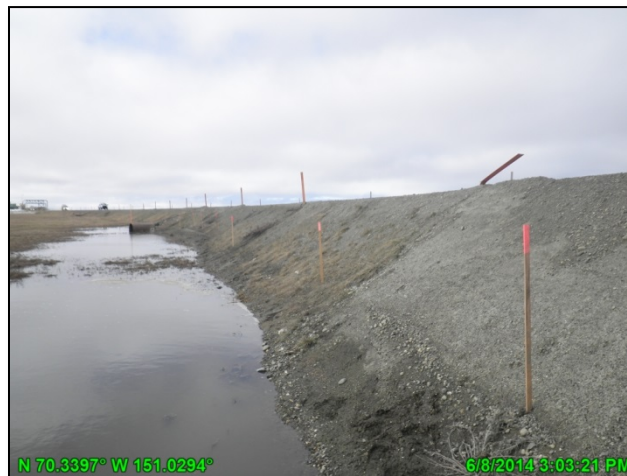
Photo C.6: CD2 Road Erosion Survey, looking north; June 8, 2014

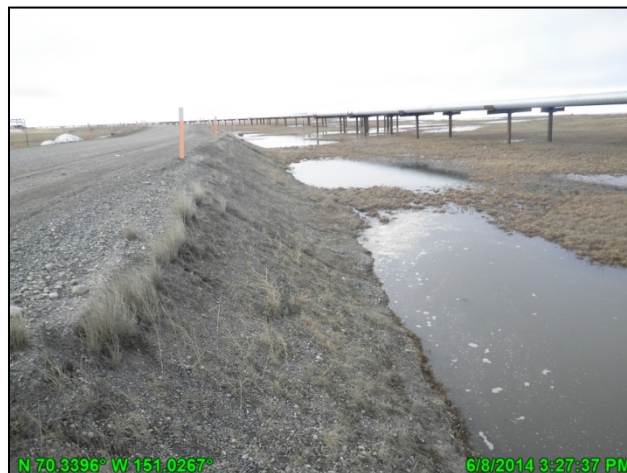
Photo C.7: CD2 Road Erosion Survey, looking north; June 8, 2014

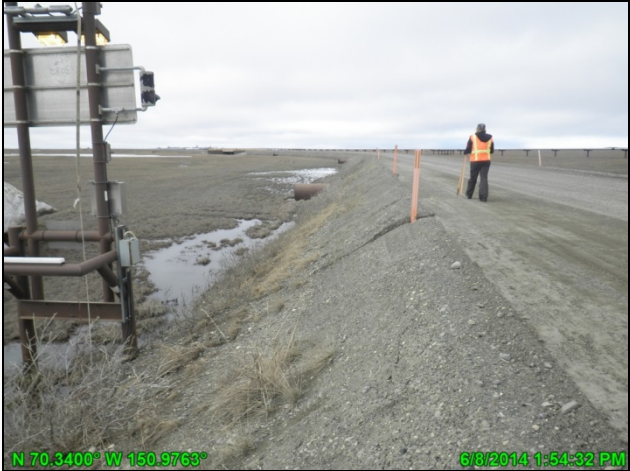
Photo C.8: CD2 Road Erosion Survey, looking north; June 8, 2014

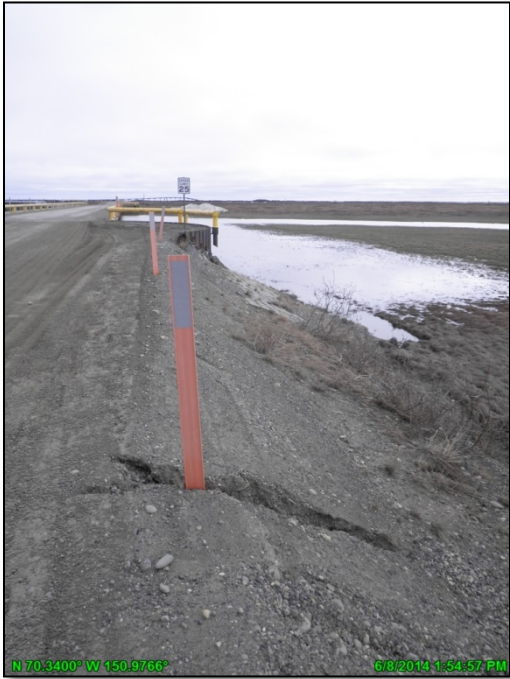
Photo C.9: CD2 Road Erosion Survey, looking north; June 8, 2014

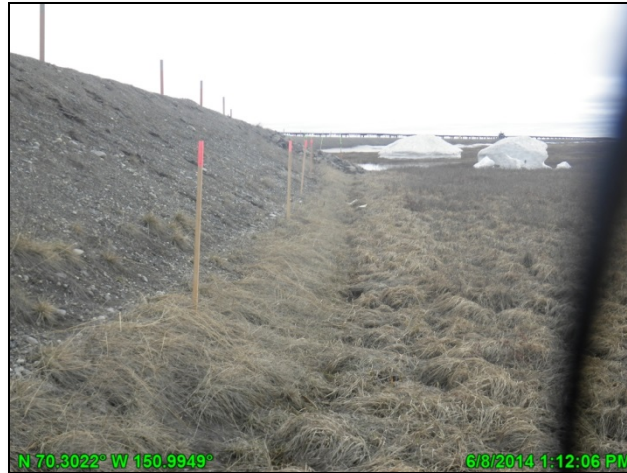
Photo C.10: CD4 Road Erosion Survey; June 8, 2014

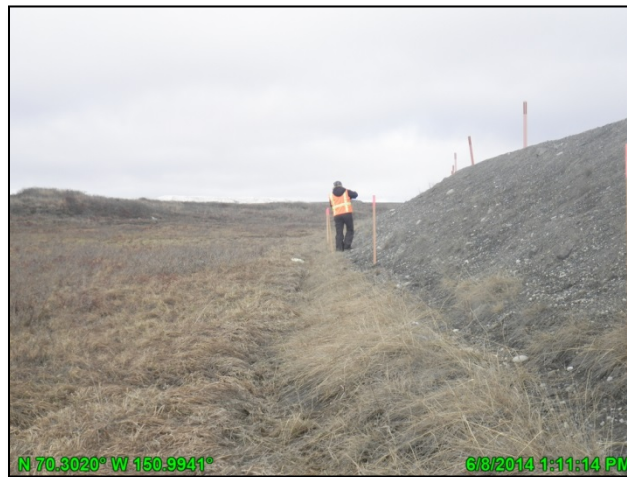
Photo C.11: CD4 Road Erosion Survey; June 8, 2014

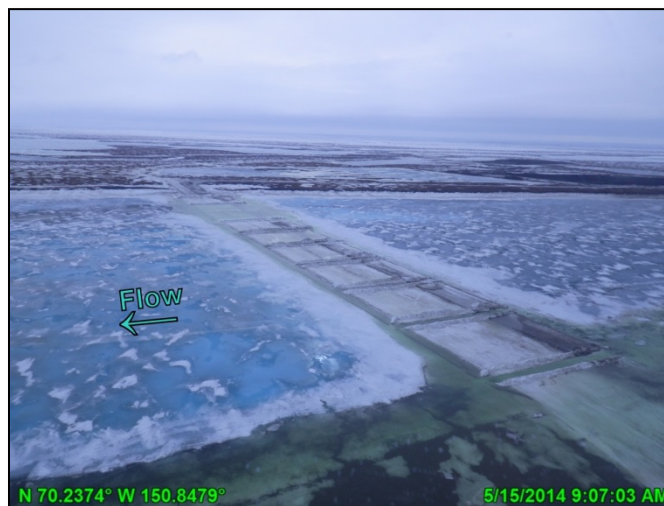
Photo C.12: Colville East Channel ice road crossing slotted, looking east; May 15, 2014

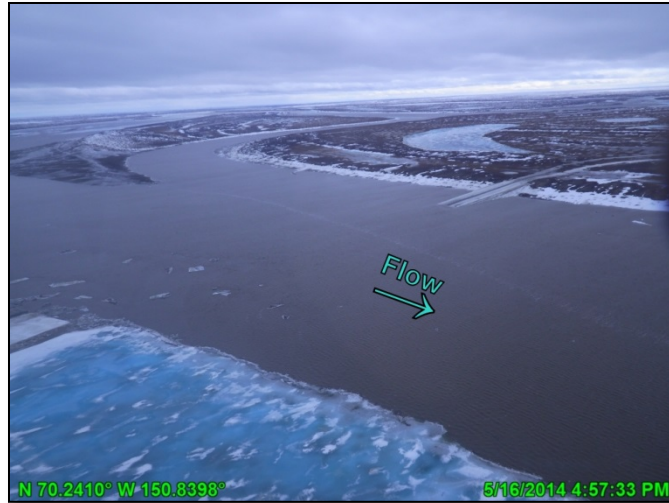
Photo C.13: Colville East Channel ice road crossing ramps, looking southwest; May 16, 2014

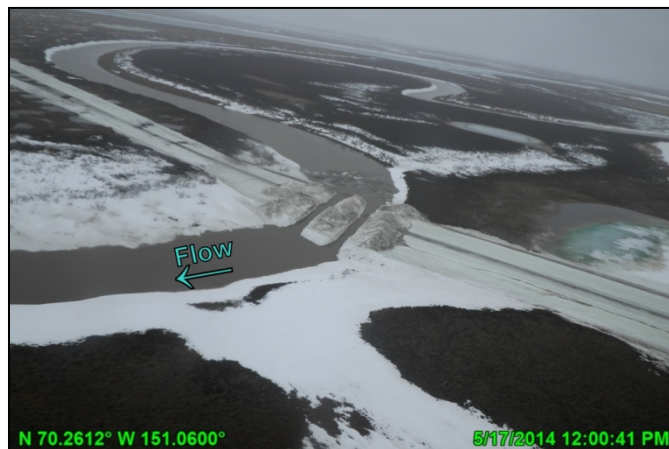
Photo C.15: Flow through slotted sections of the Nigliagvik exploration ice road crossing, looking southeast; May 17, 2014

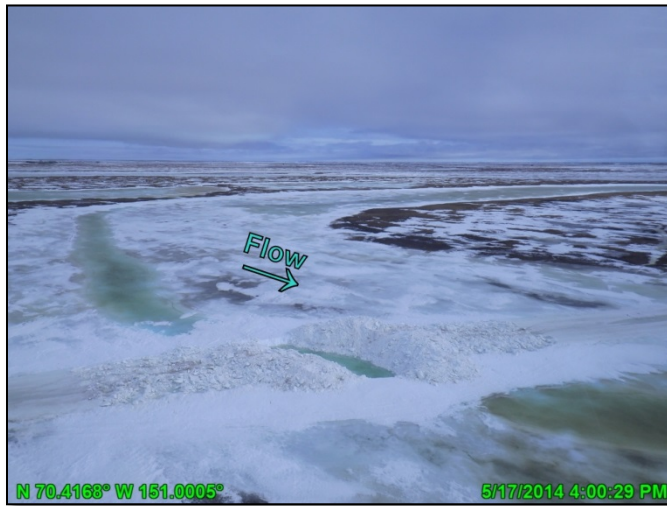
Photo C.20: Slotted Slemph Slough ice road crossing, looking east; May 17, 2014

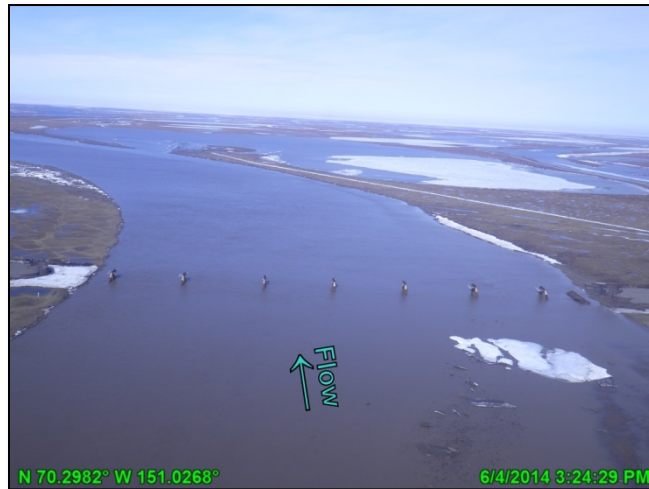
Photo C.26: Open channel at Nigliq Channel Bridge crossing, looking north; June 3, 2014

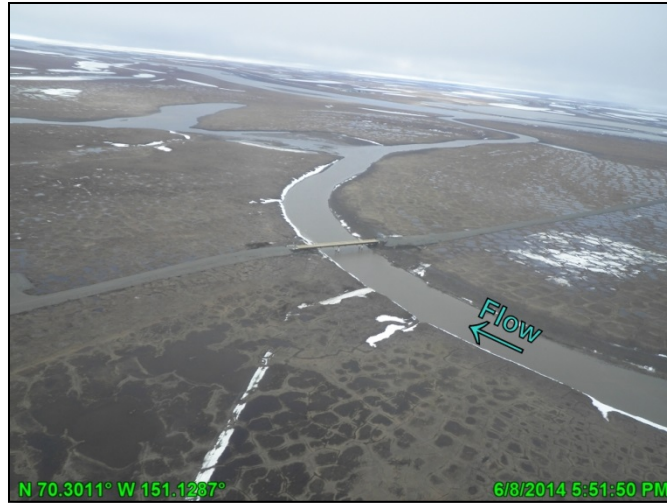
Photo C.28: Open channel at Nigliagvik Bridge crossing, looking north; June 8, 2014

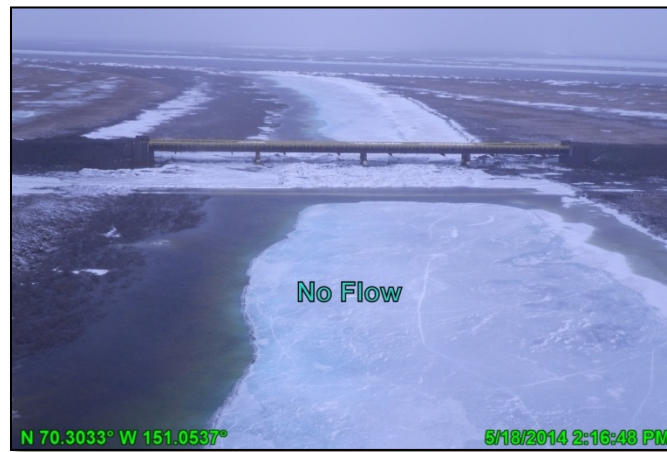
Photo C.29: Lake L9341 Bridge and construction ice pad, looking northeast; May 18, 2014

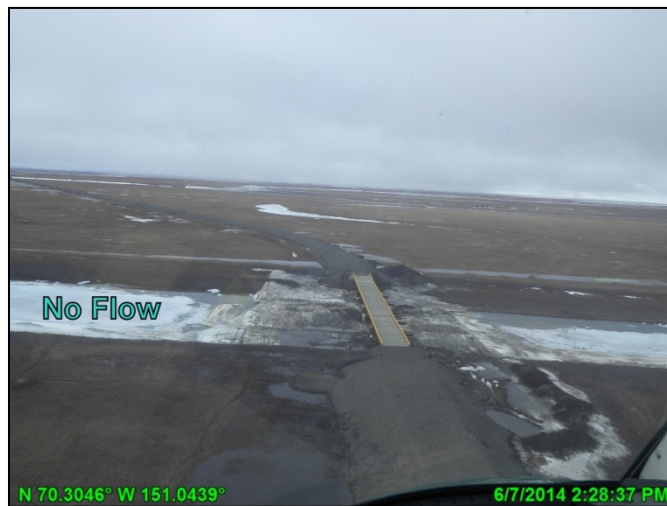
Photo C.30: Lake L9341 Bridge and construction ice pad, looking west; June 7, 2014

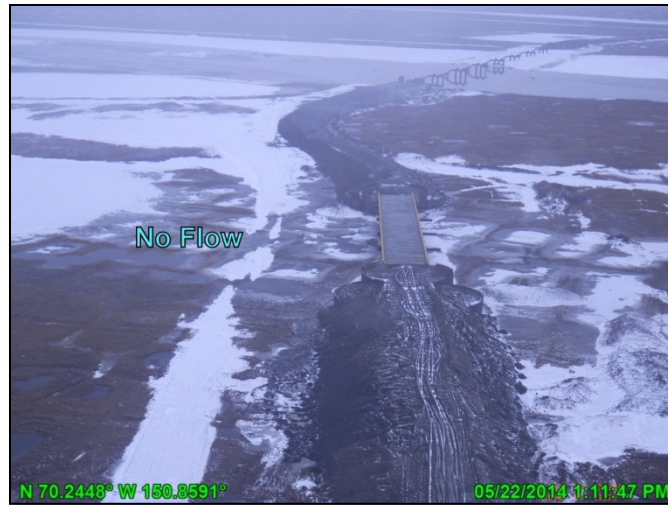
Photo C.31: Lake L9323 Bridge and construction ice pad, looking west, May 22, 2014

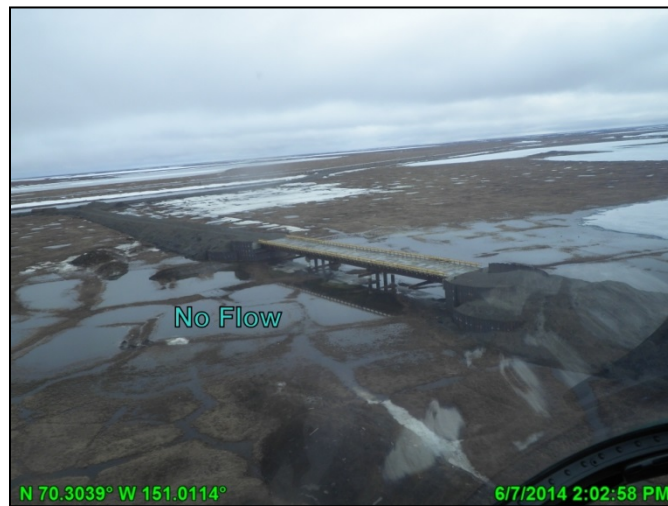
Photo C.32: Lake L9323 Bridge crossing open water, looking southeast; June 7, 2014
