2015 COLVILLE RIVER DELTA SPRING BREAKUP MONITORING AND HYDROLOGICAL ASSESSMENT

148414-MBJ-RPT-001 | November 2015

EXECUTIVE SUMMARY

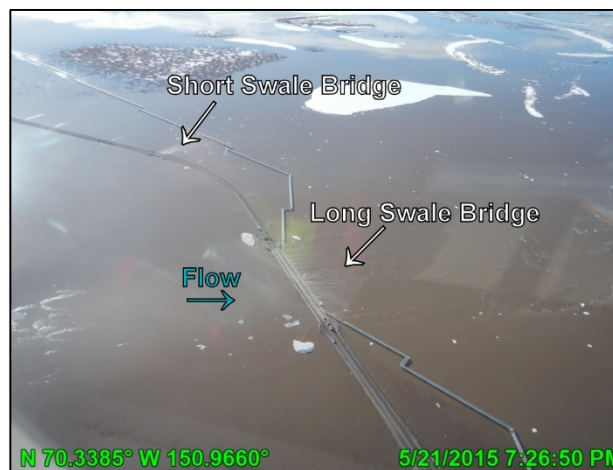
All three paired gages along the CD2 road followed a similar trend, rising and falling rapidly over a 48 hour period. The first hydrologic connection of floodwaters between upstream and downstream was observed on May 20. On May 21, backwater behind the ice jam in the East Channel was being diverted into the Nigliq Channel and stage continued to increase throughout the day around the CD2 road and pad, submerging culvert inlets and increasing flow through the swale bridges (Photo 3.14). Peak WSE occurred in the early morning on May 22 and water levels reached the bottom chord of the swale bridges (Photo 3.14 and Photo 3.15).

Photo 3.15: CD2 road swale bridges near the time of peak WSE, looking northwest; May 21, 2015

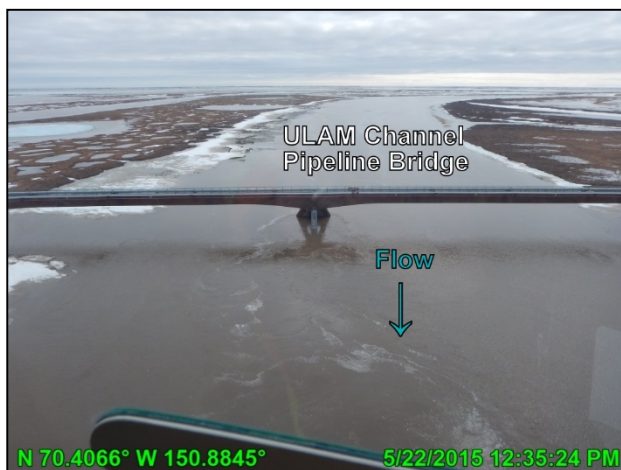
The leading edge of floodwater reached the TAM and ULAM pipeline crossing on May 18 and the SAK pipeline crossing on May 19. The channels at the pipeline crossings were mostly clear of snow and ice on May 20 and stage continued to rise. PT data shows the WSE trends at the TAM and ULAM gages were nearly identical (Graph 3.10). A large ice jam in the East Channel upstream of the Tamayayak Channel held back water on May 20 and 21. Stage peaked at the TAM and ULAM gages during the afternoon on May 22 (Table 3.9). At the time of peak stage there was minimal overbank flooding in the vicinity of the ULAM gage and moderate overbank flooding at the TAM gage (Photo 3.16 and Photo 3.17).

Photo 3.16: Ulamnigiq Channel at the CD3 pipeline crossing near the time of peak flooding, looking southeast; May 22, 2015

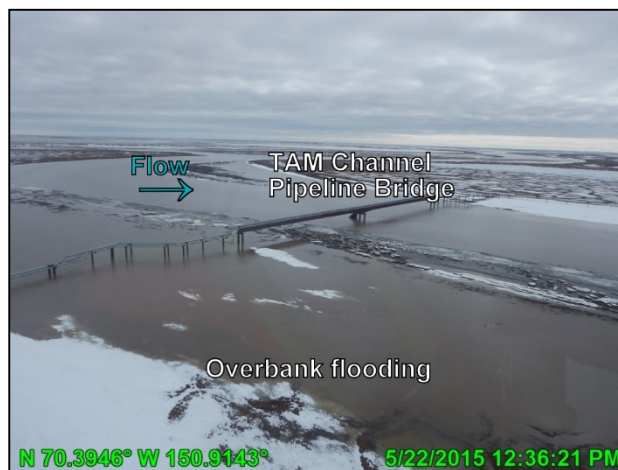
Photo 3.17: Tamayayak Channel at the CD3 pipeline crossing near the time of peak flooding, looking southeast; May 22, 2015

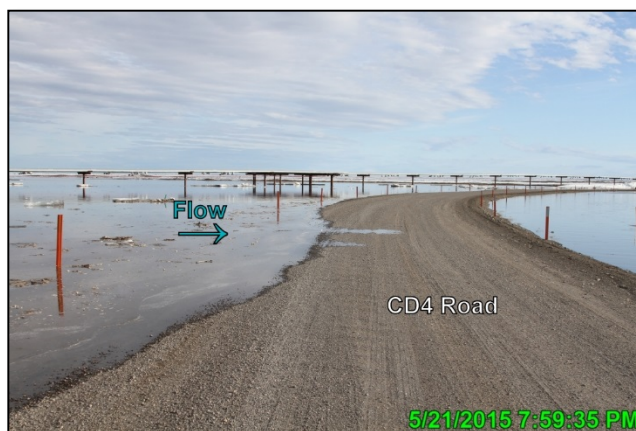
The culvert inlets and outlets at the south battery were submerged by water moving west overland from the Sakoongang Channel through the South Paleo Lake and eastward overbank flow from the Nigliq Channel (Photo 3.20). As the water flowed north around the CD4 pad, large head differentials formed at the north culvert battery. At 8:00 PM on May 21, WSEs at the north culvert battery were 15.17 feet BPMSL at gage G16 on the

Photo 3.20: Floodwater overtopping the road near gage G18 prior to peak stage, looking south; May 21, 2015

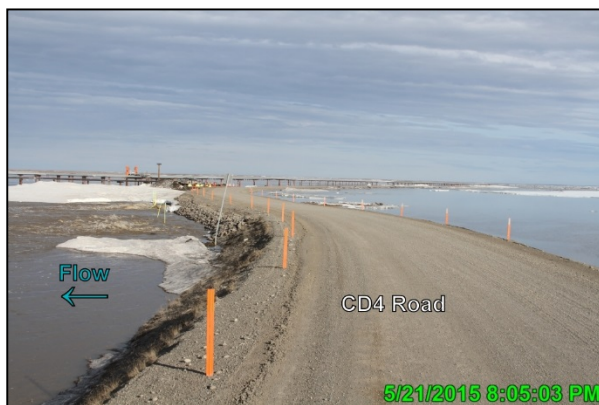
south side of the road and 9.43 feet BPMSL at gage G15 on the north side of the road. This equated to the maximum observed differential of 5.74 feet between gages G16 and G15 (Photo 3.21). The WSE south of the south culvert battery (gage G18), was 15.85 feet BPMSL. At this time, the CD4 road, northeast of gage G18, was overtopped and eventually breached. Three hours later the differential between gages G16 and G15 had dropped to 1.6 feet as stage increased in the low-lying area east of the road. At 8:00 AM on May 22, most of the culvert inlets were no longer submerged and the differential was 0.44 feet. Floodwater was still flowing through the breach in the road on the morning of May 22 (Photo 3.22). On May 23, floodwaters had receded from the area and flow through the culverts ceased. The peak WSE at gage G18, surveyed from a HWM, was 16.58 feet BPMSL occurring sometime on the morning of May 22. A HWM of 17.33 feet BPMSL was recorded at gage G19 on the south side of CD4 Pad.

Photo 3.21: CD4 road looking southeast at north culvert battery at the time of the 5.74 foot WSE differential; May 21, 2015

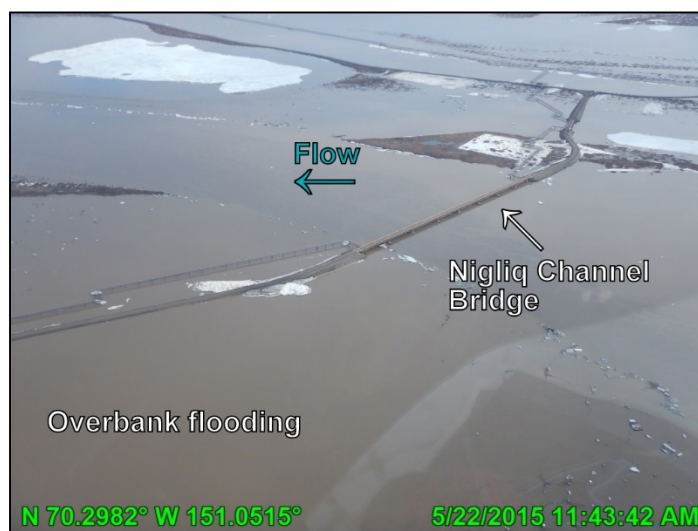
Photo 3.24: Inundation around the Nigliq Bridge 10 hours after peak stage, looking northeast; May 22, 2015

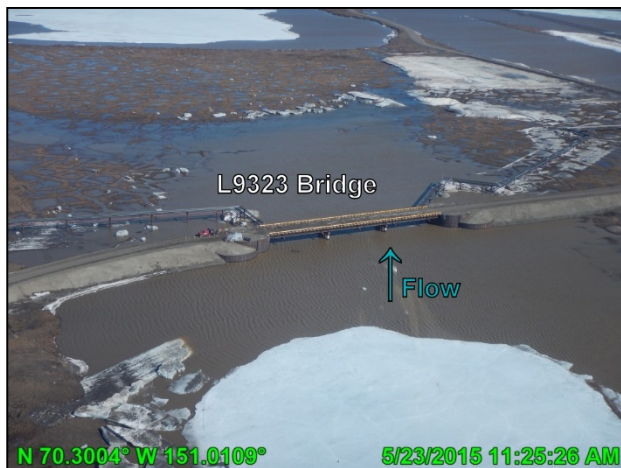
Photo 3.25: Lake L9323 Bridge following peak flooding, looking north toward connection with Nanuq Lake; May 23, 2015

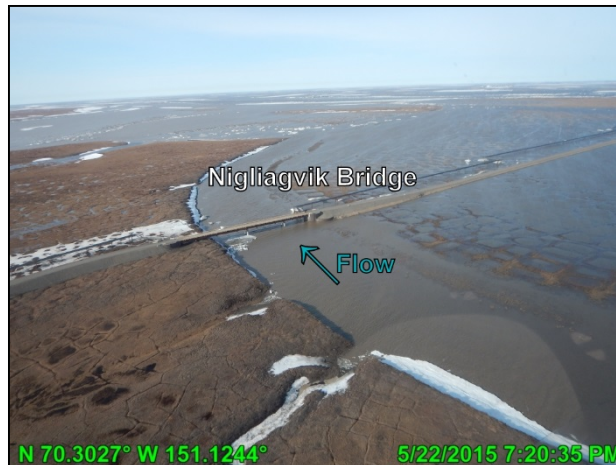
Photo 3.27 Nigliagvik Bridge following peak stage, looking north east; May 22, 2015

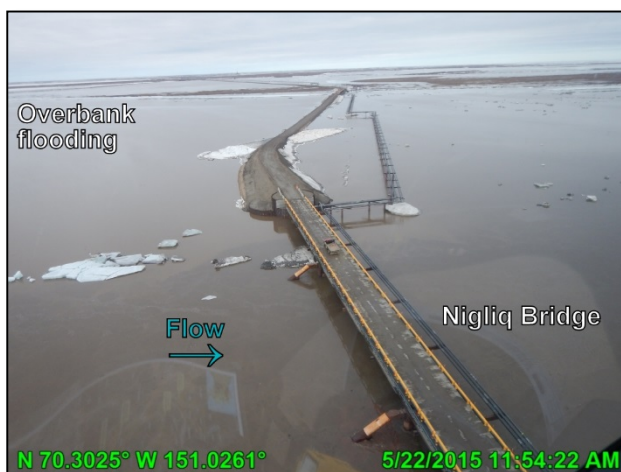
Aerial observation and HWMs along the CD5 road between the Nigliq and Nigliagvik channels show the culverts were inundated to the same elevation as the bridge locations. The entire area was flooded during the evening on May 21 through May 22 (Photo 3.28 and Photo 3.29). The maximum upstream and downstream differential was similar at all the culverts, less than 1.5 feet.

Photo 3.28: Inundation around the eastern half of the CD5 road, looking west after peak stage; May 22, 2015

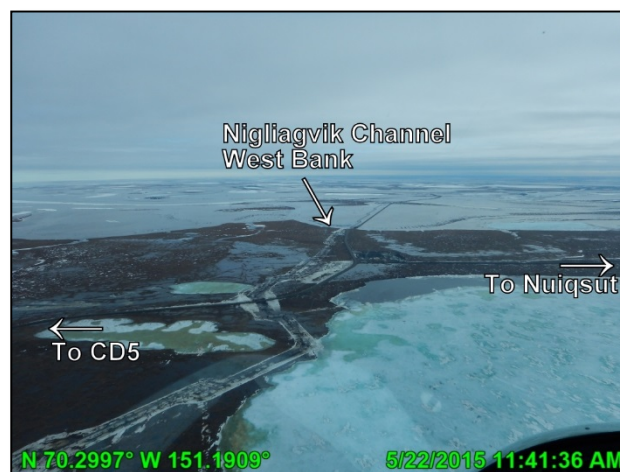
Photo 3.29: CD5 road looking east, flooding is contained by the Nigliagvik Channel and Lake M0356; May 22, 2015

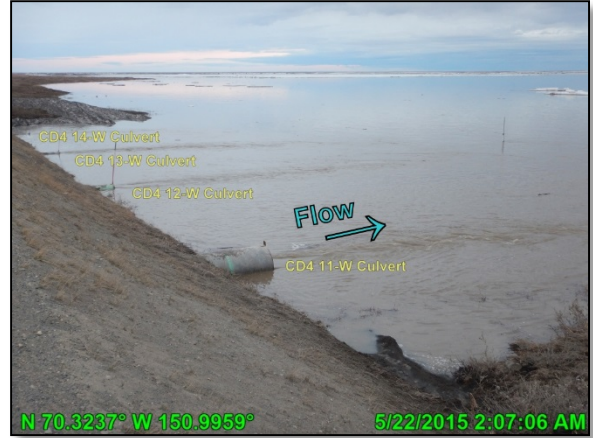
Visual observations of flow conditions at each CD4 road culvert are summarized in Table 4.3 below. Photo 4.2 and Photo 4.3 shows the CD4 north culvert battery and south culvert battery respectively conveying flow

Photo 4.3: CD4 road north battery conveying flowing during peak conditions, looking north; May 22, 2015

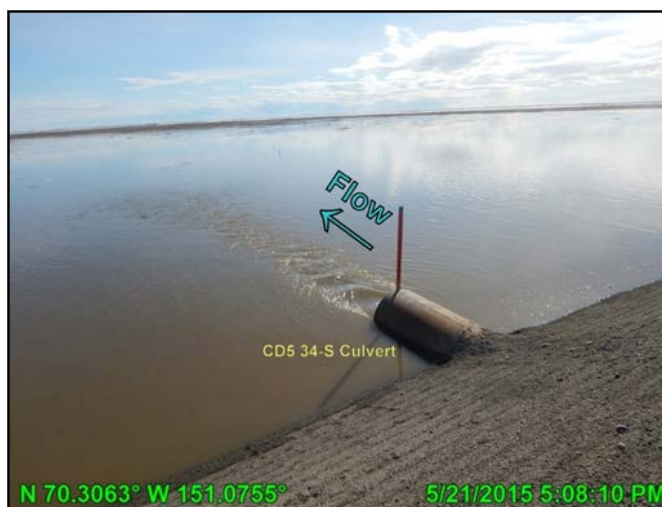
Visual observations of flow conditions at each CD5 road culvert are summarized in Table 4.5 below. Photo 4.4 shows a culvert along the CD5 road conveying flow prior to peak stage. CD5 road culvert peak discharge was calculated using WSE data from the gages located in the vicinity of the culverts. The WSE differential for the CD5 road gages is presented in Graph 4.9 and Graph 4.10.

Photo 4.4: CD5 road culvert conveying flow during peak conditions; May 21, 2015

Total peak discharge through the CD5 road culverts was estimate at 890 cfs at approximately 5:00 AM on May 22. At the time of peak discharge, culvert CD5-26 was conveying 7 percent of the flow, culverts CD5-27 through CD5-31 were conveying 43% of the flow, culverts CD5-32 through CD5-36 were conveying 22% of the flow, culverts CD5-37 through CD5-39 were conveying 7 percent of the flow, culverts CD5-40 through CD5-42 were conveying 18% of the flow, and culvert CD5-43 was conveying 3 percent of the flow. Culvert CD5-26 had the highest average velocity of 7.2 fps.

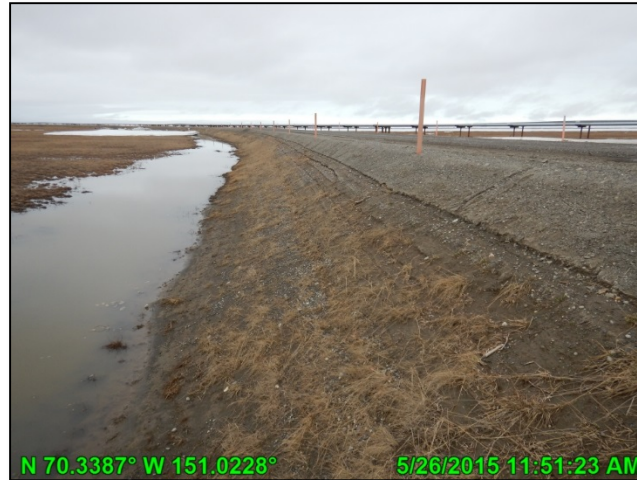
Photo C.3: Wash line on the south side of the western section of CD2 road, looking west between gages G6 and G12; May 26, 2015

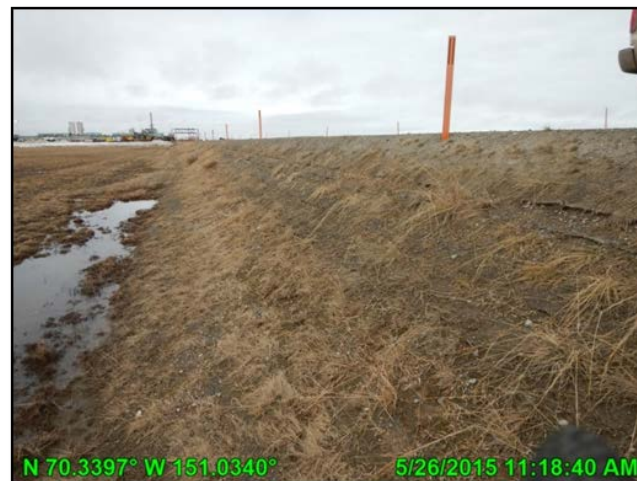
Photo C.4: HWMs along the south side of CD2 road near CD2 pad, looking west; May 26, 2015

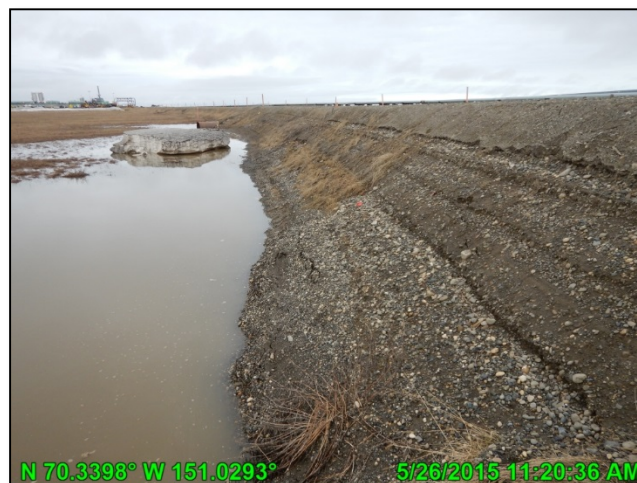
Photo C.5: Wash lines and vegetation scour around culvert CD2-4 on the western section of CD2 road, looking west at the south side of the road toward culvert CD2-3; May 26, 2015

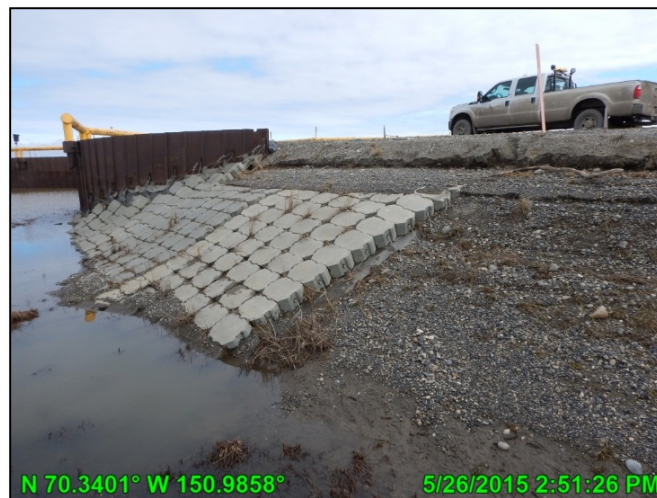
Photo C.7: Wash line at the Short Swale Bridge on the north side of the road, looking east; May 26, 2015

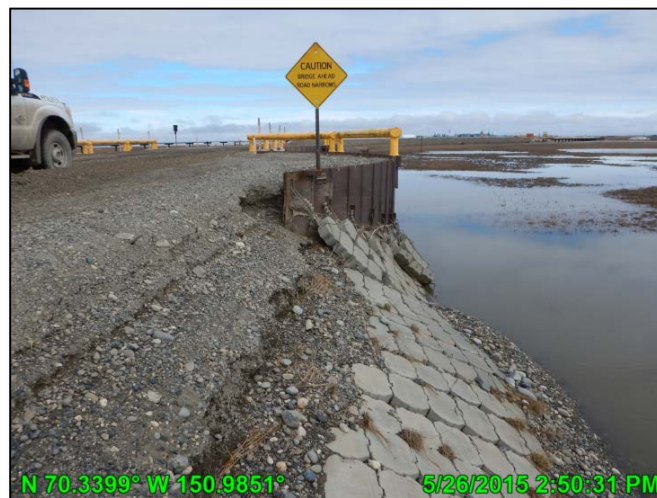
Photo C.8: Wash line at the Short Swale Bridge on the south side of the road showing scour at the sheet pile abutment, looking east; May 26, 2015

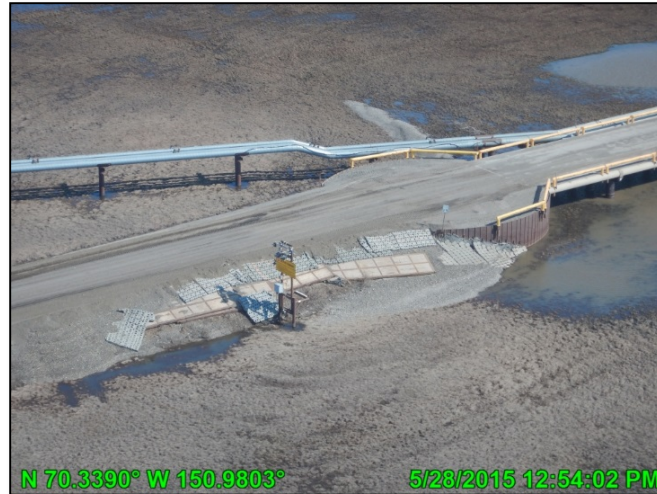
Photo C.9: Scour and deposition at the Long Swale Bridge west abutment, looking northeast; May 26, 2015

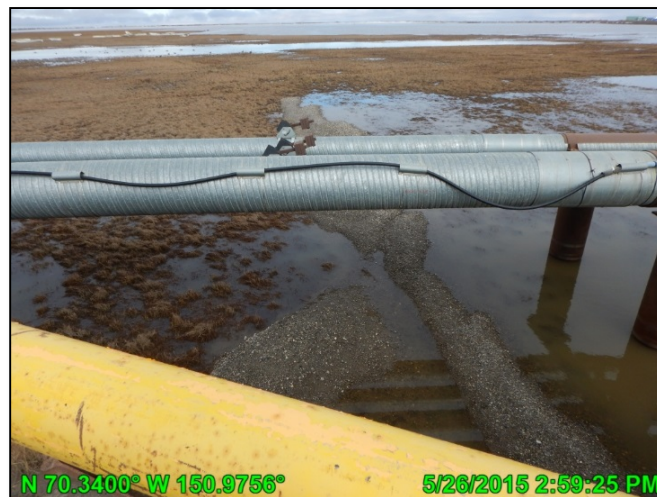
Photo C.10: Gravel outwash deposited on the north side of the Long Swale Bridge, looking north; May 26, 2015

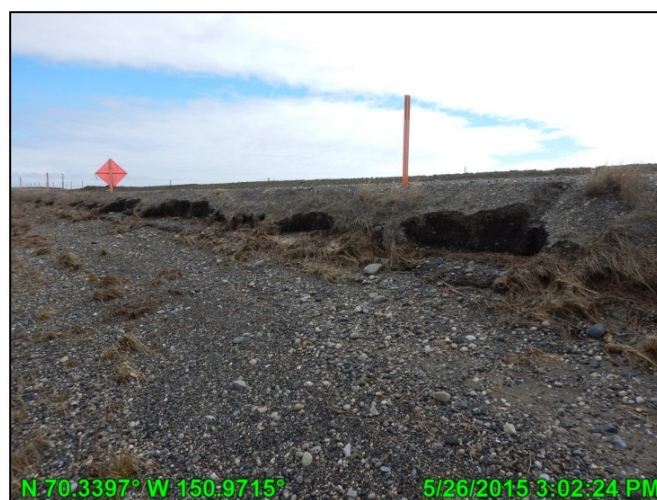
Photo C.11: Scour and deposition along the north side road embankment east of the Long Swale Bridge, looking south east; May 26, 2015

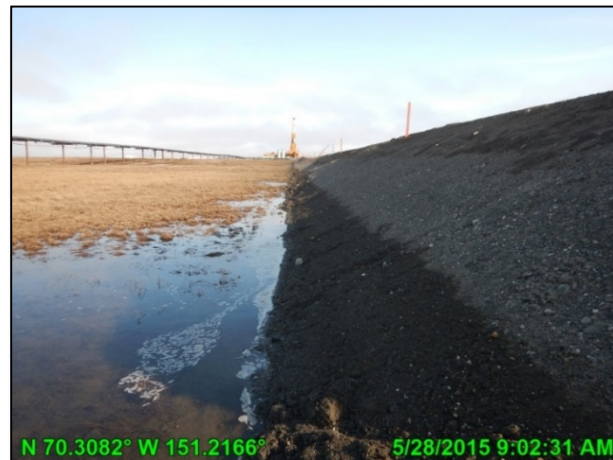
Photo C.18: CD5 road near the CD5 pad showing water saturated embankment on the west side of the road, looking north toward CD5 pad; May 28, 2015

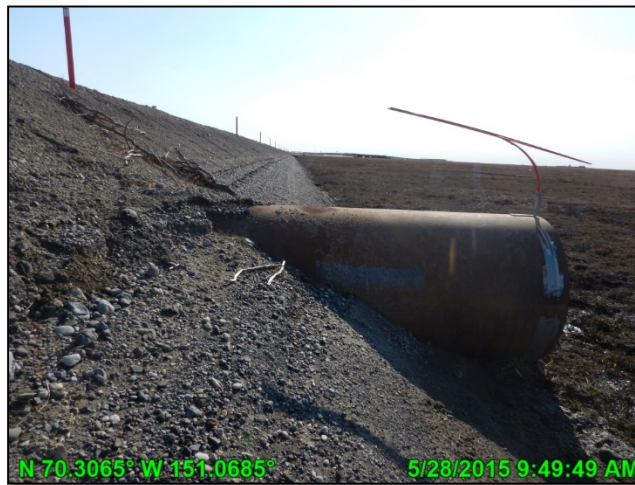
Photo C.24: Wash line on the south side of the CD5 road between the Nigliagvik and L9341 bridges, looking east at culvert CD5-35; May 28, 2015

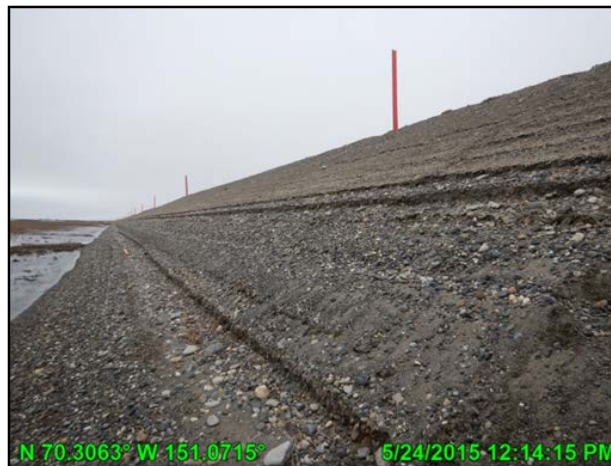
Photo C.25: Wash lines on the south side of the CD5 road between the Nigliagvik and L9341 bridges, looking west; May 24, 2015

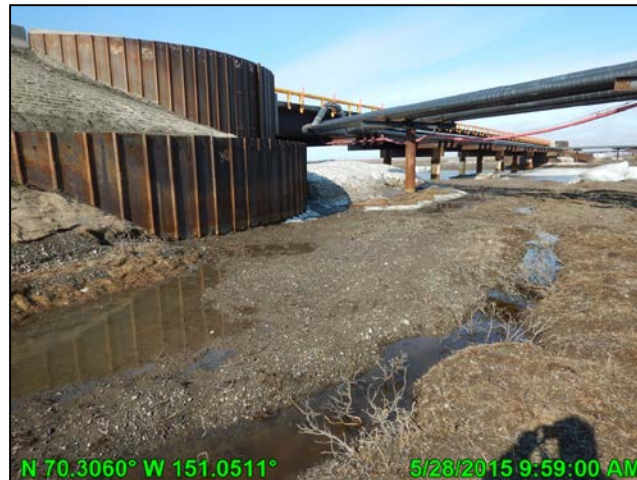
Photo C.26: Wash line and deposition at the north side of the L9341 Bridge east abutment, looking west; May 28, 2015

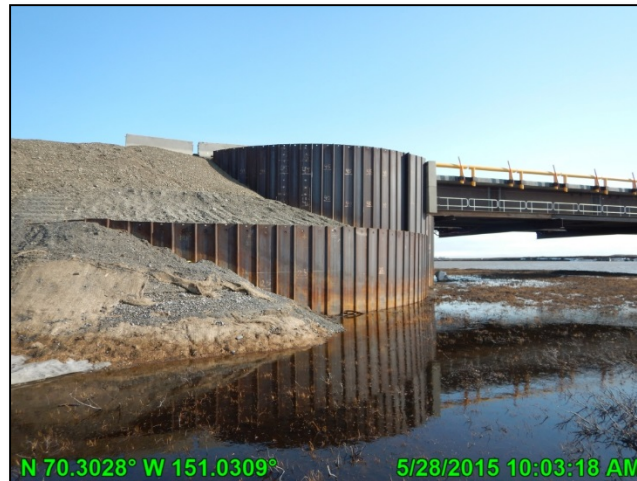
Photo C.27: Nigliq Bridge west abutment wash line and erosion control material, looking north east; May 25, 2015

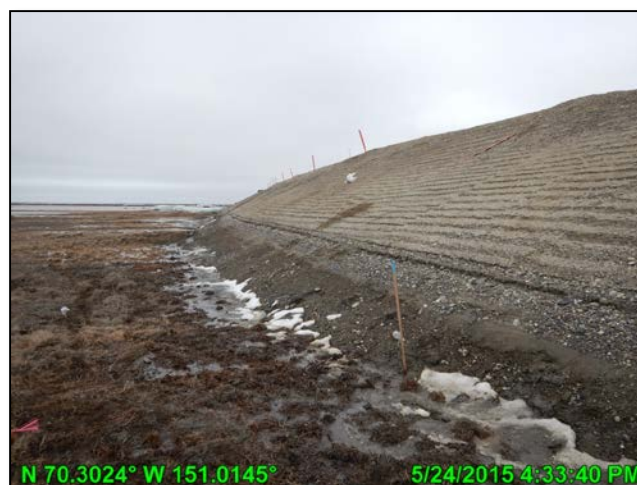
Photo C.28: Wash lines east of the Nigliq Bridge, looking west at south side of road; May 24, 2015

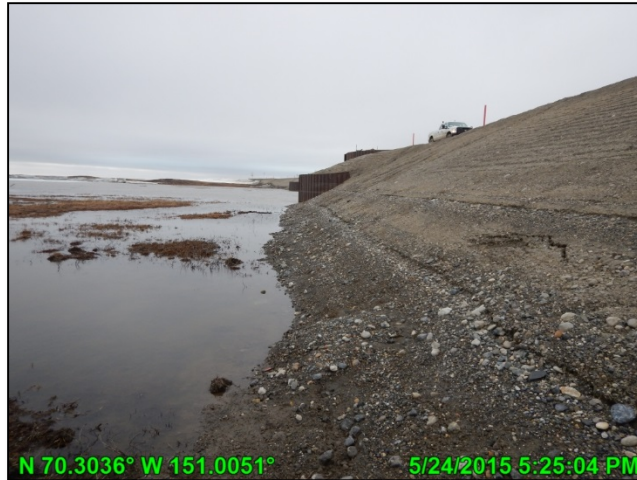
Photo C.29: Wash lines along the CD5 road east of the L9323 Bridge, looking west at south side of the road; May 24, 2015

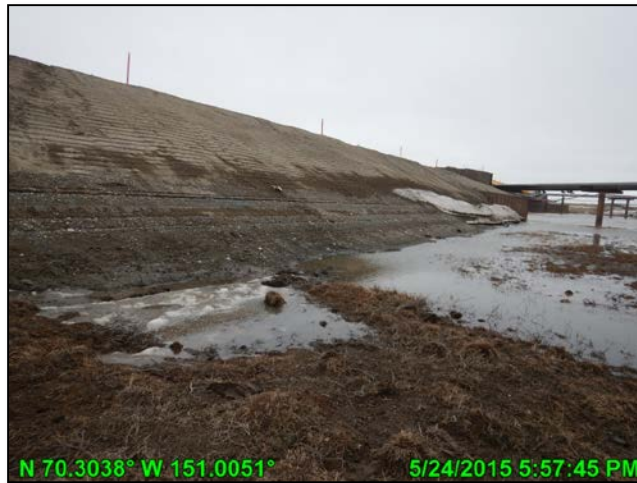
Photo C.30: Wash lines along the CD5 road east of the L9323 Bridge, looking west at north side of road; May 24, 2015

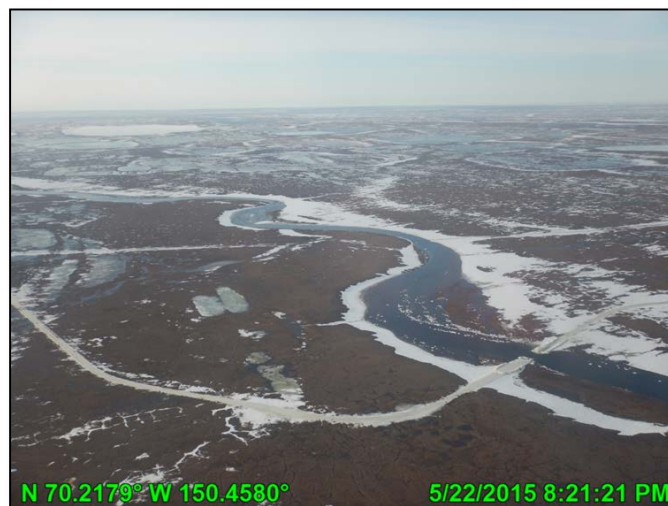
Photo C.35: Kachemach River ice road crossing during breakup, looking north; May 22, 2015

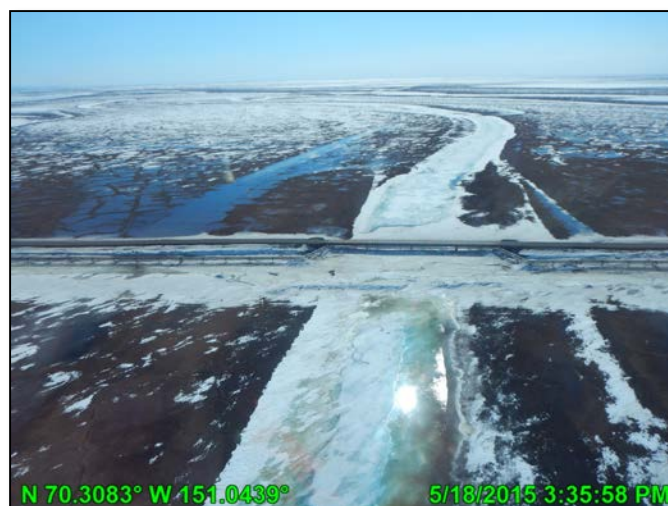
Photo C.36: Lake L9341 ice road crossing at CD5 road prior to breakup, looking south; May 18, 2015

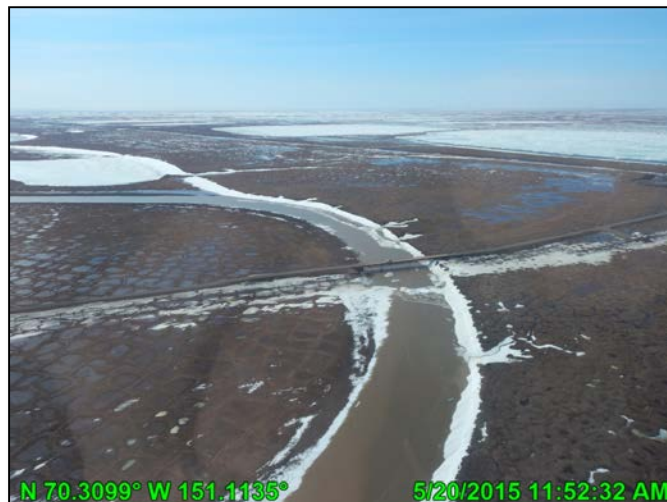
Photo C.41: Nigliagvik ice road crossing at CD5 road during breakup, looking south; May 20, 2015

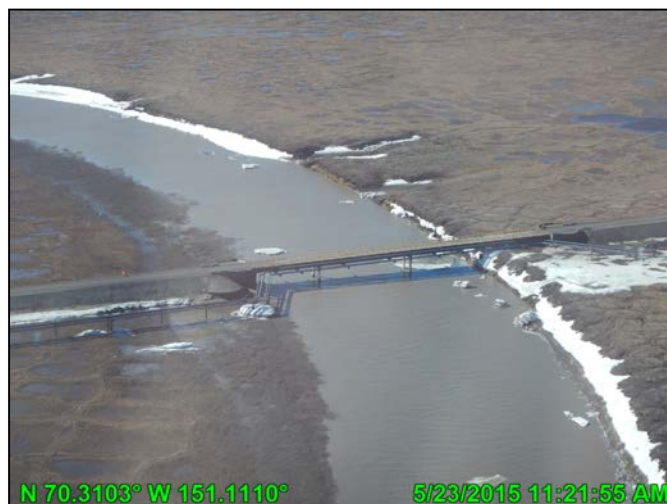
Photo C.42: Nigliagvik ice road crossing at CD5 road following breakup, looking south; May 23, 2015

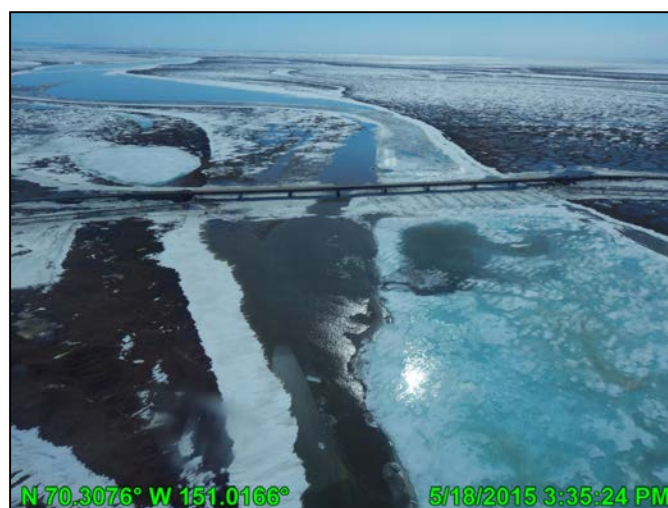
Photo C.45: Nigliq Channel ice road crossing at CD5 road during initial breakup, looking south; May 18, 2015

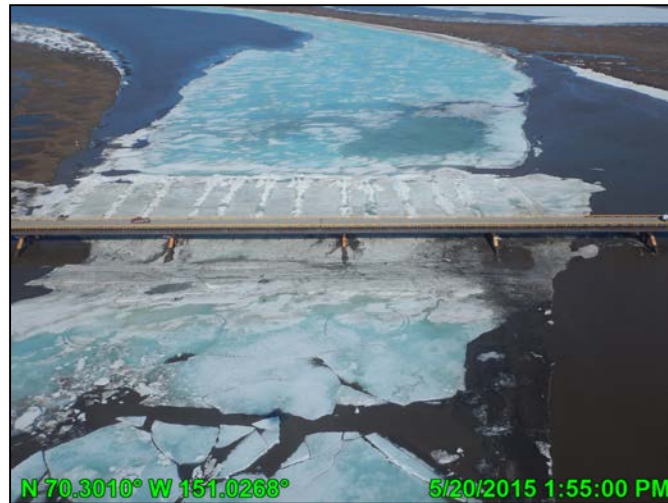
Photo C.46: Nigliq Channel ice road crossing at CD5 road during breakup, looking north; May 20, 2015

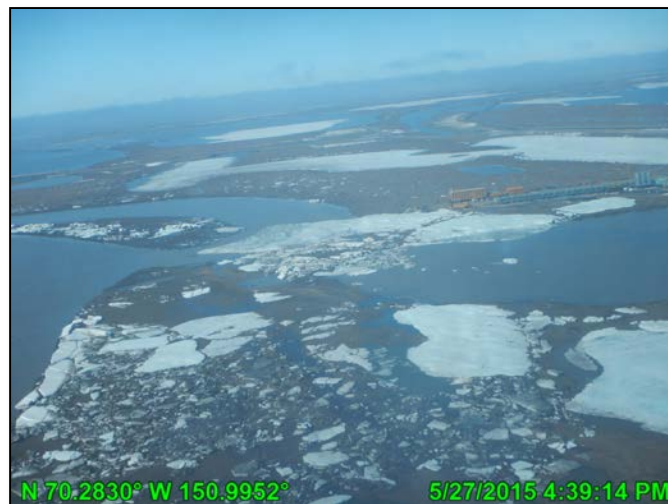
Photo C.56: Silas Slough ice road crossing following breakup, looking north; May 27, 2015

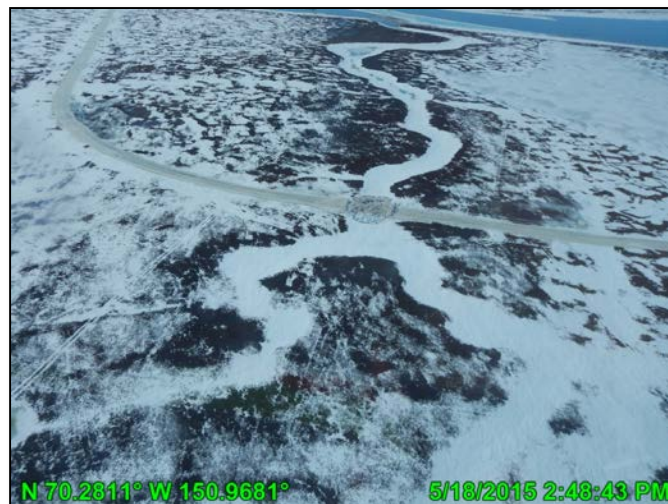
Photo C.62: Toolbox Creek ice road crossing prior to breakup, looking west; May 18, 2015

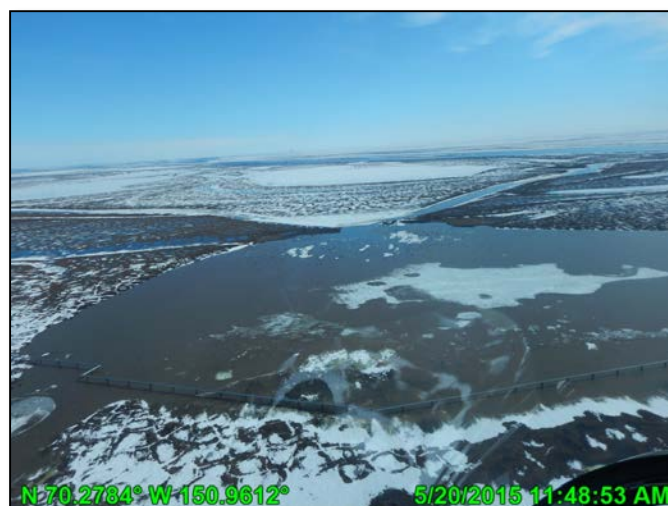
Photo C.63: Toolbox Creek ice road crossing during breakup, looking northwest; May 20, 2015

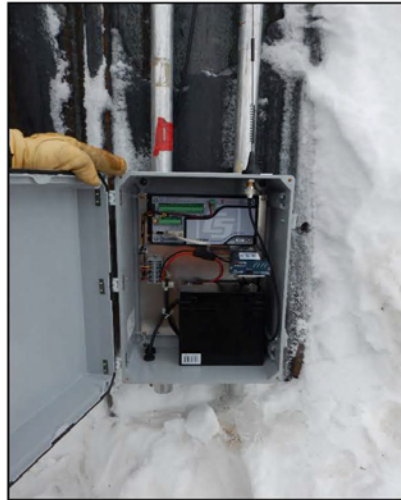
Photo 1: Electronics including the datalogger, cellular modem, and battery; May 2015

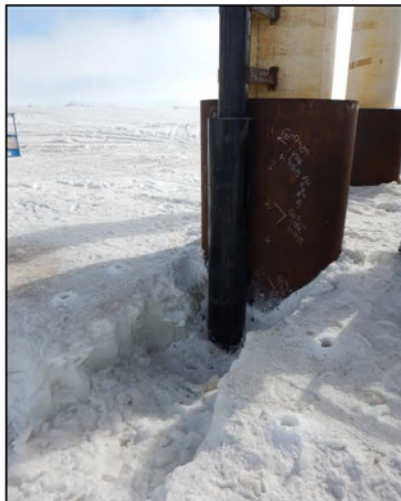
Photo 2: Bottom of the protective steel casing after ice removal; May 2015

Steel pipe casing was installed by ConocoPhillips (CPAI) on pier 3 of the Nigliagvik Bridge to protect the sonar transducer and cable from ice impacts. The casing extends from the pile cap down to an elevation of approximately 1 foot BPMSL (Photo 2). Following the casing installation, the sonar system electronics and hardware were shipped to Alpine, Alaska.

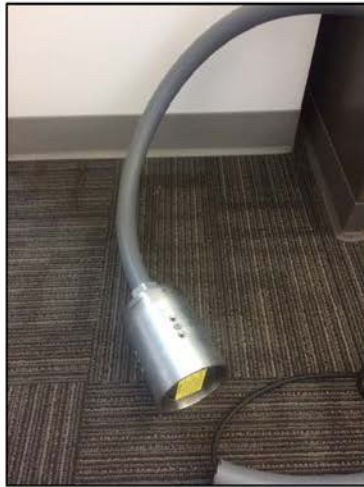
Photo 3: Nigliagvik Bridge steel housing; May 2015

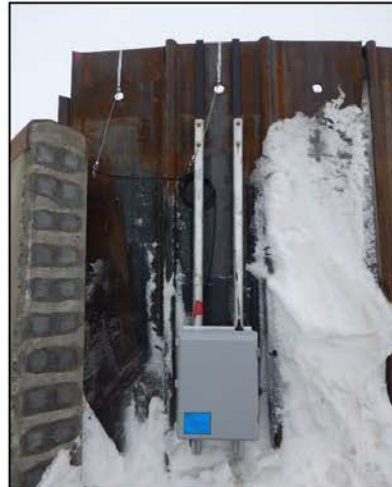
Photo 4: Nigliagvik Bridge fiberglass electronics enclosure hanging from the west abutment sheet pile; May 2015

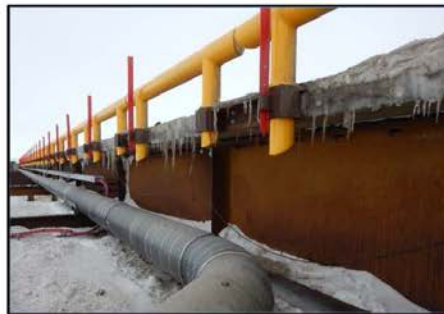
Photo 5: Nigliagvik Bridge sonar transducer cable routed through hangers from pier 3 to the west abutment; May 2015

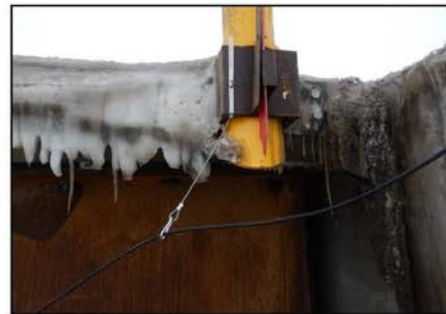
Photo 6: Nigliagvik Bridge sonar transducer cable hanger detail; May 2015
