Project Note:

2007 Lake L9323 Monitoring and Analysis

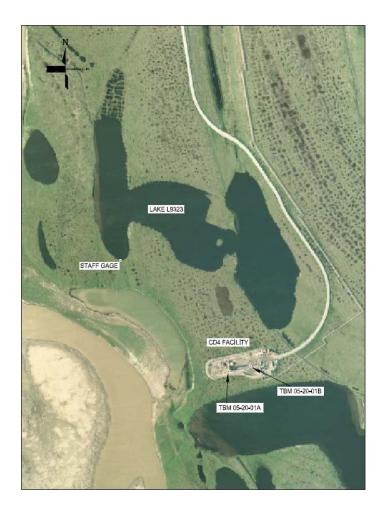
Figure 1: Lake L9323 with stream staff gage and temporary bench marks (TBMs) used to identify water surface elevations. Aerial image provided by Aeromap US Inc., from photography flown in 2006.

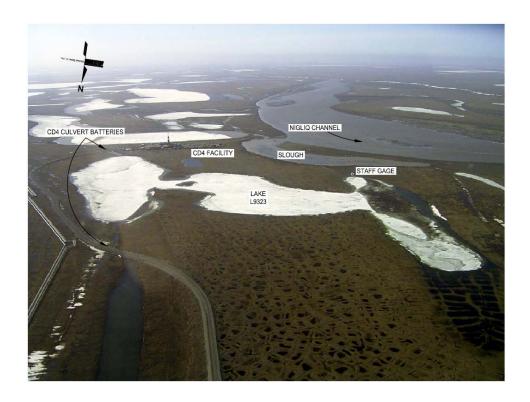
During open water conditions, water surface elevations were monitored using a graduated stream staff gage tied to local TBMs. The staff gage was located at the outlet of a shallow swale connecting a slough of the Nigliq channel to Lake L9323 (Figures 2 & 3). Support

Figure 2: Southward facing image of Lake L9323 and CD4 facility taken June 9, 2007.
