COLVILLE RIVER DELTA NORTH SLOPE, ALASKA

October, 1998

**1998 SPRING BREAKUP AND HYDROLOGIC ASSESSMENT
COLVILLE RIVER DELTA
NORTH SLOPE, ALASKA**

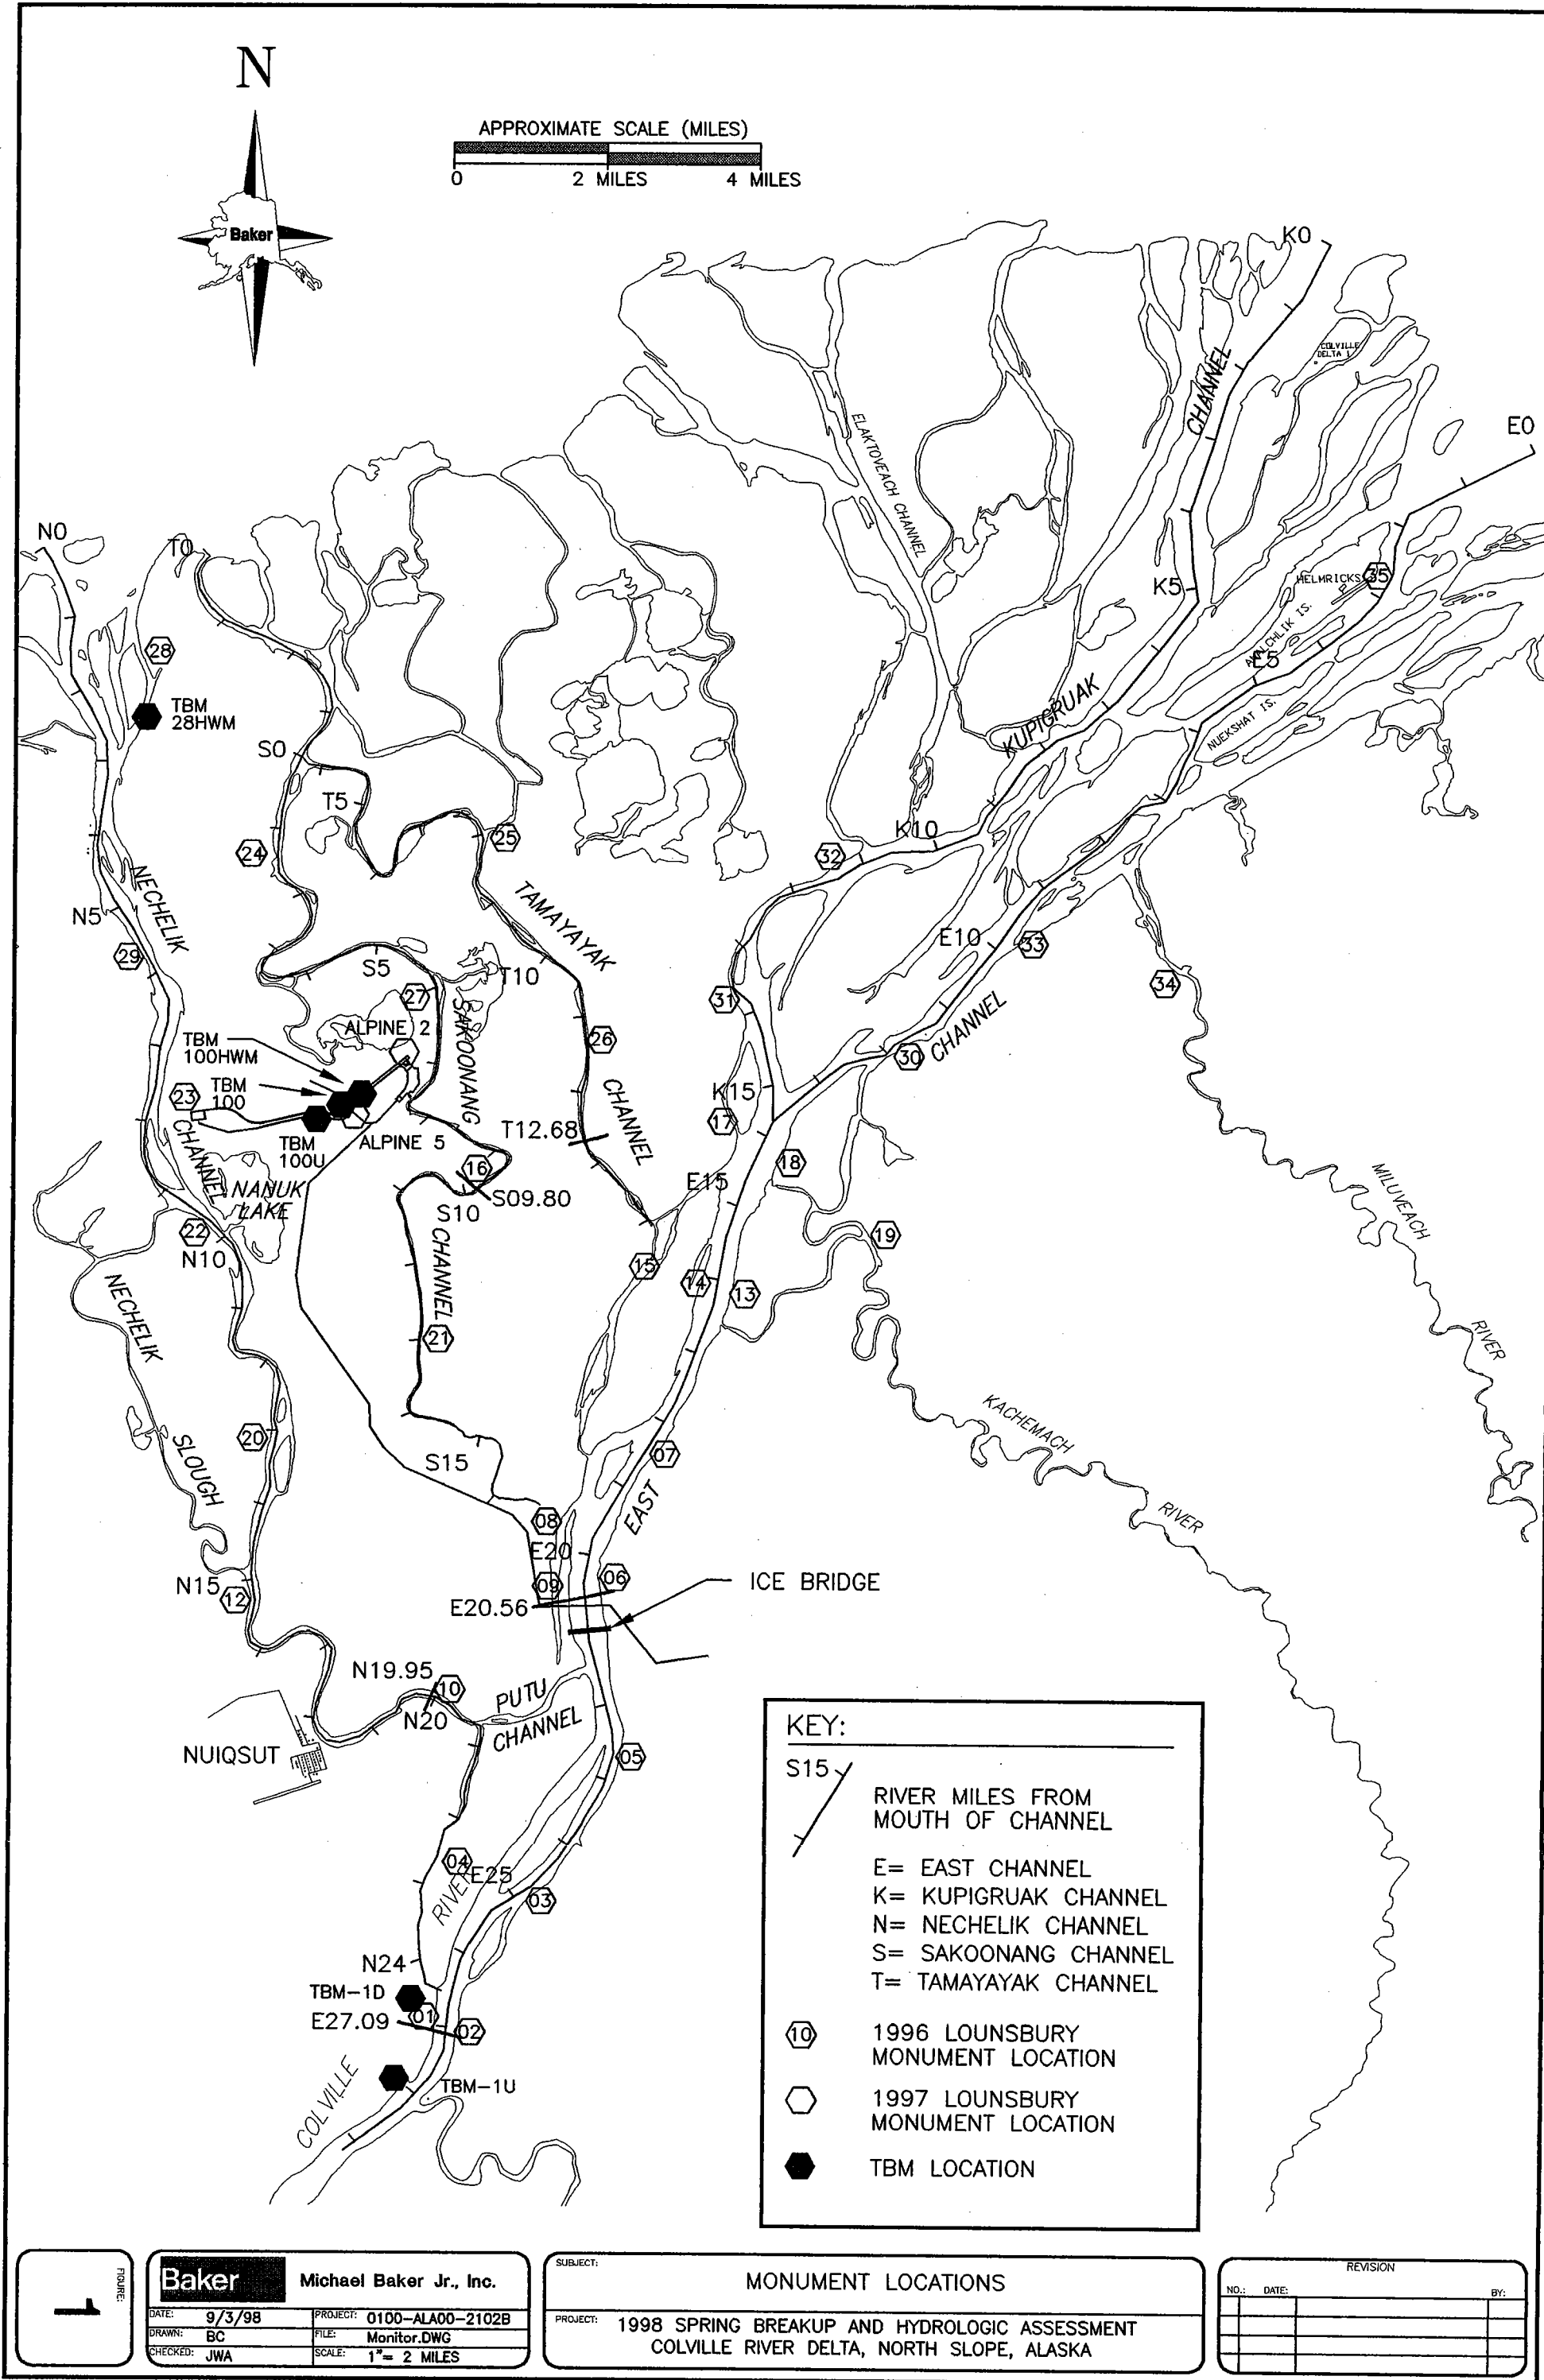
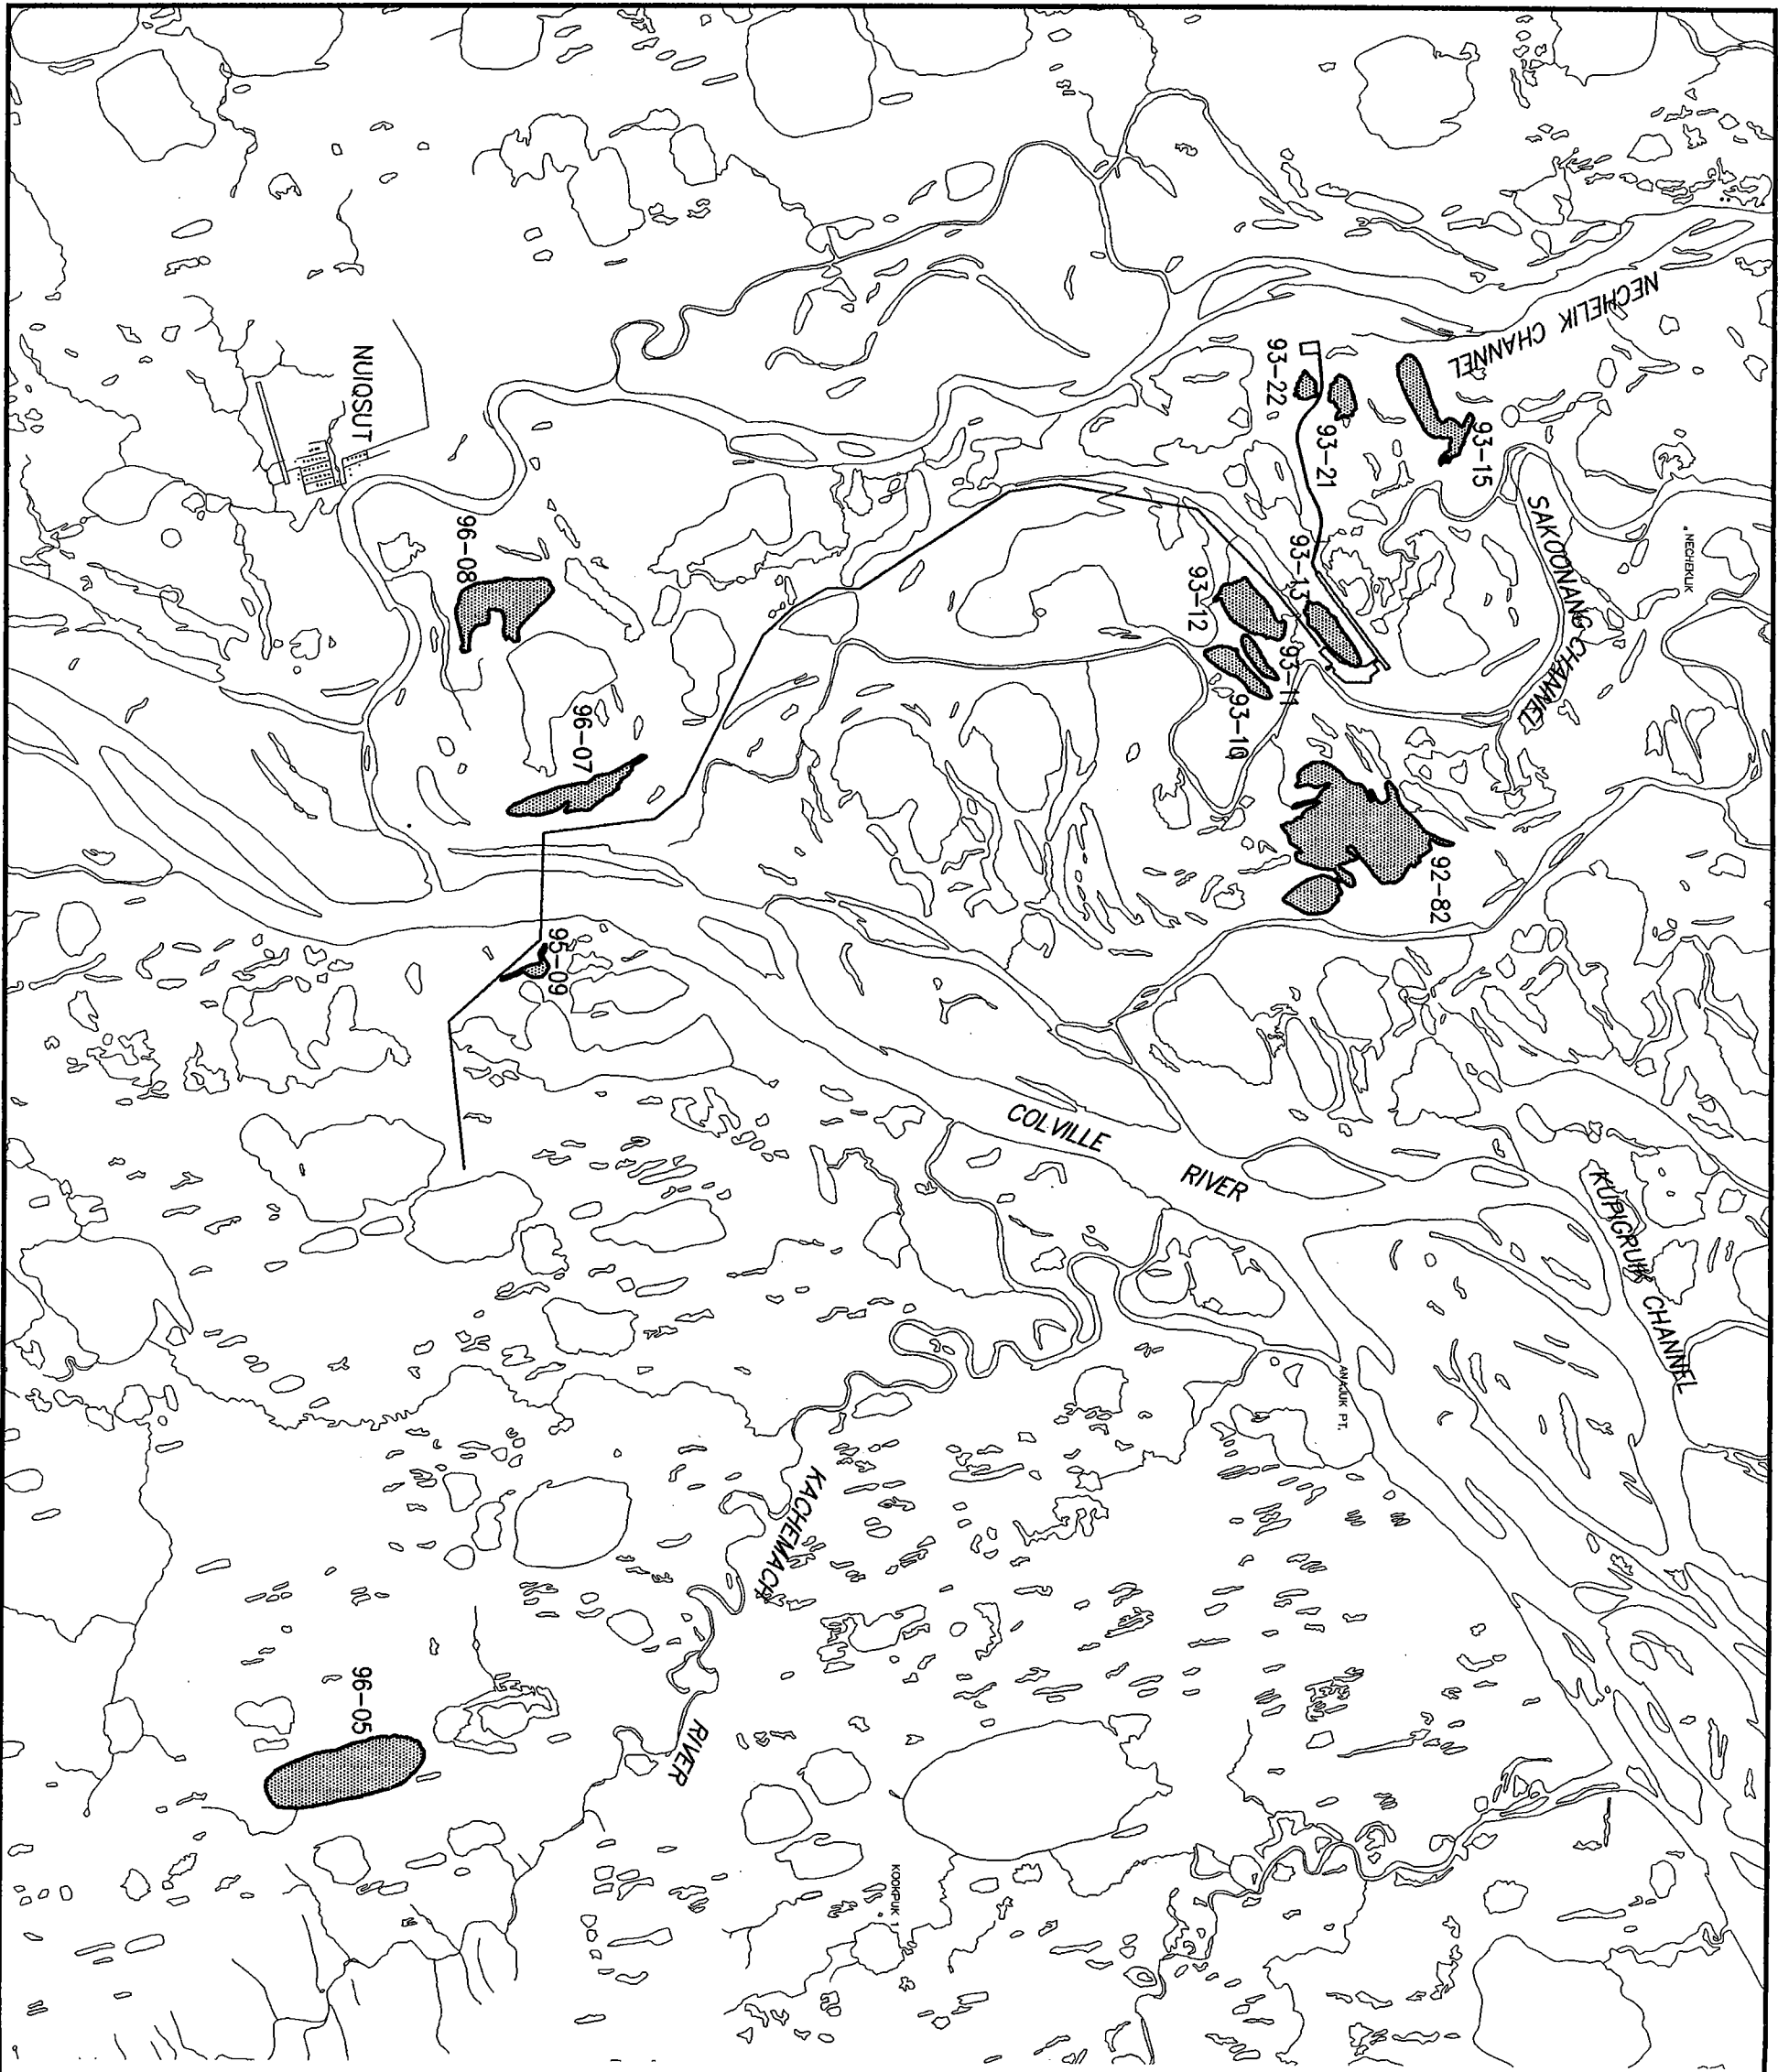
FIGURE:
2

Figure 2: Lake Locations

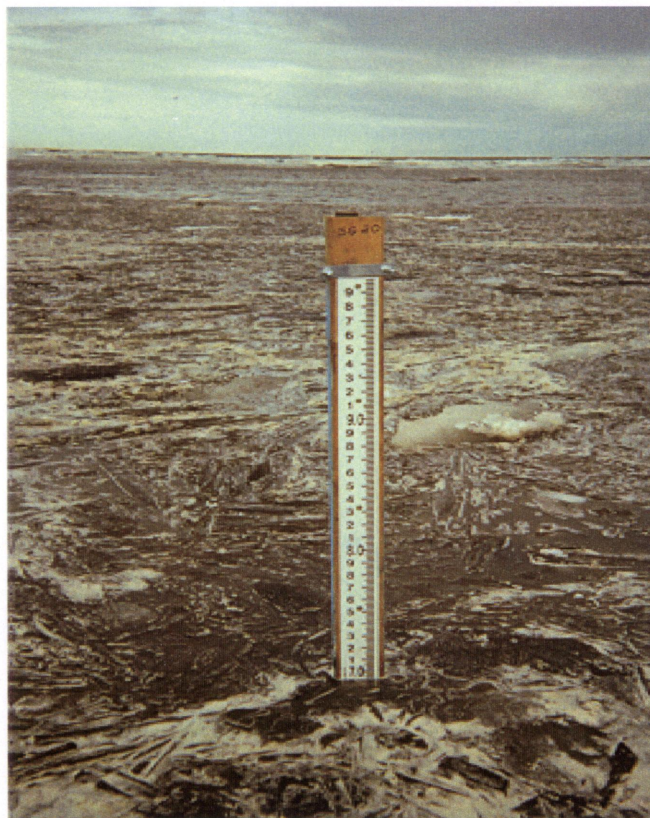
The low-flow-channel ice in the Sakoonang Channel was floating in place on 27 May and remained floating in place throughout the breakup event (Photo 2, Appendix C). There was little change in the Sakoonang over the course of the day. Water surface elevations rose 0.18-feet between 11:49 AM and 5:49 PM at Monument 16 and rose 0.07-feet between 5:25 PM and 8:45 PM at Monument 27.

Photo 2: Looking downstream from the staff gage at Monument 24 on the Sakoonang Channel. Low-flow-channel ice floating in place. (5/27/98 12:45)

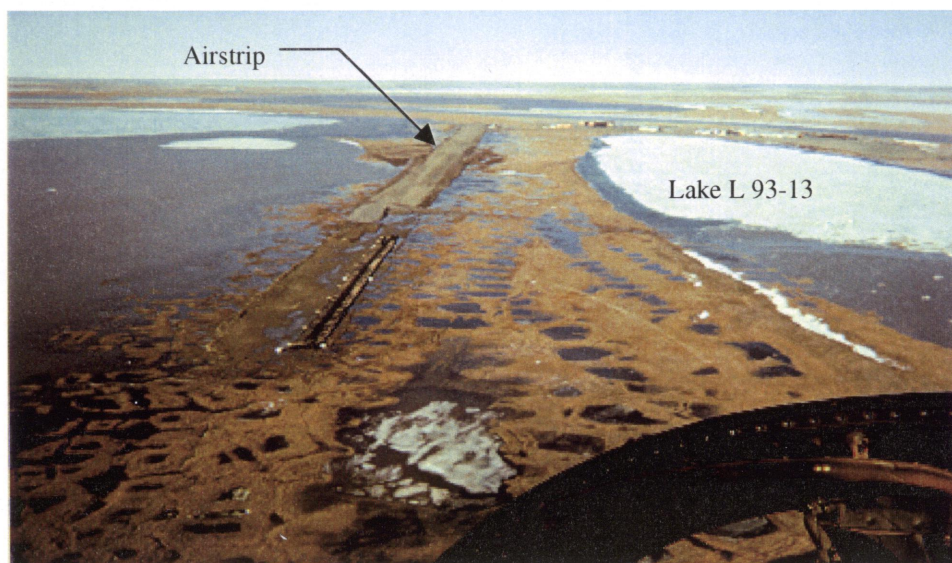
Photo 10: Looking east toward the proposed facility (5/29/98 approx. 20:00)
