Colville River Delta 2- and 10-Year Flood Models

April 17, 2001
24307-MBJ-RPT-001

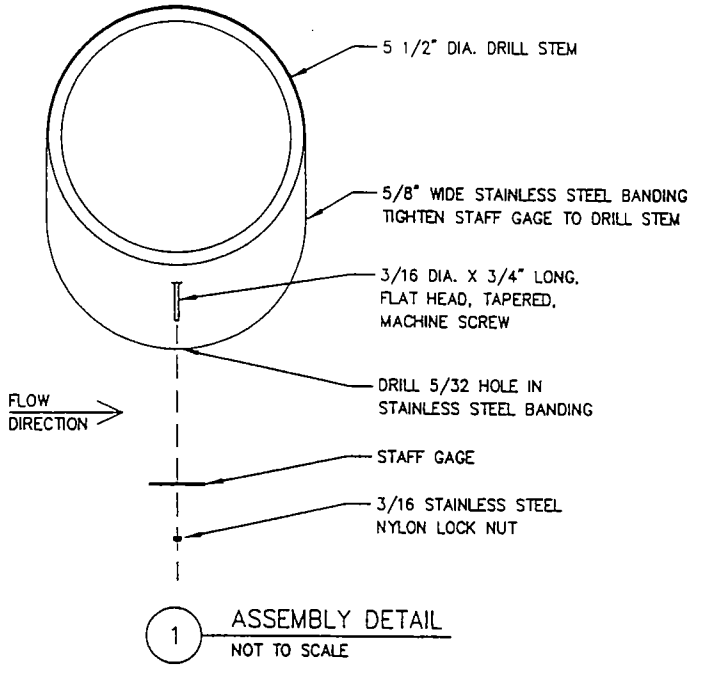
1 ASSEMBLY DETAIL
NOT TO SCALE

MATERIALS PER 3 1/2 FT SECTION	
DISCRPTION	QNTY
3'-6" GAGE PLATE	1
5/8" WDE BANDING	5
3/16" FLATHEAD SCREW	5
3/16 NYLON LOCK NUT	5

At the two bridges located on the road between Drill Sites 1 and 2, the staff gages should be attached to the existing bridge pile as shown in Drawing 2, Assembly Detail 1. However, the stainless steel banding will need to be sized to accommodate the diameter of the bridge piles.
