# 2019 Willow Spring Breakup & Summer Monitoring & Hydrological Assessment

Prepared for:

**ConocoPhillips**  
Alaska

MSA Contract No. 296937

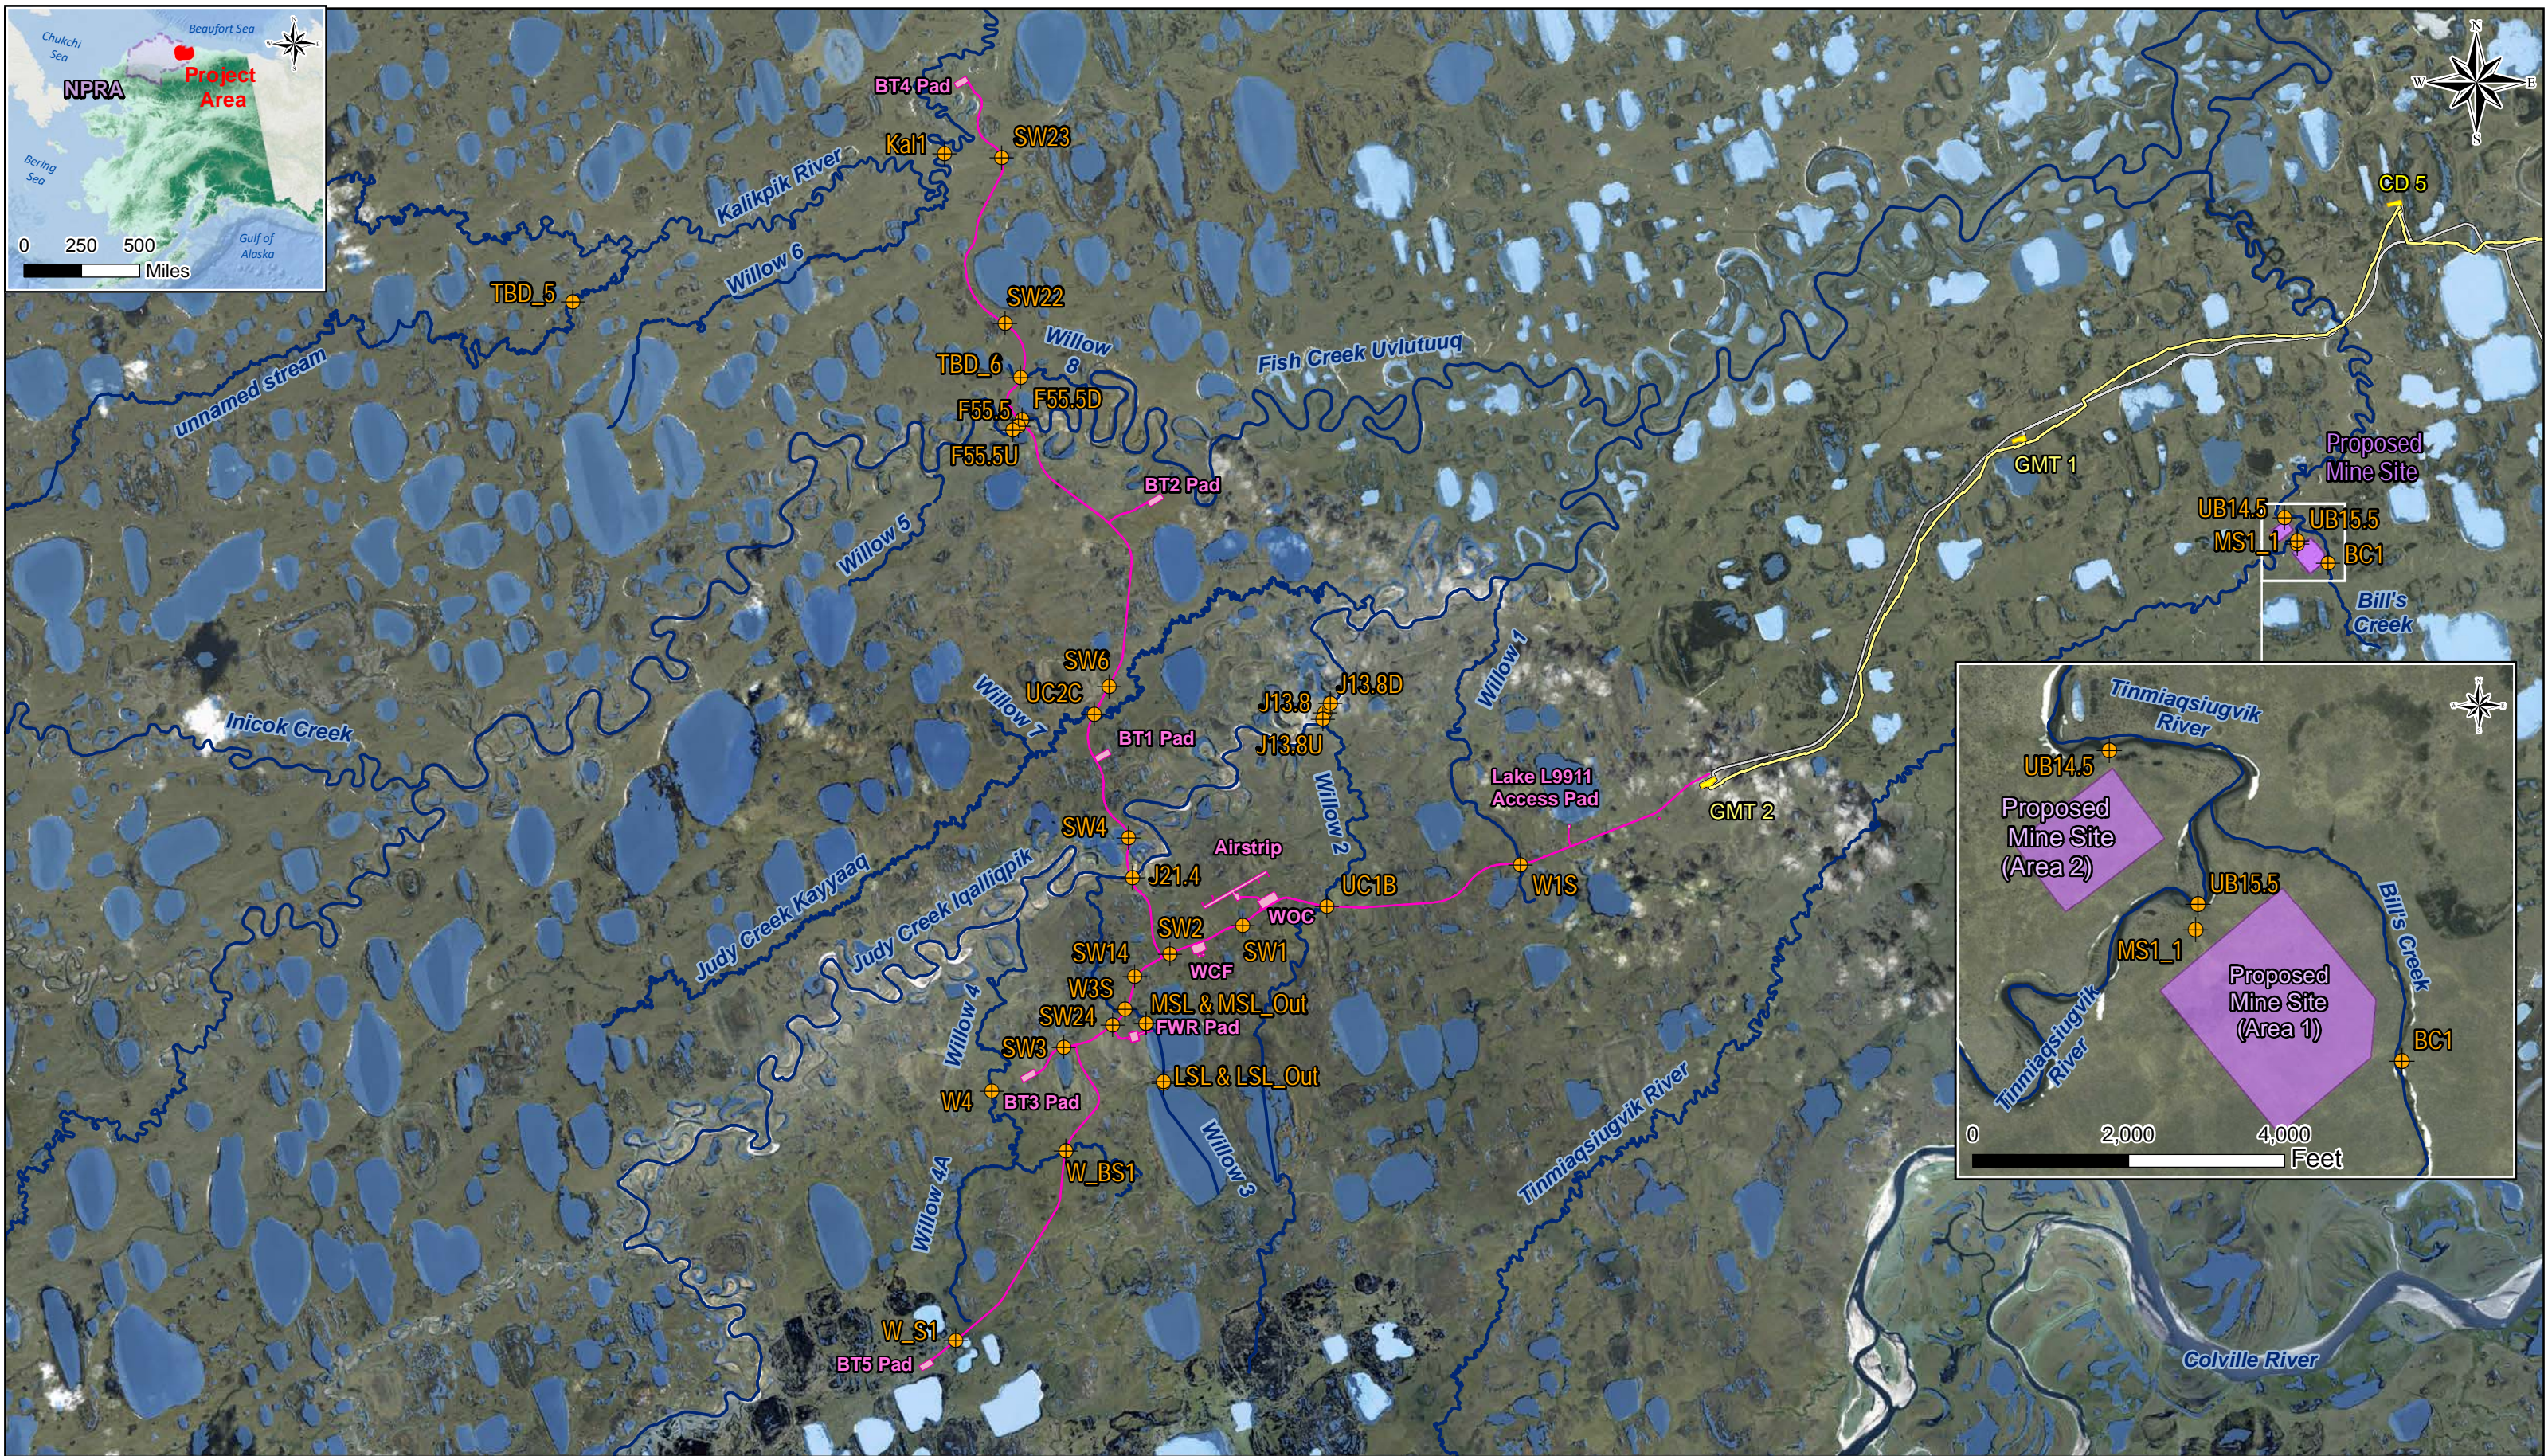
**2019 Willow Gage Stations**  
**Proposed Roads & Facilities**  
FIGURE: 1.2

Gage Location	<b>Willow Alternative B</b>	Pipeline
Stream / River	Proposed Road	Road
Lake	Proposed Facility	Facility

Figure 1.2 presents the Willow monitoring locations and gage stations. Figure 1.3 and Figure 1.4 show a north and south detail of the locations and gage stations, respectively. Table 1.1 details the monitoring locations, gage stations, and tasks per location. Stage and discharge data were used to either begin or continue the historical hydrologic record at the Willow gage stations presented below.

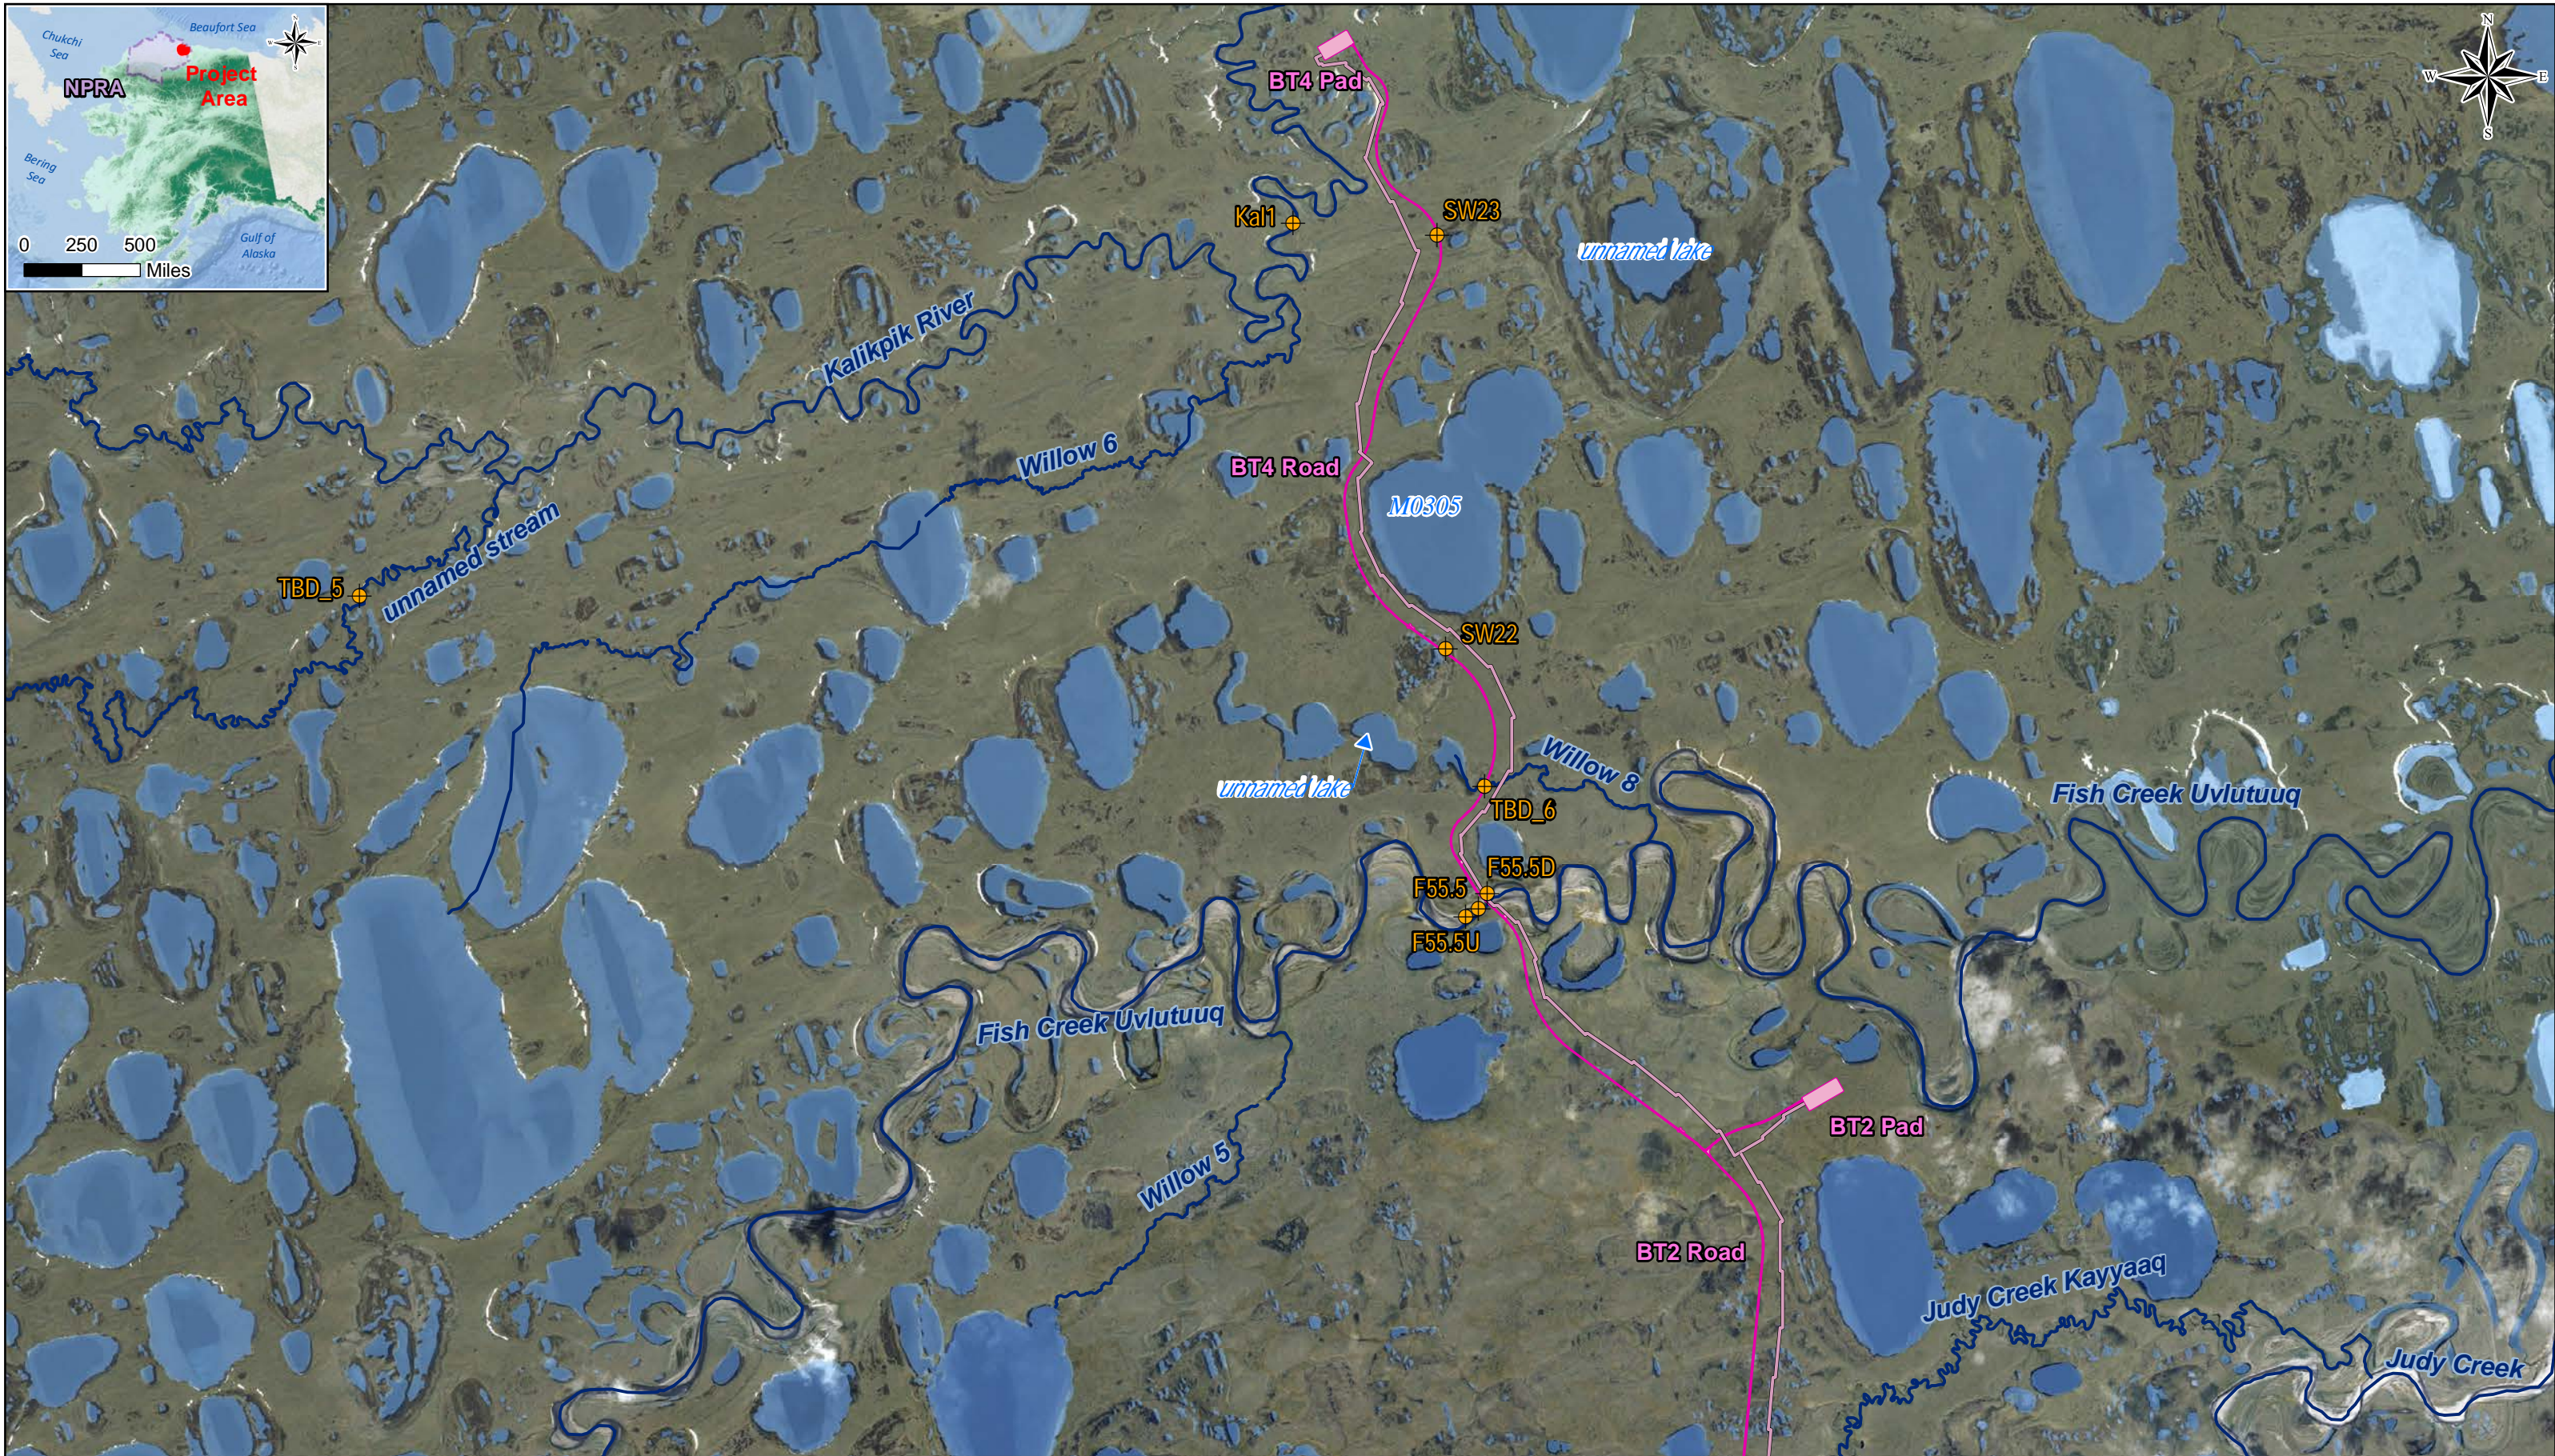
FIGURE: 1.3

Gage Location	<b>Willow Alternative B</b>	Proposed Facility
Stream / River	Proposed Road	
Lake	Proposed Pipeline

**Proposed Roads & Facilities**

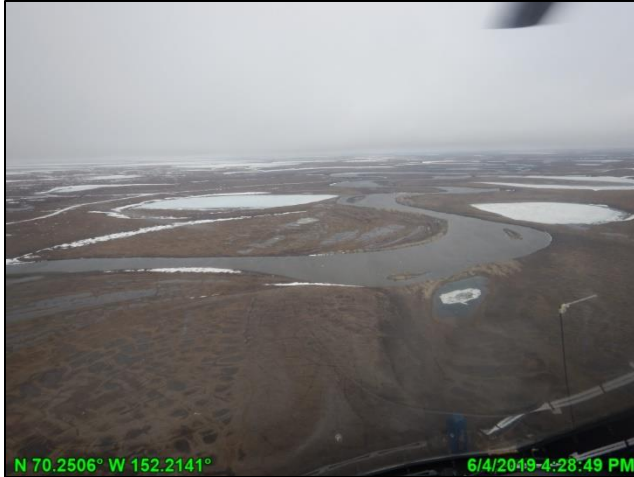
**Photo 3.1 Fish creek near F55.5, looking northeast (downstream); June 4, 2019**

Initial meltwater was first recorded in the Willow area on May 20 at Judy Creek Kayyaaq. Stage increased throughout Willow from May 20 to May 27. Peak stage conditions generally occurred in the major Willow streams near May 27. During peak stage, snow and ice in the drainages confined meltwater and elevated stage. By June 4, most major drainages were free of ice and snow and stage was decreasing (Photo 3.1). Effects from ice jamming was minimal across the Willow area.

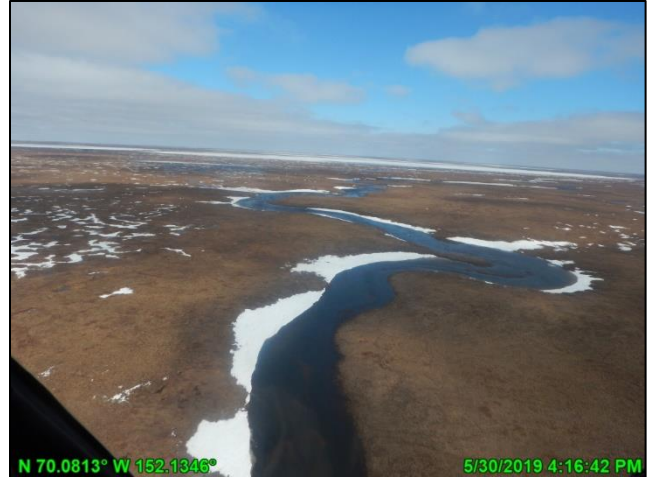
**Photo 3.2: Willow 4 near W\_BS1, looking east (upstream); May 30, 2019**

Peak stage was observed at small streams between May 25 and May 29 and was the result of elevated water levels associated with flow through snow-packed channels. By May 30, stage was receding at most Willow small stream monitoring locations. Snow was approximated at 10 percent coverage over surrounding tundra, but snow was still present in channels and along river banks (Photo 3.2). All swales, except SW2, peaked May 25 while SW2 peaked on May 27, and most were hydraulically connected by May 27.

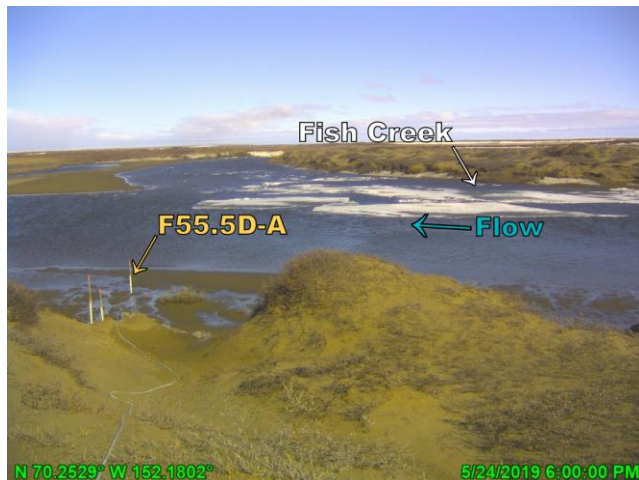
**Photo 4.1: RTFM photo of meltwater first reaching F55.5D-A gage, looking east; May 24, 2019**

On May 24, initial meltwater was first recorded at F55.5, and stage began to steadily rise (Photo 4.1). On-site visual observations of F55.5 on May 27 showed elevated stage below bankfull, with periodic ice floes in the channel (Photo 4.2). Minimal channel ice was observed in the F55.5 reach at this time, though it is likely some was still grounded. PT data reveals the May 27 observations occurred during a sharp, steady rise in the stage hydrograph. Stage crested in the morning on May 28 and dropped before a sharp spike in stage was recorded in the evening, likely resulting from an upstream ice jam and associated backwater release. Peak stage occurred in the evening on May 28 and stage remained elevated through the next week (Photo 4.3).

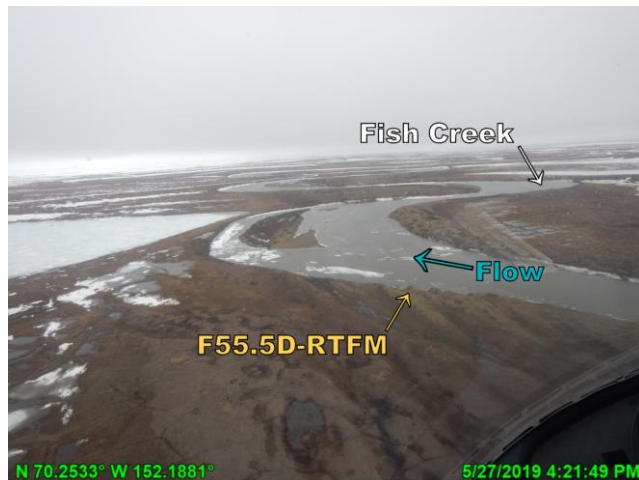
**Photo 4.2: F55.5 before peak stage, looking east (downstream); May 27, 2019**

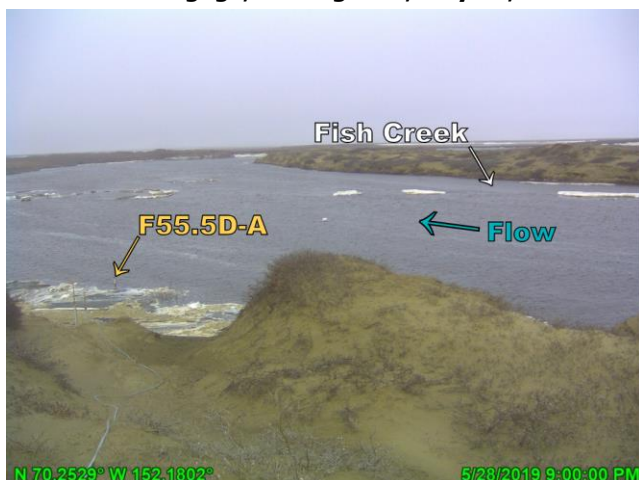
**Photo 4.3: RTFM photo of peak stage conditions at F55.5D, looking east; May 28, 2019**

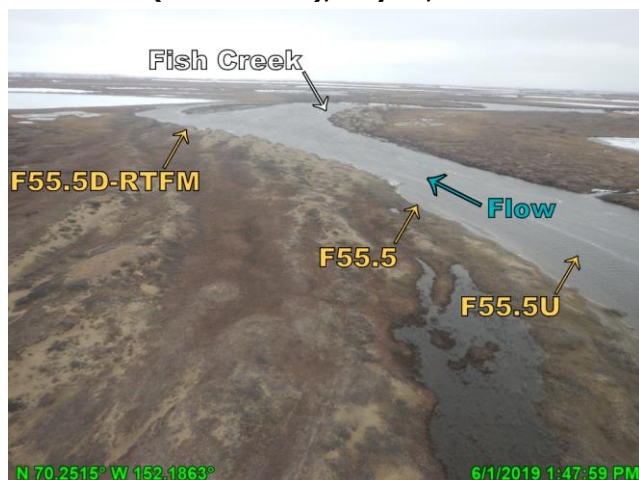
**Photo 4.4: F55.5 reach after peak stage, looking northeast (downstream); June 1, 2019**

On May 31 visual observations revealed minimal snow along the banks and stage below bankfull height. No overbank flooding was observed, and no evidence was found to suggest overbank flooding occurred at or near peak stage on May 28. Stranded ice was observed partially submerged in the outer reaches of the channel, particularly around the downstream gage, suggesting stage had peaked and was receding. Minimal change to these conditions were noted during observations on June 1 (Photo 4.4).

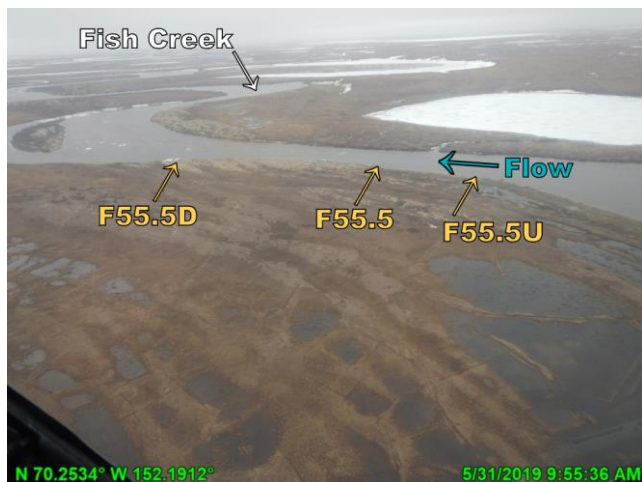
**Photo 4.5: F55.5 reach on the day of the discharge measurement, looking northeast (downstream); May 31, 2019**

Discharge was measured using a tethered ADCP at F55.5 on May 31, approximately 3 days after peak stage conditions occurred (Photo 4.5). During the measurement, ice floes were observed moving down the reach, but minimal snow remained in the channel and along the banks (Photo 4.6). The measurement was influenced by a moving bed, which was analyzed and applied as a correction to the discharge data. The overall quality of the discharge measurement was classified as fair, based on the uncertainty associated with a highly mobile channel bed, and the ice in the channel.

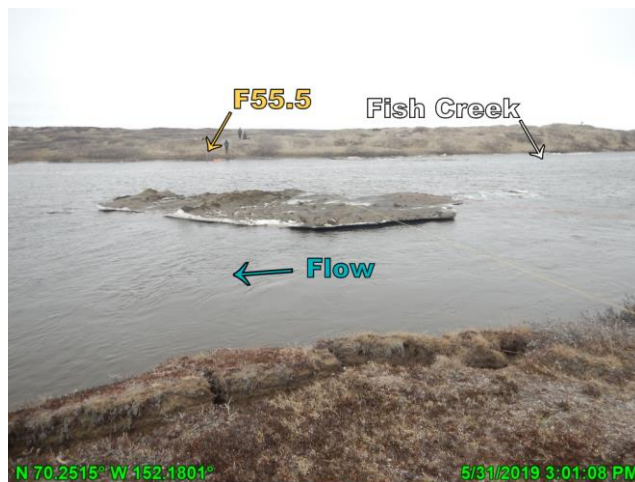
**Photo 4.6: Ice pan passing through discharge measurement cross section, looking northwest (upstream); May 31, 2019**

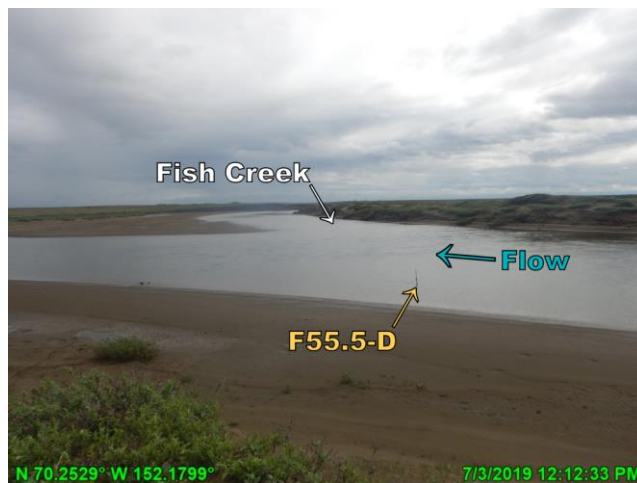
Photo 4.7: Low-flow summer conditions at F55.5D, looking southeast (downstream); July 3, 2019

Summer stage was measured at F55.5C, just upstream of the proposed crossing location. Stage fluctuations associated with precipitation were recorded throughout the summer; water levels remained below peak spring stage (Photo 4.7). During a late summer precipitation event, stage crested at levels observed near the end of spring breakup. Summer stage at Fish Creek at F55.5 is presented in Graph 4.2.

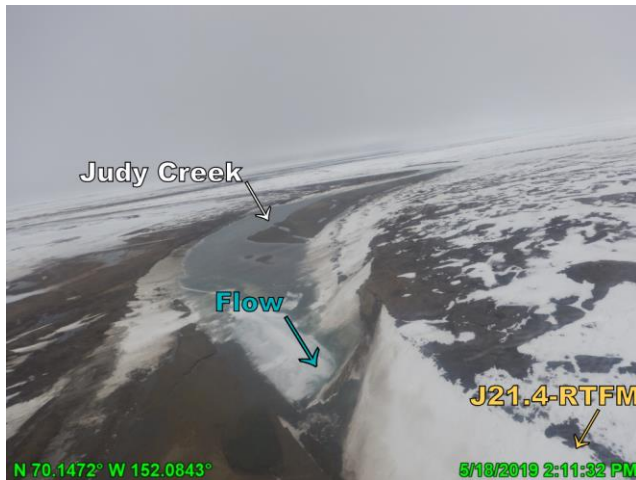
**Photo 4.8: The leading edge of meltwater downstream of J21.4, looking northwest (upstream); May 18, 2019**

On May 18, aerial observations revealed the leading edge of meltwater to be slightly downstream of J21.4 (Photo 4.8), although stage was not high enough to register on the J21.4 PT until May 23. At J13.8, meltwater was first recorded at the downstream PT on May 24. Visual observations on May 27 show the J13.8 reach generally clear of ice and snow, although saturated snow was observed near the banks of the channel, particularly around bends. Stage at all Judy Creek monitoring stations was below bankfull on May 27, except in an area where minor flooding was observed in low-lying land near the Willow 2 and Judy Creek confluence (Photo 4.9). Peak stage occurred at J21.4 on the morning of May 27 (Photo 4.10).

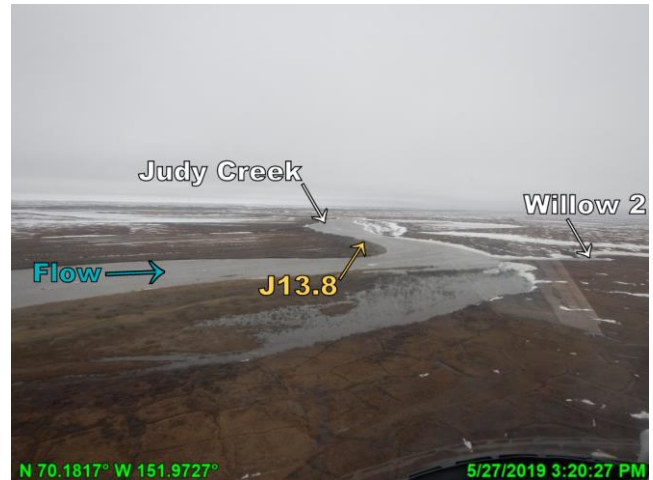
**Photo 4.9: Minor flooding near Willow 2 – Judy Creek confluence, looking north (downstream); May 27, 2019**

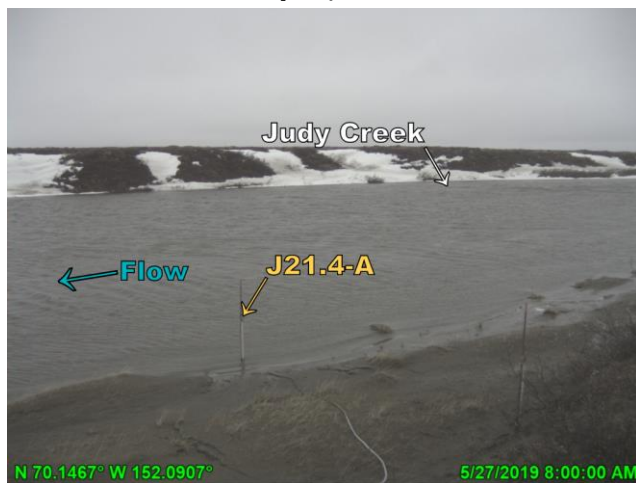
**Photo 4.10: RTFM photo of peak stage at J21.4, looking southwest (upstream); May 27, 2019**

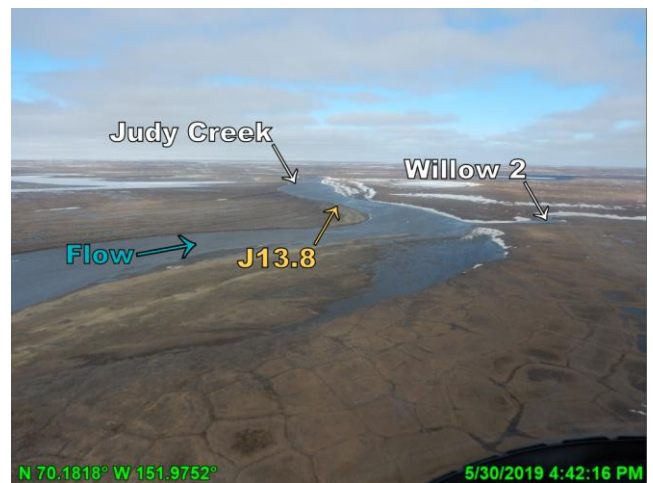
**Photo 4.11: Minor flooding near Willow 2 – Judy Creek confluence, looking north (downstream); May 30, 2019**

Following another stage spike to near peak conditions at J13.8 on May 29, visual observations on May 30 revealed stage had noticeably receded at all Judy creek monitoring locations. No evidence of overbank flooding from peak stage was observed. Minor flooding near the Willow 2 and Judy Creek confluence persisted (Photo 4.11). The channel was free of ice while saturated snow was observed along the banks. By June 1, stage had receded to near low-flow summer conditions at J13.8 and J21.4 monitoring locations.

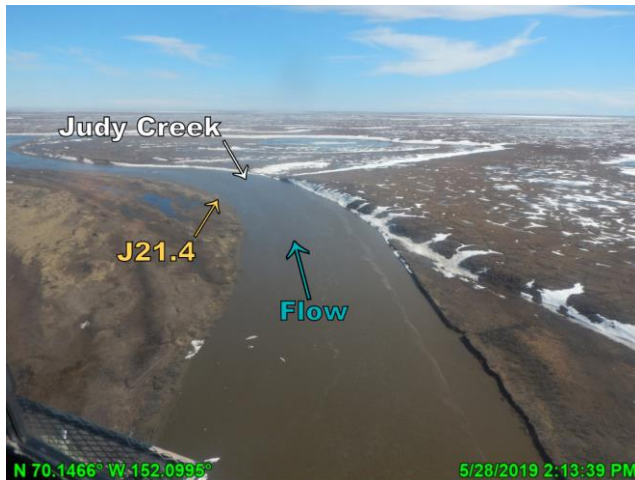
**Photo 4.12: J21.4 reach on the day of the first discharge measurement at J13.8, looking east (downstream); May 28, 2019**

Discharge was measured twice using a tethered ADCP at J13.8, once on May 28, and again on June 1. During the first measurement on May 28, minimal ice floes were observed in the channel and some saturated snow was present along the banks (Photo 4.12 and Photo 4.13). Similar conditions were observed during the second measurement on June 1 (Photo 4.14). No bottom-fast ice was observed during either discharge measurement. Both measurements were influenced by moving bed conditions, the effects of which were analyzed and applied as corrections to both measurements. A moving bed velocity averaging 0.37 foot per second (fps) was observed during the ADCP discharge measurements. The quality of the first measurement was classified as poor due to the equipment Bluetooth malfunction producing incomplete cross-sectional transect data. The quality of the second measurement was classified as fair due to the remaining snowpack along the banks and moving bed conditions.

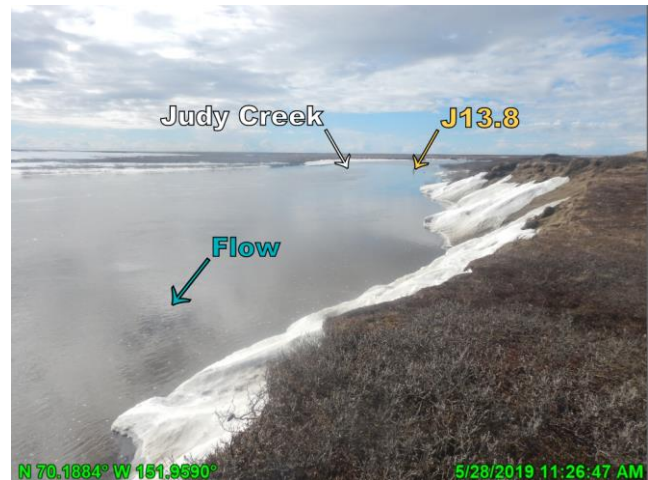
**Photo 4.13: J13.8 reach on the day of the first discharge measurement, looking south (upstream); May 28, 2018**

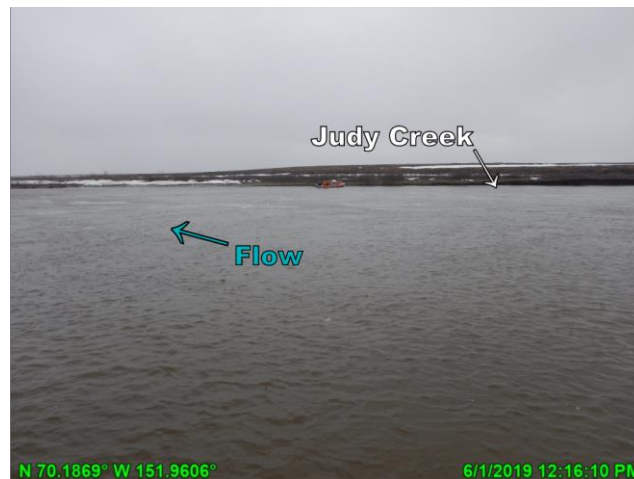
**Photo 4.14: Conditions at J13.8 during the second discharge measurement, looking east (downstream); June 1, 2019**

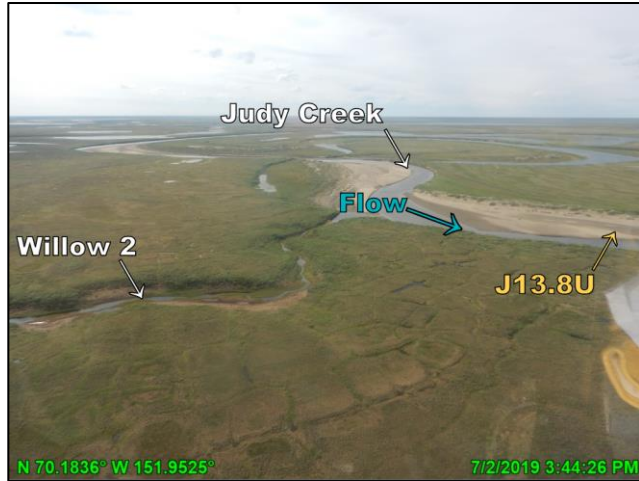
Photo 4.15: Summer conditions at J21.4, looking west (upstream); July 2, 2019

Summer stage was measured at J21.4 near the proposed crossing location. Stage fluctuations associated with precipitation were recorded throughout the summer; water levels remained below peak spring stage (Photo 4.15). During a late summer precipitation event, stage crested at levels observed near the end of spring breakup. Summer stage at Judy Creek J21.4 is presented in Graph 4.5.

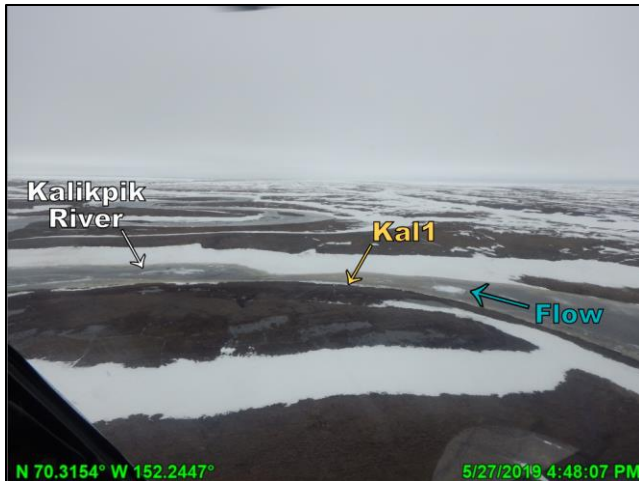
**Photo 4.16: Saturated snow in the Kal1 reach, the day after peak stage, looking east; May 27, 2019**

The leading edge of meltwater arrived at the Kal1 monitoring station on May 25, based on game camera images. Peak stage conditions quickly followed on May 26, likely elevated by large quantities of saturated snow and bottom-fast channel ice. A site visit performed on May 27 confirmed the influence of ice and snow on peak stage. On that day, the channel width was mostly filled with saturated snow, and meltwater appeared to flow overtop of bottom-fast ice (Photo 4.16). Stranded ice was observed in the channel near the gage station, indicating stage had crested and was now receding (Photo 4.17). Beyond the channel banks, no stranded ice or other evidence of overbank flooding was observed.

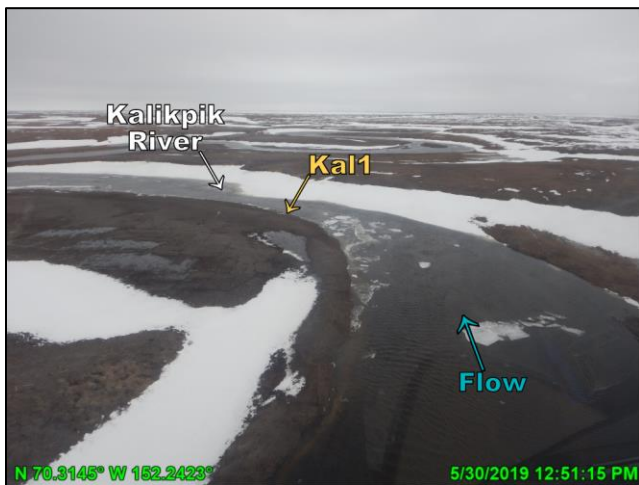
**Photo 4.18: Small ice jam upstream of Kal1 gage, looking north (downstream); May 30, 2019**

The PT data indicated that stage fluctuated, but generally receded, after May 27. Visual observations from May 30 revealed similar conditions to those observed on May 27. The extent of saturated snow and bottom-fast ice had diminished slightly, and a small ice jam had formed on a bend just upstream of Kal1 (Photo 4.18). By June 1, stage had receded to near low-flow summer conditions and significant snow remained in the channel and on the banks (Photo 4.19).

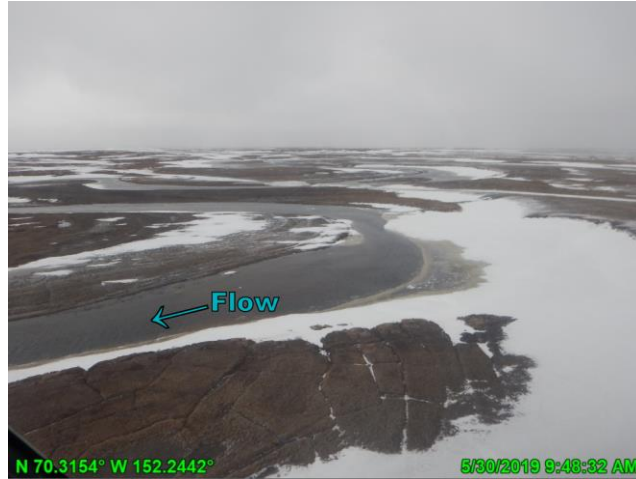
Photo 4.20: Kal1 on the day of the discharge measurement, looking south (upstream); May 30, 2019

Discharge was measured using a tethered ADCP at Kal1 on May 30. During the measurement, stage was below bankfull and a small ice jam had formed just upstream of the discharge cross section. In the channel, saturated snow remained along the south bank and bottom-fast ice was observed (Photo 4.20). These factors resulted in a discharge measurement with a quality classification of poor.

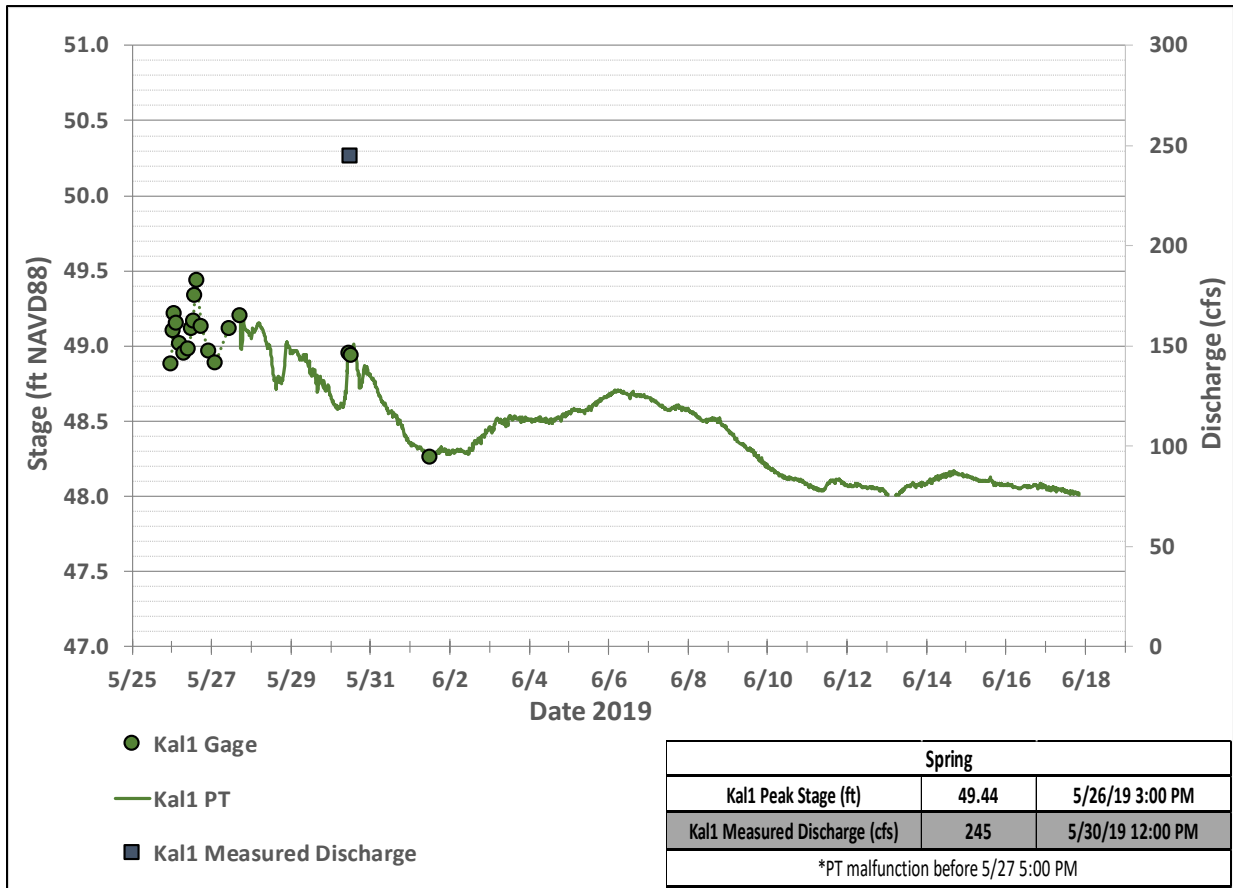
Graph 4.6: Kalikpik River at Kal1 Spring Breakup Stage & Discharge

Kalikpik River spring breakup stage and discharge data is provided in Graph 4.6. Detailed measured discharge data and plan and profile drawings are presented in Appendix C. Elevations are referenced to NAVD88.

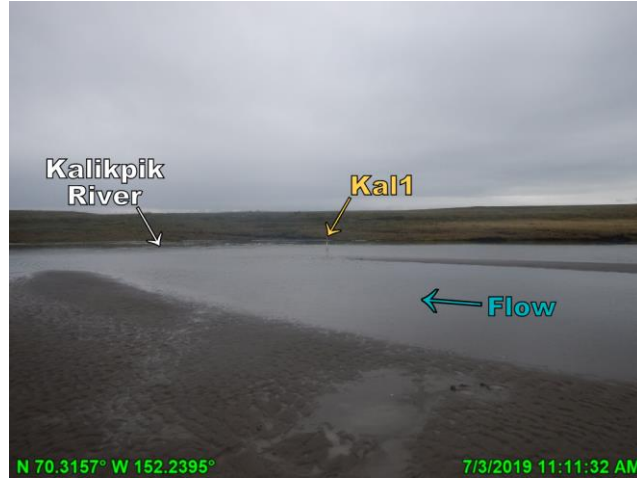
**Photo 4.21: Summer conditions near Kal1, looking north (downstream); July 3, 2019**

Stage fluctuations associated with summer precipitation were recorded in the summer stage data; water levels remained below spring breakup peak stage (Photo 4.21). The stage increase at the end of the summer monitoring period is associated with a late precipitation event. Summer stage at Kal1 gage site is presented in Graph 4.7.

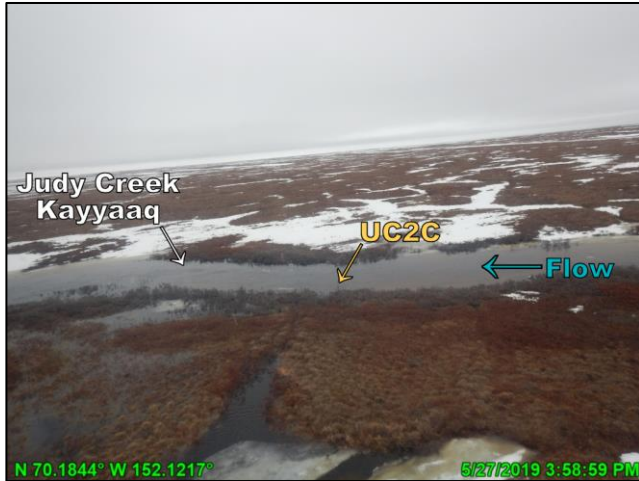
Photo 4.22: Minor overbank flooding at UC2C, looking north; May 27, 2019

Meltwater was first recorded on Judy Creek Kayyaaq at UC2C on May 20. Stage rise over the next week was characterized by cyclical periods of rapidly increasing stage, followed by prolonged periods of slight stage recession. Three such cycles accounted for the nearly 7-foot stage increase at UC2C from May 20 to May 27. Peak stage occurred on May 27, following a period of 1.5-foot stage increase over 6 hours. Aerial observations from May 27 revealed bankfull stage at UC2C, with minor overbank flooding in low-lying areas (Photo 4.22). Minimal snow was observed on the surrounding tundra, but submerged snow was present in the channel and along the banks (Photo 4.23). The appearance of bottom-fast channel ice was noted, but difficult to confirm due to the deep, incised channel. An ice road crossing on Judy Creek Kayyaaq downstream of UC2C was slotted and observed conveying flow (Photo 4.24).

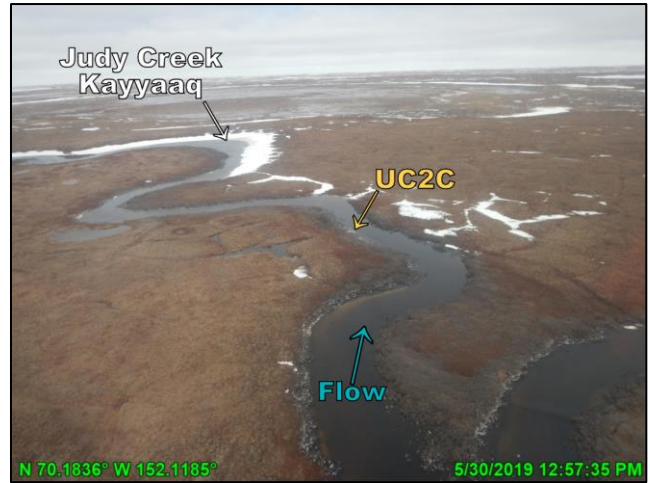
Photo 4.25: Conditions at UC2C after peak stage, looking northwest (downstream); May 30, 2019

Following peak stage on May 27, stage began to steadily recede at UC2C. On May 30, aerial observations show stage below bankfull and submerged snow present in the outer reaches of the channel (Photo 4.25). By June 1, stage had receded further and the snow coverage on the surrounding tundra was approximately 5 percent (Photo 4.26).

Discharge during spring breakup was measured using a tethered ADCP at the UC2C gage station on May 30, three days after peak stage. During the measurement, no ice was observed moving down the channel and flow was confined to the defined channel (Photo 4.25). The overall quality of the discharge measurement was classified as good. The moving bed measurement associated with UC2C was minimal and not included as a correction to the overall measurement.

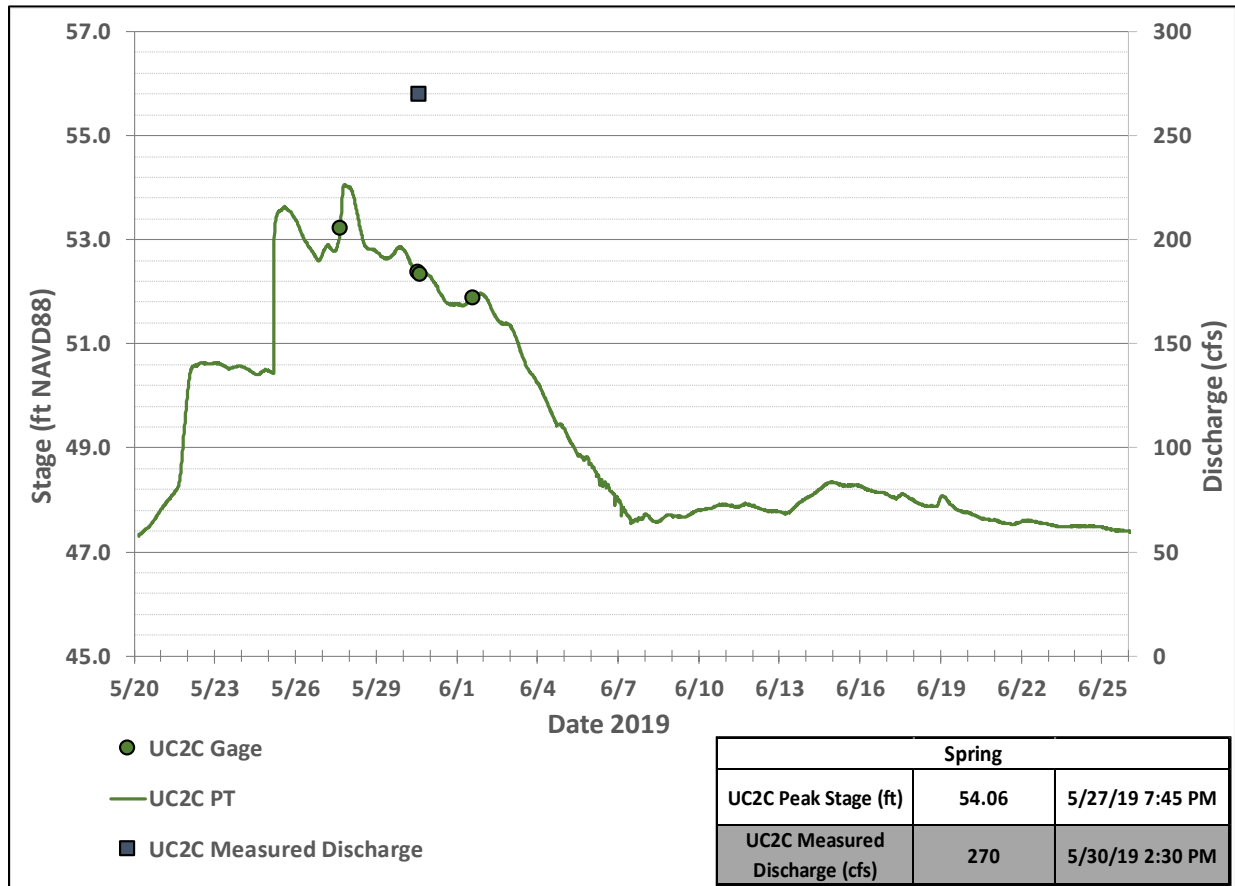
**Graph 4.8: Judy Creek Kayyaaq at UC2C Spring Breakup Stage & Discharge**

Judy Creek Kayyaaq UC2C spring breakup stage data is provided in Graph 4.8. Detailed measured discharge data and plan and profile drawings are presented in Appendix C. Elevations are referenced to NAVD88.

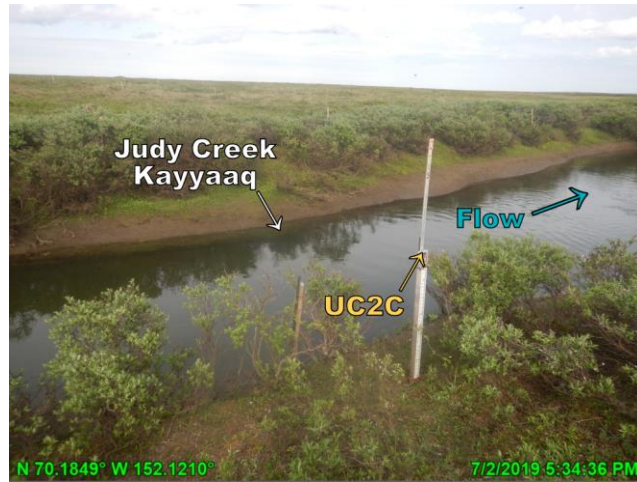
Photo 4.27: Summer conditions at UC2C, looking north (downstream); July 2, 2019

Stage fluctuations associated with summer precipitation were recorded in the PT data; water levels remained below spring breakup peak stage (Photo 4.27). The stage increase at the end of the summer monitoring period is associated with a late summer precipitation event. Summer stage in Judy Creek Kayyaaq at UC2C is presented in Graph 4.9.

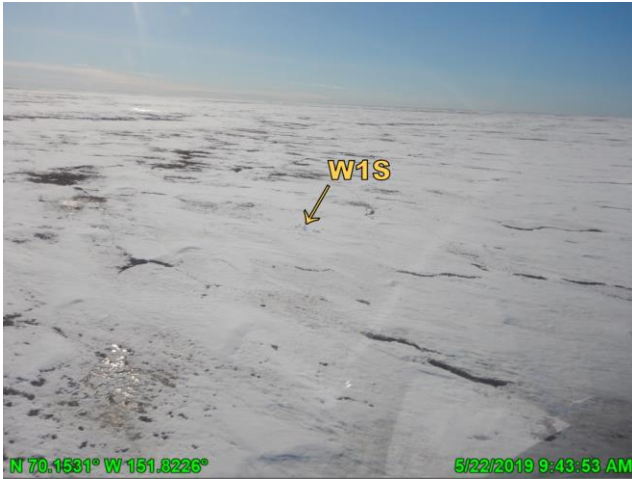
Photo 4.28: Initial meltwater at W1S, looking south; May 22, 2019

Aerial observations from May 22 show small, isolated pockets of meltwater in the Willow 1 drainage (Photo 4.28). Local meltwater was first observed ponding at the W1S gage station on May 25. Game camera footage from the following days show increasing meltwater and rising stage. Aerial observations from May 27 reveal widespread meltwater across the drainage area with no apparent channel or flow path (Photo 4.29). Saturated snow was present across the drainage, particularly around the gage station. Within the poorly defined drainage network, approximately 95 percent of the tundra was covered with meltwater or saturated snow, with only the highest portion of polygon crests remaining above water level.

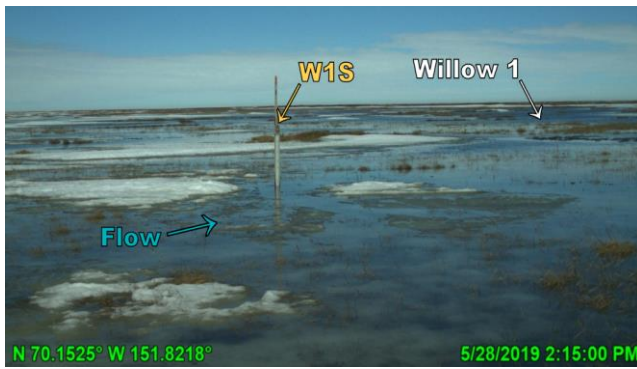
Photo 4.30: Game camera image of peak stage at W1S; May 28, 2019

Peak stage conditions occurred on May 28, based on measurements from game camera images. At peak stage, meltwater and saturated snow were still widespread across the drainage area (Photo 4.30). After peak, stage receded throughout the rest of the monitoring period. On May 30, widespread meltwater was still present in the drainage, but minimal saturated snow remained (Photo 4.31). Approximately 80 percent of the tundra was covered with meltwater. By June 3, game camera footage revealed no remaining saturated snow, and meltwater still ponding in low-lying areas.

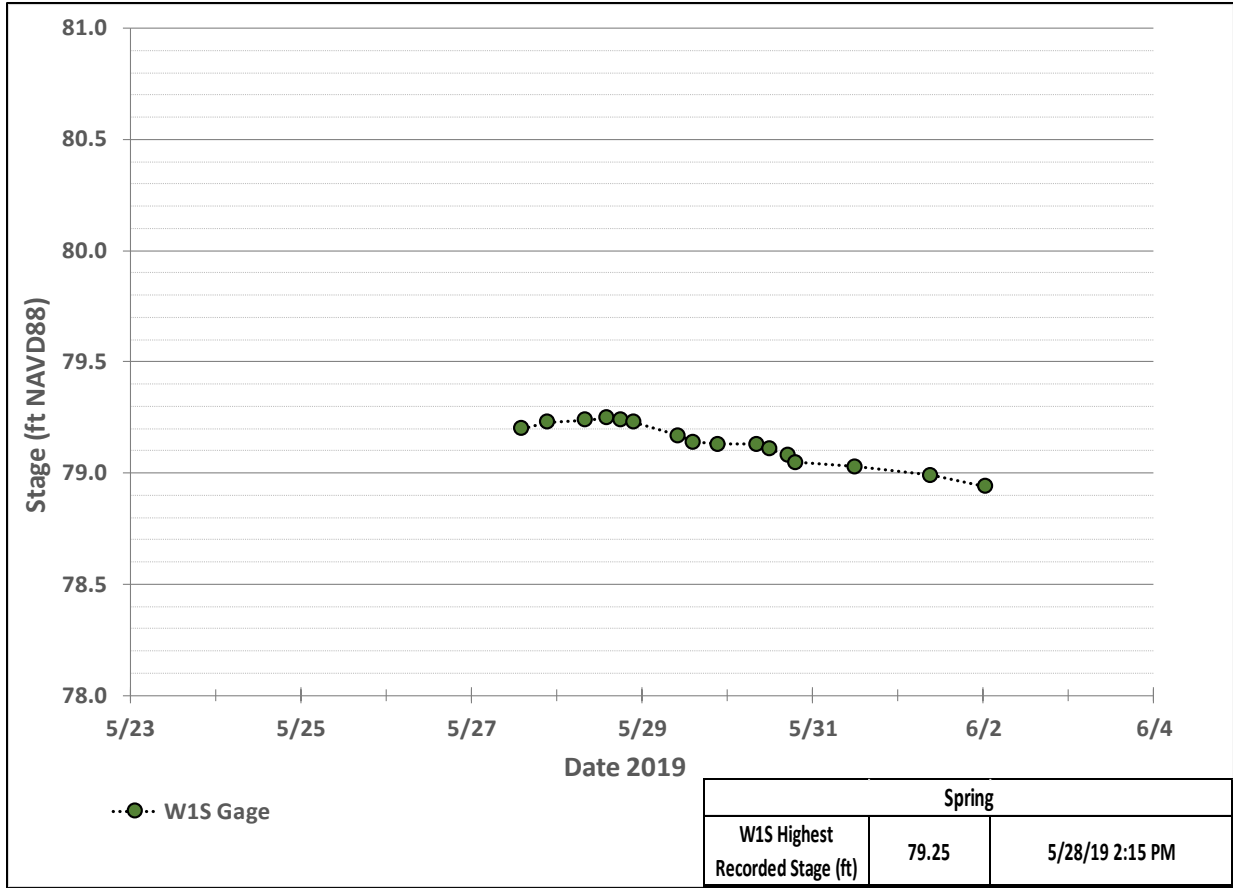
Graph 4.10: Willow 1 at W1S Spring Breakup Stage

Willow 1 at W1S spring breakup stage data is provided in Graph 4.10. Elevations are referenced to NAVD88.
