# 2019 Willow Spring Breakup & Summer Monitoring & Hydrological Assessment

Prepared for:

**ConocoPhillips**  
Alaska

MSA Contract No. 296937

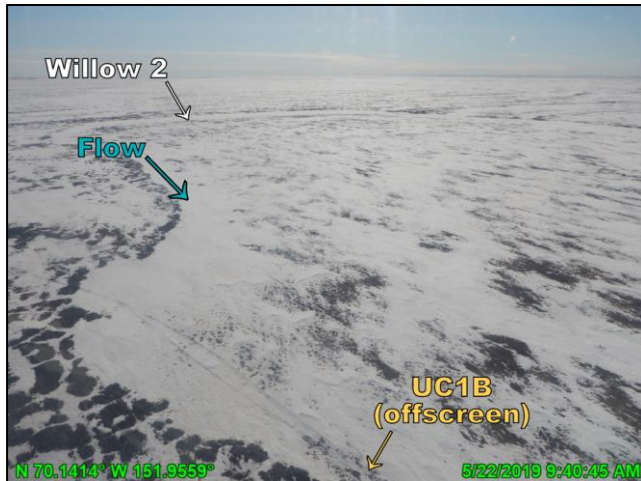
**Photo 4.32: Drifted snow in the Willow 2 drainage, looking south (upstream); May 22, 2019**

Willow 2 was filled with wind-driven snow at the onset of spring breakup. On May 22, isolated pockets of local melt were observed along the snow-filled channel. Snow cover on surrounding tundra was approximately 80 percent near the west bank of the Willow 2 drainage (Photo 4.32). The PT data indicates that stage increased approximately 6 feet in 48 hours from May 24 to May 26, elevated by saturated snow in the channel. Peak stage conditions were observed on May 26 at UC1B.

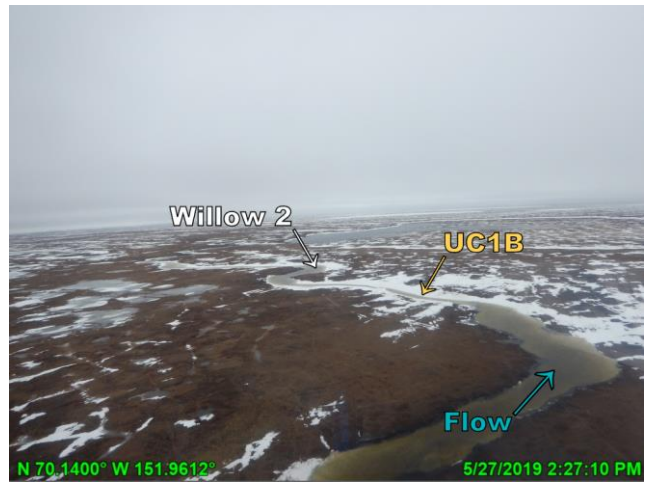
**Photo 4.33: Meltwater and saturated snow in Willow 2 near UC1B, looking northeast (downstream); May 27, 2019**

Aerial observations from May 27 show saturated snow in the channel and on the banks near UC1B. Meltwater was flowing over top of saturated snow, but stage remained below bankfull (Photo 4.33). The snow cover on the surrounding tundra was approximately 25 percent. No stranded ice or other evidence of overbank flooding was observed. After peak, stage receded quickly and dropped below the PT elevation on May 31. On June 1, observations revealed stage far below bankfull, with snow remaining along the banks overhanging the channel (Photo 4.34). Observations on June 2 revealed similar conditions to June 1 (Photo 4.35).

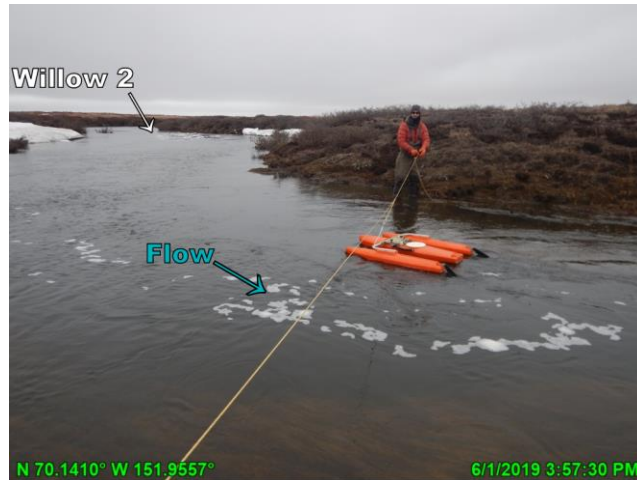
Photo 4.36: Crew conducting discharge measurements on Willow 2 near UC1B, looking south (upstream); June 1, 2019

Discharge was measured using a tethered ADCP near the UC1B gage station on June 1. During the measurement, saturated snow was present on the banks of the channel, and minimal snow remained in the channel (Photo 4.36). The quality of the measurement was classified as fair based on these conditions. This measurement coincided with a period of low stage. The moving bed measurement associated with UC1B was minimal and not included as a correction to the overall measurement.

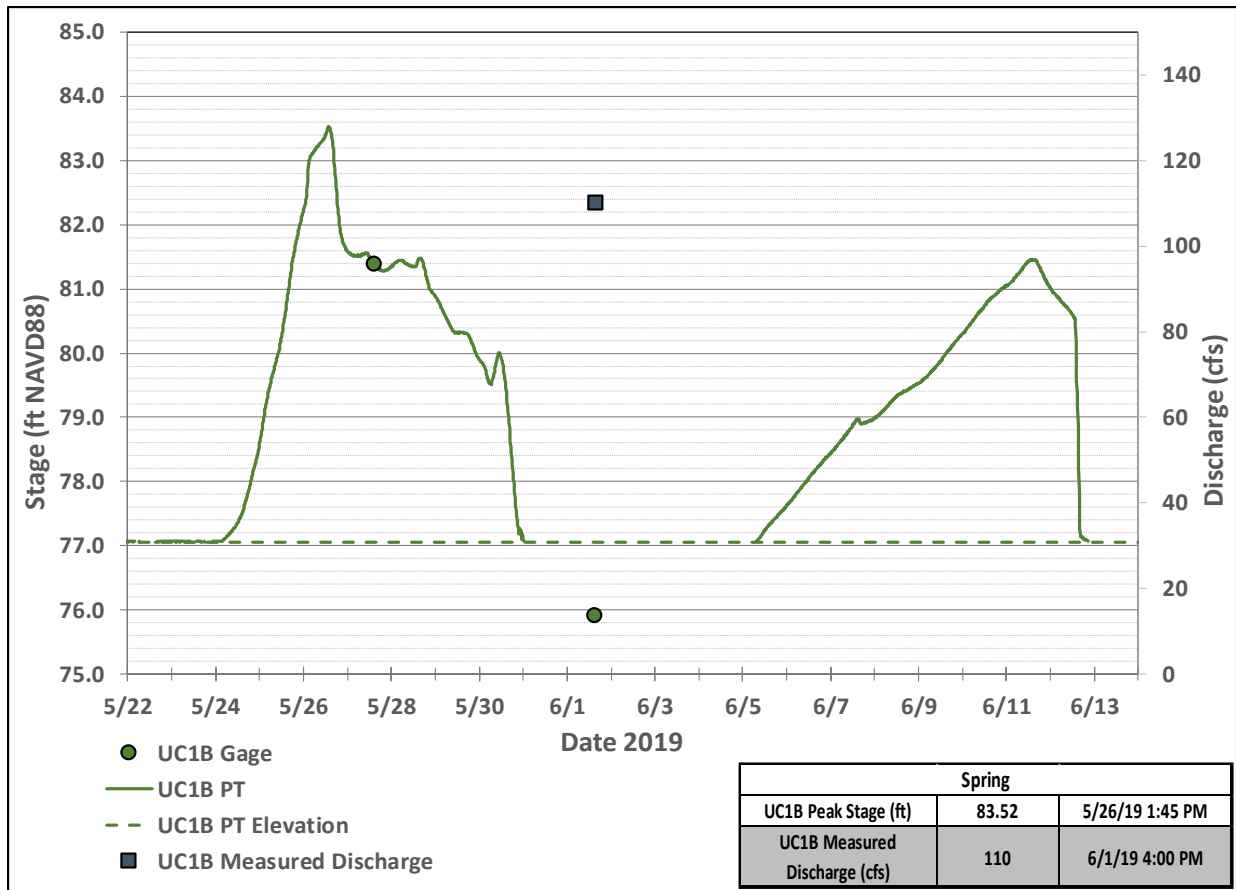
Graph 4.11: Willow 2 at UC1B Spring Breakup Stage & Discharge

Willow 2 at UC1B spring breakup stage data is provided in Graph 4.11. Detailed measured discharge data and plan and profile drawings are presented in Appendix C. Elevations are referenced to NAVD88.

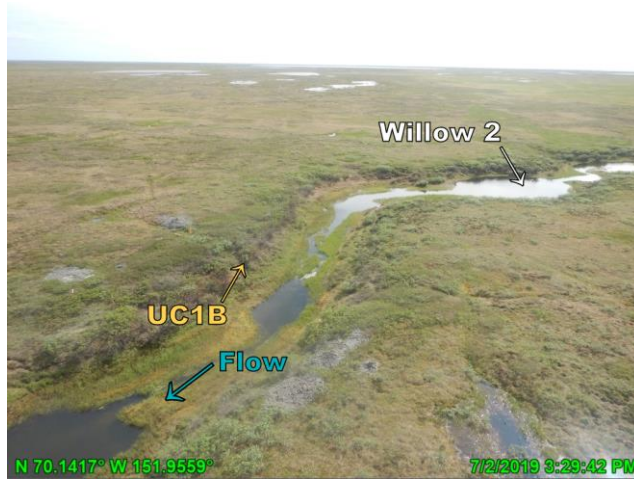
Photo 4.37: Summer conditions at UC1B, looking south (upstream); July 2, 2019

Summer stage was measured at UC1B. Stage fluctuations associated with summer precipitation events were recorded in the PT data; water levels remained below spring breakup peak stage at all locations (Photo 4.37). Summer stage in Willow 2 at UC1B is presented in Graph 4.12.

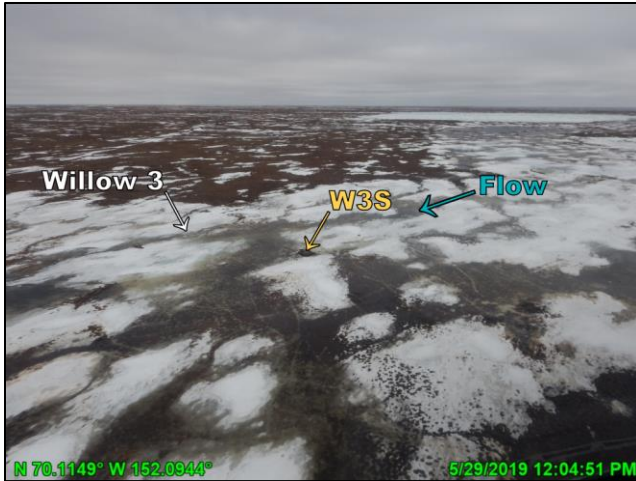
Photo 4.38: W3S drainage before peak stage, looking north (upstream); May 29, 2019

Local melt was first observed in the Willow 3 drainage on May 29. On this day, the PT was repositioned to better capture water levels at W3S. Aerial observations revealed widespread meltwater and saturated snow across the Willow 3 drainage. No defined drainage channel was apparent (Photo 4.38). Snow cover on the surrounding tundra was approximately 20 percent. Observations from May 30 revealed minimal change from conditions observed on May 29 (Photo 4.39). The PT data recorded small short-term fluctuations in stage and notably minimal overall stage gain and loss over the monitoring period. This minimal overall stage fluctuation is characteristic of poorly defined drainages in the region, as seen in Willow 3 at W3S and in Willow 1 at W1S.

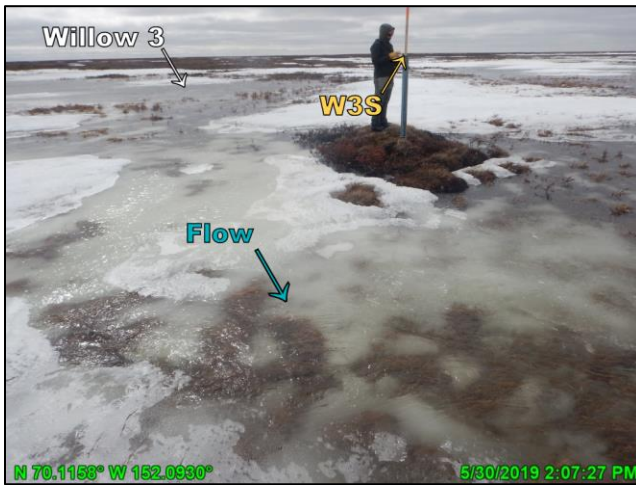
Photo 4.40: Snow in drainage during first discharge measurement on W3S, looking south (upstream); May 30, 2019

Discharge during spring breakup was measured twice at W3S using a HACH velocity meter attached to a wading rod. During the first measurement on May 30, snow and ice was present underneath flowing meltwater (Photo 4.40). The quality of the May 30 measurement was classified as poor based on the influence of ice and snow in the channel. The measurement on June 2 occurred after water had receded from peak stage and multiple flow paths had been established through the remaining snow. Some ice and snow remained in the flow paths and on the higher-situated tundra surrounding the flow paths (Photo 4.41). The quality of the measurement on June 2 was classified as fair based on these conditions.

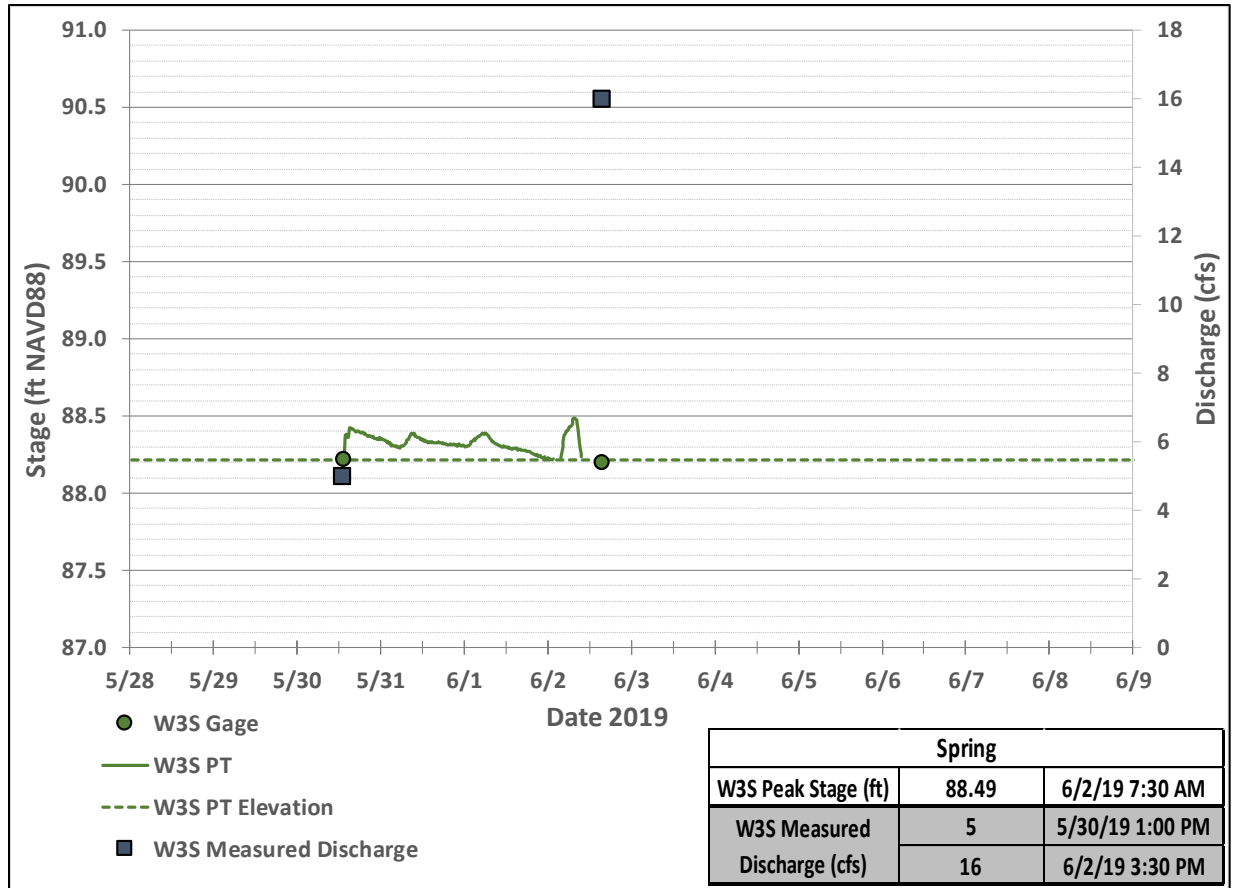
**Graph 4.13: Willow 3 at W3S Spring Breakup Stage and Discharge**

The W3S stage data is presented in Graph 4.13. Detailed measured discharge data and plan and profile drawings are presented in Appendix C. Elevations are referenced to NAVD88.

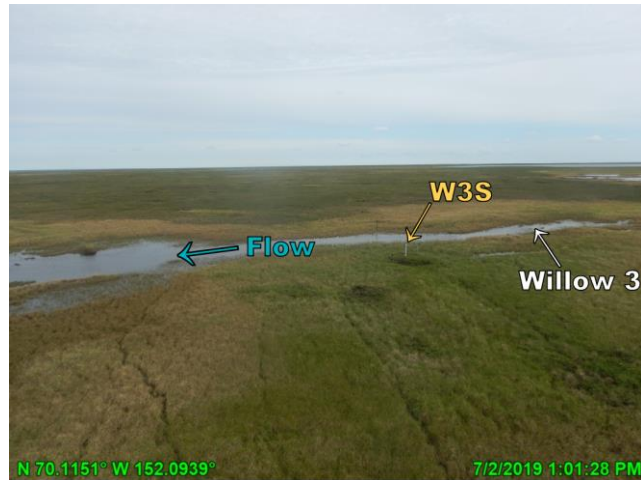
Photo 4.42: Summer conditions at W3S, looking north; July 2, 2019

Summer stage was measured at W3S. Minimal stage fluctuations associated with summer precipitation events were recorded in the PT data; water levels remained well below spring breakup peak stage (Photo 4.42). Low velocity flow through a poorly defined ephemeral channel was observed on July 2. Summer stage at W3S gage site is presented in Graph 4.14.

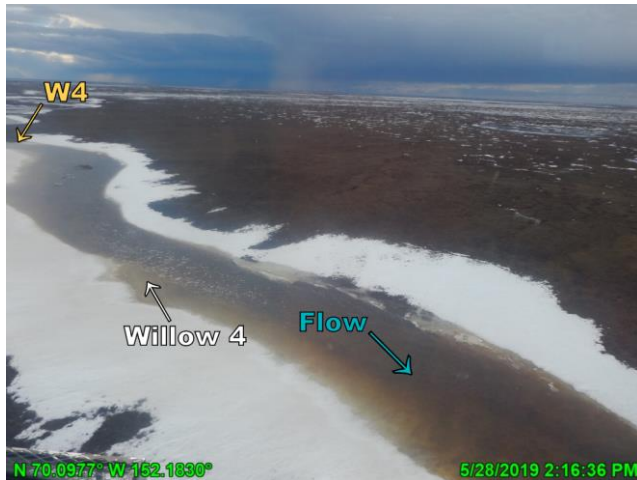
**Photo 4.43: Drifted snow in the Willow 4 drainage near W4, looking south (upstream); May 28, 2019**

Initial meltwater was first recorded on the Willow 4 PTs on May 21. Stage rose from May 21 to May 27 and was elevated by saturated snow in the channel and along the banks. Peak stage occurred at both Willow 4 monitoring locations on May 27. The upstream gage, W\_BS1, recorded peak stage about 3 hours prior to peak stage at the downstream gage, W4. Aerial observations from May 28 at W4 show meltwater flowing over the top of saturated snow in the channel and confined by drifted snow along the banks (Photo 4.43). At W\_BS1, the channel appeared clear of ice and snow, with drifted snow observed primarily along the north bank (Photo 4.44). Stage at both monitoring locations was below bankfull, and no evidence of overbank flooding from peak stage was observed.

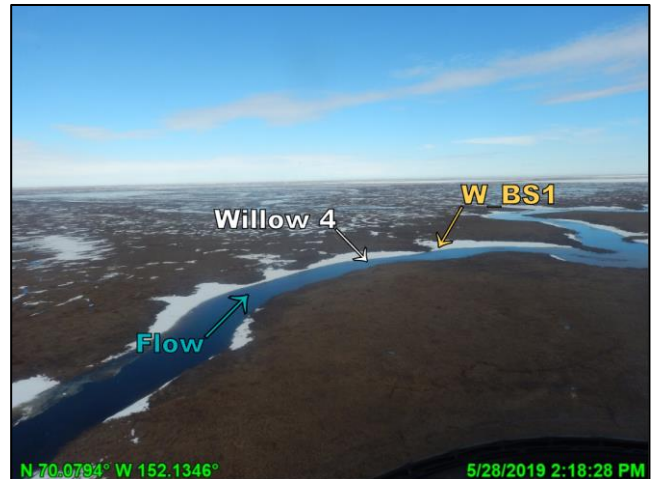
**Photo 4.44: Aerial observations of the Willow 4 drainage near W\_BS1, looking north (downstream); May 28, 2019**

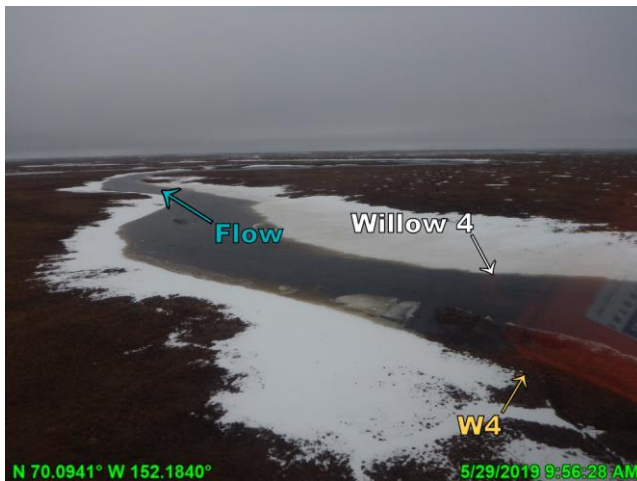
**Photo 4.45: Drifted snow remains in drainage near W4, looking north (downstream); May 29, 2019**

On May 29, observations at W4 revealed minimal change from conditions observed on May 28. Saturated snow was observed underneath meltwater across the entire channel with deep, drifted snow present along each bank (Photo 4.45). At W\_BS1, observations from May 30 show stage had decreased slightly from peak conditions, with snow still present along the east bank (Photo 4.46). By June 2, saturated snow had cleared from the channel at W4. Snow cover on the surrounding tundra was approximately 5 percent. Stage at each location decreased from peak conditions on May 29 to near low-flow summer conditions by June 12, based on PT data.

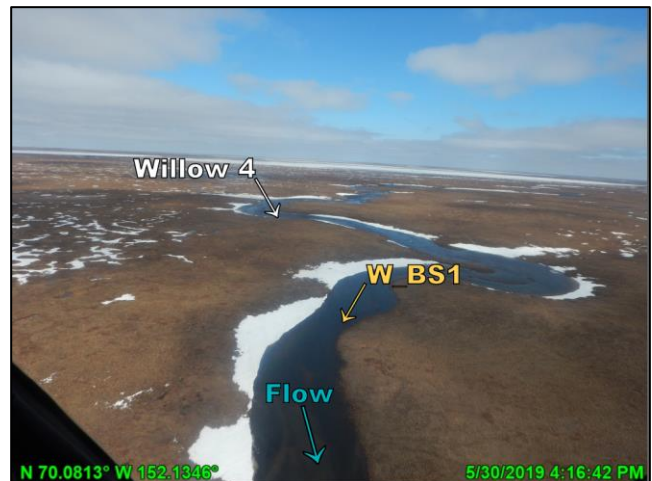
**Photo 4.46: Conditions near W\_BS1 four days after peak stage, looking east (upstream); May 30, 2019**

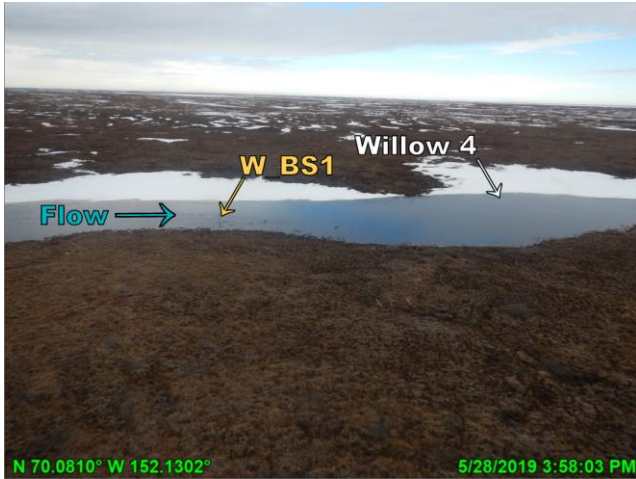
**Photo 4.47: Conditions at W\_BS1 during the discharge measurement, looking north; May 28, 2019**

Discharge during spring breakup was measured at both W4 and W\_BS1 using a tethered ADCP. Discharge at W\_BS1 was measured one day after peak stage on May 28 as the channel was mostly clear of ice and snow, with drifted snow present along the east bank (Photo 4.47). As a result, the quality of the May 28 measurement at W\_BS1 was classified as fair. Discharge was measured at W4 on June 2. By this day, stage had receded nearly 2 feet from peak conditions and saturated snow was present along each bank (Photo 4.48). As a result, the quality of the June 2 measurement at W4 was also classified as fair. Discharge at W\_BS1 will naturally be lower than W4 since it is upstream of the Willow 4A confluence.

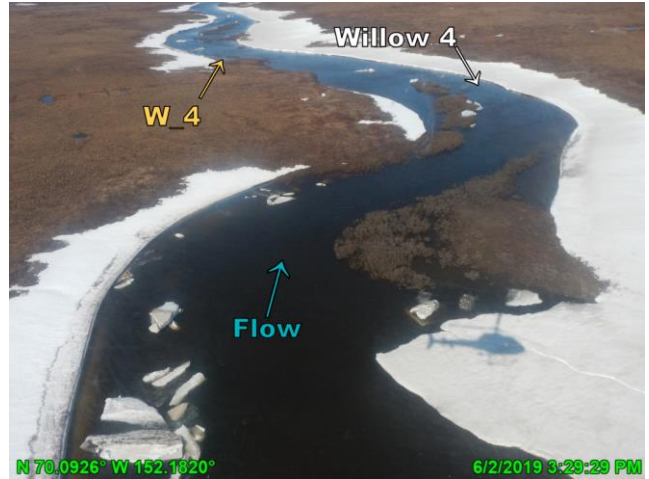
**Photo 4.48: Conditions at W4 during the discharge measurement, looking north (downstream); June 2, 2019**

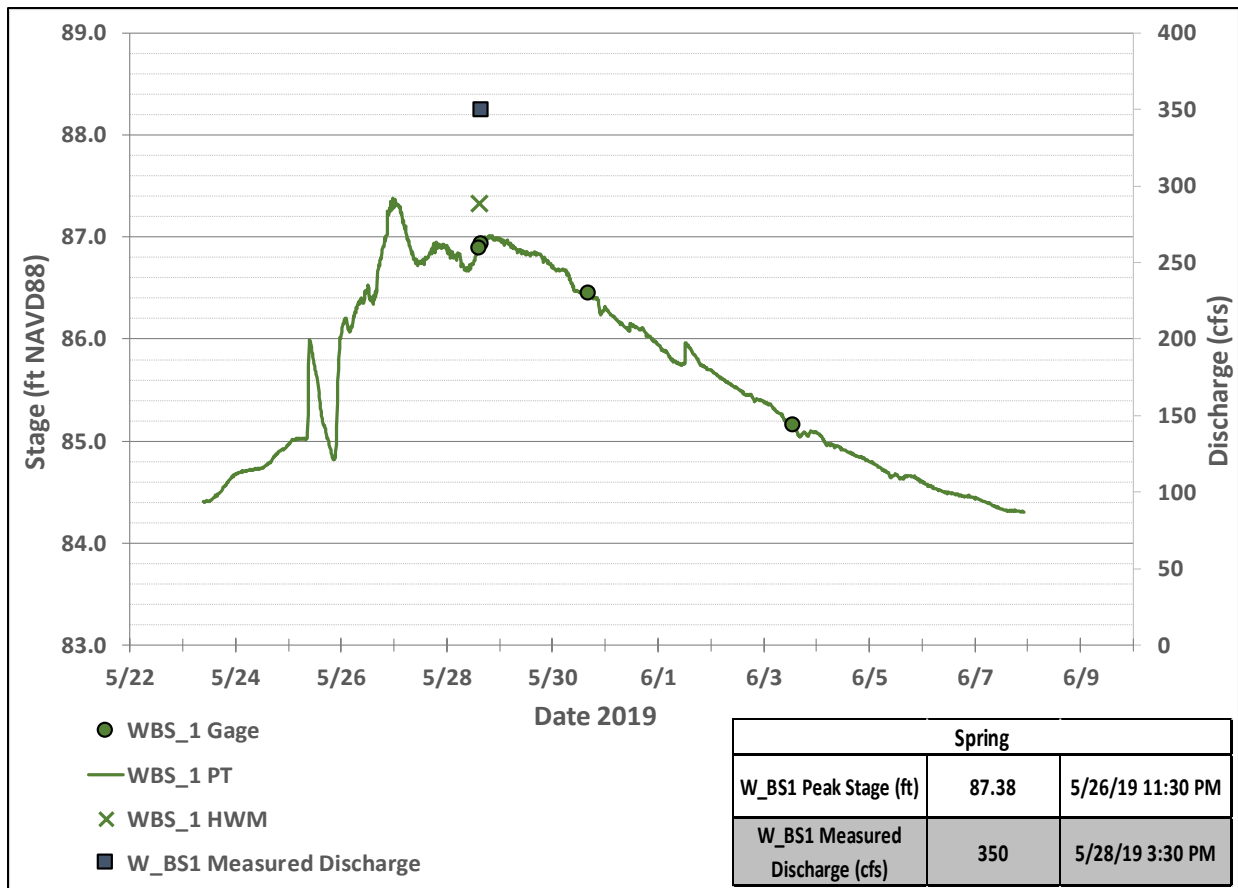
**Graph 4.15: Willow 4 At W\_BS1 Spring Breakup Stage & Discharge**

The W\_BS1 and W4 stage and measured discharge data are presented in Graph 4.15 and Graph 4.16, respectively. Measured discharge data and plan and profile figures are provided in Appendix C. Elevations at W\_BS1 are referenced to NAVD88. Elevations are referenced to an arbitrary datum based on a local control point.

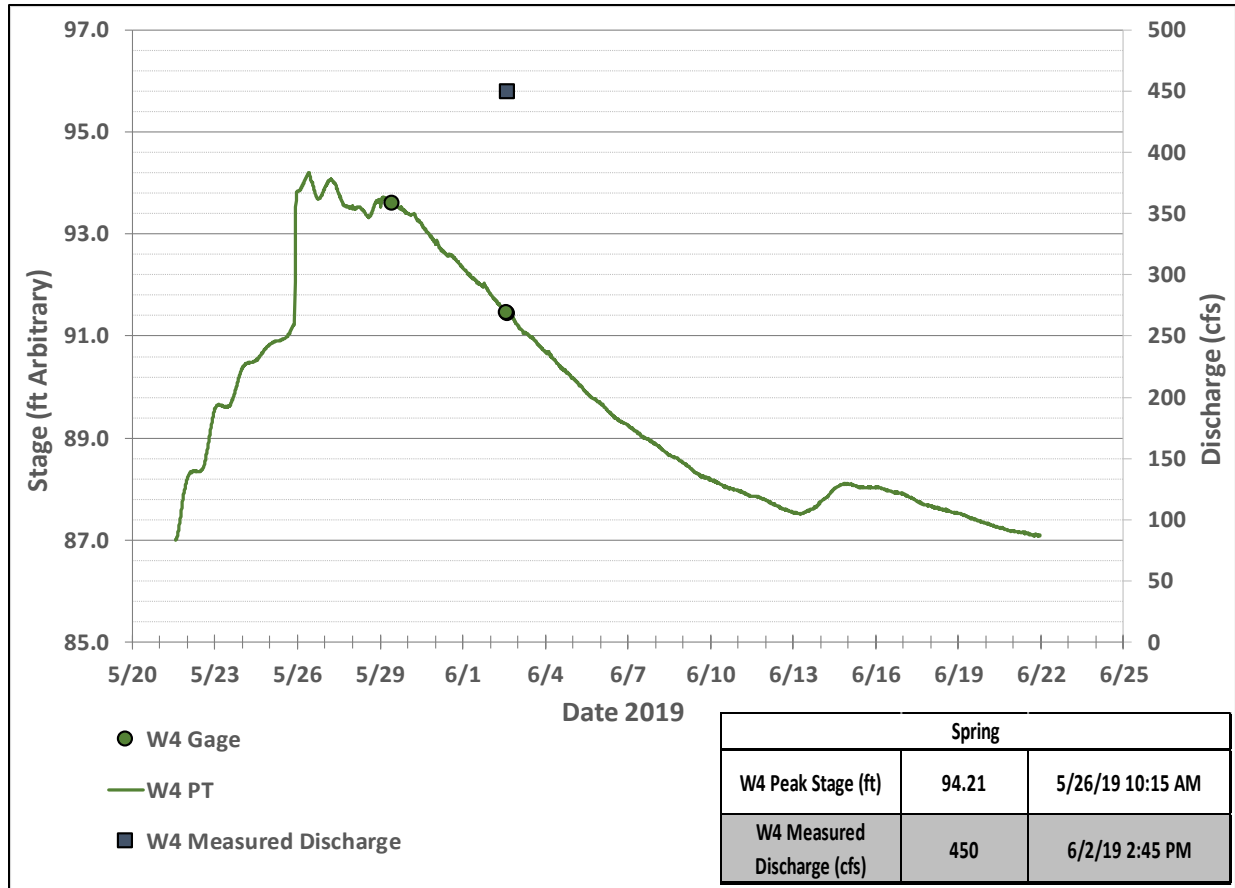
**Graph 4.16: Willow 4 At W4 Spring Breakup Stage & Discharge**

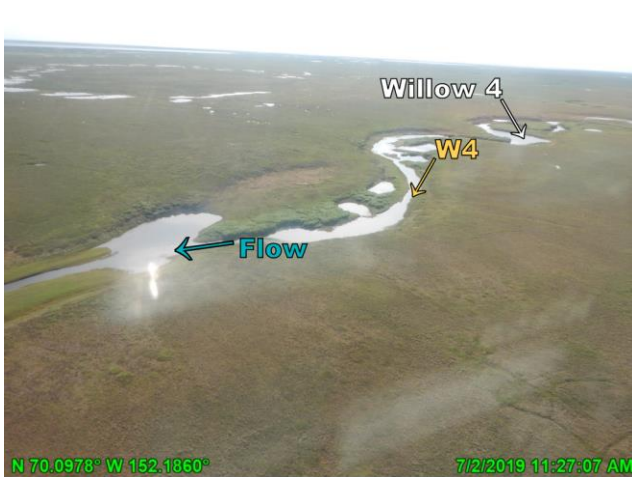
Photo 4.49: Summer conditions at W4, looking south (upstream); July 2, 2019

Summer stage was measured at both W\_BS1 and W\_4. Stage fluctuations associated with summer precipitation events were recorded in the data at each monitoring station; water levels remained below spring breakup peak stage (Photo 4.49 and Photo 4.50). The PT at W4 malfunctioned after July 31. During a late summer precipitation event, the W\_BS1 PT recorded a stage crest comparable to water levels observed near the end of spring breakup. Summer stage at W\_BS1 and W4 gage site is presented in Graph 4.17 and Graph 4.18, respectively.

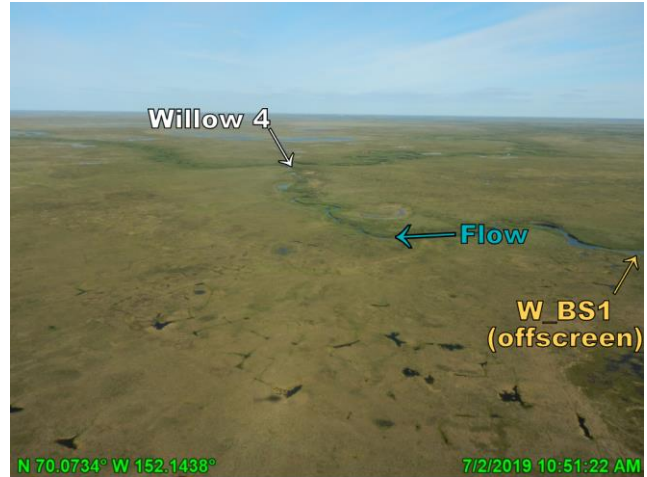
Photo 4.50: Summer conditions near W\_BS1, looking north (downstream); July 2, 2019

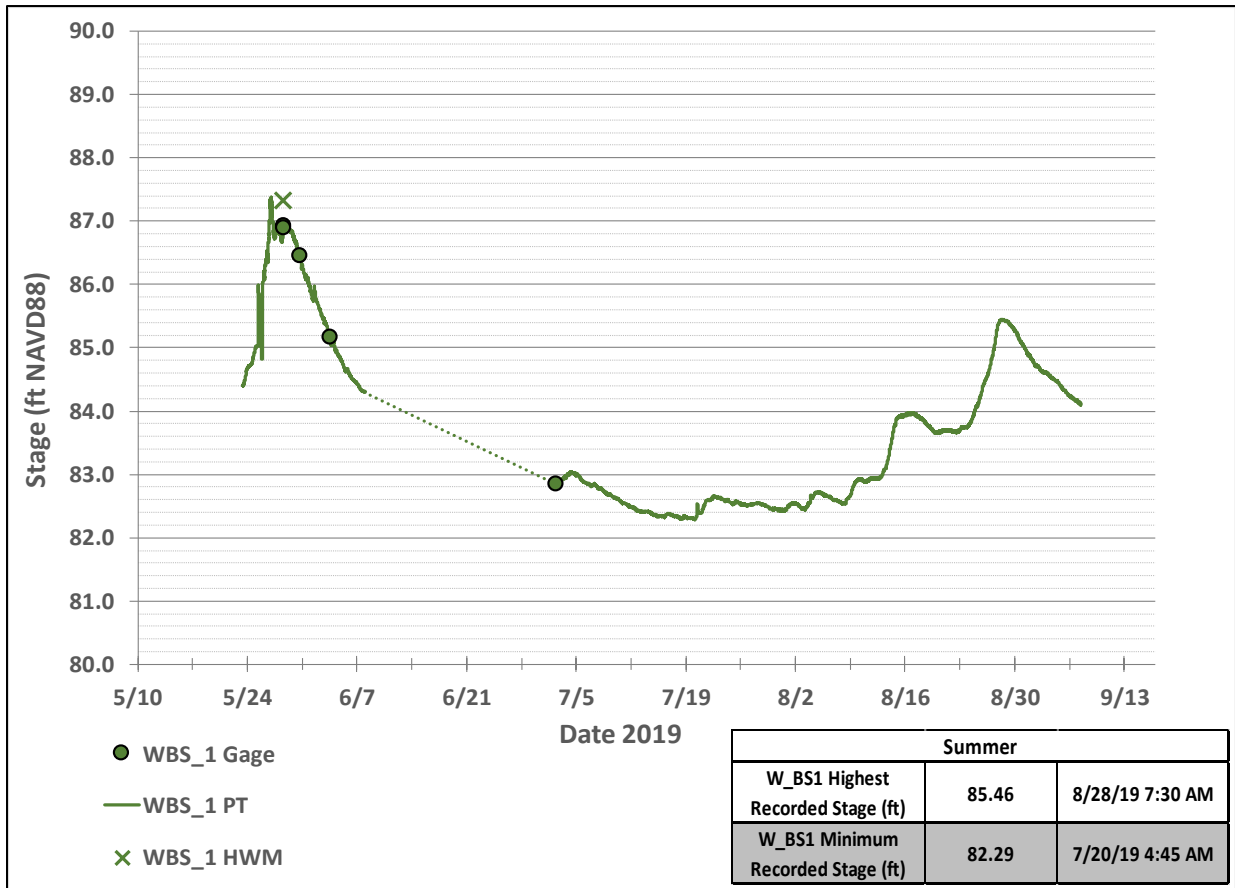
Graph 4.17: Willow 4 At W\_BS1 Summer Stage

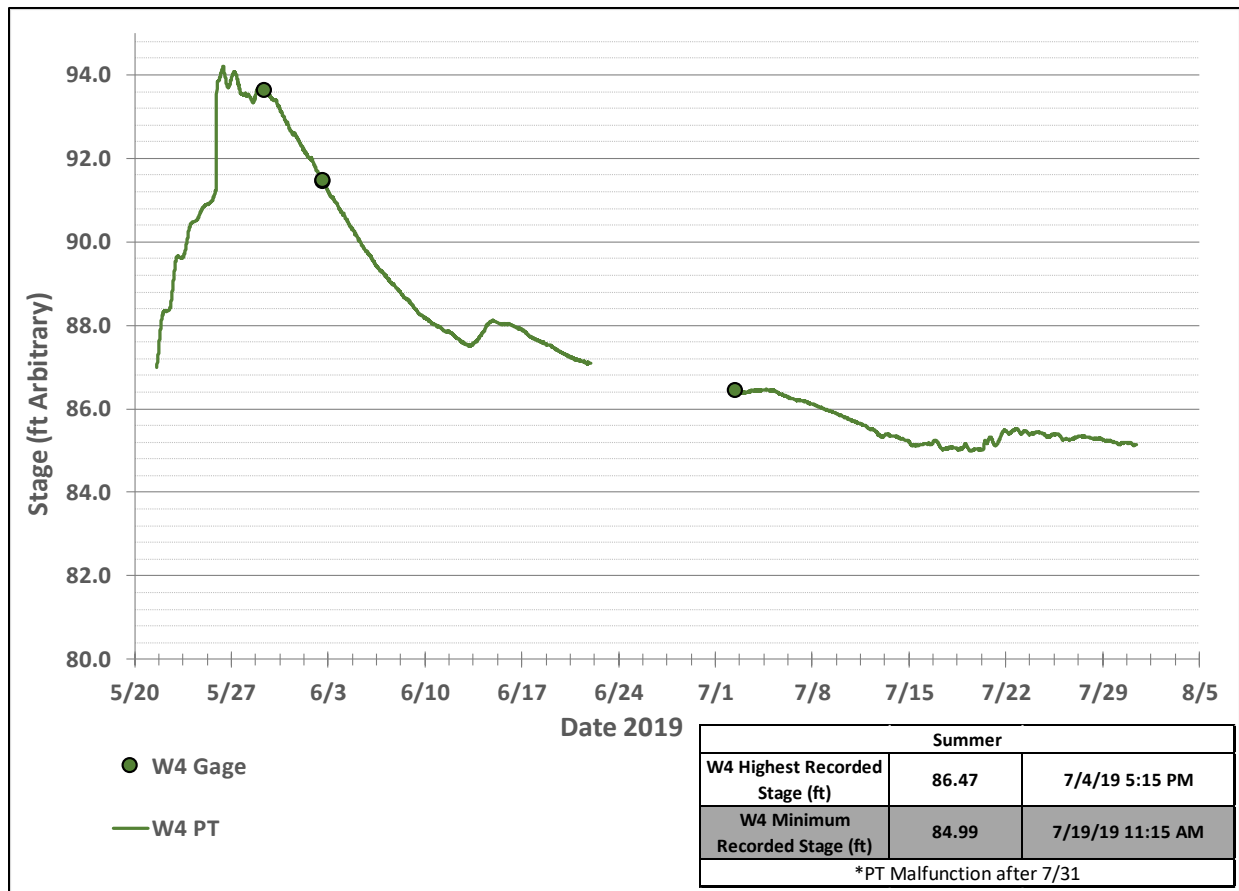
Graph 4.18: Willow 4 At W4 Summer Stage

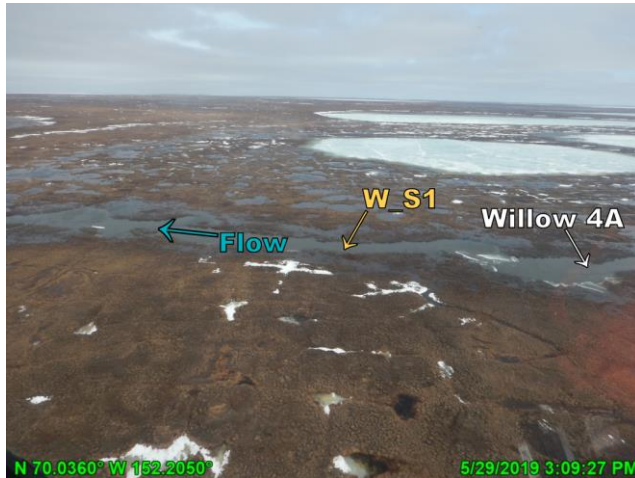
**Photo 4.51: Willow 4A drainage near W\_S1 two days after peak stage; looking east; May 29, 2019**

Initial meltwater at W\_S1 was recorded on May 22. PT data indicates stage rose until peak stage on May 27. Visual observations were first conducted on May 29, when stage had receded nearly 1-ft from peak stage. On May 29, aerial observations revealed stage above bankfull, with minor overbank flooding in low-lying areas and adjacent polygon troughs (Photo 4.51). Stranded ice was also noted above the reach of the bank (Photo 4.52). An ice jam

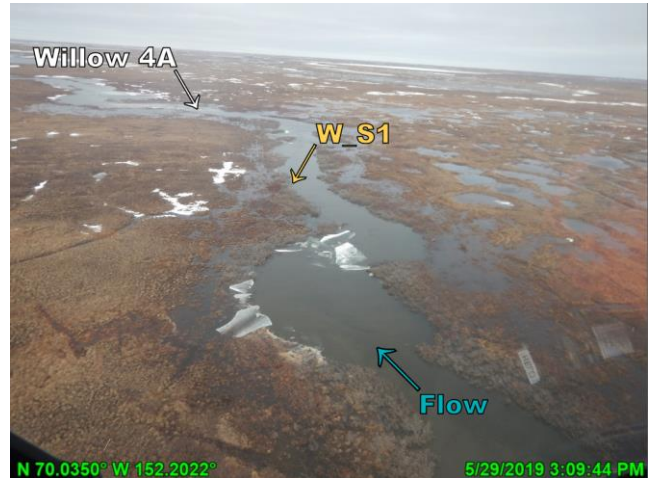
**Photo 4.52: Ice jam and stranded ice upstream of W\_S1, looking north (downstream); May 29, 2019**

had formed upstream of W\_S1 but did not appear to significantly impede flow through the area. Aerial photos suggest the presence of bottom-fast ice or saturated snow at the channel bottom.

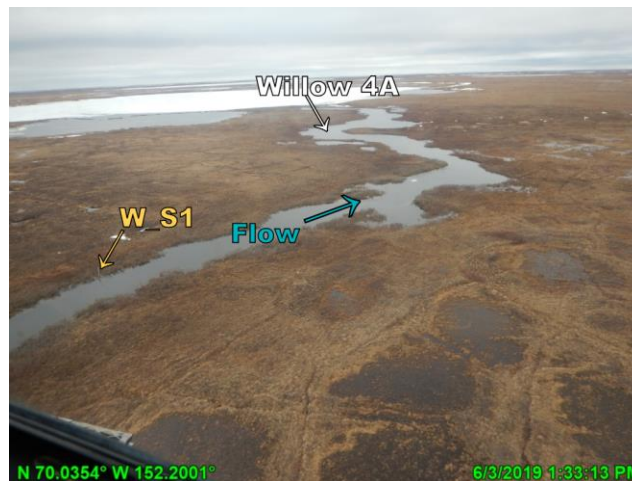
**Photo 4.53: Receding stage at W\_S1, looking north (downstream); June 3, 2019**

After peak stage on May 27, PT data indicated that stage receded but remained elevated to near bankfull levels through the end of the monitoring period. On June 3, stage was observed to be near bankfull, with minimal snow remaining in the channel and along the banks (Photo 4.53). Snow cover on the surrounding tundra was approximately 5%.

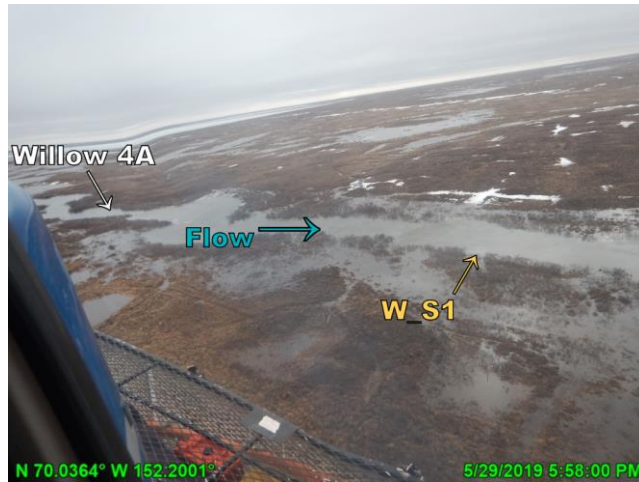
Photo 4.54: Discharge cross-section in Willow 4a near W\_S1, looking southwest (upstream); May 29, 2019

Discharge was measured using a tethered ADCP at W\_S1 on May 29, two days after peak stage. Overbank flooding was observed during the measurement, but most of the flow (over 95 percent) was confined to the channel (Photo 4.54). An ice jam located approximately 100-ft upstream of the discharge cross-section would periodically release ice through the measurement reach. The presence of bottom-fast ice was likely but ultimately inconclusive. Based on these factors, the overall quality of the discharge measurement was classified as fair.

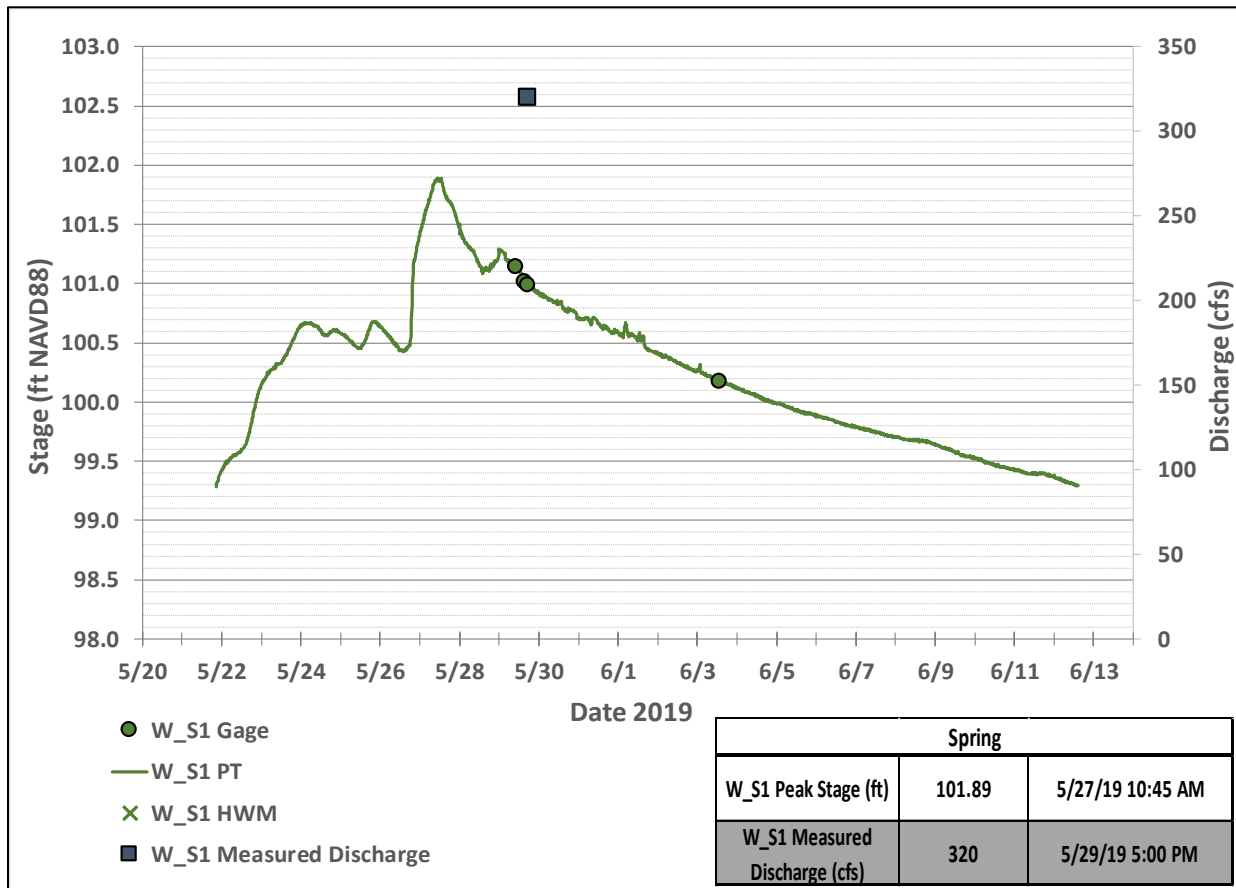
Graph 4.19: Willow 4a Stream W\_S1 Spring Breakup Stage & Discharge

The W\_S1 stage and measured discharge data are presented in Graph 4.19. Measured discharge data and plan and profile figures are provided in Appendix C. Elevations are referenced to NAVD88.

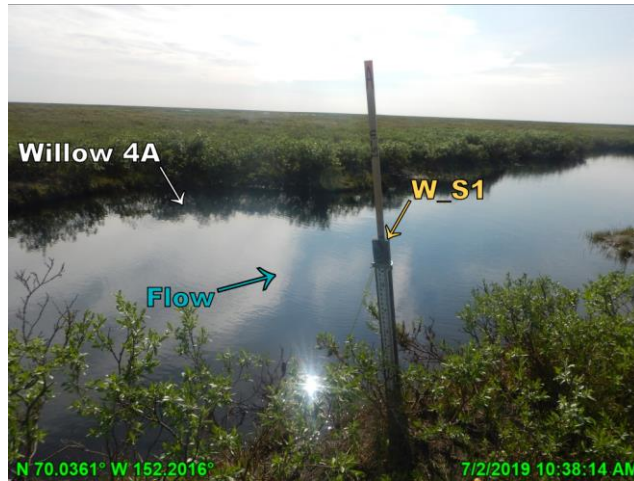
Photo 4.55: Summer conditions at W\_S1, looking east (downstream); July 2, 2019

Summer stage was measured at W\_S1. Stage fluctuations associated with summer precipitation events were recorded in the data; water levels remained well below spring breakup peak stage (Photo 4.55). The stage increase

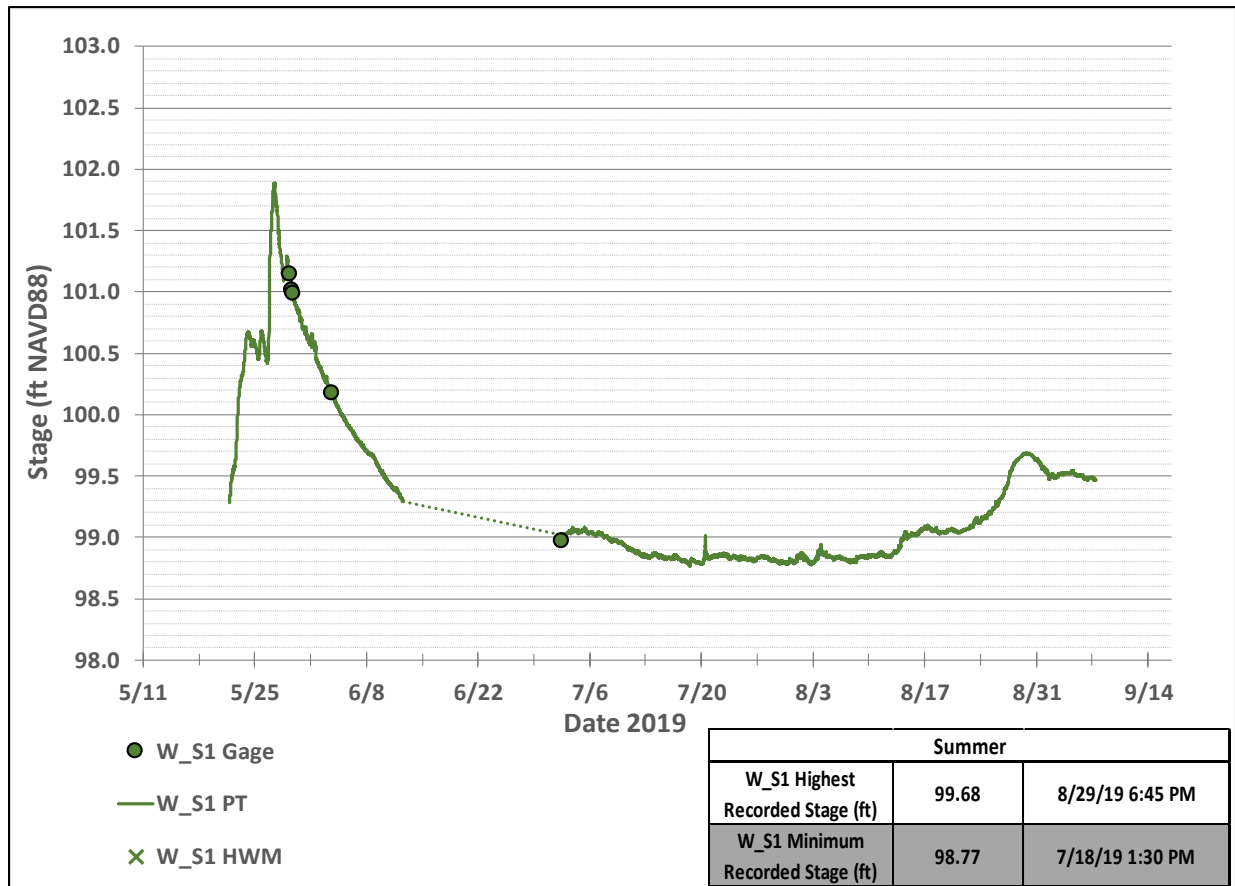
Graph 4.20: Willow 4a at W\_S1 Spring and Summer Stage

at the end of the summer monitoring period is associated with a notable precipitation event. Summer stage at W\_S1 gage site is presented in Graph 4.20.

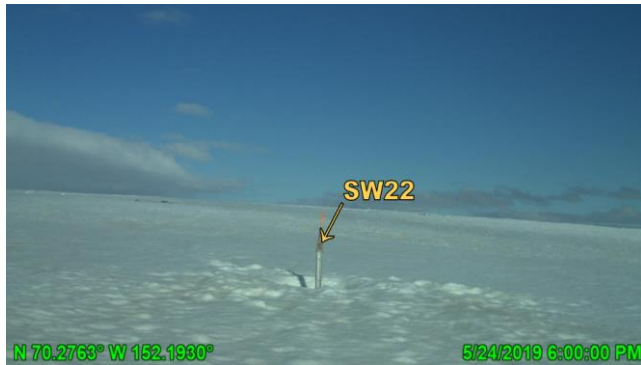
**Photo 4.56: Game camera image of Willow 8 at SW22, looking west; May 24, 2019**

Initial meltwater was recorded on both Willow 8 site PTs on May 22. At SW22, game camera images suggest this meltwater was localized and stage was elevated by drifted, saturated snow. As stage increased at SW22, images from the game camera show the area remained covered with snow. Any flow paths developed during this time were cut underneath drifted snow, and no visible flow was observed (Photo 4.56). Game camera images show this condition was maintained until June 7, when snow melt exposed flow paths previously concealed underneath drifted snow (Photo 4.57). It is noted that Willow 8 near SW22 has a wide area of possible flow paths due to low relief in the drainage, so data collected from the gage and game camera at SW22 may not capture the entirety of flow behavior through the reach.

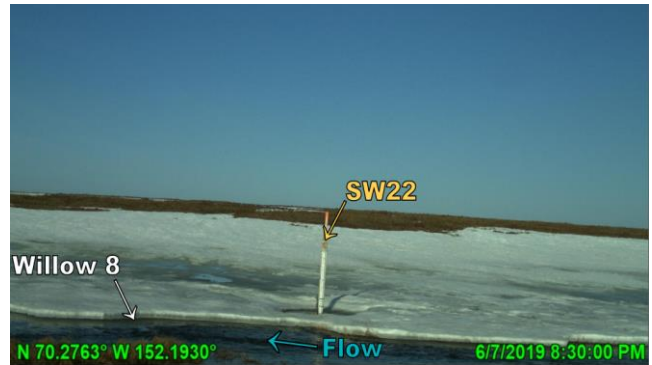
**Photo 4.57: Game camera image of Willow 8 at SW22 as first flow paths are revealed, looking north; June 7, 2019**

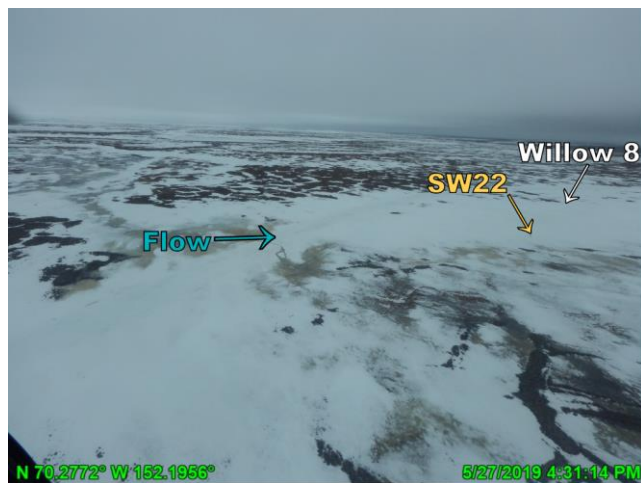
**Photo 4.58: Saturated snow in the Willow 8 drainage near SW22, looking southeast (upstream); May 27, 2019**

On May 27, aerial observations from SW22 show significant drifted snow remaining in the drainage area. A poorly defined flow path was visible from the air based on areas of dark, saturated snow (Photo 4.58). Minimal visible flow was observed as flow paths were cut underneath drifted snow. On June 1, conditions were similar to those observed on May 27 (Photo 4.59). An area of visible flow in Willow 8 was observed further upstream from SW22, but any flow around SW22 was confined underneath snow.

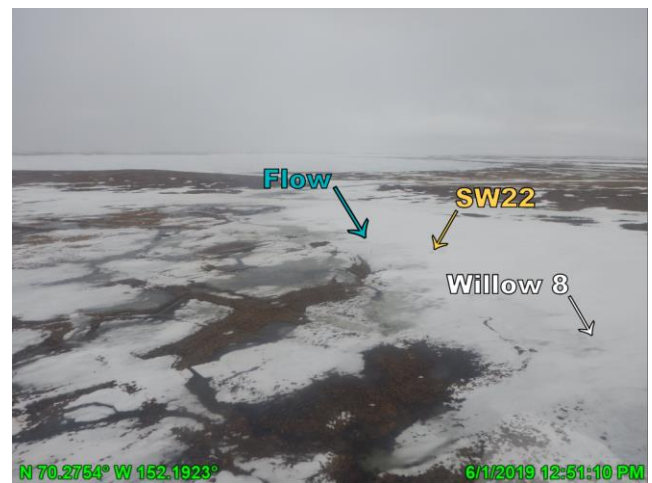
**Photo 4.59: Increasing meltwater in Willow 8 near SW22, looking north (upstream); June 1, 2019**

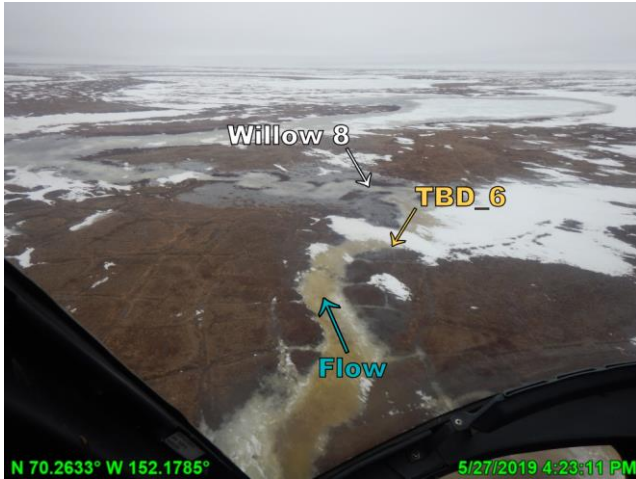
Photo 4.60: Willow 8 drainage near TBD\_6, two days before peak stage, looking west (downstream); May 27, 2019

At TBD\_6, stage increased from May 22 to May 27. On May 27, aerial observations revealed meltwater flowing over the top of saturated snow and bottom-fast ice (Photo 4.60). Stage was near bankfull, elevated by saturated snow in the channel and along the banks. A slotted ice road intersecting Willow 8 about 0.25 RMs downstream of TBD\_6 appeared to impede meltwater. Minor overbank flooding was observed upstream of this ice road, including near TBD\_6, and no overbank flooding was noted downstream of the road (Photo 4.61).

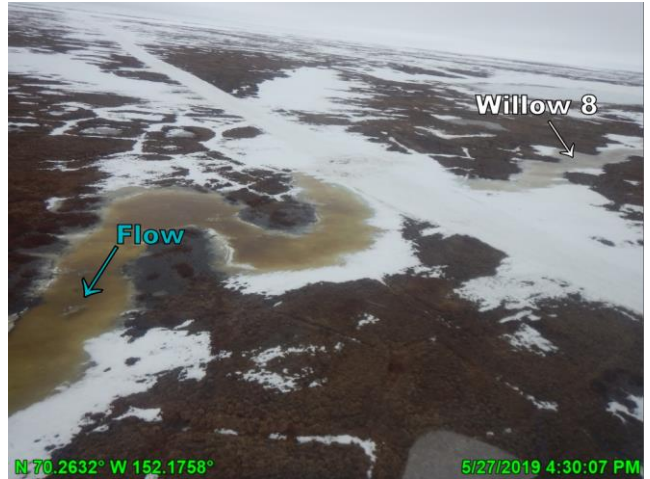
Photo 4.61: Ice road across Willow 8 downstream of TBD\_6, looking northeast (upstream); May 27, 2019

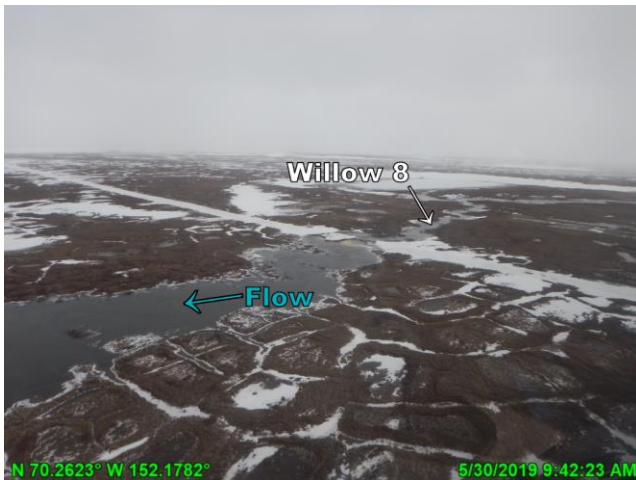
Photo 4.62: Bankfull stage in Willow 8, downstream of TBD\_6; looking northeast (upstream); May 30, 2019

The PT data at TBD\_6 indicates a general leveling of stage on May 27 and May 28, followed by a spike of nearly 1.5-ft in under 24 hours, culminating in peak stage conditions on May 29. After peaking, stage decreased at a rate of nearly 1-ft per day until June 1. This rapid stage recession is likely attributed to the disintegration of the nearby ice road, allowing meltwater to pass with decreasing impedance. On May 30, aerial observations show overbank flooding in low-lying areas upstream of the ice road, and bankfull conditions downstream of the ice road (Photo 4.62). Saturated snow and bottom-fast ice were observed in the channel near the ice road (Photo 4.63). By June 1, stage had receded to bankfull at TBD\_6, and the natural drainage path was now unimpeded from the disintegrating ice road. The snow cover on the surrounding tundra was approximately 5 percent (Photo 4.64).

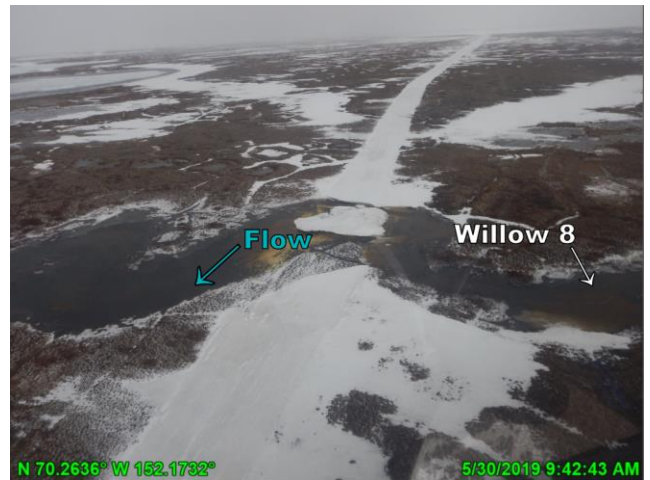
Photo 4.63: Ice road crossing in Willow 8, looking north; May 30, 2019

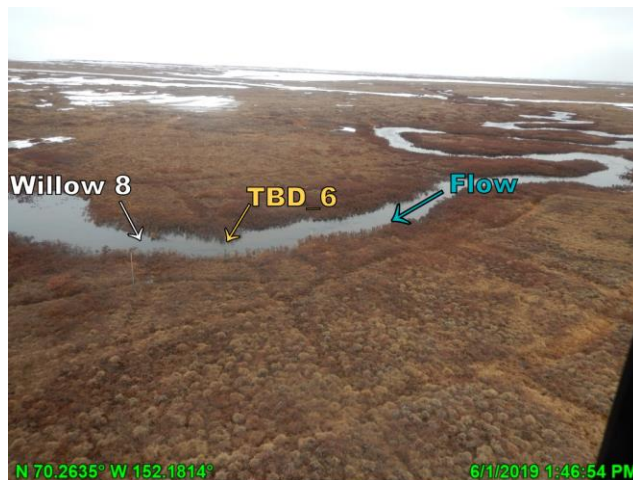
Photo 4.64: Open channel conditions at TBD\_6, looking northeast (upstream); June 1, 2019

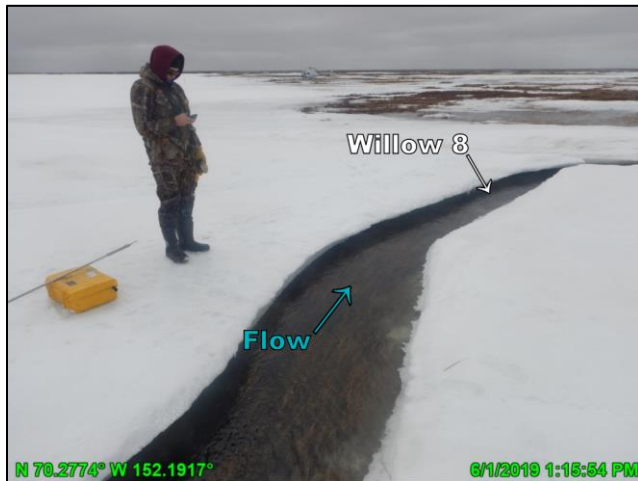
**Photo 4.65: Discharge cross-section in Willow 8 near SW22, looking south (downstream); June 1, 2019**

Discharge was measured using a tethered ADCP at TBD\_6 on May 30 and using a HACH velocity meter attached to a wading rod at SW22 on June 1. At SW22, an exposed flow path, surrounded by drifted snow, was observed and measured upstream of the gage site (Photo 4.65). The topography of the area suggests this flow path did not capture the entirety of flow through Willow 8 as the presence of additional flow paths underneath drifted snow was likely. The quality of the measurement was classified as poor based on the inherent uncertainty of drainage patterns at this location. At TBD\_6, discharge was measured about 0.4 RM downstream of the gage station, directly downstream of the degrading ice road, as minimal snow remained in the channel and along the banks at this location. Minor overbank flooding was noted during the measurement and the reach was clear of ice (Photo 4.66). The quality of the measurement was classified as fair based primarily on the minor overbank flooding.
